DAY OF WEEK DATE	Thursday February 27, 2025	PROJECT #	25RN-0060
PROJECT	Livingston Lakes - Painting		
LOCATION	15090 Palmer Lake Circle, Naples, FL 34109		
CONTRACTOR	A.M. Prestige Painting, Inc.	OWNER	Livingston Lakes Condominium Association, Inc.
WEATHER	Sunny	Temp	71°
		Time	9:00 am
PRESENT AT SITE	A.M. Prestige Crew (AMP)		
	Anthony DiNardo – Karins Engineering (KE)

Field Report #1

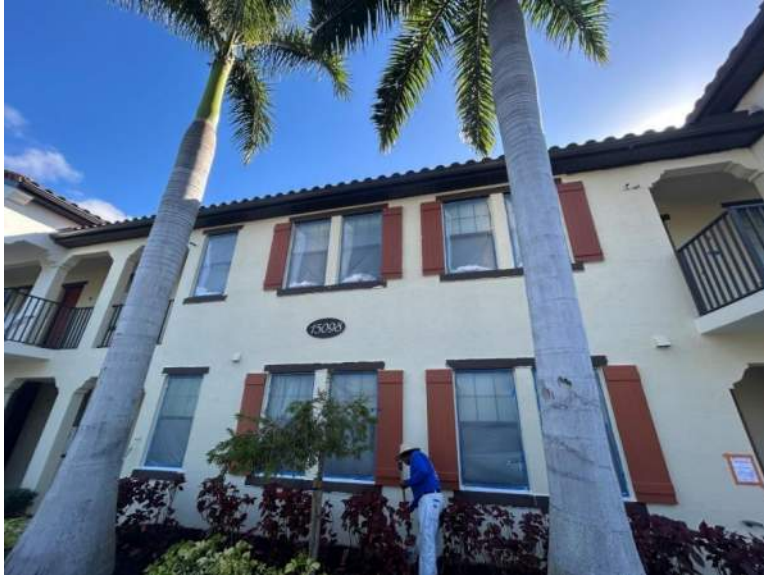
Figure 1: Installation of plastic was completed over all windows to protect from paint application.

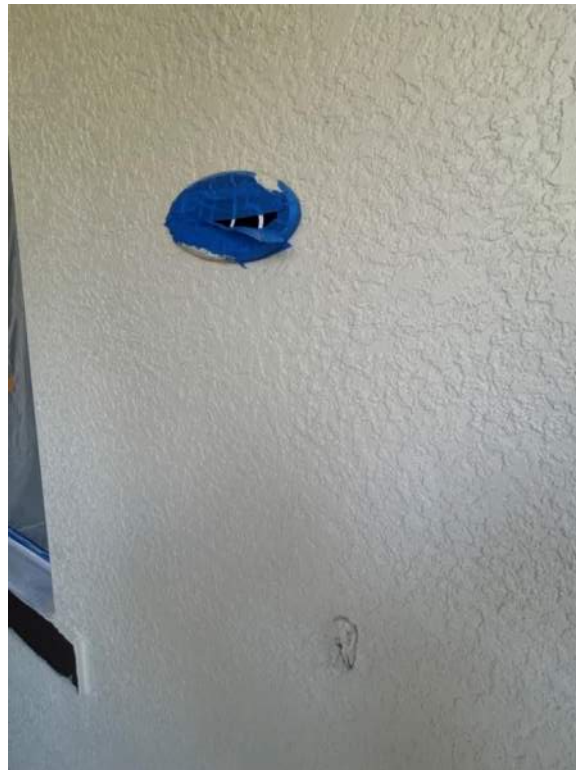
Figure 2: Installation of blue tape was completed around signs and details on the walls to protect from paint application.

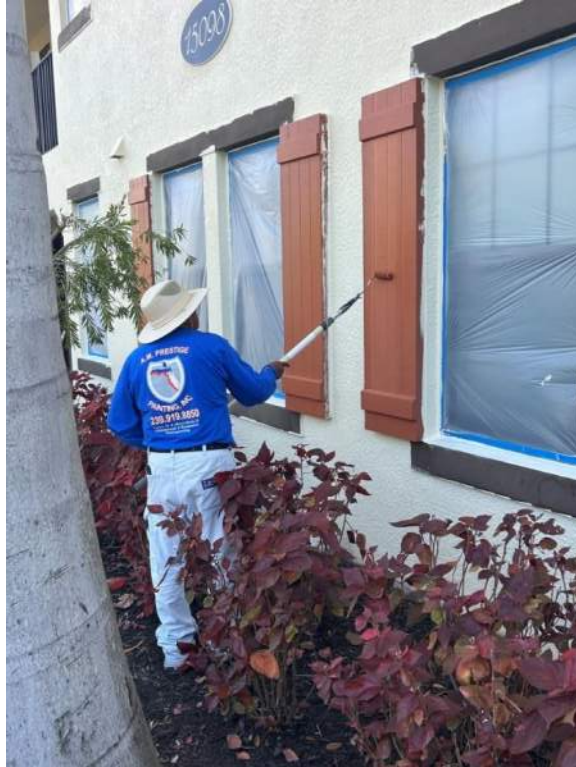
Figure 3: Roller paint application was in progress on the red details on each side of the windows.

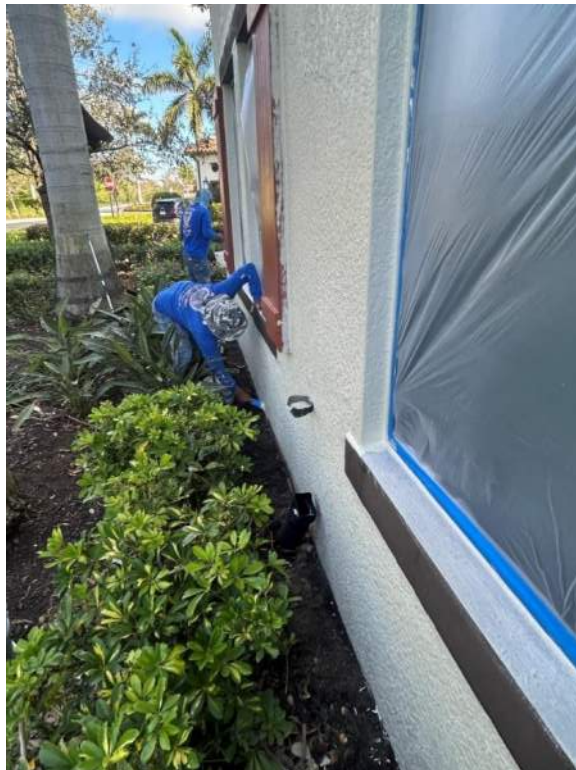
Figure 4: Cut-in paint application with brush was in progress on the west side exterior wall of the building.

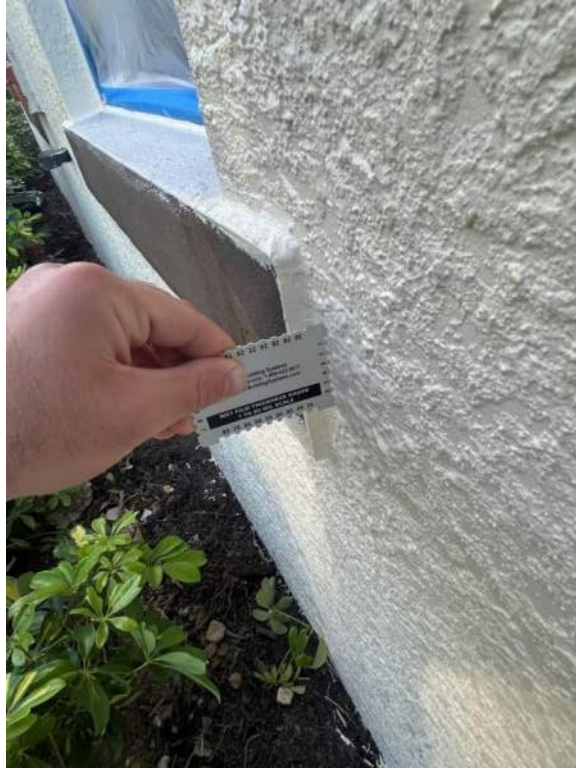
Figure 5: Wet film thickness test was completed for areas of ongoing paint application. Adequate mils was met according to specifications.

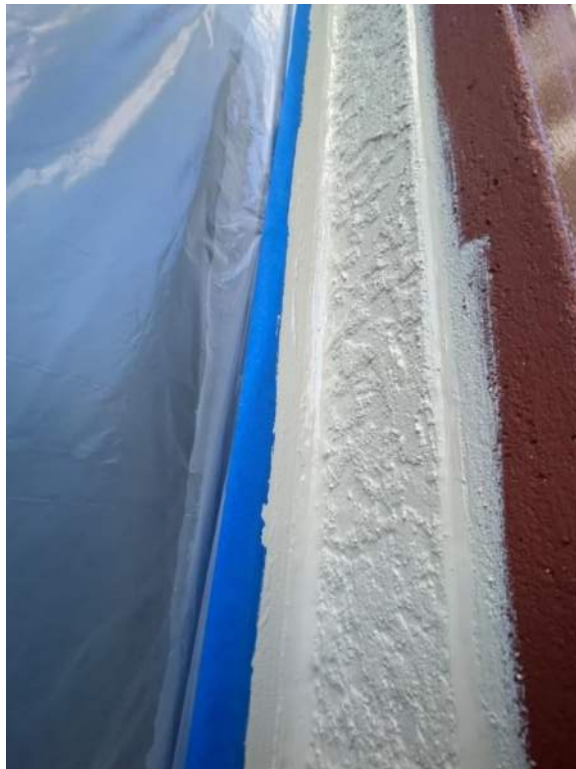
Figure 6: Stucco to metal sealant application was completed on the perimeter of all windows.

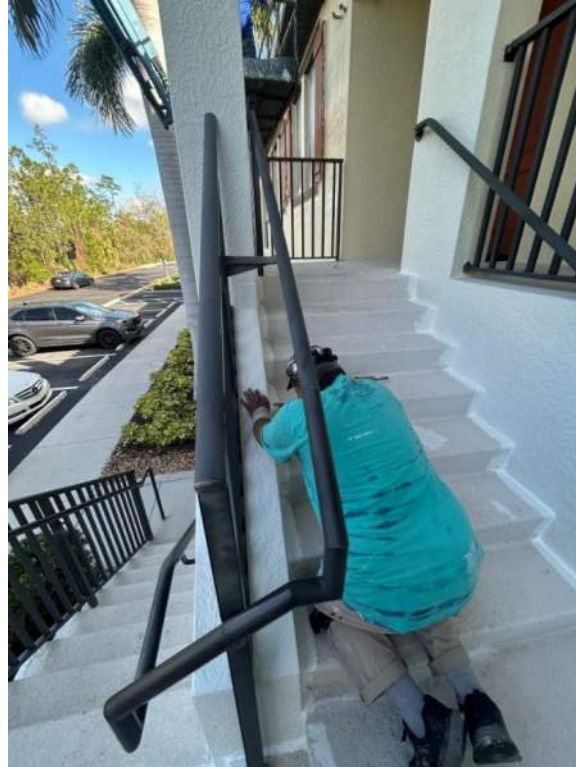
Figure 7: Stucco to stucco sealant application was in progress from the treads/risers to the wall of the south side staircase in front of the building.

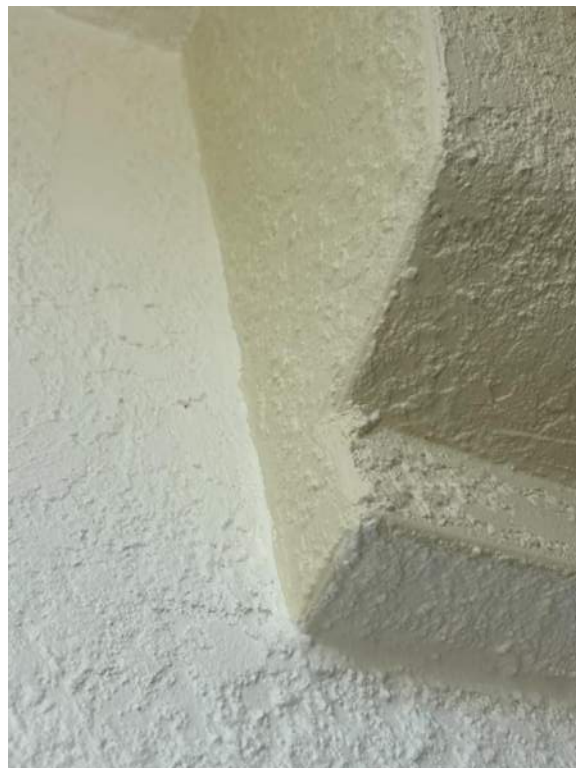
Figure 8: Stucco to stucco sealant application was completed around all corners and decorative bands.

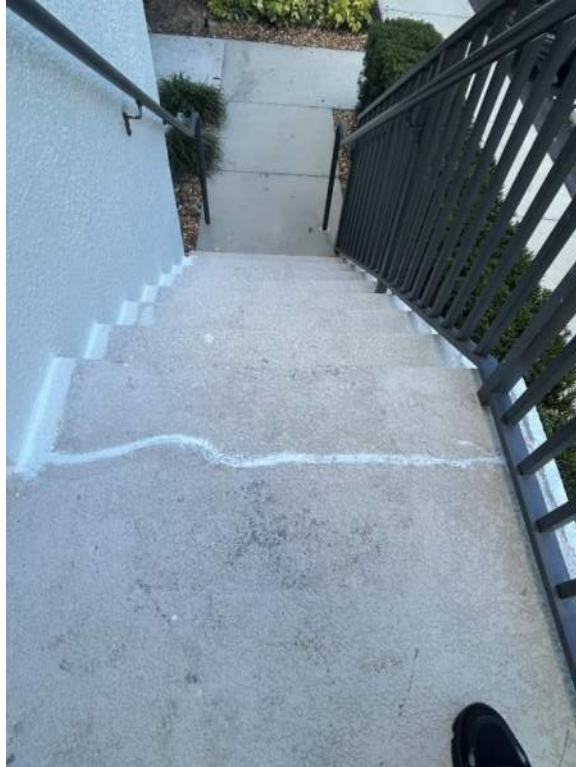
Figure 9: Crack repair was observed on the level 1 stair landings of both staircases in front of the building.

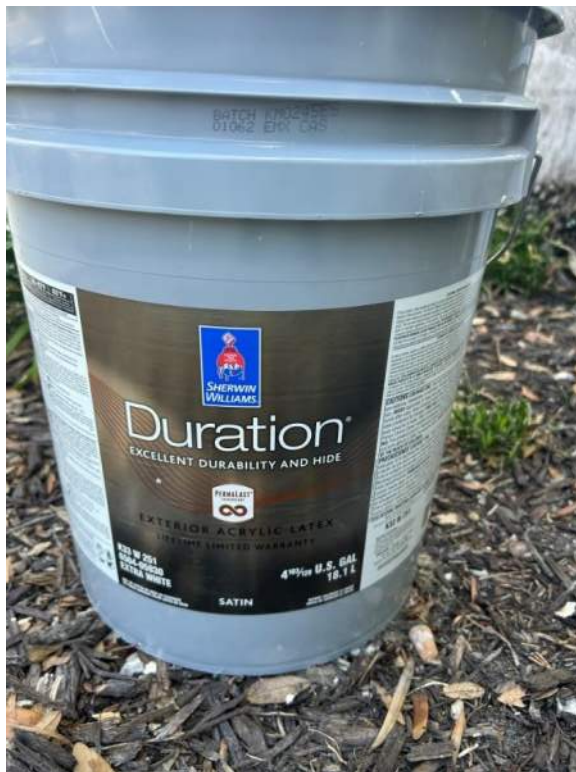
Figure 10: Duration exterior acrylic latex paint was observed on site for application.

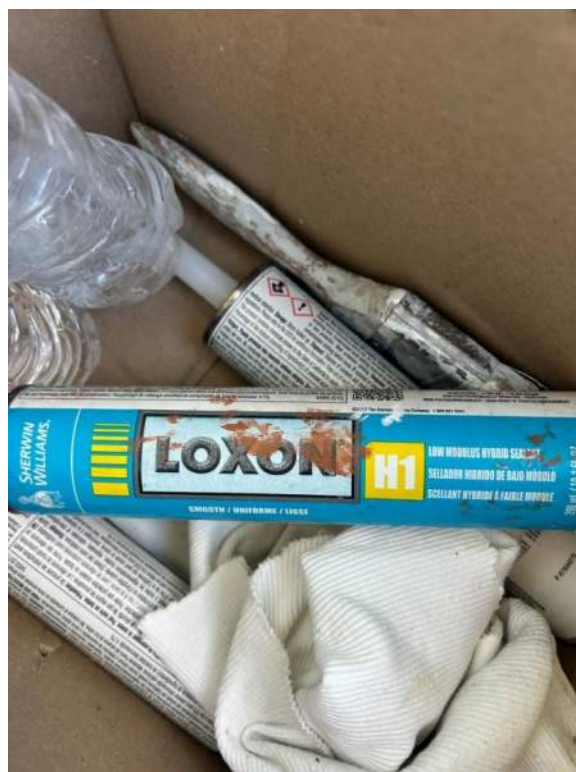
Figure 11: Sherwin Williams Loxon hybrid sealant was observed on site for application.
