DAY OF WEEK DATE	Tuesday March 04, 2025	PROJECT #	25RN-0060
PROJECT	Livingston Lakes - Painting		
LOCATION	15090 Palmer Lake Circle, Naples, FL 34109		
CONTRACTOR	A.M. Prestige Painting, Inc.	OWNER	Livingston Lakes Condominium Association, Inc.
WEATHER	Sunny	Temp	Time 65° 9:00 am
PRESENT AT SITE	A.M. Prestige Crew (AMP)		
	Anthony DiNardo – Karins Engineering (KE)

Field Report #2

Building 15098

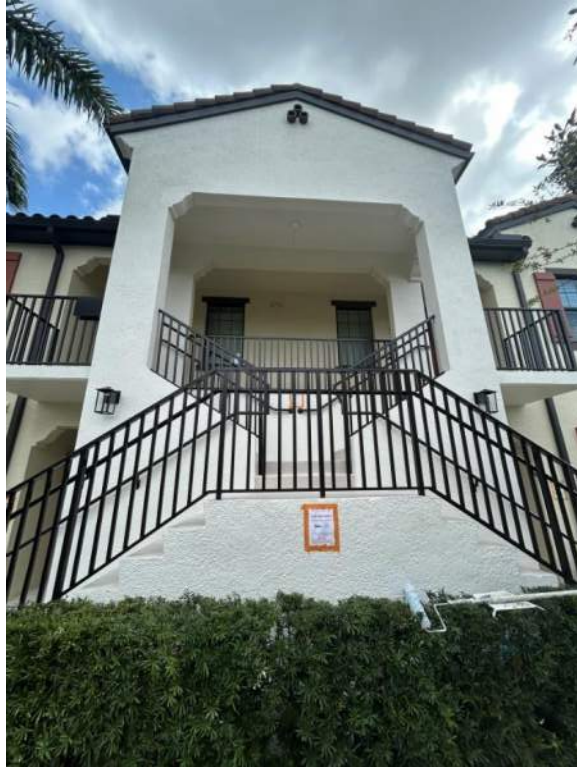
Figure 1: Paint application was completed on the exterior wall of the building.

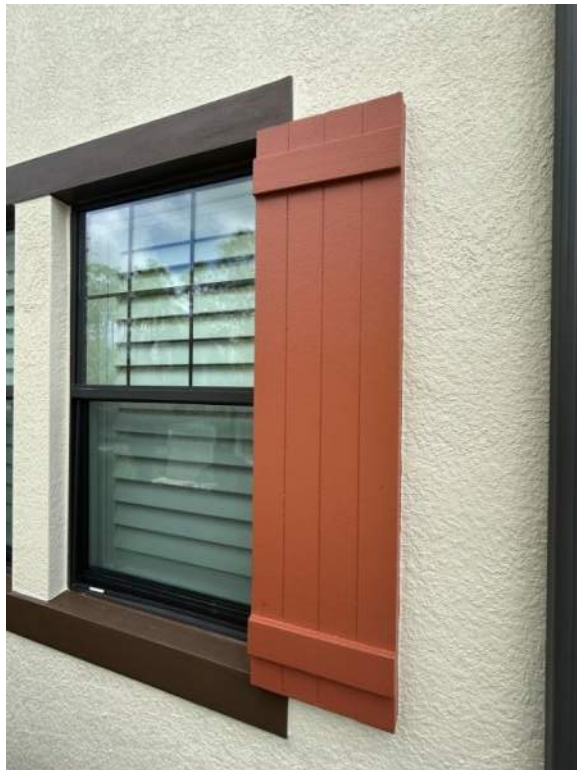
Figure 2: Paint application was completed on the red details on the sides of the windows.

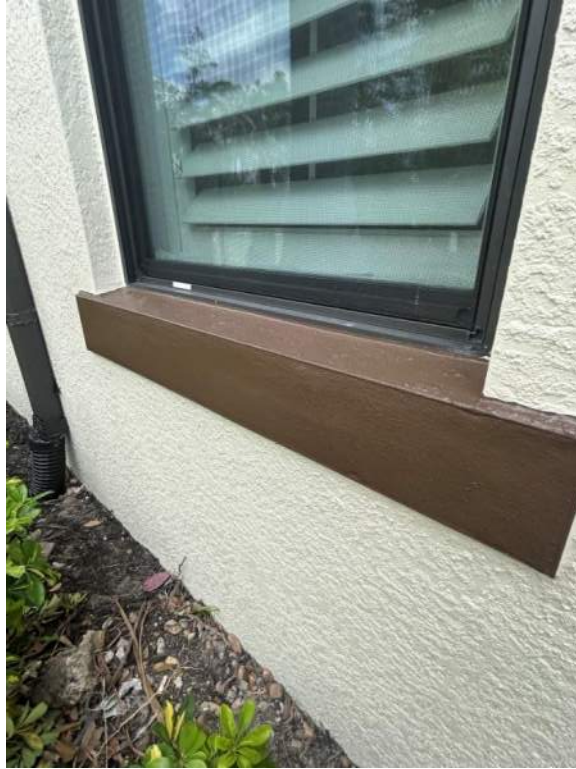
Figure 3: Paint application was completed on the brown window ledges.

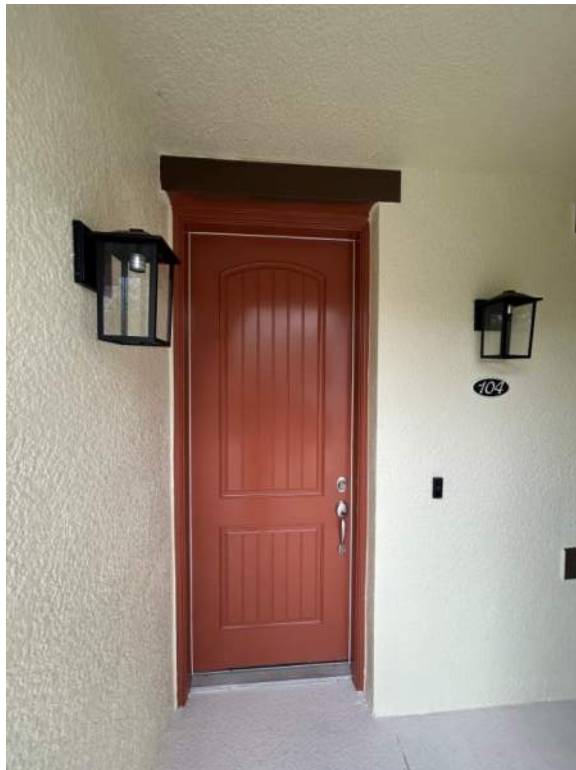
Figure 4: Paint application was completed on the red entry unit doors.

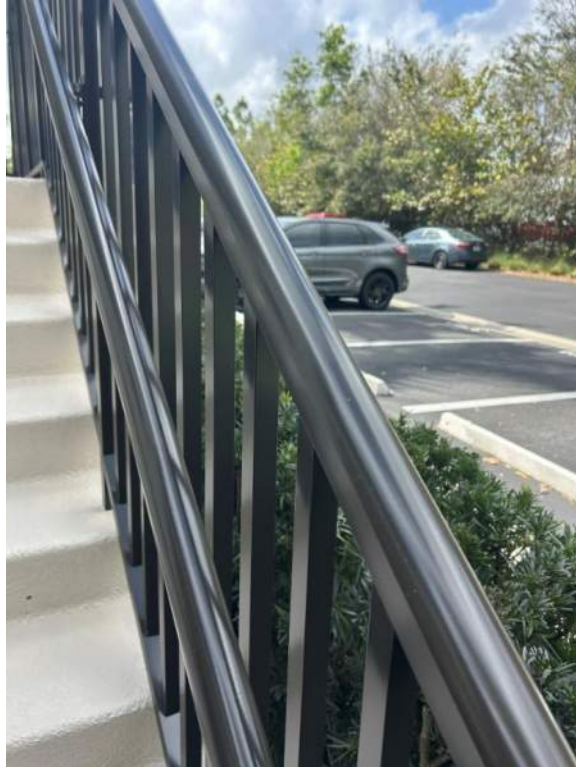
Figure 5: Paint application was completed on the guardrails of both staircases.

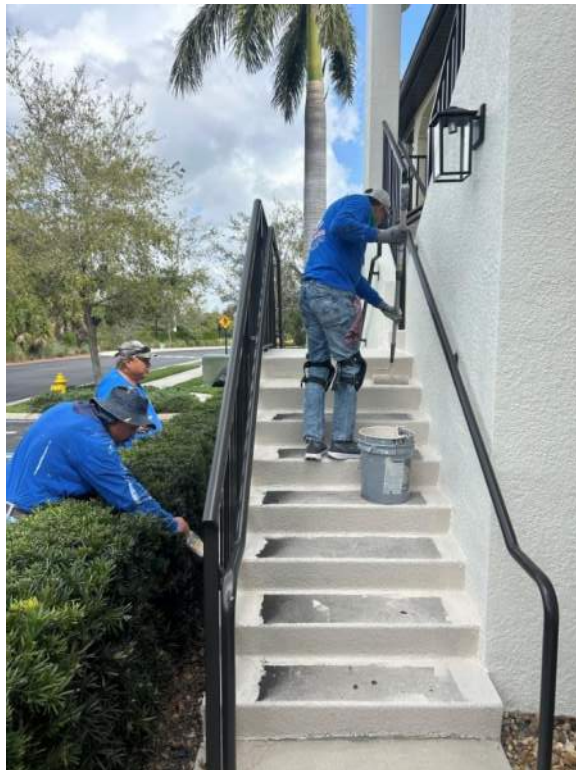
Figure 6: First coat of paint application was in progress on the left staircase.

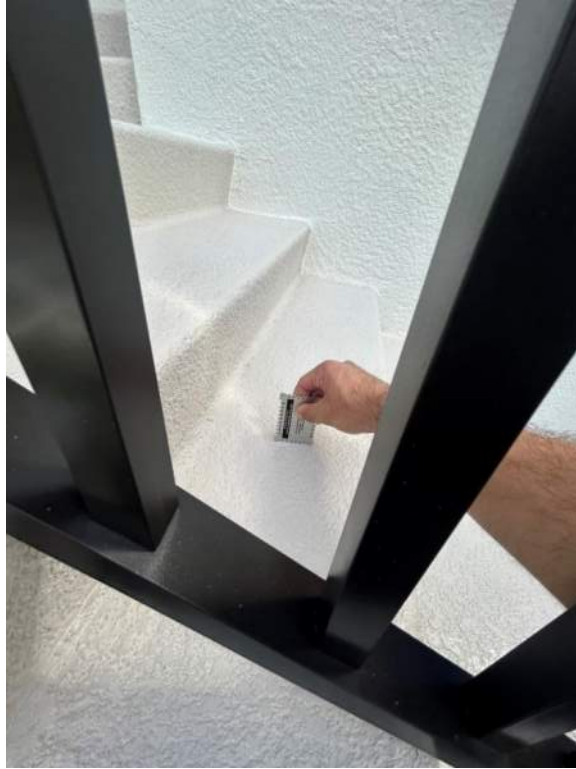
Figure 7: Wet film thickness test was completed for areas of ongoing paint application. Adequate mils was met according to the specifications.

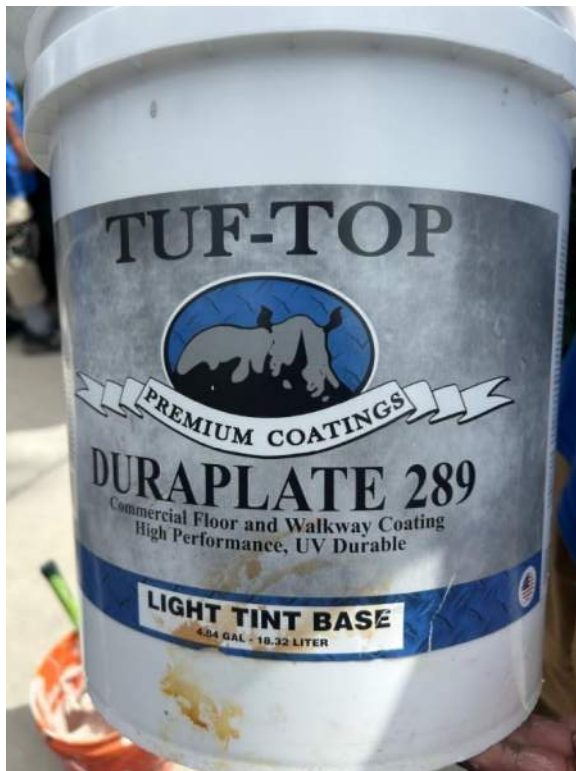
Figure 8: Tuf-Top Duraplate 289 was observed on site for paint application on stairs.

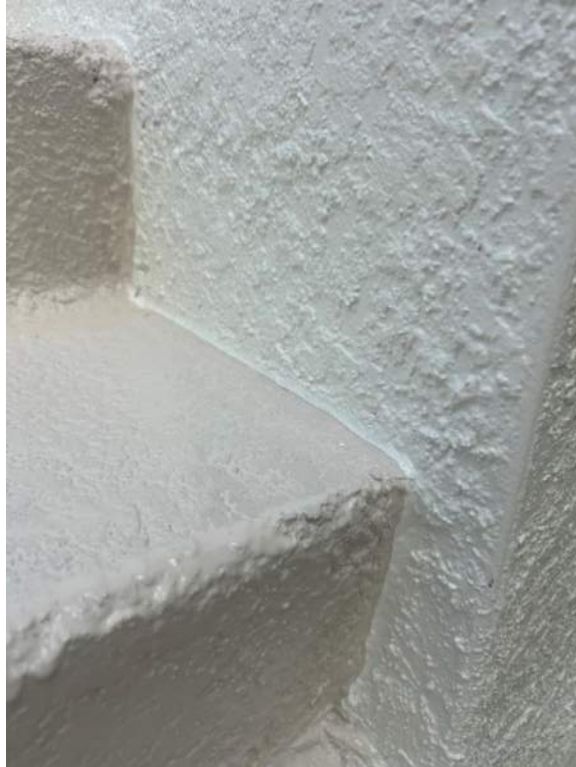
Figure 9: Stucco to stucco sealant application was completed from treads/risers to the wall of the staircases in front of the building.

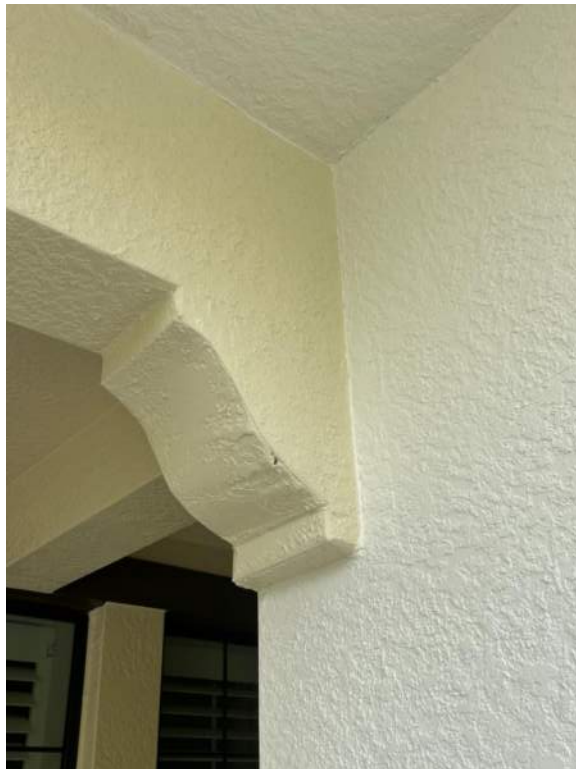
Figure 10: Stucco to stucco sealant application was completed around all corners and decorative bands.

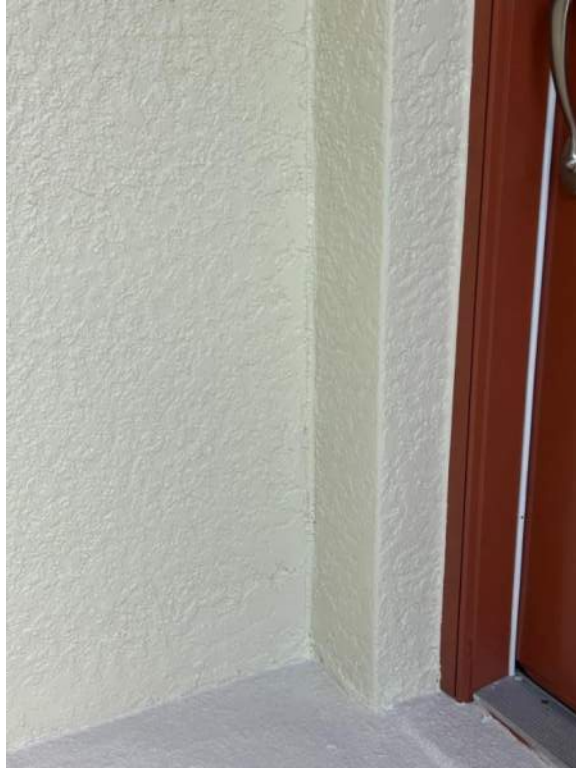
Figure 11: Stucco to stucco sealant application was completed on the vertical transitions of the building.

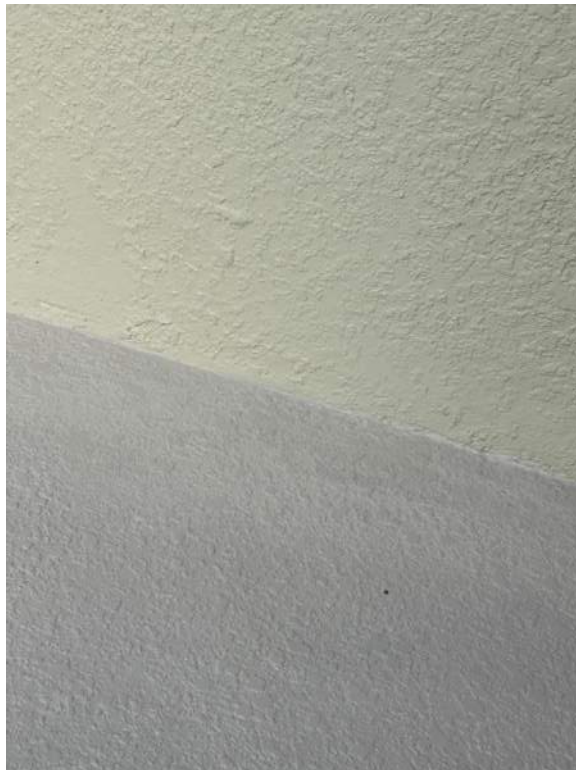
Figure 12: Stucco to stucco sealant application was completed from the walkway floor to wall.

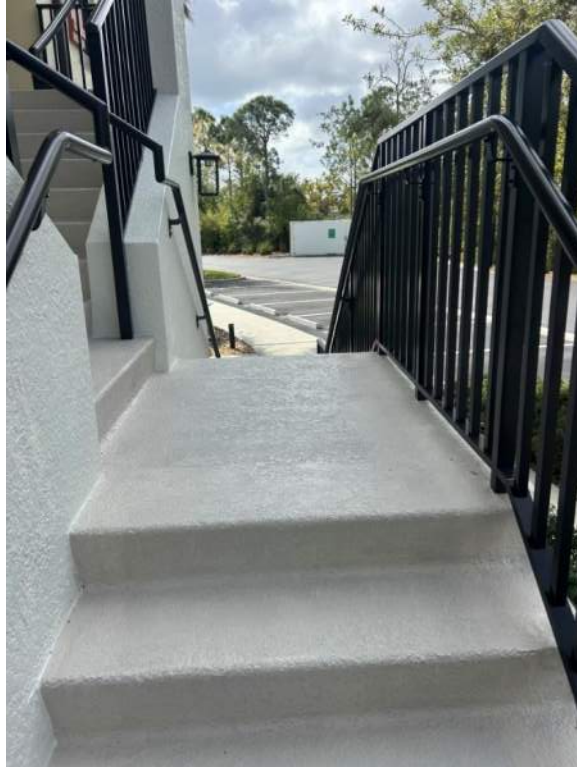
Figure 13: Crack repair was completed on the level 1 stair landings of both staircases in front of the building.
