DAY OF WEEK DATE	Monday April 28, 2025	PROJECT #	25RN-0060
PROJECT	Livingston Lakes - Painting		
LOCATION	15090 Palmer Lake Circle, Naples, FL 34109		
CONTRACTOR	A.M. Prestige Painting, Inc.	OWNER	Livingston Lakes Condominium Association, Inc.
WEATHER	Sunny	Temp	Time 72° 9:00 am
PRESENT AT SITE	A.M. Prestige Crew (AMP)		
Anthony DiNardo – Karins Engineering (KE)

Field Report #10

The purpose of this site visit was to observe the work in progress. The following was noted:

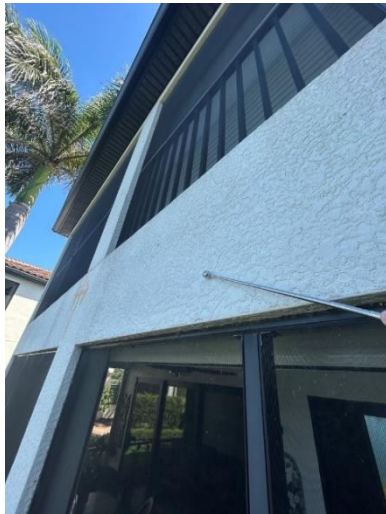
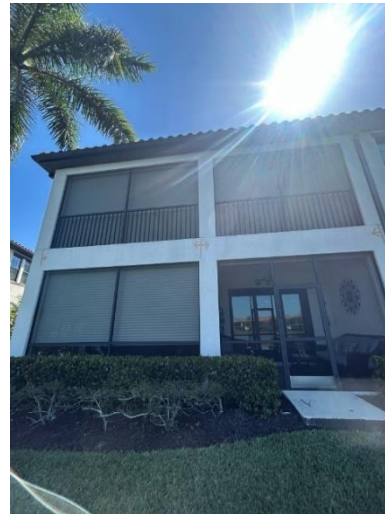
Stack 2

- Proceed as noted by the Contractor on the slab edges of stack 2.

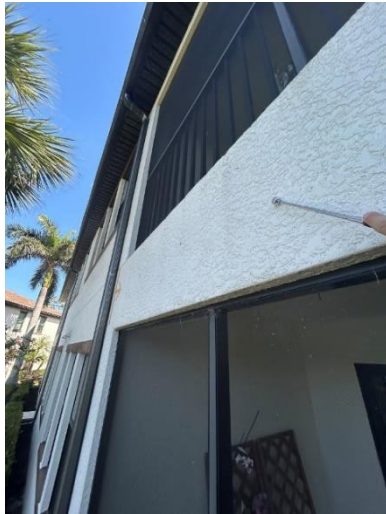
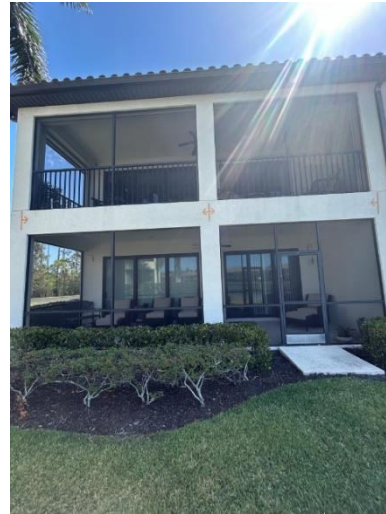
Stack 2

- Proceed as noted by the Contractor on the slab edges of stacks and 2.

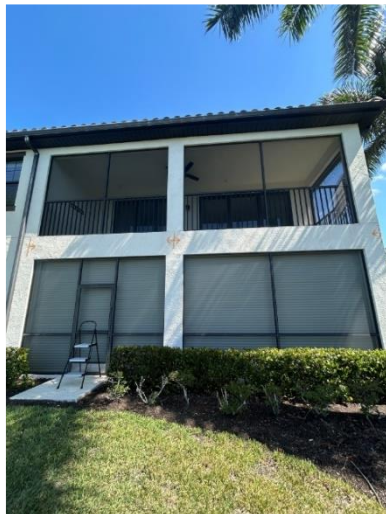
Stack 1

- Proceed as noted by the Contractor on the slab edges of stacks 1 and 2.

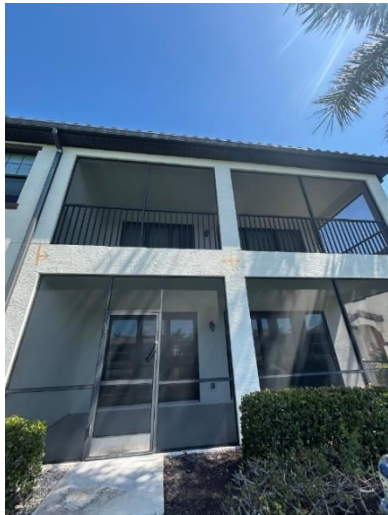
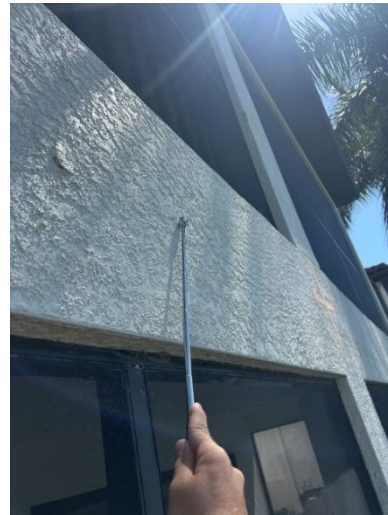
Stack 1

- Proceed as noted by the Contractor on the slab edges of stacks 1 and 2.
- Stucco removal is not required on the west side exterior wall of stack 2. Contractor to proceed with typical crack repair.

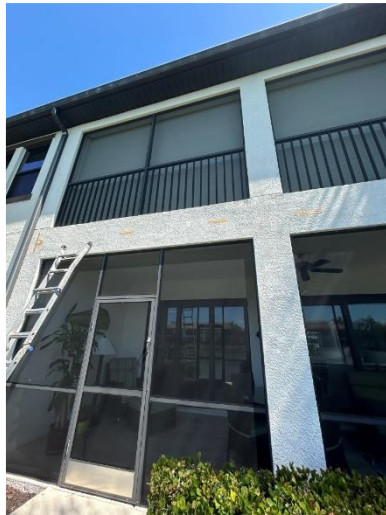
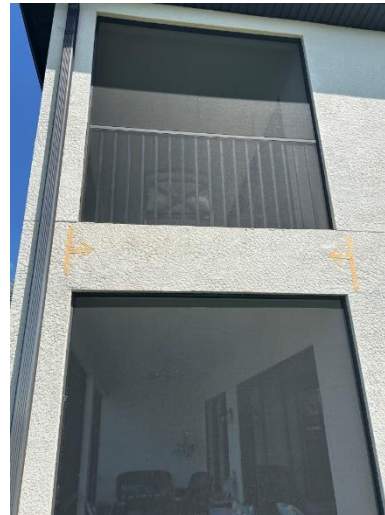
Stack 1

- Proceed as modified by the Engineer on the slab edges of stack 1.
- Proceed as noted by the Contractor on the slab edges of stack 2.
- Stucco removal is not required on the east side exterior wall of stack 1. Contractor to proceed with typical crack repair.

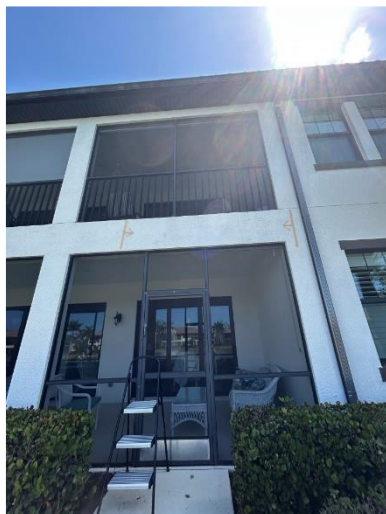
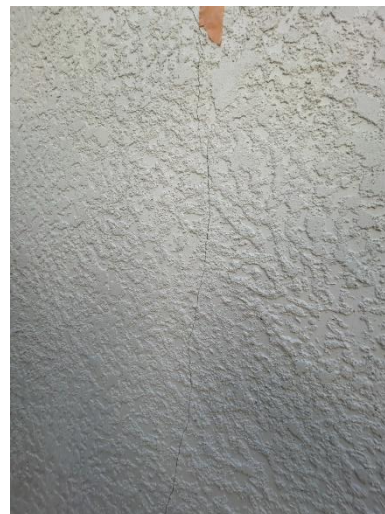
Stack 2

- Proceed as modified by the Engineer on the slab edges of stacks 1 and 2.
- Stucco removal is not required on the north side exterior wall of stack 2. Contractor to proceed with typical crack repair.

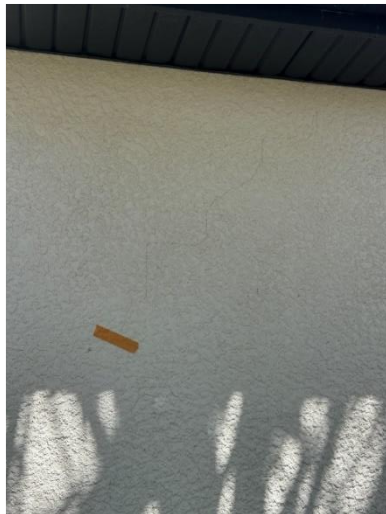
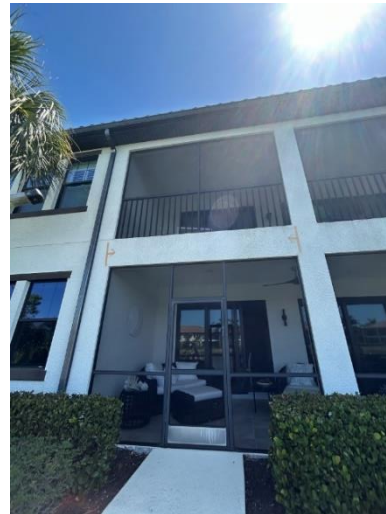
Stack 1

- Proceed as noted by the Contractor on the slab edges of stacks 1 and 2.
- Stucco removal is not required on the south side exterior wall of stack 1. Contractor to proceed with typical crack repair.
- Stucco removal is not required on the north side exterior wall of stack 2. Contractor to proceed with typical crack repair.

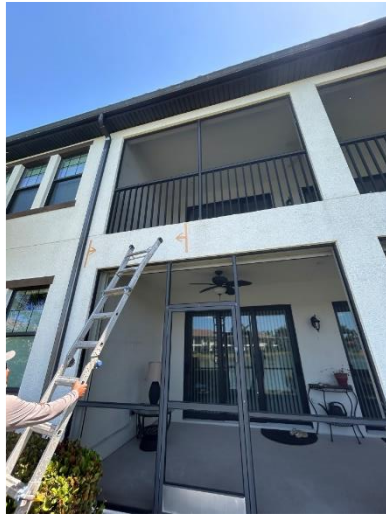
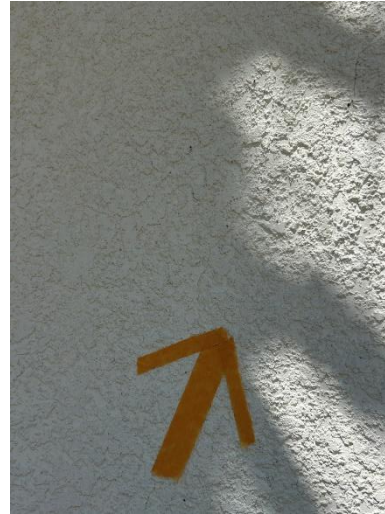
Stack 1

- Proceed as noted by the Contractor on the slab edges of stack 1.
- Proceed as modified by the Engineer on the slab edges of stack 2.
- Stucco removal is not required on the south side exterior wall of stack 1. Contractor to proceed with typical crack repair.

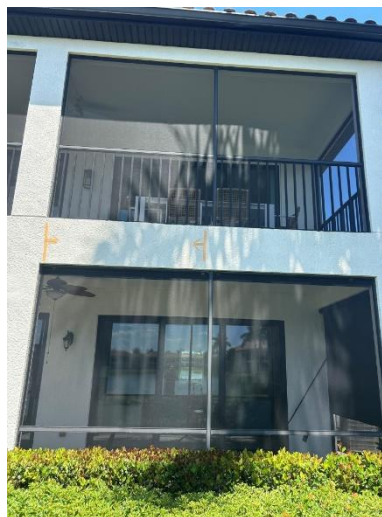
Stack 2

- Proceed as modified by the Engineer on the slab edges of stack 2.

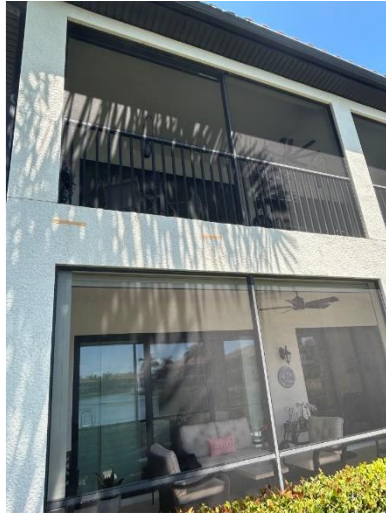
Stack 1

- Proceed as noted by the Contractor on the slab edges of stack 1.
- Proceed as modified by the Engineer on the slab edges of stack 2.

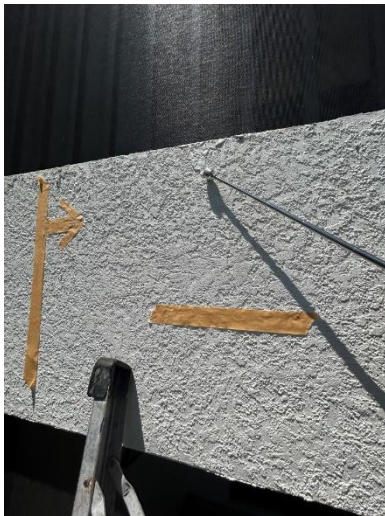
Stack 1

- Contractor to proceed with stucco removal as noted by the Engineer above the front door of the building.
- Proceed with stucco removal as modified by the Engineer on the slab edges of stack 1.

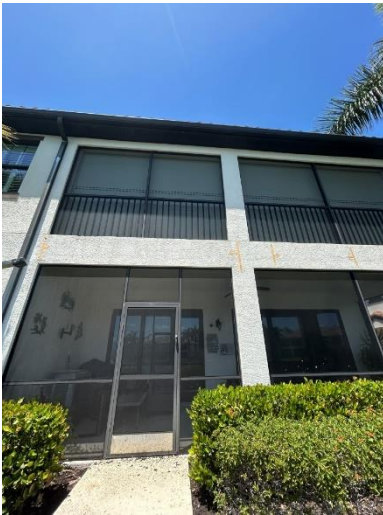
Stack 1

- Contractor to proceed with stucco removal as noted by the Engineer above the front door of the building.
- Proceed as noted by the Contractor on the slab edges of stacks 1 and 2.

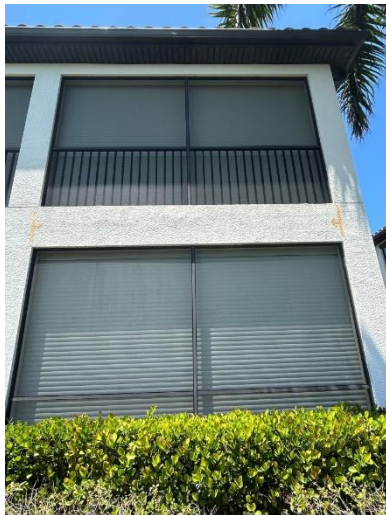
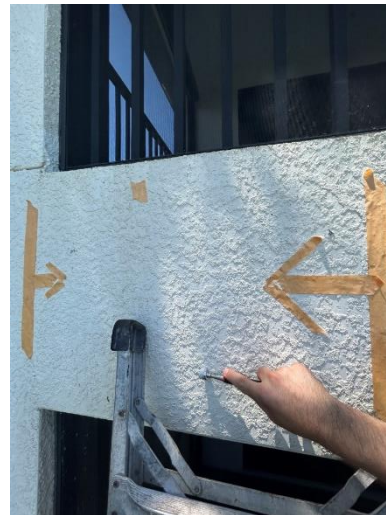
Stack 1

- Proceed as modified by the Engineer on stack 1.
