August 25th, 2025

**Livingston Lakes – Carriage Homes (15165-15213) – REVIST 1**

File # 25RN:-0060

Walkthrough

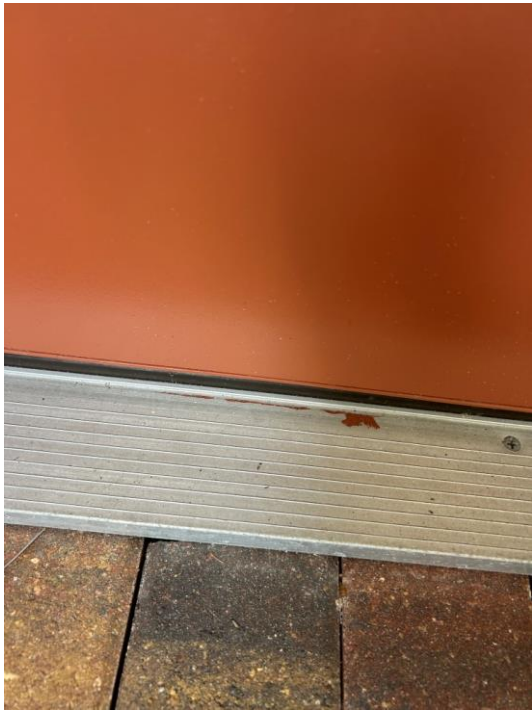
Photo 1

| <b>Carriage Homes</b> | | | |
|---|---|---|---|
| Red door paint on door threshold | 15165: entry to unit 202 | 1 | No |

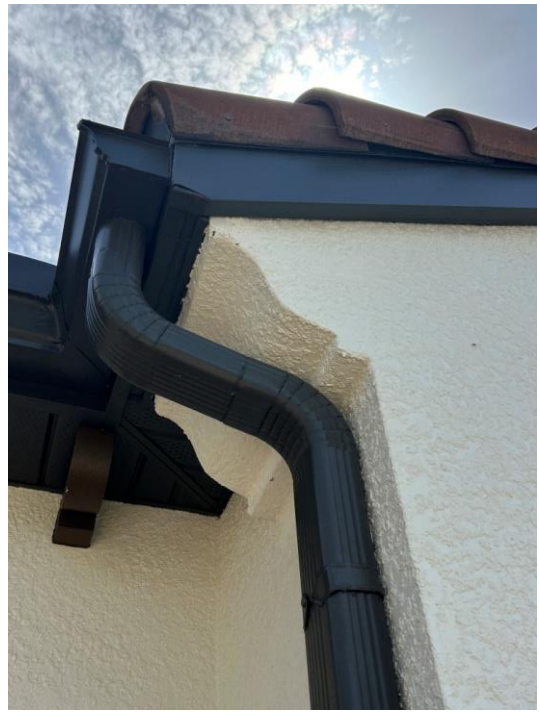
Photo 2

| <b>Carriage Homes</b> | | | |
|---|---|---|---|
| Excess body paint on fascia | 15165: above garage to unit 102 | 2 | |

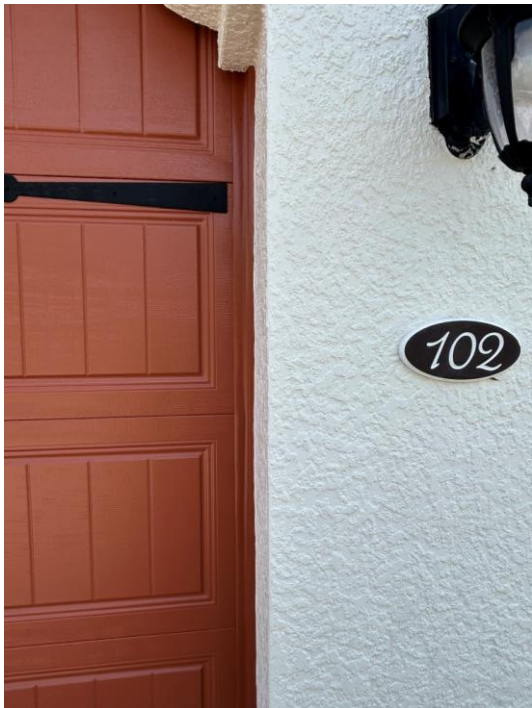
Photo 3

| <b>Carriage Homes</b> | | | |
|---|---|---|---|
| Missing red paint on garage door | 15165: unit 102 | 3 | |

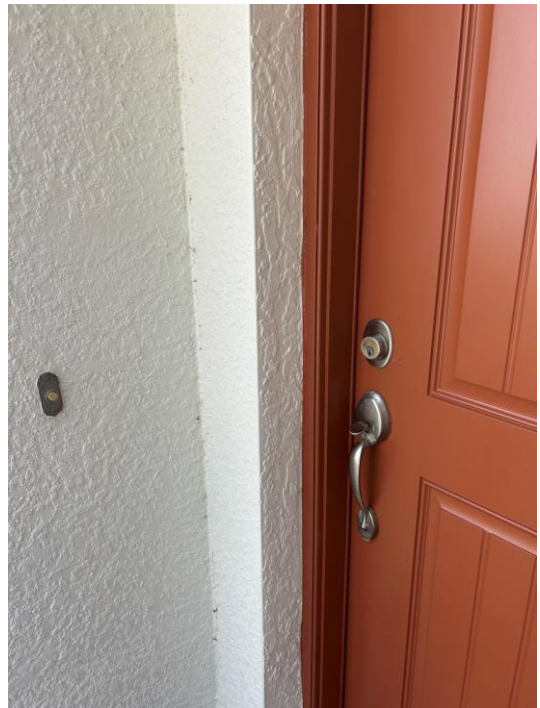
Photo 4

| <b>Carriage Homes</b> | | | |
|---|---|---|---|
| Excess door paint on wall | 15165: north side entry to unit 101 | 4 | |

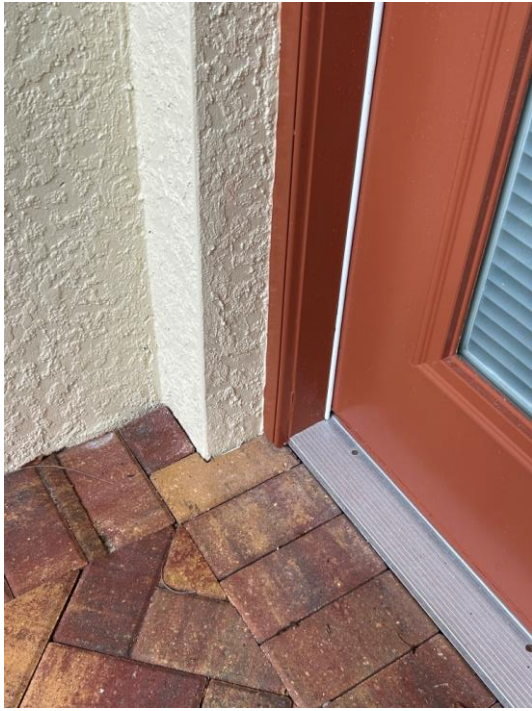
Photo 5

| <b>Carriage Homes</b> | | | |
|---|---|---|---|
| excess door paint on wall | 15169: unit 201 | 5 | |

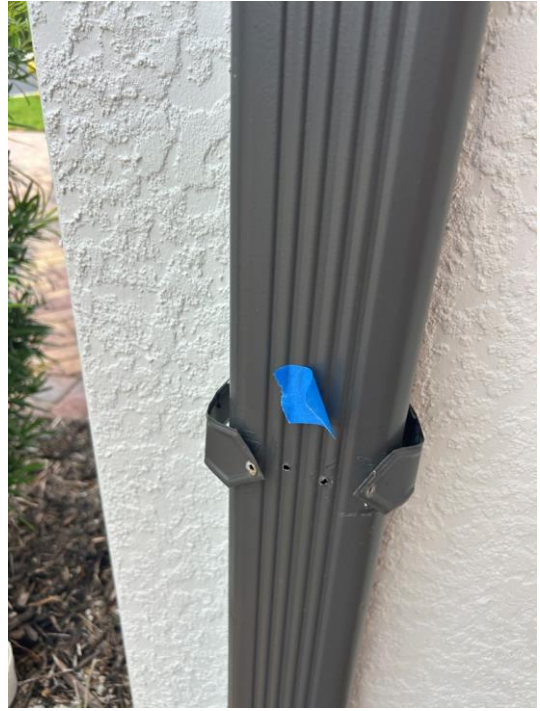
Photo 6

| <b>Carriage Homes</b> | | | |
|---|---|---|---|
| Missing screws in gutter spout | 15169: front of unit 201 | 6 | No |

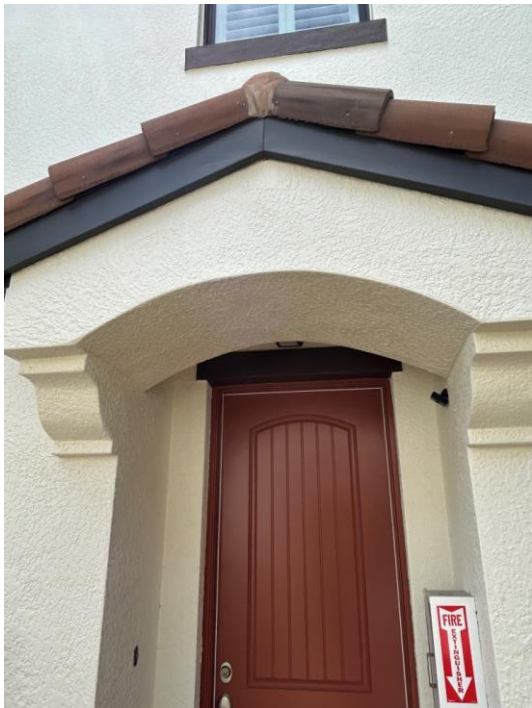
Photo 7

| <b>Carriage Homes</b> | | | |
|---|---|---|---|
| Touch up paint required | 15169: north side wall above entry door | 7 | |

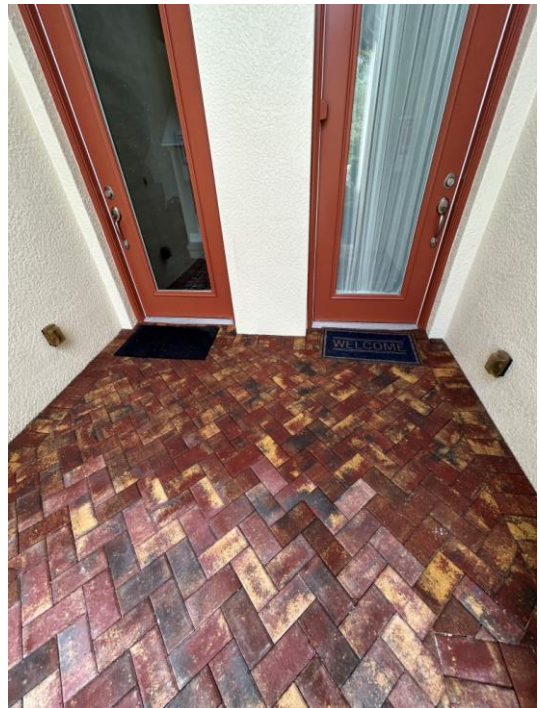
Photo 8

| <b>Carriage Homes</b> | | | |
|---|---|---|---|
| Excess paint on pavers | 15173: entry to units 201 and 202 | 8 | |

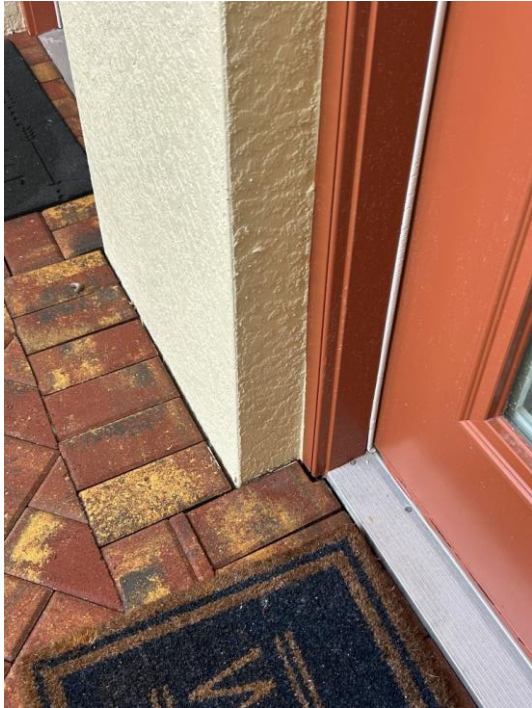
Photo 9

| <b>Carriage Homes</b> | | | |
|---|---|---|---|
| Excess door paint on wall | 15173: unit 202 | 9 | |

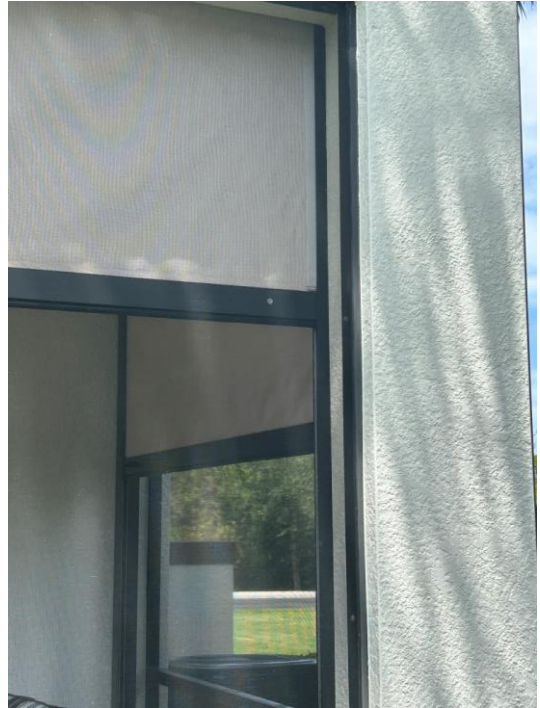
Photo 10

| <b>Carriage Homes</b> | | | |
|---|---|---|---|
| Paint over painters tape | 15173: lake side screen frame of unit 101 | 10 | |

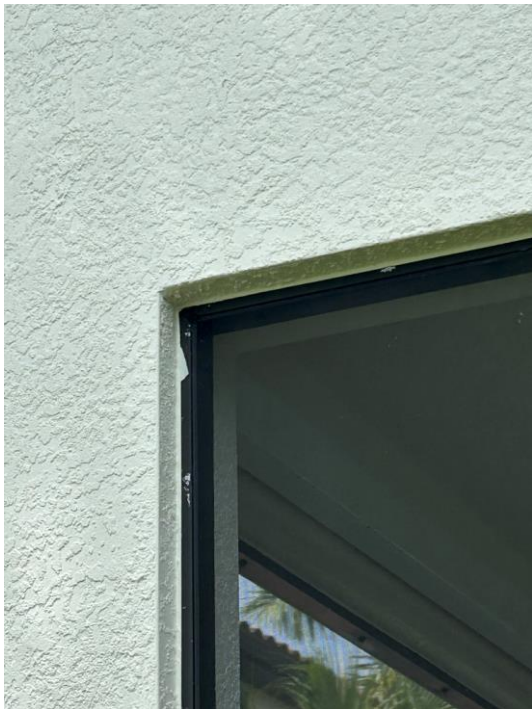
Photo 11

| <b>Carriage Homes</b> | | | |
|---|---|---|---|
| Excess paint on screen frame | 15173: lake side unit 102 | 11 | No |

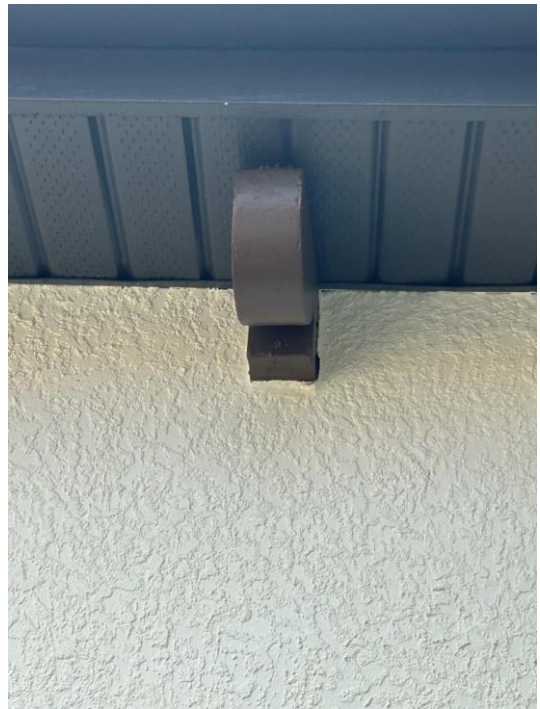
Photo 12

| <b>Carriage Homes</b> | | | |
|---|---|---|---|
| Brown body paint on wall | 15177: in front of unit door to 201 | 12 | |

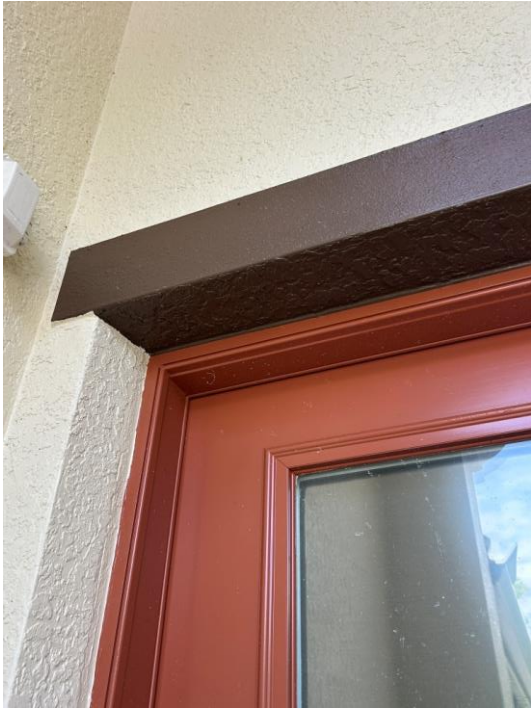
Photo 13

| <b>Carriage Homes</b> | | | |
|---|---|---|---|
| Touch up paint on door | 15181: unit 201 | 13 | |

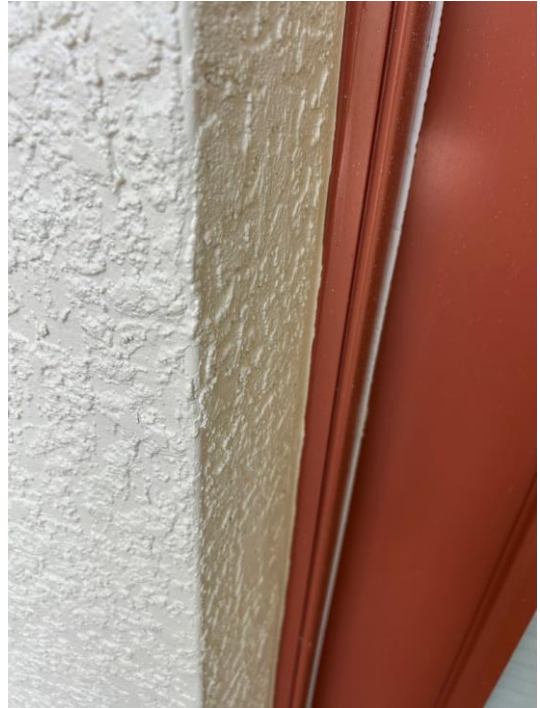
Photo 14

| <b>Carriage Homes</b> | | | |
|---|---|---|---|
| Exposed corner bead | 15181: unit 202 | 14 | |

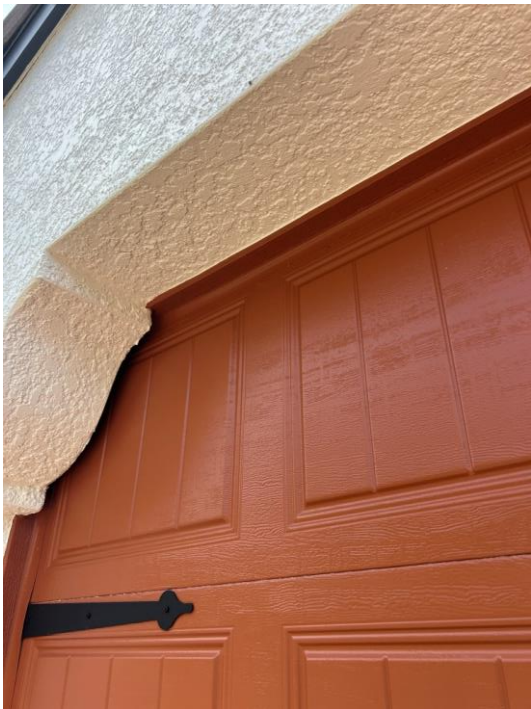
Photo 15

| <b>Carriage Homes</b> | | | |
|---|---|---|---|
| touch up paint | 15181: garage door unit 101 | 15 | |

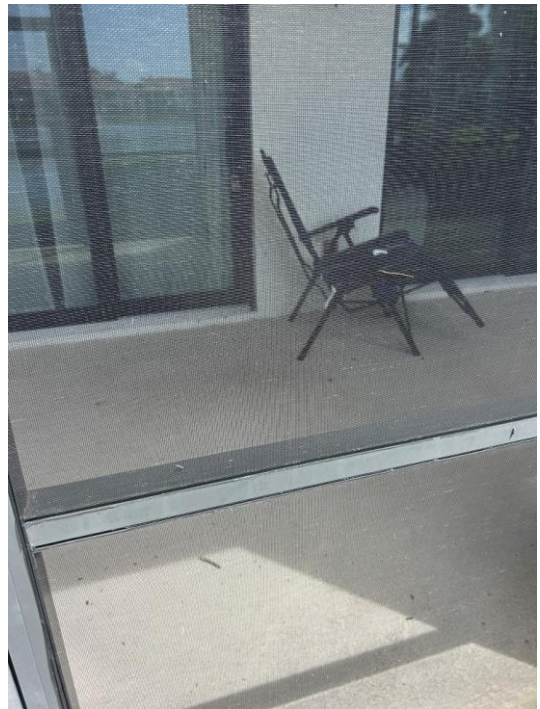
Photo 16

| <b>Carriage Homes</b> | | | |
|---|---|---|---|
| Paint on screen mesh | 15181: lake side unit 101 | 16 | |

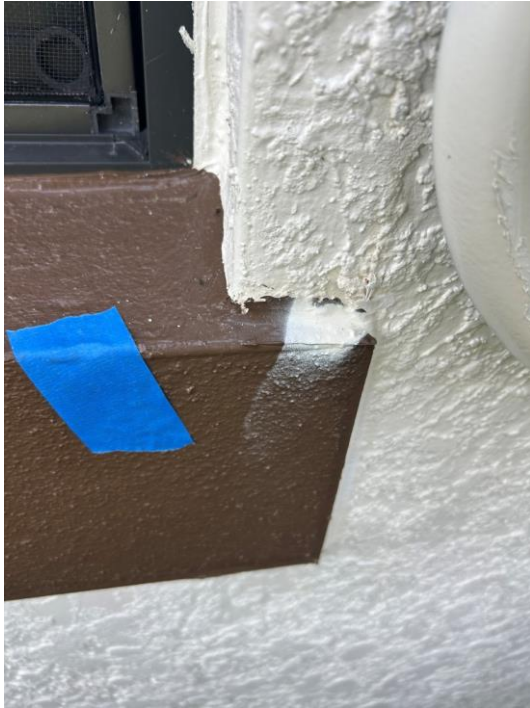
Photo 17

| <b>Carriage Homes</b> | | | |
|---|---|---|---|
| touch up paint on window ledge | 15181: west side unit 102 | 17 | No |

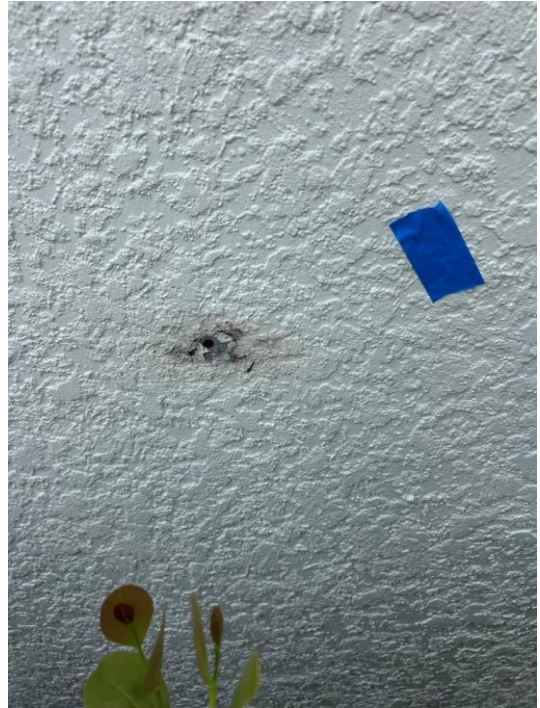
Photo 18

| <b>Carriage Homes</b> | | | |
|---|---|---|---|
| Flaking paint | 15181: west side exterior wall of unit 102 | 18 | No |

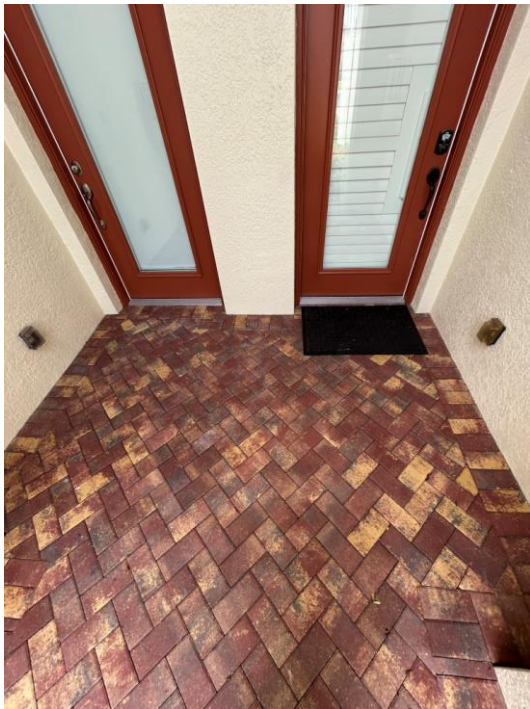
Photo 19

| <b>Carriage Homes</b> | | | |
|---|---|---|---|
| Excess paint on pavers | 15185: entryway to units 201 and 202 | 19 | |

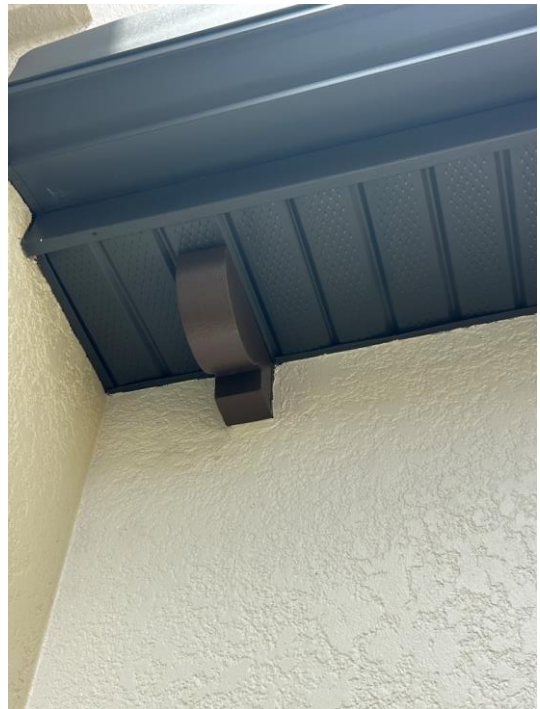
Photo 20

| <b>Carriage Homes</b> | | | |
|---|---|---|---|
| Excess body paint on soffit | 15185: exterior wall near entry to unit 202 | 20 | |

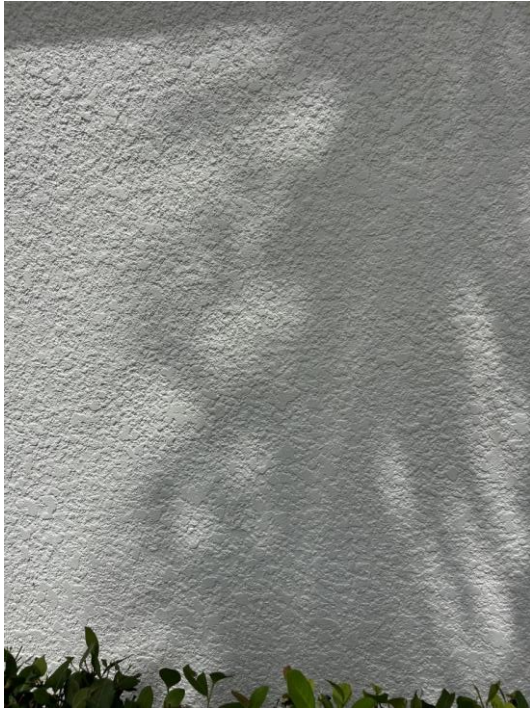
Photo 21

| <b>Carriage Homes</b> | | | |
|---|---|---|---|
| Flaking paint | 15185: east side exterior wall | 21 | |

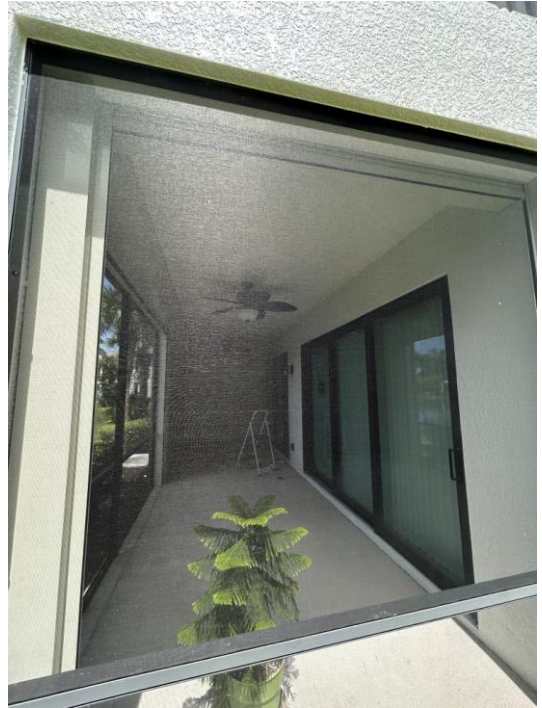
Photo 22

| <b>Carriage Homes</b> | | | |
|---|---|---|---|
| Excess paint on screen mesh | 15185: east side unit 101 | 22 | |

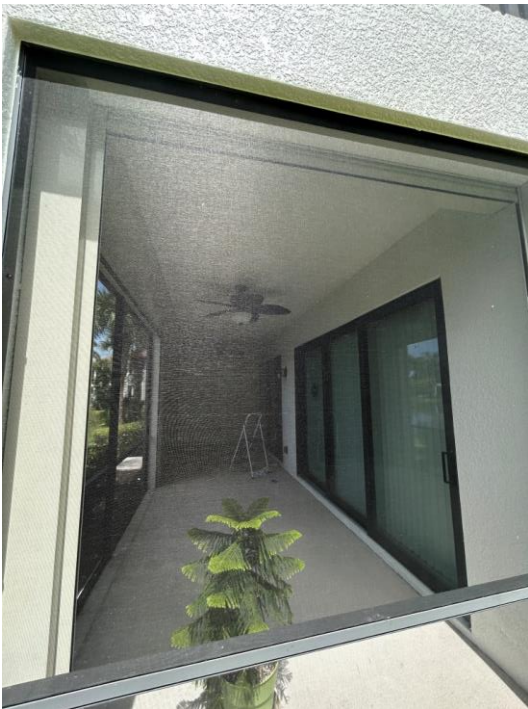
Photo 23

| <b>Carriage Homes</b> | | | |
|---|---|---|---|
| excess body paint on soffit | 15185: east side above frame to unit 201 | 23 | |

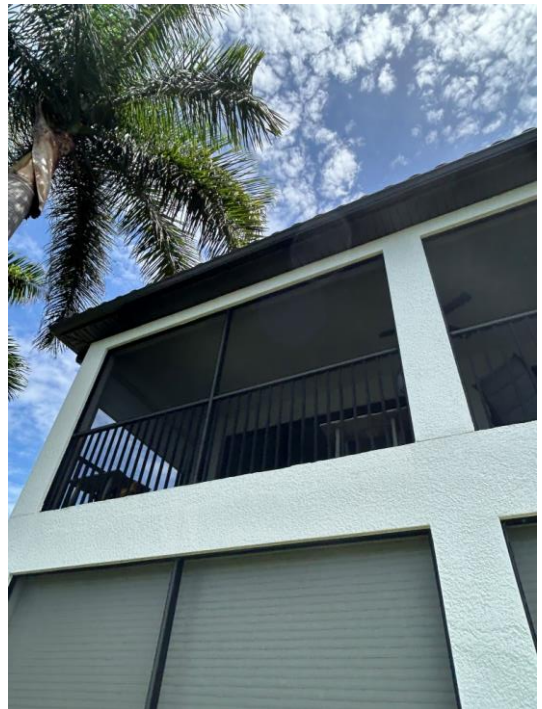
Photo 24

| <b>Carriage Homes</b> | | | |
|---|---|---|---|
| Excess paint on mesh | 15185: lake side unit 202 | 24 | |

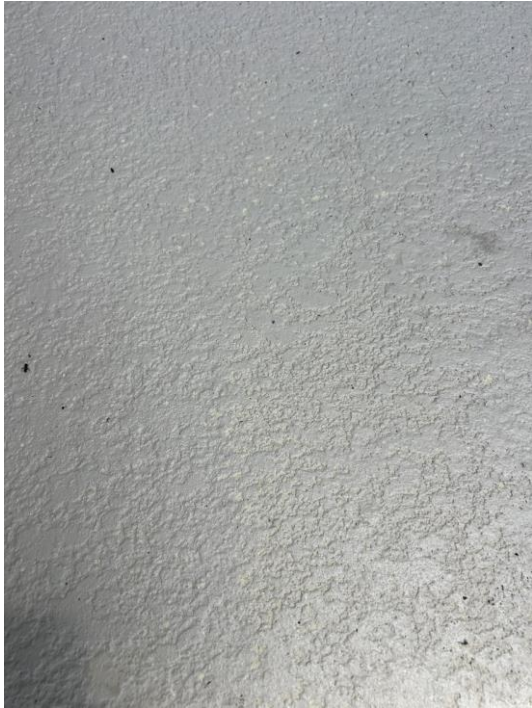
Photo 25

| <b>Carriage Homes</b> | | | |
|---|---|---|---|
| Previous paint color showing through | 15185: slab on grade entering lanai of unit 201 | 25 | No |

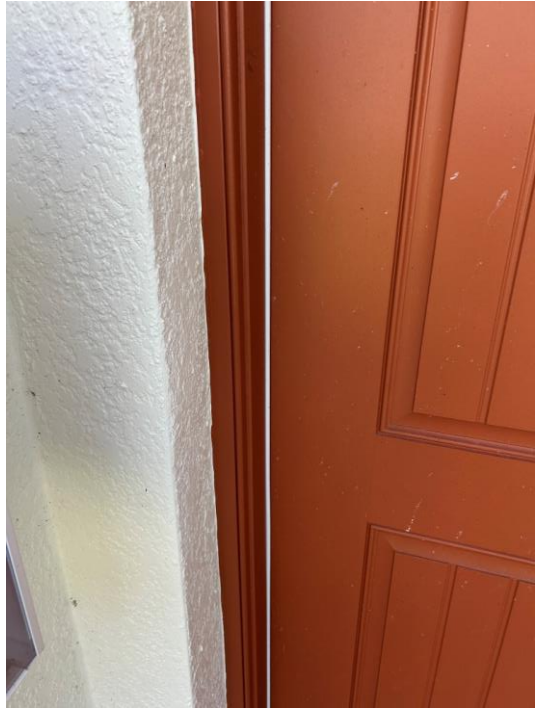
Photo 26

| Touch up paint | 15185: west side entry door to units 102 | 26 | |

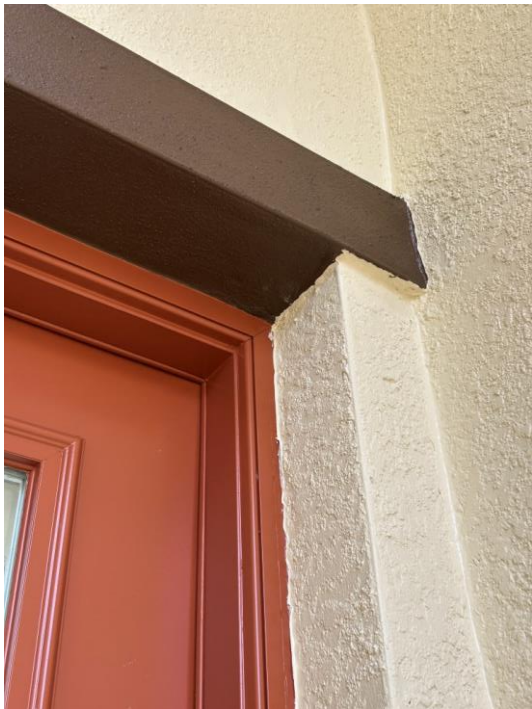
Photo 27

| Touch up paint | 15189: entry doors to units 201 and 202 | 27 | |

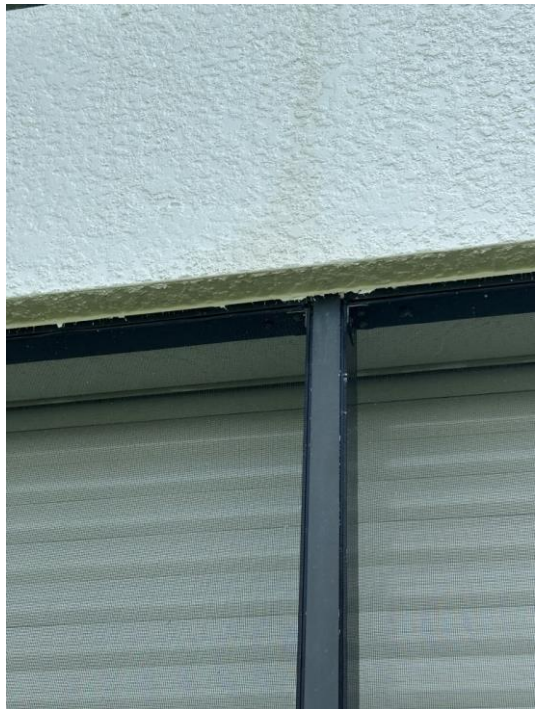
Photo 28

| Excess paint on screen frame | 15189: lake side 201 | 28 | No |

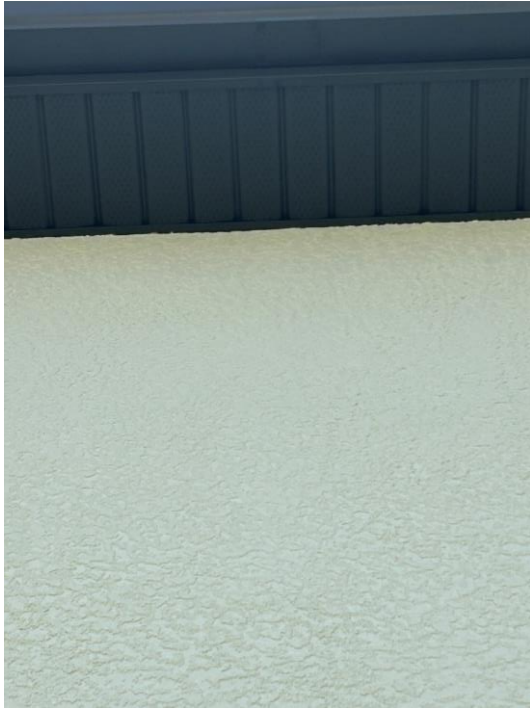
Photo 29

| Cut-in paint application | 15189: under soffit on north side of building | 29 | |

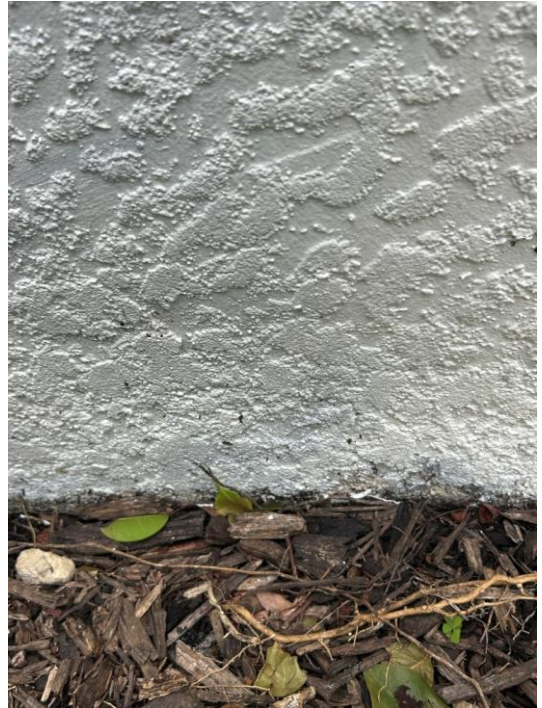
Photo 30

| Touch up paint | 15189: near north side entry to units 101 | 30 | |

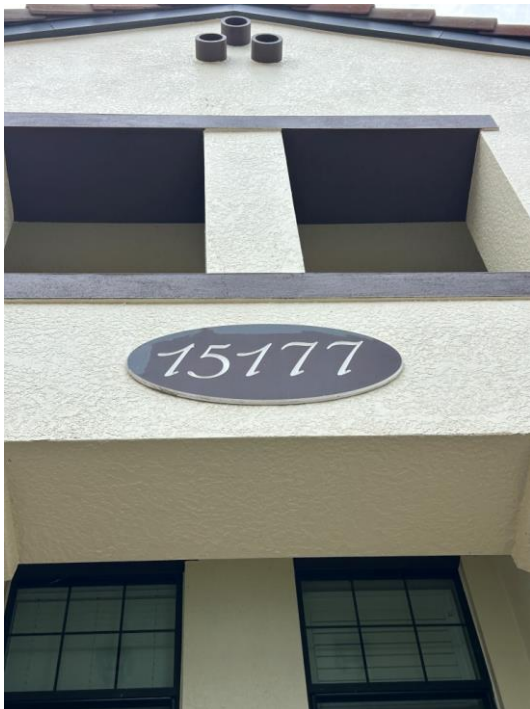
Photo 31

| Touch up paint on main sign | 15177 sign | 31 | No |

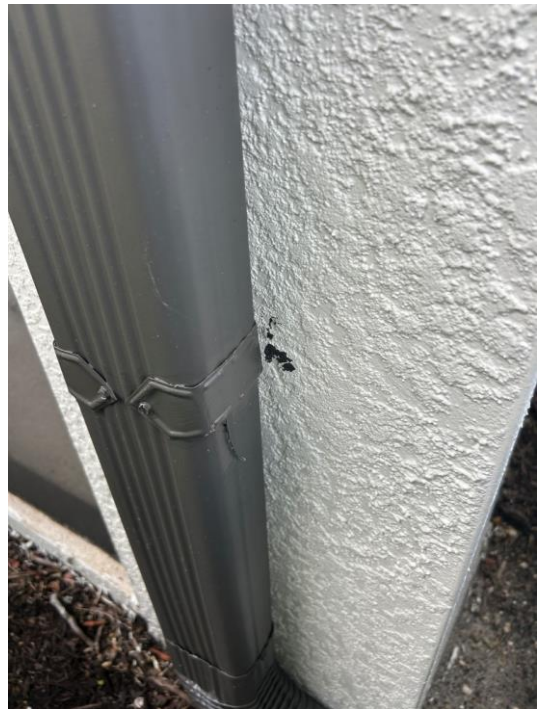
Photo 32

| Touch up paint next to gutter | 15193: north side unit 102 | 32 | No |

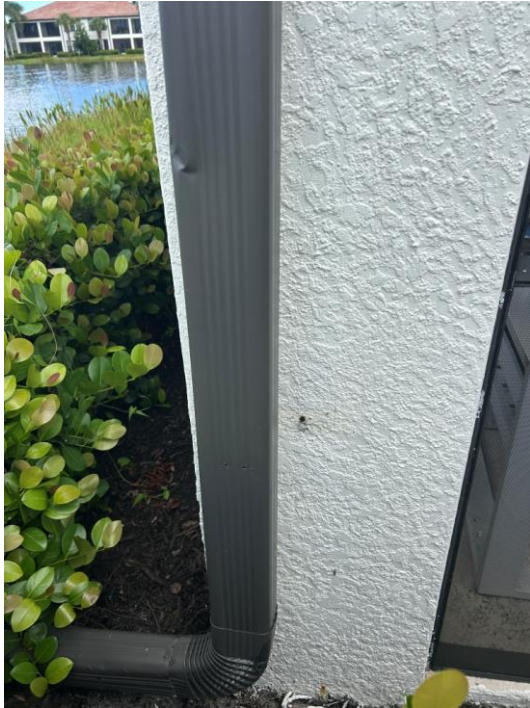
Photo 33

| Reinstallation of gutter | 15193: south side unit 101 | 33 | No |

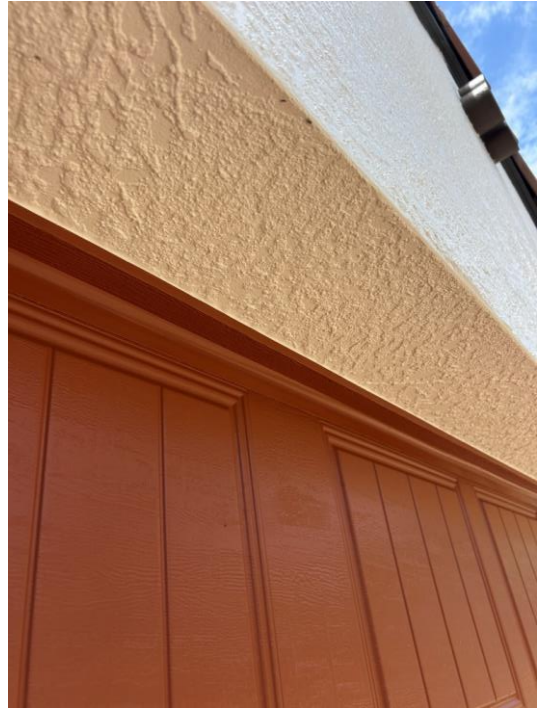
Photo 34

| Cut-in tape pending removal | 15193: garage door or unit 101 | 34 | |

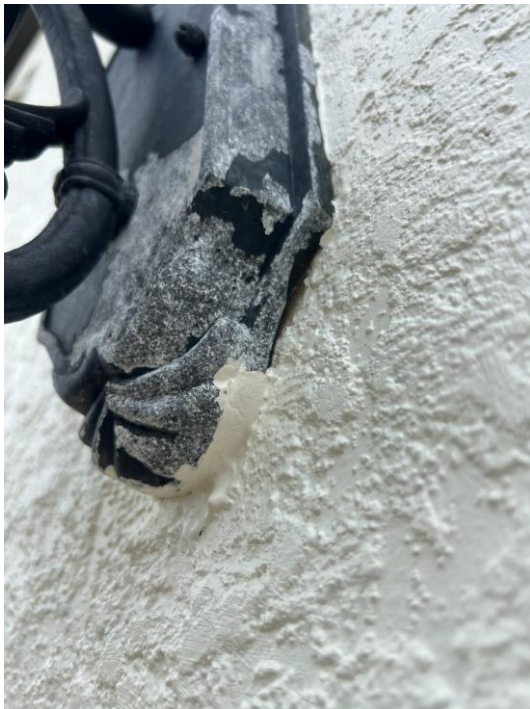
Photo 35

| Paint on light fixtures | 15197: unit 101 | 35 | No |

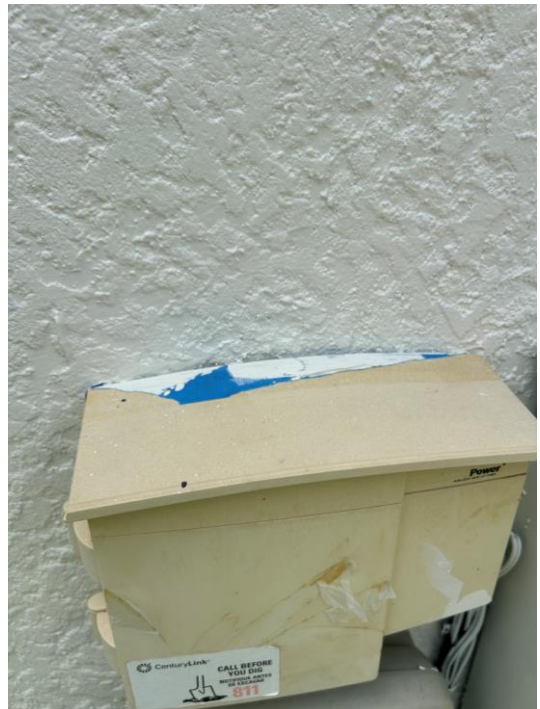
Photo 36

| Cut-in tape pending removal | 15197: east side of building | 36 | No |

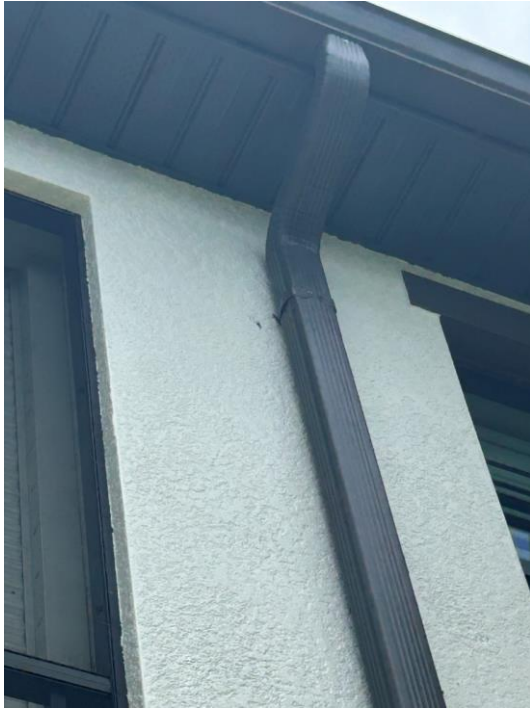
Photo 37

| Touch up paint near gutter | 15197: lake side near window to unit 202 | 37 | No |

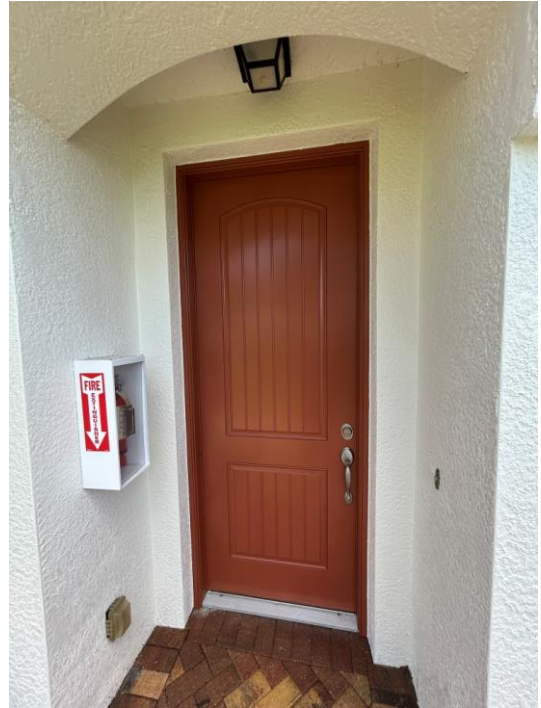
Photo 38

| Cut-in tape pending removal | 15197: unit door to 102 | 38 | |

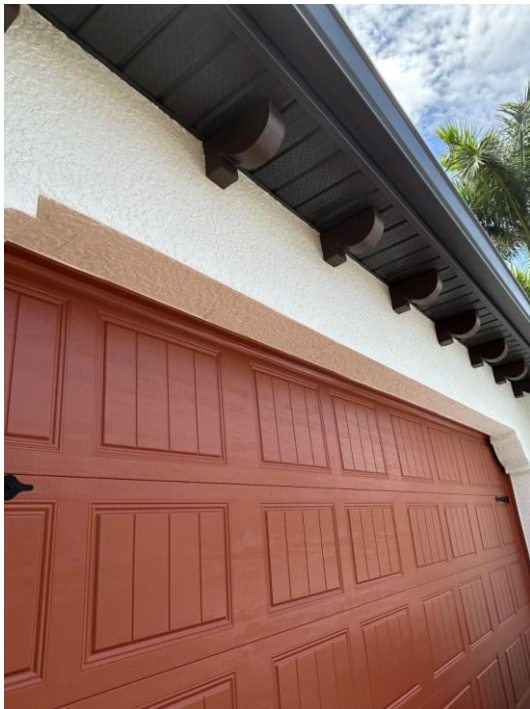
Photo 39

| Cut-in tape pending removal | 15201: garage door to unit 202 | 39 | |

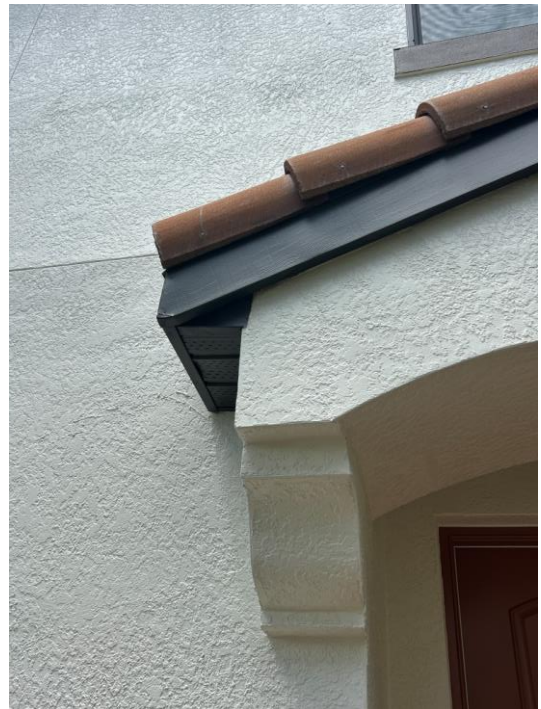
Photo 40

| Touch-up paint on fascia | 15201: East side entry to unit 101 | 40 | |

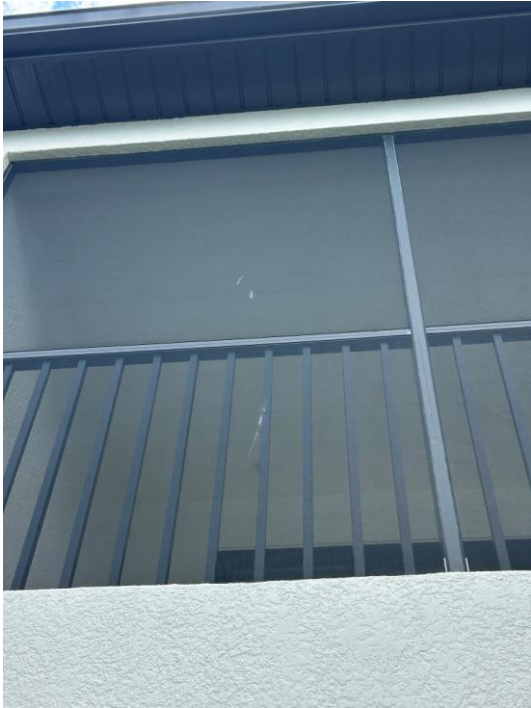
Photo 41

| Excess paint on screen mesh | 15201: lanai of unit 201 | 41 | No |

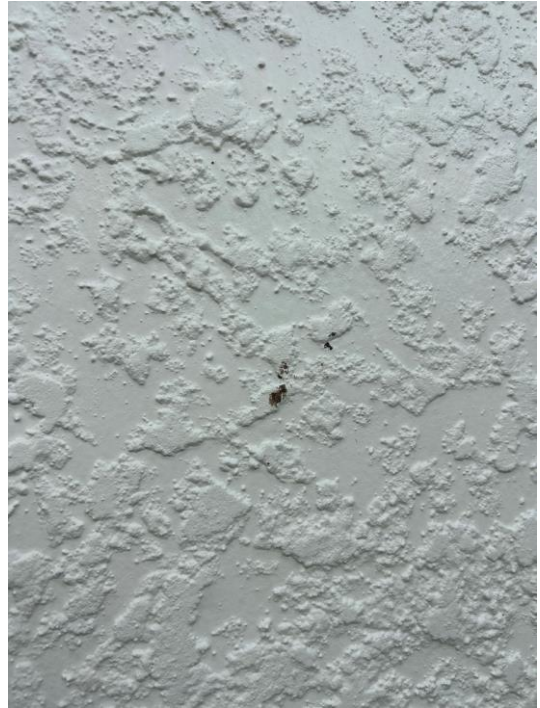
Photo 42

| Touch up paint | 15205: east side exterior wall of unit 101 | 42 | No |

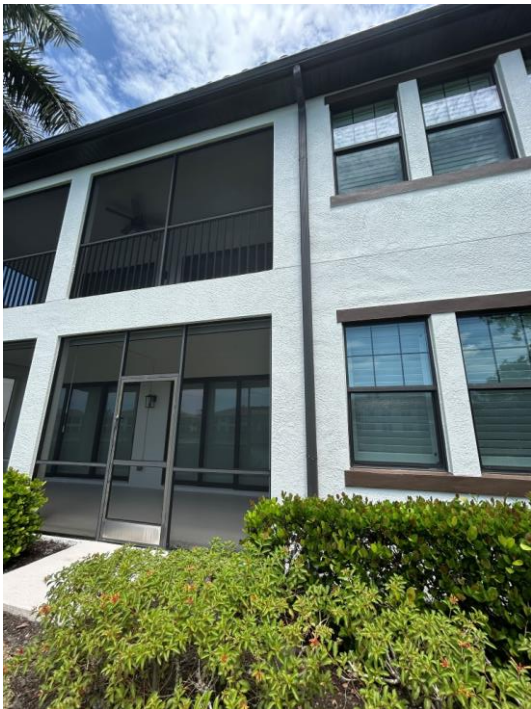
Photo 43

| Gutter pending installation | 15205: lake side of stack 2 | 43 | |

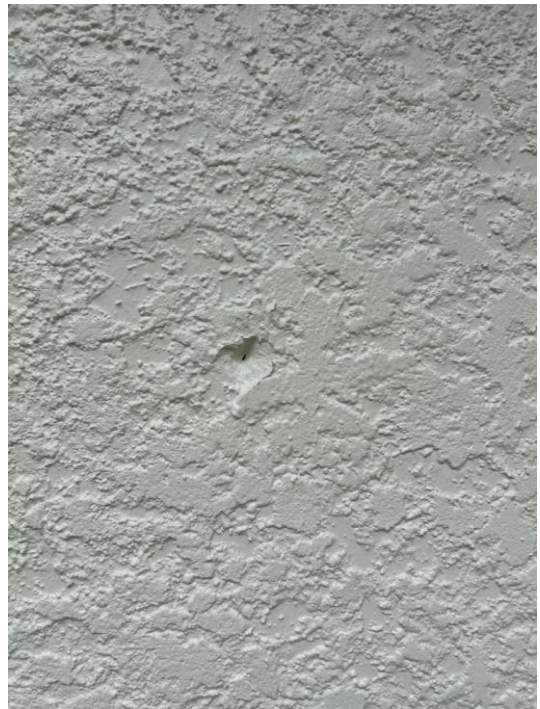
Photo 44

| Small perforation in stucco | 15209: south side of 101 | 44 | No |

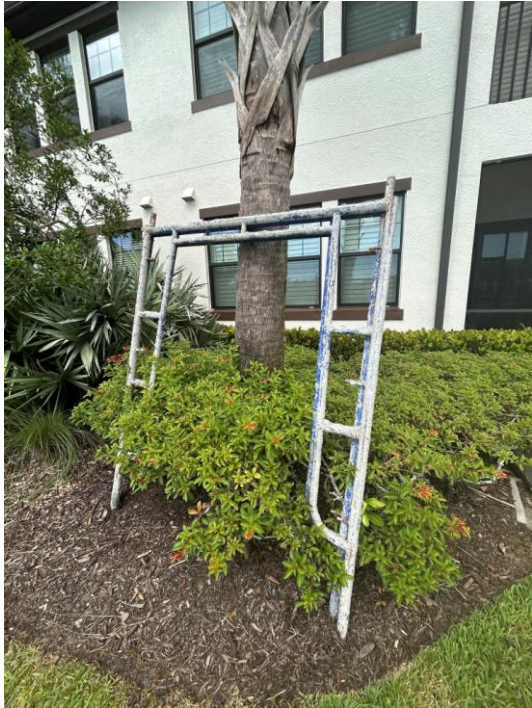
Photo 45

| scaffold remains on site | 15209: lake side of building | 45 | No |

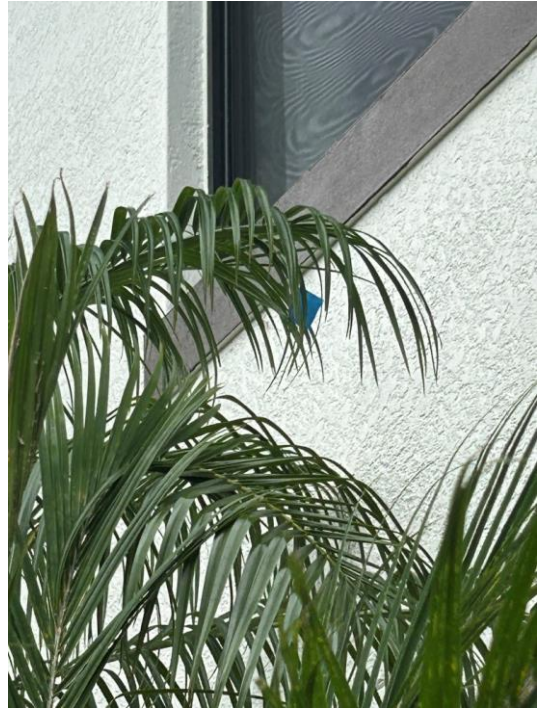
Photo 46

| painters tape in palm tree | 15209: north side of building | 46 | No |

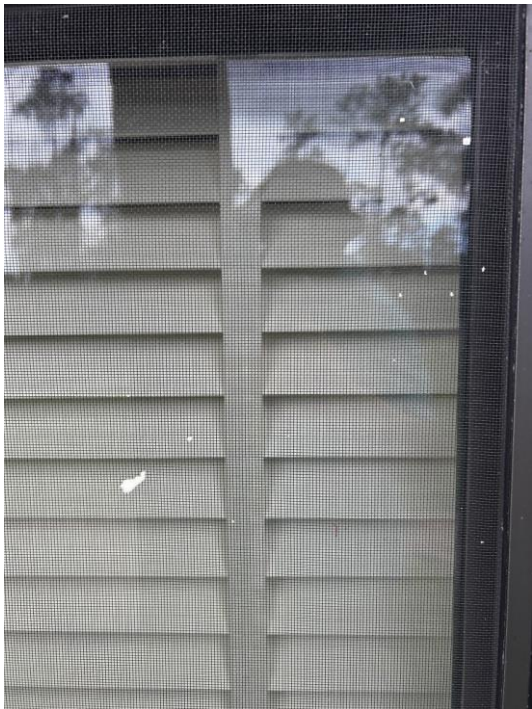
Photo 47

| Paint on screen mesh of window | 15209: north side ground level of unit 102 | 47 | No |

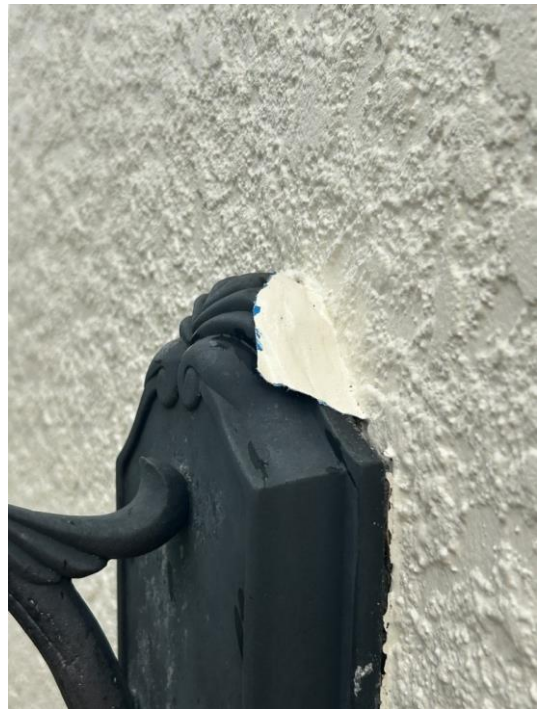
Photo 48

| Painters tape on light fixture | 15213: unit 101 | 48 | No |

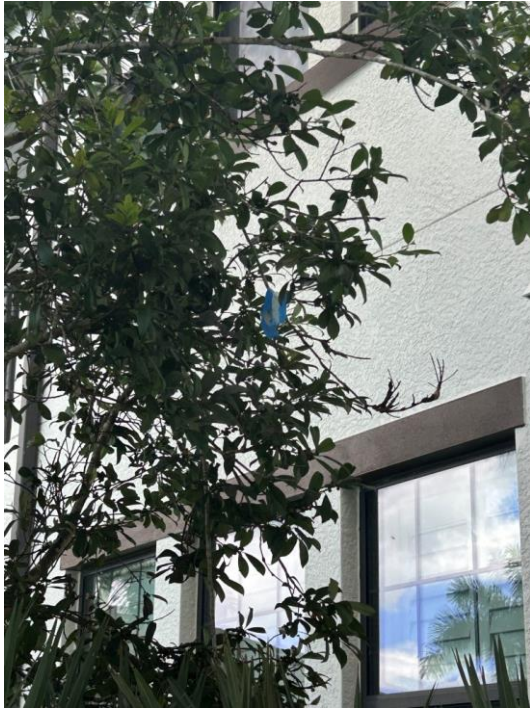
Photo 49

| painters tape in tree | 15213: lake side of building | 49 | No |

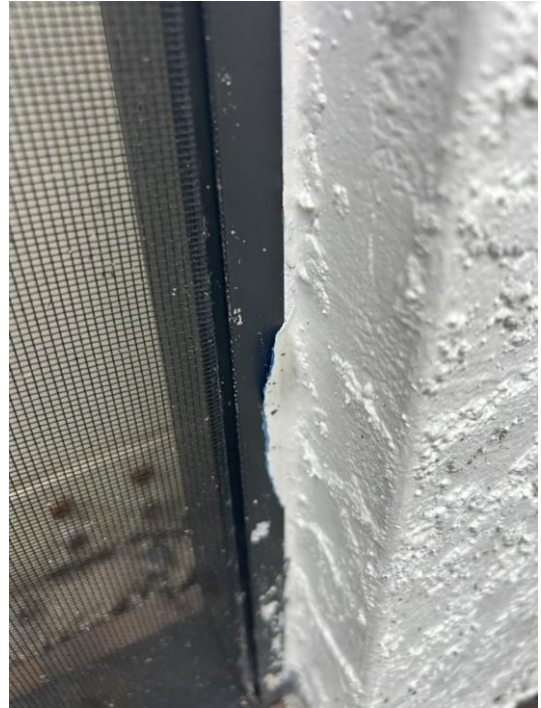
Photo 50

| Painters tape on screen frame | 15213: north side of unit 102 | 50 | No |

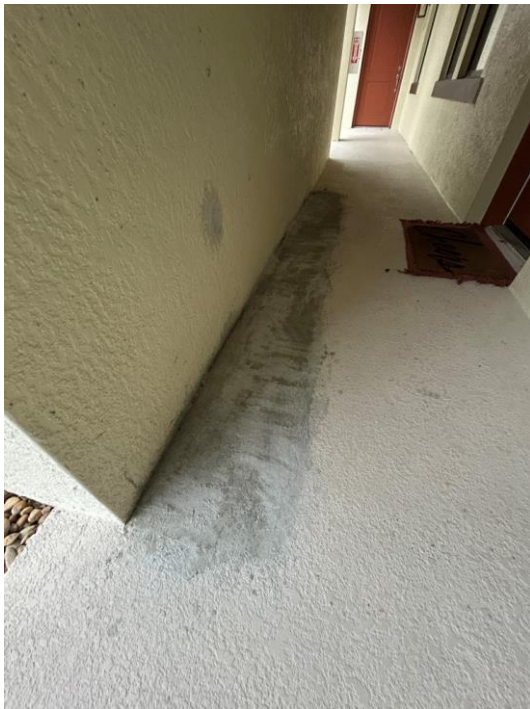
Photo 51

| Floor not painted | <b>NOTE: NOT IN CARRIAGE HOMES</b><br><br>This is outside unit 102, in bldg. 15098 of Garden Homes. | 51 | No |

**NOTE: NOT IN CARRIAGE HOMES**

This is outside unit 102, in bldg. 15098 of Garden Homes
