W.J. JOHNSON & ASSOCIATES

February 17, 2023

SUBJECT: Livingston Lakes
Water Intrusion Inspections
Project #: 17035.05

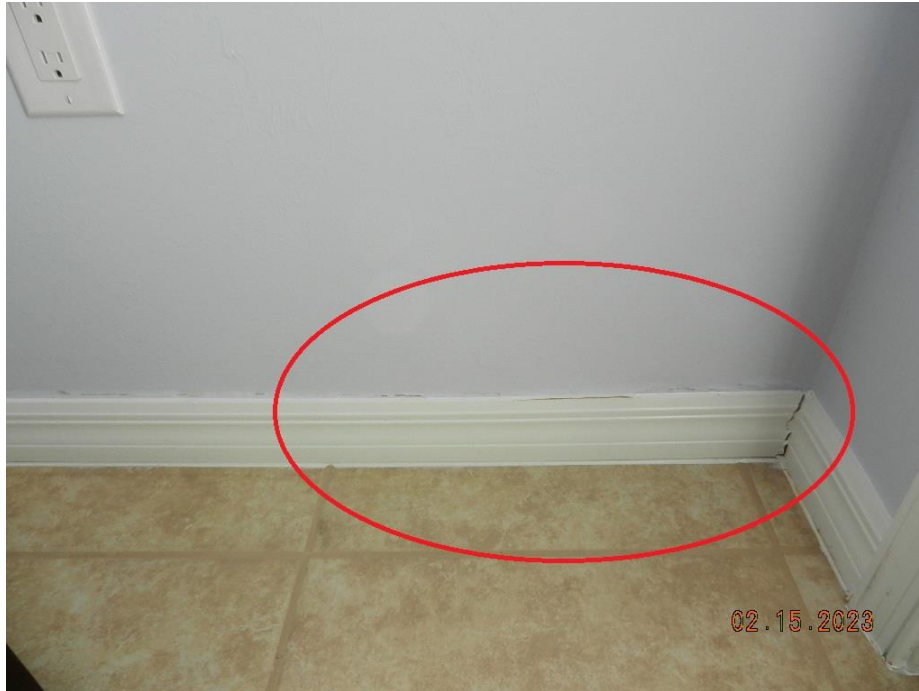
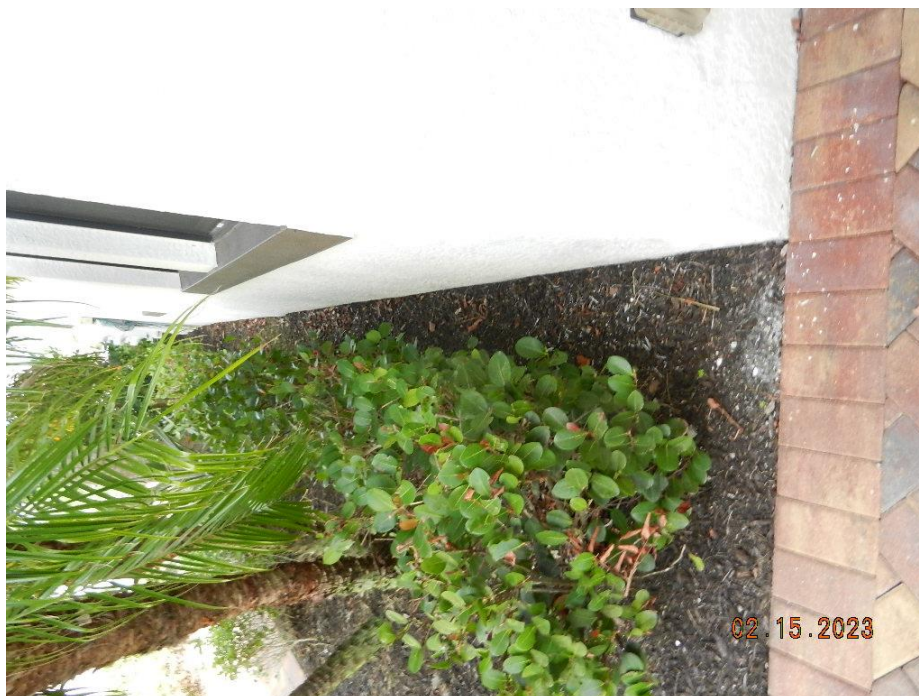
Each of these units is an end unit and they all have landscape grading that is pitched towards the building. During the hurricane, the probability is high that the gutters and downspouts were overwhelmed and overflowed along the side of the building causing ponding. Couple this with the negative pressure that occur during high winds would cause the water to infiltrate through the concrete slab and block transition.

- Landscape areas along the buildings should be lowered and graded to drain away from the building.
- Gutters and downspouts should be cleaned a minimum of four times per year.
- Downspout drains at grade should be replaced with a more durable product and pitched away from the building.
- Landscape beds should be cleaned prior to applying new mulch.
- Repair delaminating stucco at 15110 Unit 105.
- Excavate and inspect the balcony at building 15110 to determine the extent for concrete damage. Any additional units with this condition should be inspected and repaired.

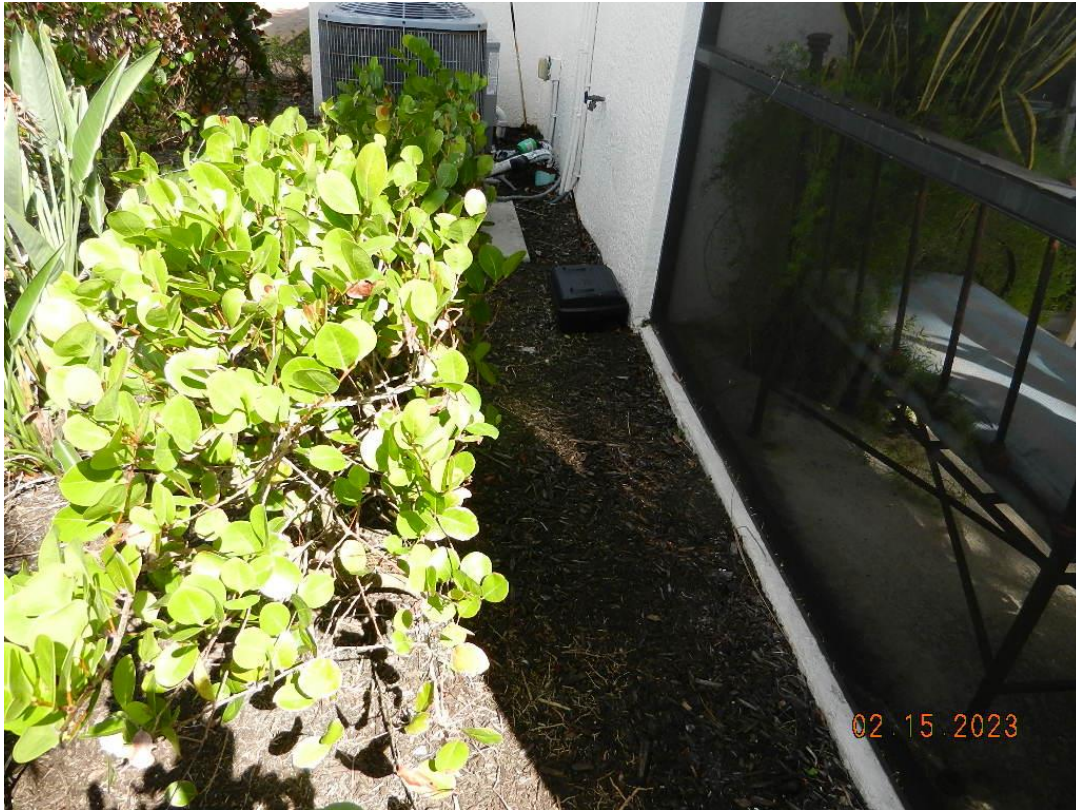
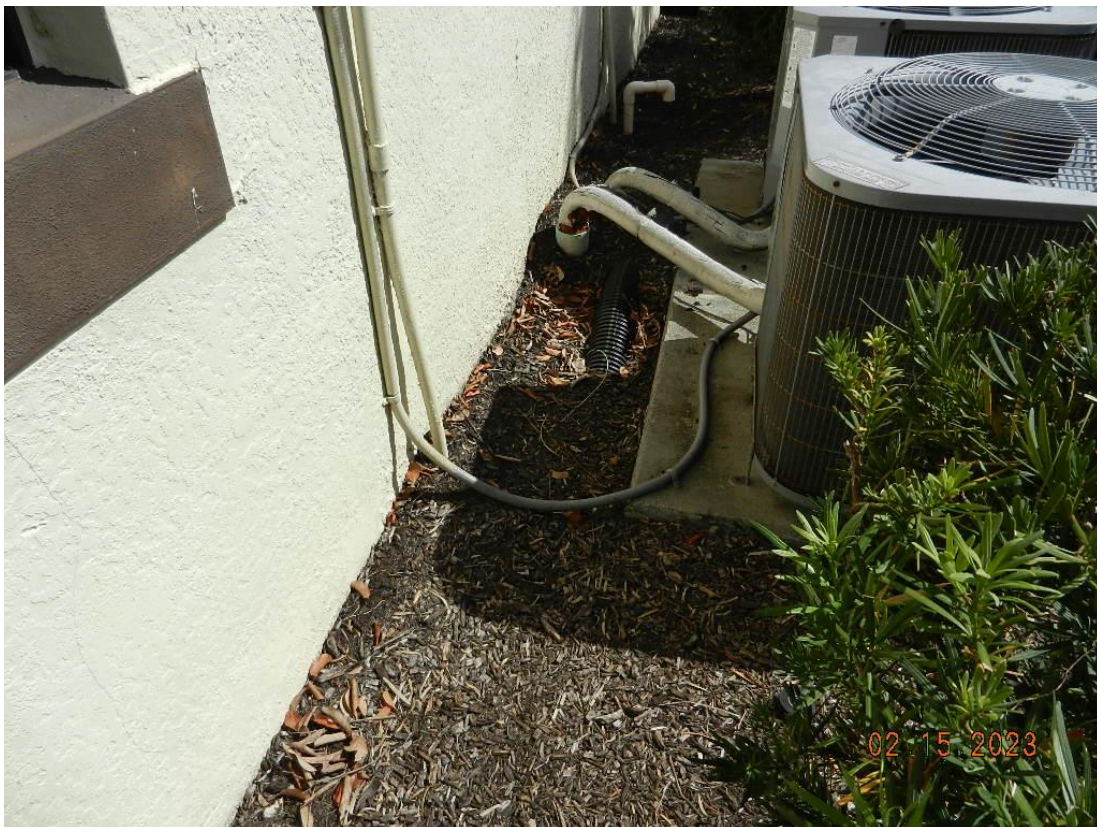
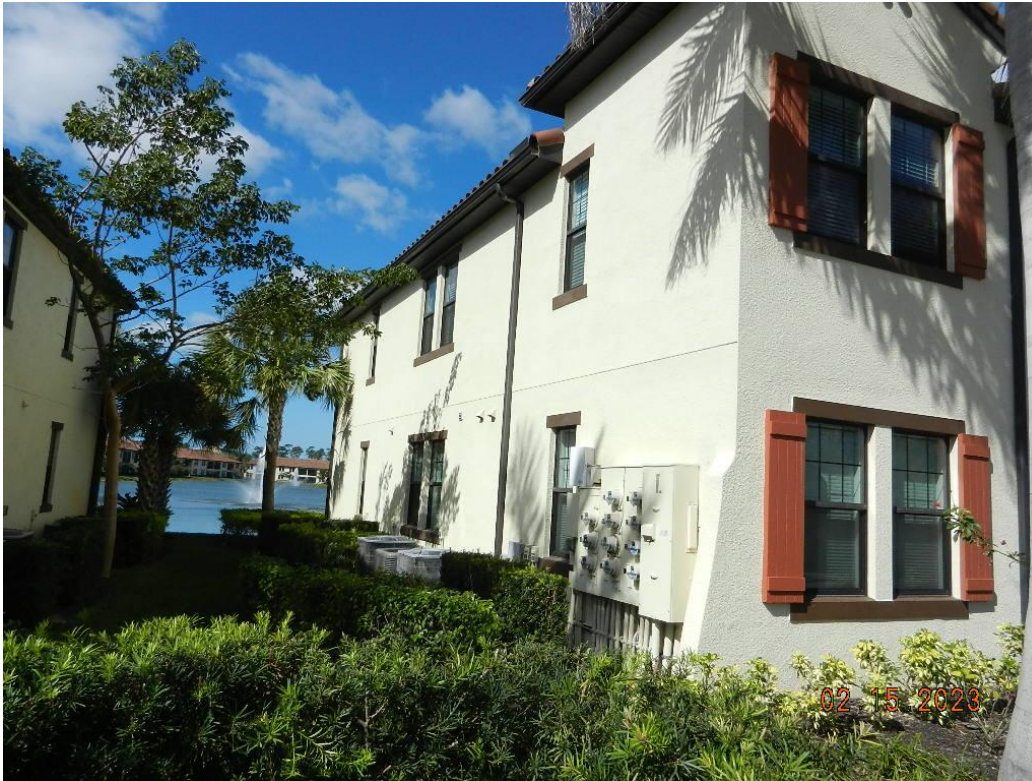
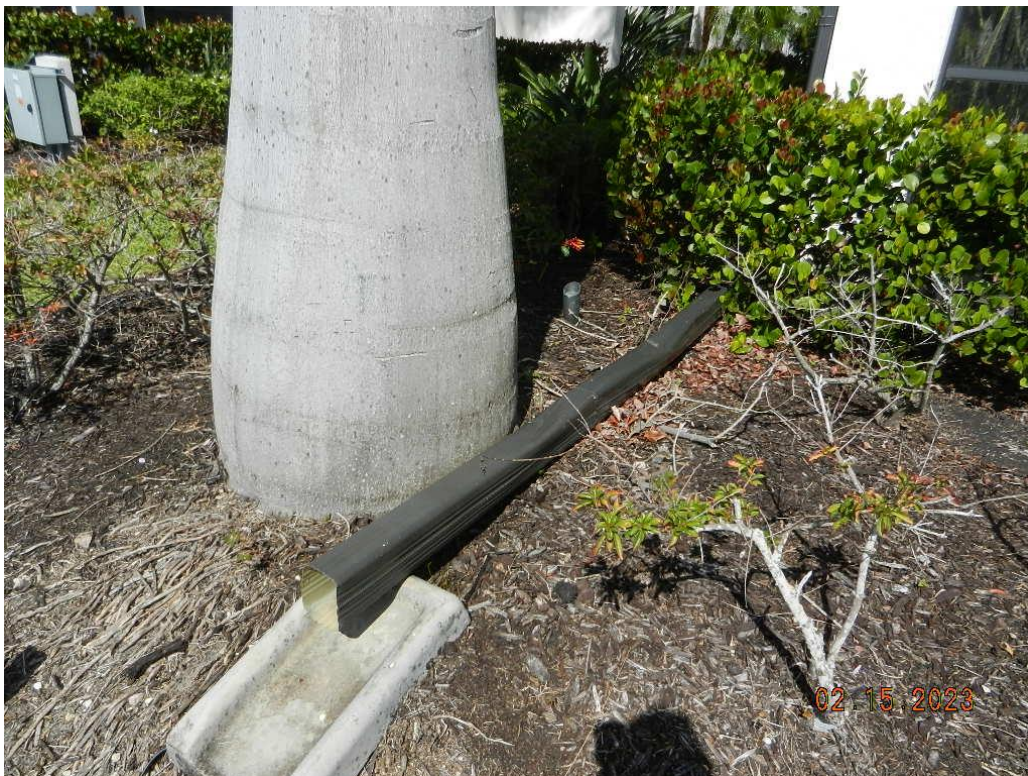
Damaged Down Spout with Negative Pitch

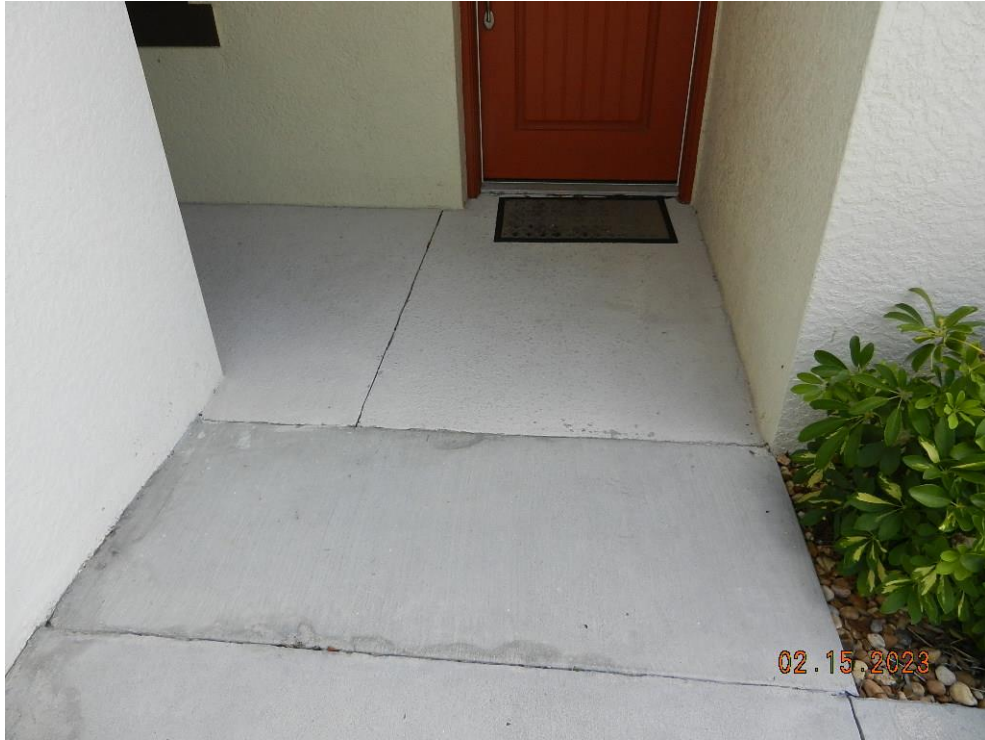
Several walkways pitched towards the entry area

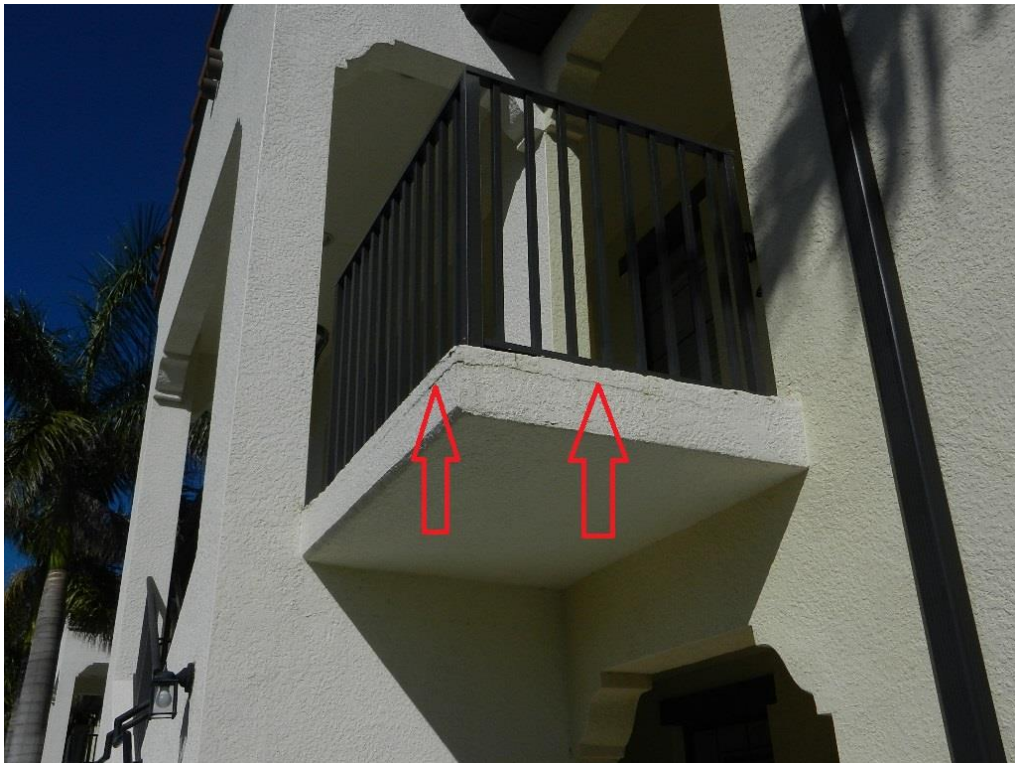
Stucco Delamination at Building 15110 with Potential Concrete / Rebar Damage

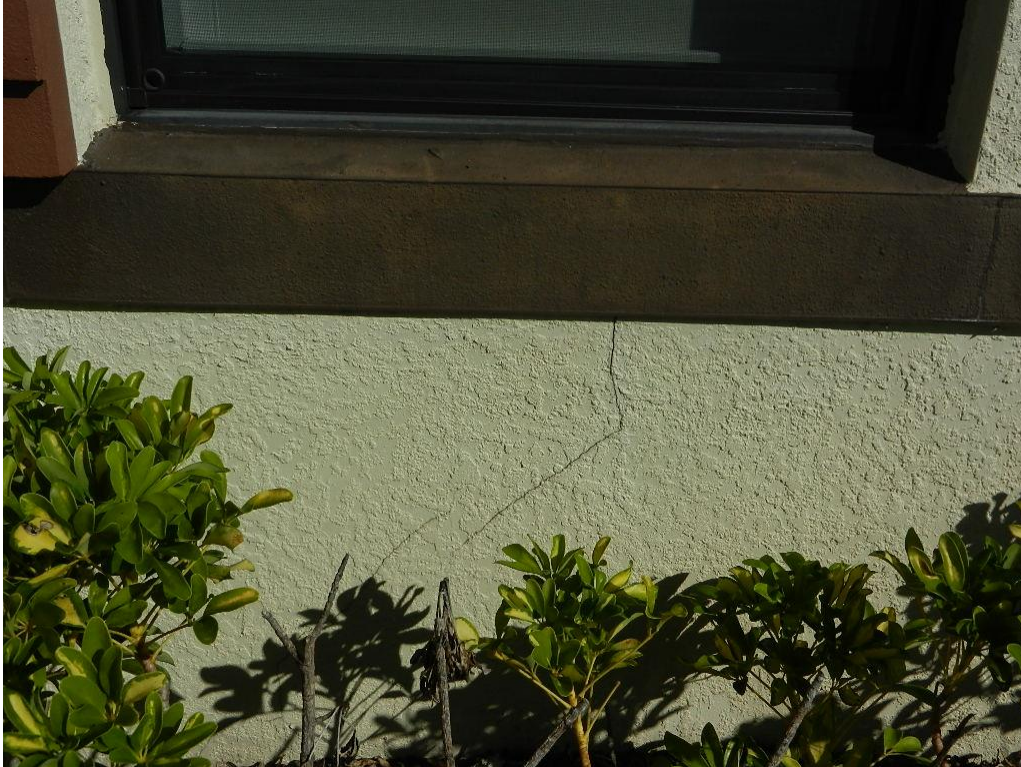
Stucco Delamination at 15110 Unit #105

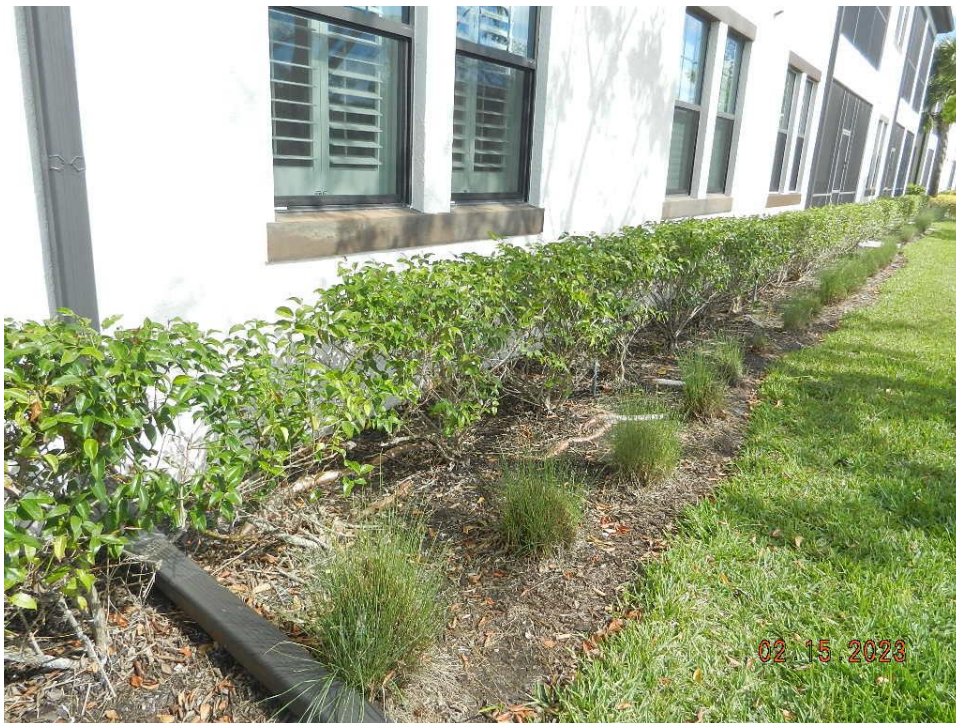
Tree Roots Encroaching on the Building Foundation at 15140 Unit 103
