# Inspection Report

**Facility:** Livingston Lakes Condo

Work Order #: 13028

**Re.: Inspection Report (2 of 3) for Livingston Lakes**

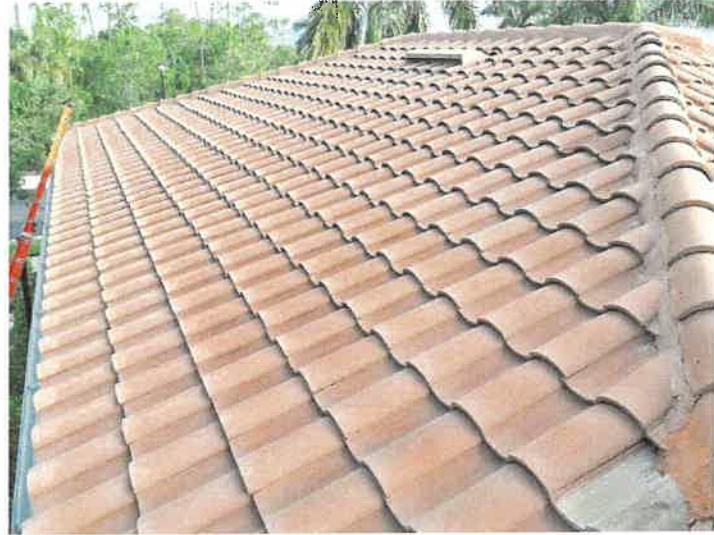
Pool House: Surface Overview  
The roof surface appears to be in good, maintainable condition at this time.

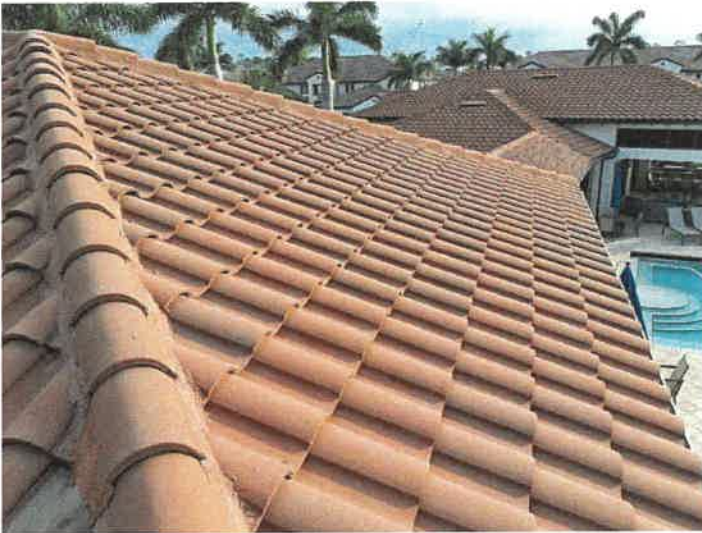
Pool House: Appearance Overview  
The roof appearance is in good, maintainable condition.

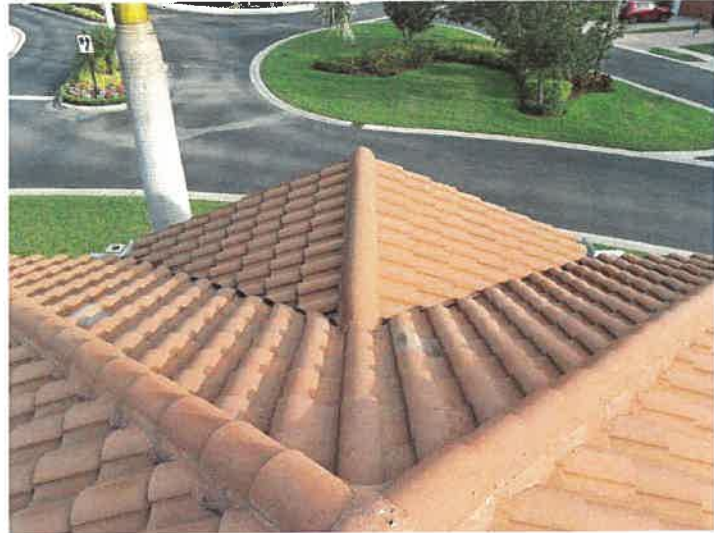
Pool House: Surface Overview  
The roof surface appears to be in good, maintainable condition at this time.

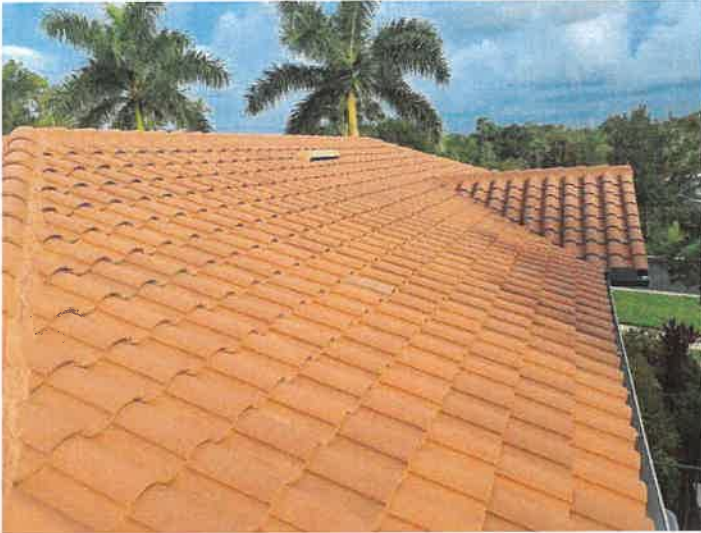
Pool House: Appearance Overview

The roof appearance is in good, maintainable condition.

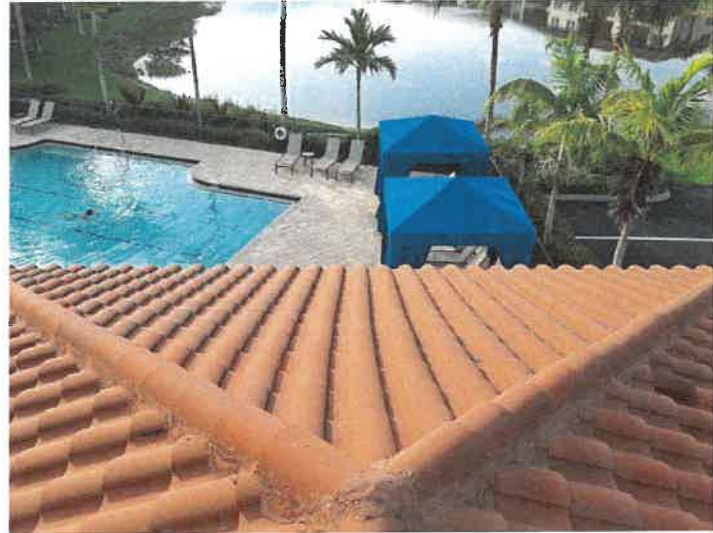
Pool House: Field Tiles

Field tiles appear to be in good condition.

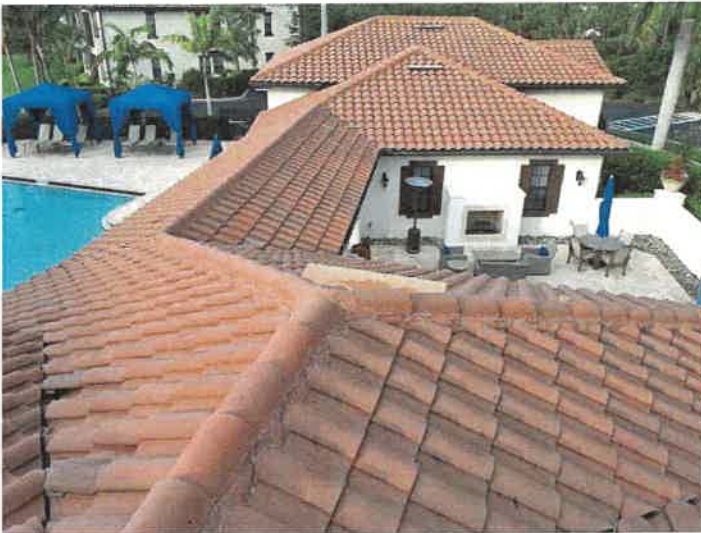
Pool House: Ridge Tiles

Ridge tiles appear to be in good condition.

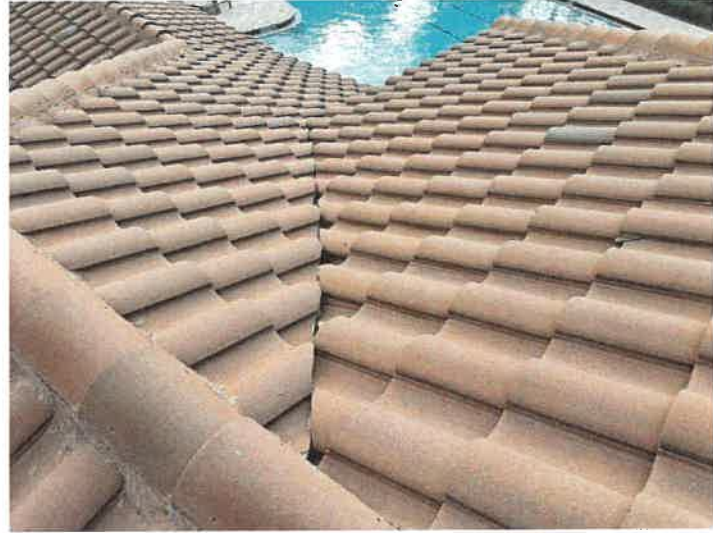
Pool House: Valley

The valley tiles appear to be in good condition.

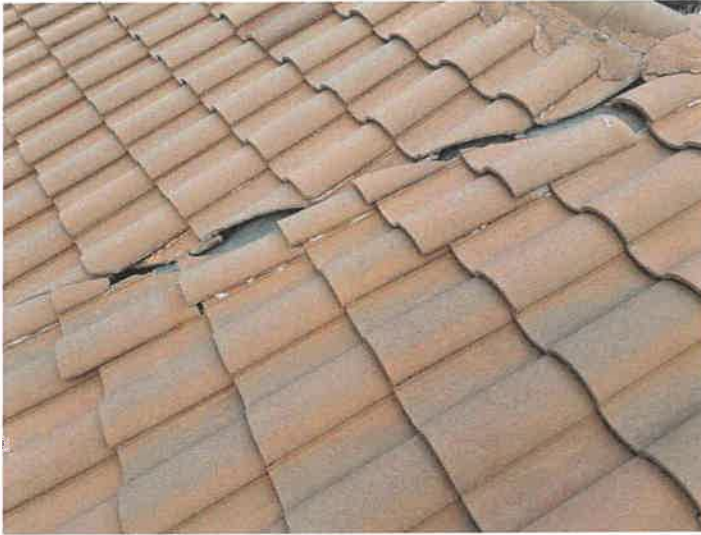
Pool House: Displaced/Missing Roof Tile

Displaced or missing roof tiles can allow premature underlayment deterioration from excessive UV exposure and potential water intrusion.

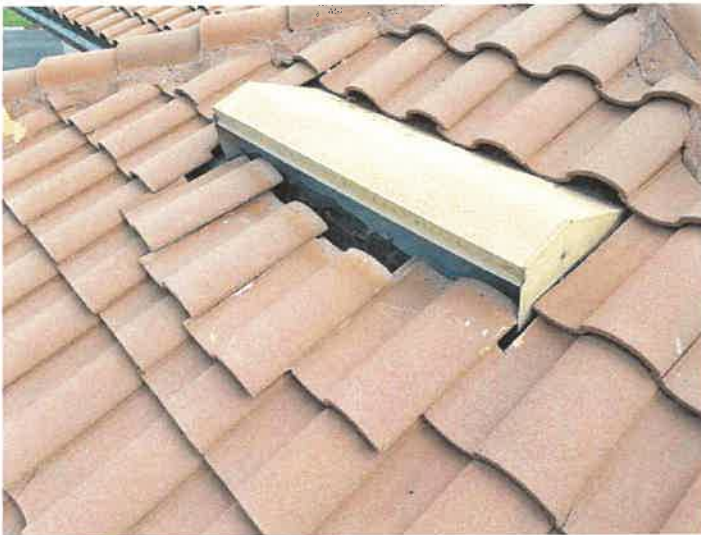
Pool House: Displaced/Missing Roof Tile

Displaced or missing roof tiles can allow premature underlayment deterioration from excessive UV exposure and potential water intrusion.

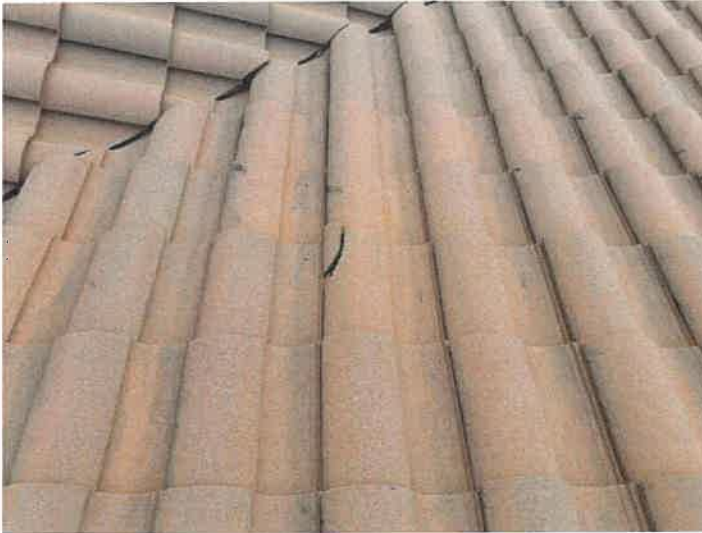
**Pool House: Identified Cracked Roof Tiles**  
Cracked roof tiles can allow premature underlayment deterioration from excessive UV exposure.

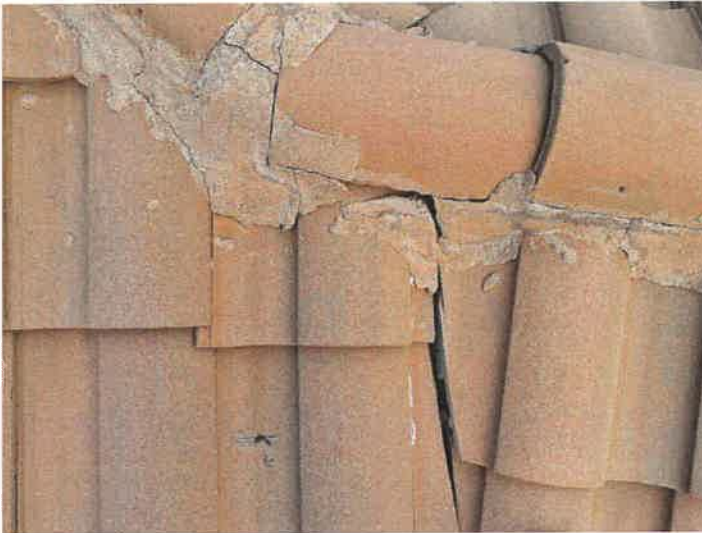
**Pool House: Displaced/Missing Roof Tile**  
Displaced or missing roof tiles can allow premature underlayment deterioration from excessive UV exposure and potential water intrusion.

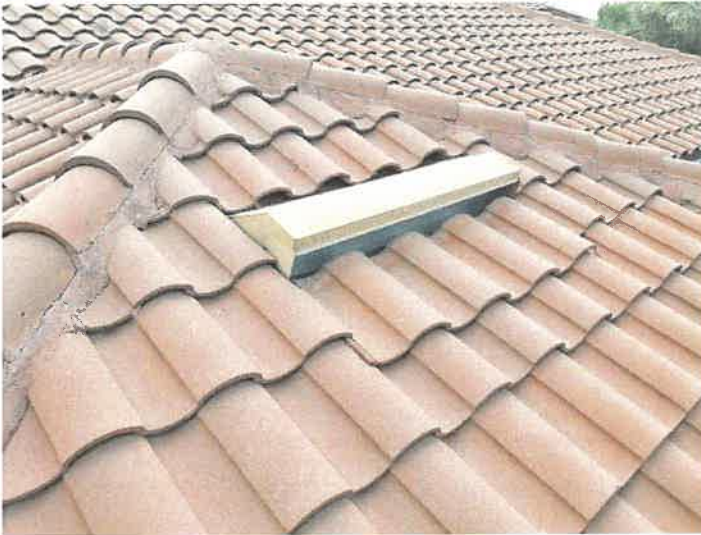
Pool House: Roof Vents

Roof vents appear to be in good condition.

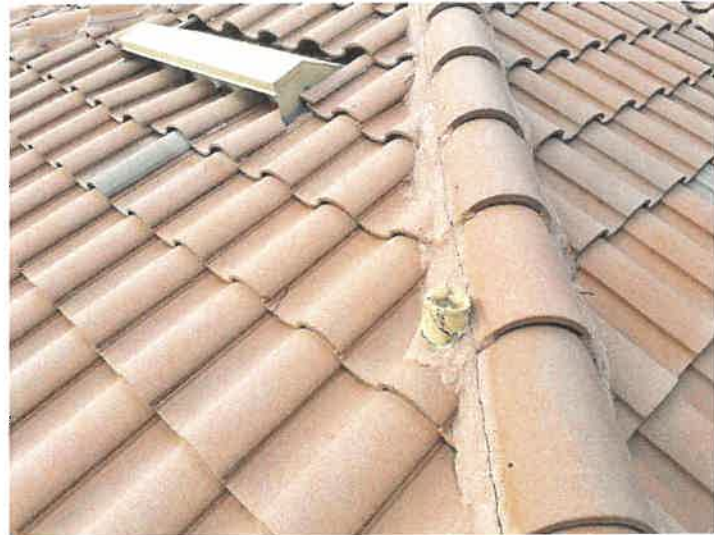
Pool House: Lead Boots

Lead boots appear to be in good condition.

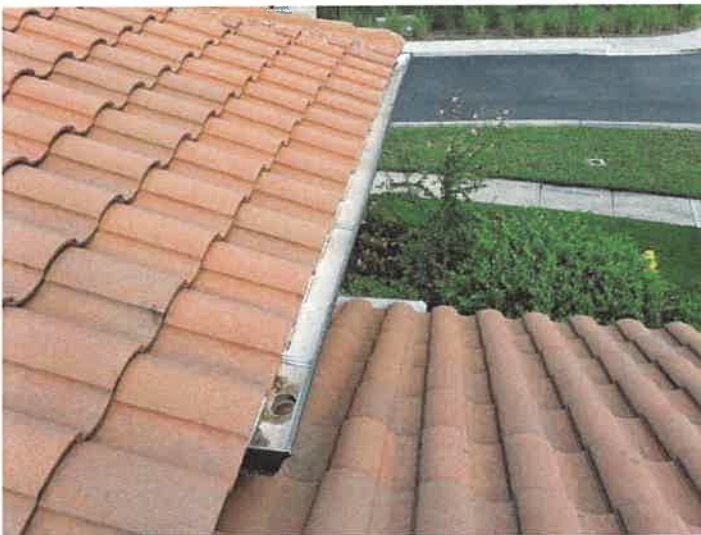
Pool House: Gutters

The gutters appear to be in good condition.

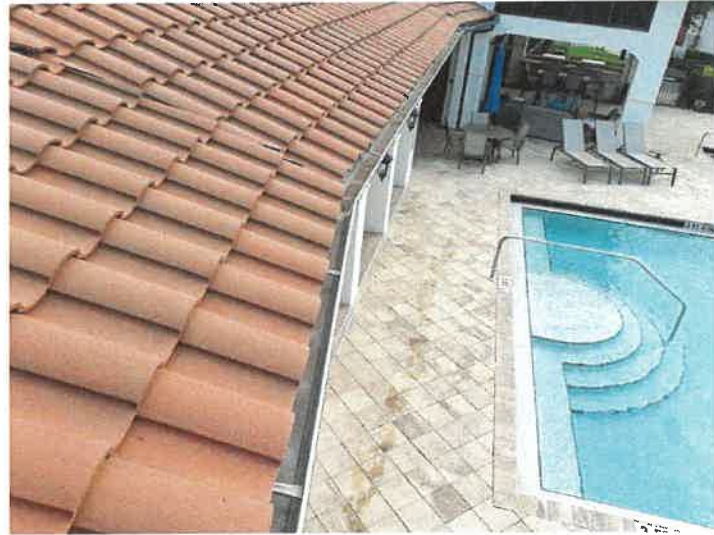
Pool House: Gutters

The gutters appear to be in good condition.

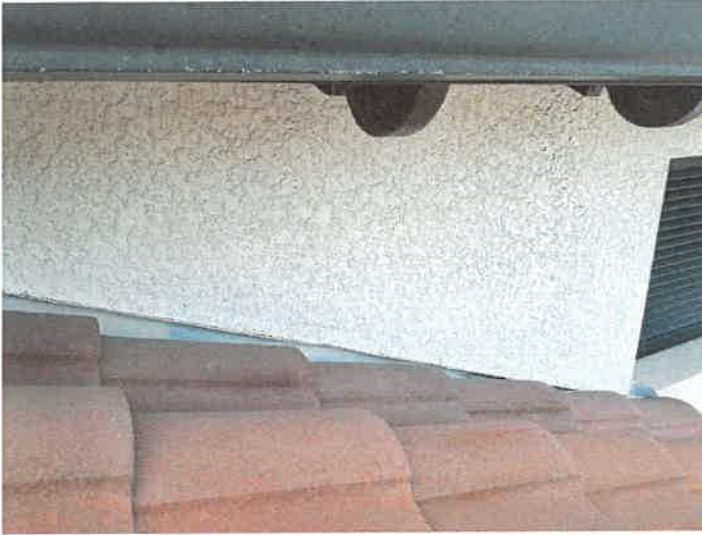
Pool House: Wall

The walls appear to be in good condition.

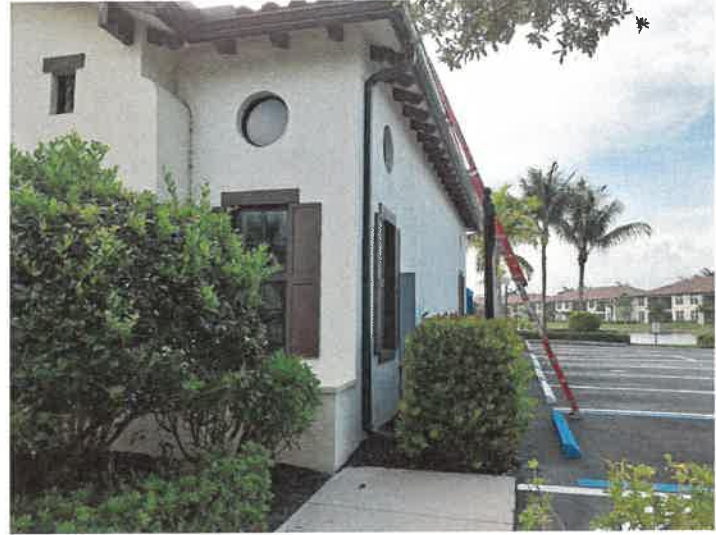
Pool House: Downspouts

The downspouts appear to be in good condition.

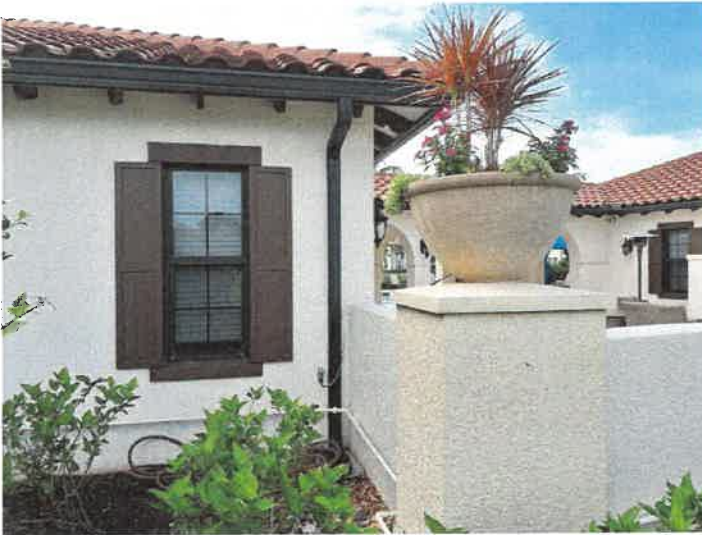
Pool House: Downspouts

The downspouts appear to be in good condition.

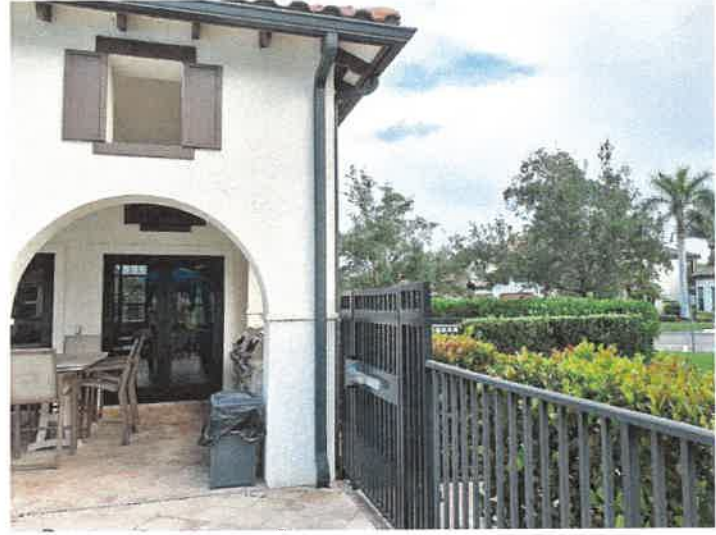
Pool House: Downspouts

The downspouts appear to be in good condition.
