Inspection Report

Facility: Livingston Lakes Condo

Work Order #: 13028

Re.: **Inspection Report (2 of 3) for Livingston Lakes**

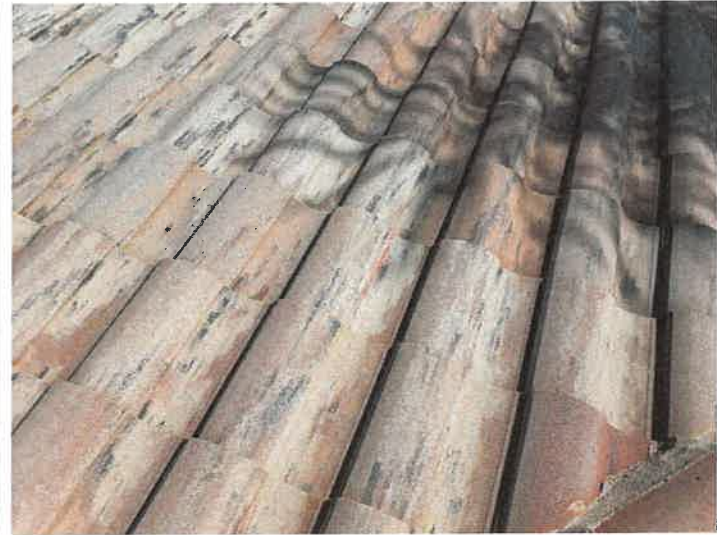
Building 15161: Identified Cracked Roof Tiles
Cracked roof tiles can allow premature underlayment deterioration from excessive UV exposure.

Building 15161: Repaired Cracked Roof Tiles
The cracked roof tiles were repaired with Titebond sealant.

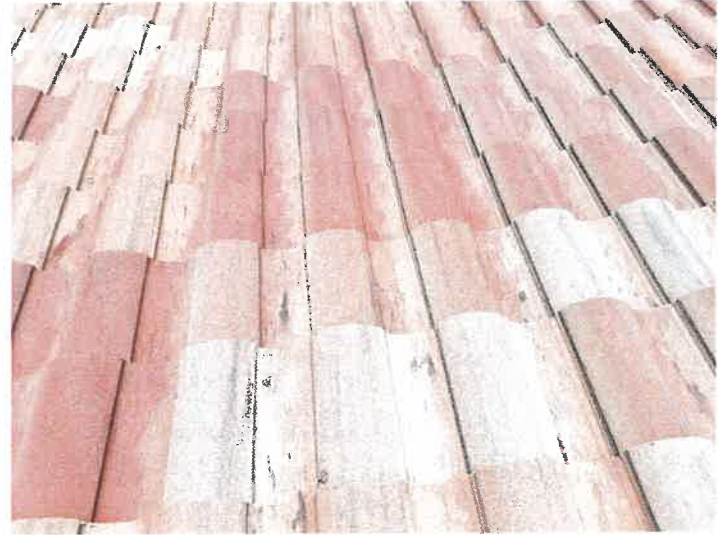
Building 15165: Identified Cracked Roof Tiles

Cracked roof tiles can allow premature underlayment deterioration from excessive UV exposure.

Building 15165: Repaired Cracked Roof Tiles

The cracked roof tiles were repaired with Titebond sealant.

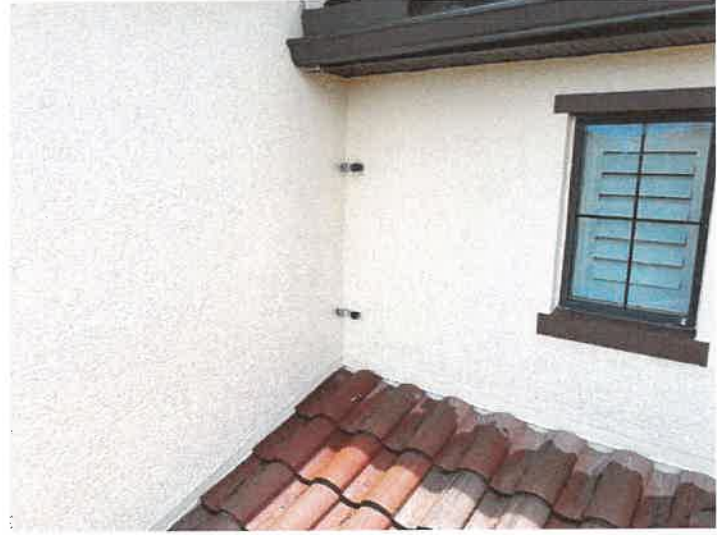
Building 15169: Downspout- missing

Downspout is missing. The painting company that is painting the exteriors in Livingston Lakes has the missing downspouts.

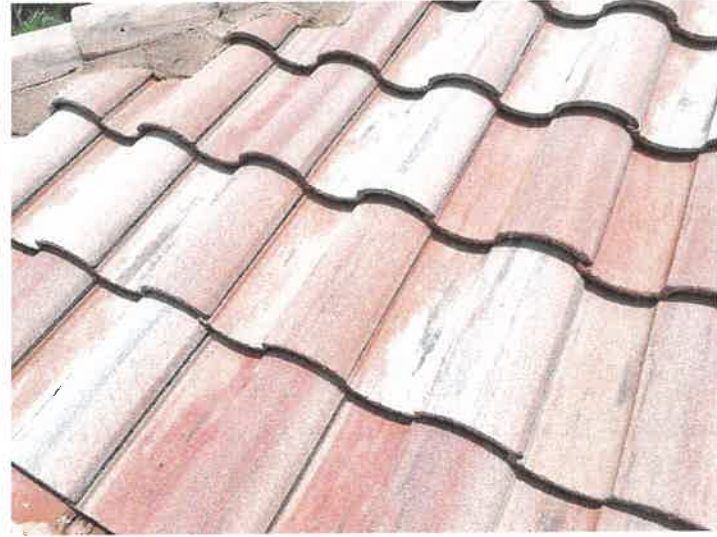
Displaced or missing roof tiles can allow premature underlayment deterioration from excessive UV exposure and potential water intrusion.

Building 15173: Repaired Displaced/Missing Roof Tile

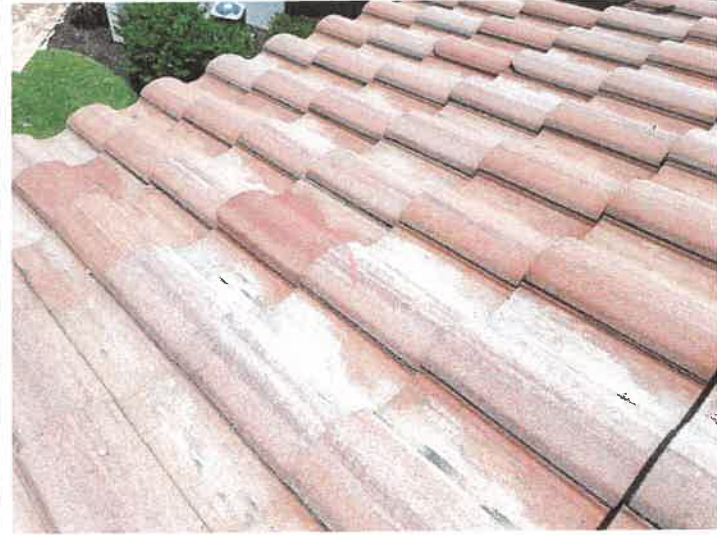
Cracked roof tiles can allow premature underlayment deterioration from excessive UV exposure.

Building 15173: Repaired Cracked Roof Tiles

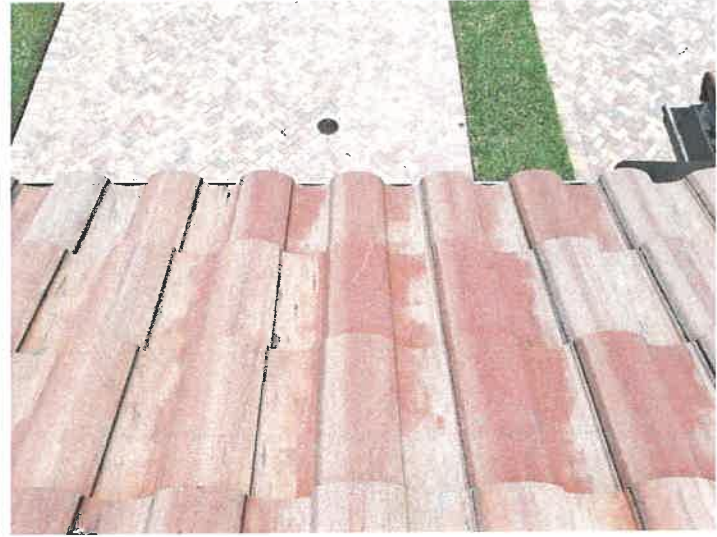
Building 15173: Identified Cracked Roof Tiles
Cracked roof tiles can allow premature underlayment deterioration from excessive UV exposure.

Building 15173: Repaired Cracked Roof Tiles
The cracked roof tiles were repaired with Titebond sealant.

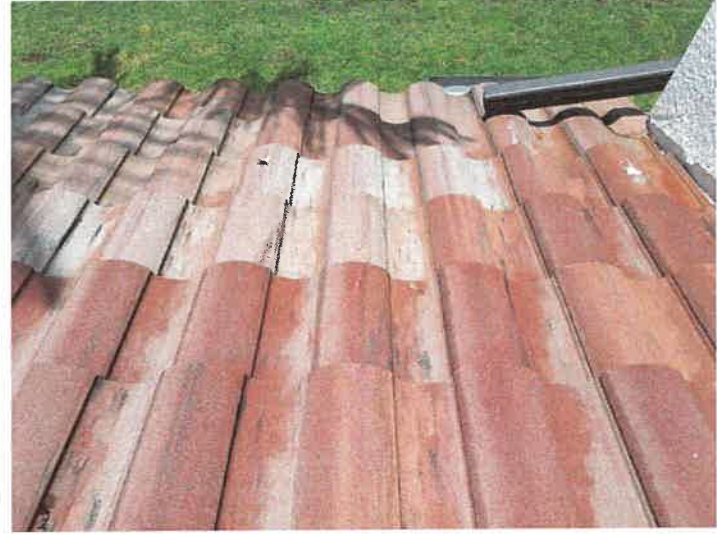
Building 15173: Identified Cracked Roof Tiles
Cracked roof tiles can allow premature underlayment deterioration from excessive UV exposure.

Building 15173: Repaired Cracked Roof Tiles
The cracked roof tiles were repaired with Titebond sealant.

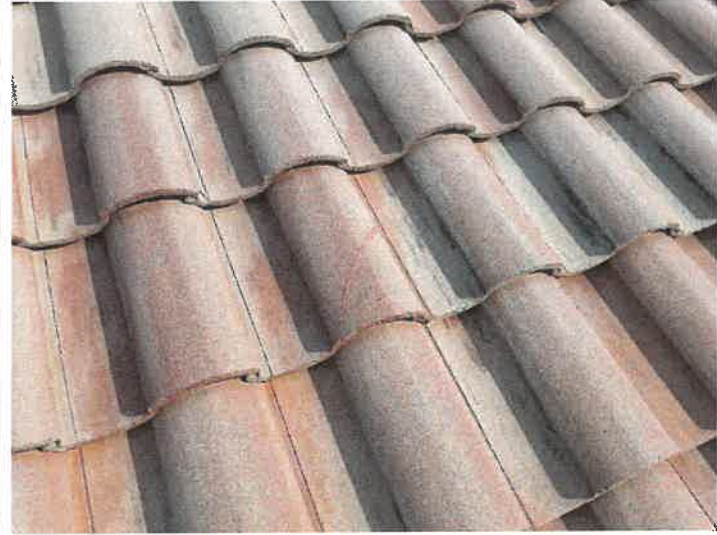
Cracked roof tiles can allow premature underlayment deterioration from excessive UV exposure.

Building 15177: Repaired Cracked Roof Tiles

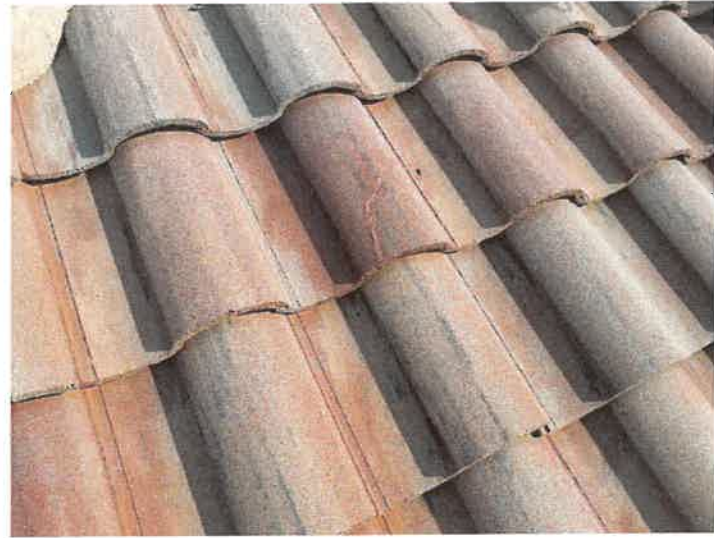
Building 15177: Identified Cracked Roof Tiles
Cracked roof tiles can allow premature underlayment deterioration from excessive UV exposure.

Building 15177: Repaired Cracked Roof Tiles
The cracked roof tiles were repaired with Titebond sealant.

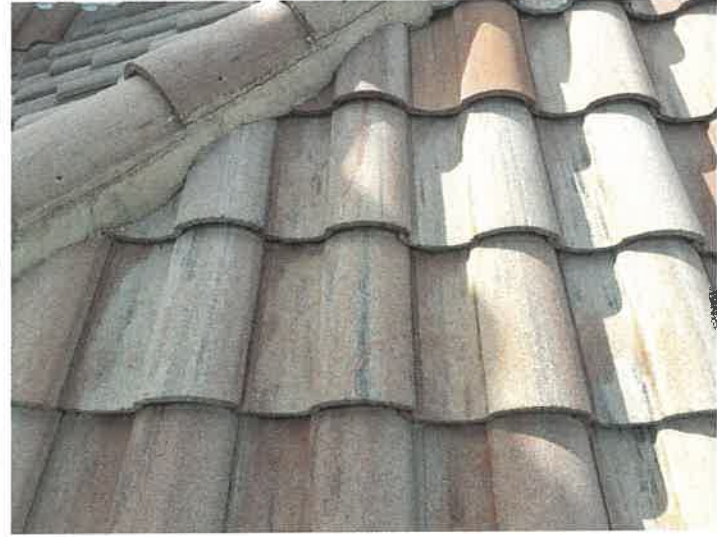
Building 15177: Identified Cracked Roof Tiles
Cracked roof tiles can allow premature underlayment deterioration from excessive UV exposure.

Building 15177: Repaired Cracked Roof Tiles
The cracked roof tiles were repaired with Titebond sealant.

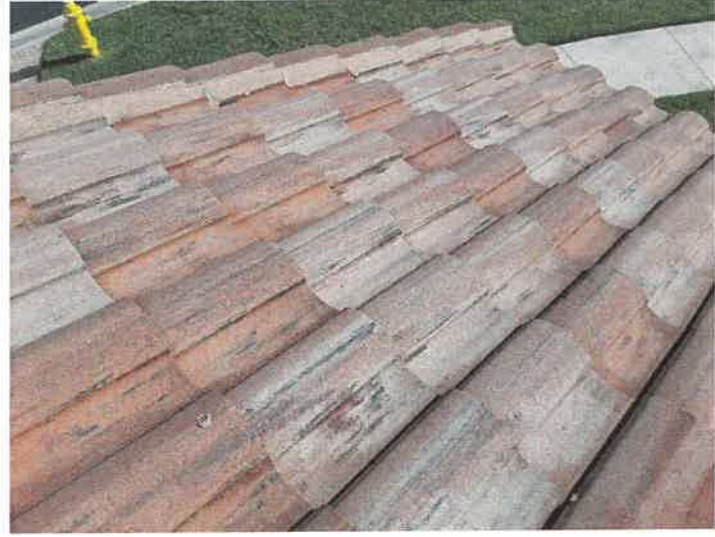
Building 15177: Identified Cracked Roof Tiles
Cracked roof tiles can allow premature underlayment deterioration from excessive UV exposure.

Building 15177: Repaired Cracked Roof Tiles
The cracked roof tiles were repaired with Titebond sealant.

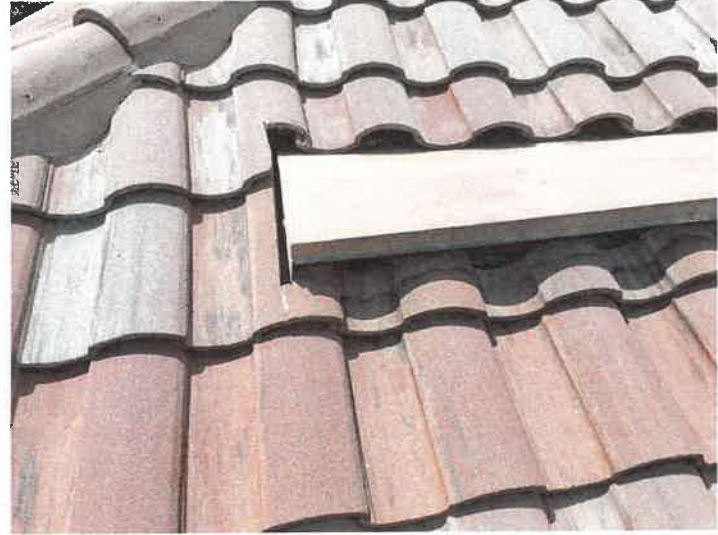
Building 15184: Identified Cracked Roof Tiles
Cracked roof tiles can allow premature underlayment deterioration from excessive UV exposure.

Building 15184: Repaired Cracked Roof Tiles
The cracked roof tiles were repaired with Titebond sealant.

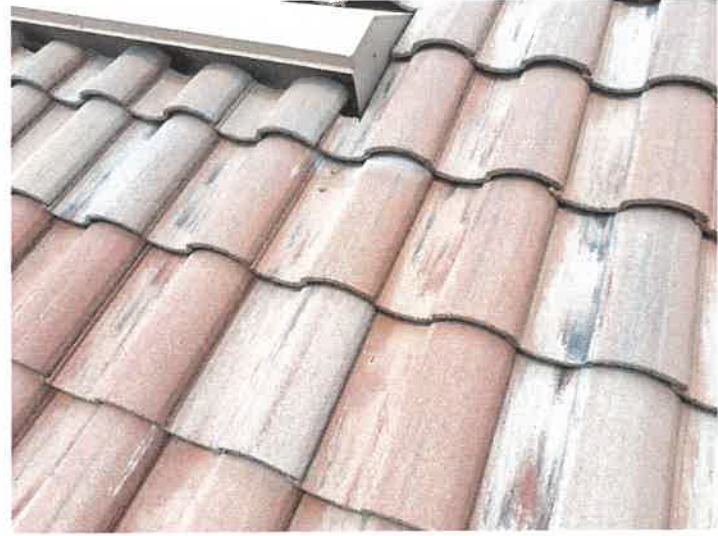
Building 15184: Displaced/Missing Roof Tile
Displaced or missing roof tiles can allow premature underlayment deterioration from excessive UV exposure and potential water intrusion.

Building 15184: Repaired Displaced/Missing Roof Tile
Replaced and secured the missing roof tile.

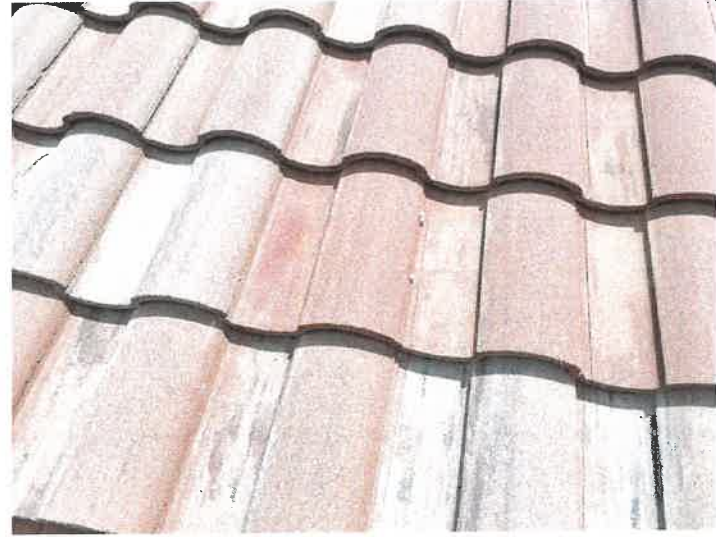
Displaced or missing roof tiles can allow premature underlayment deterioration from excessive UV exposure and potential water intrusion.

Building 15184: Repaired Displaced/Missing Roof Tile

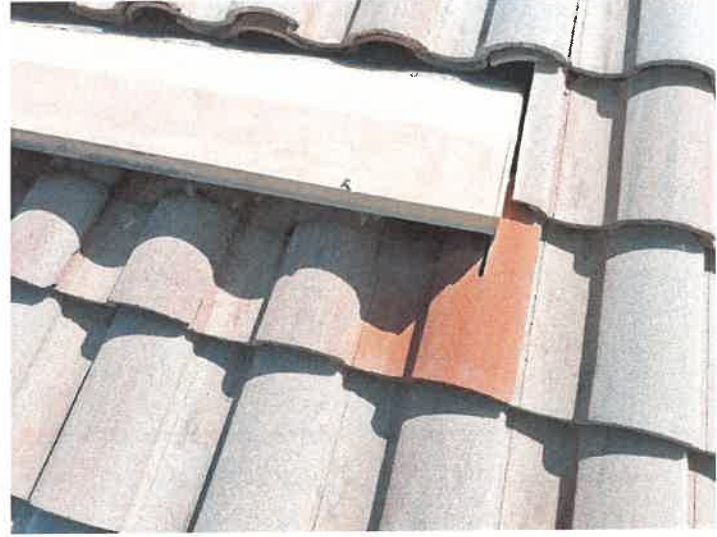
Displaced or missing roof tiles can allow premature underlayment deterioration from excessive UV exposure and potential water intrusion.

Building 15185: Repaired Displaced/Missing Roof Tile

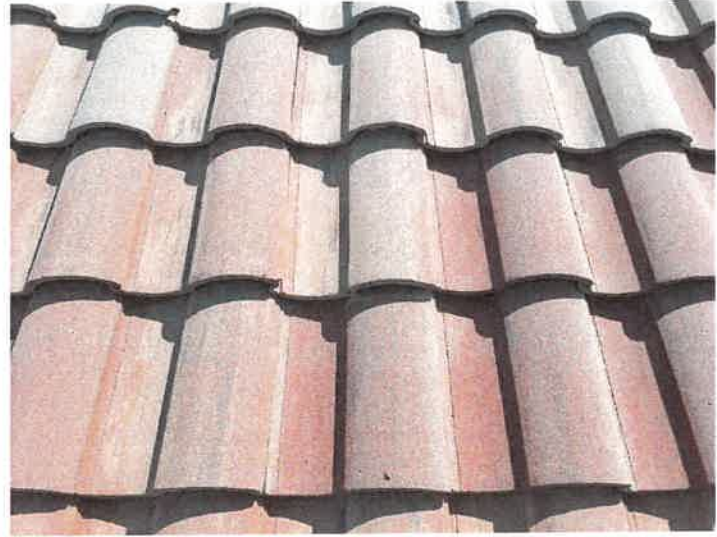
Displaced or missing roof tiles can allow premature underlayment deterioration from excessive UV exposure and potential water intrusion.

Building 15185: Repaired Displaced/Missing Roof Tile

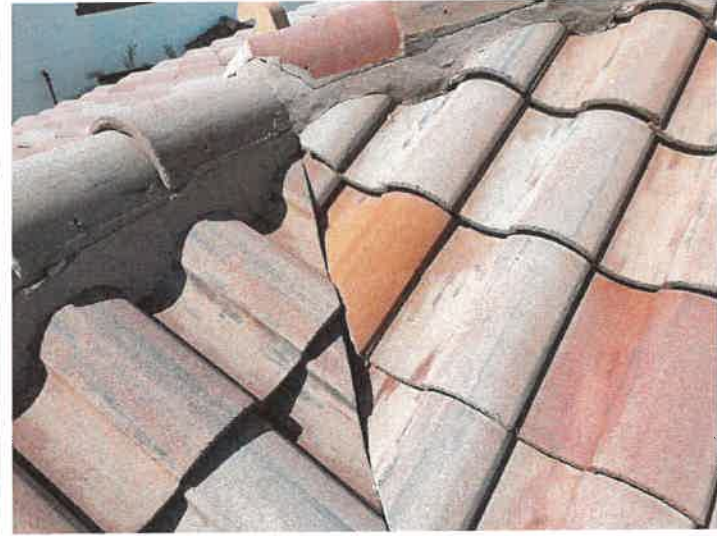
Building 15185: Identified Cracked Roof Tiles
Cracked roof tiles can allow premature underlayment deterioration from excessive UV exposure.

Building 15185: Repaired Cracked Roof Tiles
The cracked roof tiles were repaired with Titebond sealant.

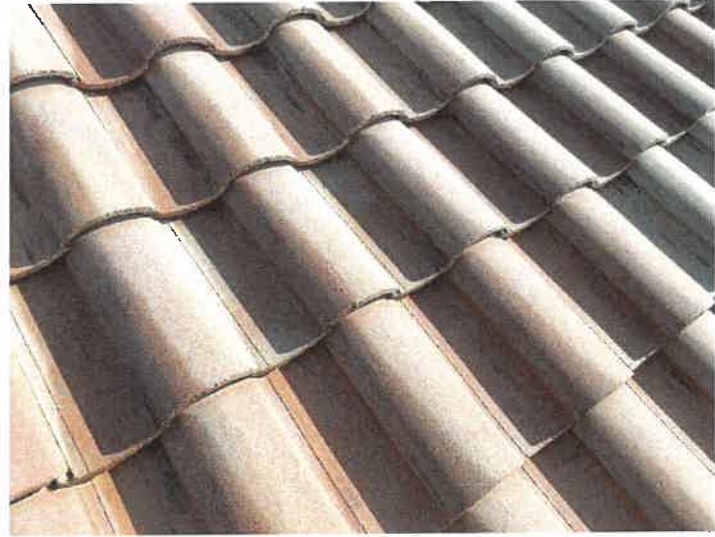
Building 15189: Identified Cracked Roof Tiles
Cracked roof tiles can allow premature underlayment deterioration from excessive UV exposure.

Building 15189: Repaired Cracked Roof Tiles
The cracked roof tiles were repaired with Titebond sealant.

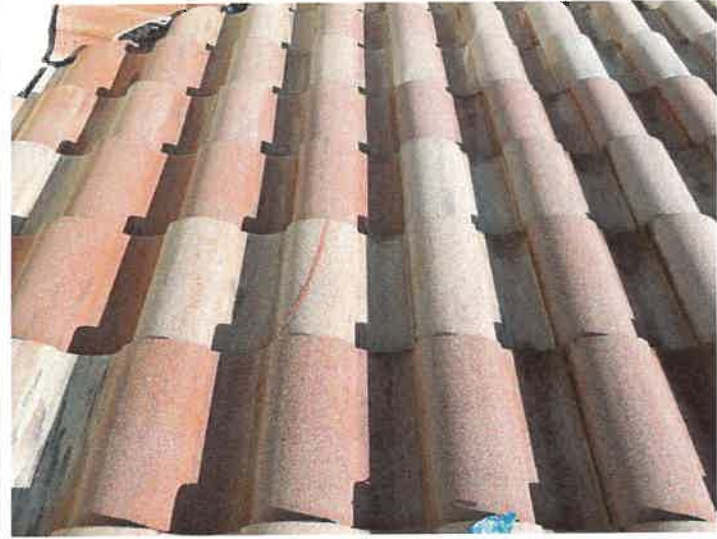
Building 15189: Identified Cracked Roof Tiles
Cracked roof tiles can allow premature underlayment deterioration from excessive UV exposure.

Building 15189: Repaired Cracked Roof Tiles
The cracked roof tiles were repaired with Titebond sealant.

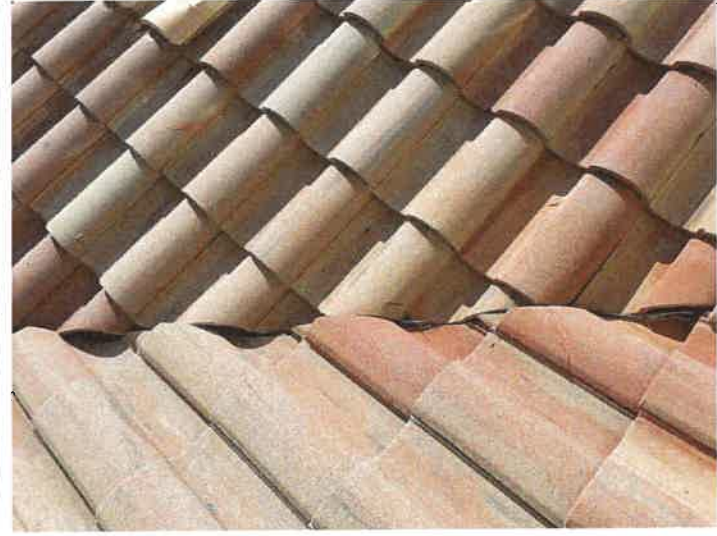
Building 15189: Identified Cracked Roof Tiles
Cracked roof tiles can allow premature underlayment deterioration from excessive UV exposure.

Building 15189: Repaired Cracked Roof Tiles
The cracked roof tiles were repaired with Titebond sealant.

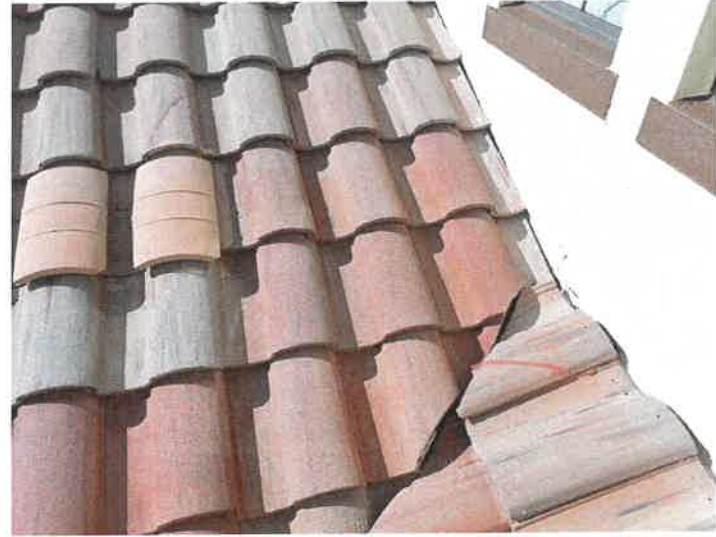
Building 15193: Identified Cracked Roof Tiles
Cracked roof tiles can allow premature underlayment deterioration from excessive UV exposure.

Building 15193: Repaired Cracked Roof Tiles
The cracked roof tiles were repaired with Titebond sealant.

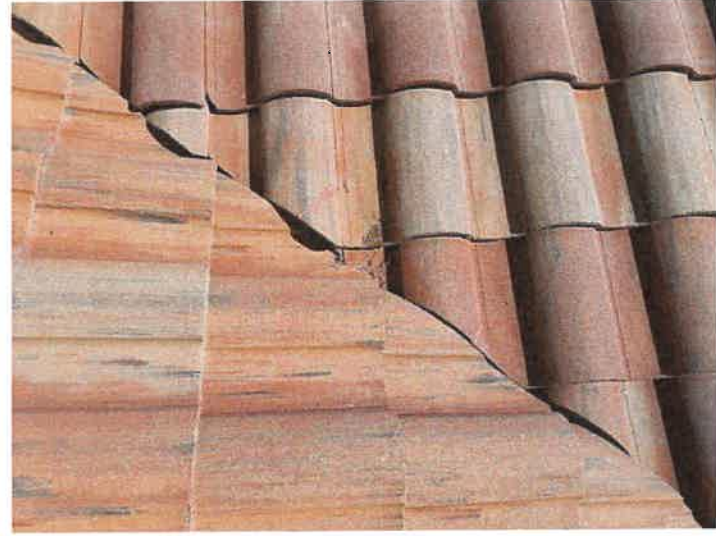
Building 15193: Identified Cracked Roof Tiles
Cracked roof tiles can allow premature underlayment deterioration from excessive UV exposure.

Building 15193: Repaired Cracked Roof Tiles
The cracked roof tiles were repaired with Titebond sealant.

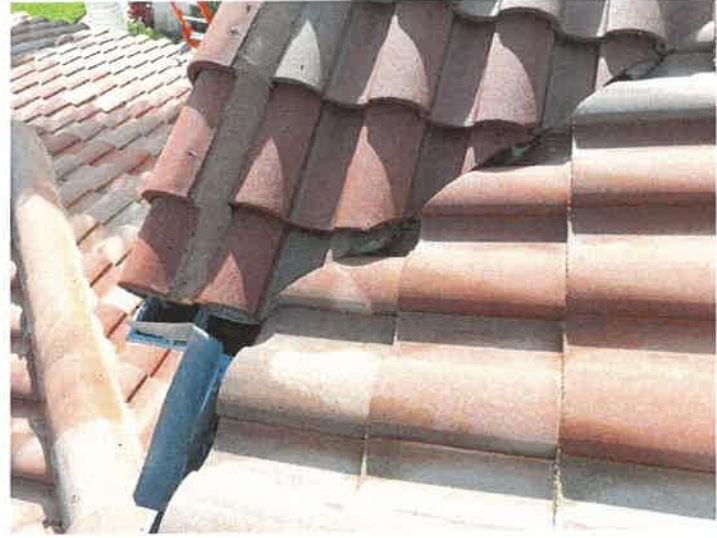
Building 15201: Identified Cracked Roof Tiles
Cracked roof tiles can allow premature underlayment deterioration from excessive UV exposure.

Building 15201: Repaired Cracked Roof Tiles
The cracked roof tiles were repaired with Titebond sealant.

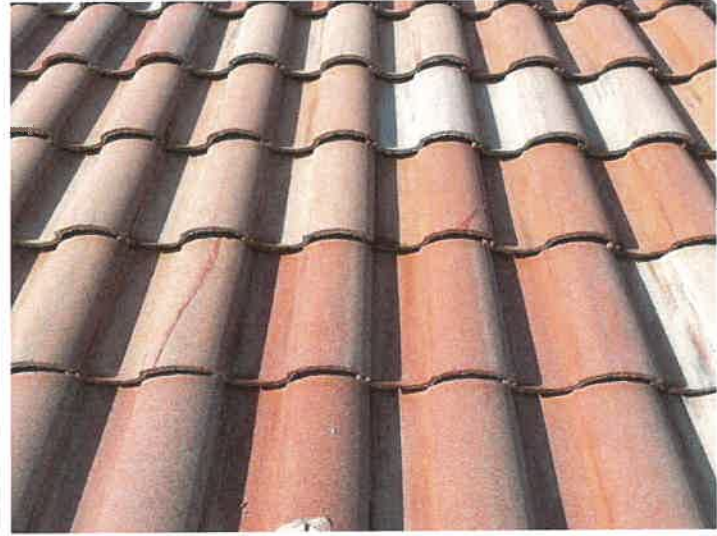
Building 15201: Identified Cracked Roof Tiles
Cracked roof tiles can allow premature underlayment deterioration from excessive UV exposure.

Building 15201: Repaired Cracked Roof Tiles
The cracked roof tiles were repaired with Titebond sealant.

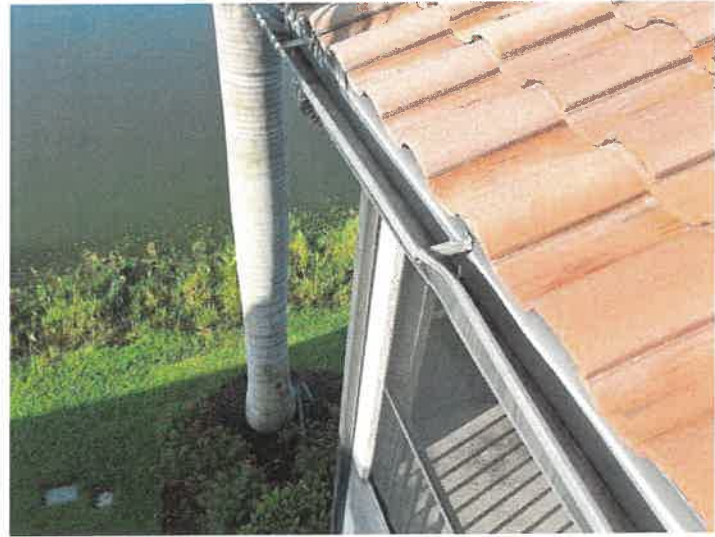
Building 15201: Gutter Metal- Broken
Gutter is broken and needs to be replaced. (1ft.6" residential model).

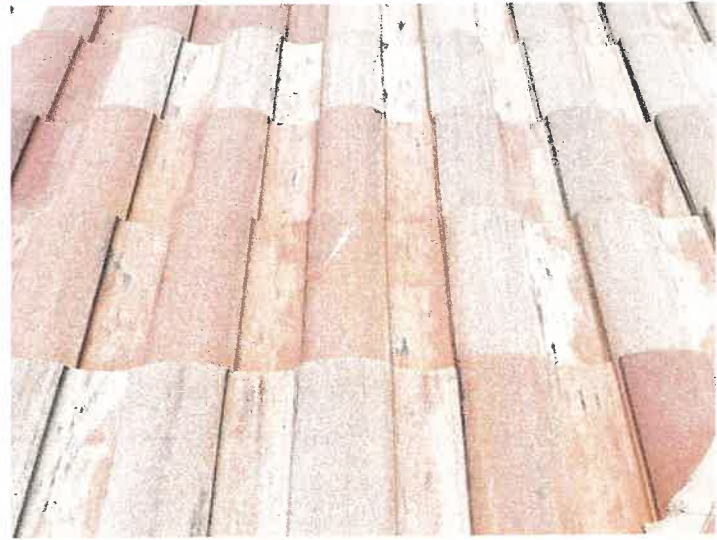
Cracked roof tiles can allow premature underlayment deterioration from excessive UV exposure.

Building 15205: Repaired Cracked Roof Tiles

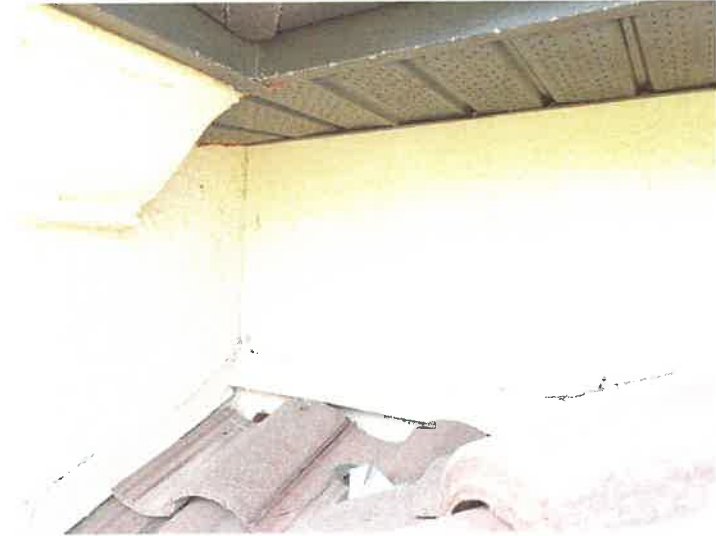
Building 15205: Loose Soffit
Identified 2-feet of loose soffit.

Building 15205: Completed Repair
Soffit was properly secured back into place.

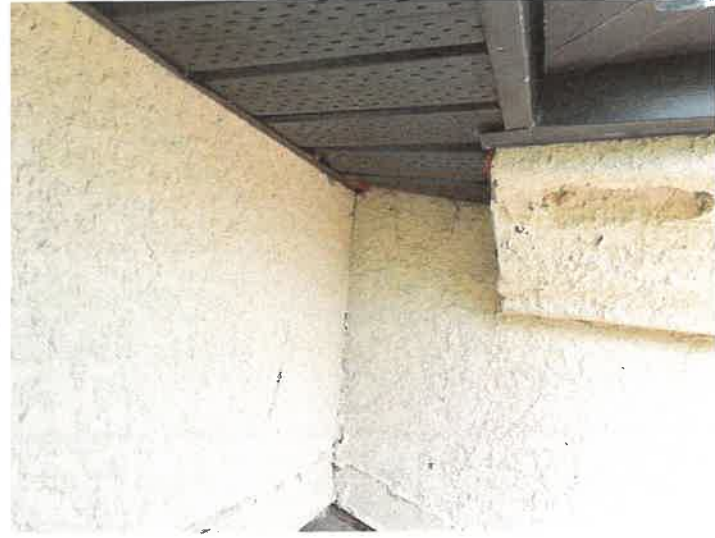
Building 15205: Loose Soffit
Identified 2-feet of loose soffit.

Building 15205: Completed Repair
Soffit was properly secured back into place.

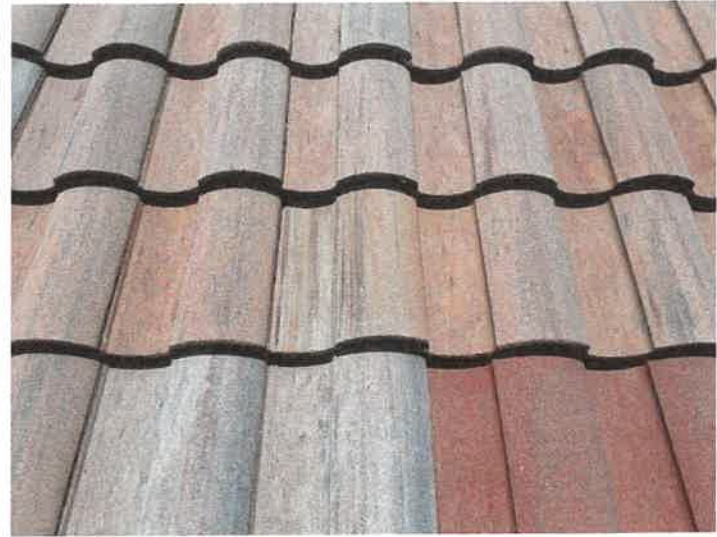
Displaced or missing roof tiles can allow premature underlayment deterioration from excessive UV exposure and potential water intrusion.

Building 15213: Repaired Displaced/Missing Roof Tile
