Inspection Report

Facility: Livingston Lakes Condo
Address: 15098 Palmer Lake Circle,
Naples, FL 34109
Customer: Cardinal Management
Address: c/o Livingston Lakes Condo, 15090
Naples, FL 34109

Livingston Lakes Condo, Naples, FL

Re.: **Inspection Report (2 of 3) for Livingston Lakes**

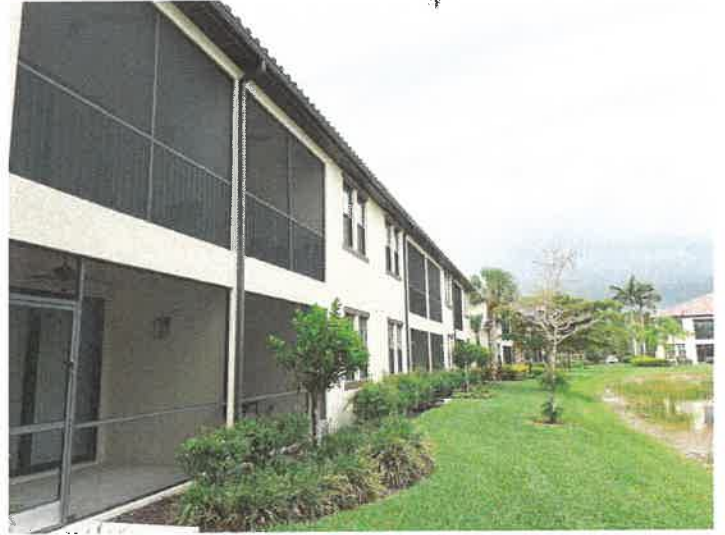
Building 15130: Downspouts

The downspouts appear to be in good condition.

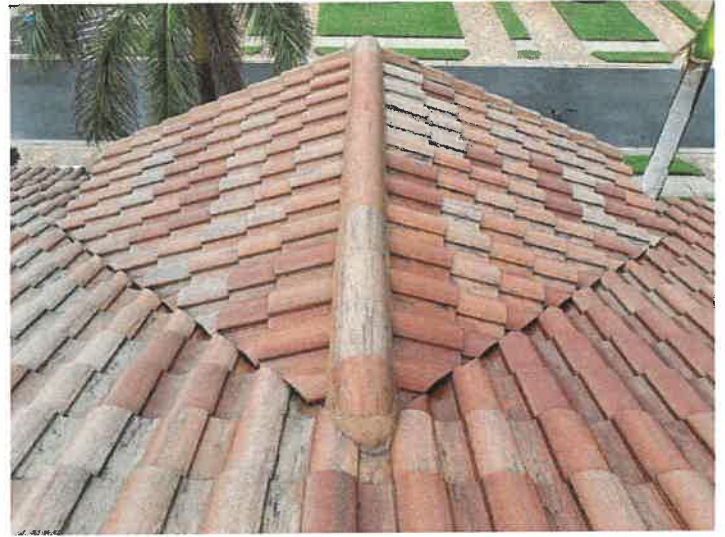
Building 15136: Valley

The valley tiles appear to be in good condition.

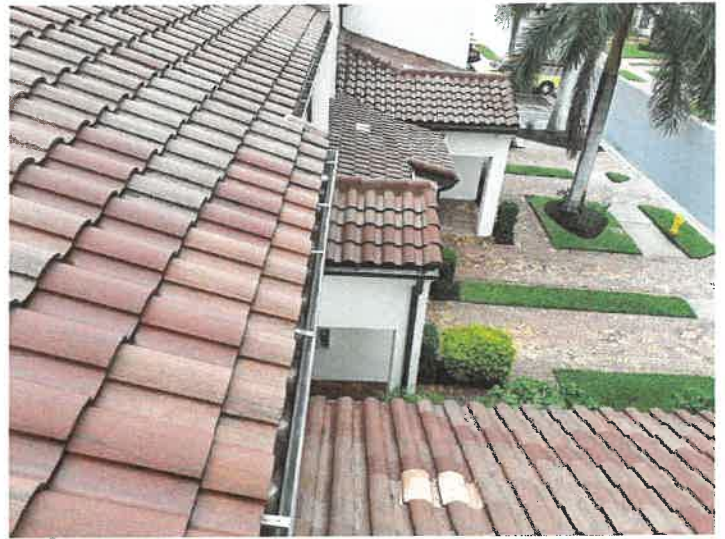
Building 15136: Gutters

The gutters appear to be in good condition.

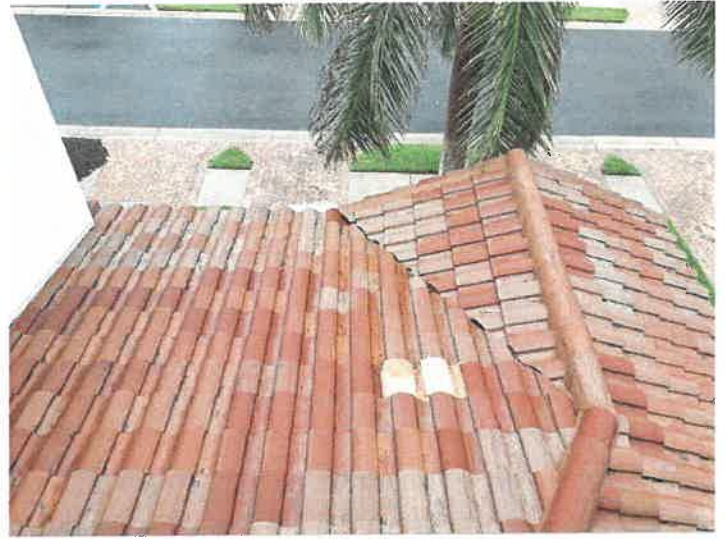
Building 15136: Appearance Overview - Lower Roof

The roof appearance is in good, maintainable condition.

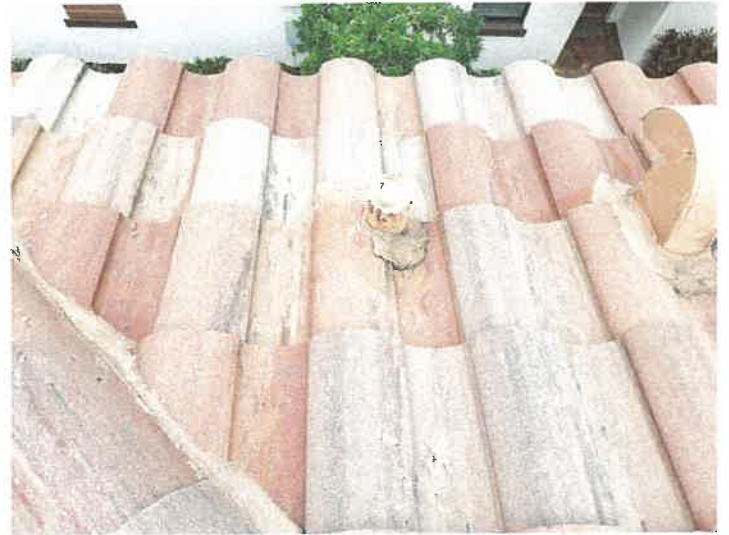
Building 15137: Repaired Cracked Roof Tiles

The cracked roof tiles were repaired with Titebond sealant.

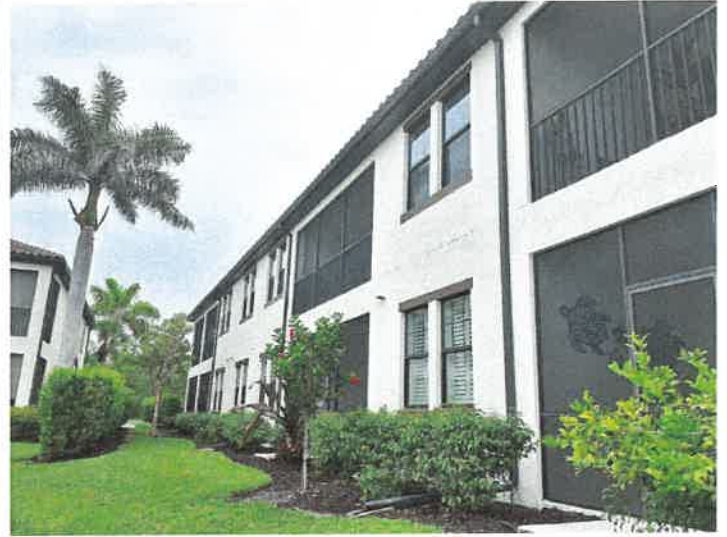
Building 15137: Gutter
Completed Repair

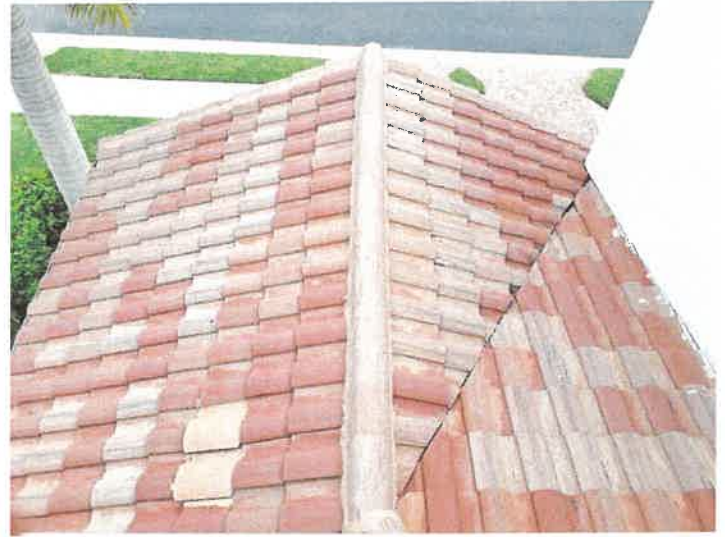
Building 15140: Appearance Overview - Lower Roof

The roof appearance is in good, maintainable condition.

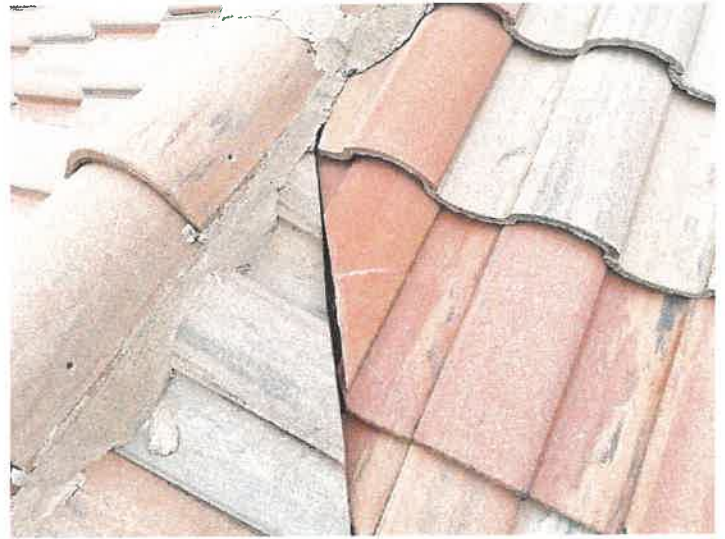
Building 15140: Repaired Cracked Roof Tiles

The cracked roof tiles were repaired with Titebond sealant.

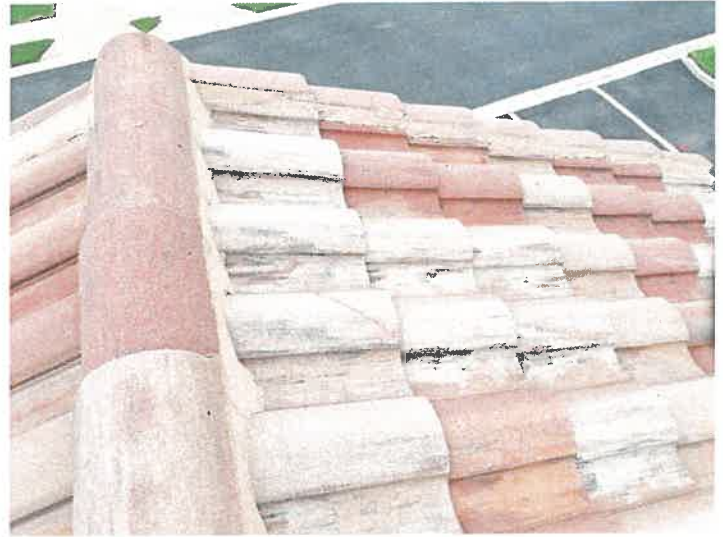
Building 15144: Repaired Cracked Roof Tiles

The cracked roof tiles were repaired with Titebond sealant.

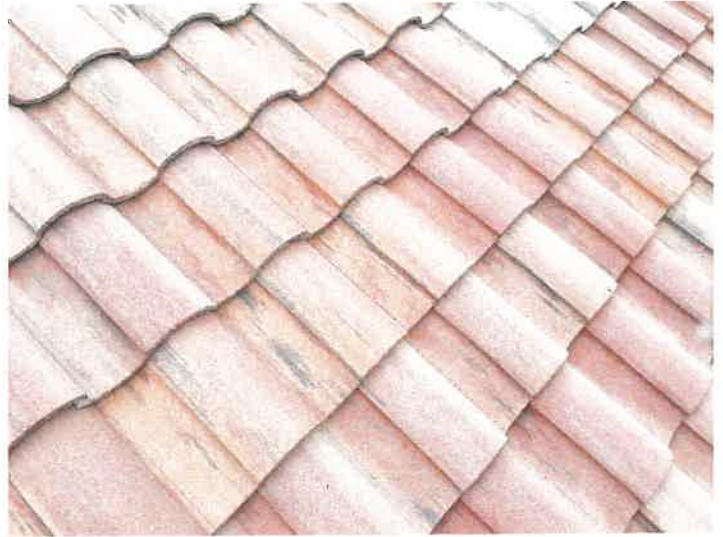
Building 15144: Repaired Cracked Roof Tiles

The cracked roof tiles were repaired with Titebond sealant.

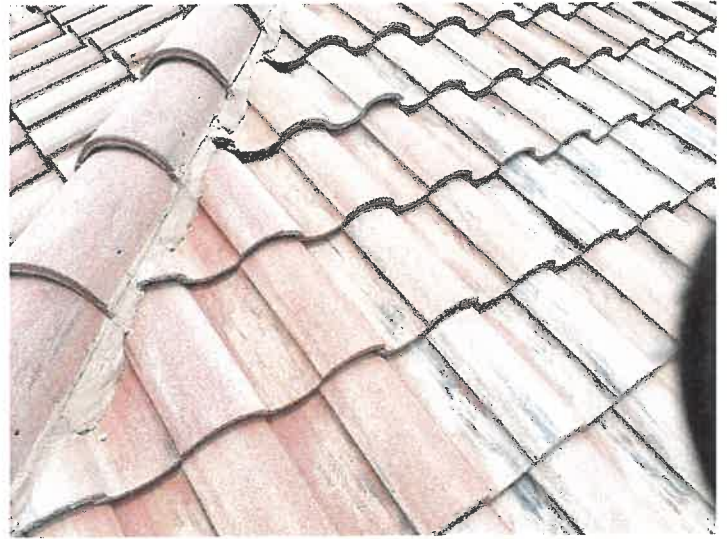
Building 15144: Repaired Displaced/Missing Roof Tile

Replaced and secured the missing roof tile.

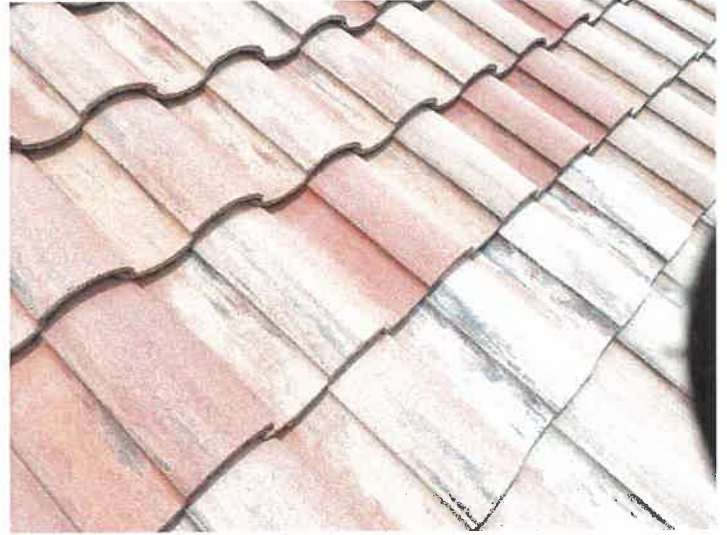
Building 15144: Repaired Displaced/Missing Roof Tile

Replaced and secured the missing roof tile.

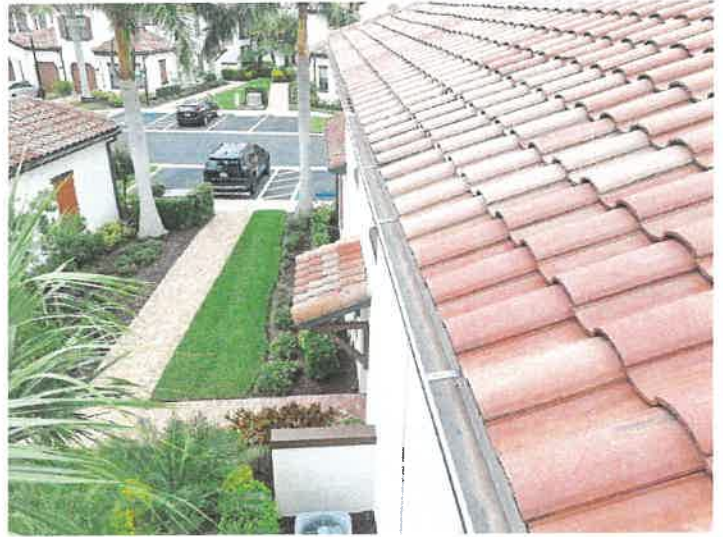
Building 15144: Gutters

The gutters appear to be in good condition.

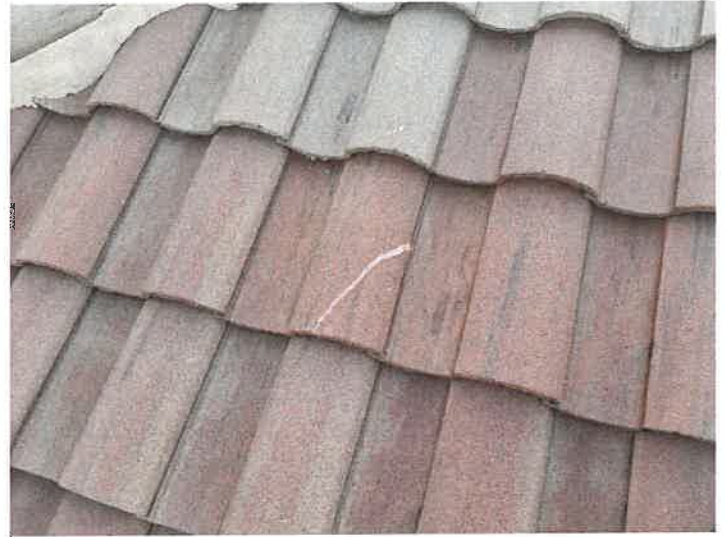
Building 15145: Repaired Cracked Roof Tiles

The cracked roof tiles were repaired with Titebond sealant.

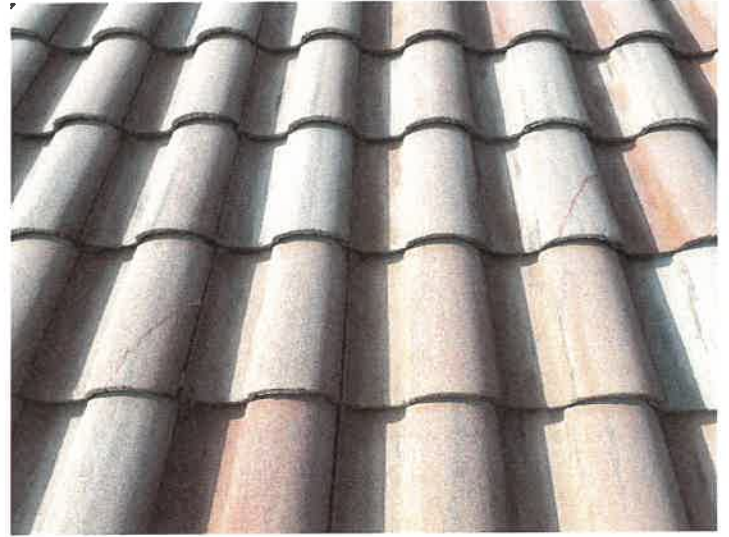
Building 15145: Repaired Cracked Roof Tiles

The cracked roof tiles were repaired with Titebond sealant.

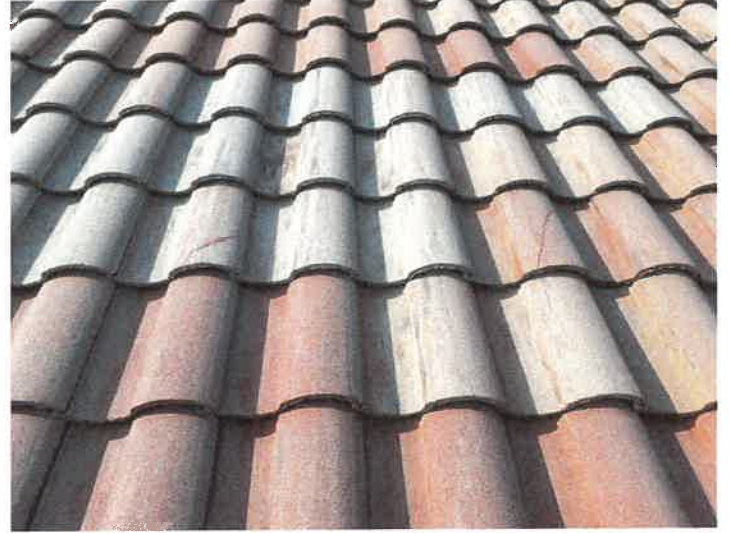
Building 15145: Repaired Cracked Roof Tiles

The cracked roof tiles were repaired with Titebond sealant.

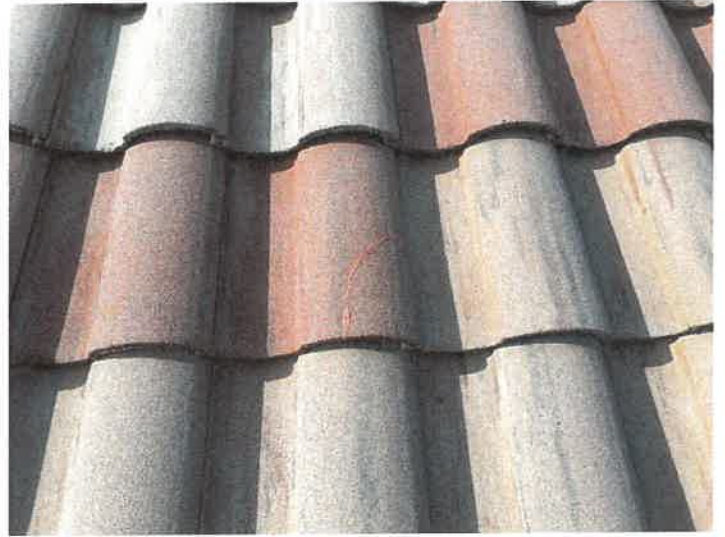
Building 15145: Repaired Cracked Roof Tiles

The cracked roof tiles were repaired with Titebond sealant.

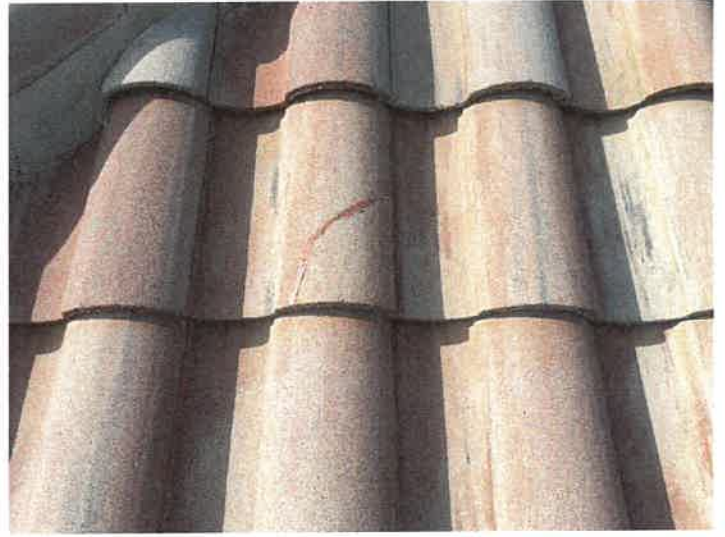
Building 15145: Repaired Cracked Roof Tiles

The cracked roof tiles were repaired with Titebond sealant.

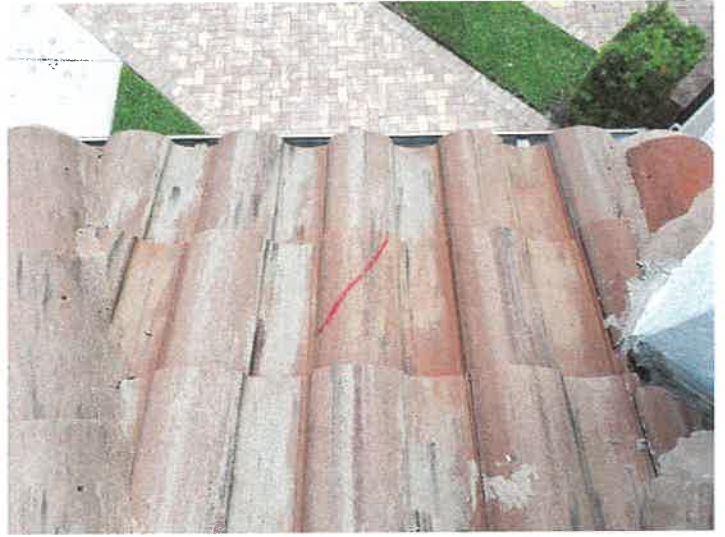
Building 15148: Repaired Cracked Roof Tiles

The cracked roof tiles were repaired with Titebond sealant.

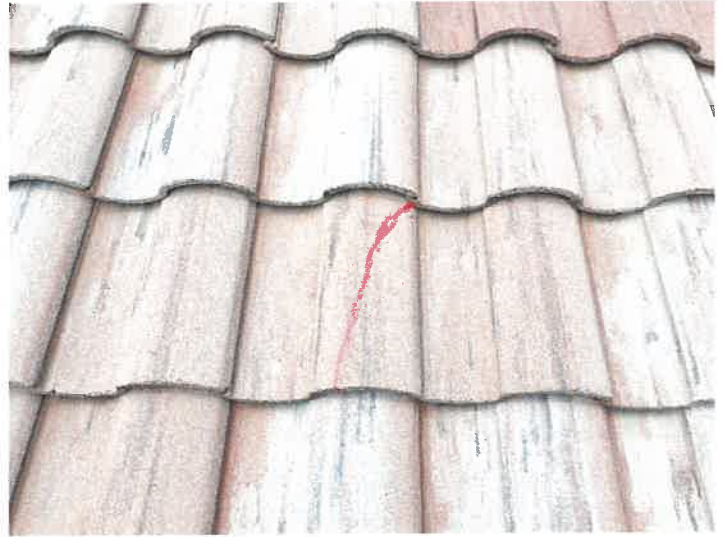
Building 15148: Repaired Cracked Roof Tiles

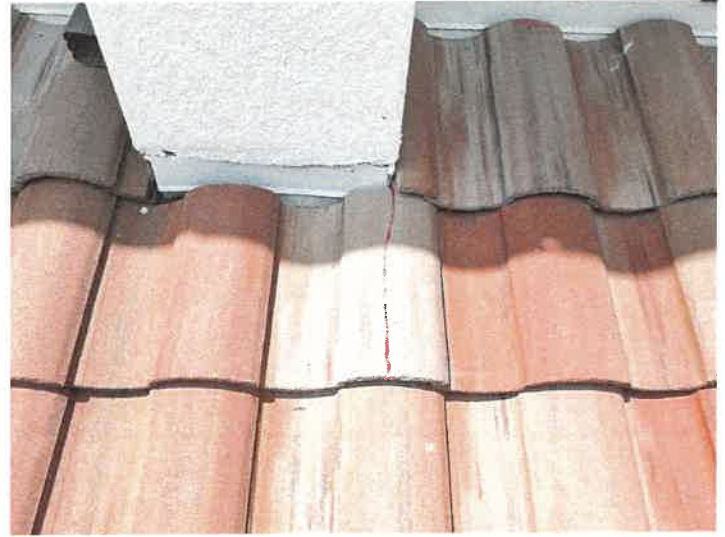
Building 15148: Repaired Cracked Roof Tiles

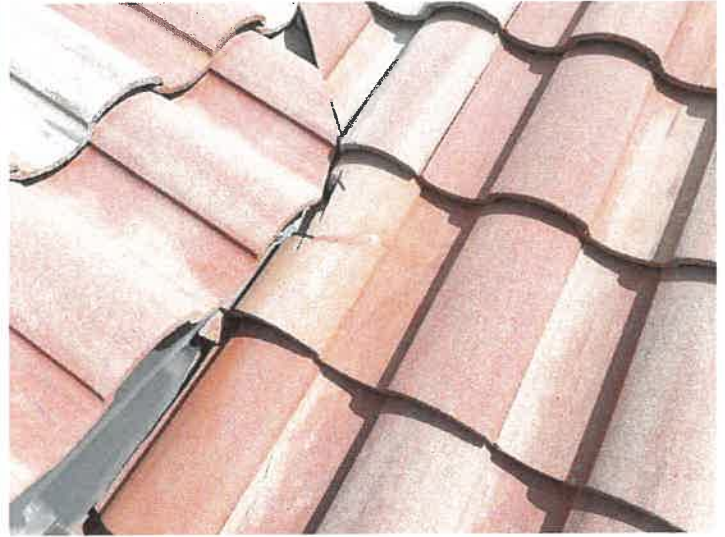
Building 15149: Repaired Cracked Roof Tiles

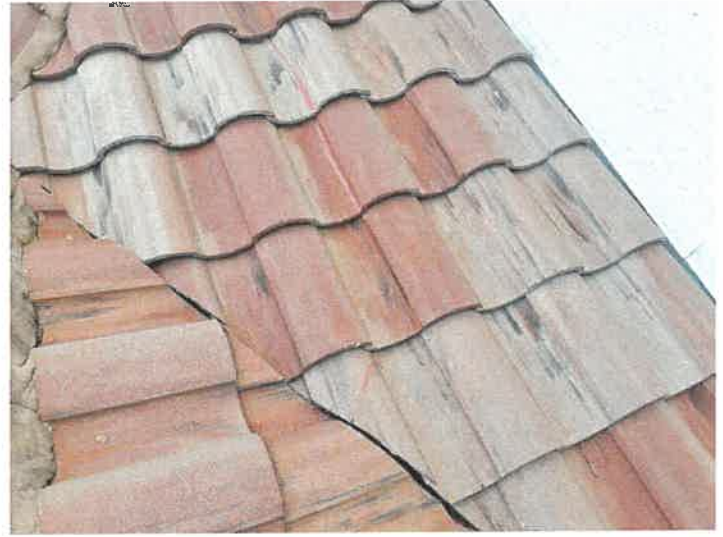
Building 15149: Repaired Cracked Roof Tiles

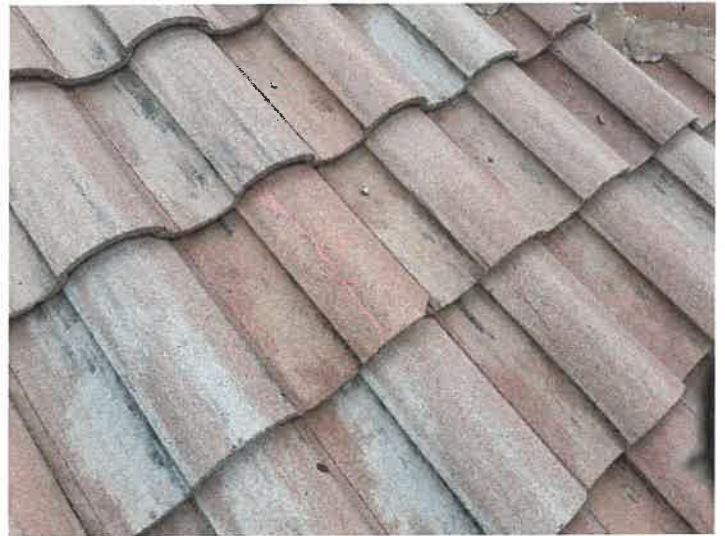
Building 15152: Repaired Cracked Roof Tiles
The cracked roof tiles were repaired with Titebond sealant.

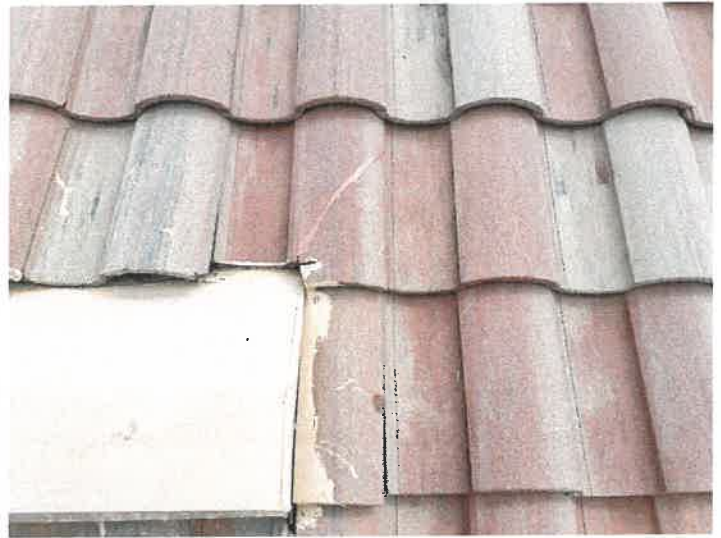
Building 15152: Repaired Cracked Roof Tiles
The cracked roof tiles were repaired with Titebond sealant.

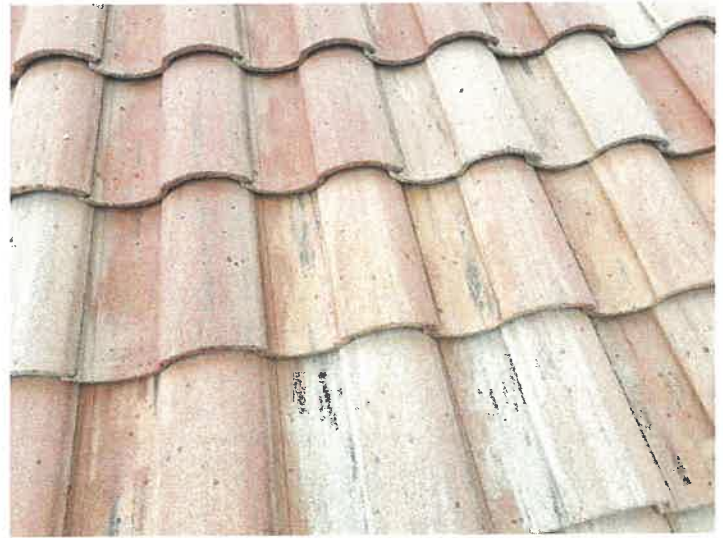
Building 15152: Repaired Cracked Roof Tiles
The cracked roof tiles were repaired with Titebond sealant.

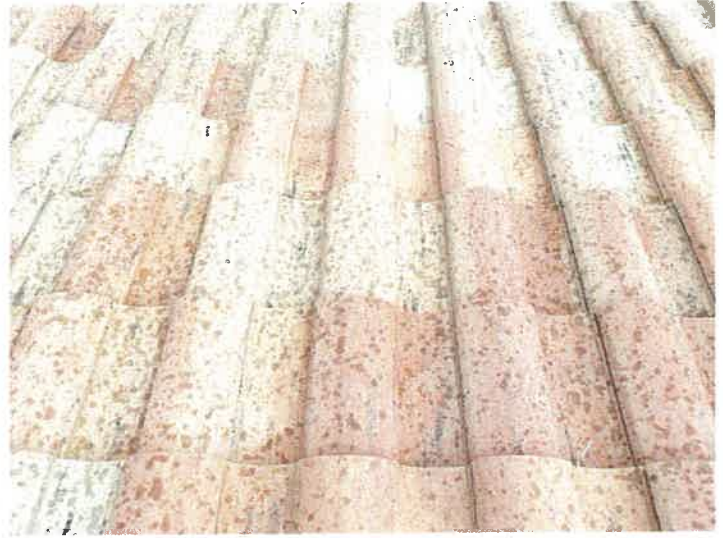
Building 15152: Repaired Cracked Roof Tiles
The cracked roof tiles were repaired with Titebond sealant.

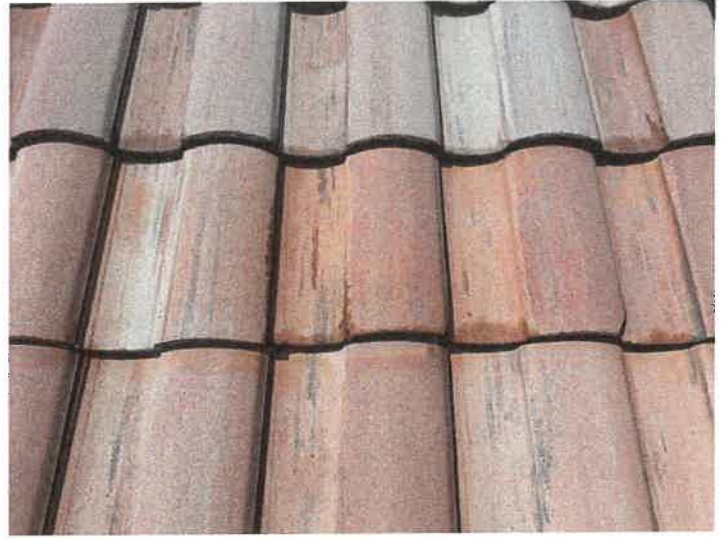
Building 15152: Repaired Displaced/Missing Roof Tile

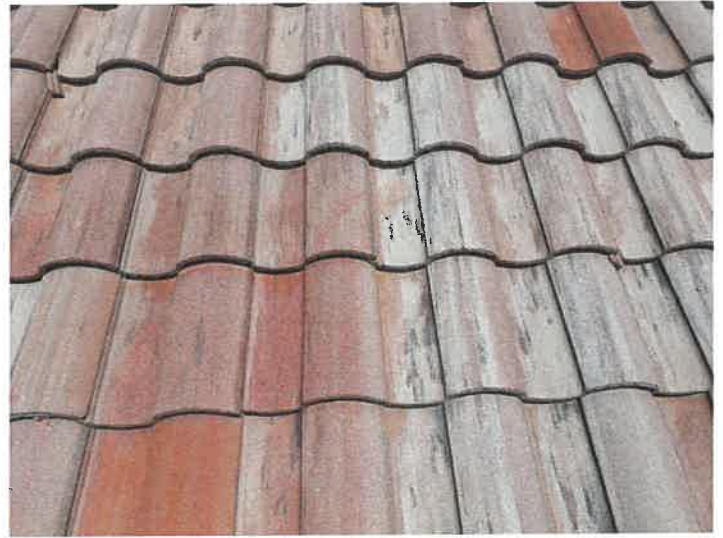
Building 15152: Repaired Cracked Roof Tiles
The cracked roof tiles were repaired with Titebond sealant.

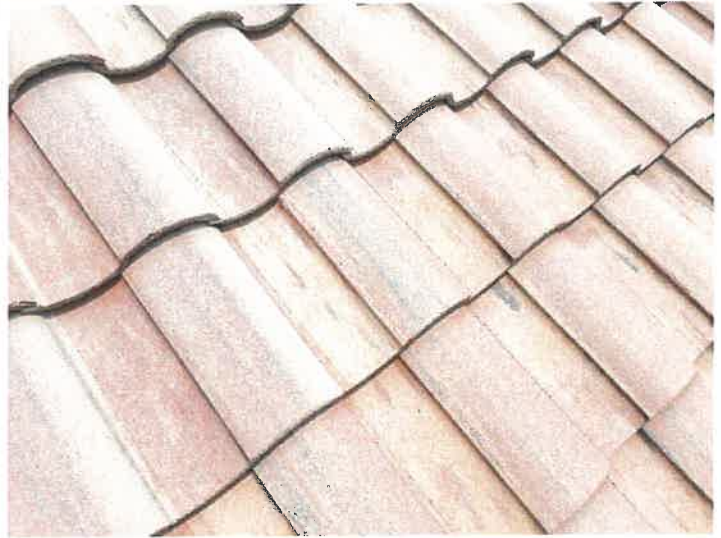
Building 15153: Repaired Cracked Roof Tiles

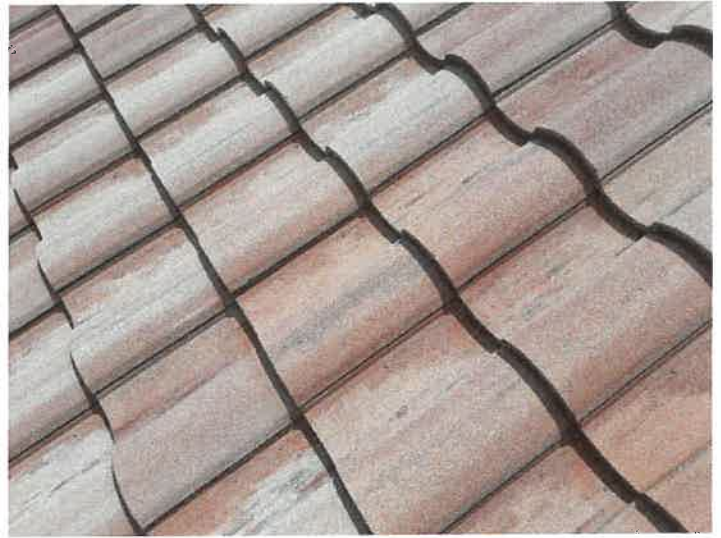
Building 15153: Repaired Displaced/Missing Roof Tile

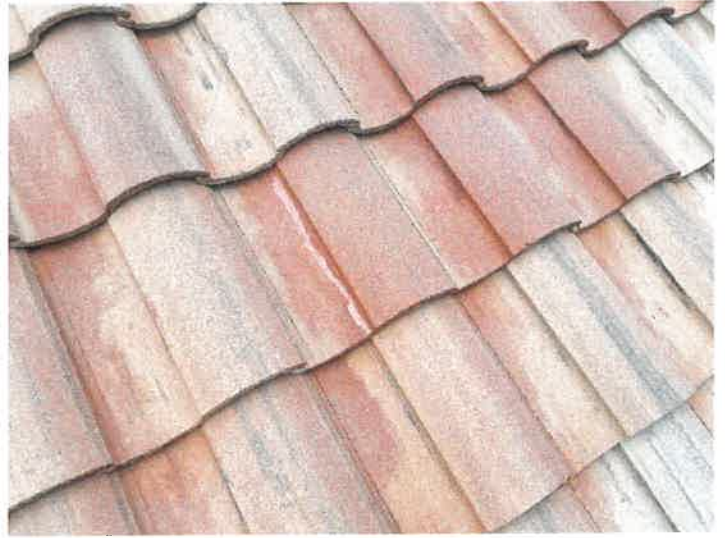
Building 15156: Repaired Cracked Roof Tiles
The cracked roof tiles were repaired with Titebond sealant.

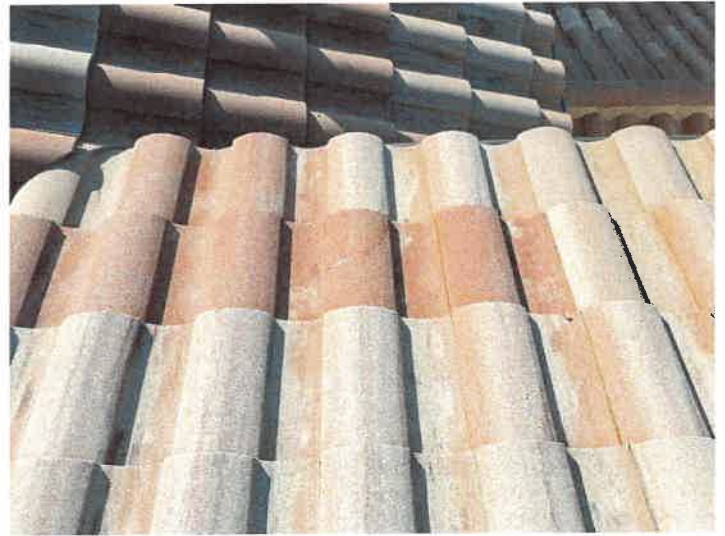
Building 15157: Repaired Cracked Roof Tiles

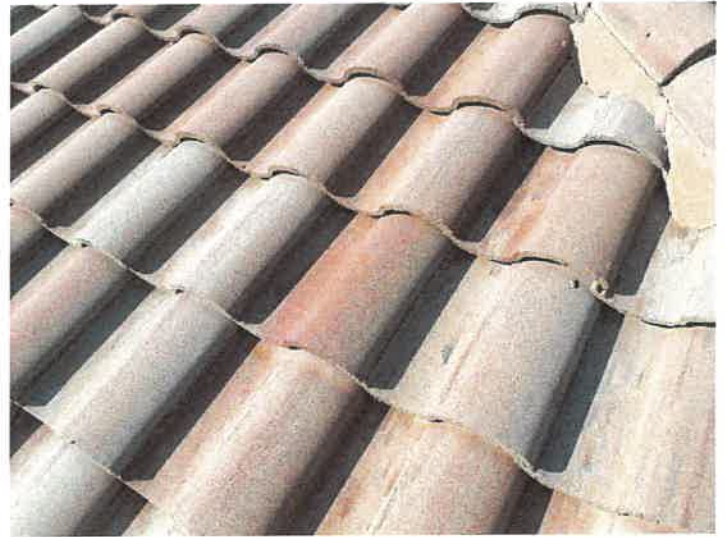
Building 15157: Repaired Displaced/Missing Roof Tile

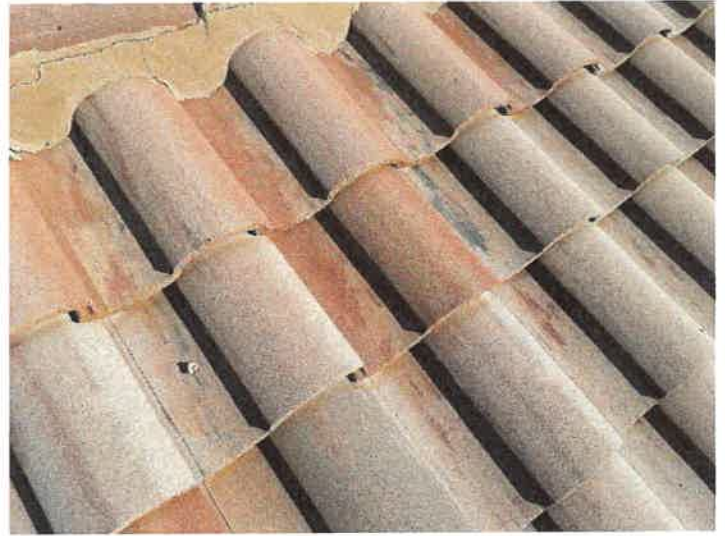
Building 15157: Repaired Displaced/Missing Roof Tile
