Inspection Report

Facility: Livingston Lakes Condo
Address: 15098 Palmer Lake Circle,
Naples, FL 34109

Work Order #: 13028

Re.: Inspection Report (2 of 3) for Livingston Lakes

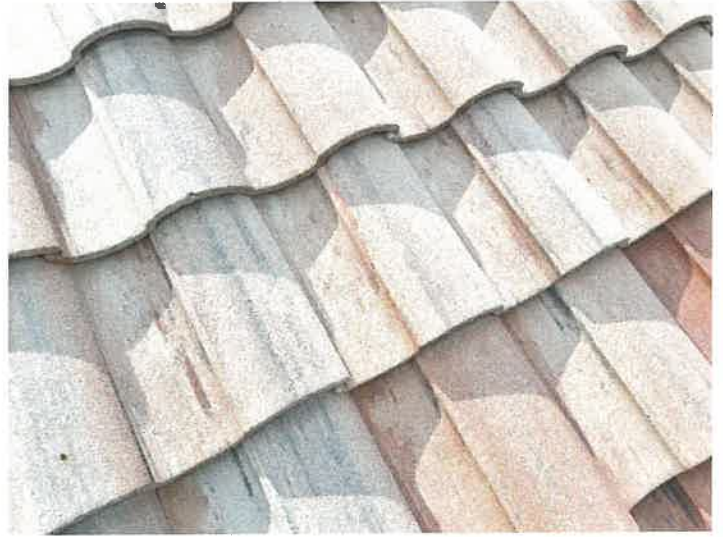
Building 15098: Identified Cracked Roof Tiles

Cracked roof tiles can allow premature underlayment deterioration from excessive UV exposure.

Building 15098: Repaired Cracked Roof Tiles

The cracked roof tiles were repaired with Titebond sealant.

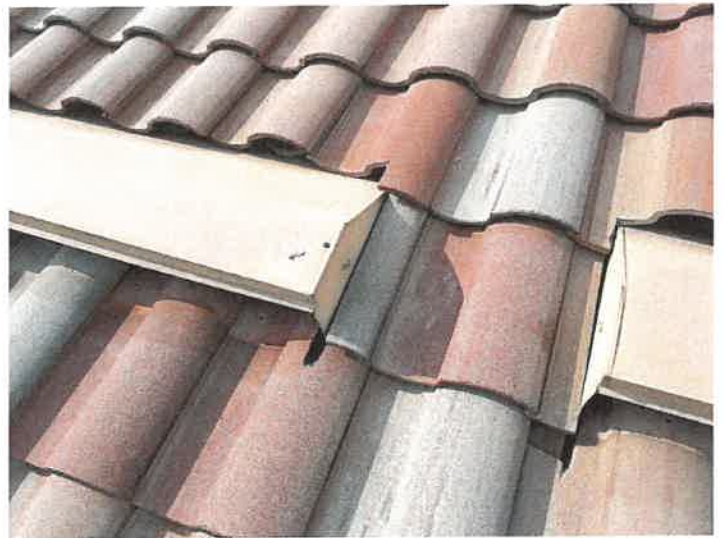
Building 15098: Displaced/Missing Roof Tile

Displaced or missing roof tiles can allow premature underlayment deterioration from excessive UV exposure and potential water intrusion.

Building 15098: Repaired Displaced/Missing Roof Tile

Replaced and secured the missing roof tile.

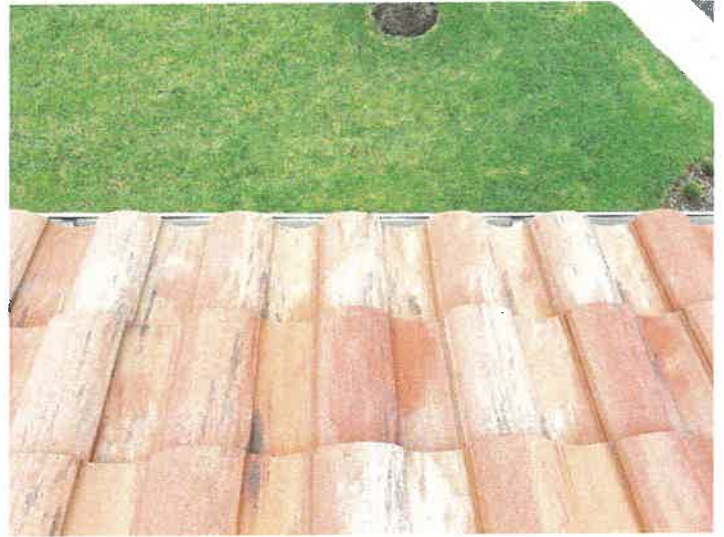
Building 15102: Identified Cracked Roof Tiles

Cracked roof tiles can allow premature underlayment deterioration from excessive UV exposure.

Building 15102: Repaired Cracked Roof Tiles

The cracked roof tiles were repaired with Titebond sealant.

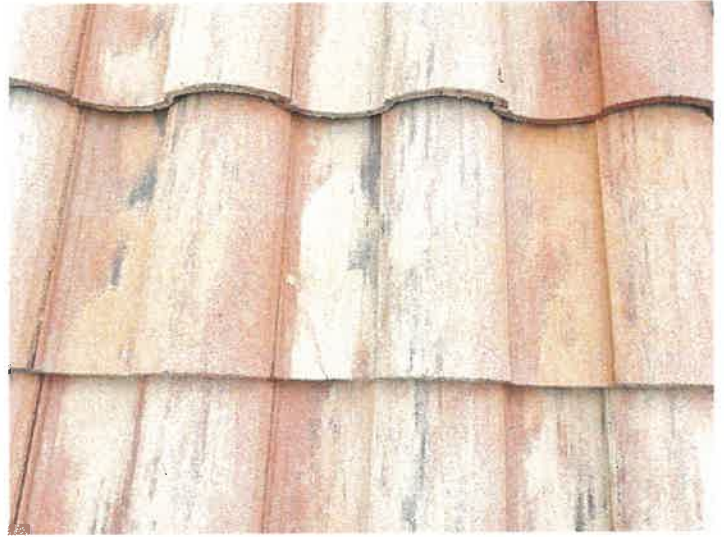
Building 15102: Identified Cracked Roof Tiles

Cracked roof tiles can allow premature underlayment deterioration from excessive UV exposure.

Building 15102: Repaired Cracked Roof Tiles

The cracked roof tiles were repaired with Titebond sealant.

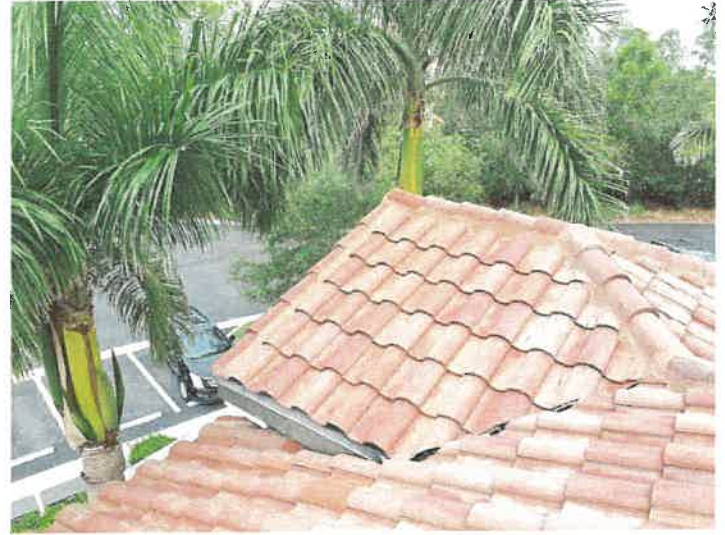
Identified tree branches hanging over the roof surface. Branches on the roof surface can cause deterioration of membrane, and act as an access for rodents and unwanted bugs/pests.

Building 15102: Tree Branches

Cut back the branches away from the roof surface and disposed of properly.

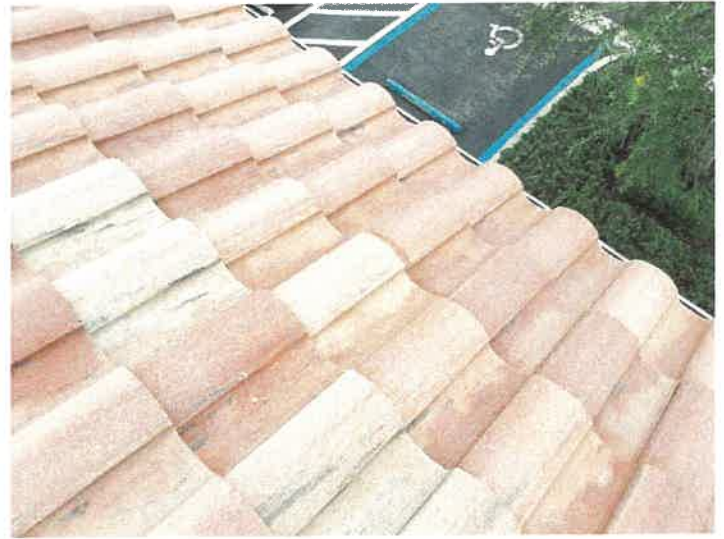
Building 15106: Displaced/Missing Roof Tile

Displaced or missing roof tiles can allow premature underlayment deterioration from excessive UV exposure and potential water intrusion.

Building 15106: Repaired Displaced/Missing Roof Tile

Replaced and secured the missing roof tile.

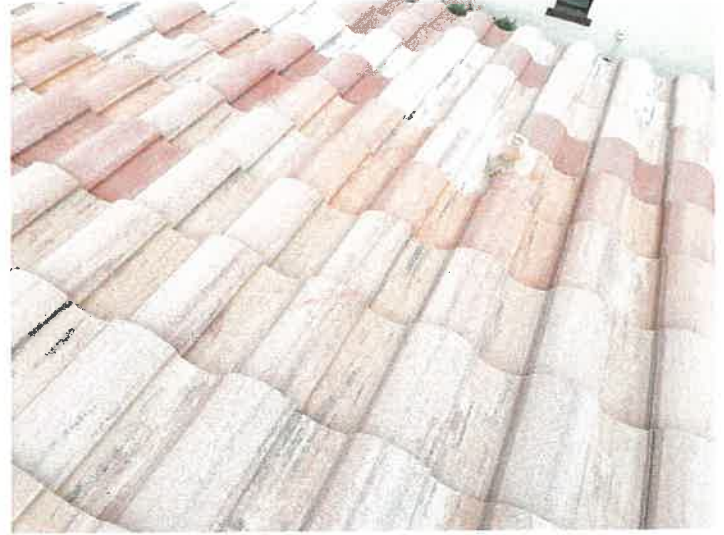
Building 15106: Identified Cracked Roof Tiles

Cracked roof tiles can allow premature underlayment deterioration from excessive UV exposure.

Building 15106: Repaired Cracked Roof Tiles

The cracked roof tiles were repaired with Titebond sealant.

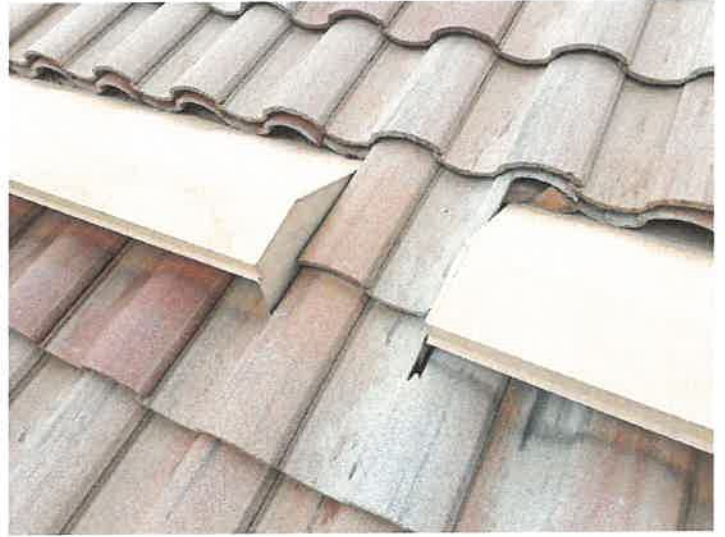
Building 15106: Displaced/Missing Roof Tile

Displaced or missing roof tiles can allow premature underlayment deterioration from excessive UV exposure and potential water intrusion.

Building 15106: Repaired Displaced/Missing Roof Tile

Replaced and secured the missing roof tile.

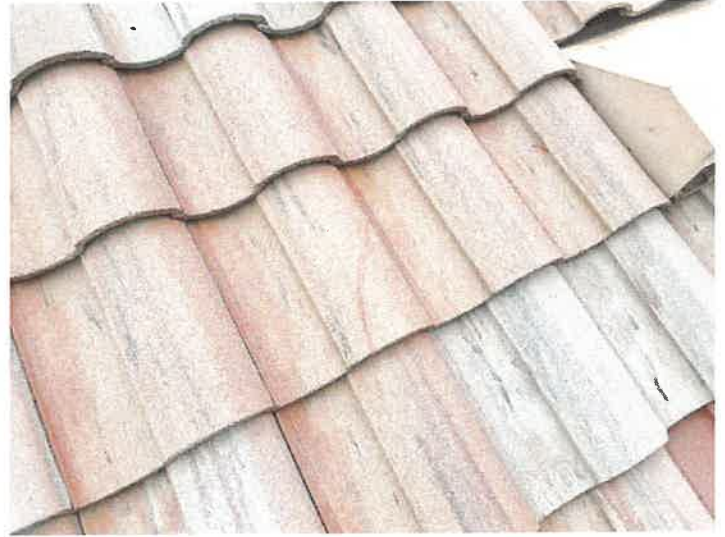
Building 15106: Identified Cracked Roof Tiles
Cracked roof tiles can allow premature underlayment deterioration from excessive UV exposure.

Building 15106: Repaired Cracked Roof Tiles
The cracked roof tiles were repaired with Titebond sealant.

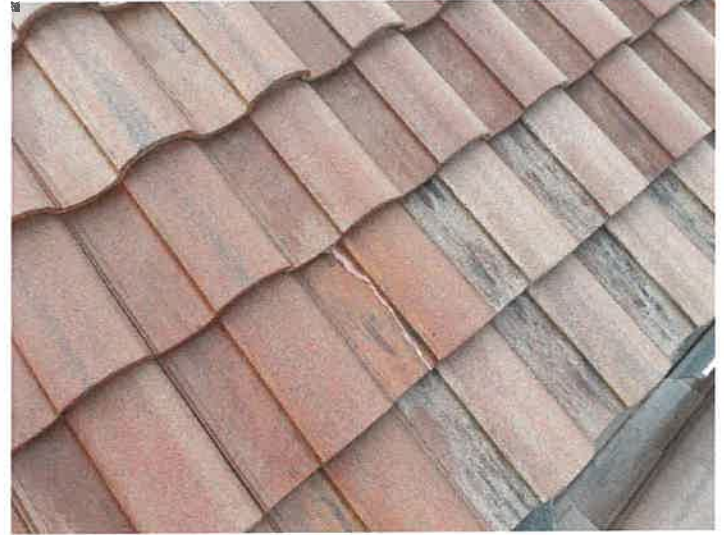
Building 15110: Identified Cracked Roof Tiles

Cracked roof tiles can allow premature underlayment deterioration from excessive UV exposure.

Building 15110: Repaired Cracked Roof Tiles

The cracked roof tiles were repaired with Titebond sealant.

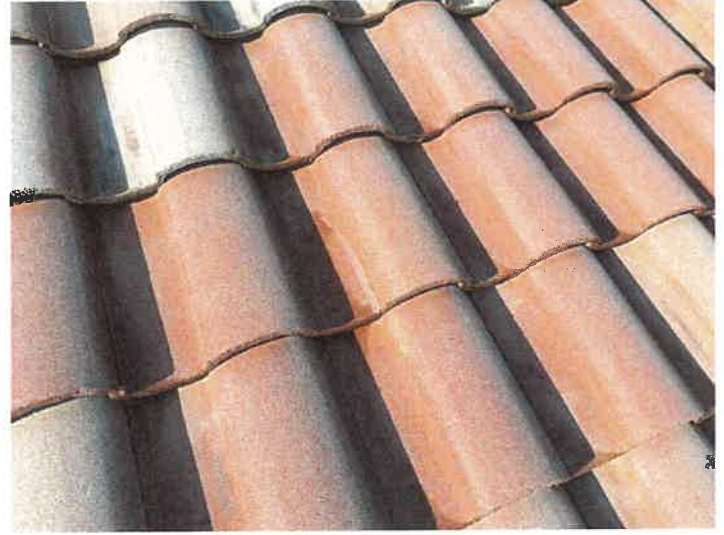
Building 15110: Identified Cracked Roof Tiles

Cracked roof tiles can allow premature underlayment deterioration from excessive UV exposure.

Building 15110: Repaired Cracked Roof Tiles

The cracked roof tiles were repaired with Titebond sealant.

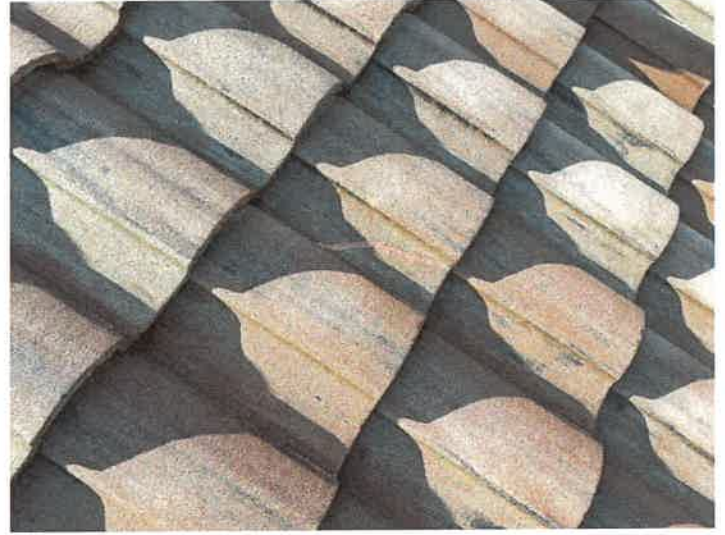
Building 15114: Identified Cracked Roof Tiles

Cracked roof tiles can allow premature underlayment deterioration from excessive UV exposure.

Building 15114: Repaired Cracked Roof Tiles

The cracked roof tiles were repaired with Titebond sealant.

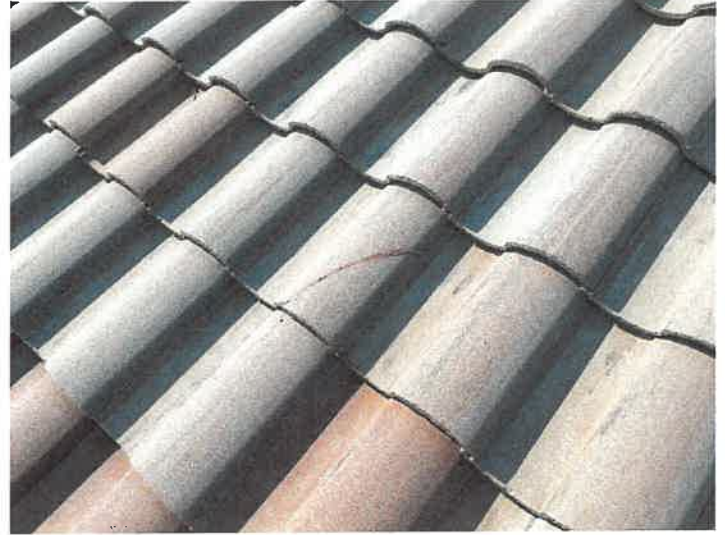
Building 15114: Identified Cracked Roof Tiles

Cracked roof tiles can allow premature underlayment deterioration from excessive UV exposure.

Building 15114: Repaired Cracked Roof Tiles

The cracked roof tiles were repaired with Titebond sealant.

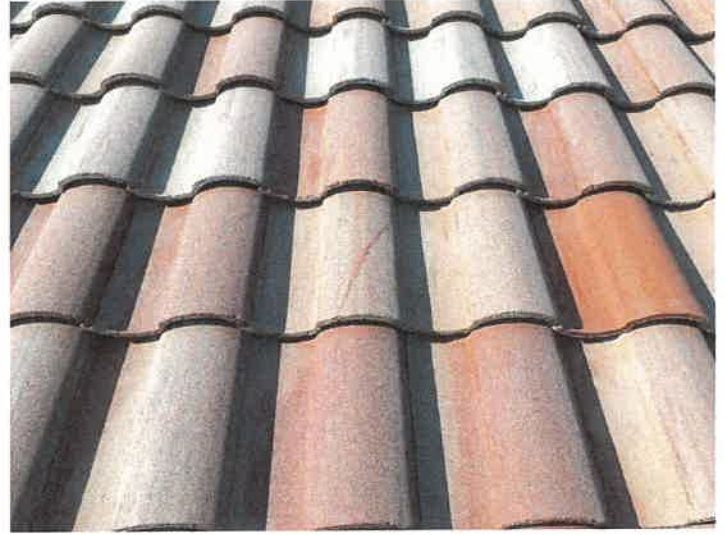
Building 15114: Identified Cracked Roof Tiles

Cracked roof tiles can allow premature underlayment deterioration from excessive UV exposure.

Building 15114: Repaired Cracked Roof Tiles

The cracked roof tiles were repaired with Titebond sealant.

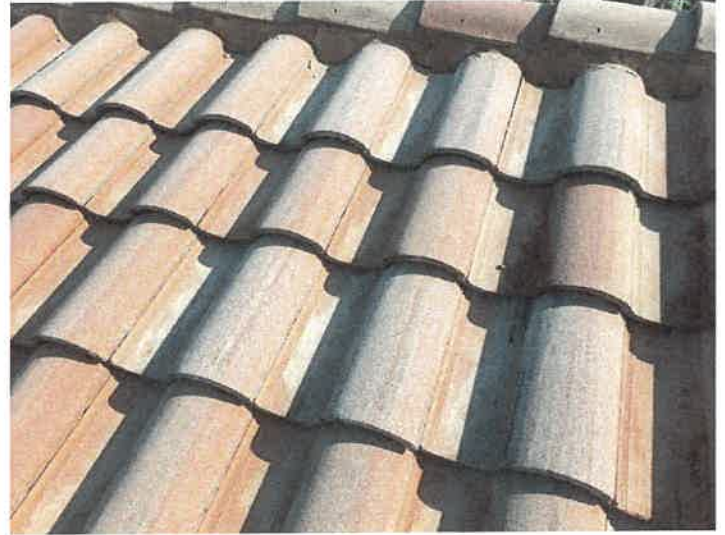
Building 15114: Displaced/Missing Roof Tile

Displaced or missing roof tiles can allow premature underlayment deterioration from excessive UV exposure and potential water intrusion.

Building 15114: Repaired Displaced/Missing Roof Tile

Replaced and secured the missing roof tile.

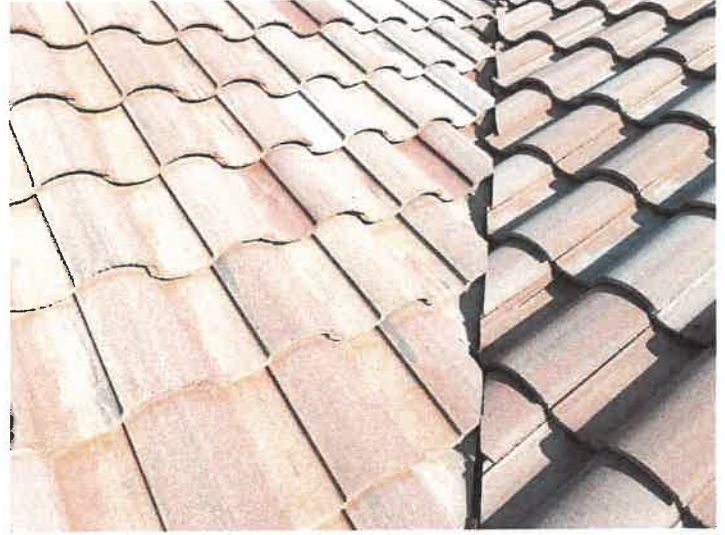
Building 15114: Displaced/Missing Roof Tile

Displaced or missing roof tiles can allow premature underlayment deterioration from excessive UV exposure and potential water intrusion.

Building 15114: Repaired Displaced/Missing Roof Tile

Replaced and secured the missing roof tile.

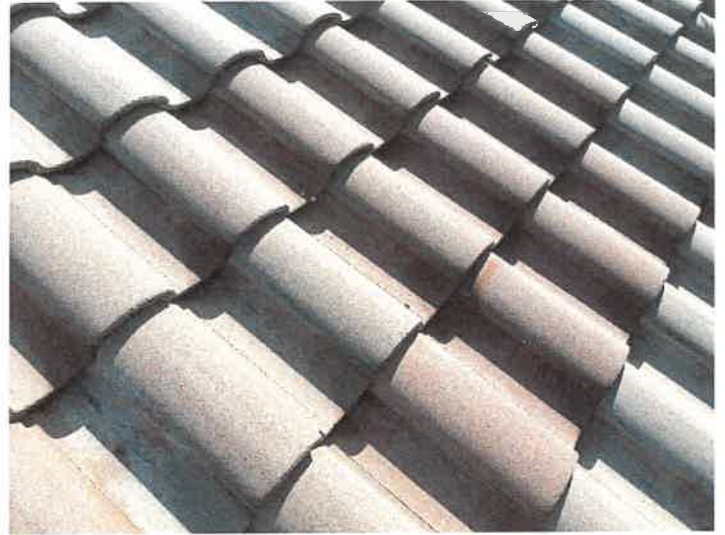
Building 15114: Displaced/Missing Roof Tile

Displaced or missing roof tiles can allow premature underlayment deterioration from excessive UV exposure and potential water intrusion.

Building 15114: Repaired Displaced/Missing Roof Tile

Replaced and secured the missing roof tile.

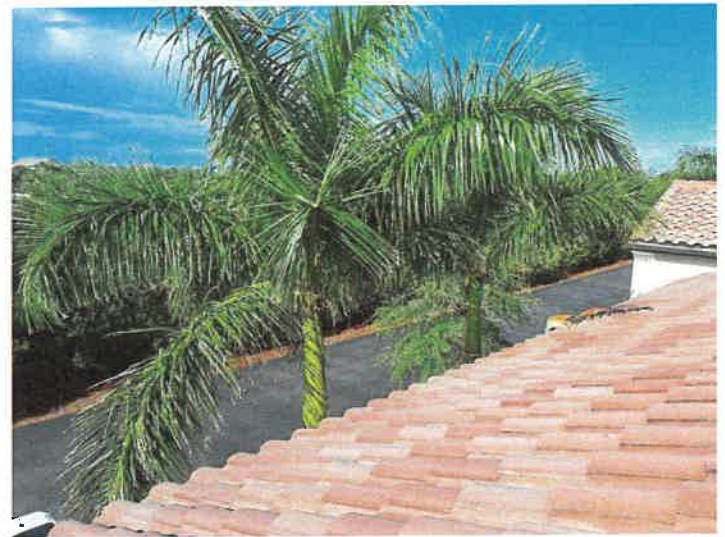
Building 15114: Tree Branches
Identified tree branches hanging over the roof surface.
Branches on the roof surface can cause deterioration of membrane, and act as an access for rodents and unwanted bugs/pests.

Building 15114: Tree Branches
Cut back the branches away from the roof surface and disposed of properly.

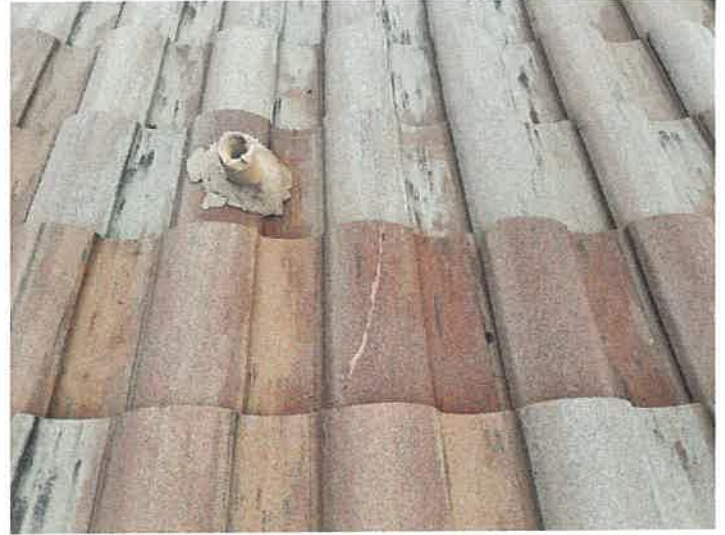
Building 15114: Identified Cracked Roof Tiles

Cracked roof tiles can allow premature underlayment deterioration from excessive UV exposure.

Building 15114: Repaired Cracked Roof Tiles

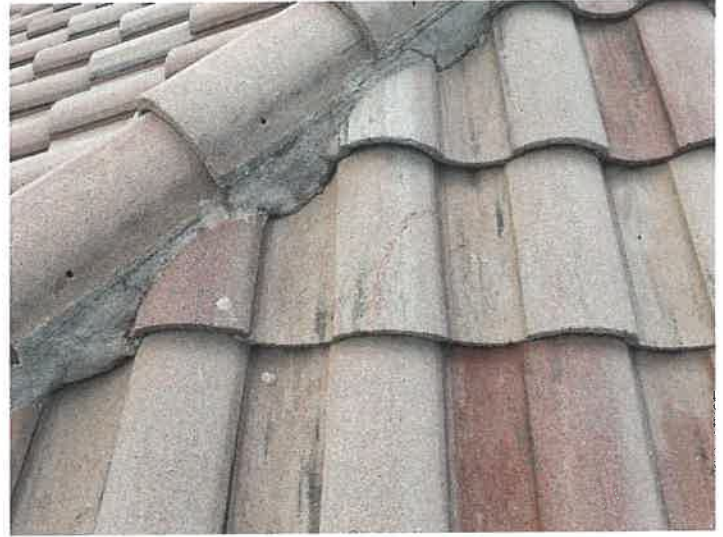
Building 15114: Identified Cracked Roof Tiles
Cracked roof tiles can allow premature underlayment deterioration from excessive UV exposure.

Building 15114: Repaired Cracked Roof Tiles
The cracked roof tiles were repaired with Titebond sealant.

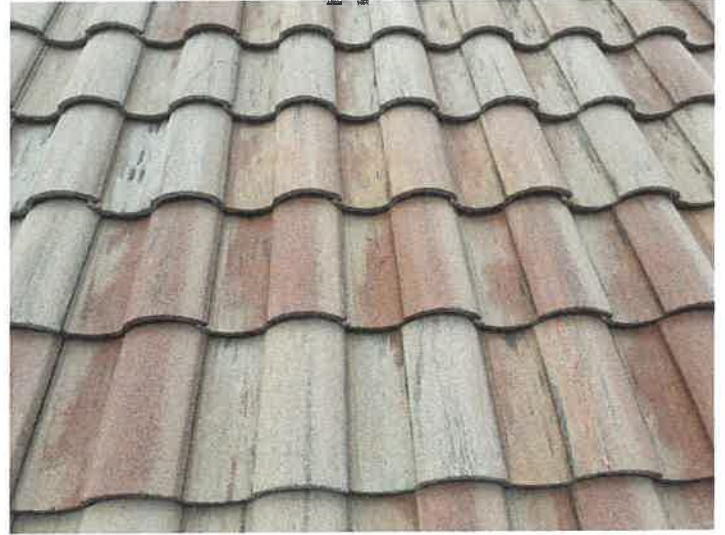
Cracked roof tiles can allow premature underlayment deterioration from excessive UV exposure.

Building 15114: Repaired Cracked Roof Tiles

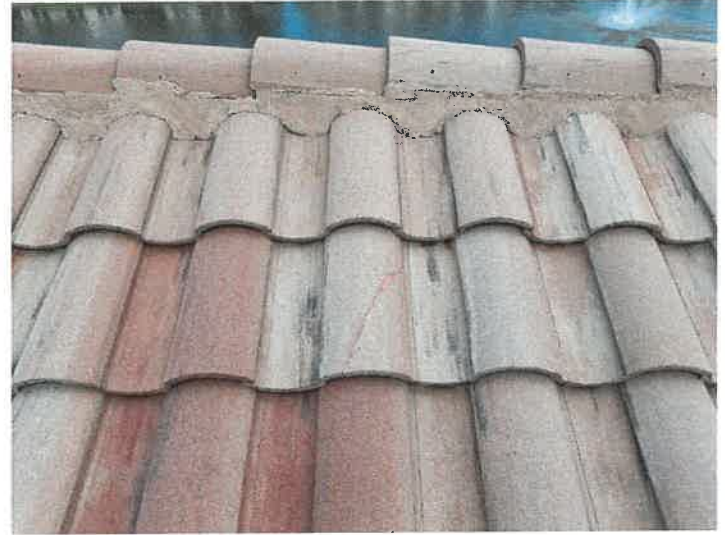
Cracked roof tiles can allow premature underlayment deterioration from excessive UV exposure.

Building 15114: Repaired Cracked Roof Tiles

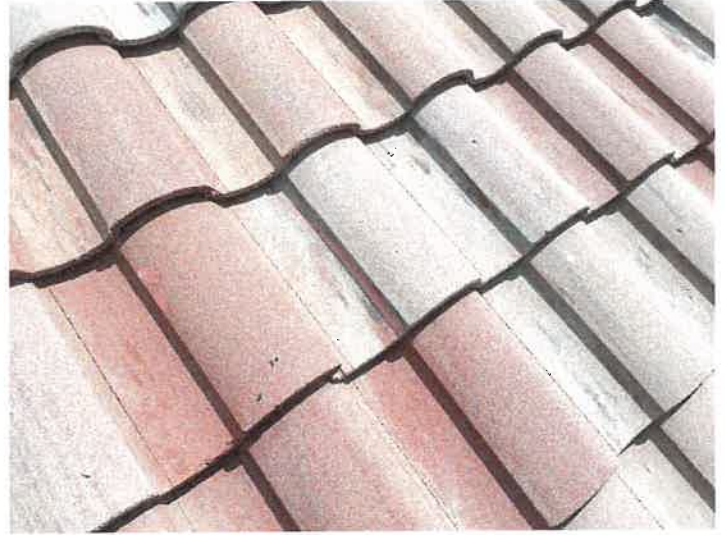
Building 15122: Identified Cracked Roof Tiles
Cracked roof tiles can allow premature underlayment deterioration from excessive UV exposure.

Building 15122: Repaired Cracked Roof Tiles
The cracked roof tiles were repaired with Titebond sealant.

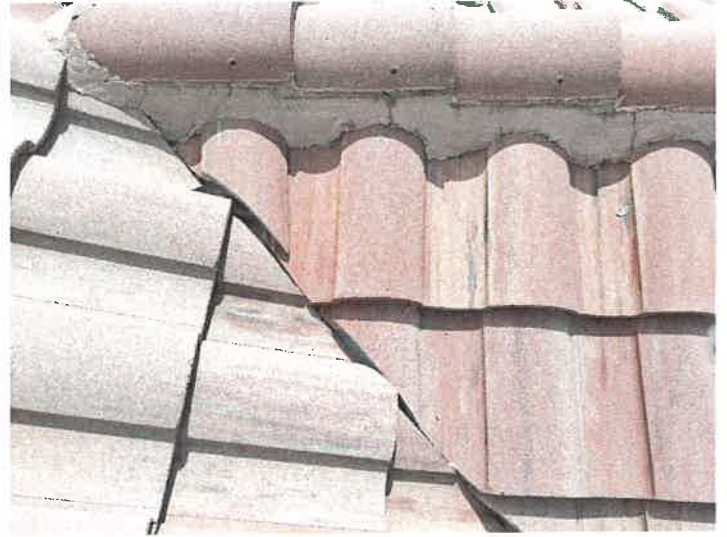
Cracked roof tiles can allow premature underlayment deterioration from excessive UV exposure.

Building 15122: Repaired Cracked Roof Tiles

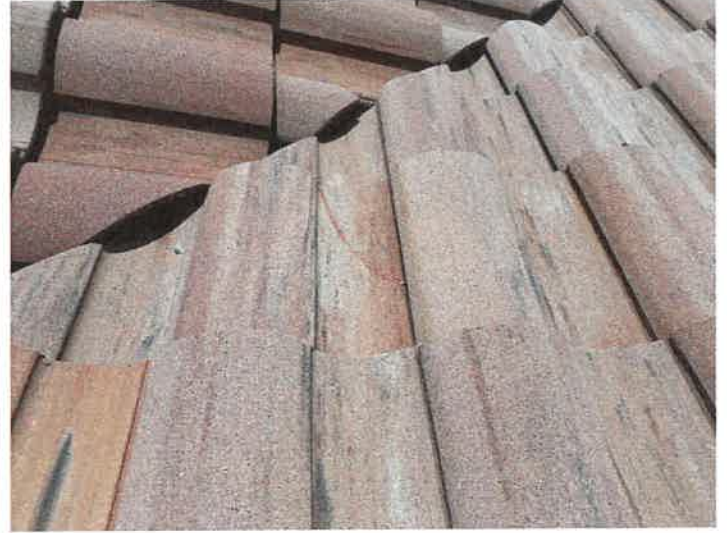
Cracked roof tiles can allow premature underlayment deterioration from excessive UV exposure.

Building 15122: Repaired Cracked Roof Tiles

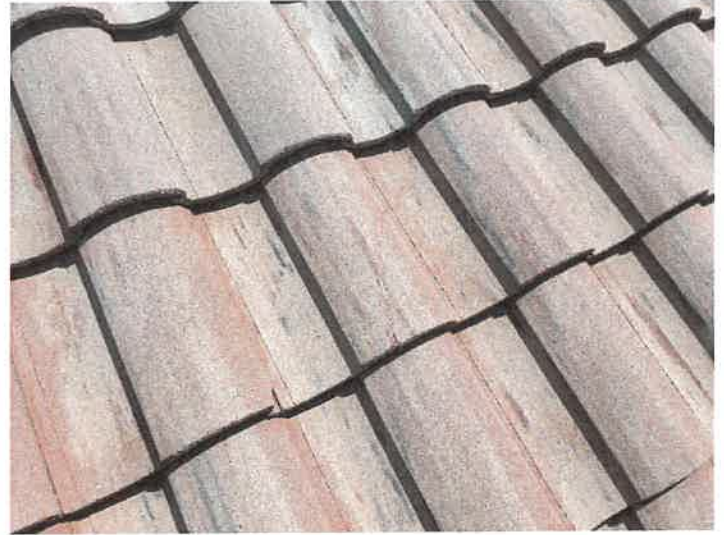
Cracked roof tiles can allow premature underlayment deterioration from excessive UV exposure.

Building 15122: Repaired Cracked Roof Tiles

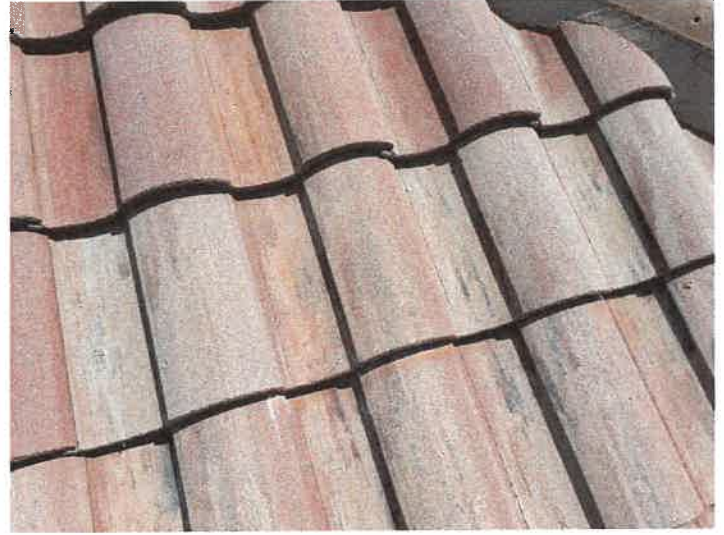
Displaced or missing roof tiles can allow premature underlayment deterioration from excessive UV exposure and potential water intrusion.

Building 15122: Repaired Displaced/Missing Roof Tile

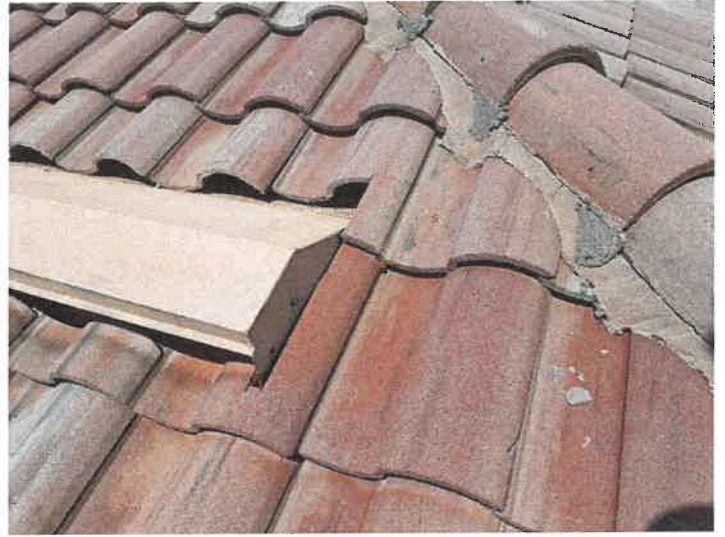
Cracked roof tiles can allow premature underlayment deterioration from excessive UV exposure.

Building 15122: Repaired Cracked Roof Tiles

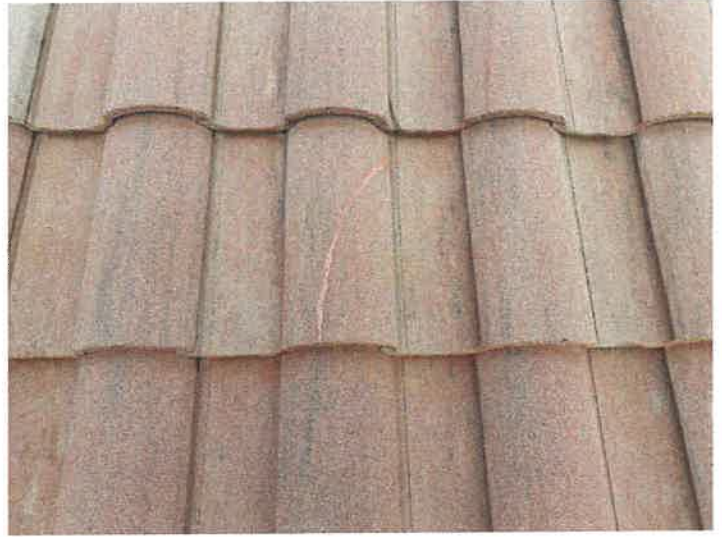
Building 15126: Identified Cracked Roof Tiles
Cracked roof tiles can allow premature underlayment deterioration from excessive UV exposure.

Building 15126: Repaired Cracked Roof Tiles
The cracked roof tiles were repaired with Titebond sealant.

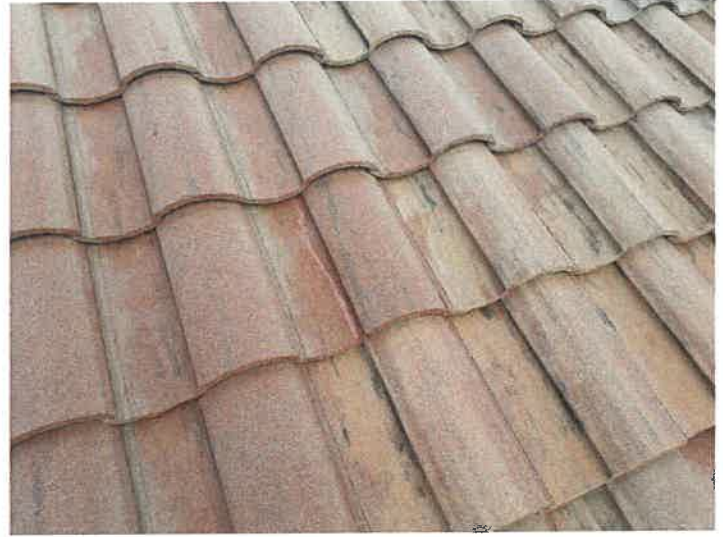
Cracked roof tiles can allow premature underlayment deterioration from excessive UV exposure.

Building 15126: Repaired Cracked Roof Tiles

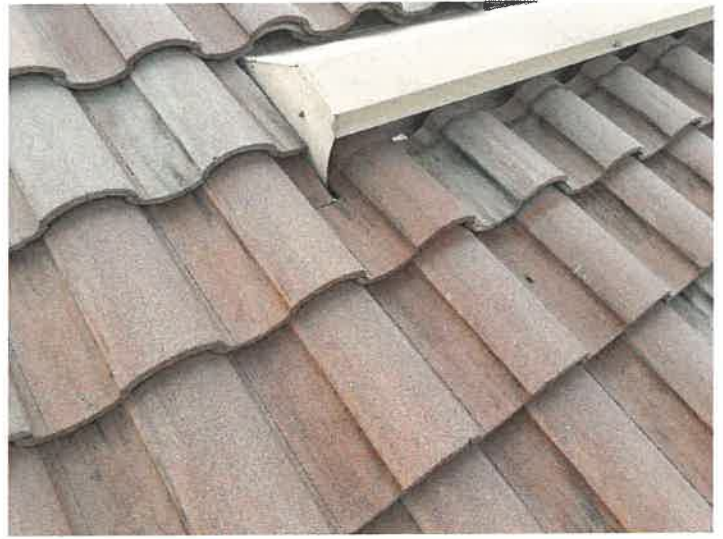
Displaced or missing roof tiles can allow premature underlayment deterioration from excessive UV exposure and potential water intrusion.

Building 15126: Repaired Displaced/Missing Roof Tile

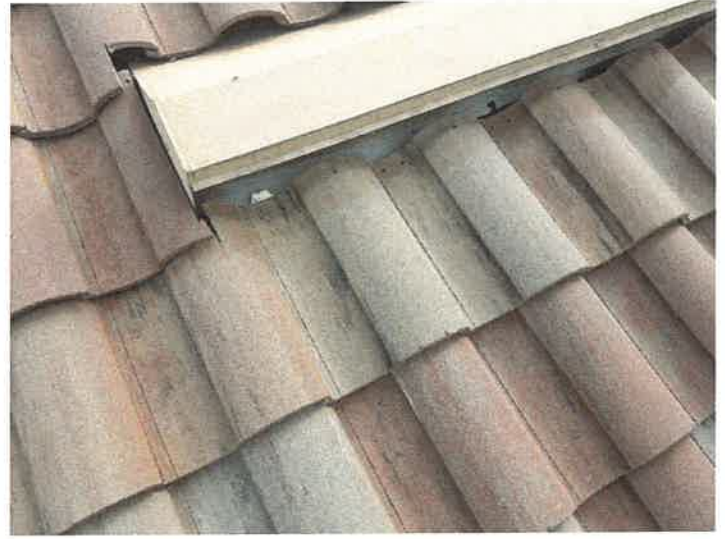
Displaced or missing roof tiles can allow premature underlayment deterioration from excessive UV exposure and potential water intrusion.

Building 15126: Repaired Displaced/Missing Roof Tile

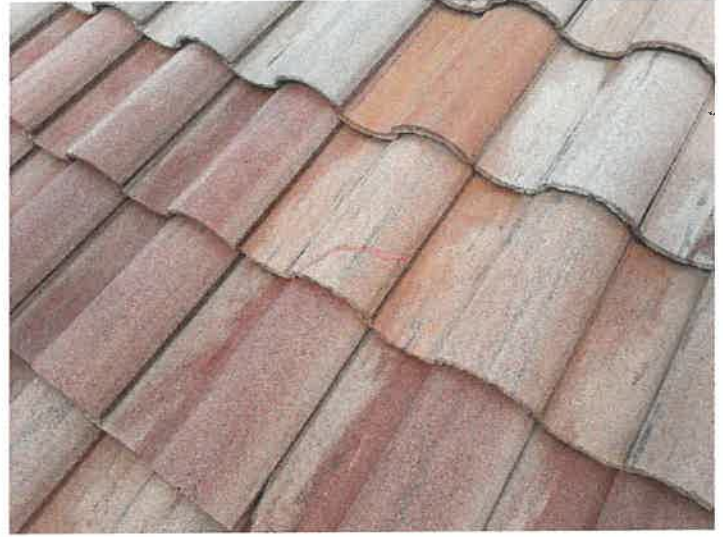
Cracked roof tiles can allow premature underlayment deterioration from excessive UV exposure.

Building 15130: Repaired Cracked Roof Tiles

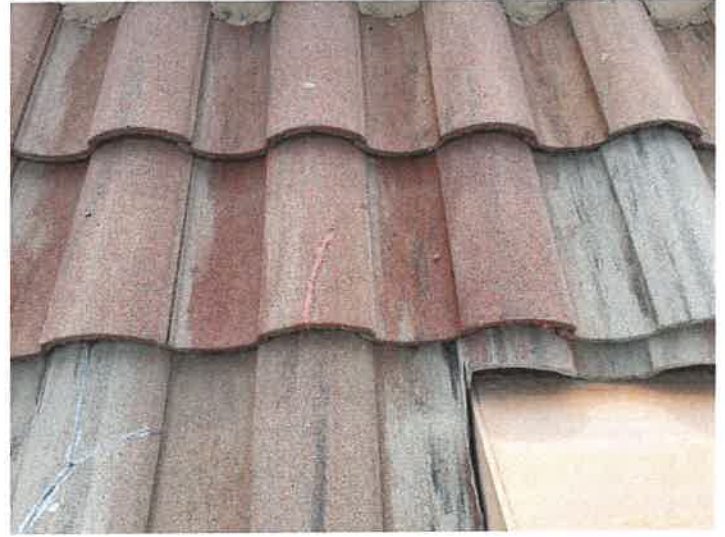
Cracked roof tiles can allow premature underlayment deterioration from excessive UV exposure.

Building 15130: Repaired Cracked Roof Tiles

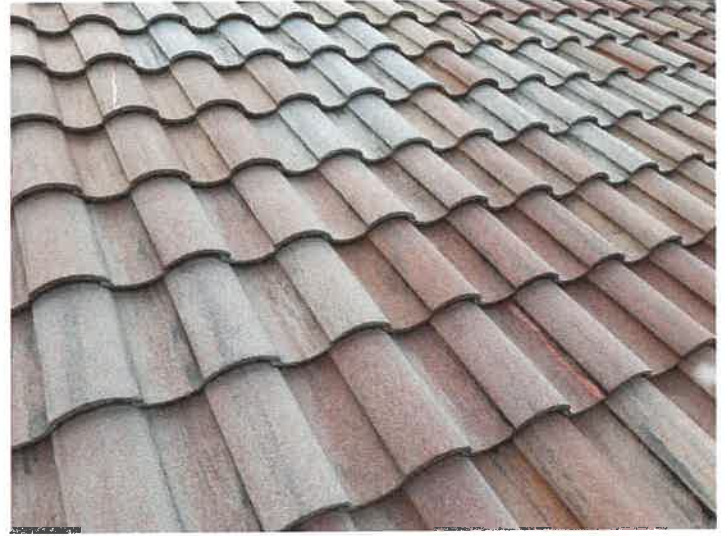
Cracked roof tiles can allow premature underlayment deterioration from excessive UV exposure.

Building 15130: Repaired Cracked Roof Tiles

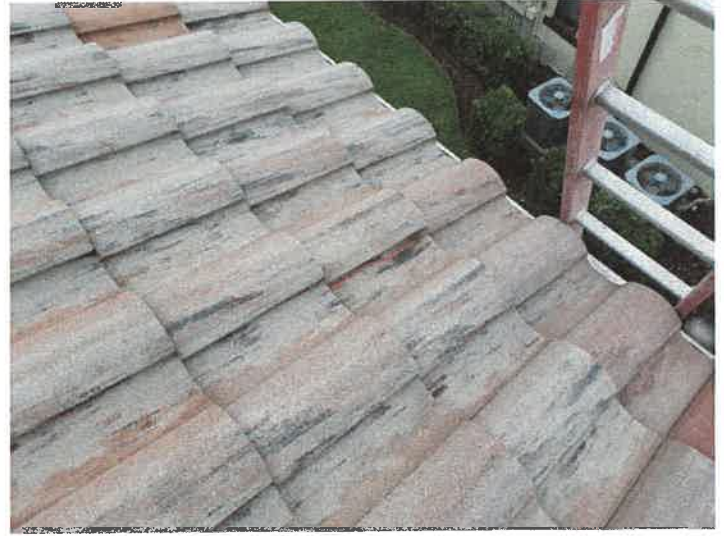
Building 15130: Identified Cracked Roof Tiles
Cracked roof tiles can allow premature underlayment deterioration from excessive UV exposure.

Building 15130: Repaired Cracked Roof Tiles
The cracked roof tiles were repaired with Titebond sealant.

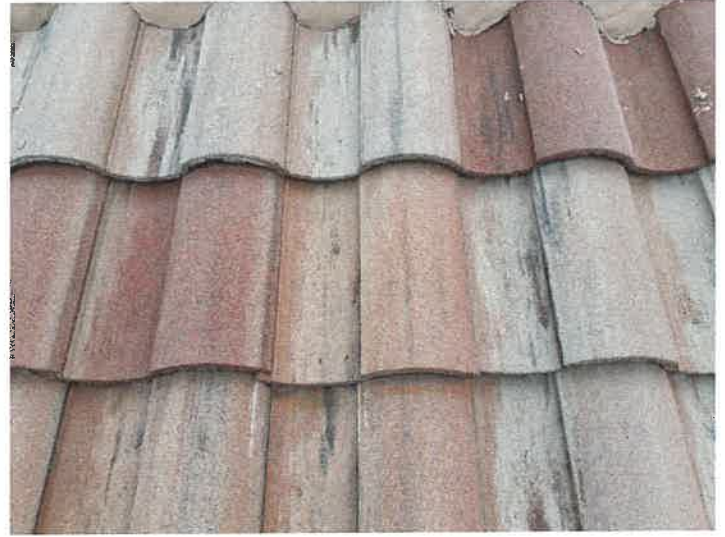
Displaced or missing roof tiles can allow premature underlayment deterioration from excessive UV exposure and potential water intrusion.

Building 15130: Repaired Displaced/Missing Roof Tile

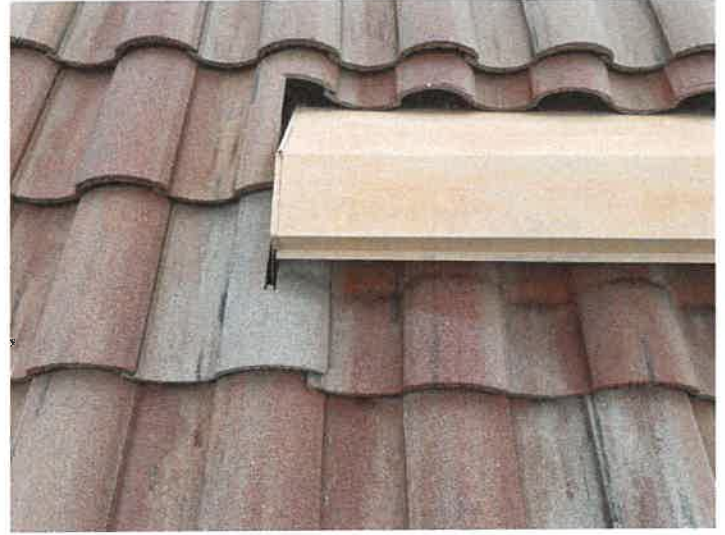
Displaced or missing roof tiles can allow premature underlayment deterioration from excessive UV exposure and potential water intrusion.

Building 15130: Repaired Displaced/Missing Roof Tile

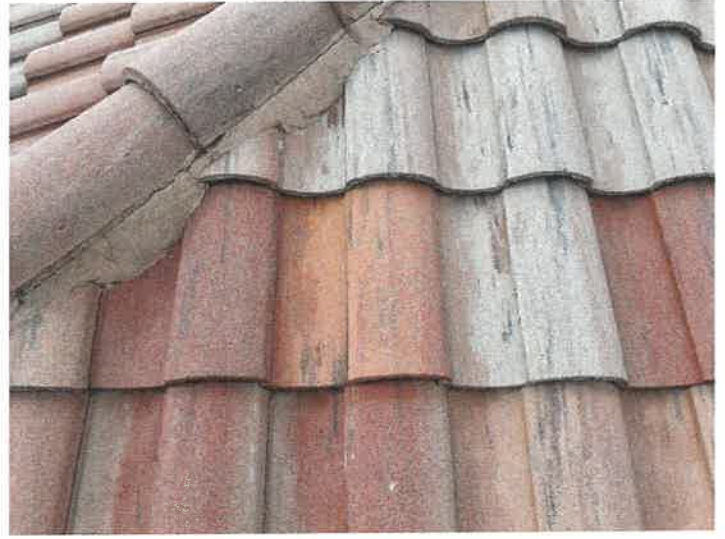
Displaced or missing roof tiles can allow premature underlayment deterioration from excessive UV exposure and potential water intrusion.

Building 15130: Repaired Displaced/Missing Roof Tile

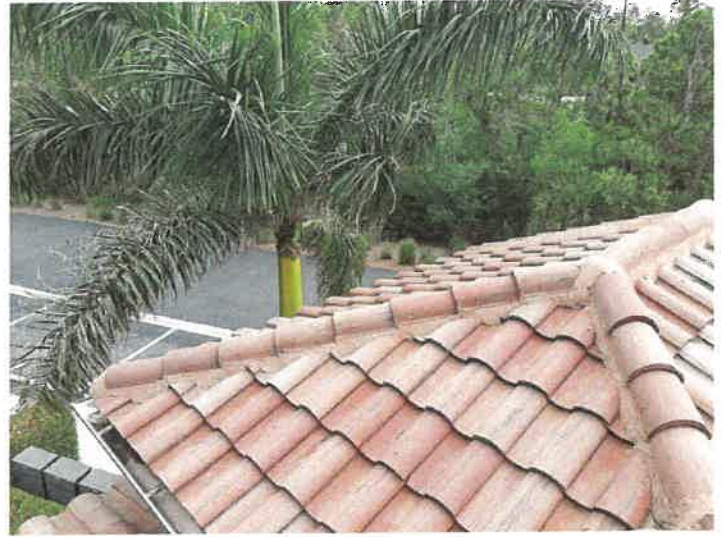
Identified tree branches hanging over the roof surface. Branches on the roof surface can cause deterioration of membrane, and act as an access for rodents and unwanted bugs/pests.

Building 15130: Tree Branches
