Pond Guru Fort Myers
P.O. Box 3439,
North Fort Myers, FL 33918,
(239) 997-8872

Service Report
REP-790

Job Sheet Name	:	FD0085
Problem Statement	:	Fountain Diagnosis P3 not working

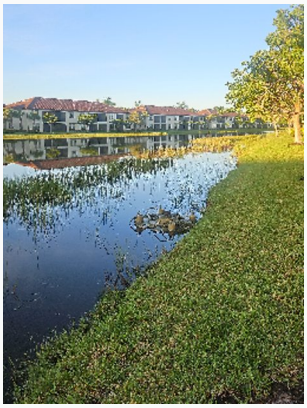
Comments	:	Customer complaint unit in op / verified unit does not function -check power out / bad -Check overload / tripped / reset / power out good high amp draw -check capacitor / bad, out of spec / install test cap run / bad high amp draw unit does not function - pull unit and separate motor and cable -meg wire / caution -meg ALC connector / bad -meg motor/ good / remove unit for thorough cleaning and suggested service ** need capacitor/ alc connector xl / recommend wire replaced 8/4 / timer battery x2 / oil and seals motor *** Quote will be prepared and sent.
Location of Fountains Inspected	:	Livingston P3
Fountain and Panel	:	Fountain and panel NOT functioning correctly
Fountain Incoming Voltage	:	Incoming voltage within acceptable range
Fountain Outgoing Voltage	:	Outgoing voltage NOT within acceptable range
Fountain Amps	:	Amps loaded NOT within acceptable range
Fountain GFCI	:	GFCI operating properly

Fountain Motor	:	Motor NOT operating properly
Fountain Motor Connection	:	Motor connection is dry
Fountain Motor Cable	:	Motor and cable NOT within acceptable range
Fountain Light Connector	:	Light connector is dry
Fountain Lights / Cable	:	Lights and cable operating properly
Fountain Lights	:	Lights operating properly
Fountain Photos	:
