Inspection Report

Facility: Livingston Lakes Condo

Work Order #: 13028

Re.: **Inspection Report (2 of 3) for Livingston Lakes**

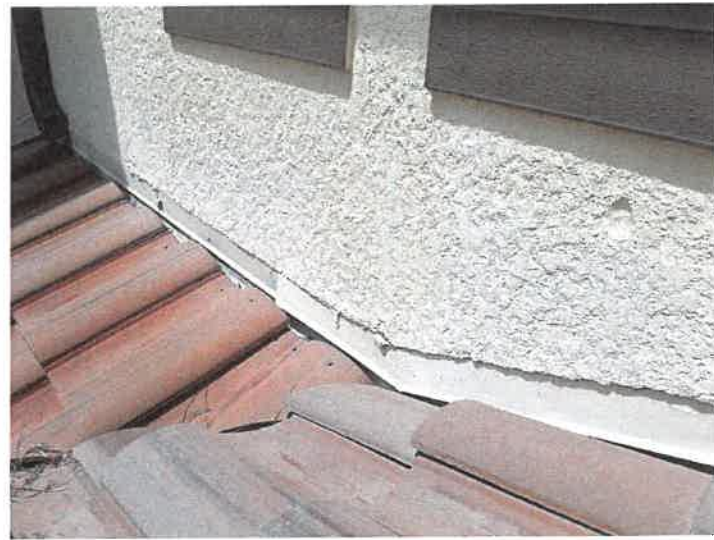
Building 15213: Wall

The walls appear to be in good condition.
