Inspection Report

Facility: Livingston Lakes Condo
Address: 15098 Palmer Lake Circle,
Naples, FL 34109
Customer: Cardinal Management
Address: c/o Livingston Lakes Condo, 15090
Naples, FL 34109

Livingston Lakes Condo, Naples, FL

Re.: **Inspection Report (2 of 3) for Livingston Lakes**

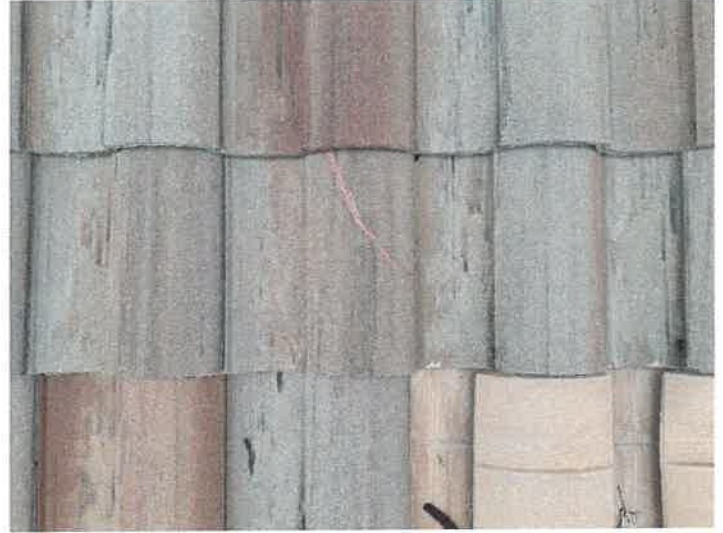
Building 15136: Identified Cracked Roof Tiles

Cracked roof tiles can allow premature underlayment deterioration from excessive UV exposure.
