Inspection Report

Facility: Livingston Lakes Condo
Address: 15098 Palmer Lake Circle,
Naples, FL 34109

Work Order #: 13028

Re.: Inspection Report (2 of 3) for Livingston Lakes

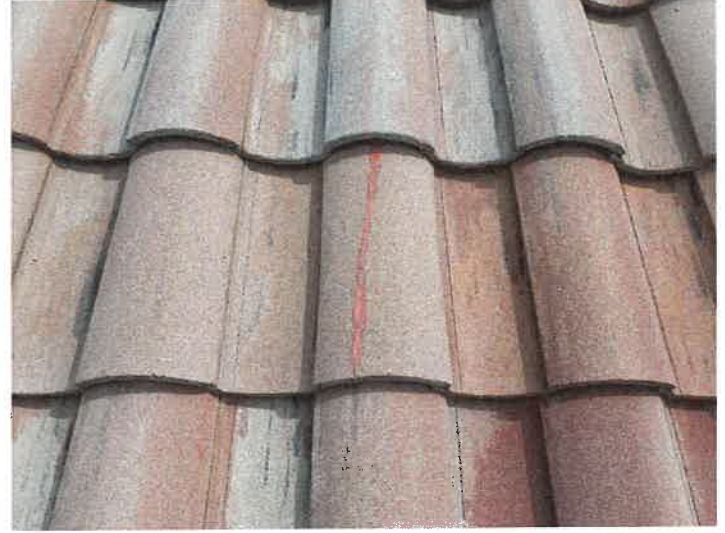
Building 15114: Identified Cracked Roof Tiles

Cracked roof tiles can allow premature underlayment deterioration from excessive UV exposure.

Building 15114: Repaired Cracked Roof Tiles

The cracked roof tiles were repaired with Titebond sealant.
