Inspection Report

Facility: Livingston Lakes Condo

Work Order #: 13028

Re.: **Inspection Report (2 of 3) for Livingston Lakes**

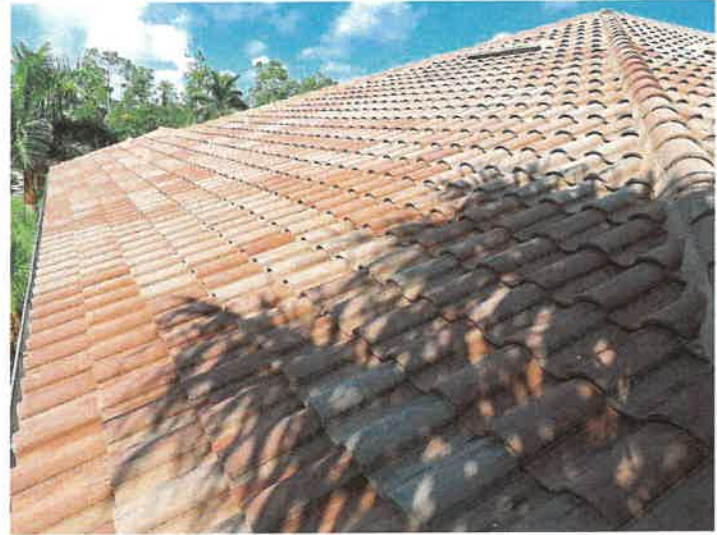
Building 15161: Surface Overview
The roof surface appears to be in good, maintainable condition at this time.

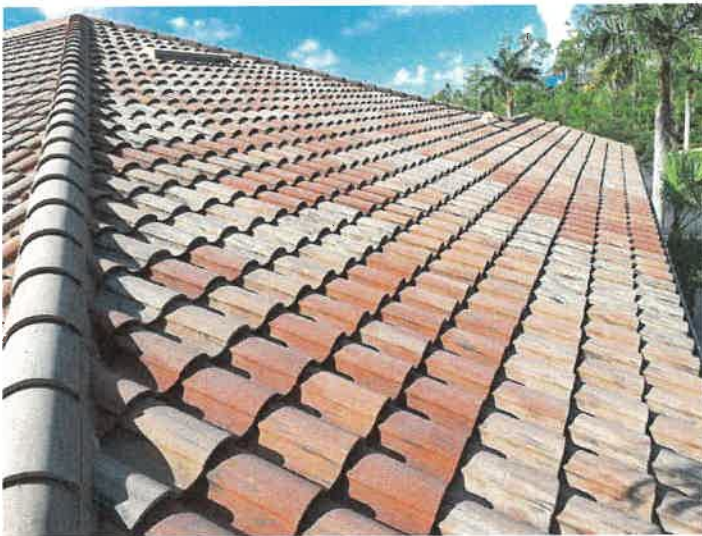
Building 15161: Appearance Overview
The roof appearance is in good, maintainable condition.

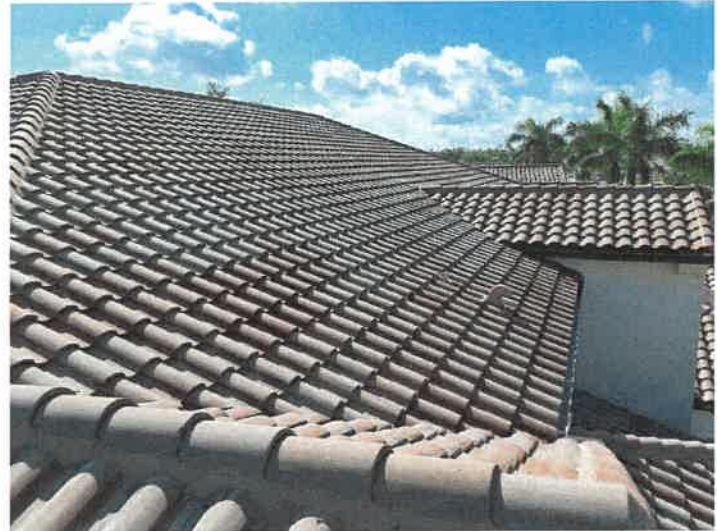
Building 15161: Surface Overview
The roof surface appears to be in good, maintainable condition at this time.

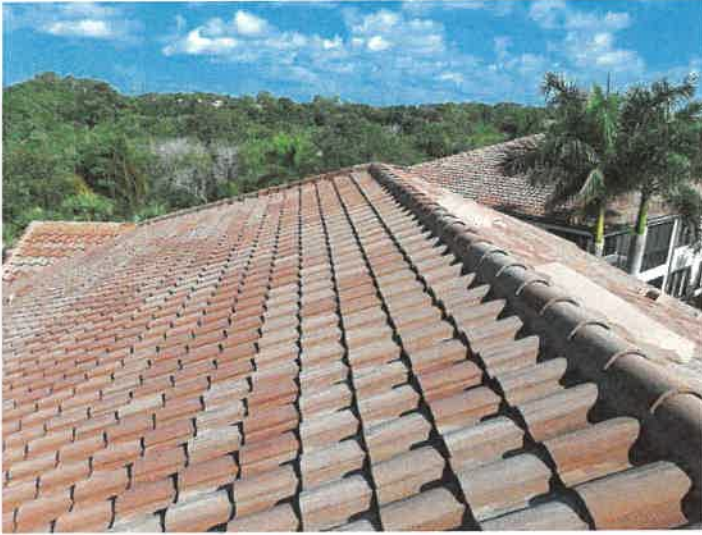
Building 15161: Ridge Tiles

Ridge tiles appear to be in good condition.

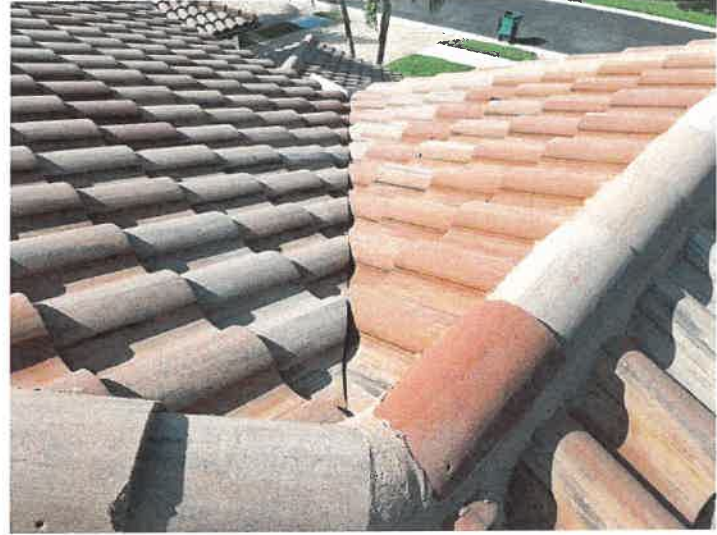
Building 15161: Valley

The valley tiles appear to be in good condition.

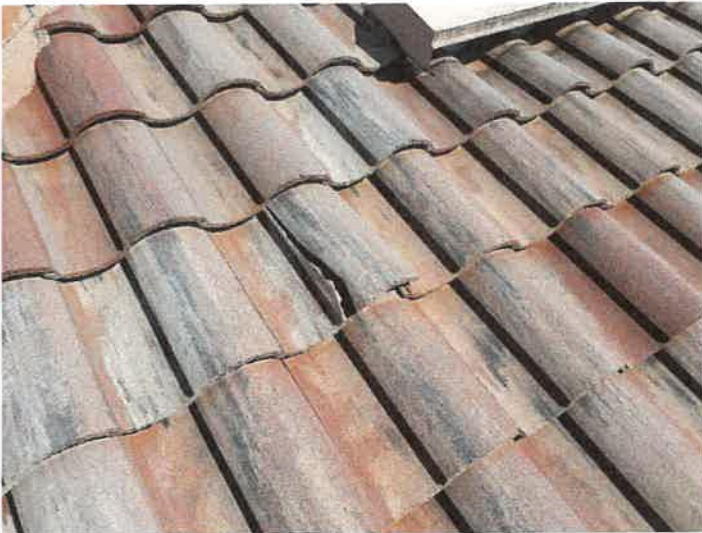
Building 15161: Identified Cracked Roof Tiles

Cracked roof tiles can allow premature underlayment deterioration from excessive UV exposure.

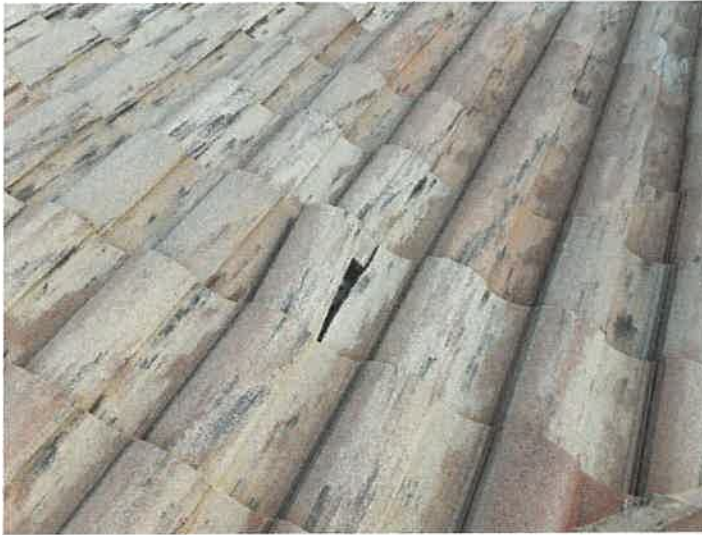
Building 15161: Identified Cracked Roof Tiles
Cracked roof tiles can allow premature underlayment deterioration from excessive UV exposure.

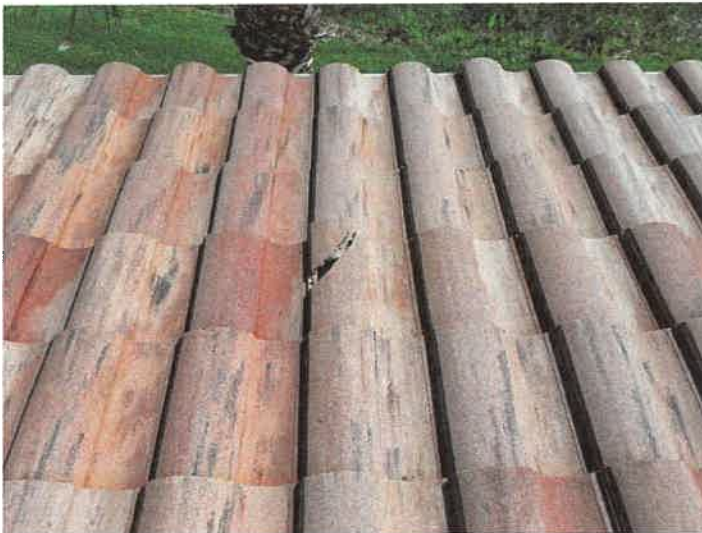
Building 15161: Identified Cracked Roof Tiles
Cracked roof tiles can allow premature underlayment deterioration from excessive UV exposure.

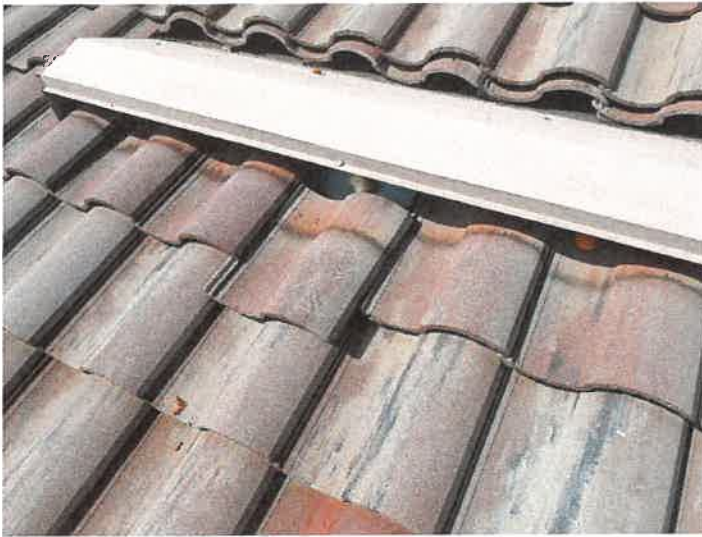
Building 15161: Displaced/Missing Roof Tile

Displaced or missing roof tiles can allow premature underlayment deterioration from excessive UV exposure and potential water intrusion.

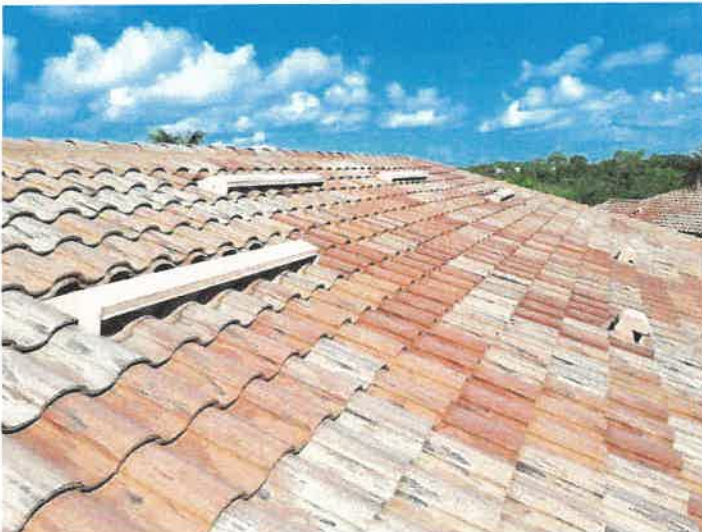
Building 15161: Roof Vents

Roof vents appear to be in good condition.

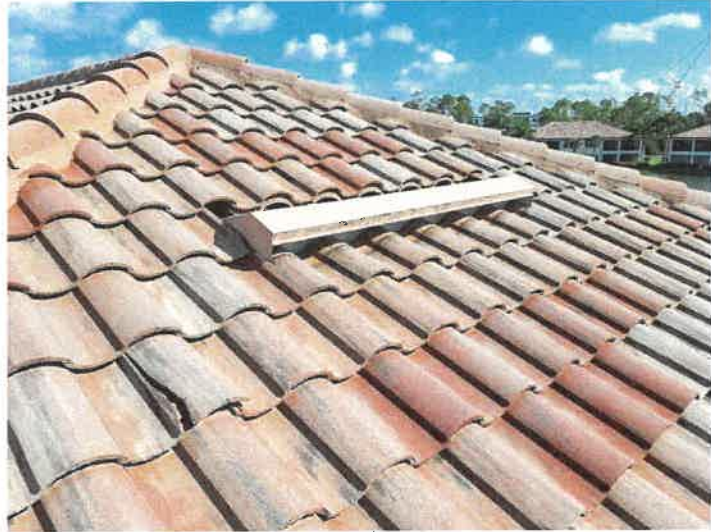
Building 15161: Roof Vents

Roof vents appear to be in good condition.

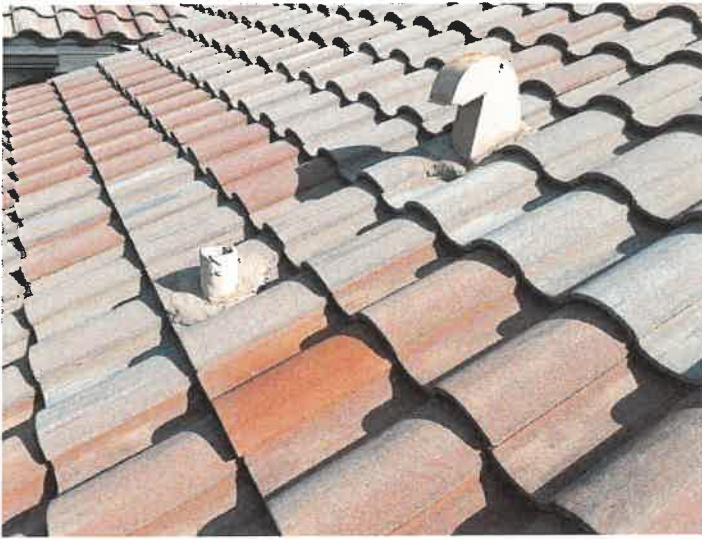
Building 15161: Lead Boots
Lead boots appear to be in good condition.

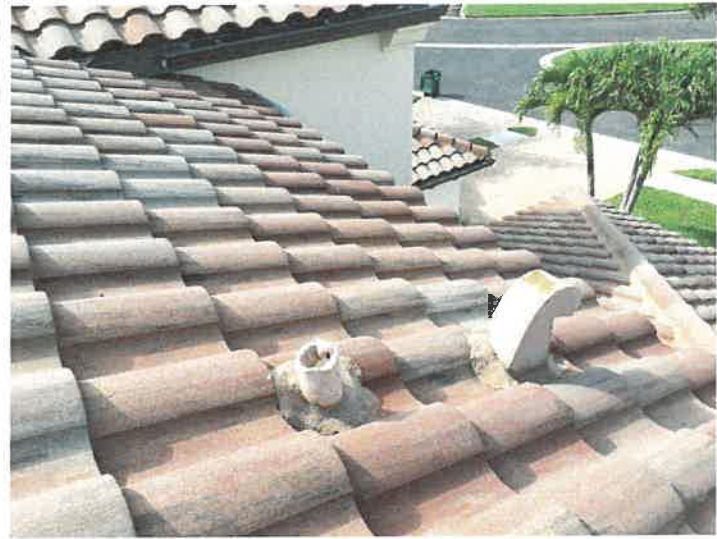
Building 15161: Lead Boots
Lead boots appear to be in good condition.

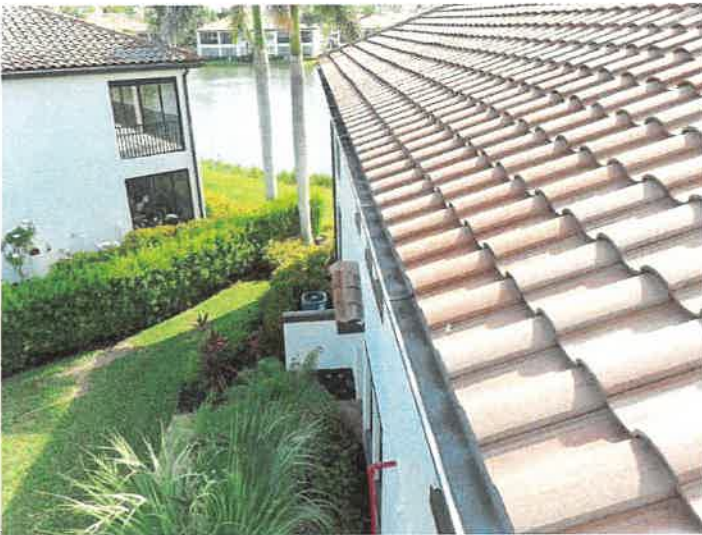
Building 15161: Gutters
The gutters appear to be in good condition.

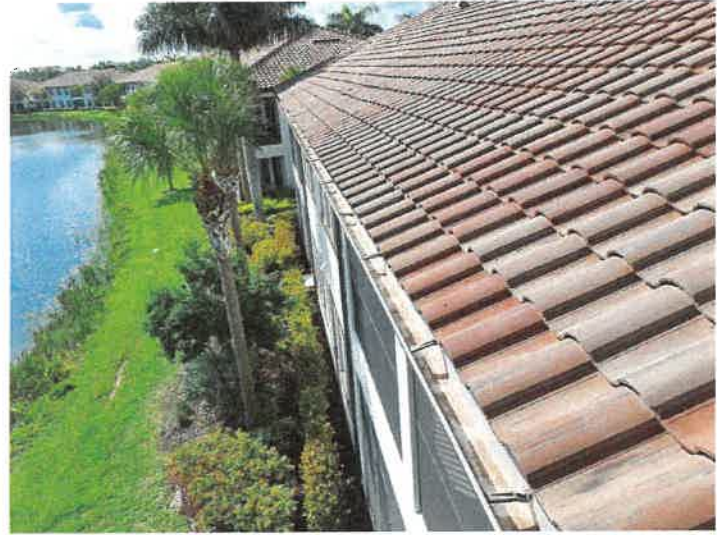
Building 15161: Gutters
The gutters appear to be in good condition.

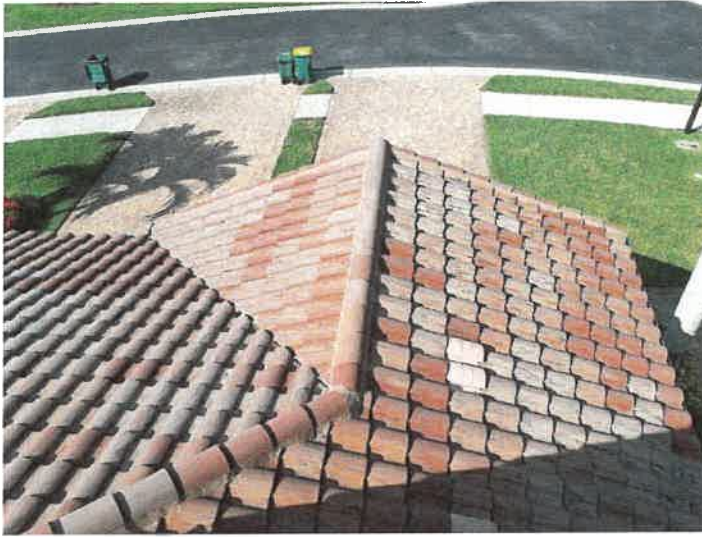
Building 15161: Surface Overview - Lower Roof
The roof surface appears to be in good, maintainable condition at this time.

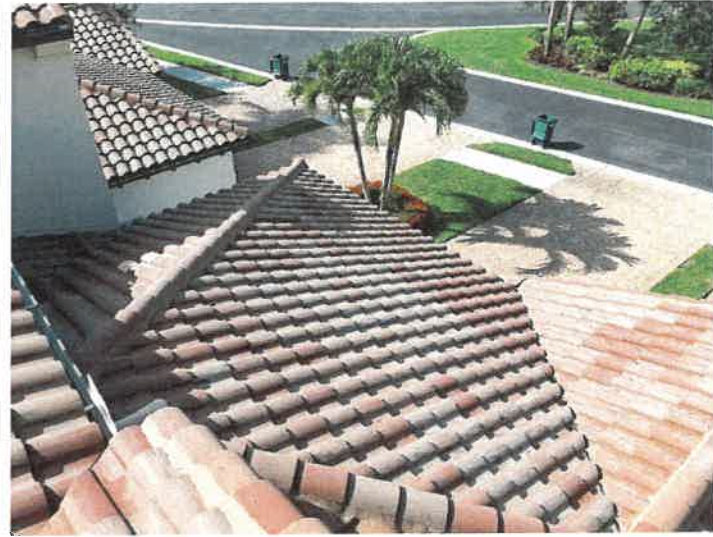
Building 15161: Appearance Overview - Lower Roof
The roof appearance is in good, maintainable condition.

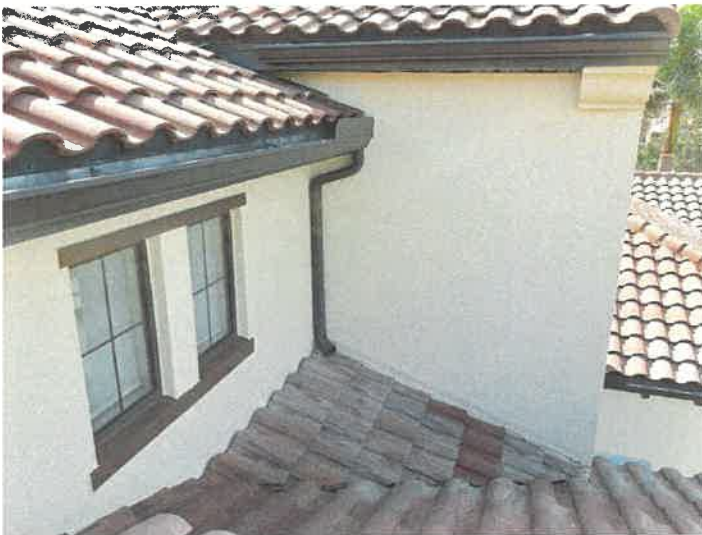
Building 15161: Wall
The walls appear to be in good condition.

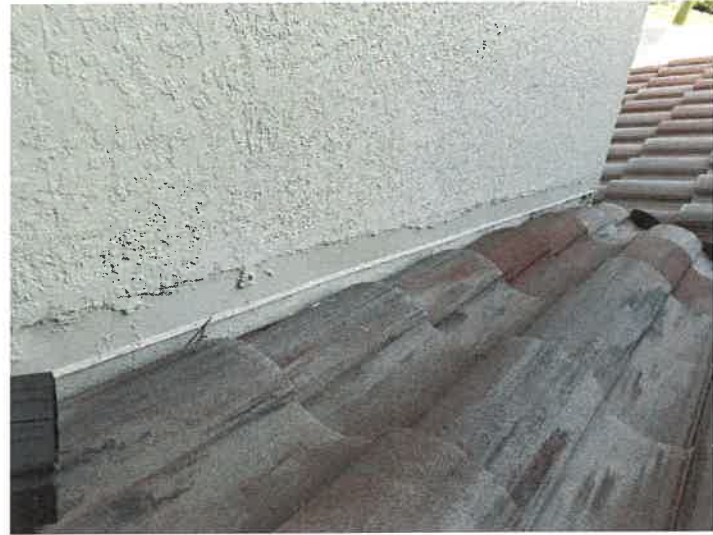
Building 15161: Counter Flashings
The counter flashing appears to be in good condition.

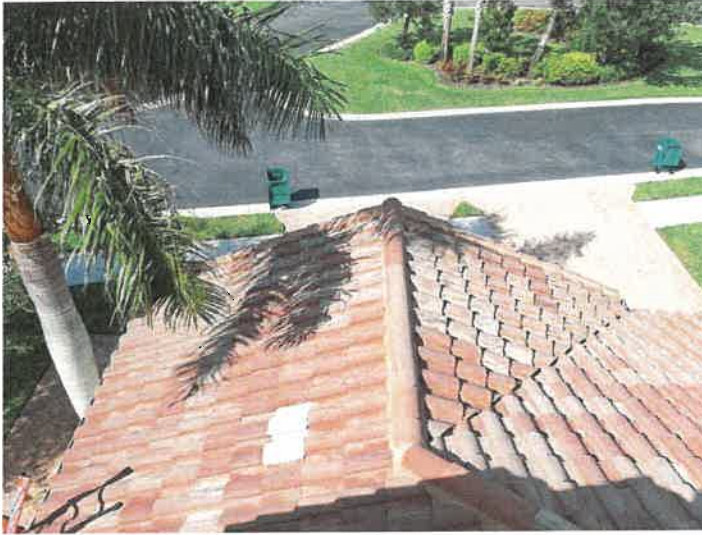
Building 15161: Appearance Overview - Lower Roof
The roof appearance is in good, maintainable condition.

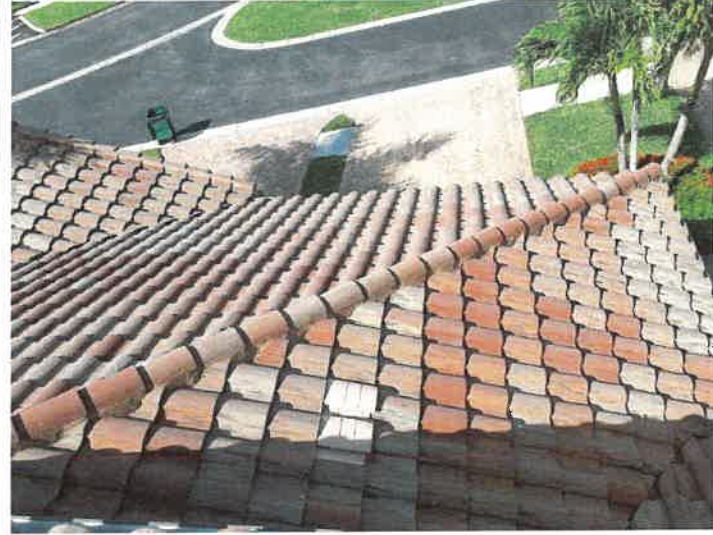
Building 15161: Surface Overview - Lower Roof
The roof surface appears to be in good, maintainable condition at this time.

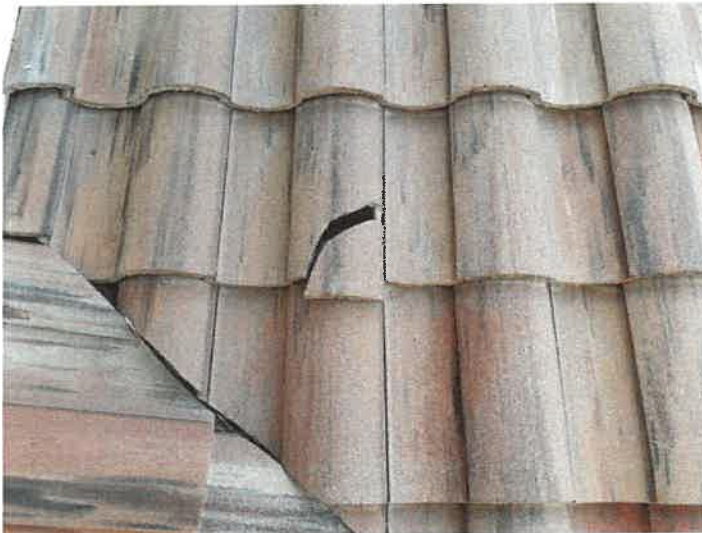
Building 15161: Identified Cracked Roof Tiles
Cracked roof tiles can allow premature underlayment deterioration from excessive UV exposure.

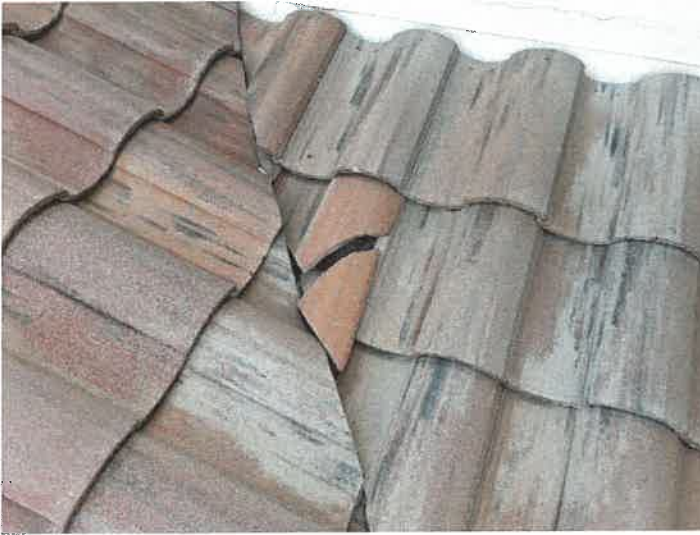
Building 15161: Identified Cracked Roof Tiles
Cracked roof tiles can allow premature underlayment deterioration from excessive UV exposure.

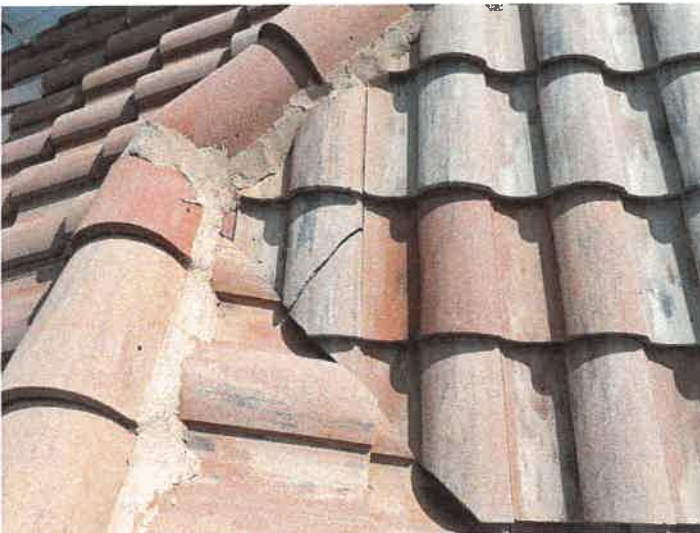
Building 15161: Identified Cracked Roof Tiles
Cracked roof tiles can allow premature underlayment deterioration from excessive UV exposure.

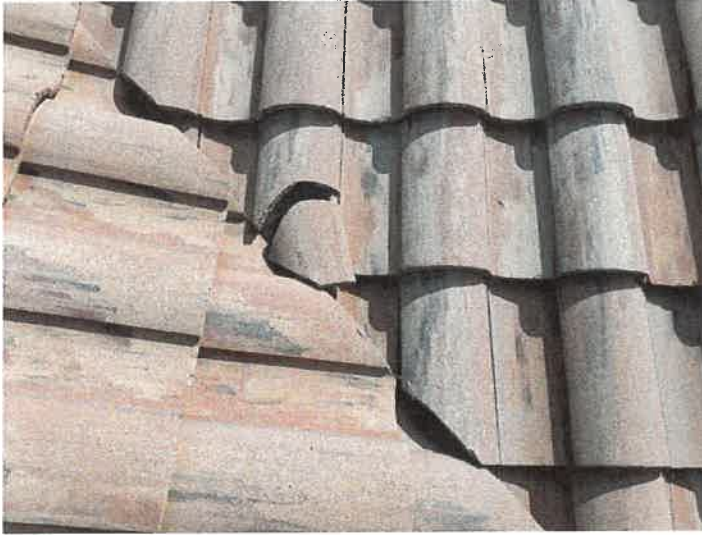
Building 15161: Identified Cracked Roof Tiles
Cracked roof tiles can allow premature underlayment deterioration from excessive UV exposure.

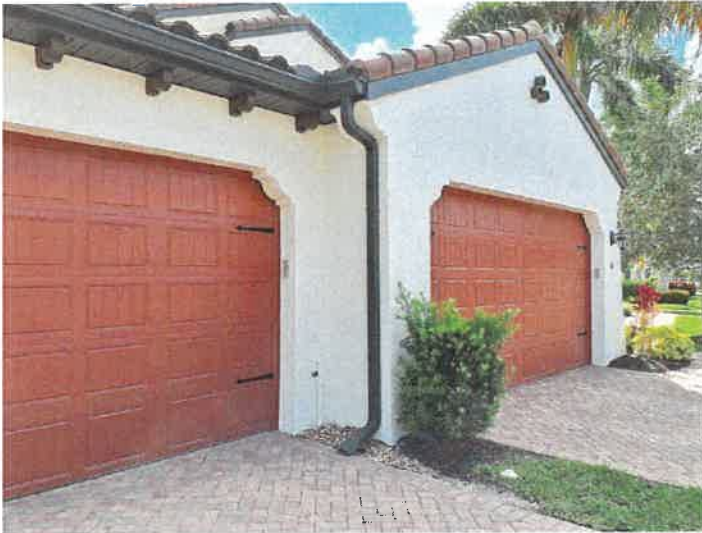
Building 15161: Downspouts
The downspouts appear to be in good condition.

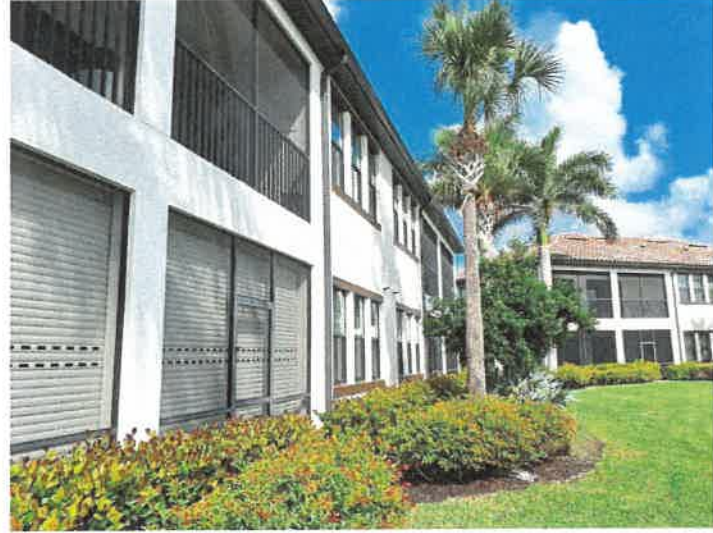
Building 15161: Downspouts
The downspouts appear to be in good condition.

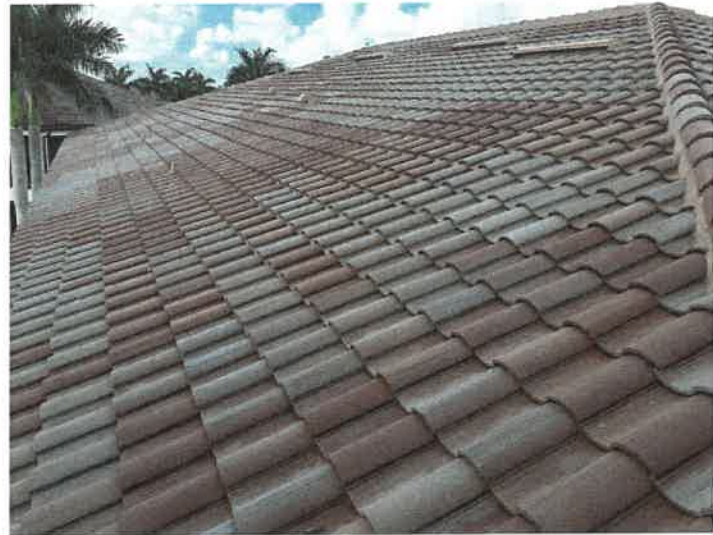
Building 15165: Surface Overview
The roof surface appears to be in good, maintainable condition at this time.

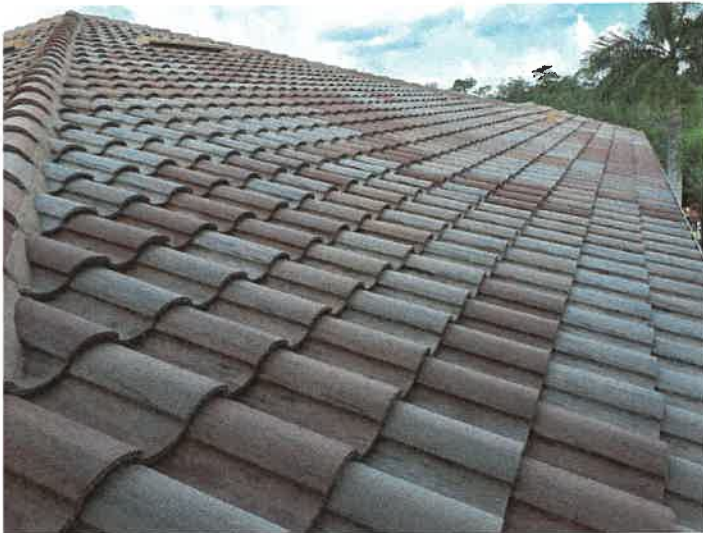
Building 15165: Appearance Overview
The roof appearance is in good, maintainable condition.

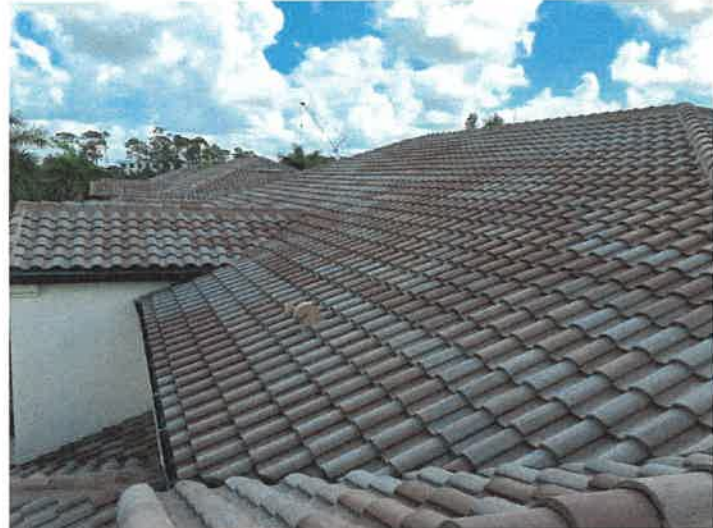
Building 15165: Surface Overview
The roof surface appears to be in good, maintainable condition at this time.

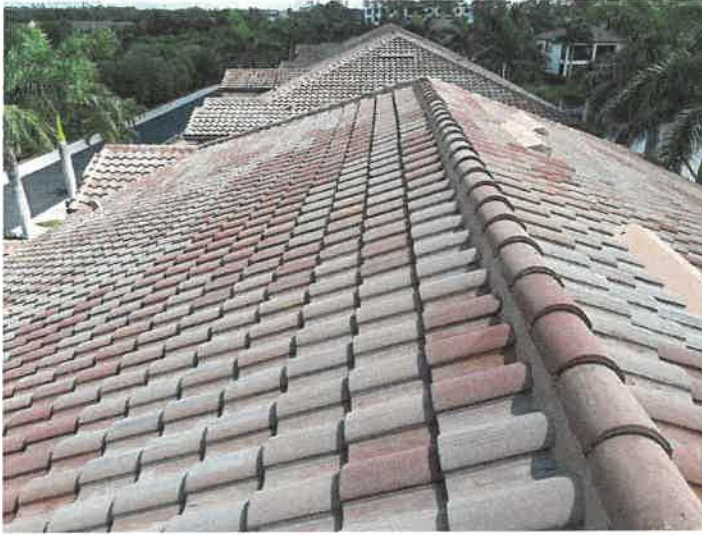
Building 15165: Ridge Tiles

Ridge tiles appear to be in good condition.

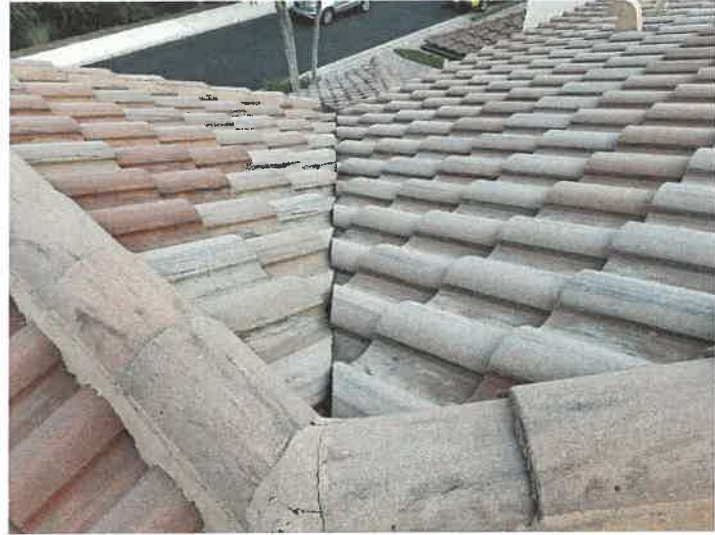
Building 15165: Valley

The valley tiles appear to be in good condition.

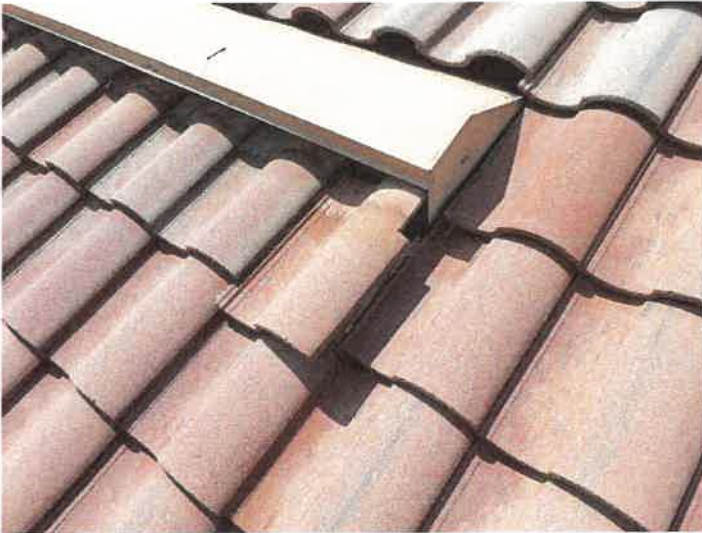
Building 15165: Displaced/Missing Roof Tile

Displaced or missing roof tiles can allow premature underlayment deterioration from excessive UV exposure and potential water intrusion.

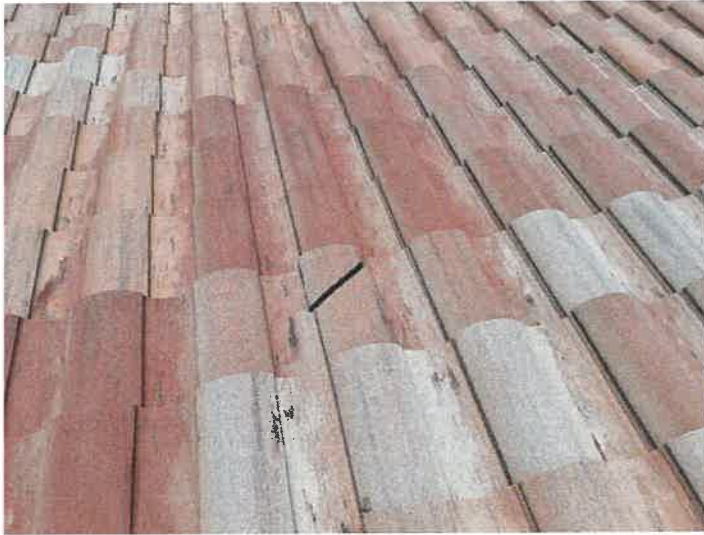
Building 15165: Identified Cracked Roof Tiles

Cracked roof tiles can allow premature underlayment deterioration from excessive UV exposure.

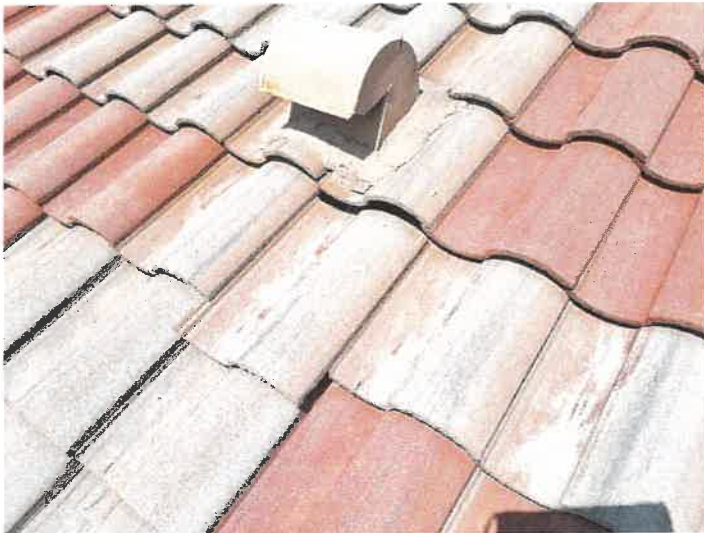
Building 15165: Displaced/Missing Roof Tile

Displaced or missing roof tiles can allow premature underlayment deterioration from excessive UV exposure and potential water intrusion.

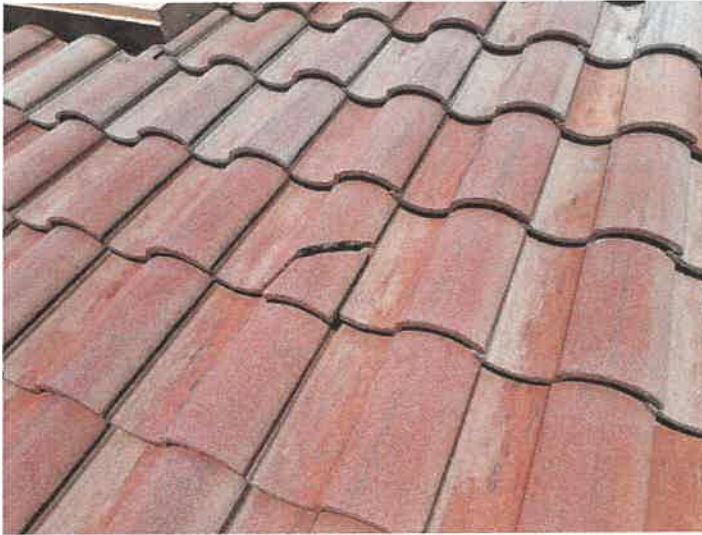
Building 15165: Identified Cracked Roof Tiles
Cracked roof tiles can allow premature underlayment deterioration from excessive UV exposure.

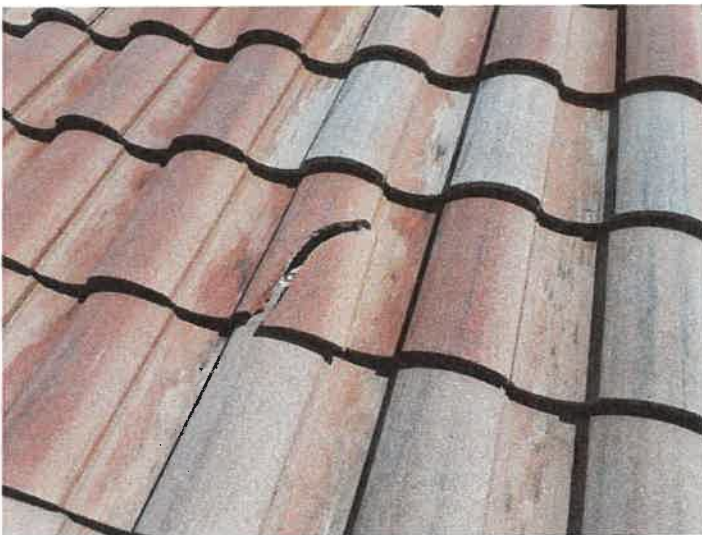
Building 15165: Identified Cracked Roof Tiles
Cracked roof tiles can allow premature underlayment deterioration from excessive UV exposure.

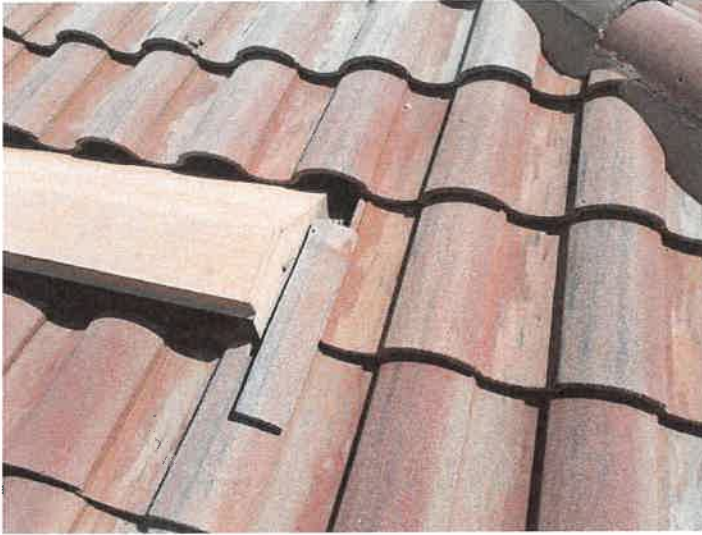
Building 15165: Displaced/Missing Roof Tile

Displaced or missing roof tiles can allow premature underlayment deterioration from excessive UV exposure and potential water intrusion.

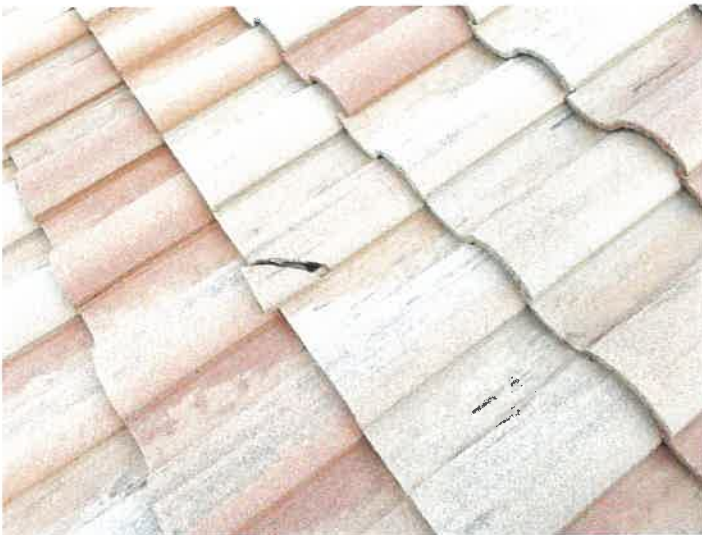
Building 15165: Identified Cracked Roof Tiles

Cracked roof tiles can allow premature underlayment deterioration from excessive UV exposure.

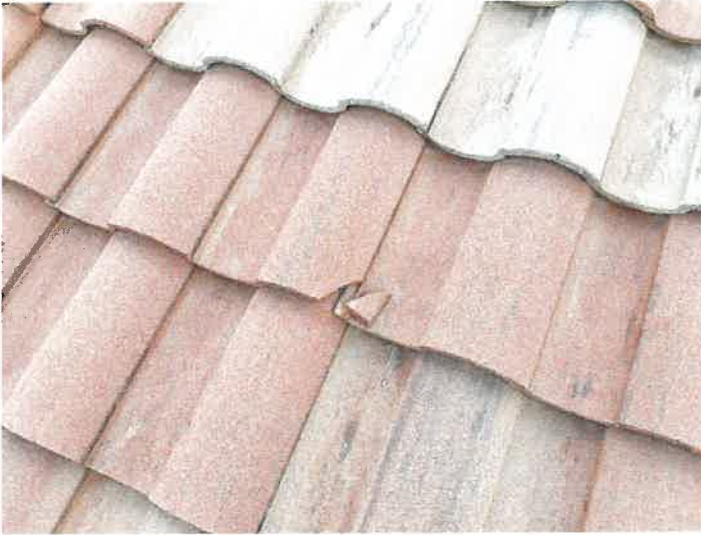
Building 15165: Identified Cracked Roof Tiles

Cracked roof tiles can allow premature underlayment deterioration from excessive UV exposure.

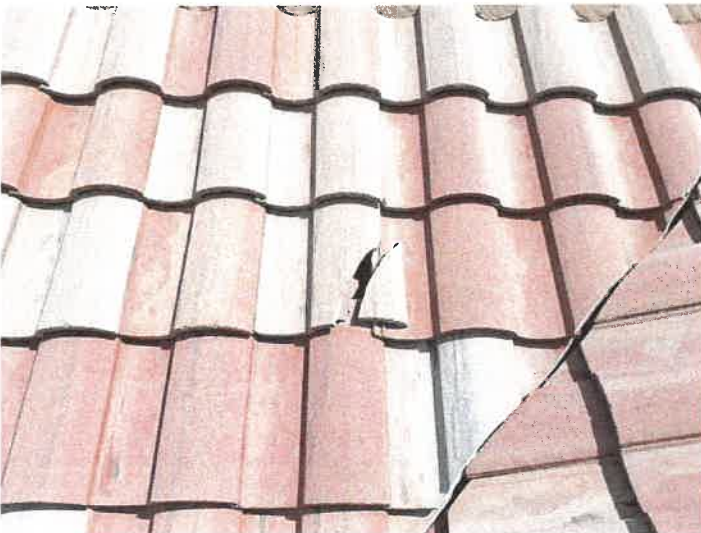
Building 15165: Identified Cracked Roof Tiles

Cracked roof tiles can allow premature underlayment deterioration from excessive UV exposure.

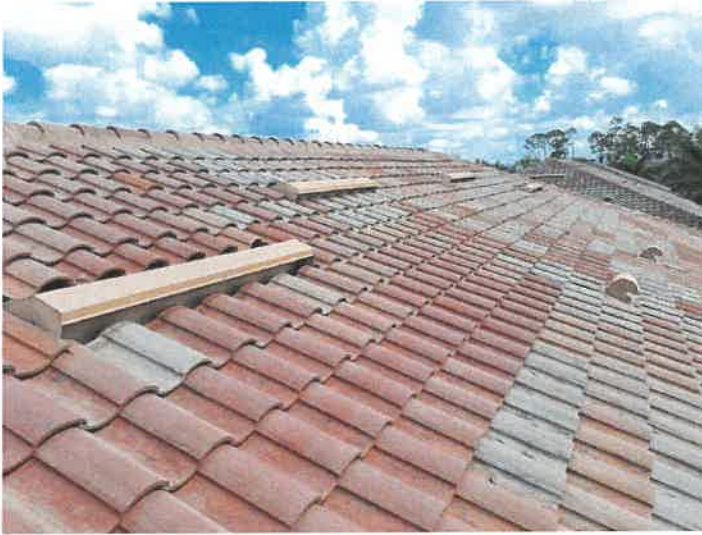
Building 15165: Roof Vents
Roof vents appear to be in good condition.

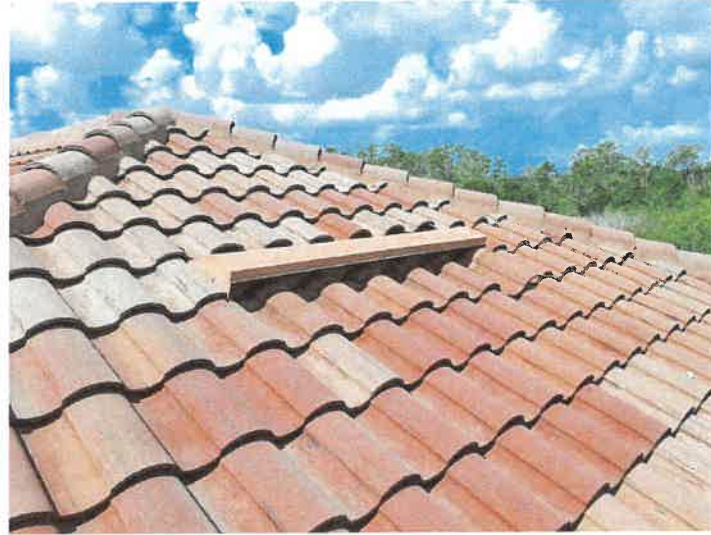
Building 15165: Roof Vents
Roof vents appear to be in good condition.

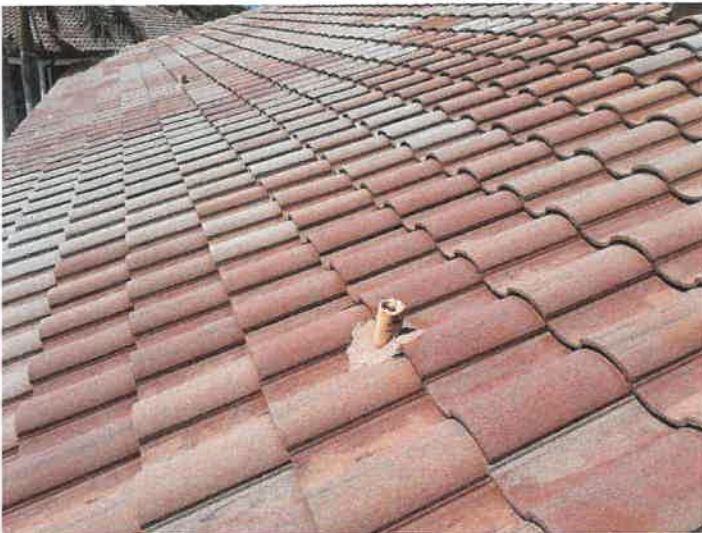
Building 15165: Lead Boots
Lead boots appear to be in good condition.

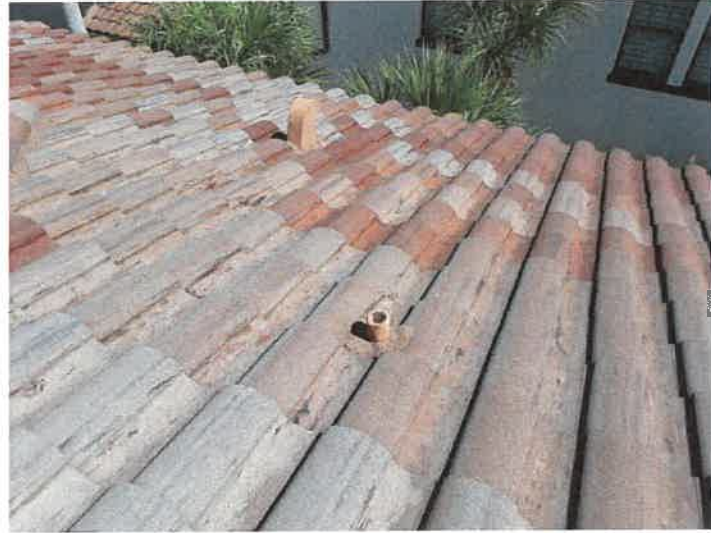
Building 15165: Lead Boots
Lead boots appear to be in good condition.

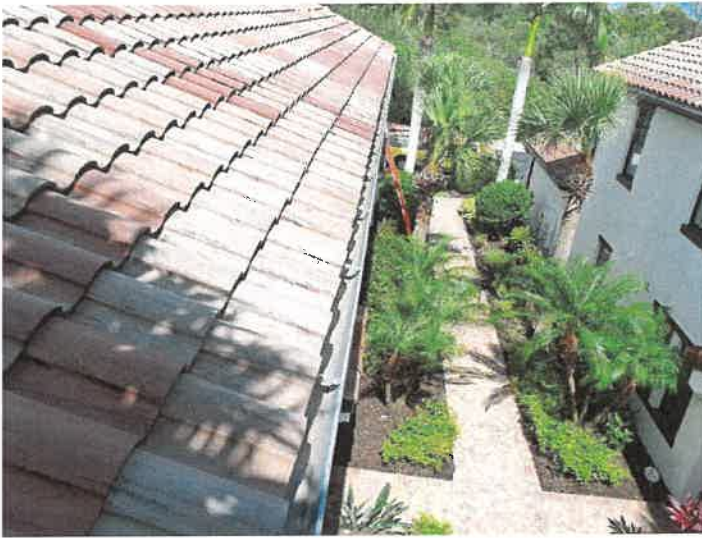
Building 15165: Gutters

The gutters appear to be in good condition.

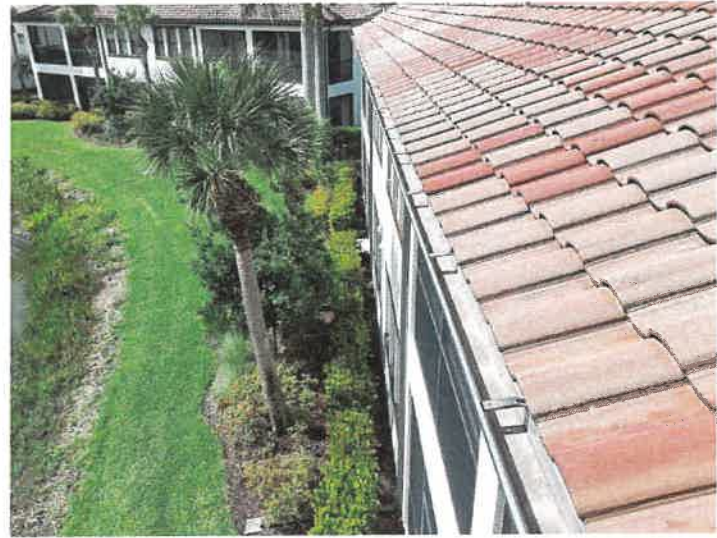
Building 15165: Gutters

The gutters appear to be in good condition.

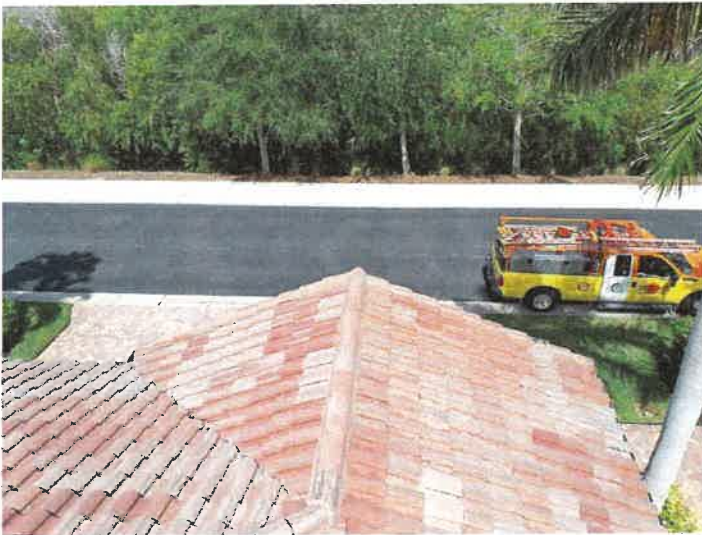
Building 15165: Surface Overview - Lower Roof

The roof surface appears to be in good, maintainable condition at this time.

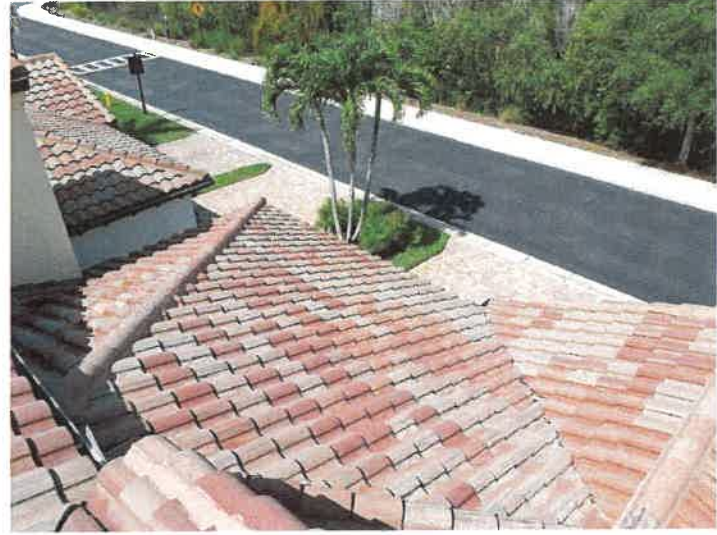
Building 15165: Appearance Overview - Lower Roof

The roof appearance is in good, maintainable condition.

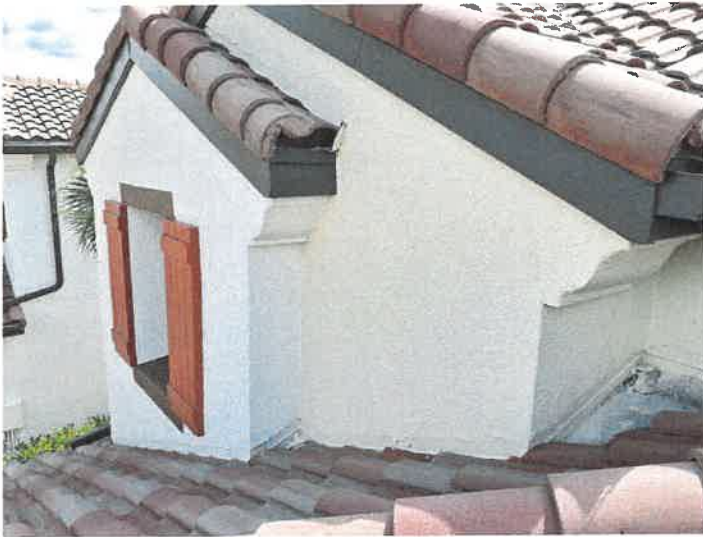
Building 15165: Wall

The walls appear to be in good condition.

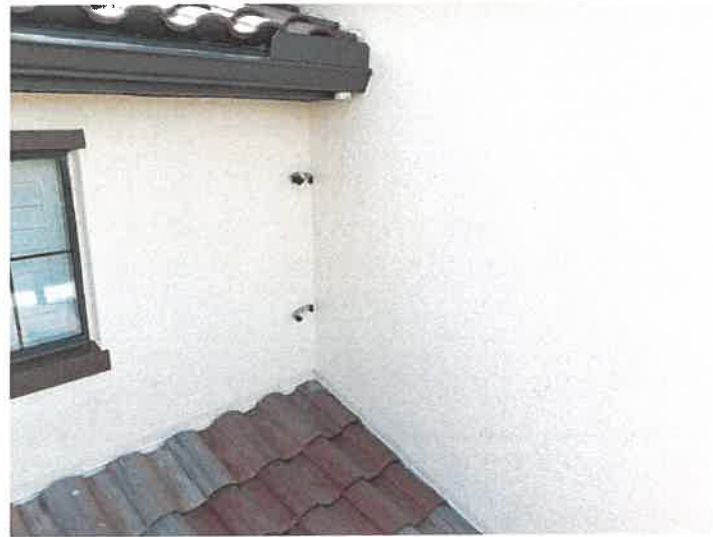
Building 15165: Downspout- missing

Downspout is missing. The painting company that is painting the exteriors in Livingston Lakes has the missing downspouts.

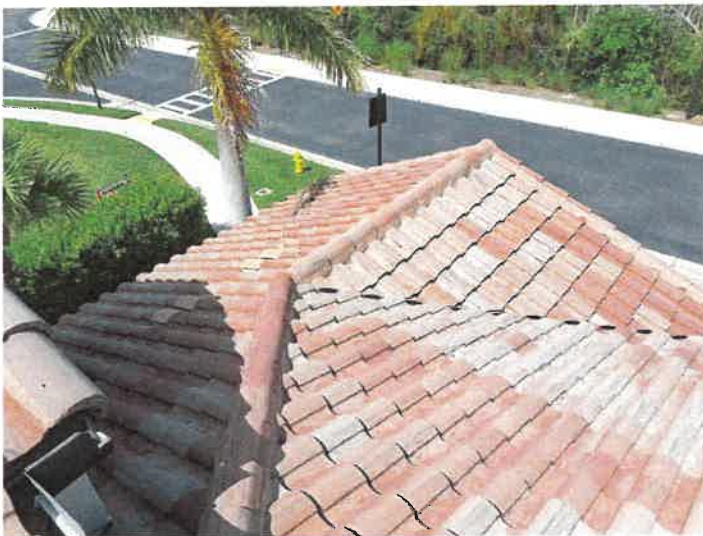
Building 15165: Surface Overview - Lower Roof

The roof surface appears to be in good, maintainable condition at this time.

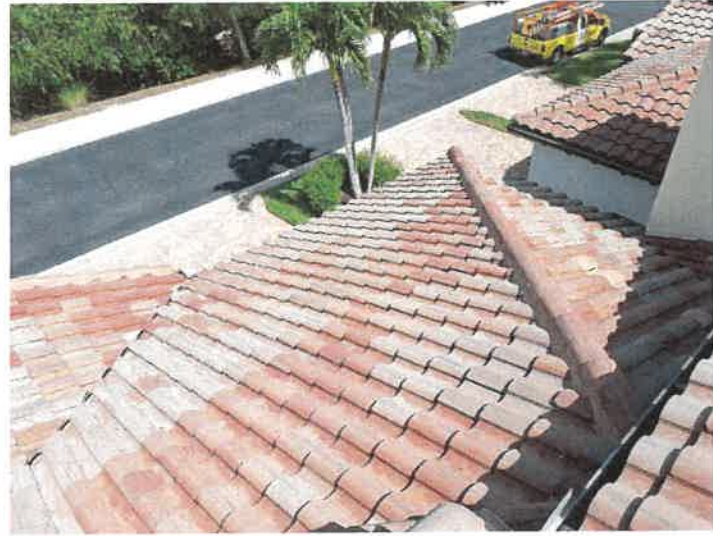
Building 15165: Appearance Overview - Lower Roof

The roof appearance is in good, maintainable condition.

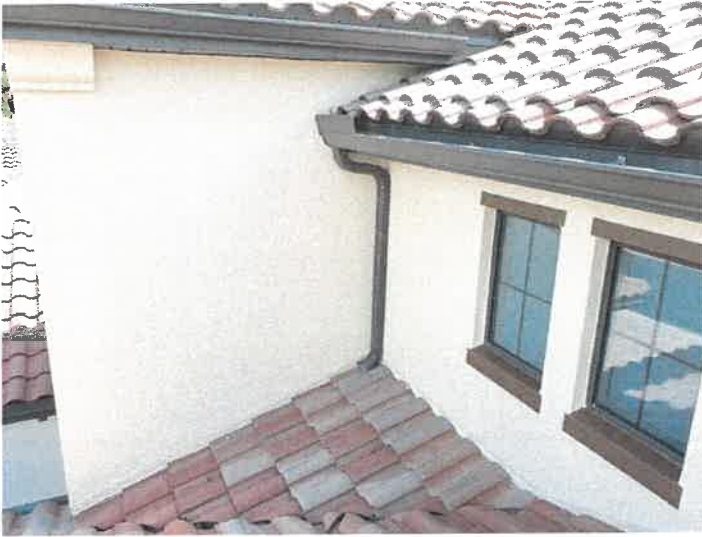
Building 15165: Wall

The walls appear to be in good condition.

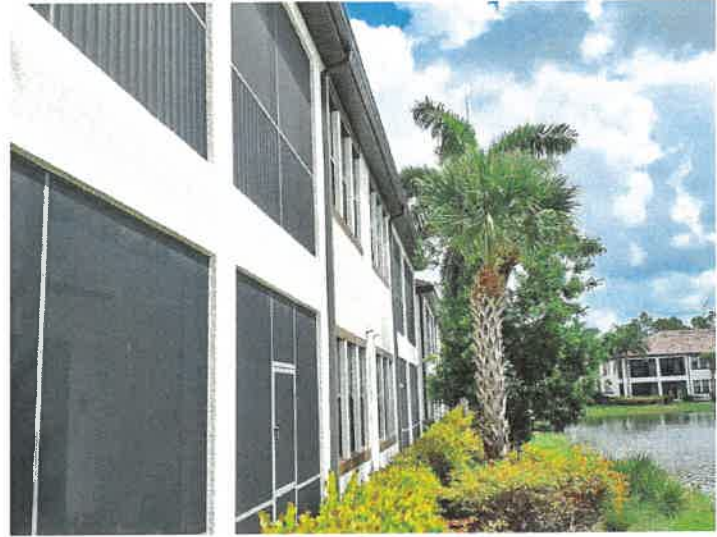
Building 15165: Downspouts

The downspouts appear to be in good condition.

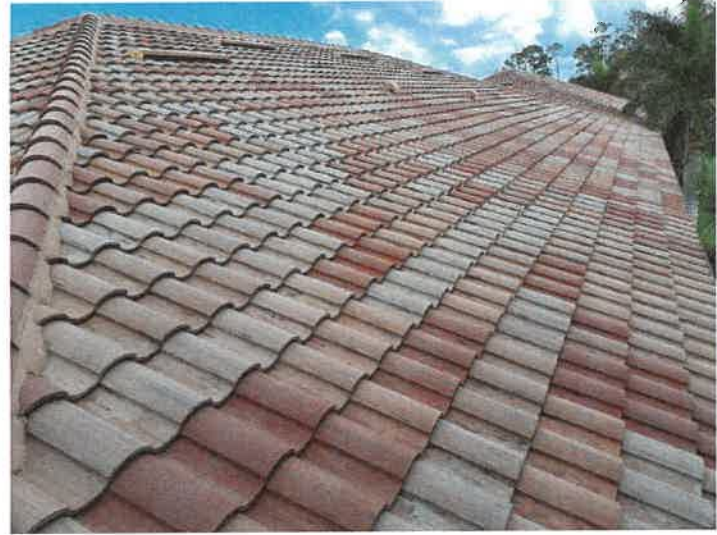
Building 15169: Surface Overview

The roof surface appears to be in good, maintainable condition at this time.

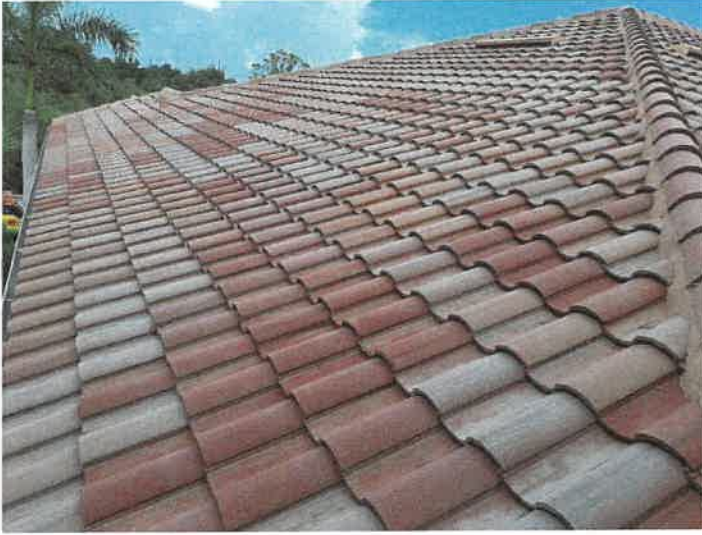
Building 15169: Appearance Overview
The roof appearance is in good, maintainable condition.
