Inspection Report

Facility: Livingston Lakes Condo

Work Order #: 13028

Re.: **Inspection Report (2 of 3) for Livingston Lakes**

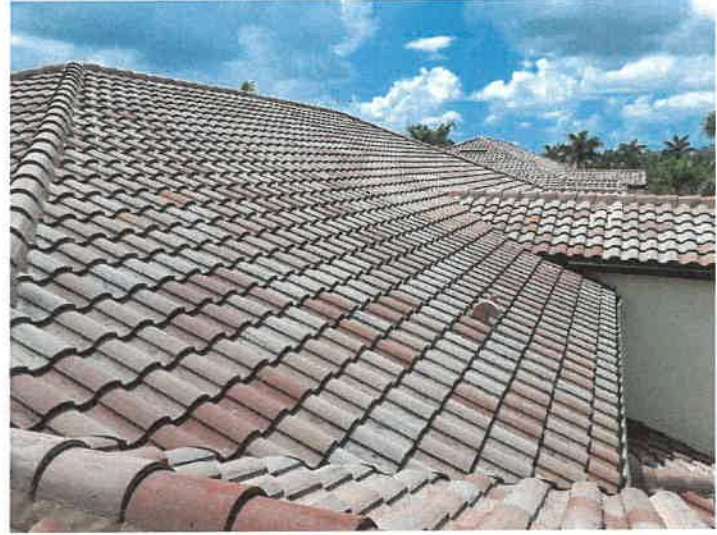
Building 15169: Appearance Overview
The roof appearance is in good, maintainable condition.

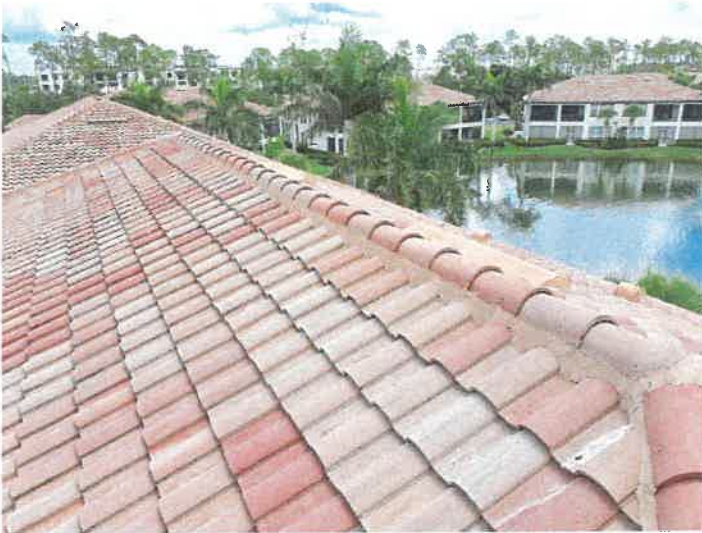
Building 15169: Ridge Tiles
Ridge tiles appear to be in good condition.

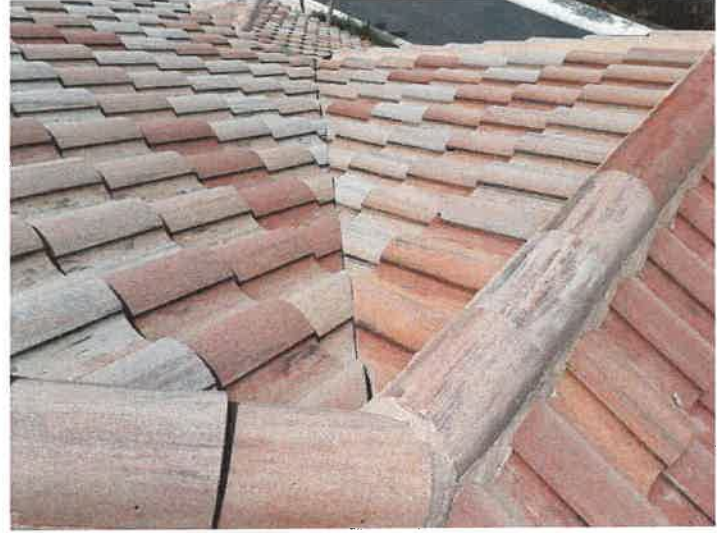
Building 15169: Valley
The valley tiles appear to be in good condition.

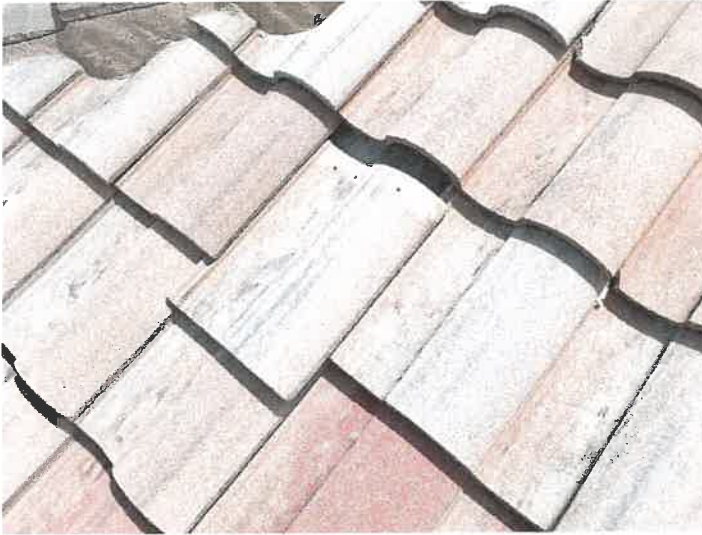
Building 15169: Displaced/Missing Roof Tile

Displaced or missing roof tiles can allow premature underlayment deterioration from excessive UV exposure and potential water intrusion.

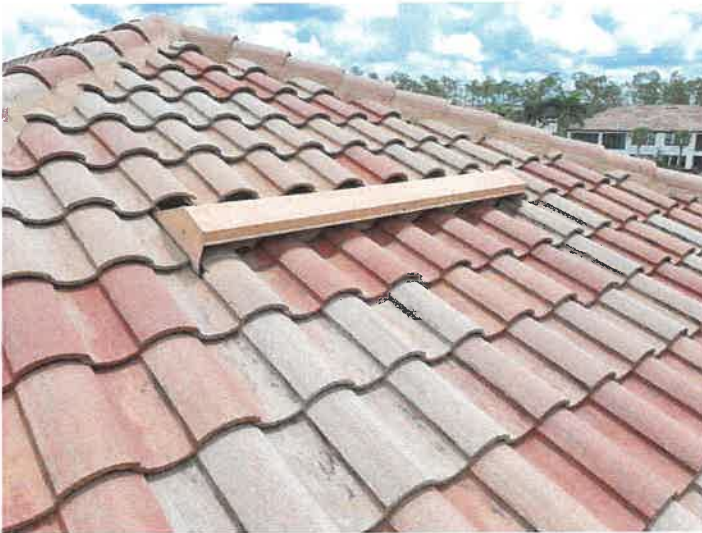
Building 15169: Roof Vents

Roof vents appear to be in good condition.

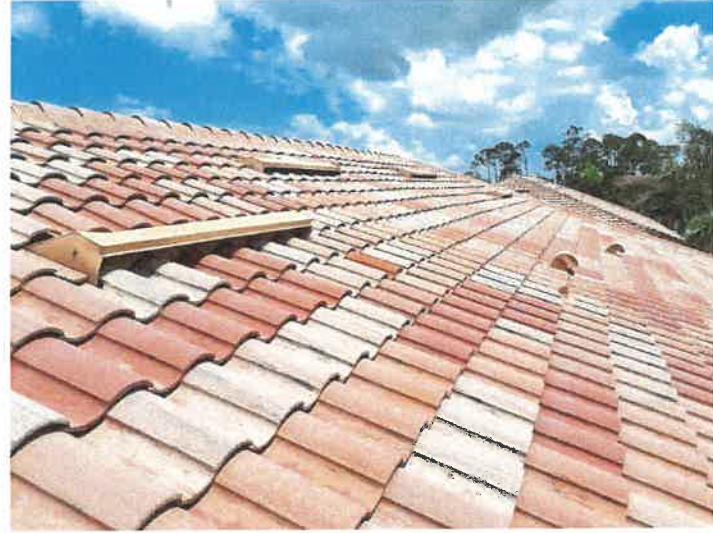
Building 15169: Roof Vents

Roof vents appear to be in good condition.

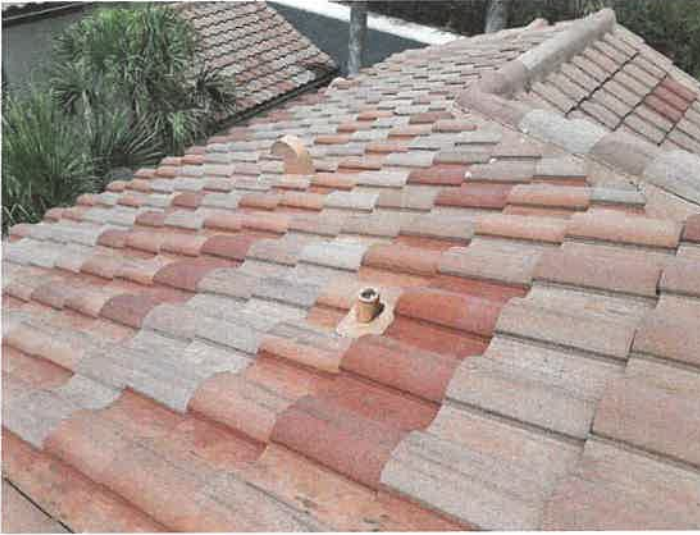
Building 15169: Lead Boots

Lead boots appear to be in good condition.

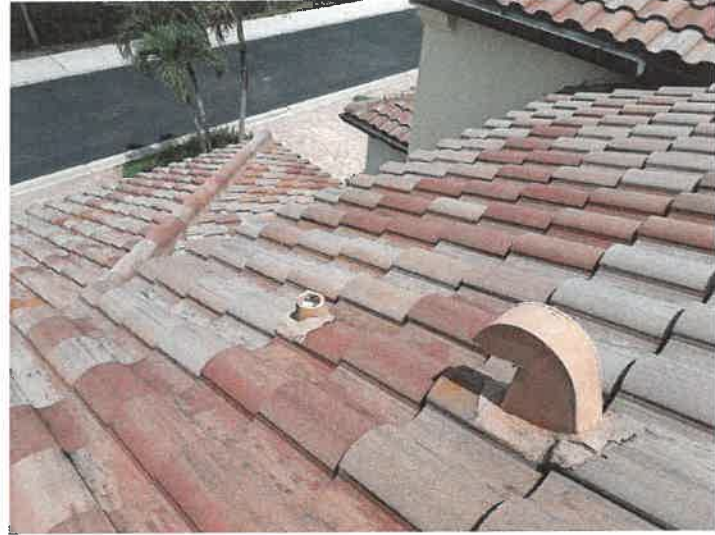
Building 15169: Lead Boots

Lead boots appear to be in good condition.

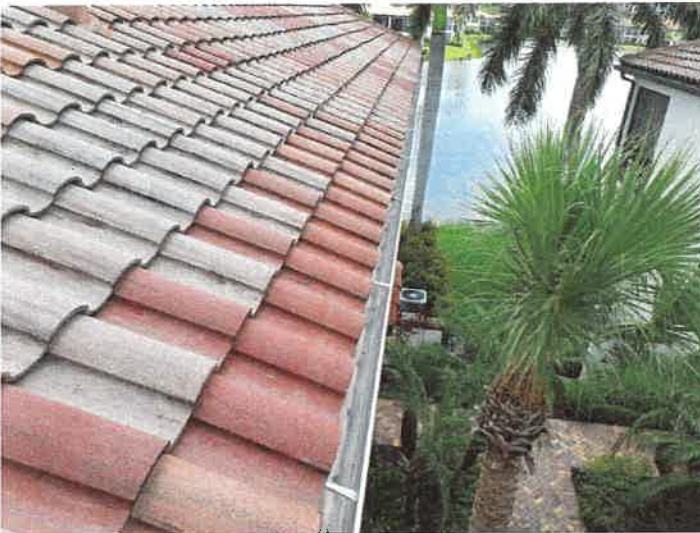
Building 15169: Gutters

The gutters appear to be in good condition.

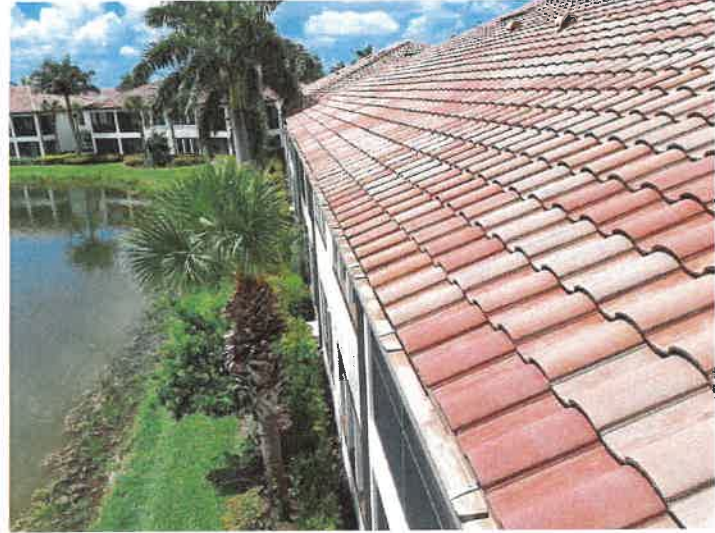
Building 15169: Gutters

The gutters appear to be in good condition.

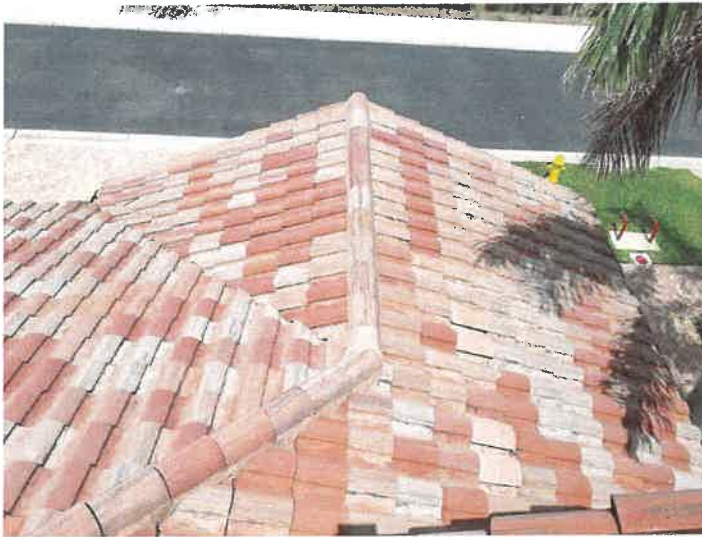
Building 15169: Surface Overview - Lower Roof
The roof surface appears to be in good, maintainable condition at this time.

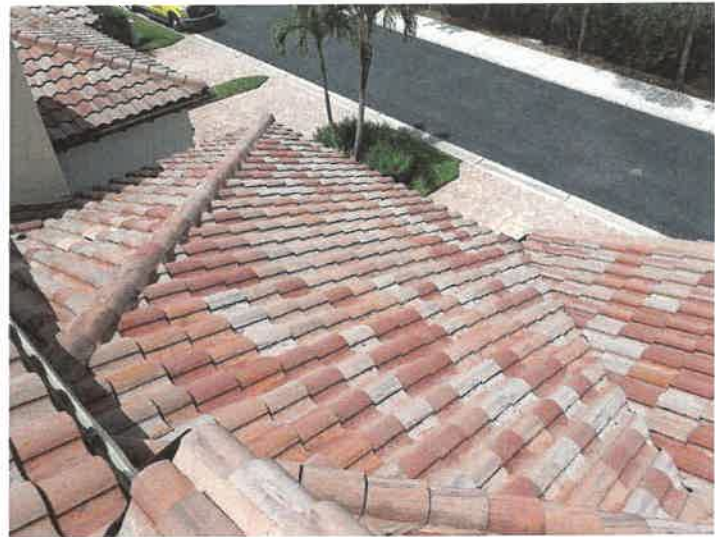
Building 15169: Appearance Overview - Lower Roof
The roof appearance is in good, maintainable condition.

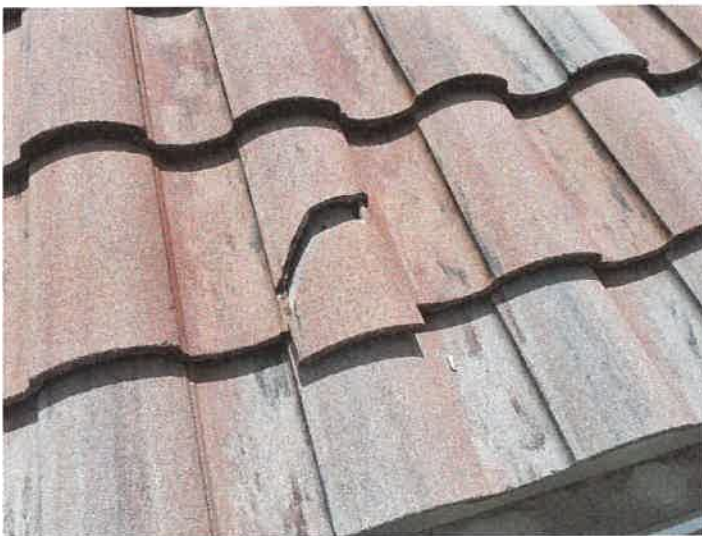
Building 15169: Identified Cracked Roof Tiles
Cracked roof tiles can allow premature underlayment deterioration from excessive UV exposure.

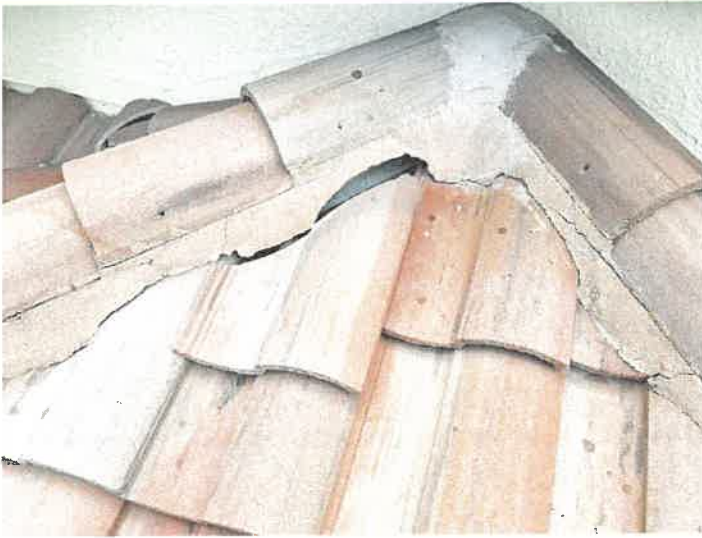
Building 15169: Displaced/Missing Roof Tile

Displaced or missing roof tiles can allow premature underlayment deterioration from excessive UV exposure and potential water intrusion.

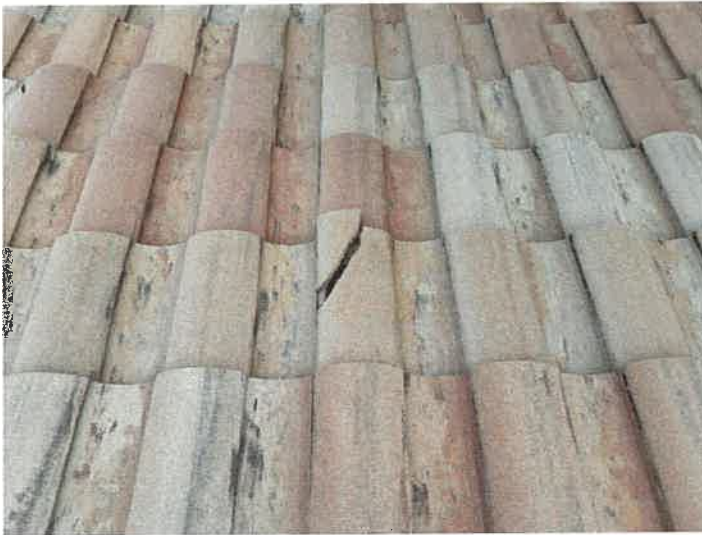
Building 15169: Identified Cracked Roof Tiles

Cracked roof tiles can allow premature underlayment deterioration from excessive UV exposure.

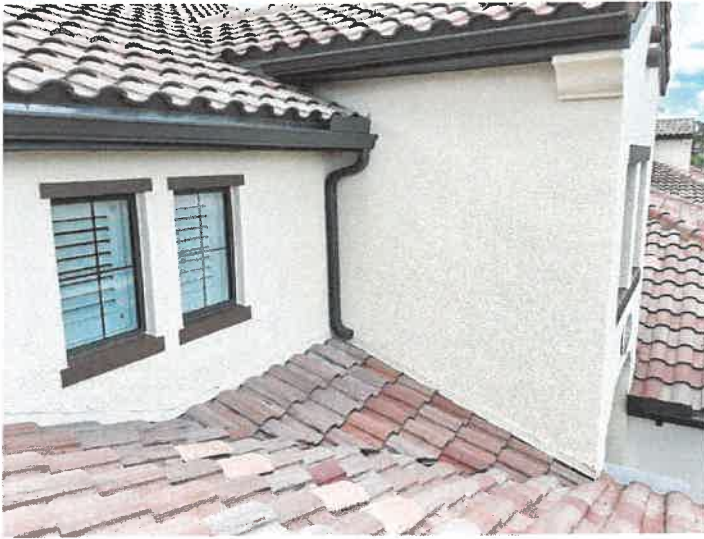
Building 15169: Wall

The walls appear to be in good condition.

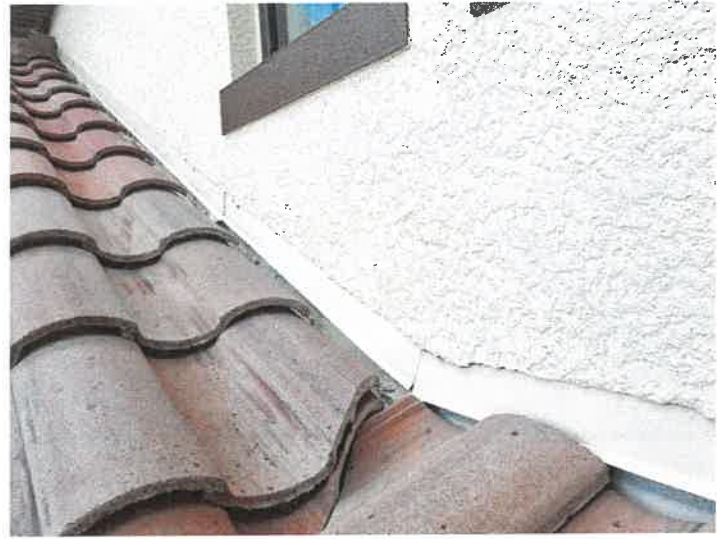
Building 15169: Counter Flashings

The counter flashing appears to be in good condition.

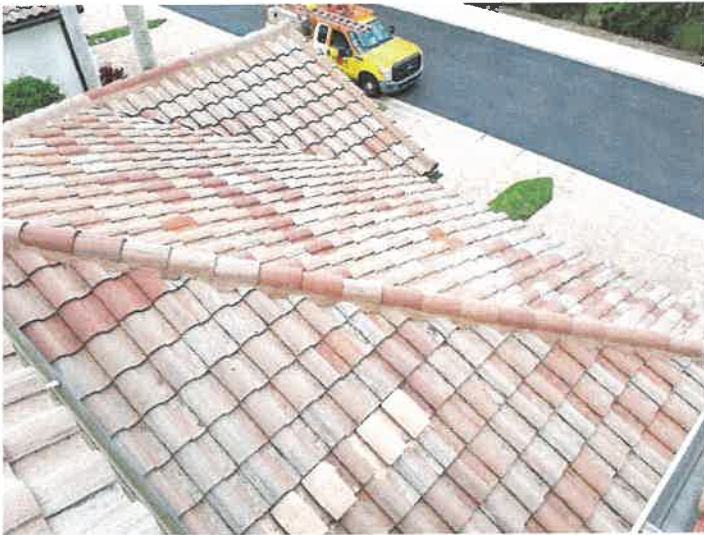
Building 15169: Surface Overview - Lower Roof

The roof surface appears to be in good, maintainable condition at this time.

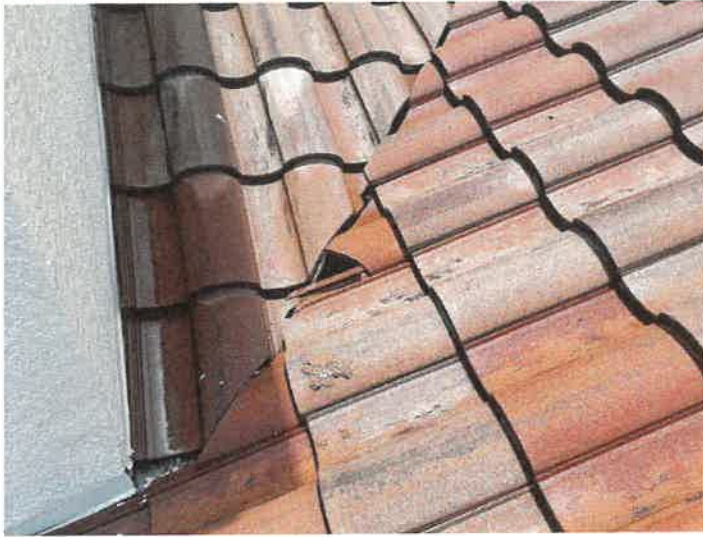
Building 15169: Identified Cracked Roof Tiles
Cracked roof tiles can allow premature underlayment deterioration from excessive UV exposure.

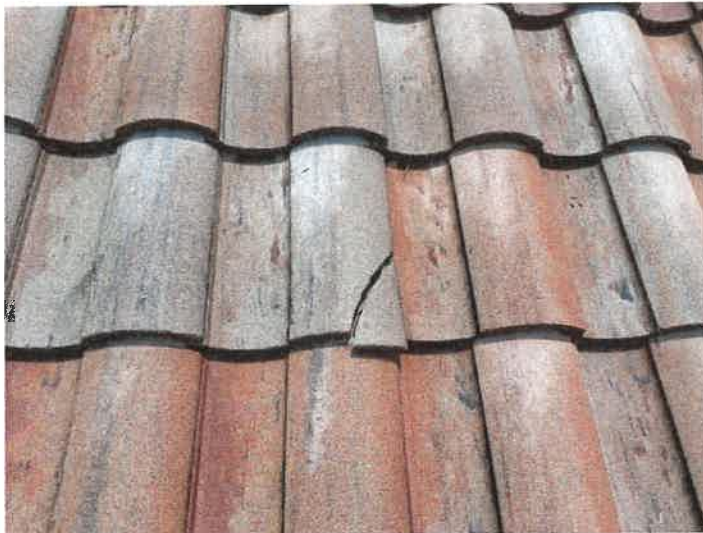
Building 15169: Identified Cracked Roof Tiles
Cracked roof tiles can allow premature underlayment deterioration from excessive UV exposure.

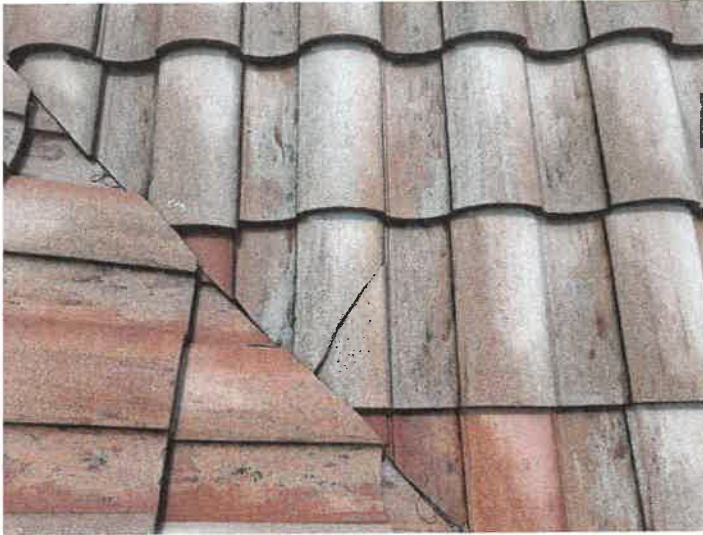
Building 15169: Identified Cracked Roof Tiles
Cracked roof tiles can allow premature underlayment deterioration from excessive UV exposure.

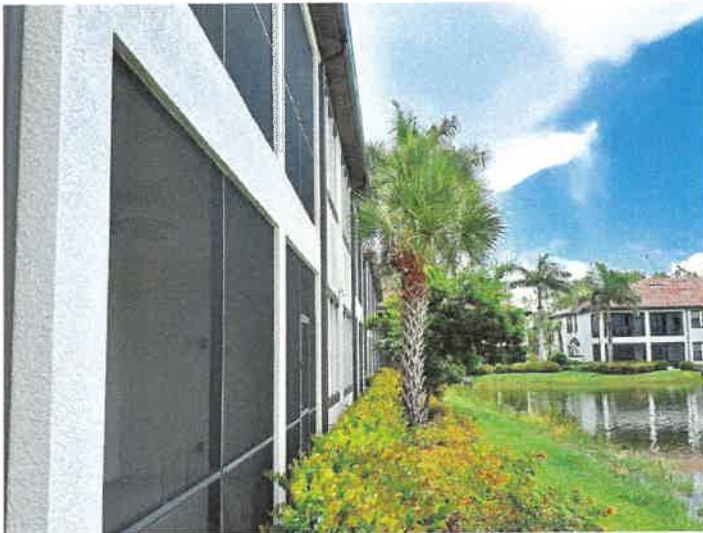
Building 15169: Downspouts
The downspouts appear to be in good condition.

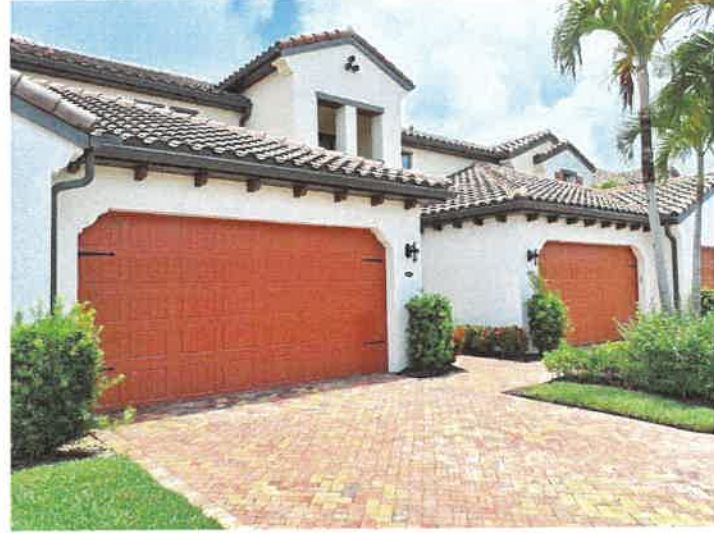
Building 15169: Downspouts
The downspouts appear to be in good condition.

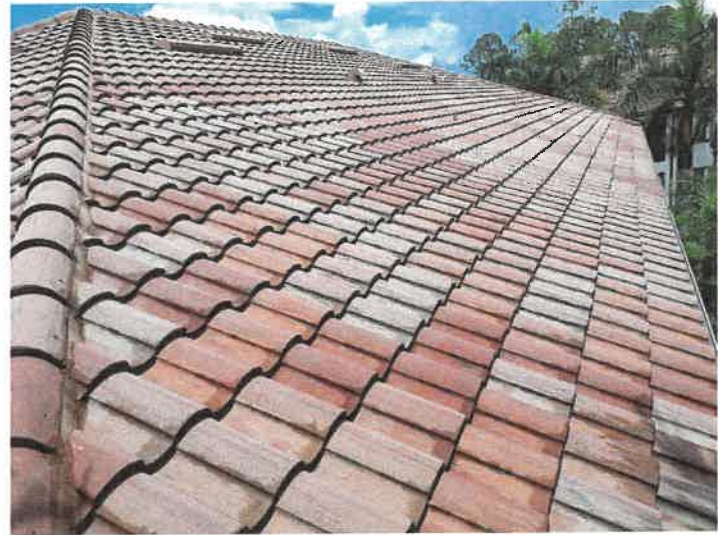
Building 15173: Surface Overview
The roof surface appears to be in good, maintainable condition at this time.

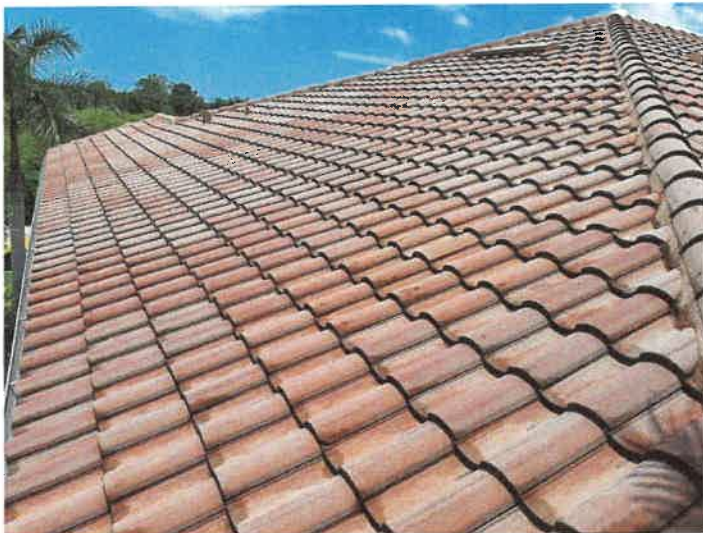
Building 15173: Appearance Overview
The roof appearance is in good, maintainable condition.

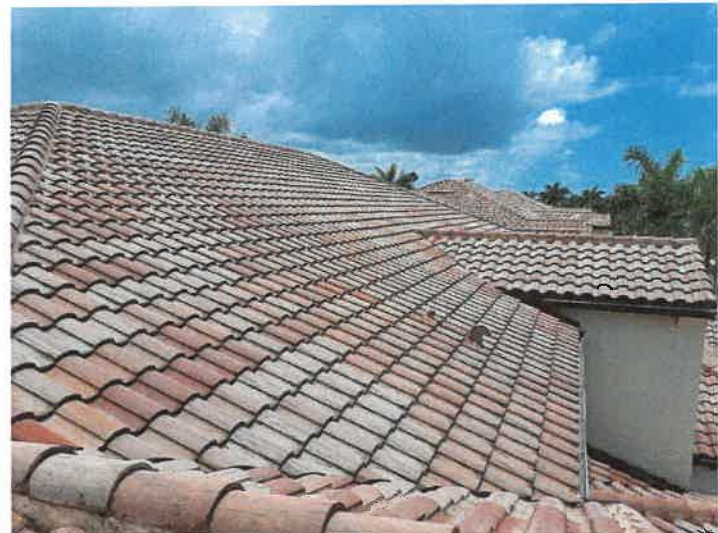
Building 15173: Appearance Overview
The roof appearance is in good, maintainable condition.

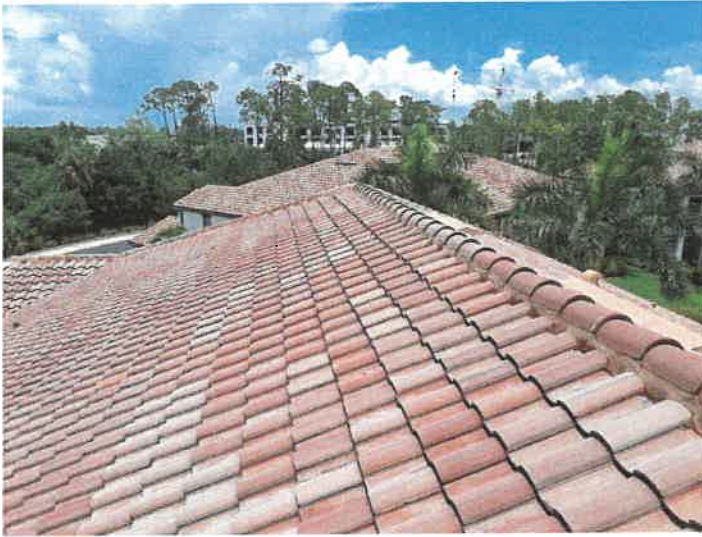
Building 15173: Ridge Tiles

Ridge tiles appear to be in good condition.

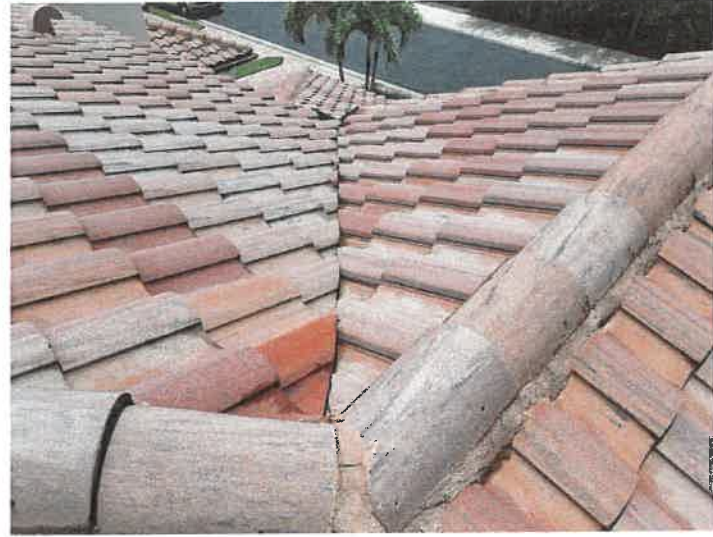
Building 15173: Valley

The valley tiles appear to be in good condition.

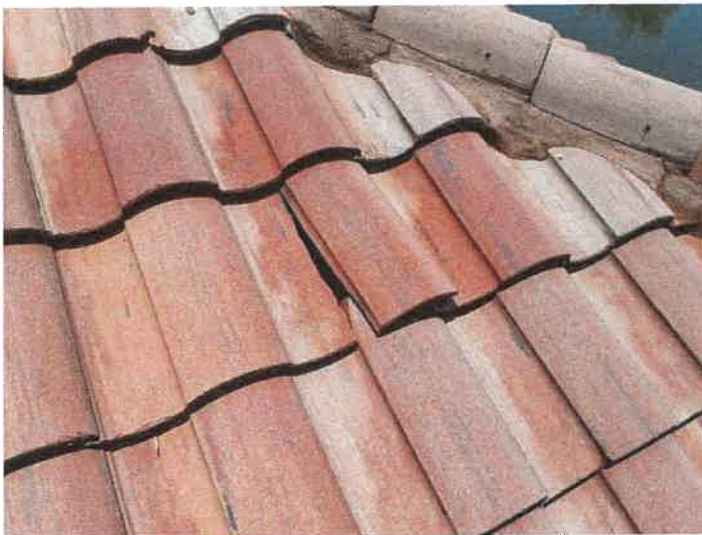
Building 15173: Identified Cracked Roof Tiles

Cracked roof tiles can allow premature underlayment deterioration from excessive UV exposure.

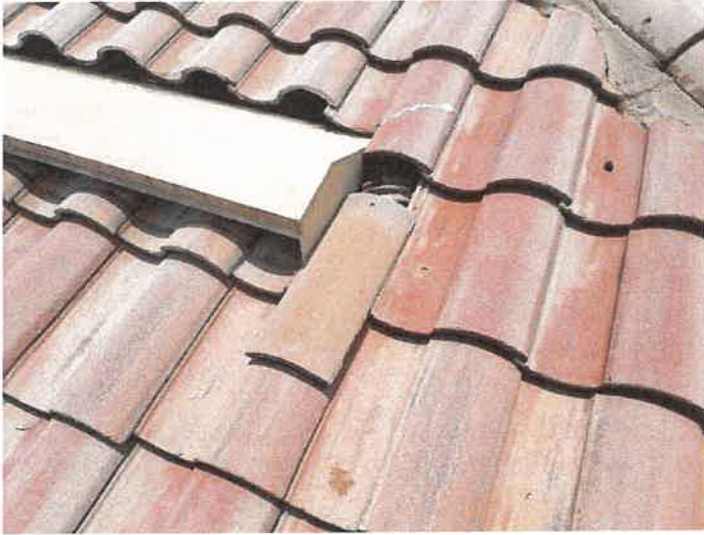
Building 15173: Displaced/Missing Roof Tile

Displaced or missing roof tiles can allow premature underlayment deterioration from excessive UV exposure and potential water intrusion.

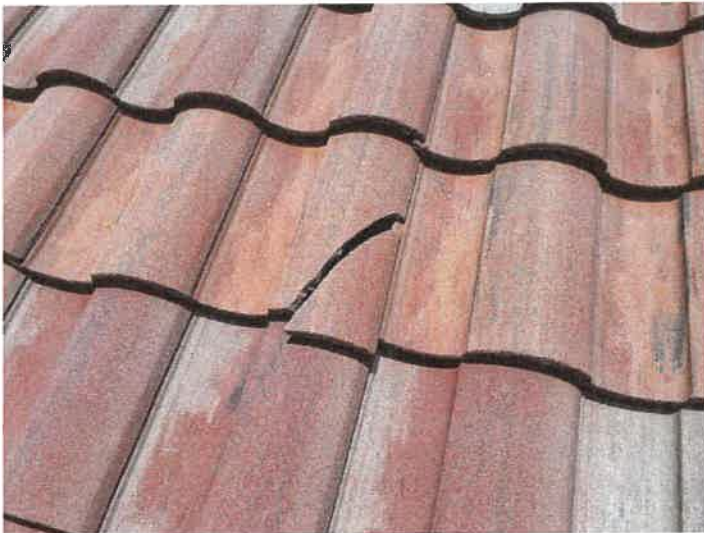
Building 15173: Identified Cracked Roof Tiles

Cracked roof tiles can allow premature underlayment deterioration from excessive UV exposure.

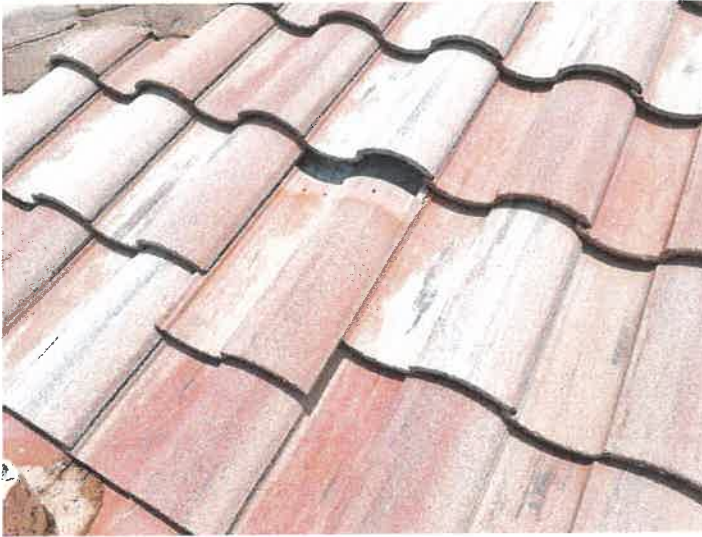
Building 15173: Displaced/Missing Roof Tile

Displaced or missing roof tiles can allow premature underlayment deterioration from excessive UV exposure and potential water intrusion.

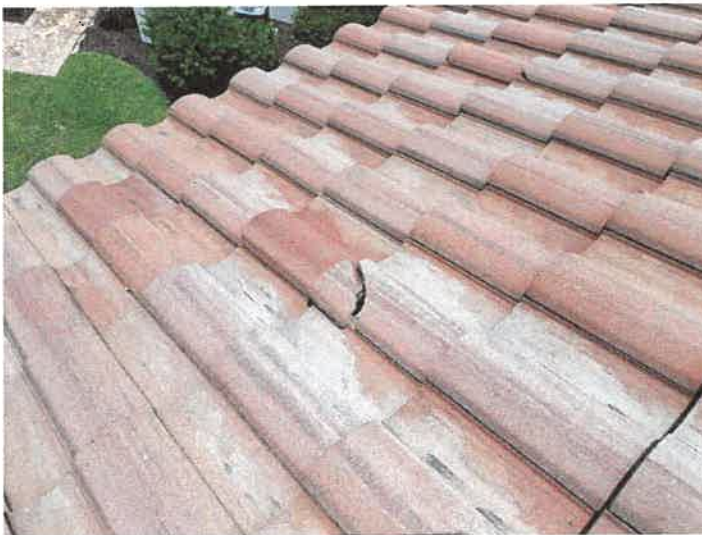
Building 15173: Identified Cracked Roof Tiles

Cracked roof tiles can allow premature underlayment deterioration from excessive UV exposure.

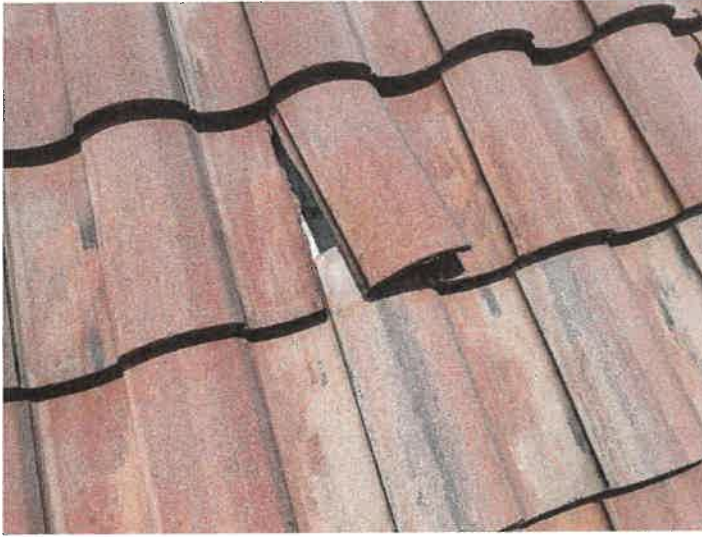
Building 15173: Identified Cracked Roof Tiles
Cracked roof tiles can allow premature underlayment deterioration from excessive UV exposure.

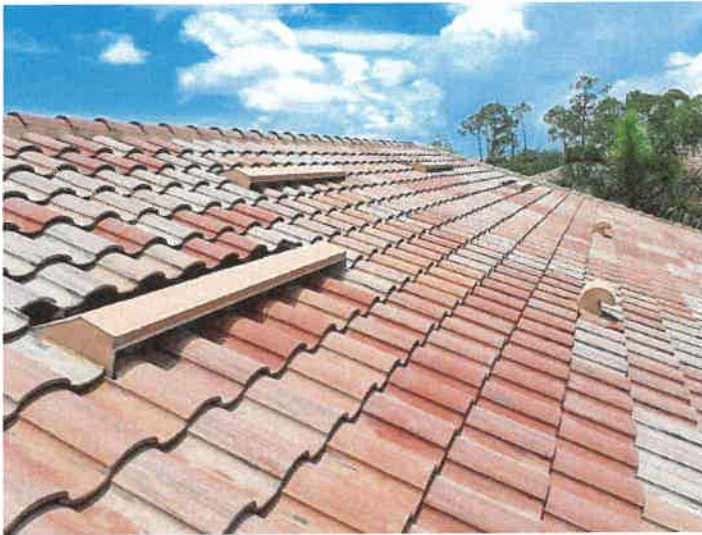
Building 15173: Roof Vents
Roof vents appear to be in good condition.

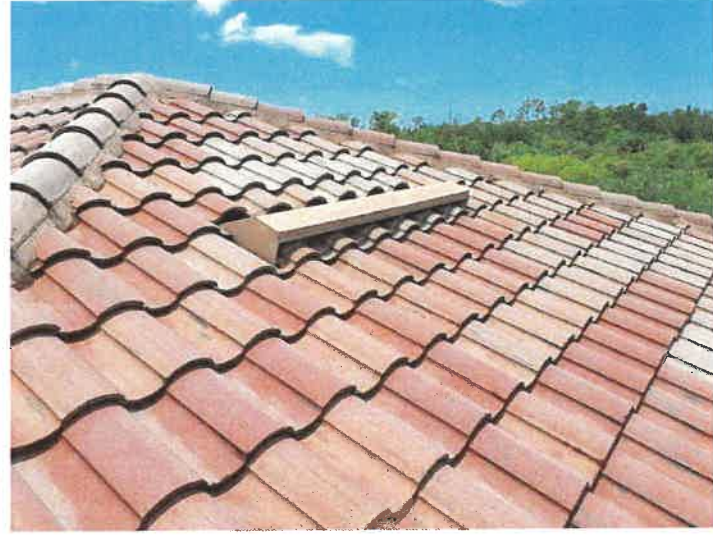
Building 15173: Roof Vents
Roof vents appear to be in good condition.

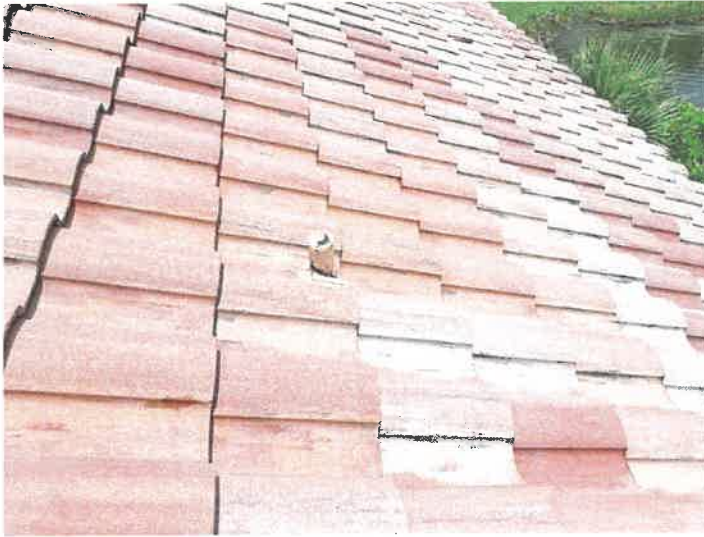
Building 15173: Lead Boots
Lead boots appear to be in good condition.

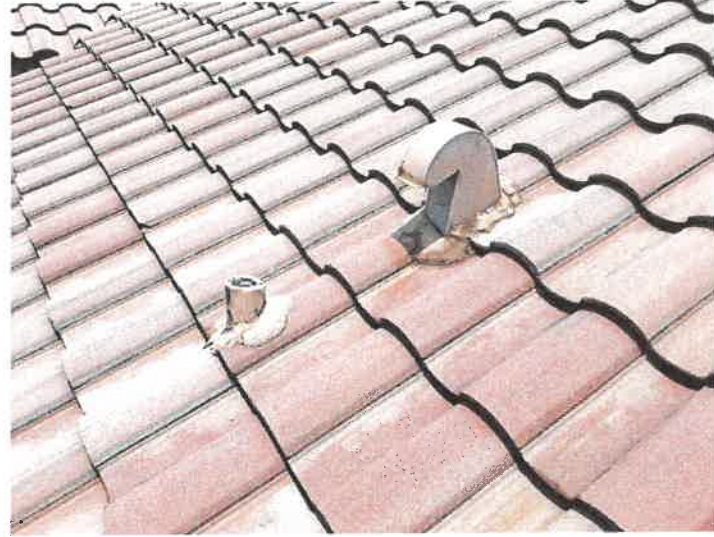
Building 15173: Lead Boots
Lead boots appear to be in good condition.

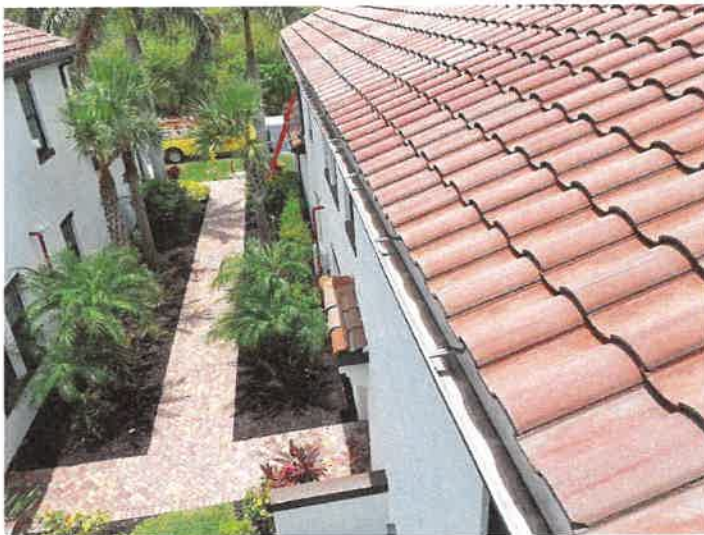
Building 15173: Gutters
The gutters appear to be in good condition.

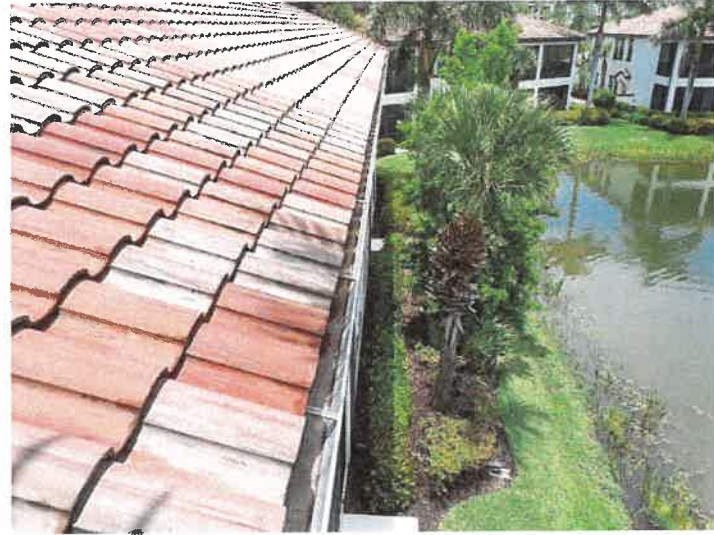
Building 15173: Gutters
The gutters appear to be in good condition.

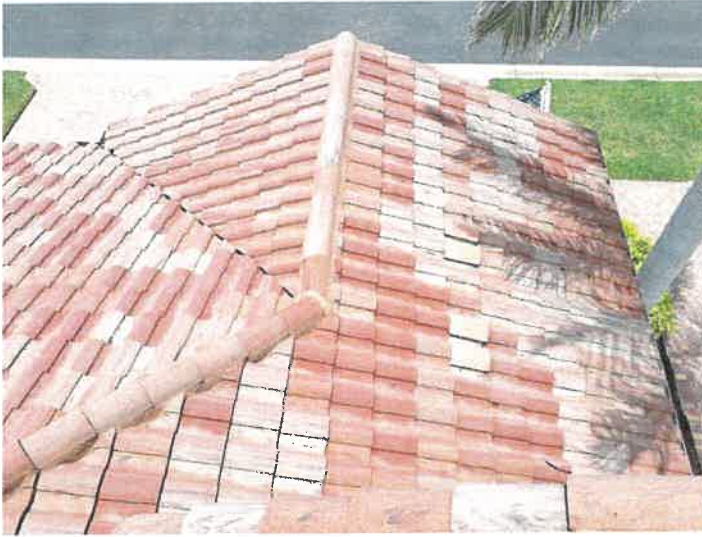
Building 15173: Surface Overview - Lower Roof
The roof surface appears to be in good, maintainable condition at this time.

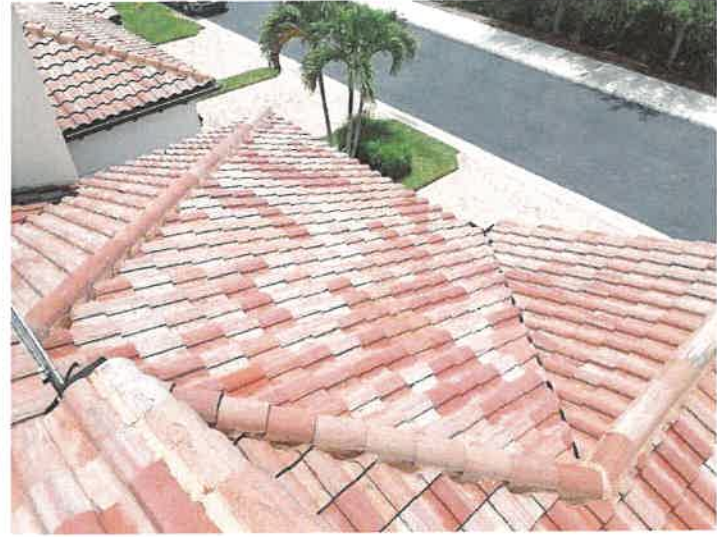
Building 15173: Appearance Overview - Lower Roof
The roof appearance is in good, maintainable condition.

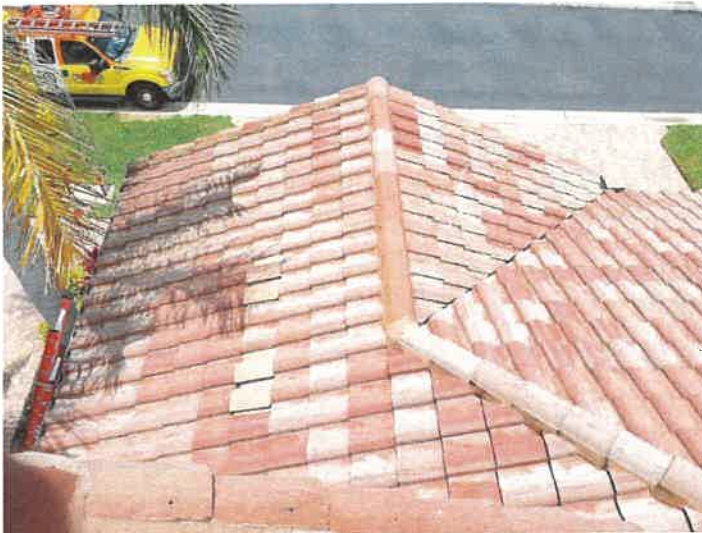
Building 15173: Surface Overview - Lower Roof
The roof surface appears to be in good, maintainable condition at this time.

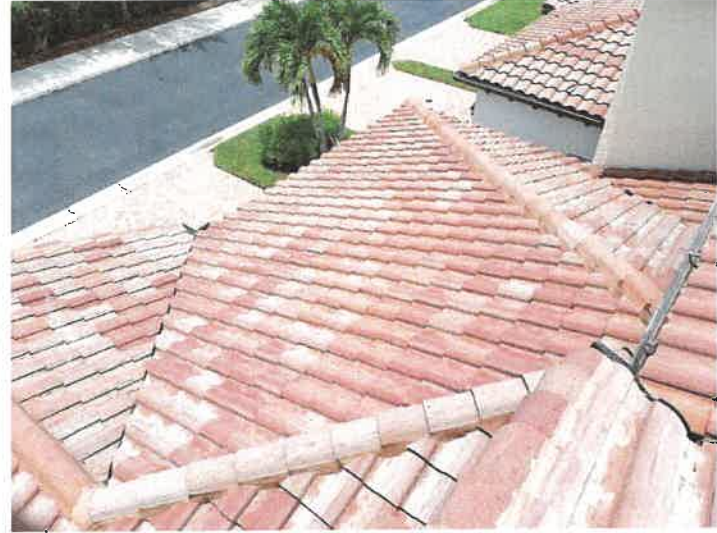
Building 15173: Appearance Overview - Lower Roof
The roof appearance is in good, maintainable condition.

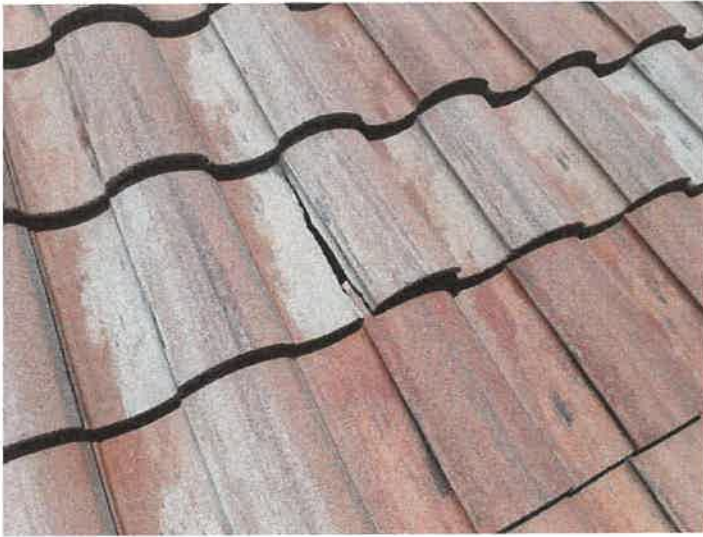
Building 15173: Identified Cracked Roof Tiles
Cracked roof tiles can allow premature underlayment deterioration from excessive UV exposure.

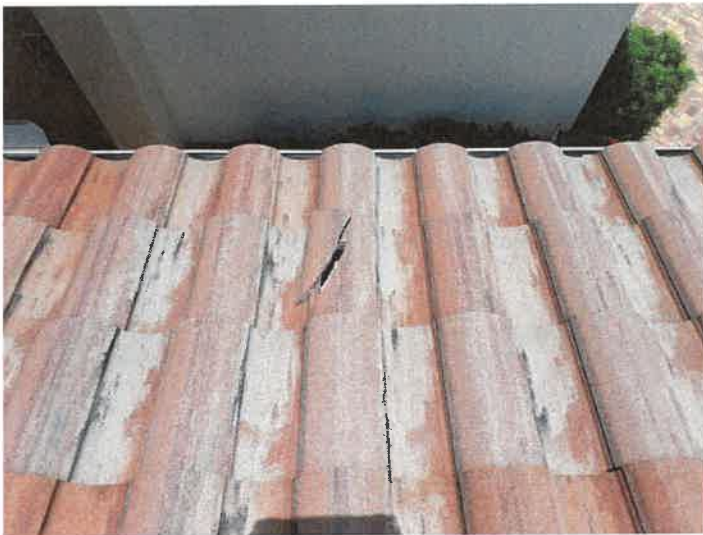
Building 15173: Identified Cracked Roof Tiles
Cracked roof tiles can allow premature underlayment deterioration from excessive UV exposure.

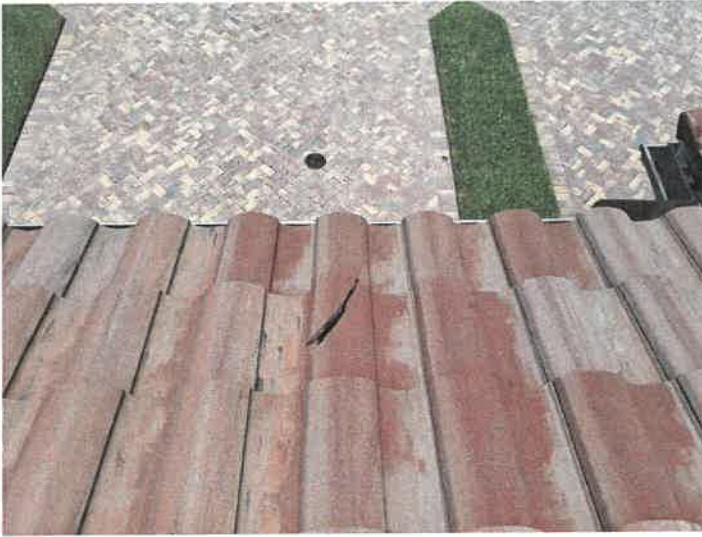
Building 15173: Identified Cracked Roof Tiles
Cracked roof tiles can allow premature underlayment deterioration from excessive UV exposure.

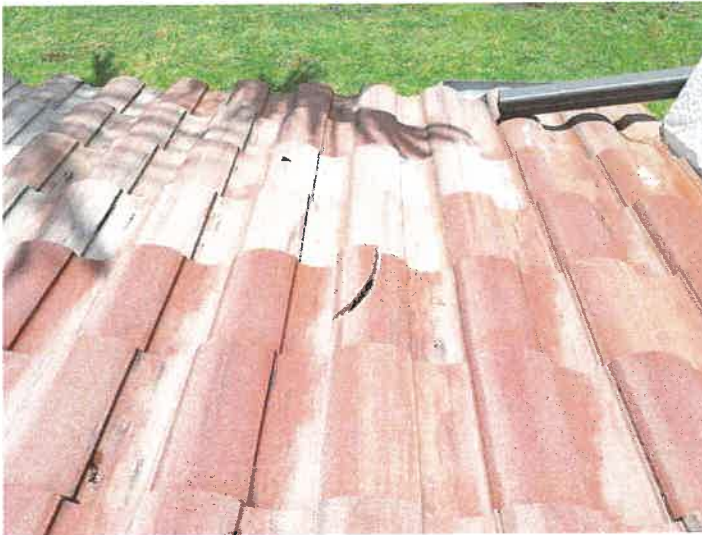
Building 15173: Identified Cracked Roof Tiles
Cracked roof tiles can allow premature underlayment deterioration from excessive UV exposure.

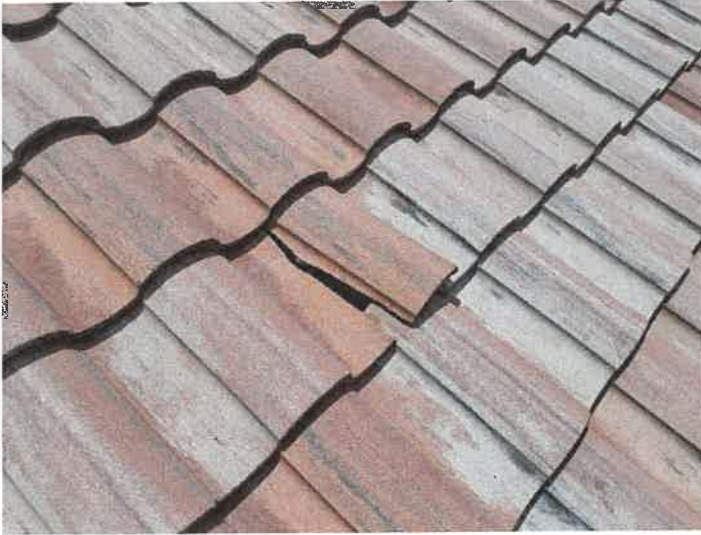
Building 15173: Identified Cracked Roof Tiles
Cracked roof tiles can allow premature underlayment deterioration from excessive UV exposure.

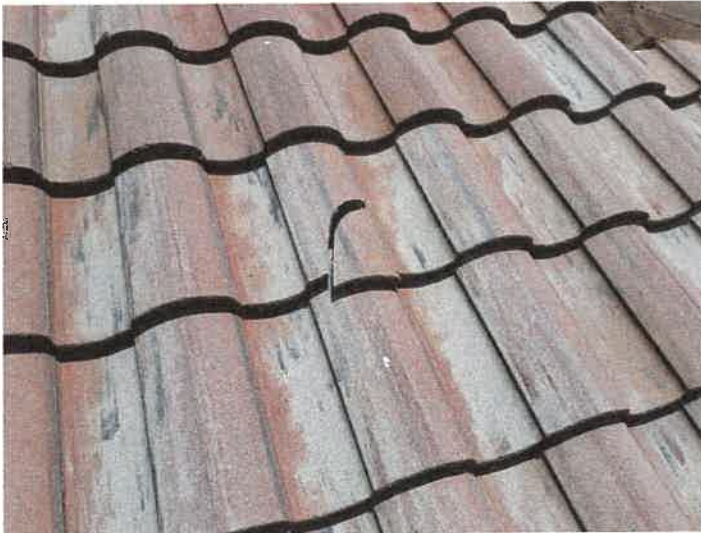
Building 15173: Identified Cracked Roof Tiles
Cracked roof tiles can allow premature underlayment deterioration from excessive UV exposure.

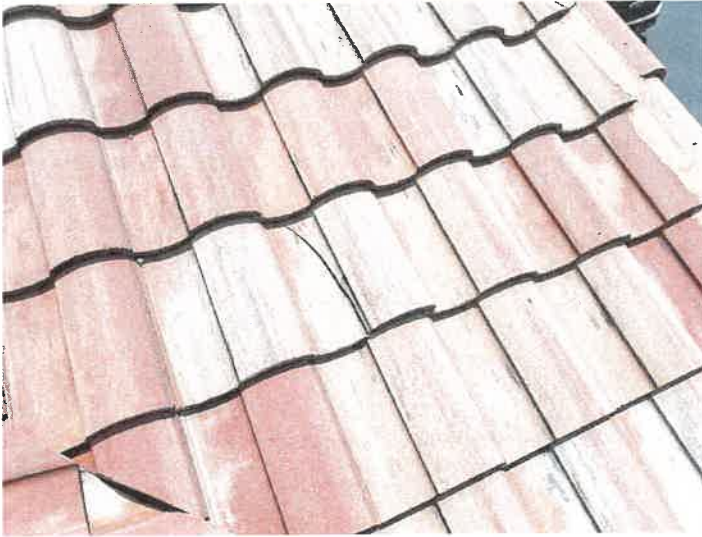
Building 15173: Identified Cracked Roof Tiles
Cracked roof tiles can allow premature underlayment deterioration from excessive UV exposure.

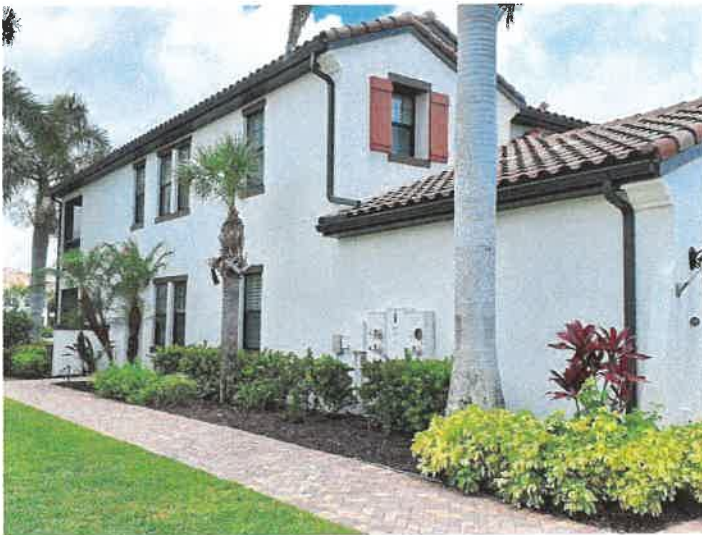
Building 15173: Downspouts
The downspouts appear to be in good condition.

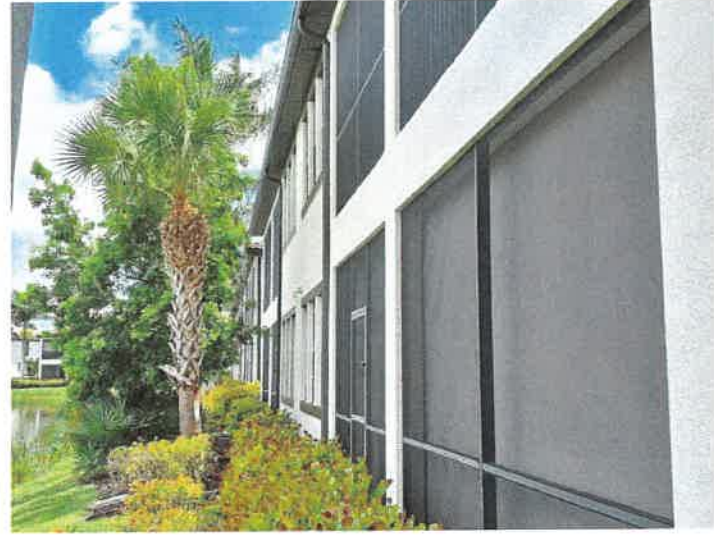
Building 15173: Downspouts
The downspouts appear to be in good condition.

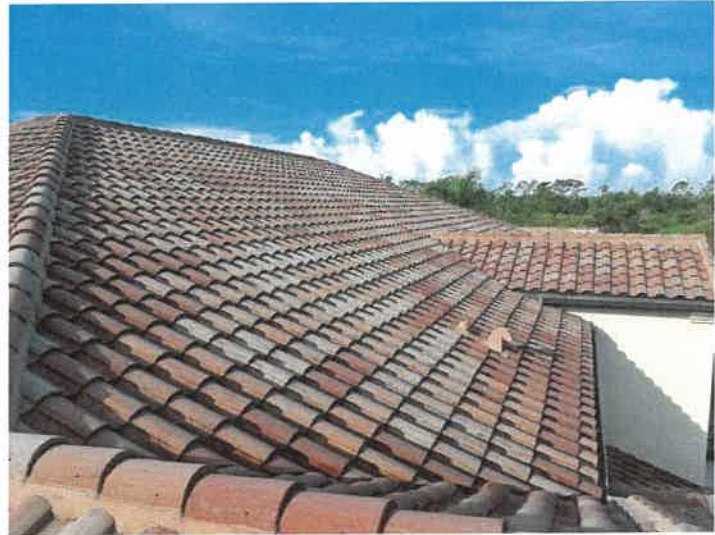
Building 15177: Surface Overview
The roof surface appears to be in good, maintainable condition at this time.

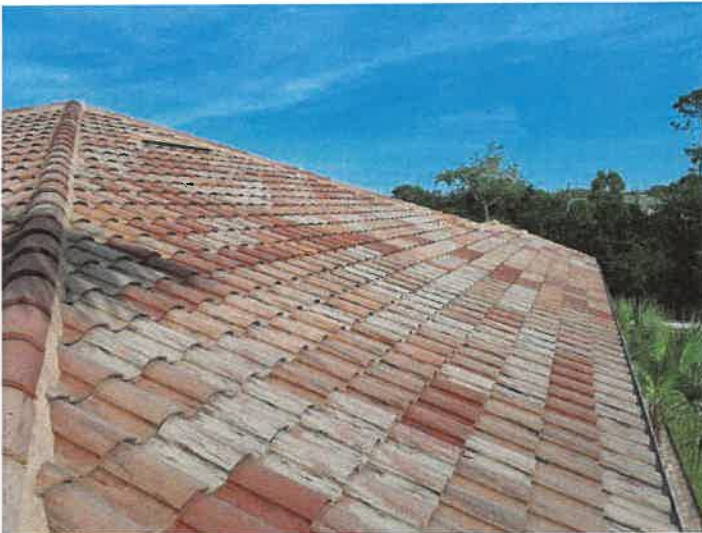
Building 15177: Appearance Overview
The roof appearance is in good, maintainable condition.

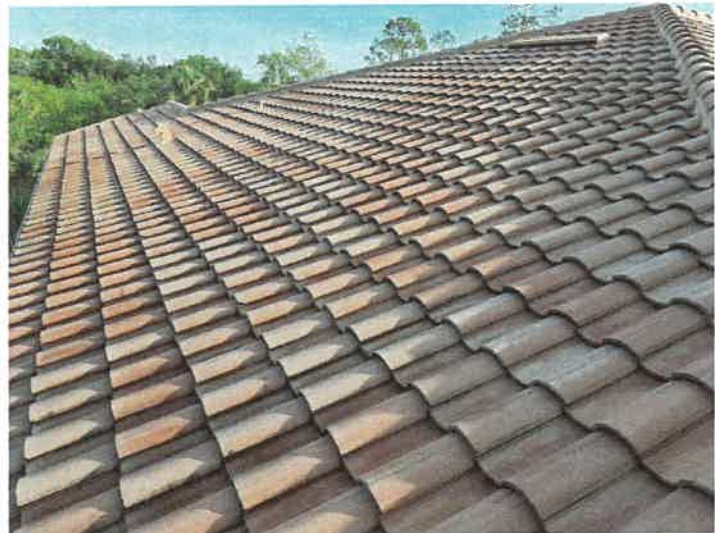
Building 15177: Surface Overview
The roof surface appears to be in good, maintainable condition at this time.
