Inspection Report

Facility: Livingston Lakes Condo

Work Order #: 13028

Re.: **Inspection Report (2 of 3) for Livingston Lakes**

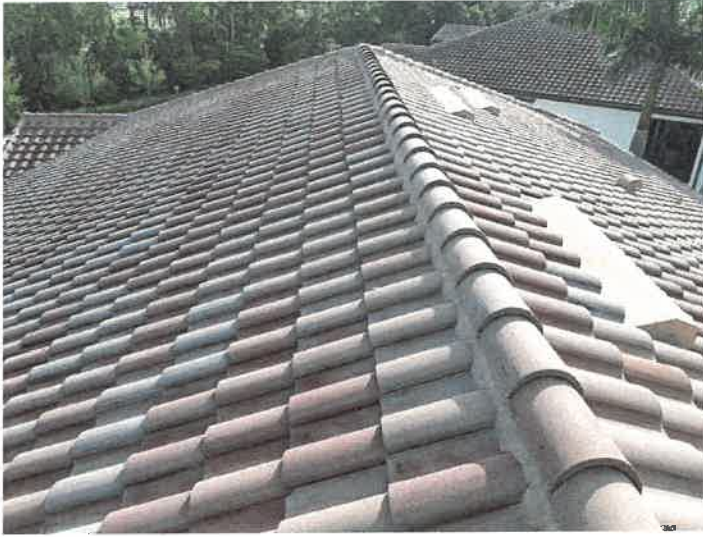
Building 15177: Ridge Tiles

Ridge tiles appear to be in good condition.

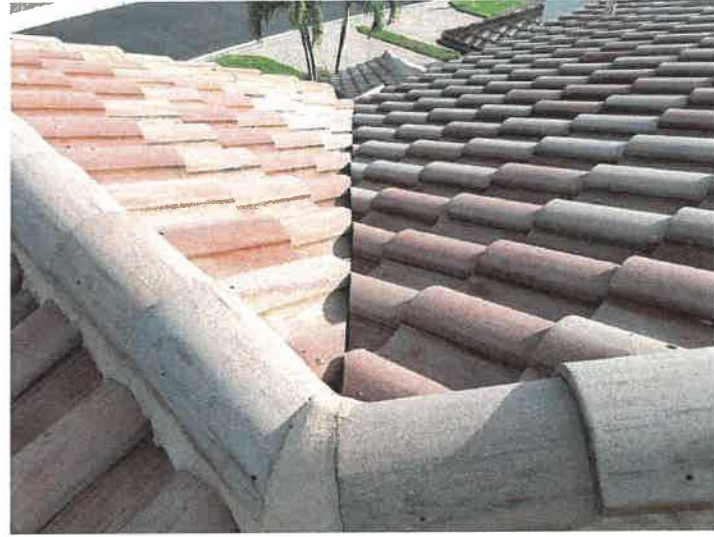
Building 15177: Valley

The valley tiles appear to be in good condition.

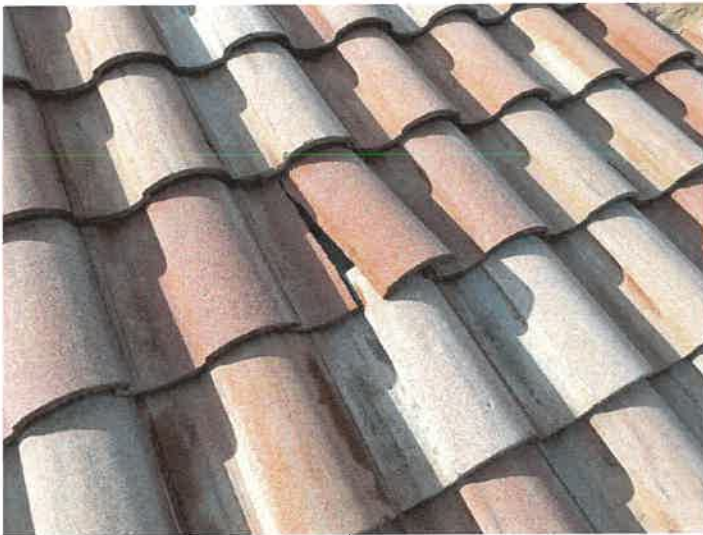
Building 15177: Identified Cracked Roof Tiles

Cracked roof tiles can allow premature underlayment deterioration from excessive UV exposure.

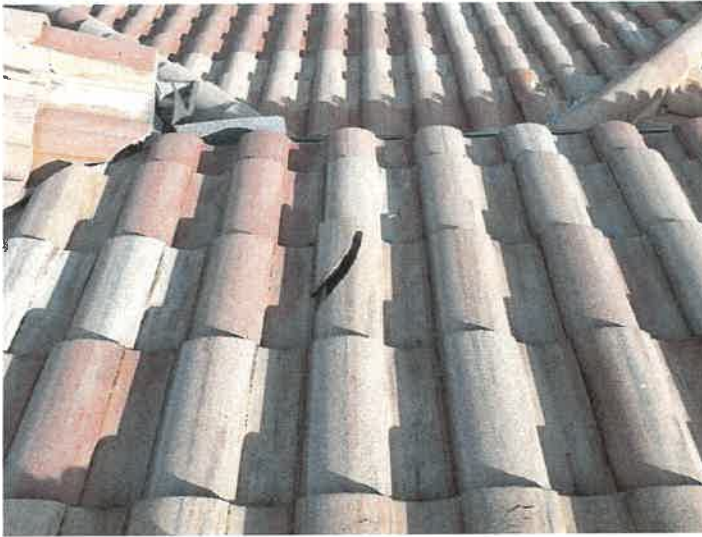
Building 15177: Identified Cracked Roof Tiles
Cracked roof tiles can allow premature underlayment deterioration from excessive UV exposure.

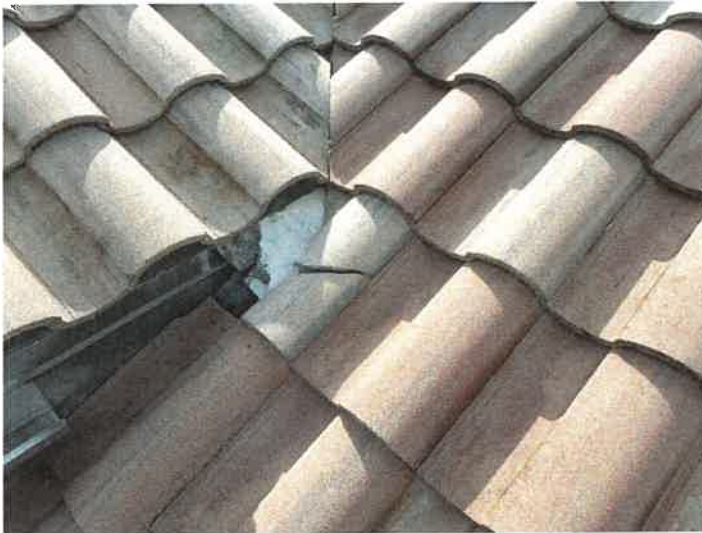
Building 15177: Identified Cracked Roof Tiles
Cracked roof tiles can allow premature underlayment deterioration from excessive UV exposure.

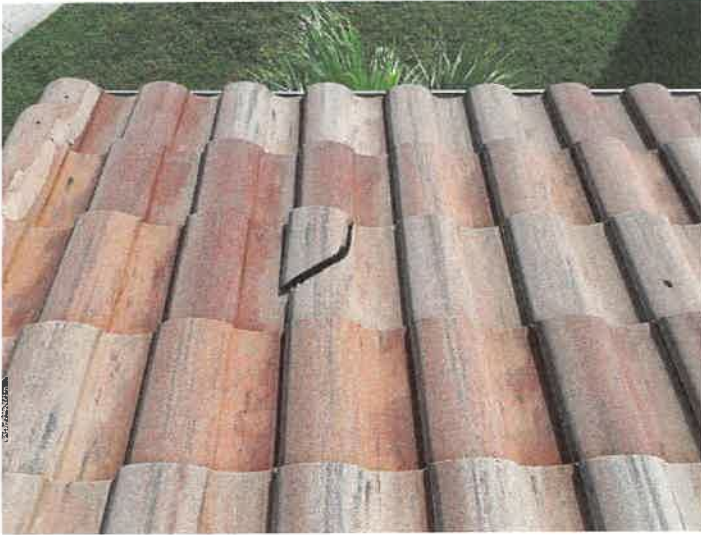
Building 15177: Identified Cracked Roof Tiles
Cracked roof tiles can allow premature underlayment deterioration from excessive UV exposure.

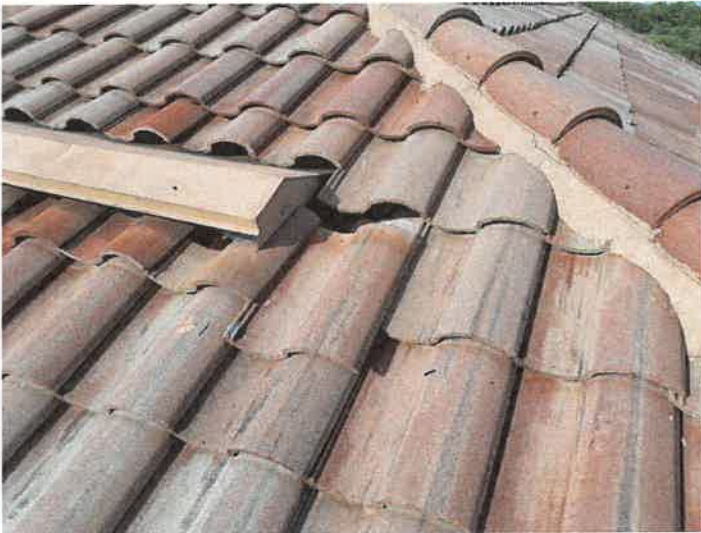
Building 15177: Displaced/Missing Roof Tile
Displaced or missing roof tiles can allow premature underlayment deterioration from excessive UV exposure and potential water intrusion.

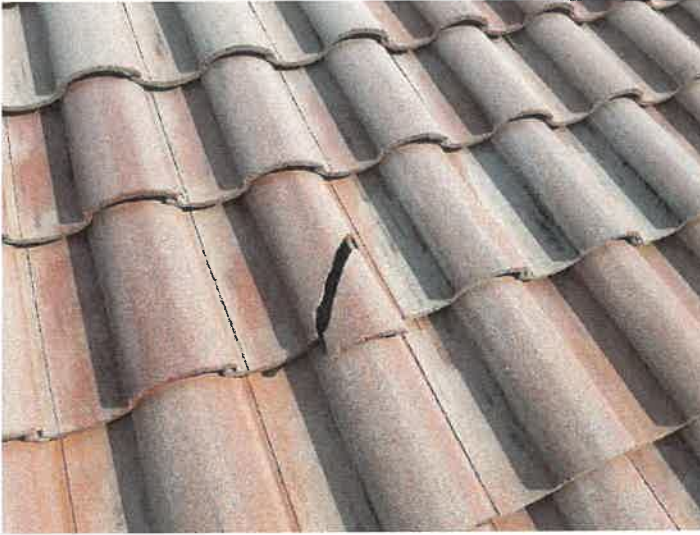
Building 15177: Identified Cracked Roof Tiles

Cracked roof tiles can allow premature underlayment deterioration from excessive UV exposure.

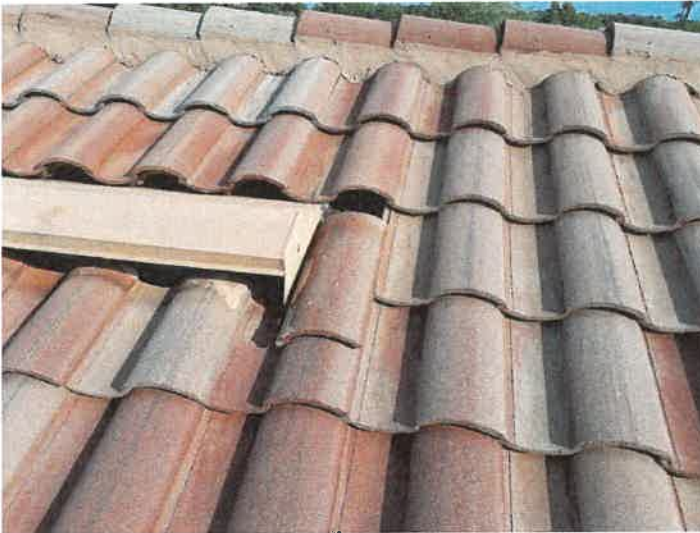
Building 15177: Displaced/Missing Roof Tile

Displaced or missing roof tiles can allow premature underlayment deterioration from excessive UV exposure and potential water intrusion.

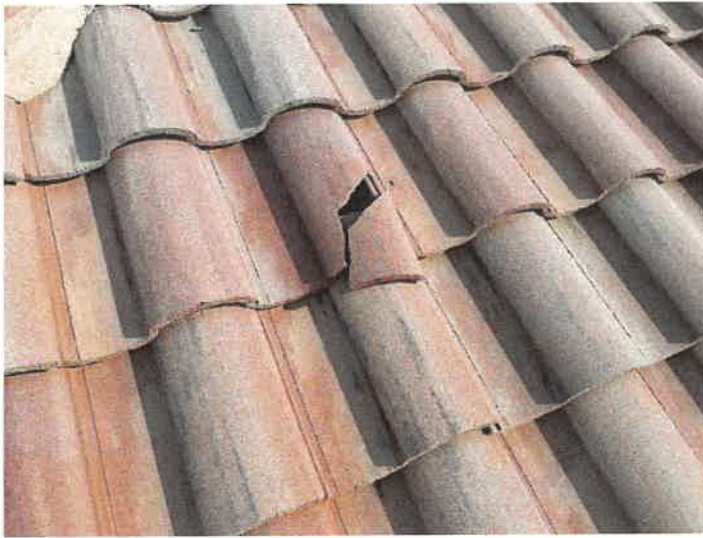
Building 15177: Identified Cracked Roof Tiles
Cracked roof tiles can allow premature underlayment deterioration from excessive UV exposure.

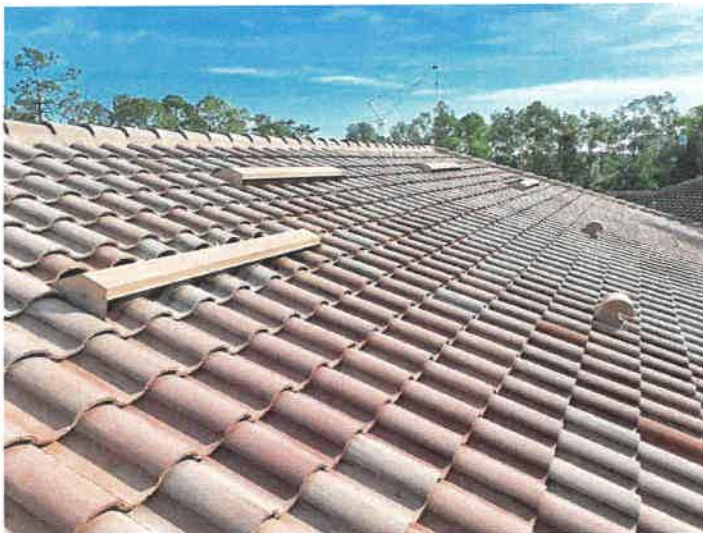
Building 15177: Roof Vents
Roof vents appear to be in good condition.

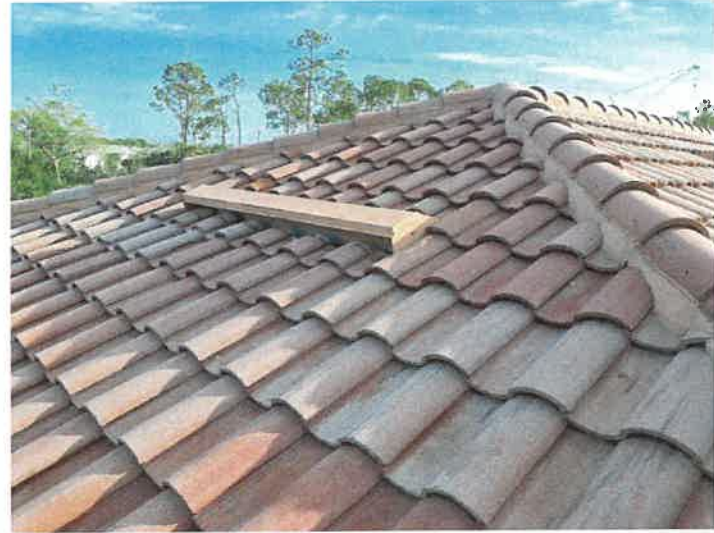
Building 15177: Roof Vents
Roof vents appear to be in good condition.

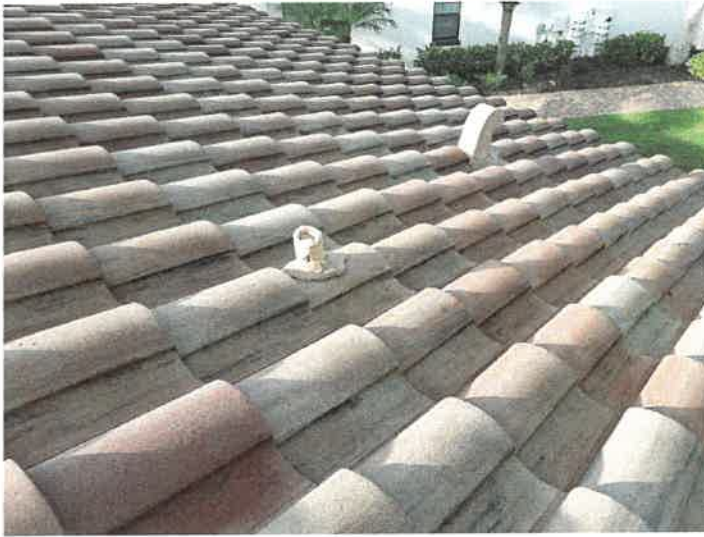
Building 15177: Lead Boots
Lead boots appear to be in good condition.

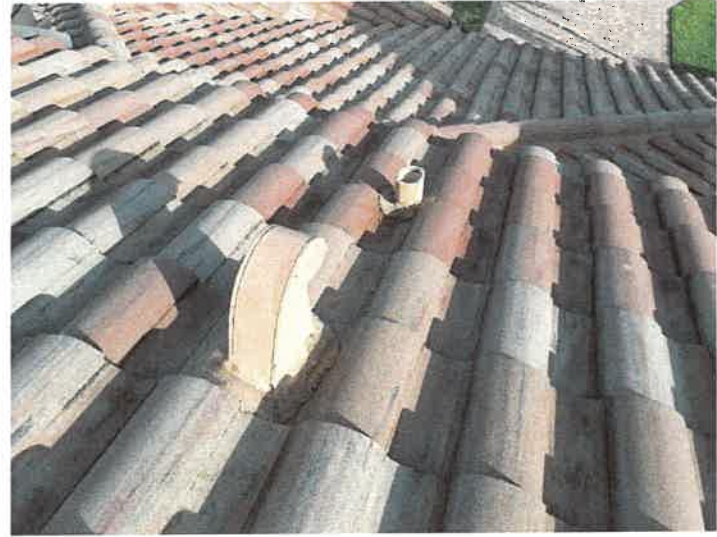
Building 15177: Lead Boots
Lead boots appear to be in good condition.

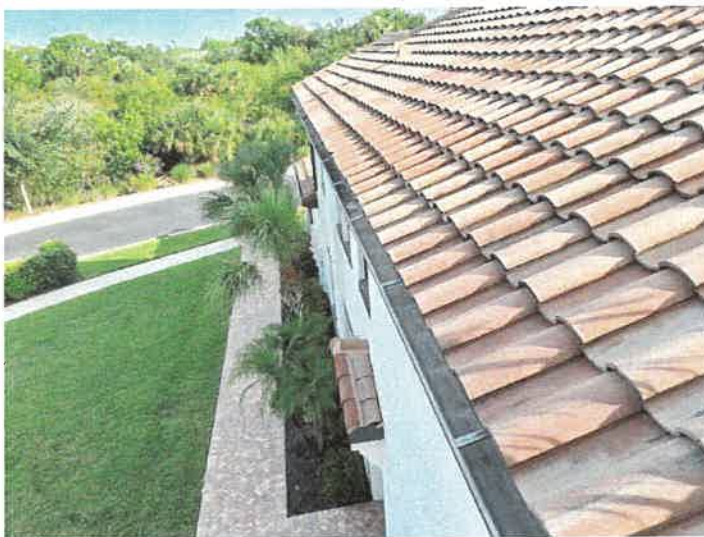
Building 15177: Gutters
The gutters appear to be in good condition.

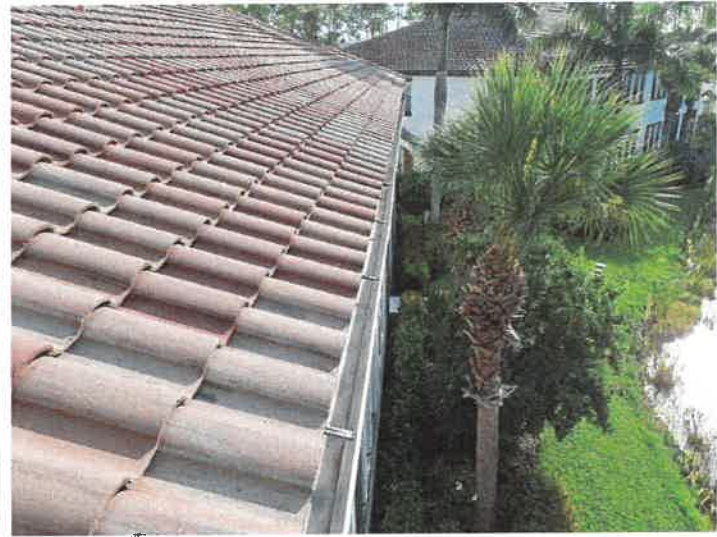
Building 15177: Gutters
The gutters appear to be in good condition.

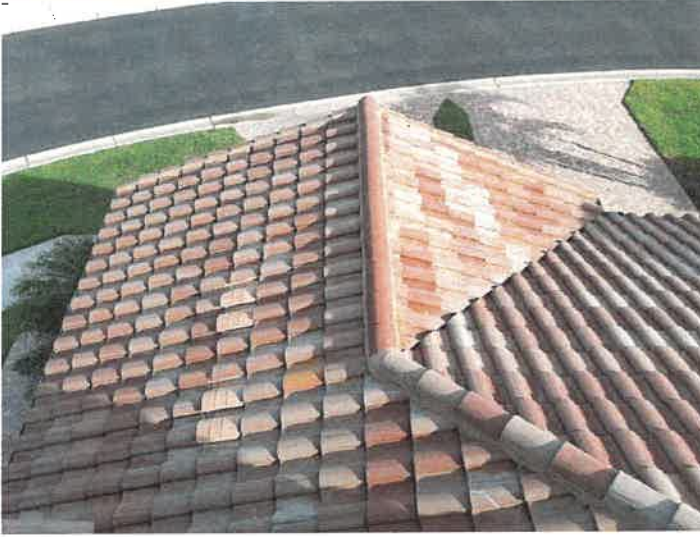
Building 15177: Surface Overview - Lower Roof
The roof surface appears to be in good, maintainable condition at this time.

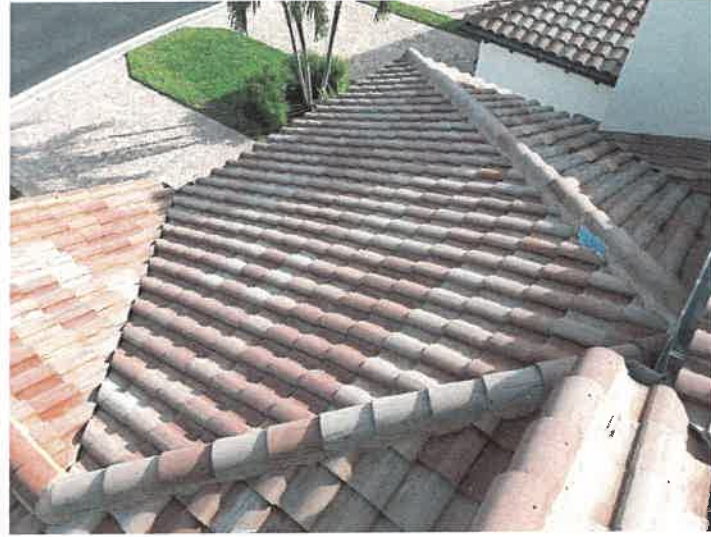
Building 15177: Appearance Overview - Lower Roof
The roof appearance is in good, maintainable condition.

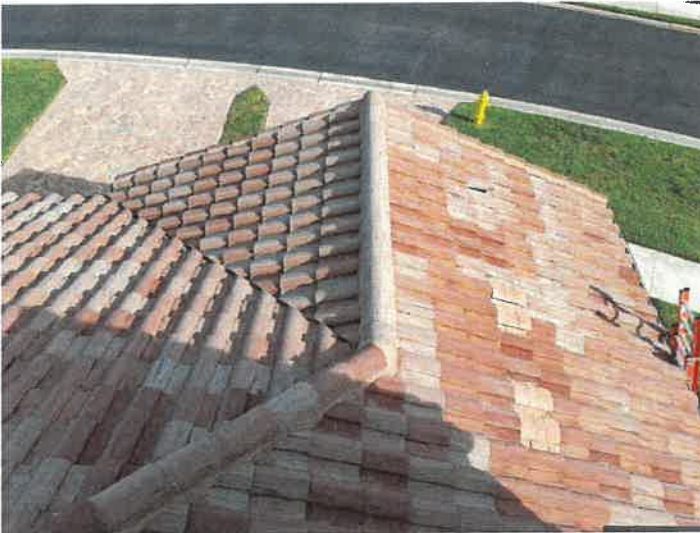
Building 15177: Surface Overview - Lower Roof
The roof surface appears to be in good, maintainable condition at this time.

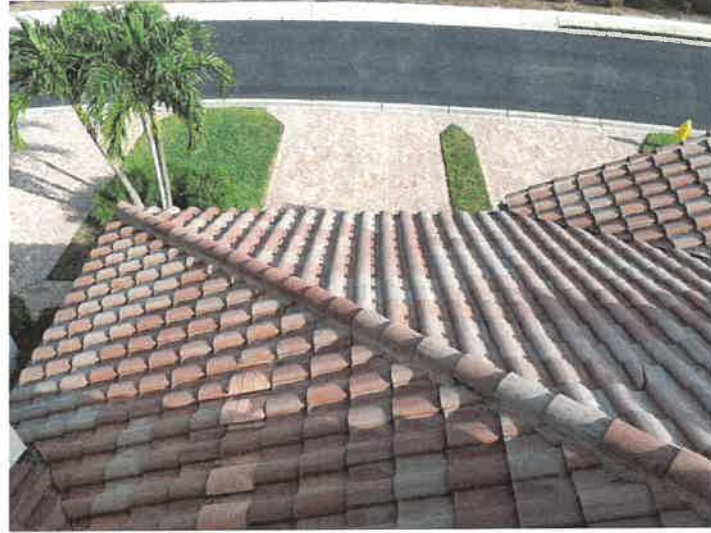
Building 15177: Appearance Overview - Lower Roof
The roof appearance is in good, maintainable condition.

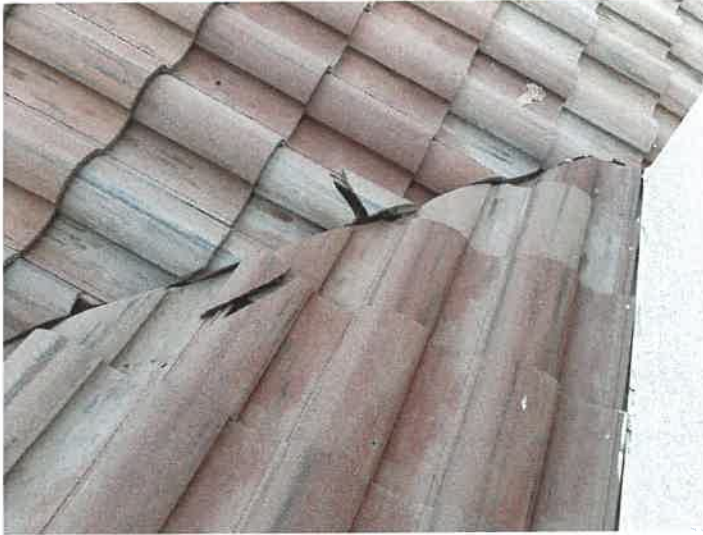
Building 15177: Identified Cracked Roof Tiles
Cracked roof tiles can allow premature underlayment deterioration from excessive UV exposure.

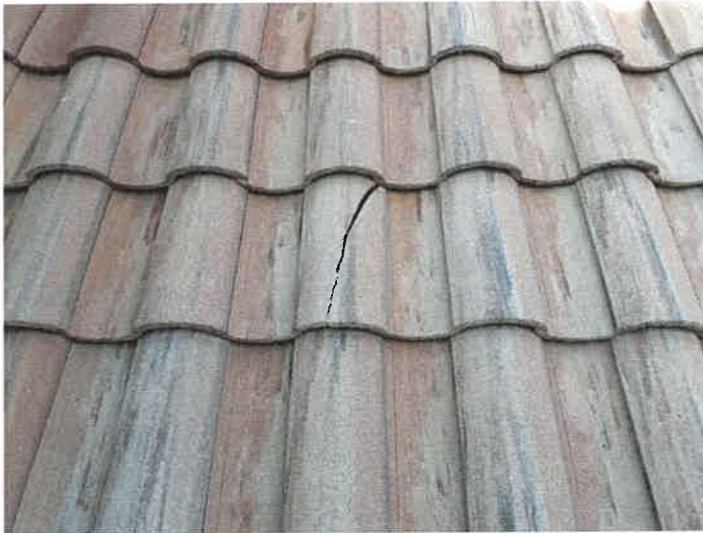
Building 15177: Identified Cracked Roof Tiles
Cracked roof tiles can allow premature underlayment deterioration from excessive UV exposure.

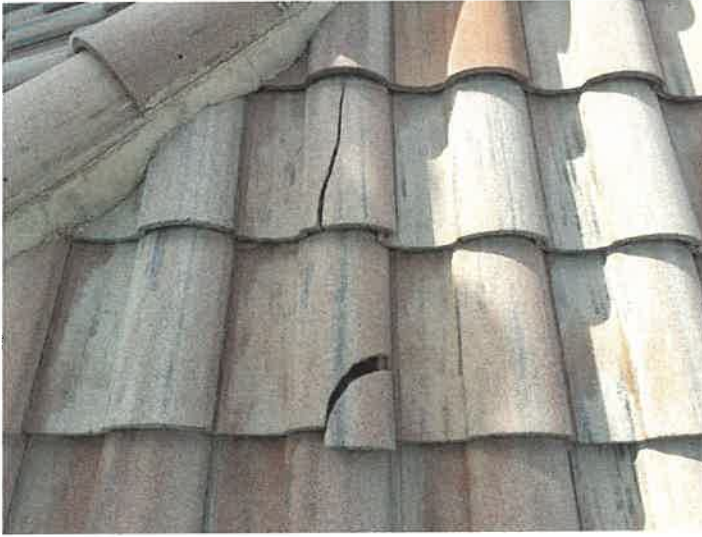
Building 15177: Identified Cracked Roof Tiles
Cracked roof tiles can allow premature underlayment deterioration from excessive UV exposure.

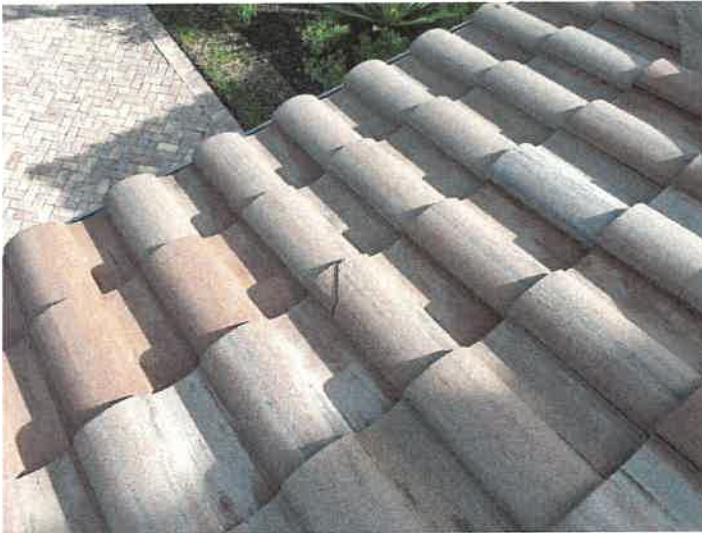
Building 15177: Identified Cracked Roof Tiles
Cracked roof tiles can allow premature underlayment deterioration from excessive UV exposure.

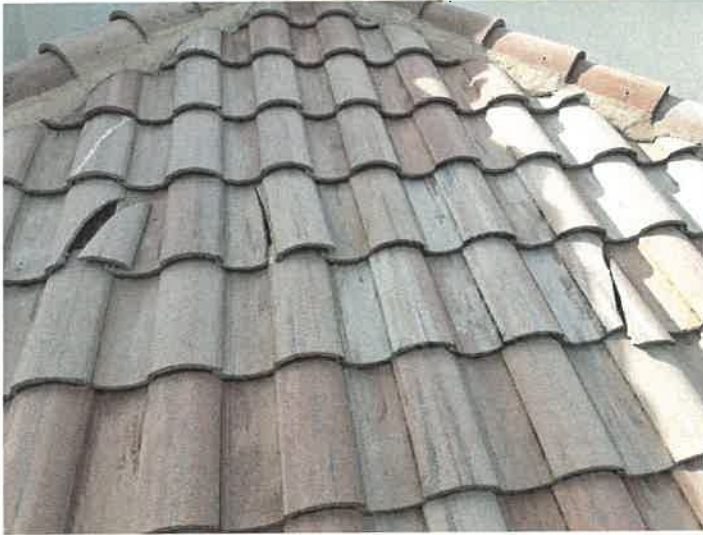
Building 15177: Identified Cracked Roof Tiles
Cracked roof tiles can allow premature underlayment deterioration from excessive UV exposure.

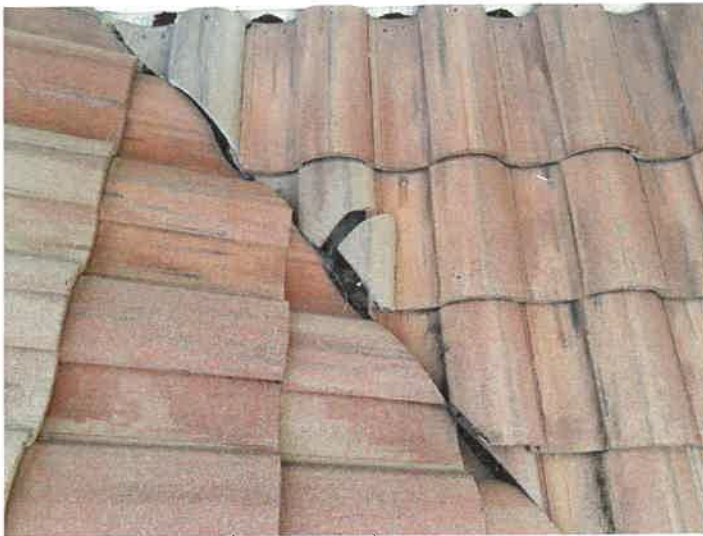
Building 15177: Identified Cracked Roof Tiles
Cracked roof tiles can allow premature underlayment deterioration from excessive UV exposure.

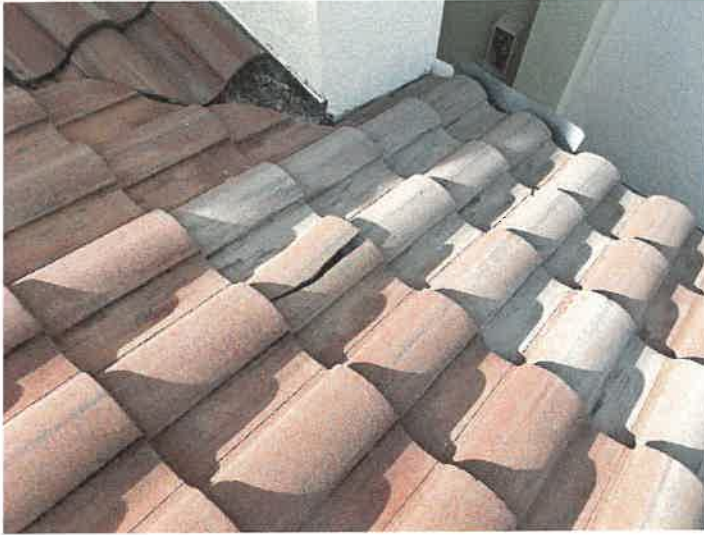
Building 15177: Identified Cracked Roof Tiles

Cracked roof tiles can allow premature underlayment deterioration from excessive UV exposure.

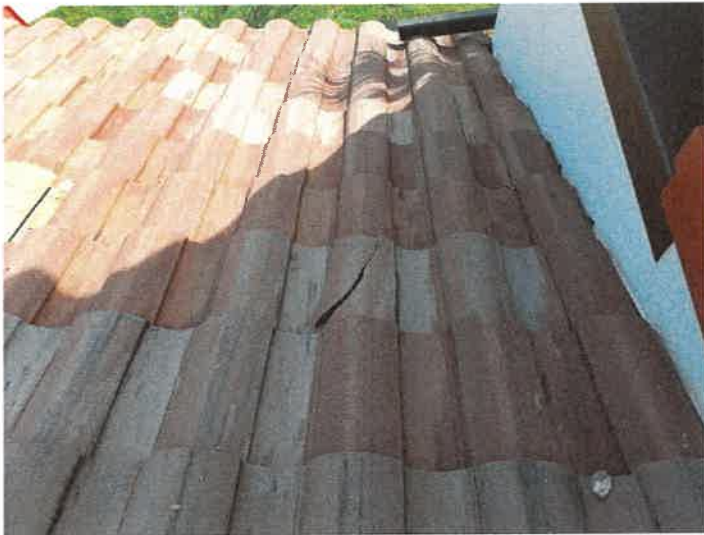
Building 15177: Identified Cracked Roof Tiles

Cracked roof tiles can allow premature underlayment deterioration from excessive UV exposure.

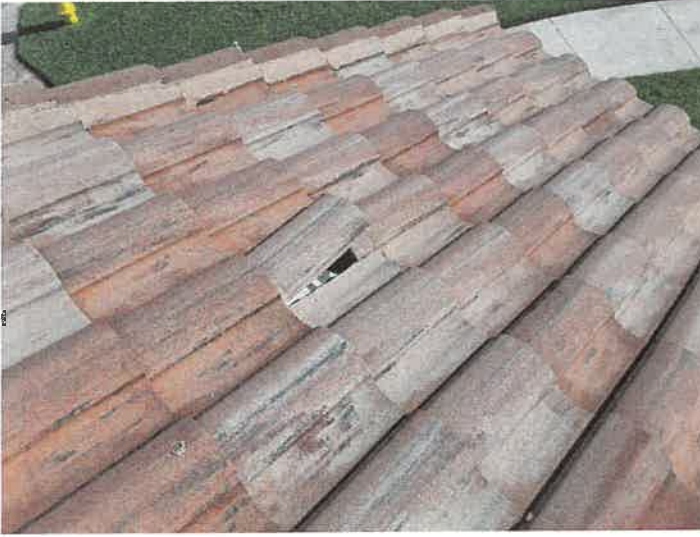
Building 15177: Identified Cracked Roof Tiles
Cracked roof tiles can allow premature underlayment deterioration from excessive UV exposure.

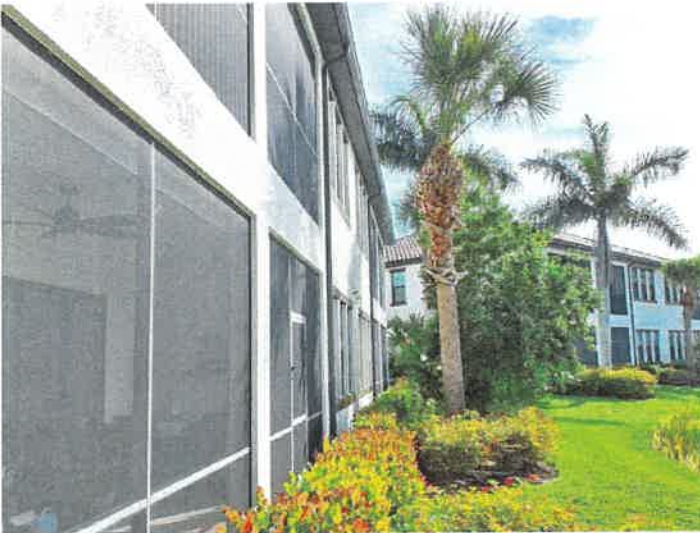
Building 15177: Downspouts
The downspouts appear to be in good condition.

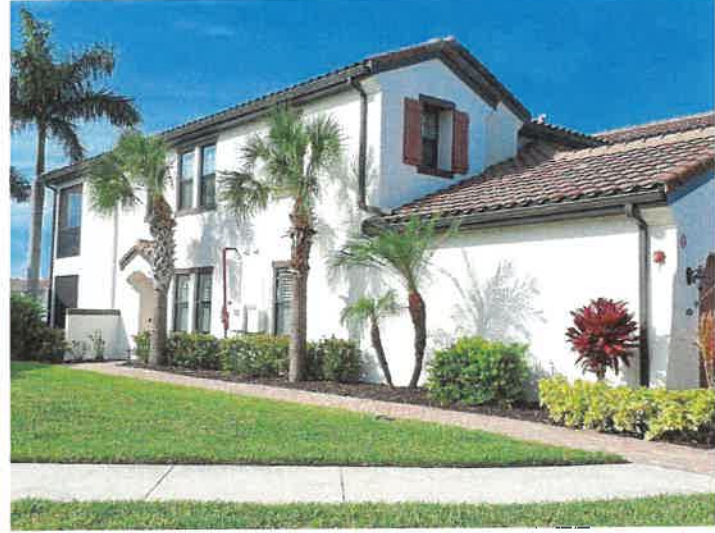
Building 15177: Downspouts
The downspouts appear to be in good condition.

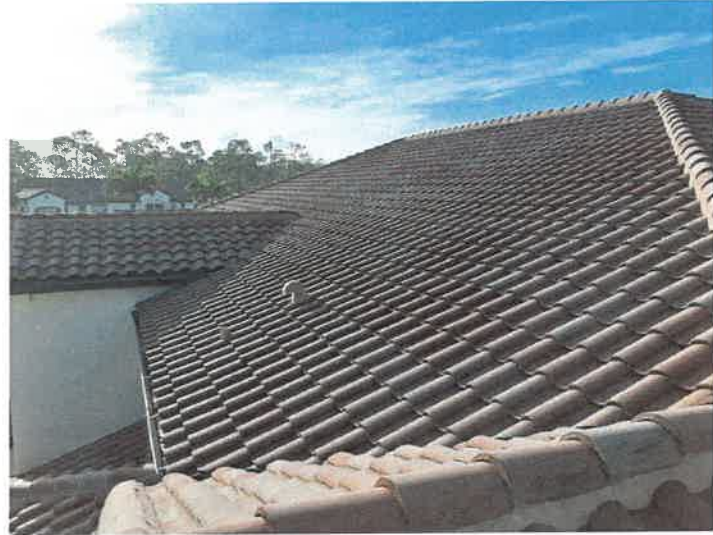
Building 15181: Surface Overview
The roof surface appears to be in good, maintainable condition at this time.

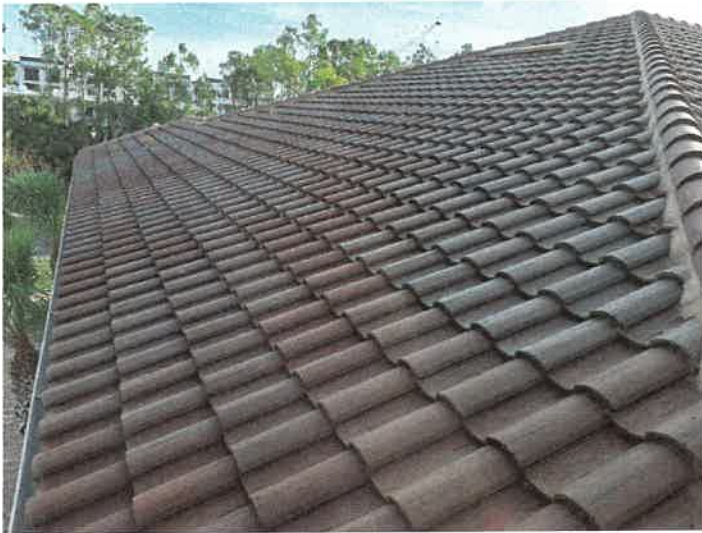
Building 15181: Appearance Overview
The roof appearance is in good, maintainable condition.

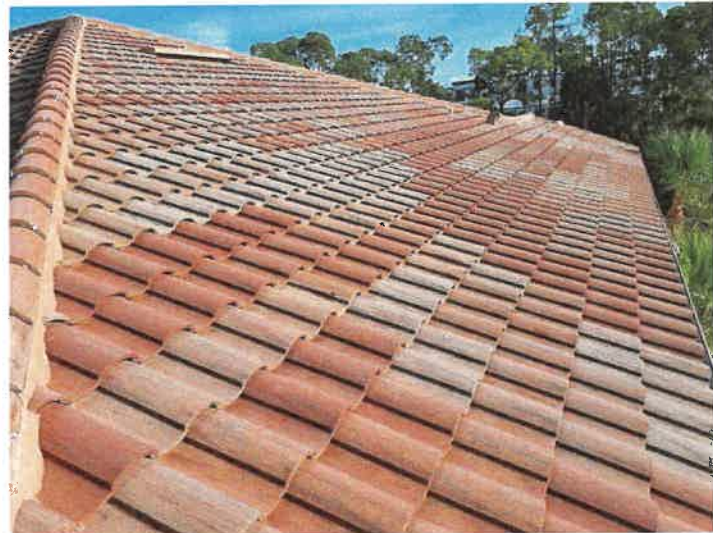
Building 15181: Surface Overview
The roof surface appears to be in good, maintainable condition at this time.

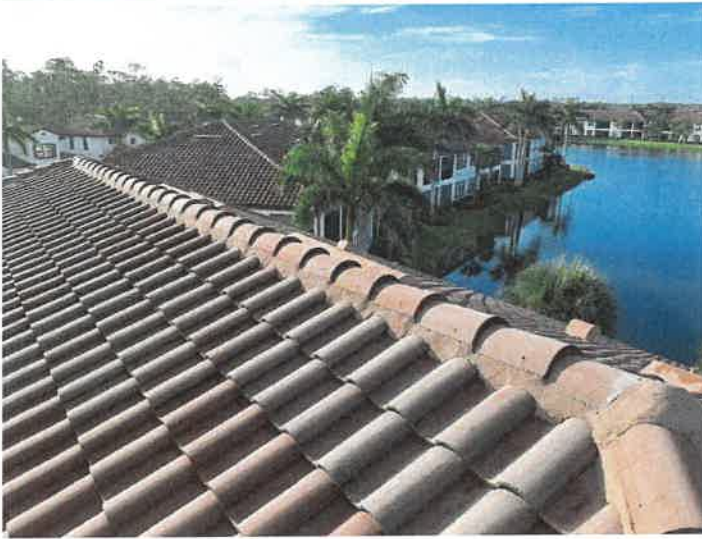
Building 15181: Ridge Tiles

Ridge tiles appear to be in good condition.

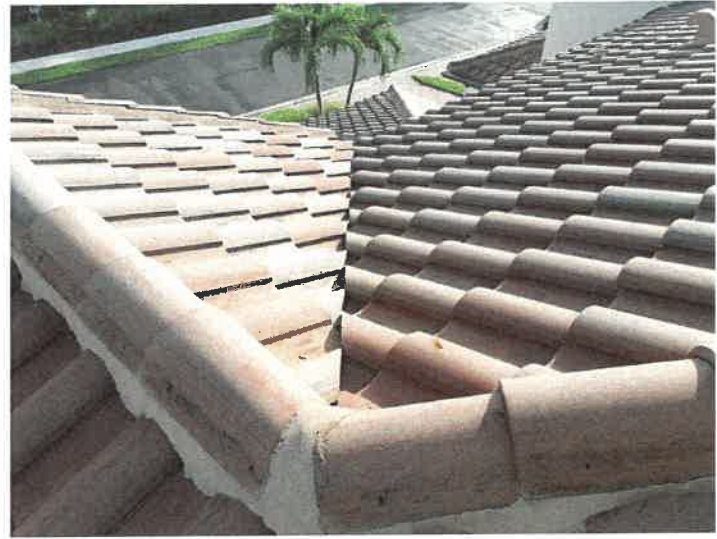
Building 15181: Valley

The valley tiles appear to be in good condition.

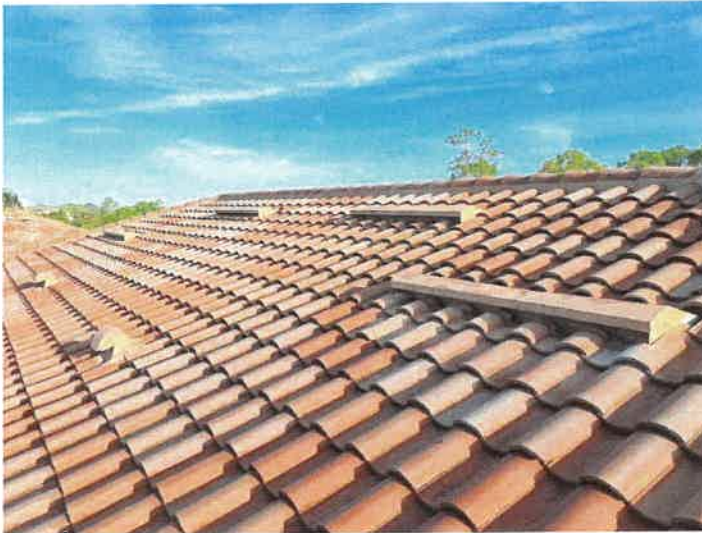
Building 15181: Roof Vents

Roof vents appear to be in good condition.

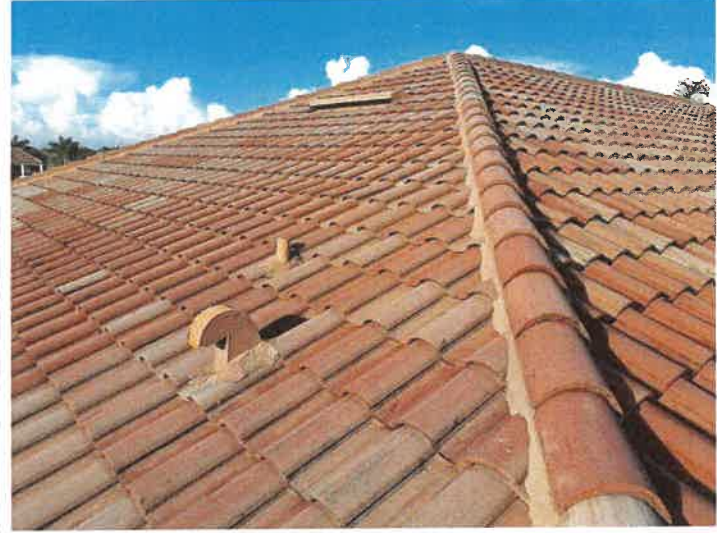
Building 15181: Roof Vents

Roof vents appear to be in good condition.

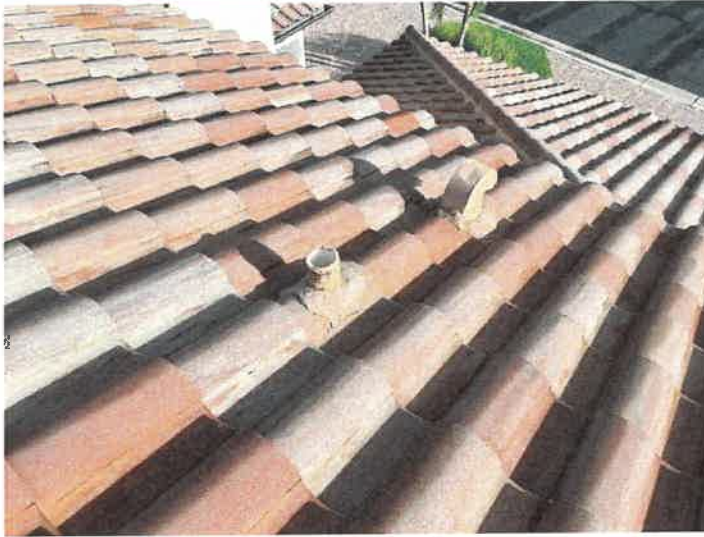
Building 15181: Lead Boots
Lead boots appear to be in good condition.

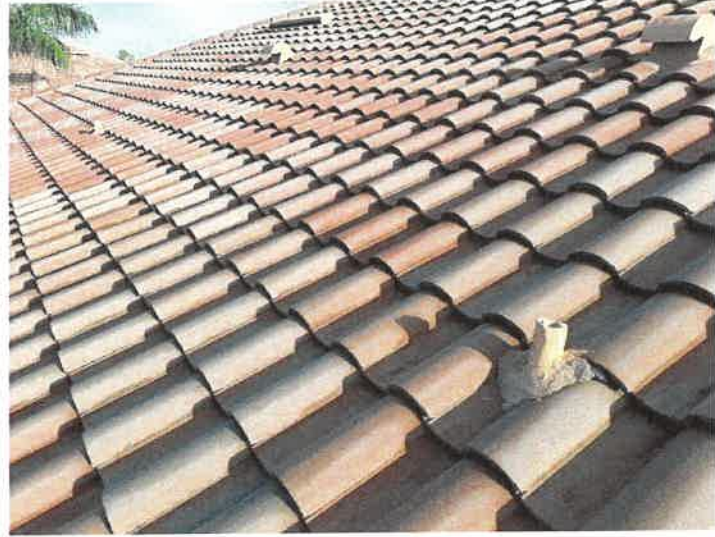
Building 15181: Lead Boots
Lead boots appear to be in good condition.

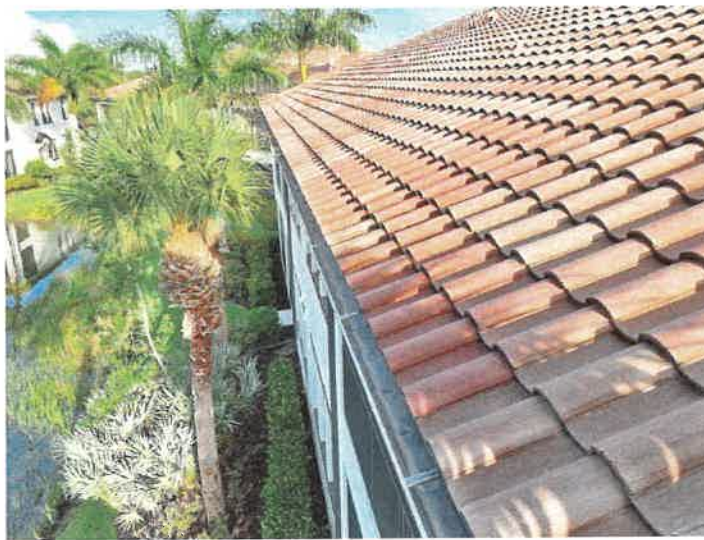
Building 15181: Gutters
The gutters appear to be in good condition.

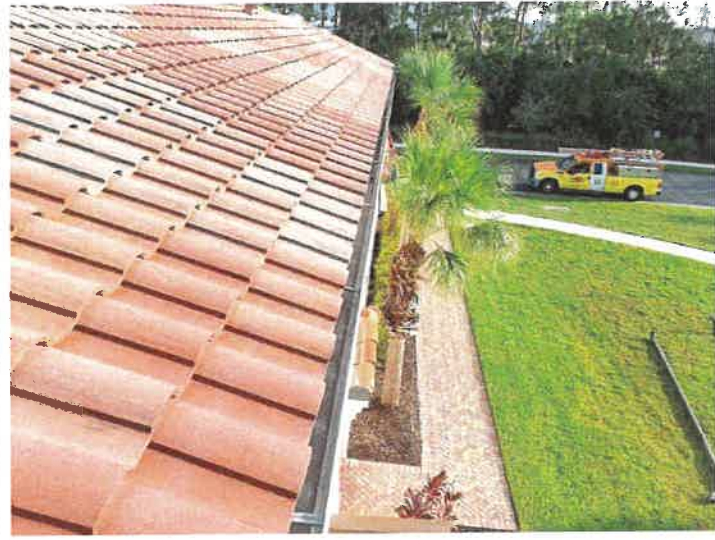
Building 15181: Gutters
The gutters appear to be in good condition.

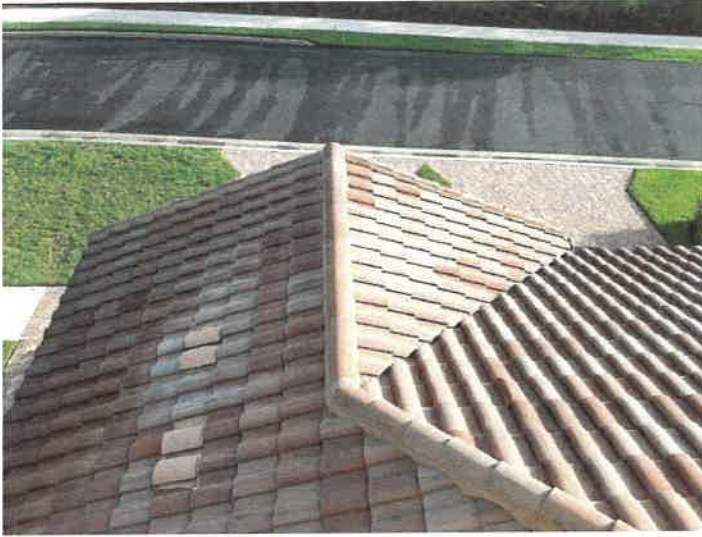
Building 15181: Surface Overview - Lower Roof
The roof surface appears to be in good, maintainable condition at this time.

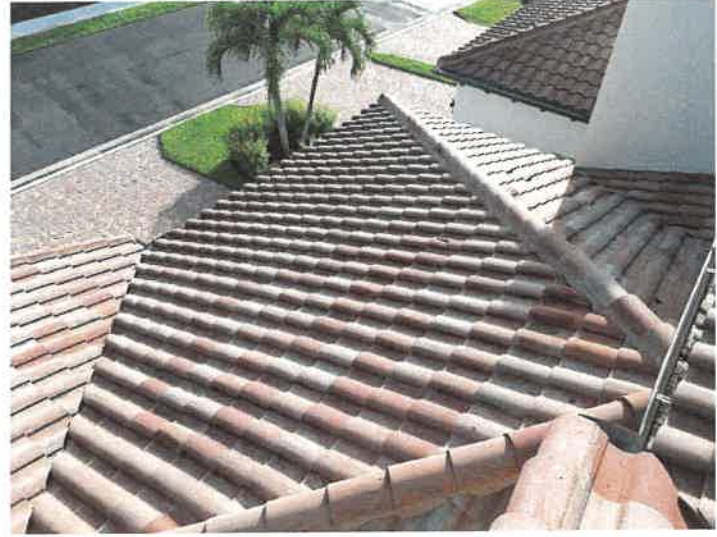
Building 15181: Appearance Overview - Lower Roof
The roof appearance is in good, maintainable condition.

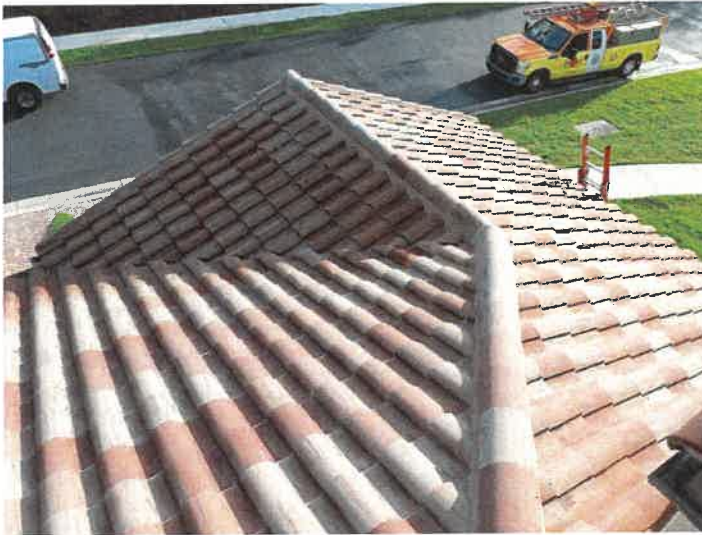
Building 15181: Surface Overview - Lower Roof
The roof surface appears to be in good, maintainable condition at this time.

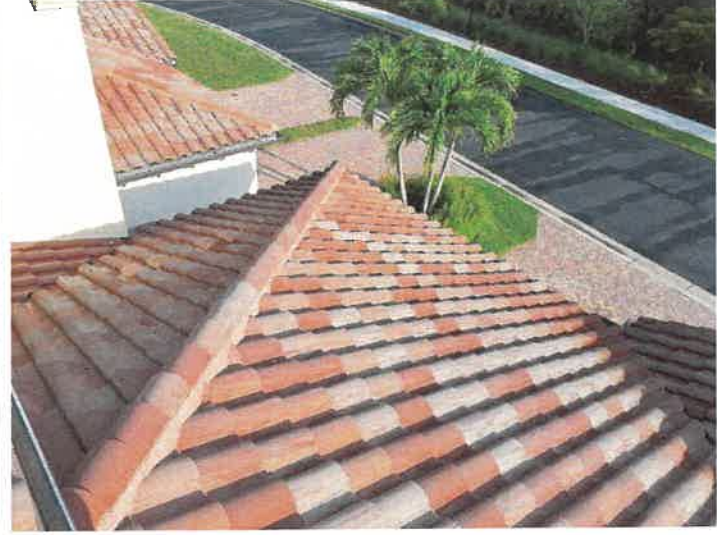
Building 15181: Appearance Overview - Lower Roof
The roof appearance is in good, maintainable condition.

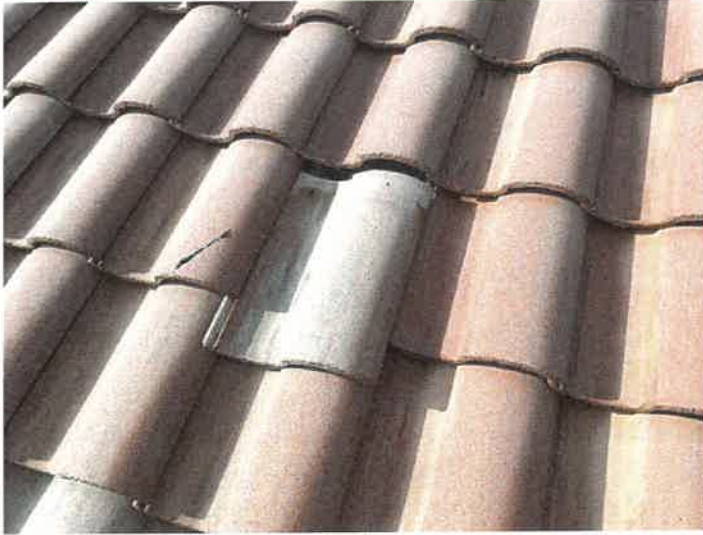
Building 15181: Displaced/Missing Roof Tile

Displaced or missing roof tiles can allow premature underlayment deterioration from excessive UV exposure and potential water intrusion.

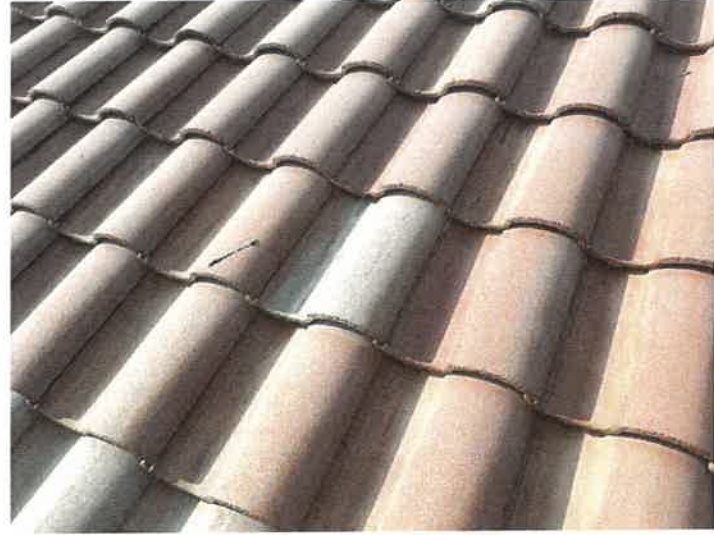
Building 15181: Repaired Displaced/Missing Roof Tile

Replaced and secured the missing roof tile.

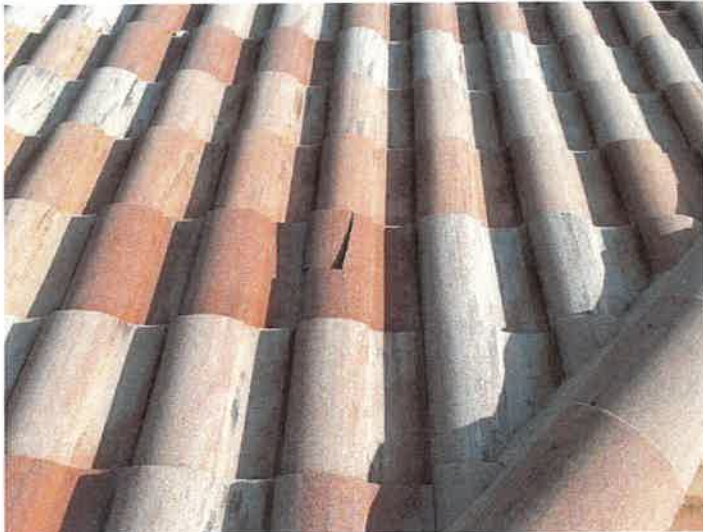
Building 15181: Identified Cracked Roof Tiles

Cracked roof tiles can allow premature underlayment deterioration from excessive UV exposure.

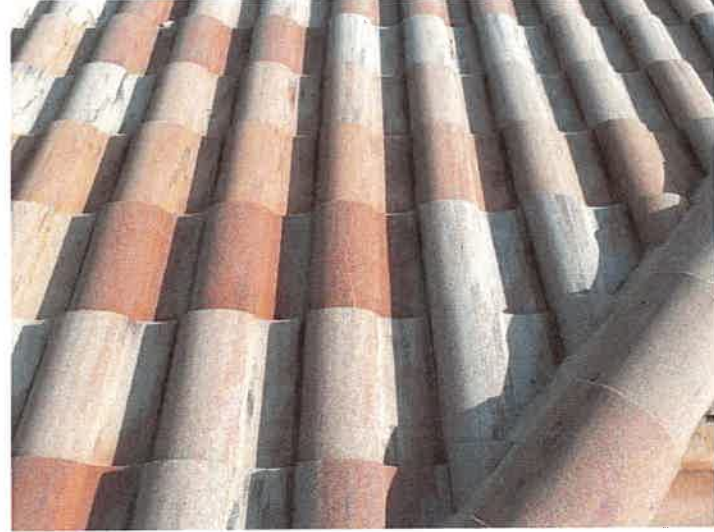
Building 15181: Repaired Cracked Roof Tiles

The cracked roof tiles were repaired with Titebond sealant.

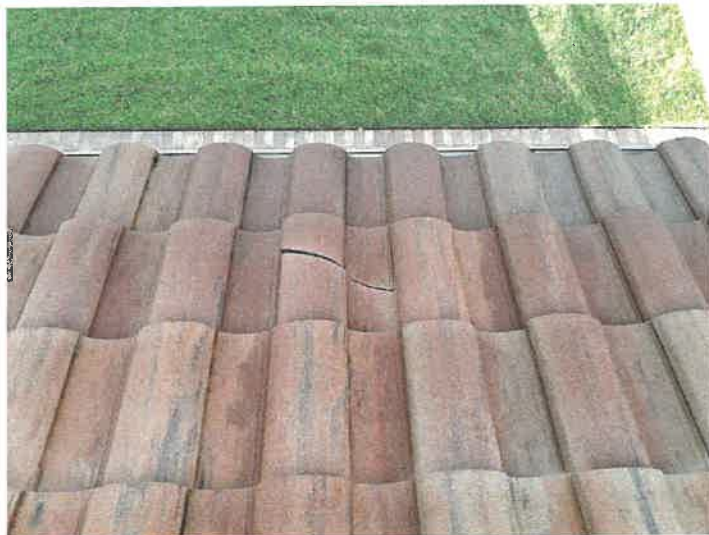
Building 15181: Identified Cracked Roof Tiles
Cracked roof tiles can allow premature underlayment deterioration from excessive UV exposure.

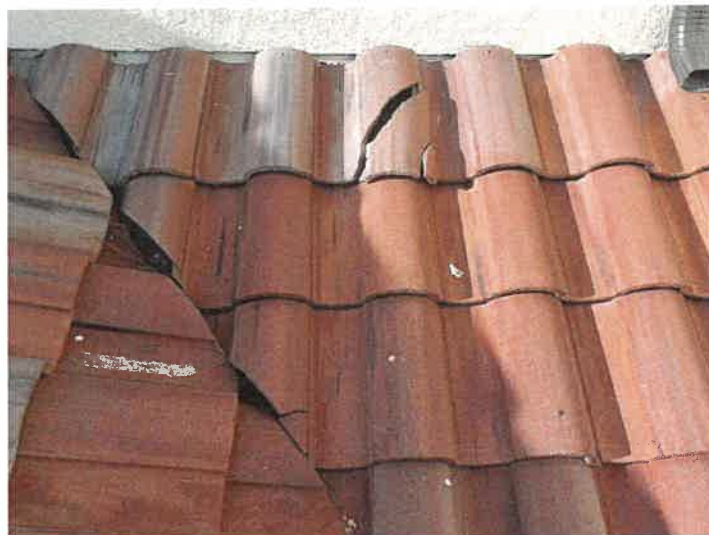
Building 15181: Identified Cracked Roof Tiles
Cracked roof tiles can allow premature underlayment deterioration from excessive UV exposure.

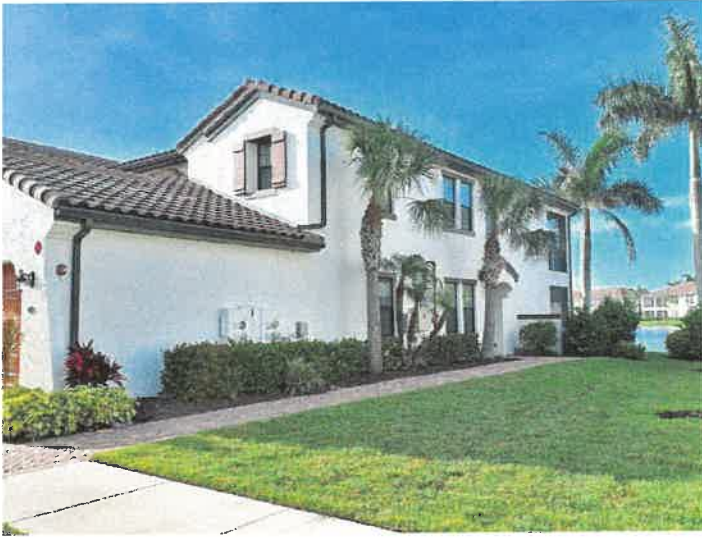
Building 15181: Downspouts

The downspouts appear to be in good condition.

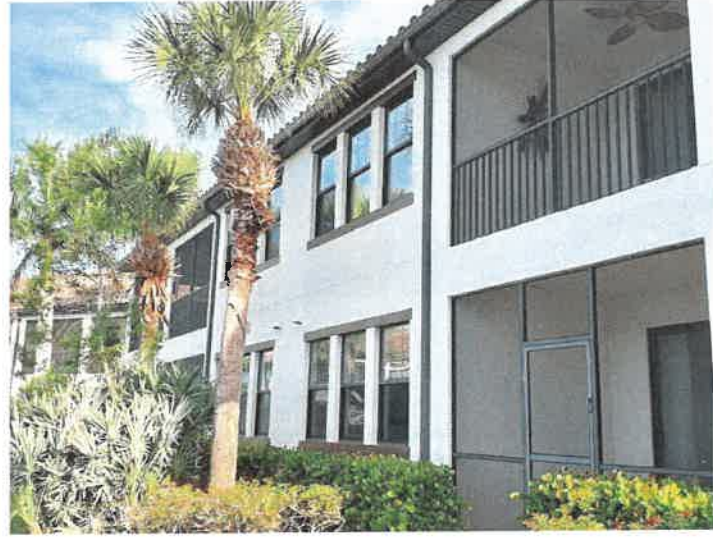
Building 15181: Downspouts

The downspouts appear to be in good condition.

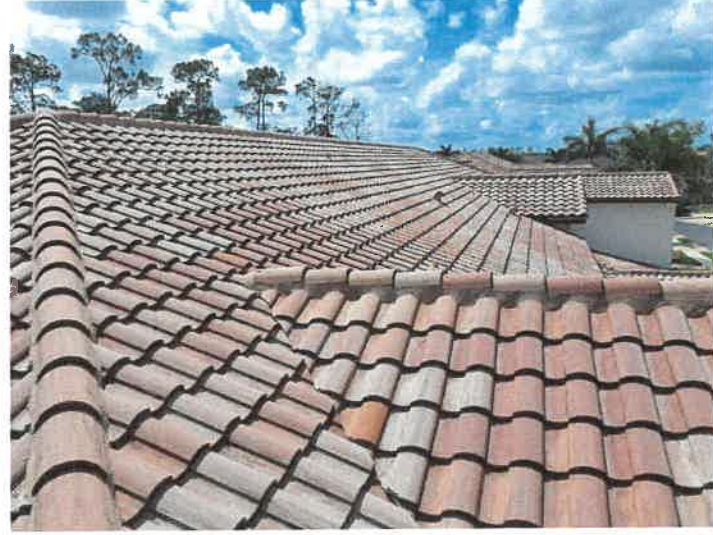
Building 15184: Surface Overview

The roof surface appears to be in good, maintainable condition at this time.

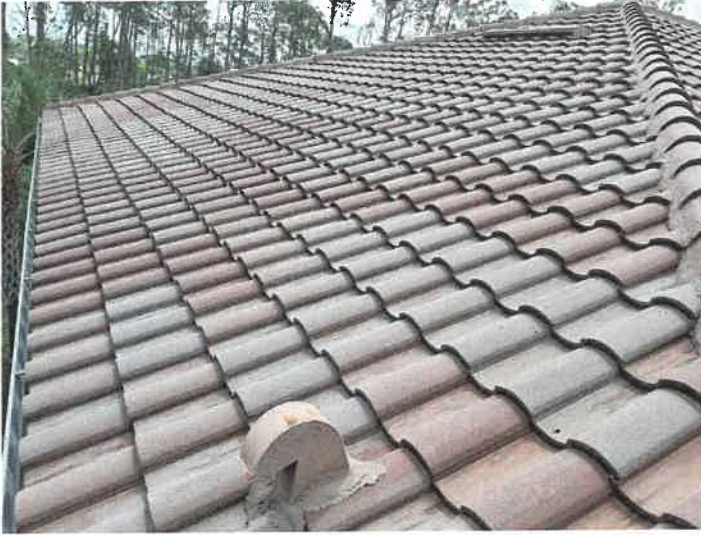
Building 15184: Appearance Overview
The roof appearance is in good, maintainable condition.
