Inspection Report

Facility: Livingston Lakes Condo

Work Order #: 13028

Re.: **Inspection Report (2 of 3) for Livingston Lakes**

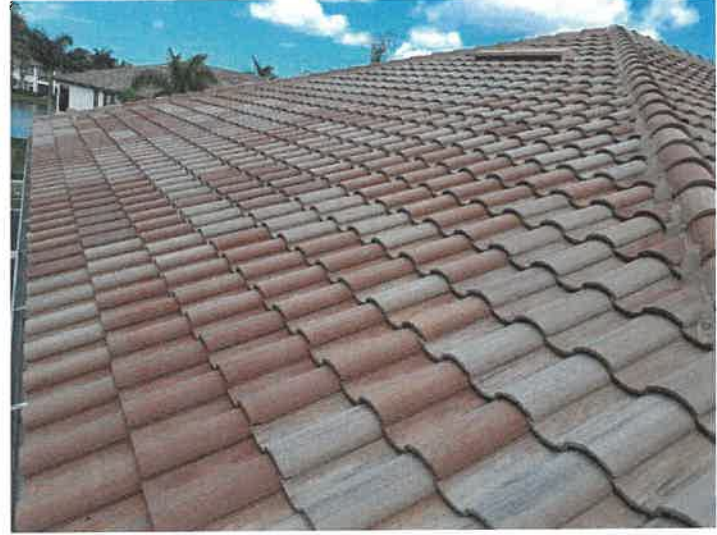
Building 15184: Appearance Overview
The roof appearance is in good, maintainable condition.

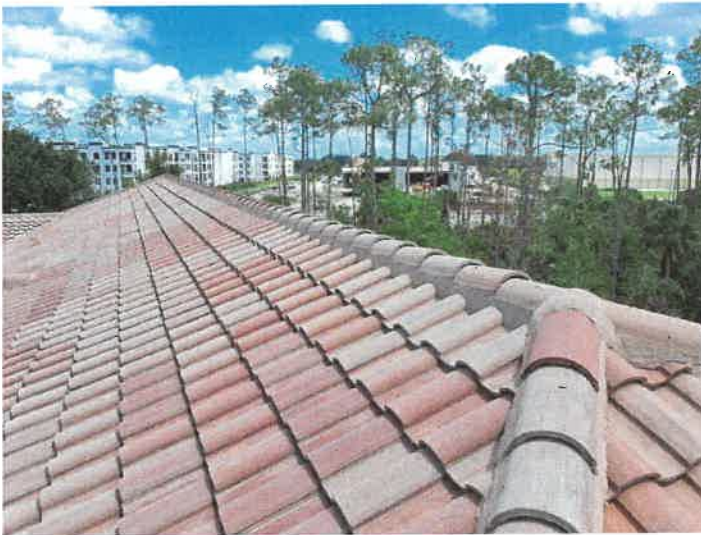
Building 15184: Ridge Tiles
Ridge tiles appear to be in good condition.

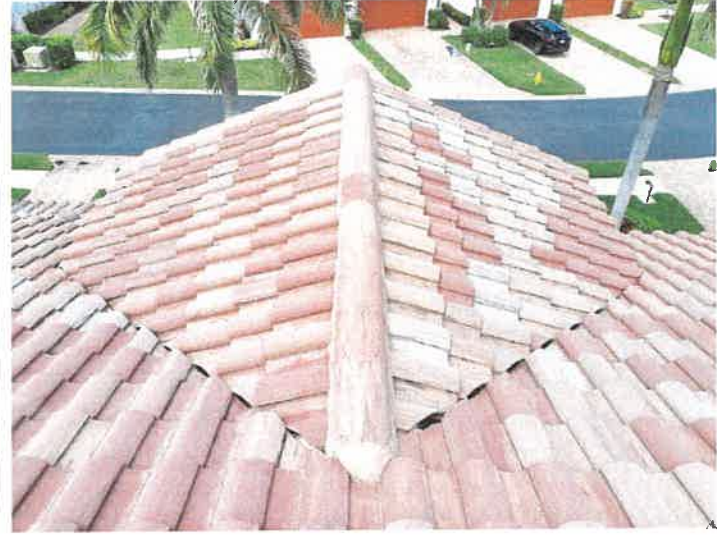
Building 15184: Valley
The valley tiles appear to be in good condition.

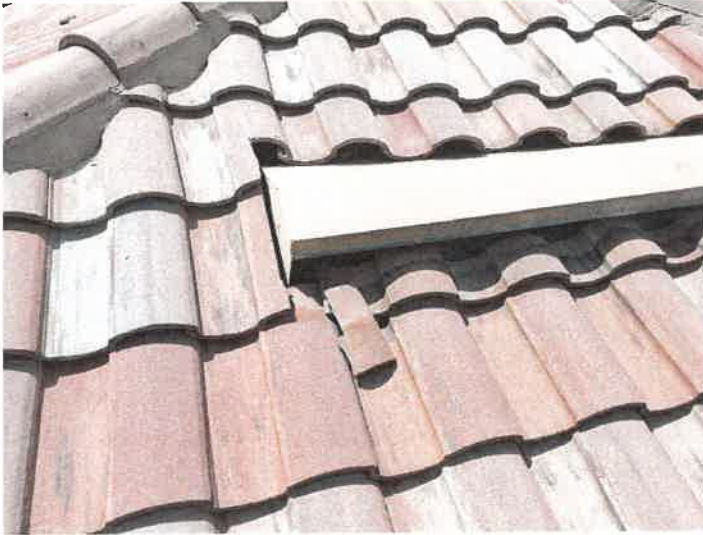
Building 15184: Identified Cracked Roof Tiles
Cracked roof tiles can allow premature underlayment deterioration from excessive UV exposure.

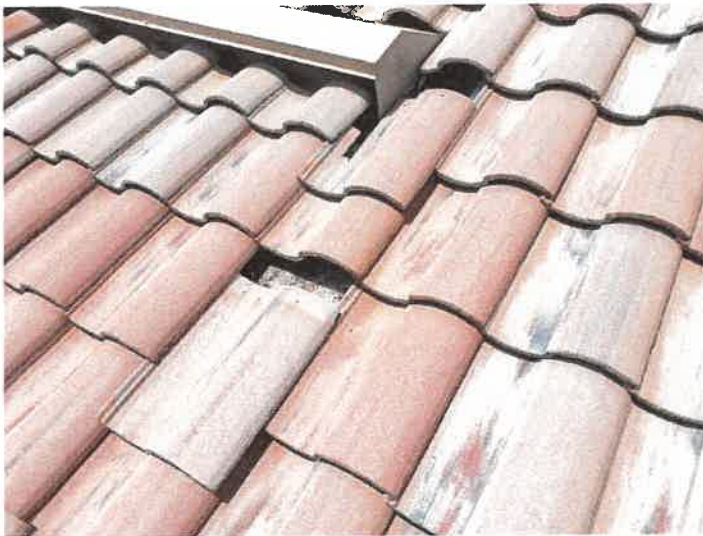
Building 15184: Displaced/Missing Roof Tile
Displaced or missing roof tiles can allow premature underlayment deterioration from excessive UV exposure and potential water intrusion.

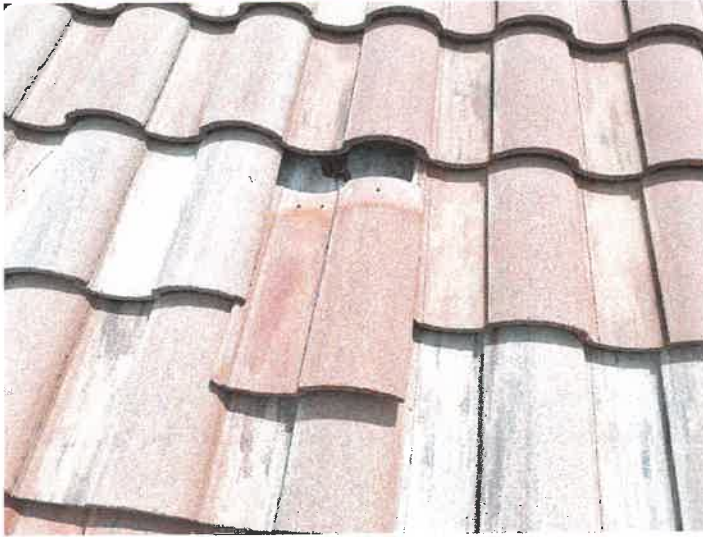
Building 15184: Displaced/Missing Roof Tile

Displaced or missing roof tiles can allow premature underlayment deterioration from excessive UV exposure and potential water intrusion.

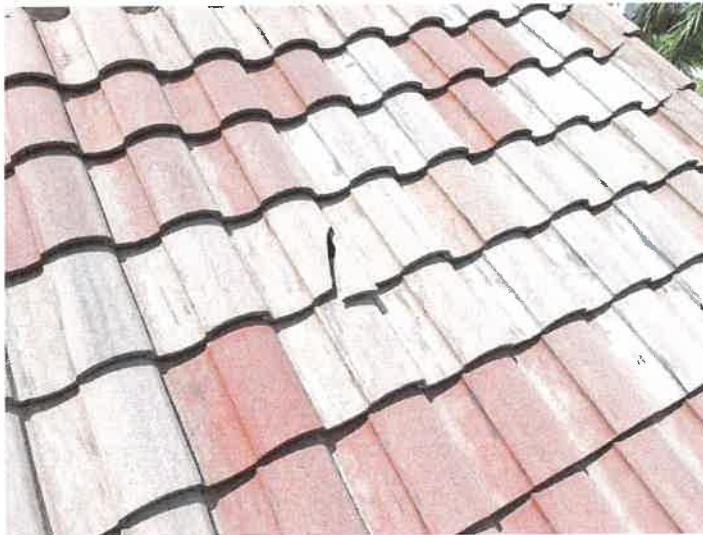
Building 15184: Identified Cracked Roof Tiles

Cracked roof tiles can allow premature underlayment deterioration from excessive UV exposure.

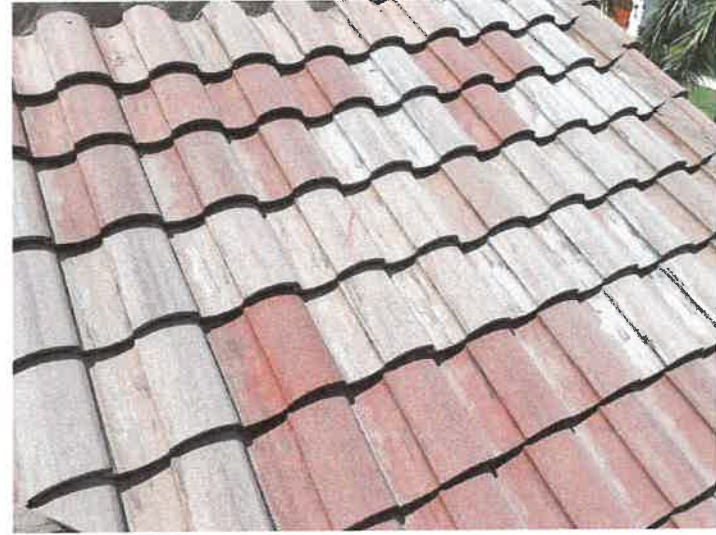
Building 15184: Repaired Cracked Roof Tiles

The cracked roof tiles were repaired with Titebond sealant.

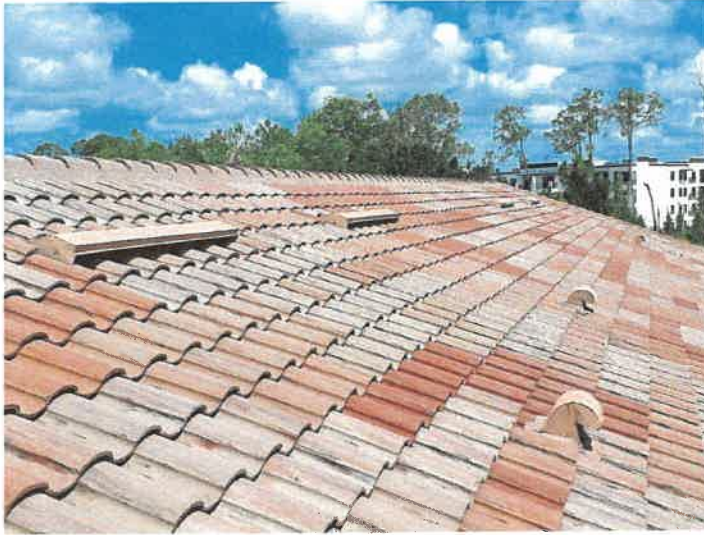
Building 15184: Roof Vents
Roof vents appear to be in good condition.

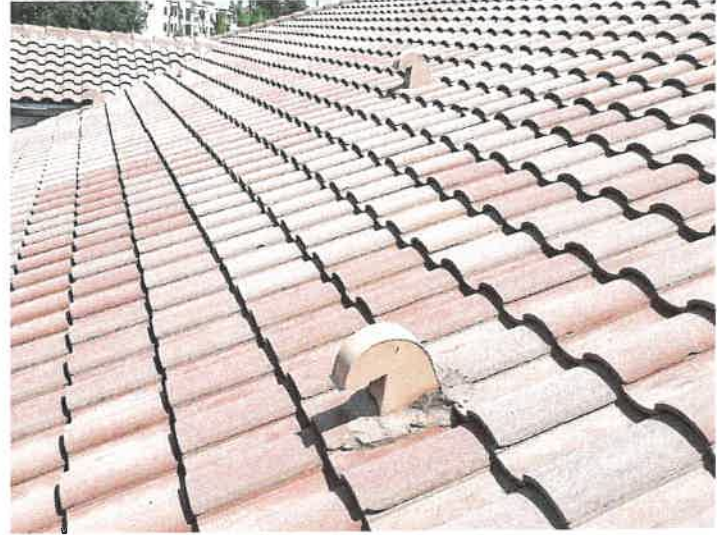
Building 15184: Roof Vents
Roof vents appear to be in good condition.

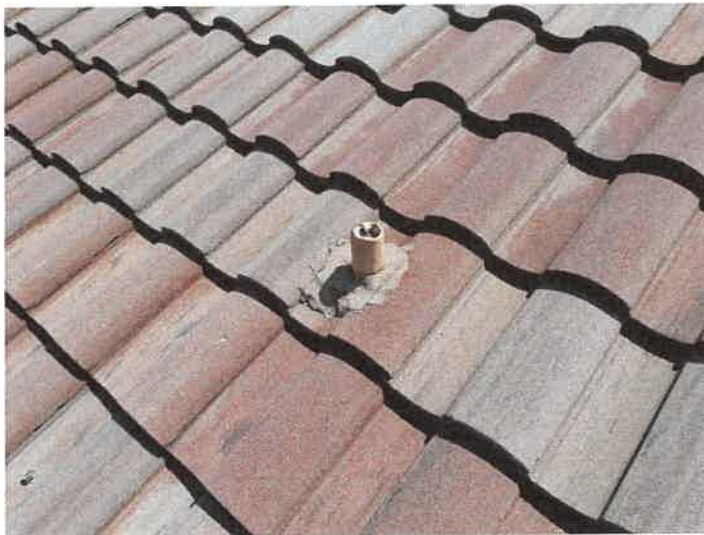
Building 15184: Lead Boots
Lead boots appear to be in good condition.

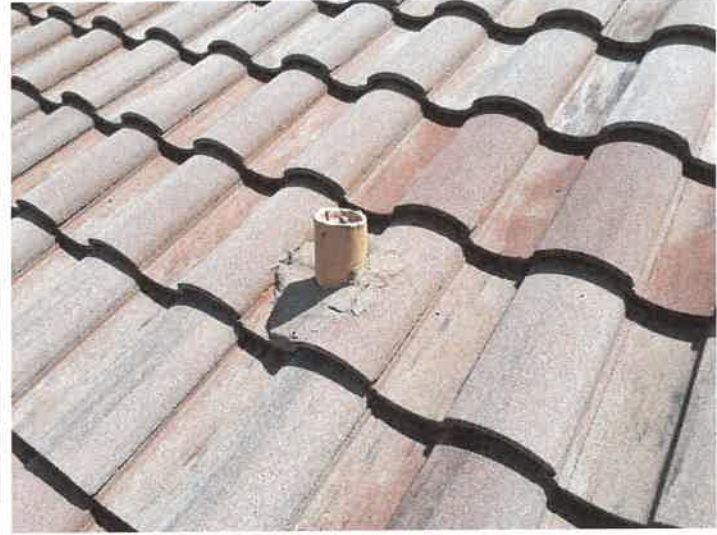
Building 15184: Lead Boots
Lead boots appear to be in good condition.

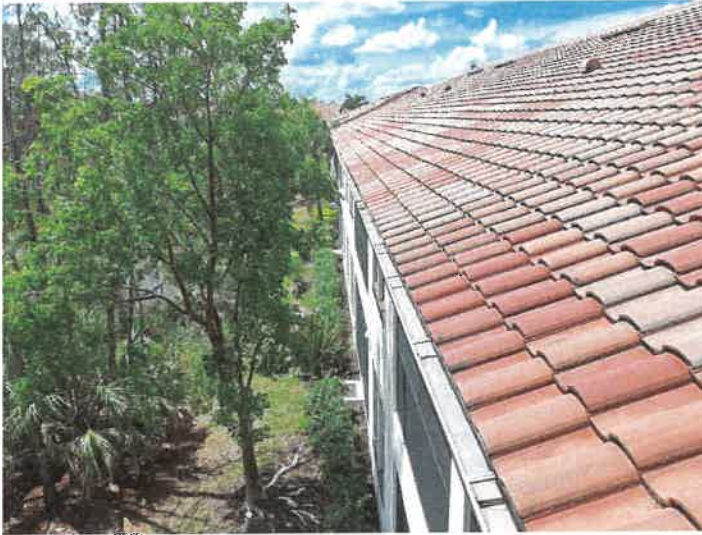
Building 15184: Gutters

The gutters appear to be in good condition.

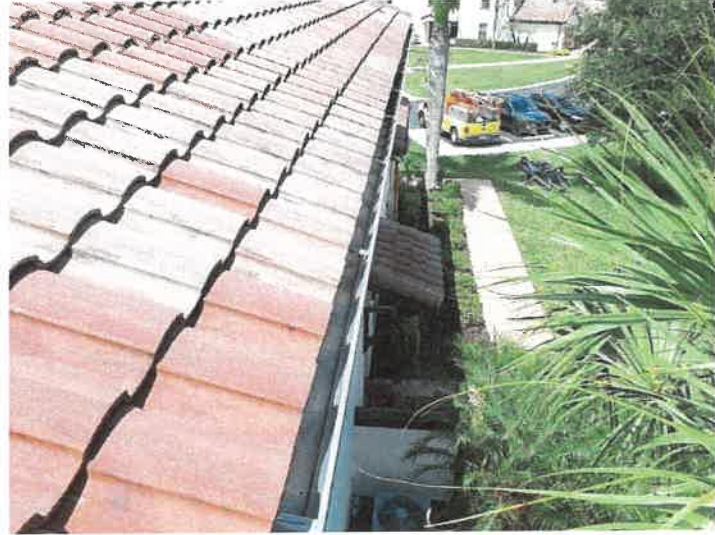
Building 15184: Gutters

The gutters appear to be in good condition.

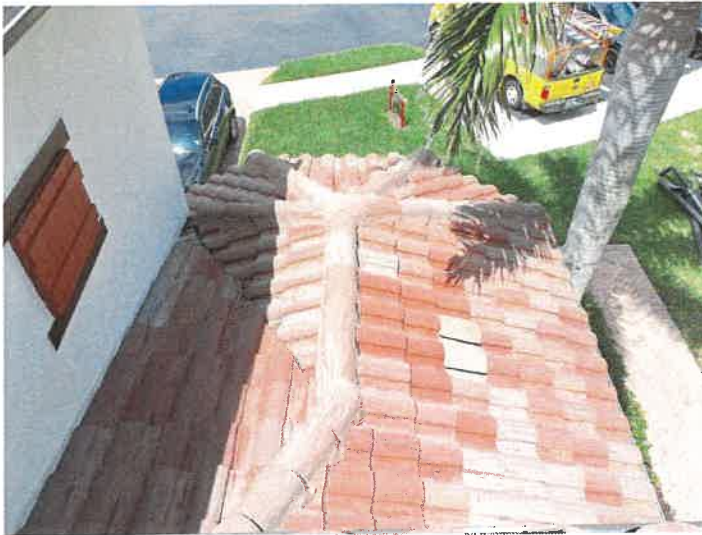
Building 15184: Surface Overview - Lower Roof

The roof surface appears to be in good, maintainable condition at this time.

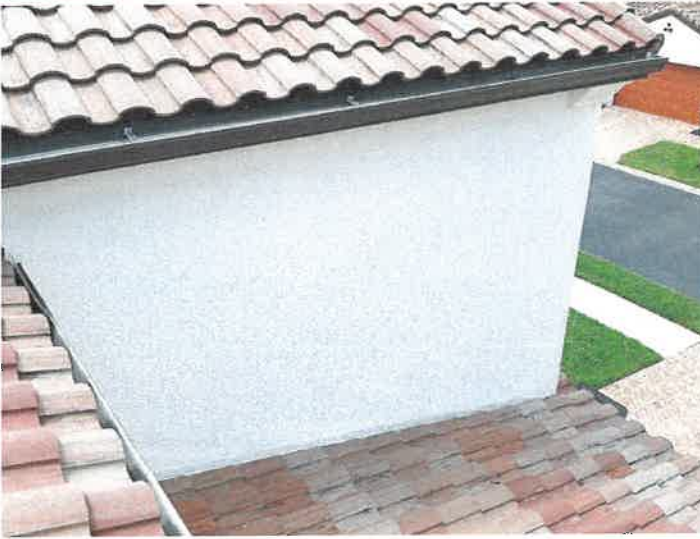
Building 15184: Appearance Overview - Lower Roof

The roof appearance is in good, maintainable condition.

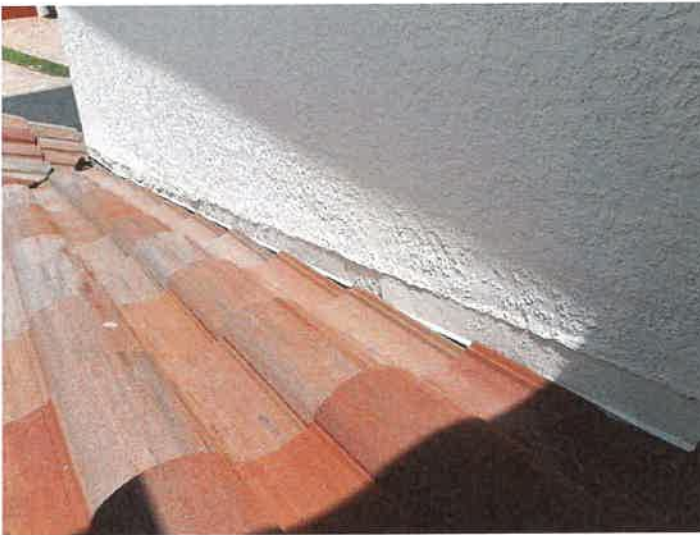
Building 15184: Appearance Overview - Lower Roof

The roof appearance is in good, maintainable condition.

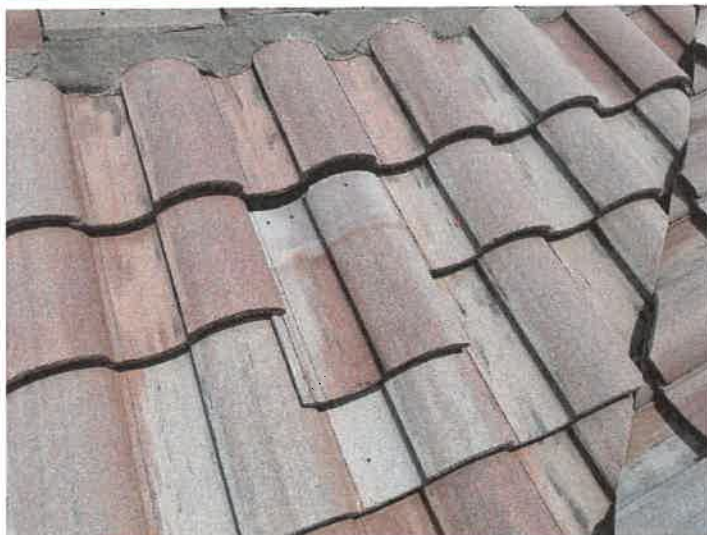
Building 15184: Surface Overview - Lower Roof

The roof surface appears to be in good, maintainable condition at this time.

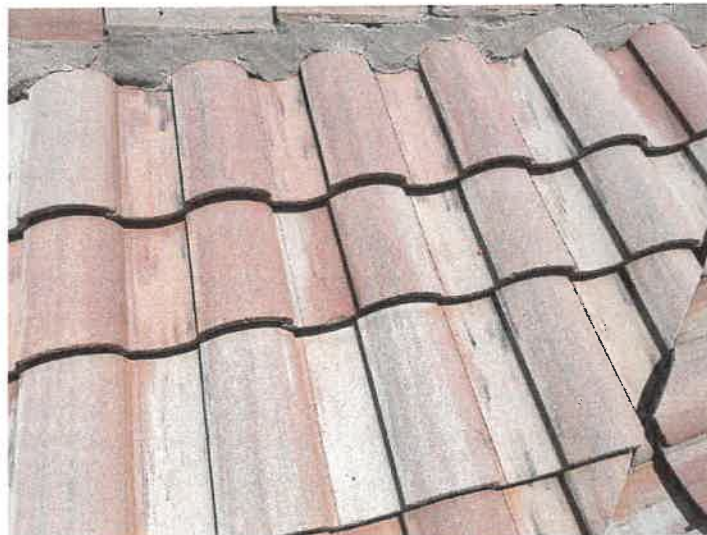
Building 15184: Displaced/Missing Roof Tile

Displaced or missing roof tiles can allow premature underlayment deterioration from excessive UV exposure and potential water intrusion.

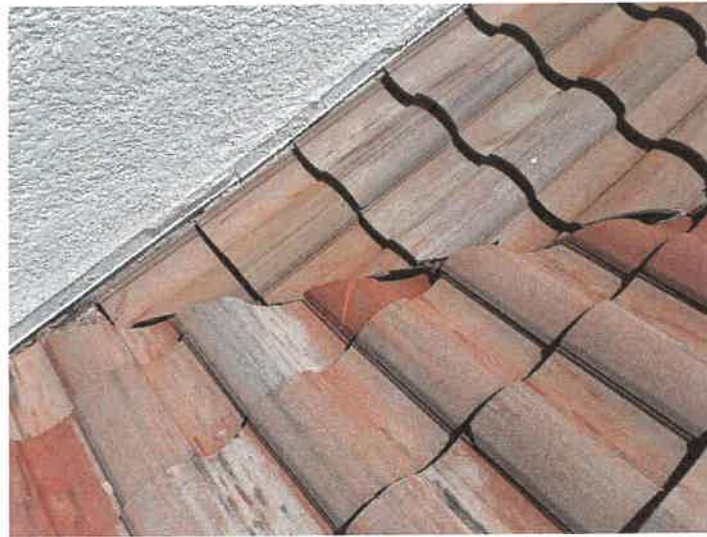
Building 15184: Identified Cracked Roof Tiles

Cracked roof tiles can allow premature underlayment deterioration from excessive UV exposure.

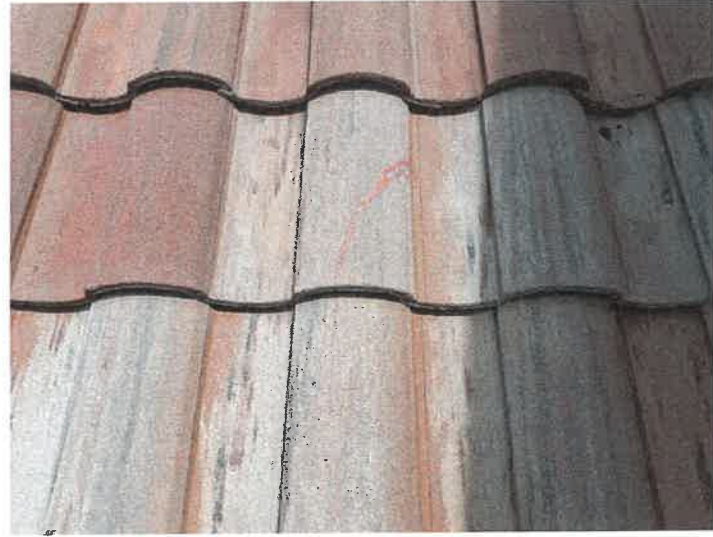
Building 15184: Identified Cracked Roof Tiles
Cracked roof tiles can allow premature underlayment deterioration from excessive UV exposure.

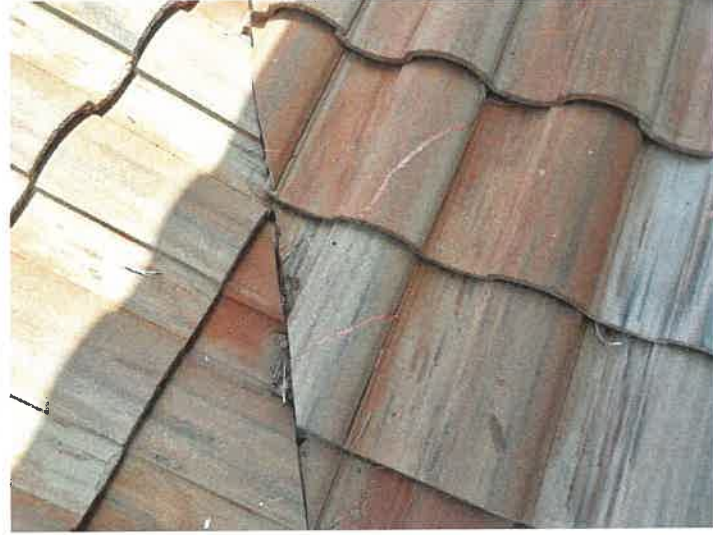
Building 15184: Identified Cracked Roof Tiles
Cracked roof tiles can allow premature underlayment deterioration from excessive UV exposure.

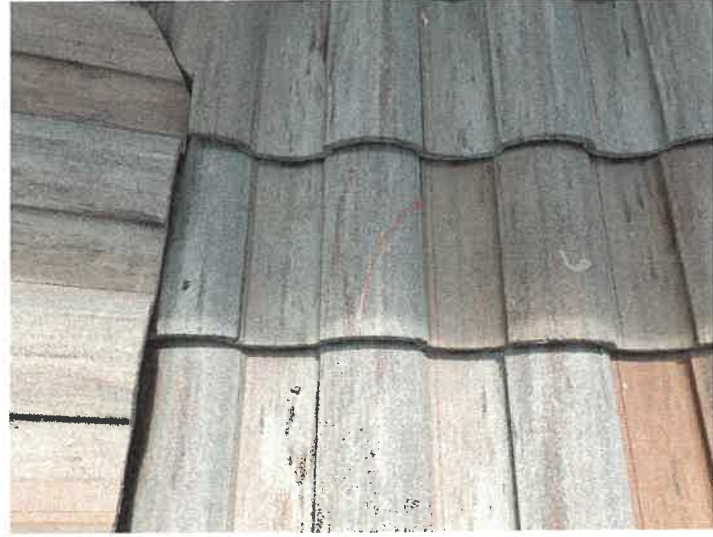
Building 15184: Identified Cracked Roof Tiles
Cracked roof tiles can allow premature underlayment deterioration from excessive UV exposure.

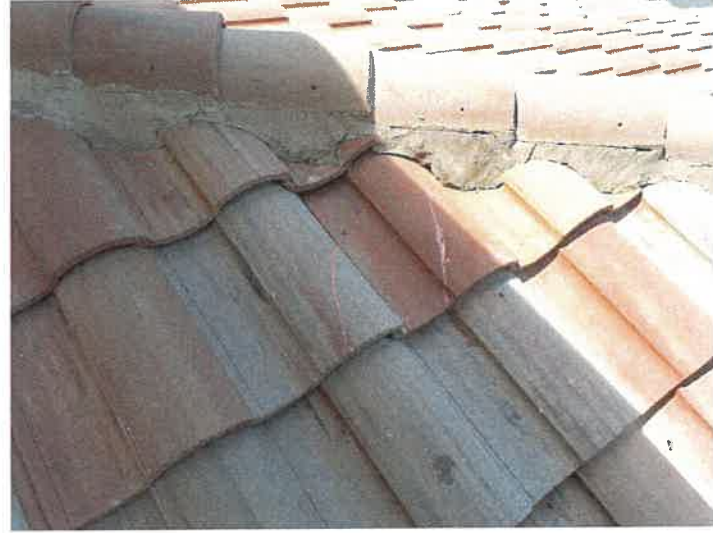
Building 15184: Identified Cracked Roof Tiles
Cracked roof tiles can allow premature underlayment deterioration from excessive UV exposure.

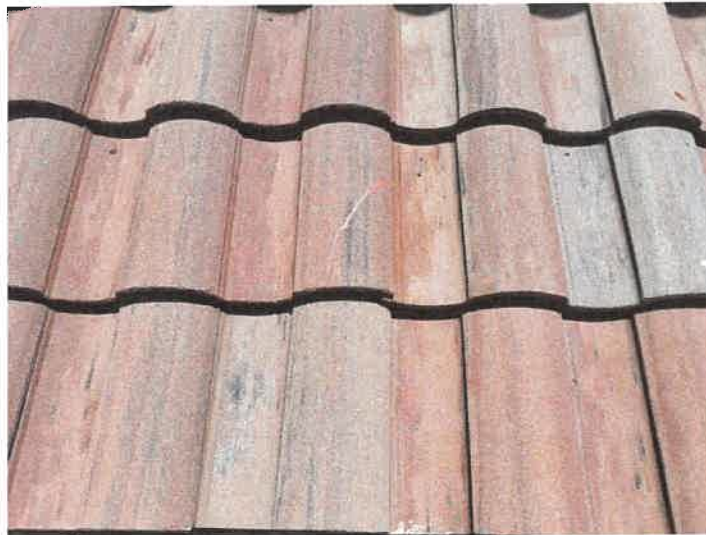
Building 15184: Identified Cracked Roof Tiles
Cracked roof tiles can allow premature underlayment deterioration from excessive UV exposure.

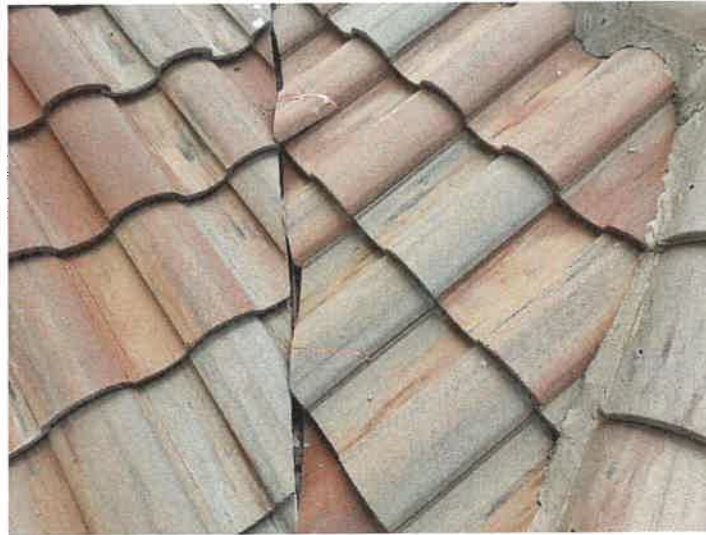
Building 15184: Identified Cracked Roof Tiles
Cracked roof tiles can allow premature underlayment deterioration from excessive UV exposure.

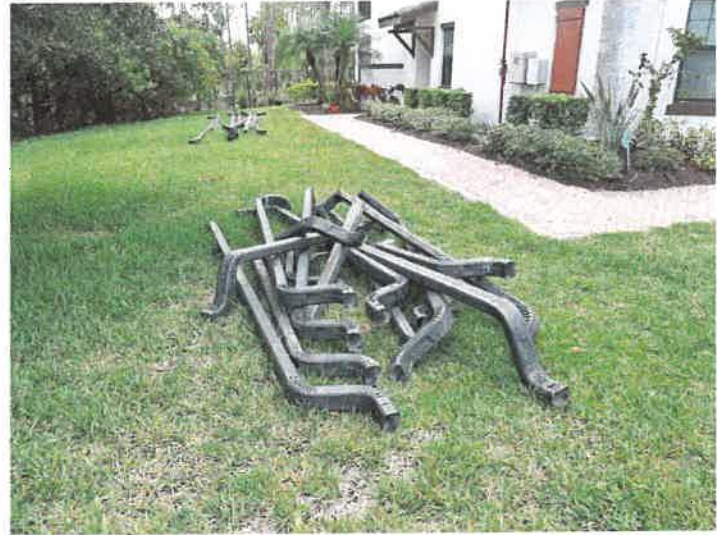
Building 15184: Downspout- missing
Downspout is missing.

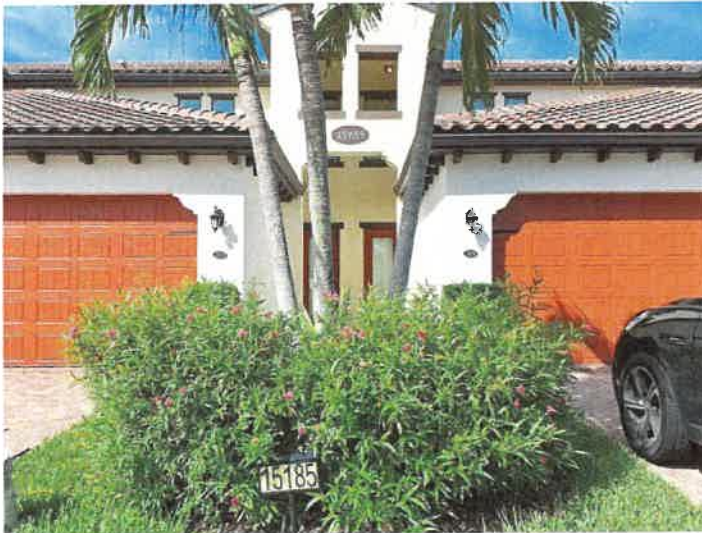
Building 15184: Downspout- missing
The painting company that is painting the exteriors in Livingston Lakes has the missing downspouts.

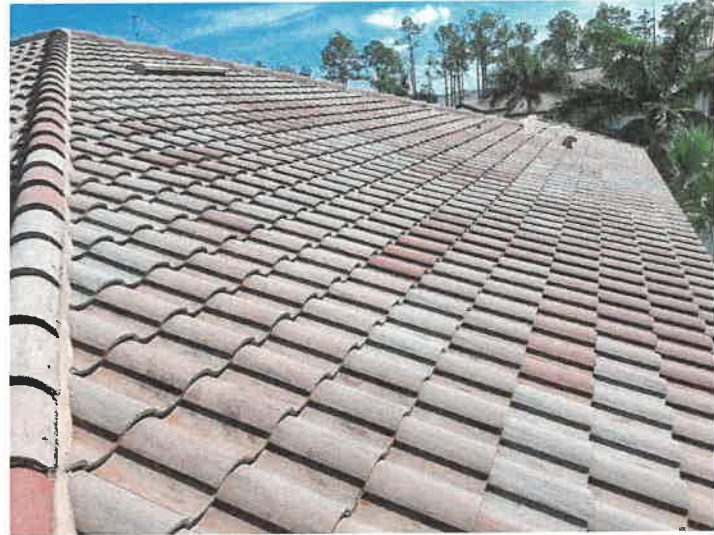
Building 15185: Appearance Overview

The roof appearance is in good, maintainable condition.

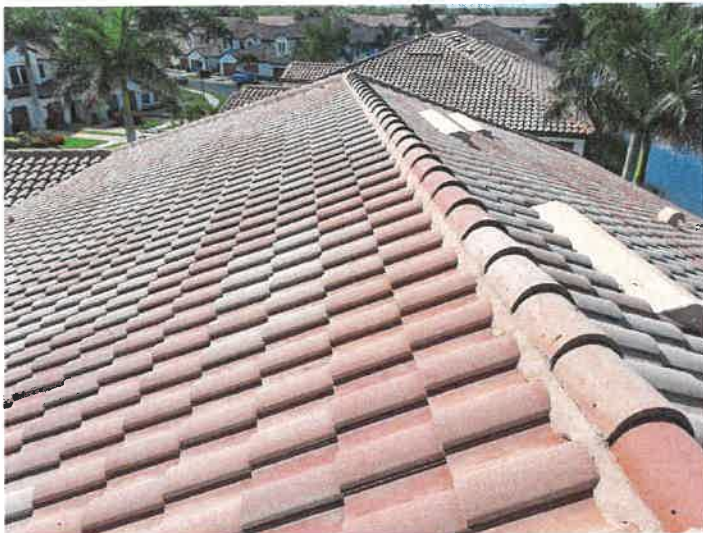
Building 15185: Surface Overview

The roof surface appears to be in good, maintainable condition at this time.

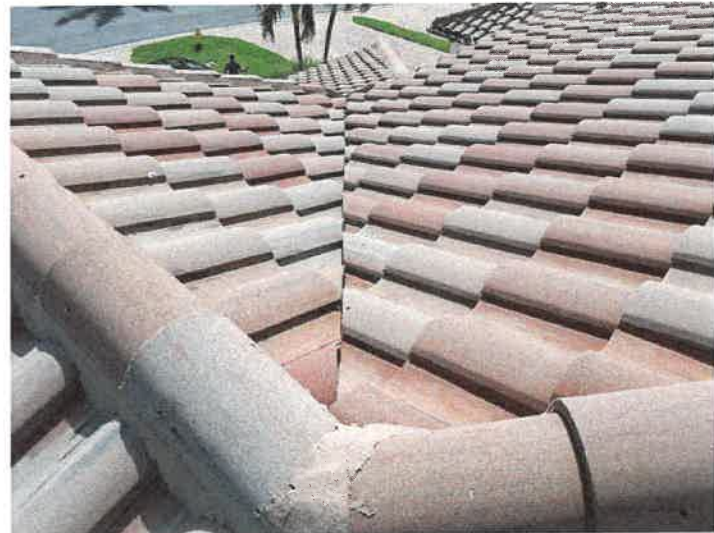
Building 15185: Ridge Tiles

Ridge tiles appear to be in good condition.

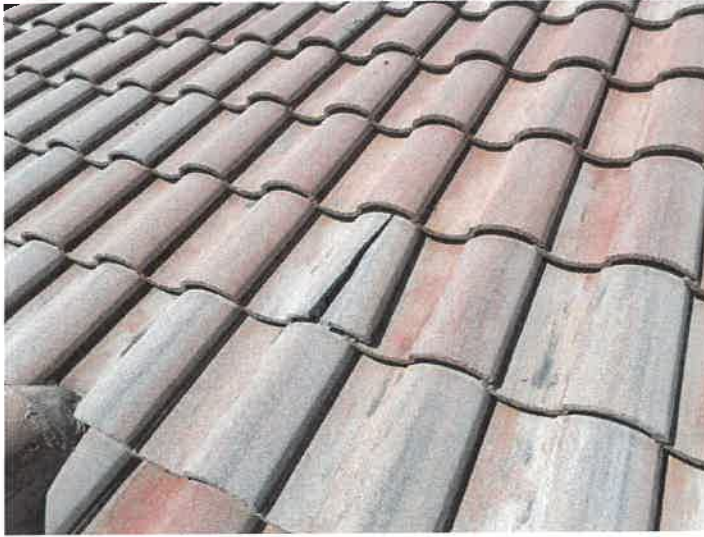
Building 15185: Valley

The valley tiles appear to be in good condition.

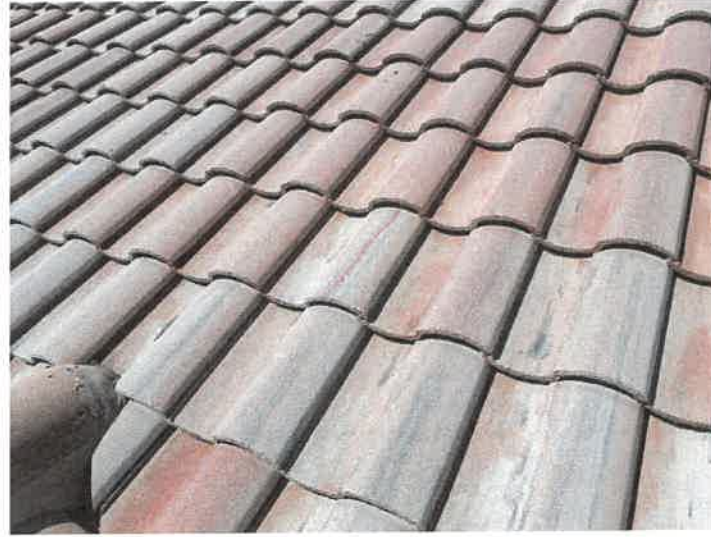
Building 15185: Identified Cracked Roof Tiles
Cracked roof tiles can allow premature underlayment deterioration from excessive UV exposure.

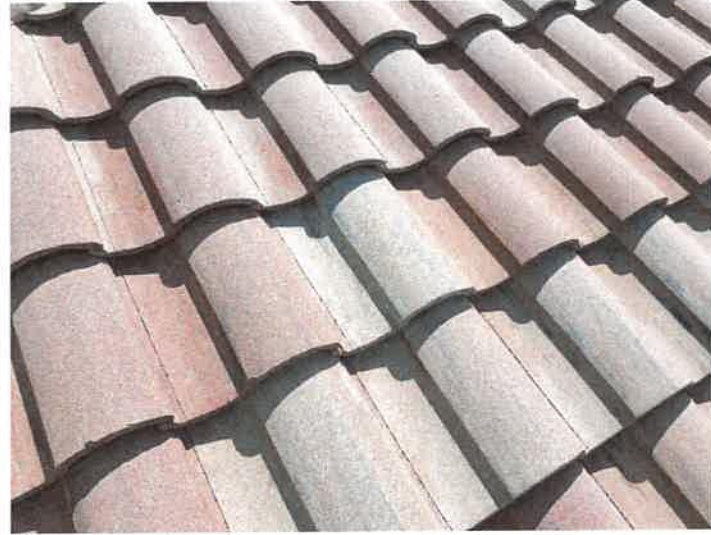
Building 15185: Displaced/Missing Roof Tile
Displaced or missing roof tiles can allow premature underlayment deterioration from excessive UV exposure and potential water intrusion.

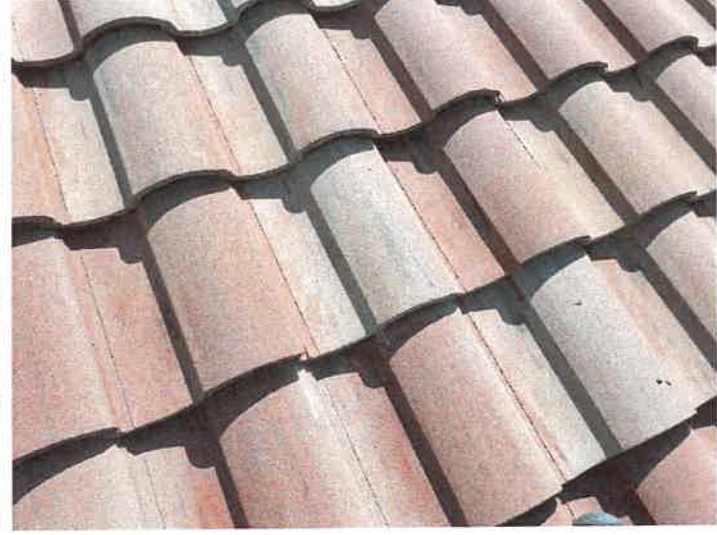
Building 15185: Displaced/Missing Roof Tile

Displaced or missing roof tiles can allow premature underlayment deterioration from excessive UV exposure and potential water intrusion.

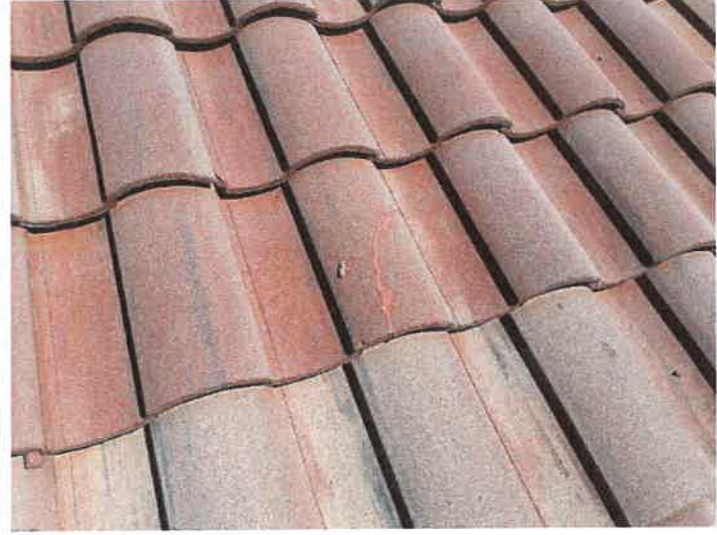
Building 15185: Identified Cracked Roof Tiles

Cracked roof tiles can allow premature underlayment deterioration from excessive UV exposure.

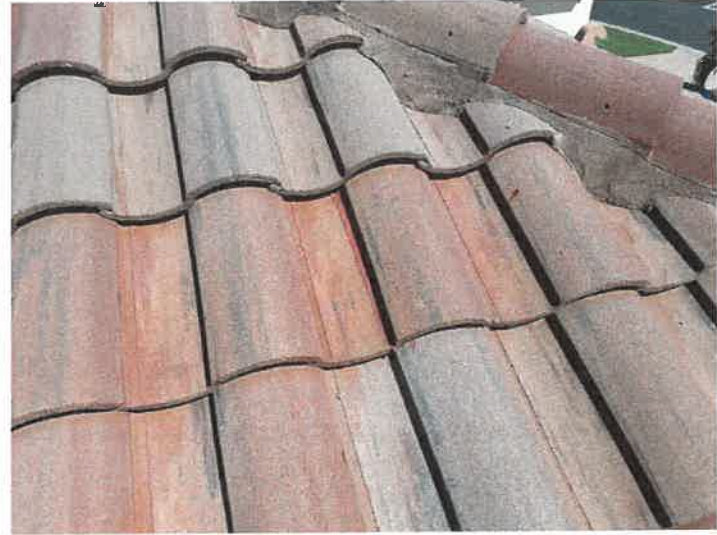
Building 15185: Identified Cracked Roof Tiles
Cracked roof tiles can allow premature underlayment deterioration from excessive UV exposure.

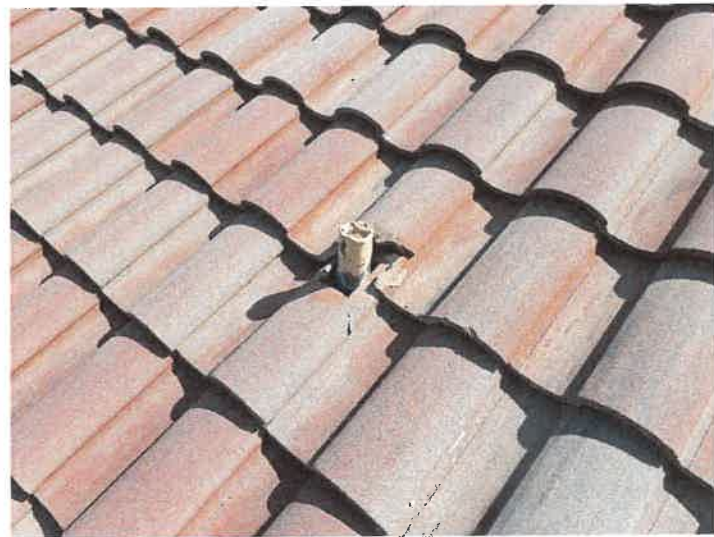
Building 15185: Missing Mortar
Identified missing mortar around of lead boot. Crowther Roofing suggests installing mortar.

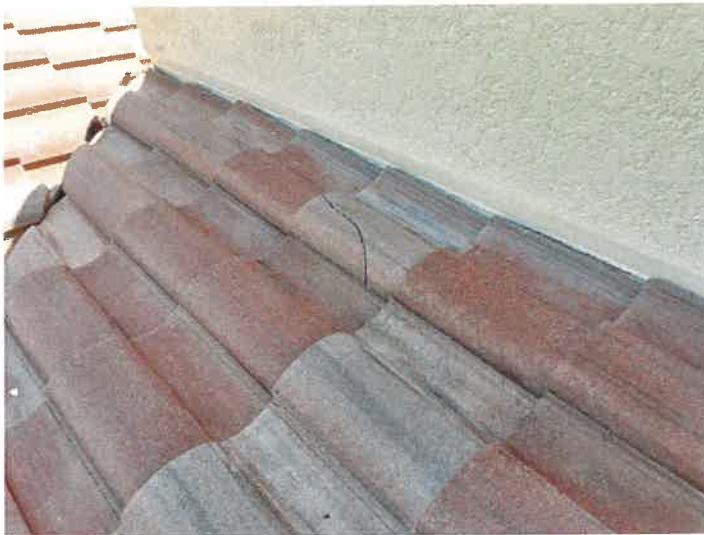
Building 15185: Identified Cracked Roof Tiles
Cracked roof tiles can allow premature underlayment deterioration from excessive UV exposure.

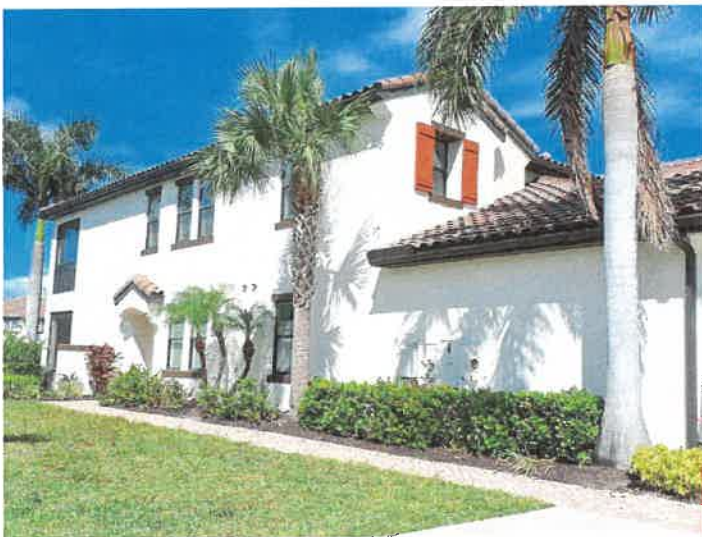
Building 15185: Downspout- missing

Downspout is missing. The painting company that is painting the exteriors in Livingston Lakes has the missing downspouts.

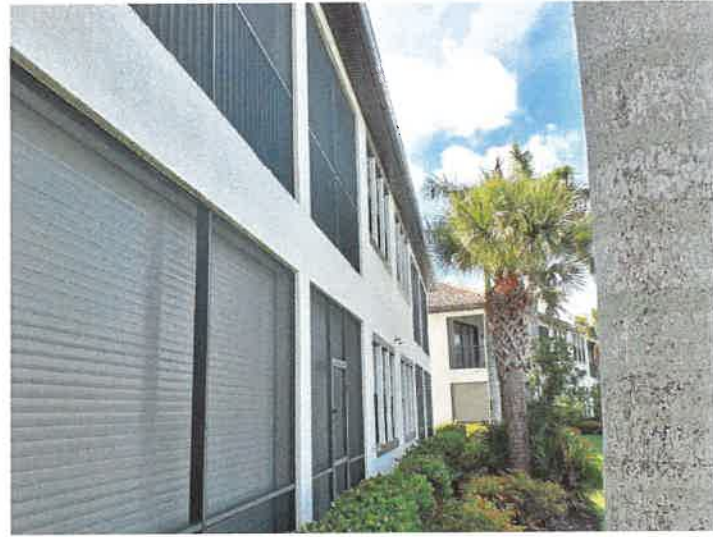
Building 15185: Downspout- missing

Downspout is missing.

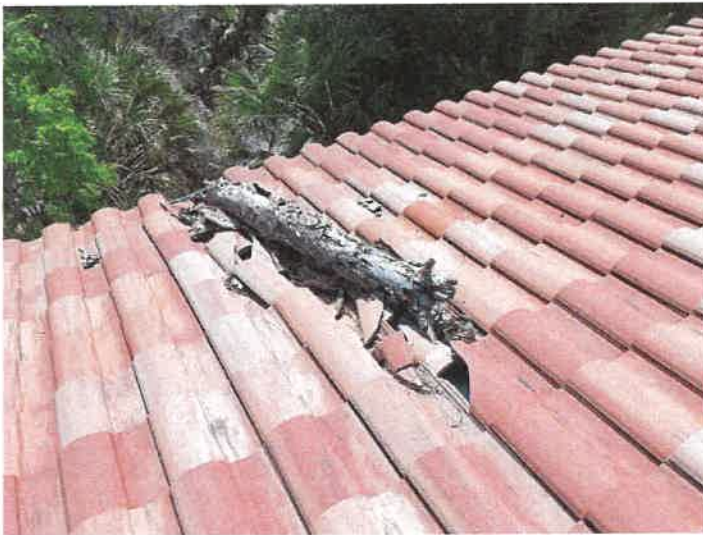
Building 15188: Debris on Roof
Identified debris on the surface of the roof that could damage the membrane.

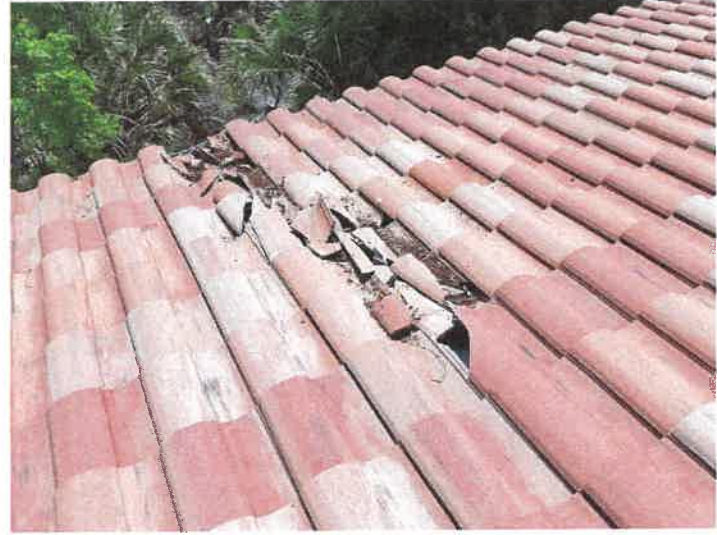
Building 15188: Broken Roof Tiles
Crowther Roofing suggests replacing 15 cracked roof tiles.

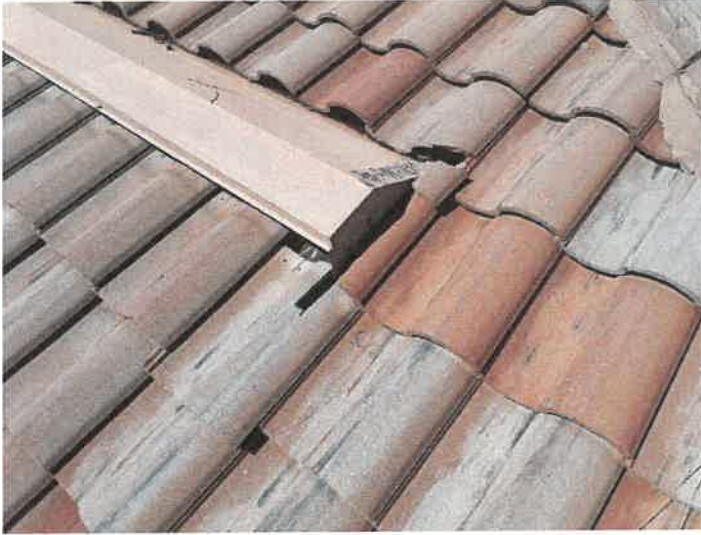
Building 15188: Displaced/Missing Roof Tile

Displaced or missing roof tiles can allow premature underlayment deterioration from excessive UV exposure and potential water intrusion.

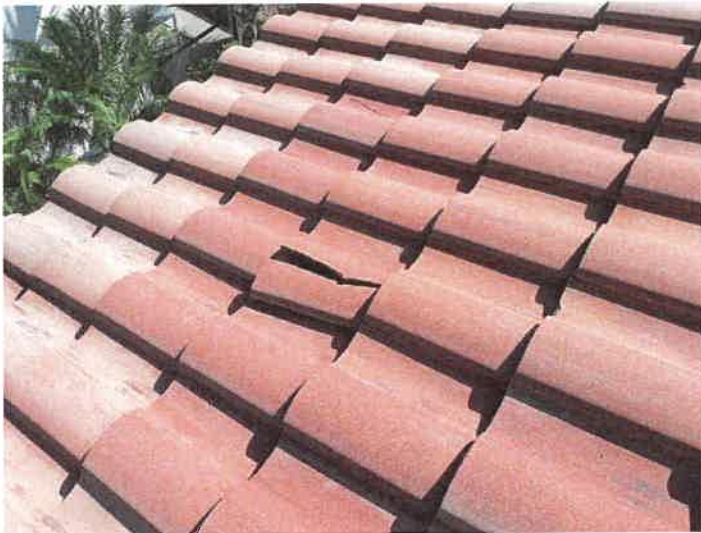
Building 15188: Identified Cracked Roof Tiles

Cracked roof tiles can allow premature underlayment deterioration from excessive UV exposure.

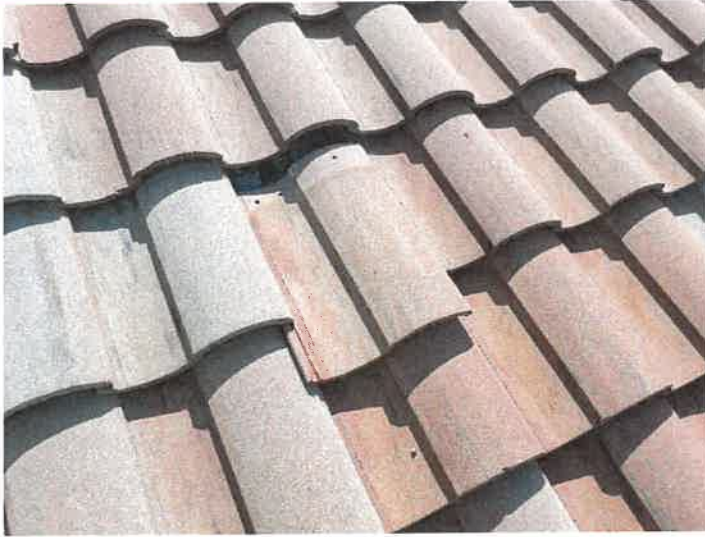
Building 15188: Displaced/Missing Roof Tile

Displaced or missing roof tiles can allow premature underlayment deterioration from excessive UV exposure and potential water intrusion.

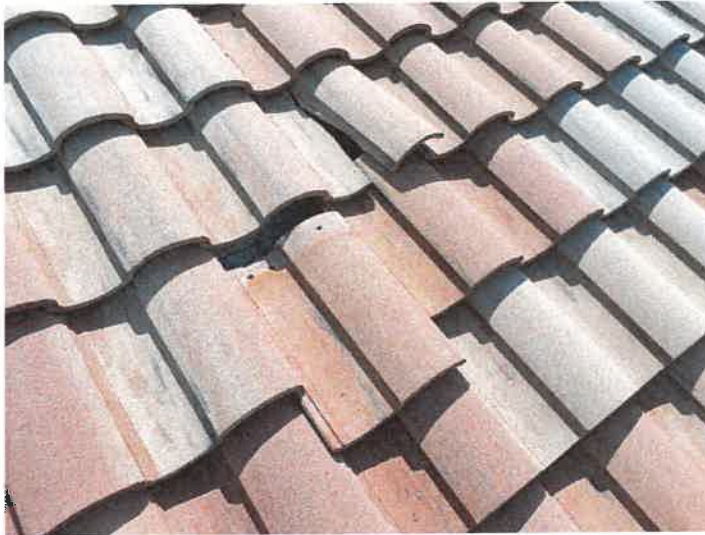
Building 15188: Displaced/Missing Roof Tile

Displaced or missing roof tiles can allow premature underlayment deterioration from excessive UV exposure and potential water intrusion.

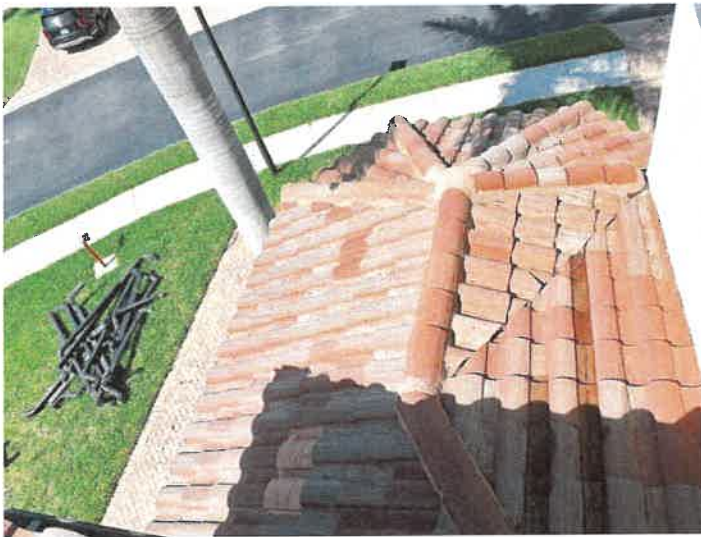
Building 15188: Surface Overview - Lower Roof

The roof surface appears to be in good, maintainable condition at this time.

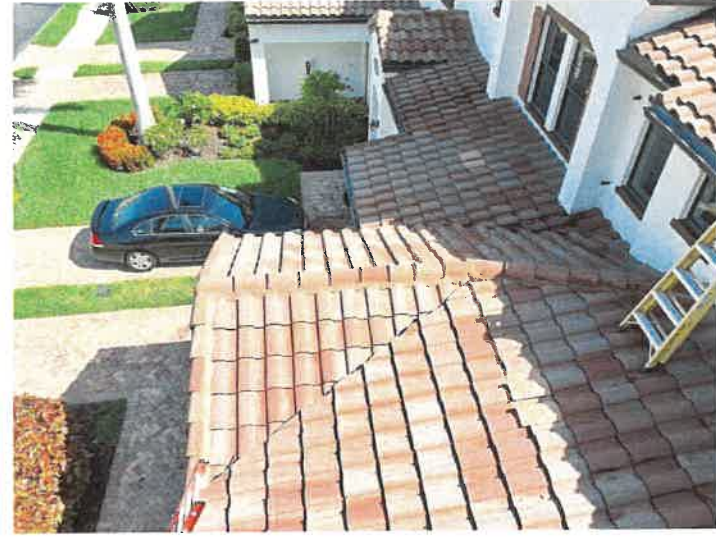
Building 15188: Appearance Overview - Lower Roof

The roof appearance is in good, maintainable condition.

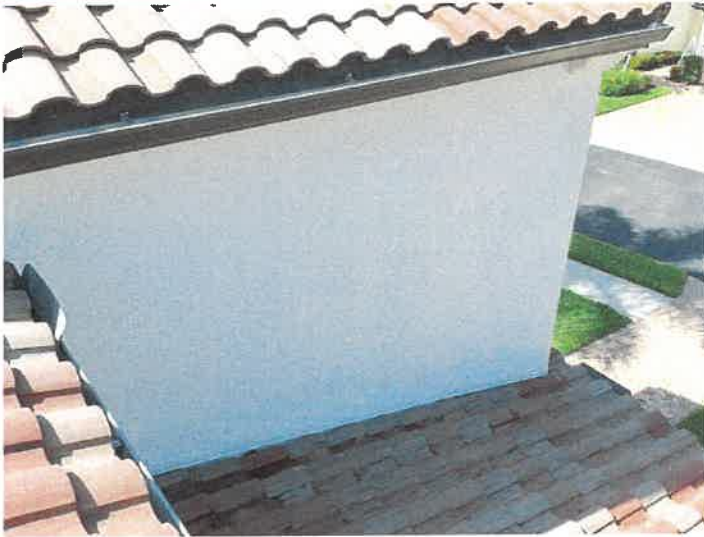
Building 15188: Wall

The walls appear to be in good condition.

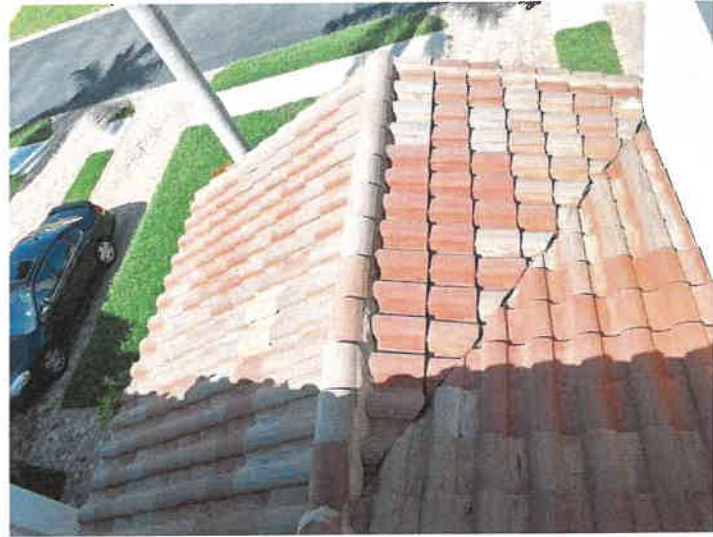
Building 15188: Appearance Overview - Lower Roof

The roof appearance is in good, maintainable condition.

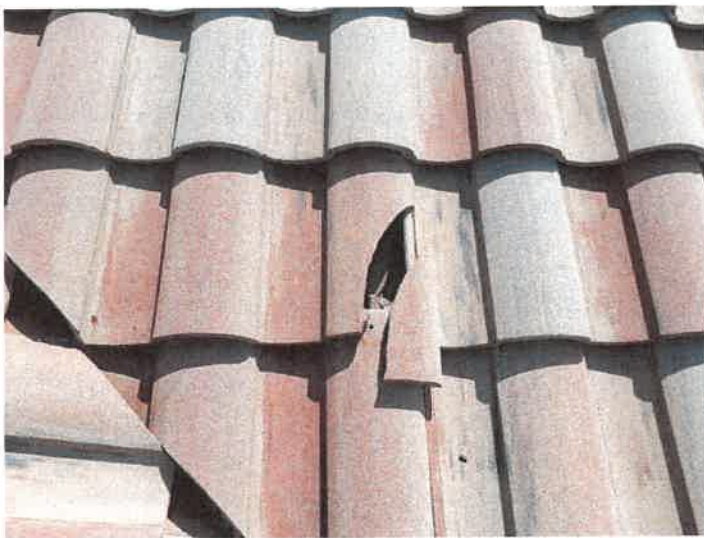
Building 15188: Identified Cracked Roof Tiles

Cracked roof tiles can allow premature underlayment deterioration from excessive UV exposure.

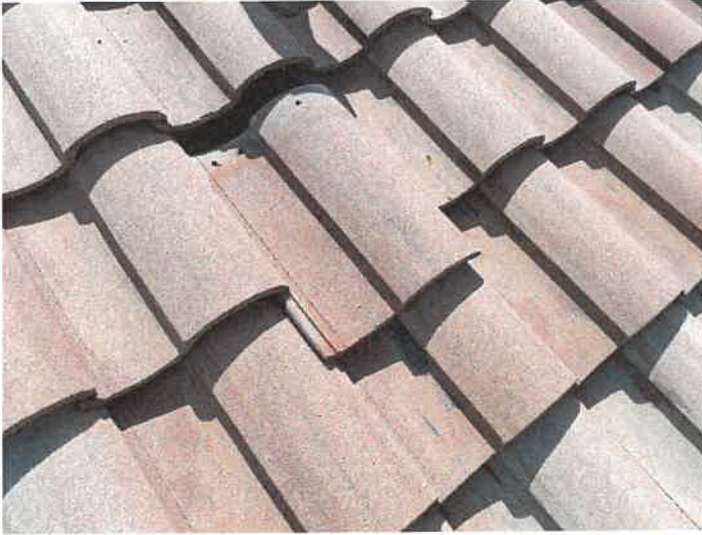
Building 15188: Displaced/Missing Roof Tile

Displaced or missing roof tiles can allow premature underlayment deterioration from excessive UV exposure and potential water intrusion.

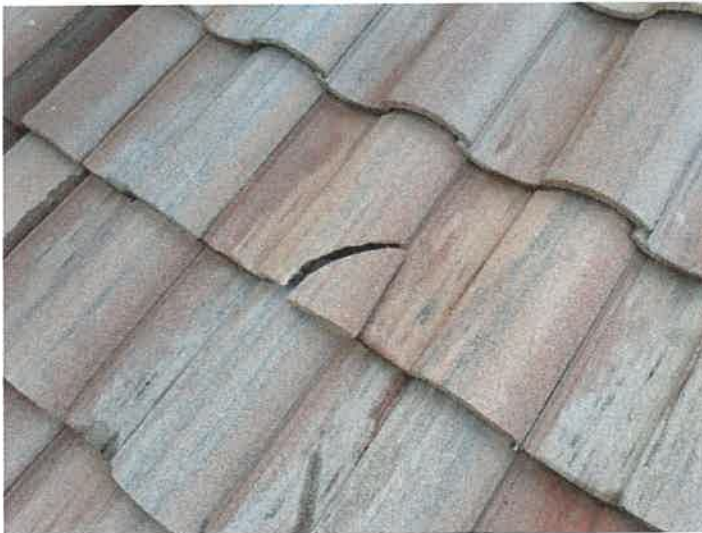
Building 15188: Identified Cracked Roof Tiles

Cracked roof tiles can allow premature underlayment deterioration from excessive UV exposure.

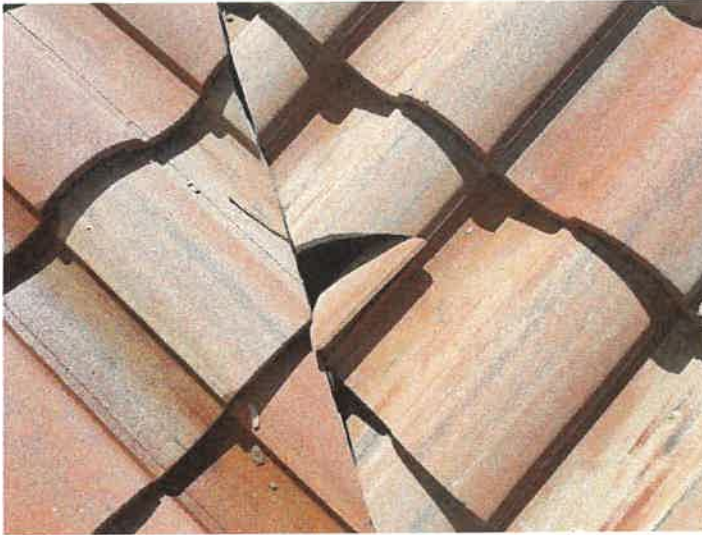
Building 15188: Identified Cracked Roof Tiles
Cracked roof tiles can allow premature underlayment deterioration from excessive UV exposure.

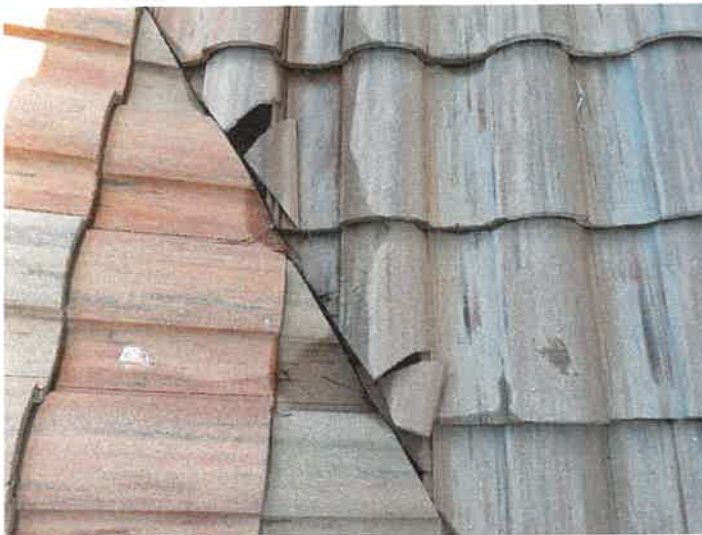
Building 15188: Identified Cracked Roof Tiles
Cracked roof tiles can allow premature underlayment deterioration from excessive UV exposure.
