Inspection Report

Facility: Livingston Lakes Condo

Work Order #: 13028

Re.: **Inspection Report (2 of 3) for Livingston Lakes**

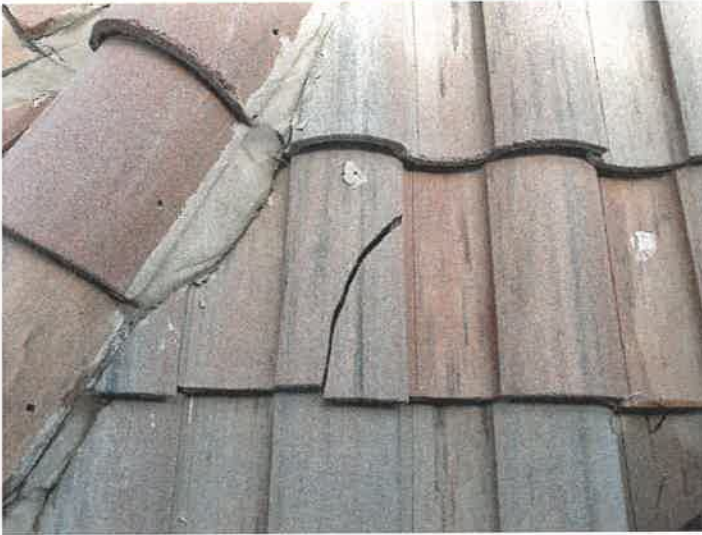
Building 15188: Identified Cracked Roof Tiles
Cracked roof tiles can allow premature underlayment deterioration from excessive UV exposure.

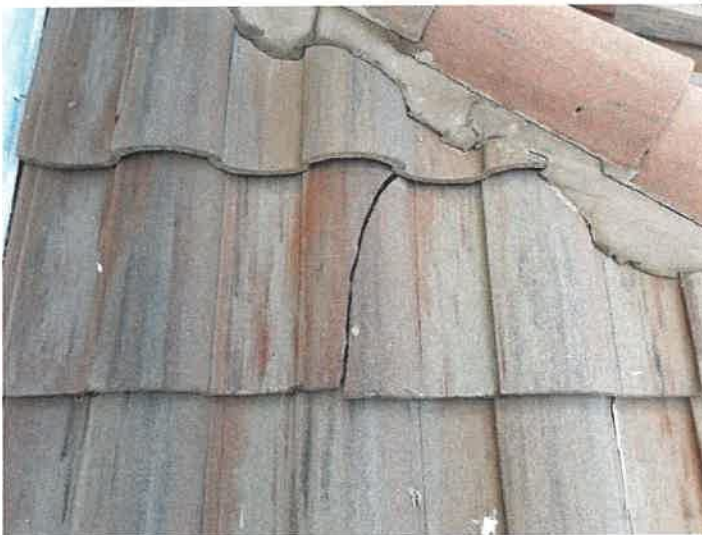
Building 15188: Identified Cracked Roof Tiles
Cracked roof tiles can allow premature underlayment deterioration from excessive UV exposure.

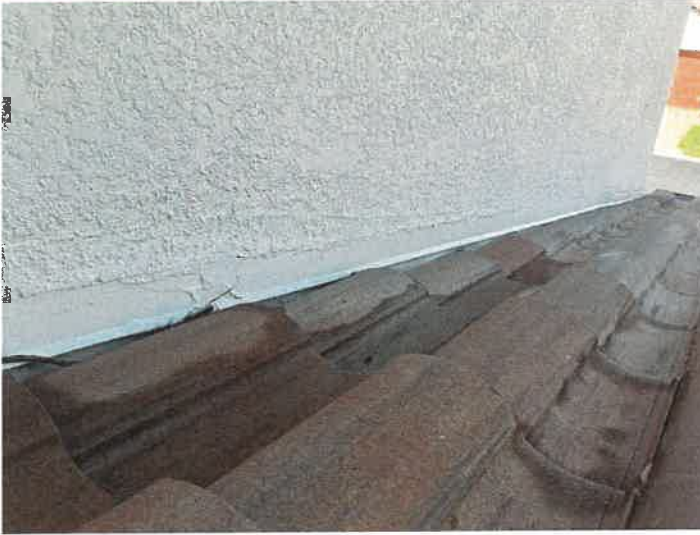
Building 15188: Counter Flashings

The counter flashing appears to be in good condition.

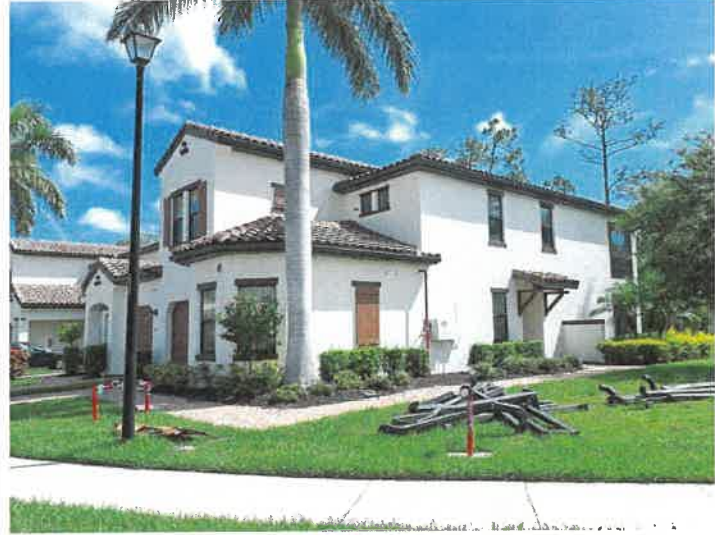
Building 15188: Downspout- missing

Downspout is missing. The painting company that is painting the exteriors in Livingston Lakes has the missing downspouts.

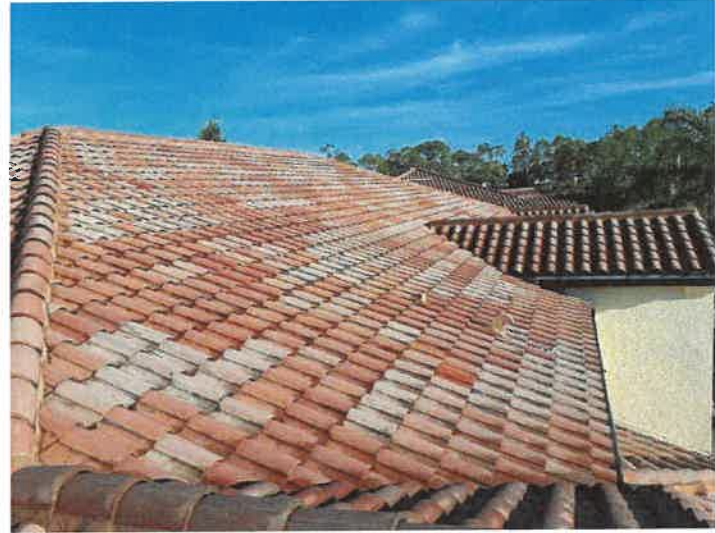
Building 15189: Surface Overview

The roof surface appears to be in good, maintainable condition at this time.

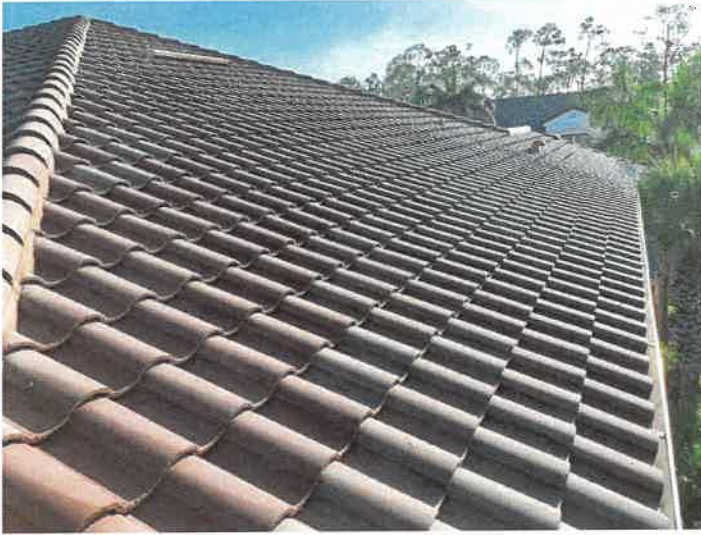
Building 15189: Appearance Overview

The roof appearance is in good, maintainable condition.

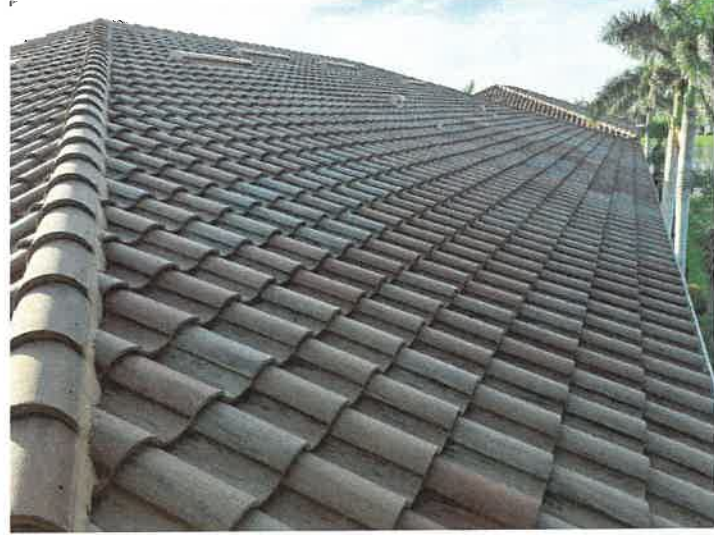
Building 15189: Surface Overview

The roof surface appears to be in good, maintainable condition at this time.

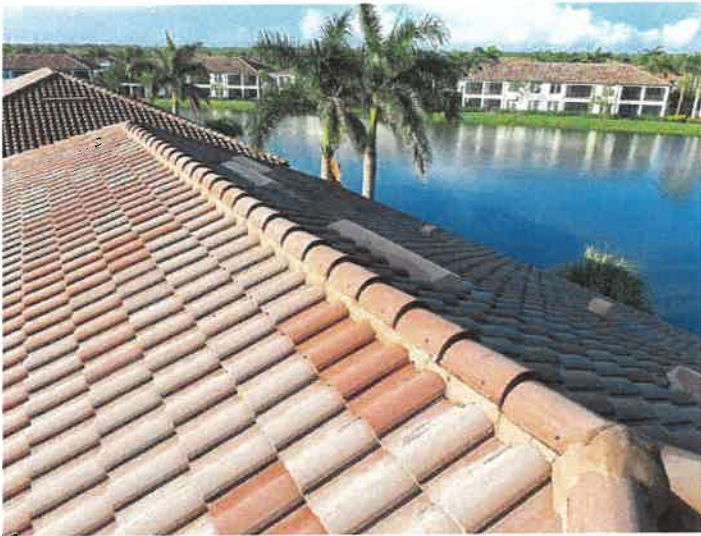
Building 15189: Ridge Tiles

Ridge tiles appear to be in good condition.

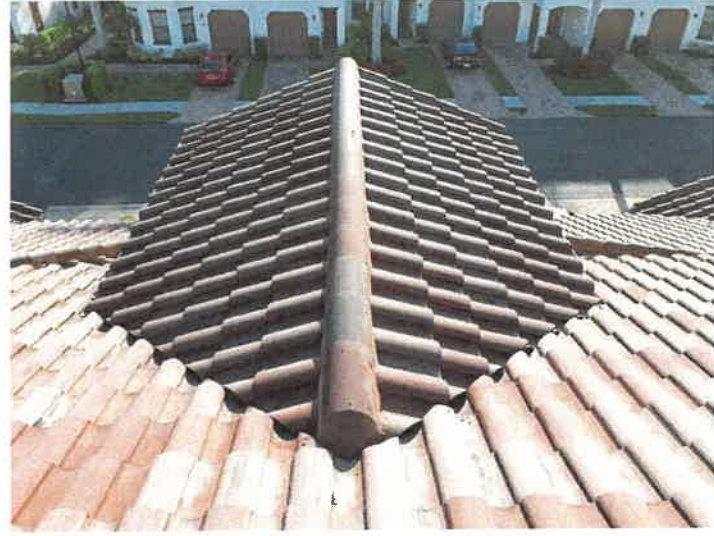
Building 15189: Valley

The valley tiles appear to be in good condition.

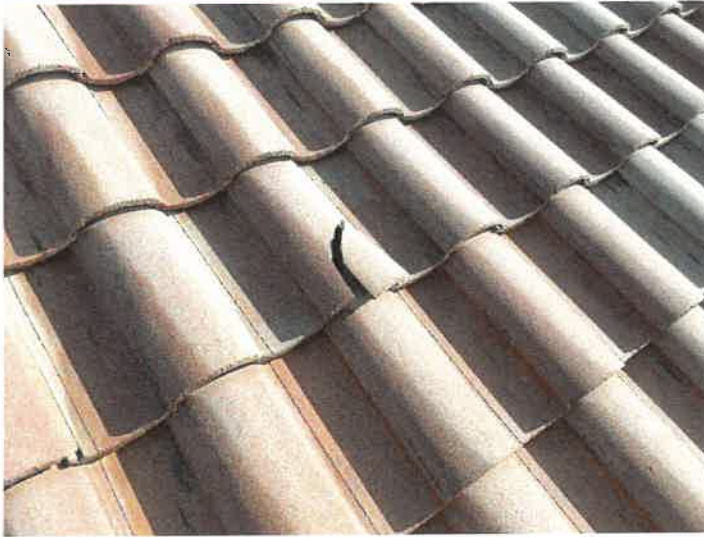
Building 15189: Identified Cracked Roof Tiles
Cracked roof tiles can allow premature underlayment deterioration from excessive UV exposure.

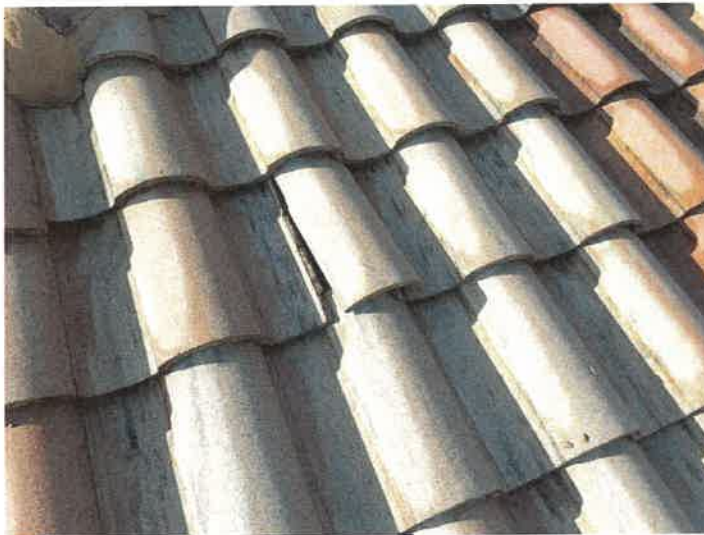
Building 15189: Identified Cracked Roof Tiles
Cracked roof tiles can allow premature underlayment deterioration from excessive UV exposure.

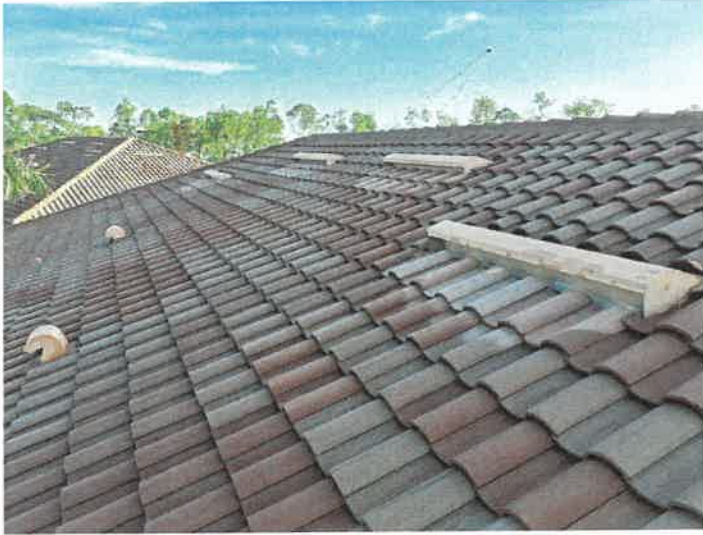
Building 15189: Roof Vents
Roof vents appear to be in good condition.

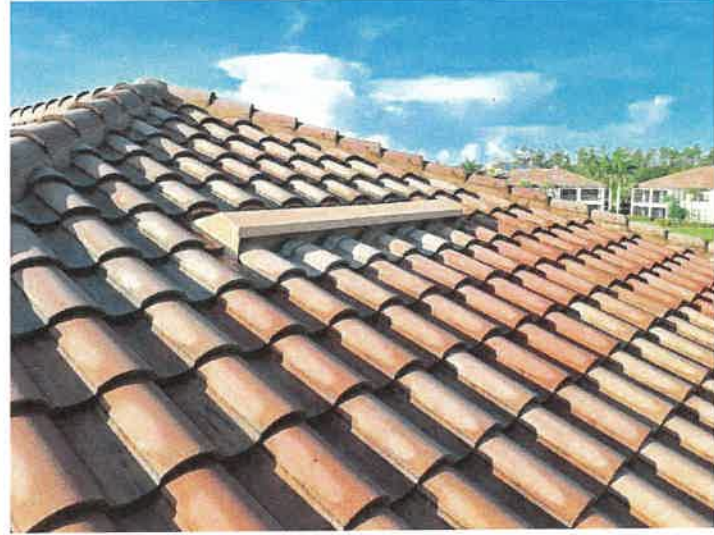
Building 15189: Roof Vents
Roof vents appear to be in good condition.

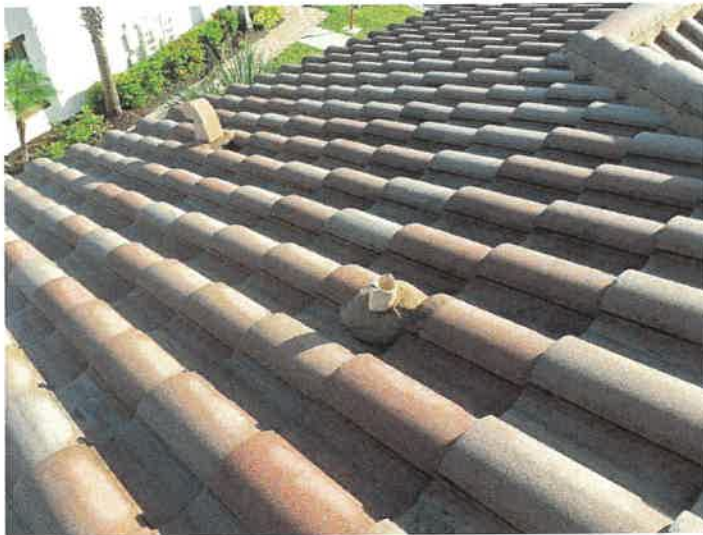
Building 15189: Lead Boots
Lead boots appear to be in good condition.

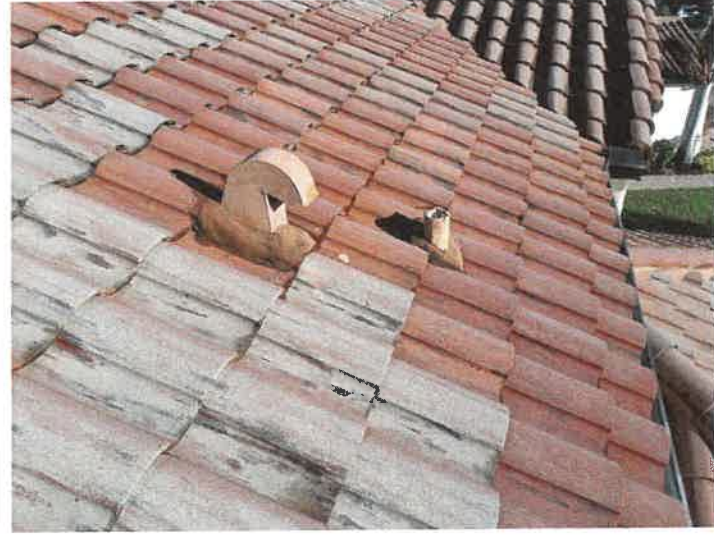
Building 15189: Lead Boots
Lead boots appear to be in good condition.

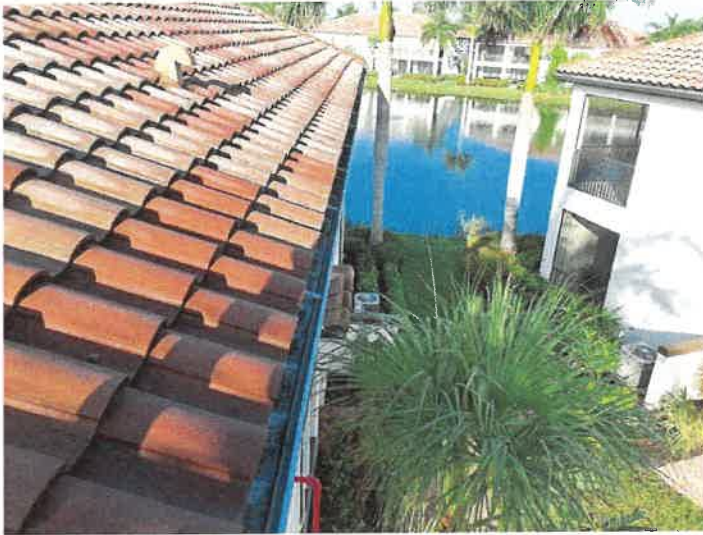
Building 15189: Gutters

The gutters appear to be in good condition.

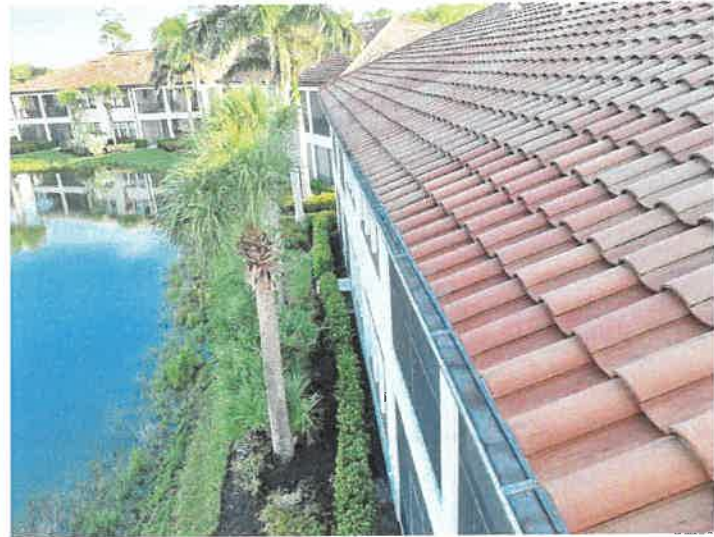
Building 15189: Gutters

The gutters appear to be in good condition.

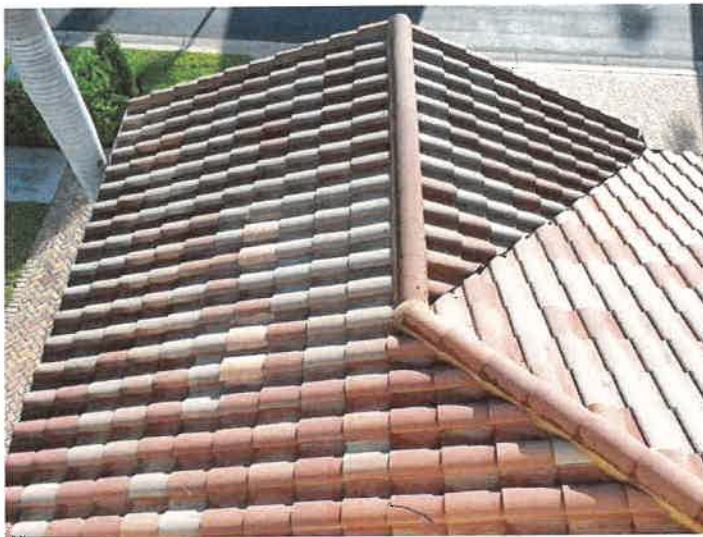
Building 15189: Surface Overview - Lower Roof

The roof surface appears to be in good, maintainable condition at this time.

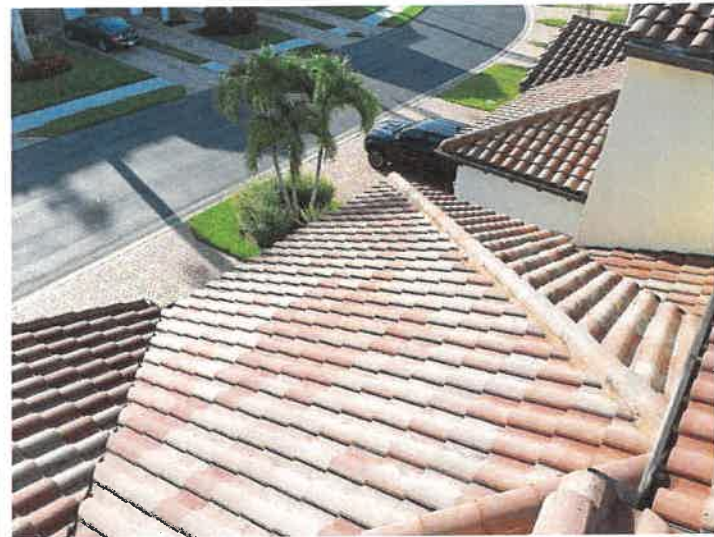
Building 15189: Appearance Overview - Lower Roof

The roof appearance is in good, maintainable condition.

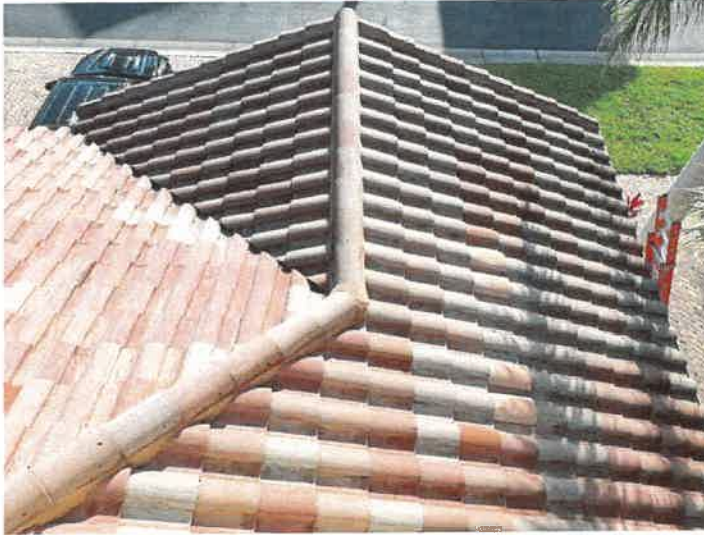
Building 15189: Surface Overview - Lower Roof
The roof surface appears to be in good, maintainable condition at this time.

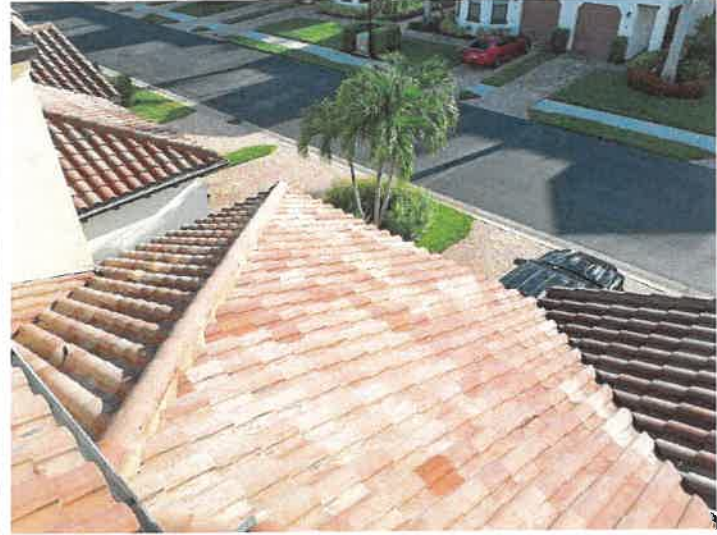
Building 15189: Surface Overview - Lower Roof
The roof surface appears to be in good, maintainable condition at this time.

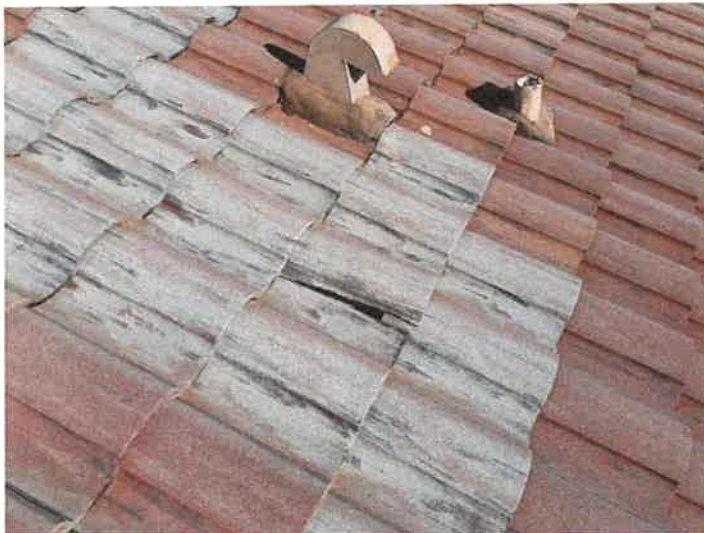
Building 15189: Identified Cracked Roof Tiles
Cracked roof tiles can allow premature underlayment deterioration from excessive UV exposure.

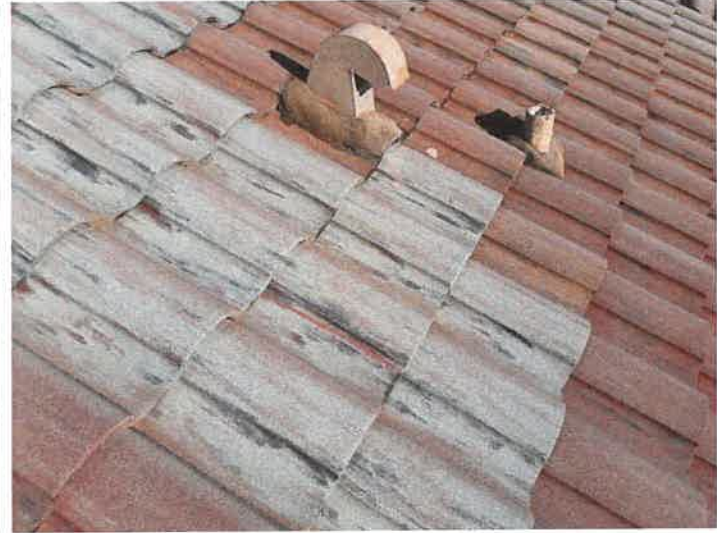
Building 15189: Repaired Cracked Roof Tiles
The cracked roof tiles were repaired with Titebond sealant.

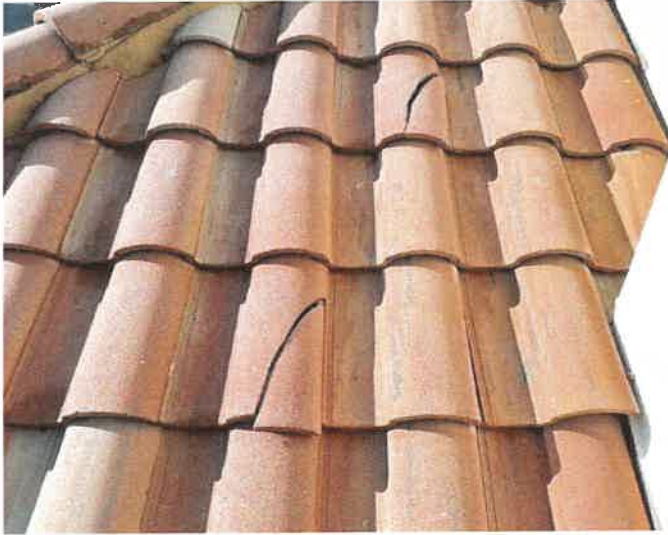
Building 15189: Identified Cracked Roof Tiles

Cracked roof tiles can allow premature underlayment deterioration from excessive UV exposure.

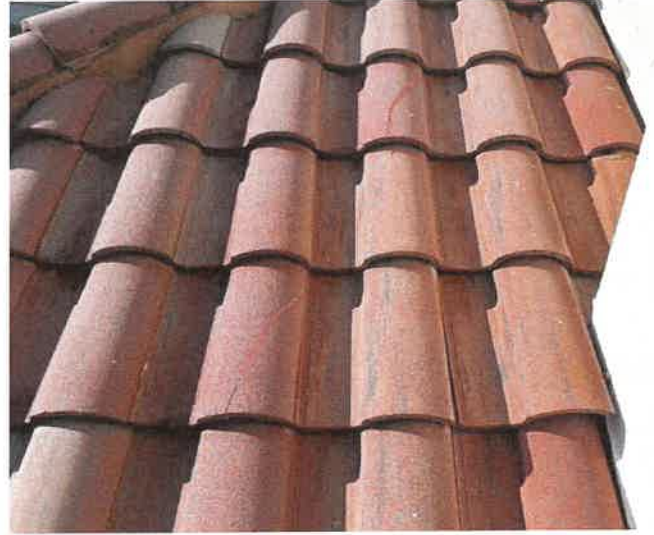
Building 15189: Repaired Cracked Roof Tiles

The cracked roof tiles were repaired with Titebond sealant.

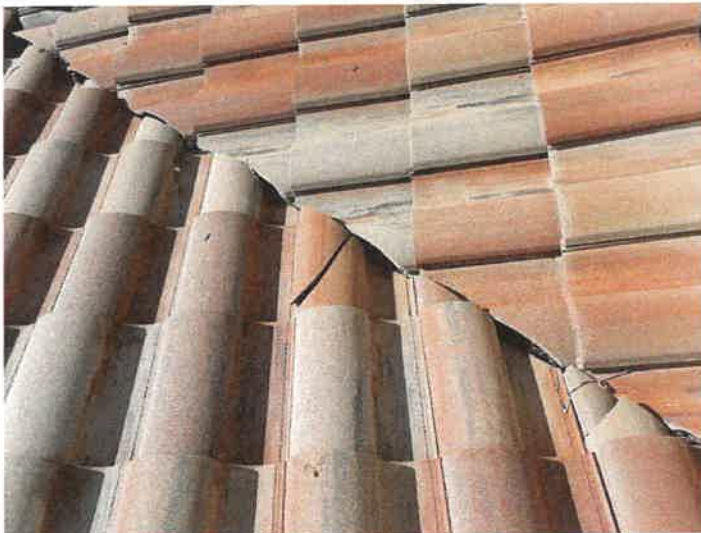
Building 15189: Identified Cracked Roof Tiles

Cracked roof tiles can allow premature underlayment deterioration from excessive UV exposure.

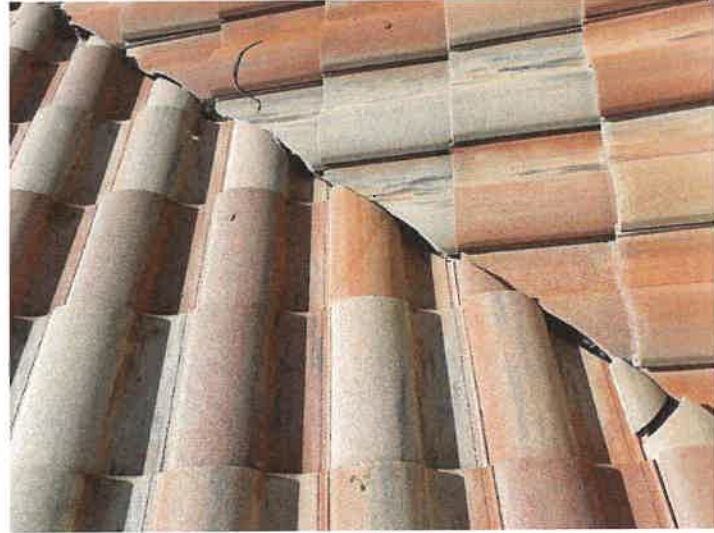
Building 15189: Repaired Cracked Roof Tiles

The cracked roof tiles were repaired with Titebond sealant.

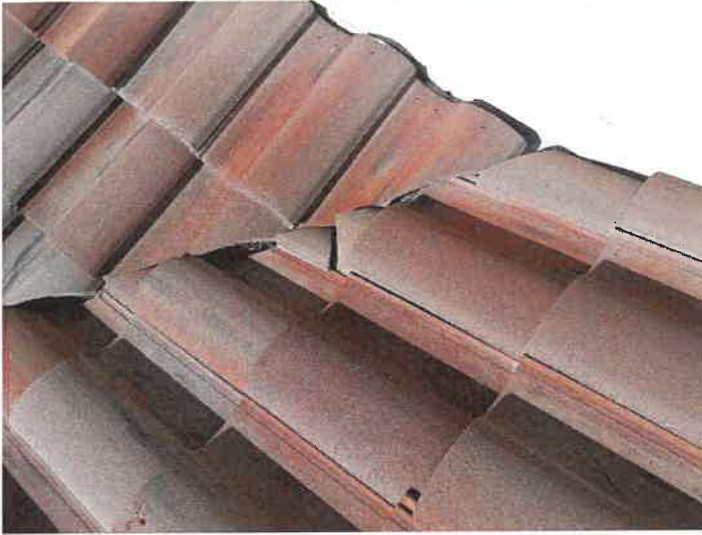
Building 15189: Identified Cracked Roof Tiles
Cracked roof tiles can allow premature underlayment deterioration from excessive UV exposure.

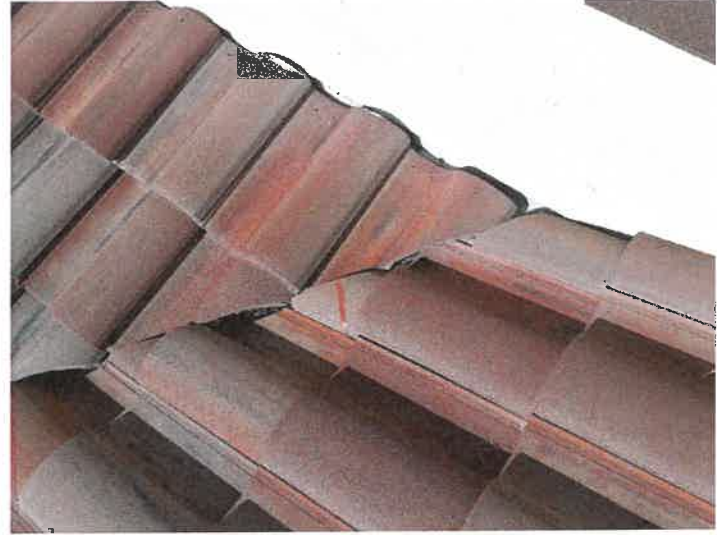
Building 15189: Repaired Cracked Roof Tiles
The cracked roof tiles were repaired with Titebond sealant.

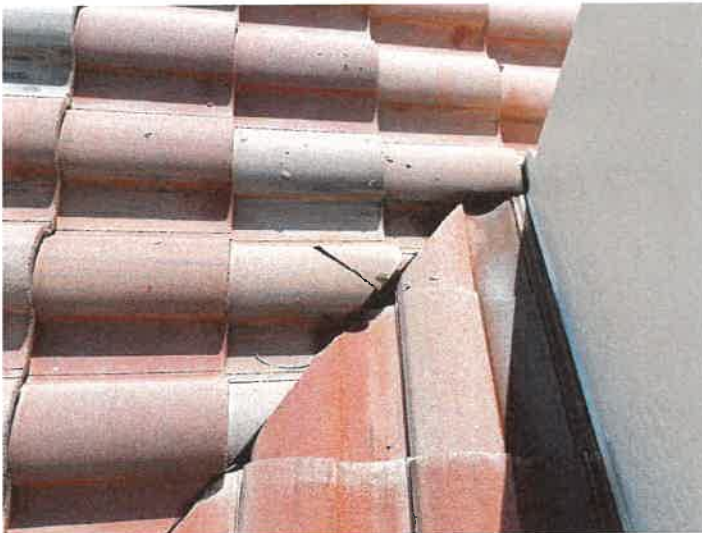
Building 15189: Identified Cracked Roof Tiles
Cracked roof tiles can allow premature underlayment deterioration from excessive UV exposure.

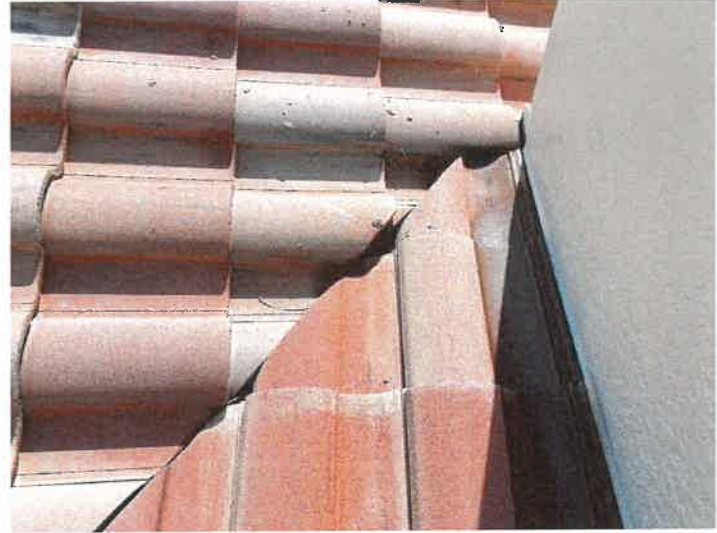
Building 15189: Repaired Cracked Roof Tiles
The cracked roof tiles were repaired with Titebond sealant.

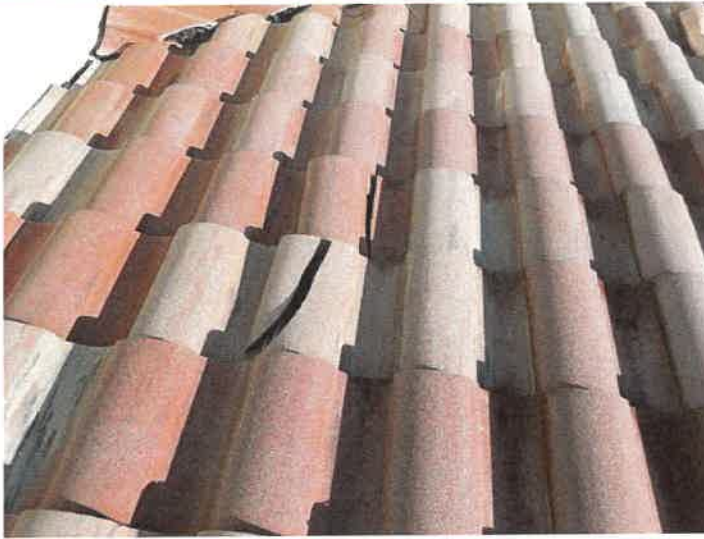
Building 15189: Identified Cracked Roof Tiles
Cracked roof tiles can allow premature underlayment deterioration from excessive UV exposure.

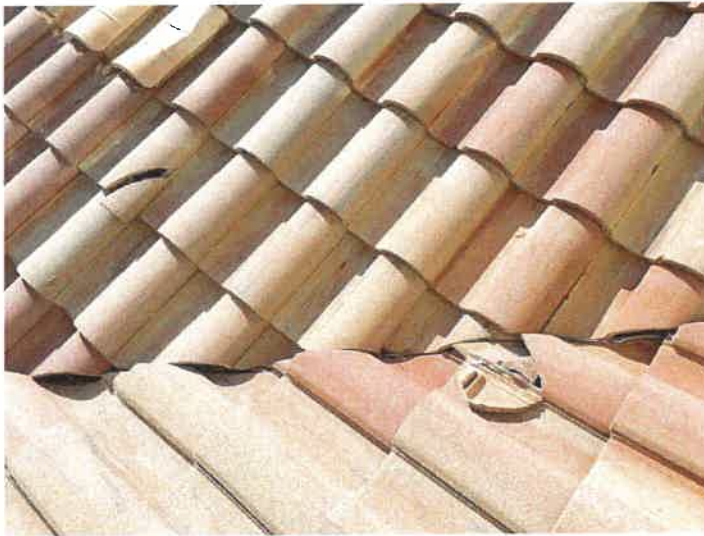
Building 15189: Identified Cracked Roof Tiles
Cracked roof tiles can allow premature underlayment deterioration from excessive UV exposure.

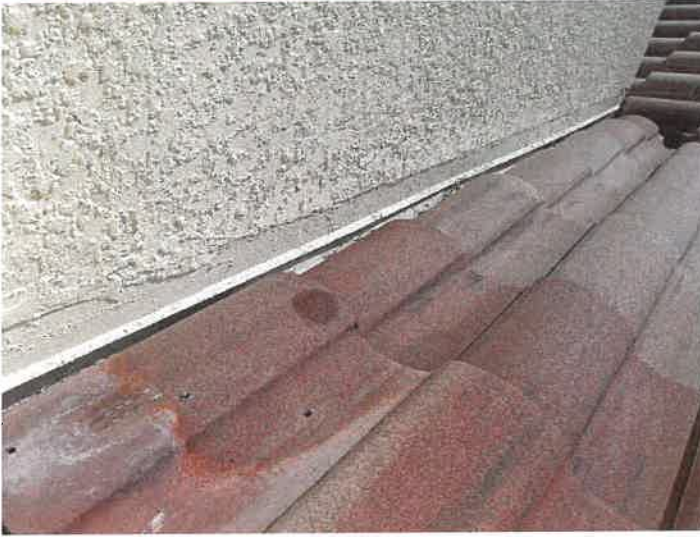
Building 15189: Counter Flashings

The counter flashing appears to be in good condition.

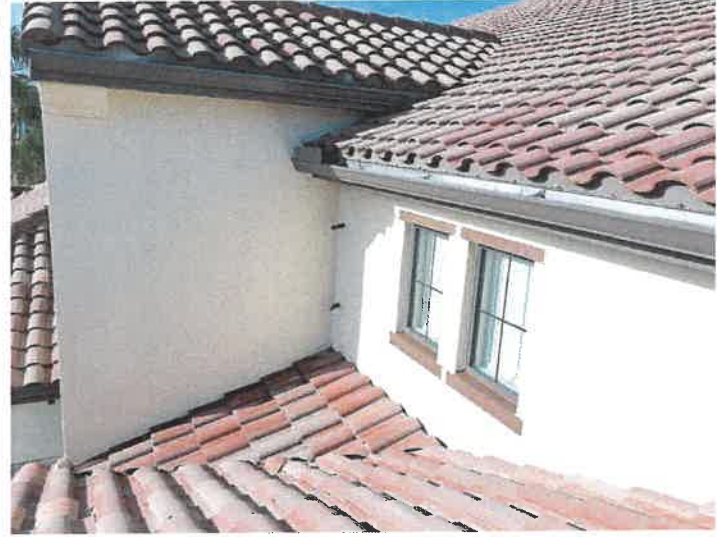
Building 15189: Wall

The walls appear to be in good condition.

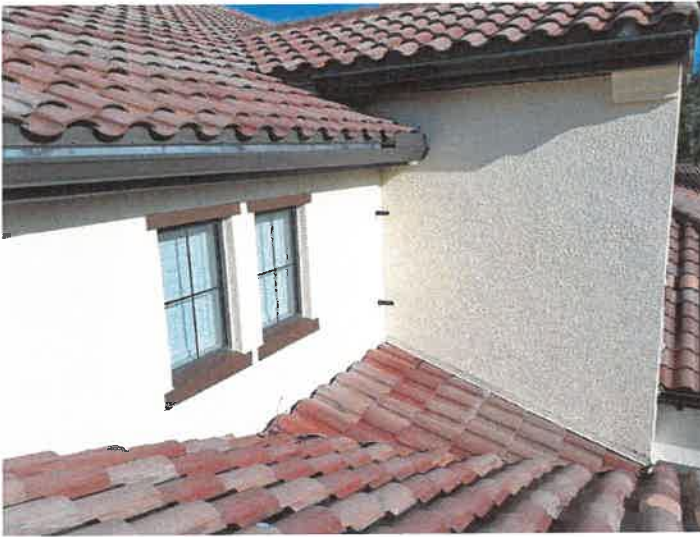
Building 15189: Wall

The walls appear to be in good condition.

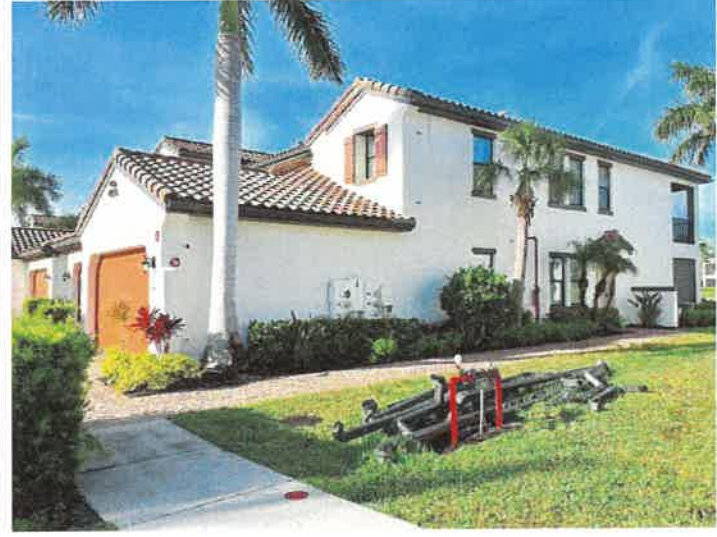
Building 15189: Downspout- missing

Downspout is missing. The painting company that is painting the exteriors in Livingston Lakes has the missing downspouts.

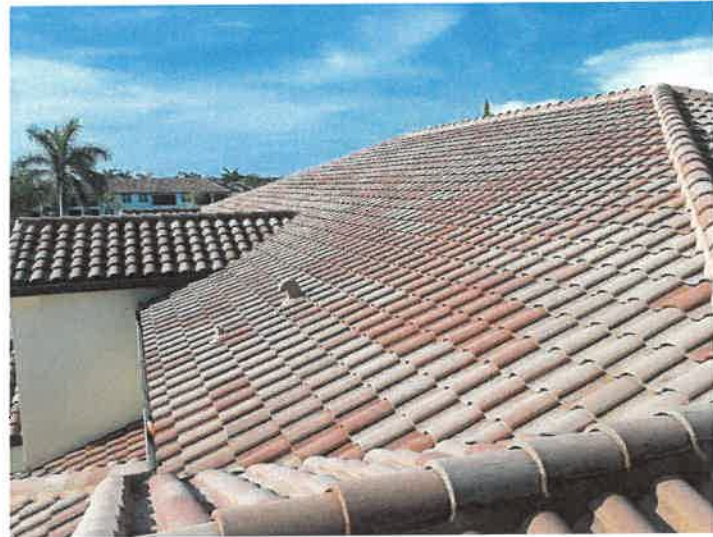
Building 15193: Surface Overview
The roof surface appears to be in good, maintainable condition at this time.

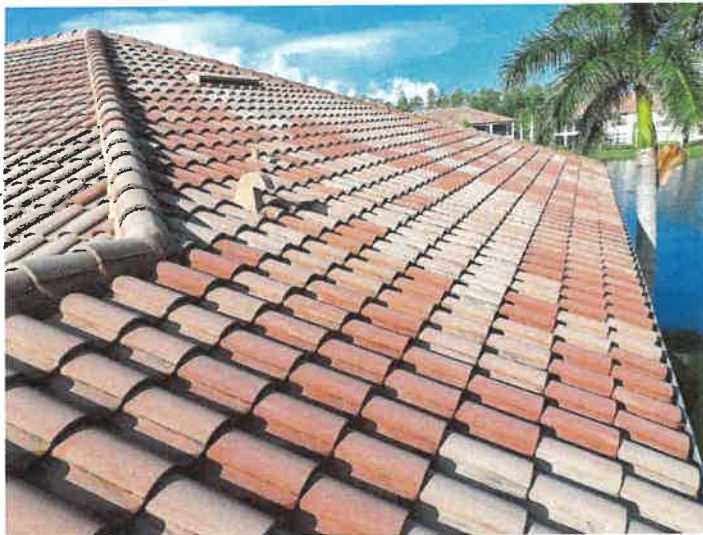
Building 15193: Appearance Overview
The roof appearance is in good, maintainable condition.

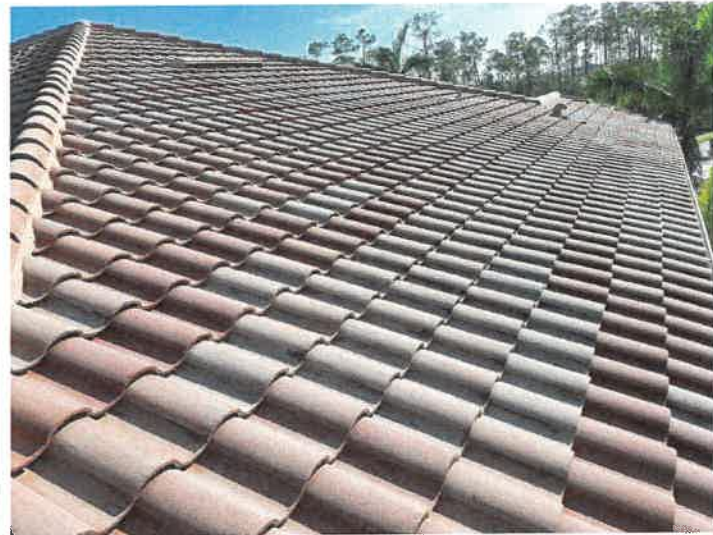
Building 15193: Surface Overview
The roof surface appears to be in good, maintainable condition at this time.

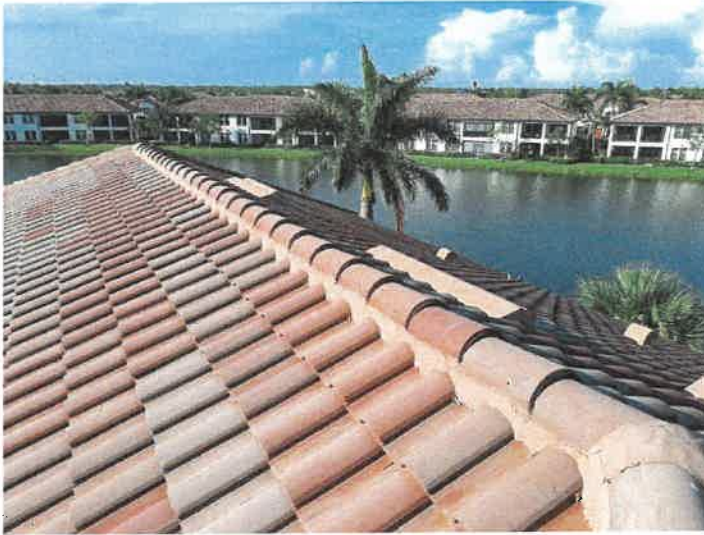
Building 15193: Ridge Tiles

Ridge tiles appear to be in good condition.

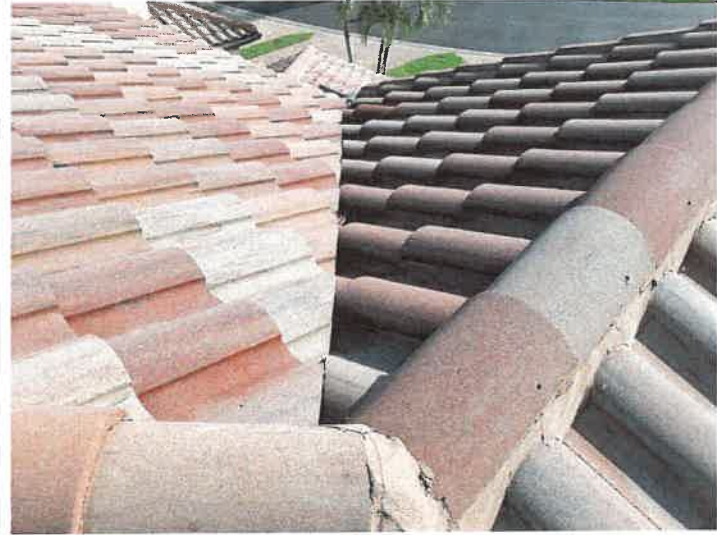
Building 15193: Valley

The valley tiles appear to be in good condition.

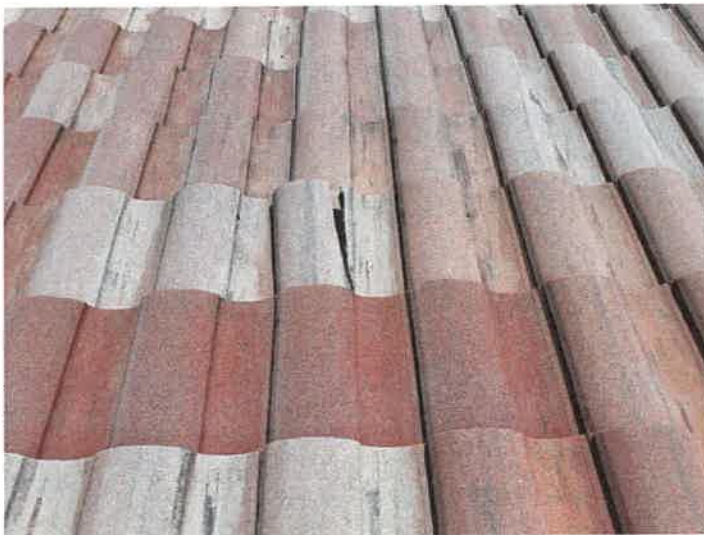
Building 15193: Identified Cracked Roof Tiles

Cracked roof tiles can allow premature underlayment deterioration from excessive UV exposure.

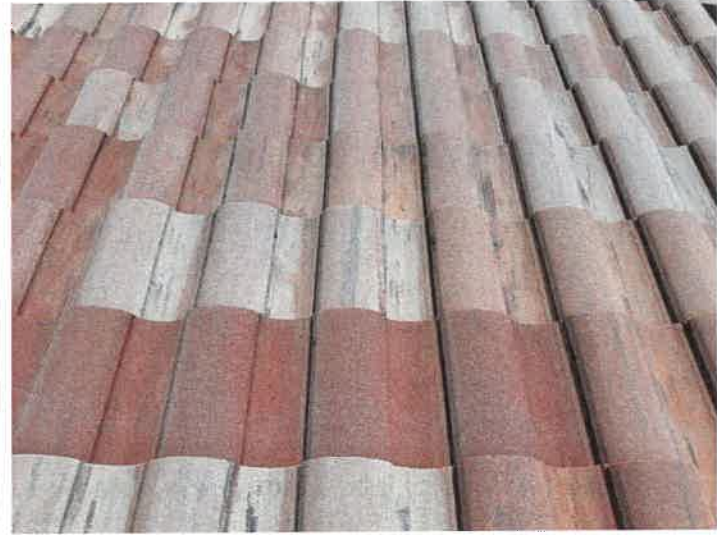
Building 15193: Repaired Cracked Roof Tiles

The cracked roof tiles were repaired with Titebond sealant.

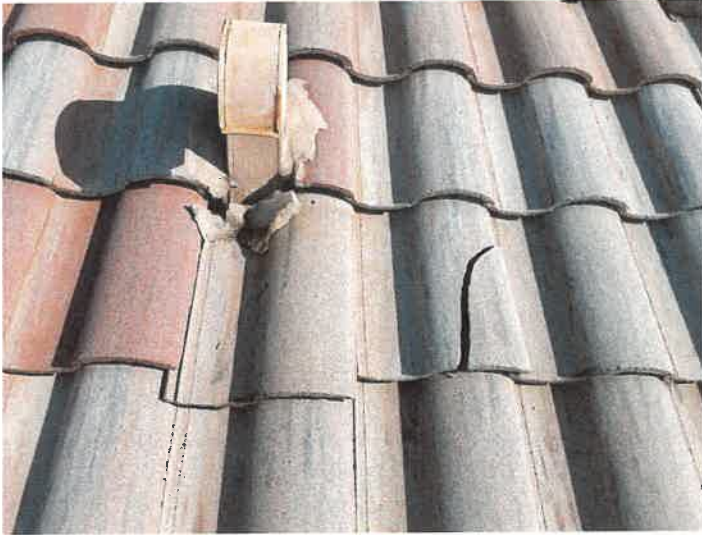
Building 15193: Displaced/Missing Roof Tile

Displaced or missing roof tiles can allow premature underlayment deterioration from excessive UV exposure and potential water intrusion.

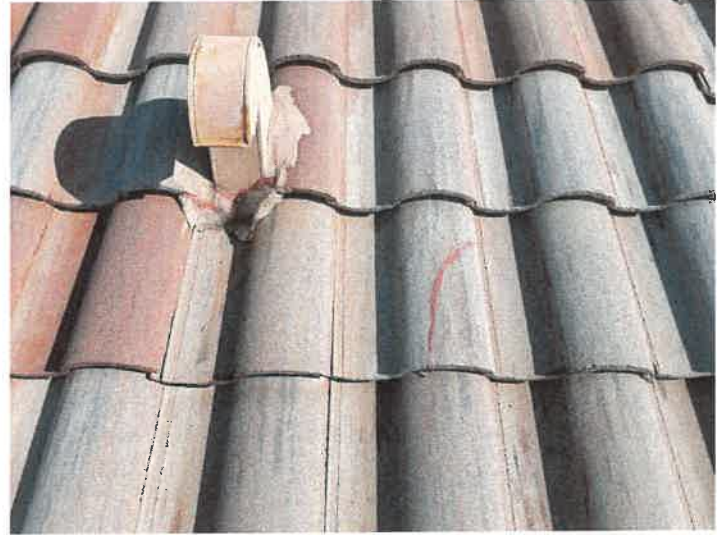
Building 15193: Repaired Displaced/Missing Roof Tile

Replaced and secured the missing roof tile.

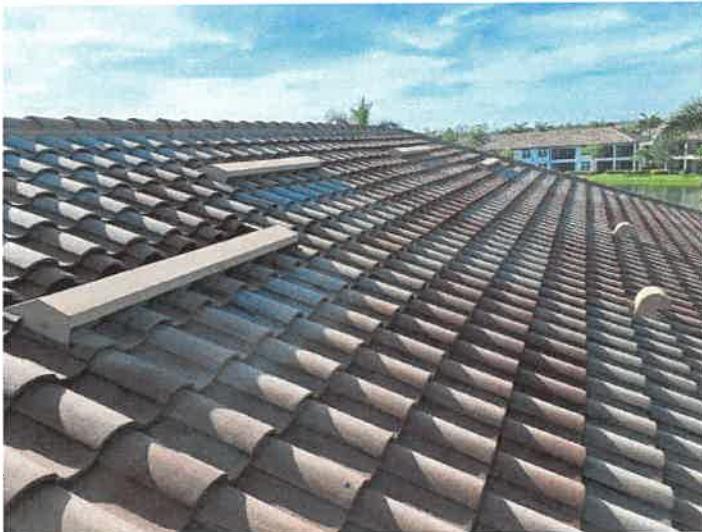
Building 15193: Roof Vents

Roof vents appear to be in good condition.

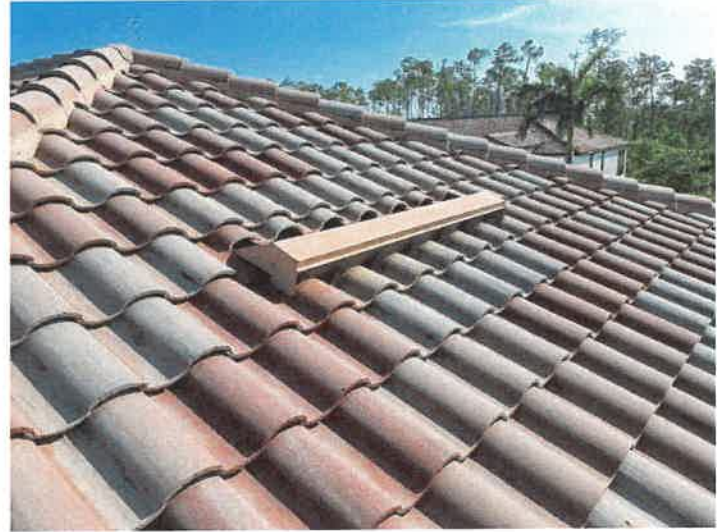
Building 15193: Roof Vents

Roof vents appear to be in good condition.

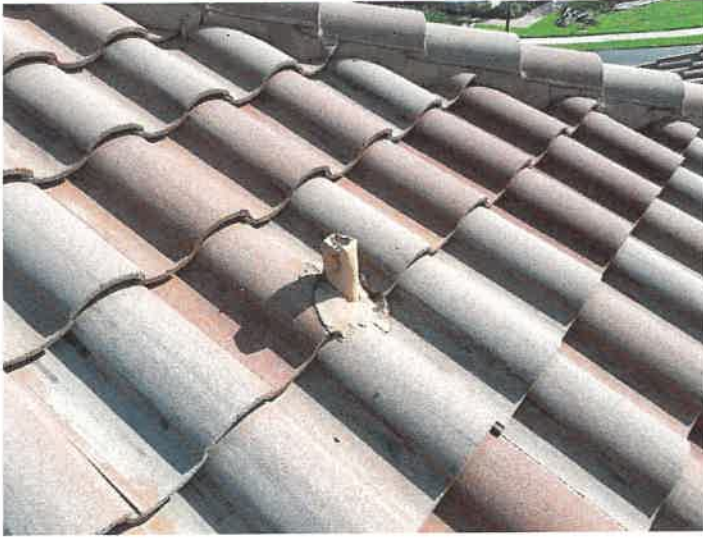
Building 15193: Lead Boots
Lead boots appear to be in good condition.

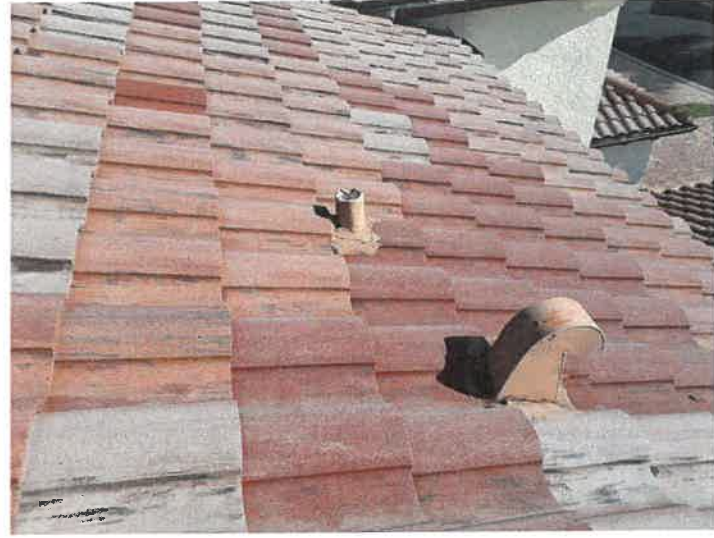
Building 15193: Lead Boots
Lead boots appear to be in good condition.

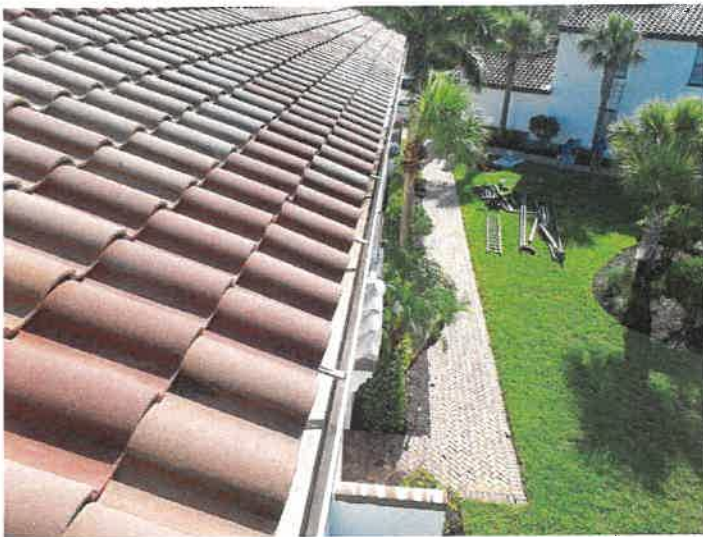
Building 15193: Gutters
The gutters appear to be in good condition.

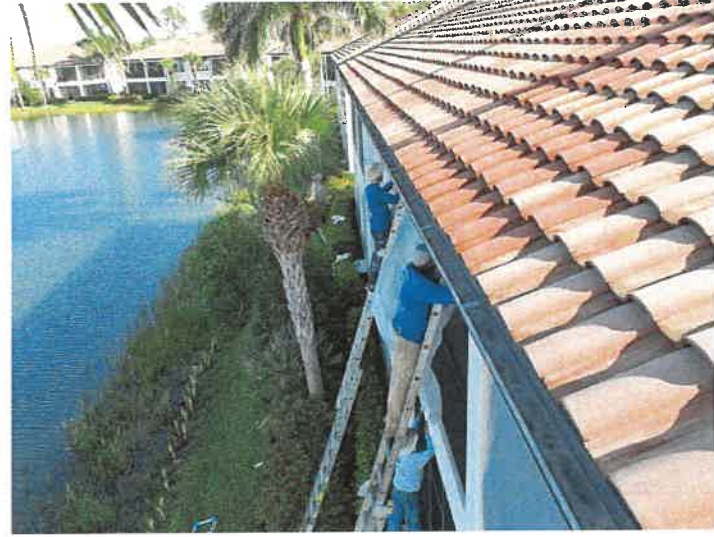
Building 15193: Gutters
The gutters appear to be in good condition.

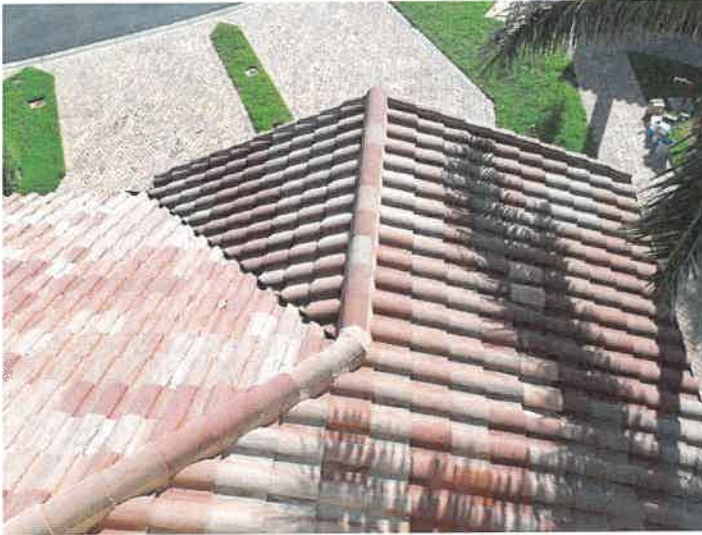
Building 15193: Surface Overview - Lower Roof
The roof surface appears to be in good, maintainable condition at this time.

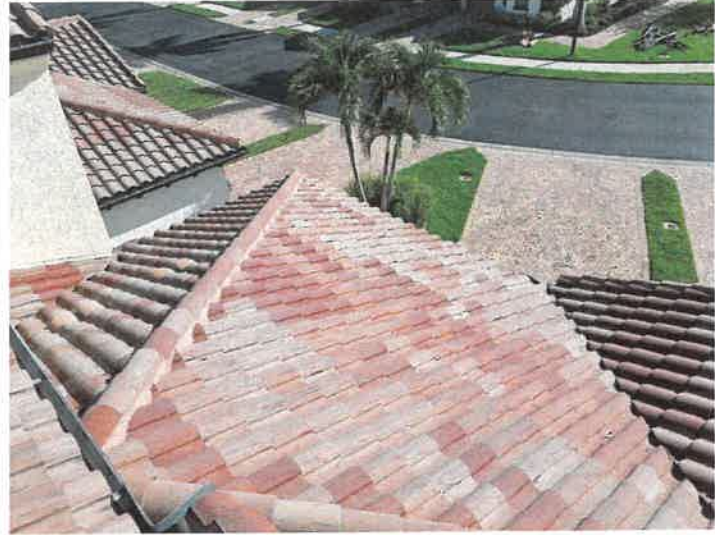
Building 15193: Appearance Overview - Lower Roof
The roof appearance is in good, maintainable condition.

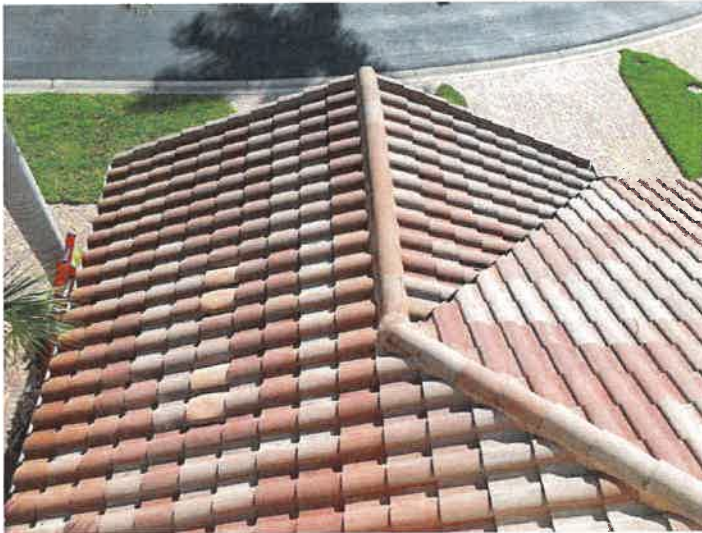
Building 15193: Surface Overview - Lower Roof
The roof surface appears to be in good, maintainable condition at this time.

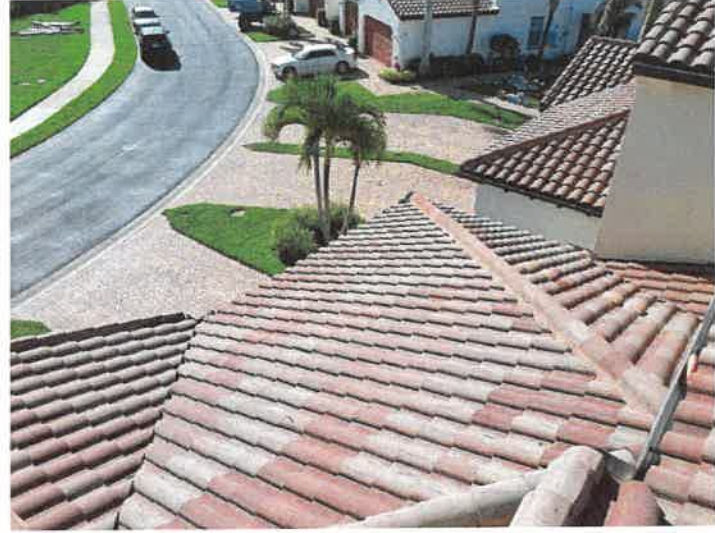
Building 15193: Appearance Overview - Lower Roof
The roof appearance is in good, maintainable condition.

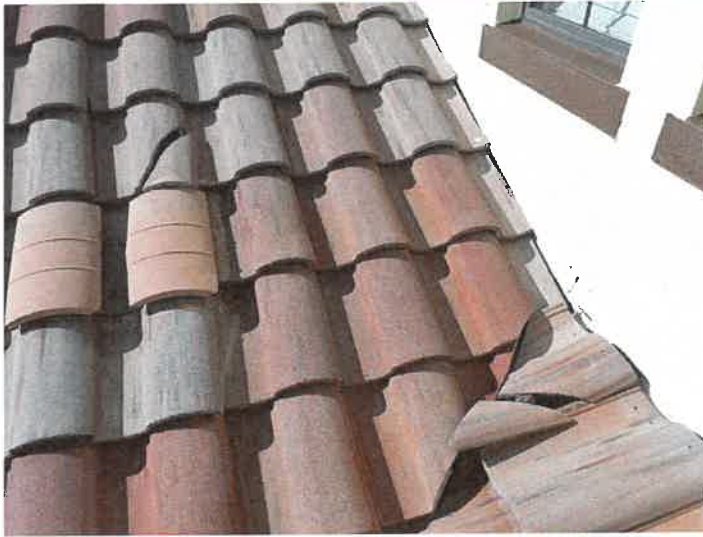
Building 15193: Identified Cracked Roof Tiles
Cracked roof tiles can allow premature underlayment deterioration from excessive UV exposure.
