Inspection Report

Facility: Livingston Lakes Condo

Work Order #: 13028

Re.: **Inspection Report (2 of 3) for Livingston Lakes**

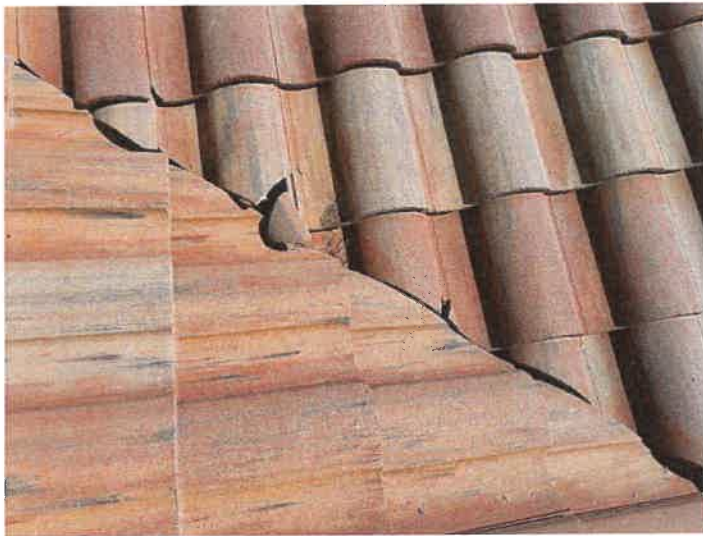
Building 15193: Identified Cracked Roof Tiles
Cracked roof tiles can allow premature underlayment deterioration from excessive UV exposure.

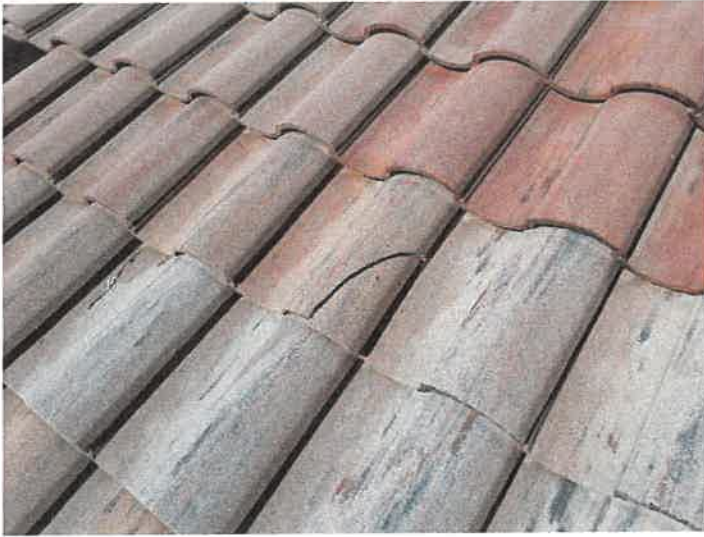
Building 15193: Identified Cracked Roof Tiles
Cracked roof tiles can allow premature underlayment deterioration from excessive UV exposure.

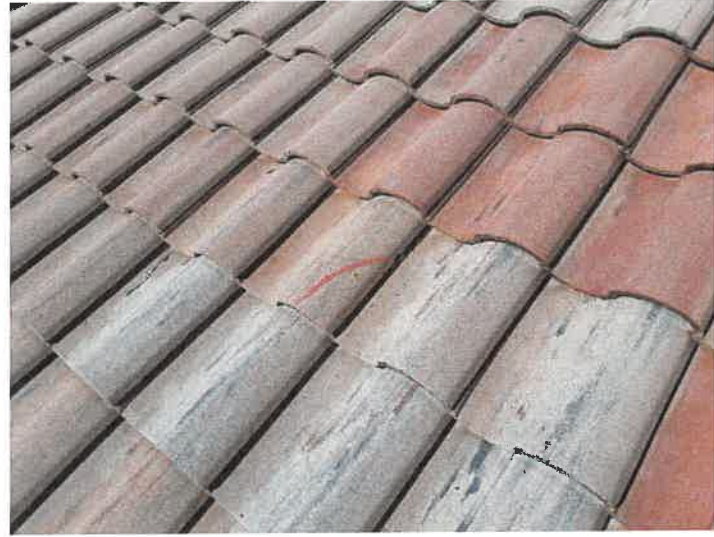
Building 15193: Repaired Cracked Roof Tiles
The cracked roof tiles were repaired with Titebond sealant.

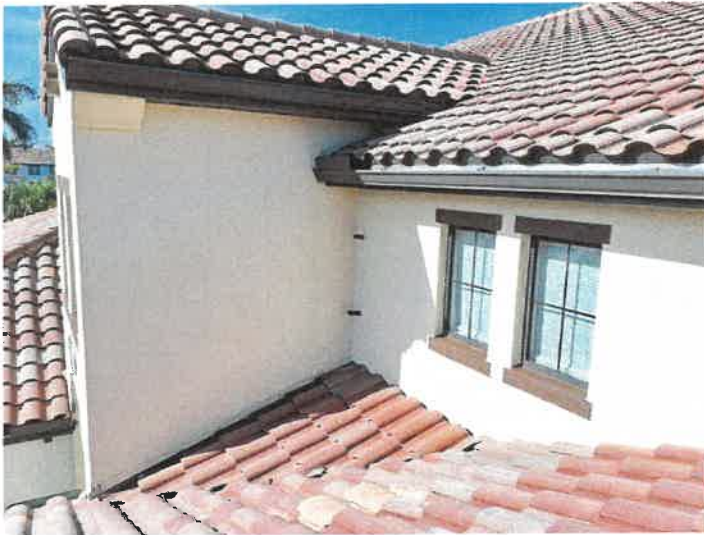
Building 15193: Wall
The walls appear to be in good condition.

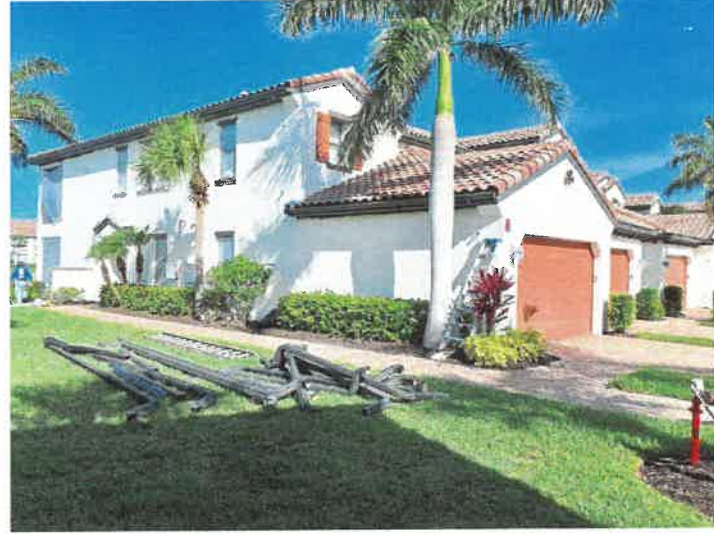
Building 15193: Downspout- missing
Downspout is missing. The painting company that is painting the exteriors in Livingston Lakes has the missing downspouts.

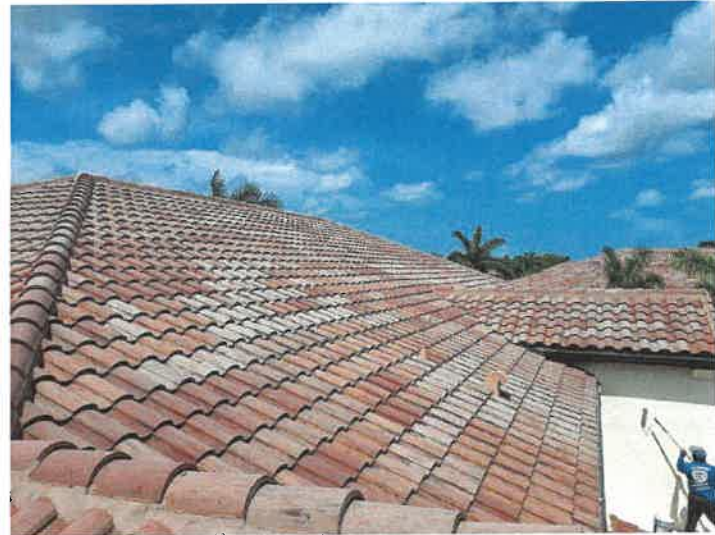
Building 15197: Surface Overview
The roof surface appears to be in good, maintainable condition at this time.

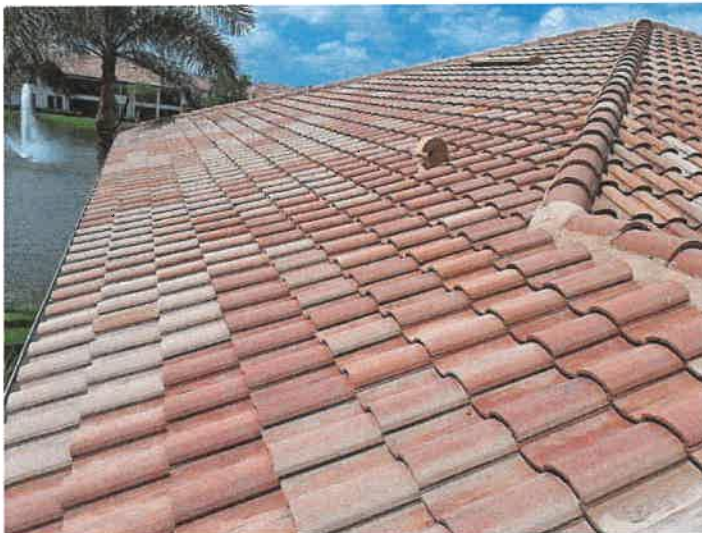
Building 15197: Appearance Overview
The roof appearance is in good, maintainable condition.

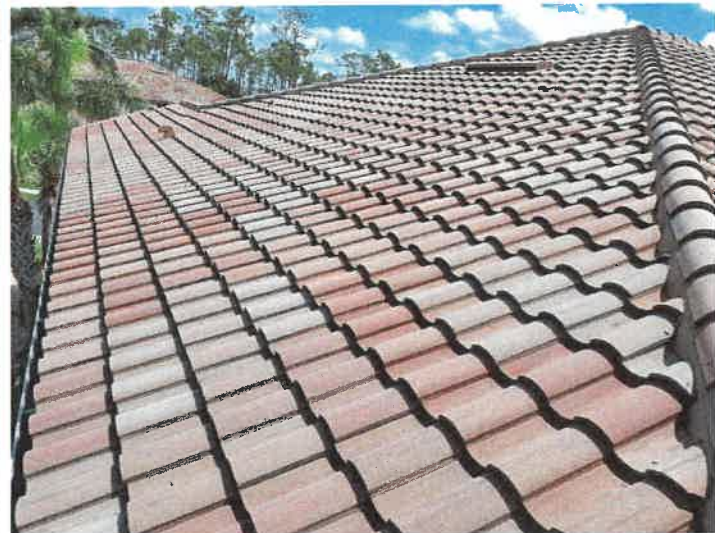
Building 15197: Surface Overview
The roof surface appears to be in good, maintainable condition at this time.

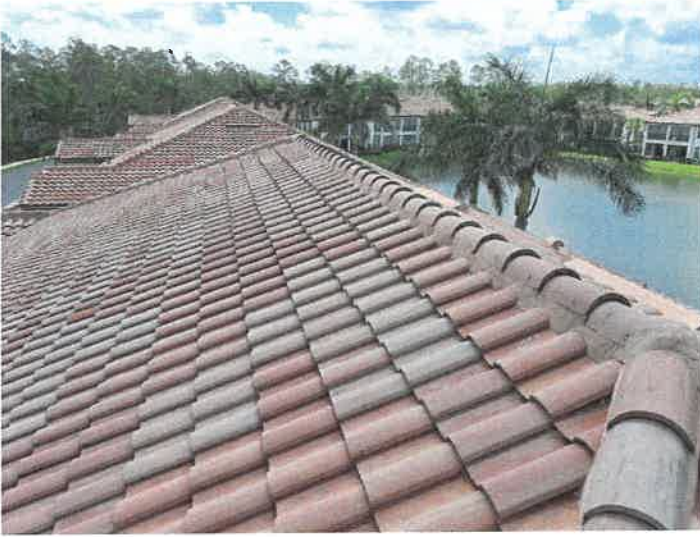
Building 15197: Ridge Tiles

Ridge tiles appear to be in good condition.

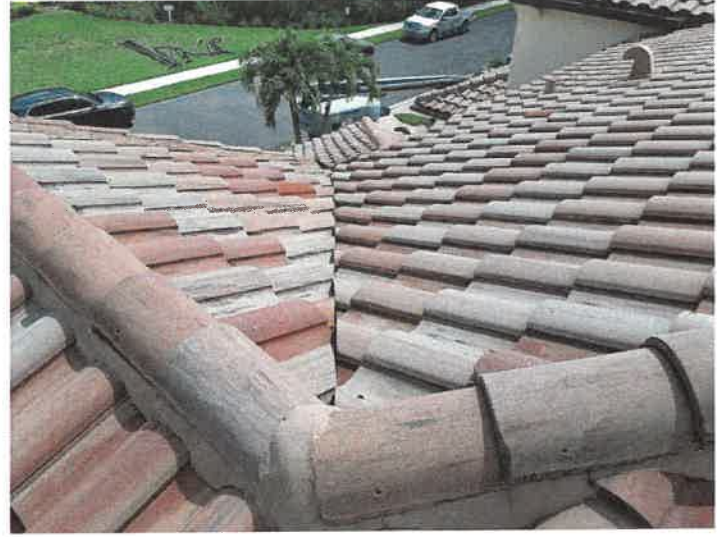
Building 15197: Valley

The valley tiles appear to be in good condition.

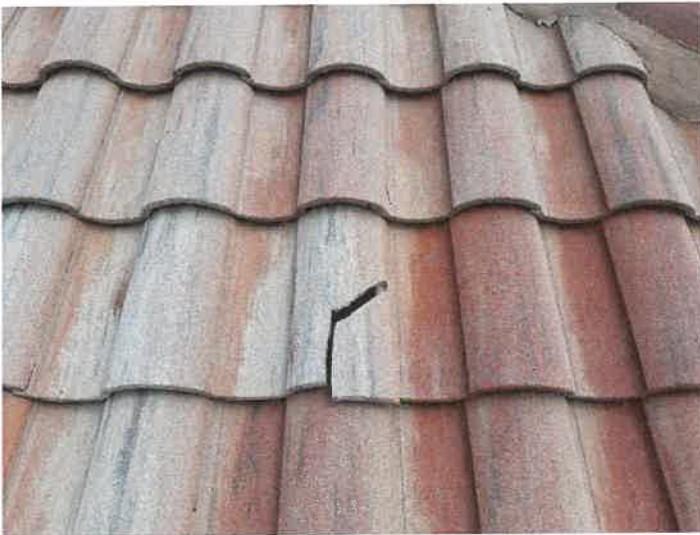
Building 15197: Identified Cracked Roof Tiles

Cracked roof tiles can allow premature underlayment deterioration from excessive UV exposure.

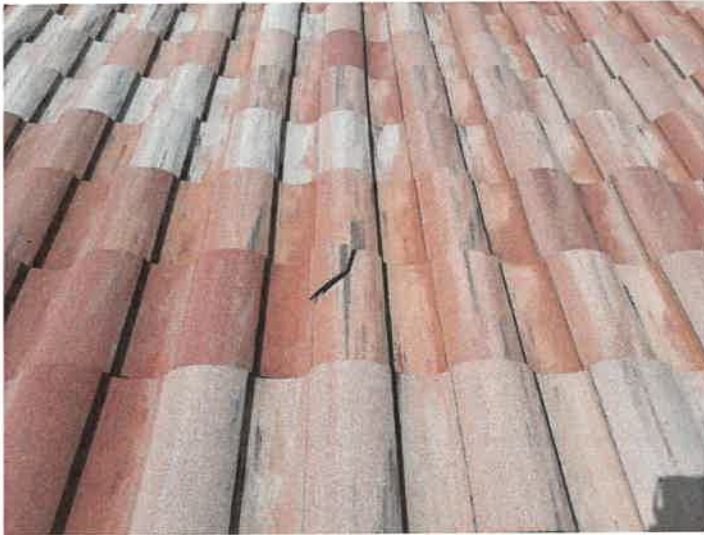
Building 15197: Identified Cracked Roof Tiles
Cracked roof tiles can allow premature underlayment deterioration from excessive UV exposure.

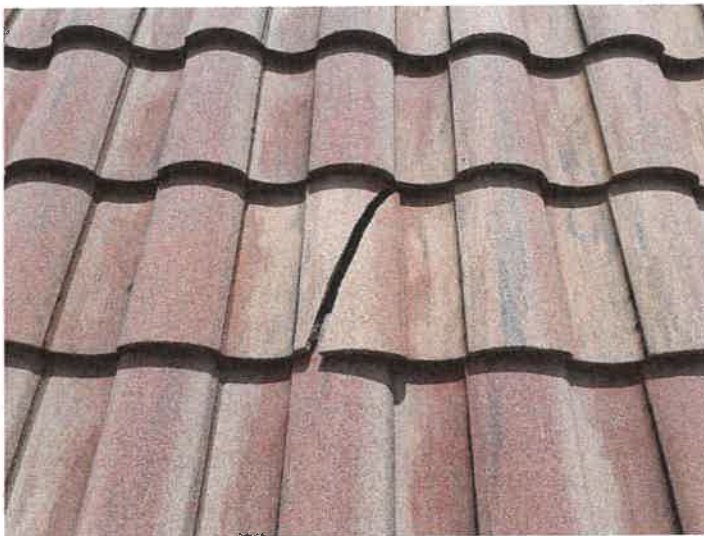
Building 15197: Identified Cracked Roof Tiles
Cracked roof tiles can allow premature underlayment deterioration from excessive UV exposure.

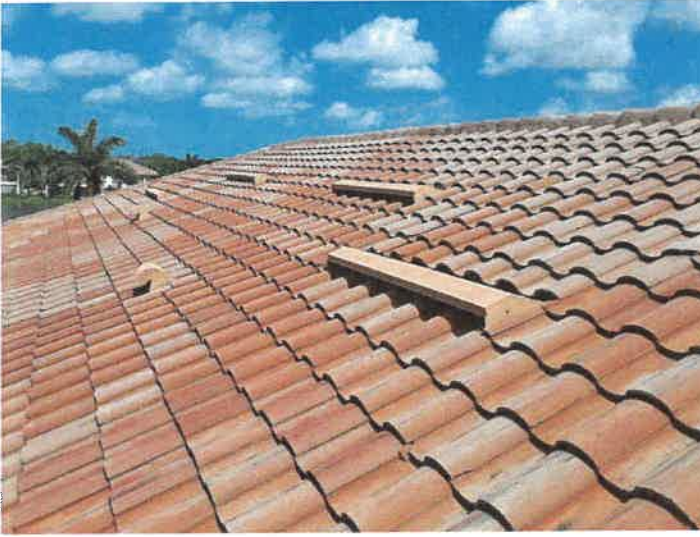
Building 15197: Roof Vents

Roof vents appear to be in good condition.

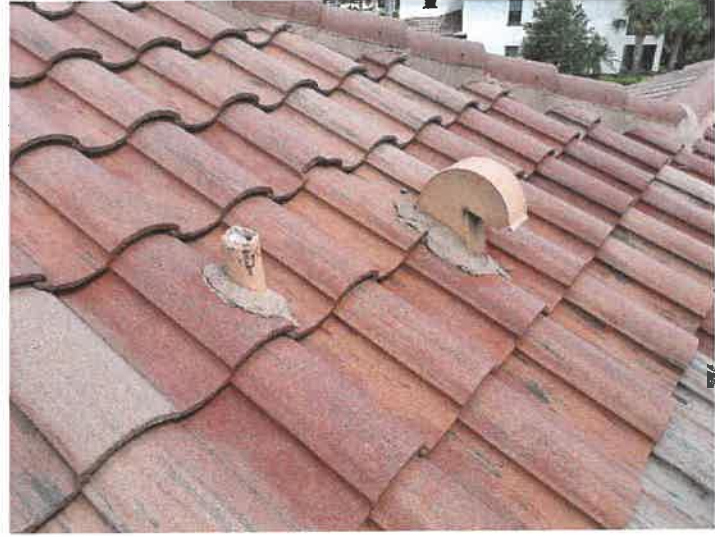
Building 15197: Lead Boots

Lead boots appear to be in good condition.

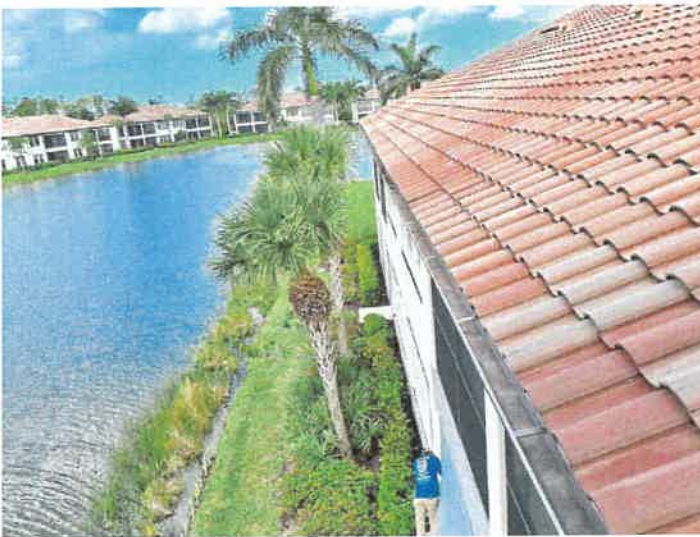
Building 15197: Gutters

The gutters appear to be in good condition.

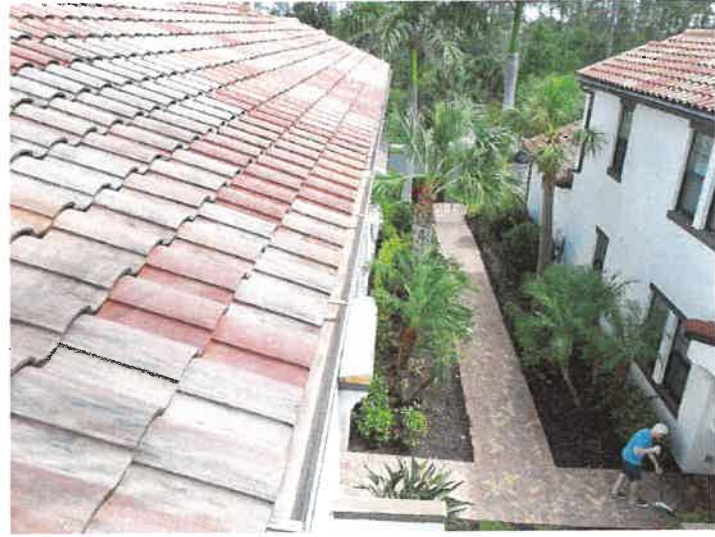
Building 15197: Gutters

The gutters appear to be in good condition.

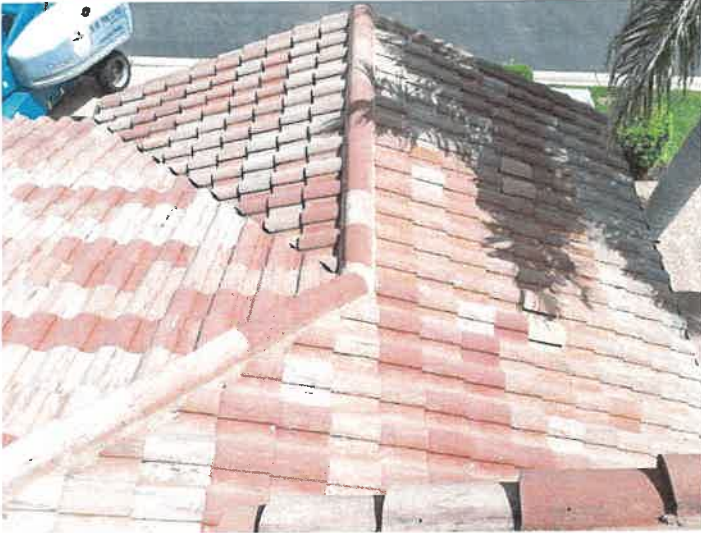
Building 15197: Surface Overview - Lower Roof
The roof surface appears to be in good, maintainable condition at this time.

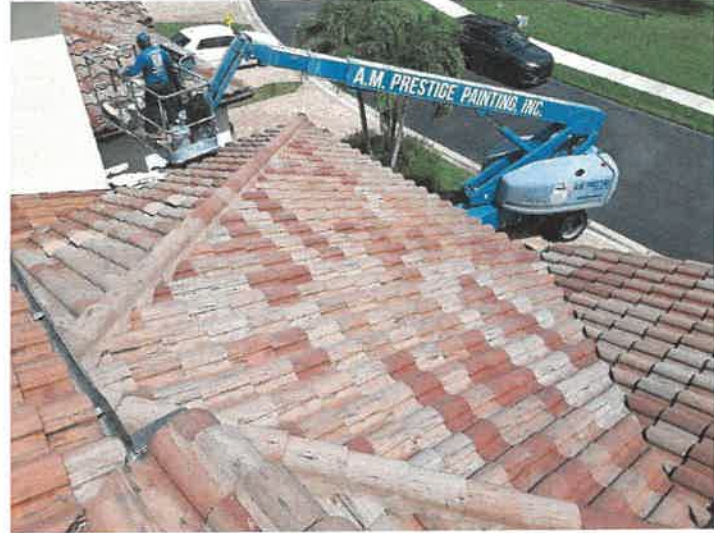
Building 15197: Appearance Overview - Lower Roof
The roof appearance is in good, maintainable condition.

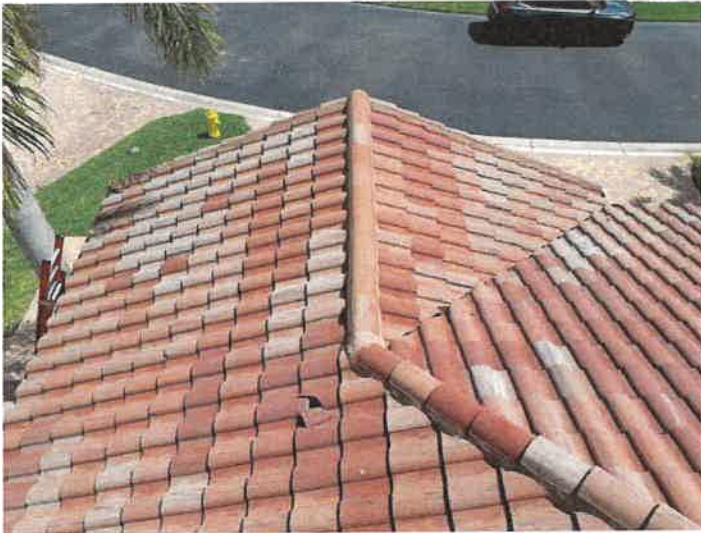
Building 15197: Appearance Overview - Lower Roof
The roof appearance is in good, maintainable condition.

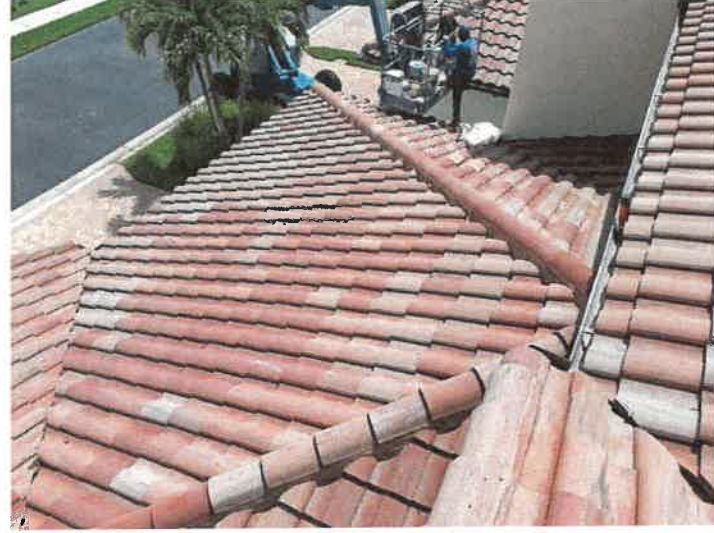
Building 15197: Surface Overview - Lower Roof
The roof surface appears to be in good, maintainable condition at this time.

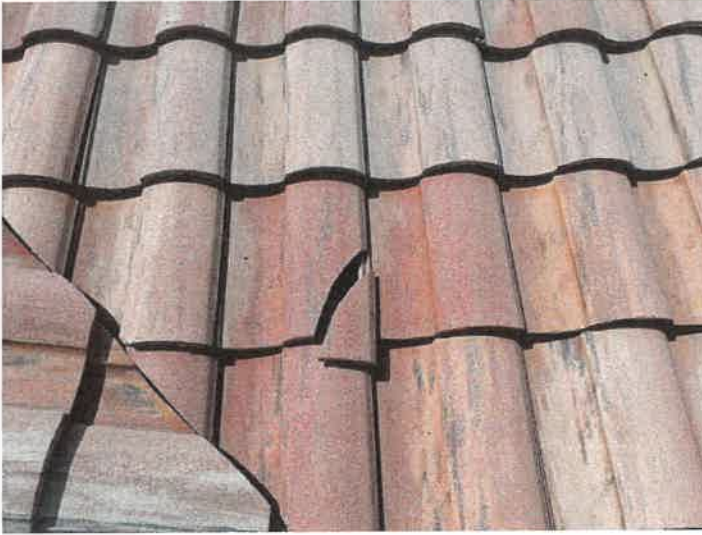
Building 15197: Identified Cracked Roof Tiles
Cracked roof tiles can allow premature underlayment deterioration from excessive UV exposure.

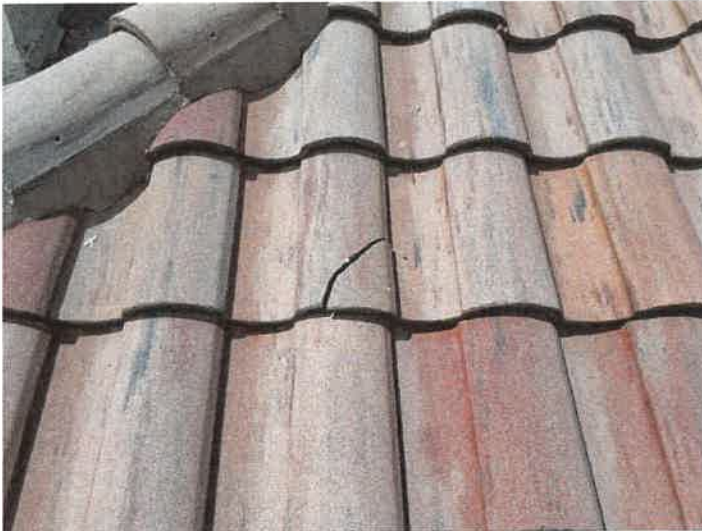
Building 15197: Identified Cracked Roof Tiles
Cracked roof tiles can allow premature underlayment deterioration from excessive UV exposure.

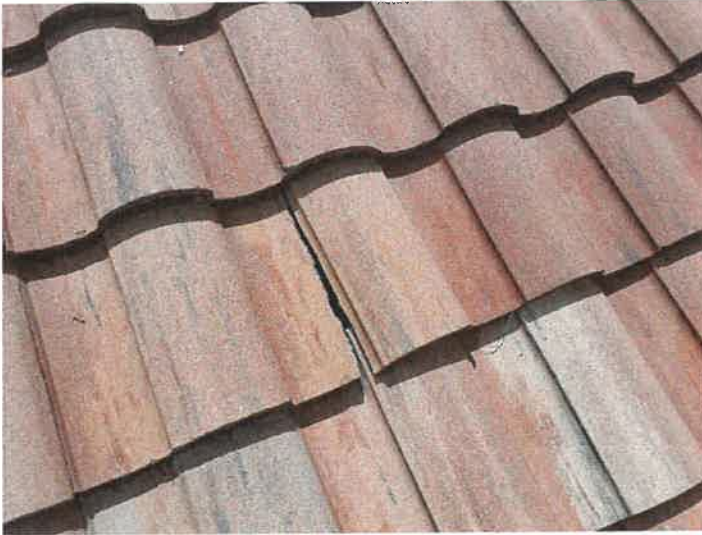
Building 15197: Identified Cracked Roof Tiles
Cracked roof tiles can allow premature underlayment deterioration from excessive UV exposure.

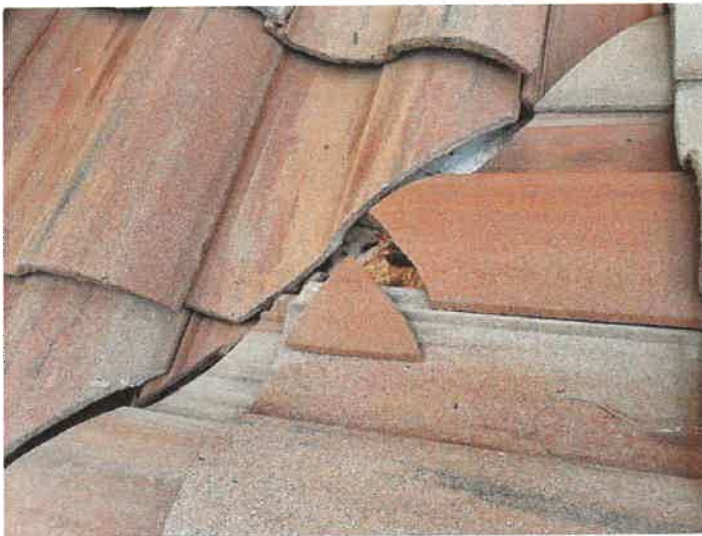
Building 15197: Identified Cracked Roof Tiles
Cracked roof tiles can allow premature underlayment deterioration from excessive UV exposure.

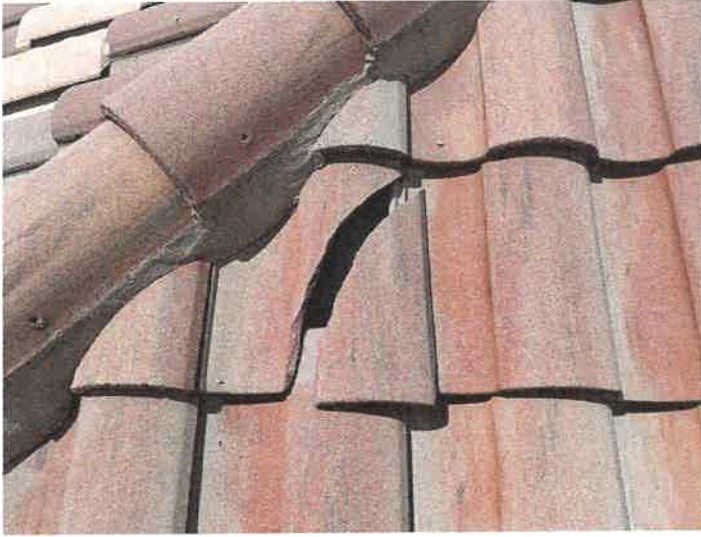
Building 15197: Identified Cracked Roof Tiles

Cracked roof tiles can allow premature underlayment deterioration from excessive UV exposure.

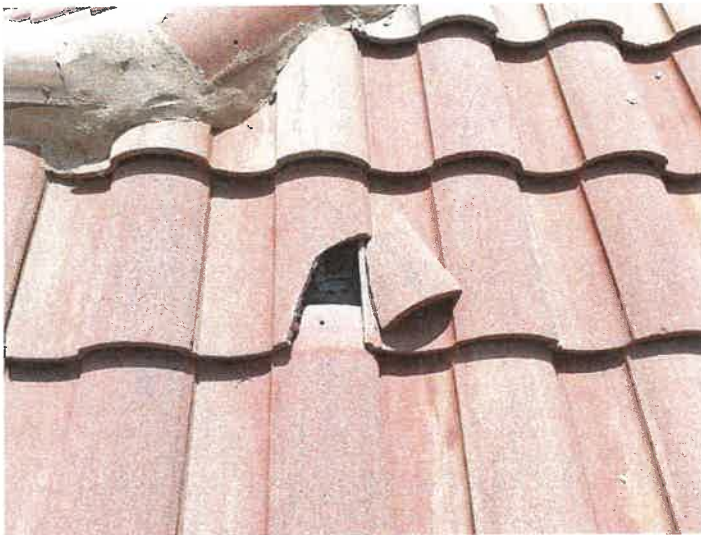
Building 15197: Identified Cracked Roof Tiles

Cracked roof tiles can allow premature underlayment deterioration from excessive UV exposure.

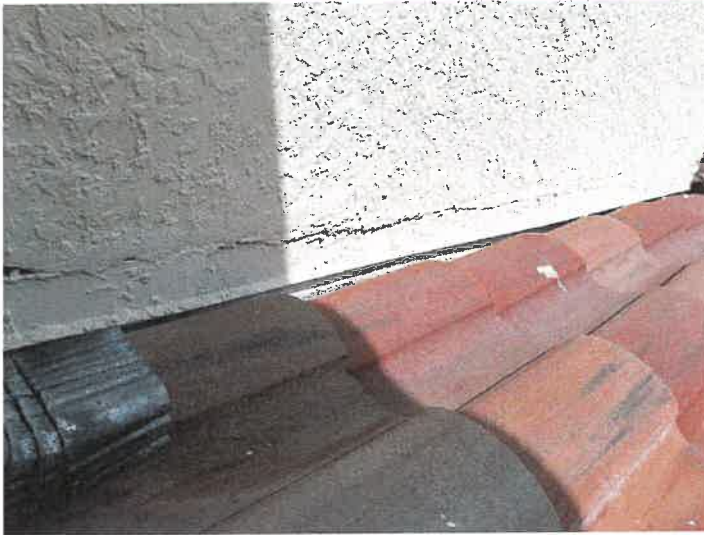
Building 15197: Counter Flashings

The counter flashing appears to be in good condition.

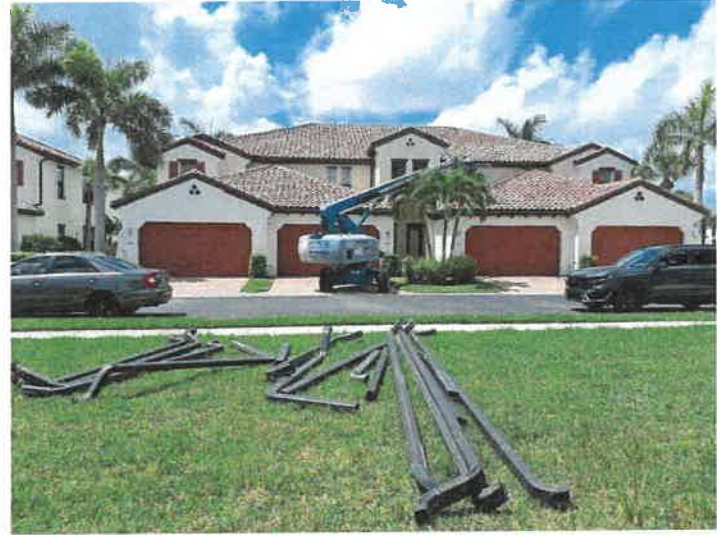
Building 15197: Downspout- missing

Downspout is missing. The painting company that is painting the exteriors in Livingston Lakes has the missing downspouts.

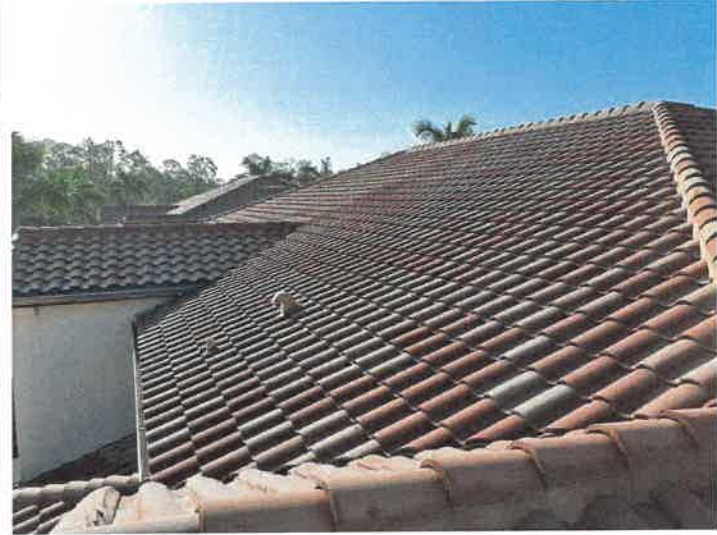
Building 15201: Surface Overview
The roof surface appears to be in good, maintainable condition at this time.

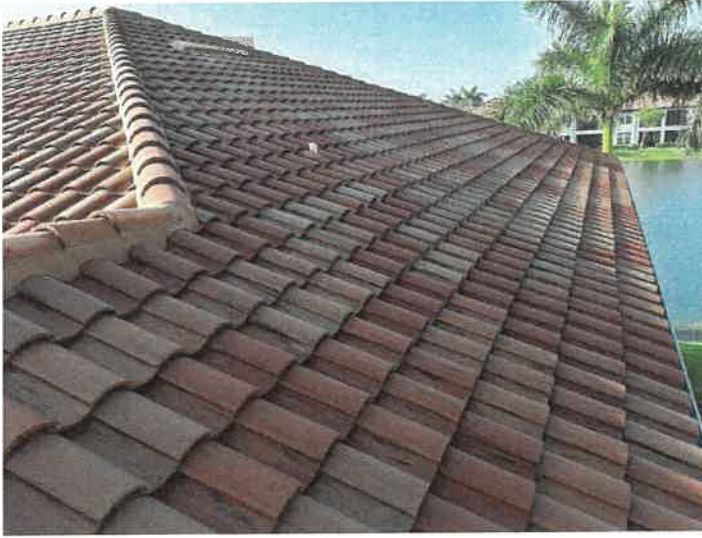
Building 15201: Appearance Overview

The roof appearance is in good, maintainable condition.

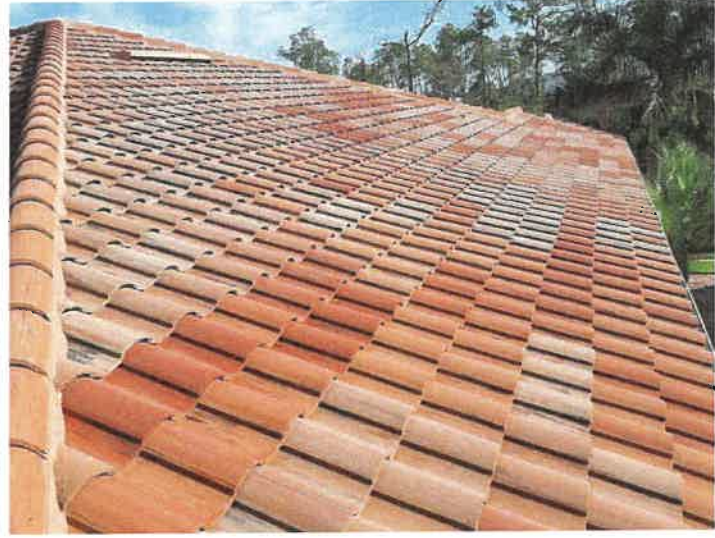
Building 15201: Surface Overview

The roof surface appears to be in good, maintainable condition at this time.

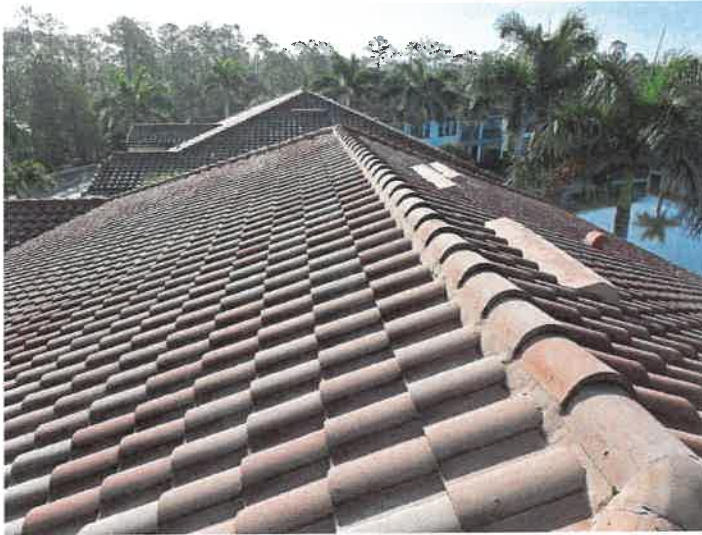
Building 15201: Ridge Tiles

Ridge tiles appear to be in good condition.

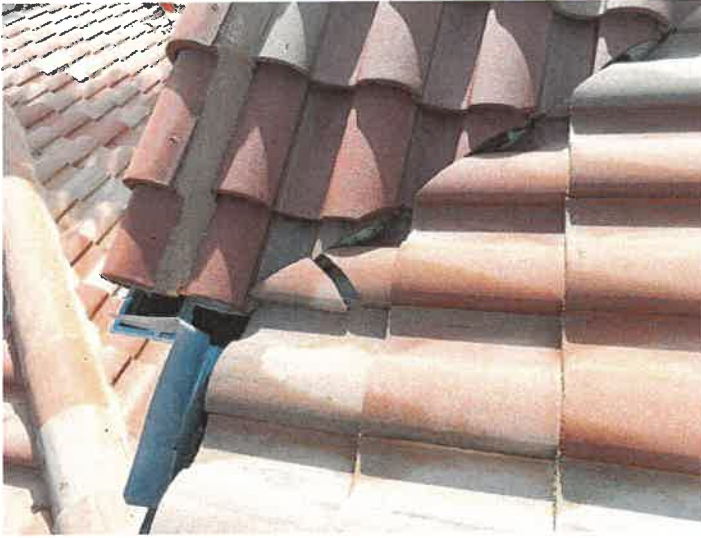
Building 15201: Identified Cracked Roof Tiles
Cracked roof tiles can allow premature underlayment deterioration from excessive UV exposure.

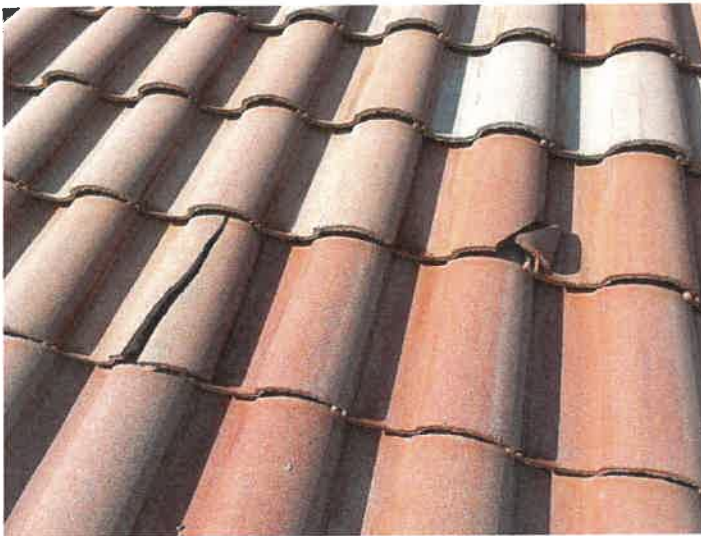
Building 15201: Identified Cracked Roof Tiles
Cracked roof tiles can allow premature underlayment deterioration from excessive UV exposure.

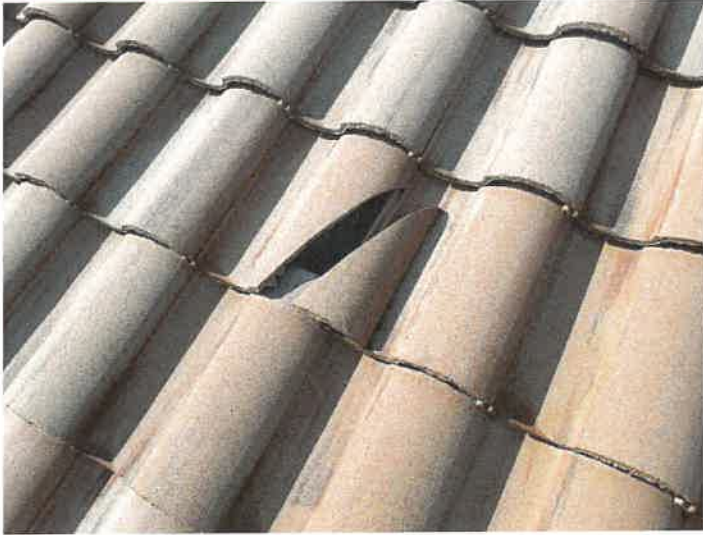
Building 15201: Identified Cracked Roof Tiles

Cracked roof tiles can allow premature underlayment deterioration from excessive UV exposure.

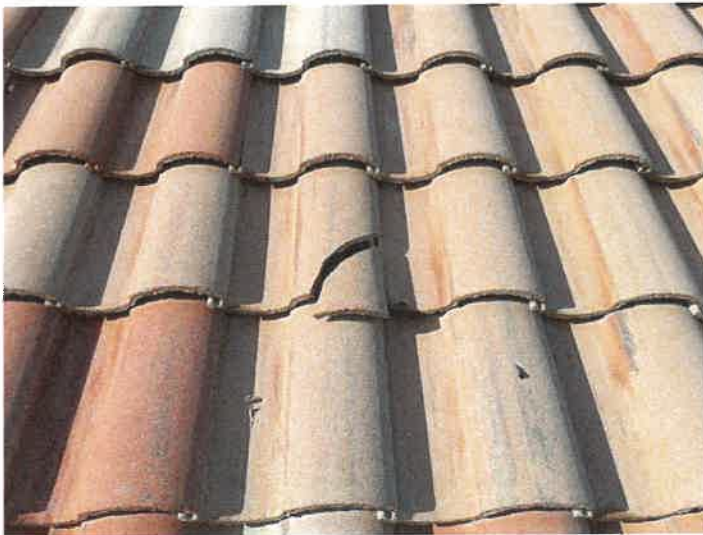
Building 15201: Identified Cracked Roof Tiles

Cracked roof tiles can allow premature underlayment deterioration from excessive UV exposure.

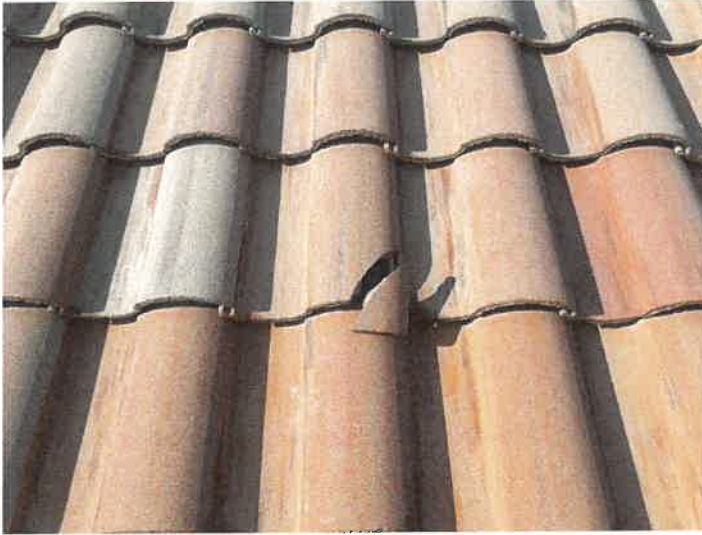
Building 15201: Identified Cracked Roof Tiles
Cracked roof tiles can allow premature underlayment deterioration from excessive UV exposure.

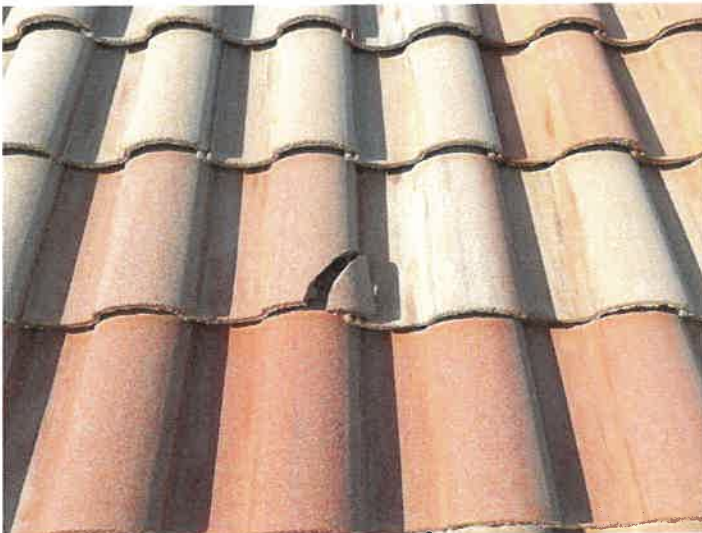
Building 15201: Identified Cracked Roof Tiles
Cracked roof tiles can allow premature underlayment deterioration from excessive UV exposure.

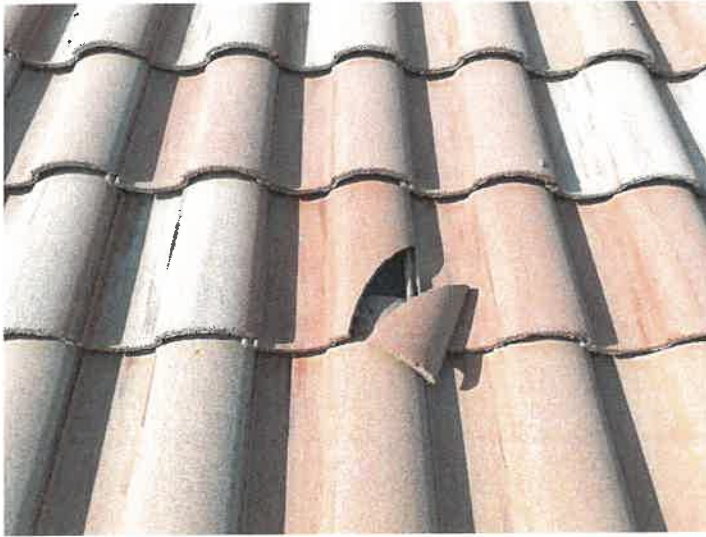
Building 15201: Identified Cracked Roof Tiles
Cracked roof tiles can allow premature underlayment deterioration from excessive UV exposure.

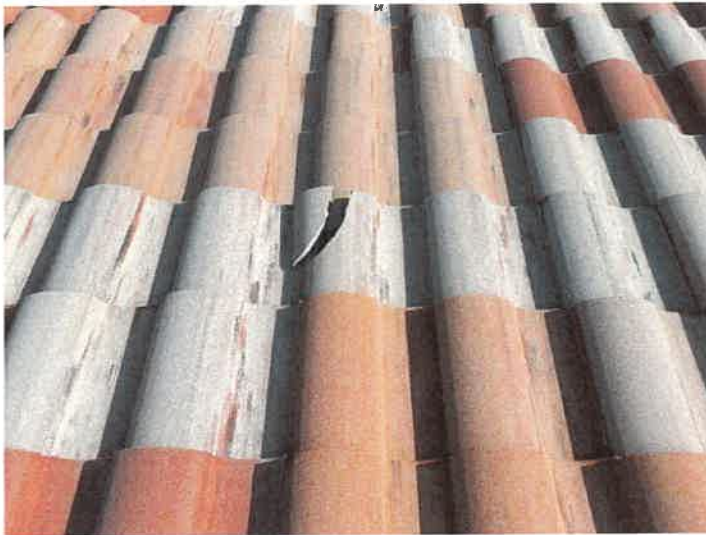
Building 15201: Identified Cracked Roof Tiles
Cracked roof tiles can allow premature underlayment deterioration from excessive UV exposure.

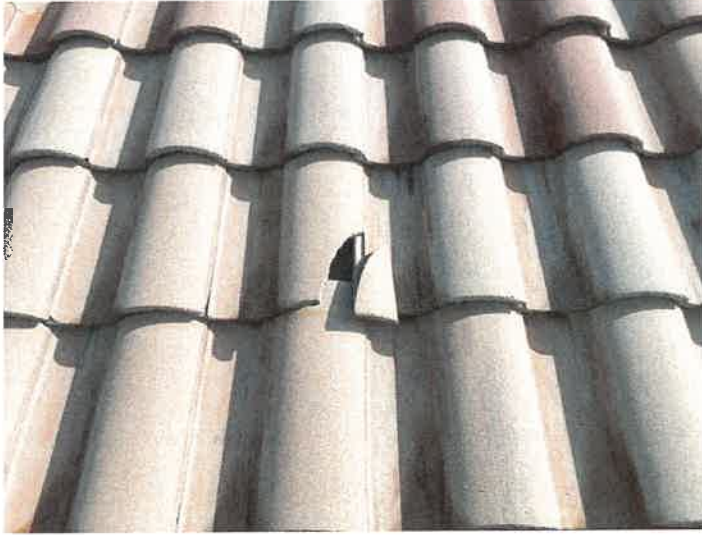
Building 15201: Identified Cracked Roof Tiles
Cracked roof tiles can allow premature underlayment deterioration from excessive UV exposure.

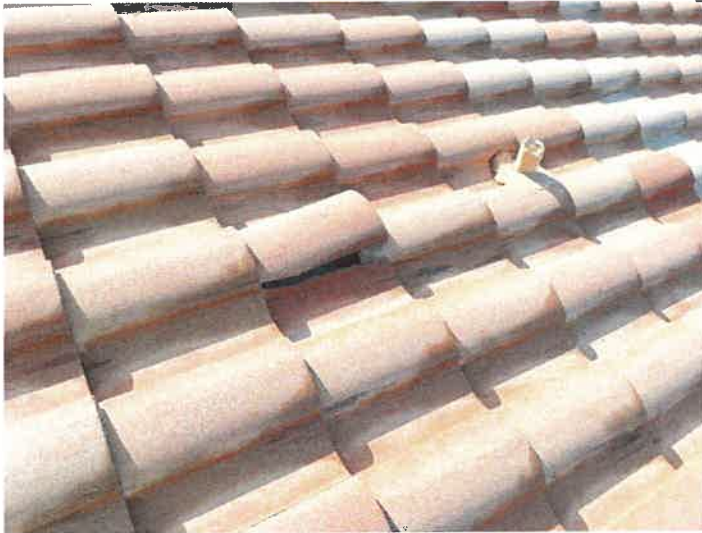
Building 15201: Identified Cracked Roof Tiles
Cracked roof tiles can allow premature underlayment deterioration from excessive UV exposure.

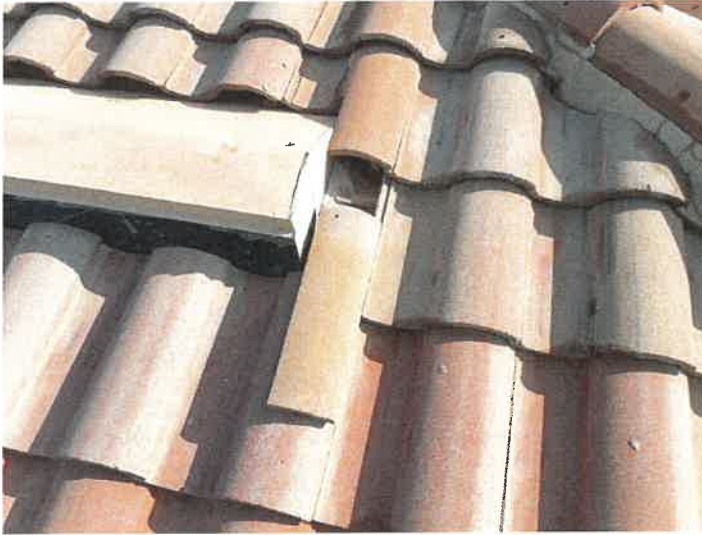
Building 15201: Displaced/Missing Roof Tile

Displaced or missing roof tiles can allow premature underlayment deterioration from excessive UV exposure and potential water intrusion.

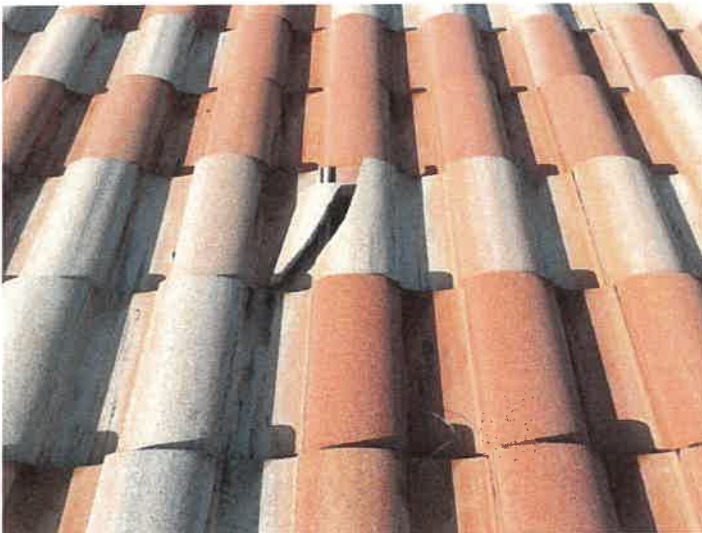
Building 15201: Identified Cracked Roof Tiles

Cracked roof tiles can allow premature underlayment deterioration from excessive UV exposure.

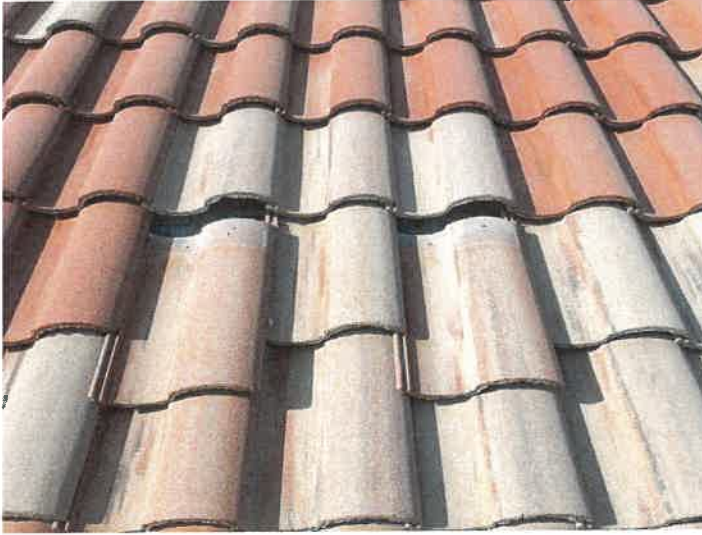
Building 15201: Displaced/Missing Roof Tile

Displaced or missing roof tiles can allow premature underlayment deterioration from excessive UV exposure and potential water intrusion.

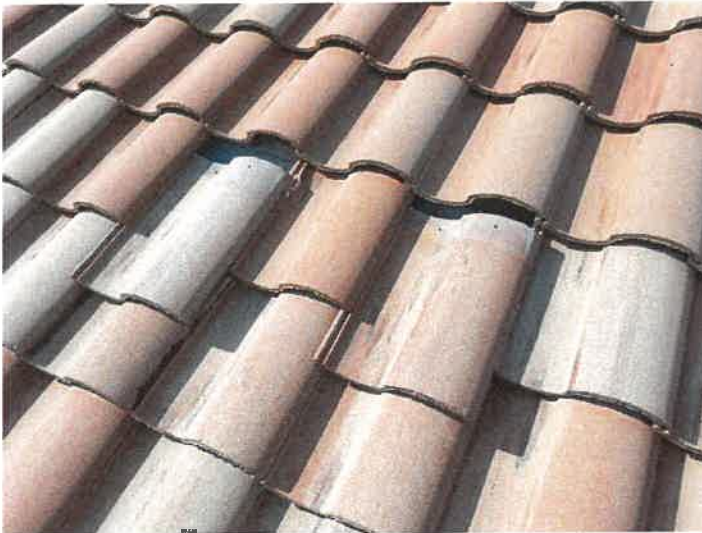
Building 15201: Displaced/Missing Roof Tile

Displaced or missing roof tiles can allow premature underlayment deterioration from excessive UV exposure and potential water intrusion.

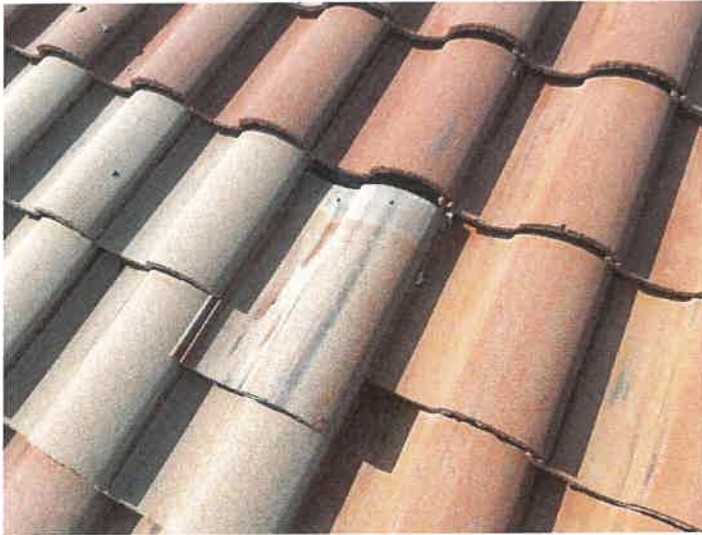
Building 15201: Displaced/Missing Roof Tile

Displaced or missing roof tiles can allow premature underlayment deterioration from excessive UV exposure and potential water intrusion.

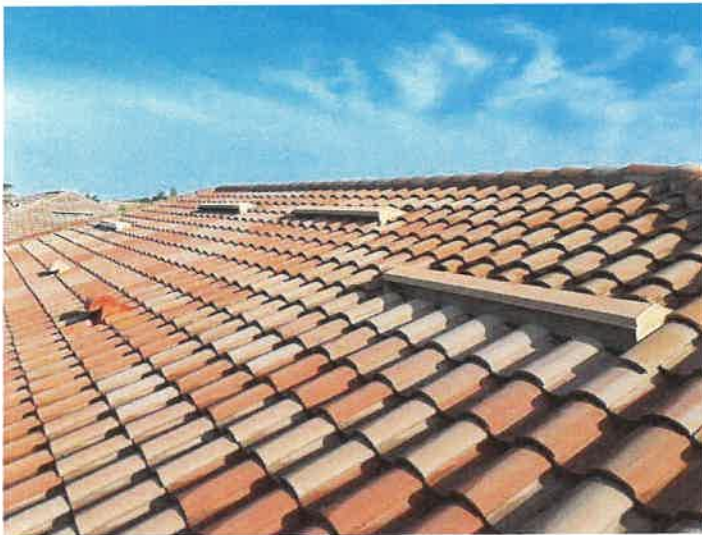
Building 15201: Roof Vents

Roof vents appear to be in good condition.

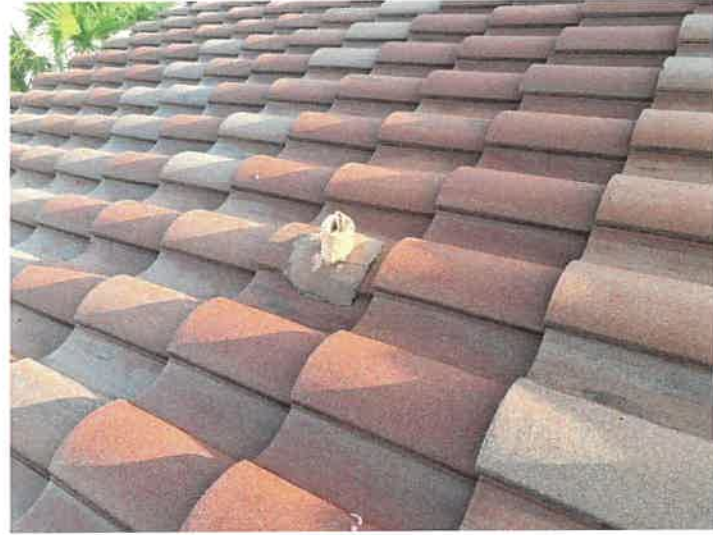
Building 15201: Lead Boots

Lead boots appear to be in good condition.

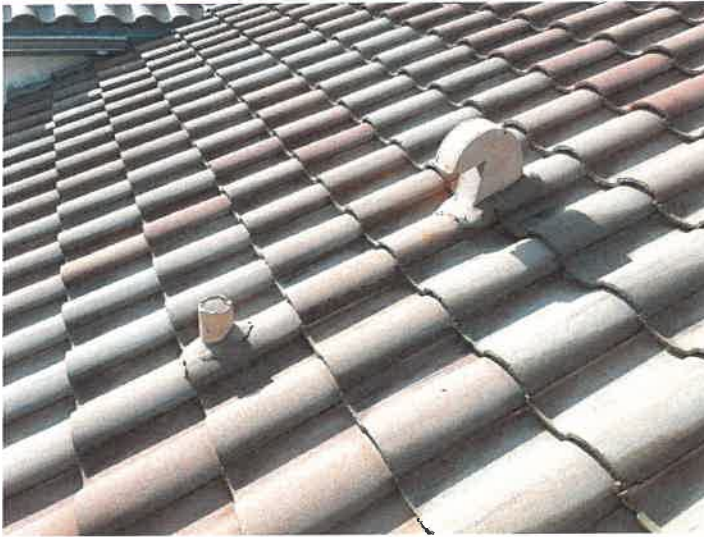
Building 15201: Lead Boots
Lead boots appear to be in good condition.

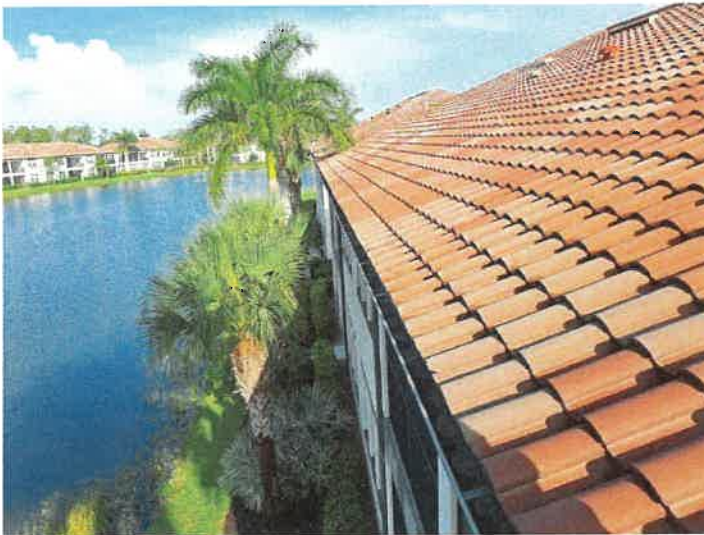
Building 15201: Gutters
The gutters appear to be in good condition.

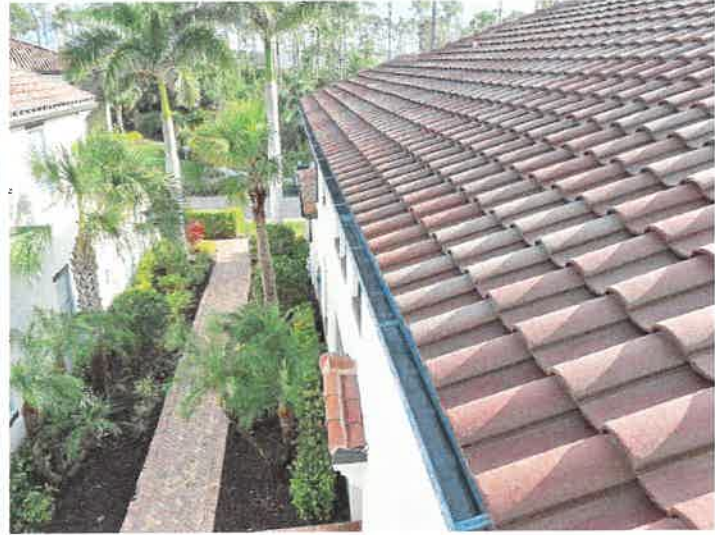
Building 15201: Gutters
The gutters appear to be in good condition.

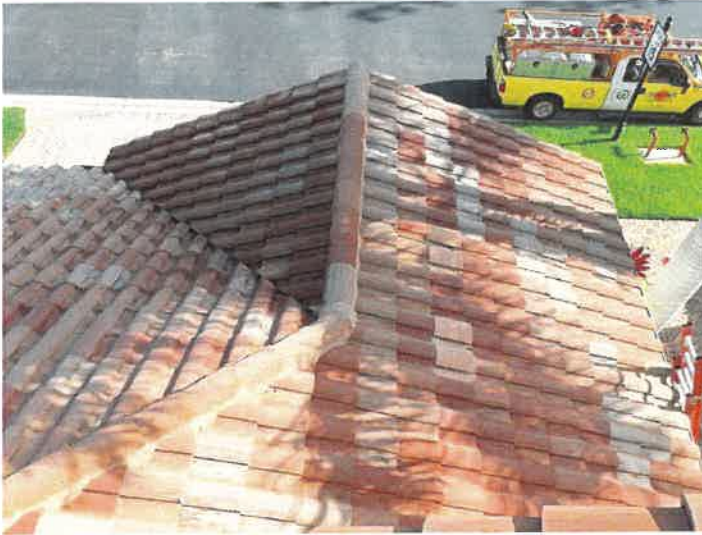
Building 15201: Surface Overview - Lower Roof
The roof surface appears to be in good, maintainable condition at this time.

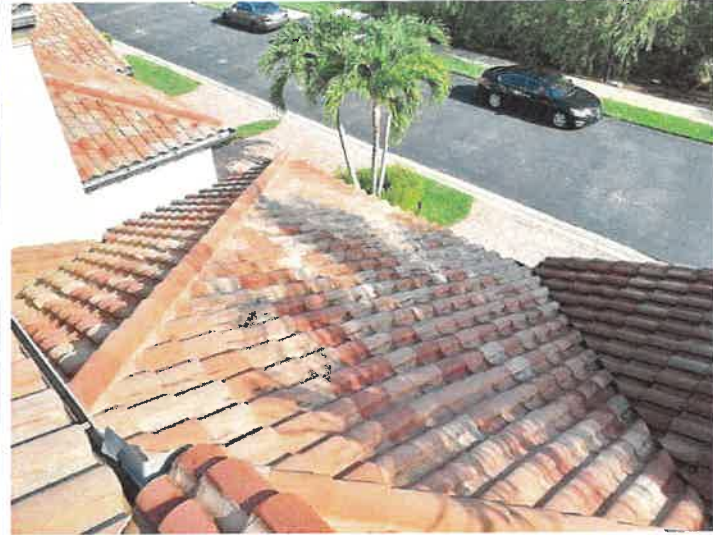
Building 15201: Appearance Overview - Lower Roof
The roof appearance is in good, maintainable condition.

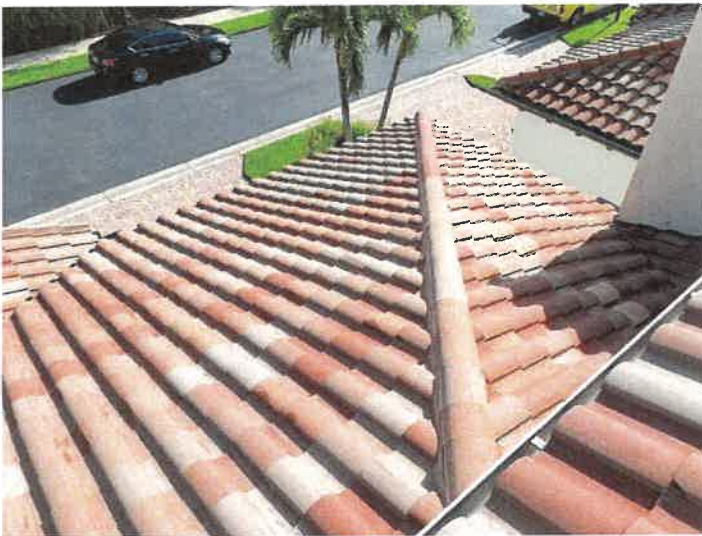
Building 15201: Surface Overview - Lower Roof
The roof surface appears to be in good, maintainable condition at this time.
