Inspection Report

Facility: Livingston Lakes Condo

Work Order #: 13028

Re.: **Inspection Report (2 of 3) for Livingston Lakes**

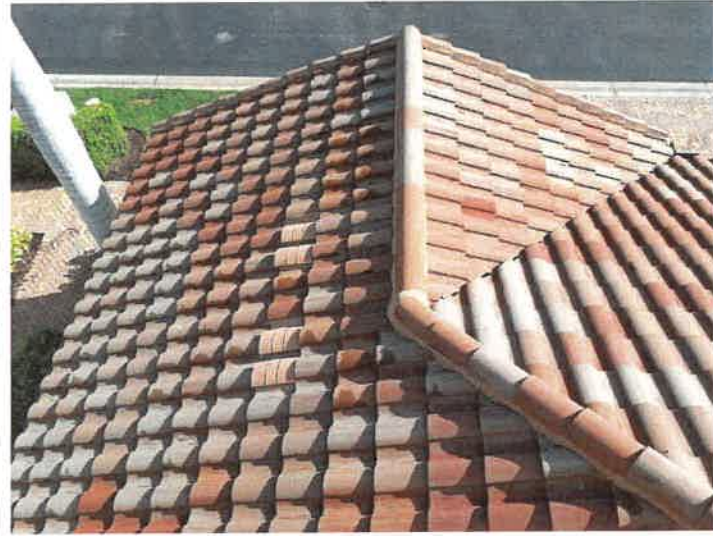
Building 15201: Appearance Overview - Lower Roof
The roof appearance is in good, maintainable condition.

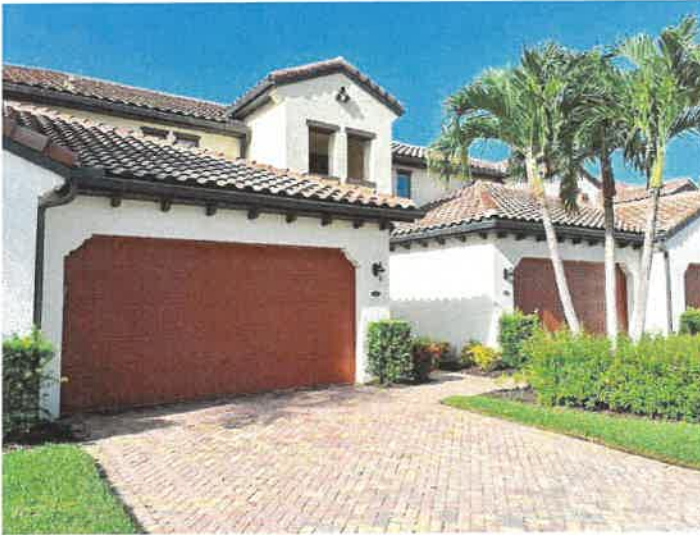
Building 15201: Downspouts

The downspouts appear to be in good condition.

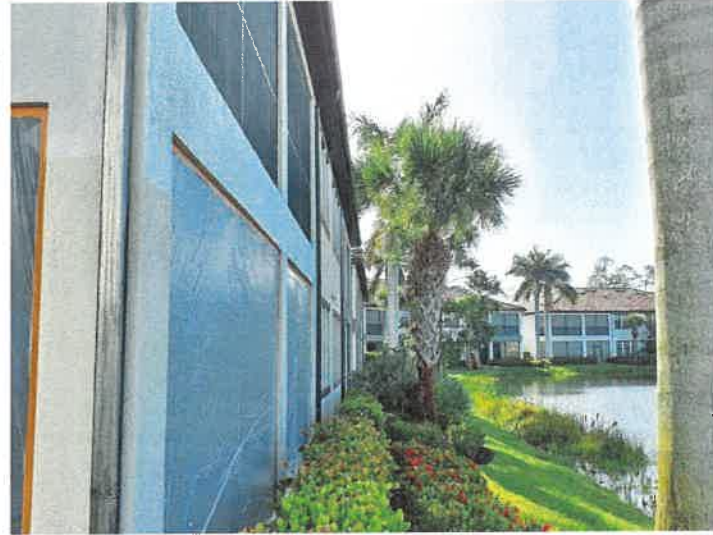
Building 15201: Downspouts

The downspouts appear to be in good condition.

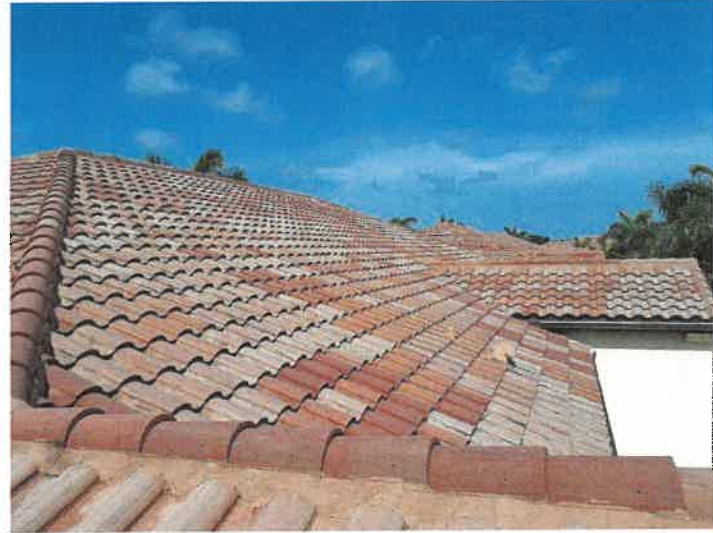
Building 15205: Surface Overview

The roof surface appears to be in good, maintainable condition at this time.

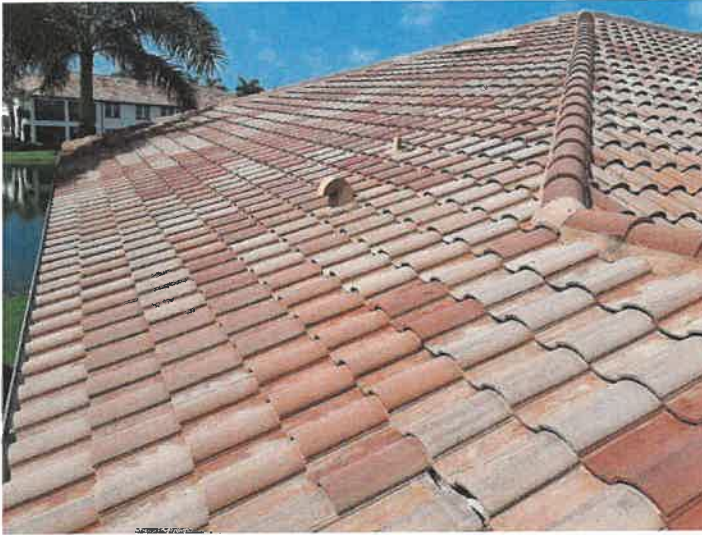
Building 15205: Appearance Overview

The roof appearance is in good, maintainable condition.

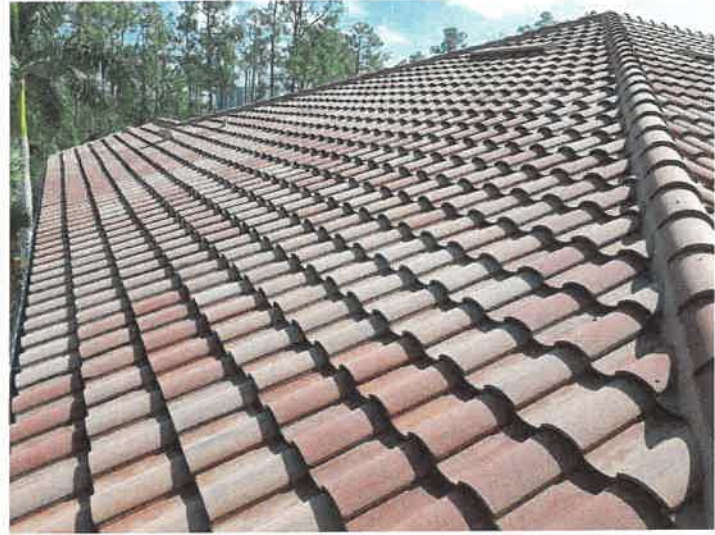
Building 15205: Surface Overview

The roof surface appears to be in good, maintainable condition at this time.

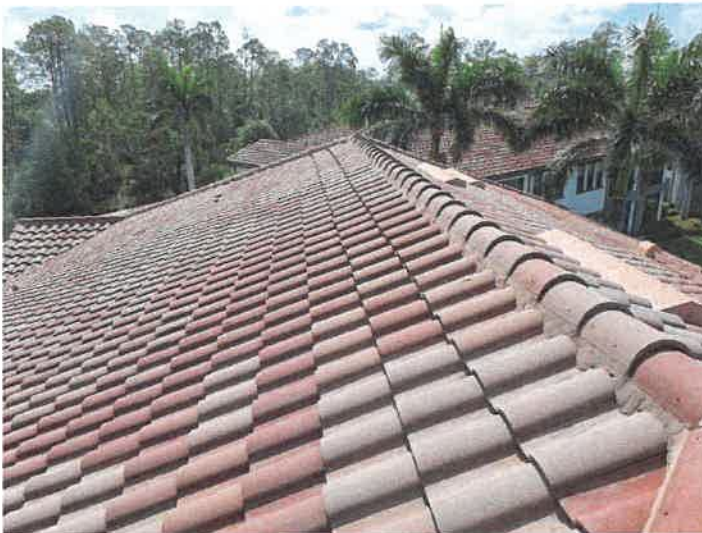
Building 15205: Ridge Tiles

Ridge tiles appear to be in good condition.

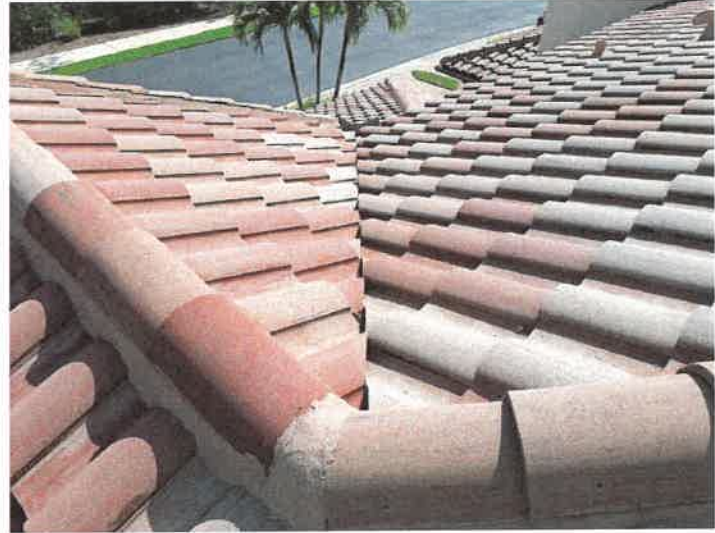
Building 15205: Valley

The valley tiles appear to be in good condition.

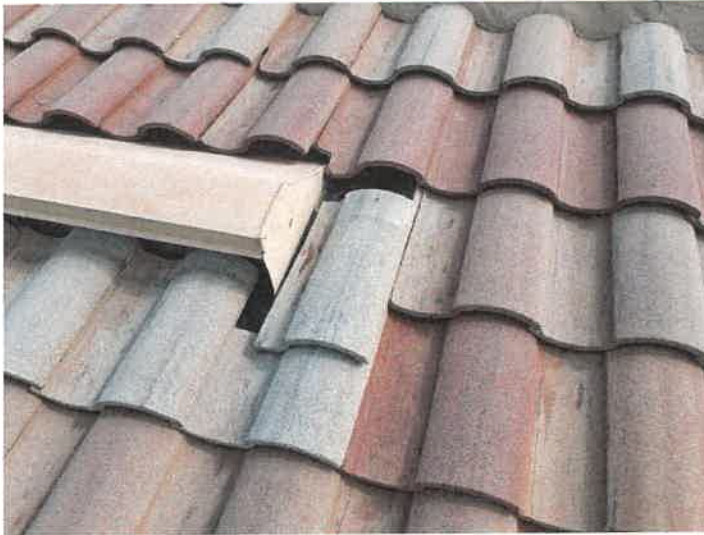
Building 15205: Displaced/Missing Roof Tile

Displaced or missing roof tiles can allow premature underlayment deterioration from excessive UV exposure and potential water intrusion.

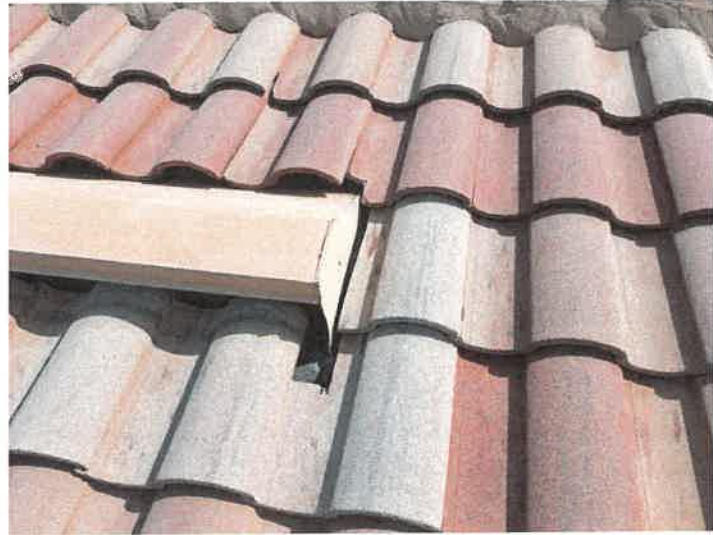
Building 15205: Repaired Displaced/Missing Roof Tile

Replaced and secured the missing roof tile.

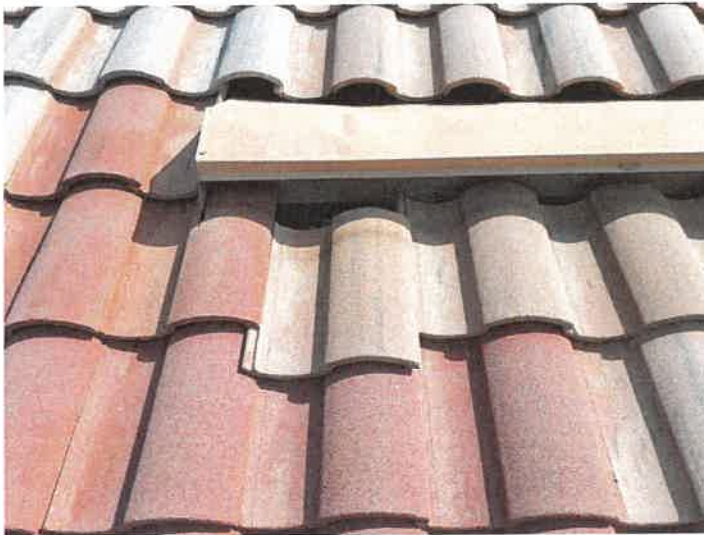
Building 15205: Displaced/Missing Roof Tile

Displaced or missing roof tiles can allow premature underlayment deterioration from excessive UV exposure and potential water intrusion.

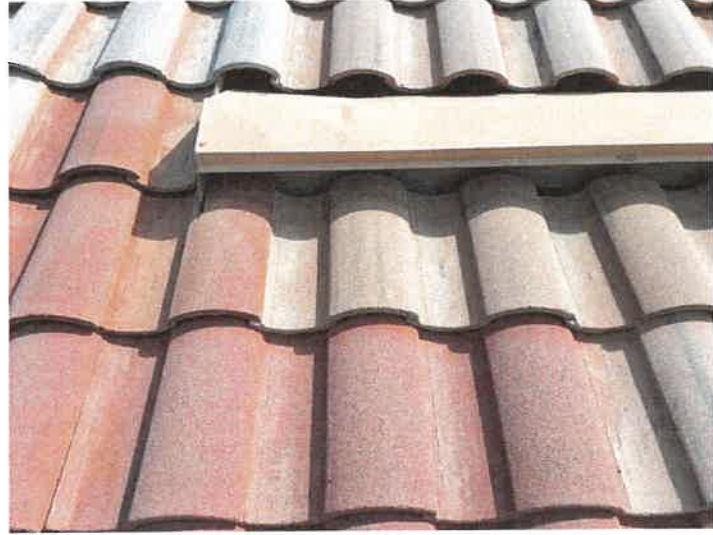
Building 15205: Repaired Displaced/Missing Roof Tile

Replaced and secured the missing roof tile.

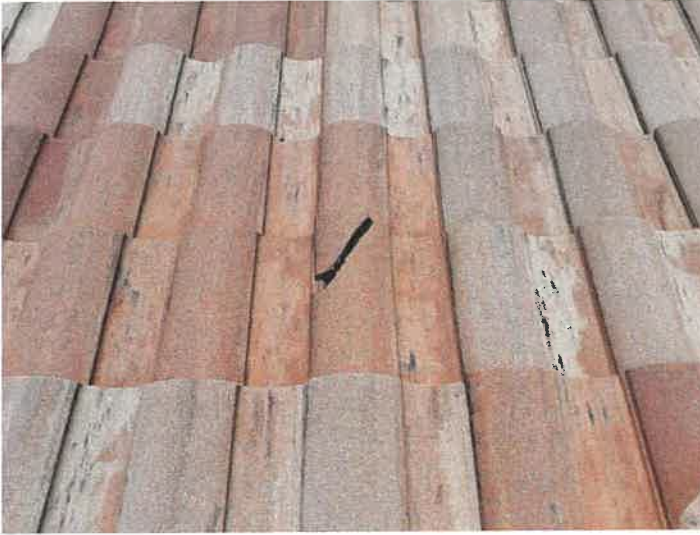
Building 15205: Identified Cracked Roof Tiles

Cracked roof tiles can allow premature underlayment deterioration from excessive UV exposure.

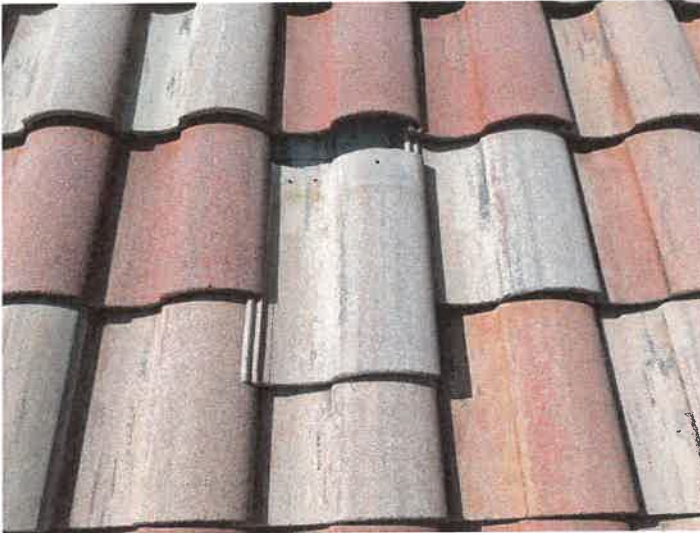
Building 15205: Displaced/Missing Roof Tile

Displaced or missing roof tiles can allow premature underlayment deterioration from excessive UV exposure and potential water intrusion.

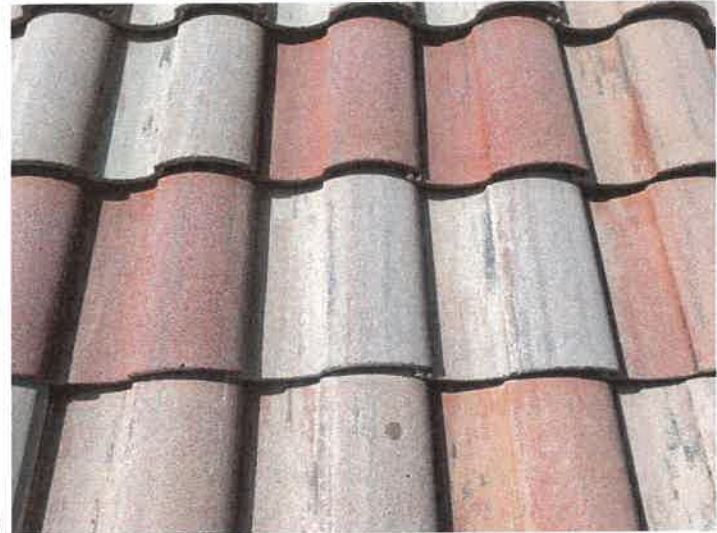
Building 15205: Repaired Displaced/Missing Roof Tile

Replaced and secured the missing roof tile.

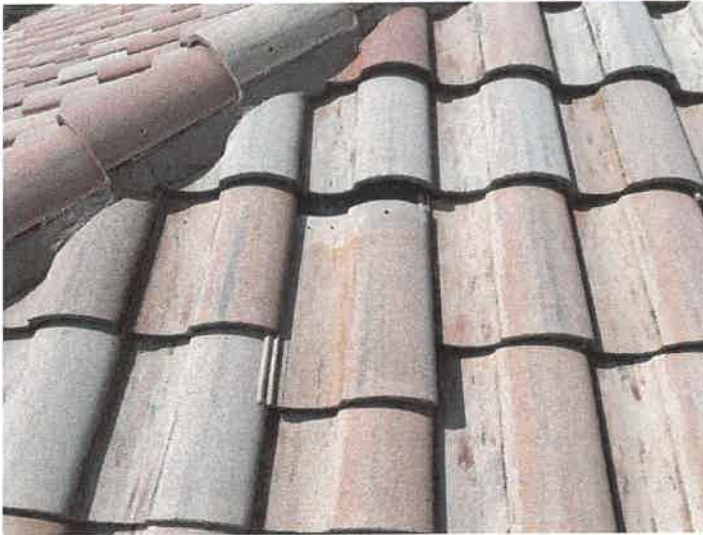
Building 15205: Displaced/Missing Roof Tile

Displaced or missing roof tiles can allow premature underlayment deterioration from excessive UV exposure and potential water intrusion.

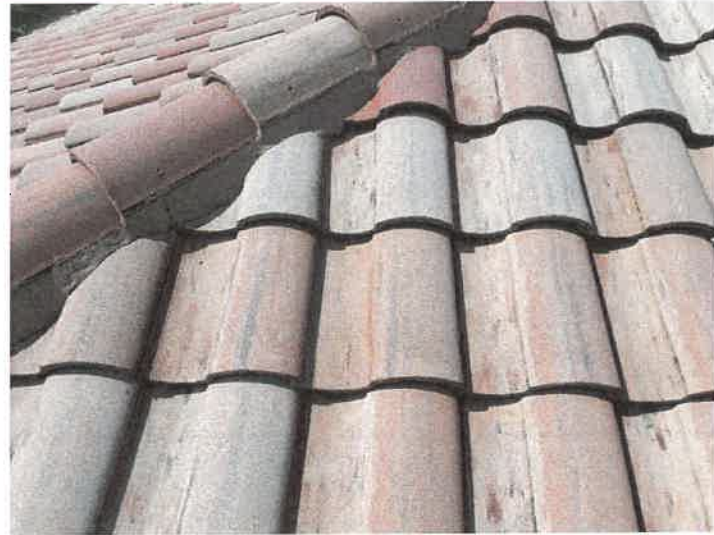
Building 15205: Repaired Displaced/Missing Roof Tile

Replaced and secured the missing roof tile.

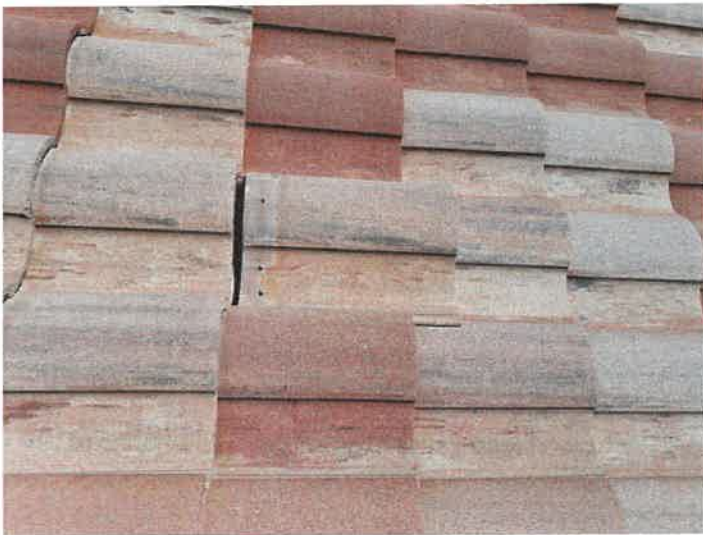
Building 15205: Displaced/Missing Roof Tile

Displaced or missing roof tiles can allow premature underlayment deterioration from excessive UV exposure and potential water intrusion.

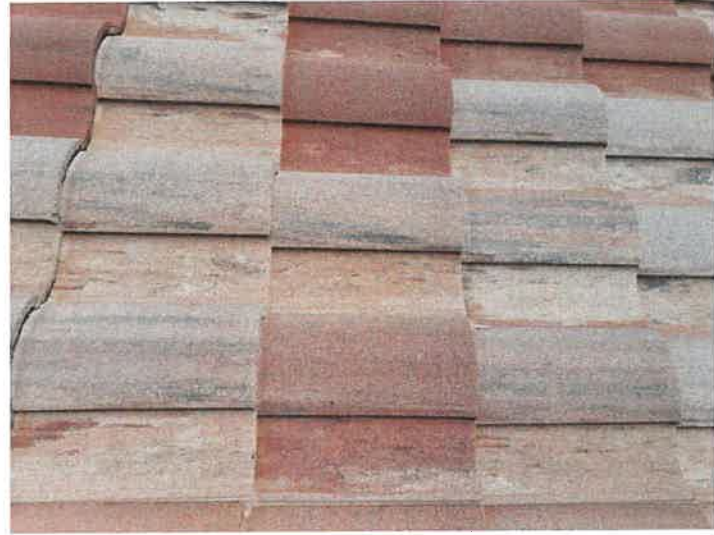
Building 15205: Repaired Displaced/Missing Roof Tile

Replaced and secured the missing roof tile.

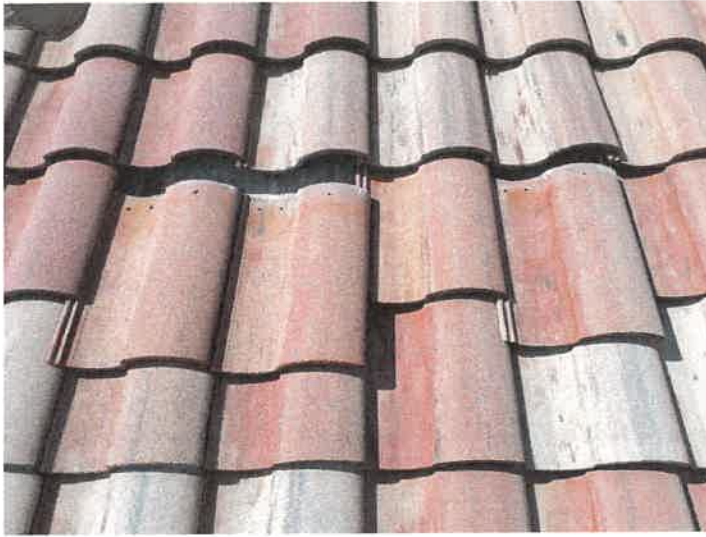
Building 15205: Displaced/Missing Roof Tile

Displaced or missing roof tiles can allow premature underlayment deterioration from excessive UV exposure and potential water intrusion.

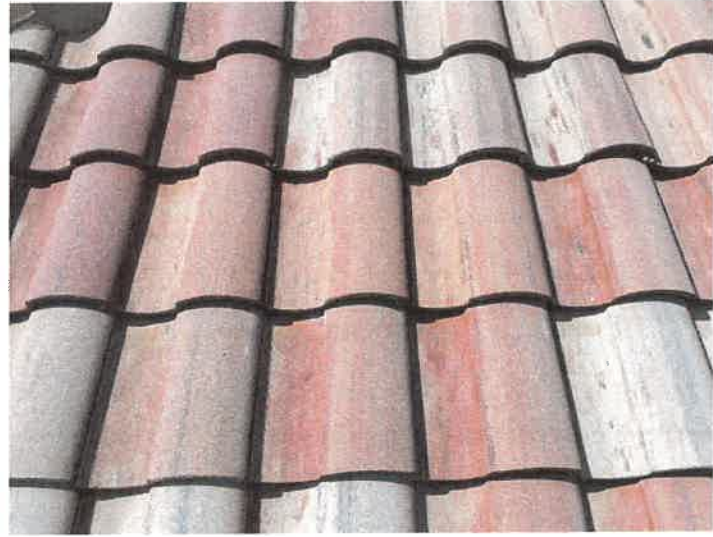
Building 15205: Repaired Displaced/Missing Roof Tile

Replaced and secured the missing roof tile.

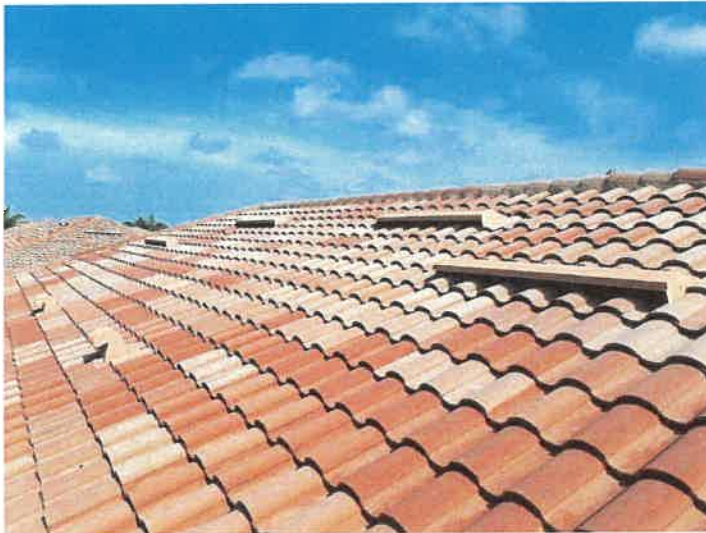
Building 15205: Roof Vents

Roof vents appear to be in good condition.

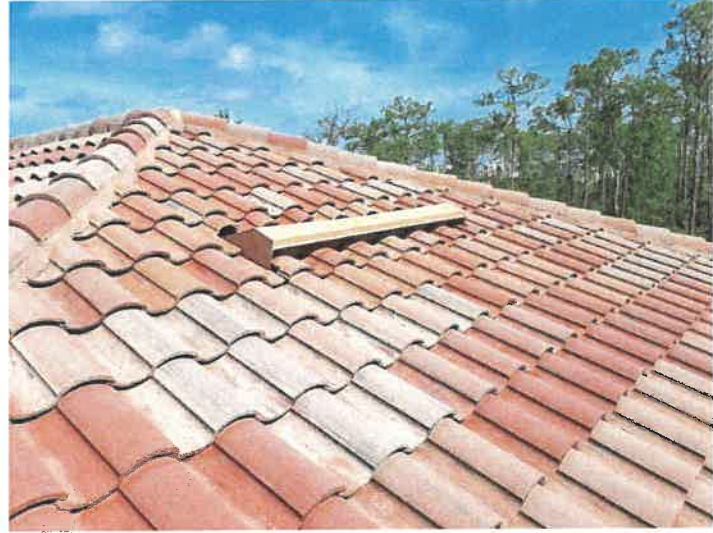
Building 15205: Roof Vents

Roof vents appear to be in good condition.

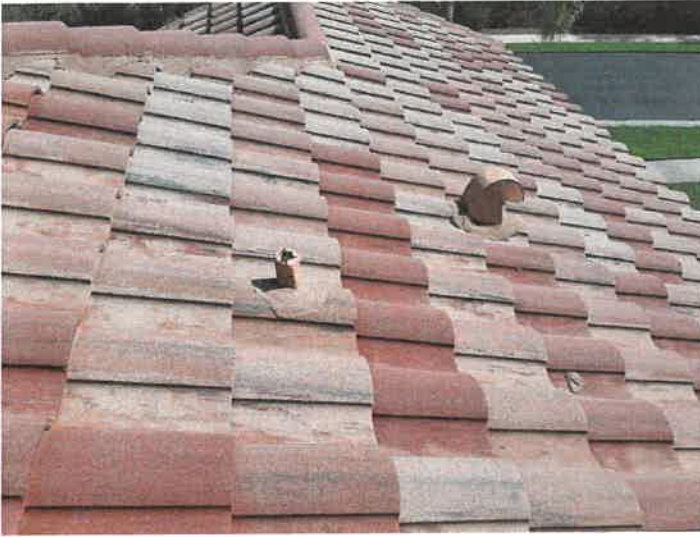
Building 15205: Lead Boots

Lead boots appear to be in good condition.

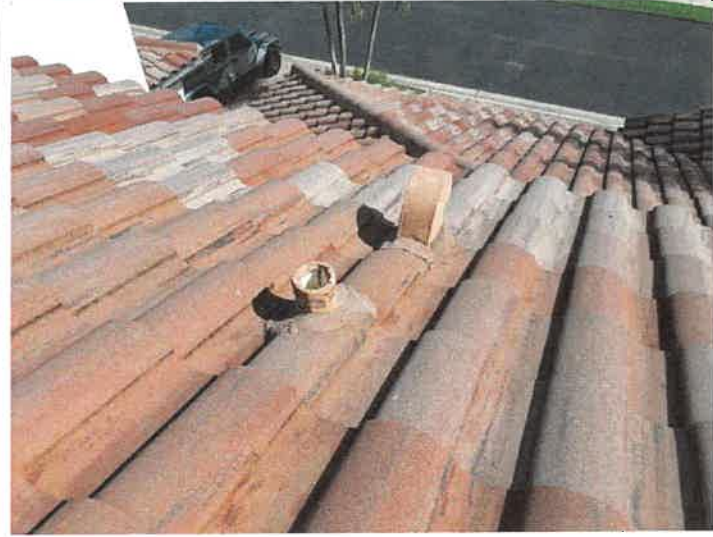
Building 15205: Lead Boots

Lead boots appear to be in good condition.

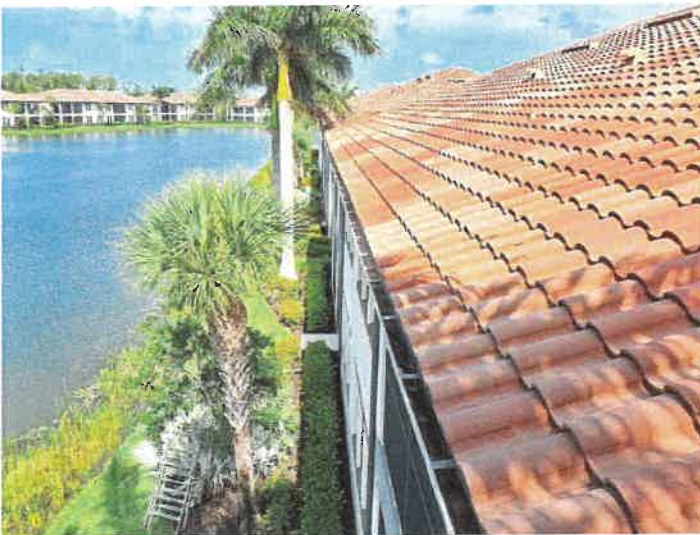
Building 15205: Gutters

The gutters appear to be in good condition.

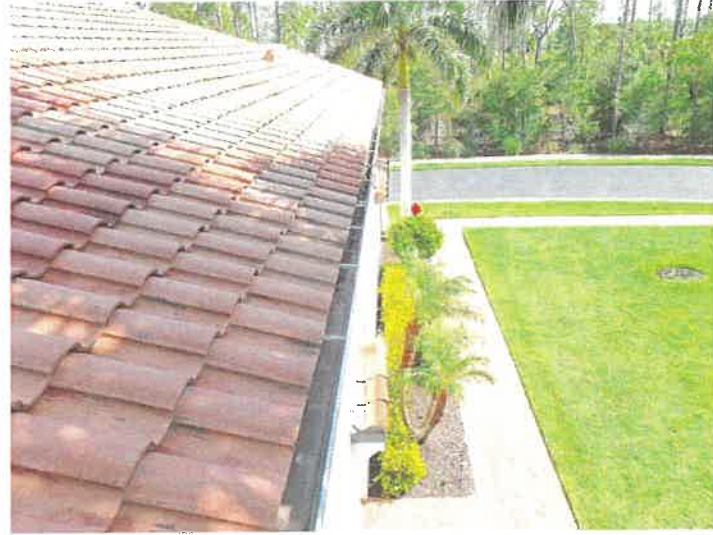
Building 15205: Gutters

The gutters appear to be in good condition.

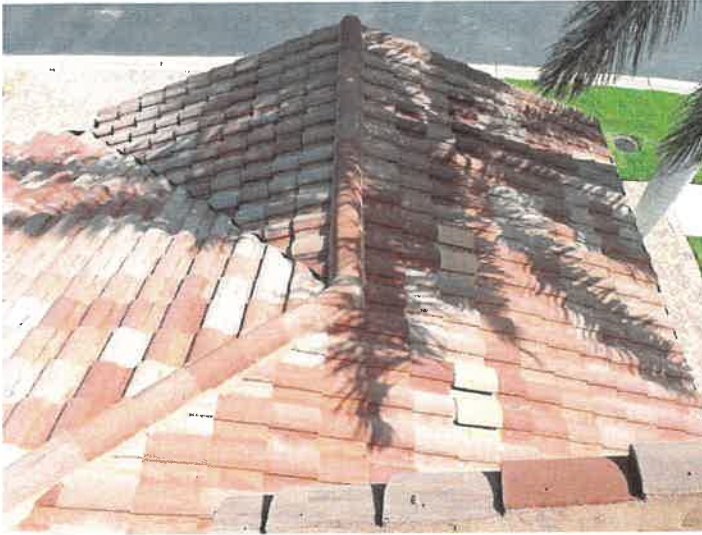
Building 15205: Surface Overview - Lower Roof
The roof surface appears to be in good, maintainable condition at this time.

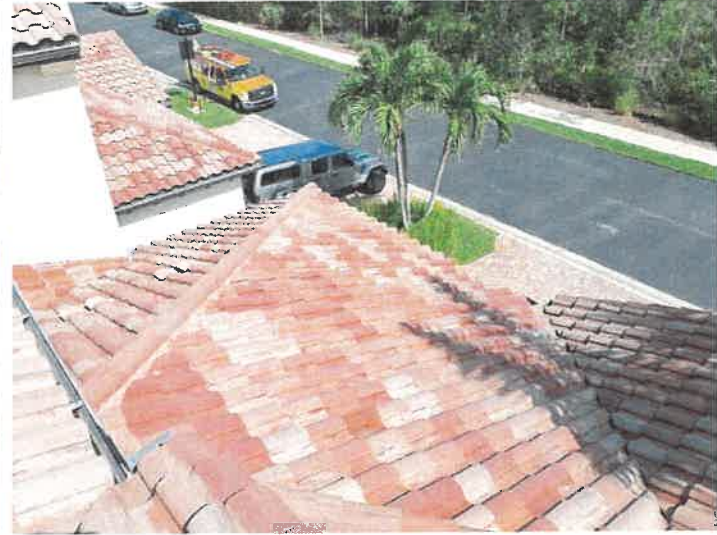
Building 15205: Appearance Overview - Lower Roof
The roof appearance is in good, maintainable condition.

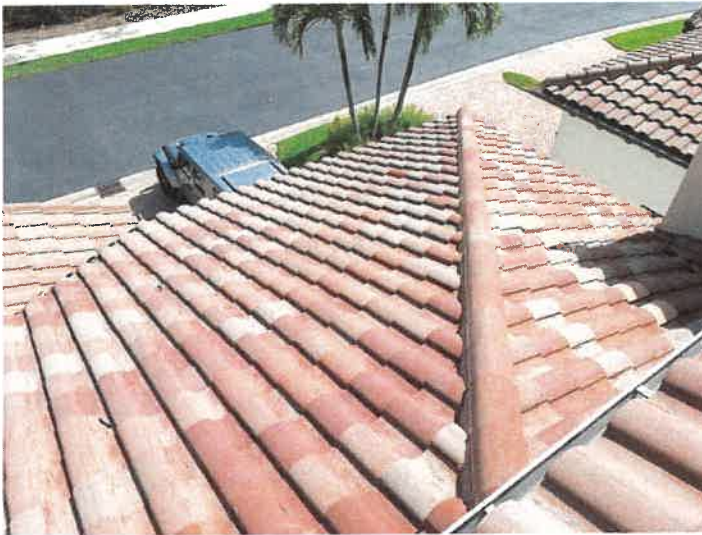
Building 15205: Surface Overview - Lower Roof
The roof surface appears to be in good, maintainable condition at this time.

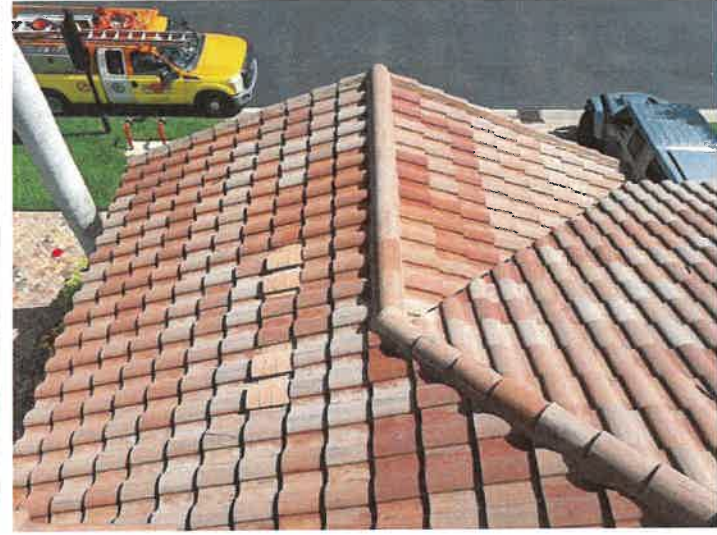
Building 15205: Appearance Overview - Lower Roof
The roof appearance is in good, maintainable condition.

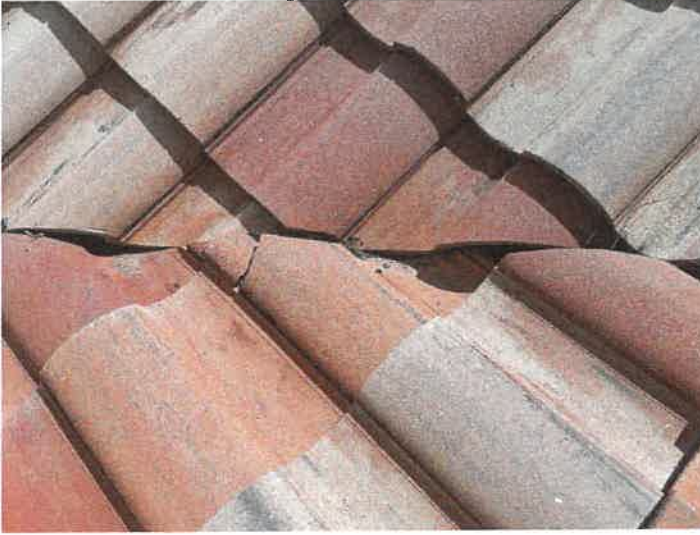
Building 15205: Identified Cracked Roof Tiles
Cracked roof tiles can allow premature underlayment deterioration from excessive UV exposure.

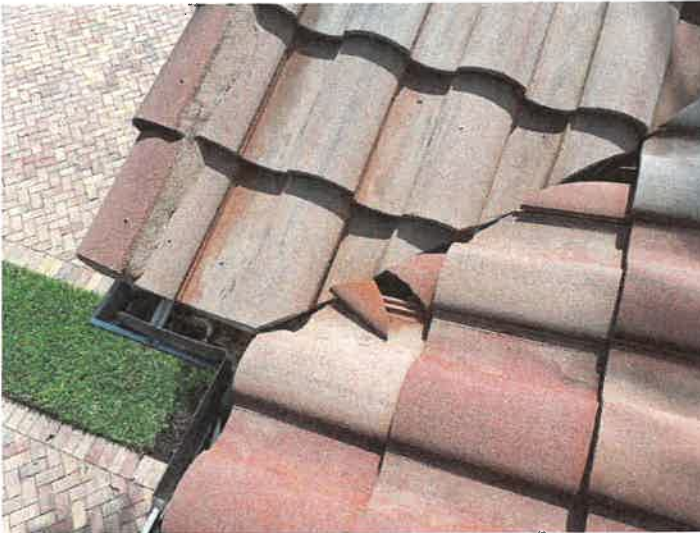
Building 15205: Identified Cracked Roof Tiles
Cracked roof tiles can allow premature underlayment deterioration from excessive UV exposure.

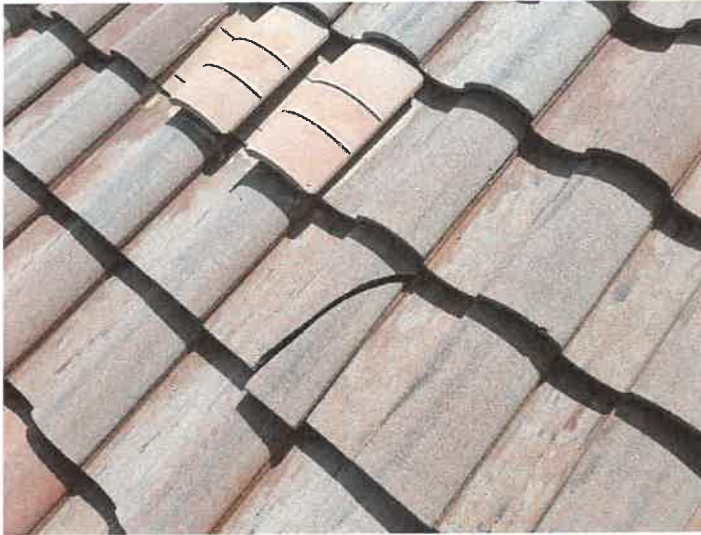
Building 15205: Identified Cracked Roof Tiles
Cracked roof tiles can allow premature underlayment deterioration from excessive UV exposure.

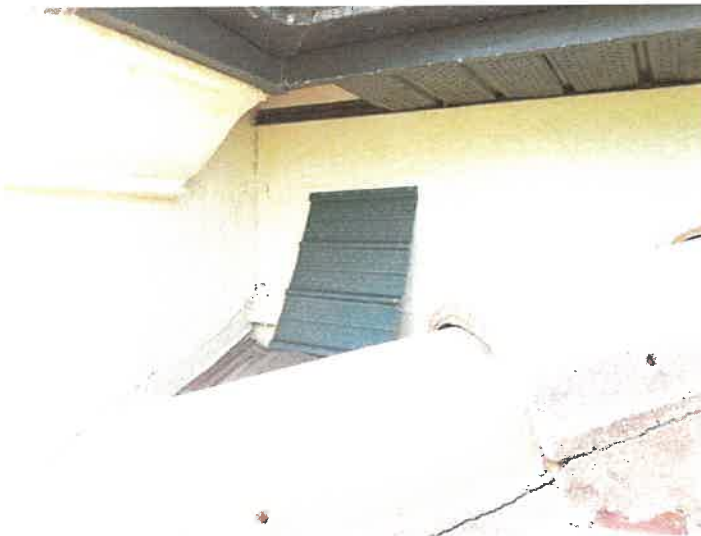
Building 15205: Loose Soffit
Identified 2-feet of loose soffit.

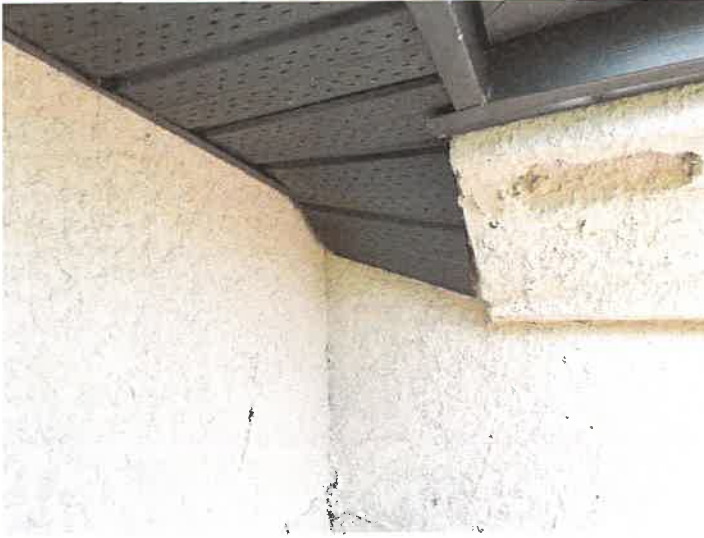
Building 15205: Loose Soffit
Identified 2-feet of loose soffit.

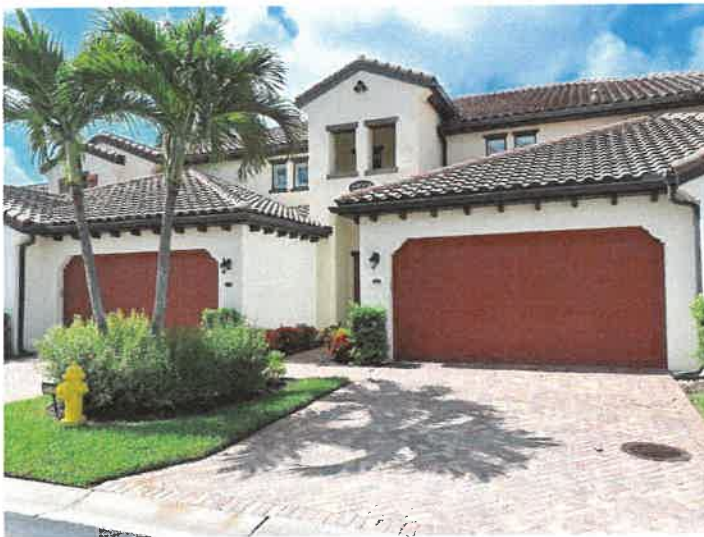
Building 15205: Downspouts
The downspouts appear to be in good condition.

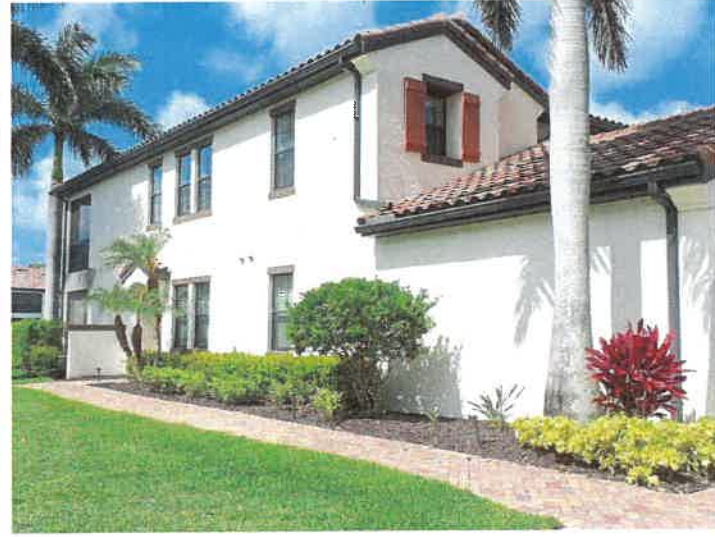
Building 15205: Downspouts
The downspouts appear to be in good condition.

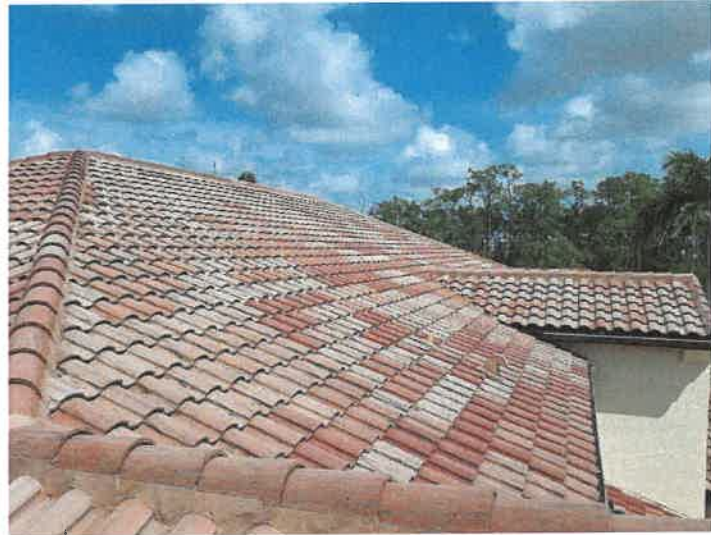
Building 15209: Surface Overview
The roof surface appears to be in good, maintainable condition at this time.

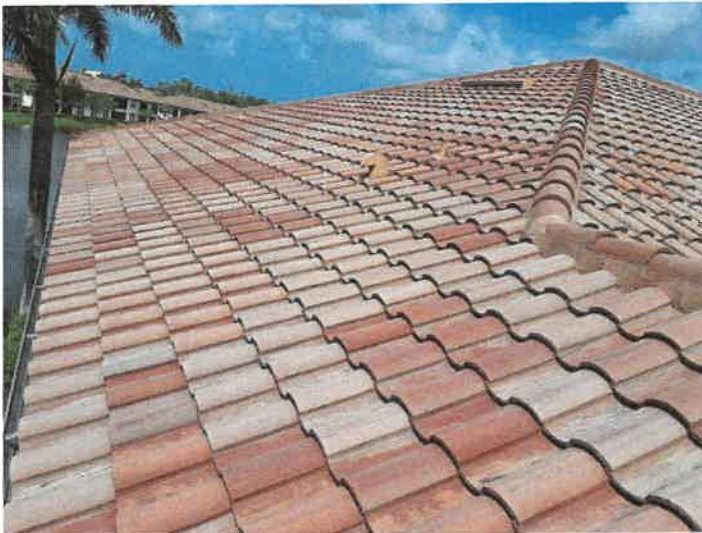
Building 15209: Appearance Overview
The roof appearance is in good, maintainable condition.

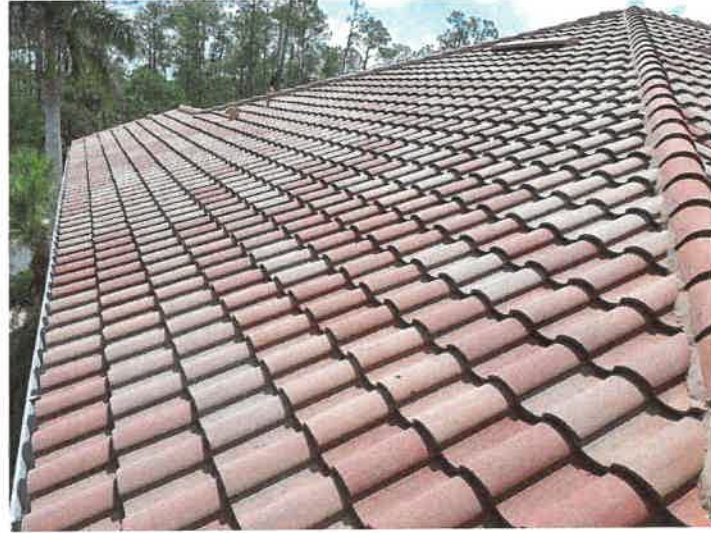
Building 15209: Surface Overview
The roof surface appears to be in good, maintainable condition at this time.

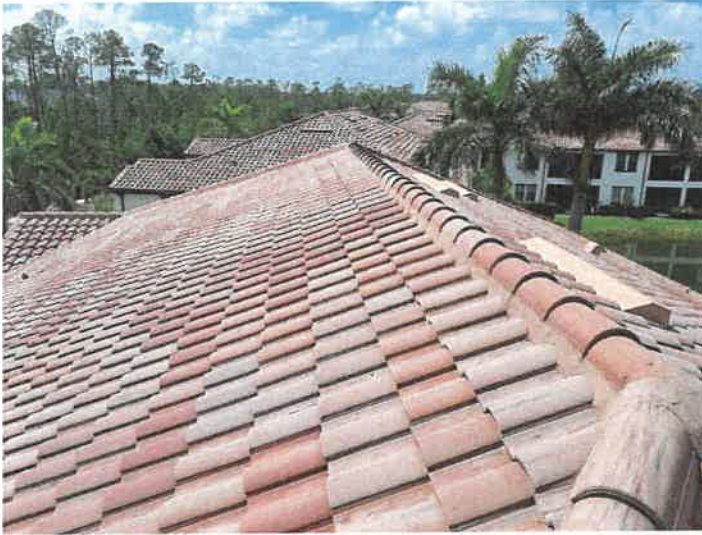
Building 15209: Ridge Tiles

Ridge tiles appear to be in good condition.

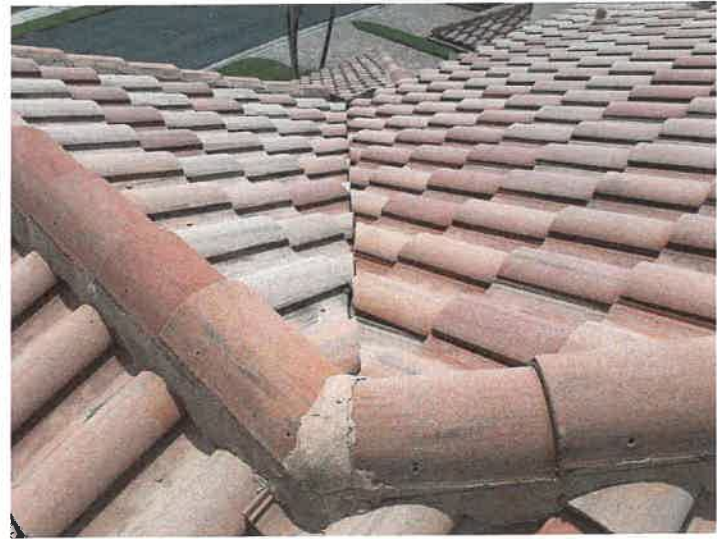
Building 15209: Valley

The valley tiles appear to be in good condition.

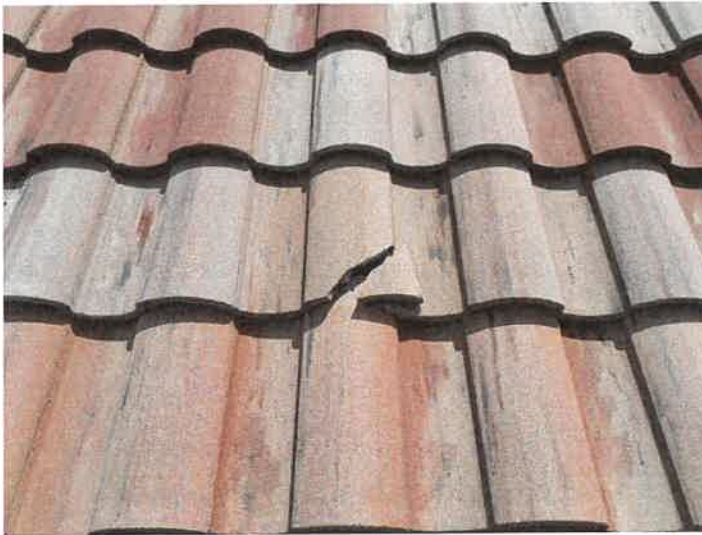
Building 15209: Identified Cracked Roof Tiles

Cracked roof tiles can allow premature underlayment deterioration from excessive UV exposure.

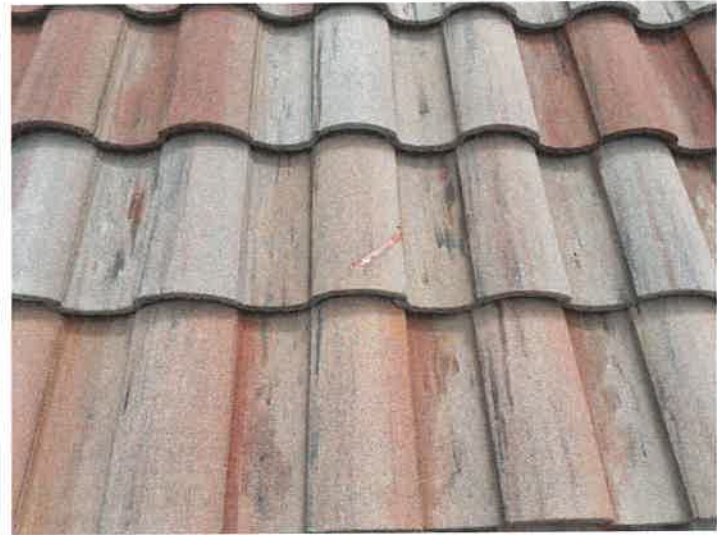
Building 15209: Repaired Cracked Roof Tiles

The cracked roof tiles were repaired with Titebond sealant.

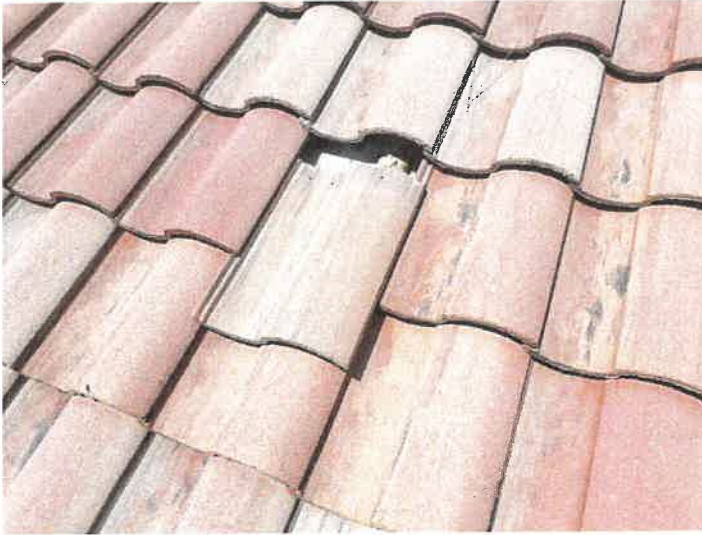
Displaced/Missing Roof Tile

Displaced or missing roof tiles can allow premature underlayment deterioration from excessive UV exposure and potential water intrusion.

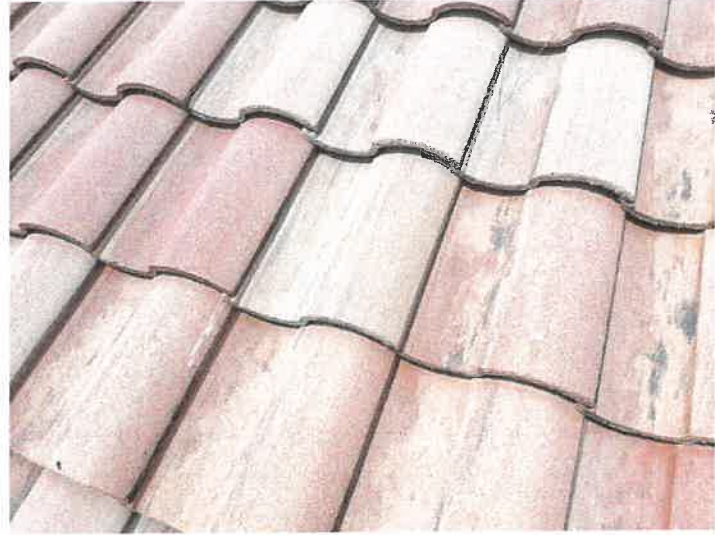
Repaired Displaced/Missing Roof Tile

Replaced and secured the missing roof tile.

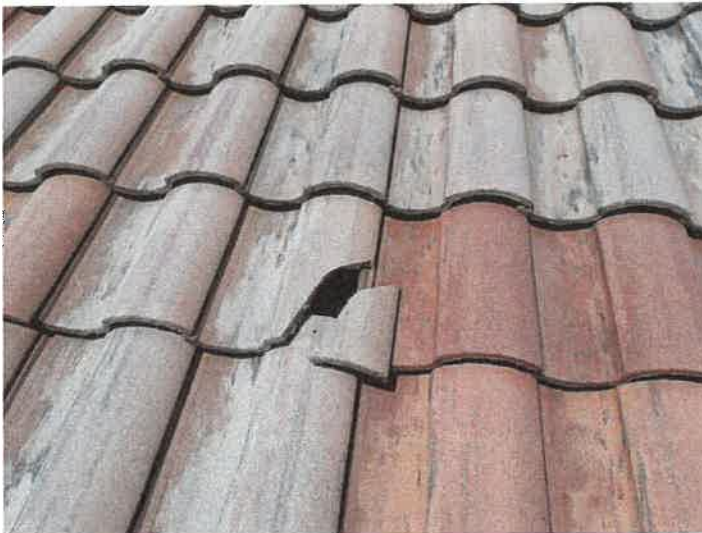
Building 15209: Identified Cracked Roof Tiles

Cracked roof tiles can allow premature underlayment deterioration from excessive UV exposure.

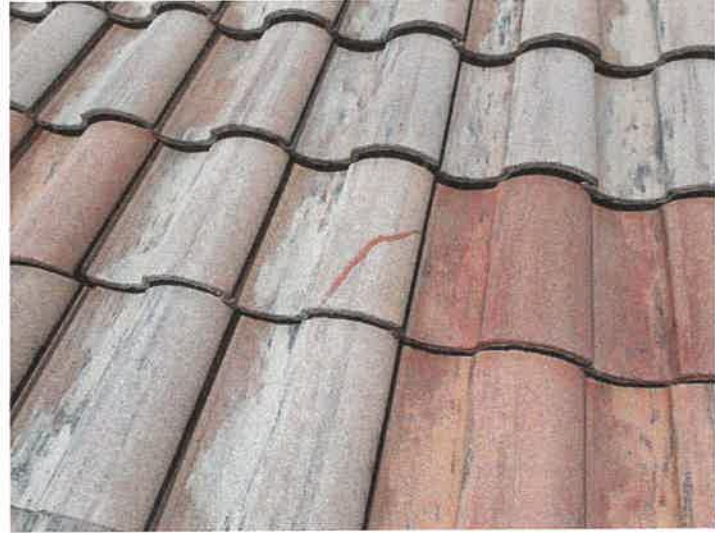
Building 15209: Repaired Cracked Roof Tiles

The cracked roof tiles were repaired with Titebond sealant.

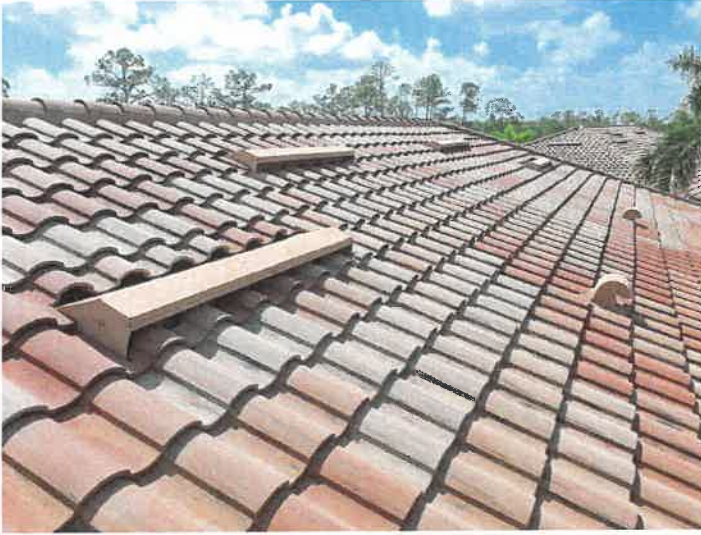
Building 15209: Roof Vents
Roof vents appear to be in good condition.

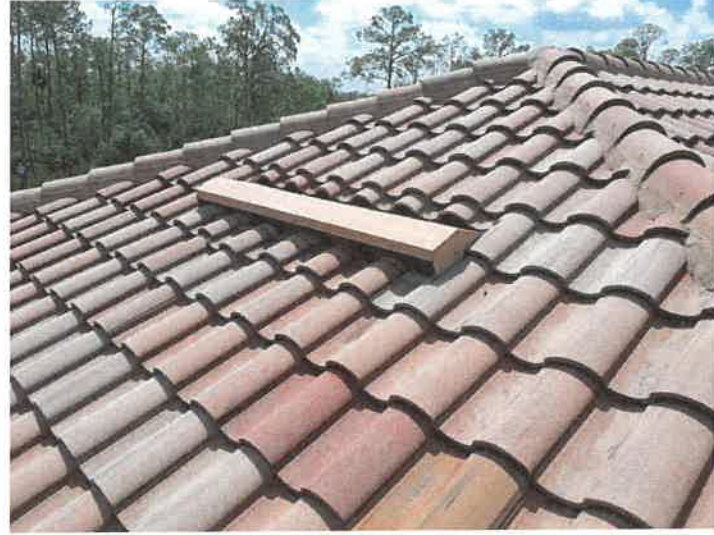
Building 15209: Roof Vents
Roof vents appear to be in good condition.

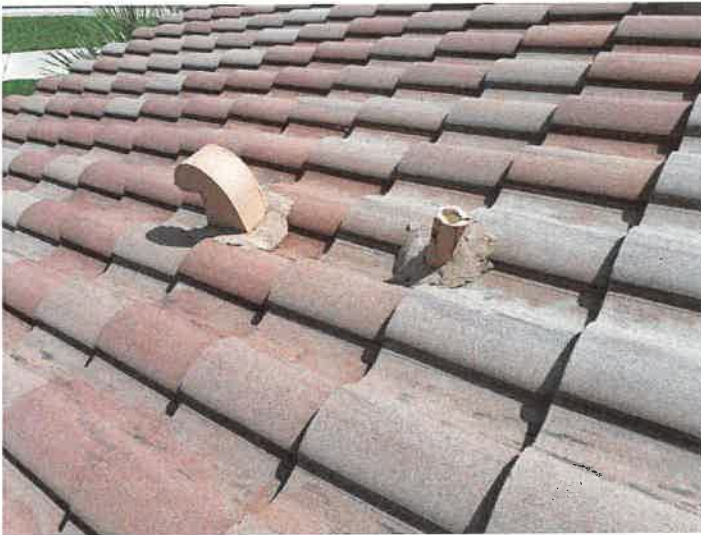
Building 15209: Lead Boots
Lead boots appear to be in good condition.

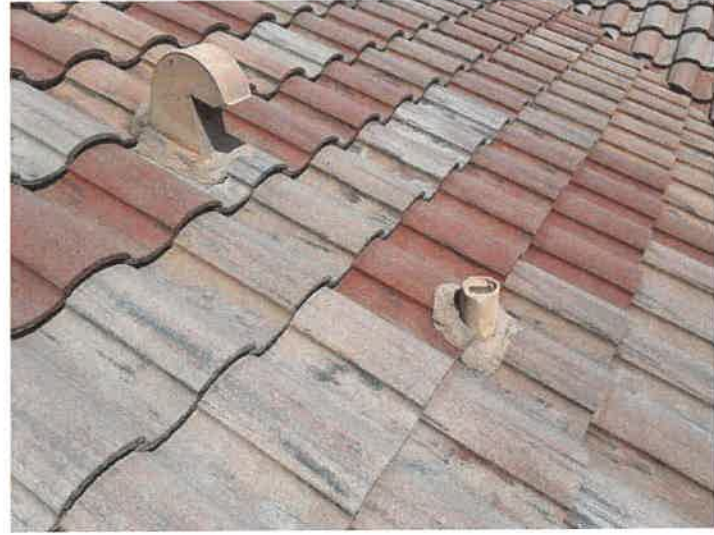
Building 15209: Lead Boots
Lead boots appear to be in good condition.

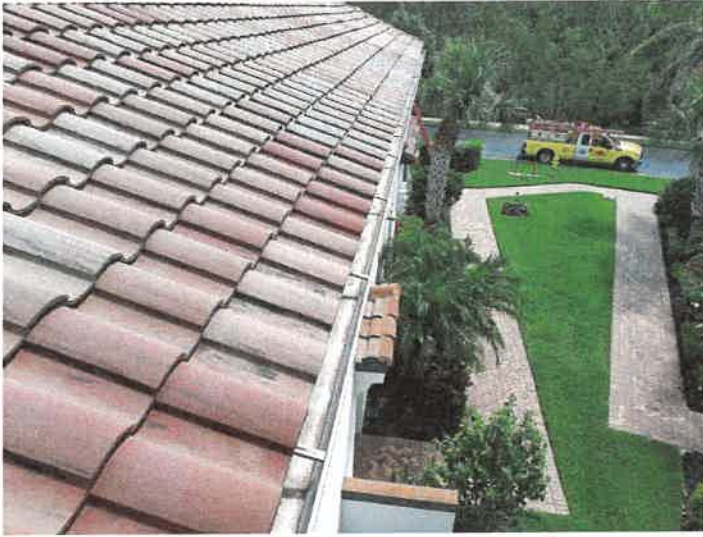
Building 15209: Gutters

The gutters appear to be in good condition.

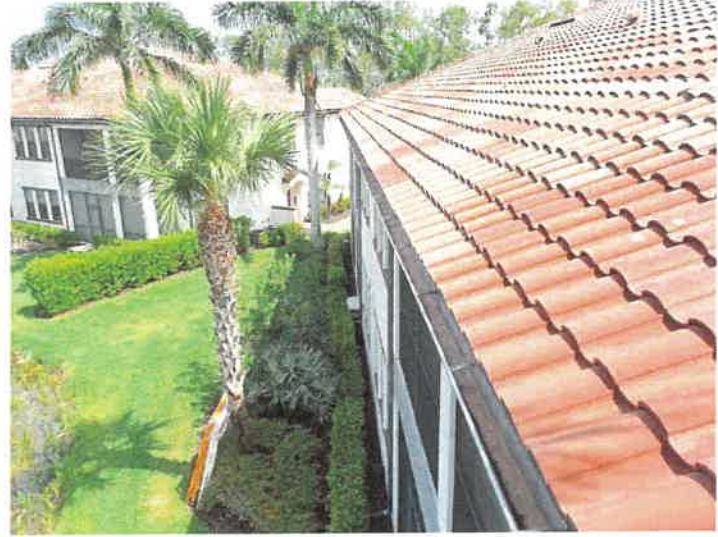
Building 15209: Gutters

The gutters appear to be in good condition.

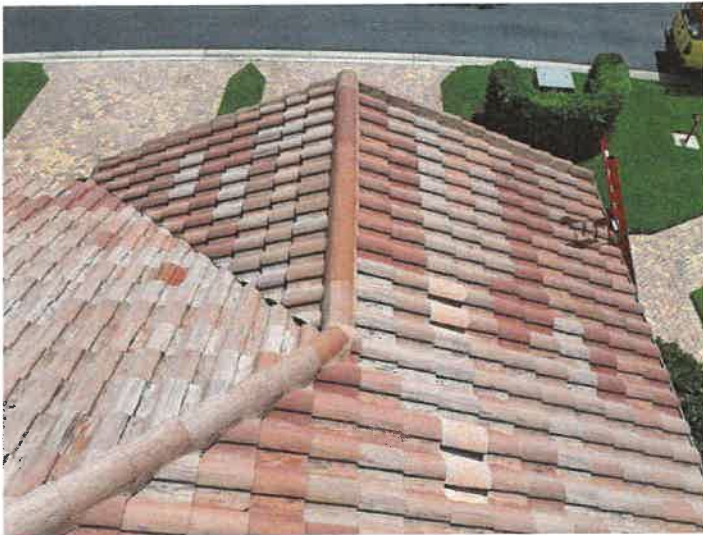
Building 15209: Surface Overview - Lower Roof

The roof surface appears to be in good, maintainable condition at this time.

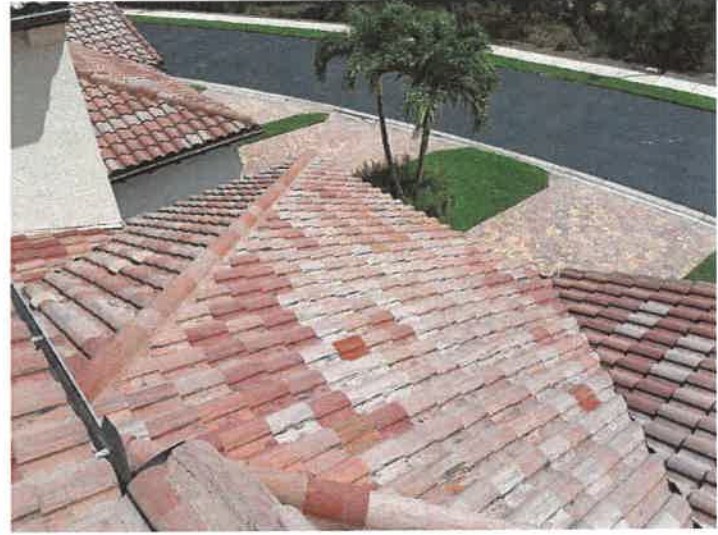
Building 15209: Appearance Overview - Lower Roof

The roof appearance is in good, maintainable condition.
