Inspection Report

Facility: Livingston Lakes Condo

Work Order #: 13028

Re.: **Inspection Report (2 of 3) for Livingston Lakes**

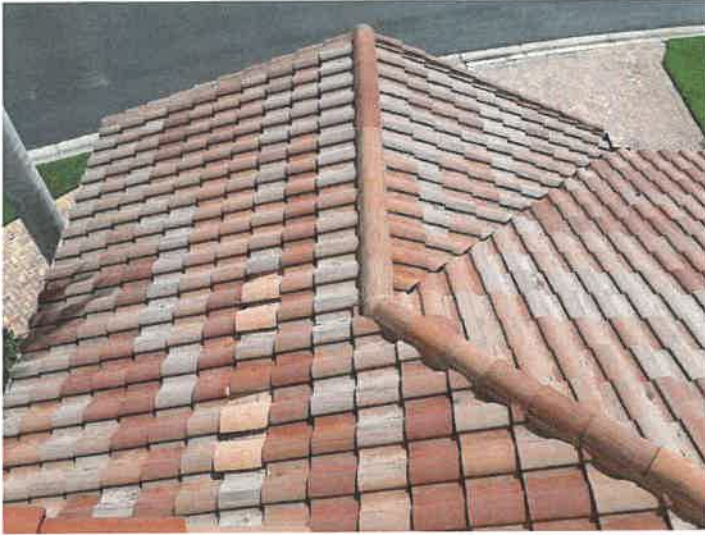
Building 15209: Surface Overview - Lower Roof
The roof surface appears to be in good, maintainable condition at this time.

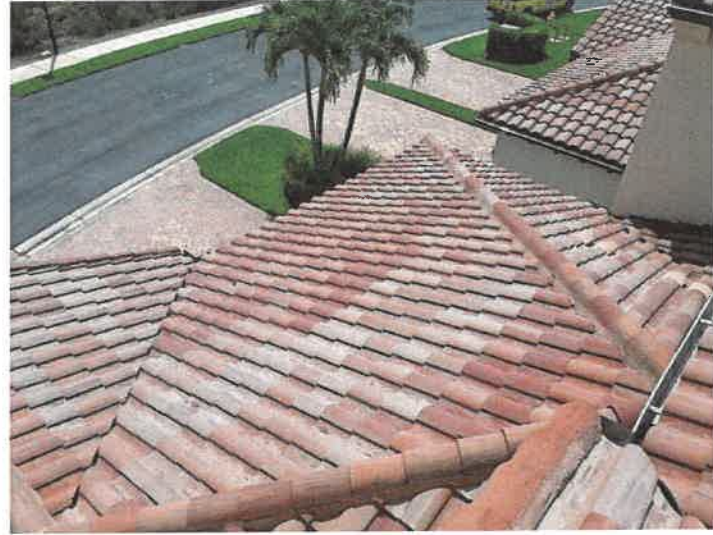
Building 15209: Appearance Overview - Lower Roof
The roof appearance is in good, maintainable condition.

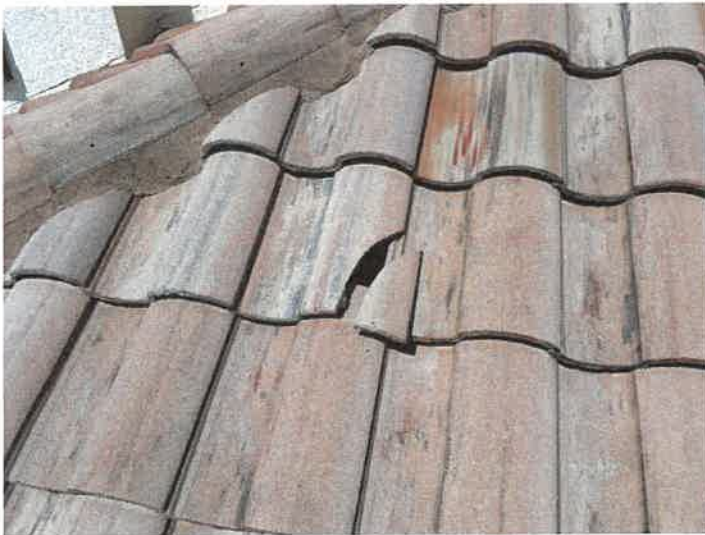
Building 15209: Identified Cracked Roof Tiles
Cracked roof tiles can allow premature underlayment deterioration from excessive UV exposure.

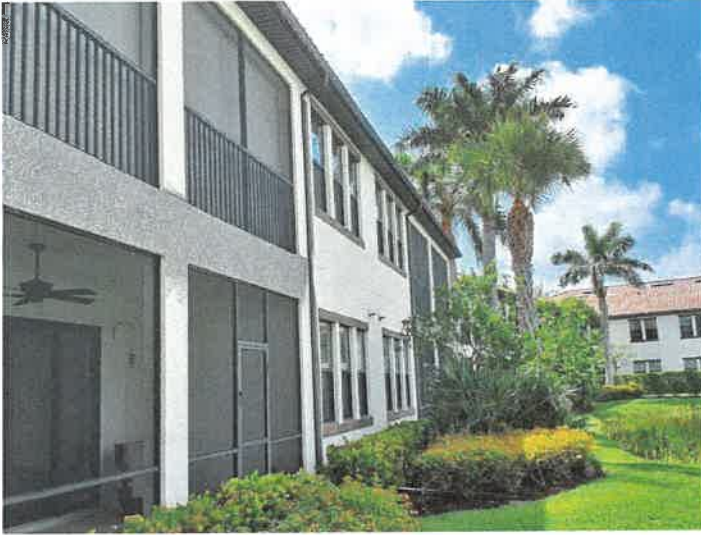
Building 15209: Downspouts
The downspouts appear to be in good condition.

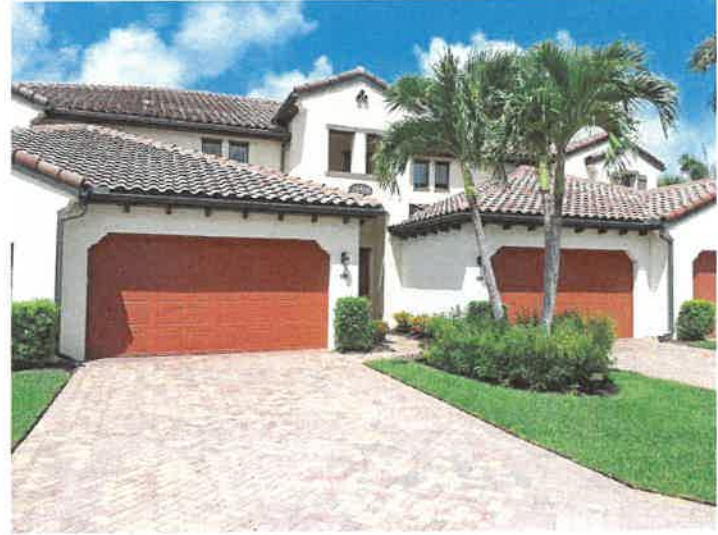
Building 15209: Downspouts
The downspouts appear to be in good condition.

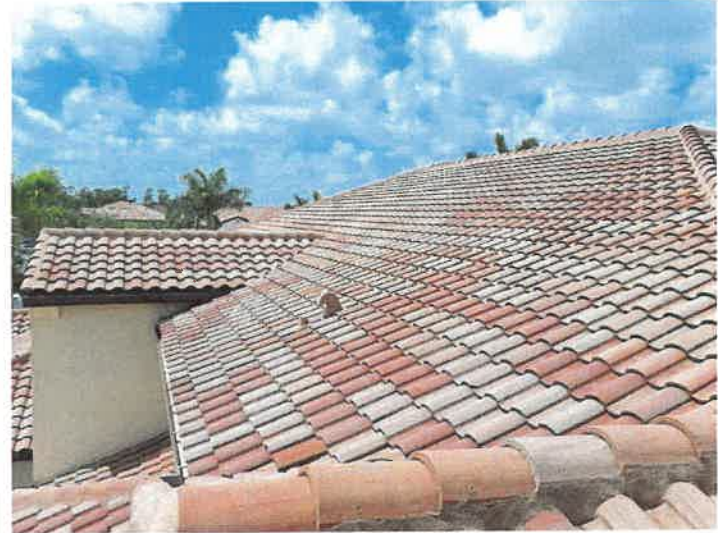
Building 15213: Surface Overview
The roof surface appears to be in good, maintainable condition at this time.

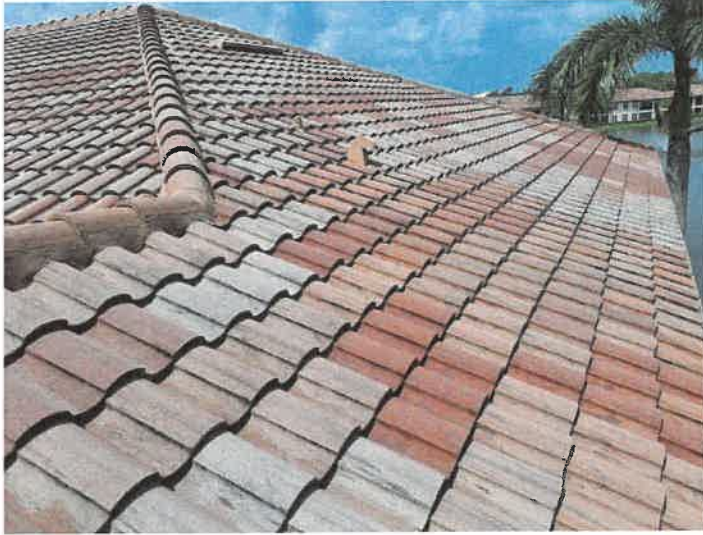
Building 15213: Appearance Overview

The roof appearance is in good, maintainable condition.

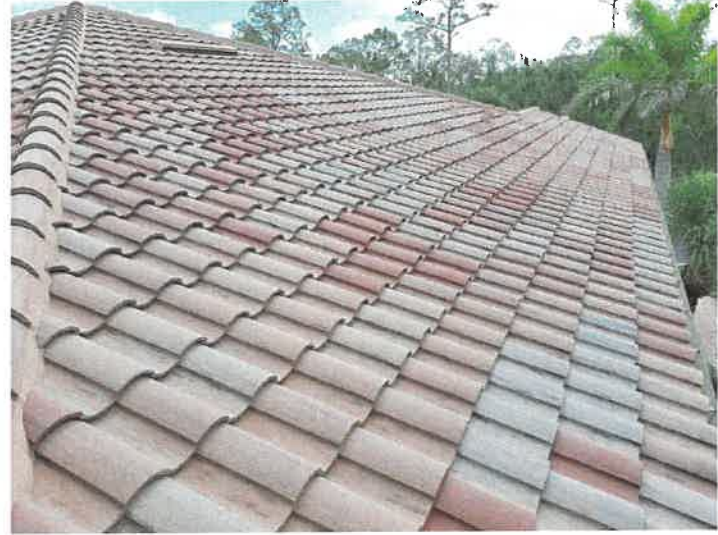
Building 15213: Surface Overview

The roof surface appears to be in good, maintainable condition at this time.

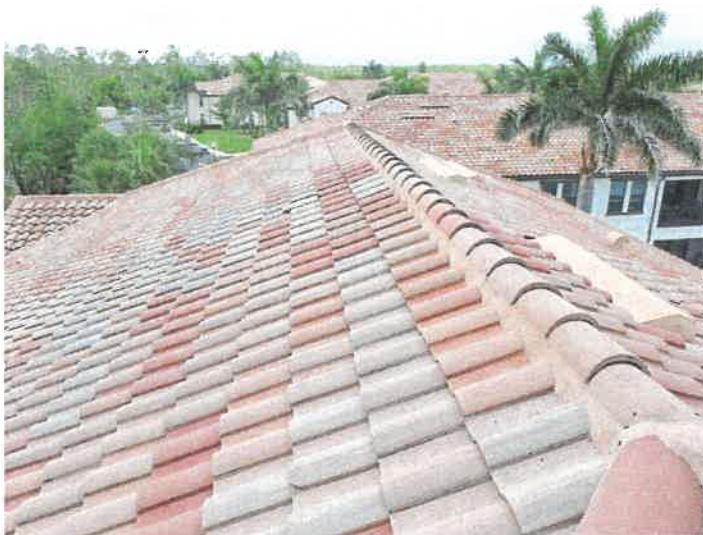
Building 15213: Ridge Tiles

Ridge tiles appear to be in good condition.

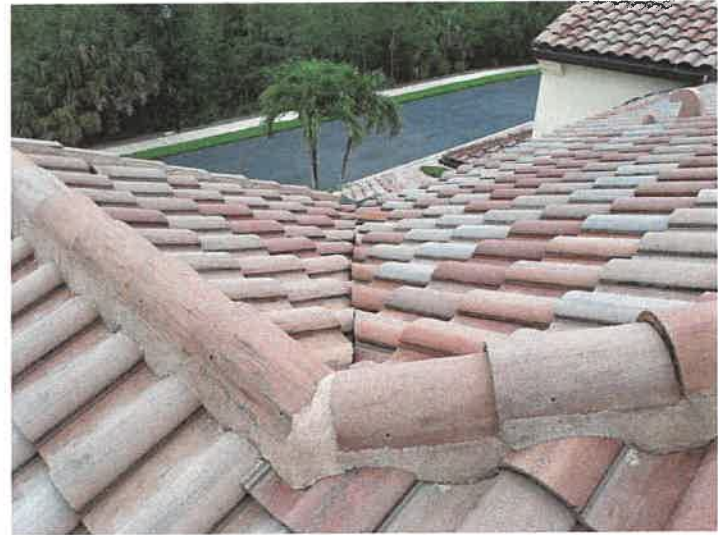
Building 15213: Valley

The valley tiles appear to be in good condition.

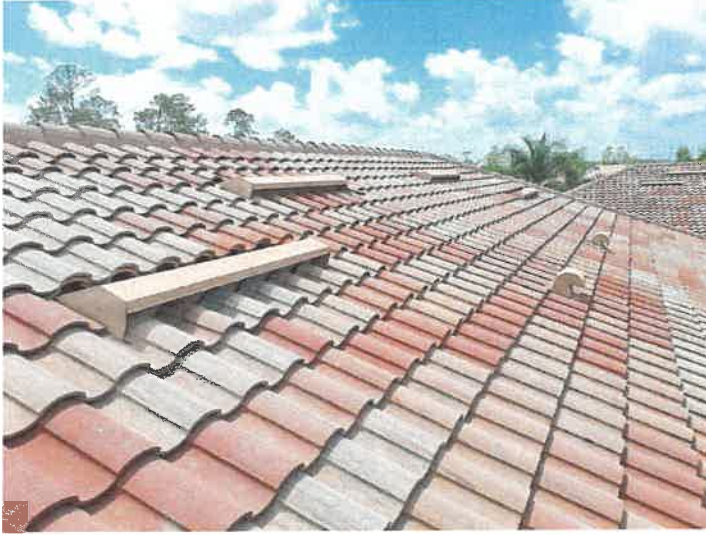
Building 15213: Roof Vents

Roof vents appear to be in good condition.

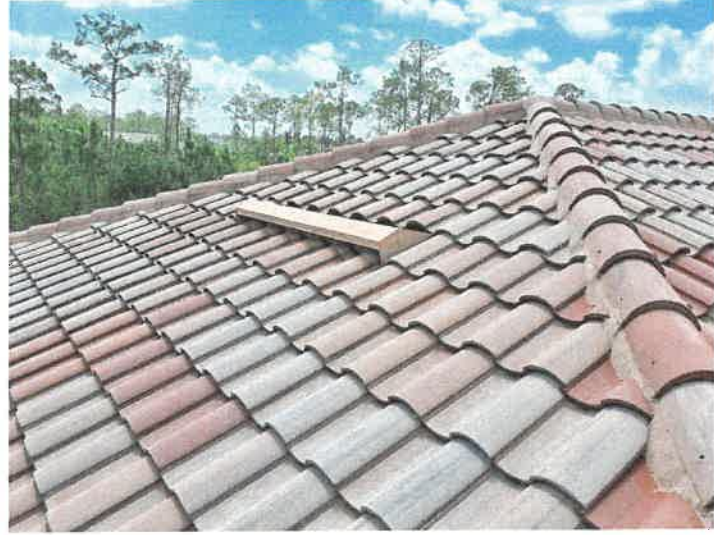
Building 15213: Roof Vents

Roof vents appear to be in good condition.

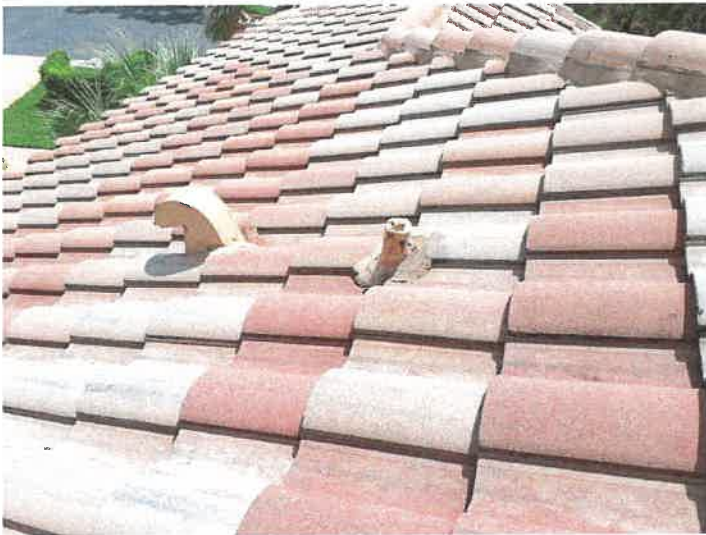
Building 15213: Lead Boots

Lead boots appear to be in good condition.

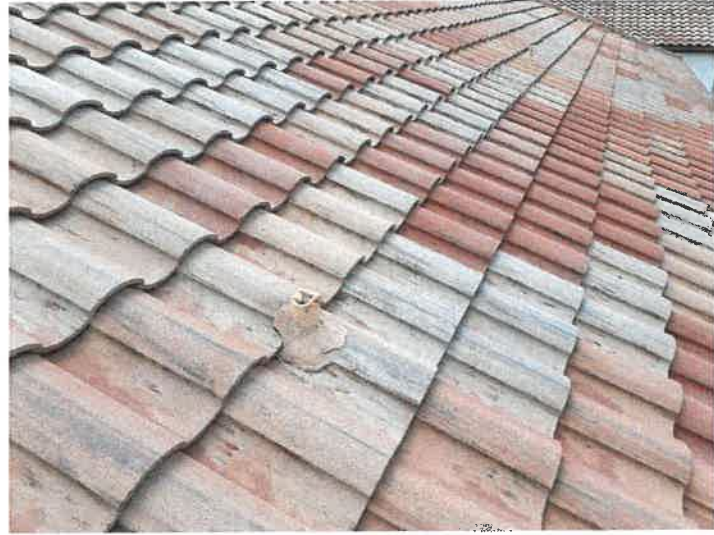
Building 15213: Lead Boots

Lead boots appear to be in good condition.

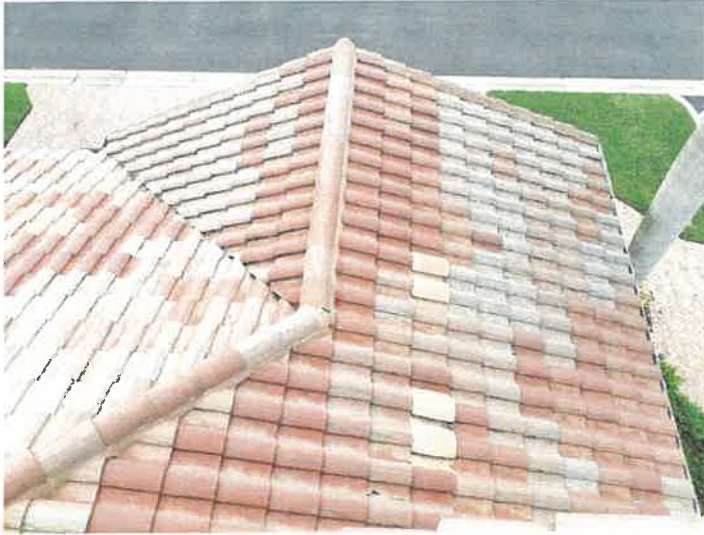
Building 15213: Surface Overview - Lower Roof
The roof surface appears to be in good, maintainable condition at this time.

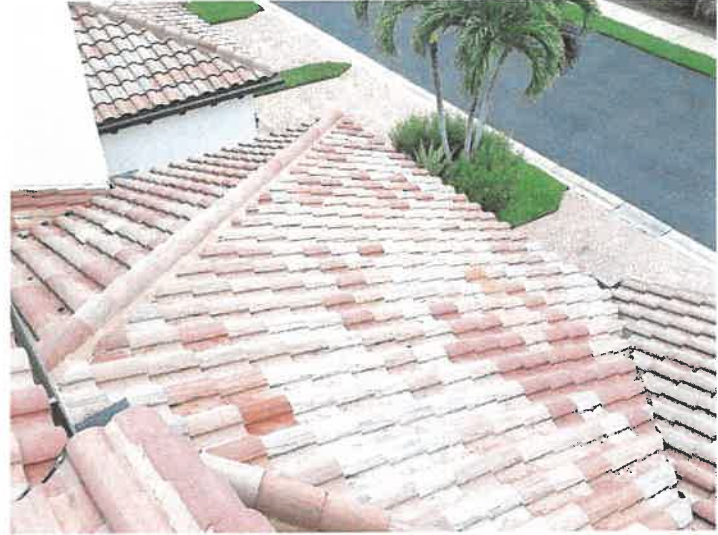
Building 15213: Appearance Overview - Lower Roof
The roof appearance is in good, maintainable condition.

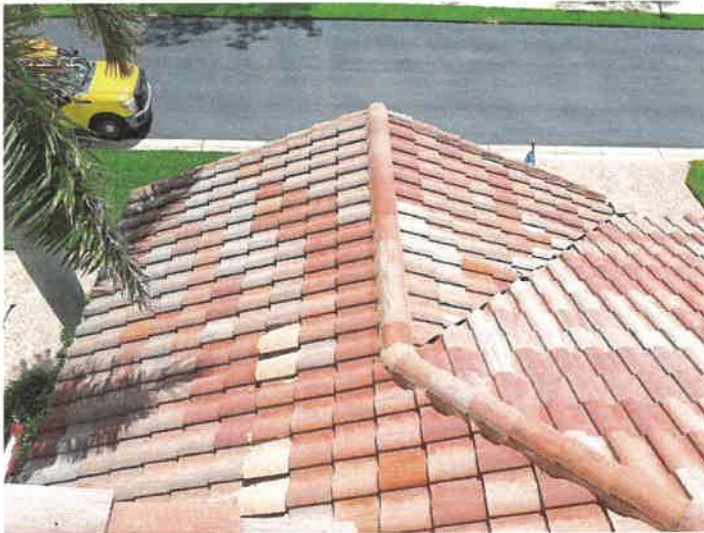
Building 15213: Surface Overview - Lower Roof
The roof surface appears to be in good, maintainable condition at this time.

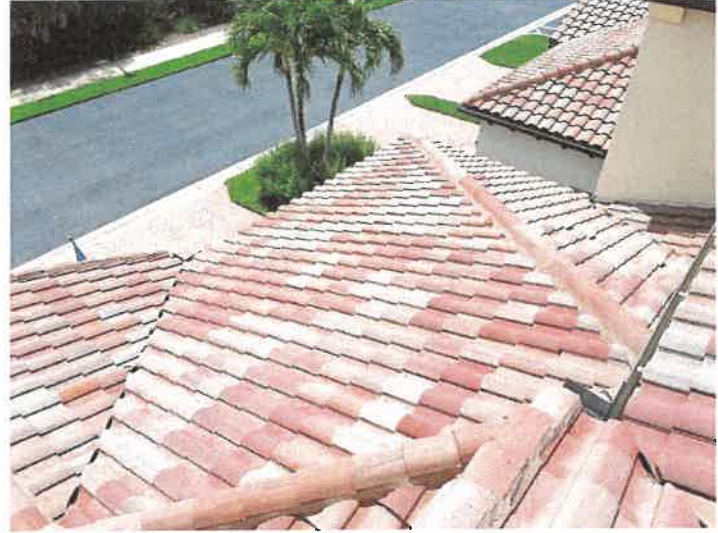
Building 15213: Appearance Overview - Lower Roof
The roof appearance is in good, maintainable condition.

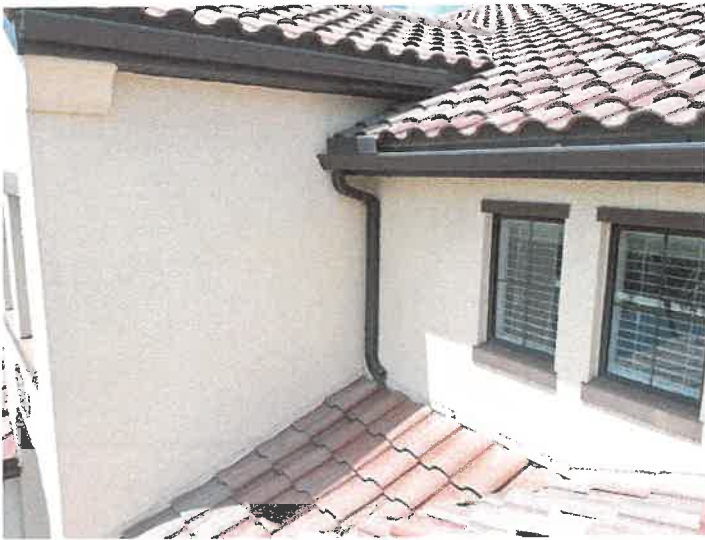
Building 15213: Wall

The walls appear to be in good condition.

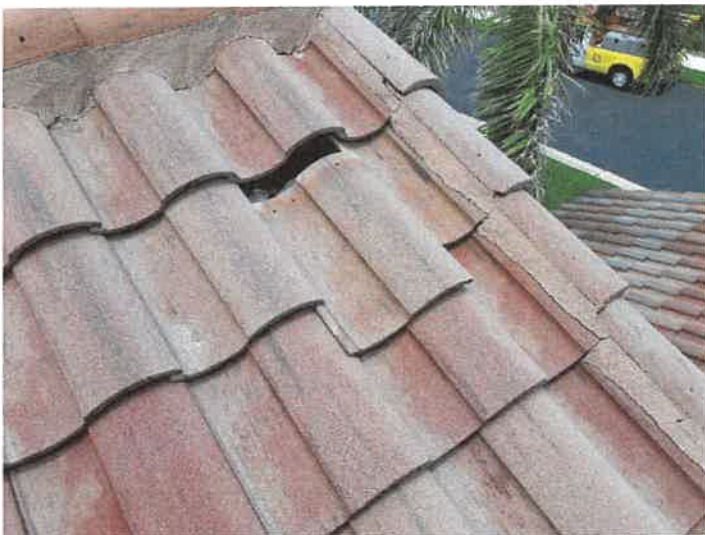
Building 15213: Counter Flashings

The counter flashing appears to be in good condition.

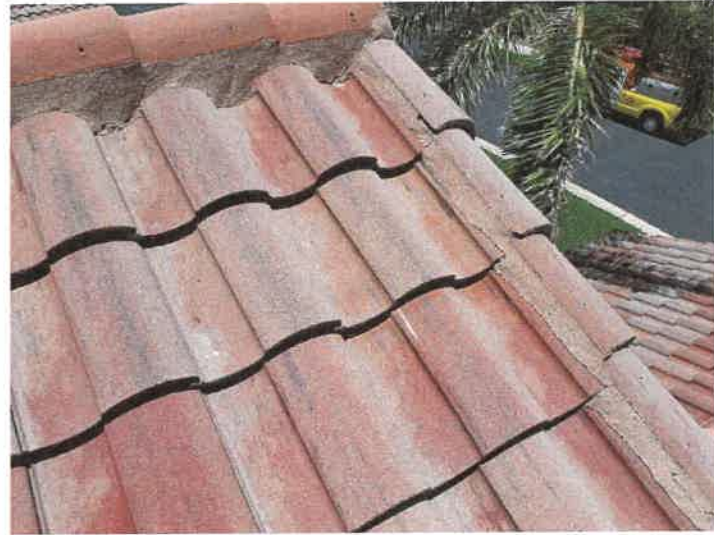
Building 15213: Displaced/Missing Roof Tile

Displaced or missing roof tiles can allow premature underlayment deterioration from excessive UV exposure and potential water intrusion.

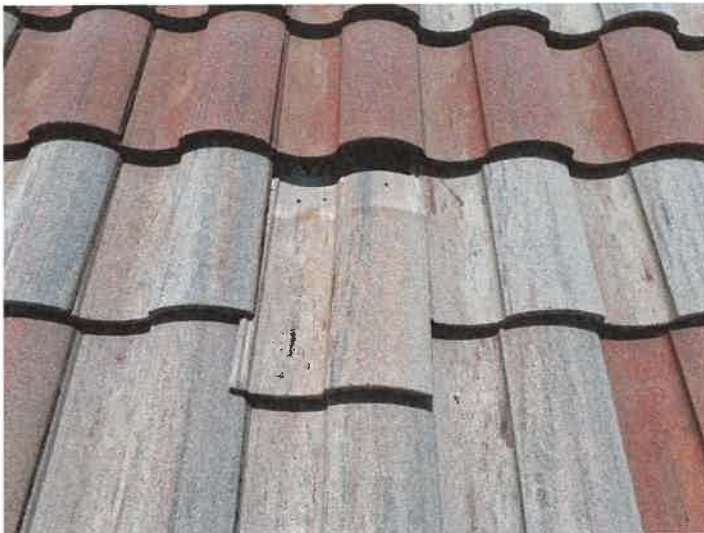
Building 15213: Displaced/Missing Roof Tile

Displaced or missing roof tiles can allow premature underlayment deterioration from excessive UV exposure and potential water intrusion.

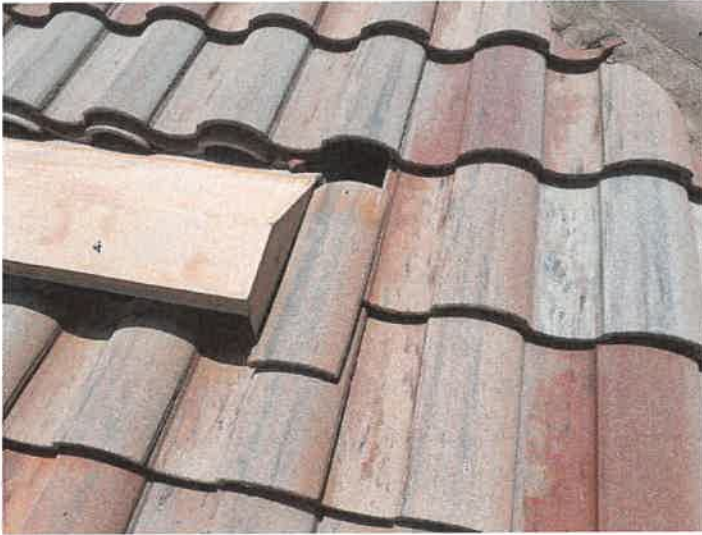
Building 15213: Displaced/Missing Roof Tile

Displaced or missing roof tiles can allow premature underlayment deterioration from excessive UV exposure and potential water intrusion.

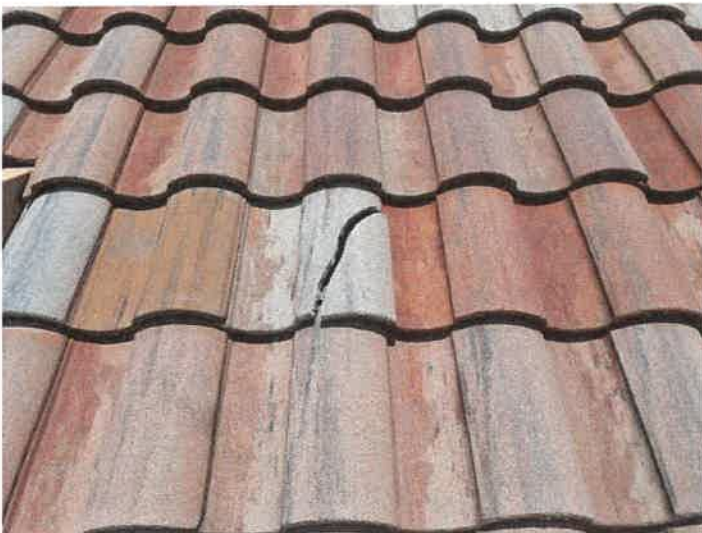
Building 15213: Identified Cracked Roof Tiles

Cracked roof tiles can allow premature underlayment deterioration from excessive UV exposure.

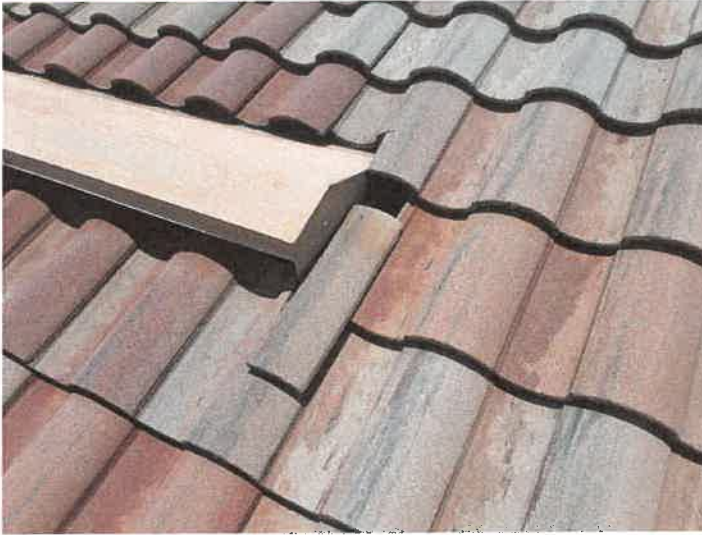
Building 15213: Displaced/Missing Roof Tile

Displaced or missing roof tiles can allow premature underlayment deterioration from excessive UV exposure and potential water intrusion.

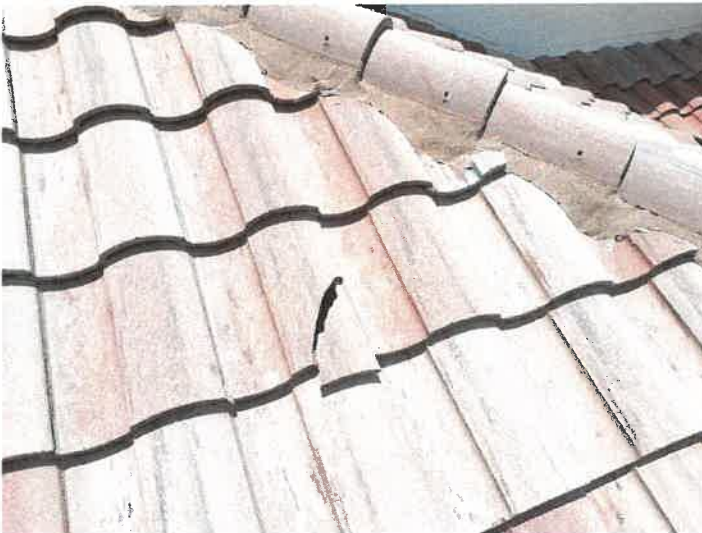
Building 15213: Identified Cracked Roof Tiles

Cracked roof tiles can allow premature underlayment deterioration from excessive UV exposure.

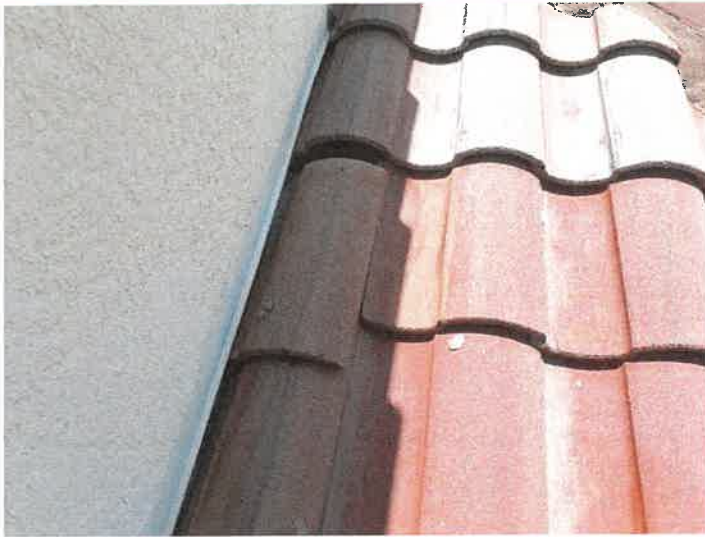
Building 15213: Displaced/Missing Roof Tile

Displaced or missing roof tiles can allow premature underlayment deterioration from excessive UV exposure and potential water intrusion.

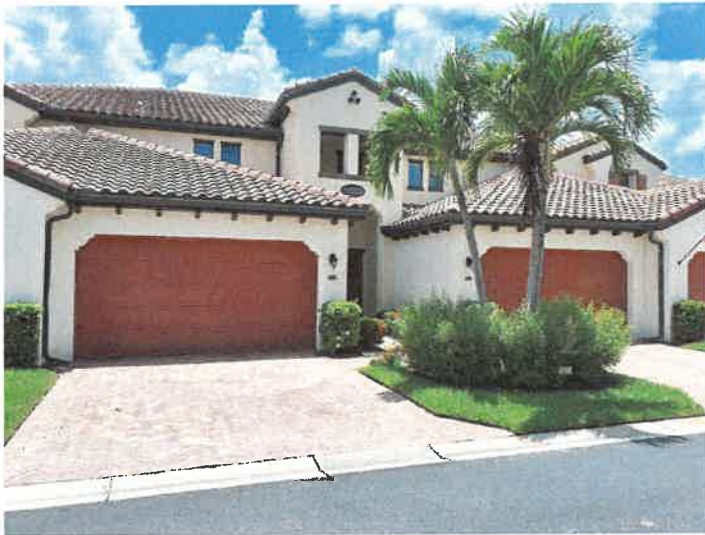
Building 15213: Downspouts

The downspouts appear to be in good condition.

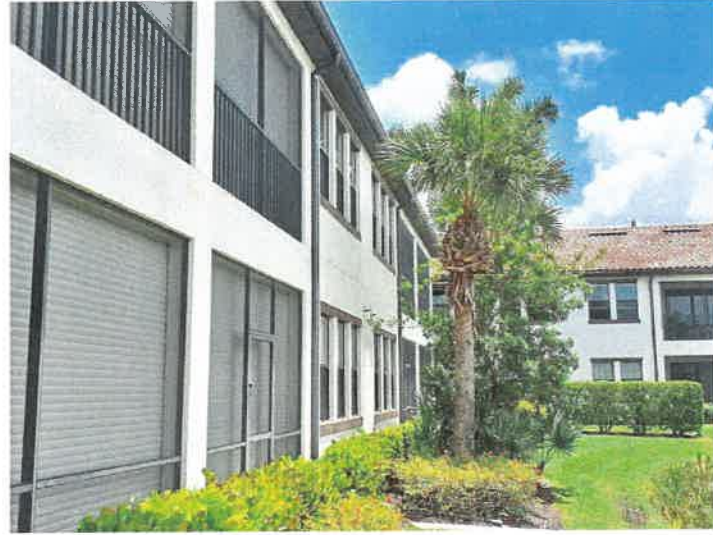
Building 15213: Downspouts

The downspouts appear to be in good condition.
