Inspection Report

Facility: Livingston Lakes Condo
Address: 15098 Palmer Lake Circle,
Naples, FL 34109
Customer: Cardinal Management
Address: c/o Livingston Lakes Condo, 15090
Naples, FL 34109

Livingston Lakes Condo, Naples, FL

Re.: **Inspection Report (2 of 3) for Livingston Lakes**

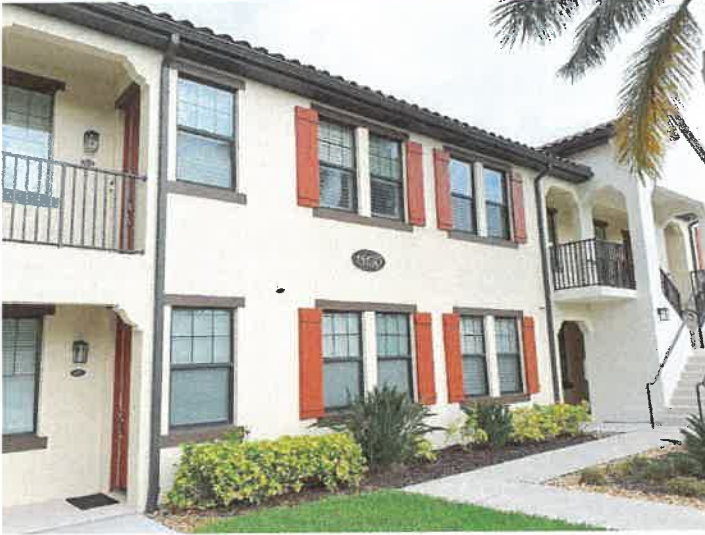
Building 15130: Downspouts

The downspouts appear to be in good condition.

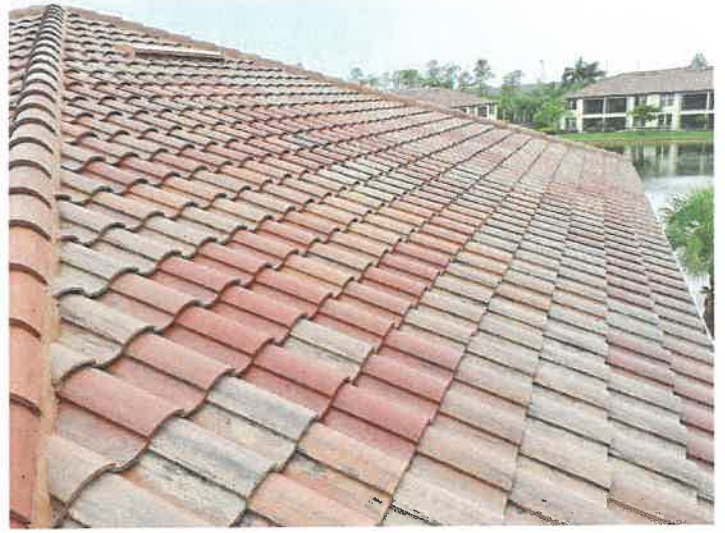
Building 15136: Surface Overview

The roof surface appears to be in good, maintainable condition at this time.

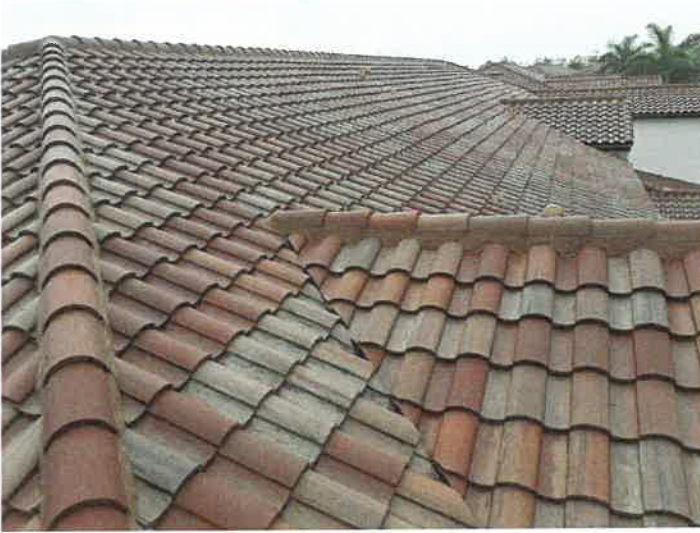
Building 15136: Appearance Overview

The roof appearance is in good, maintainable condition.

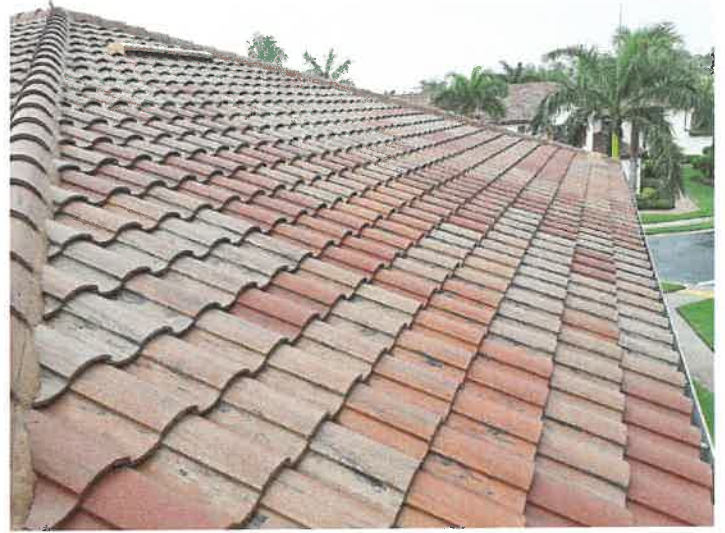
Building 15136: Surface Overview

The roof surface appears to be in good, maintainable condition at this time.

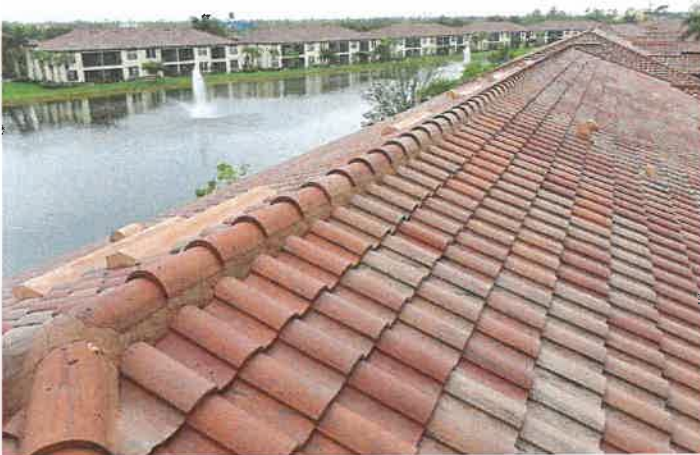
Building 15136: Ridge Tiles

Ridge tiles appear to be in good condition.

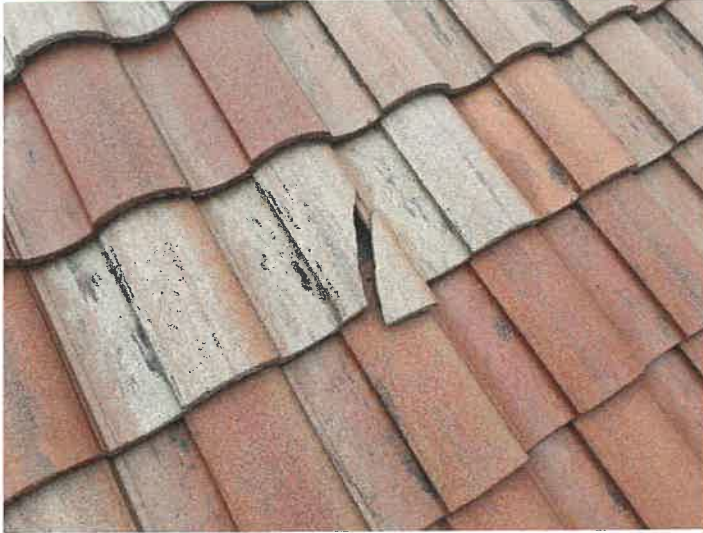
Building 15136: Identified Cracked Roof Tiles

Cracked roof tiles can allow premature underlayment deterioration from excessive UV exposure.

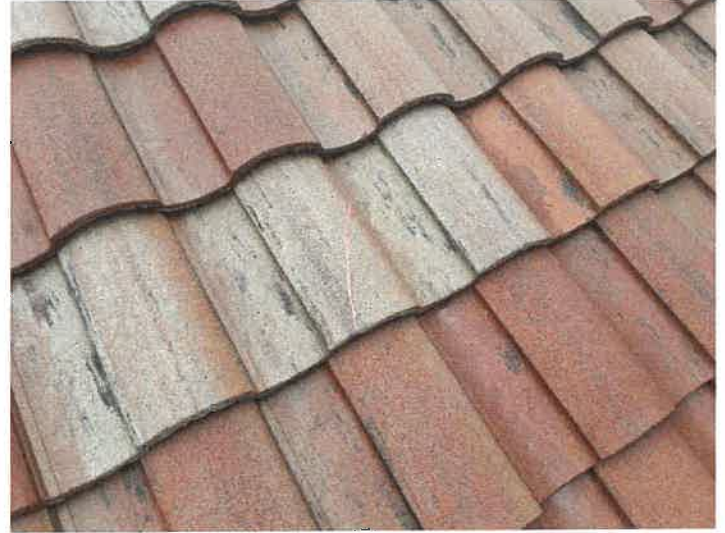
Building 15136: Repaired Cracked Roof Tiles

The cracked roof tiles were repaired with Titebond sealant.

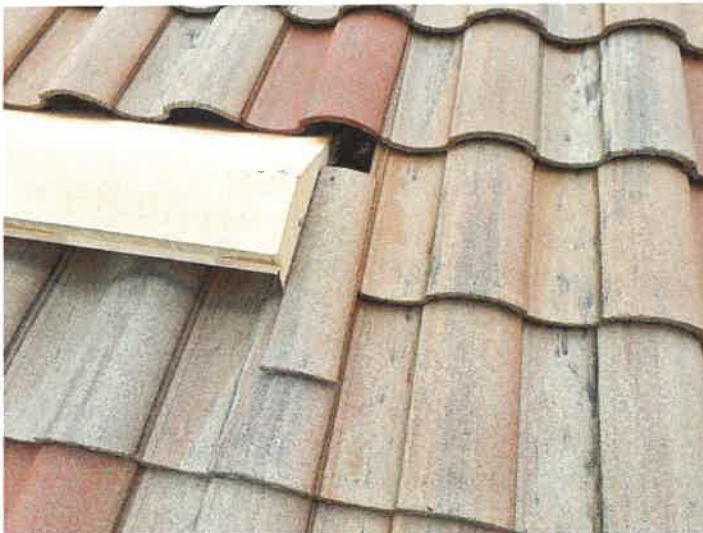
Building 15136: Displaced/Missing Roof Tile

Displaced or missing roof tiles can allow premature underlayment deterioration from excessive UV exposure and potential water intrusion.

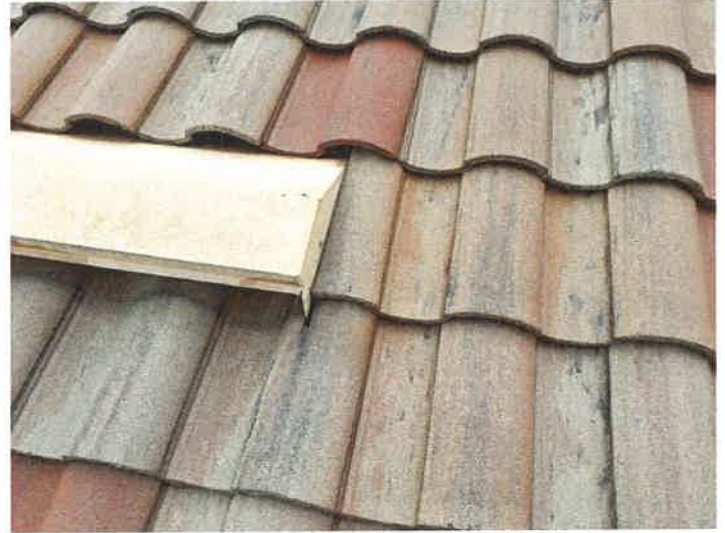
Building 15136: Repaired Displaced/Missing Roof Tile

Replaced and secured the missing roof tile.

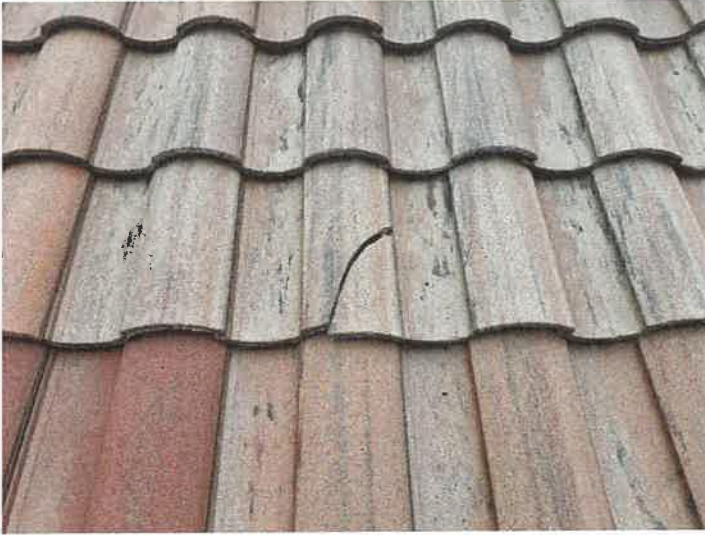
Building 15136: Identified Cracked Roof Tiles
Cracked roof tiles can allow premature underlayment deterioration from excessive UV exposure.

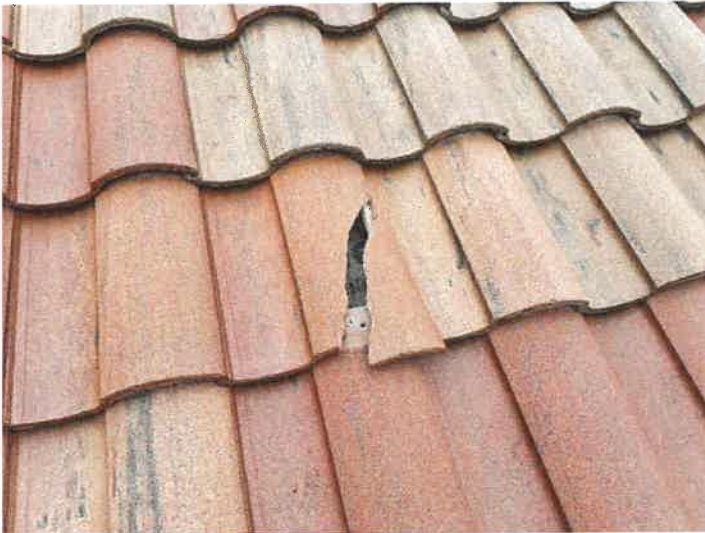
Building 15136: Identified Cracked Roof Tiles
Cracked roof tiles can allow premature underlayment deterioration from excessive UV exposure.

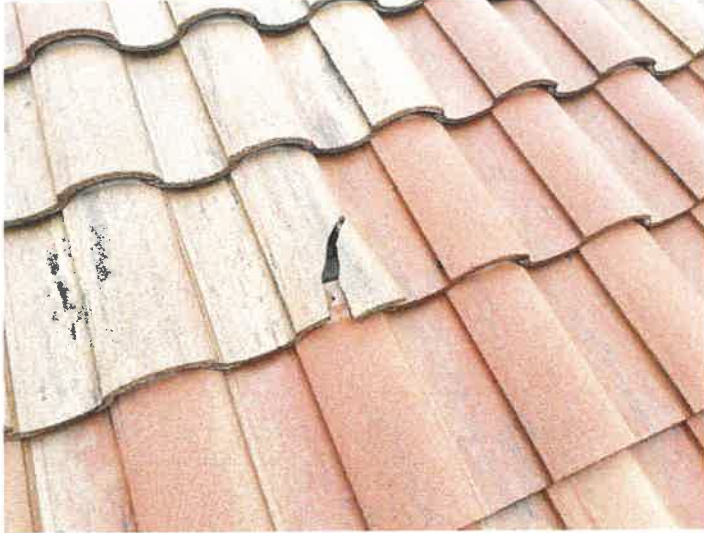
Building 15136: Identified Cracked Roof Tiles

Cracked roof tiles can allow premature underlayment deterioration from excessive UV exposure.

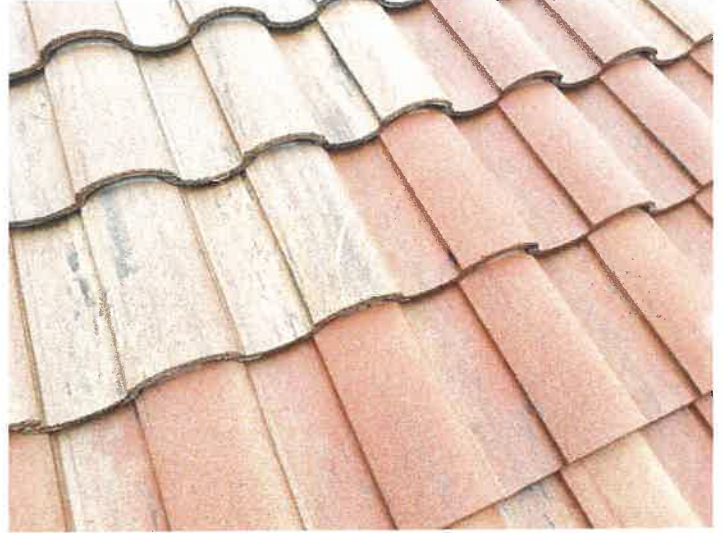
Building 15136: Repaired Cracked Roof Tiles

The cracked roof tiles were repaired with Titebond sealant.

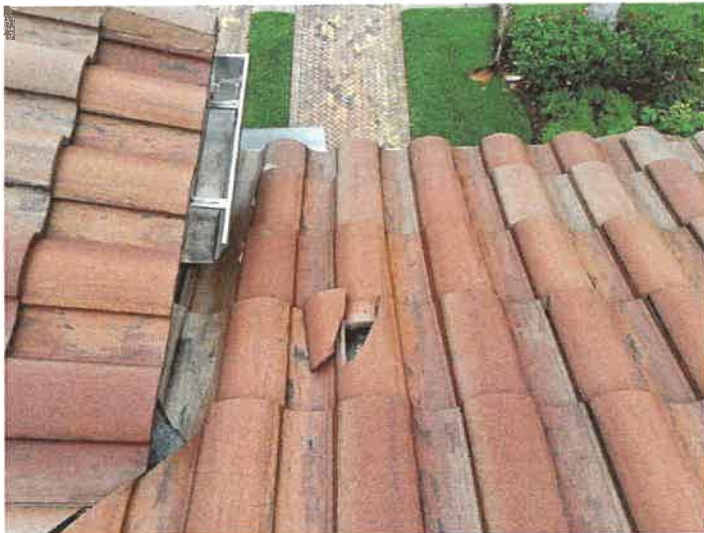
Building 15136: Identified Cracked Roof Tiles

Cracked roof tiles can allow premature underlayment deterioration from excessive UV exposure.

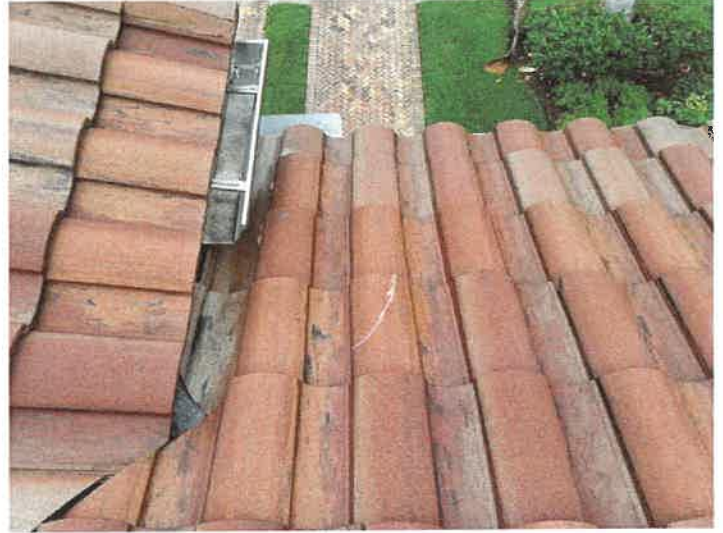
Building 15136: Repaired Cracked Roof Tiles

The cracked roof tiles were repaired with Titebond sealant.

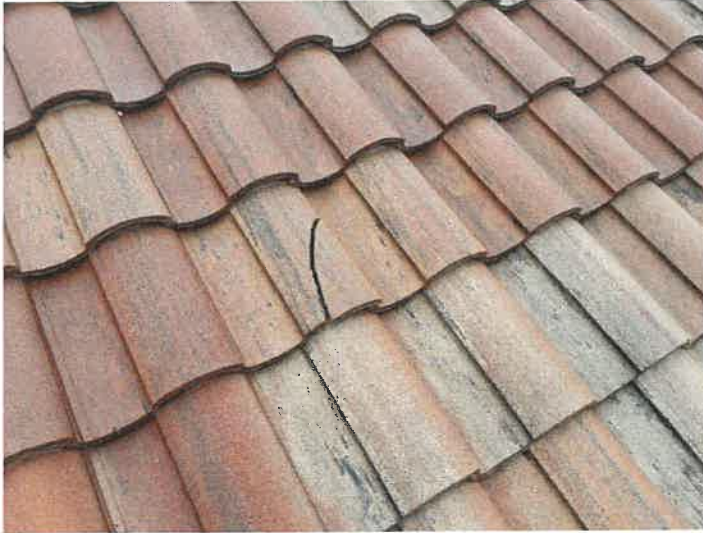
Building 15136: Identified Cracked Roof Tiles
Cracked roof tiles can allow premature underlayment deterioration from excessive UV exposure.

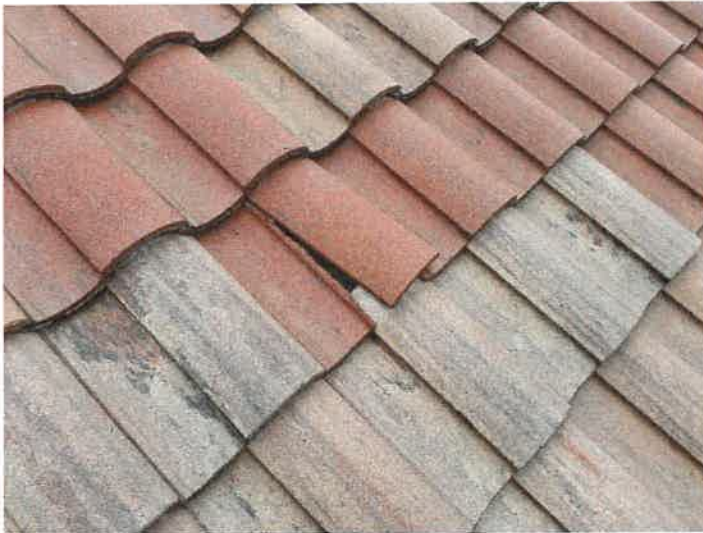
Building 15136: Identified Cracked Roof Tiles
Cracked roof tiles can allow premature underlayment deterioration from excessive UV exposure.

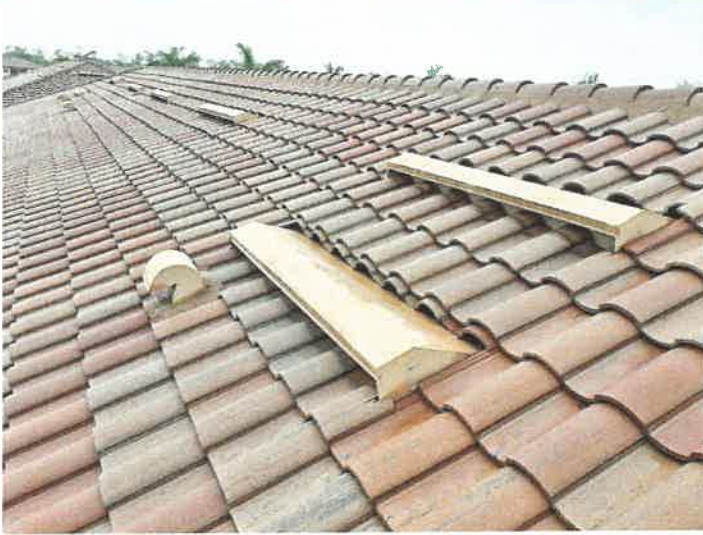
Building 15136: Roof Vents
Roof vents appear to be in good condition.

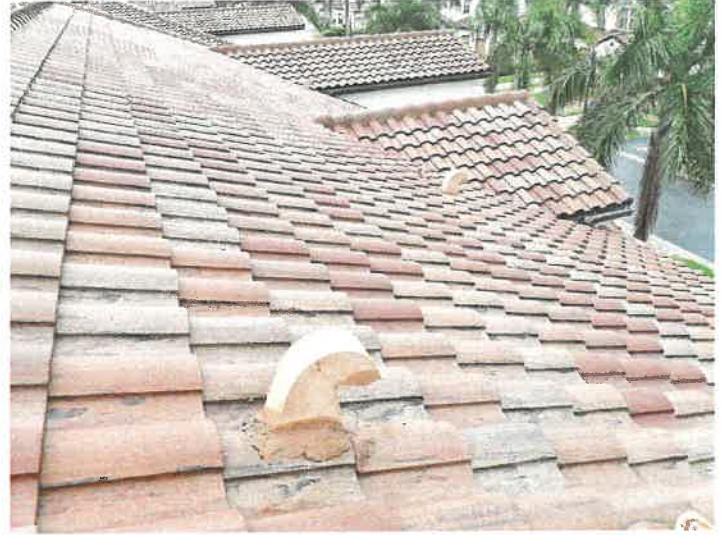
Building 15136: Roof Vents
Roof vents appear to be in good condition.

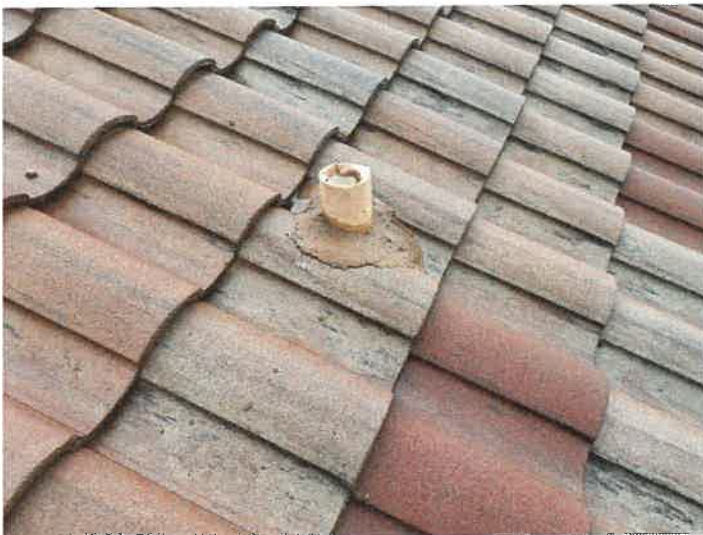
Building 15136: Lead Boots
Lead boots appear to be in good condition.

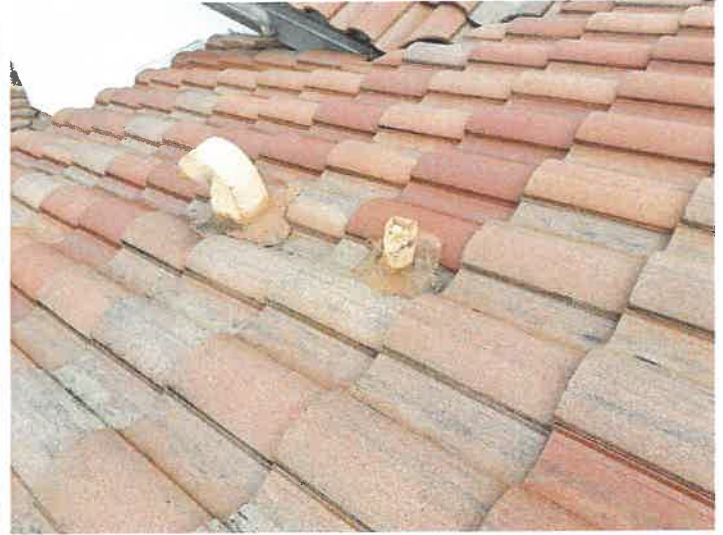
Building 15136: Lead Boots
Lead boots appear to be in good condition.

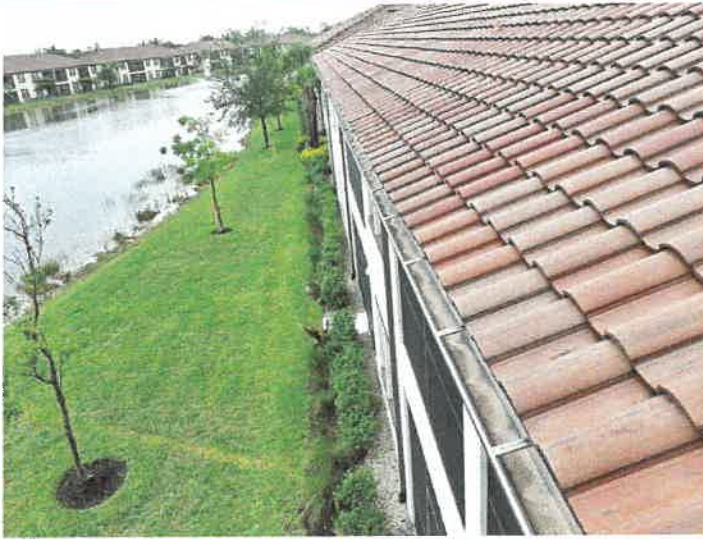
Building 15136: Gutters

The gutters appear to be in good condition.

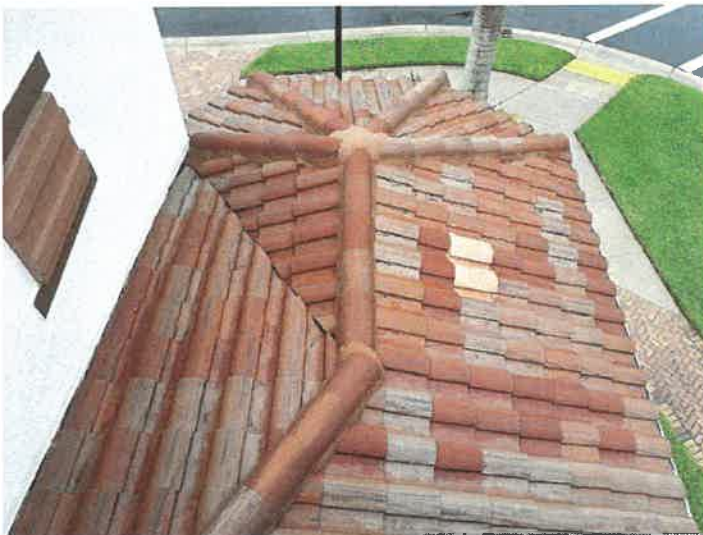
Building 15136: Surface Overview - Lower Roof

The roof surface appears to be in good, maintainable condition at this time.

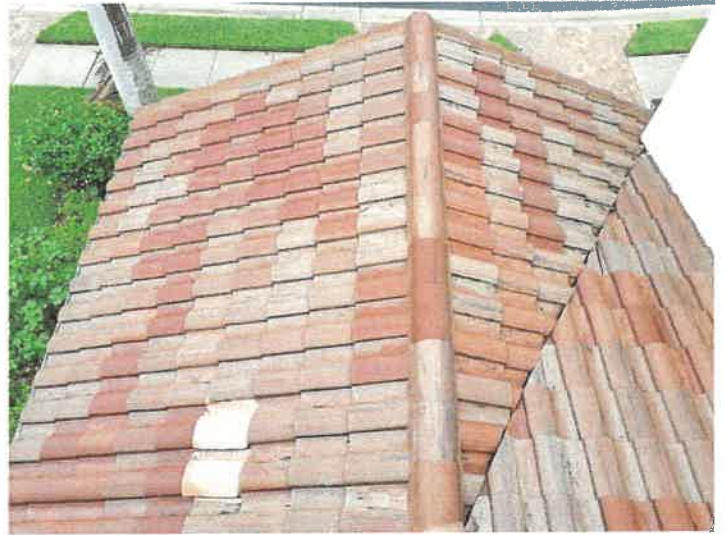
Building 15136: Appearance Overview - Lower Roof

The roof appearance is in good, maintainable condition.

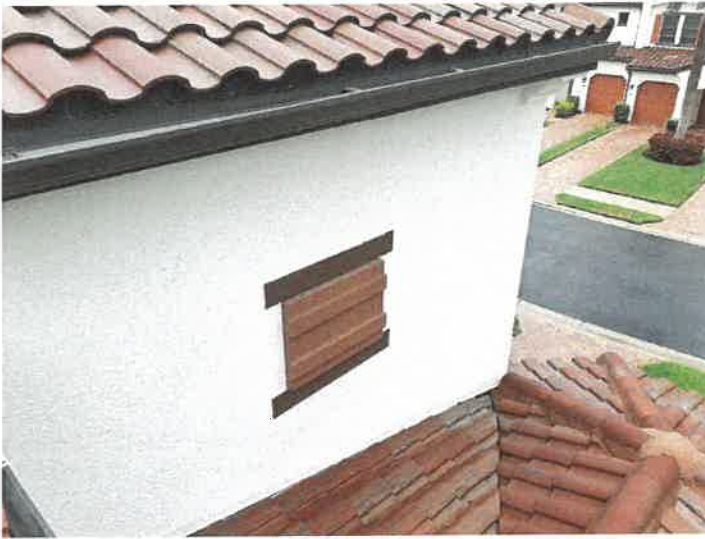
Building 15136: Wall

The walls appear to be in good condition.

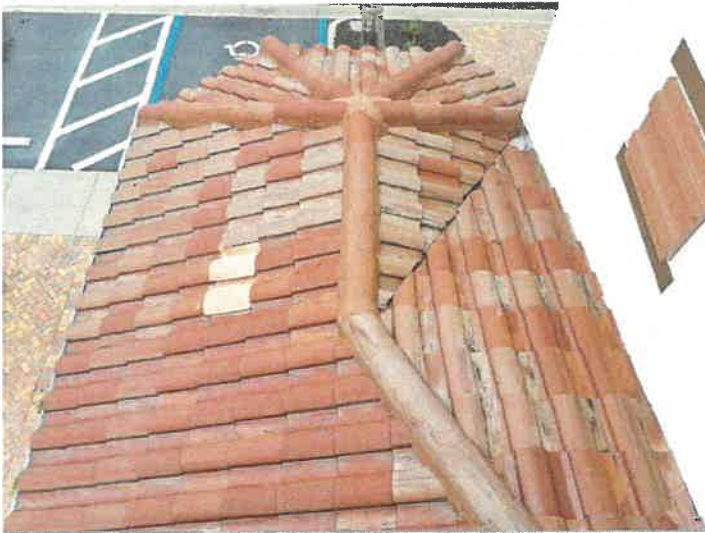
Building 15136: Surface Overview - Lower Roof

The roof surface appears to be in good, maintainable condition at this time.

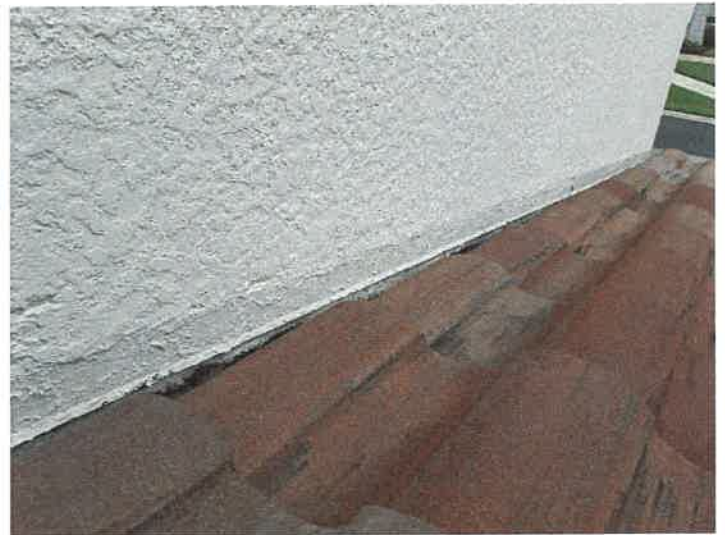
Building 15136: Counter Flashings

The counter flashing appears to be in good condition.

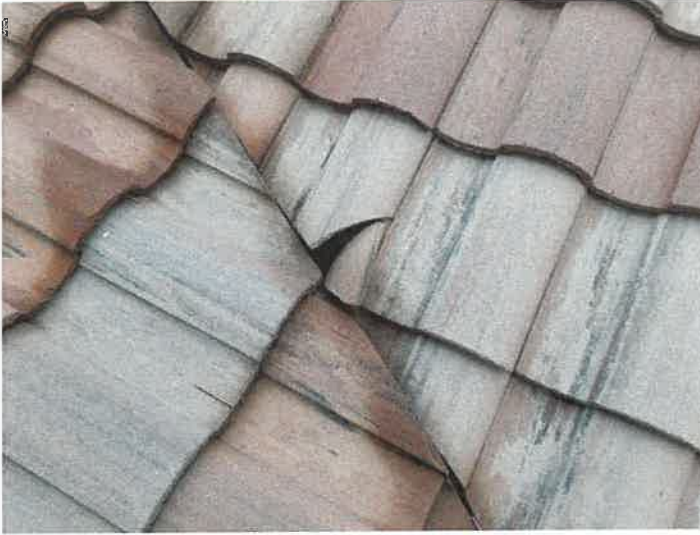
Building 15136: Identified Cracked Roof Tiles

Cracked roof tiles can allow premature underlayment deterioration from excessive UV exposure.

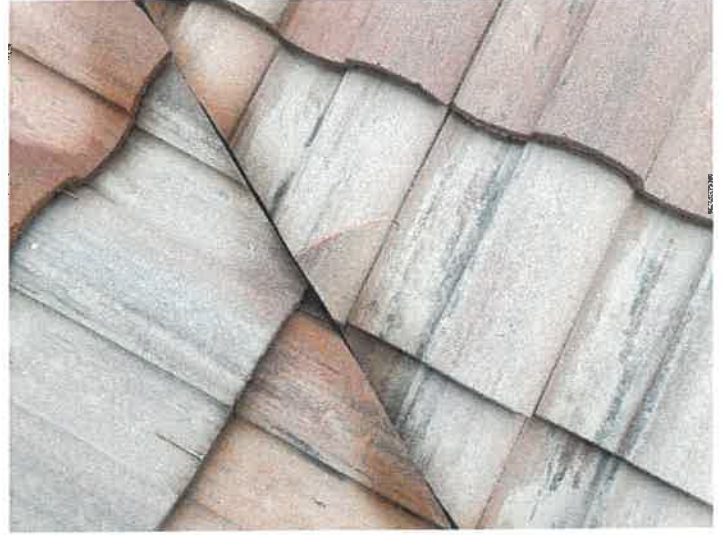
Building 15136: Repaired Cracked Roof Tiles

The cracked roof tiles were repaired with Titebond sealant.

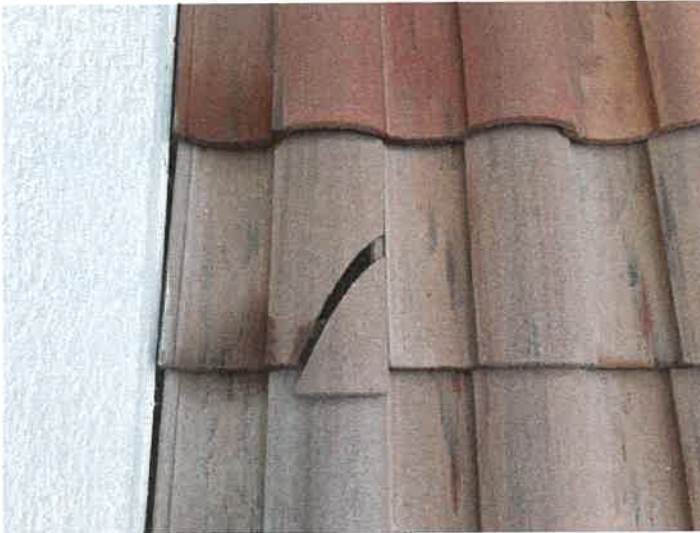
Building 15136: Identified Cracked Roof Tiles

Cracked roof tiles can allow premature underlayment deterioration from excessive UV exposure.

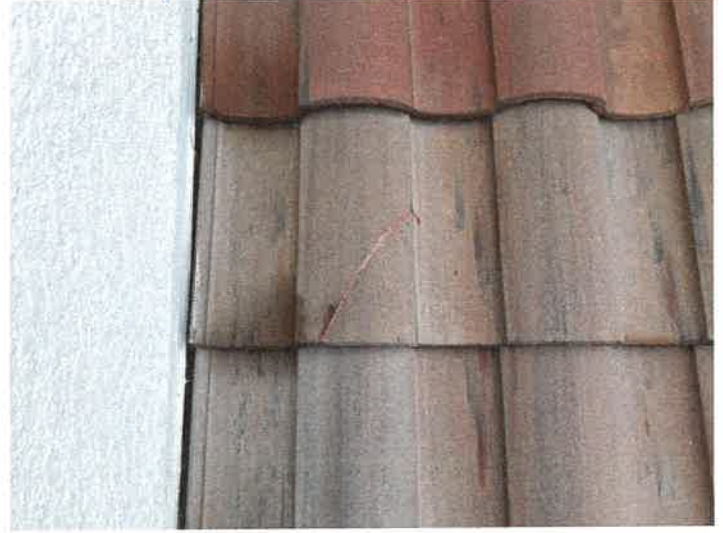
Building 15136: Repaired Cracked Roof Tiles

The cracked roof tiles were repaired with Titebond sealant.

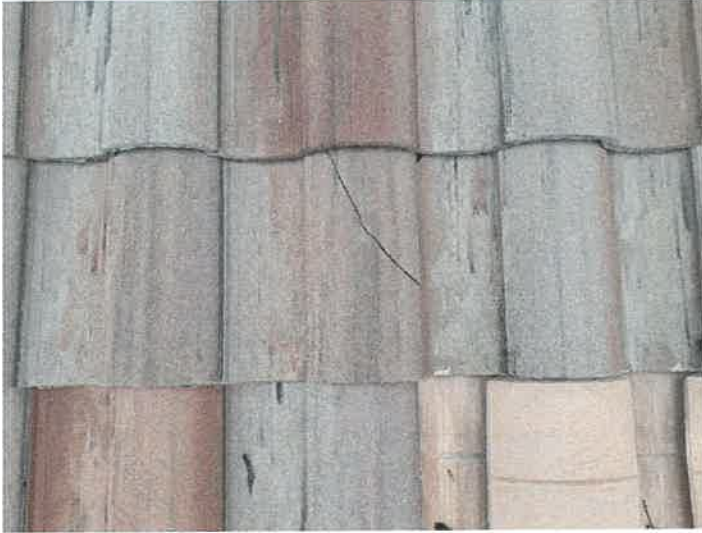
Building 15136: Identified Cracked Roof Tiles

Cracked roof tiles can allow premature underlayment deterioration from excessive UV exposure.

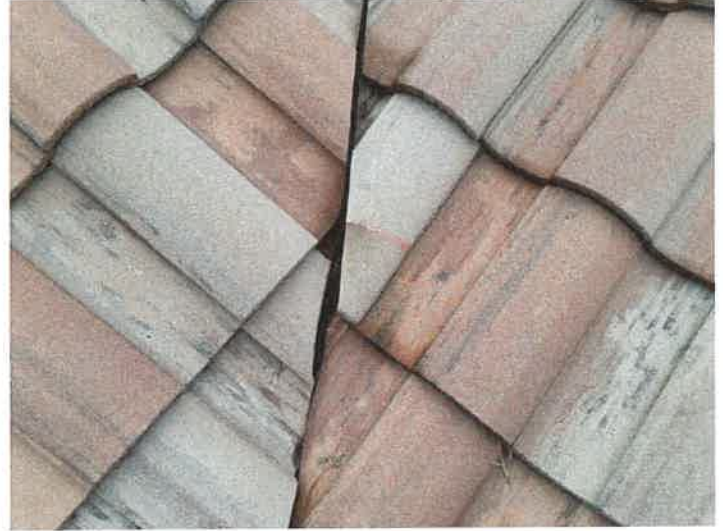
Building 15136: Identified Cracked Roof Tiles

Cracked roof tiles can allow premature underlayment deterioration from excessive UV exposure.

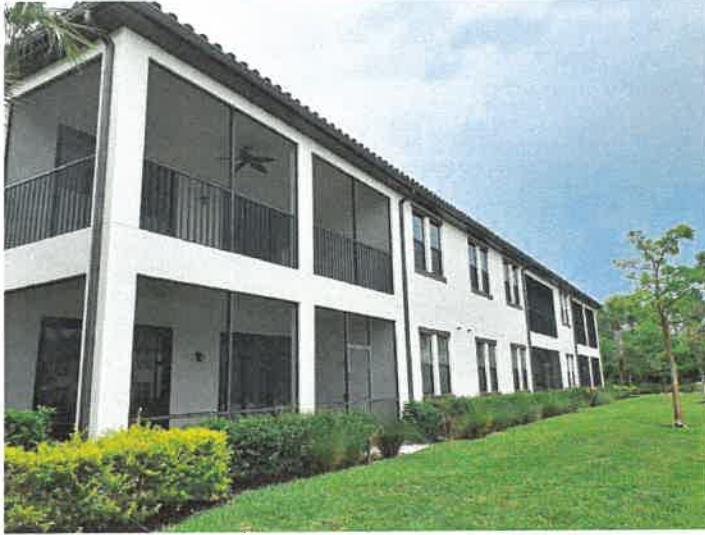
Building 15136: Downspouts

The downspouts appear to be in good condition.

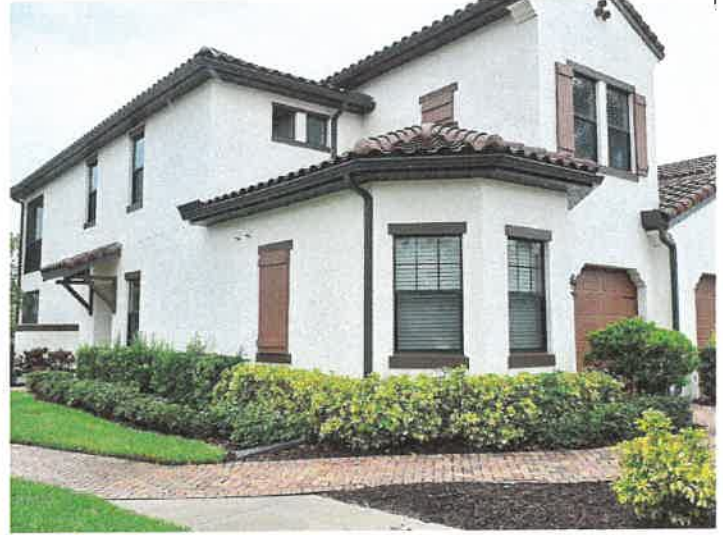
Building 15136: Downspouts

The downspouts appear to be in good condition.

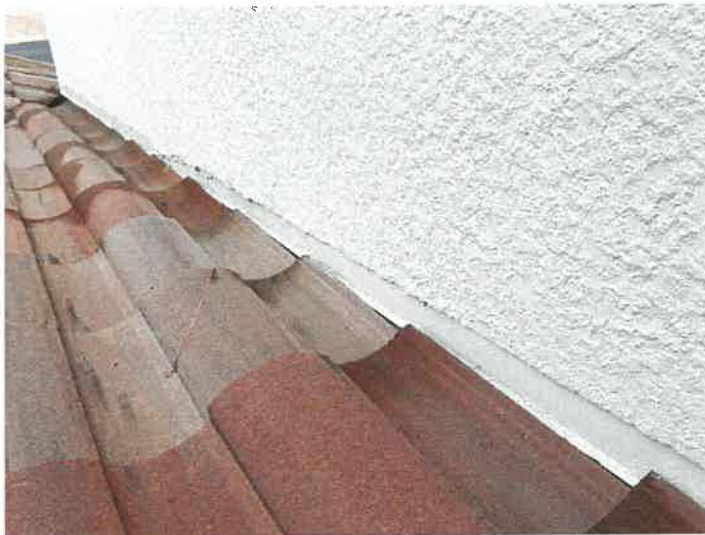
Building 15136: Counter Flashings

The counter flashing appears to be in good condition.

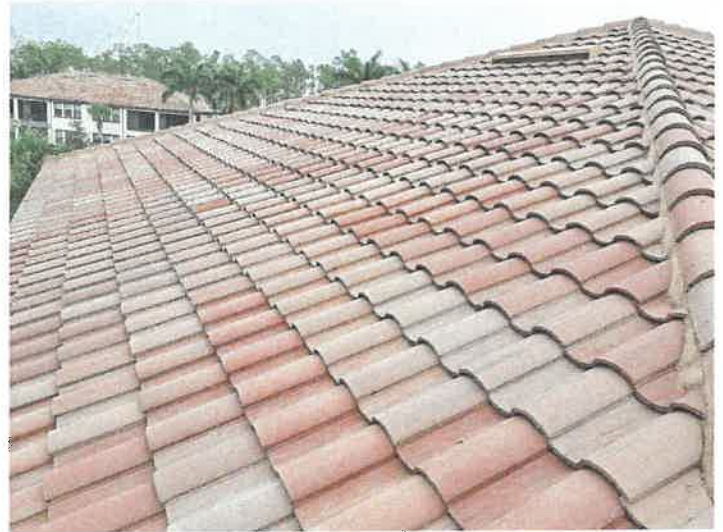
Building 15137: Surface Overview
The roof surface appears to be in good, maintainable condition at this time.

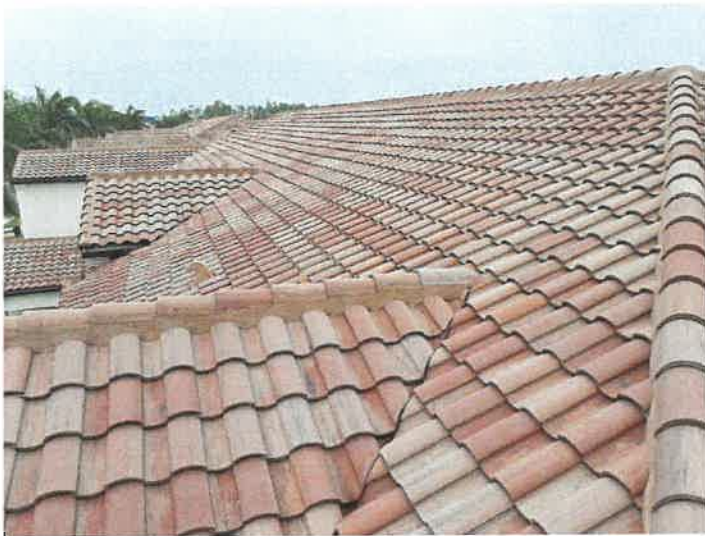
Building 15137: Appearance Overview
The roof appearance is in good, maintainable condition.

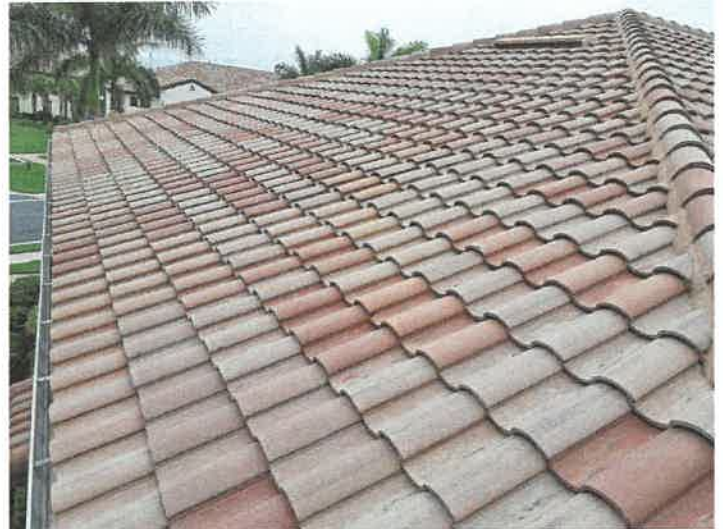
Building 15137: Surface Overview
The roof surface appears to be in good, maintainable condition at this time.

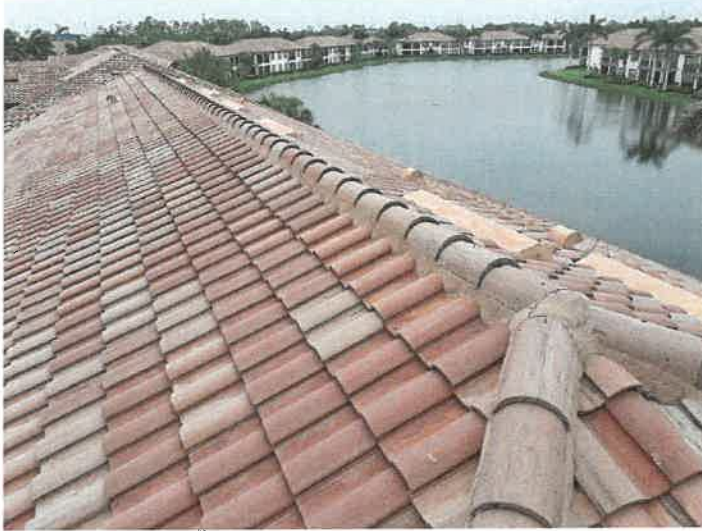
Building 15137: Ridge Tiles

Ridge tiles appear to be in good condition.

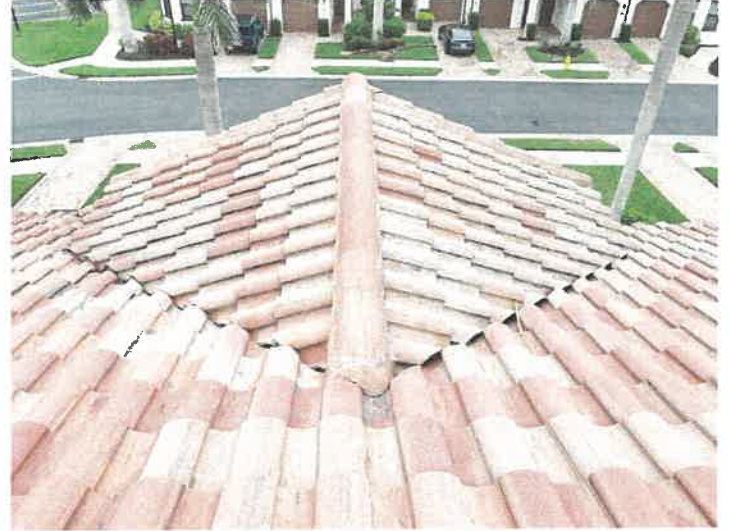
Building 15137: Valley

The valley tiles appear to be in good condition.

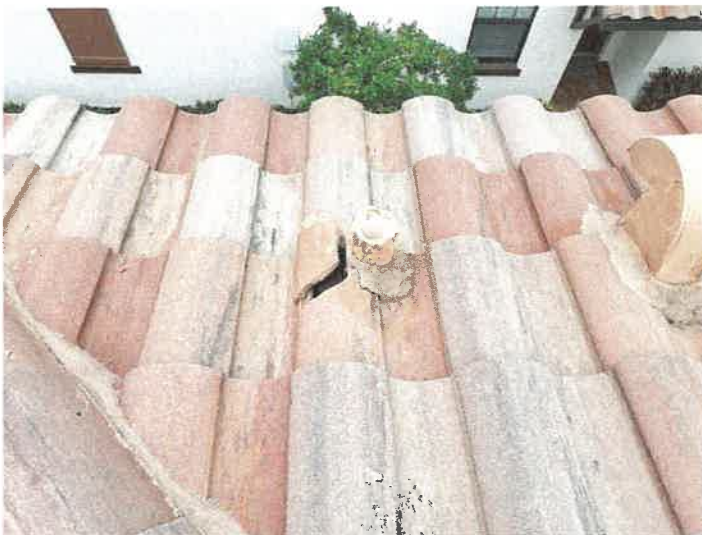
Building 15137: Identified Cracked Roof Tiles

Cracked roof tiles can allow premature underlayment deterioration from excessive UV exposure.

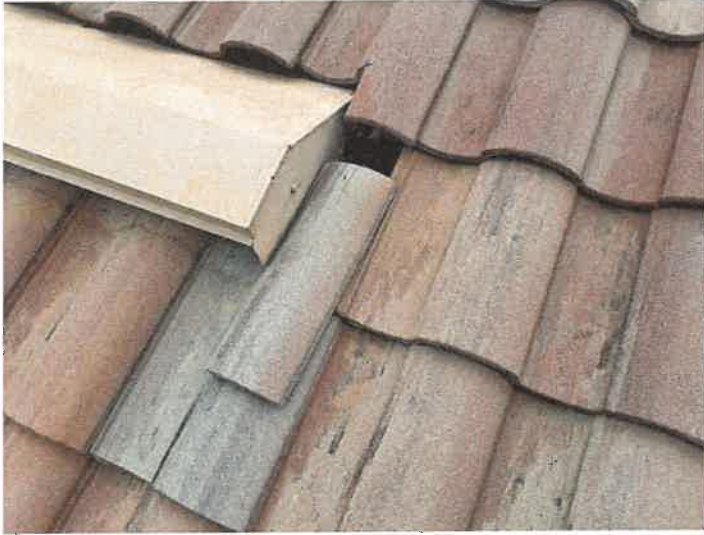
Building 15137: Displaced/Missing Roof Tile

Displaced or missing roof tiles can allow premature underlayment deterioration from excessive UV exposure and potential water intrusion.

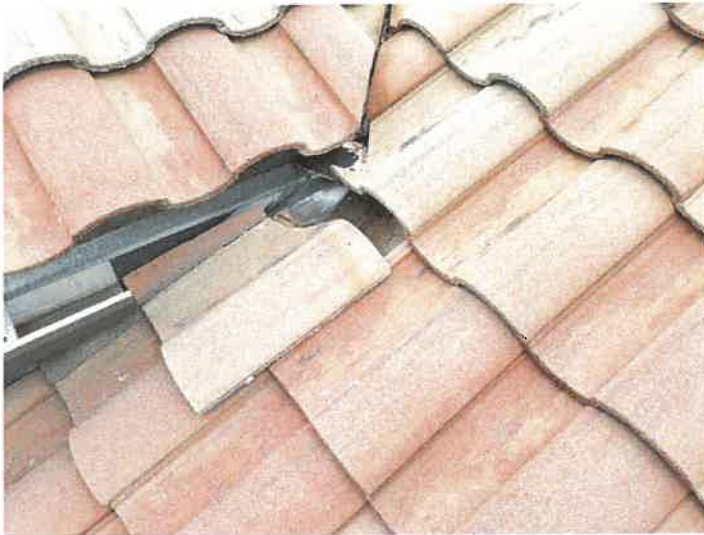
Building 15137: Displaced/Missing Roof Tile

Displaced or missing roof tiles can allow premature underlayment deterioration from excessive UV exposure and potential water intrusion.

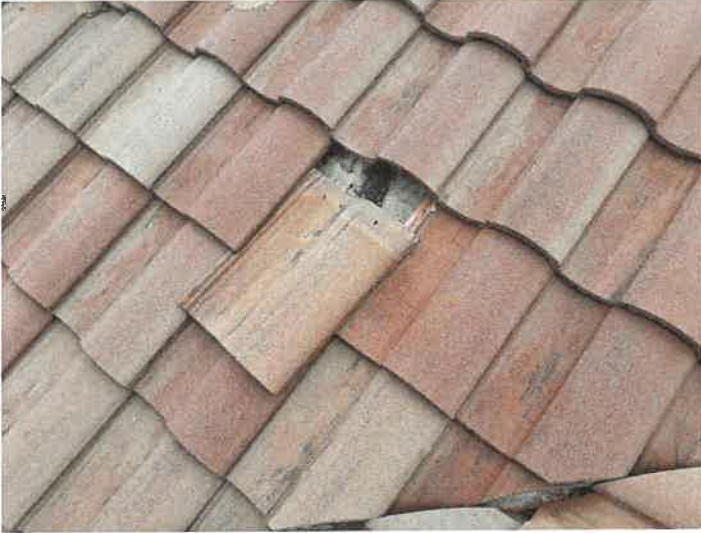
Building 15137: Displaced/Missing Roof Tile

Displaced or missing roof tiles can allow premature underlayment deterioration from excessive UV exposure and potential water intrusion.

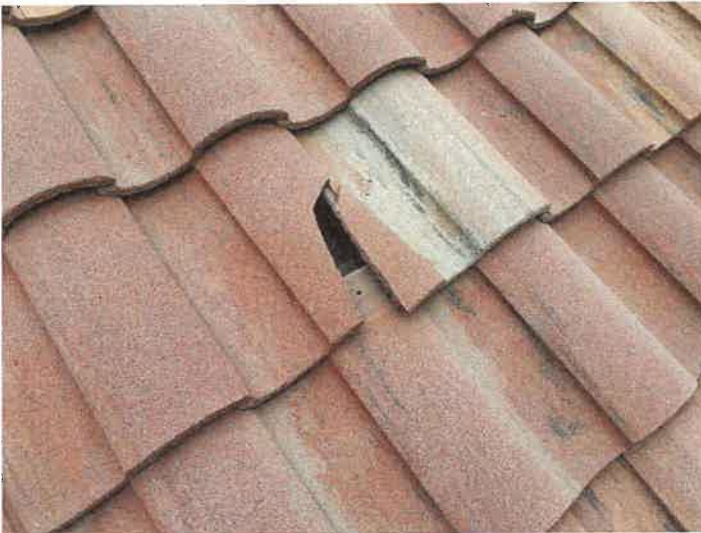
Building 15137: Identified Cracked Roof Tiles

Cracked roof tiles can allow premature underlayment deterioration from excessive UV exposure.

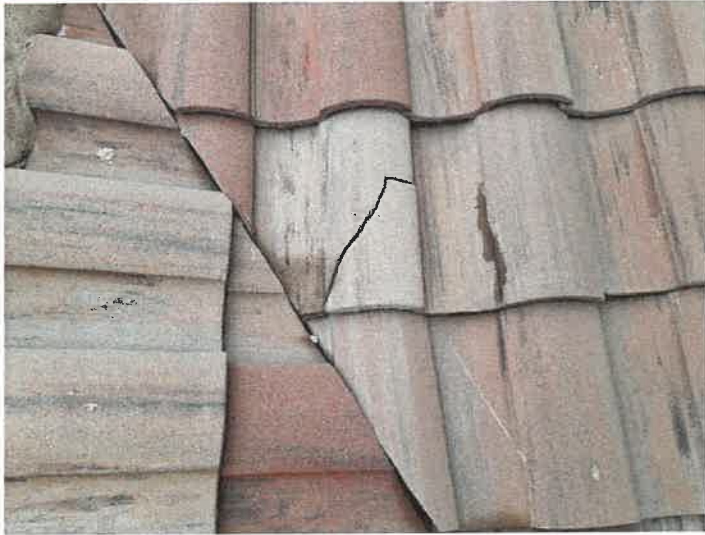
Building 15137: Identified Cracked Roof Tiles

Cracked roof tiles can allow premature underlayment deterioration from excessive UV exposure.

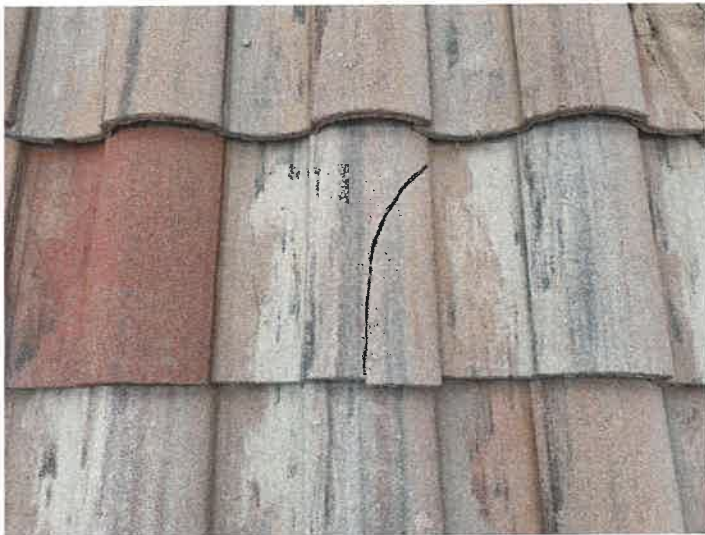
Building 15137: Identified Cracked Roof Tiles

Cracked roof tiles can allow premature underlayment deterioration from excessive UV exposure.

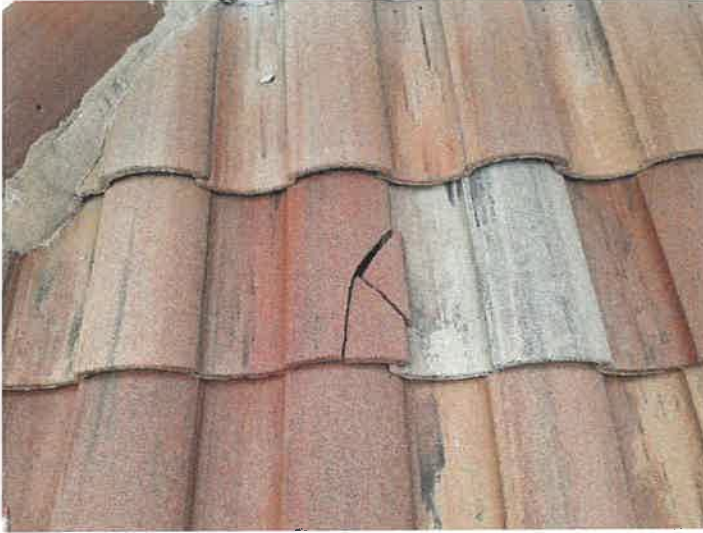
Building 15137: Identified Cracked Roof Tiles

Cracked roof tiles can allow premature underlayment deterioration from excessive UV exposure.

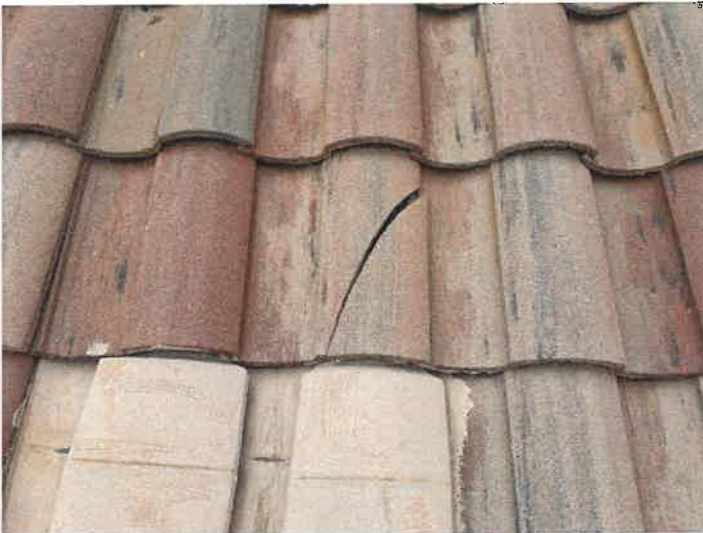
Building 15137: Identified Cracked Roof Tiles

Cracked roof tiles can allow premature underlayment deterioration from excessive UV exposure.

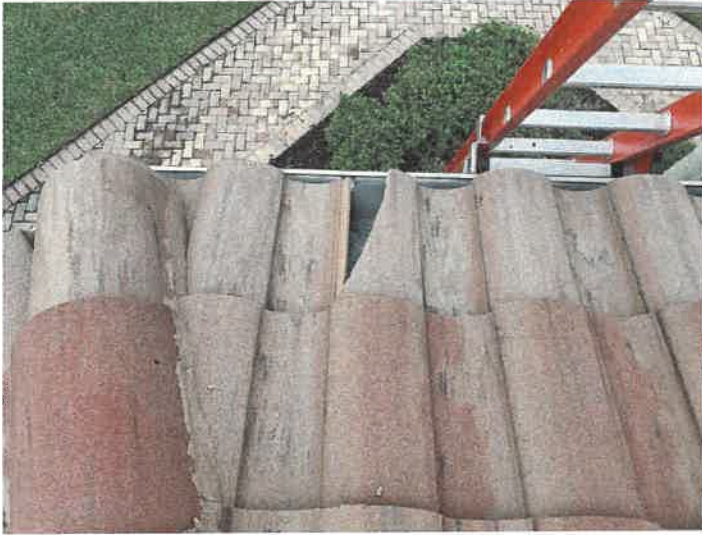
Building 15137: Identified Cracked Roof Tiles

Cracked roof tiles can allow premature underlayment deterioration from excessive UV exposure.

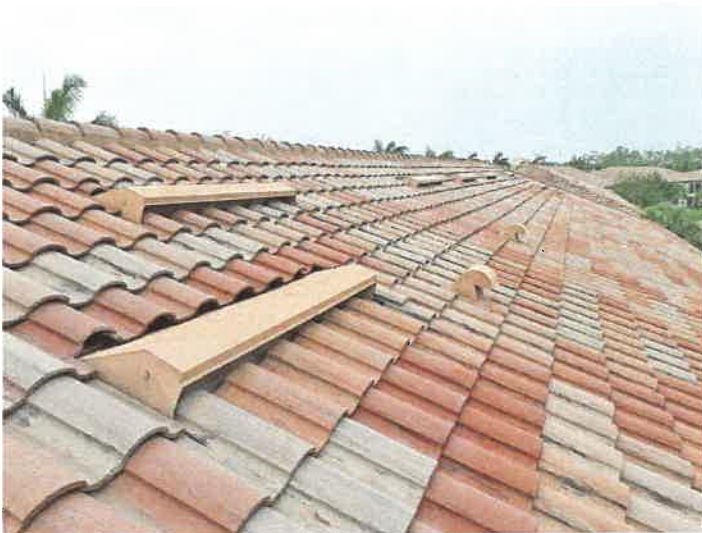
Building 15137: Roof Vents

Roof vents appear to be in good condition.

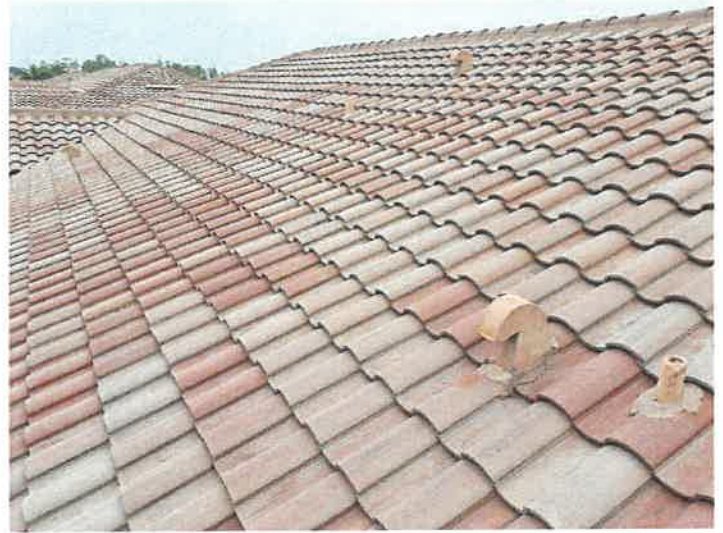
Building 15137: Roof Vents

Roof vents appear to be in good condition.

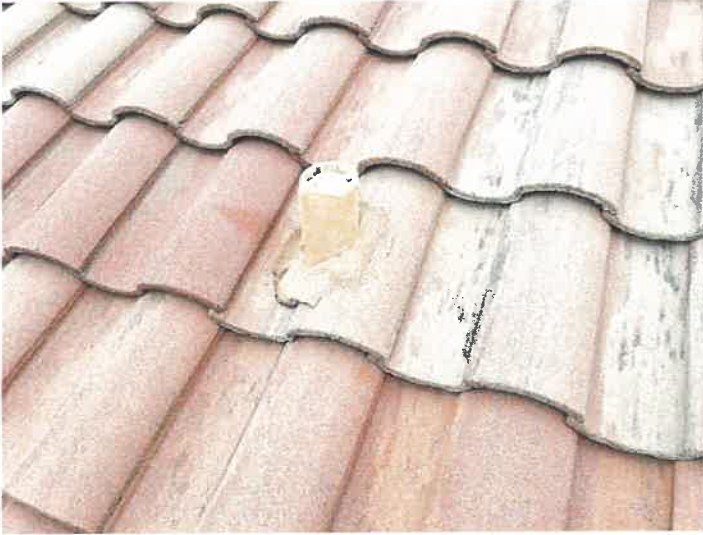
Building 15137: Lead Boots
Lead boots appear to be in good condition.

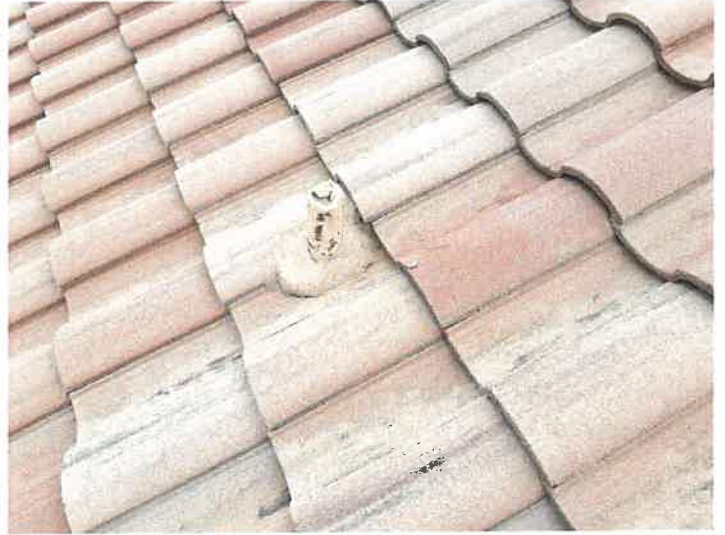
Building 15137: Lead Boots
Lead boots appear to be in good condition.

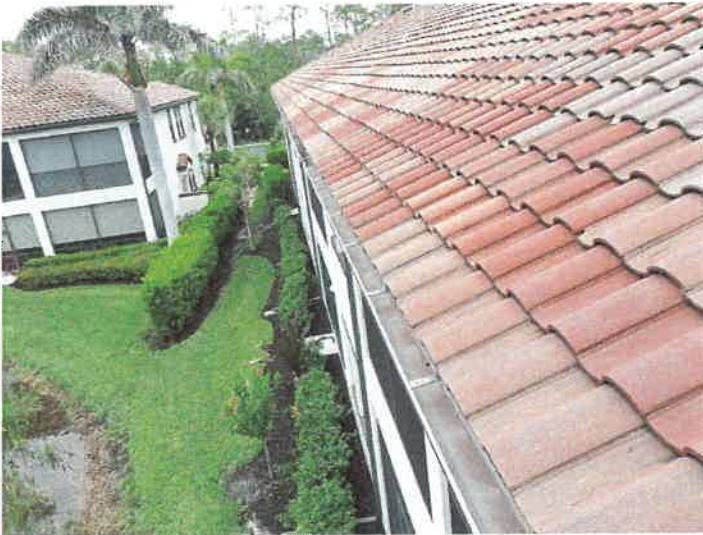
Building 15137: Gutters
The gutters appear to be in good condition.
