Inspection Report

Facility: Livingston Lakes Condo
Address: 15098 Palmer Lake Circle,
Naples, FL 34109
Customer: Cardinal Management
Address: c/o Livingston Lakes Condo, 15090
Naples, FL 34109

Livingston Lakes Condo, Naples, FL

Re.: **Inspection Report (2 of 3) for Livingston Lakes**

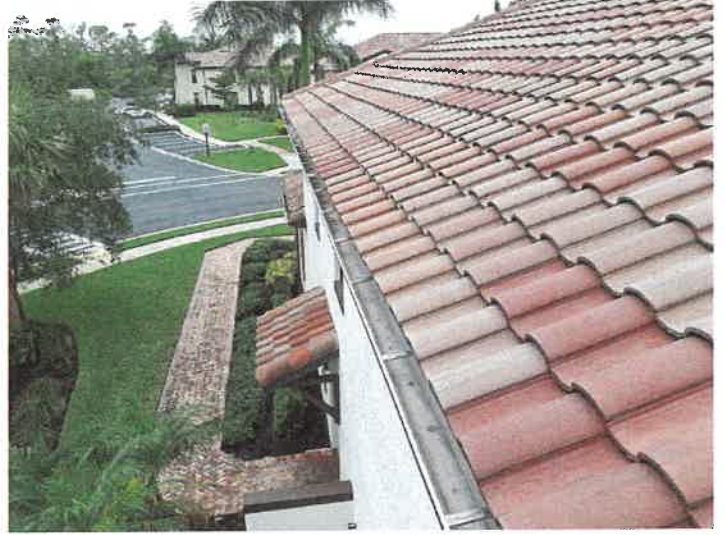
Building 15137: Gutters
The gutters appear to be in good condition.

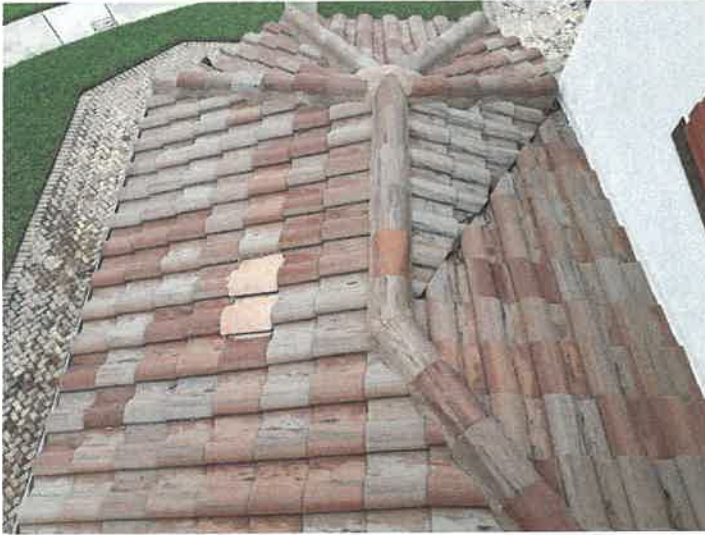
Building 15137: Surface Overview - Lower Roof
The roof surface appears to be in good, maintainable condition at this time.

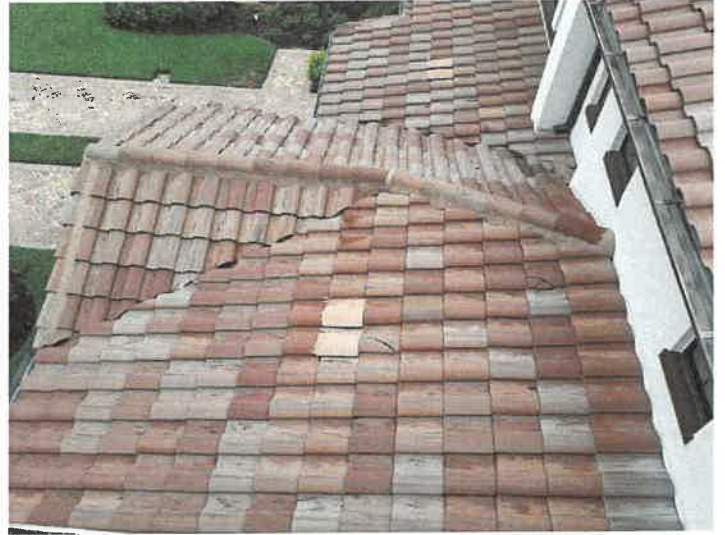
Building 15137: Appearance Overview - Lower Roof
The roof appearance is in good, maintainable condition.

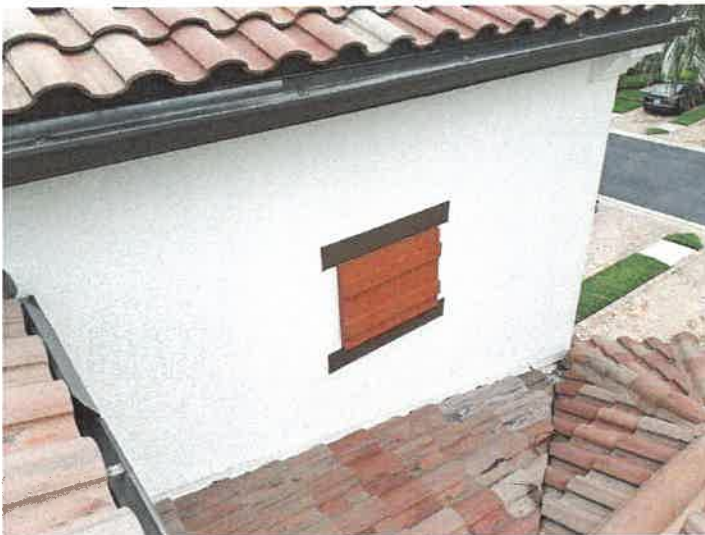
Building 15137: Wall
The walls appear to be in good condition.

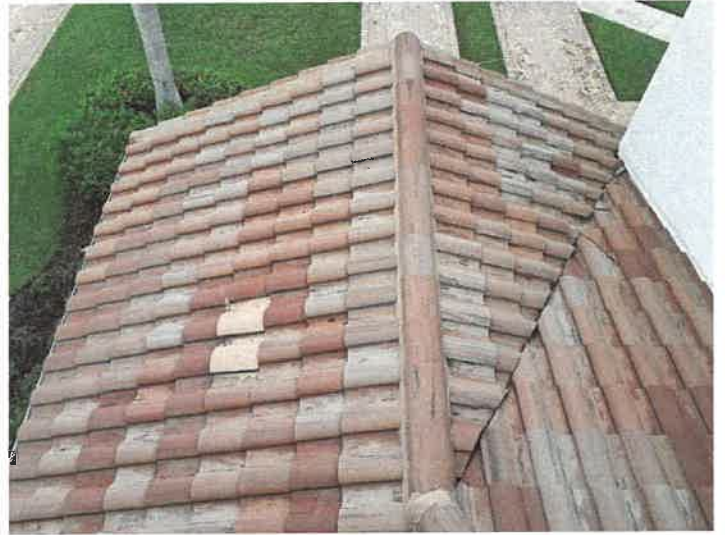
Building 15137: Surface Overview - Lower Roof
The roof surface appears to be in good, maintainable condition at this time.

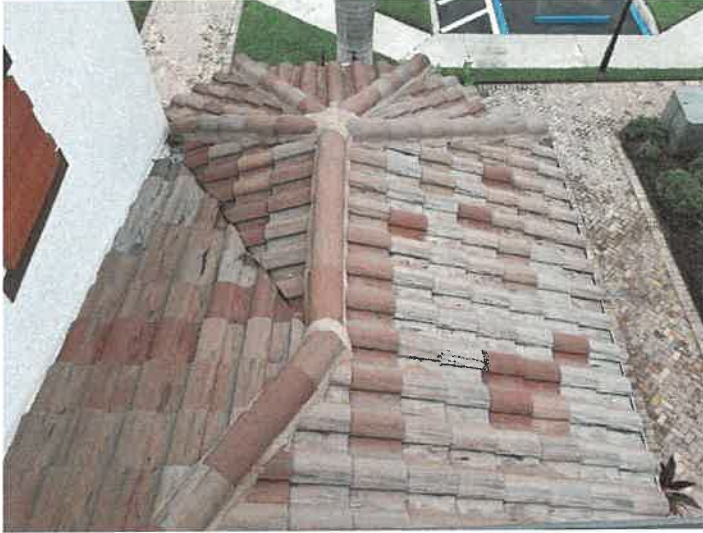
Building 15137: Appearance Overview - Lower Roof
The roof appearance is in good, maintainable condition.

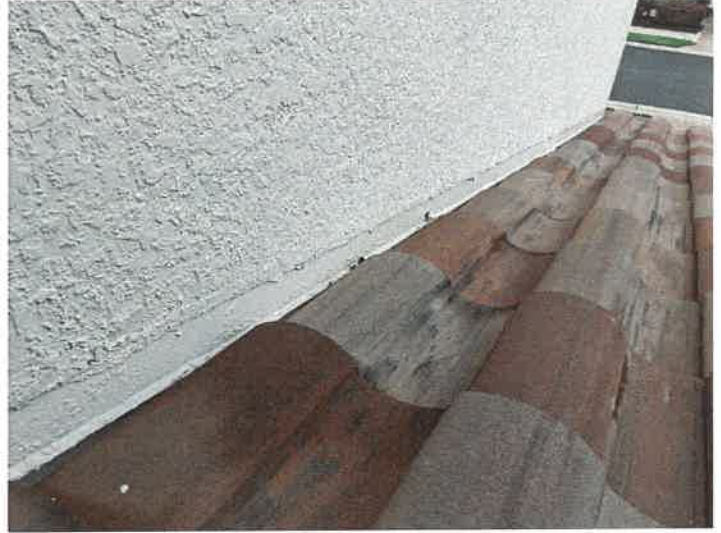
Building 15137: Counter Flashings
The counter flashing appears to be in good condition.

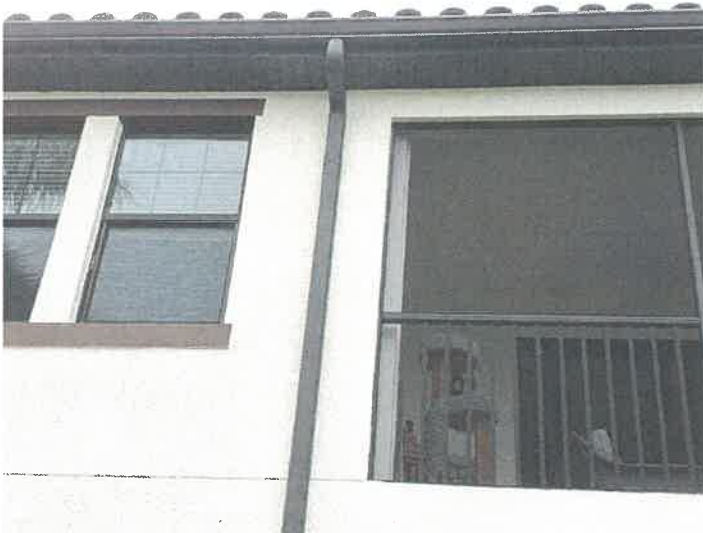
Building 15137: Gutter- Interior gutter issue (Location)
Interior gutter has issues that will/have lead to water penetration. Remove and replace waterproofing material immediately.

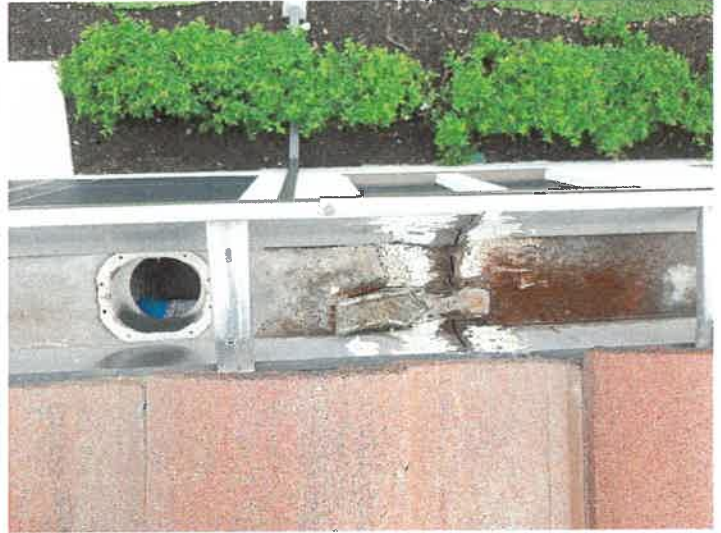
Building 15137: Gutter- Interior gutter issue
Interior gutter has issues that will/have lead to water penetration. Remove and replace waterproofing material immediately.

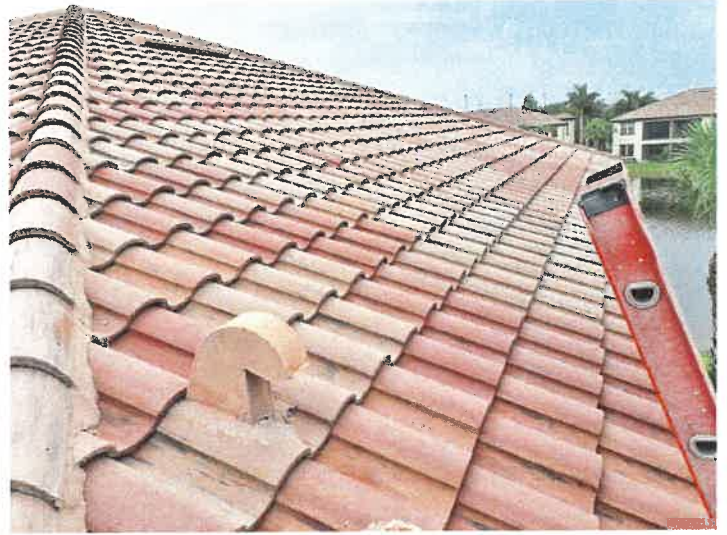
Building 15140: Surface Overview
The roof surface appears to be in good, maintainable condition at this time.

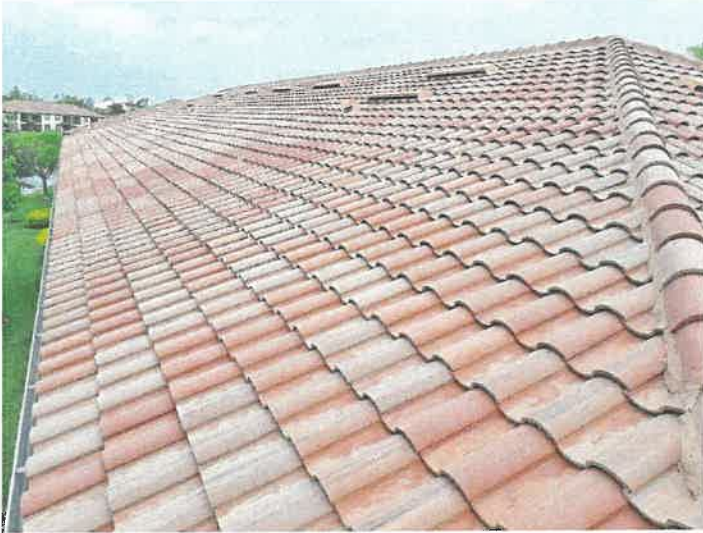
Building 15140: Appearance Overview

The roof appearance is in good, maintainable condition.

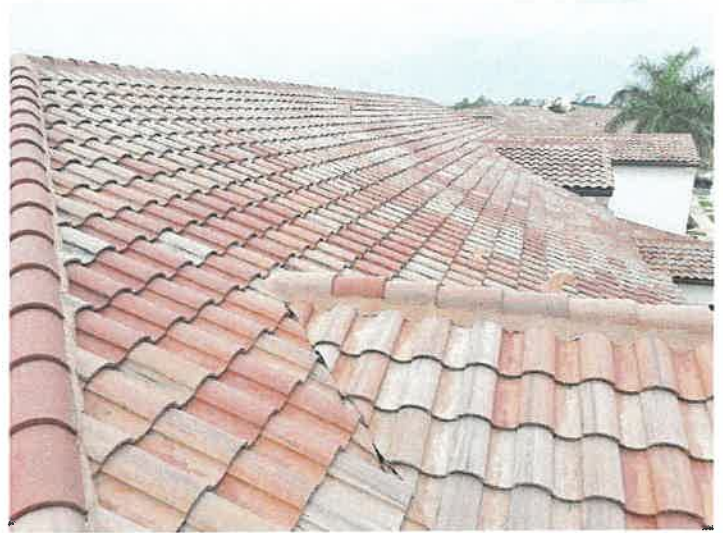
Building 15140: Appearance Overview

The roof appearance is in good, maintainable condition.

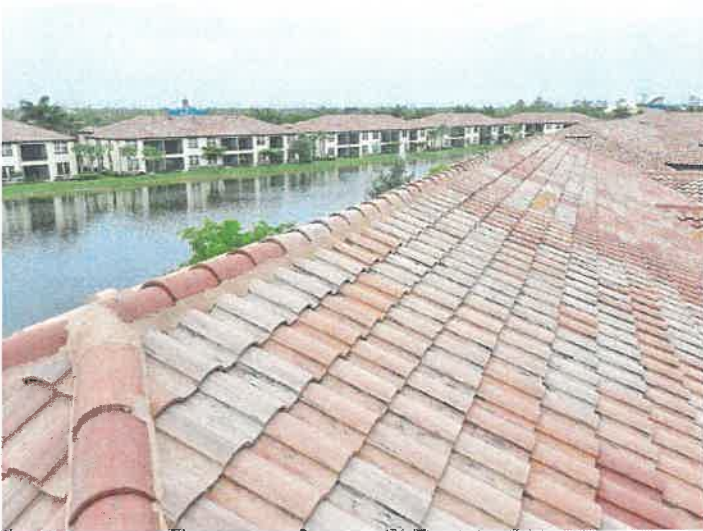
Building 15140: Ridge Tiles

Ridge tiles appear to be in good condition.

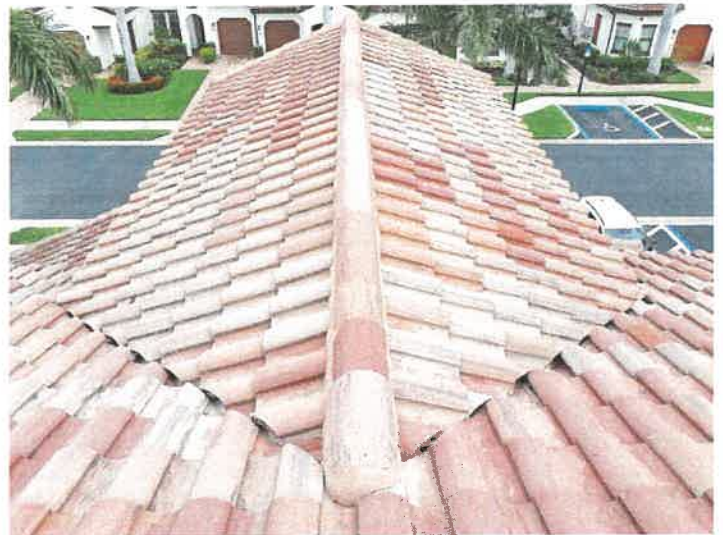
Building 15140: Valley

The valley tiles appear to be in good condition.

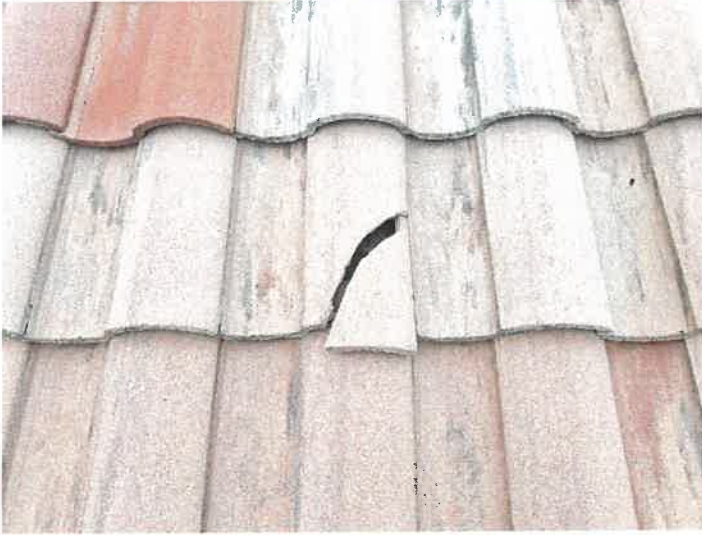
Building 15140: Identified Cracked Roof Tiles

Cracked roof tiles can allow premature underlayment deterioration from excessive UV exposure.

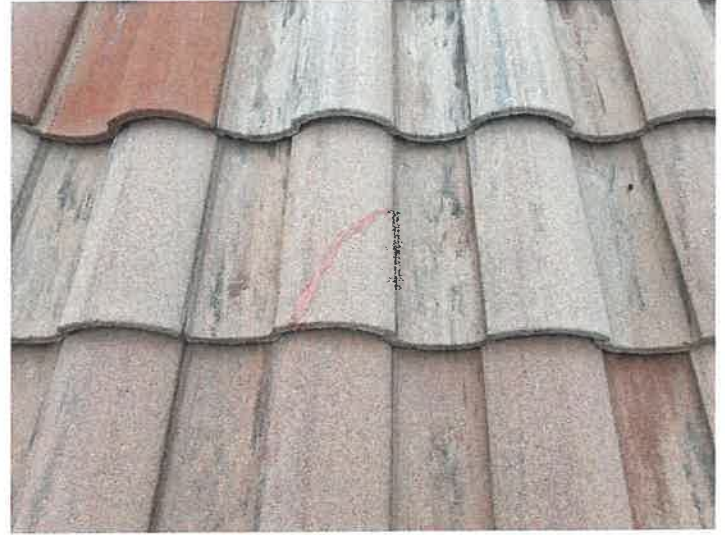
Building 15140: Repaired Cracked Roof Tiles

The cracked roof tiles were repaired with Titebond sealant.

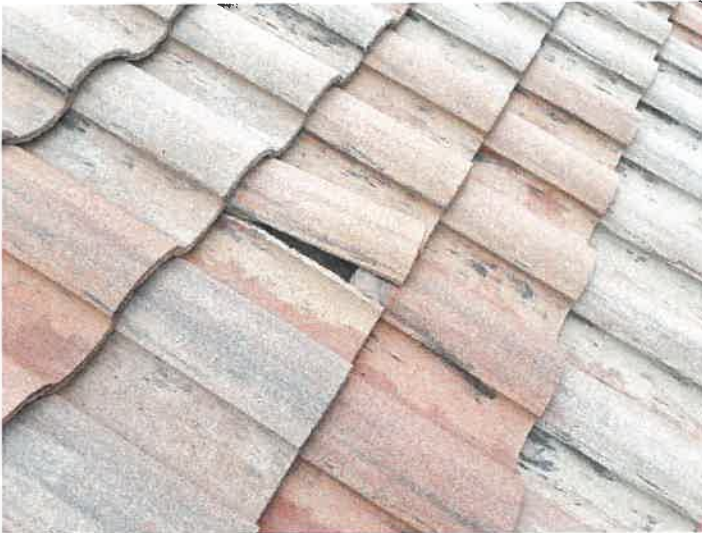
Building 15140: Identified Cracked Roof Tiles

Cracked roof tiles can allow premature underlayment deterioration from excessive UV exposure.

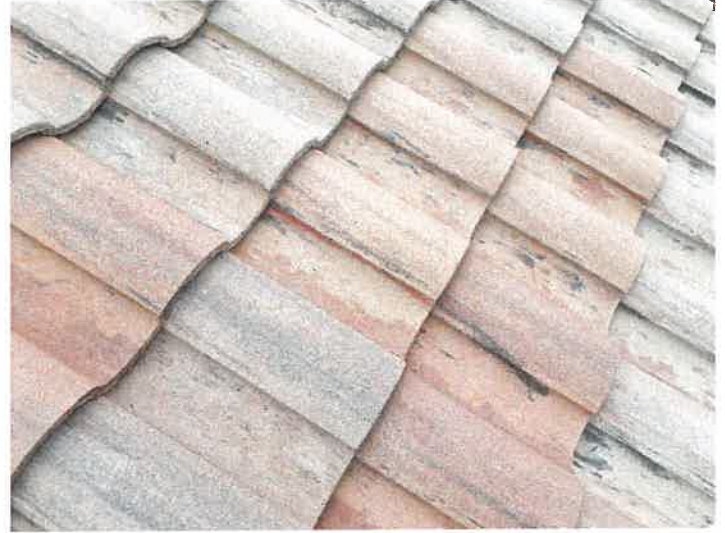
Building 15140: Repaired Cracked Roof Tiles

The cracked roof tiles were repaired with Titebond sealant.

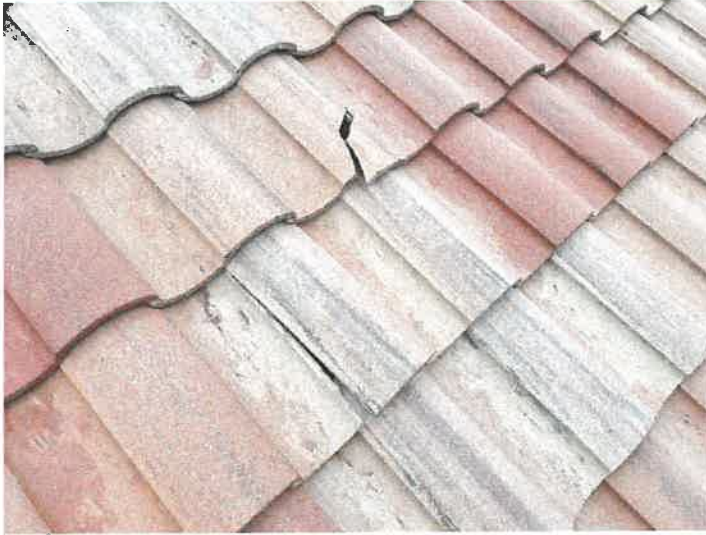
Building 15140: Identified Cracked Roof Tiles

Cracked roof tiles can allow premature underlayment deterioration from excessive UV exposure.

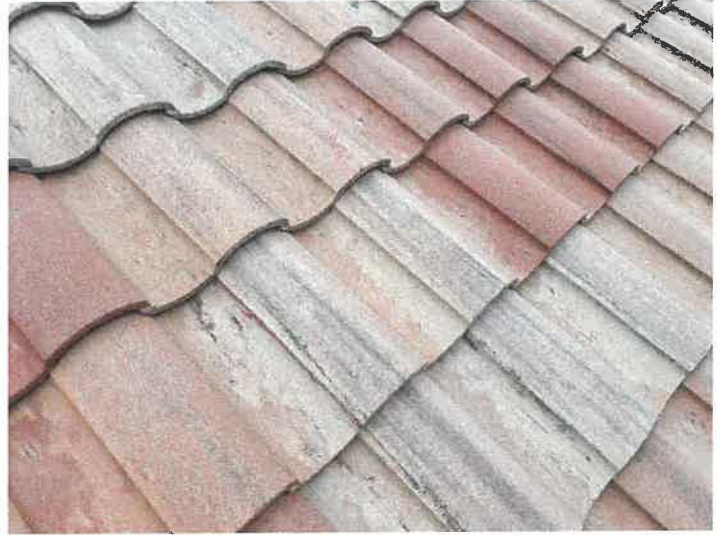
Building 15140: Repaired Cracked Roof Tiles

The cracked roof tiles were repaired with Titebond sealant.

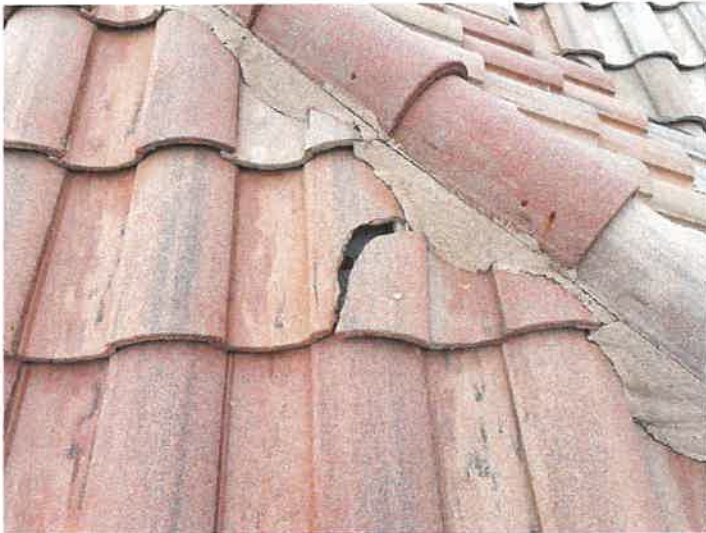
Building 15140: Identified Cracked Roof Tiles

Cracked roof tiles can allow premature underlayment deterioration from excessive UV exposure.

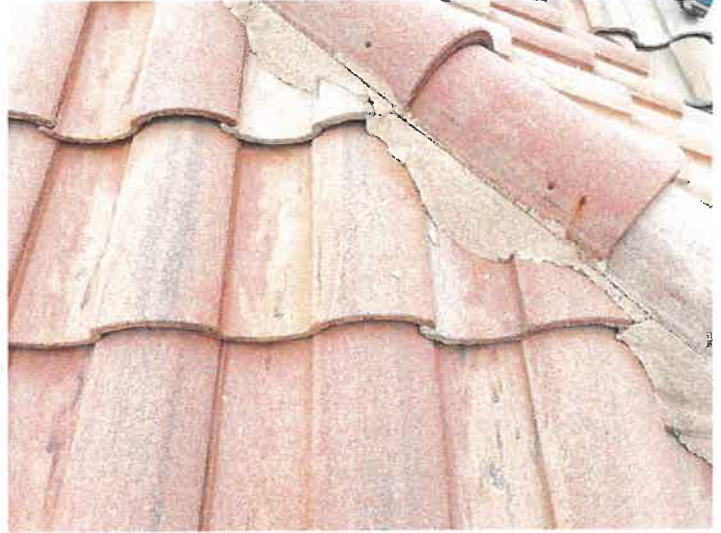
Building 15140: Repaired Cracked Roof Tiles

The cracked roof tiles were repaired with Titebond sealant.

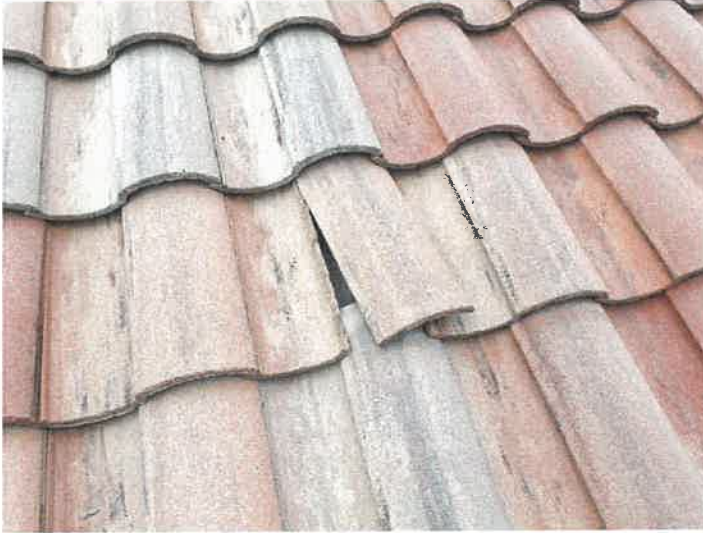
Building 15140: Identified Cracked Roof Tiles

Cracked roof tiles can allow premature underlayment deterioration from excessive UV exposure.

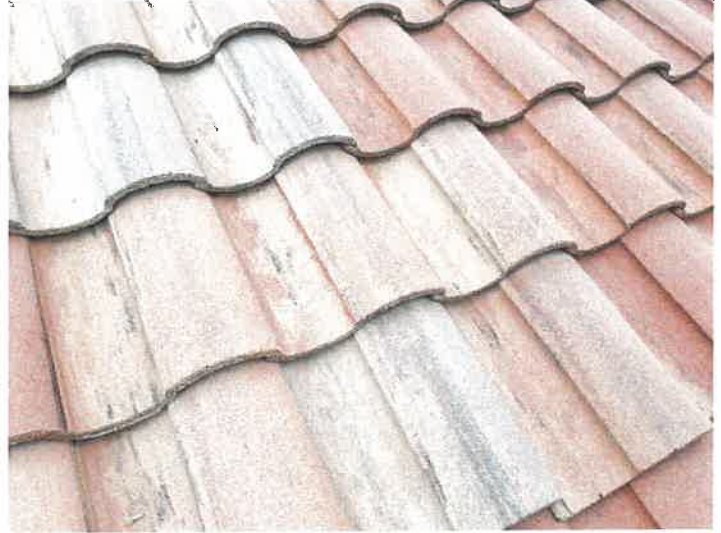
Building 15140: Repaired Cracked Roof Tiles

The cracked roof tiles were repaired with Titebond sealant.

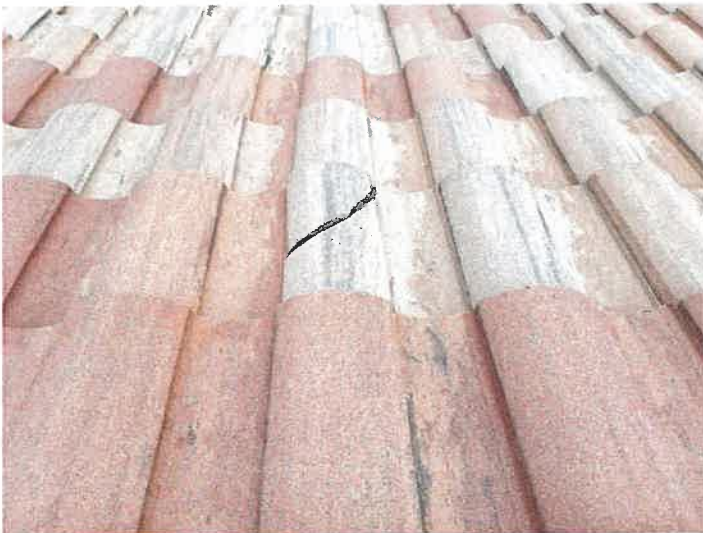
Building 15140: Identified Cracked Roof Tiles

Cracked roof tiles can allow premature underlayment deterioration from excessive UV exposure.

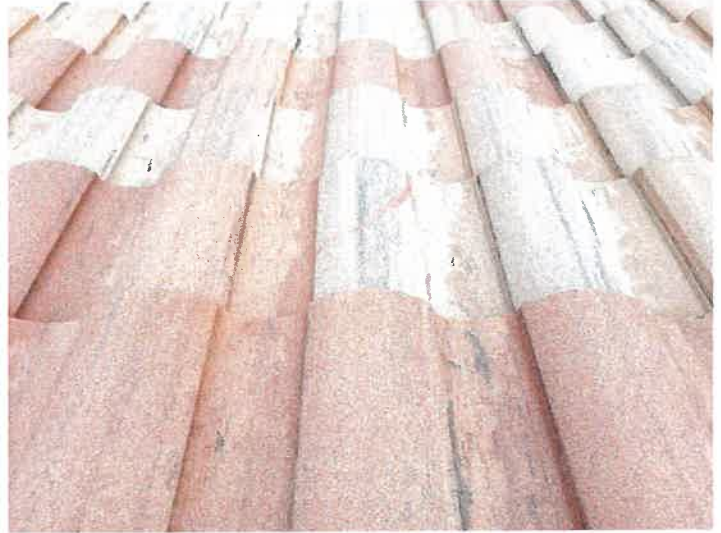
Building 15140: Repaired Cracked Roof Tiles

The cracked roof tiles were repaired with Titebond sealant.

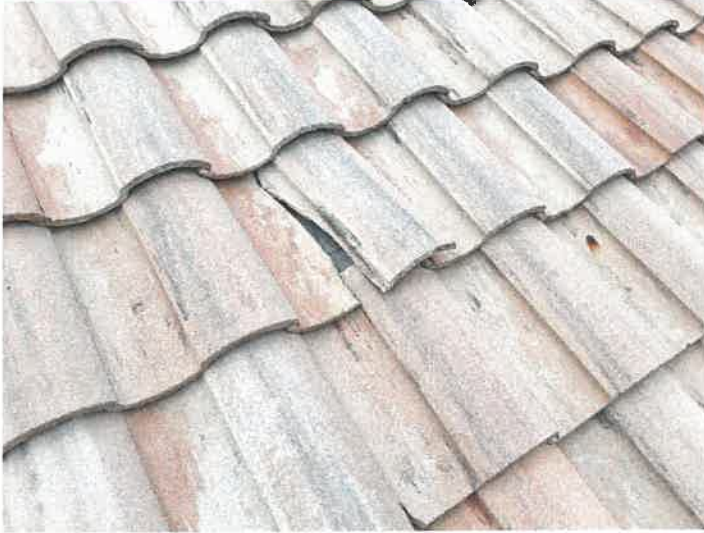
Building 15140: Identified Cracked Roof Tiles

Cracked roof tiles can allow premature underlayment deterioration from excessive UV exposure.

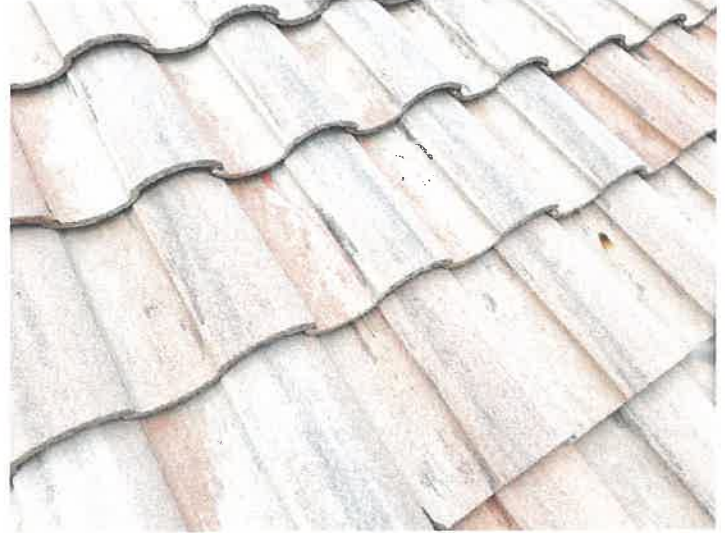
Building 15140: Repaired Cracked Roof Tiles

The cracked roof tiles were repaired with Titebond sealant.

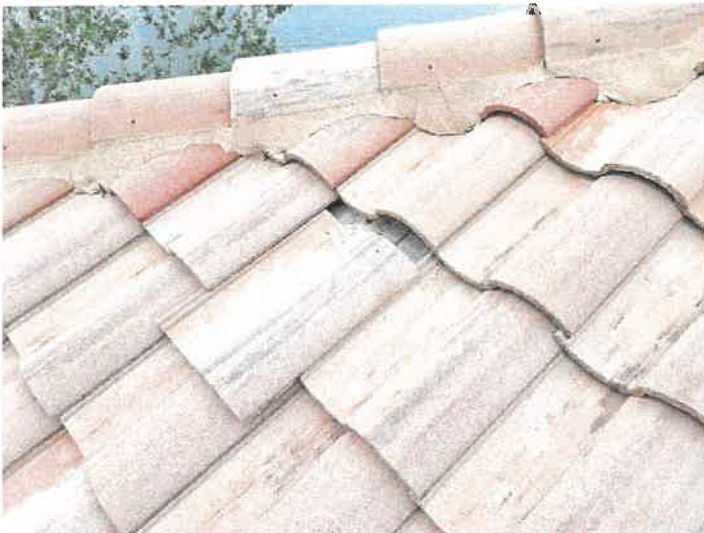
Building 15140: Displaced/Missing Roof Tile

Displaced or missing roof tiles can allow premature underlayment deterioration from excessive UV exposure and potential water intrusion.

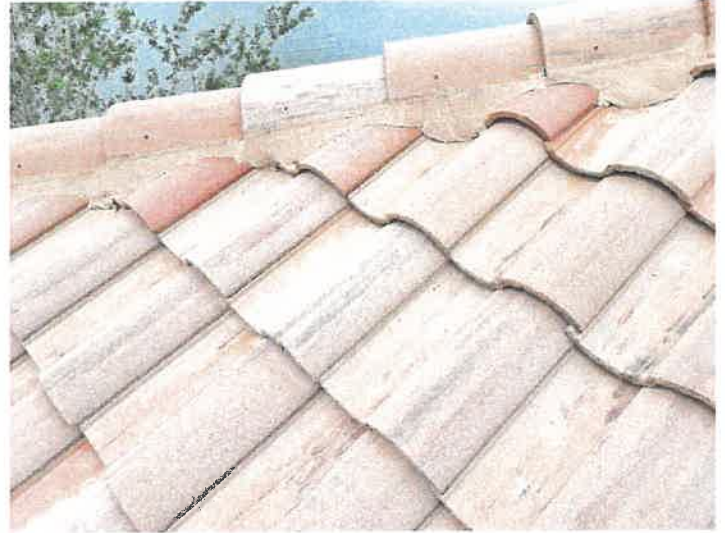
Building 15140: Repaired Displaced/Missing Roof Tile

Replaced and secured the missing roof tile.

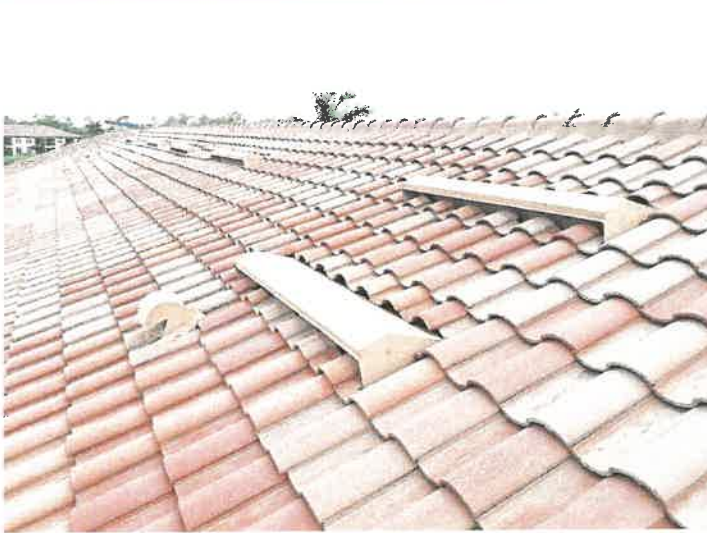
Building 15140: Roof Vents
Roof vents appear to be in good condition.

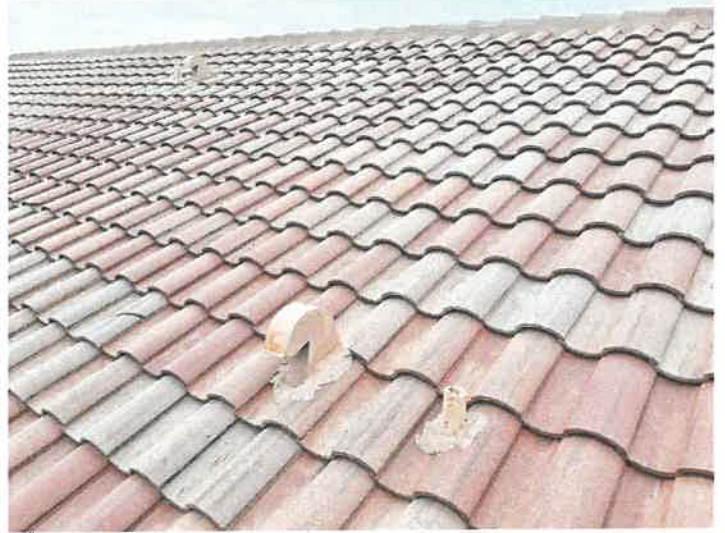
Building 15140: Roof Vents
Roof vents appear to be in good condition.

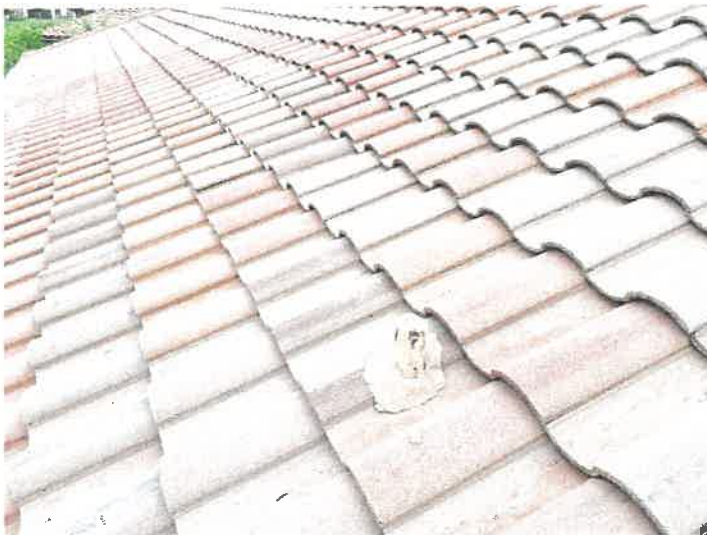
Building 15140: Lead Boots
Lead boots appear to be in good condition.

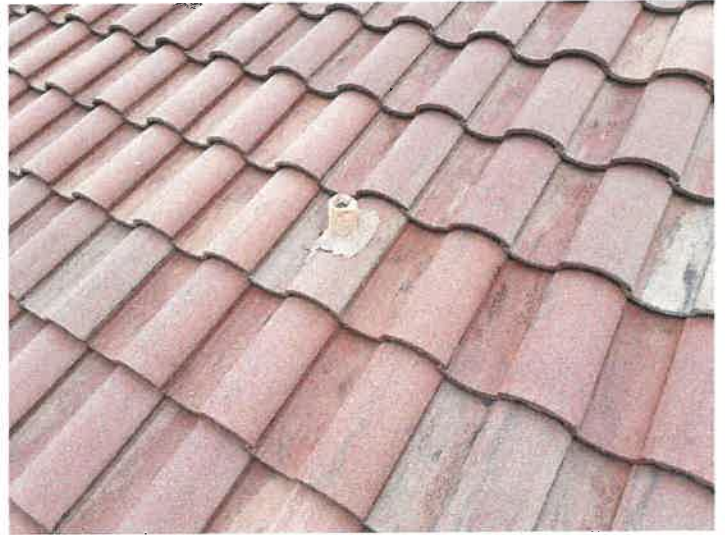
Building 15140: Lead Boots
Lead boots appear to be in good condition.

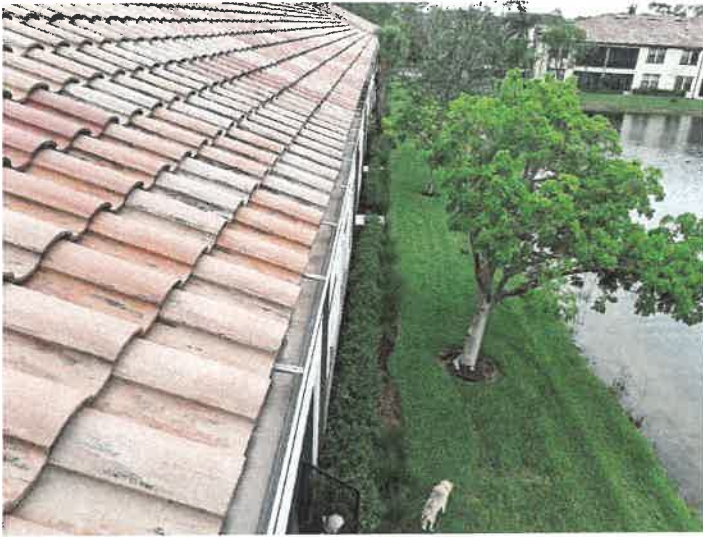
Building 15140: Gutters

The gutters appear to be in good condition.

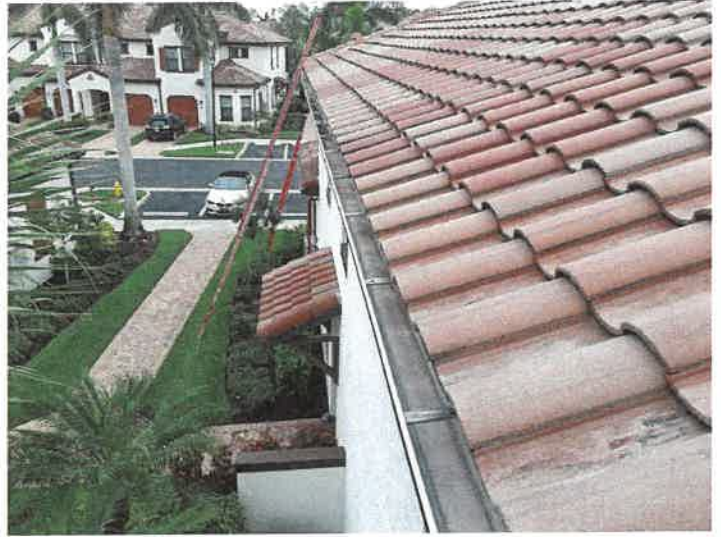
Building 15140: Gutters

The gutters appear to be in good condition.

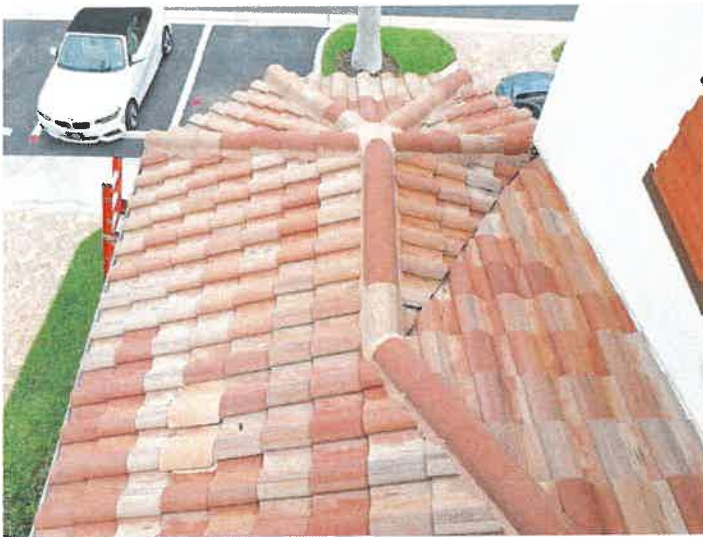
Building 15140: Surface Overview - Lower Roof

The roof surface appears to be in good, maintainable condition at this time.

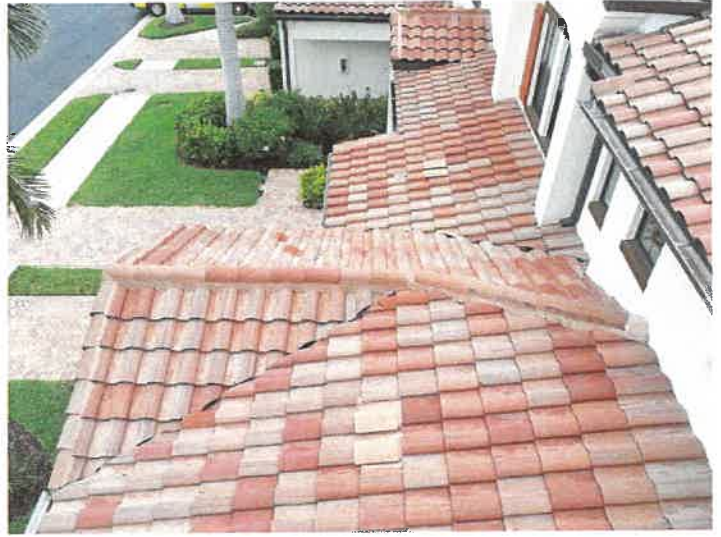
Building 15140: Appearance Overview - Lower Roof

The roof appearance is in good, maintainable condition.

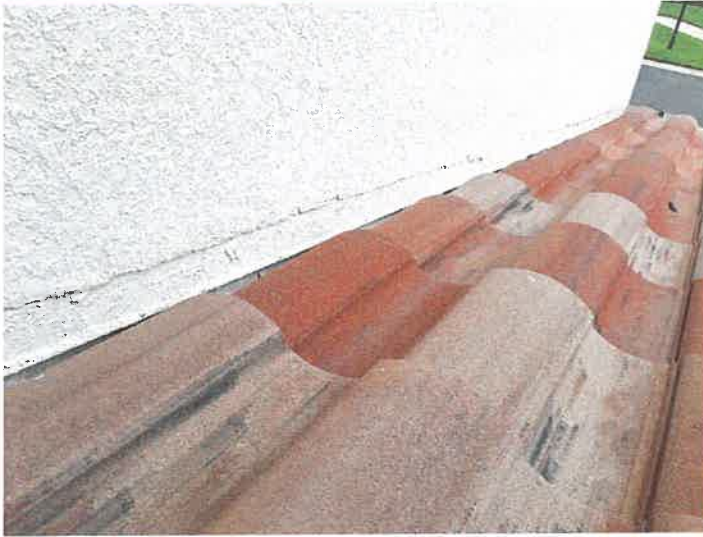
Building 15140: Counter Flashings

The counter flashing appears to be in good condition.

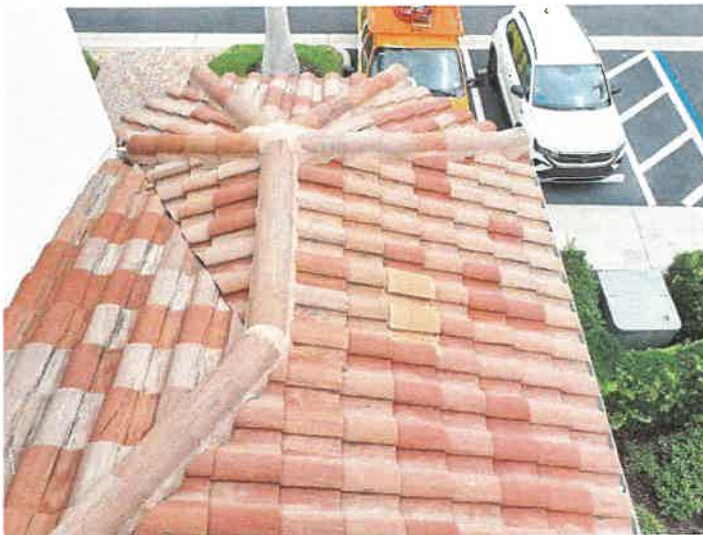
Building 15140: Surface Overview - Lower Roof

The roof surface appears to be in good, maintainable condition at this time.

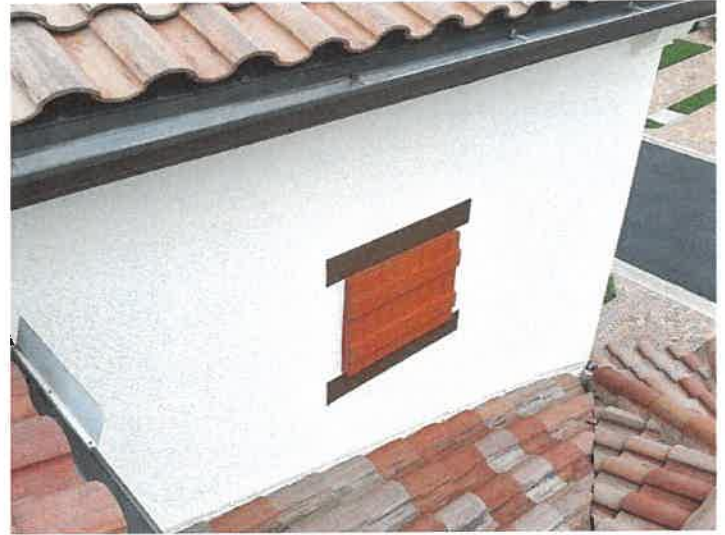
Building 15140: Wall

The walls appear to be in good condition.

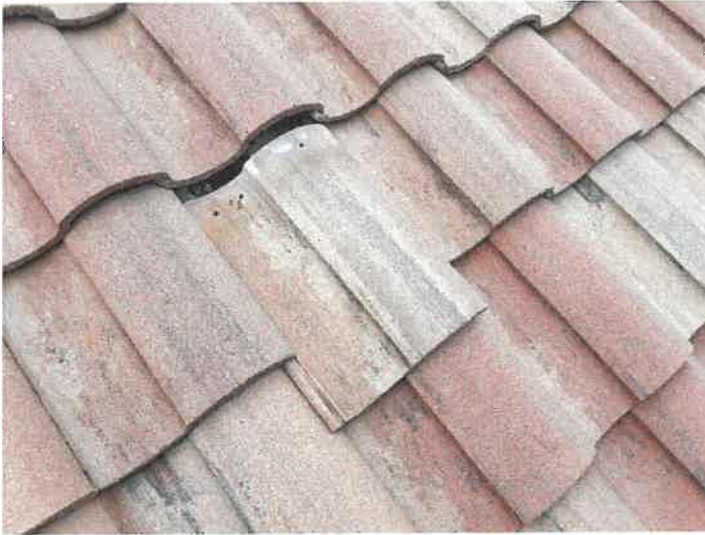
Building 15140: Displaced/Missing Roof Tile

Displaced or missing roof tiles can allow premature underlayment deterioration from excessive UV exposure and potential water intrusion.

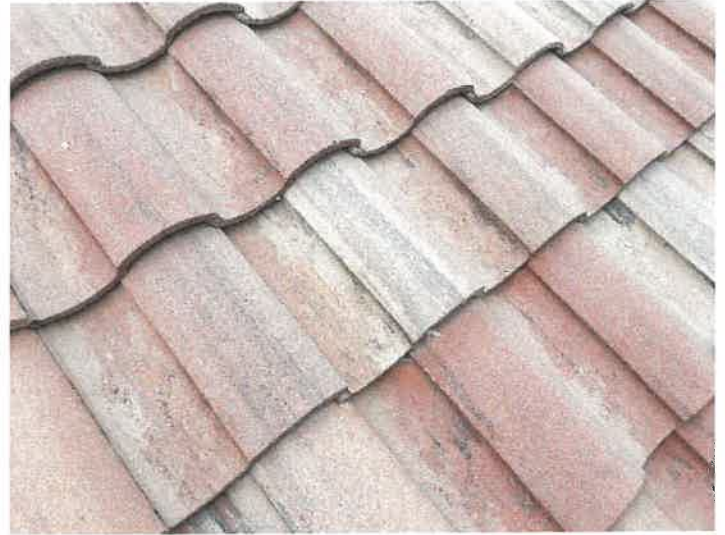
Building 15140: Repaired Displaced/Missing Roof Tile

Replaced and secured the missing roof tile.

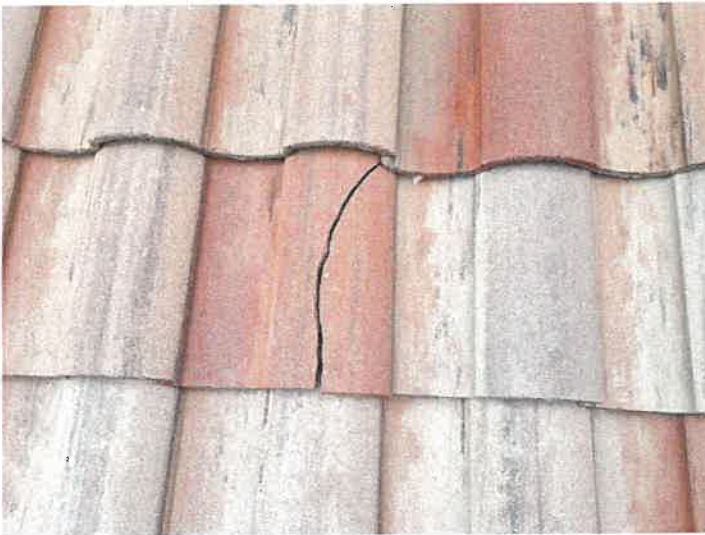
Building 15140: Identified Cracked Roof Tiles

Cracked roof tiles can allow premature underlayment deterioration from excessive UV exposure.

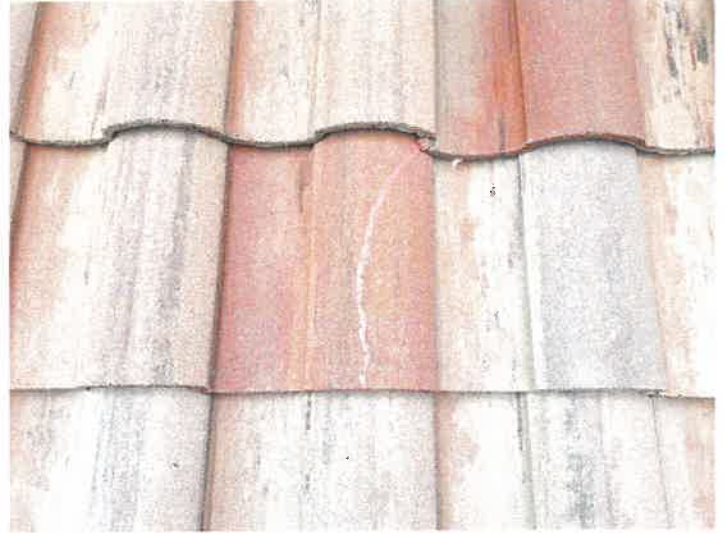
Building 15140: Repaired Cracked Roof Tiles

The cracked roof tiles were repaired with Titebond sealant.

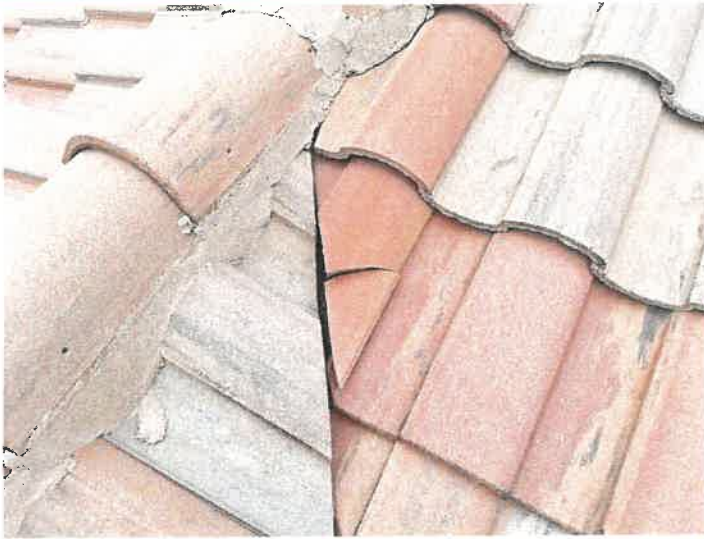
Building 15140: Identified Cracked Roof Tiles

Cracked roof tiles can allow premature underlayment deterioration from excessive UV exposure.

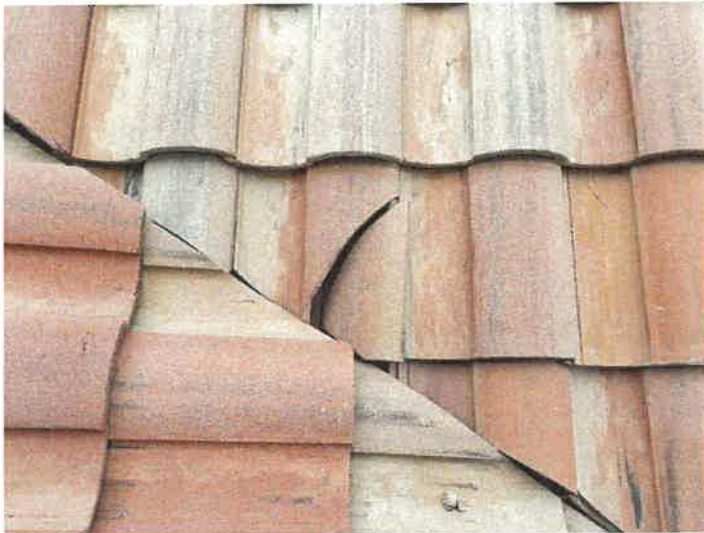
Building 15140: Identified Cracked Roof Tiles

Cracked roof tiles can allow premature underlayment deterioration from excessive UV exposure.

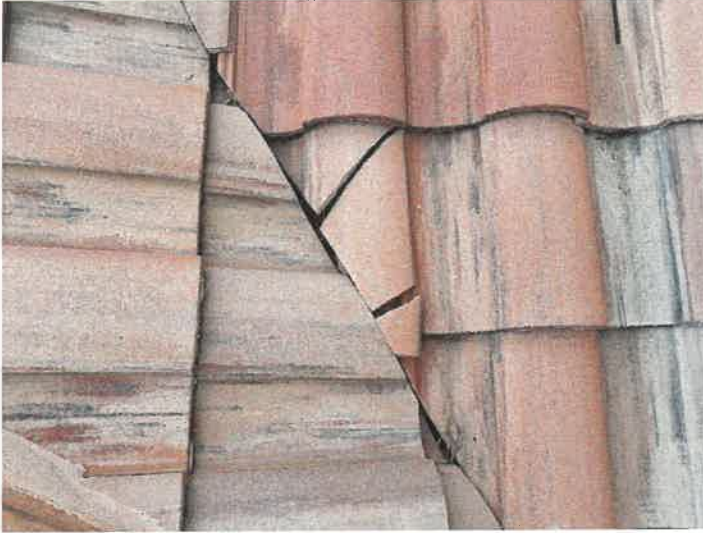
Building 15140: Identified Cracked Roof Tiles

Cracked roof tiles can allow premature underlayment deterioration from excessive UV exposure.

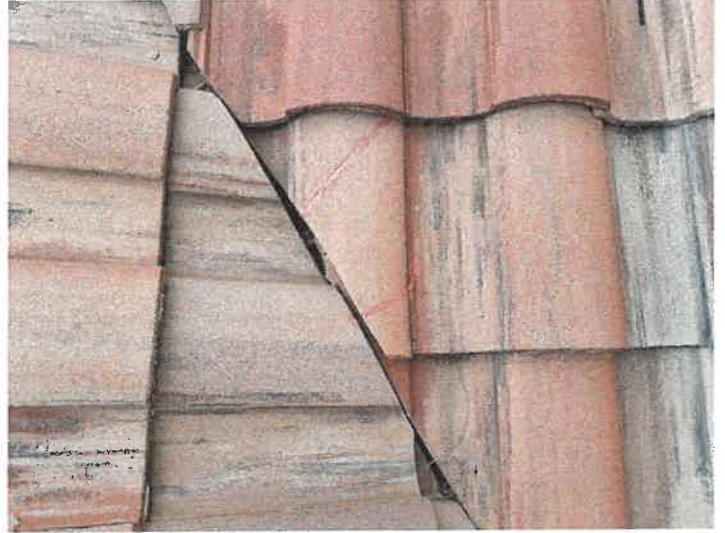
Building 15140: Repaired Cracked Roof Tiles

The cracked roof tiles were repaired with Titebond sealant.

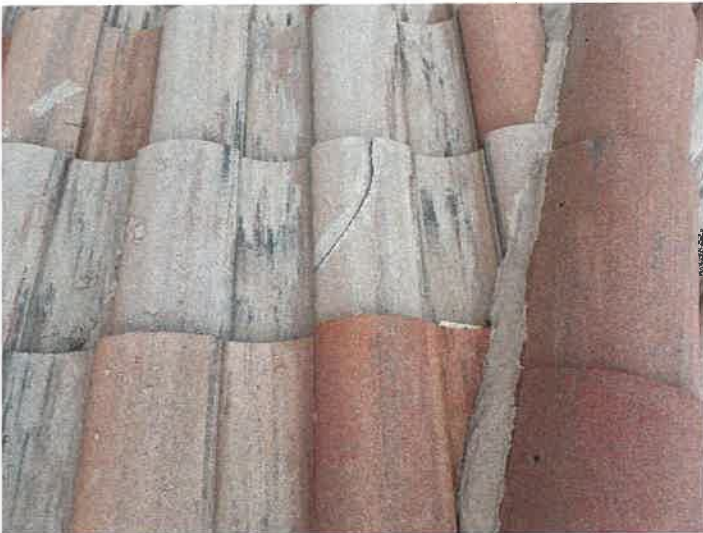
Building 15140: Identified Cracked Roof Tiles

Cracked roof tiles can allow premature underlayment deterioration from excessive UV exposure.

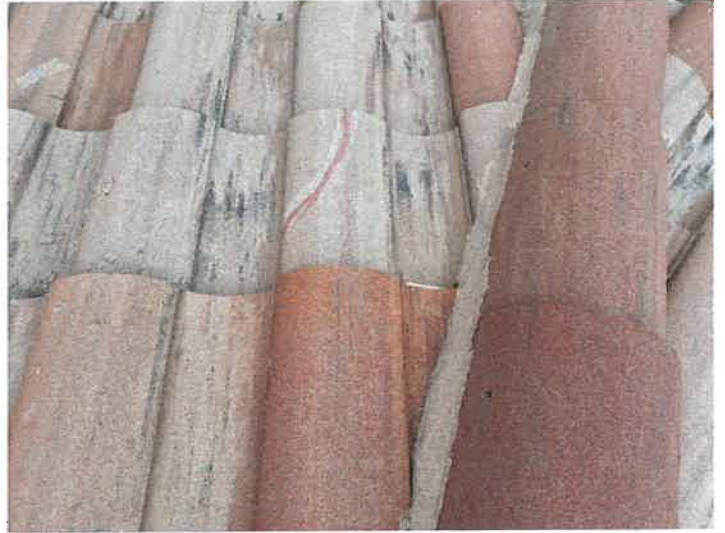
Building 15140: Repaired Cracked Roof Tiles

The cracked roof tiles were repaired with Titebond sealant.

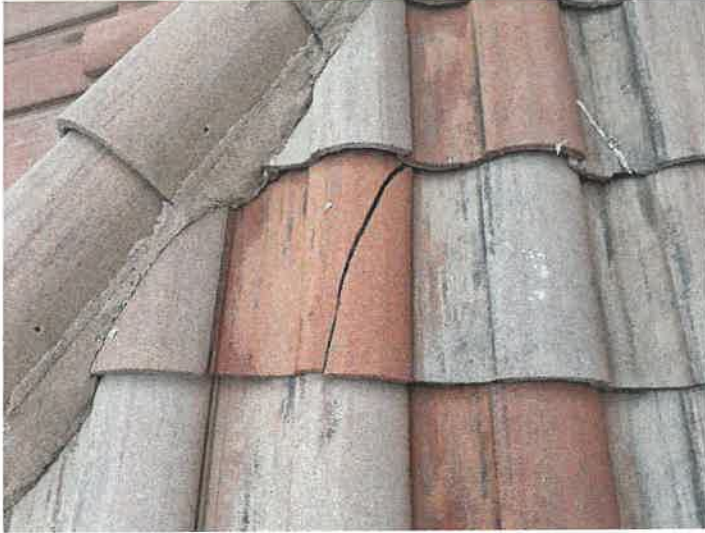
Building 15140: Identified Cracked Roof Tiles

Cracked roof tiles can allow premature underlayment deterioration from excessive UV exposure.

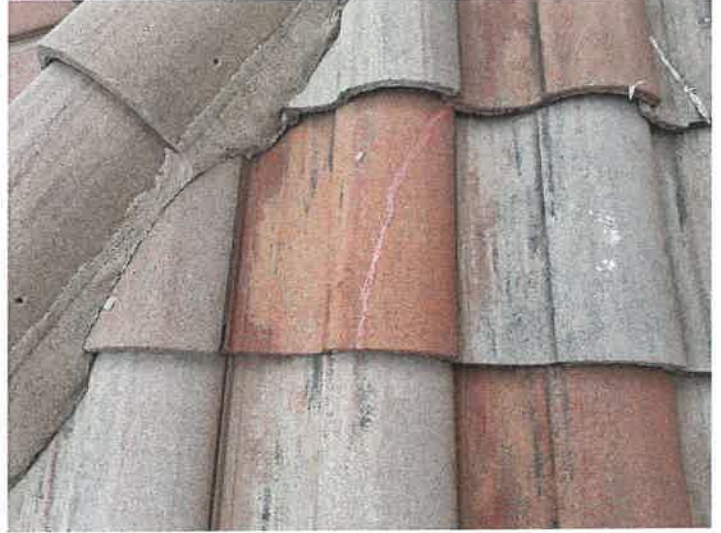
Building 15140: Repaired Cracked Roof Tiles

The cracked roof tiles were repaired with Titebond sealant.

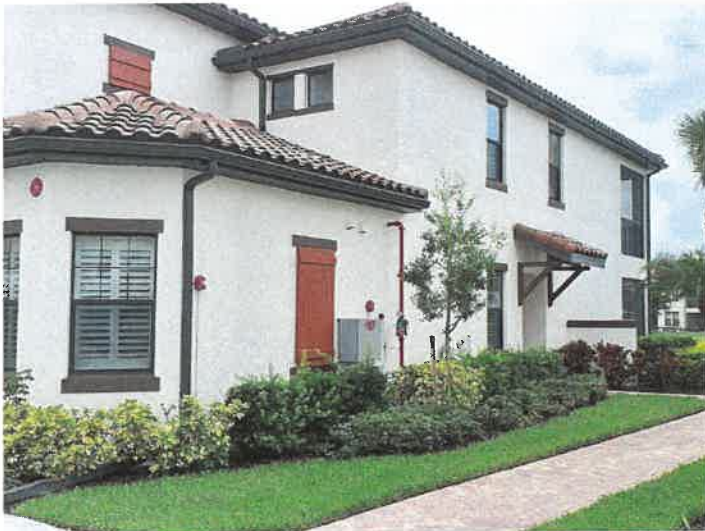
Building 15140: Downspouts

The downspouts appear to be in good condition.

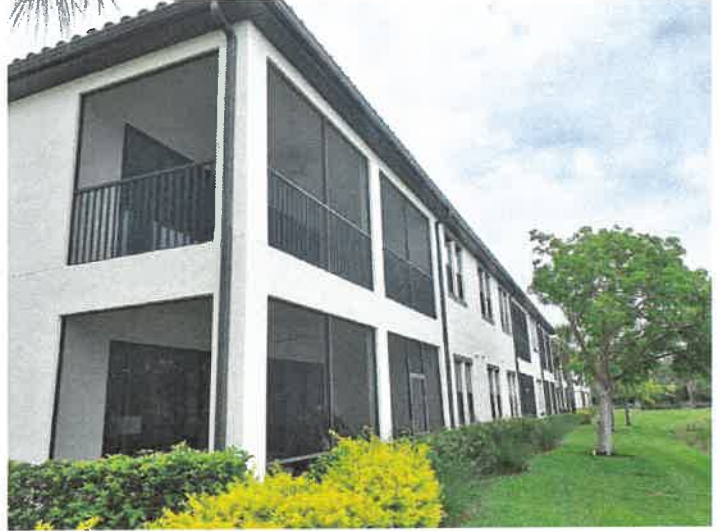
Building 15140: Downspouts

The downspouts appear to be in good condition.

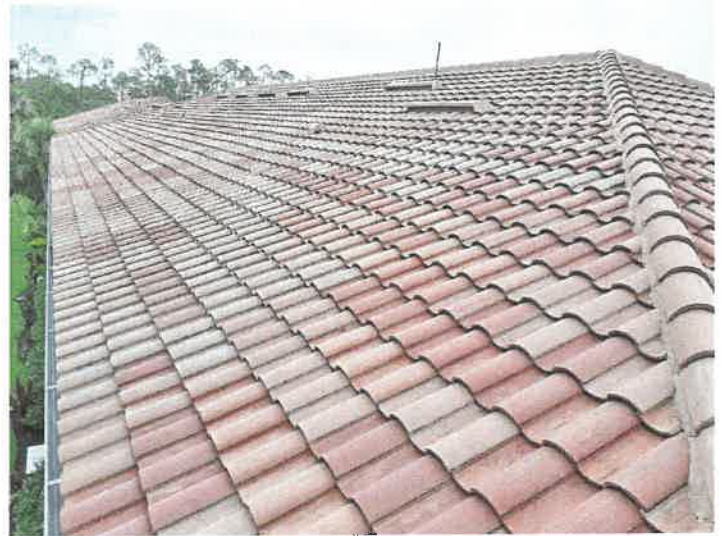
Building 15141: Surface Overview
The roof surface appears to be in good, maintainable condition at this time.
