Inspection Report

Facility: Livingston Lakes Condo
Address: 15098 Palmer Lake Circle,
Naples, FL 34109
Customer: Cardinal Management
Address: c/o Livingston Lakes Condo, 15090
Naples, FL 34109

Livingston Lakes Condo, Naples, FL

Re.: **Inspection Report (2 of 3) for Livingston Lakes**

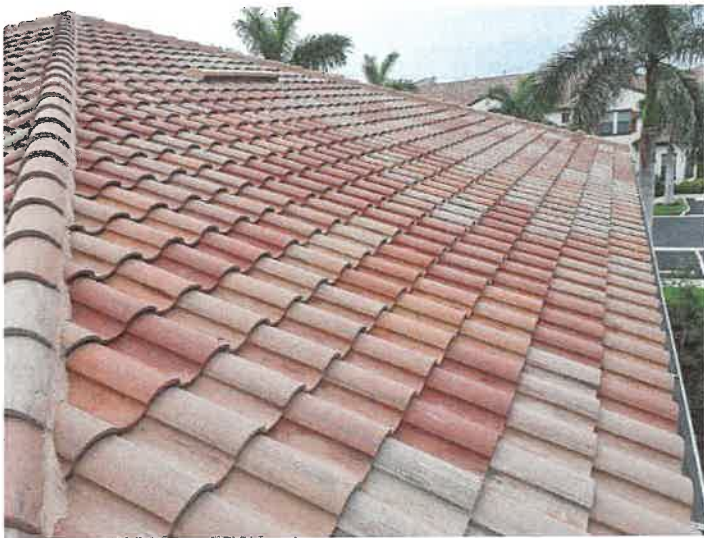
Building 15141: Appearance Overview
The roof appearance is in good, maintainable condition.

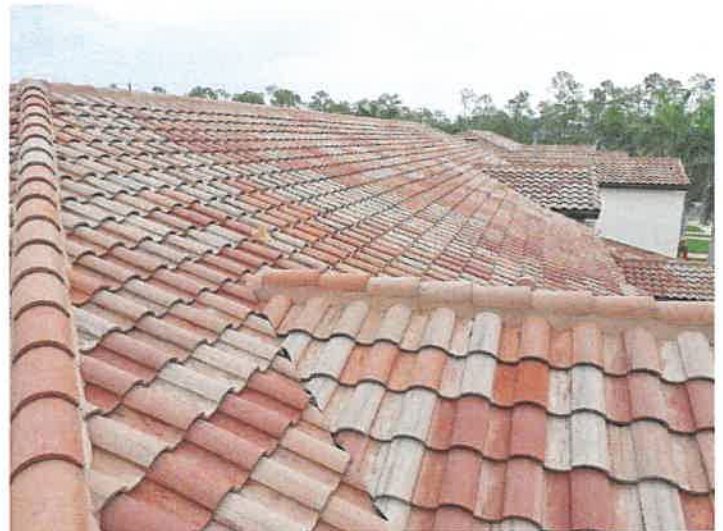
Building 15141: Surface Overview
The roof surface appears to be in good, maintainable condition at this time.

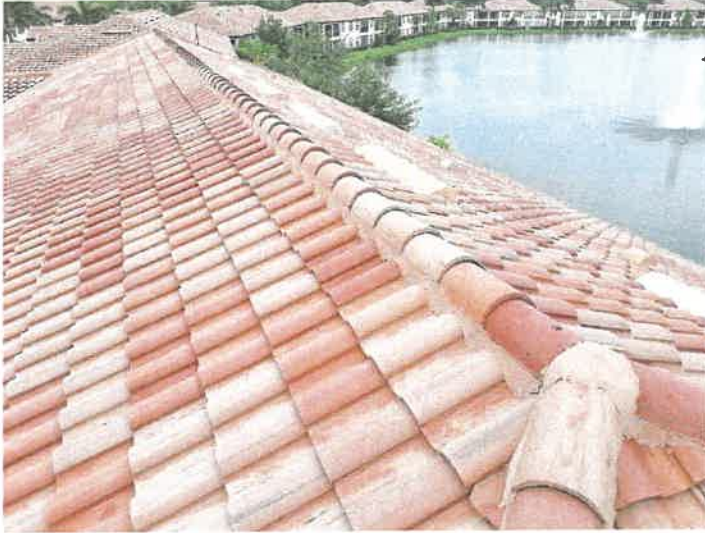
Building 15141: Ridge Tiles

Ridge tiles appear to be in good condition.

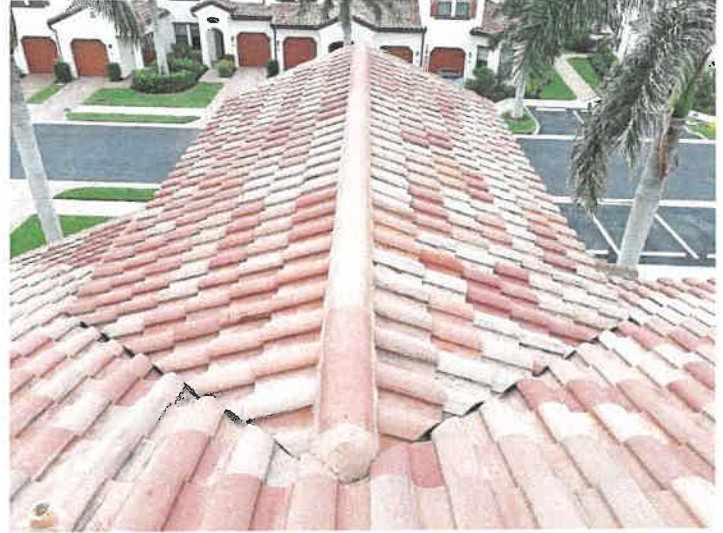
Building 15141: Valley

The valley tiles appear to be in good condition.

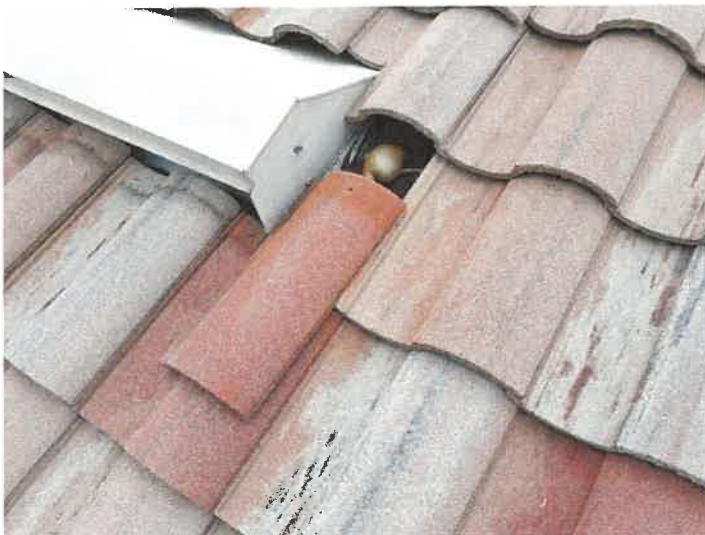
Building 15141: Displaced/Missing Roof Tile

Displaced or missing roof tiles can allow premature underlayment deterioration from excessive UV exposure and potential water intrusion.

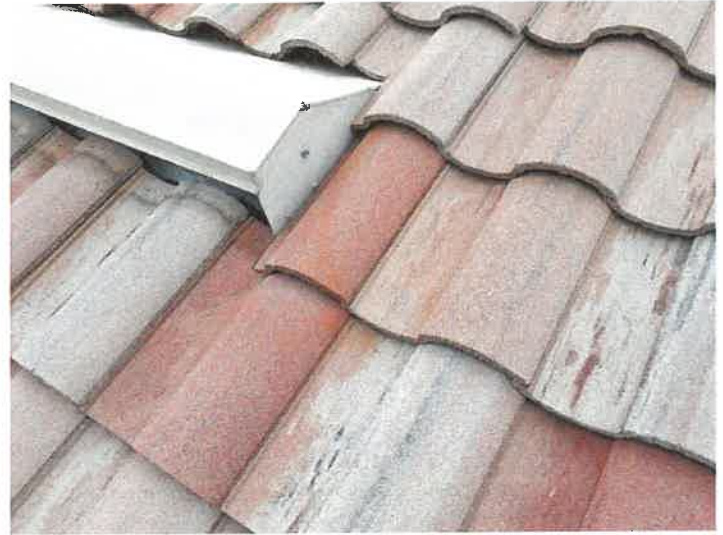
Building 15141: Repaired Displaced/Missing Roof Tile

Replaced and secured the missing roof tile.

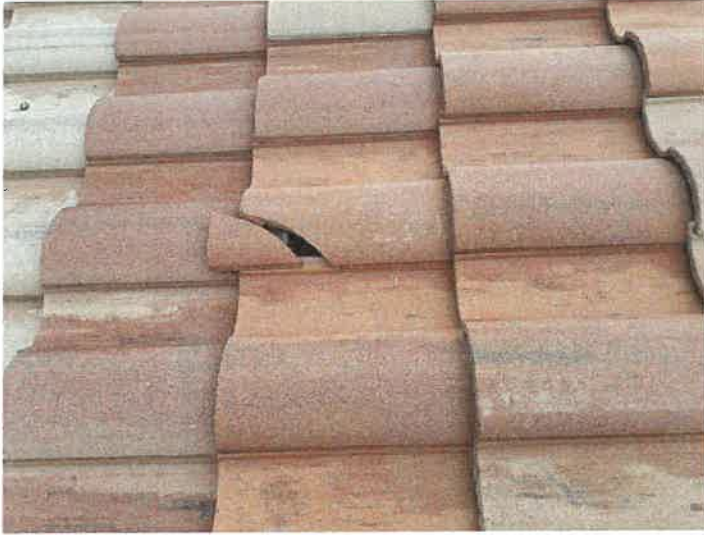
Building 15141: Identified Cracked Roof Tiles

Cracked roof tiles can allow premature underlayment deterioration from excessive UV exposure.

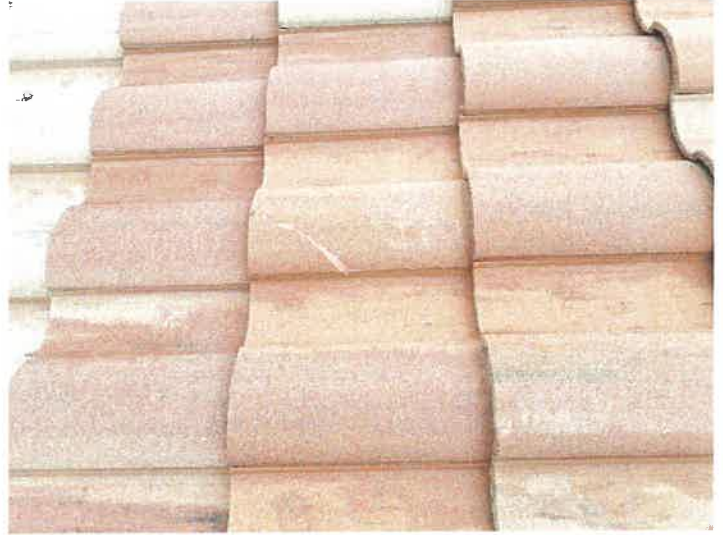
Building 15141: Repaired Cracked Roof Tiles

The cracked roof tiles were repaired with Titebond sealant.

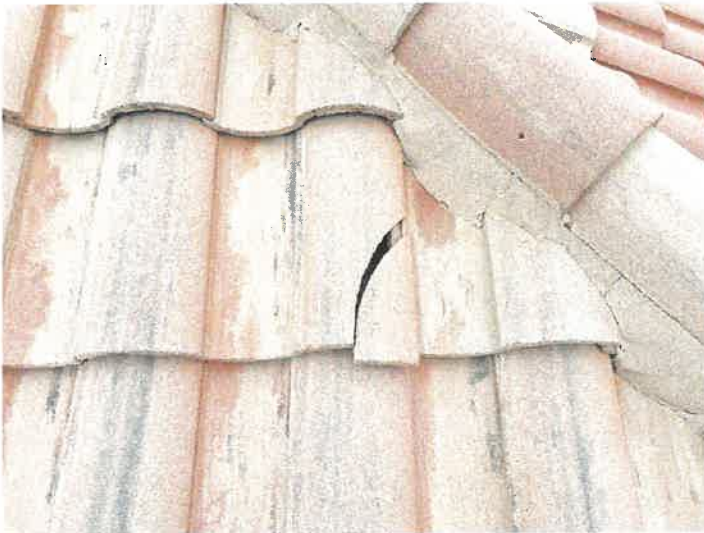
Building 15141: Identified Cracked Roof Tiles

Cracked roof tiles can allow premature underlayment deterioration from excessive UV exposure.

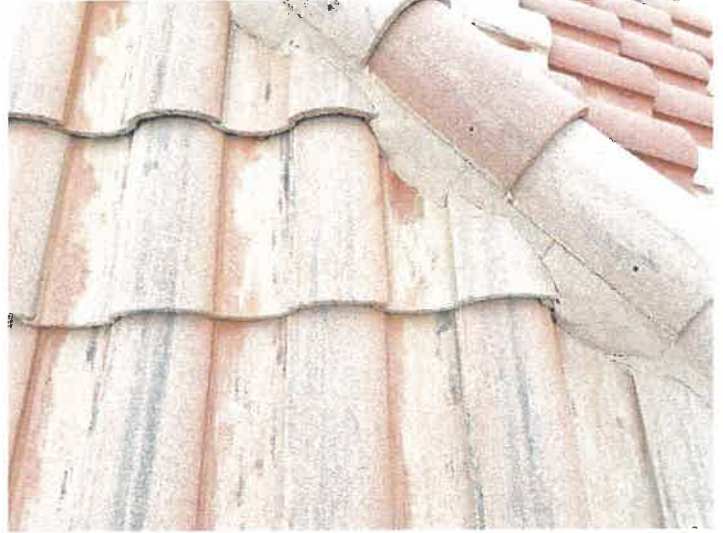
Building 15141: Repaired Cracked Roof Tiles

The cracked roof tiles were repaired with Titebond sealant.

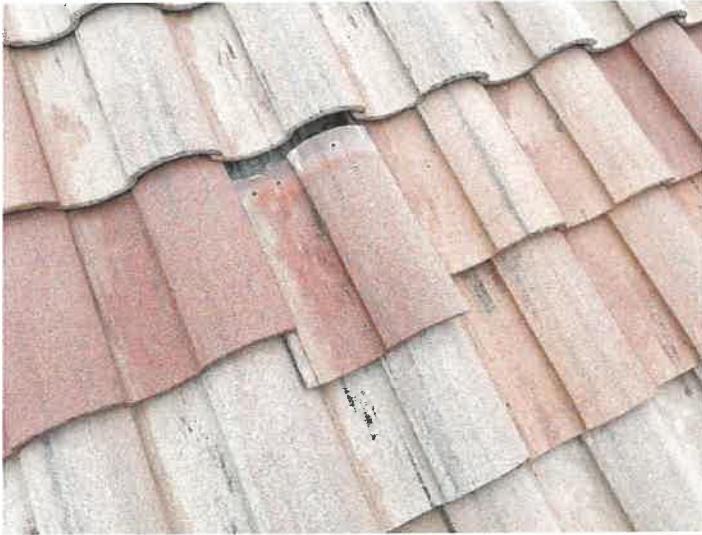
Displaced/Missing Roof Tile

Displaced or missing roof tiles can allow premature underlayment deterioration from excessive UV exposure and potential water intrusion.

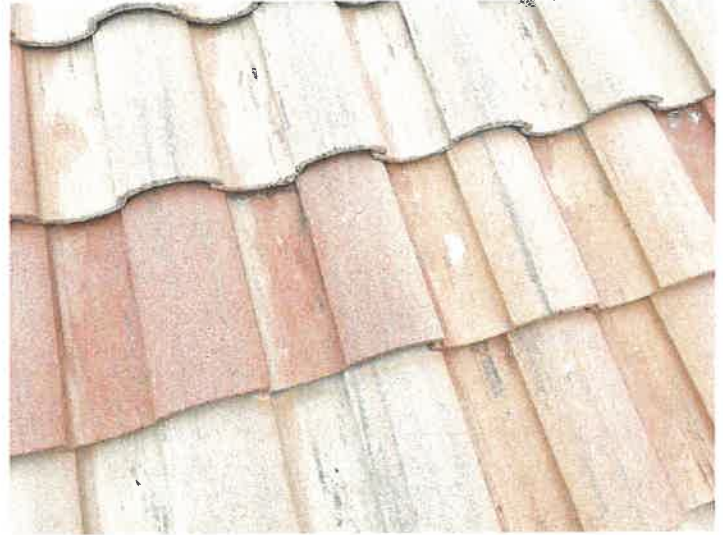
Repaired Displaced/Missing Roof Tile

Replaced and secured the missing roof tile.

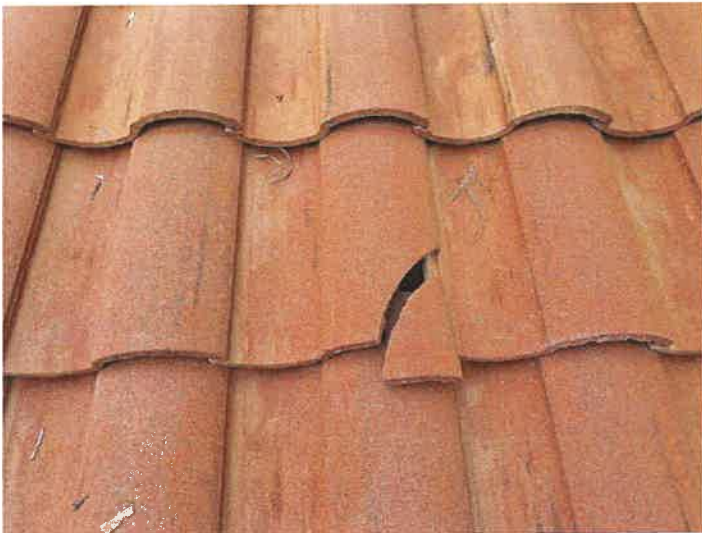
Building 15141: Identified Cracked Roof Tiles

Cracked roof tiles can allow premature underlayment deterioration from excessive UV exposure.

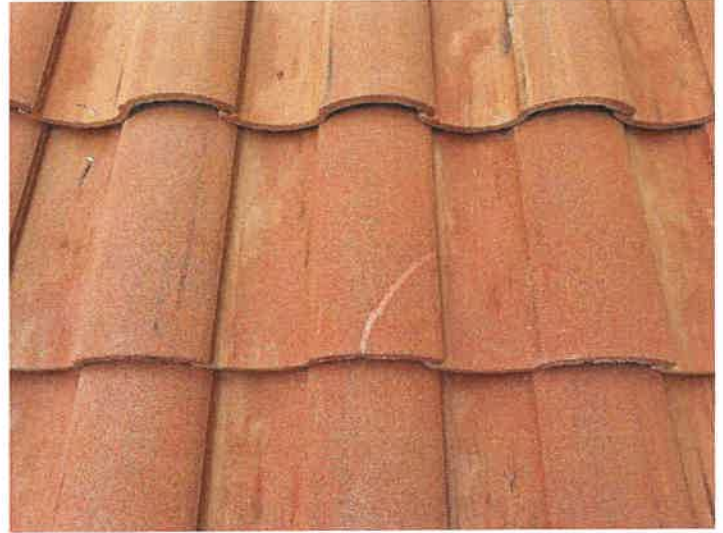
Building 15141: Repaired Cracked Roof Tiles

The cracked roof tiles were repaired with Titebond sealant.

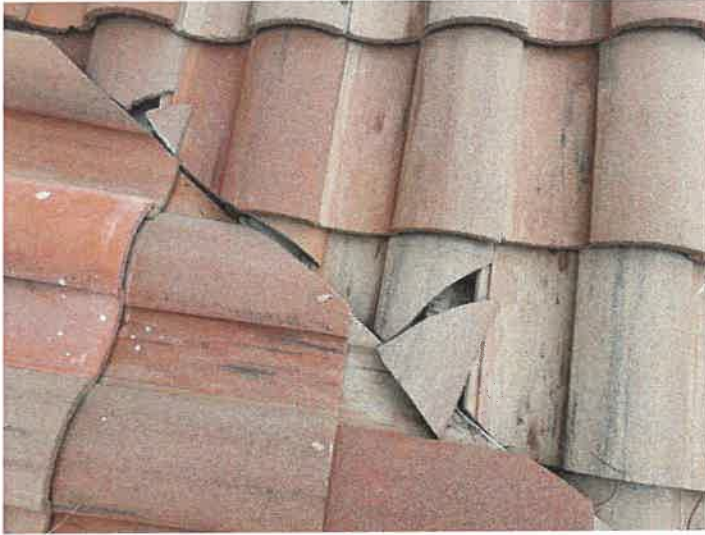
Building 15141: Identified Cracked Roof Tiles
Cracked roof tiles can allow premature underlayment deterioration from excessive UV exposure.

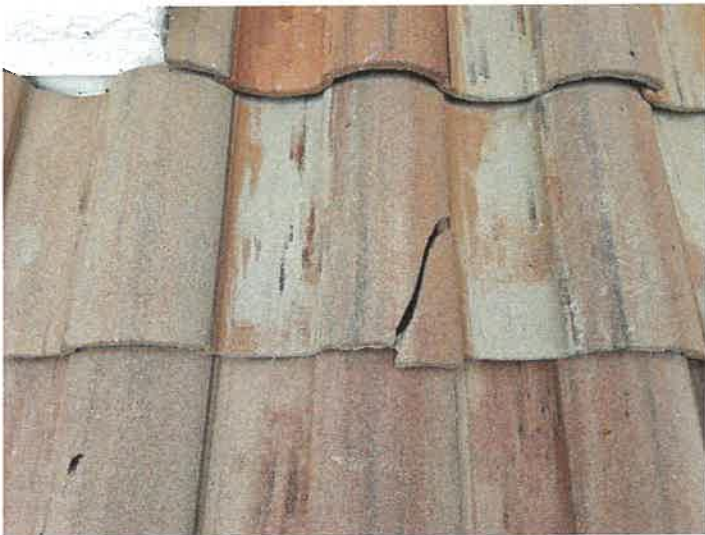
Building 15141: Identified Cracked Roof Tiles
Cracked roof tiles can allow premature underlayment deterioration from excessive UV exposure.

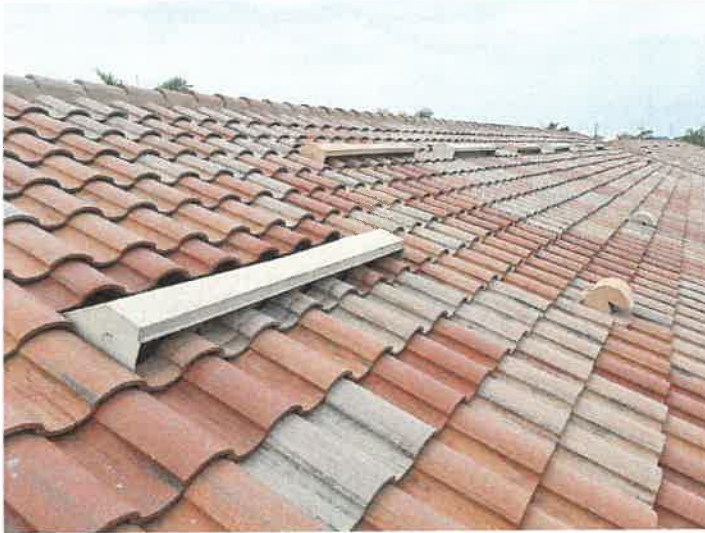
Building 15141: Roof Vents
Roof vents appear to be in good condition.

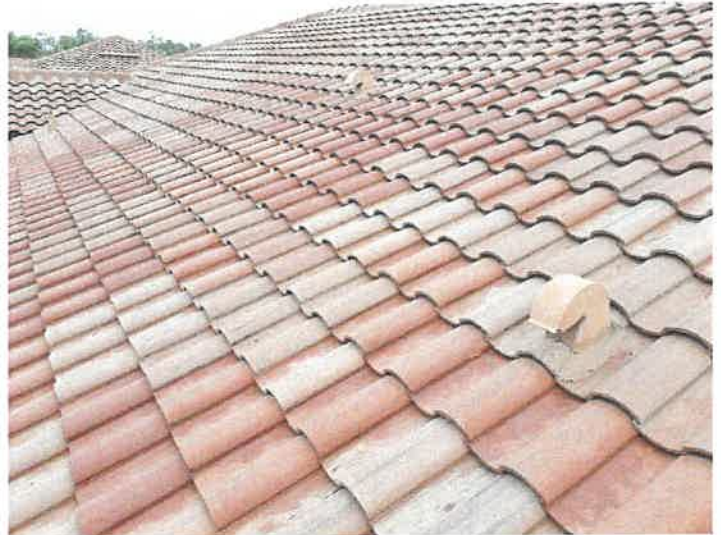
Building 15141: Roof Vents
Roof vents appear to be in good condition.

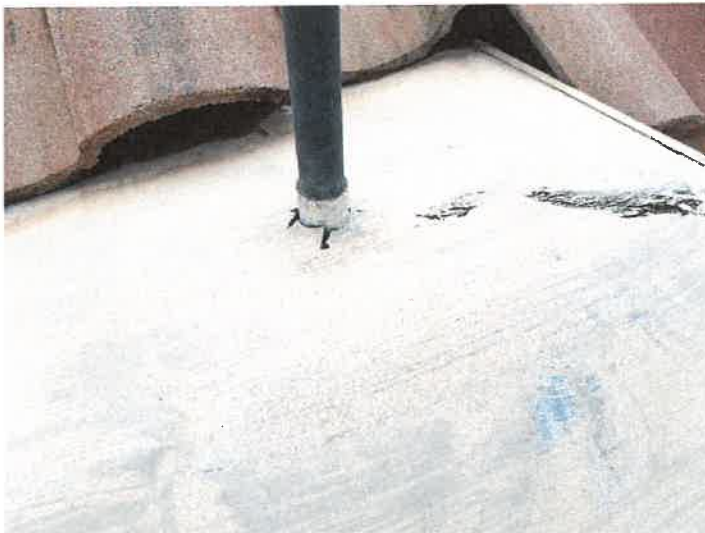
Building 15141: Sealant Failure
Identified a void in the sealant.

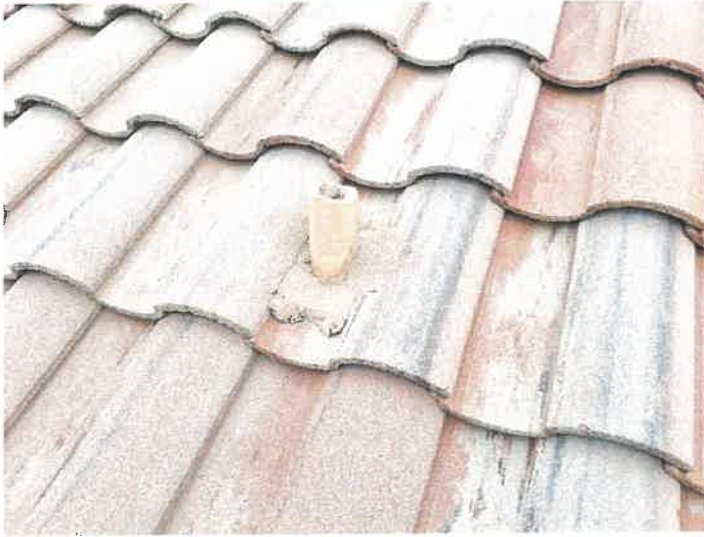
Building 15141: Lead Boots
Lead boots appear to be in good condition.

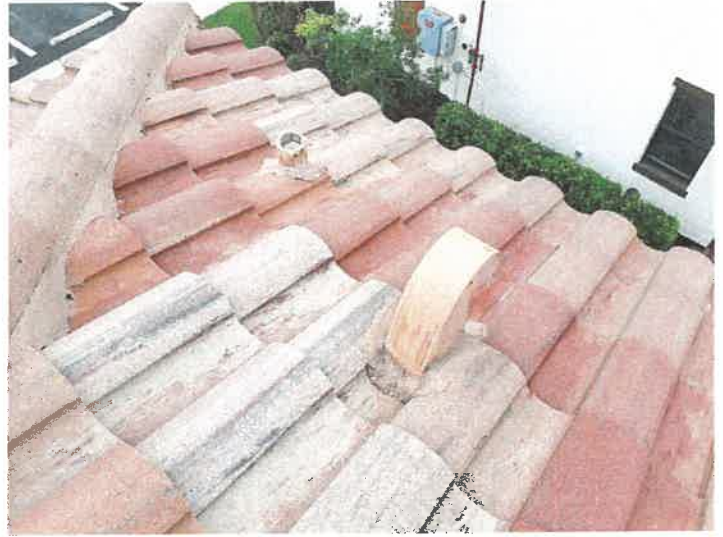
Building 15141: Lead Boots
Lead boots appear to be in good condition.

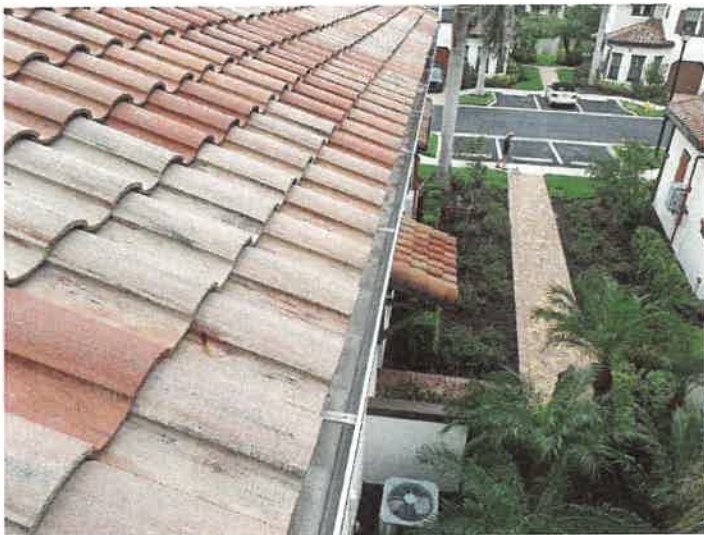
Building 15141: Gutters
The gutters appear to be in good condition.

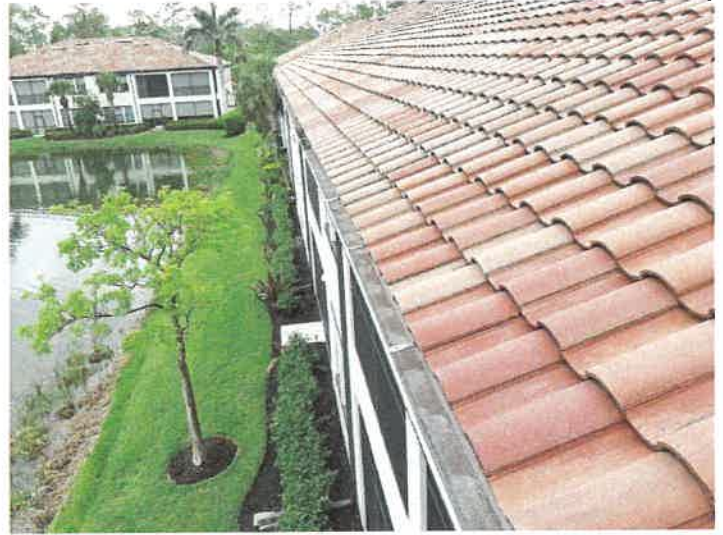
Building 15141: Gutters
The gutters appear to be in good condition.

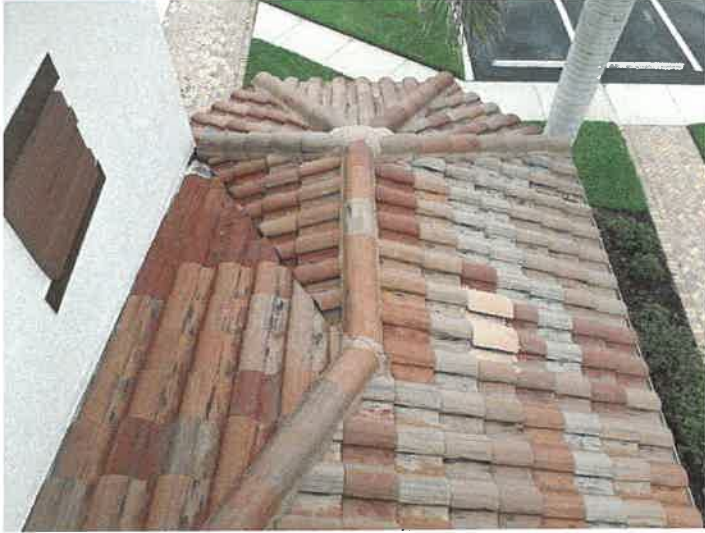
Building 15141: Surface Overview - Lower Roof
The roof surface appears to be in good, maintainable condition at this time.

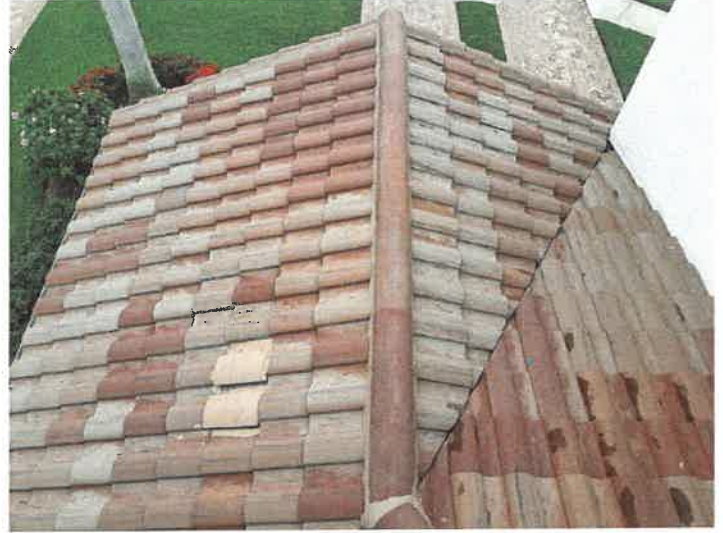
Building 15141: Appearance Overview - Lower Roof
The roof appearance is in good, maintainable condition.

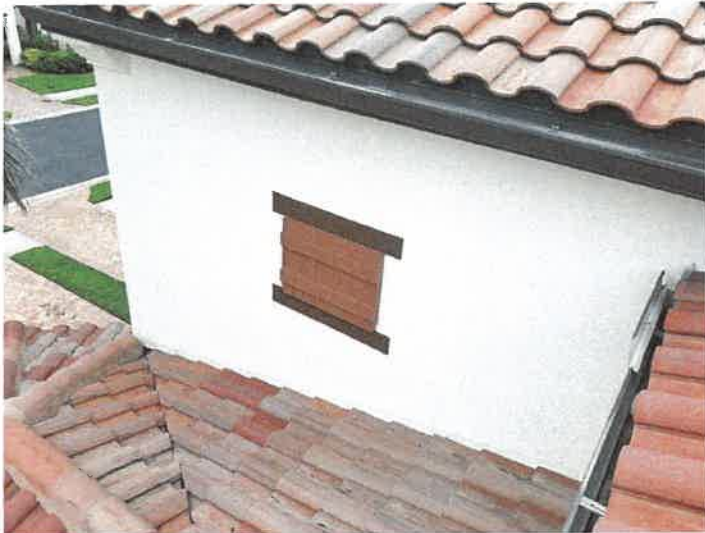
Building 15141: Wall
The walls appear to be in good condition.

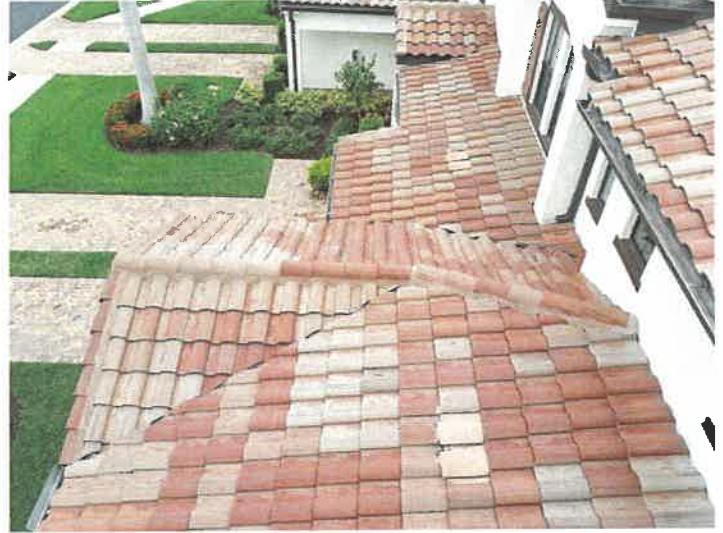
Building 15141: Surface Overview - Lower Roof
The roof surface appears to be in good, maintainable condition at this time.

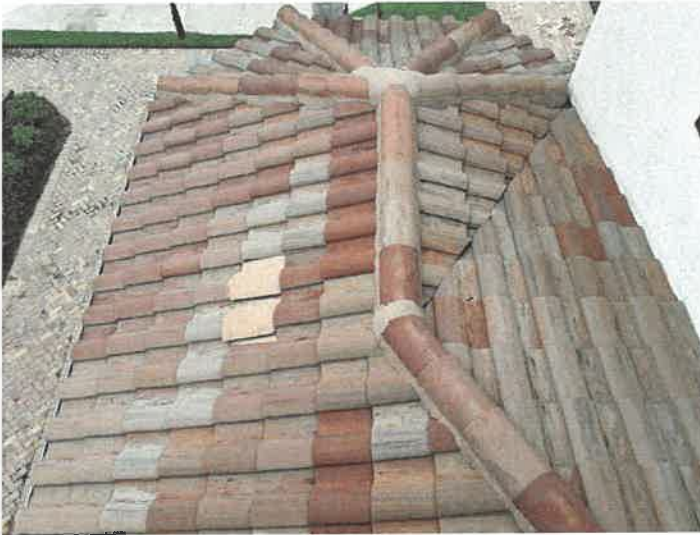
Building 15141: Appearance Overview - Lower Roof
The roof appearance is in good, maintainable condition.

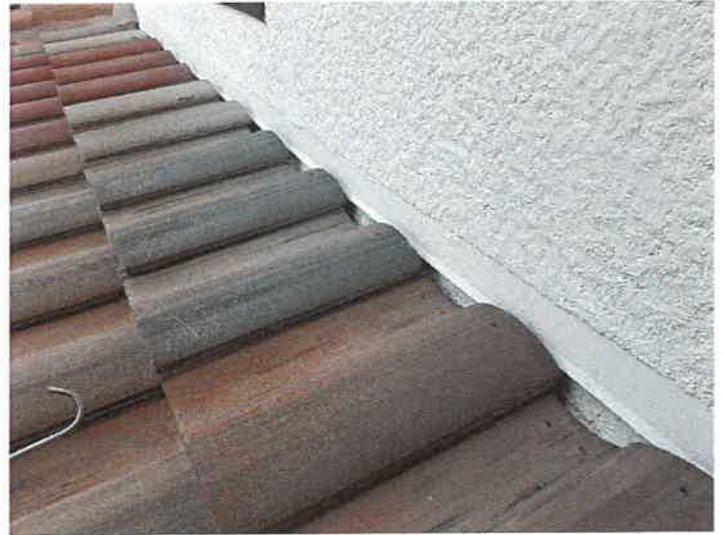
Building 15141: Counter Flashings
The counter flashing appears to be in good condition.

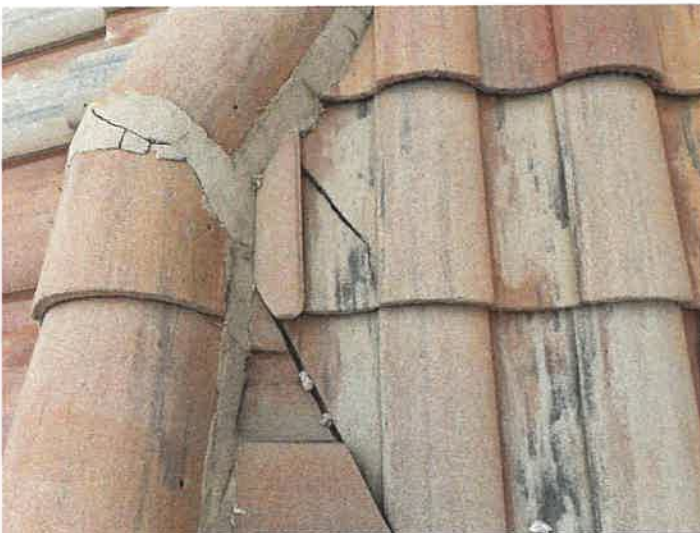
Building 15141: Identified Cracked Roof Tiles
Cracked roof tiles can allow premature underlayment deterioration from excessive UV exposure.

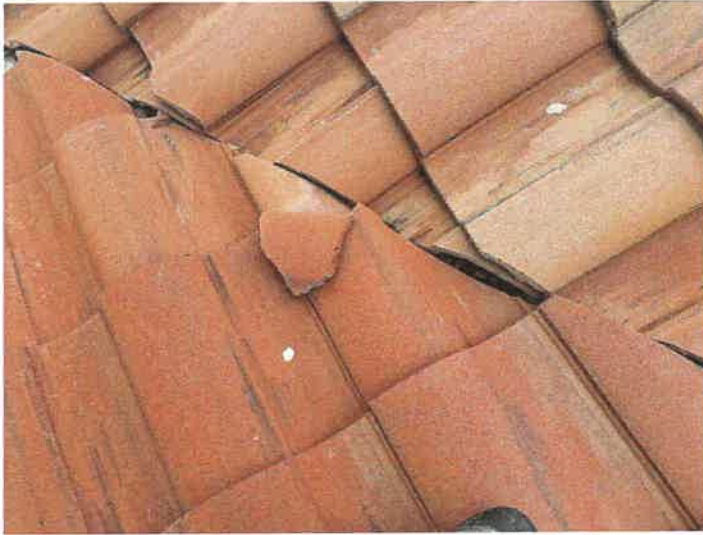
Building 15141: Identified Cracked Roof Tiles
Cracked roof tiles can allow premature underlayment deterioration from excessive UV exposure.

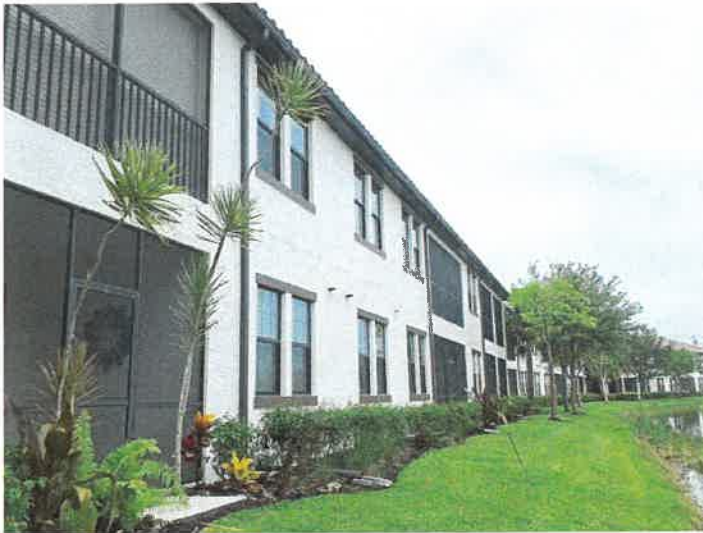
Building 15141: Downspouts
The downspouts appear to be in good condition.

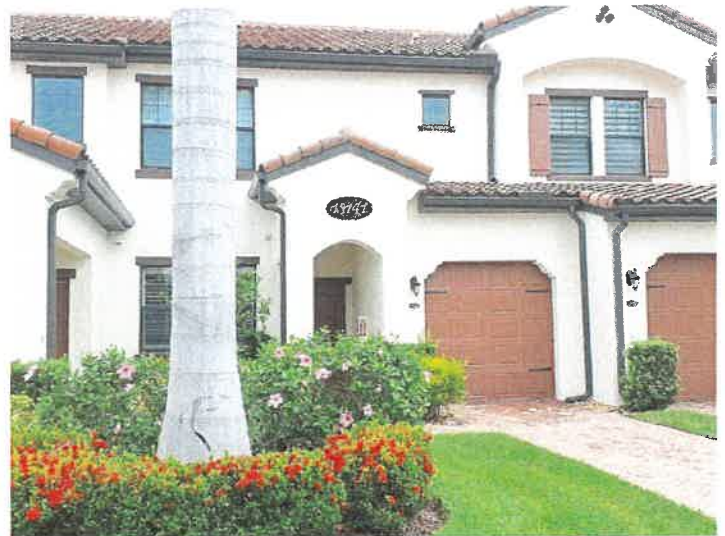
Building 15141: Downspouts
The downspouts appear to be in good condition.

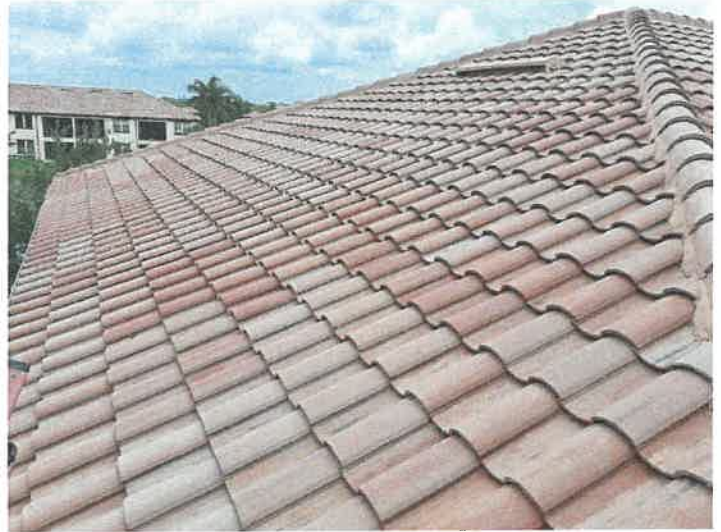
Building 15144: Surface Overview
The roof surface appears to be in good, maintainable condition at this time.

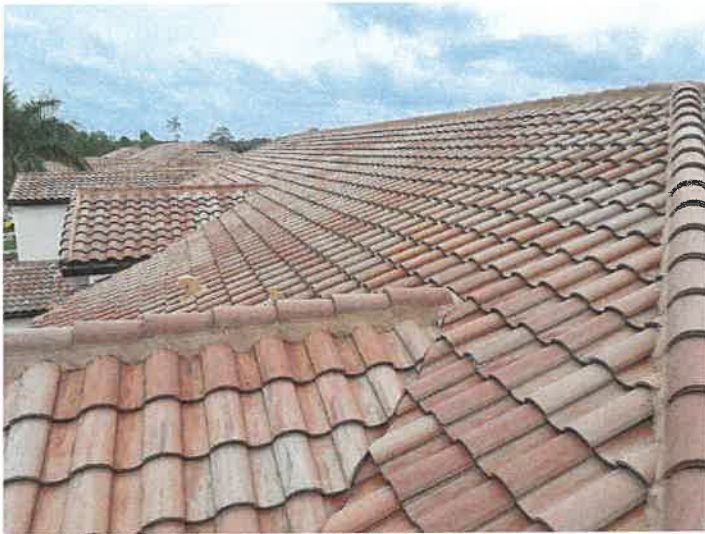
Building 15144: Appearance Overview
The roof appearance is in good, maintainable condition.

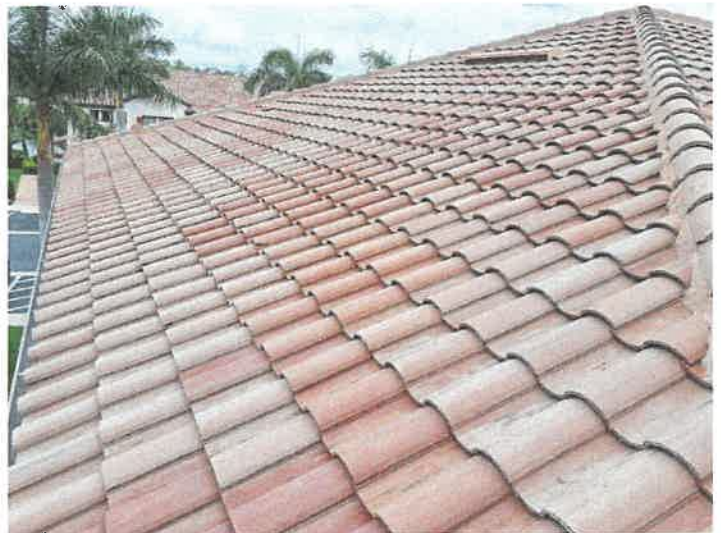
Building 15144: Surface Overview
The roof surface appears to be in good, maintainable condition at this time.

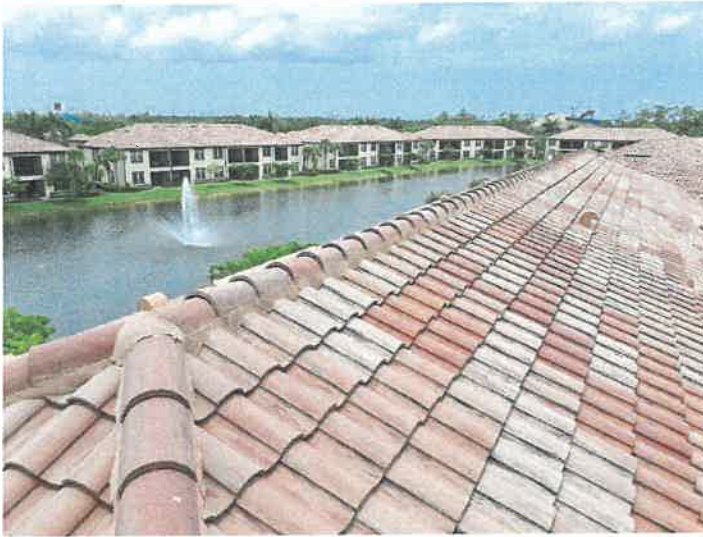
Building 15144: Ridge Tiles

Ridge tiles appear to be in good condition.

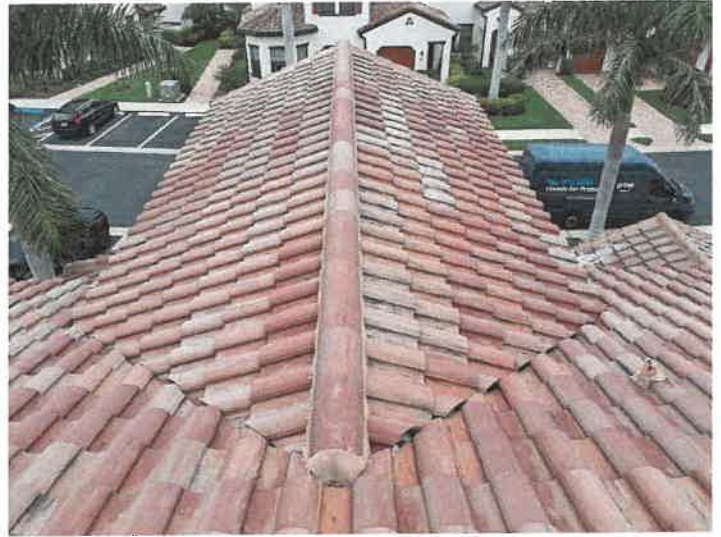
Building 15144: Valley

The valley tiles appear to be in good condition.

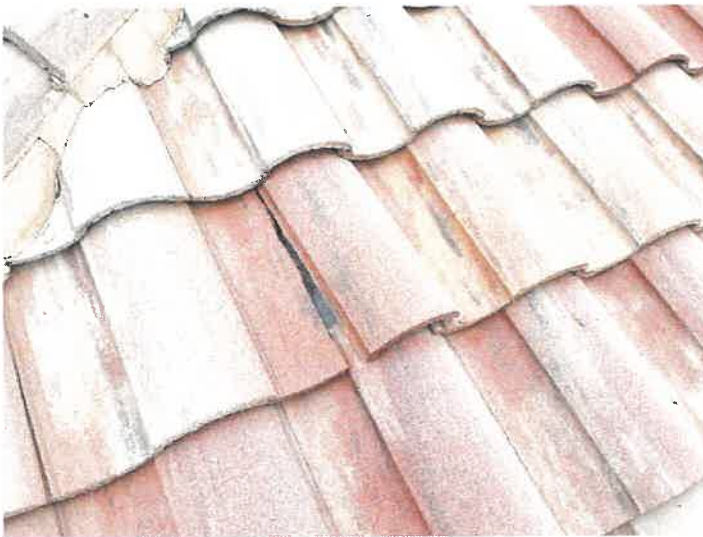
Building 15144: Identified Cracked Roof Tiles

Cracked roof tiles can allow premature underlayment deterioration from excessive UV exposure.

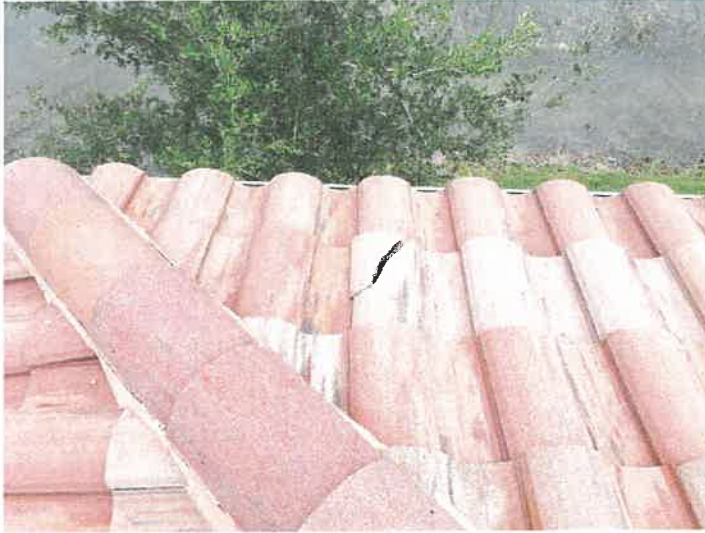
Building 15144: Identified Cracked Roof Tiles

Cracked roof tiles can allow premature underlayment deterioration from excessive UV exposure.

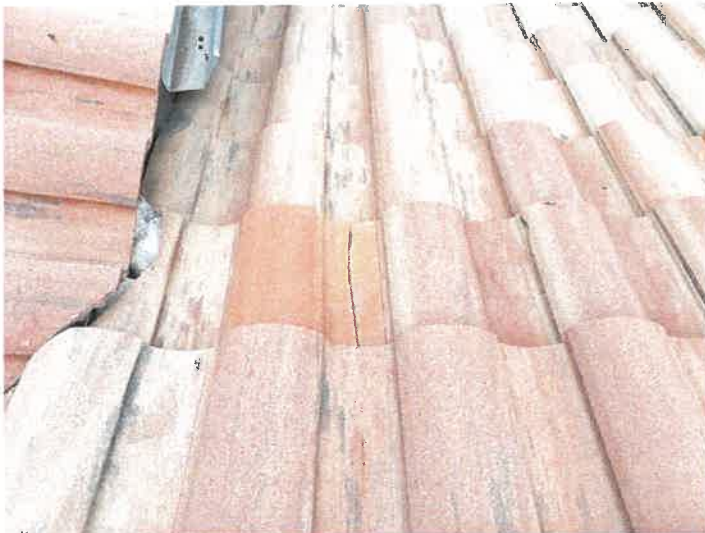
Building 15144: Identified Cracked Roof Tiles

Cracked roof tiles can allow premature underlayment deterioration from excessive UV exposure.

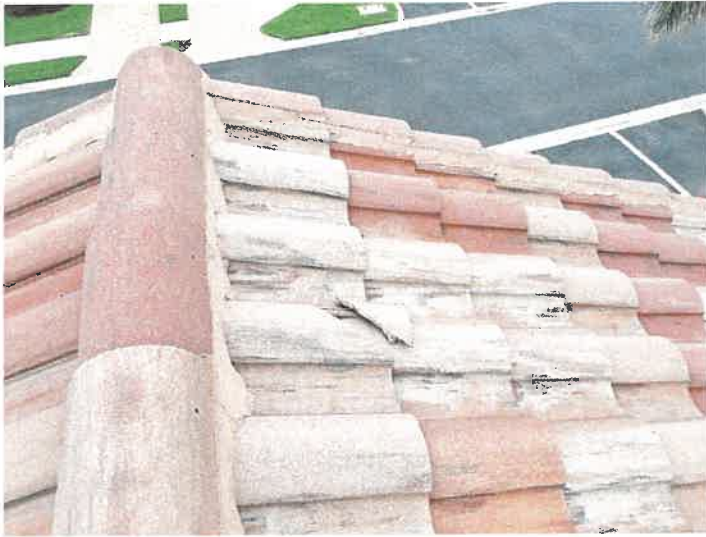
Building 15144: Identified Cracked Roof Tiles

Cracked roof tiles can allow premature underlayment deterioration from excessive UV exposure.

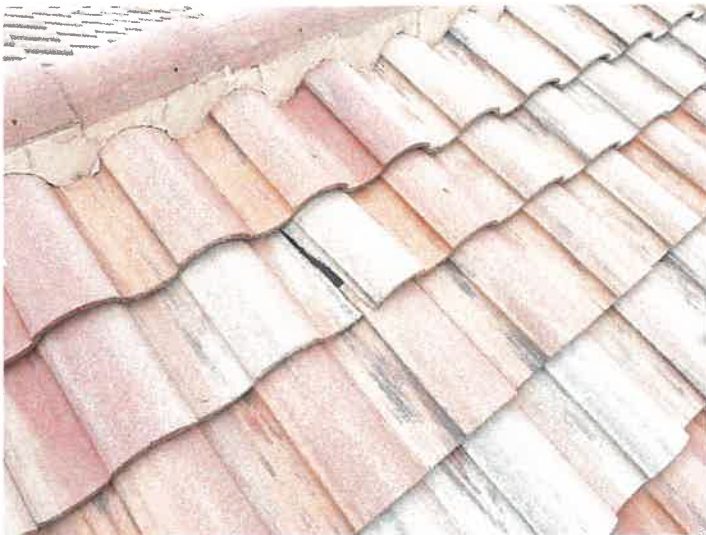
Building 15144: Identified Cracked Roof Tiles

Cracked roof tiles can allow premature underlayment deterioration from excessive UV exposure.

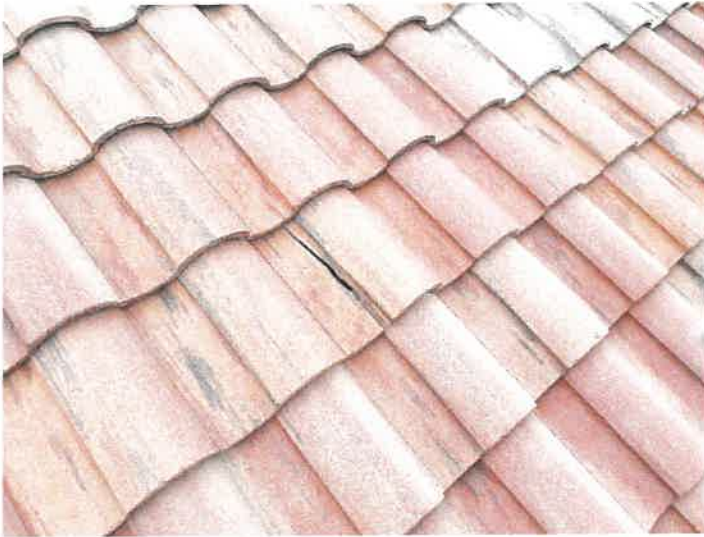
Building 15144: Identified Cracked Roof Tiles

Cracked roof tiles can allow premature underlayment deterioration from excessive UV exposure.

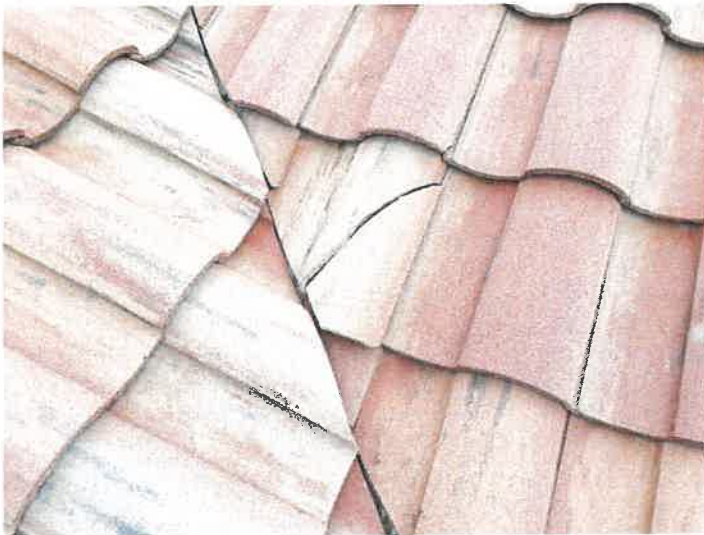
Building 15144: Identified Cracked Roof Tiles

Cracked roof tiles can allow premature underlayment deterioration from excessive UV exposure.

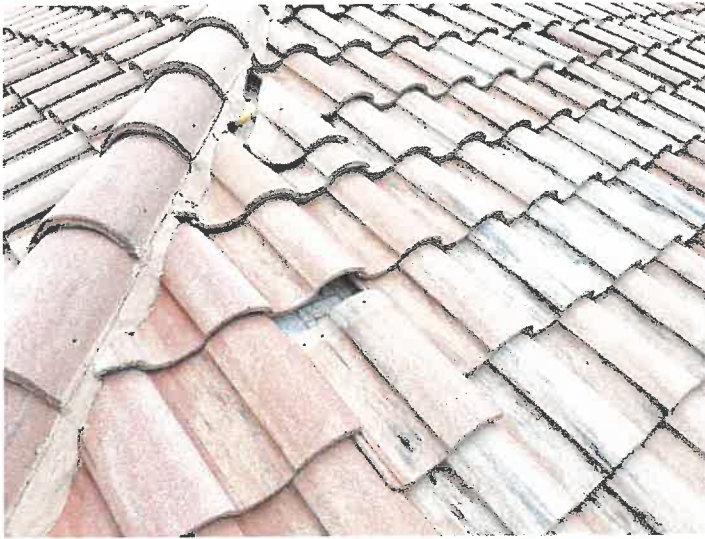
Building 15144: Displaced/Missing Roof Tile

Displaced or missing roof tiles can allow premature underlayment deterioration from excessive UV exposure and potential water intrusion.

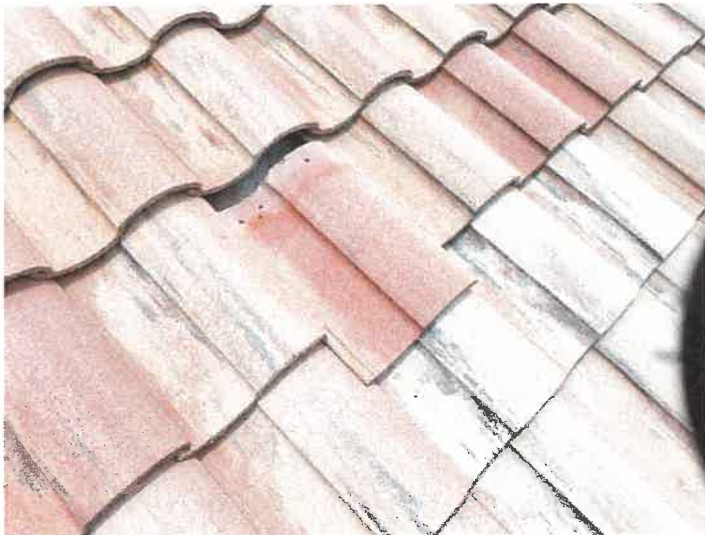
Building 15144: Displaced/Missing Roof Tile

Displaced or missing roof tiles can allow premature underlayment deterioration from excessive UV exposure and potential water intrusion.

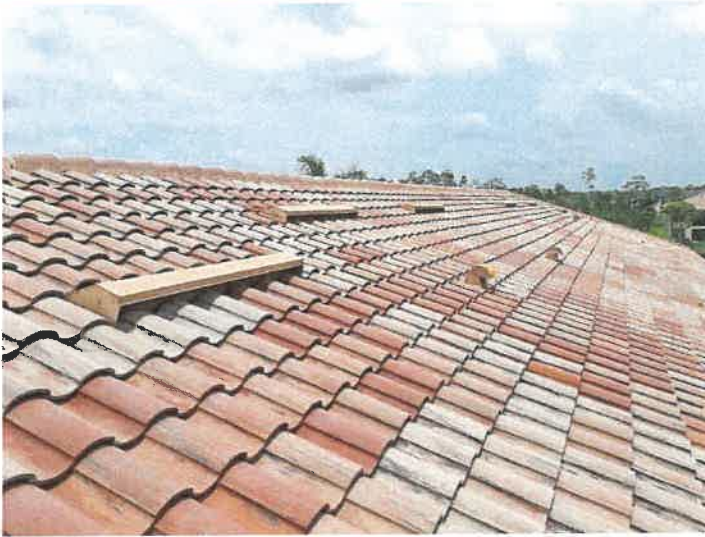
Building 15144: Roof Vents
Roof vents appear to be in good condition.

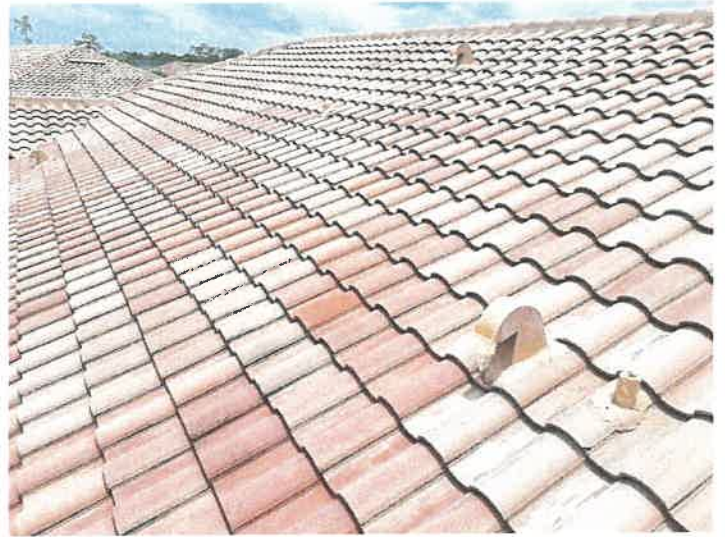
Building 15144: Roof Vents
Roof vents appear to be in good condition.

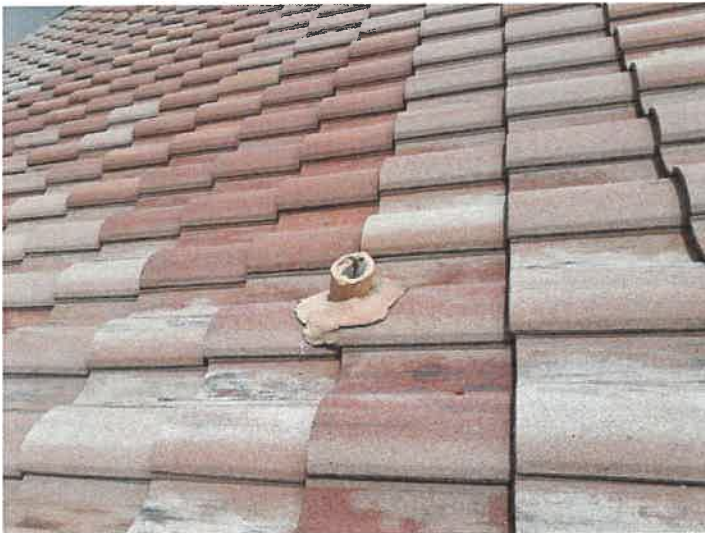
Building 15144: Lead Boots
Lead boots appear to be in good condition.

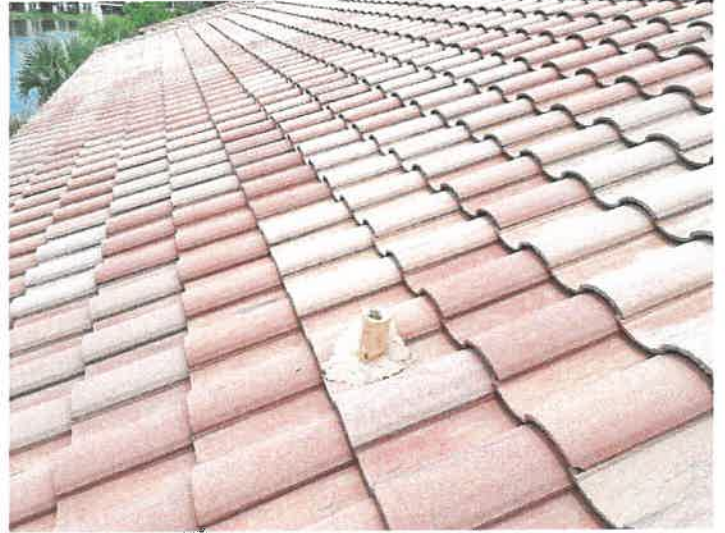
Building 15144: Lead Boots
Lead boots appear to be in good condition.

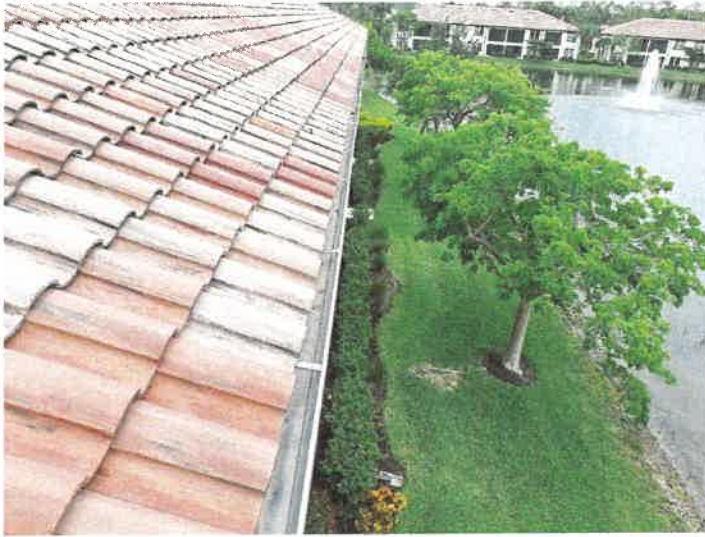
Building 15144: Gutters

The gutters appear to be in good condition.

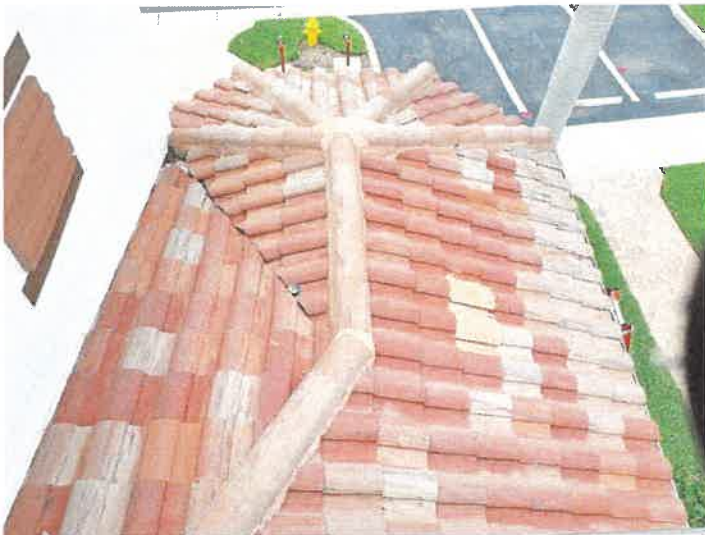
Building 15144: Surface Overview - Lower Roof

The roof surface appears to be in good, maintainable condition at this time.

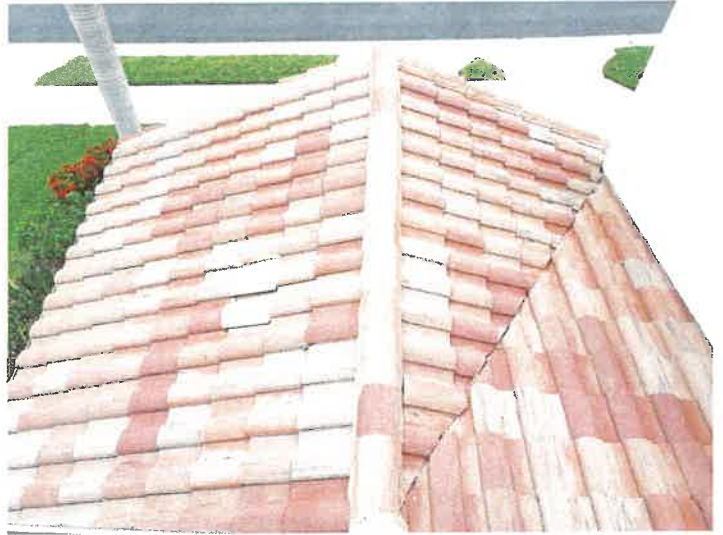
Building 15144: Appearance Overview - Lower Roof

The roof appearance is in good, maintainable condition.

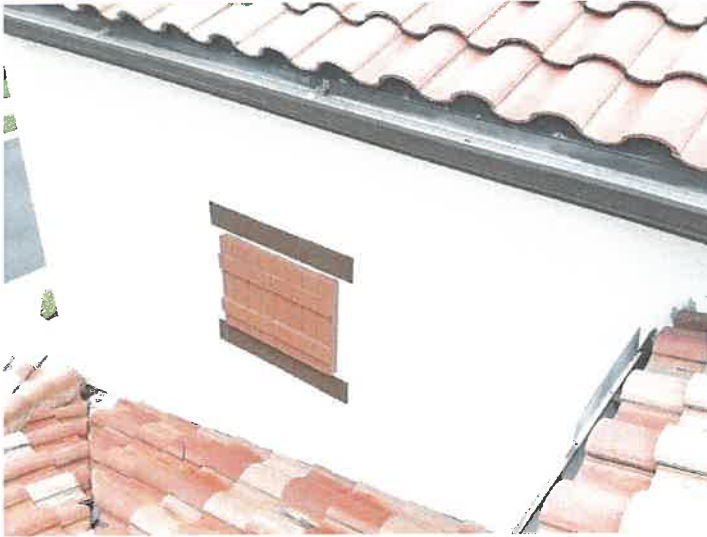
Building 15144: Wall

The walls appear to be in good condition.

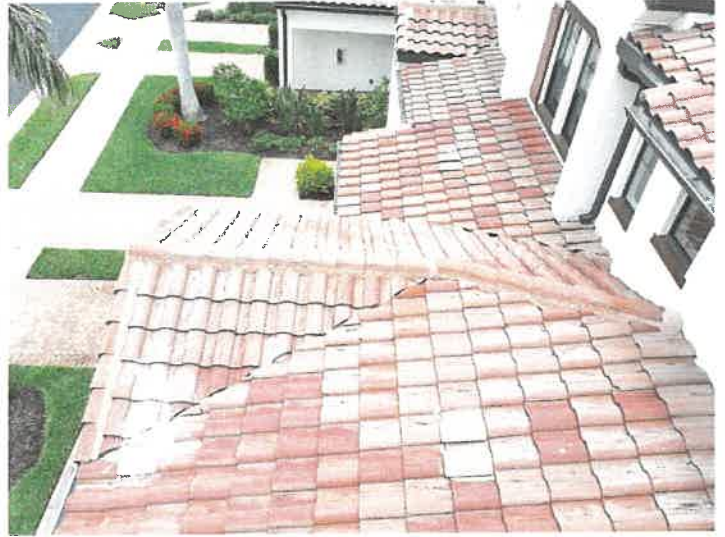
Building 15144: Surface Overview

The roof surface appears to be in good, maintainable condition at this time.
