Inspection Report

Facility: Livingston Lakes Condo
Address: 15098 Palmer Lake Circle,
Naples, FL 34109
Customer: Cardinal Management
Address: c/o Livingston Lakes Condo, 15090
Naples, FL 34109

Livingston Lakes Condo, Naples, FL

Re.: **Inspection Report (2 of 3) for Livingston Lakes**

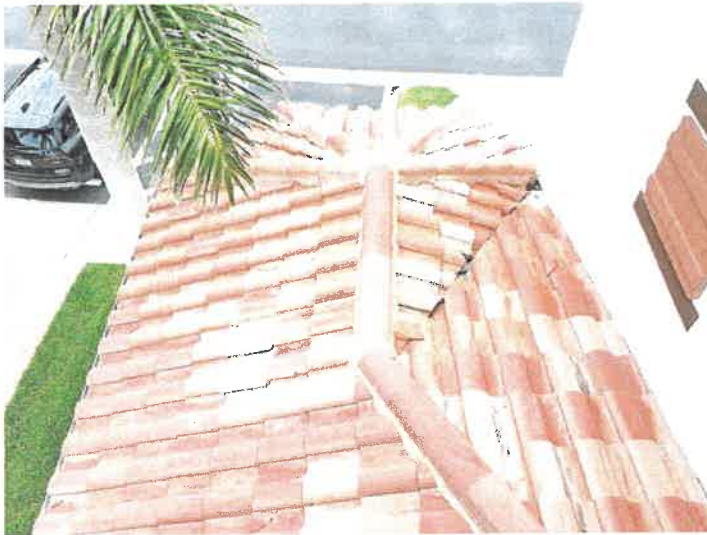
Building 15144: Appearance Overview - Lower Roof

The roof appearance is in good, maintainable condition.

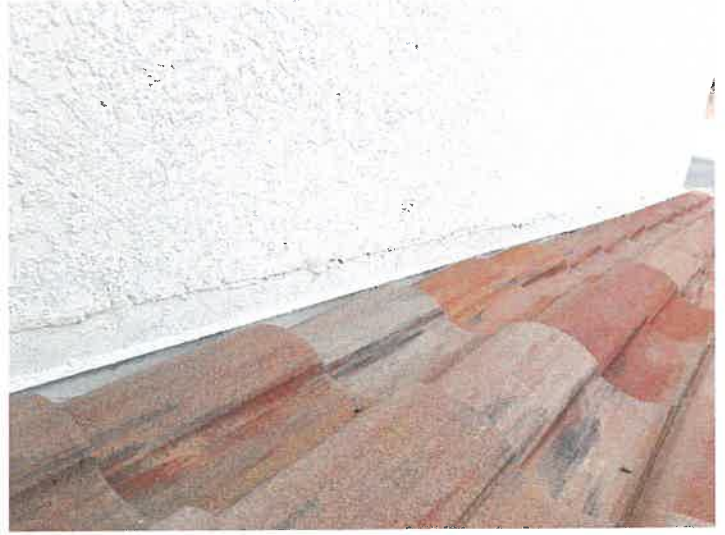
Building 15144: Counter Flashings

The counter flashing appears to be in good condition.

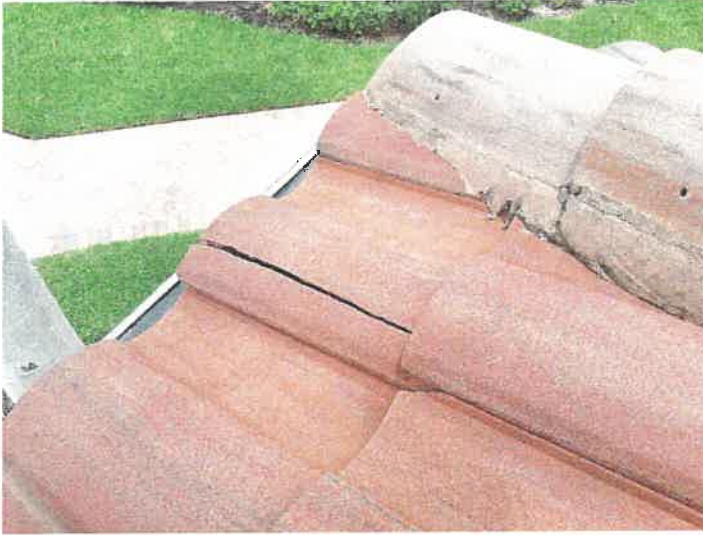
Building 15144: Identified Cracked Roof Tiles

Cracked roof tiles can allow premature underlayment deterioration from excessive UV exposure.

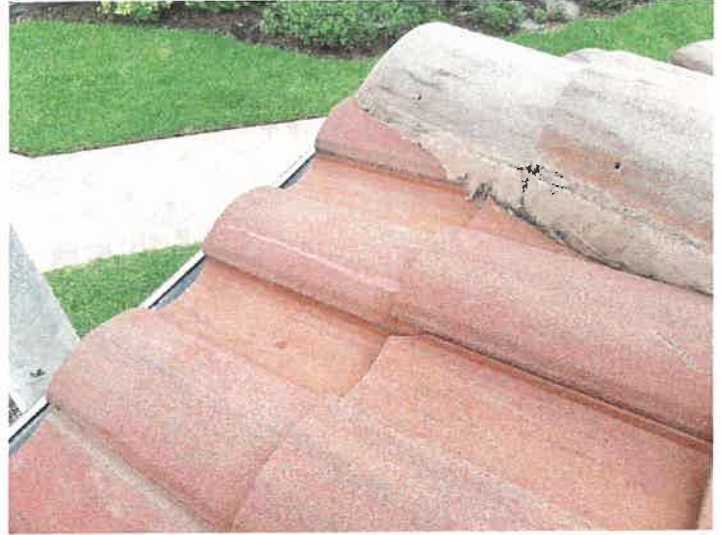
Building 15144: Repaired Cracked Roof Tiles

The cracked roof tiles were repaired with Titebond sealant.

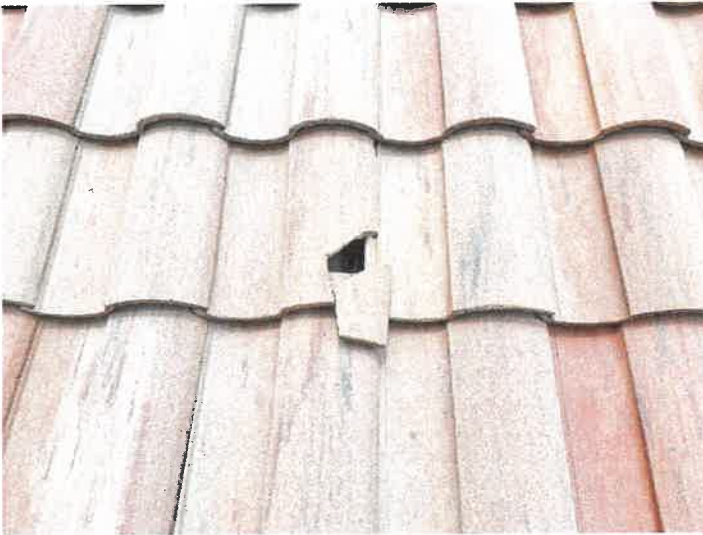
Building 15144: Identified Cracked Roof Tiles

Cracked roof tiles can allow premature underlayment deterioration from excessive UV exposure.

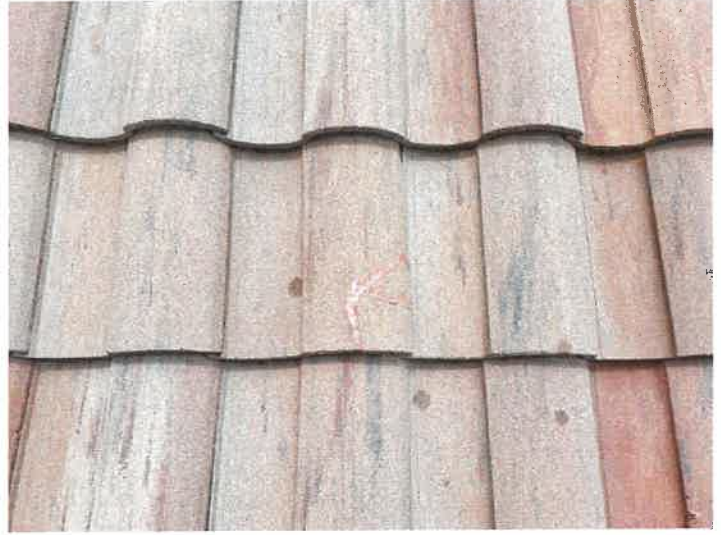
Building 15144: Repaired Cracked Roof Tiles

The cracked roof tiles were repaired with Titebond sealant.

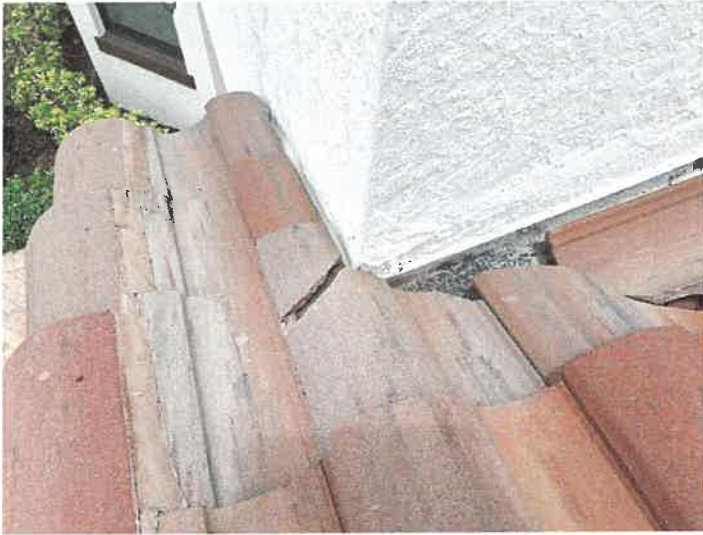
Building 15144: Identified Cracked Roof Tiles

Cracked roof tiles can allow premature underlayment deterioration from excessive UV exposure.

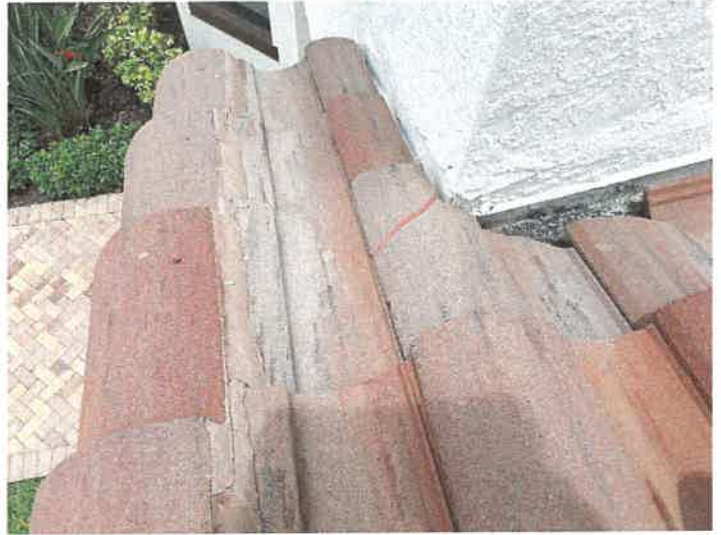
Building 15144: Repaired Cracked Roof Tiles

The cracked roof tiles were repaired with Titebond sealant.

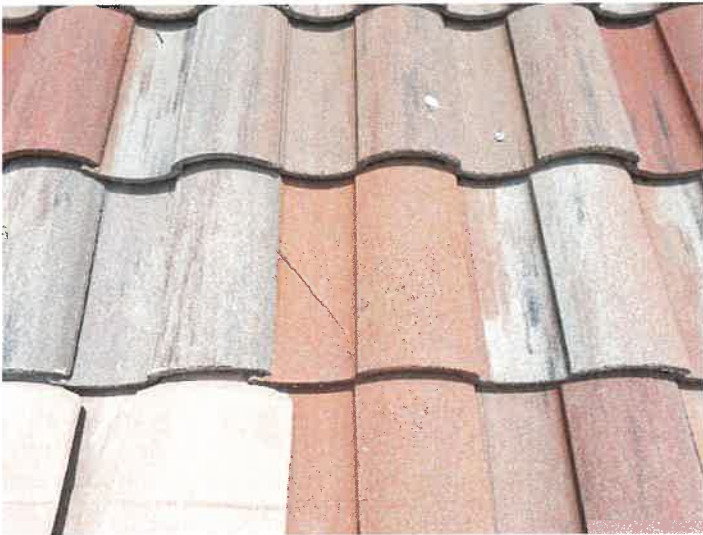
Building 15144: Identified Cracked Roof Tiles

Cracked roof tiles can allow premature underlayment deterioration from excessive UV exposure.

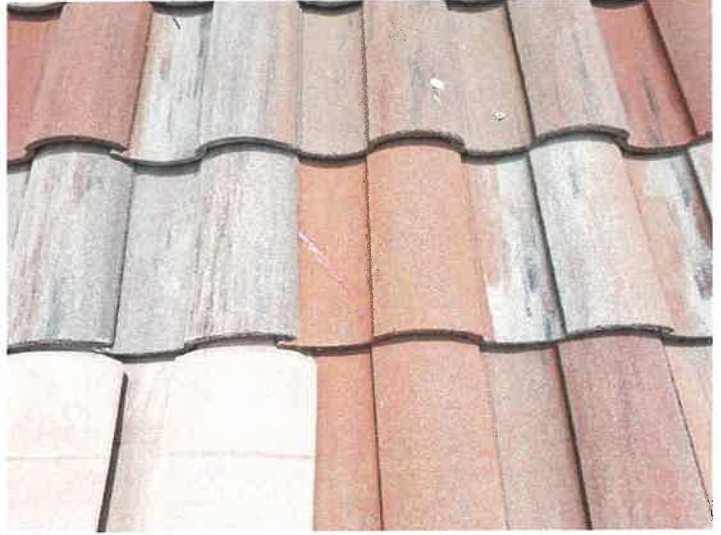
Building 15144: Repaired Cracked Roof Tiles

The cracked roof tiles were repaired with Titebond sealant.

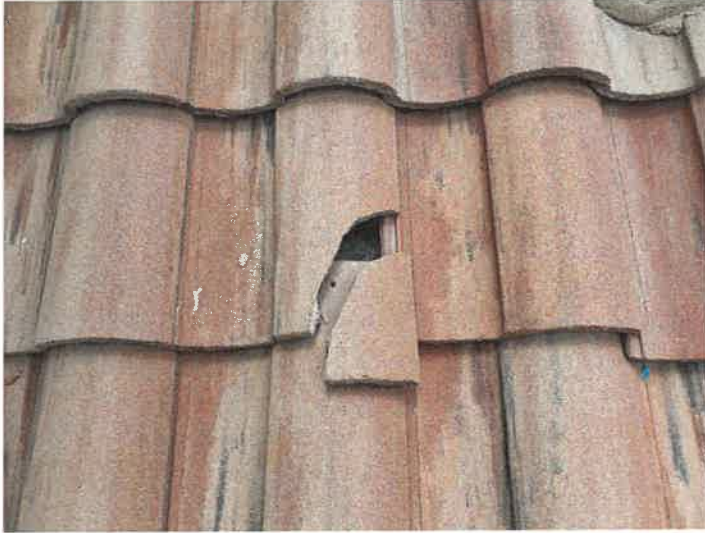
Building 15144: Identified Cracked Roof Tiles

Cracked roof tiles can allow premature underlayment deterioration from excessive UV exposure.

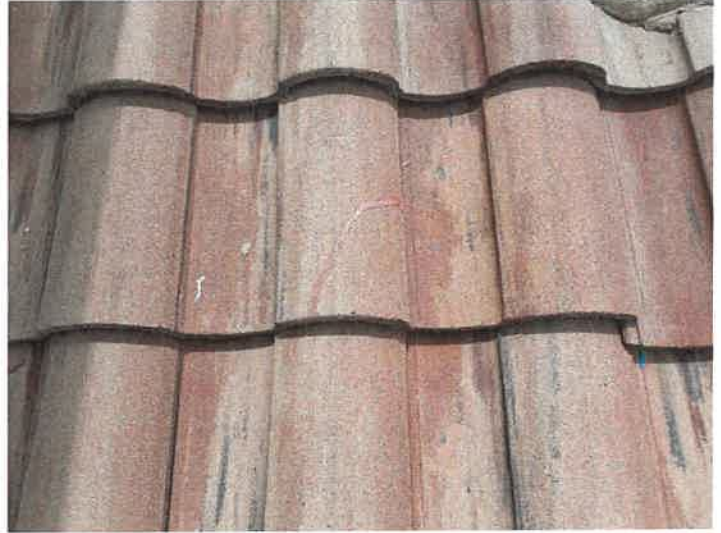
Building 15144: Repaired Cracked Roof Tiles

The cracked roof tiles were repaired with Titebond sealant.

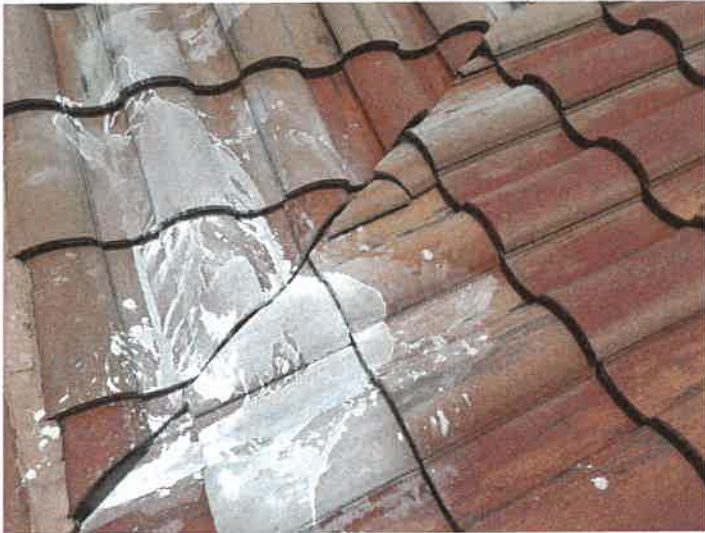
Building 15144: Identified Cracked Roof Tiles

Cracked roof tiles can allow premature underlayment deterioration from excessive UV exposure.

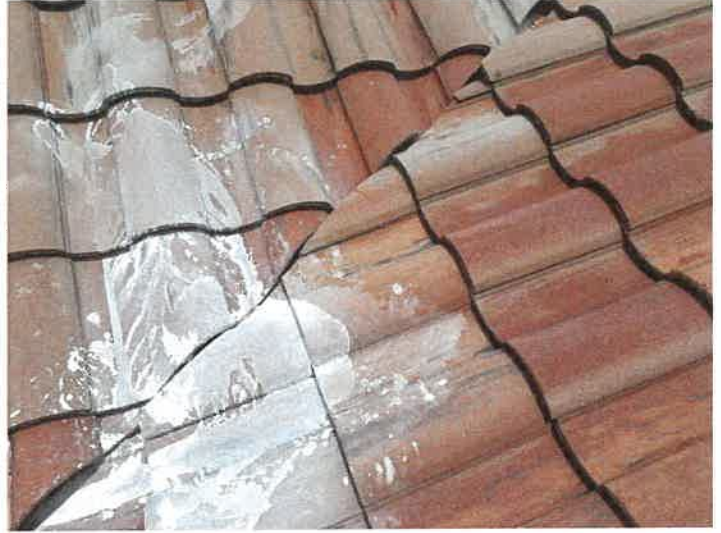
Building 15144: Repaired Cracked Roof Tiles

The cracked roof tiles were repaired with Titebond sealant.

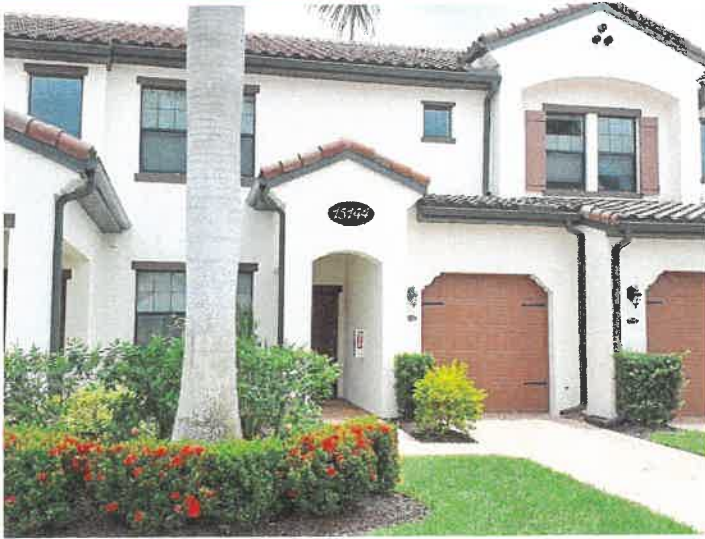
Building 15144: Downspouts
The downspouts appear to be in good condition.

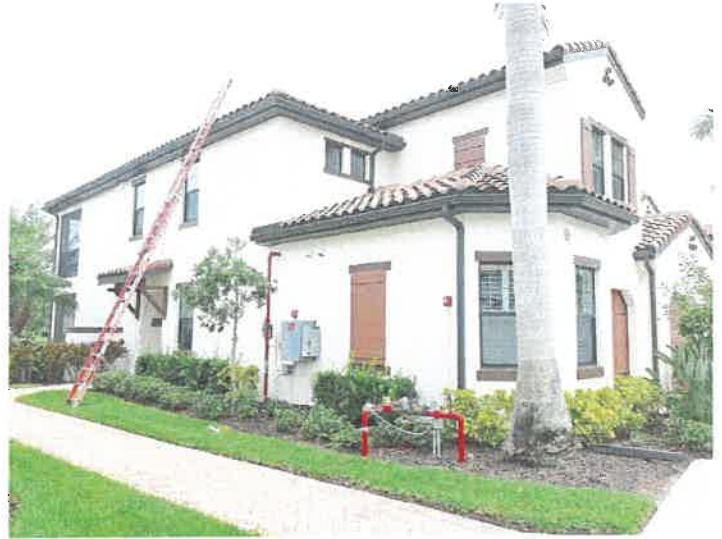
Building 15144: Downspouts
The downspouts appear to be in good condition.

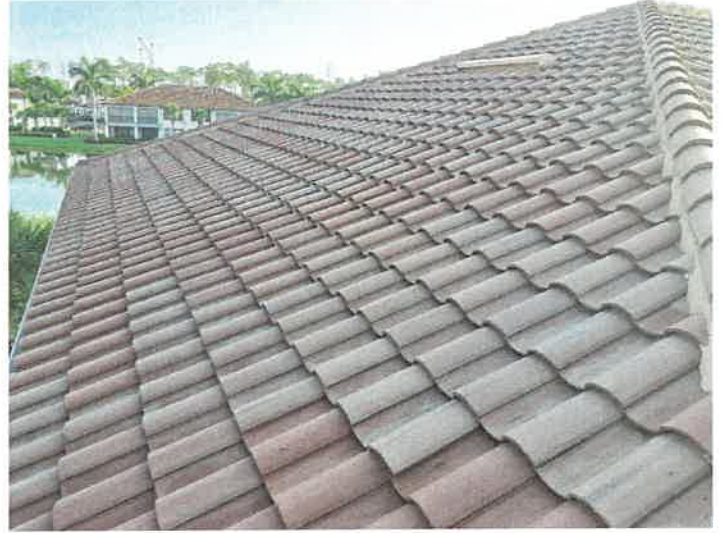
Building 15145: Surface Overview
The roof surface appears to be in good, maintainable condition at this time.

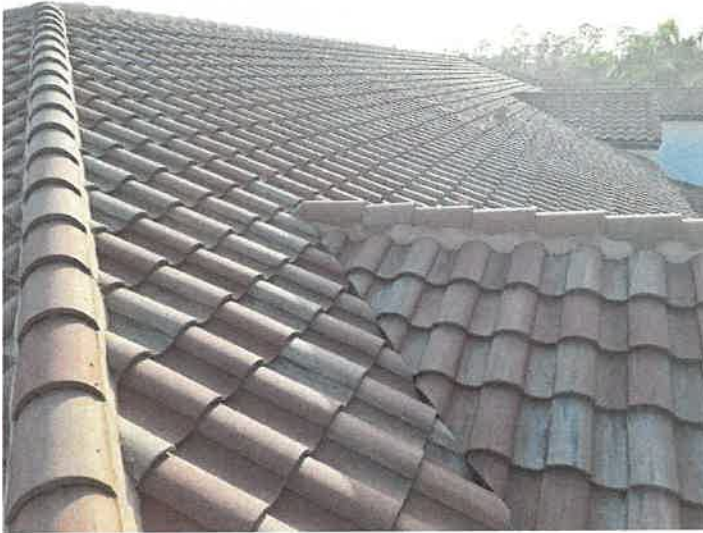
Building 15145: Appearance Overview

The roof appearance is in good, maintainable condition.

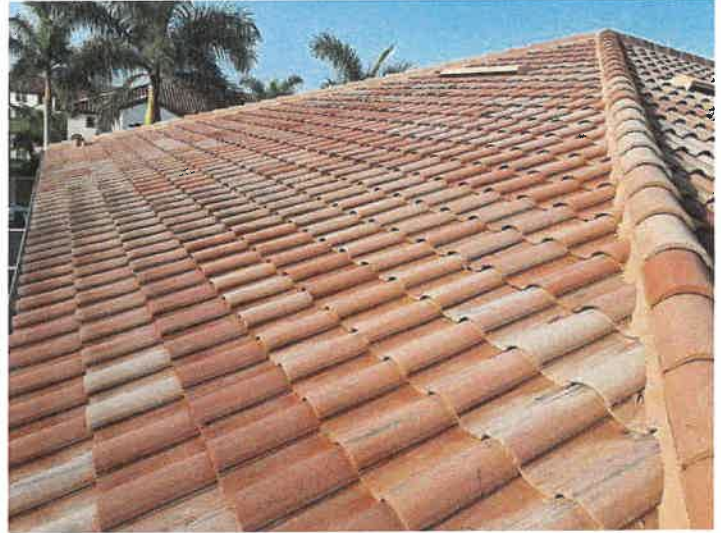
Building 15145: Surface Overview

The roof surface appears to be in good, maintainable condition at this time.

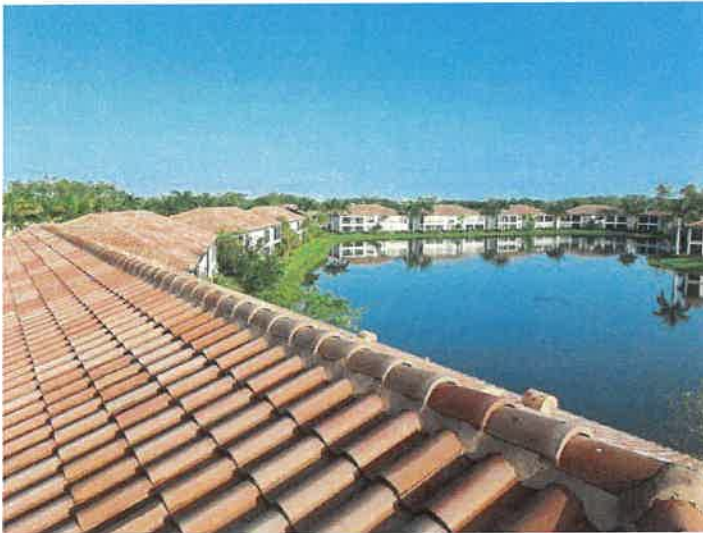
Building 15145: Ridge Tiles

Ridge tiles appear to be in good condition.

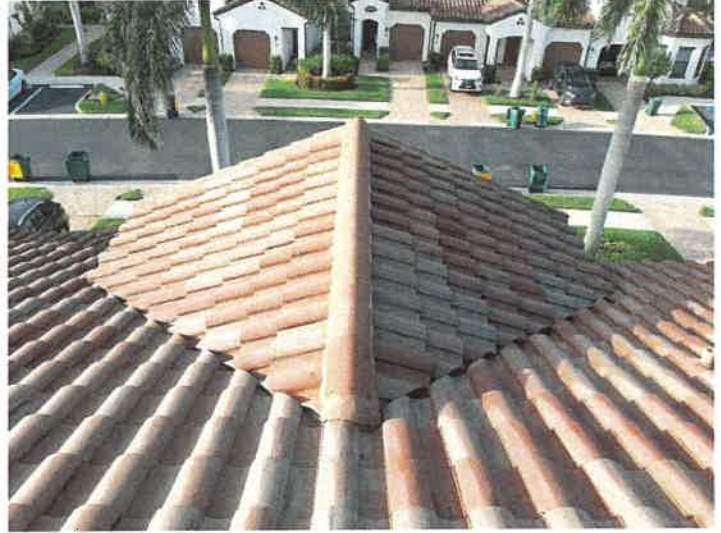
Building 15145: Valley

The valley tiles appear to be in good condition.

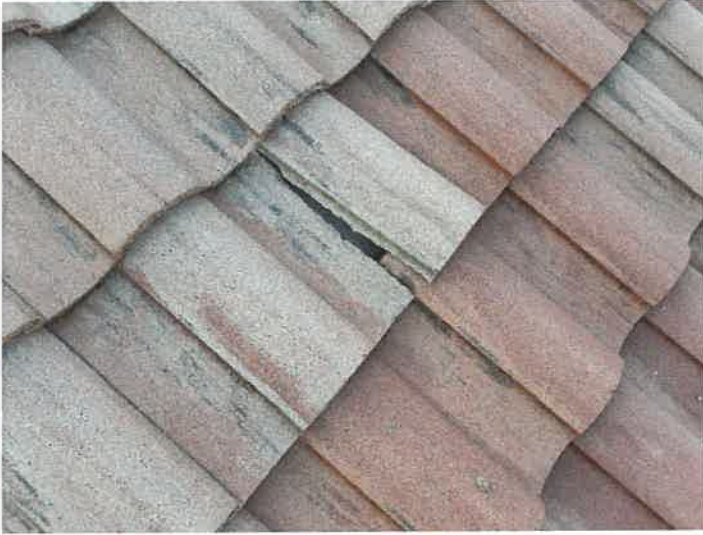
Building 15145: Identified Cracked Roof Tiles
Cracked roof tiles can allow premature underlayment deterioration from excessive UV exposure.

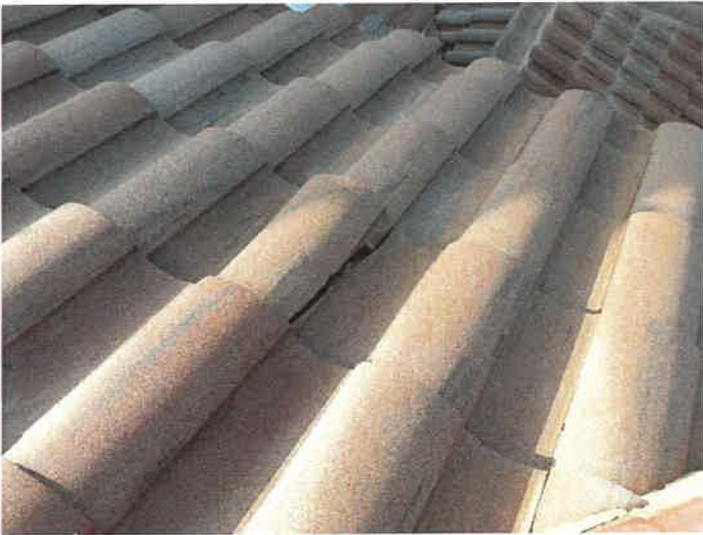
Building 15145: Identified Cracked Roof Tiles
Cracked roof tiles can allow premature underlayment deterioration from excessive UV exposure.

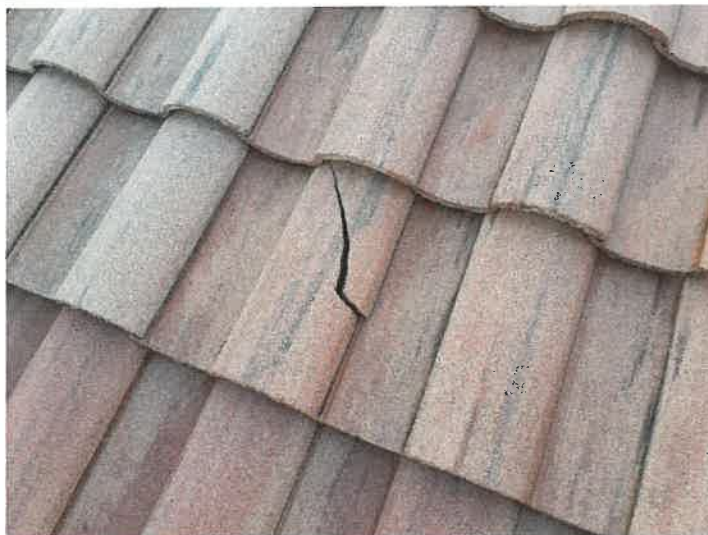
Building 15145: Identified Cracked Roof Tiles

Cracked roof tiles can allow premature underlayment deterioration from excessive UV exposure.

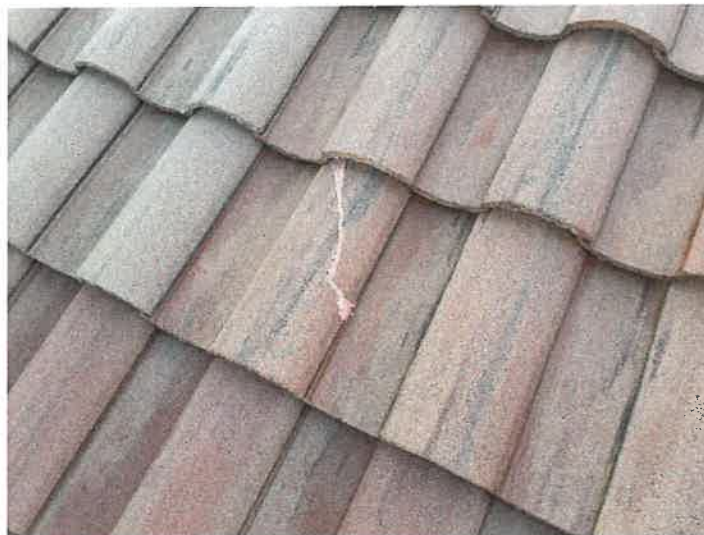
Building 15145: Repaired Cracked Roof Tiles

The cracked roof tiles were repaired with Titebond sealant.

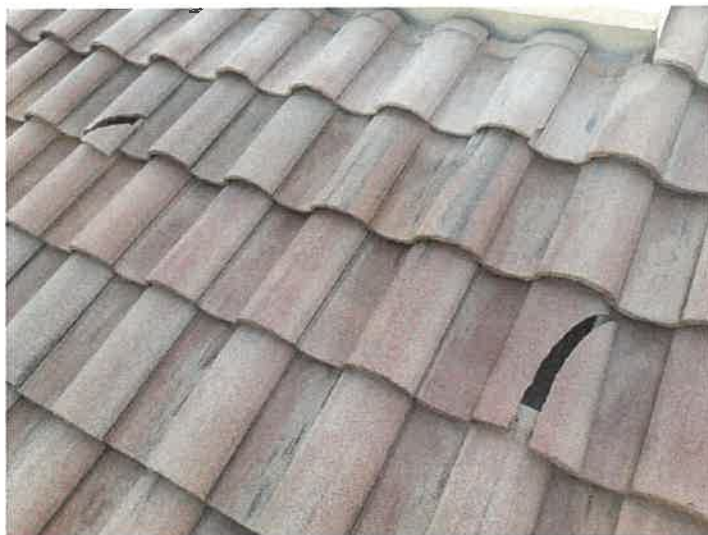
Building 15145: Identified Cracked Roof Tiles

Cracked roof tiles can allow premature underlayment deterioration from excessive UV exposure.

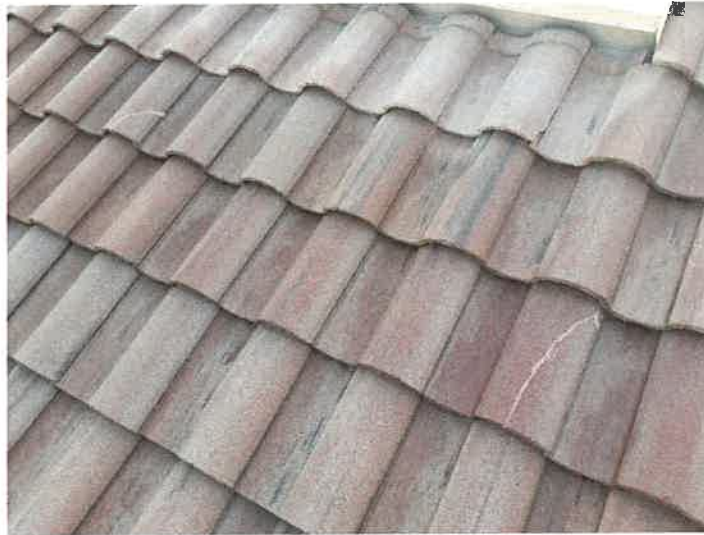
Building 15145: Repaired Cracked Roof Tiles

The cracked roof tiles were repaired with Titebond sealant.

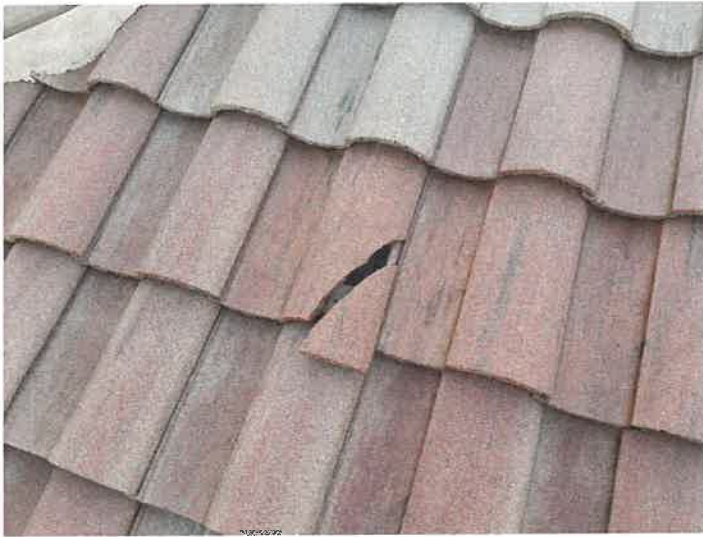
Building 15145: Identified Cracked Roof Tiles

Cracked roof tiles can allow premature underlayment deterioration from excessive UV exposure.

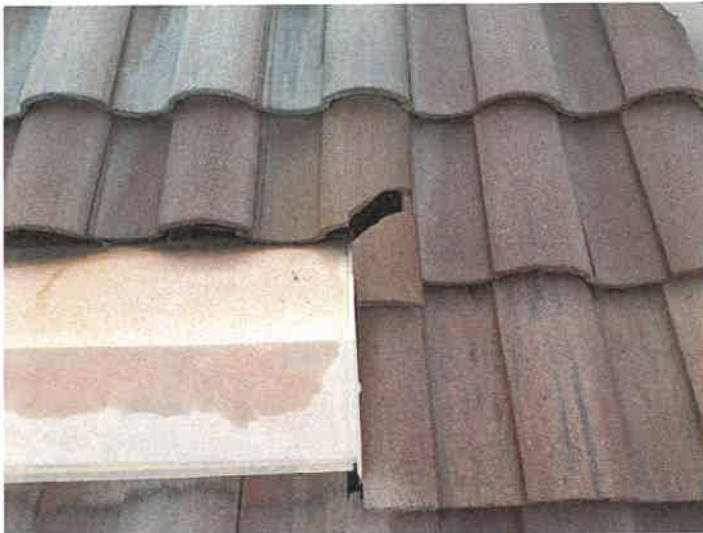
Building 15145: Identified Cracked Roof Tiles

Cracked roof tiles can allow premature underlayment deterioration from excessive UV exposure.

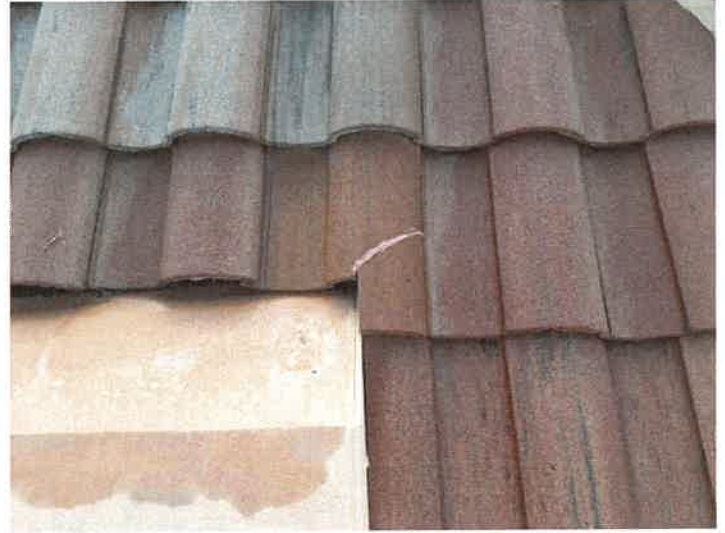
Building 15145: Repaired Cracked Roof Tiles

The cracked roof tiles were repaired with Titebond sealant.

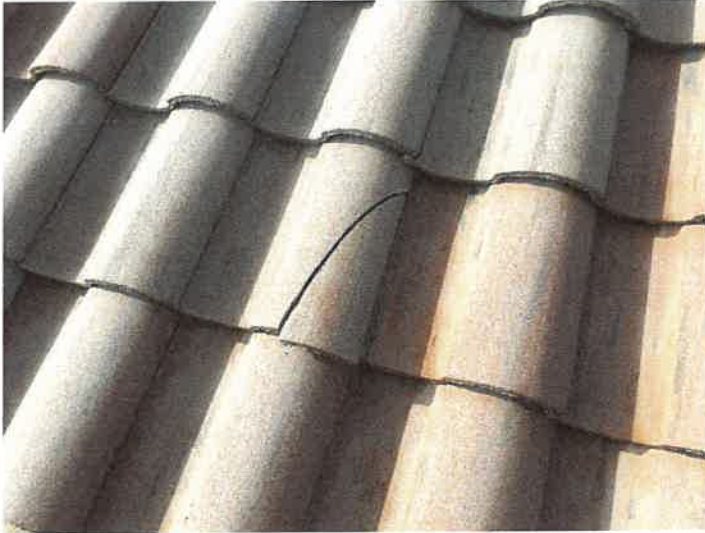
Building 15145: Identified Cracked Roof Tiles
Cracked roof tiles can allow premature underlayment deterioration from excessive UV exposure.

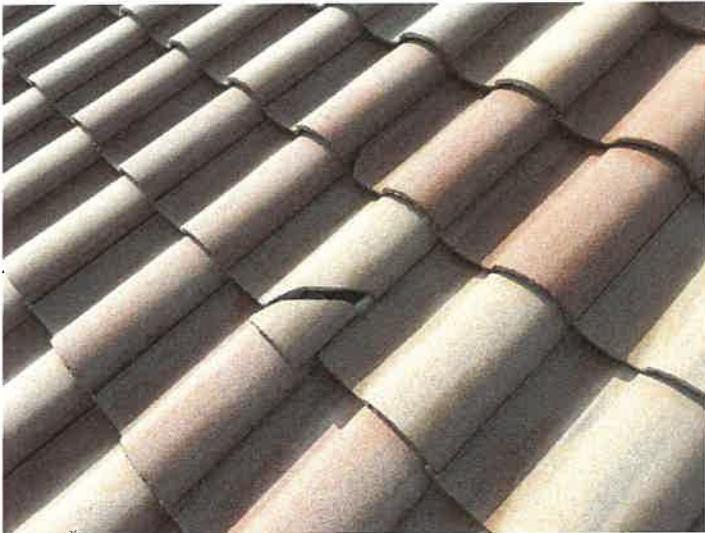
Building 15145: Identified Cracked Roof Tiles
Cracked roof tiles can allow premature underlayment deterioration from excessive UV exposure.

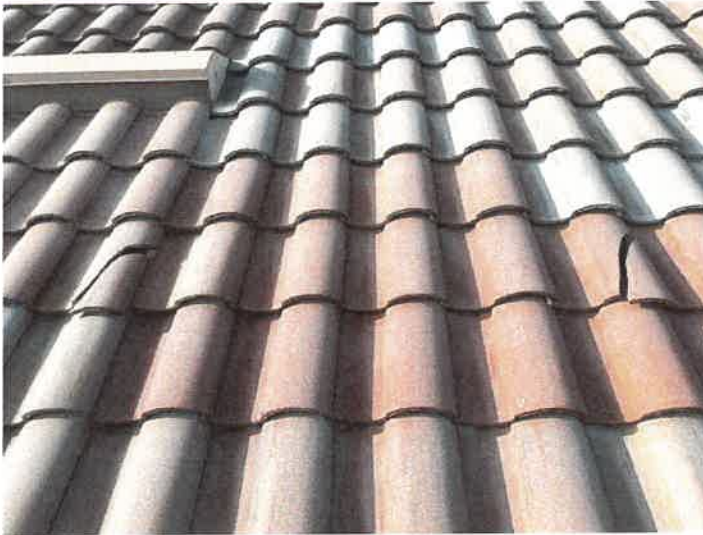
Building 15145: Identified Cracked Roof Tiles

Cracked roof tiles can allow premature underlayment deterioration from excessive UV exposure.

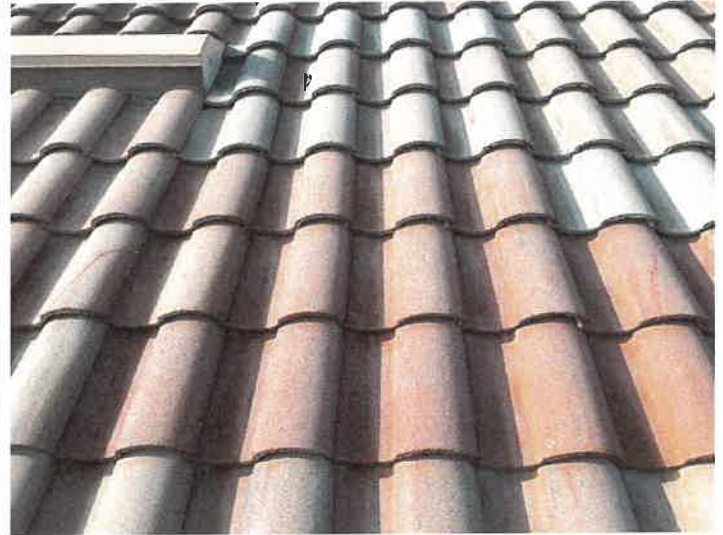
Building 15145: Repaired Cracked Roof Tiles

The cracked roof tiles were repaired with Titebond sealant.

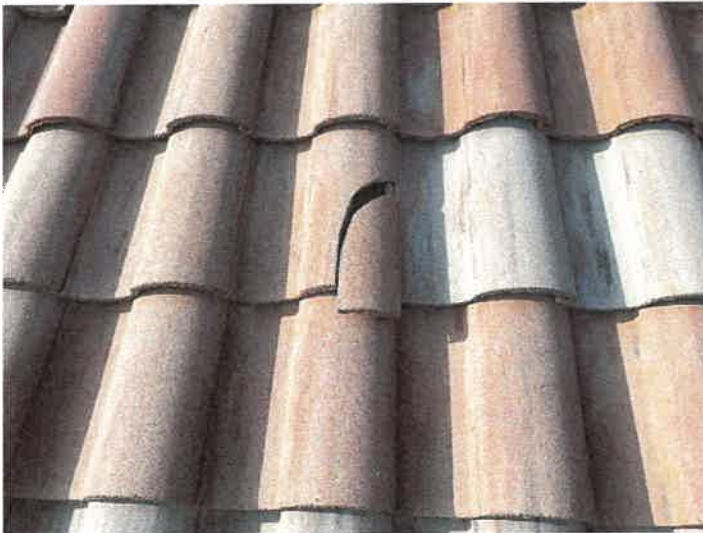
Building 15145: Identified Cracked Roof Tiles

Cracked roof tiles can allow premature underlayment deterioration from excessive UV exposure.

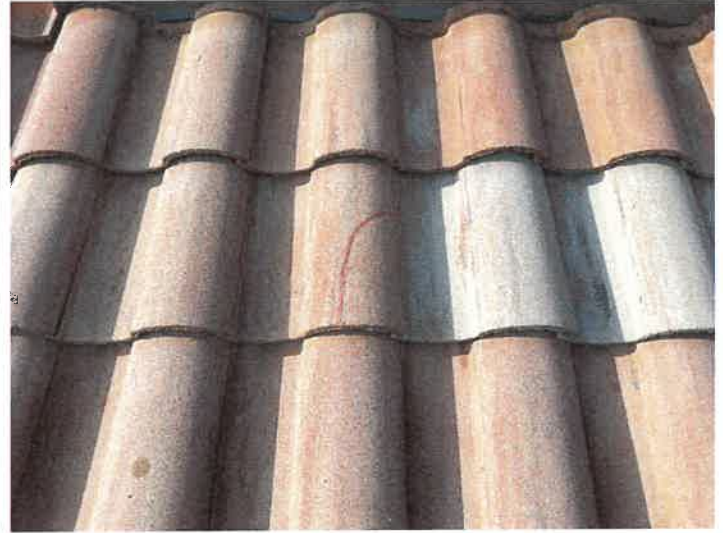
Building 15145: Repaired Cracked Roof Tiles

The cracked roof tiles were repaired with Titebond sealant.

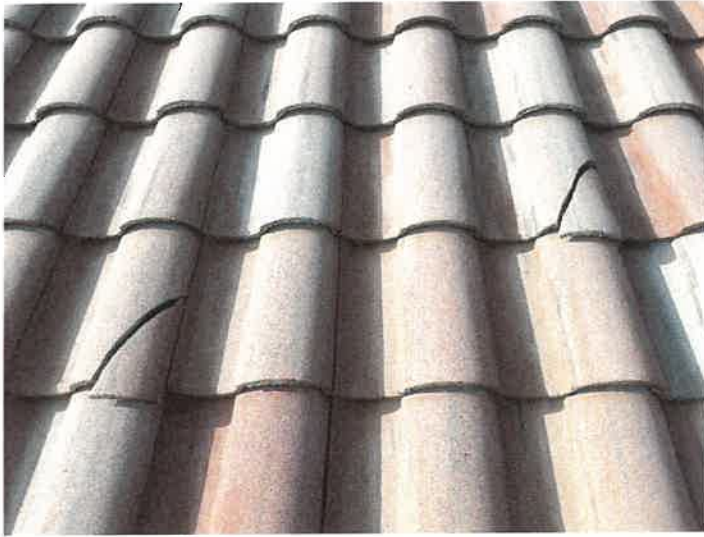
Building 15145: Identified Cracked Roof Tiles

Cracked roof tiles can allow premature underlayment deterioration from excessive UV exposure.

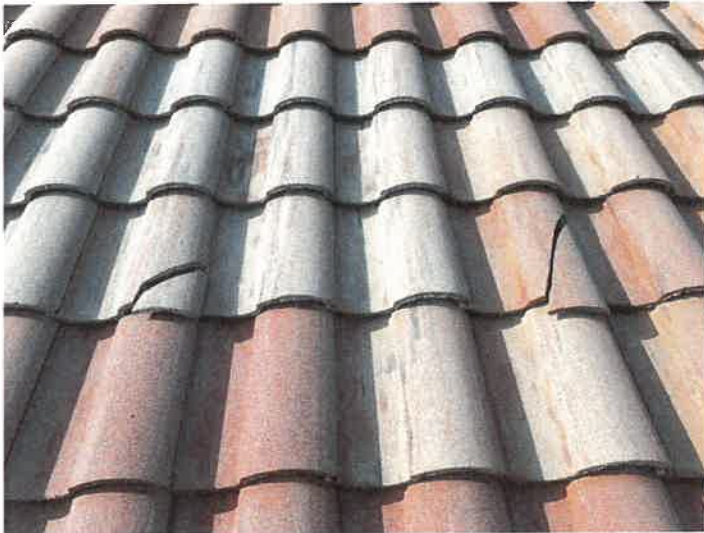
Building 15145: Identified Cracked Roof Tiles

Cracked roof tiles can allow premature underlayment deterioration from excessive UV exposure.

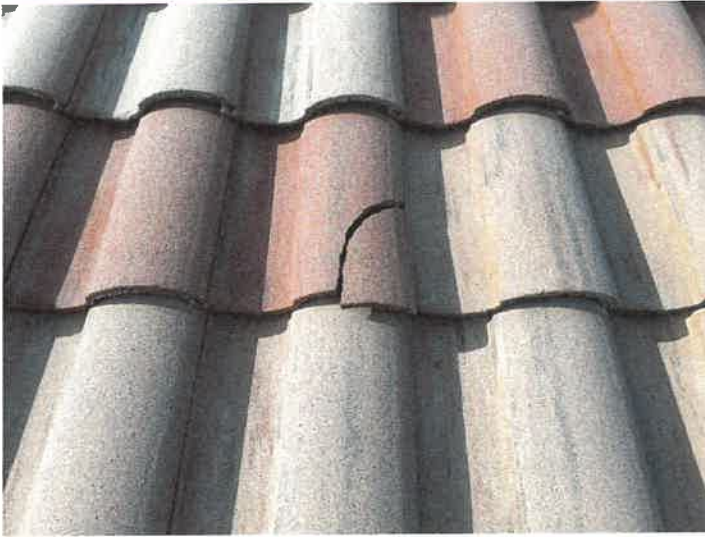
Building 15145: Identified Cracked Roof Tiles

Cracked roof tiles can allow premature underlayment deterioration from excessive UV exposure.

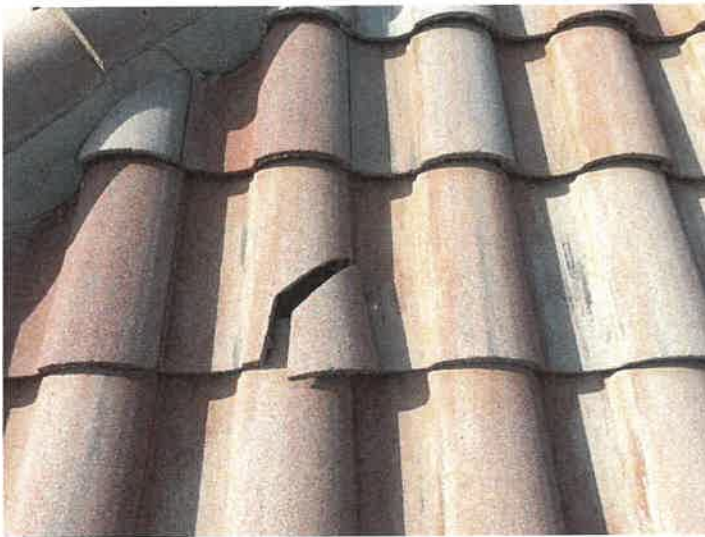
Building 15145: Identified Cracked Roof Tiles

Cracked roof tiles can allow premature underlayment deterioration from excessive UV exposure.

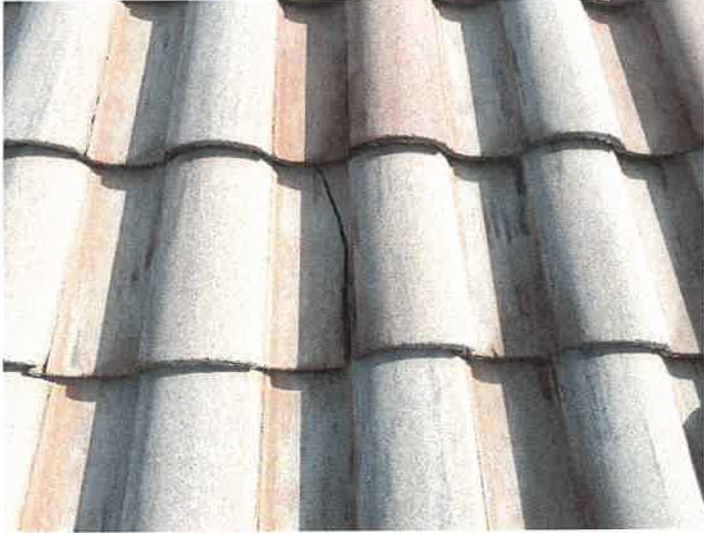
Building 15145: Identified Cracked Roof Tiles

Cracked roof tiles can allow premature underlayment deterioration from excessive UV exposure.

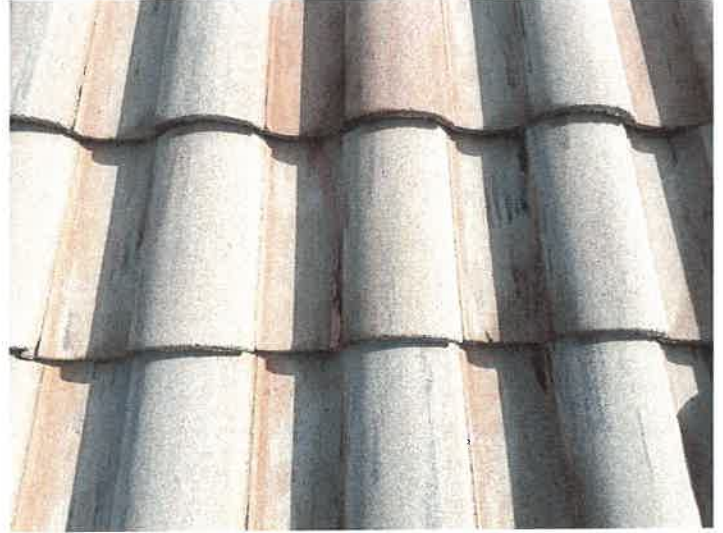
Building 15145: Repaired Cracked Roof Tiles

The cracked roof tiles were repaired with Titebond sealant.

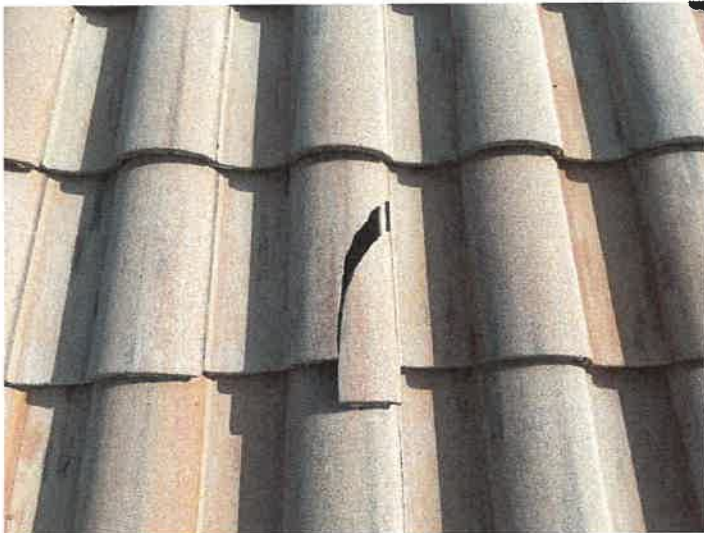
Building 15145: Identified Cracked Roof Tiles

Cracked roof tiles can allow premature underlayment deterioration from excessive UV exposure.

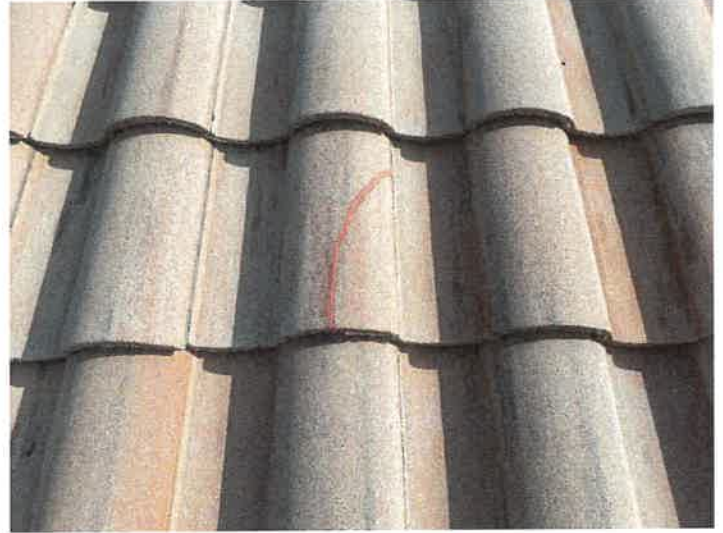
Building 15145: Repaired Cracked Roof Tiles

The cracked roof tiles were repaired with Titebond sealant.

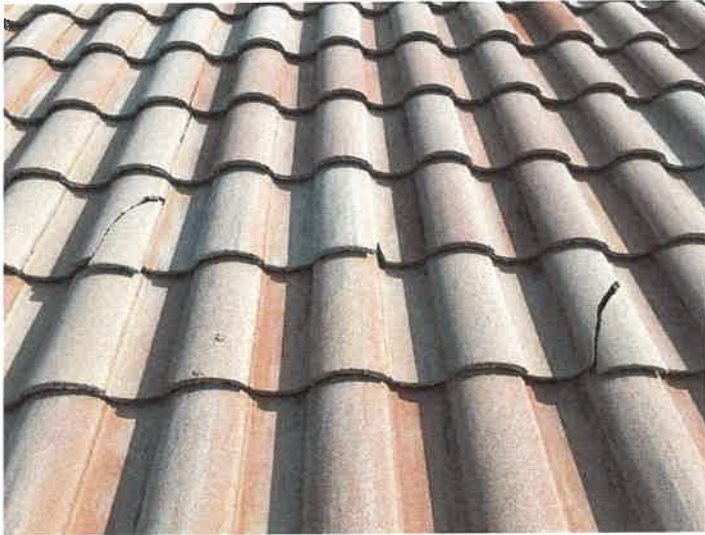
Building 15145: Identified Cracked Roof Tiles

Cracked roof tiles can allow premature underlayment deterioration from excessive UV exposure.

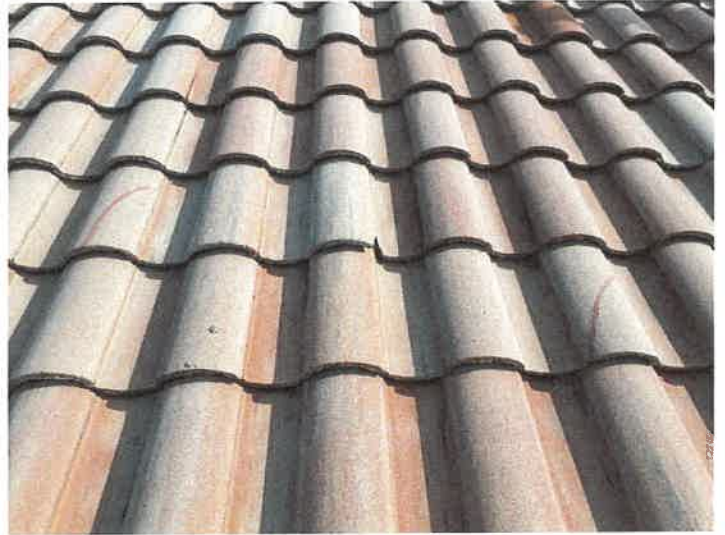
Building 15145: Repaired Cracked Roof Tiles

The cracked roof tiles were repaired with Titebond sealant.

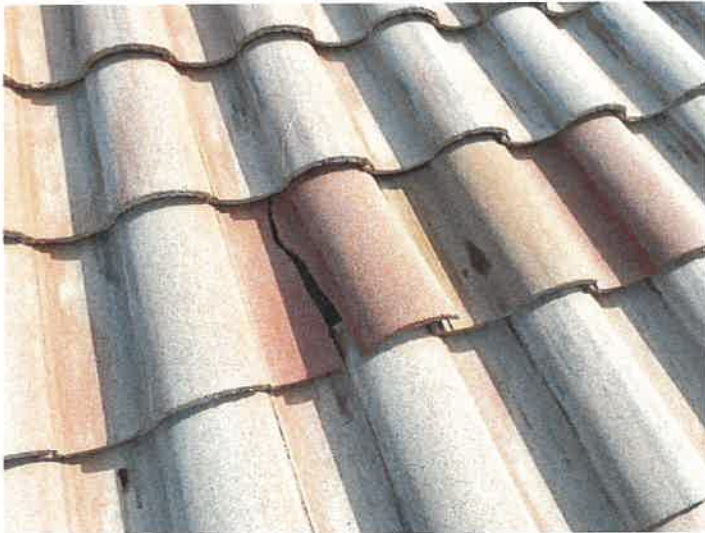
Building 15145: Identified Cracked Roof Tiles

Cracked roof tiles can allow premature underlayment deterioration from excessive UV exposure.

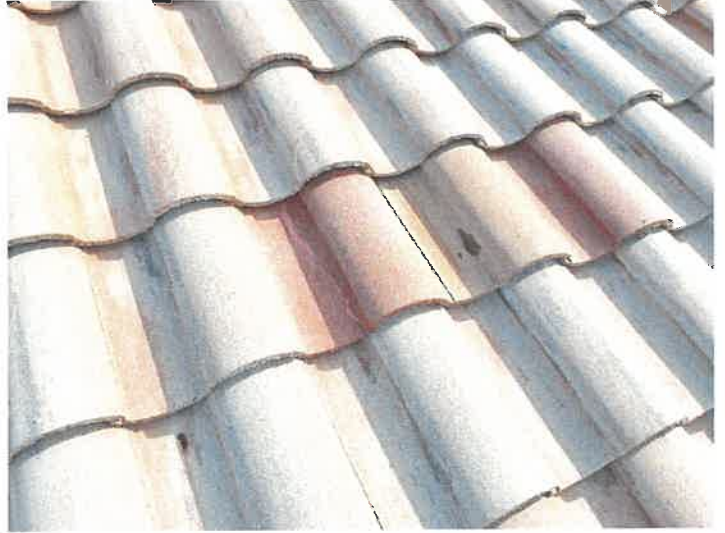
Building 15145: Repaired Cracked Roof Tiles

The cracked roof tiles were repaired with Titebond sealant.

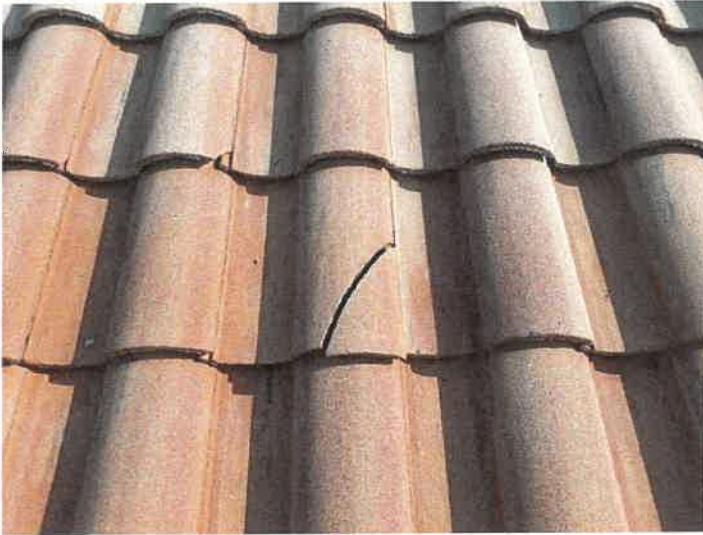
Building 15145: Identified Cracked Roof Tiles

Cracked roof tiles can allow premature underlayment deterioration from excessive UV exposure.

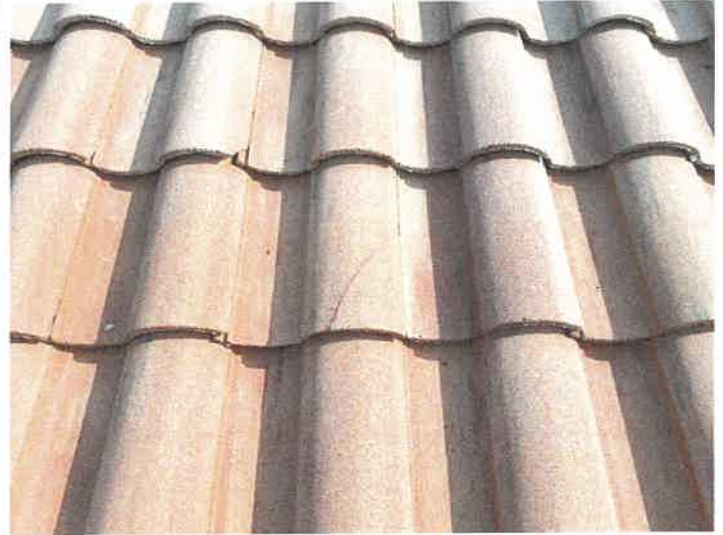
Building 15145: Repaired Cracked Roof Tiles

The cracked roof tiles were repaired with Titebond sealant.

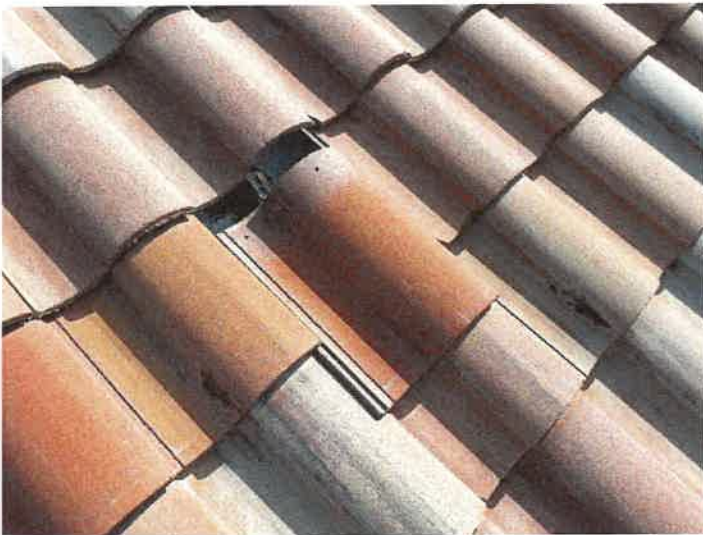
Building 15145: Displaced/Missing Roof Tile

Displaced or missing roof tiles can allow premature underlayment deterioration from excessive UV exposure and potential water intrusion.

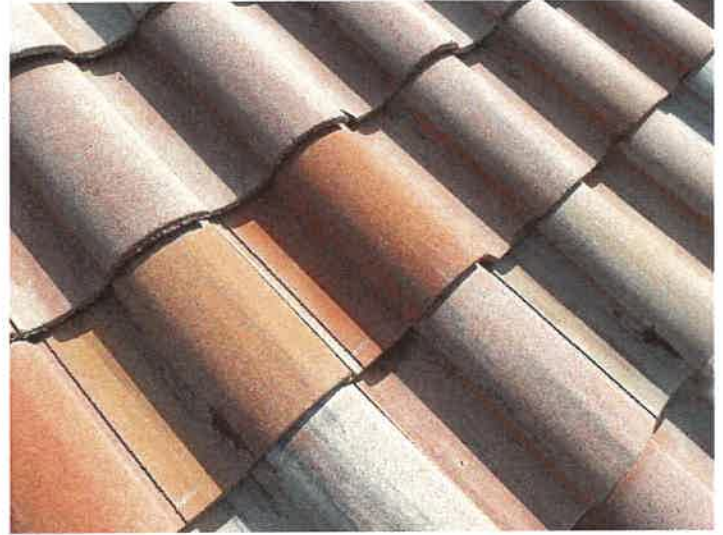
Building 15145: Repaired Displaced/Missing Roof Tile

Replaced and secured the missing roof tile.

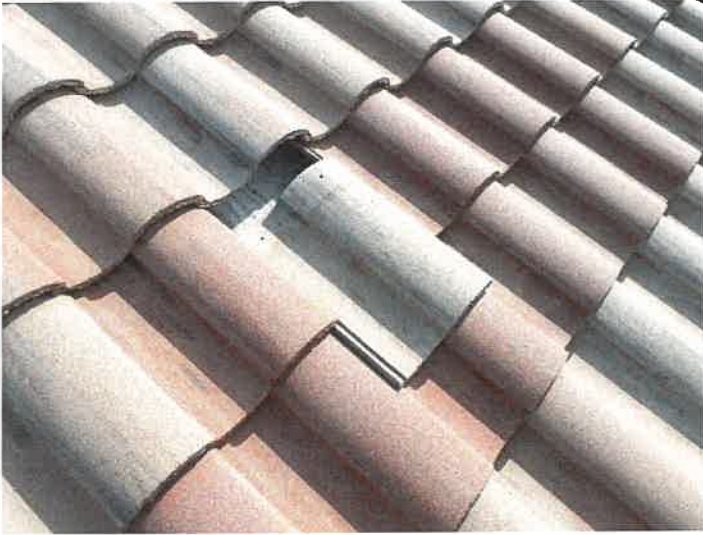
Building 15145: Displaced/Missing Roof Tile

Displaced or missing roof tiles can allow premature underlayment deterioration from excessive UV exposure and potential water intrusion.

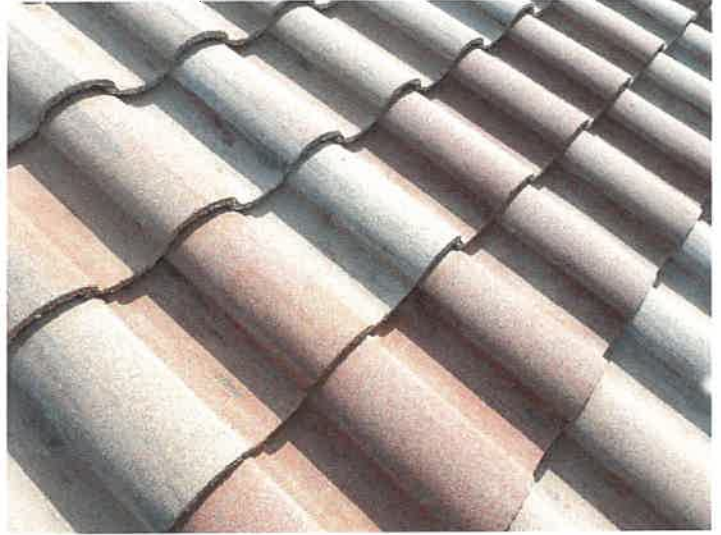
Building 15145: Repaired Displaced/Missing Roof Tile

Replaced and secured the missing roof tile.

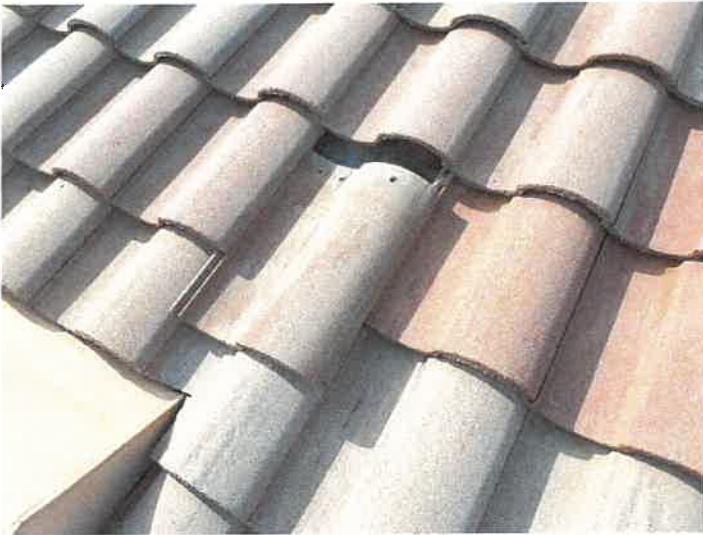
Building 15145: Displaced/Missing Roof Tile

Displaced or missing roof tiles can allow premature underlayment deterioration from excessive UV exposure and potential water intrusion.
