Inspection Report

Facility: Livingston Lakes Condo
Address: 15098 Palmer Lake Circle,
Naples, FL 34109
Customer: Cardinal Management
Address: c/o Livingston Lakes Condo, 15090
Naples, FL 34109

Livingston Lakes Condo, Naples, FL

Re.: **Inspection Report (2 of 3) for Livingston Lakes**

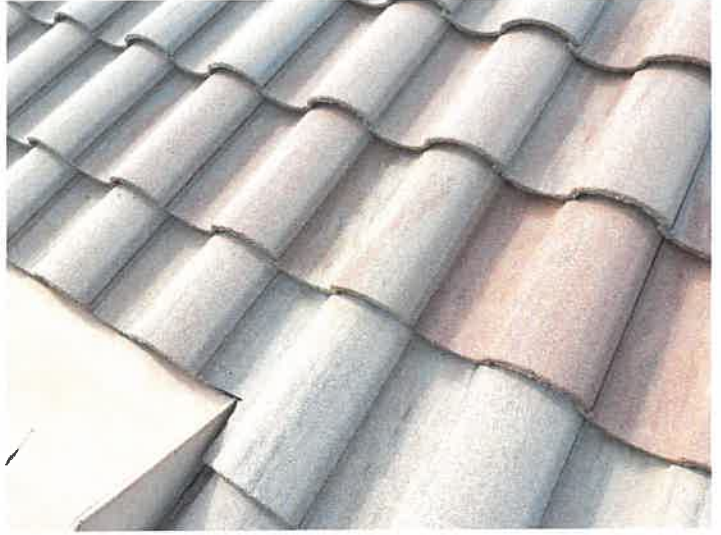
Building 15145: Repaired Displaced/Missing Roof Tile

Replaced and secured the missing roof tile.

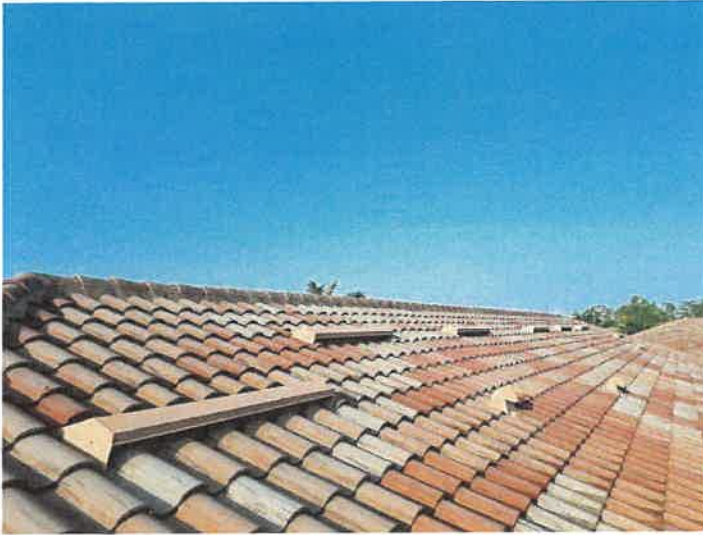
Building 15145: Roof Vents
Roof vents appear to be in good condition.

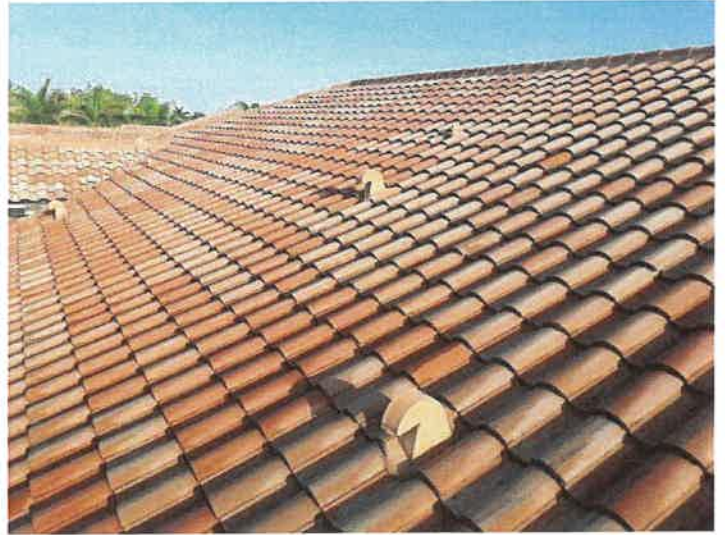
Building 15145: Roof Vents
Roof vents appear to be in good condition.

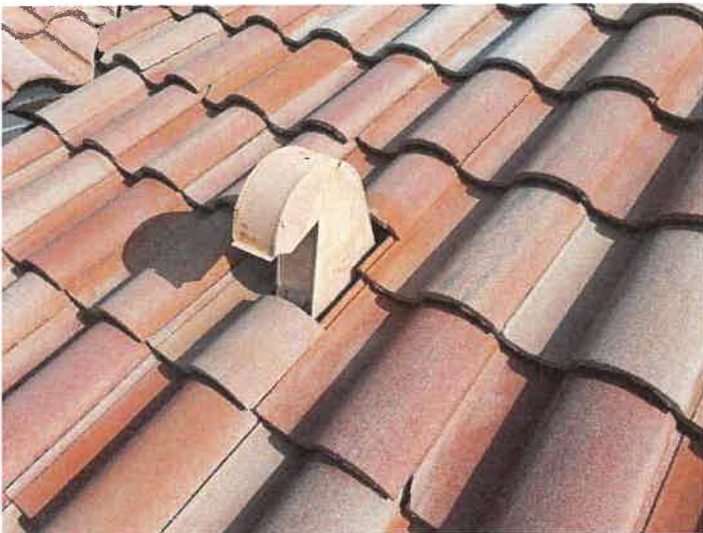
Building 15145: Missing Mortar
Identified missing mortar around of the roof vent. Crowther Roofing suggests installing mortar.

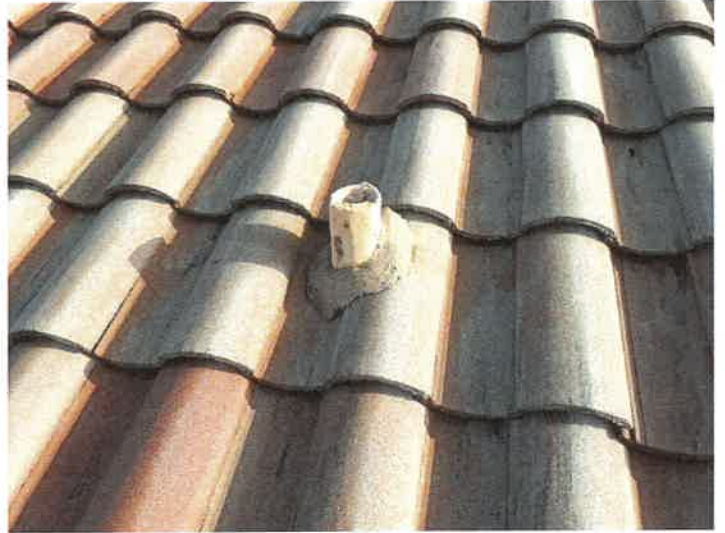
Building 15145: Lead Boots
Lead boots appear to be in good condition.

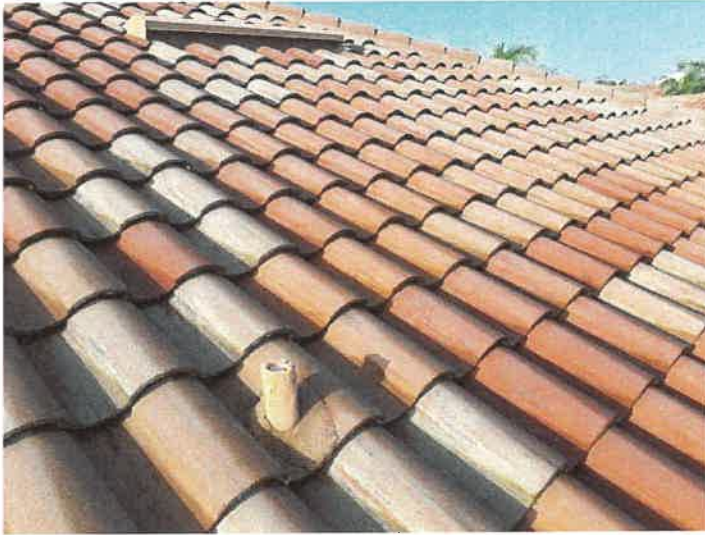
Building 15145: Lead Boots
Lead boots appear to be in good condition.

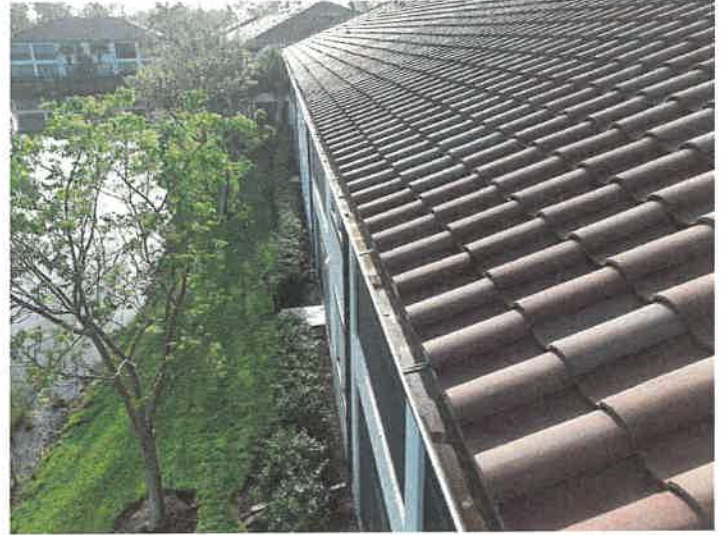
Building 15145: Gutters
The gutters appear to be in good condition.

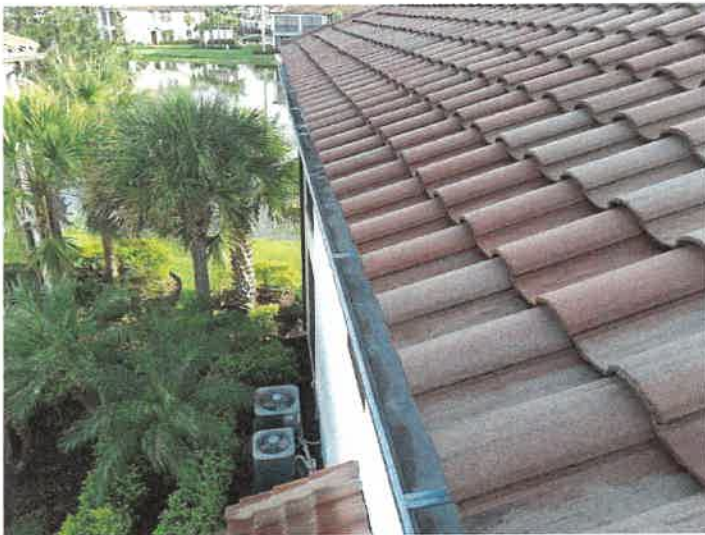
Building 15145: Gutters
The gutters appear to be in good condition.

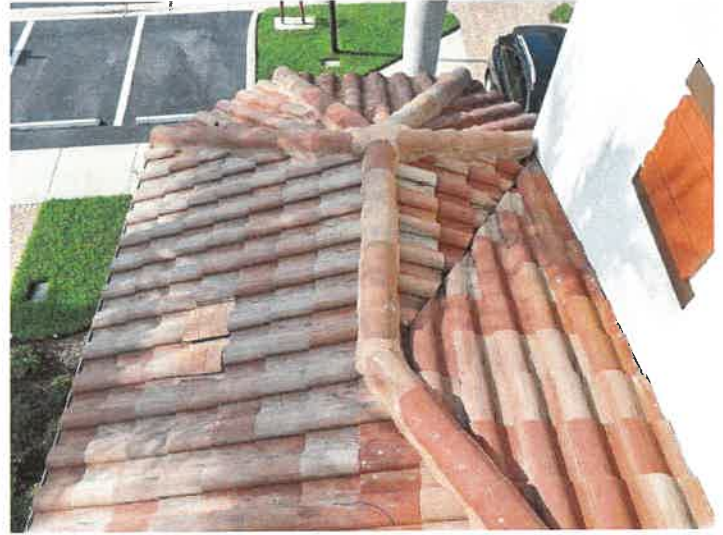
Building 15145: Surface Overview - Lower Roof
The roof surface appears to be in good, maintainable condition at this time.

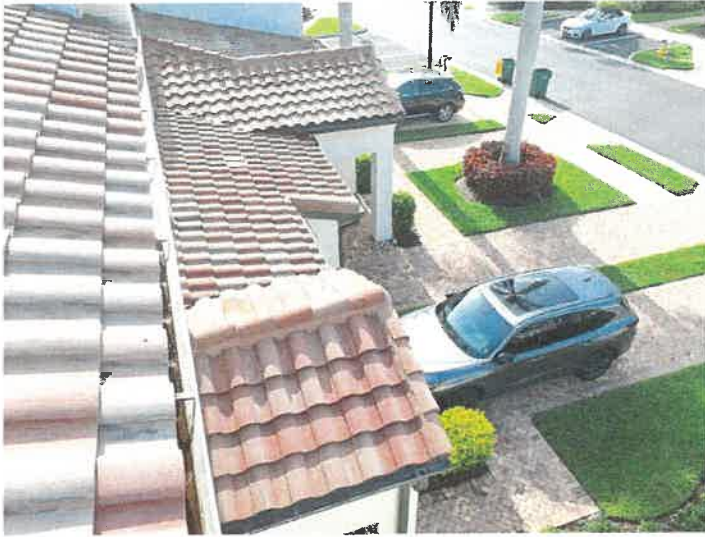
Building 15145: Appearance Overview - Lower Roof
The roof appearance is in good, maintainable condition.

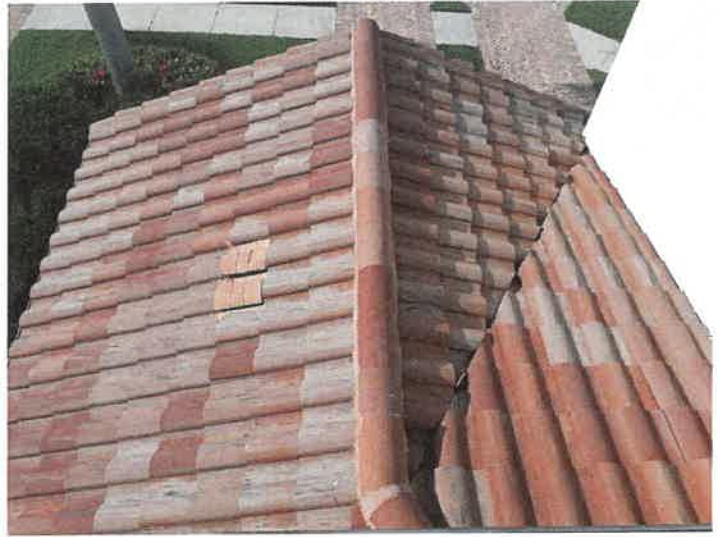
Building 15145: Surface Overview - Lower Roof
The roof surface appears to be in good, maintainable condition at this time.

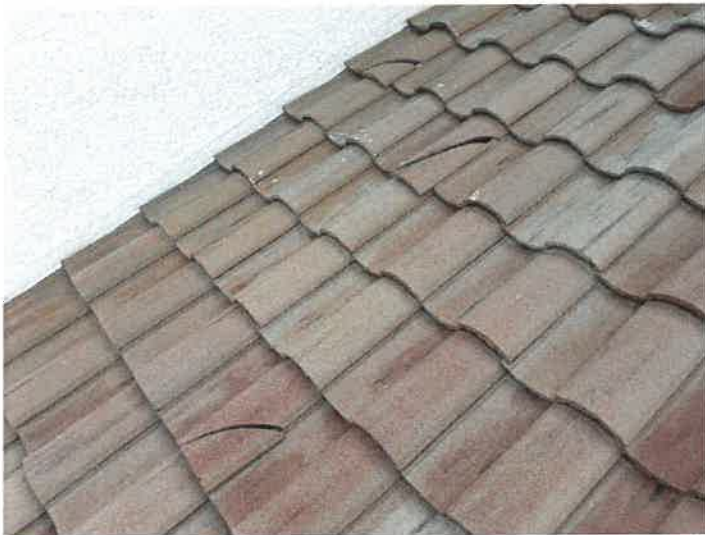
Building 15145: Identified Cracked Roof Tiles
Cracked roof tiles can allow premature underlayment deterioration from excessive UV exposure.

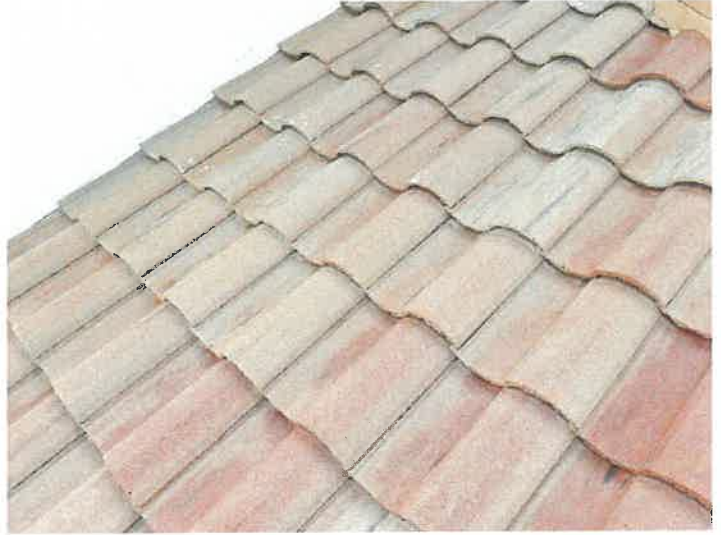
Building 15145: Repaired Cracked Roof Tiles
The cracked roof tiles were repaired with Titebond sealant.

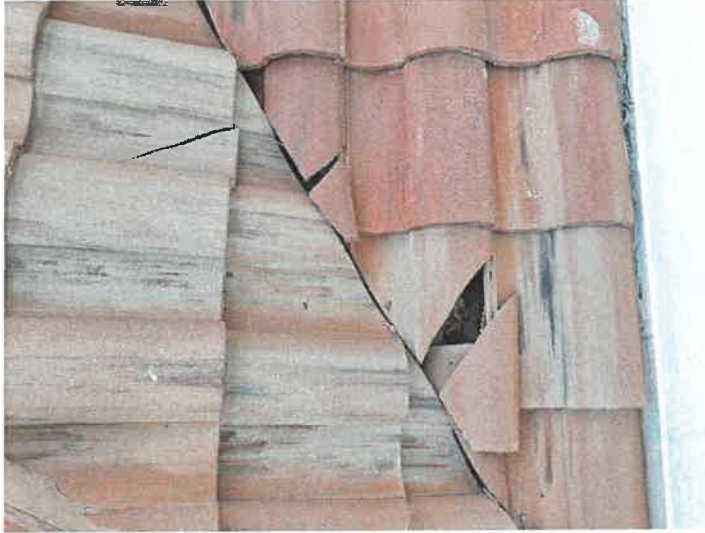
Building 15145: Identified Cracked Roof Tiles
Cracked roof tiles can allow premature underlayment deterioration from excessive UV exposure.

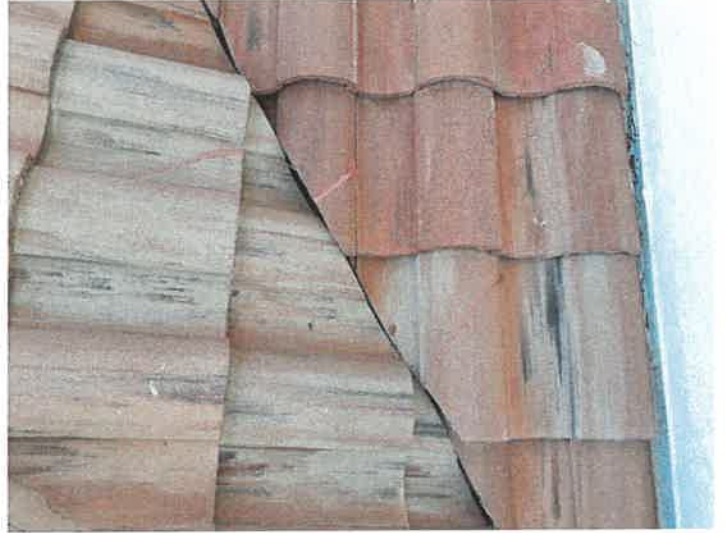
Building 15145: Repaired Cracked Roof Tiles
The cracked roof tiles were repaired with Titebond sealant.

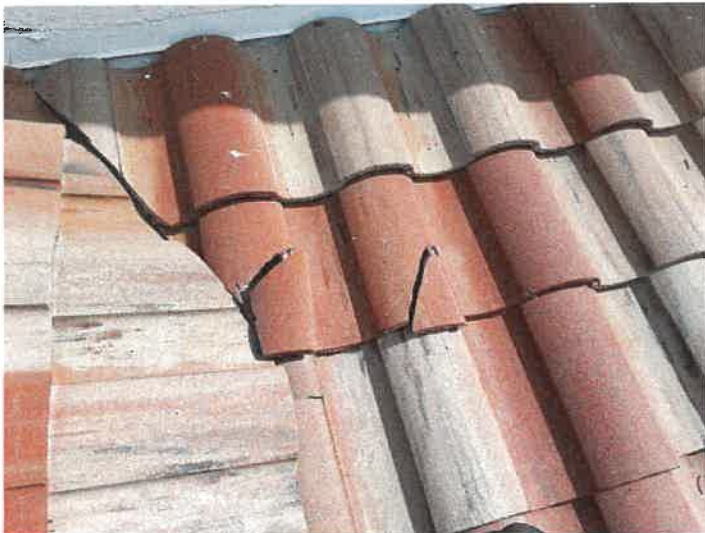
Building 15145: Identified Cracked Roof Tiles
Cracked roof tiles can allow premature underlayment deterioration from excessive UV exposure.

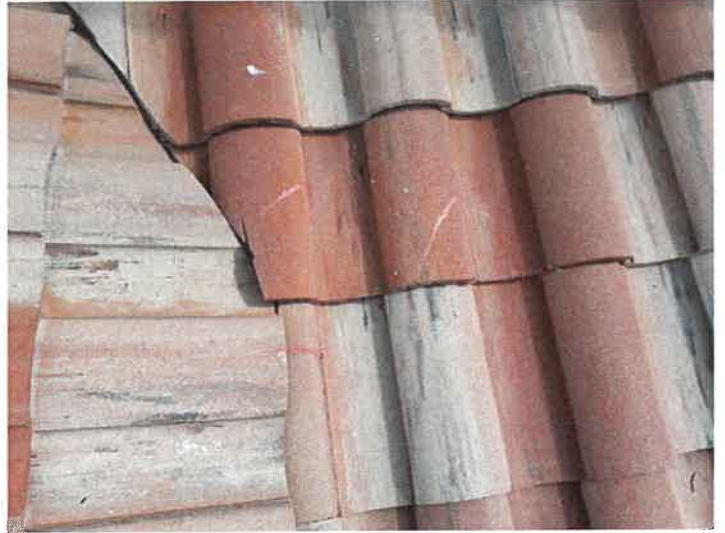
Building 15145: Repaired Cracked Roof Tiles
The cracked roof tiles were repaired with Titebond sealant.

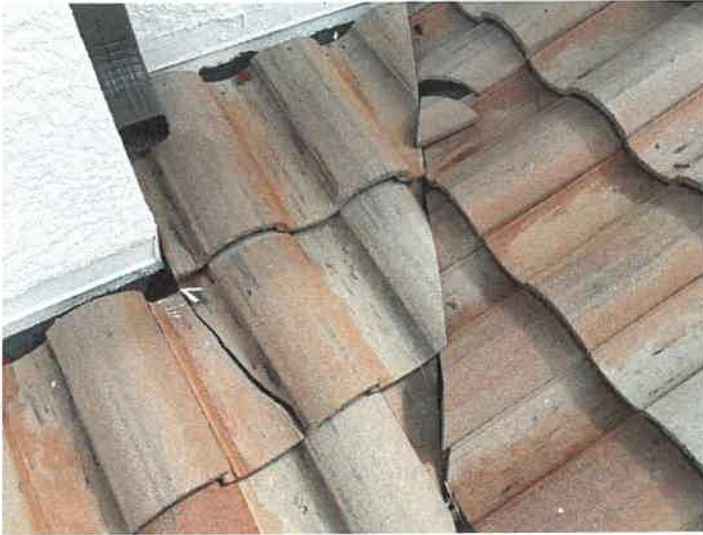
Building 15145: Identified Cracked Roof Tiles

Cracked roof tiles can allow premature underlayment deterioration from excessive UV exposure.

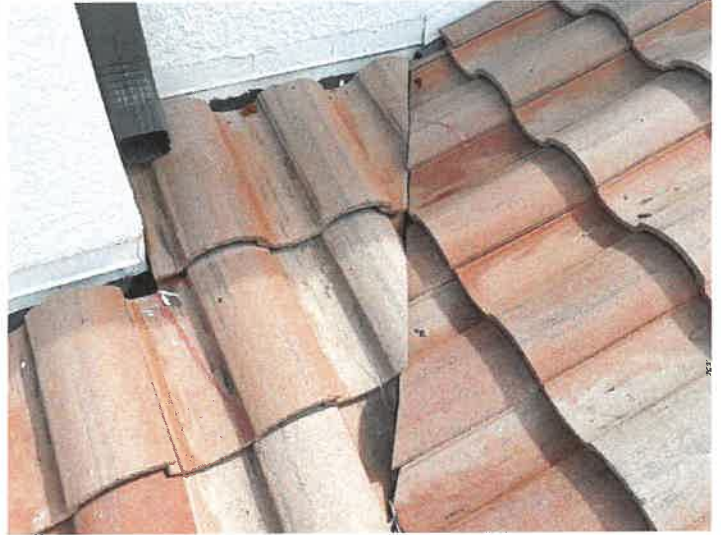
Building 15145: Repaired Cracked Roof Tiles

The cracked roof tiles were repaired with Titebond sealant.

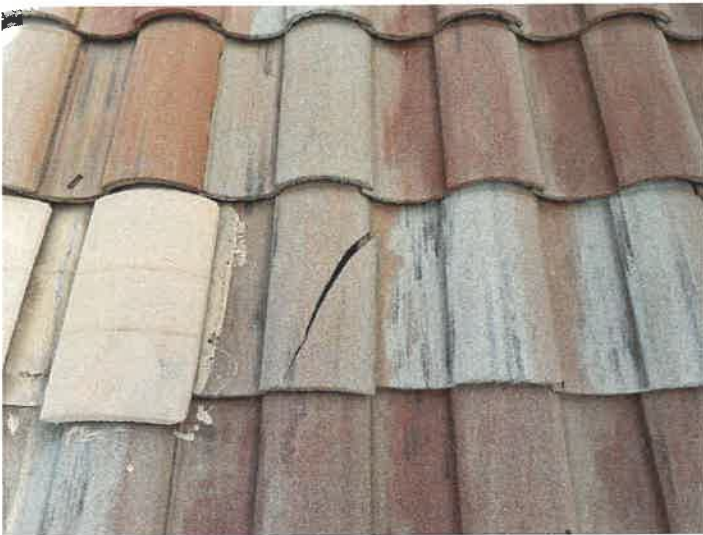
Building 15145: Identified Cracked Roof Tiles

Cracked roof tiles can allow premature underlayment deterioration from excessive UV exposure.

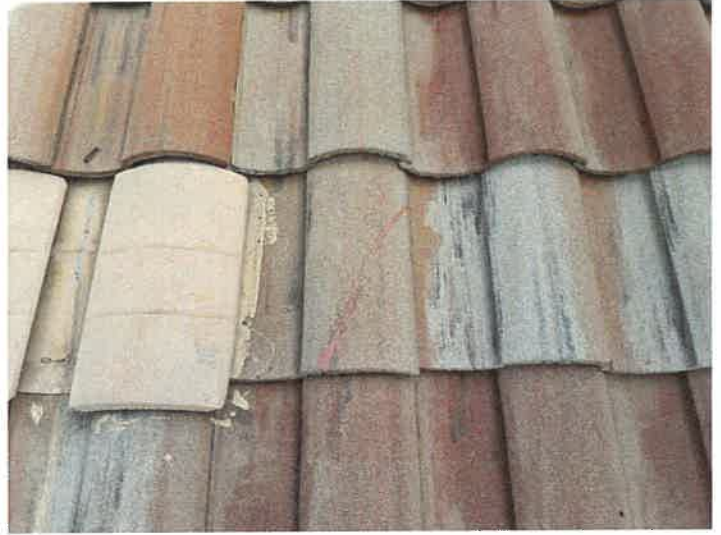
Building 15145: Repaired Cracked Roof Tiles

The cracked roof tiles were repaired with Titebond sealant.

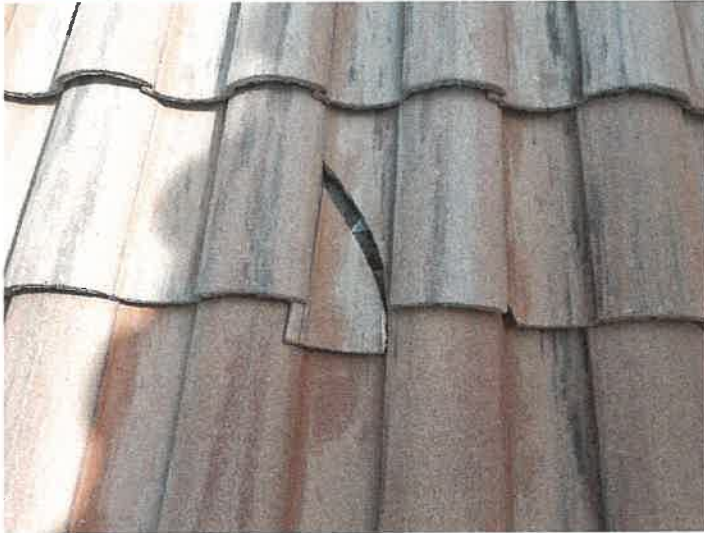
Building 15145: Identified Cracked Roof Tiles
Cracked roof tiles can allow premature underlayment deterioration from excessive UV exposure.

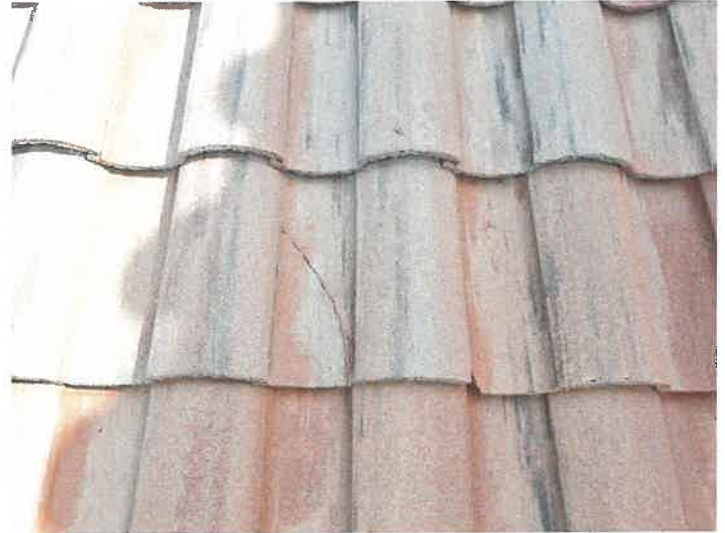
Building 15145: Repaired Cracked Roof Tiles
The cracked roof tiles were repaired with Titebond sealant.

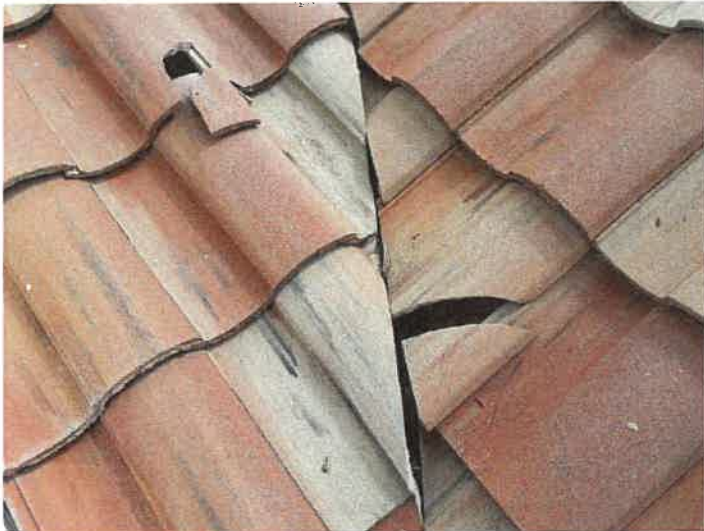
Building 15145: Identified Cracked Roof Tiles
Cracked roof tiles can allow premature underlayment deterioration from excessive UV exposure.

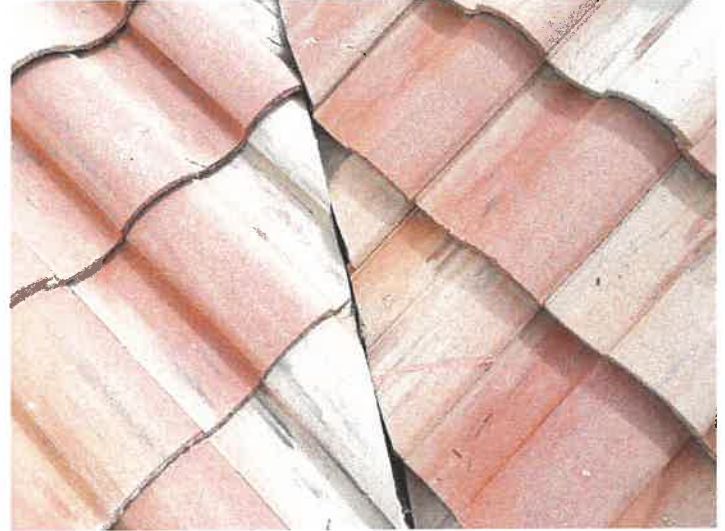
Building 15145: Repaired Cracked Roof Tiles
The cracked roof tiles were repaired with Titebond sealant.

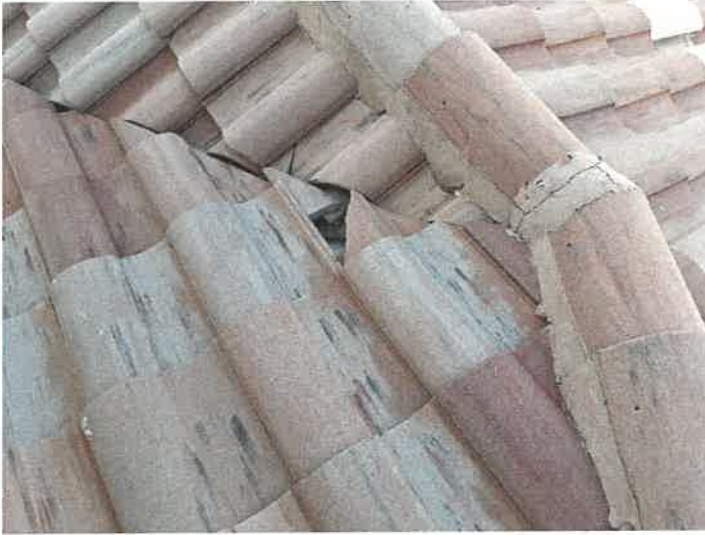
Building 15145: Broken Roof Tile

Crowther Roofing suggests replacing the broken roof tile.

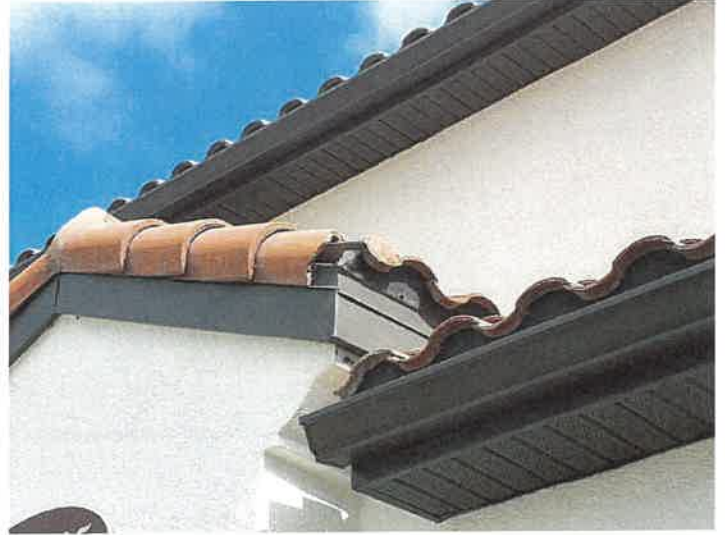
Building 15145: Broken Ridge Tile

Crowther Roofing suggests replacing the ridge tile.

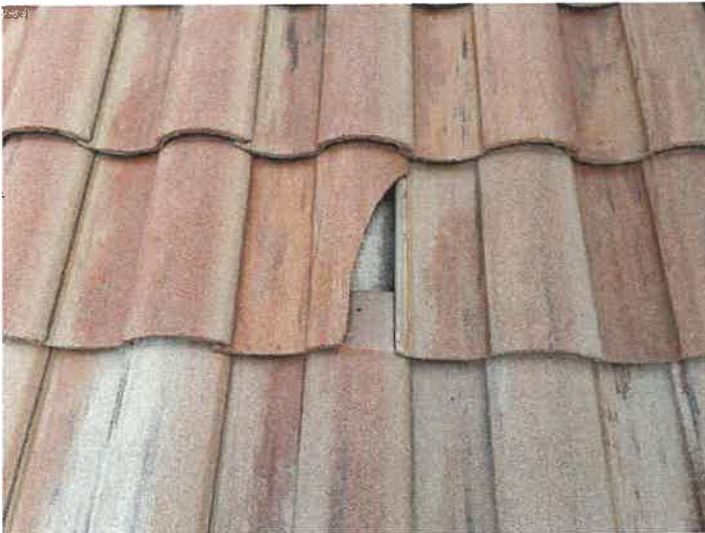
Building 15145: Broken Roof Tile

Crowther Roofing suggests replacing the broken roof tile.

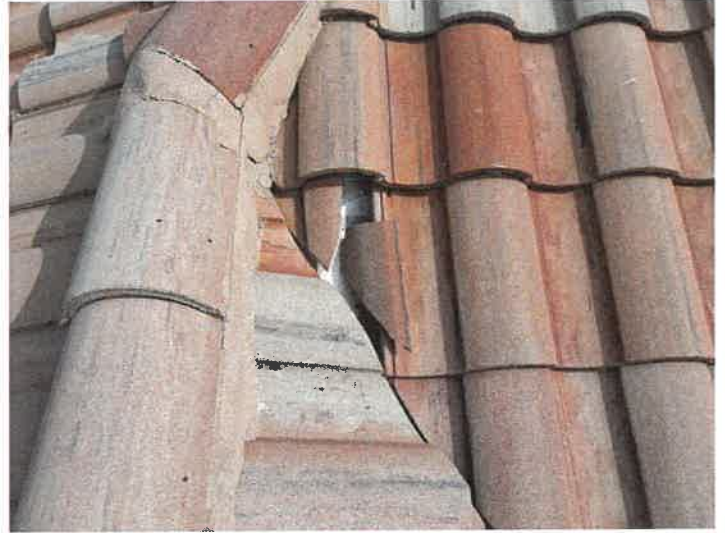
Building 15145: Broken Roof Tile

Crowther Roofing suggests replacing the broken roof tile.

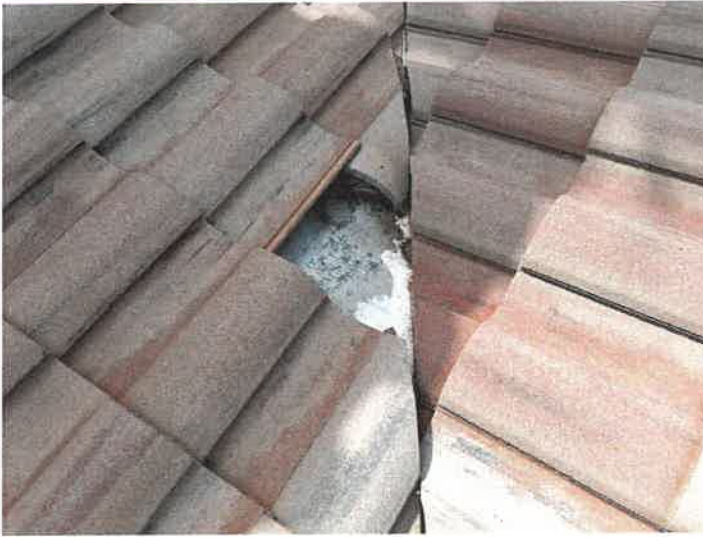
Building 15145: Missing Roof Tile

Crowther Roofing suggests replacing the missing roof tile.

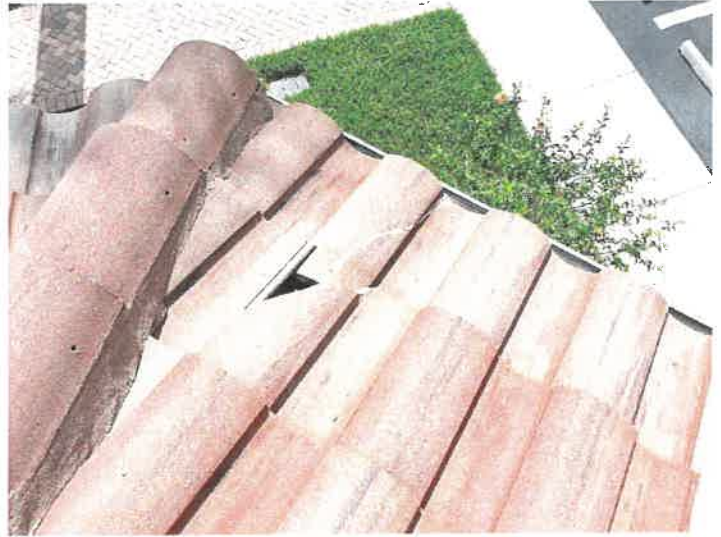
Building 15145: Broken Roof Tile

Crowther Roofing suggests replacing the broken roof tile.

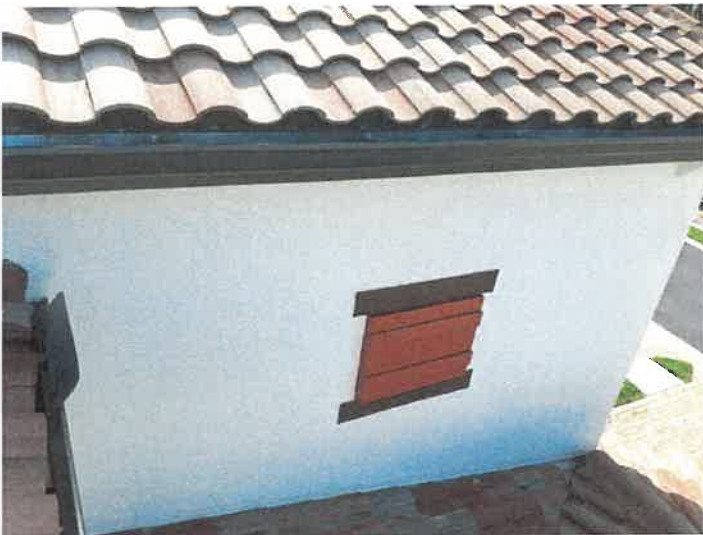
Building 15145: Wall

The walls appear to be in good condition.

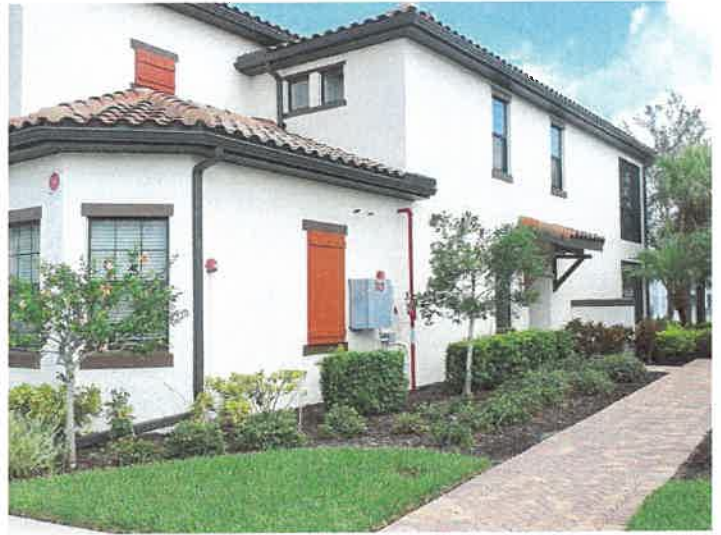
Building 15145: Downspouts

The downspouts appear to be in good condition.

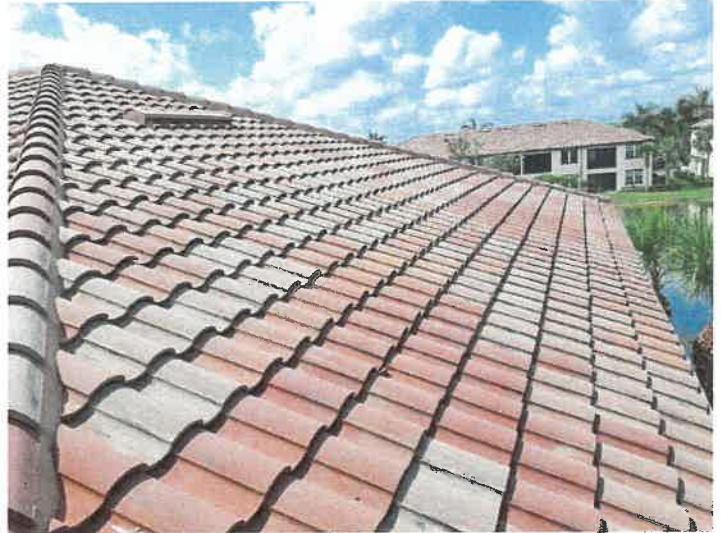
Building 15148: Surface Overview
The roof surface appears to be in good, maintainable condition at this time.

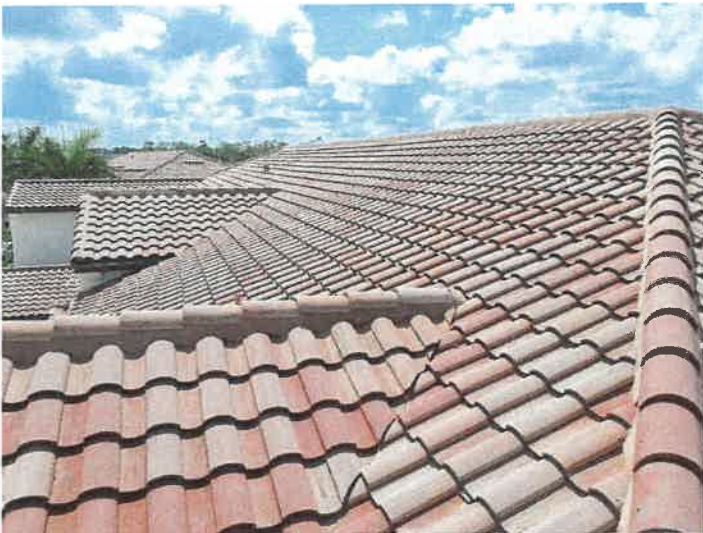
Building 15148: Appearance Overview
The roof appearance is in good, maintainable condition.

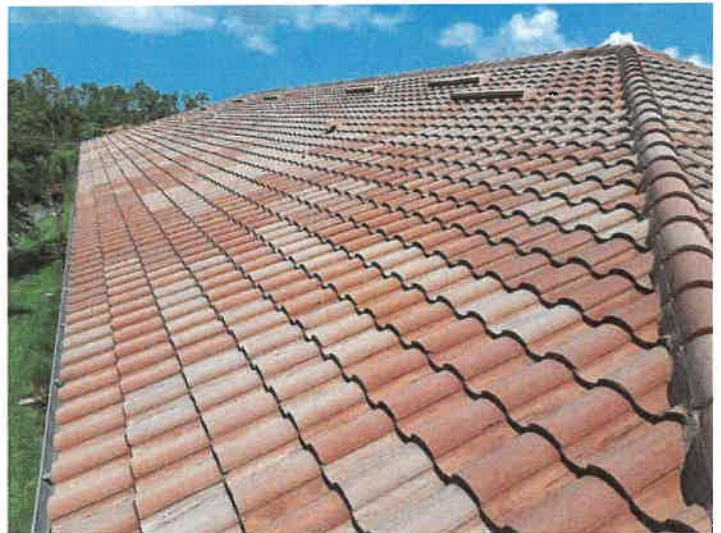
Building 15148: Surface Overview
The roof surface appears to be in good, maintainable condition at this time.

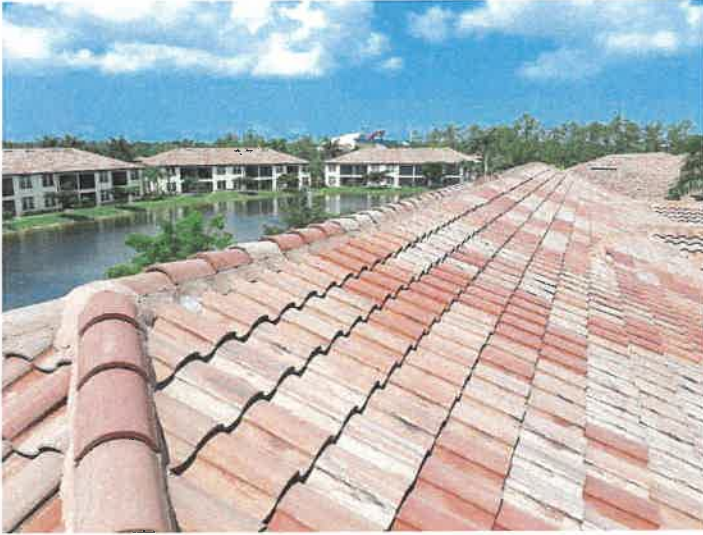
Building 15148: Ridge Tiles
Ridge tiles appear to be in good condition.

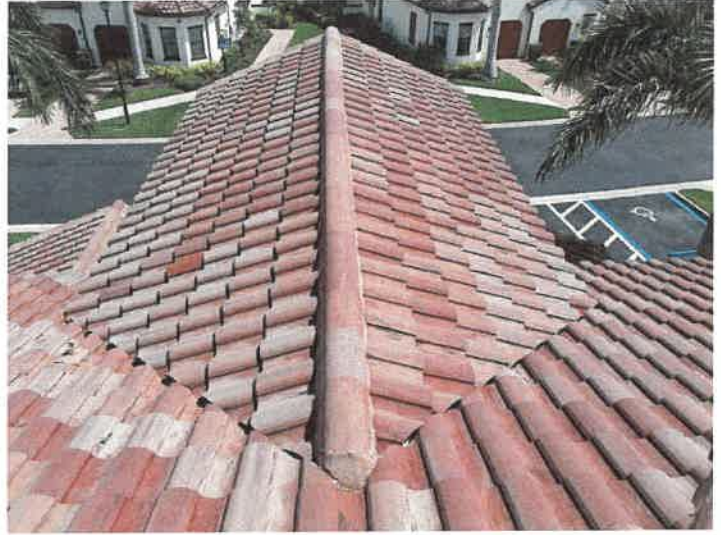
Building 15148: Valley
The valley tiles appear to be in good condition.

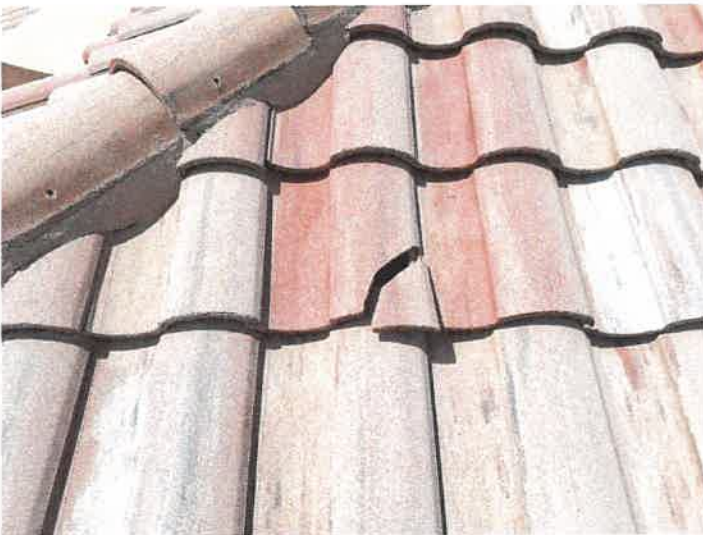
Building 15148: Identified Cracked Roof Tiles
Cracked roof tiles can allow premature underlayment deterioration from excessive UV exposure.

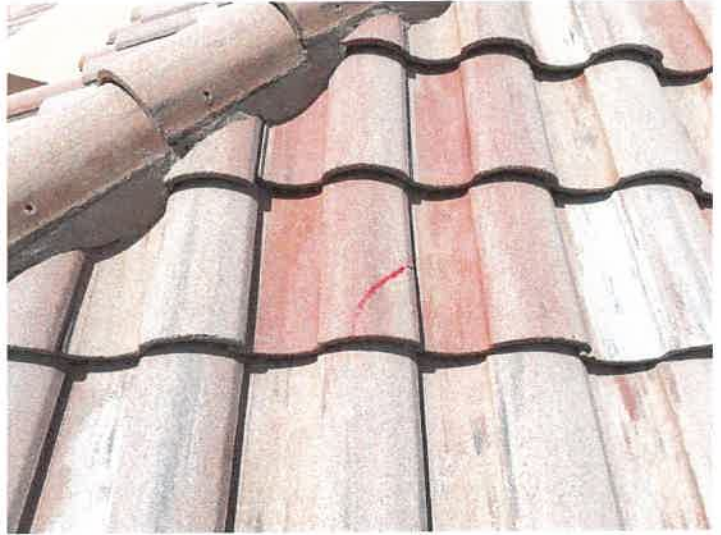
Building 15148: Repaired Cracked Roof Tiles
The cracked roof tiles were repaired with Titebond sealant.

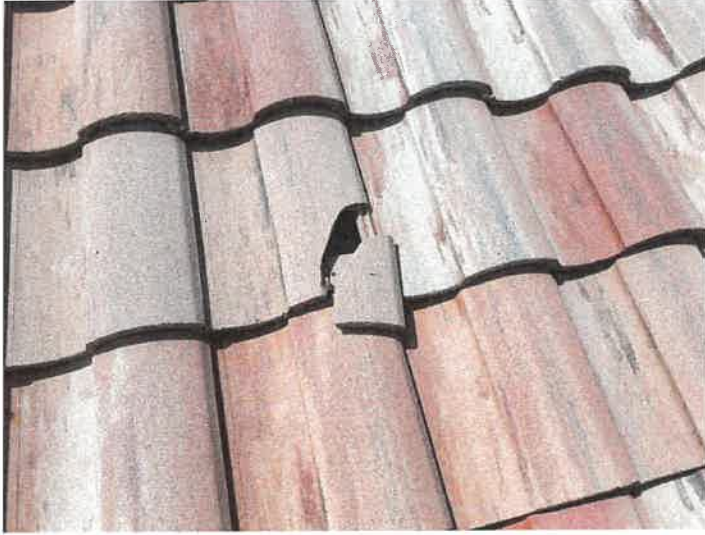
Building 15148: Identified Cracked Roof Tiles

Cracked roof tiles can allow premature underlayment deterioration from excessive UV exposure.

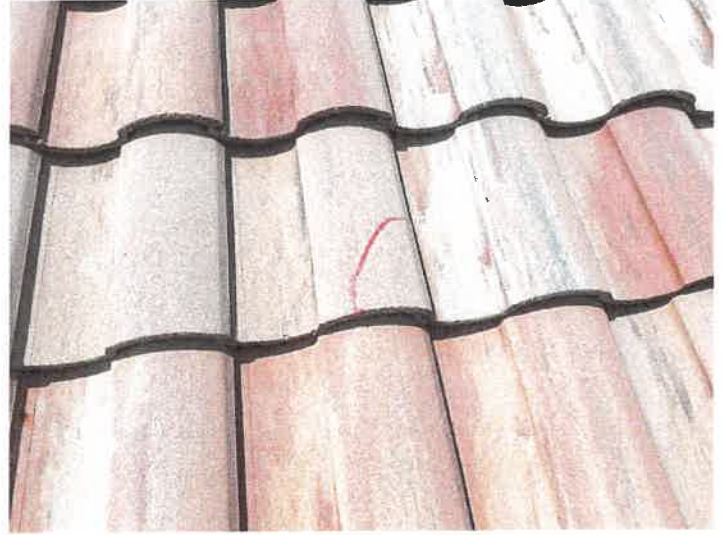
Building 15148: Repaired Cracked Roof Tiles

The cracked roof tiles were repaired with Titebond sealant.

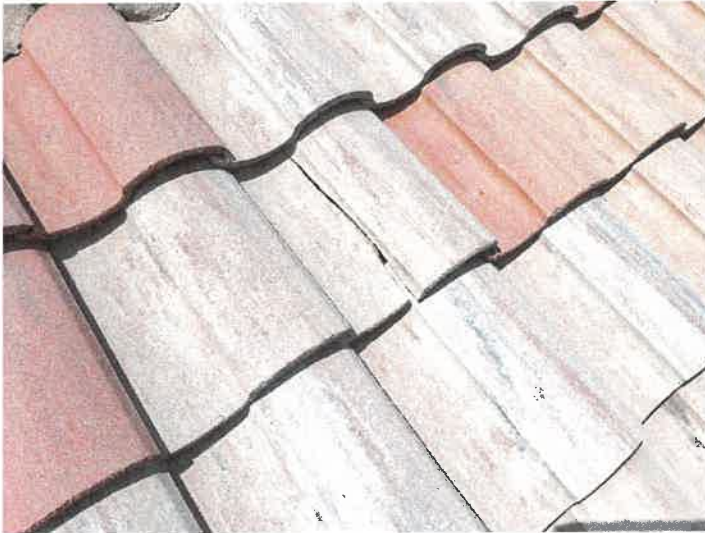
Building 15148: Identified Cracked Roof Tiles

Cracked roof tiles can allow premature underlayment deterioration from excessive UV exposure.

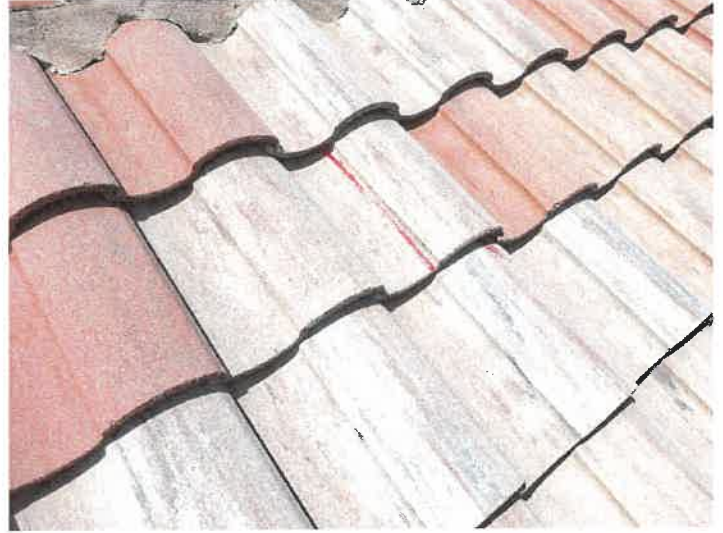
Building 15148: Repaired Cracked Roof Tiles

The cracked roof tiles were repaired with Titebond sealant.

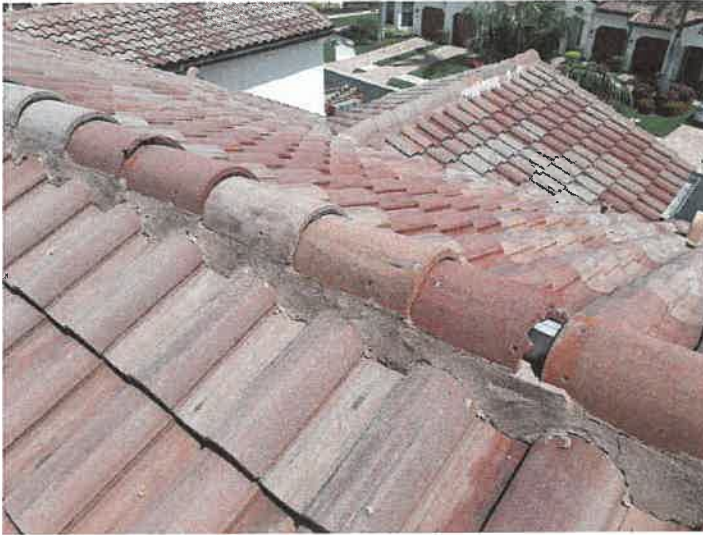
Building 15148: Broken Ridge Tiles

Crowther Roofing suggests replacing two (2) broken ridge tiles.

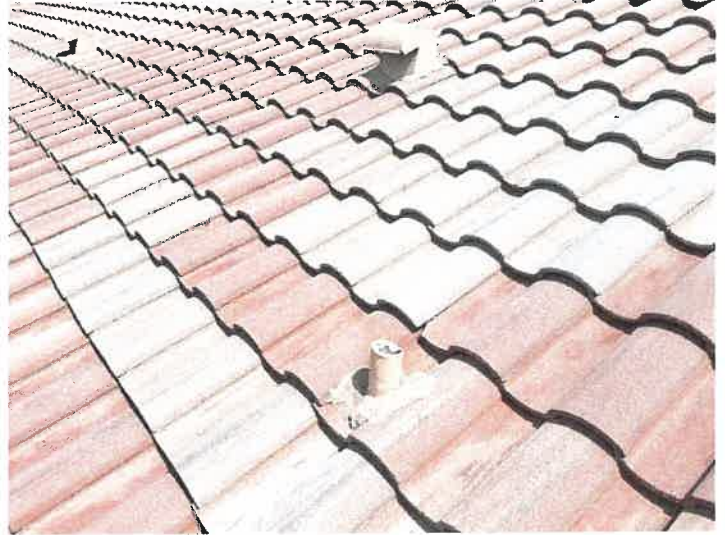
Building 15148: Lead Boots

Lead boots appear to be in good condition.

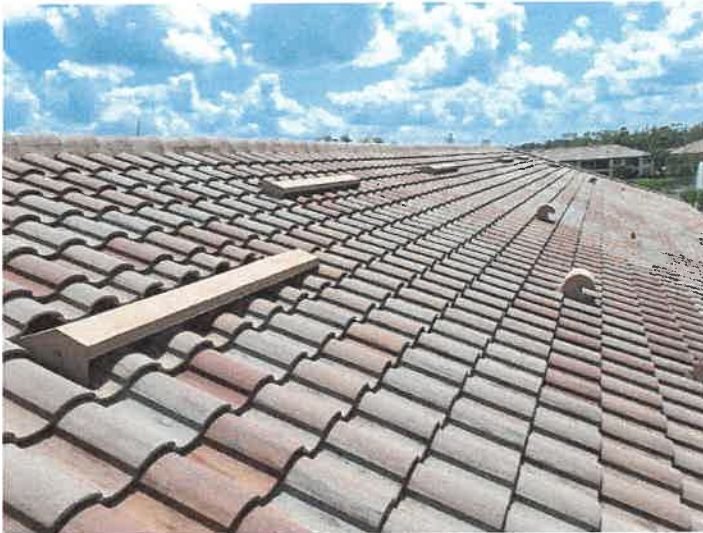
Building 15148: Roof Vents

Roof vents appear to be in good condition.

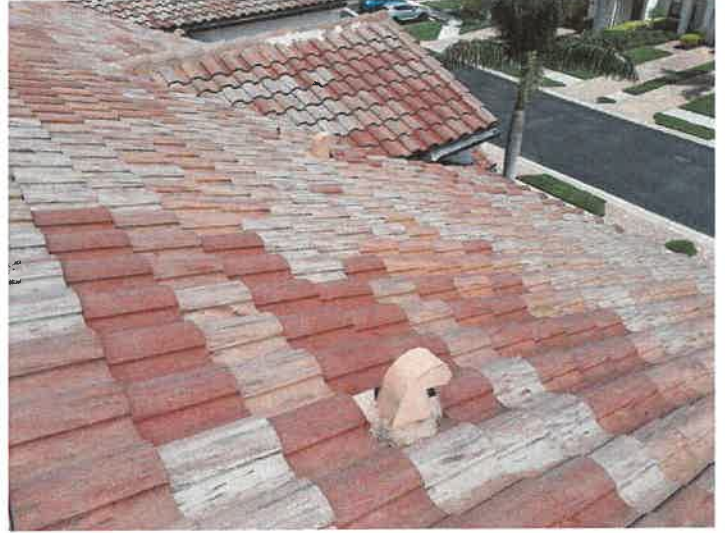
Building 15148: Roof Vents

Roof vents appear to be in good condition.

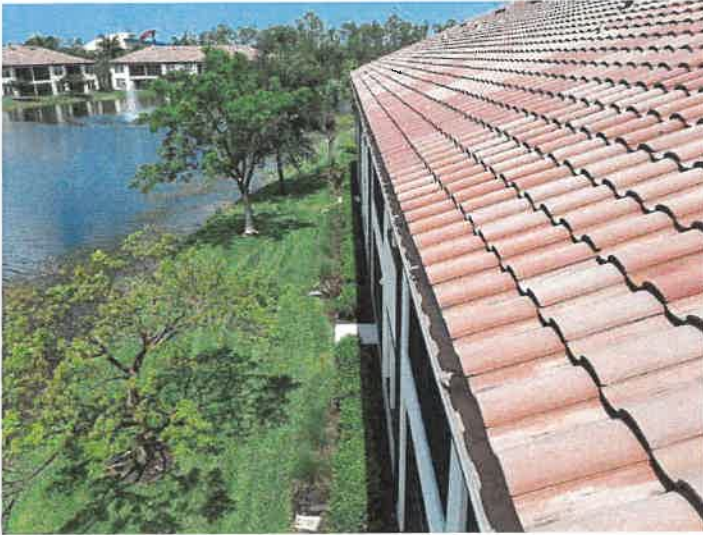
Building 15148: Gutters

The gutters appear to be in good condition.

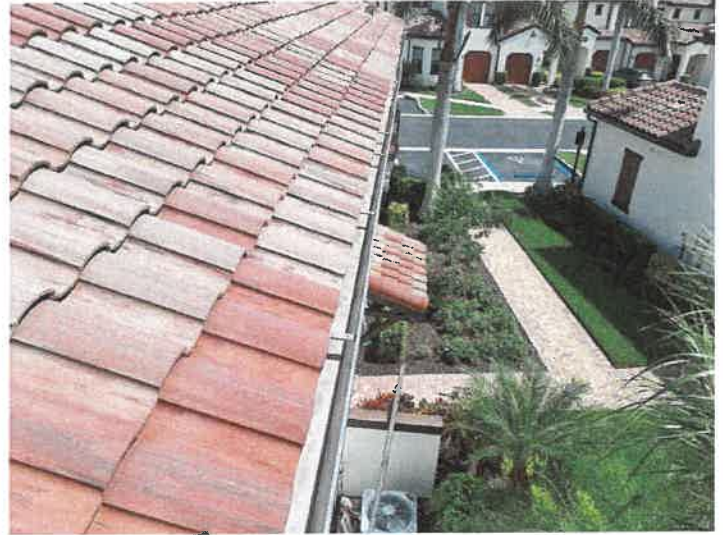
Building 15148: Gutters

The gutters appear to be in good condition.

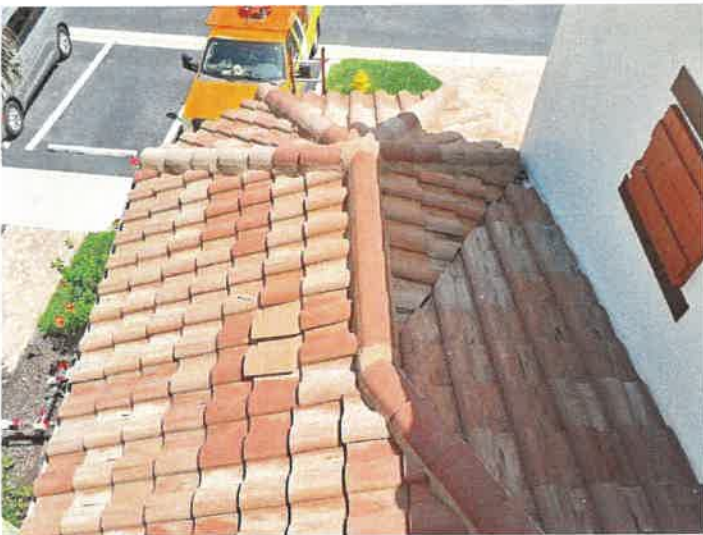
Building 15148: Surface Overview - Lower Roof

The roof surface appears to be in good, maintainable condition at this time.

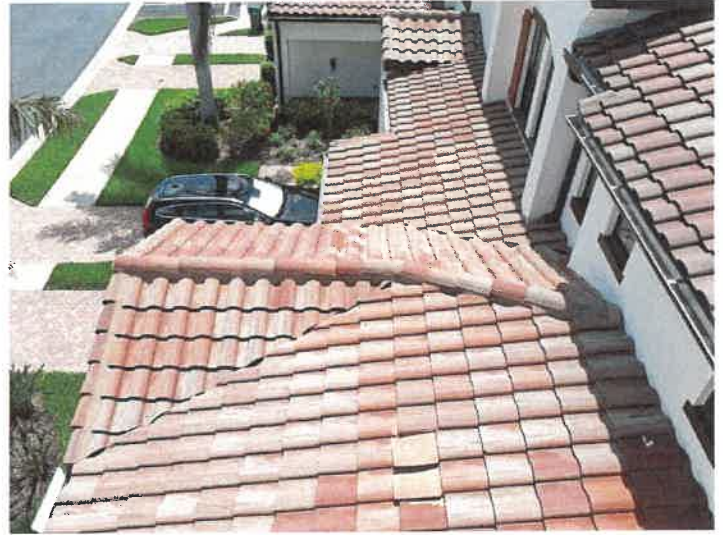
Building 15148: Appearance Overview - Lower Roof

The roof appearance is in good, maintainable condition.

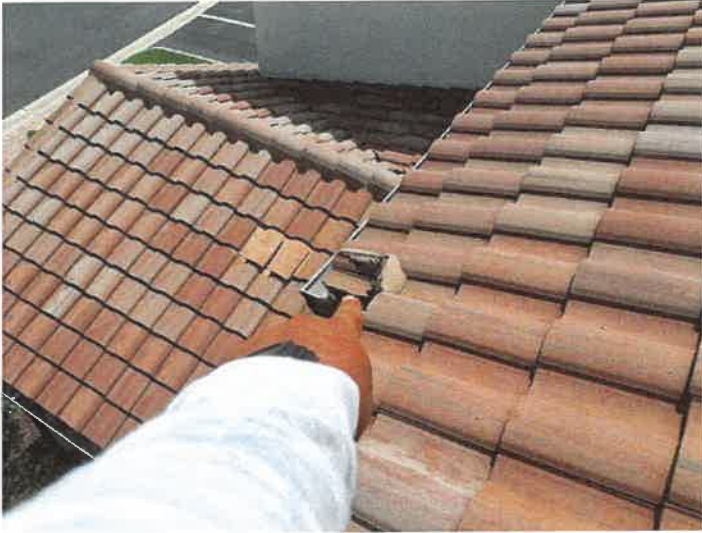
Building 15148: Broken Ridge Tile

Crowther Roofing suggests replacing the broken ridge tile.

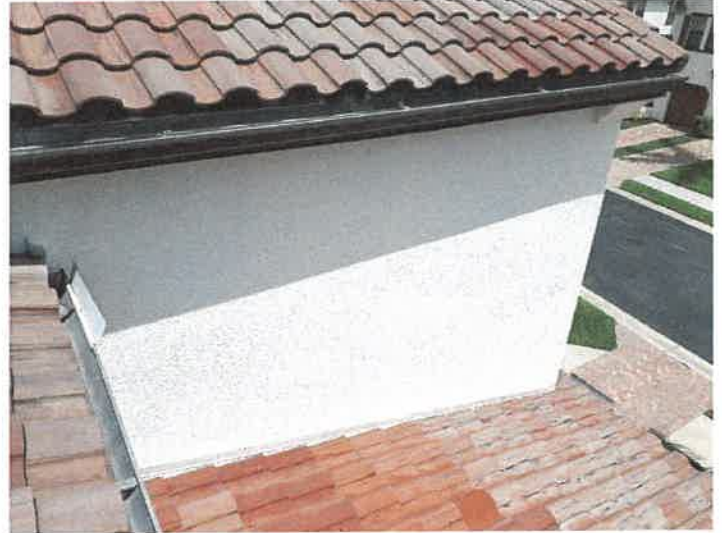
Building 15148: Wall

The walls appear to be in good condition.

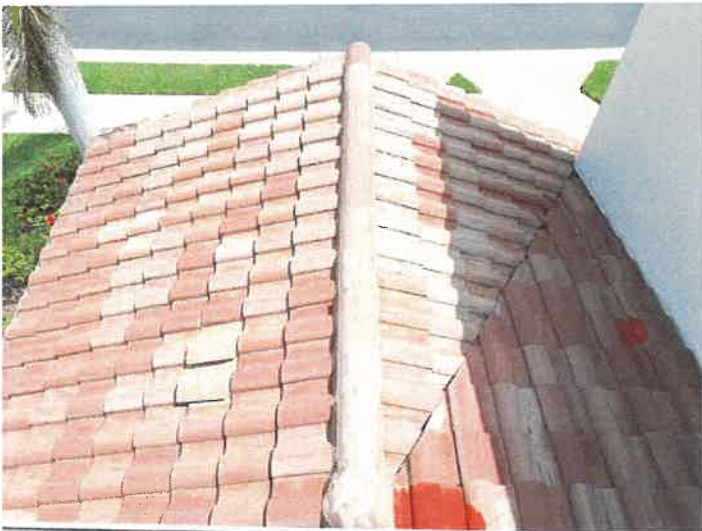
Building 15148: Appearance Overview - Lower Roof

The roof appearance is in good, maintainable condition.

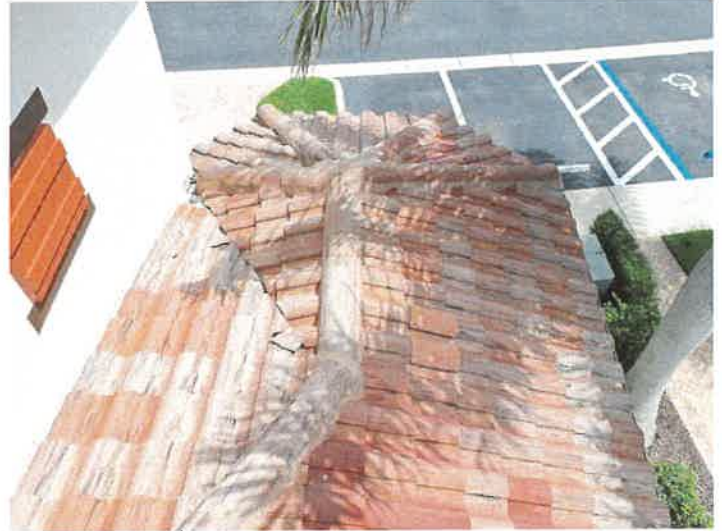
Building 15148: Surface Overview - Lower Roof

The roof surface appears to be in good, maintainable condition at this time.
