Inspection Report

Facility: Livingston Lakes Condo
Address: 15098 Palmer Lake Circle,
Naples, FL 34109
Customer: Cardinal Management
Address: c/o Livingston Lakes Condo, 15090
Naples, FL 34109

Livingston Lakes Condo, Naples, FL

Re.: **Inspection Report (2 of 3) for Livingston Lakes**

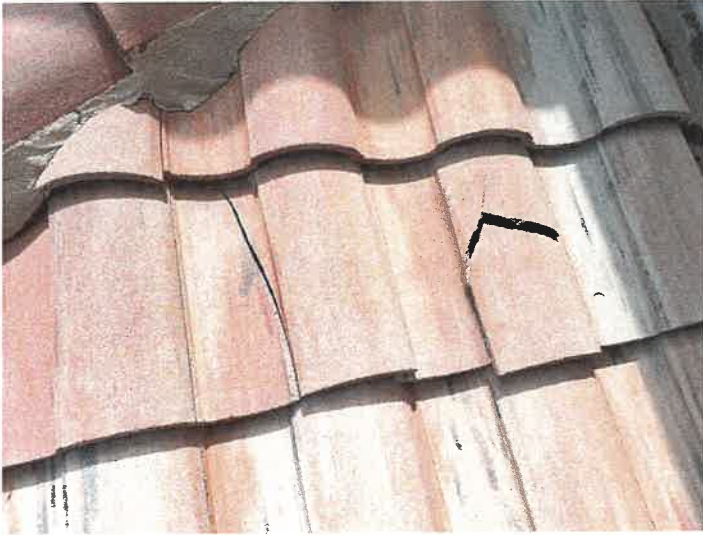
Building 15148: Identified Cracked Roof Tiles

Cracked roof tiles can allow premature underlayment deterioration from excessive UV exposure.

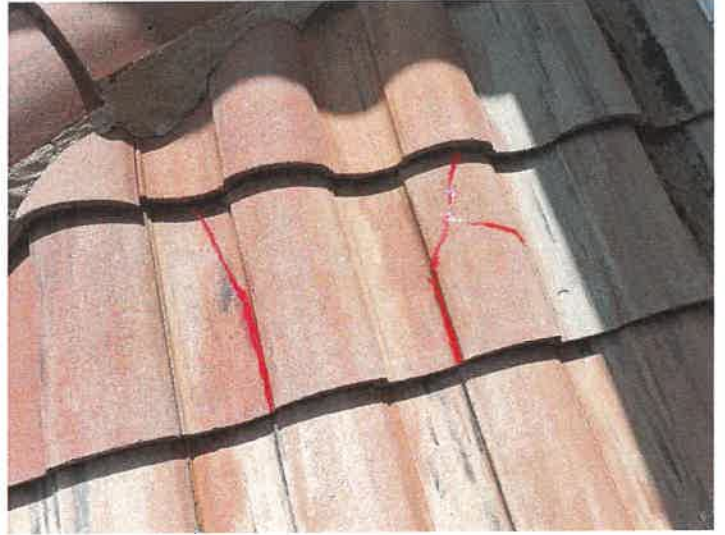
Building 15148: Repaired Cracked Roof Tiles

The cracked roof tiles were repaired with Titebond sealant.

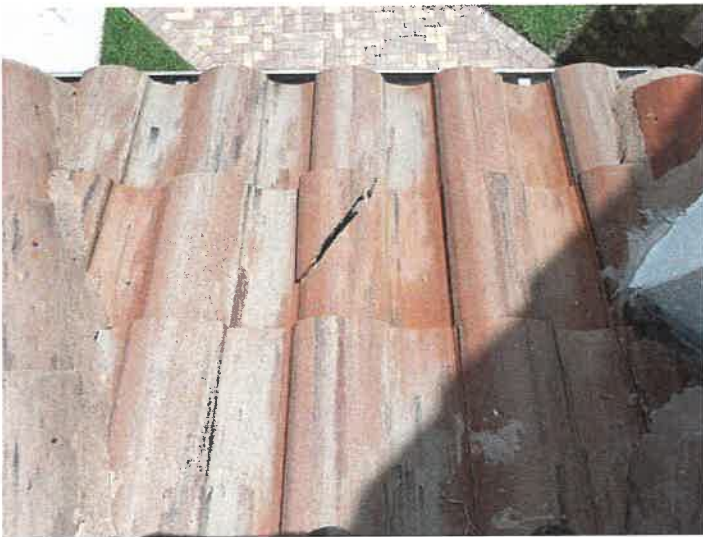
Building 15148: Identified Cracked Roof Tiles

Cracked roof tiles can allow premature underlayment deterioration from excessive UV exposure.

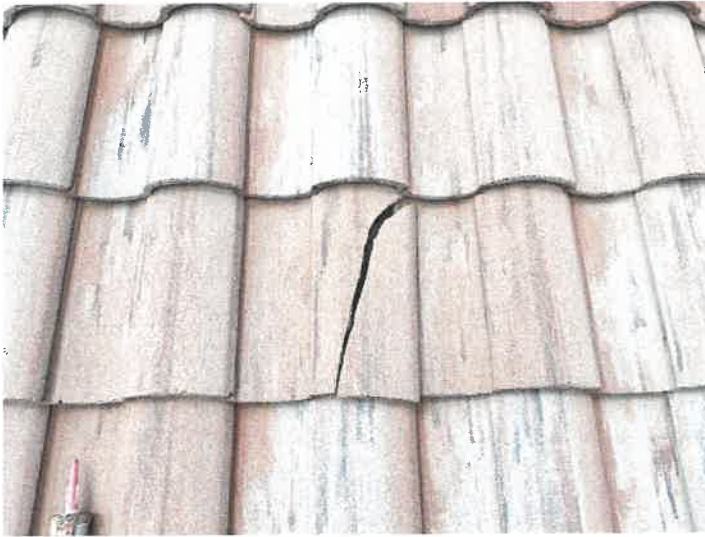
Building 15148: Identified Cracked Roof Tiles

Cracked roof tiles can allow premature underlayment deterioration from excessive UV exposure.

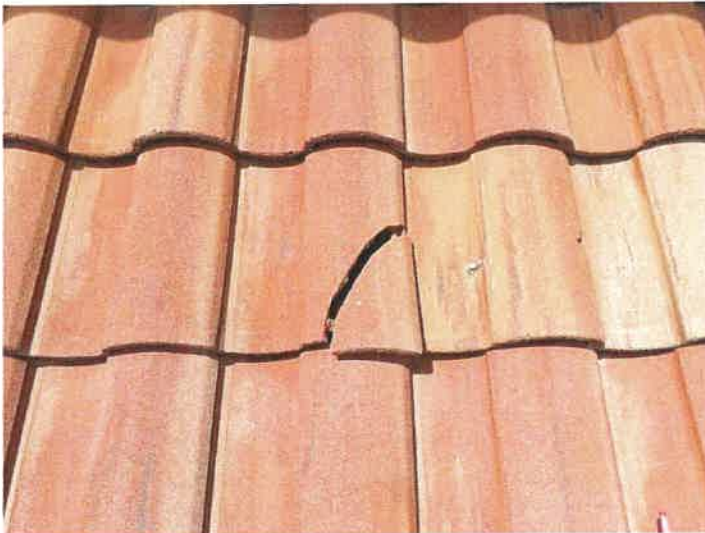
Building 15148: Identified Cracked Roof Tiles

Cracked roof tiles can allow premature underlayment deterioration from excessive UV exposure.

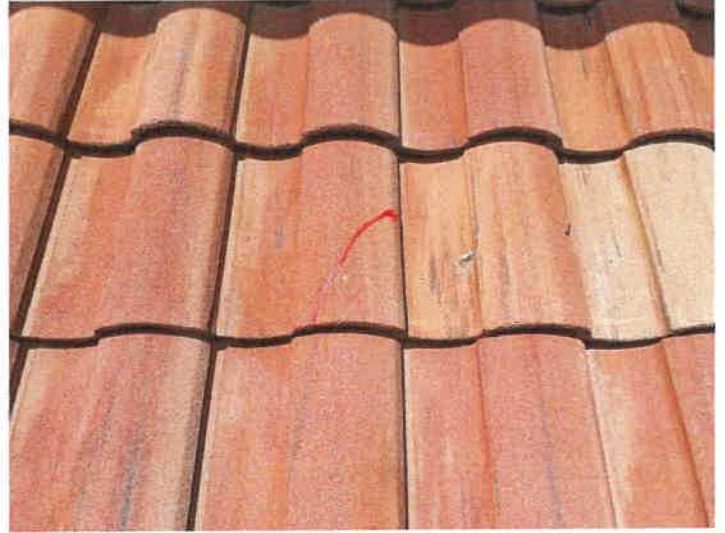
Building 15148: Repaired Cracked Roof Tiles

The cracked roof tiles were repaired with Titebond sealant.

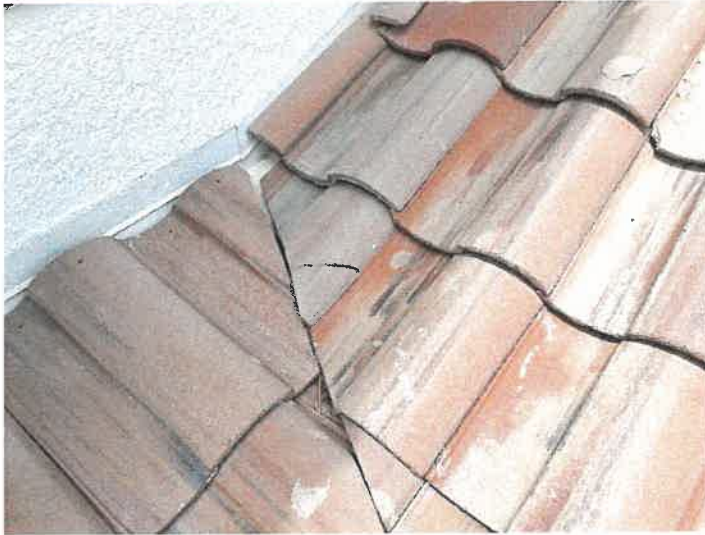
Building 15148: Identified Cracked Roof Tiles

Cracked roof tiles can allow premature underlayment deterioration from excessive UV exposure.

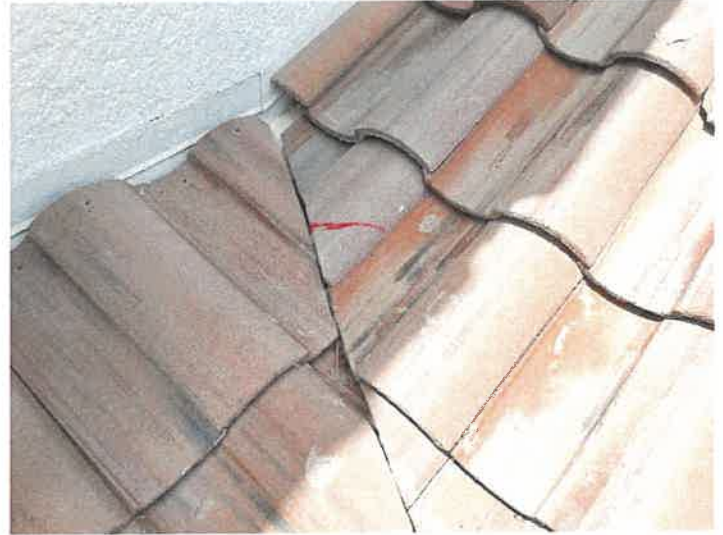
Building 15148: Repaired Cracked Roof Tiles

The cracked roof tiles were repaired with Titebond sealant.

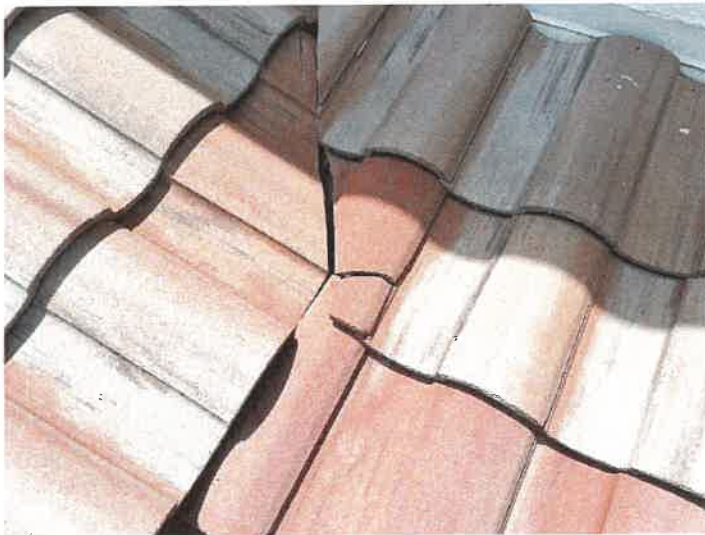
Building 15148: Identified Cracked Roof Tiles

Cracked roof tiles can allow premature underlayment deterioration from excessive UV exposure.

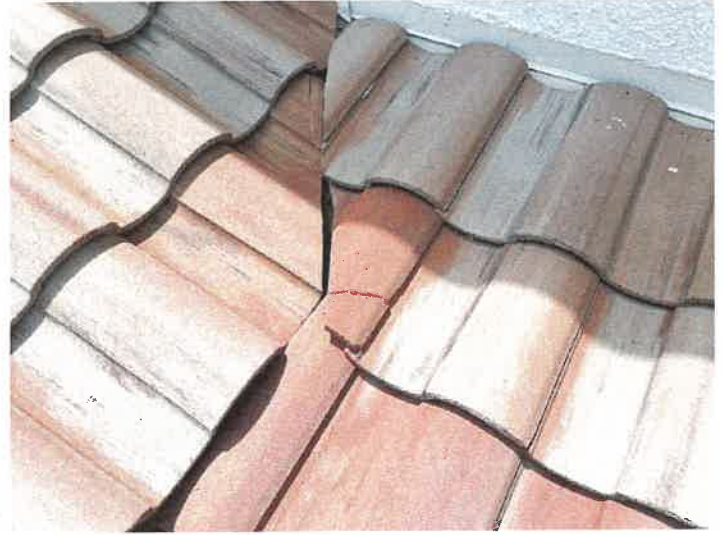
Building 15148: Repaired Cracked Roof Tiles

The cracked roof tiles were repaired with Titebond sealant.

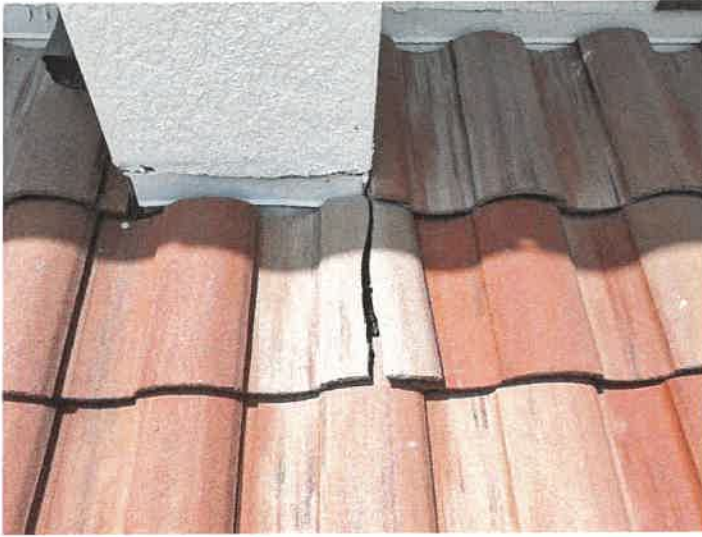
Building 15148: Identified Cracked Roof Tiles

Cracked roof tiles can allow premature underlayment deterioration from excessive UV exposure.

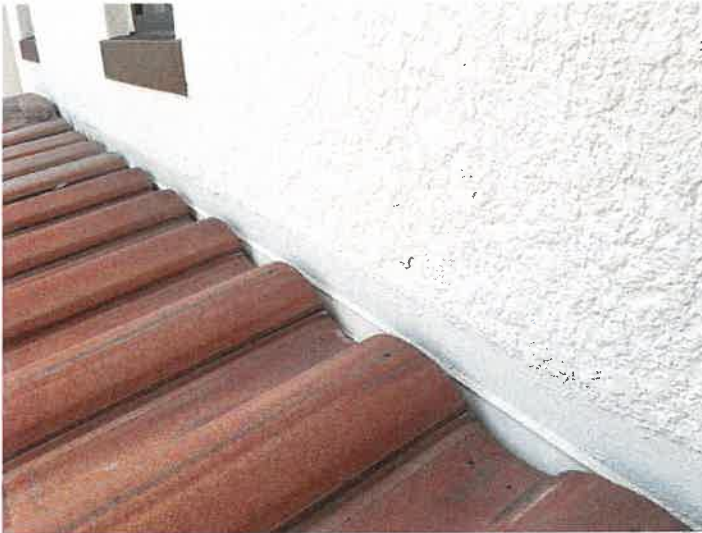
Building 15148: Counter Flashings

The counter flashing appears to be in good condition.

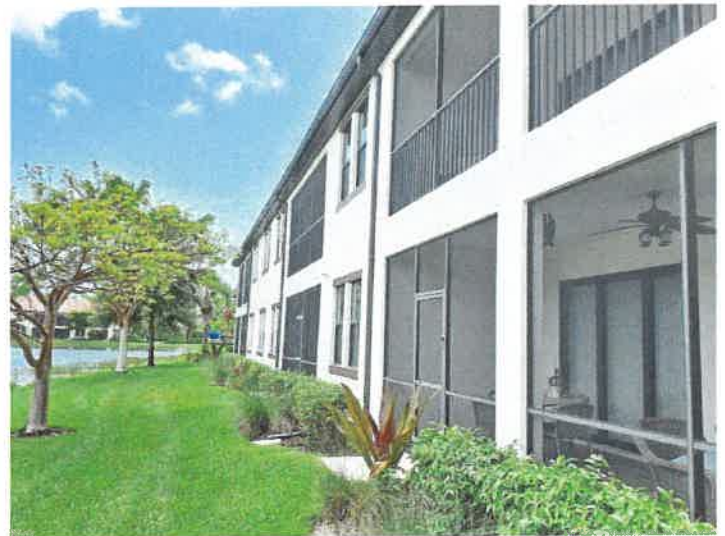
Building 15148: Downspouts

The downspouts appear to be in good condition.

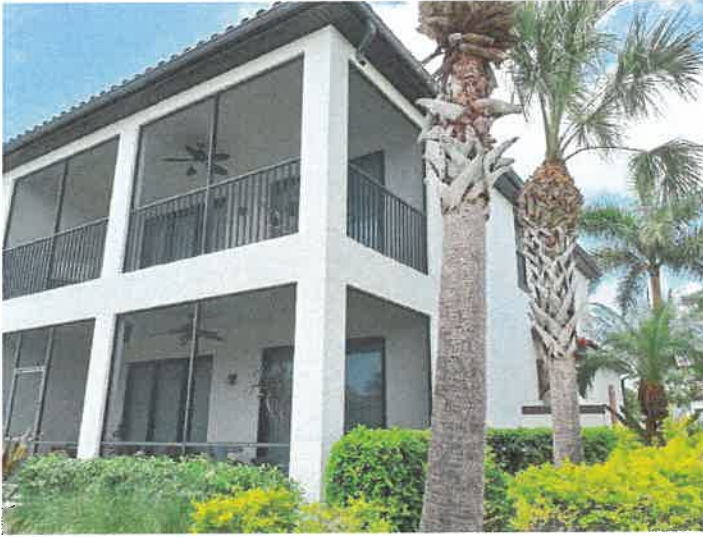
Building 15148: Downspout- missing
Downspout is missing.

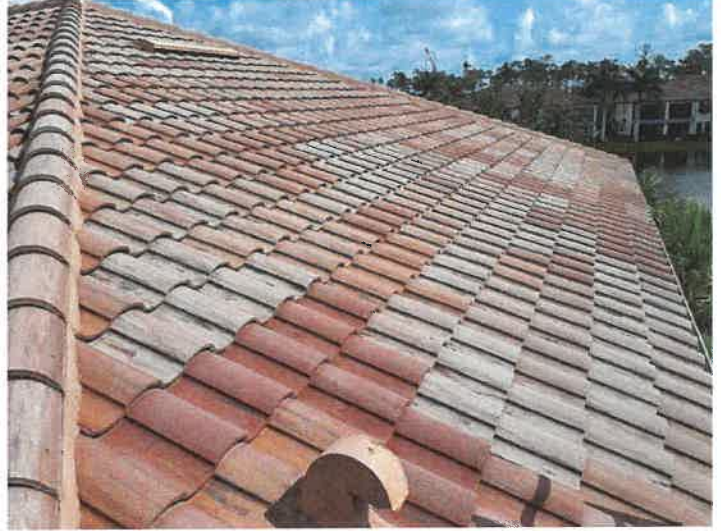
Building 15149: Surface Overview
The roof surface appears to be in good, maintainable condition at this time.

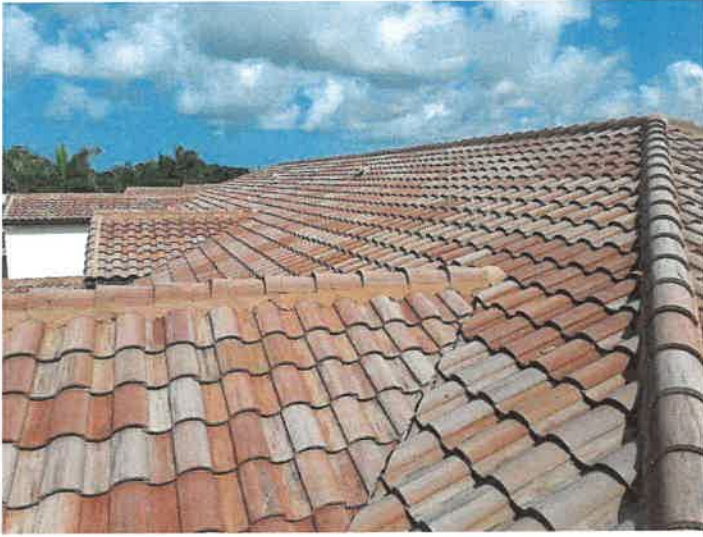
Building 15149: Appearance Overview

The roof appearance is in good, maintainable condition.

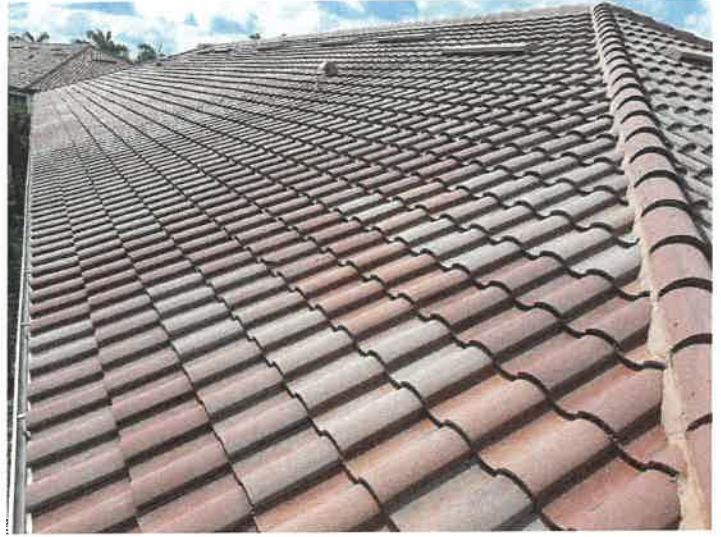
Building 15149: Surface Overview

The roof surface appears to be in good, maintainable condition at this time.

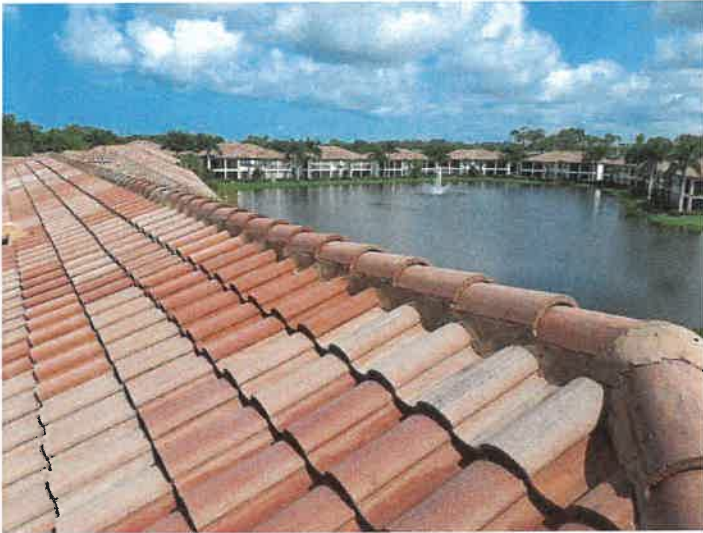
Building 15149: Ridge Tiles

Ridge tiles appear to be in good condition.

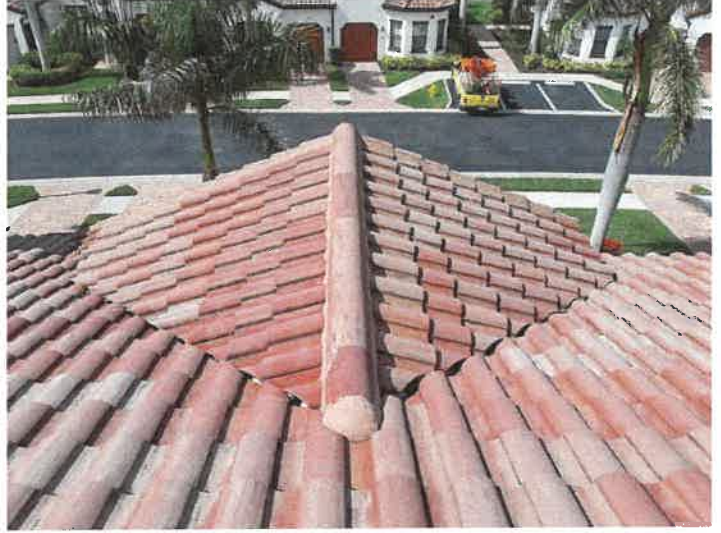
Building 15149: Valley

The valley tiles appear to be in good condition.

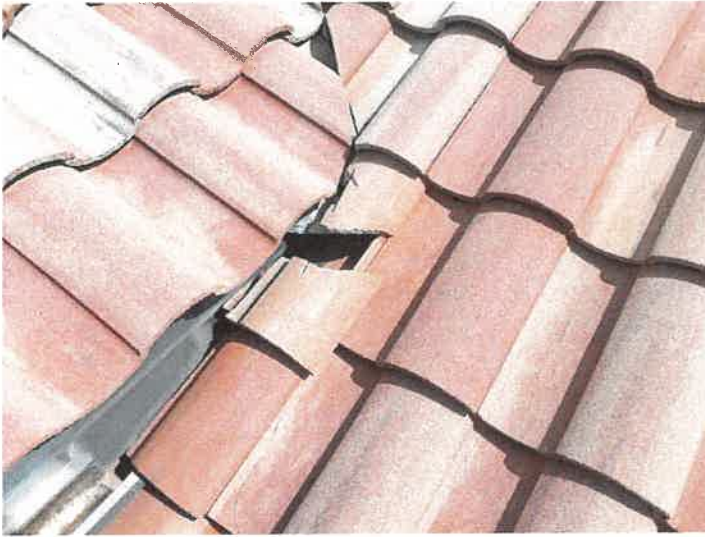
Building 15149: Identified Cracked Roof Tiles

Cracked roof tiles can allow premature underlayment deterioration from excessive UV exposure.

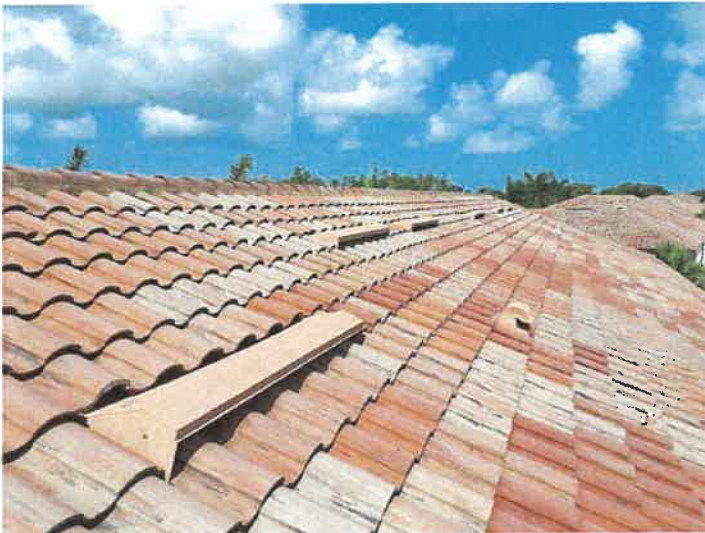
Building 15149: Roof Vents

Roof vents appear to be in good condition.

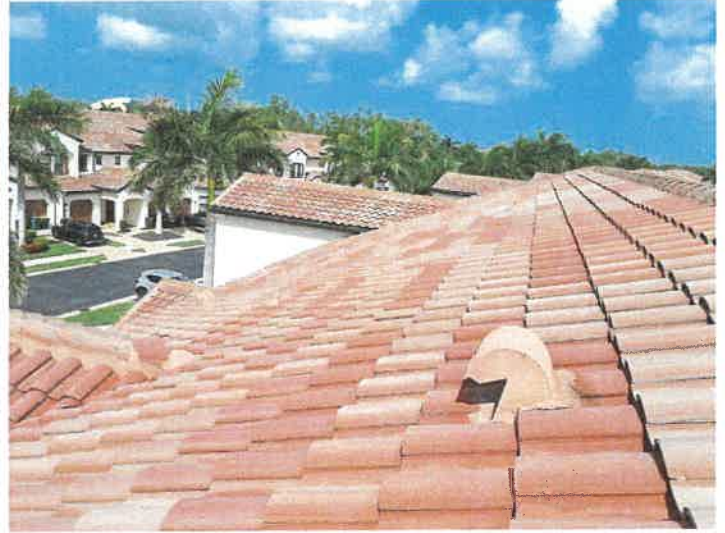
Building 15149: Roof Vents

Roof vents appear to be in good condition.

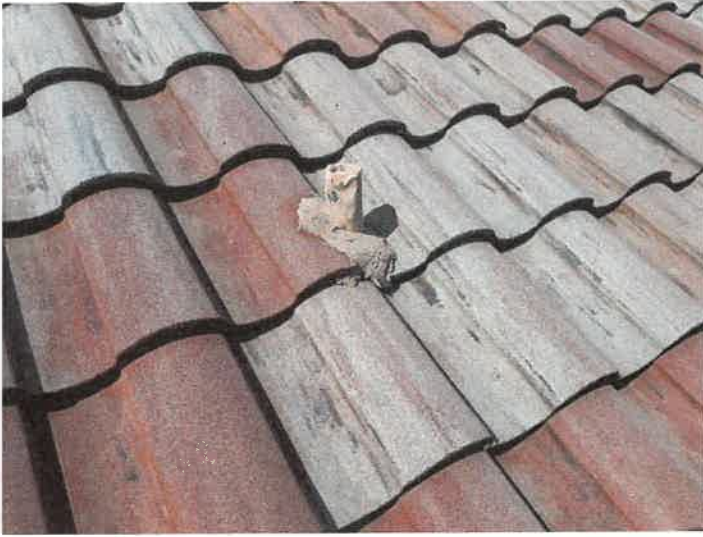
Building 15149: Lead Boots
Lead boots appear to be in good condition.

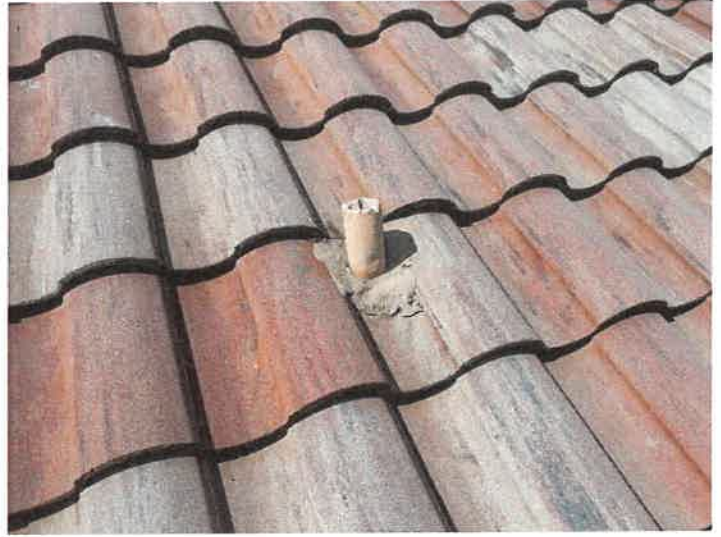
Building 15149: Lead Boots
Lead boots appear to be in good condition.

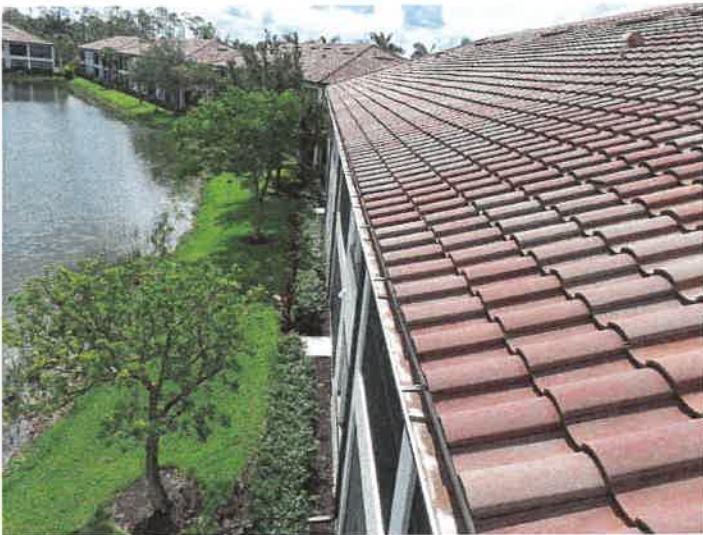
Building 15149: Gutters
The gutters appear to be in good condition.

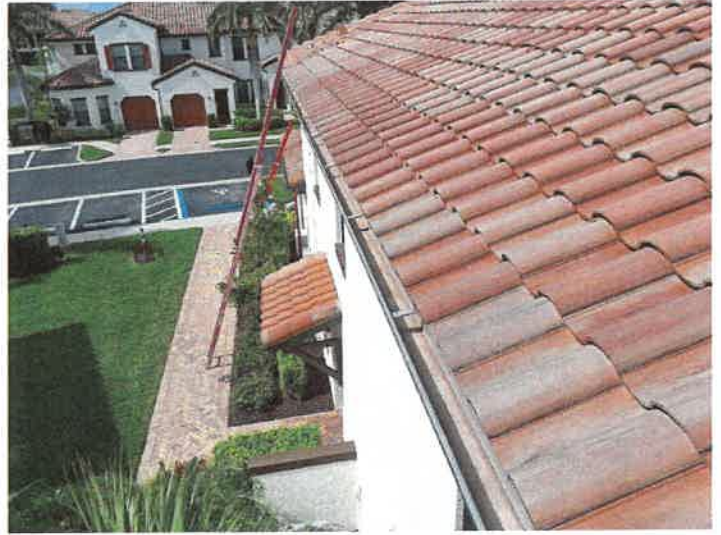
Building 15149: Gutters
The gutters appear to be in good condition.

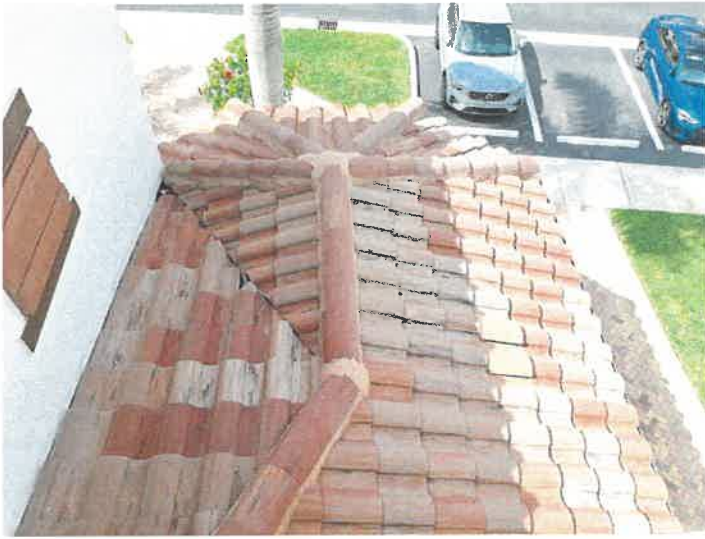
Building 15149: Surface Overview - Lower Roof

The roof surface appears to be in good, maintainable condition at this time.

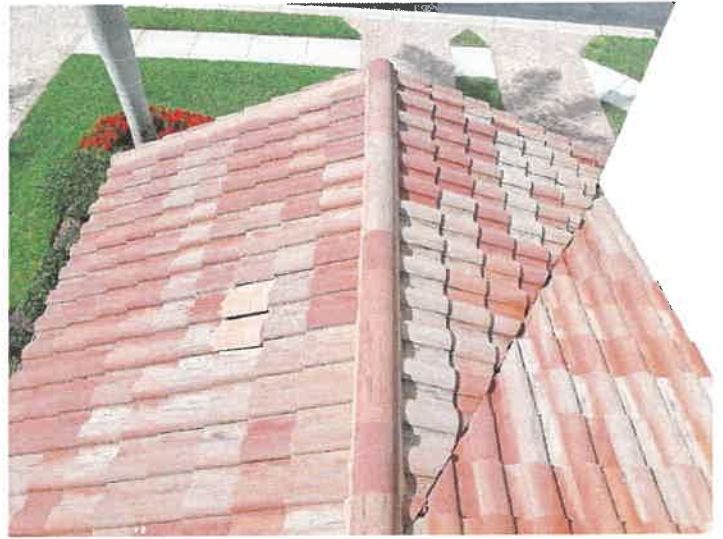
Building 15149: Appearance Overview - Lower Roof

The roof appearance is in good, maintainable condition.

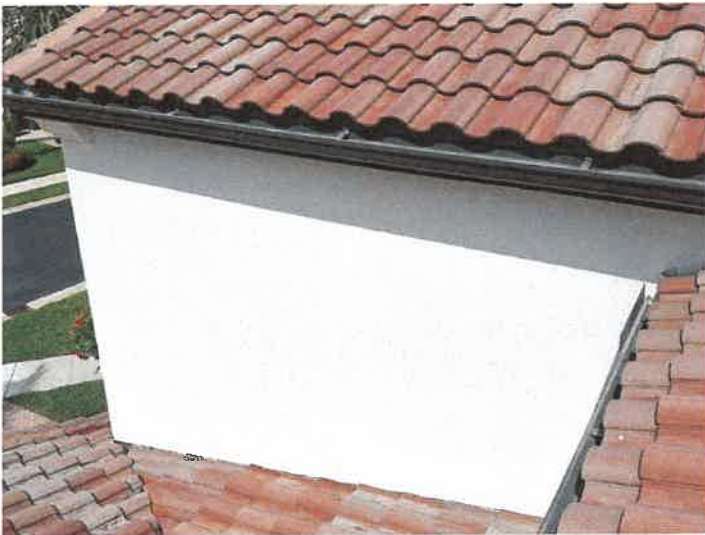
Building 15149: Wall

The walls appear to be in good condition.

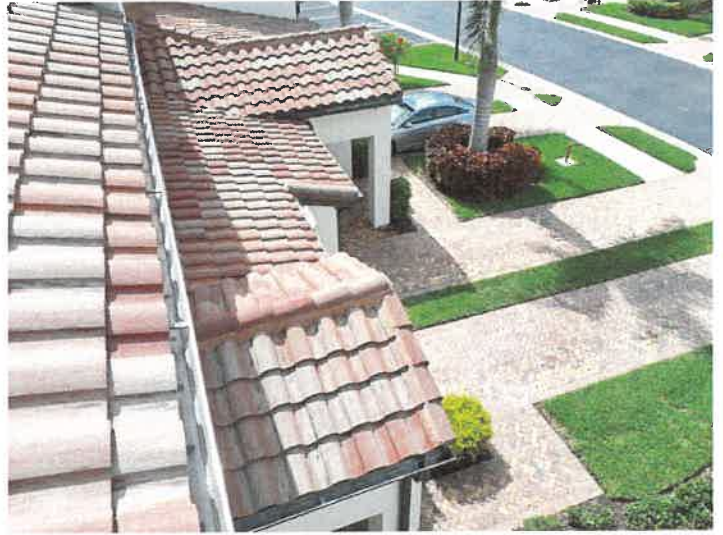
Building 15149: Appearance Overview - Lower Roof

The roof appearance is in good, maintainable condition.

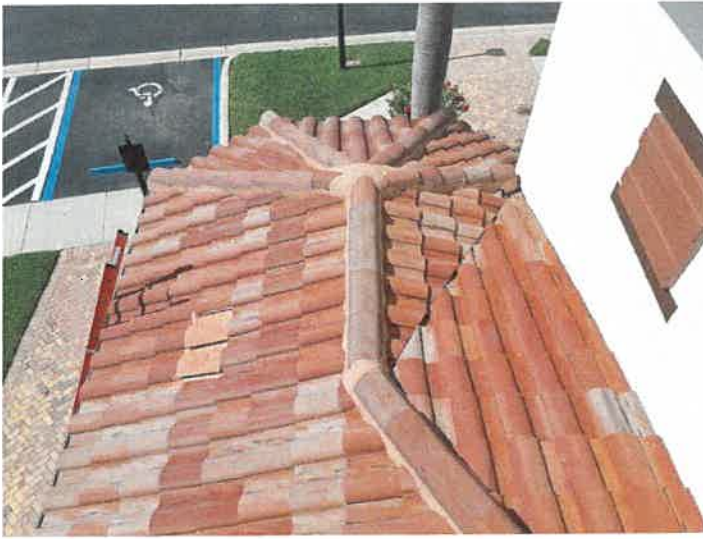
Building 15149: Surface Overview - Lower Roof

The roof surface appears to be in good, maintainable condition at this time.

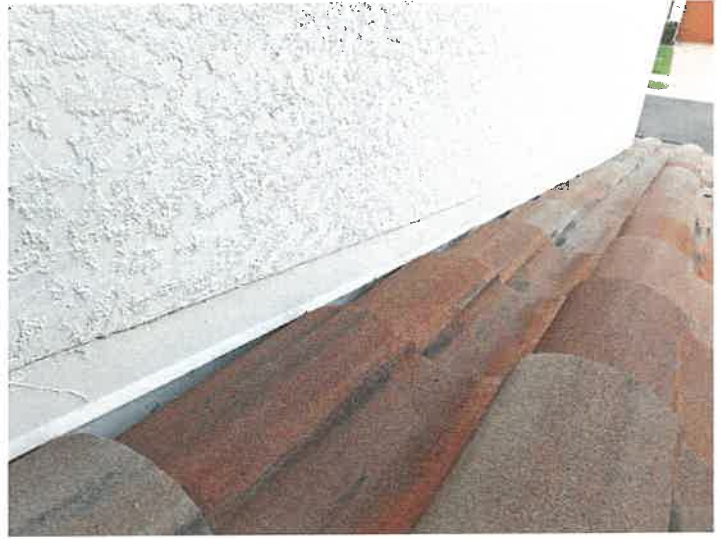
Building 15149: Counter Flashings

The counter flashing appears to be in good condition.

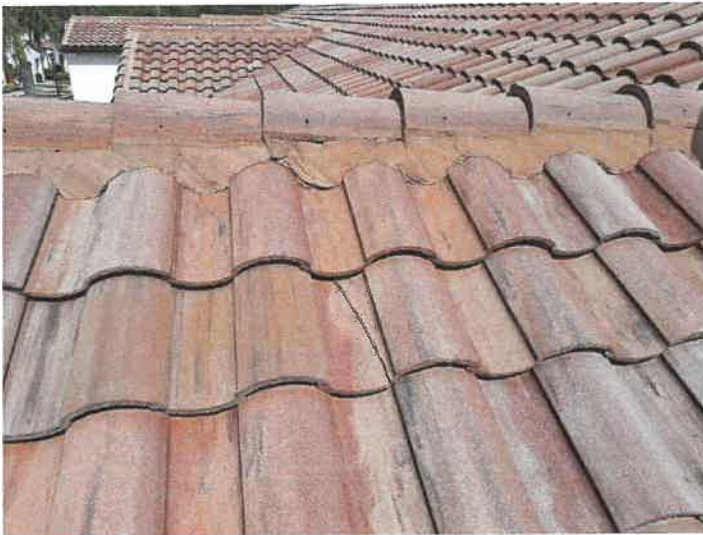
Building 15149: Identified Cracked Roof Tiles

Cracked roof tiles can allow premature underlayment deterioration from excessive UV exposure.

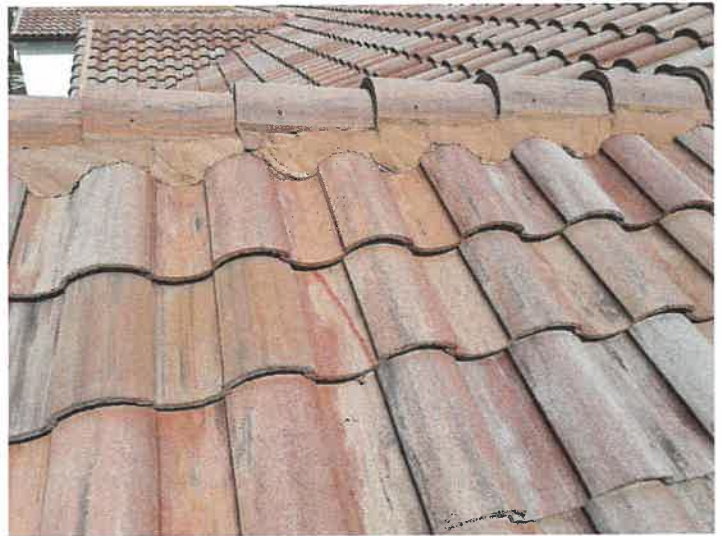
Building 15149: Repaired Cracked Roof Tiles

The cracked roof tiles were repaired with Titebond sealant.

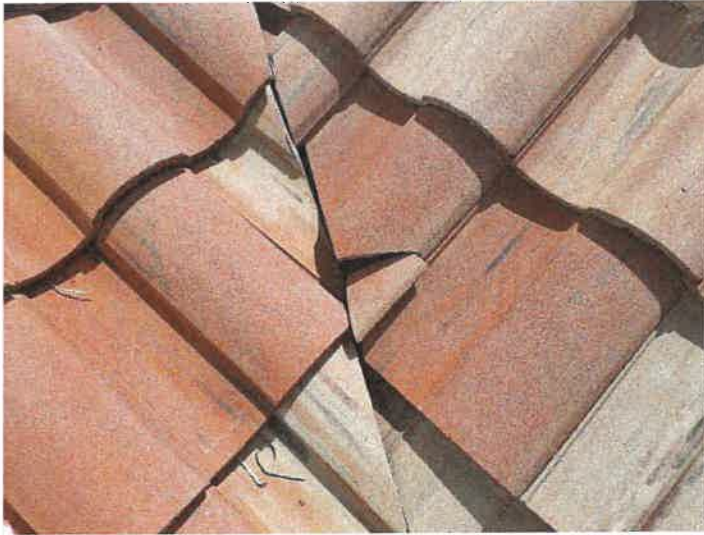
Building 15149: Identified Cracked Roof Tiles

Cracked roof tiles can allow premature underlayment deterioration from excessive UV exposure.

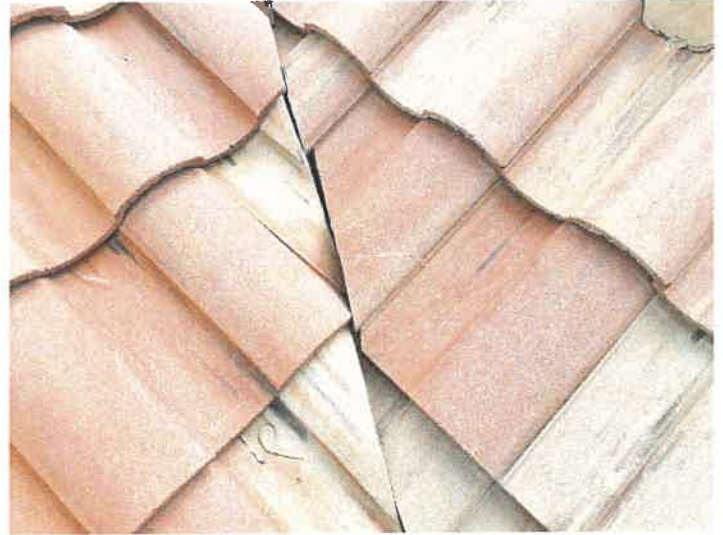
Building 15149: Repaired Cracked Roof Tiles

The cracked roof tiles were repaired with Titebond sealant.

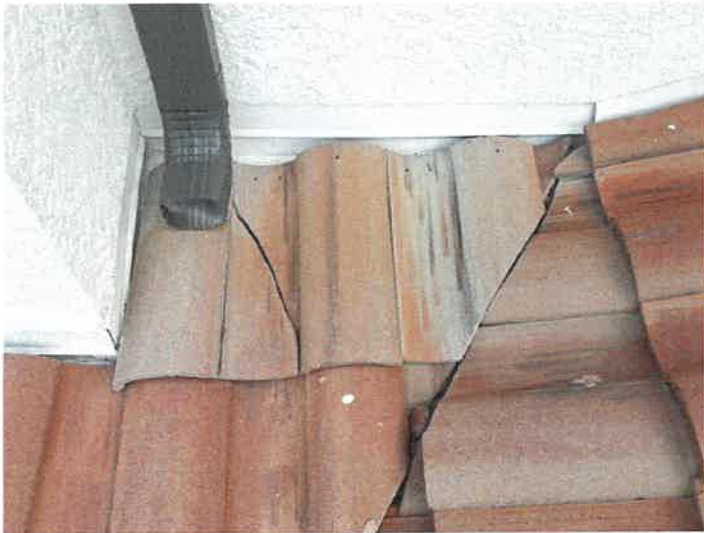
Building 15149: Identified Cracked Roof Tiles

Cracked roof tiles can allow premature underlayment deterioration from excessive UV exposure.

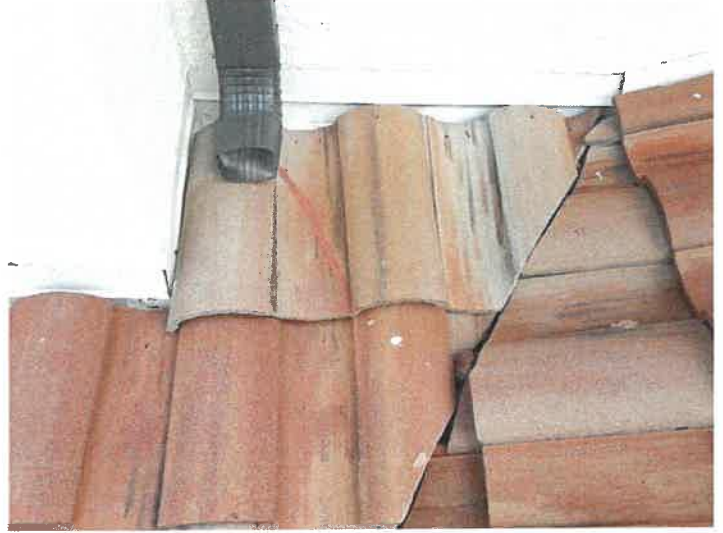
Building 15149: Repaired Cracked Roof Tiles

The cracked roof tiles were repaired with Titebond sealant.

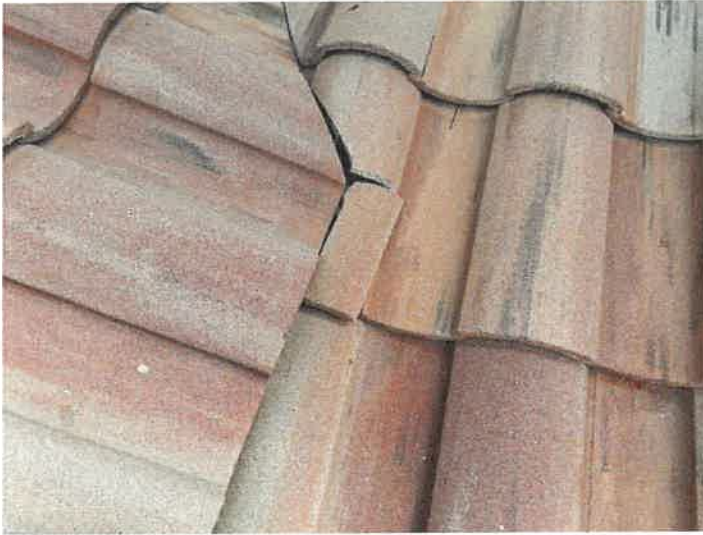
Building 15149: Identified Cracked Roof Tiles

Cracked roof tiles can allow premature underlayment deterioration from excessive UV exposure.

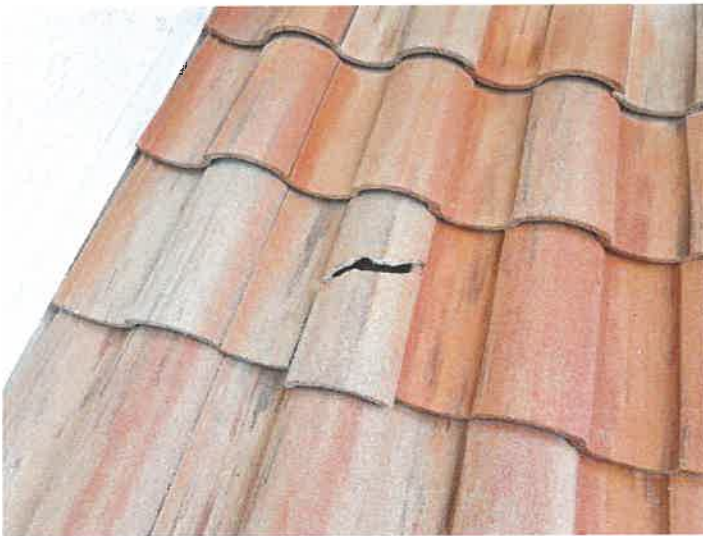
Building 15149: Identified Cracked Roof Tiles

Cracked roof tiles can allow premature underlayment deterioration from excessive UV exposure.

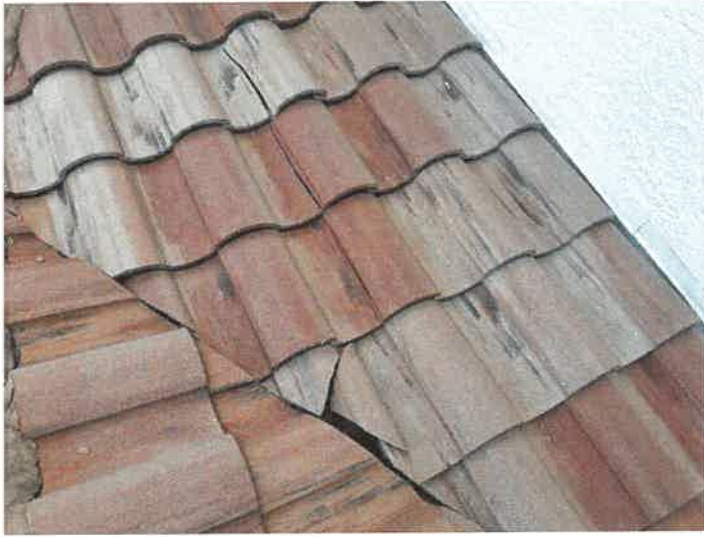
Building 15149: Identified Cracked Roof Tiles

Cracked roof tiles can allow premature underlayment deterioration from excessive UV exposure.

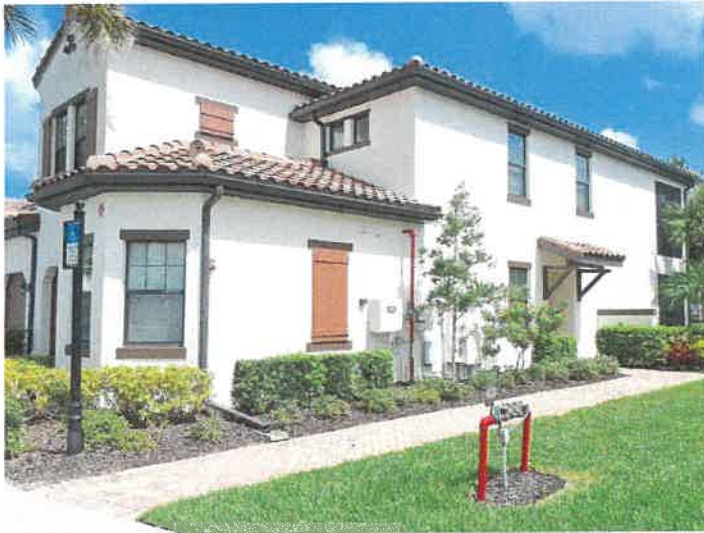
Building 15149: Downspouts

The downspouts appear to be in good condition.

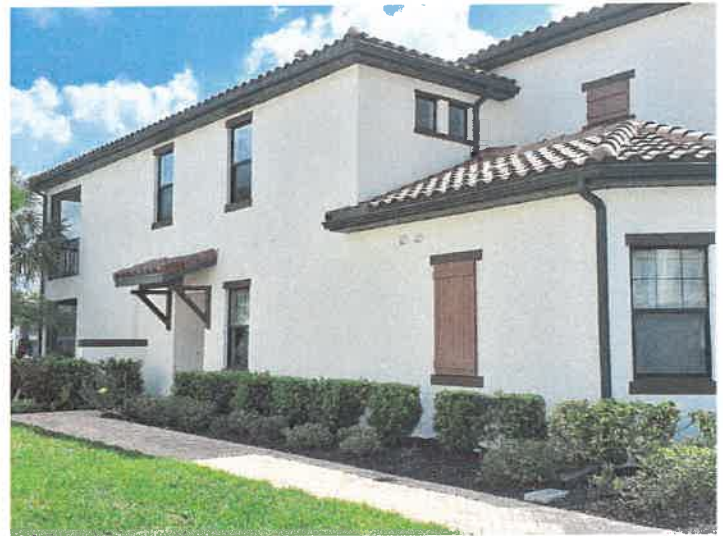
Building 15149: Downspouts

The downspouts appear to be in good condition.

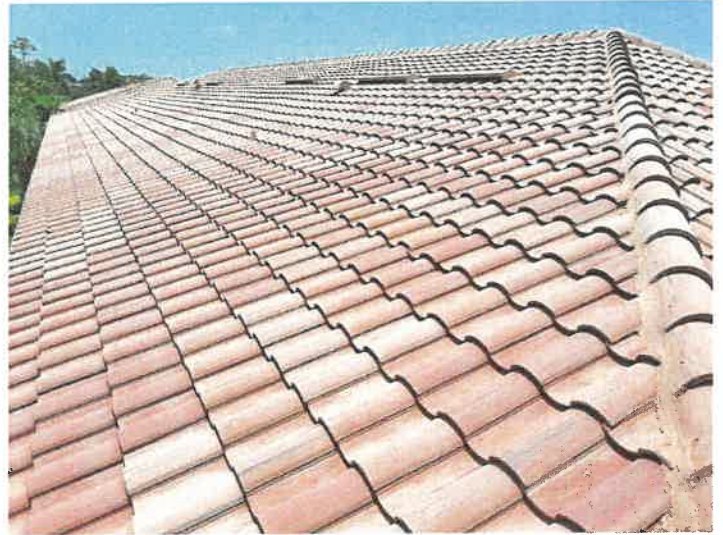
Building 15152: Surface Overview
The roof surface appears to be in good, maintainable condition at this time.

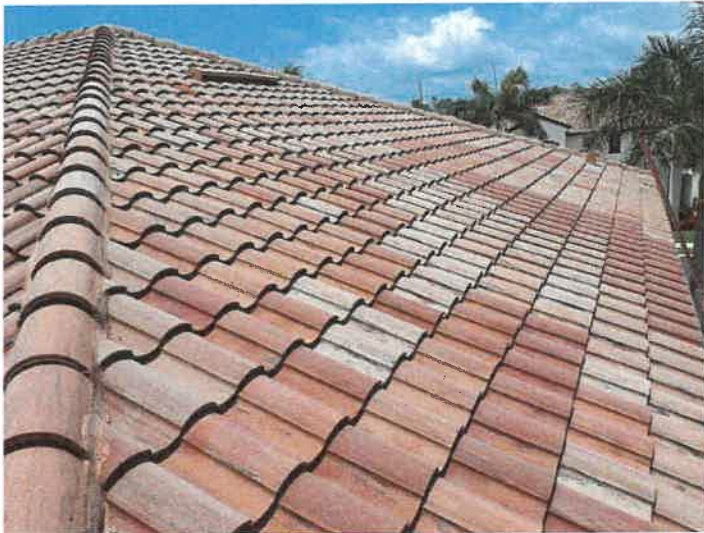
Building 15152: Appearance Overview
The roof appearance is in good, maintainable condition.

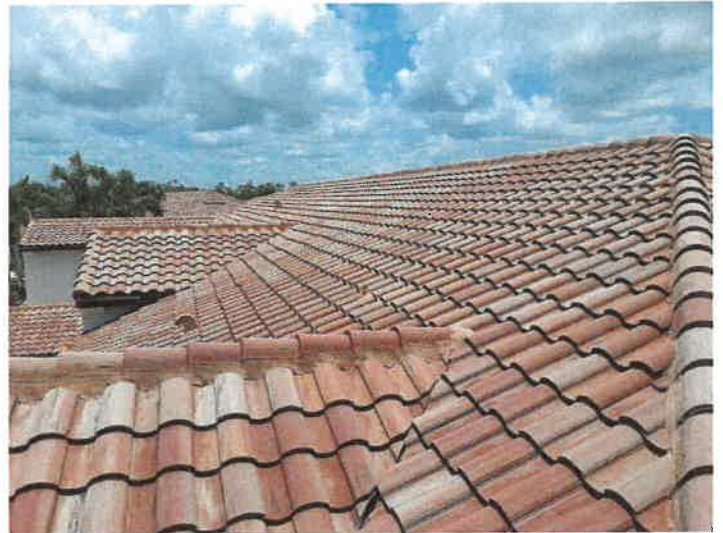
Building 15152: Field Tiles
Field tiles appear to be in good condition.

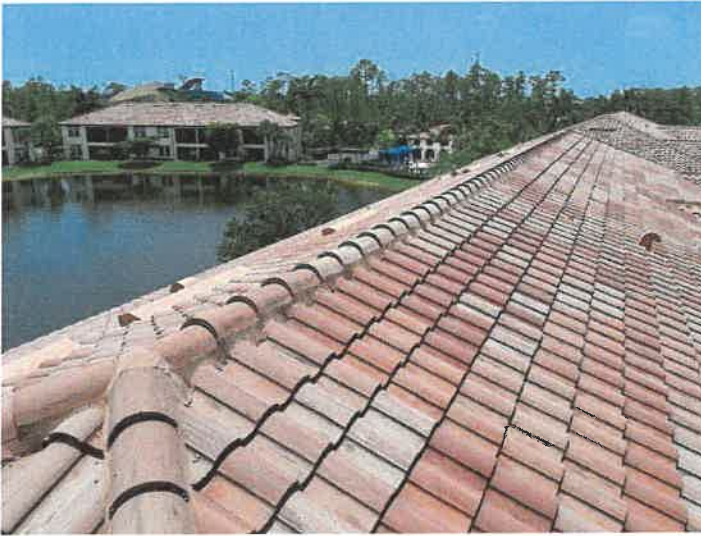
Building 15152: Ridge Tiles

Ridge tiles appear to be in good condition.

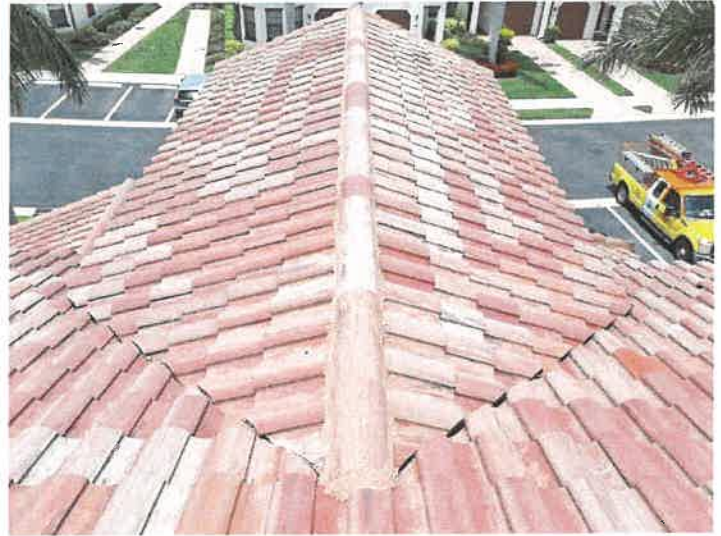
Building 15152: Valley

The valley tiles appear to be in good condition.

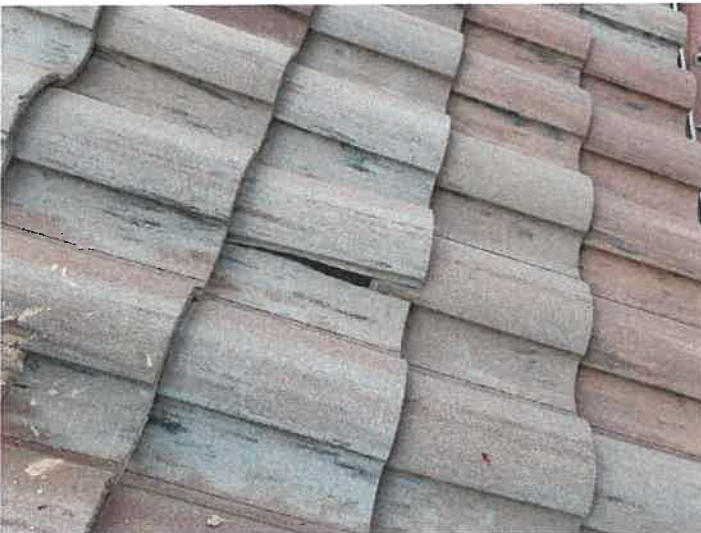
Building 15152: Identified Cracked Roof Tiles

Cracked roof tiles can allow premature underlayment deterioration from excessive UV exposure.

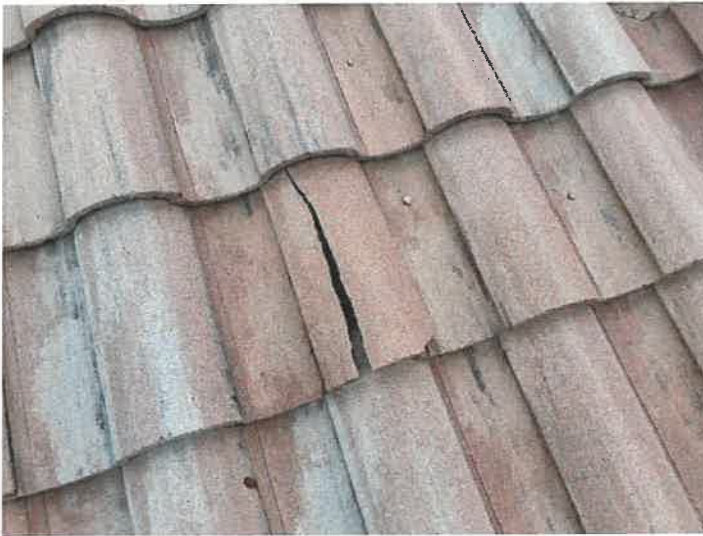
Building 15152: Identified Cracked Roof Tiles
Cracked roof tiles can allow premature underlayment deterioration from excessive UV exposure.

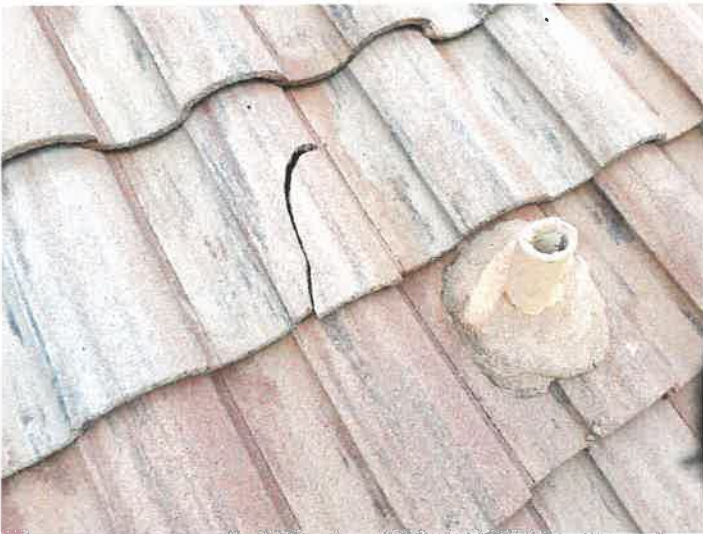
Building 15152: Identified Cracked Roof Tiles
Cracked roof tiles can allow premature underlayment deterioration from excessive UV exposure.

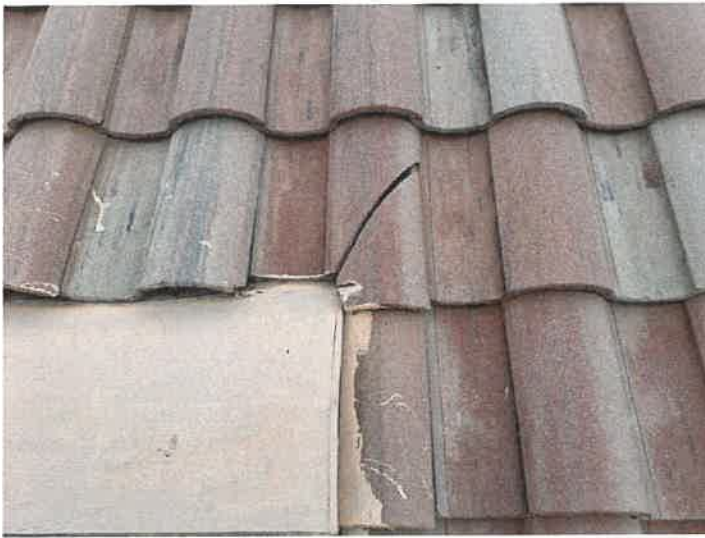
Building 15152: Identified Cracked Roof Tiles
Cracked roof tiles can allow premature underlayment deterioration from excessive UV exposure.

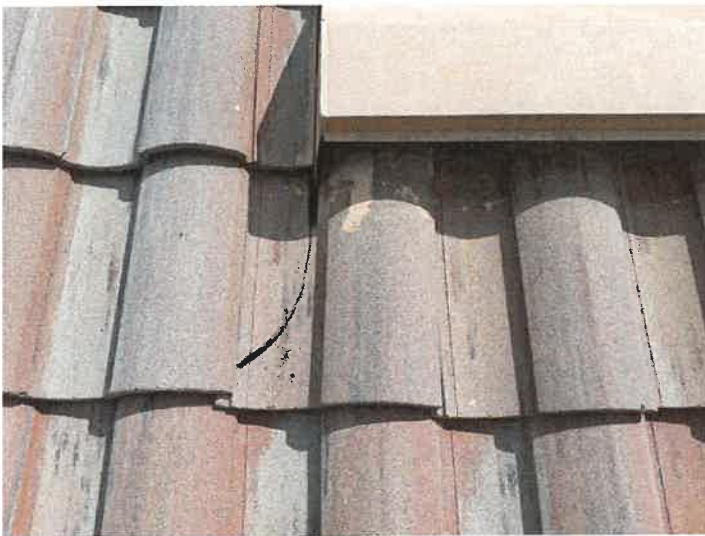
Building 15152: Identified Cracked Roof Tiles
Cracked roof tiles can allow premature underlayment deterioration from excessive UV exposure.

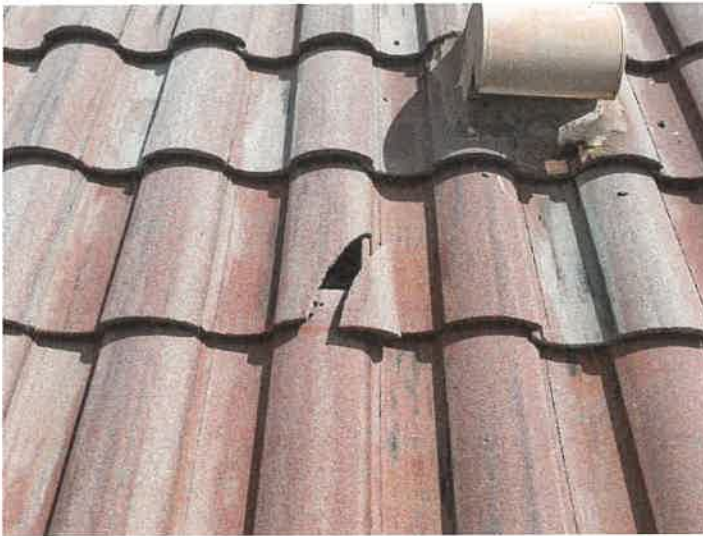
Building 15152: Identified Cracked Roof Tiles

Cracked roof tiles can allow premature underlayment deterioration from excessive UV exposure.

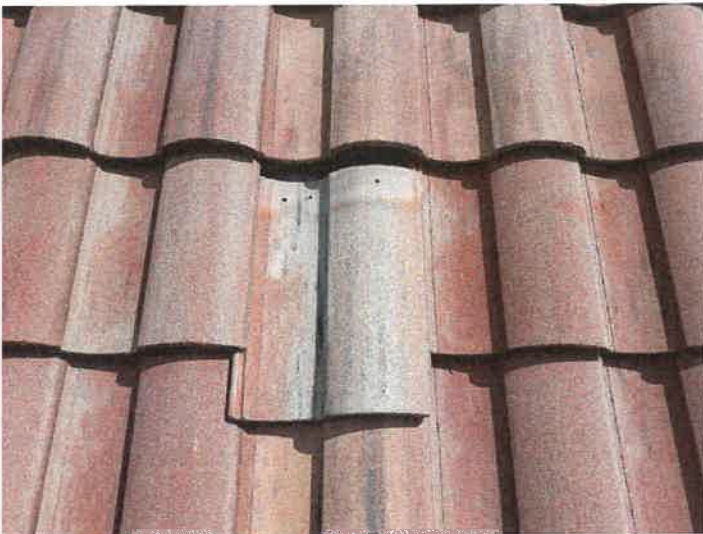
Building 15152: Displaced/Missing Roof Tile

Displaced or missing roof tiles can allow premature underlayment deterioration from excessive UV exposure and potential water intrusion.

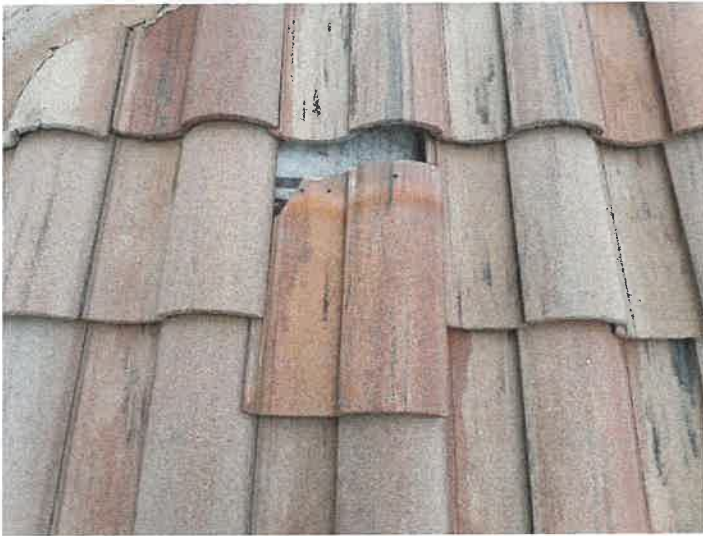
Building 15152: Displaced/Missing Roof Tile

Displaced or missing roof tiles can allow premature underlayment deterioration from excessive UV exposure and potential water intrusion.
