Inspection Report

Facility: Livingston Lakes Condo
Address: 15098 Palmer Lake Circle,
Naples, FL 34109
Customer: Cardinal Management
Address: c/o Livingston Lakes Condo, 15090
Naples, FL 34109

Livingston Lakes Condo, Naples, FL

Re.: **Inspection Report (2 of 3) for Livingston Lakes**

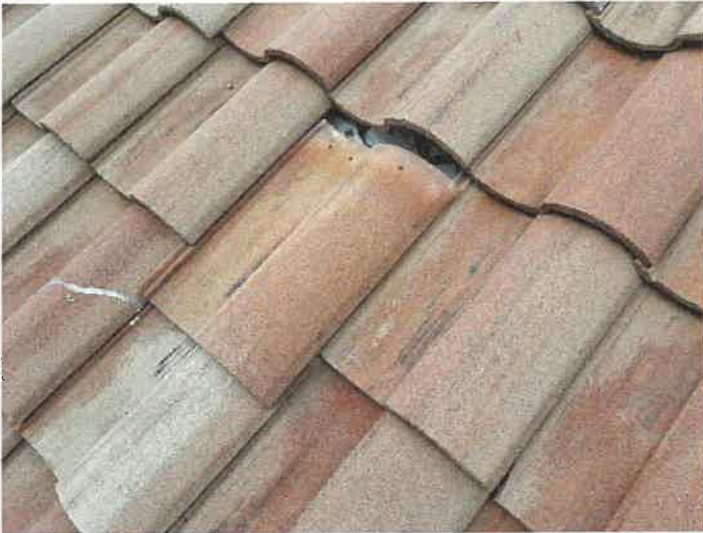
Building 15152: Displaced/Missing Roof Tile

Displaced or missing roof tiles can allow premature underlayment deterioration from excessive UV exposure and potential water intrusion.

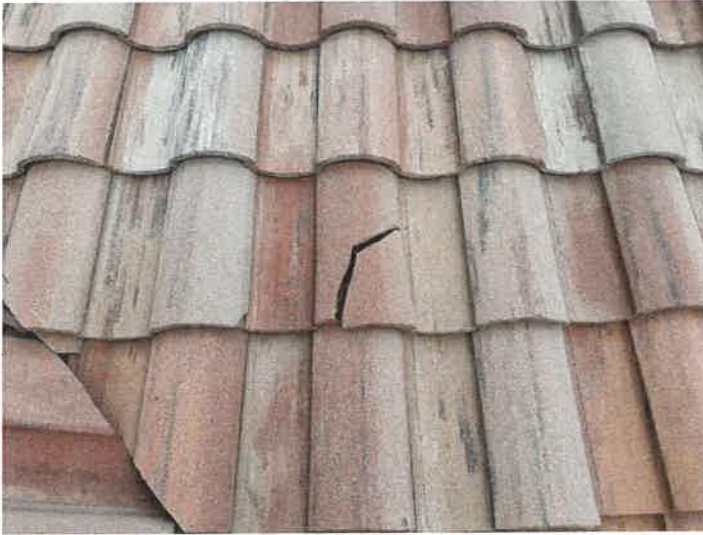
Building 15152: Identified Cracked Roof Tiles

Cracked roof tiles can allow premature underlayment deterioration from excessive UV exposure.

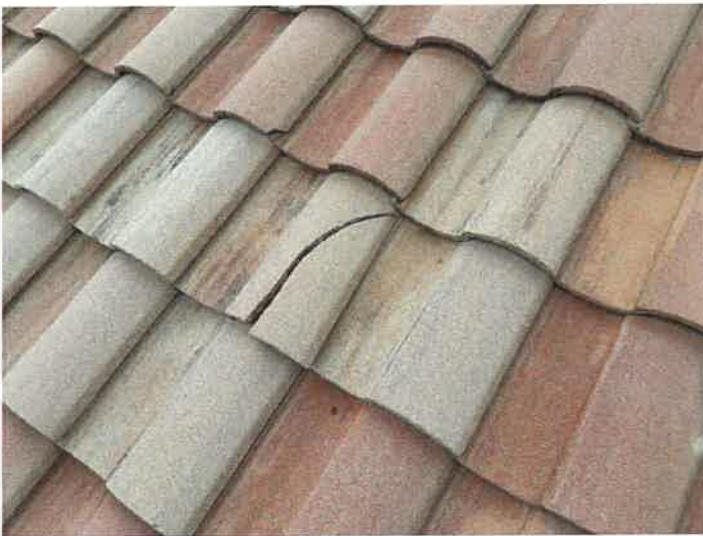
Building 15152: Identified Cracked Roof Tiles

Cracked roof tiles can allow premature underlayment deterioration from excessive UV exposure.

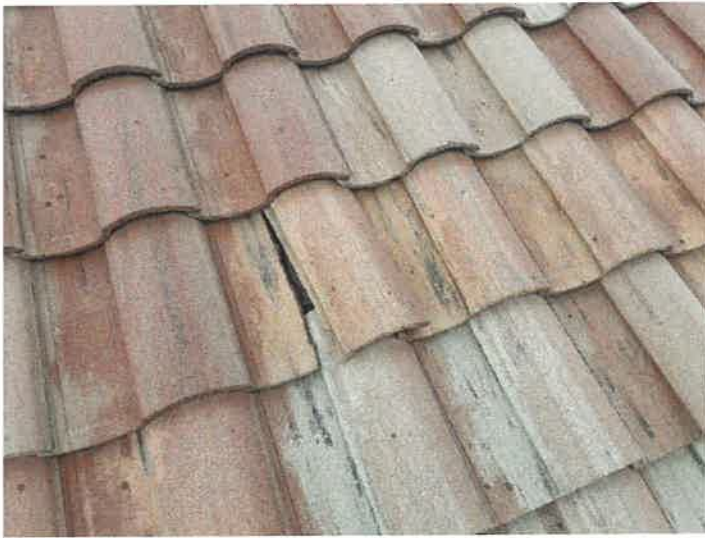
Building 15152: Identified Cracked Roof Tiles
Cracked roof tiles can allow premature underlayment deterioration from excessive UV exposure.

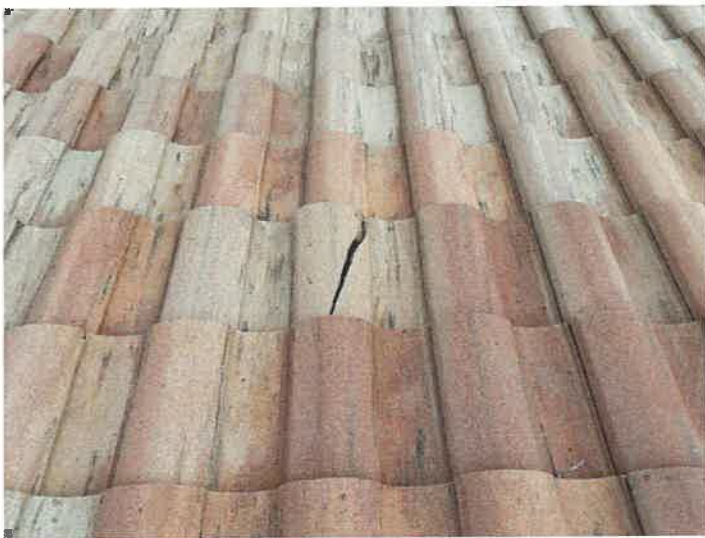
Building 15152: Identified Cracked Roof Tiles
Cracked roof tiles can allow premature underlayment deterioration from excessive UV exposure.

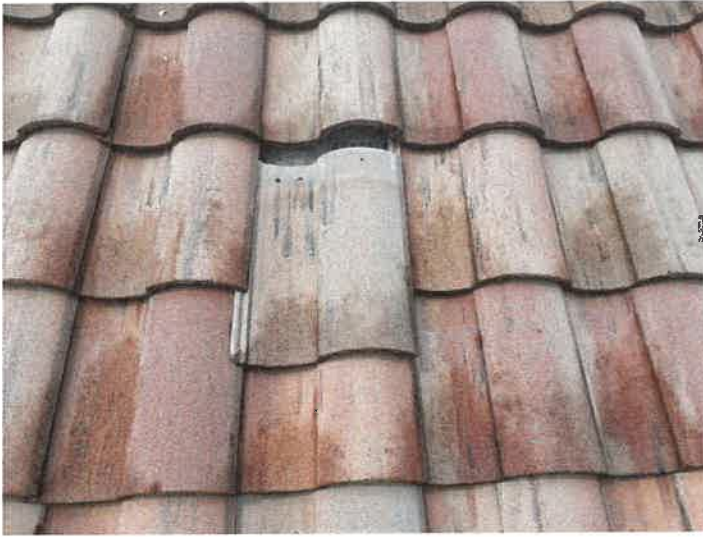
Building 15152: Displaced/Missing Roof Tile

Displaced or missing roof tiles can allow premature underlayment deterioration from excessive UV exposure and potential water intrusion.

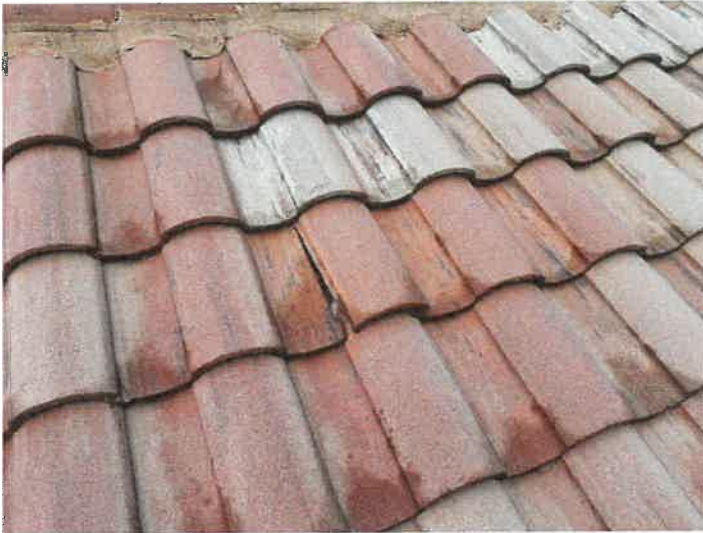
Building 15152: Identified Cracked Roof Tiles

Cracked roof tiles can allow premature underlayment deterioration from excessive UV exposure.

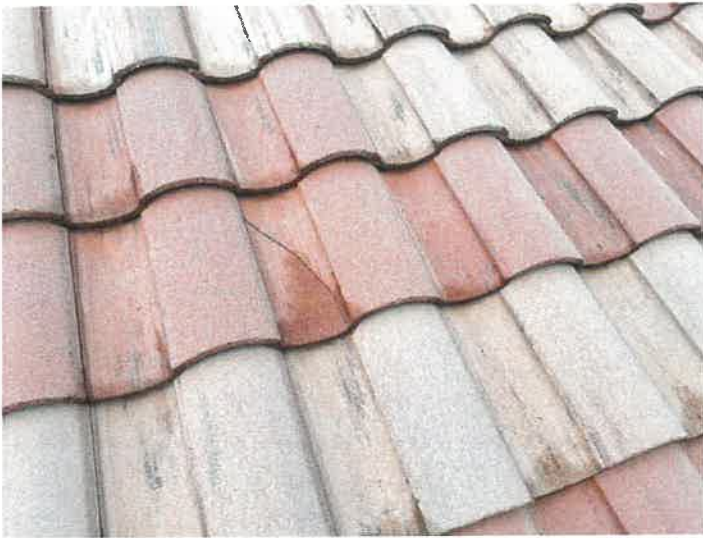
Building 15152: Identified Cracked Roof Tiles

Cracked roof tiles can allow premature underlayment deterioration from excessive UV exposure.

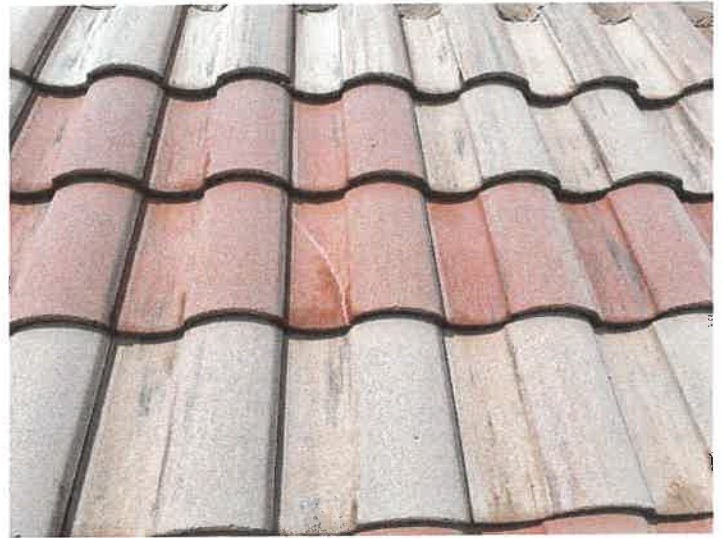
Building 15152: Repaired Cracked Roof Tiles

The cracked roof tiles were repaired with Titebond sealant.

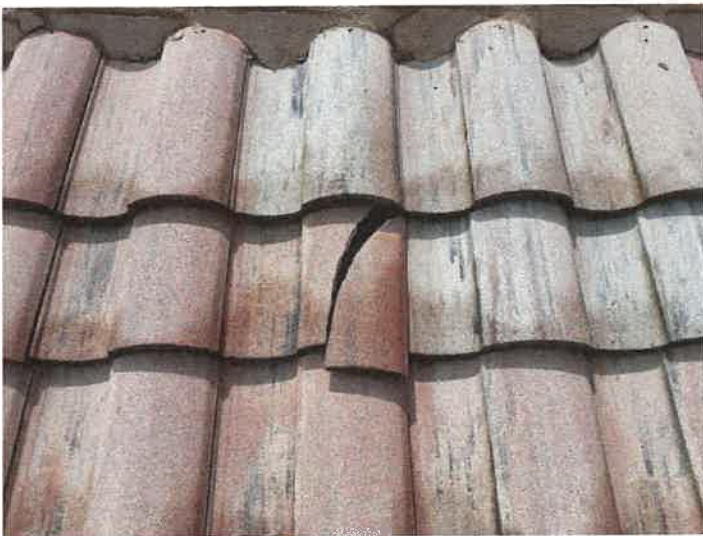
Building 15152: Identified Cracked Roof Tiles

Cracked roof tiles can allow premature underlayment deterioration from excessive UV exposure.

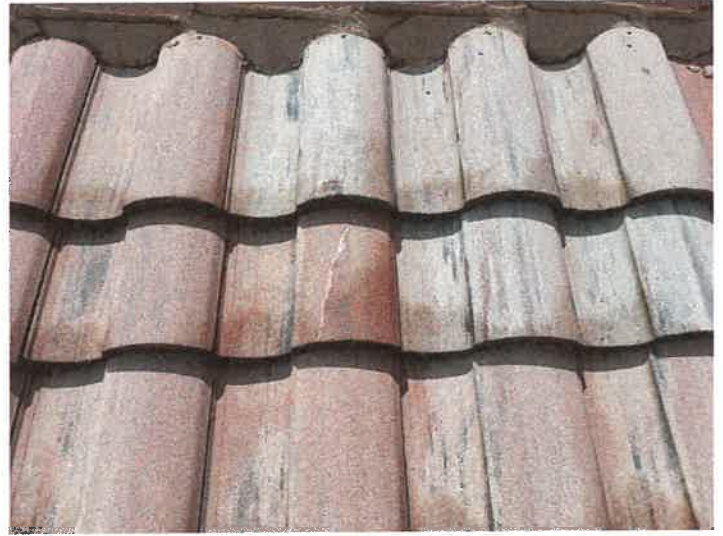
Building 15152: Repaired Cracked Roof Tiles

The cracked roof tiles were repaired with Titebond sealant.

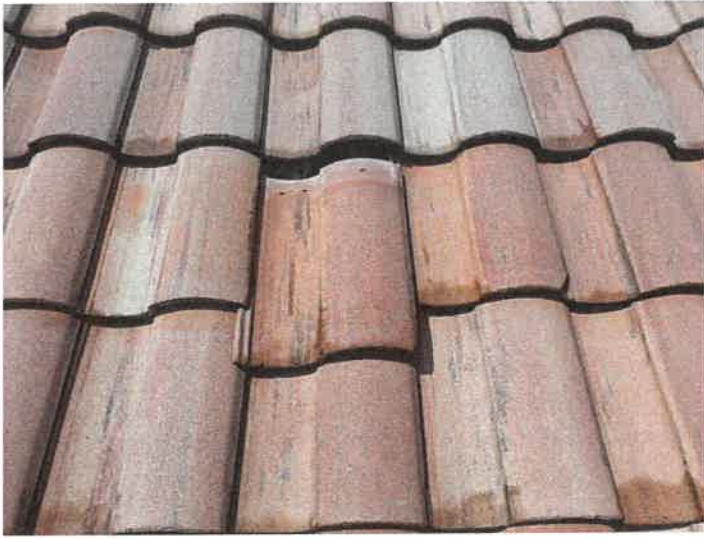
Building 15152: Displaced/Missing Roof Tile

Displaced or missing roof tiles can allow premature underlayment deterioration from excessive UV exposure and potential water intrusion.

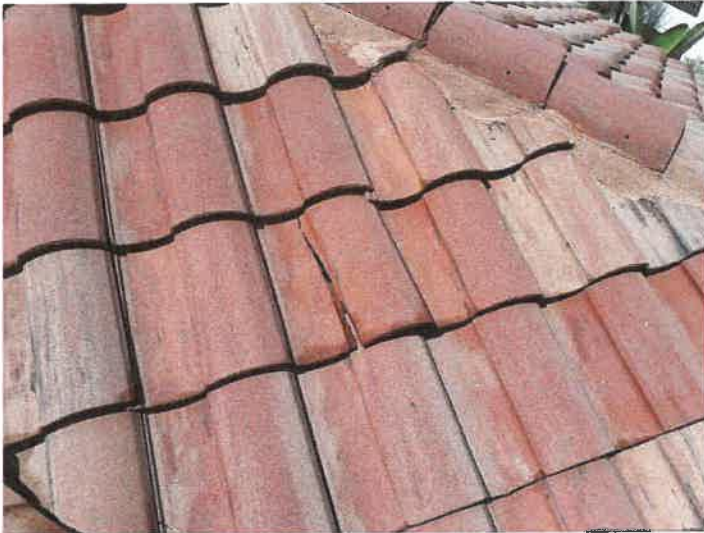
Building 15152: Identified Cracked Roof Tiles

Cracked roof tiles can allow premature underlayment deterioration from excessive UV exposure.

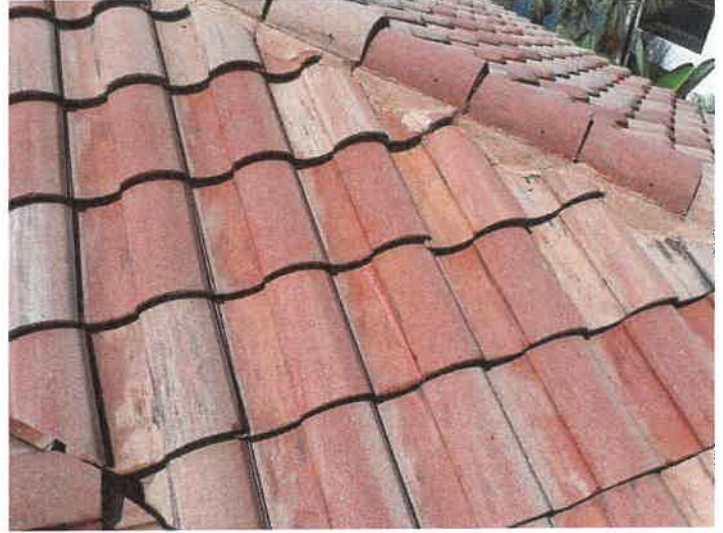
Building 15152: Repaired Cracked Roof Tiles

The cracked roof tiles were repaired with Titebond sealant.

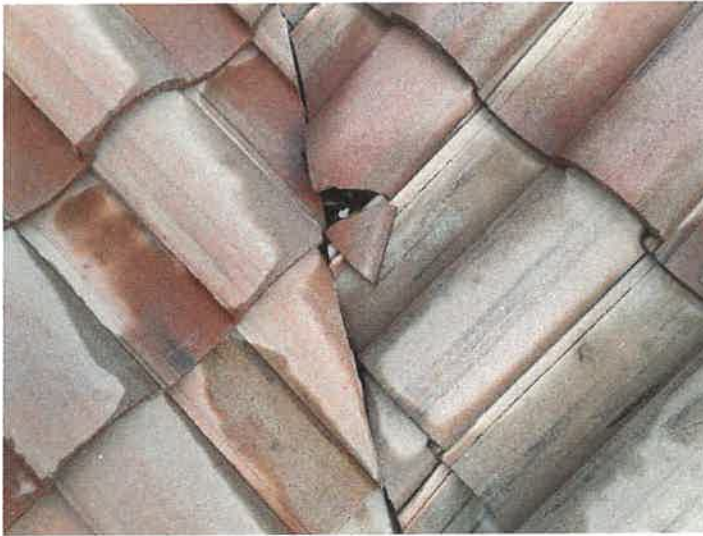
Building 15152: Identified Cracked Roof Tiles

Cracked roof tiles can allow premature underlayment deterioration from excessive UV exposure.

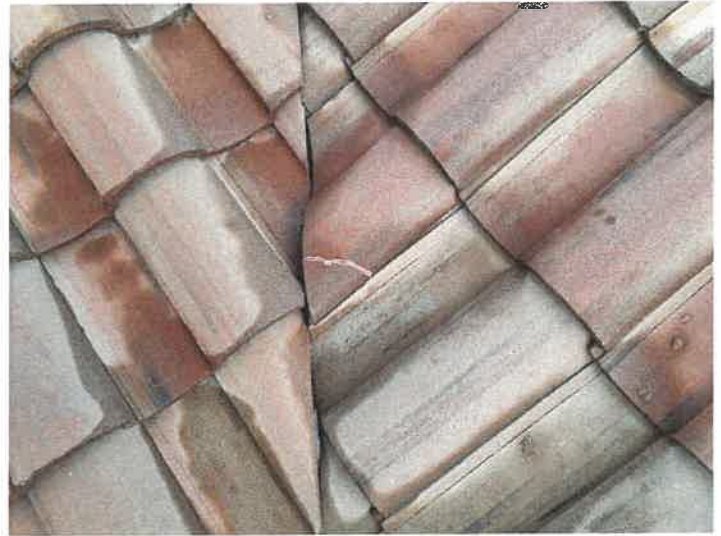
Building 15152: Repaired Cracked Roof Tiles

The cracked roof tiles were repaired with Titebond sealant.

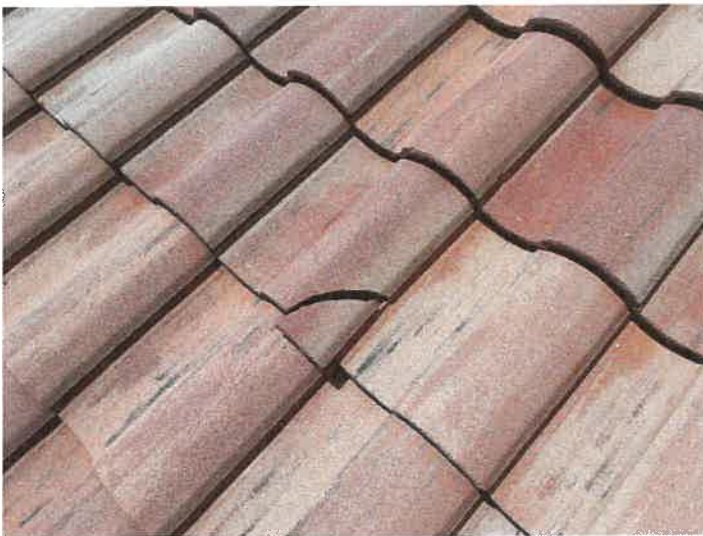
Building 15152: Identified Cracked Roof Tiles

Cracked roof tiles can allow premature underlayment deterioration from excessive UV exposure.

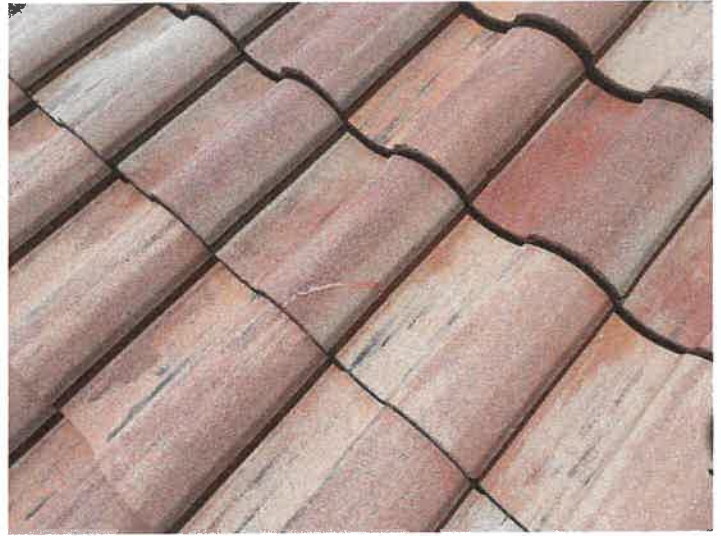
Building 15152: Repaired Cracked Roof Tiles

The cracked roof tiles were repaired with Titebond sealant.

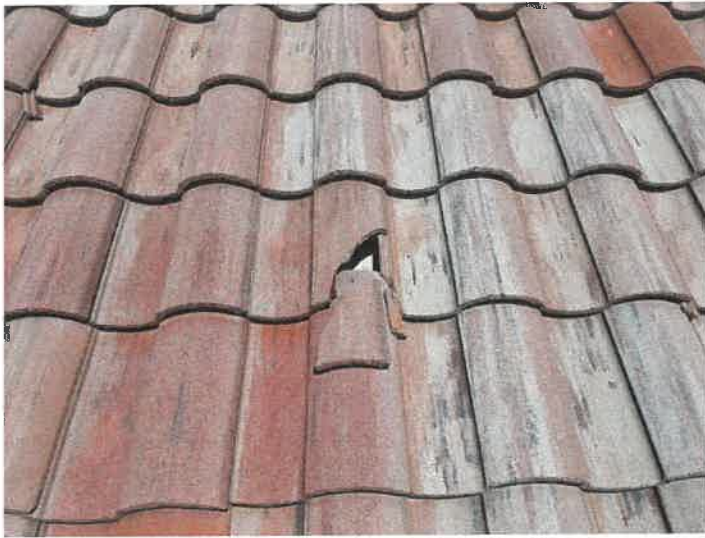
Building 15152: Identified Cracked Roof Tiles
Cracked roof tiles can allow premature underlayment deterioration from excessive UV exposure.

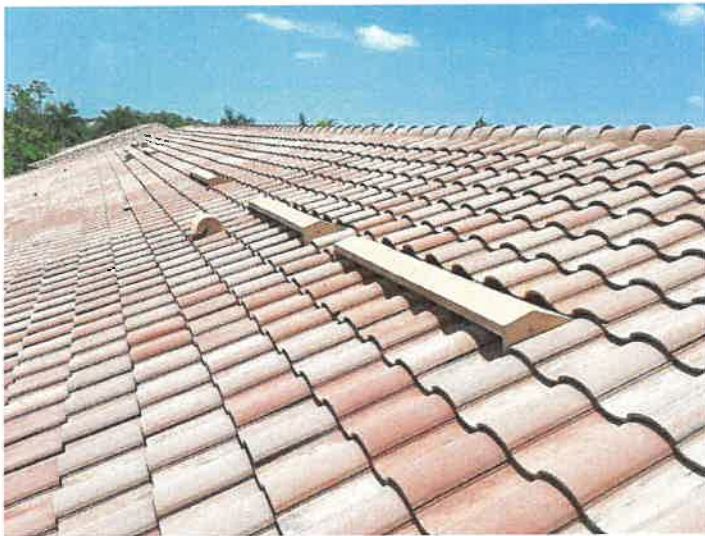
Building 15152: Roof Vents
Roof vents appear to be in good condition.

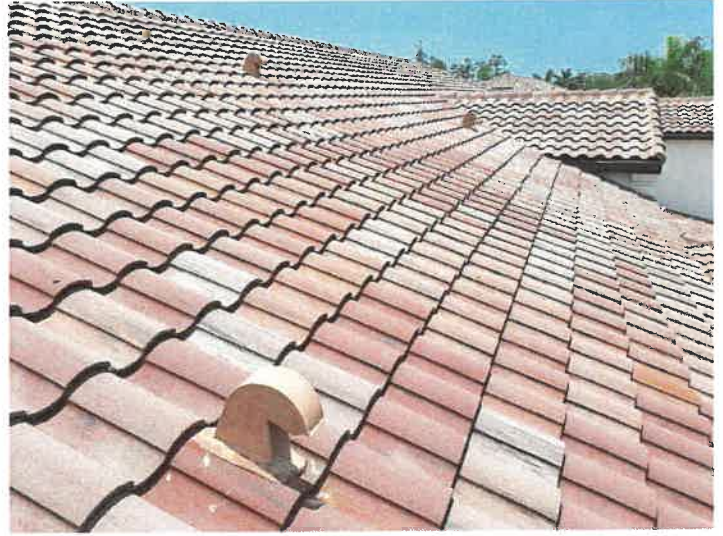
Building 15152: Roof Vents
Roof vents appear to be in good condition.

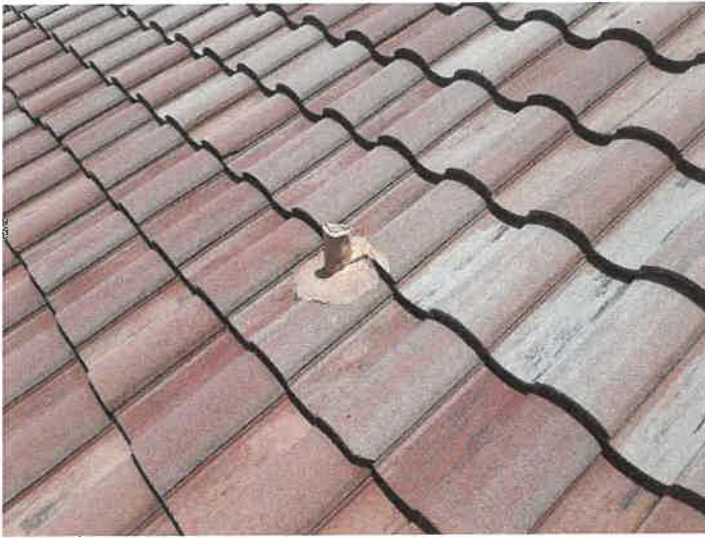
Building 15152: Lead Boots
Lead boots appear to be in good condition.

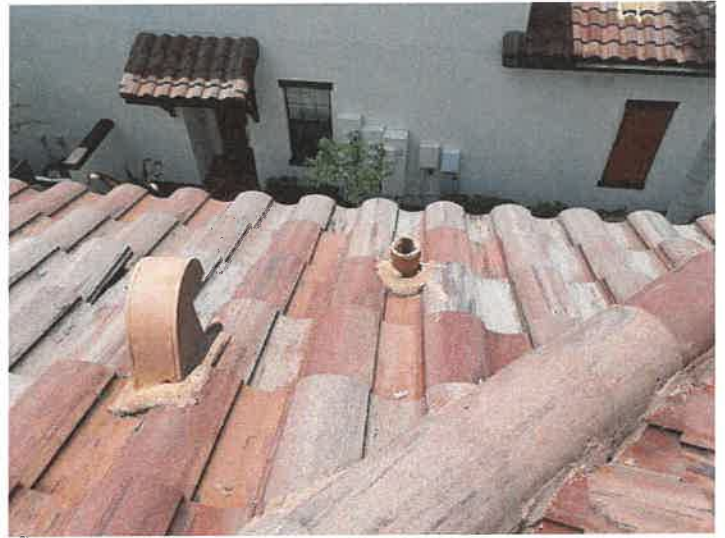
Building 15152: Lead Boots
Lead boots appear to be in good condition.

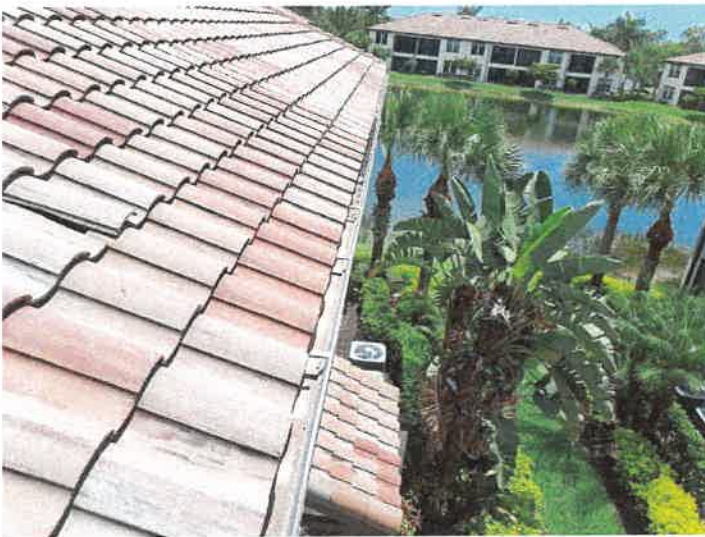
Building 15152: Gutters
The gutters appear to be in good condition.

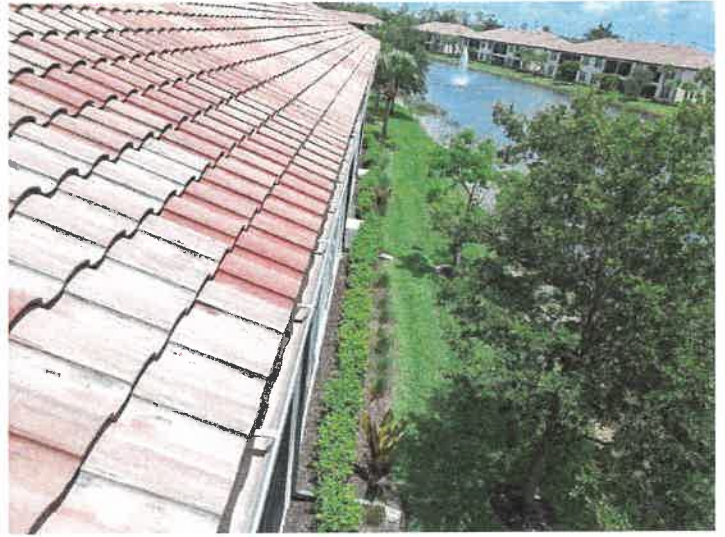
Building 15152: Gutters
The gutters appear to be in good condition.

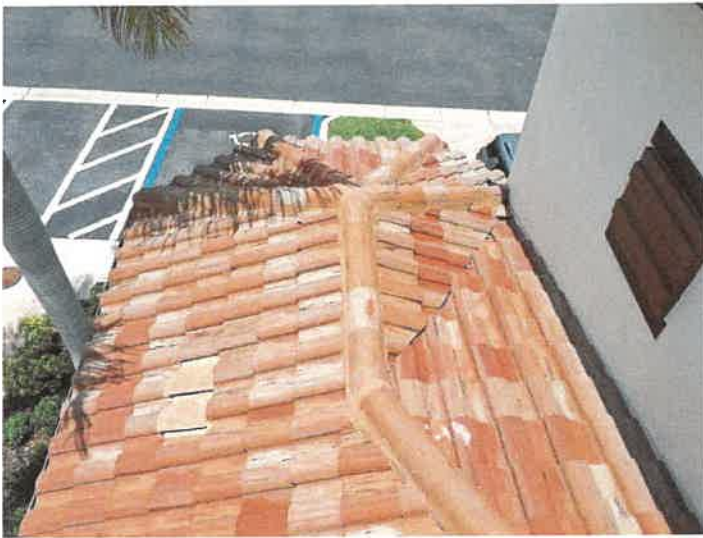
Building 15152: Surface Overview - Lower Roof

The roof surface appears to be in good, maintainable condition at this time.

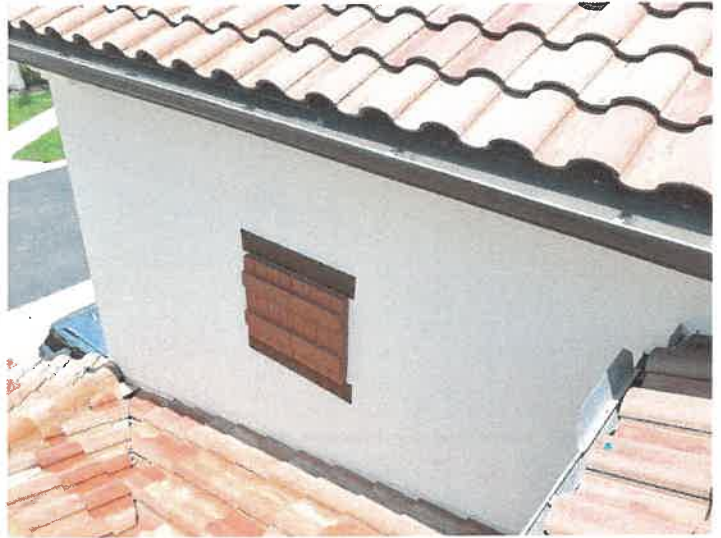
Building 15152: Wall

The walls appear to be in good condition.

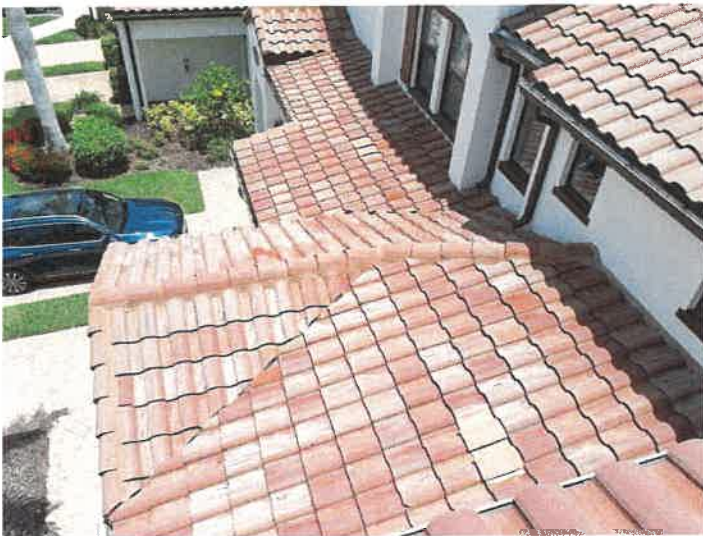
Building 15152: Surface Overview - Lower Roof

The roof surface appears to be in good, maintainable condition at this time.

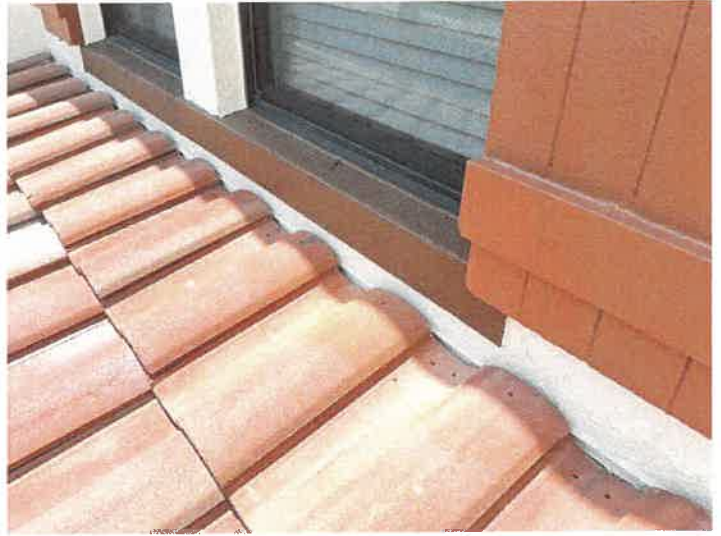
Building 15152: Counter Flashings

The counter flashing appears to be in good condition.

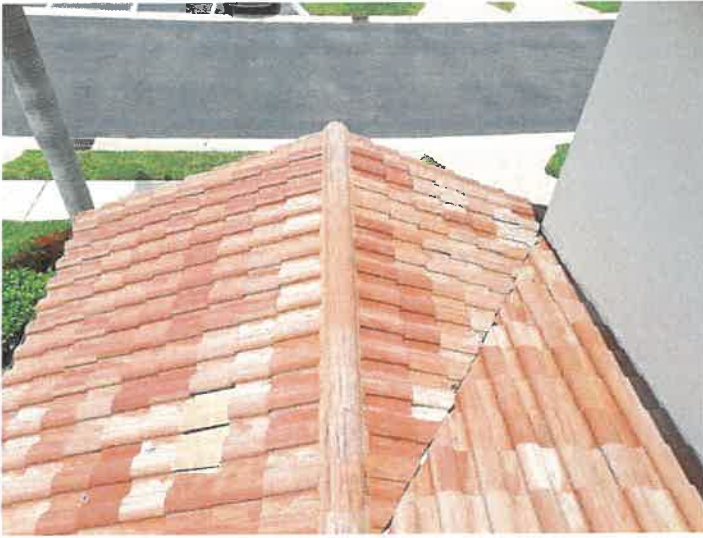
Building 15152: Appearance Overview - Lower Roof
The roof appearance is in good, maintainable condition.

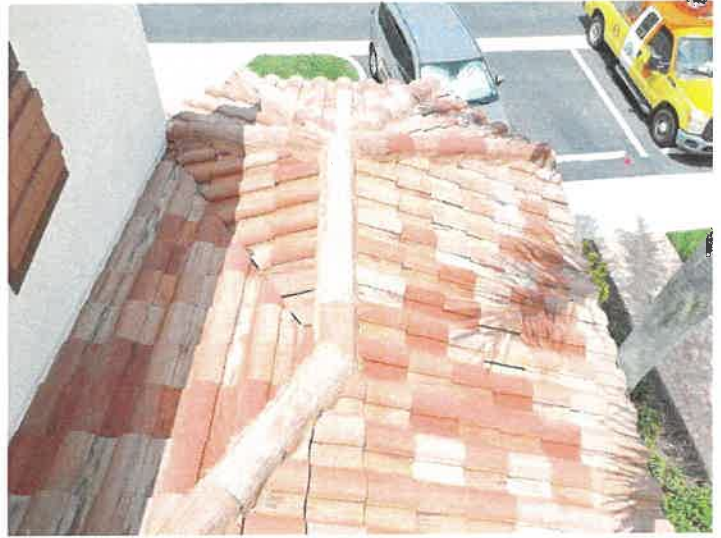
Building 15152: Surface Overview - Lower Roof
The roof surface appears to be in good, maintainable condition at this time.

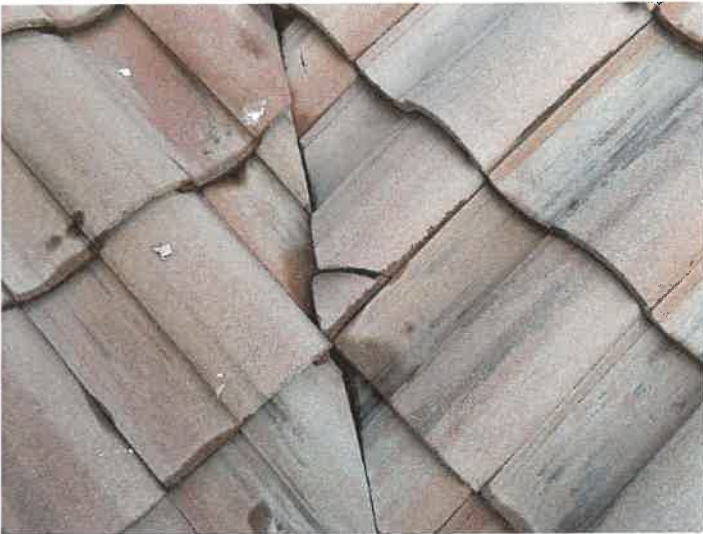
Building 15152: Identified Cracked Roof Tiles
Cracked roof tiles can allow premature underlayment deterioration from excessive UV exposure.

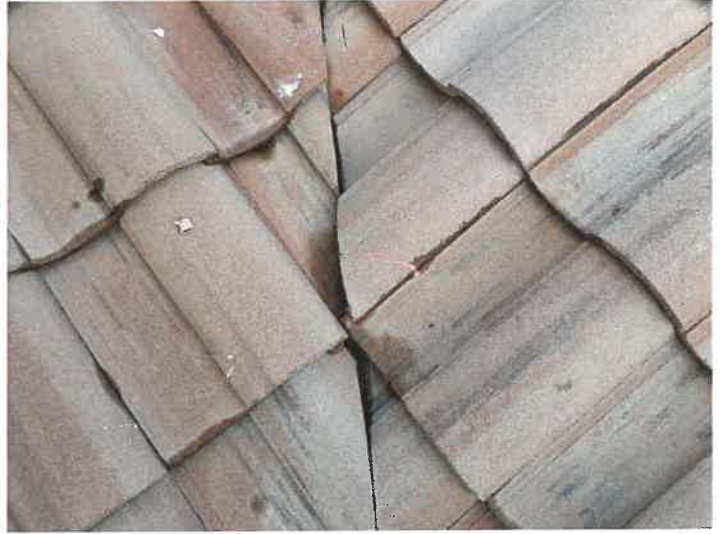
Building 15152: Repaired Cracked Roof Tiles
The cracked roof tiles were repaired with Titebond sealant.

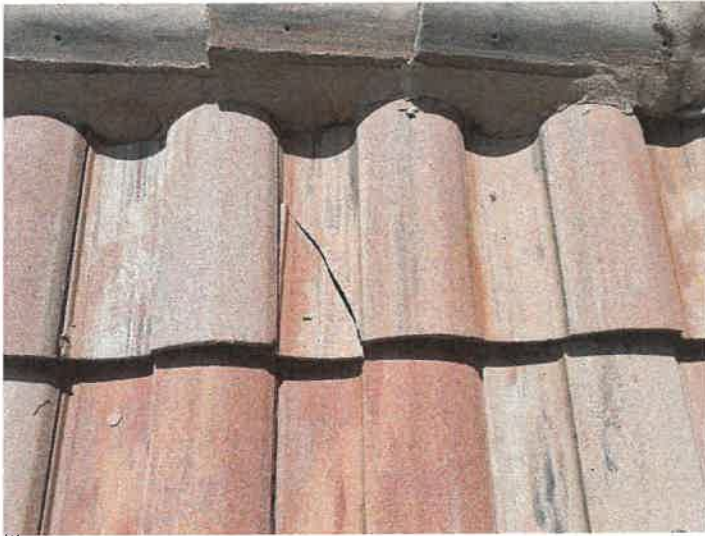
Building 15152: Identified Cracked Roof Tiles

Cracked roof tiles can allow premature underlayment deterioration from excessive UV exposure.

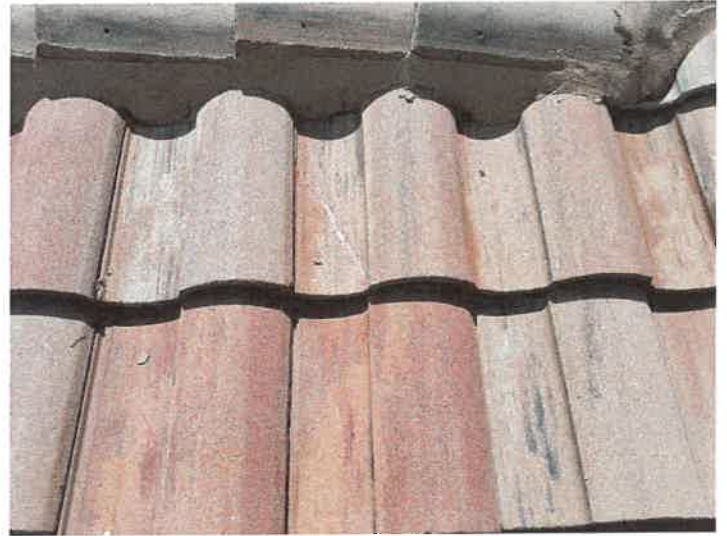
Building 15152: Repaired Cracked Roof Tiles

The cracked roof tiles were repaired with Titebond sealant.

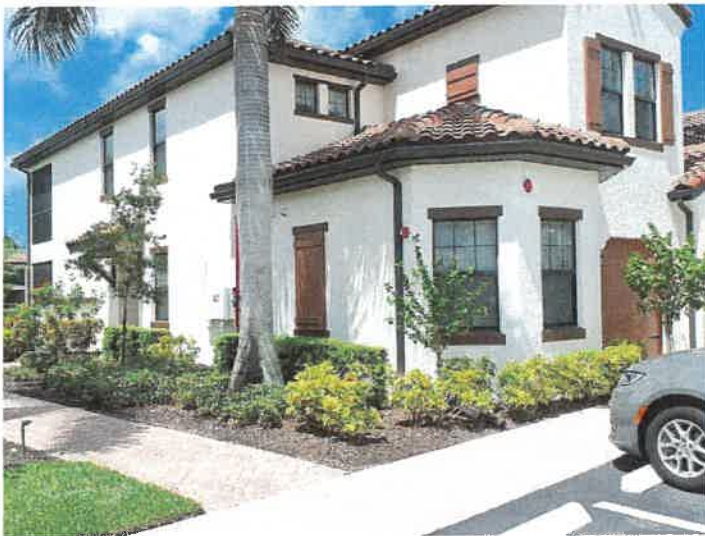
Building 15152: Downspouts

The downspouts appear to be in good condition.

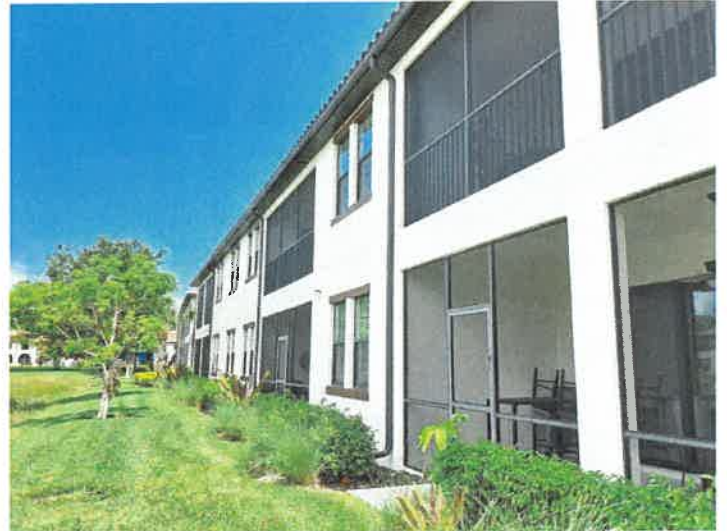
Building 15152: Downspouts

The downspouts appear to be in good condition.

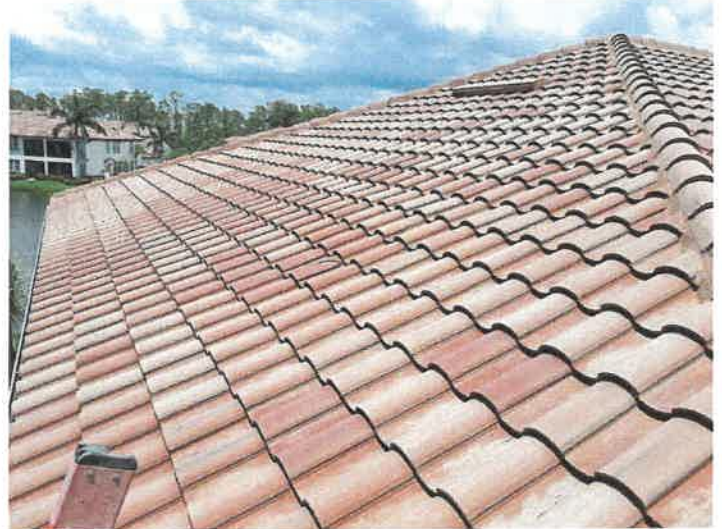
Building 15153: Surface Overview
The roof surface appears to be in good, maintainable condition at this time.

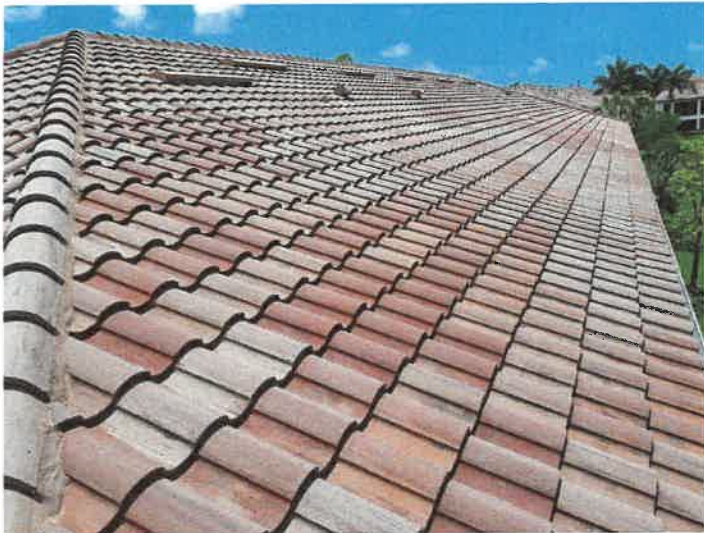
Building 15153: Appearance Overview
The roof appearance is in good, maintainable condition.

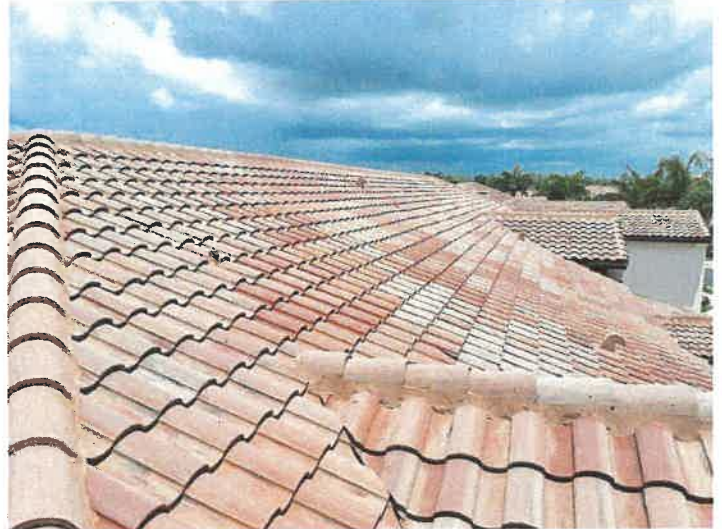
Building 15153: Surface Overview
The roof surface appears to be in good, maintainable condition at this time.

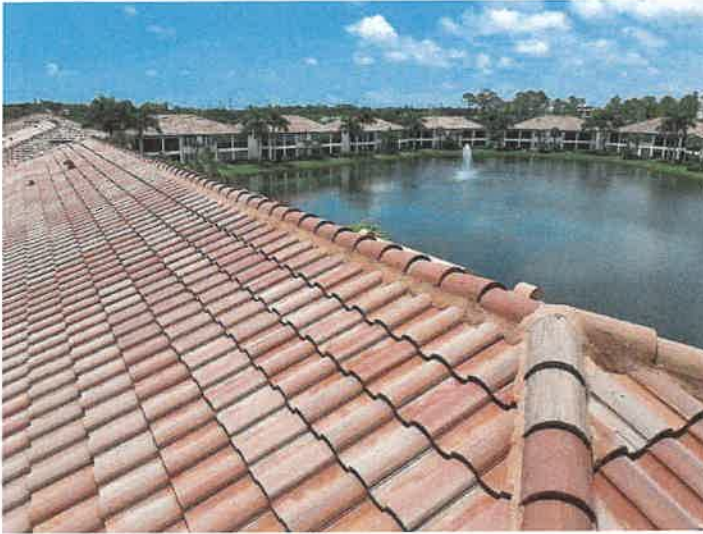
Building 15153: Ridge Tiles
Ridge tiles appear to be in good condition.

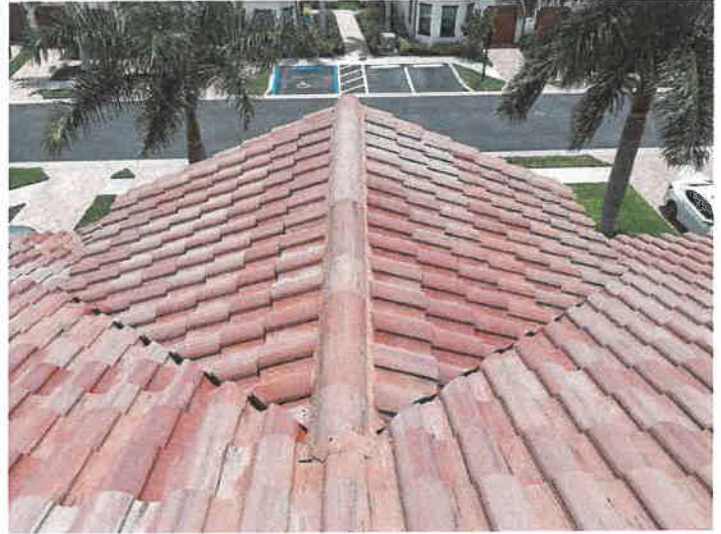
Building 15153: Valley
The valley tiles appear to be in good condition.

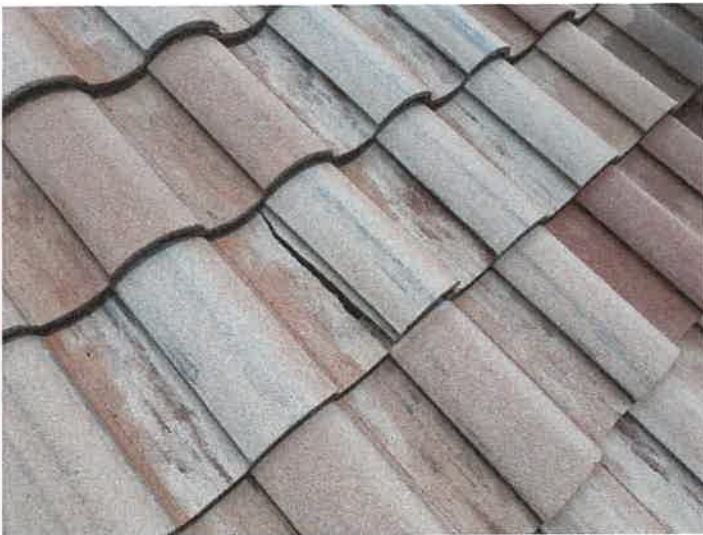
Building 15153: Identified Cracked Roof Tiles
Cracked roof tiles can allow premature underlayment deterioration from excessive UV exposure.

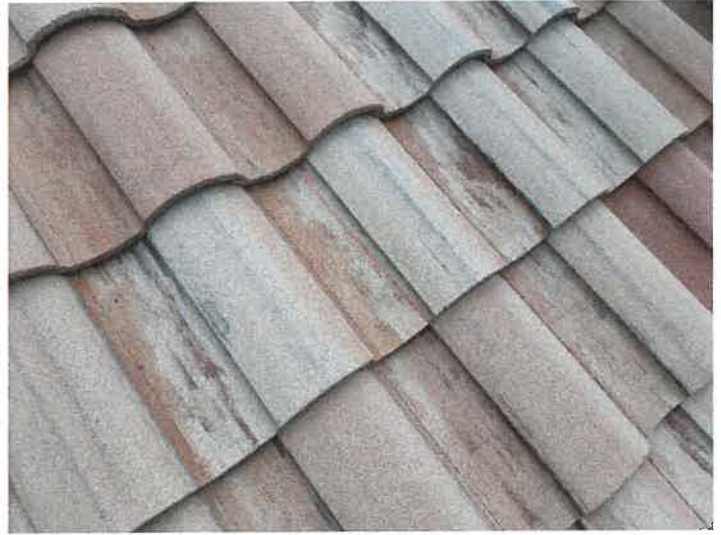
Building 15153: Repaired Cracked Roof Tiles
The cracked roof tiles were repaired with Titebond sealant.

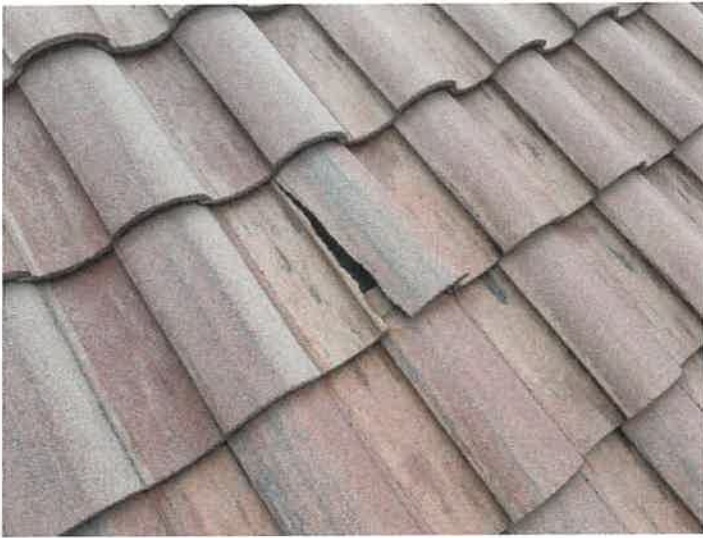
Building 15153: Identified Cracked Roof Tiles

Cracked roof tiles can allow premature underlayment deterioration from excessive UV exposure.

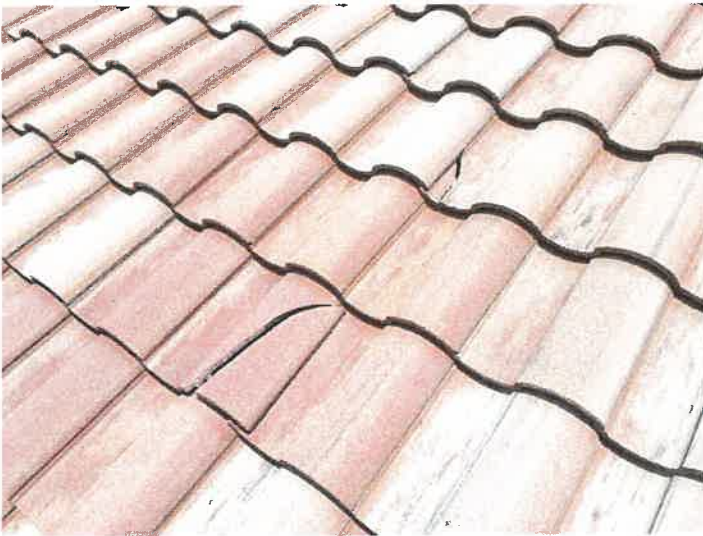
Building 15153: Identified Cracked Roof Tiles

Cracked roof tiles can allow premature underlayment deterioration from excessive UV exposure.

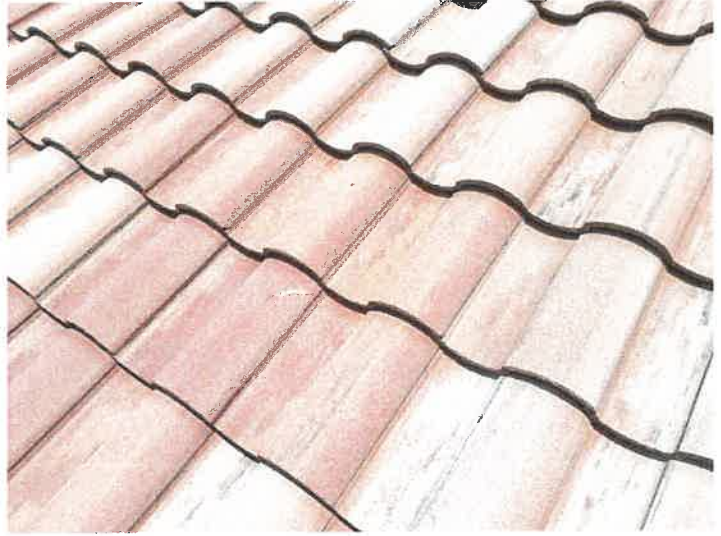
Building 15153: Repaired Cracked Roof Tiles

The cracked roof tiles were repaired with Titebond sealant.

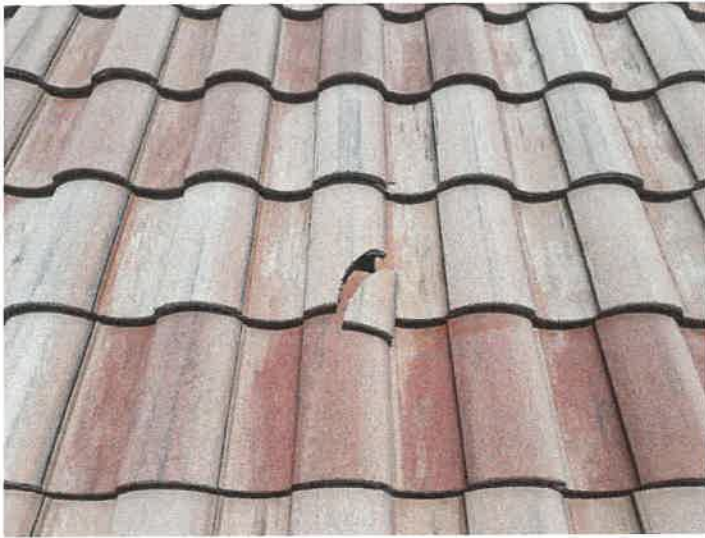
Building 15153: Identified Cracked Roof Tiles

Cracked roof tiles can allow premature underlayment deterioration from excessive UV exposure.

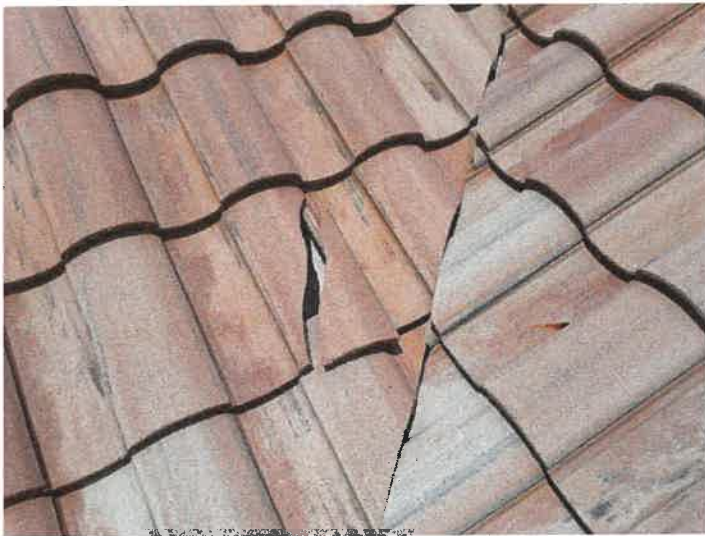
Building 15153: Identified Cracked Roof Tiles

Cracked roof tiles can allow premature underlayment deterioration from excessive UV exposure.

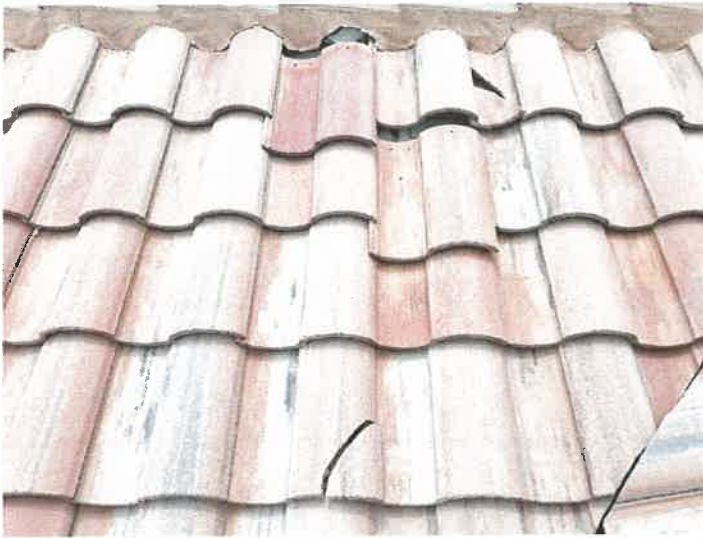
Identified Cracked Roof Tiles

Cracked roof tiles can allow premature underlayment deterioration from excessive UV exposure.

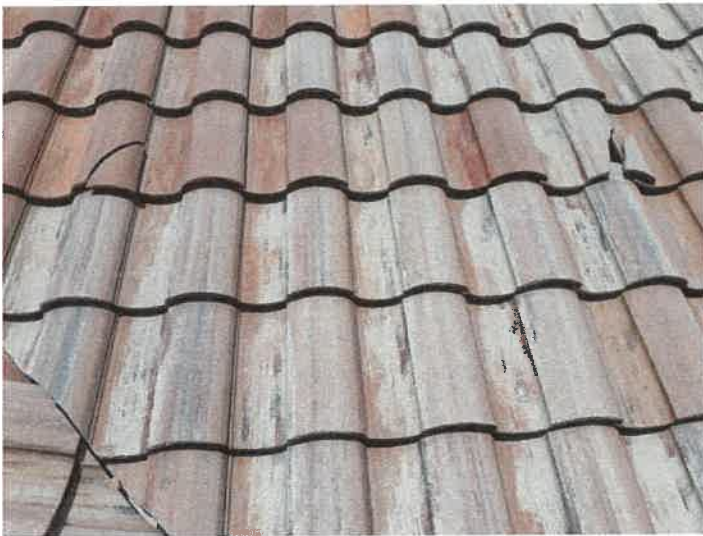
Building 15153: Identified Cracked Roof Tiles

Cracked roof tiles can allow premature underlayment deterioration from excessive UV exposure.

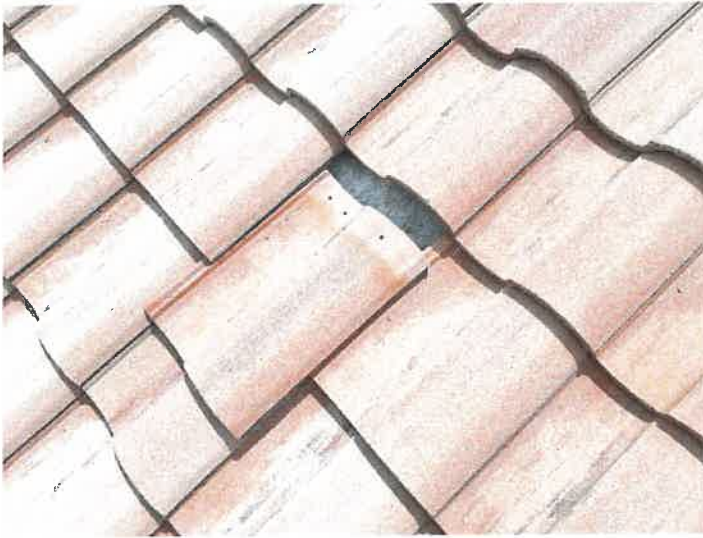
Building 15153: Displaced/Missing Roof Tile

Displaced or missing roof tiles can allow premature underlayment deterioration from excessive UV exposure and potential water intrusion.

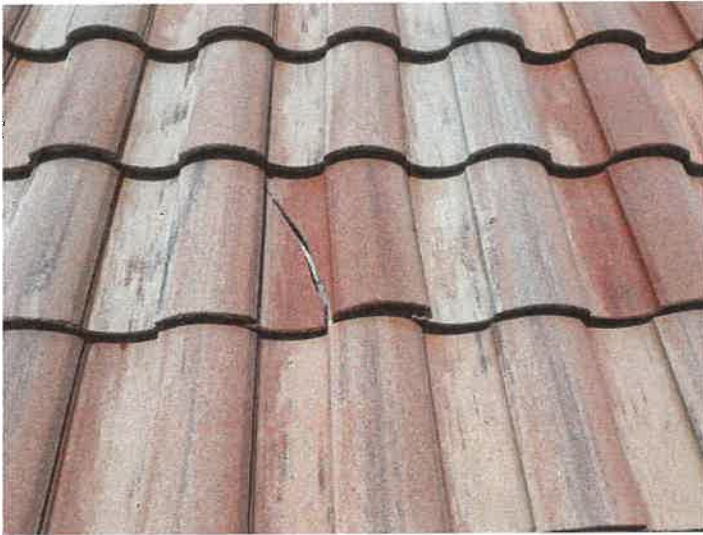
Building 15153: Identified Cracked Roof Tiles

Cracked roof tiles can allow premature underlayment deterioration from excessive UV exposure.

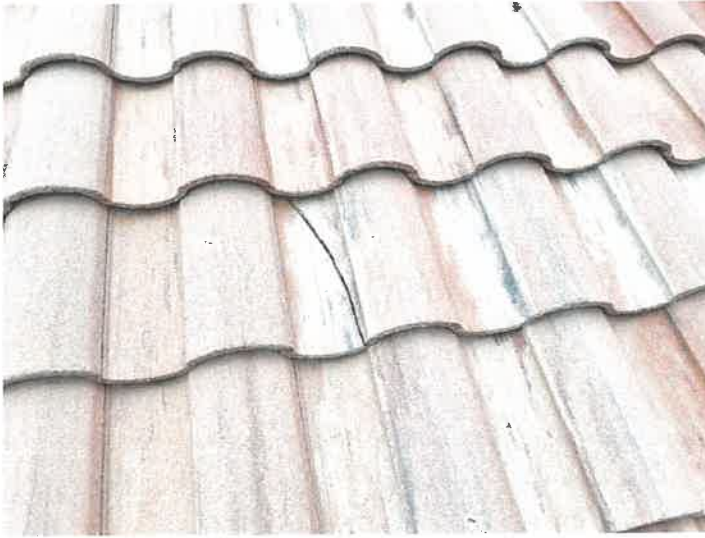
Building 15153: Identified Cracked Roof Tiles

Cracked roof tiles can allow premature underlayment deterioration from excessive UV exposure.

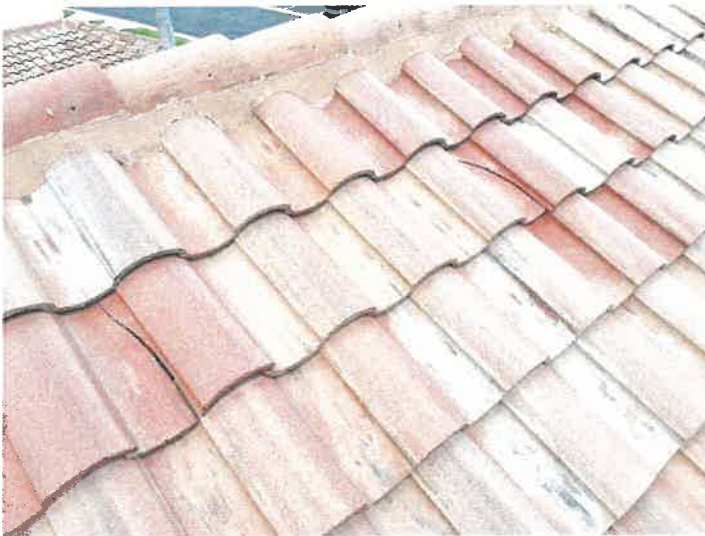
Building 15153: Identified Cracked Roof Tiles

Cracked roof tiles can allow premature underlayment deterioration from excessive UV exposure.

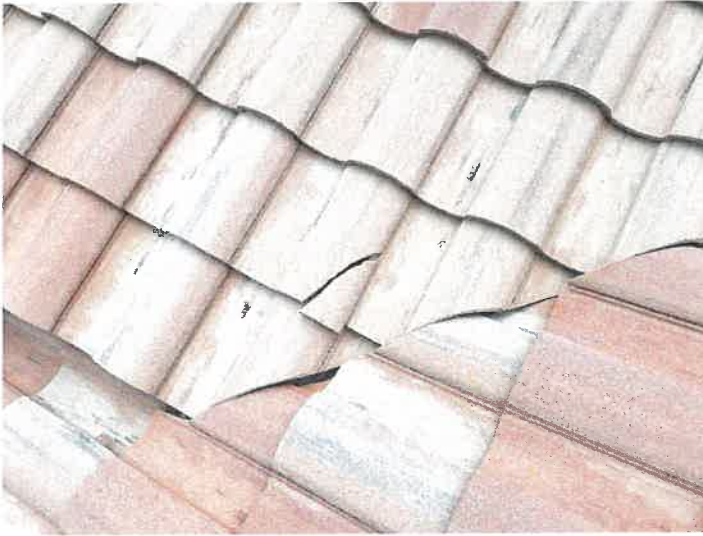
Building 15153: Identified Cracked Roof Tiles

Cracked roof tiles can allow premature underlayment deterioration from excessive UV exposure.
