Inspection Report

Facility: Livingston Lakes Condo
Address: 15098 Palmer Lake Circle,
Naples, FL 34109
Customer: Cardinal Management
Address: c/o Livingston Lakes Condo, 15090
Naples, FL 34109

Livingston Lakes Condo, Naples, FL

Re.: **Inspection Report (2 of 3) for Livingston Lakes**

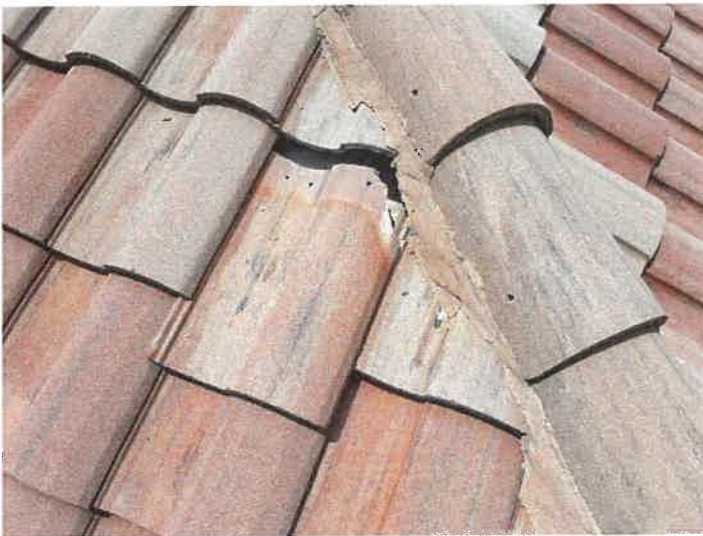
Building 15153: Displaced/Missing Roof Tile

Displaced or missing roof tiles can allow premature underlayment deterioration from excessive UV exposure and potential water intrusion.

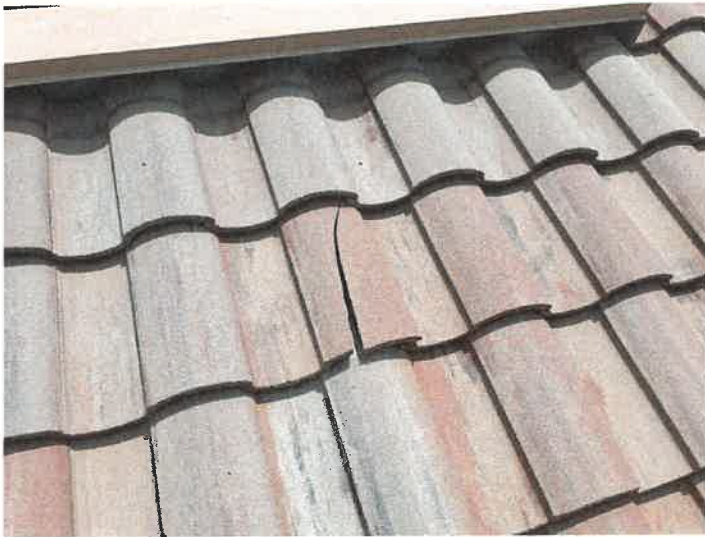
Building 15153: Identified Cracked Roof Tiles

Cracked roof tiles can allow premature underlayment deterioration from excessive UV exposure.

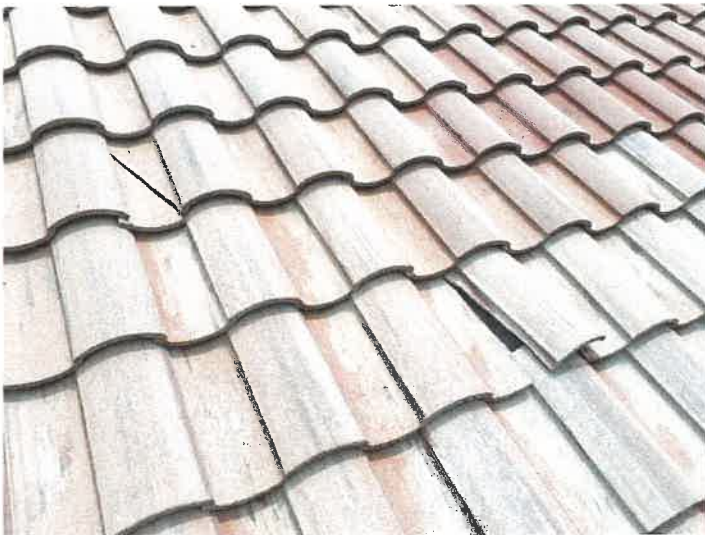
Building 15153: Identified Cracked Roof Tiles

Cracked roof tiles can allow premature underlayment deterioration from excessive UV exposure.

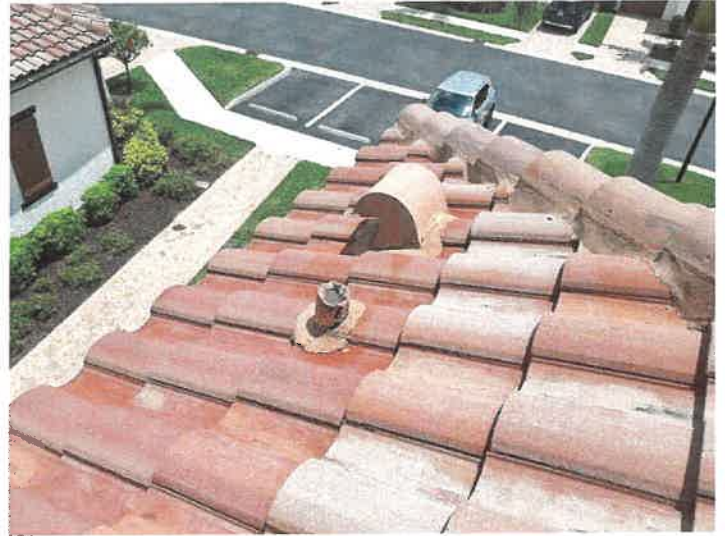
Building 15153: Lead Boots

Lead boots appear to be in good condition.

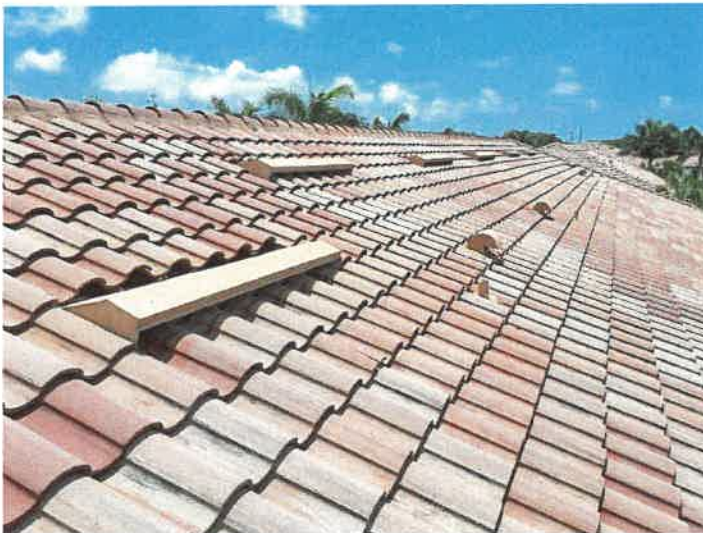
Building 15153: Roof Vents

Roof vents appear to be in good condition.

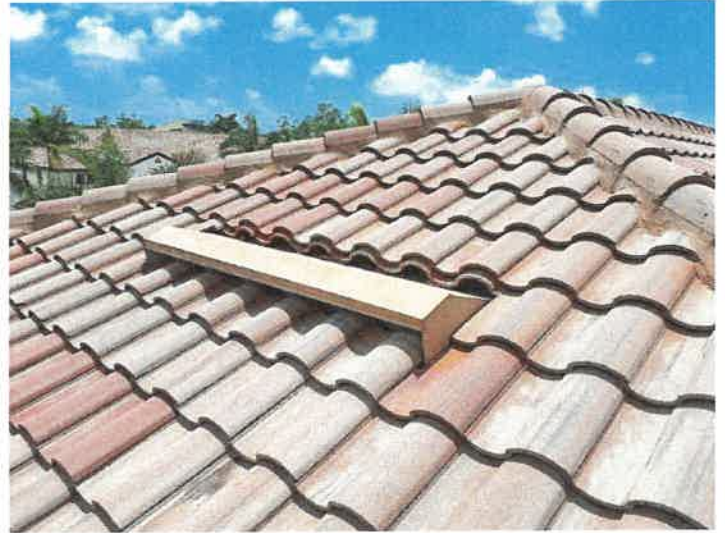
Building 15153: Roof Vents

Roof vents appear to be in good condition.

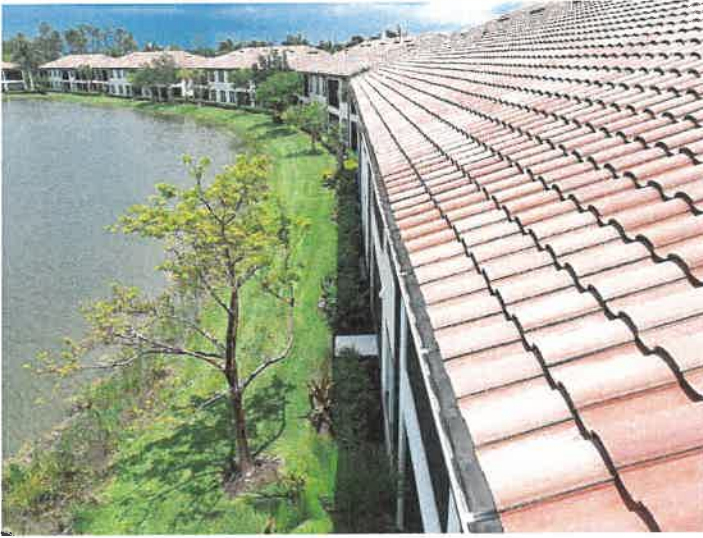
Building 15153: Gutters

The gutters appear to be in good condition.

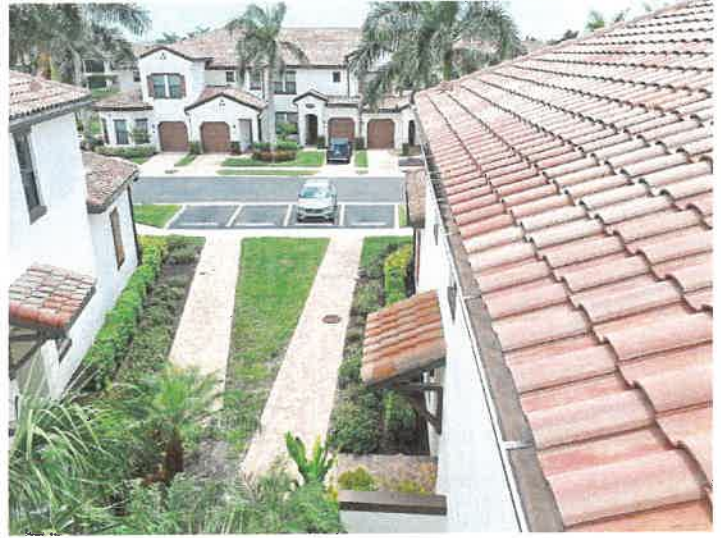
Building 15153: Gutters

The gutters appear to be in good condition.

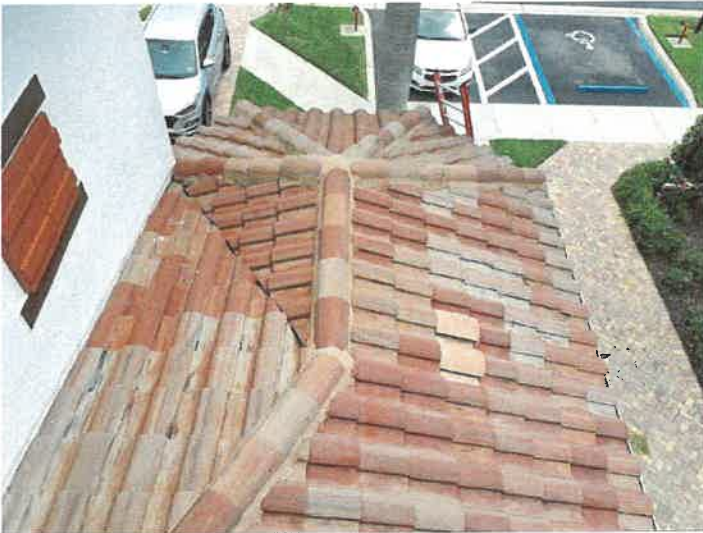
Building 15153: Surface Overview - Lower Roof

The roof surface appears to be in good, maintainable condition at this time.

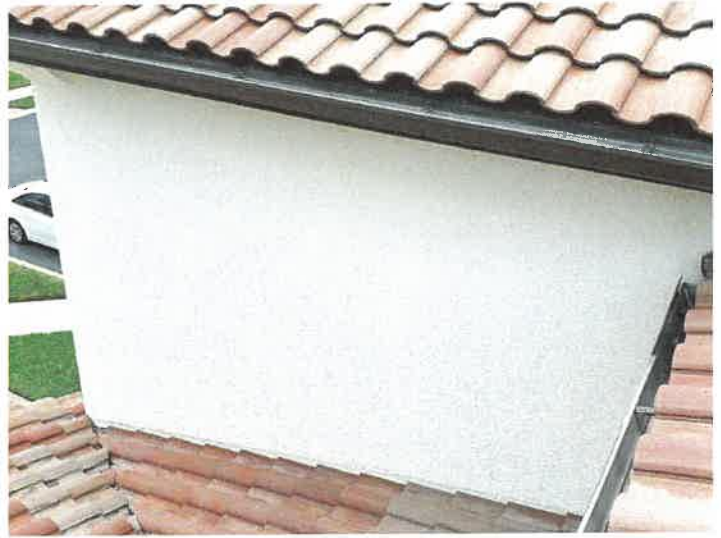
Building 15153: Wall

The walls appear to be in good condition.

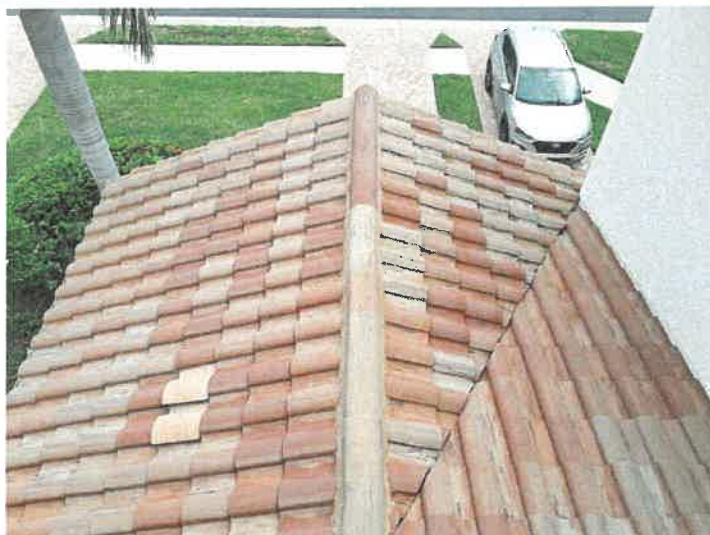
Building 15153: Appearance Overview - Lower Roof
The roof appearance is in good, maintainable condition.

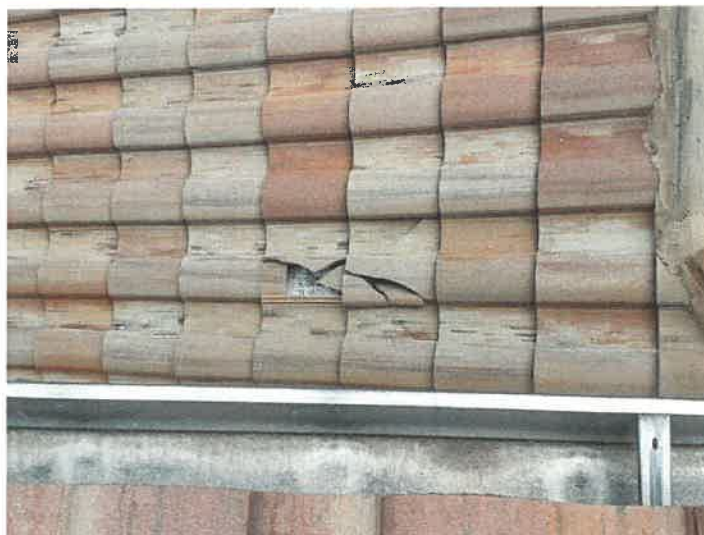
Building 15153: Broken Roof Tiles
Crowther Roofing suggests replacing two (2) broken roof tiles.

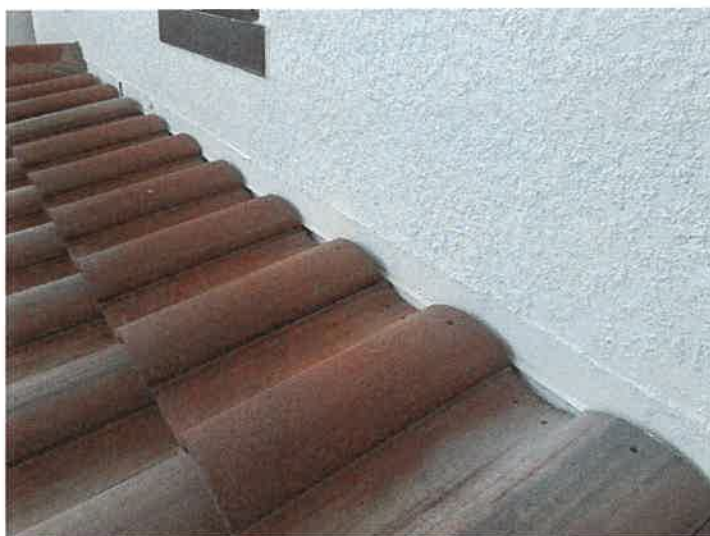
Building 15153: Counter Flashings
The counter flashing appears to be in good condition.

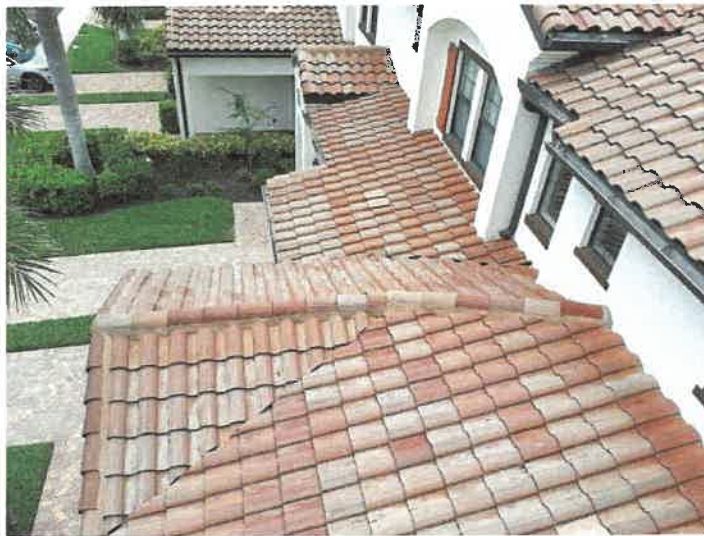
Building 15153: Surface Overview - Lower Roof
The roof surface appears to be in good, maintainable condition at this time.

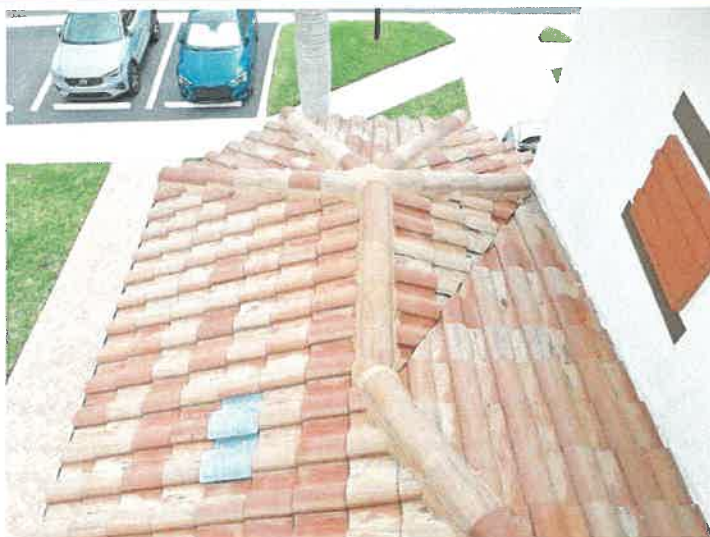
Building 15153: Appearance Overview - Lower Roof

The roof appearance is in good, maintainable condition.

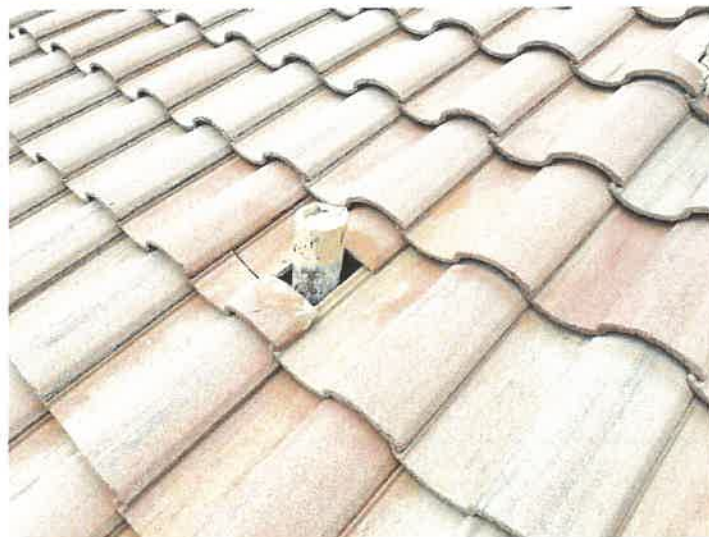
Building 15153: Missing Mortar

Identified missing mortar around the lead boot. Crowther Roofing suggests installing mortar.

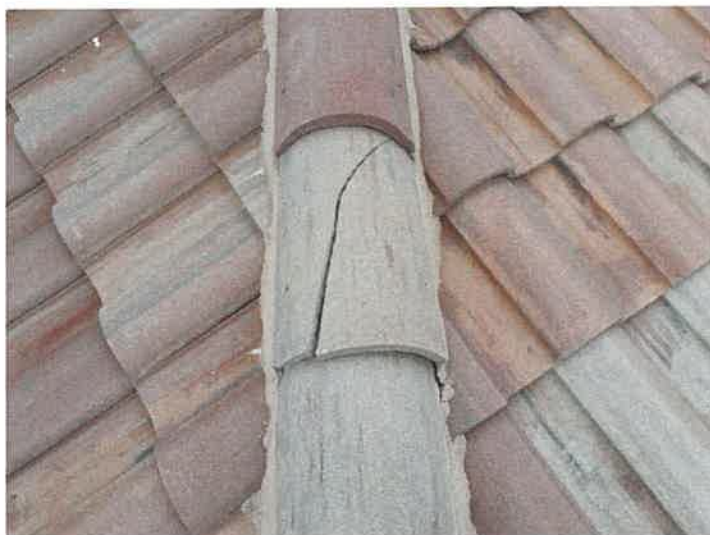
Building 15153: Identified Cracked Roof Tiles

Cracked roof tiles can allow premature underlayment deterioration from excessive UV exposure.

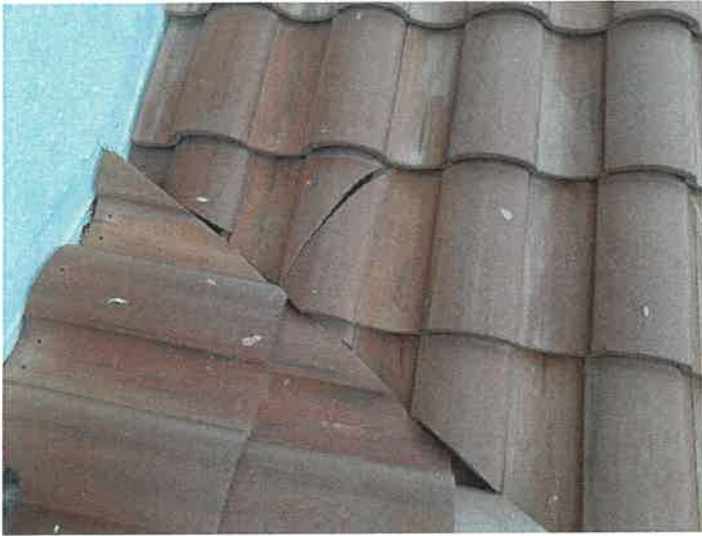
Building 15153: Identified Cracked Roof Tiles

Cracked roof tiles can allow premature underlayment deterioration from excessive UV exposure.

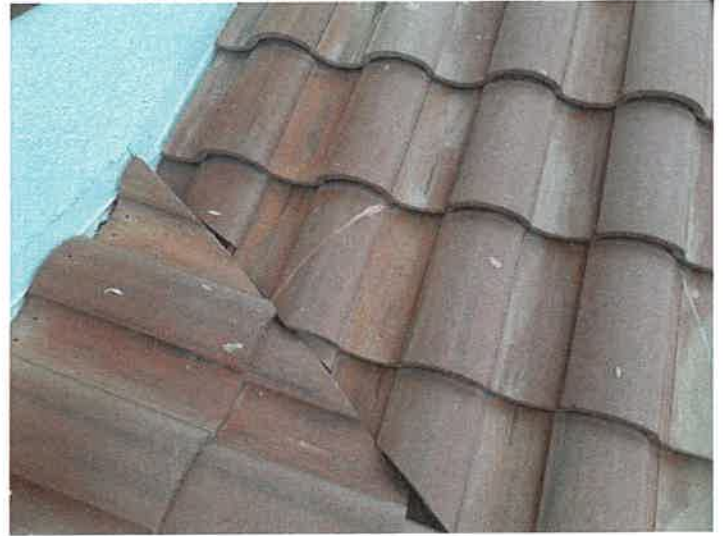
Building 15153: Repaired Cracked Roof Tiles

The cracked roof tiles were repaired with Titebond sealant.

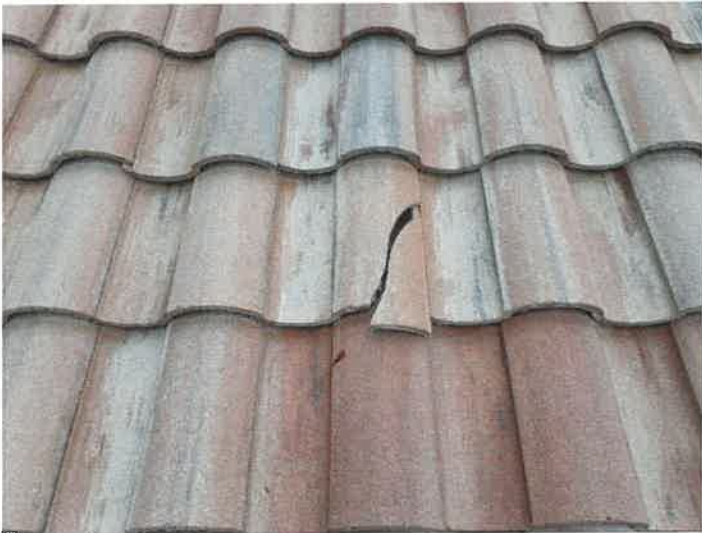
Building 15153: Identified Cracked Roof Tiles

Cracked roof tiles can allow premature underlayment deterioration from excessive UV exposure.

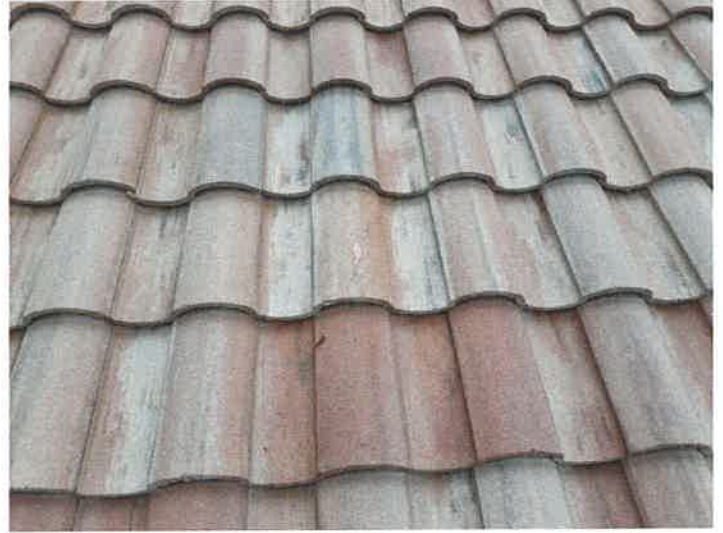
Building 15153: Repaired Cracked Roof Tiles

The cracked roof tiles were repaired with Titebond sealant.

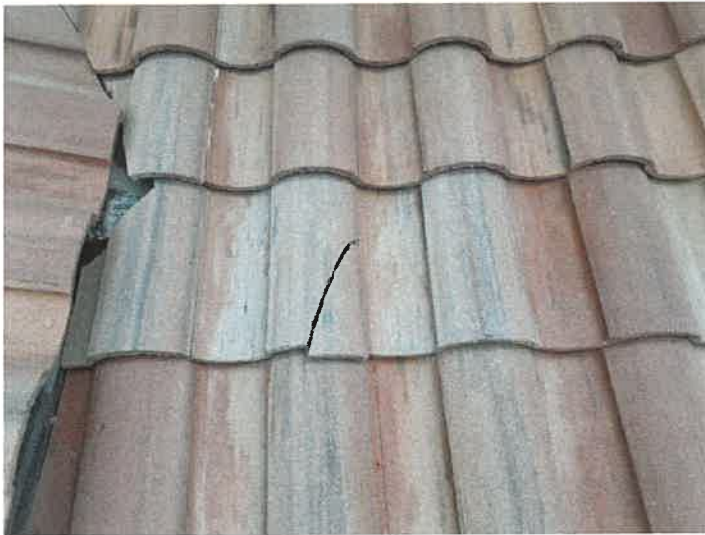
Building 15153: Identified Cracked Roof Tiles

Cracked roof tiles can allow premature underlayment deterioration from excessive UV exposure.

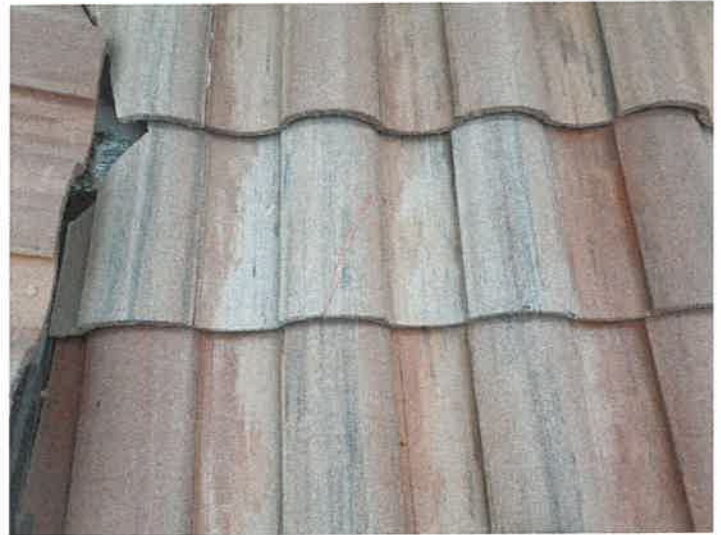
Building 15153: Repaired Cracked Roof Tiles

The cracked roof tiles were repaired with Titebond sealant.

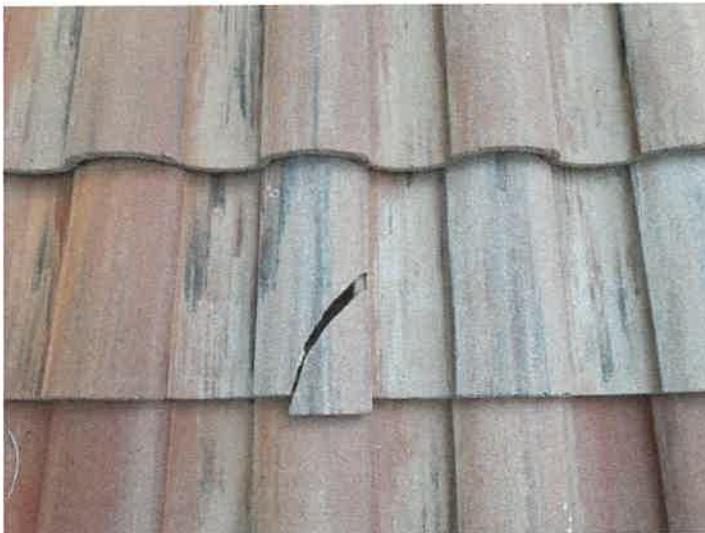
Building 15153: Identified Cracked Roof Tiles

Cracked roof tiles can allow premature underlayment deterioration from excessive UV exposure.

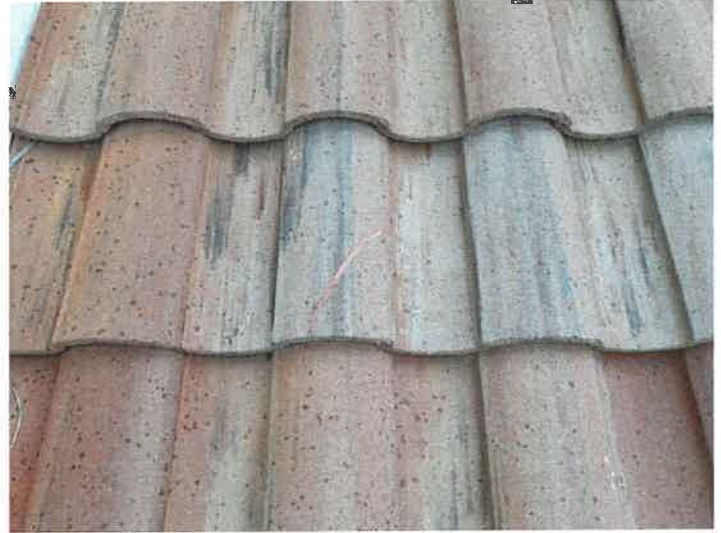
Building 15153: Repaired Cracked Roof Tiles

The cracked roof tiles were repaired with Titebond sealant.

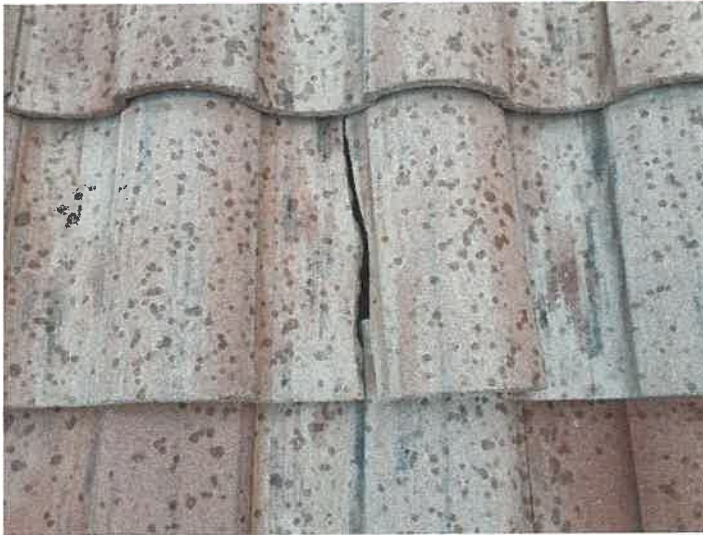
Building 15153: Identified Cracked Roof Tiles

Cracked roof tiles can allow premature underlayment deterioration from excessive UV exposure.

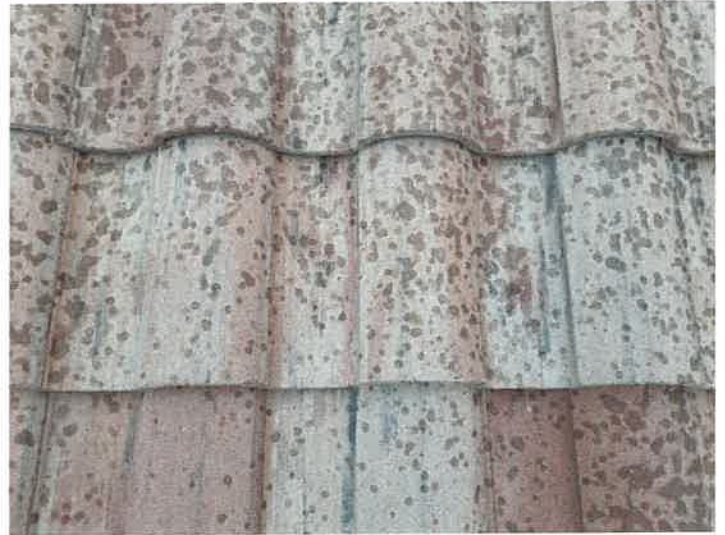
Building 15153: Repaired Cracked Roof Tiles

The cracked roof tiles were repaired with Titebond sealant.

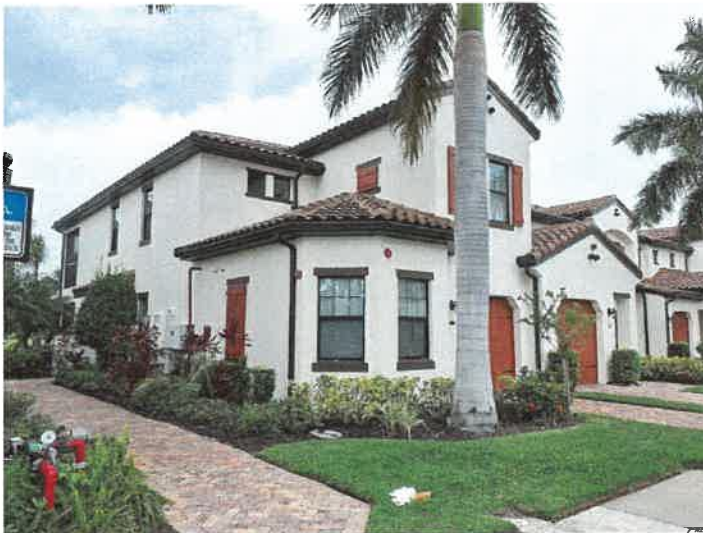
Building 15153: Downspouts

The downspouts appear to be in good condition.

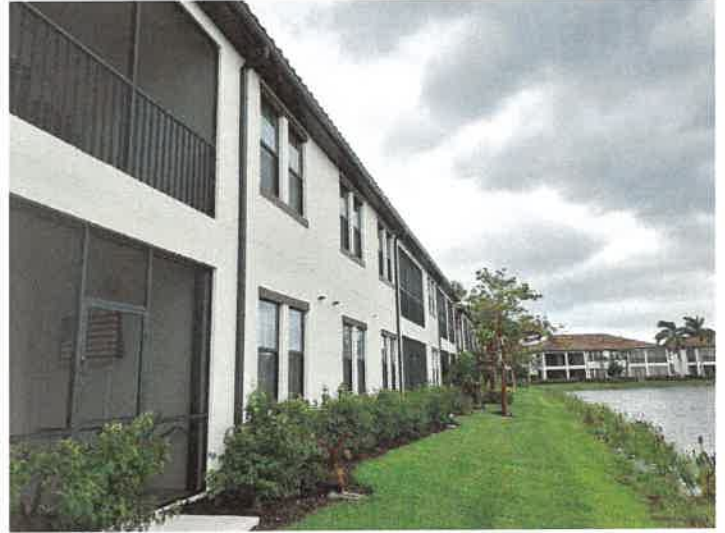
Building 15153: Downspouts

The downspouts appear to be in good condition.

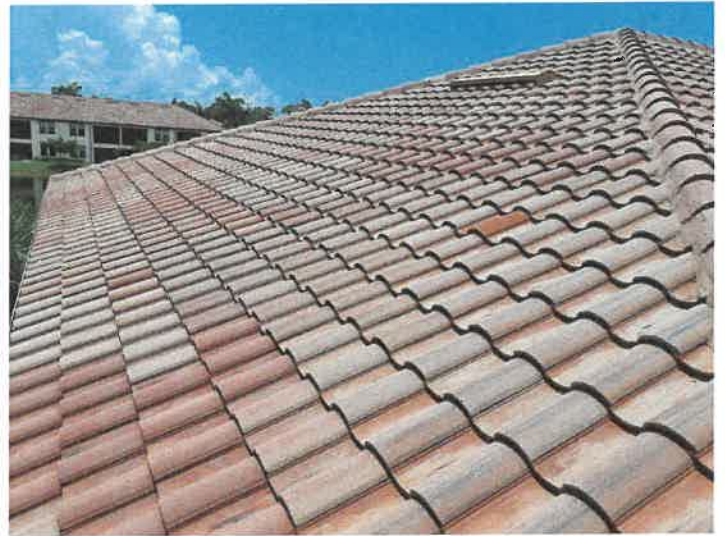
Building 15156: Surface Overview
The roof surface appears to be in good, maintainable condition at this time.

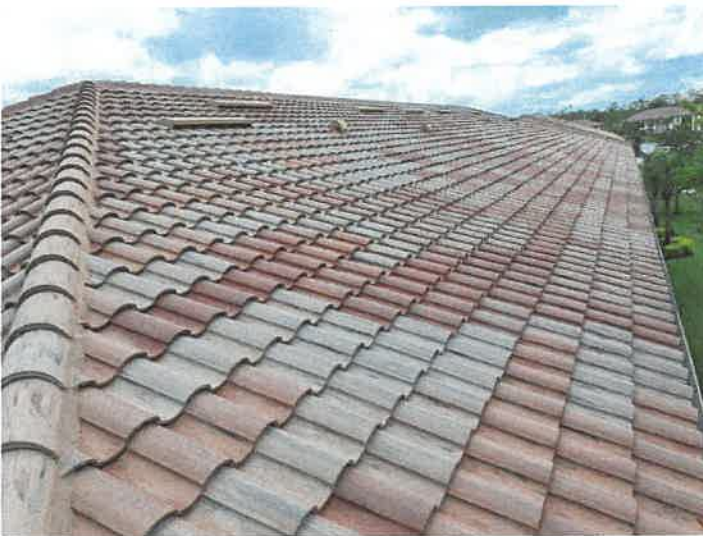
Building 15156: Appearance Overview
The roof appearance is in good, maintainable condition.

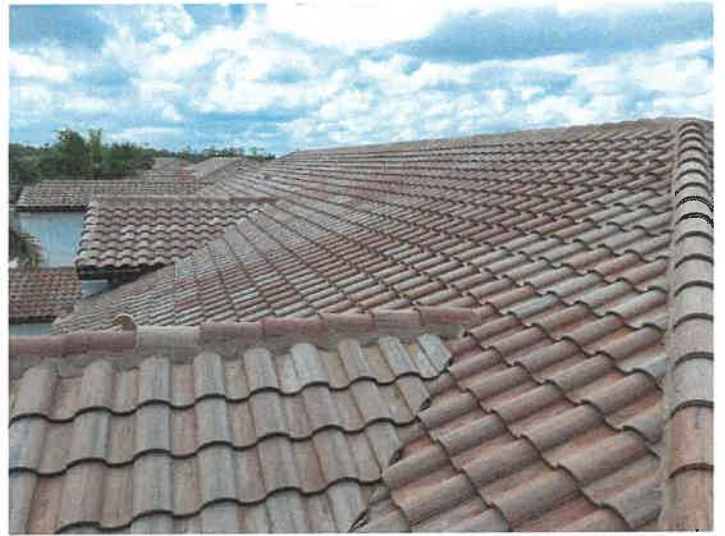
Building 15156: Appearance Overview
The roof appearance is in good, maintainable condition.

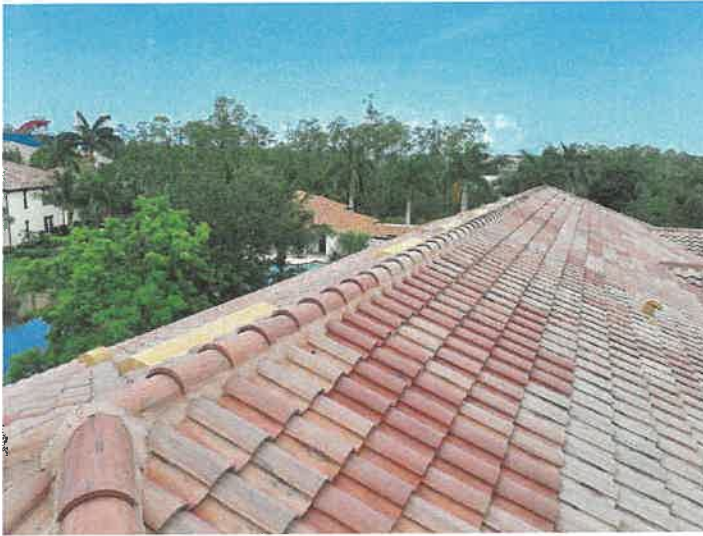
Building 15156: Ridge Tiles
Ridge tiles appear to be in good condition.

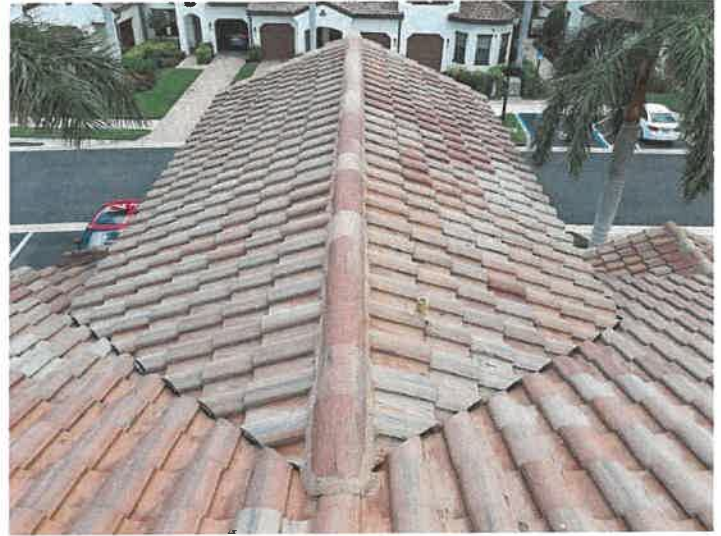
Building 15156: Valley
The valley tiles appear to be in good condition.

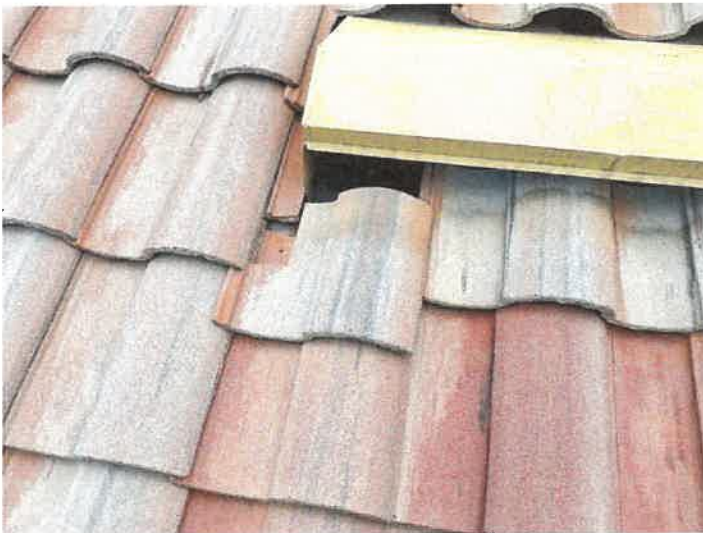
Building 15156: Identified Cracked Roof Tiles
Cracked roof tiles can allow premature underlayment deterioration from excessive UV exposure.

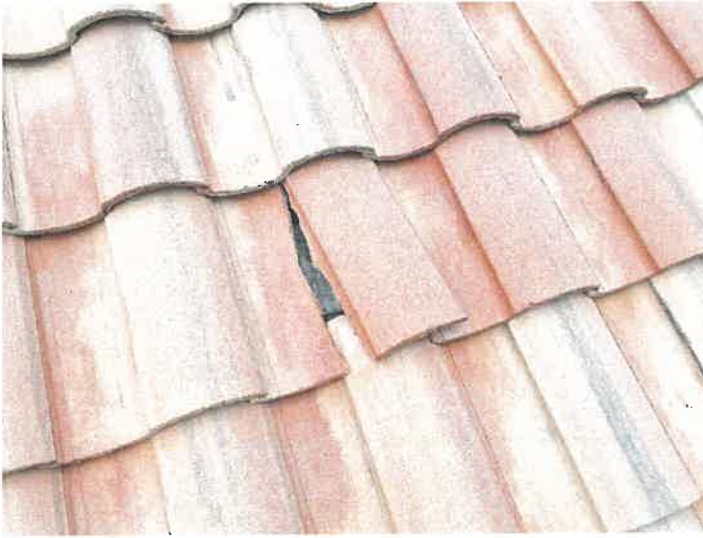
Building 15156: Identified Cracked Roof Tiles
Cracked roof tiles can allow premature underlayment deterioration from excessive UV exposure.

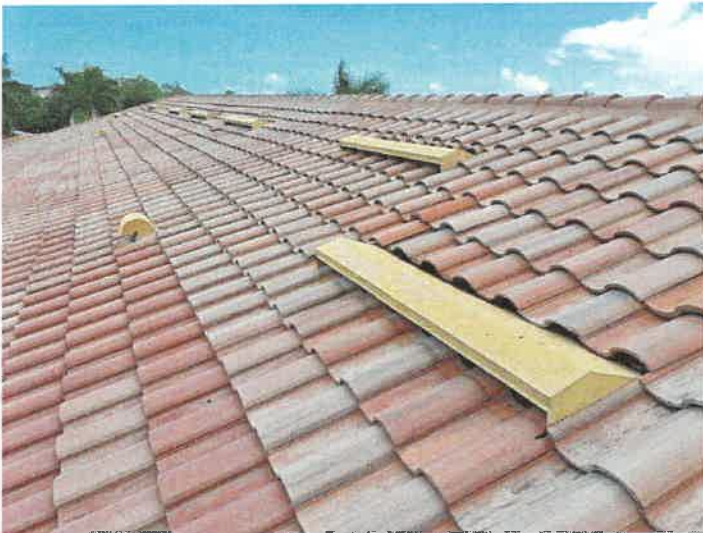
Building 15156: Roof Vents
Roof vents appear to be in good condition.

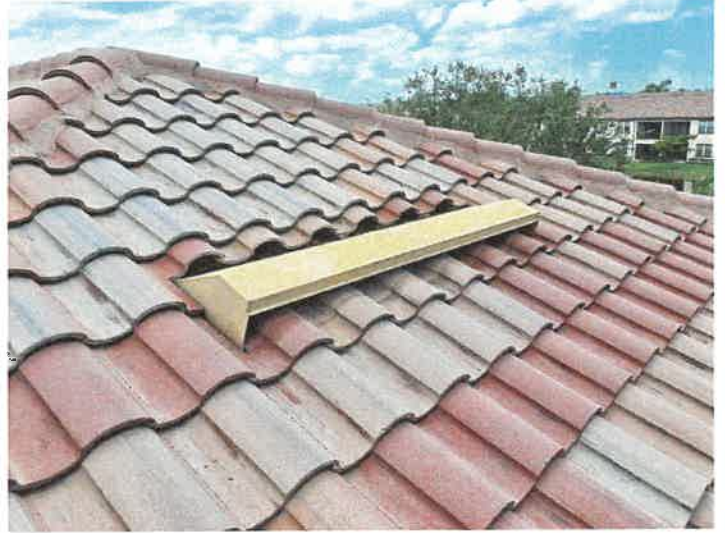
Building 15156: Roof Vents
Roof vents appear to be in good condition.

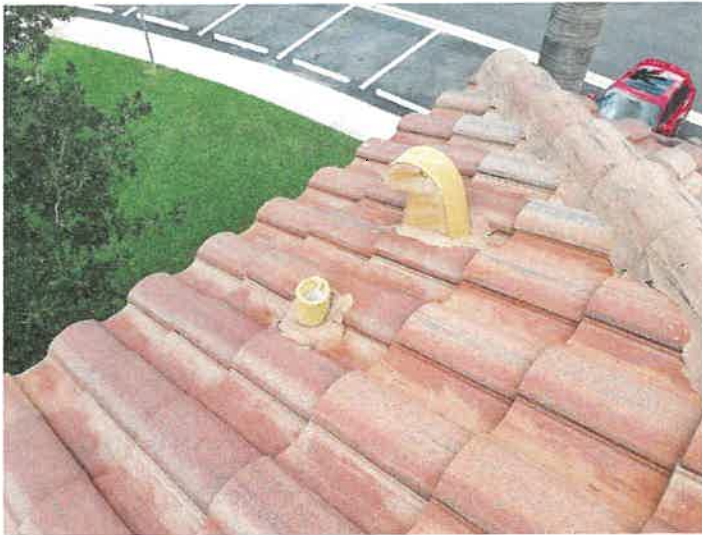
Building 15156: Lead Boots
Lead boots appear to be in good condition.

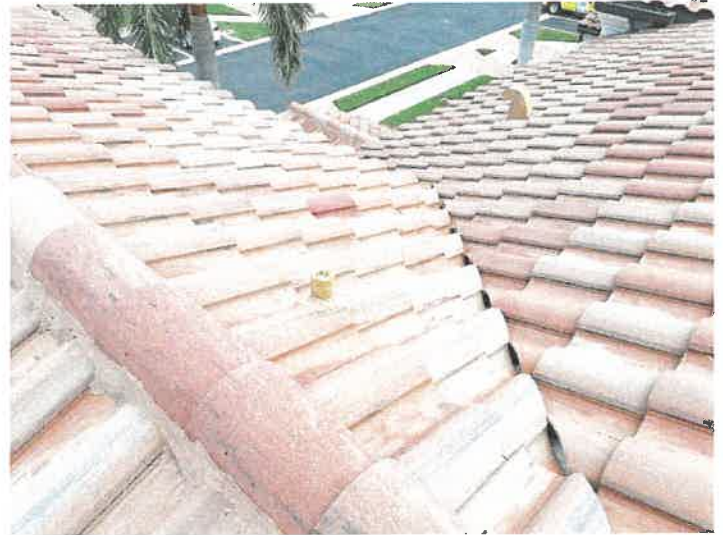
Building 15156: Lead Boots
Lead boots appear to be in good condition.

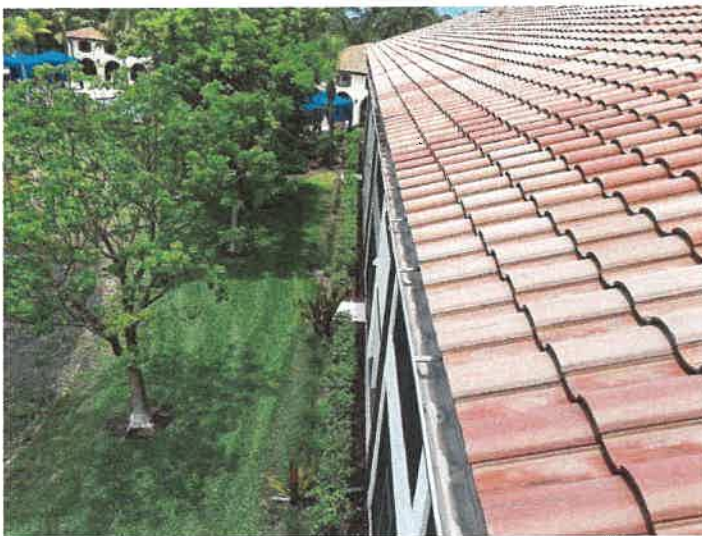
Building 15156: Gutters
The gutters appear to be in good condition.

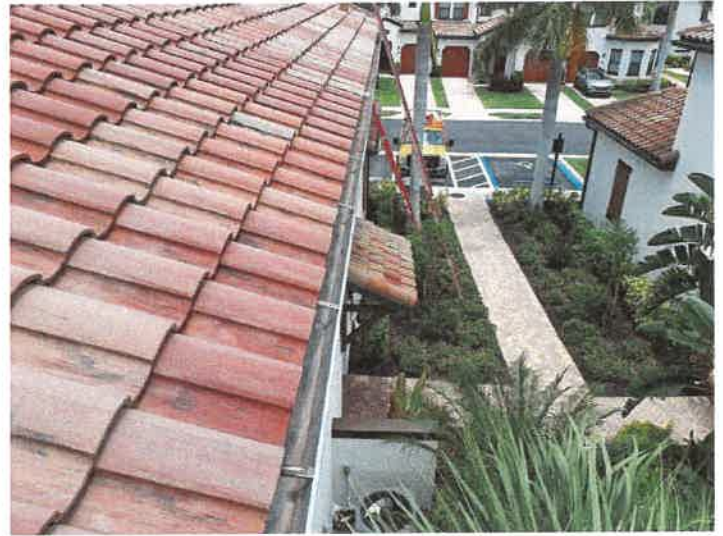
Building 15156: Gutters
The gutters appear to be in good condition.

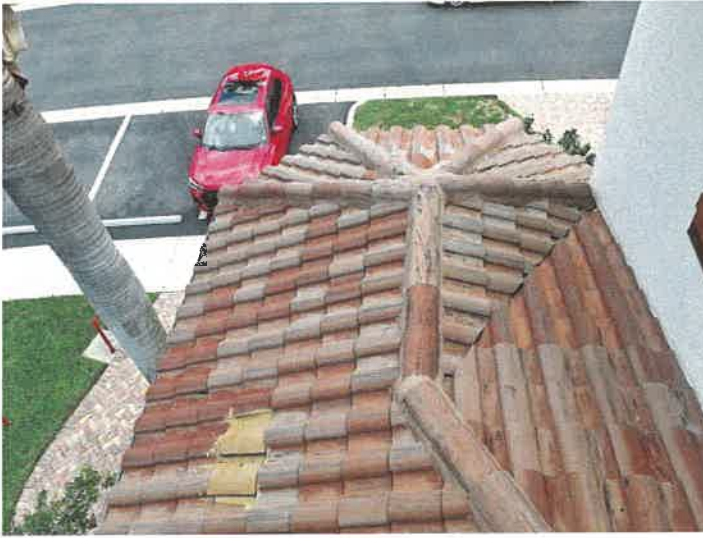
Building 15156: Surface Overview - Lower Roof

The roof surface appears to be in good, maintainable condition at this time.

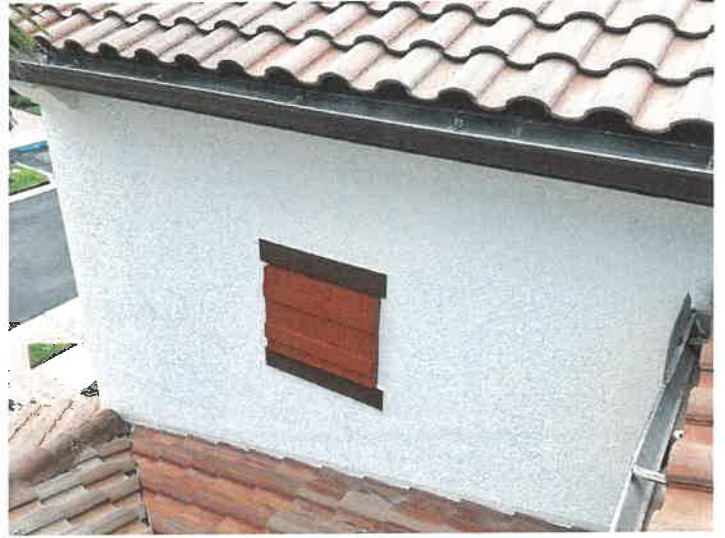
Building 15156: Wall

The walls appear to be in good condition.

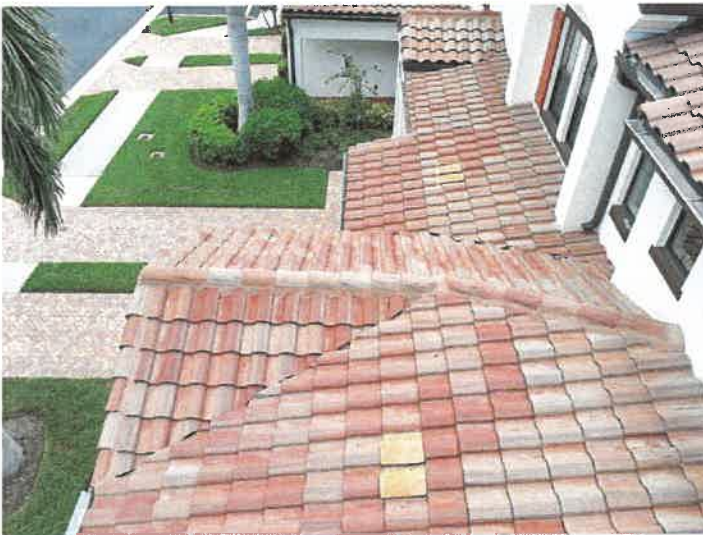
Building 15156: Appearance Overview - Lower Roof

The roof appearance is in good, maintainable condition.

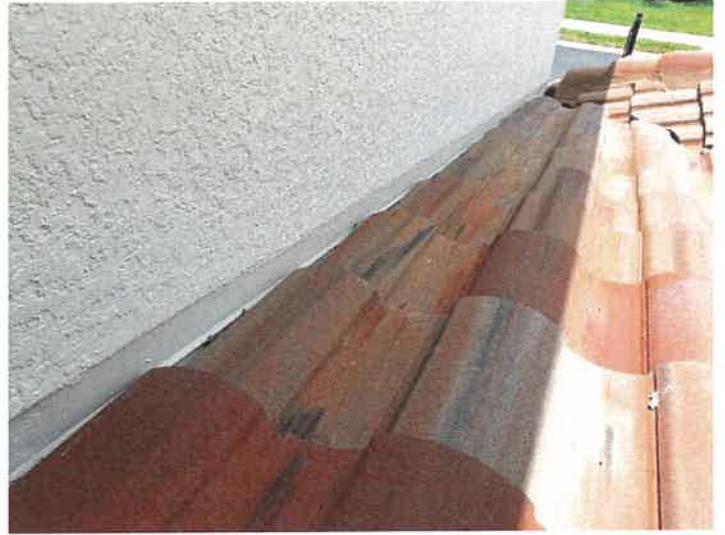
Building 15156: Counter Flashings

The counter flashing appears to be in good condition.

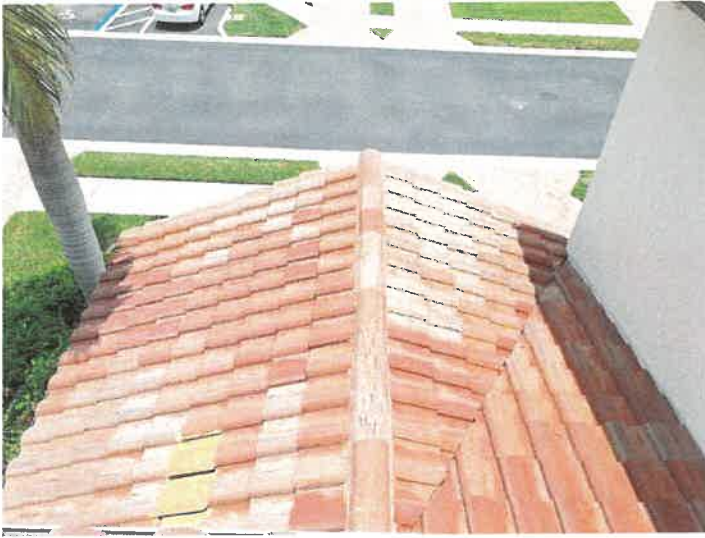
Building 15156: Appearance Overview - Lower Roof
The roof appearance is in good, maintainable condition.

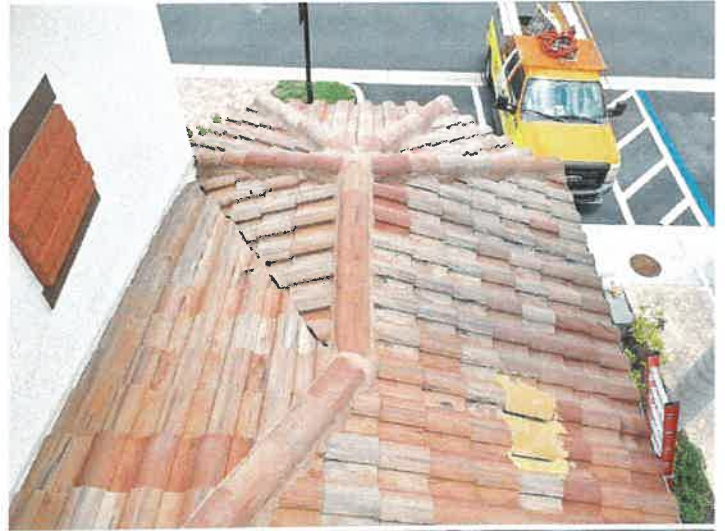
Building 15156: Surface Overview - Lower Roof
The roof surface appears to be in good, maintainable condition at this time.

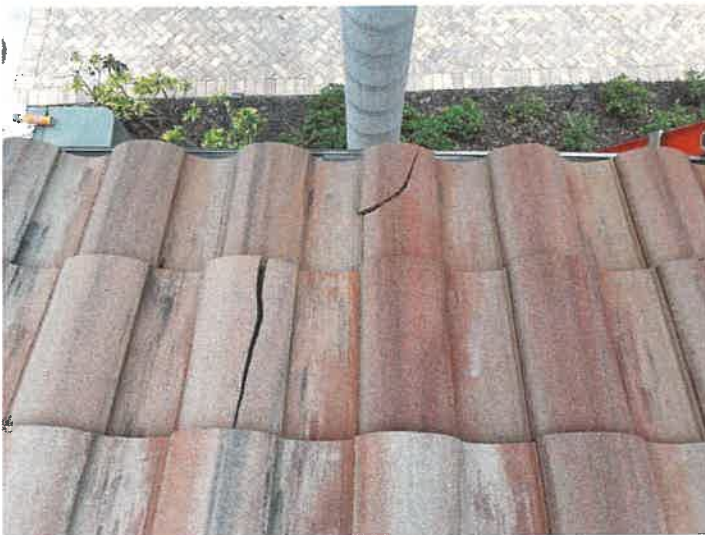
Building 15156: Identified Cracked Roof Tiles
Cracked roof tiles can allow premature underlayment deterioration from excessive UV exposure.

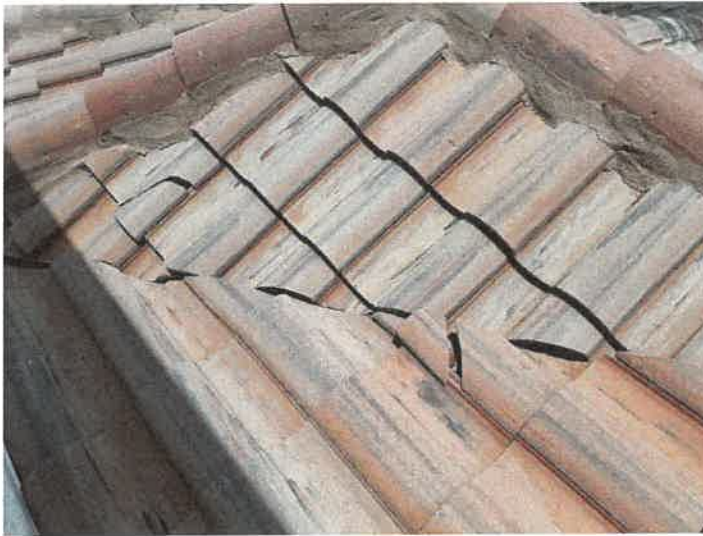
Building 15156: Identified Cracked Roof Tiles

Cracked roof tiles can allow premature underlayment deterioration from excessive UV exposure.

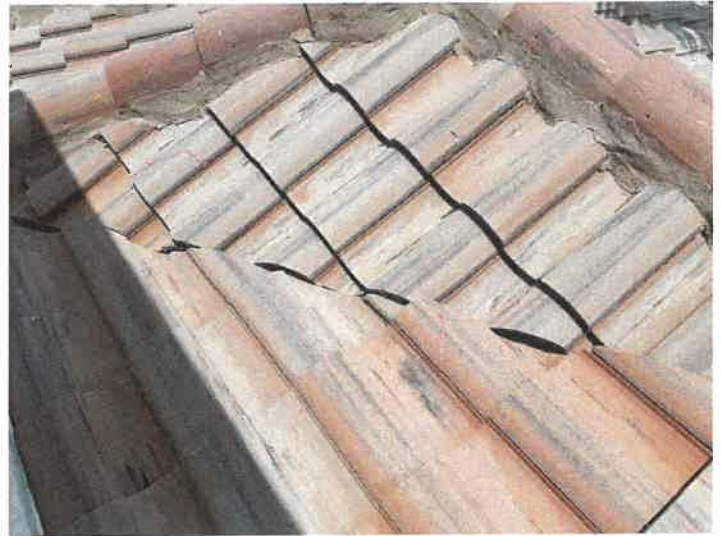
Building 15156: Repaired Cracked Roof Tiles

The cracked roof tiles were repaired with Titebond sealant.

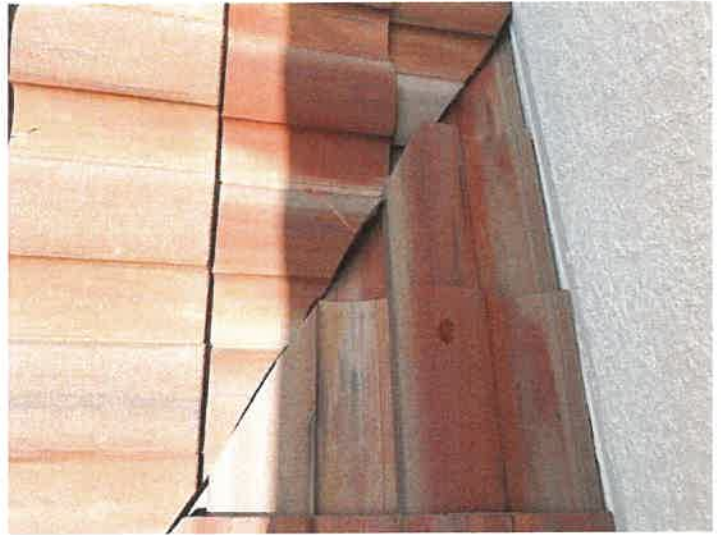
Building 15156: Repaired Cracked Roof Tiles

The cracked roof tiles were repaired with Titebond sealant.

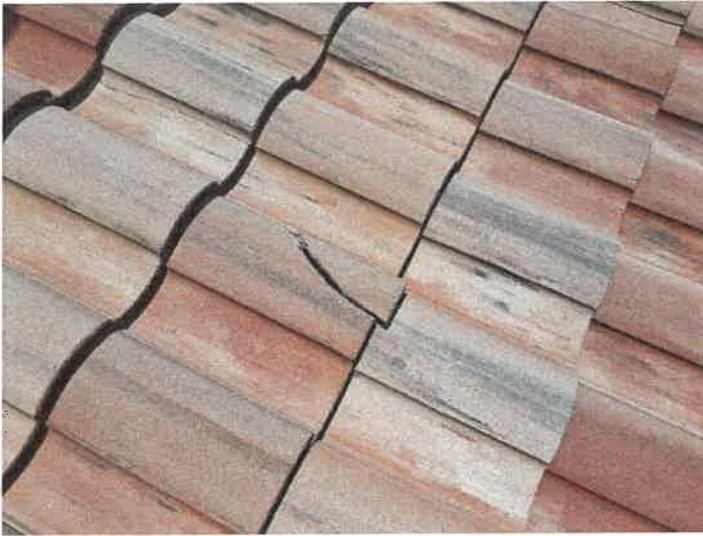
Building 15156: Identified Cracked Roof Tiles

Cracked roof tiles can allow premature underlayment deterioration from excessive UV exposure.

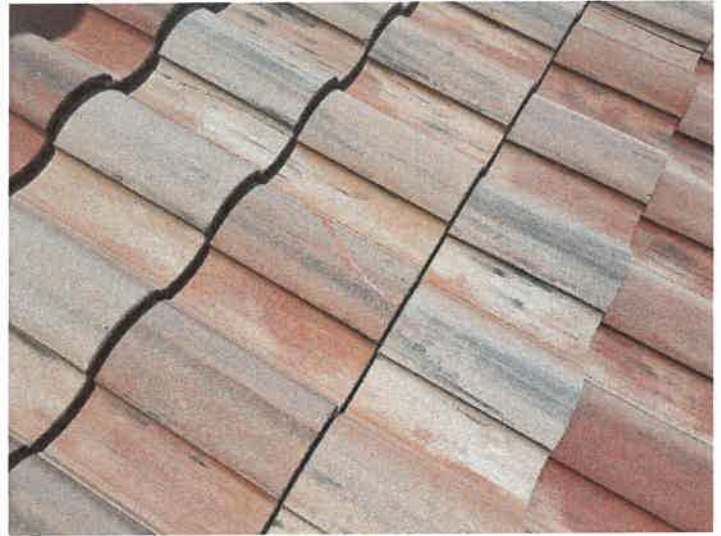
Building 15156: Repaired Cracked Roof Tiles

The cracked roof tiles were repaired with Titebond sealant.

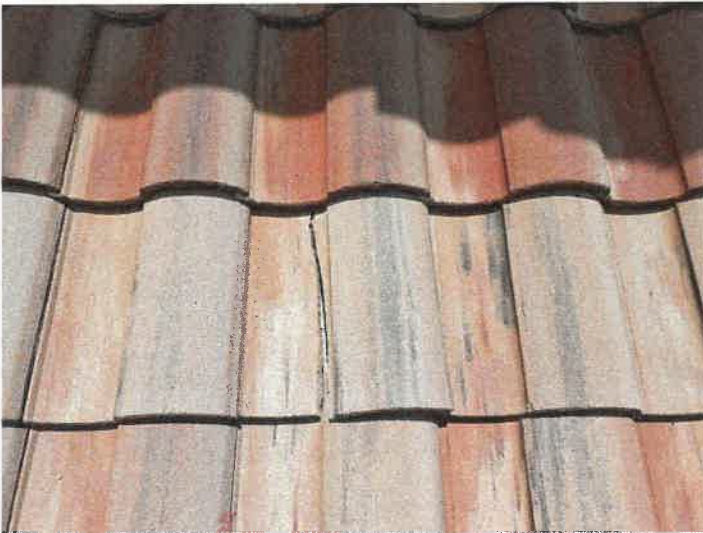
Building 15156: Identified Cracked Roof Tiles

Cracked roof tiles can allow premature underlayment deterioration from excessive UV exposure.

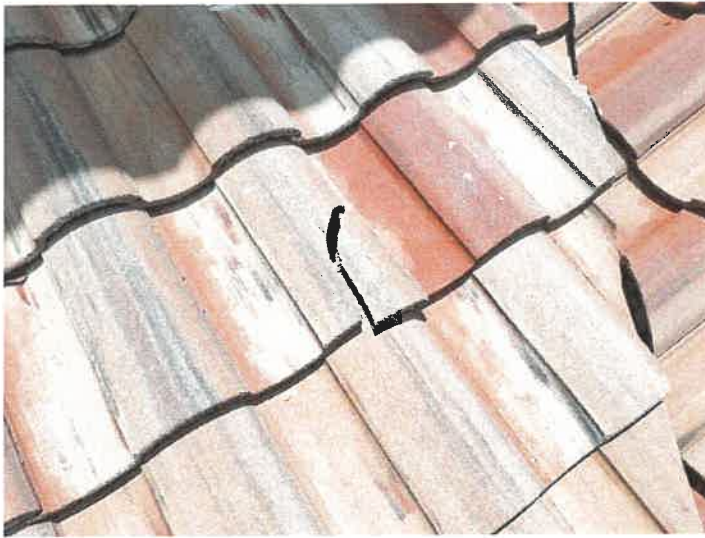
Building 15156: Identified Cracked Roof Tiles

Cracked roof tiles can allow premature underlayment deterioration from excessive UV exposure.
