Inspection Report

Facility: Livingston Lakes Condo
Address: 15098 Palmer Lake Circle,
Naples, FL 34109
Customer: Cardinal Management
Address: c/o Livingston Lakes Condo, 15090
Naples, FL 34109

Livingston Lakes Condo, Naples, FL

Re.: **Inspection Report (2 of 3) for Livingston Lakes**

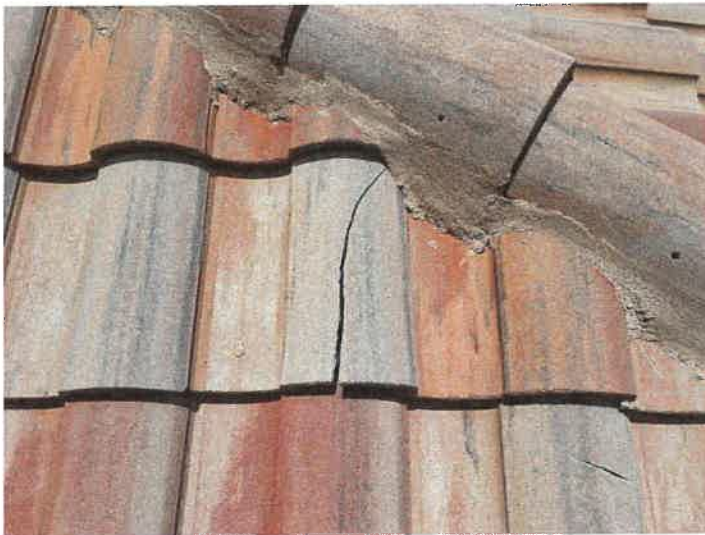
Building 15156: Identified Cracked Roof Tiles

Cracked roof tiles can allow premature underlayment deterioration from excessive UV exposure.

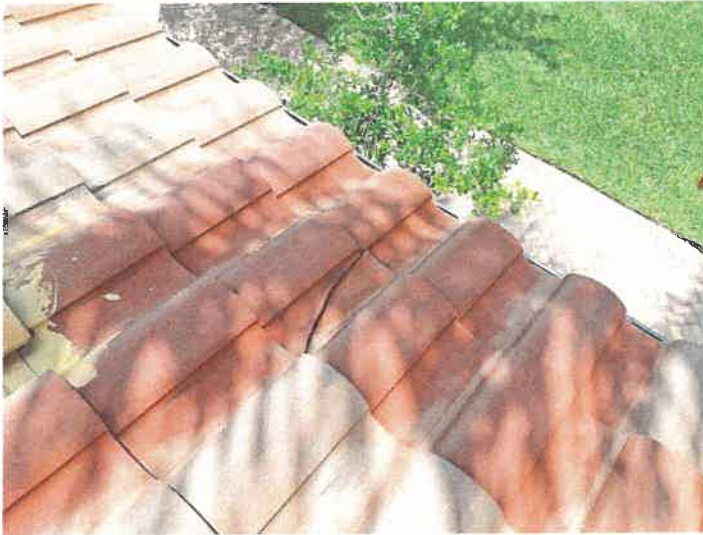
Building 15156: Identified Cracked Roof Tiles

Cracked roof tiles can allow premature underlayment deterioration from excessive UV exposure.

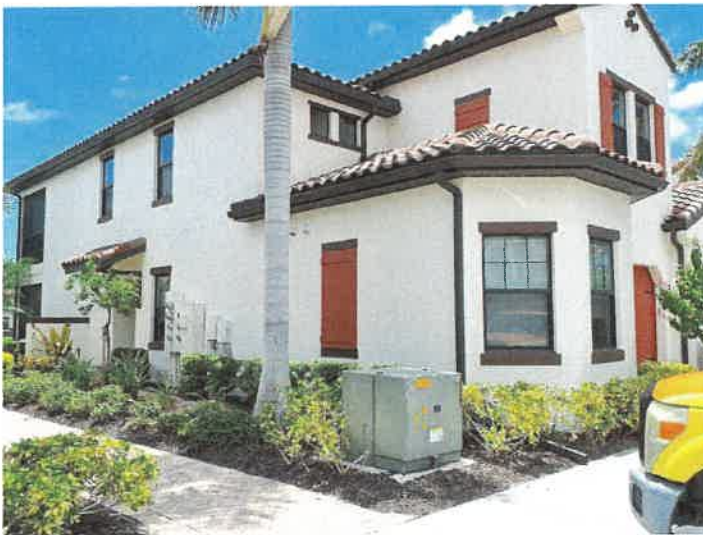
Building 15156: Downspouts

The downspouts appear to be in good condition.

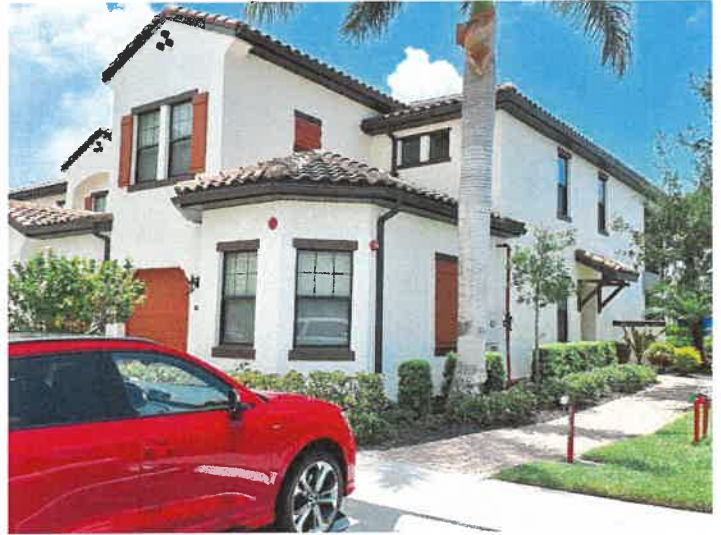
Building 15156: Downspouts

The downspouts appear to be in good condition.

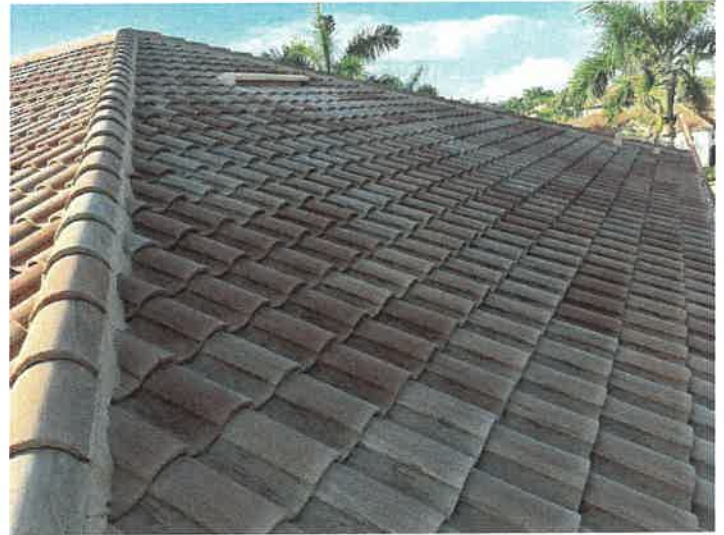
Building 15157: Surface Overview
The roof surface appears to be in good, maintainable condition at this time.

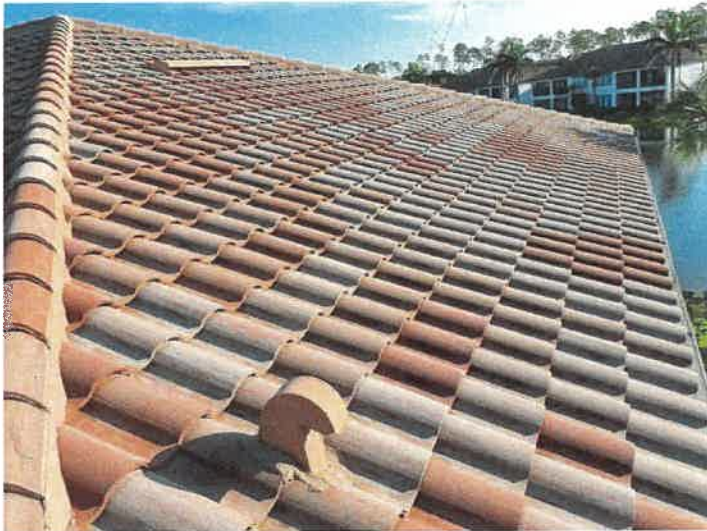
Building 15157: Surface Overview
The roof surface appears to be in good, maintainable condition at this time.

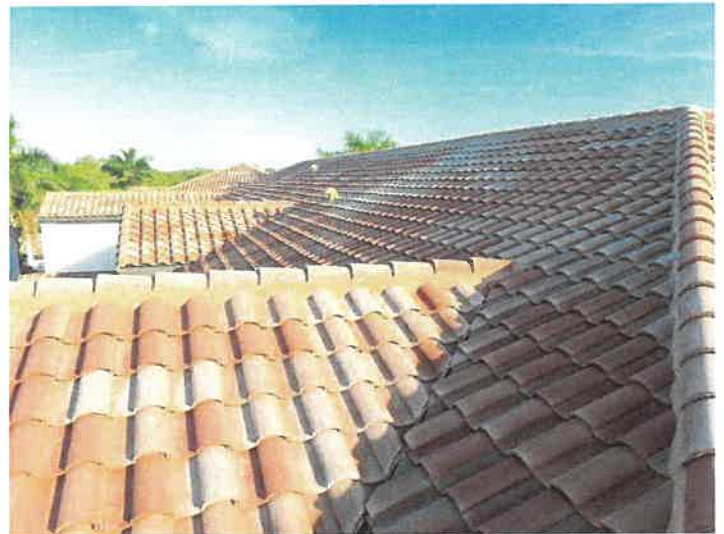
Building 15157: Appearance Overview
The roof appearance is in good, maintainable condition.

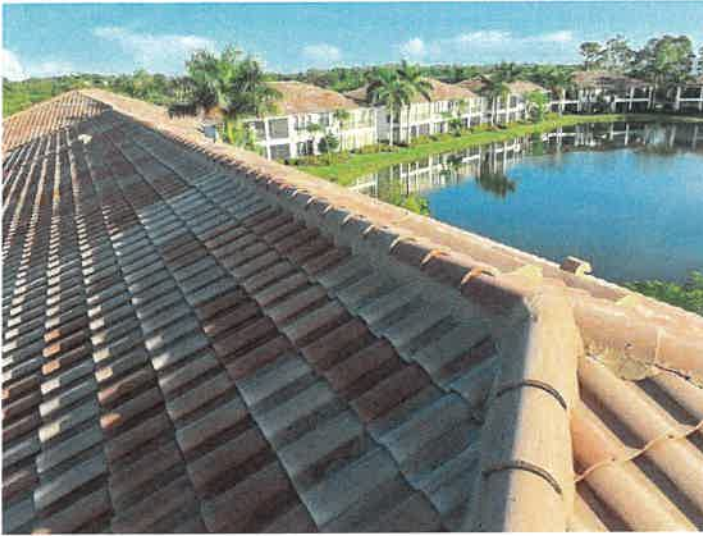
Building 15157: Ridge Tiles

Ridge tiles appear to be in good condition.

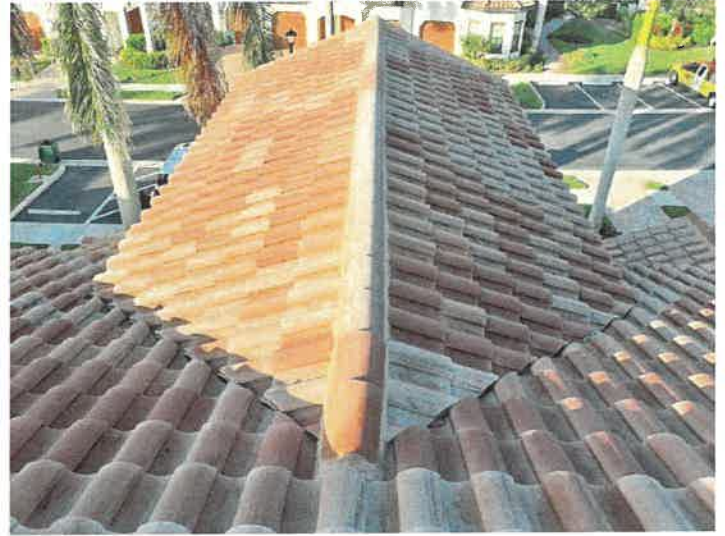
Building 15157: Valley

The valley tiles appear to be in good condition.

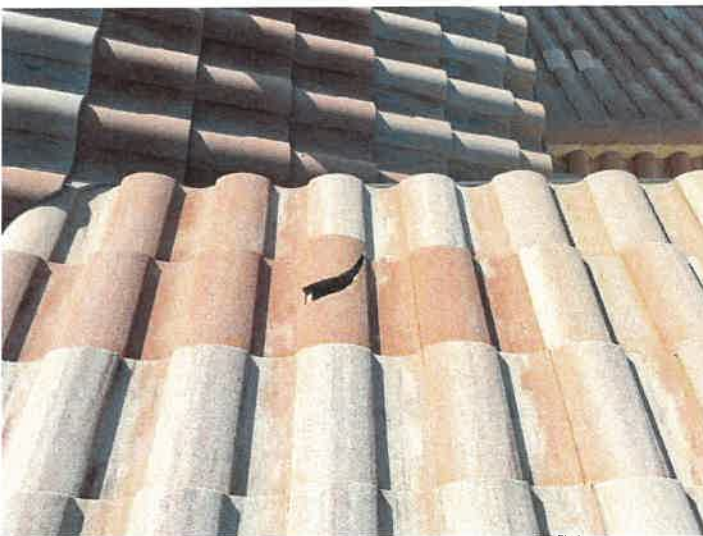
Building 15157: Identified Cracked Roof Tiles

Cracked roof tiles can allow premature underlayment deterioration from excessive UV exposure.

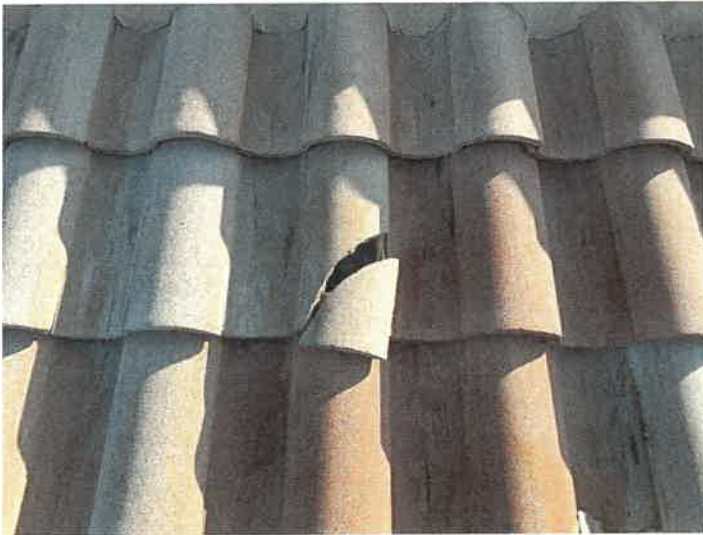
Building 15157: Identified Cracked Roof Tiles

Cracked roof tiles can allow premature underlayment deterioration from excessive UV exposure.

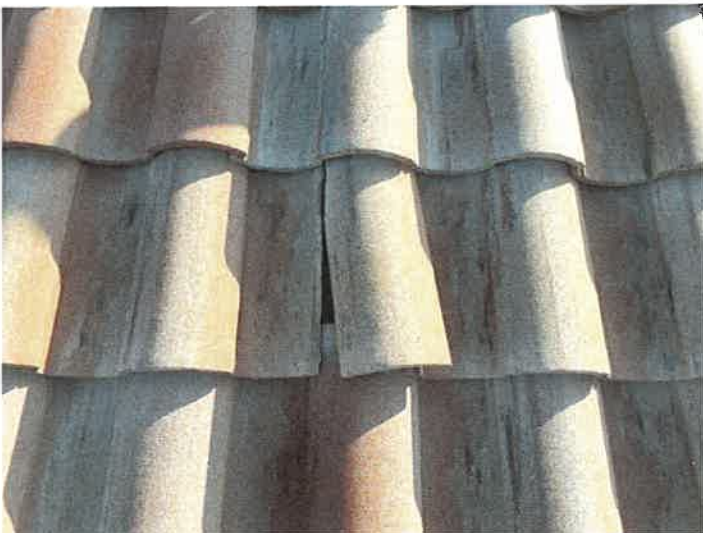
Building 15157: Identified Cracked Roof Tiles

Cracked roof tiles can allow premature underlayment deterioration from excessive UV exposure.

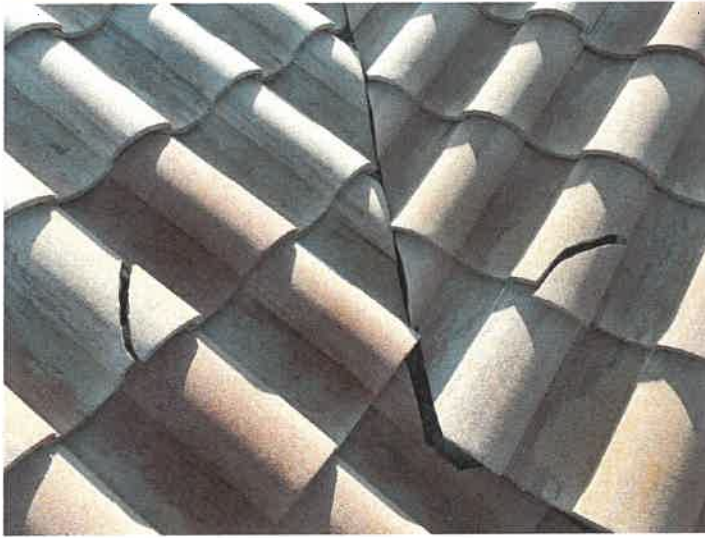
Building 15157: Identified Cracked Roof Tiles

Cracked roof tiles can allow premature underlayment deterioration from excessive UV exposure.

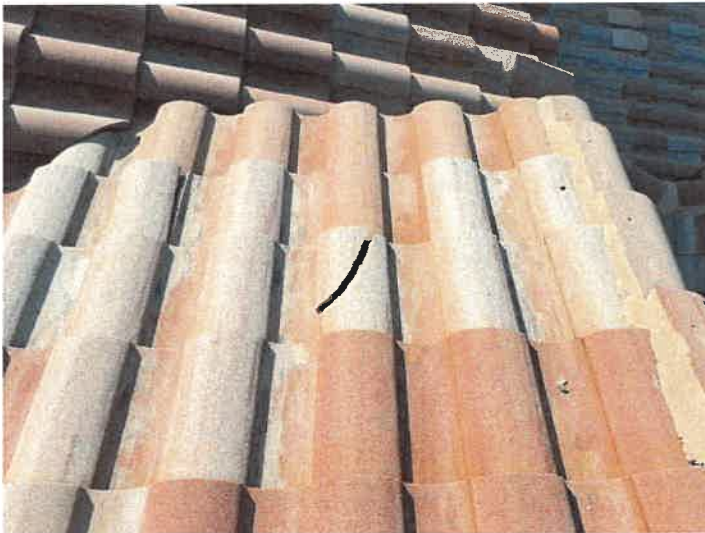
Building 15157: Identified Cracked Roof Tiles

Cracked roof tiles can allow premature underlayment deterioration from excessive UV exposure.

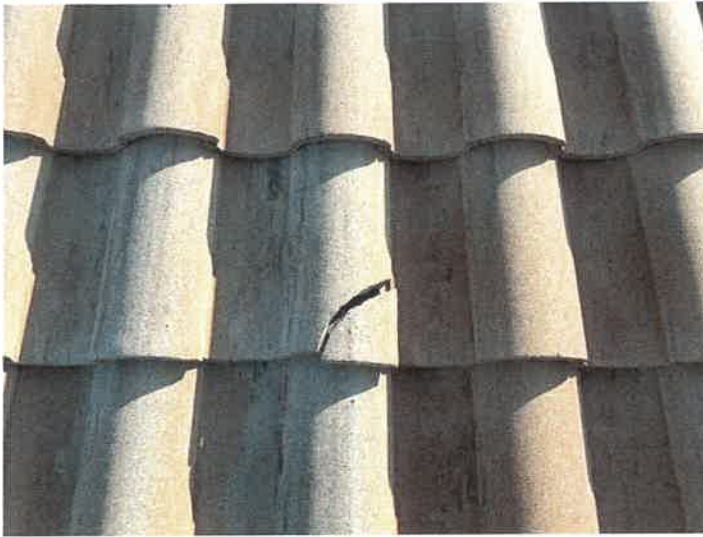
Building 15157: Identified Cracked Roof Tiles

Cracked roof tiles can allow premature underlayment deterioration from excessive UV exposure.

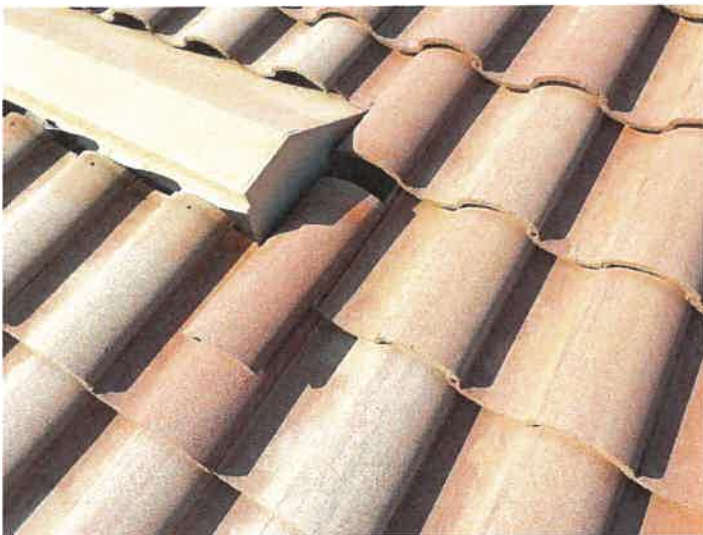
Displaced/Missing Roof Tile

Displaced or missing roof tiles can allow premature underlayment deterioration from excessive UV exposure and potential water intrusion.

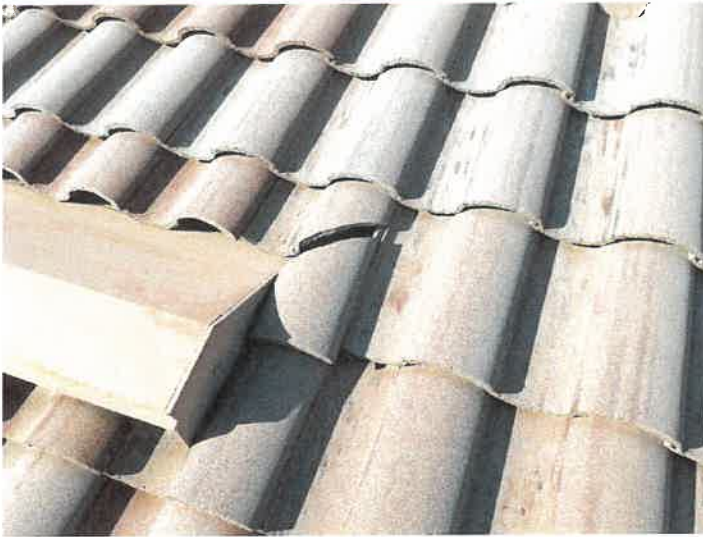
Building 15157: Identified Cracked Roof Tiles

Cracked roof tiles can allow premature underlayment deterioration from excessive UV exposure.

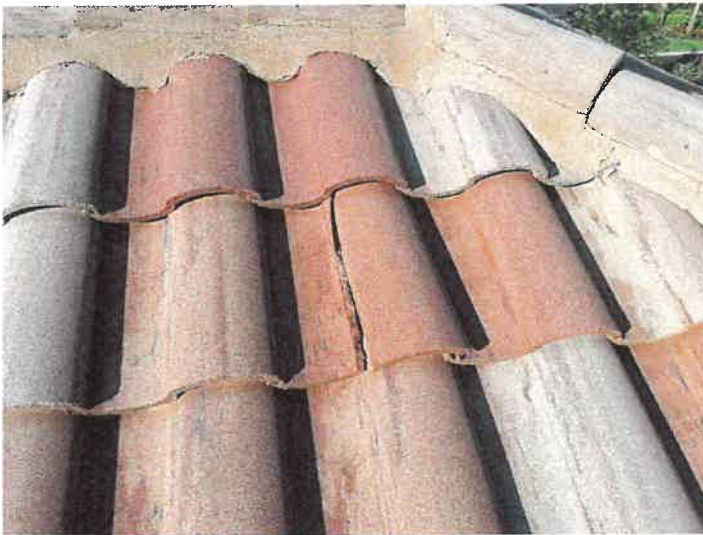
Building 15157: Identified Cracked Roof Tiles

Cracked roof tiles can allow premature underlayment deterioration from excessive UV exposure.

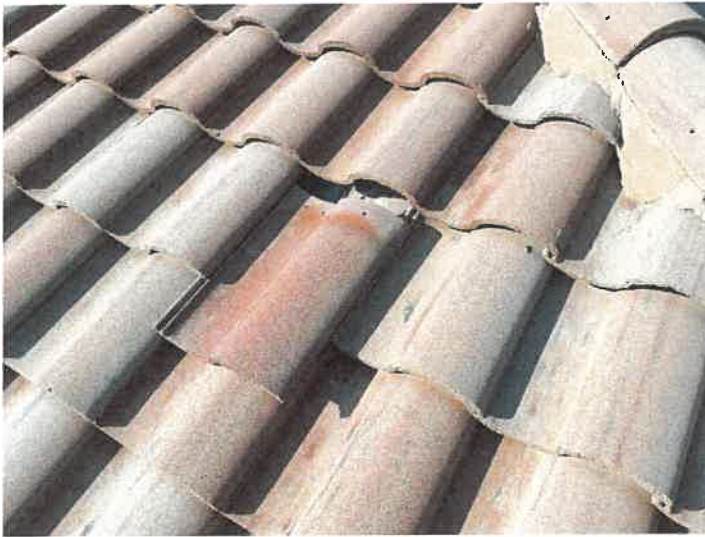
Building 15157: Displaced/Missing Roof Tile

Displaced or missing roof tiles can allow premature underlayment deterioration from excessive UV exposure and potential water intrusion.

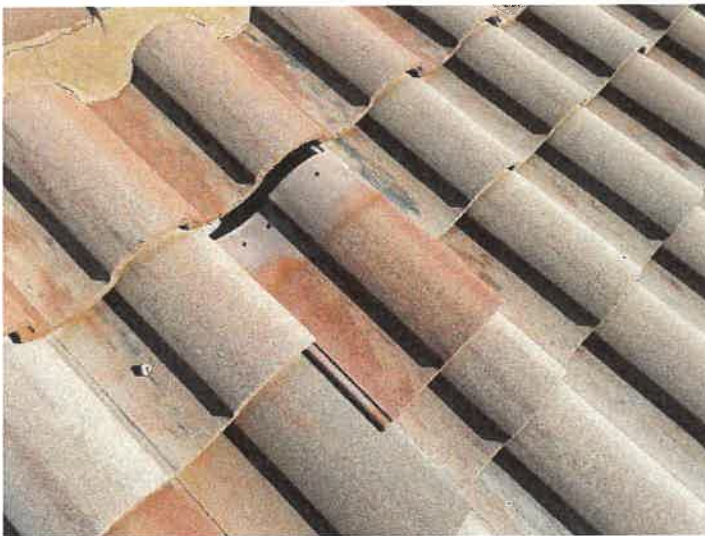
Building 15157: Displaced/Missing Roof Tile

Displaced or missing roof tiles can allow premature underlayment deterioration from excessive UV exposure and potential water intrusion.

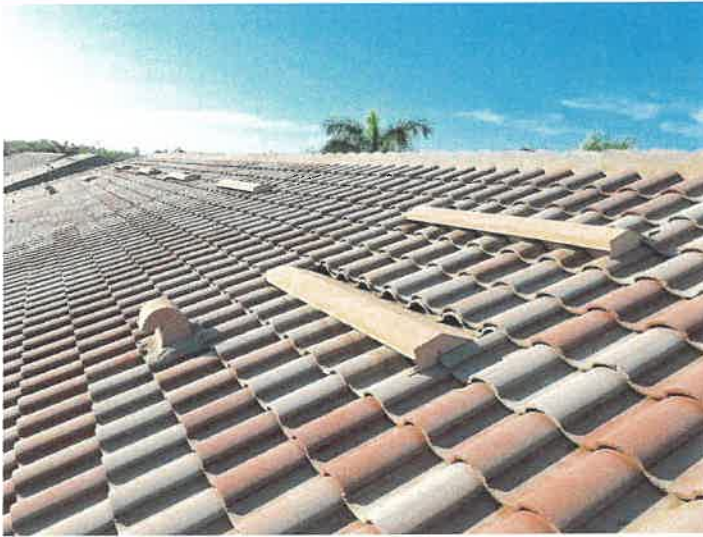
Building 15157: Roof Vents
Roof vents appear to be in good condition.

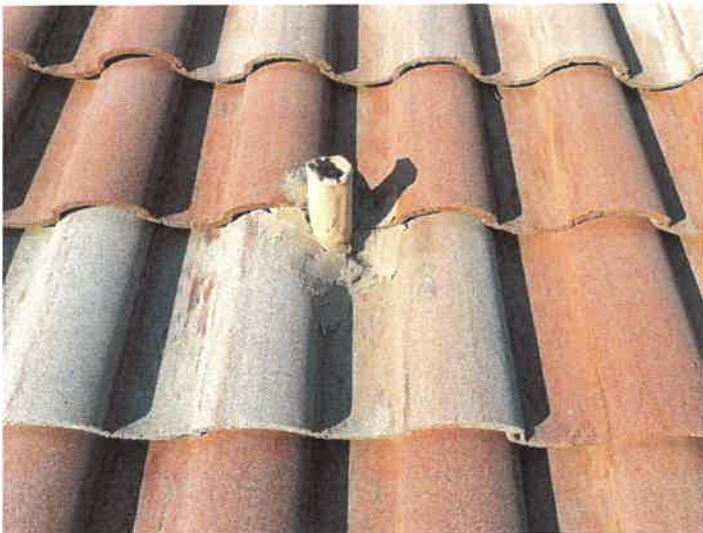
Building 15157: Lead Boots
Lead boots appear to be in good condition.

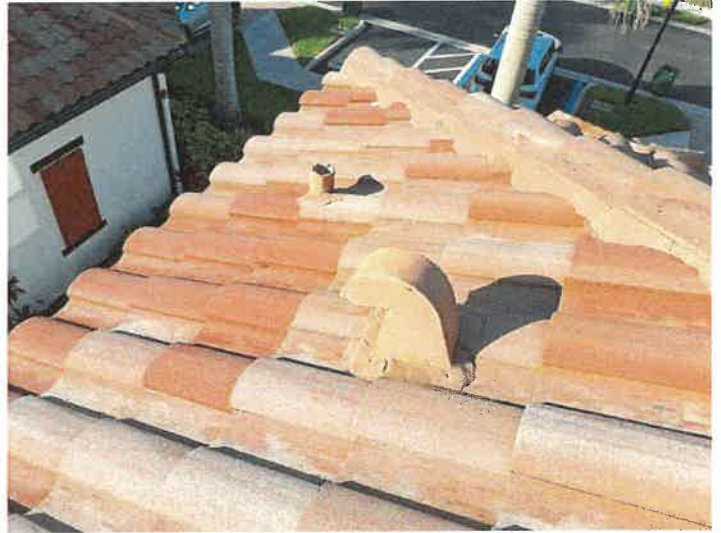
Building 15157: Lead Boots
Lead boots appear to be in good condition.

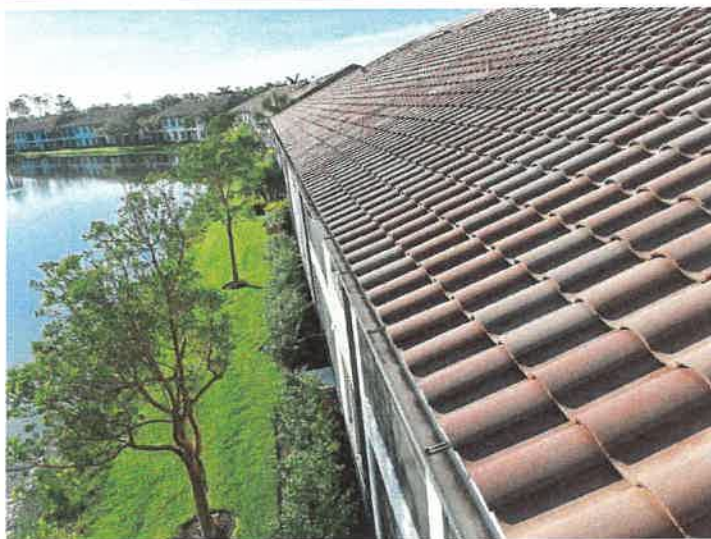
Building 15157: Gutters

The gutters appear to be in good condition.

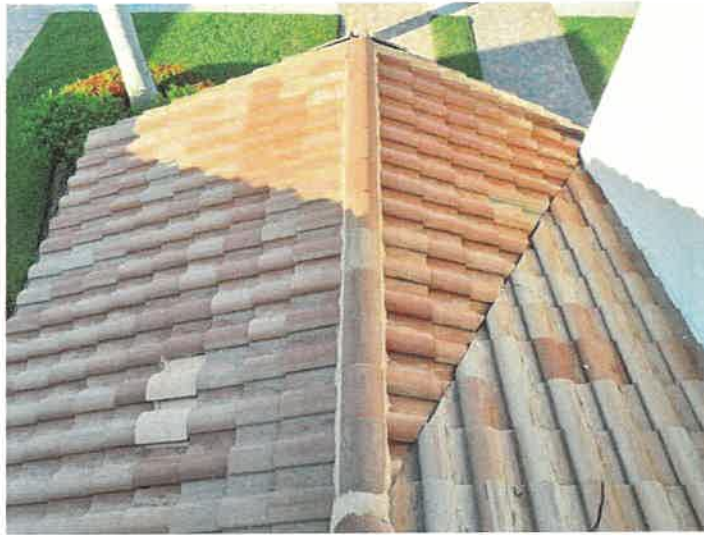
Building 15157: Surface Overview - Lower Roof

The roof surface appears to be in good, maintainable condition at this time.

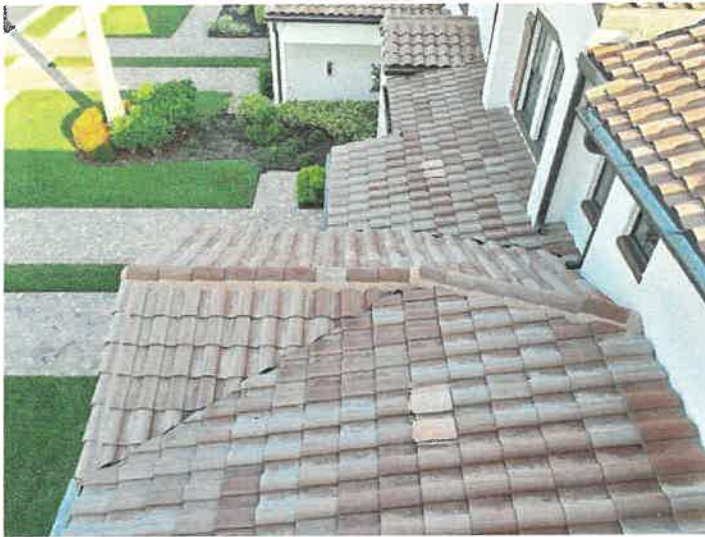
Building 15157: Appearance Overview - Lower Roof

The roof appearance is in good, maintainable condition.

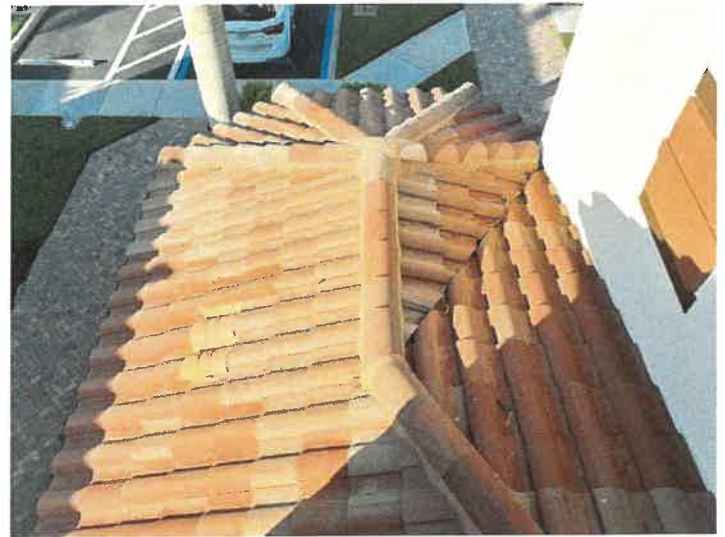
Building 15157: Surface Overview - Lower Roof

The roof surface appears to be in good, maintainable condition at this time.

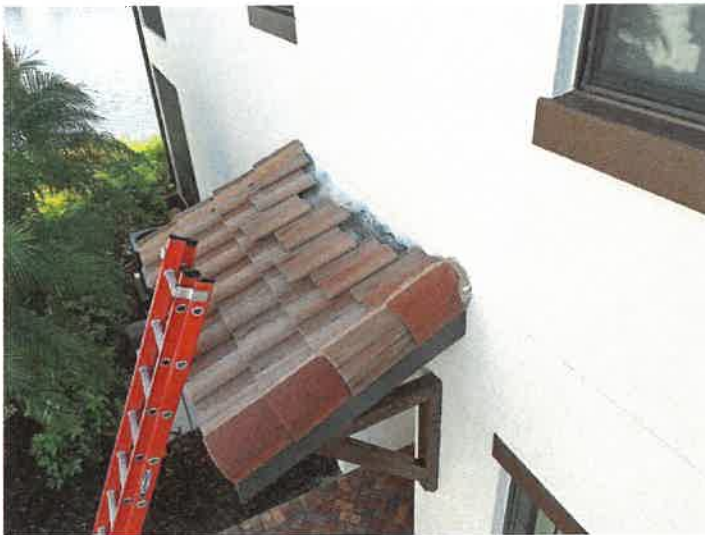
Building 15157: Appearance Overview - Lower Roof

The roof appearance is in good, maintainable condition.

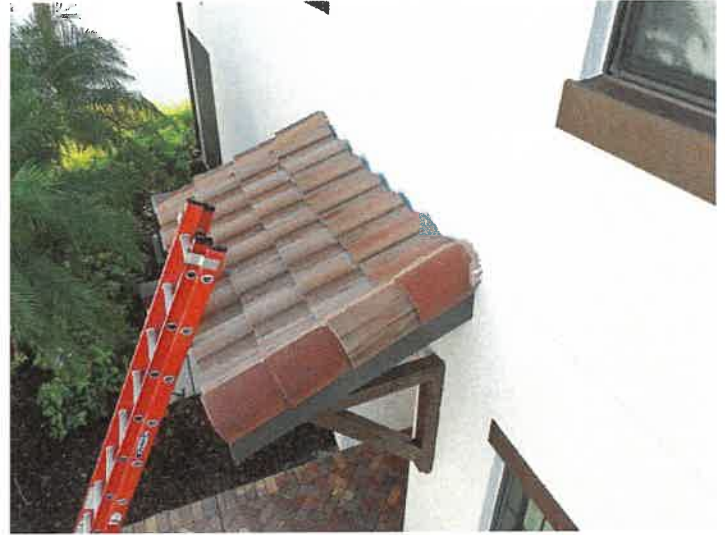
Building 15157: Displaced/Missing Roof Tile

Displaced or missing roof tiles can allow premature underlayment deterioration from excessive UV exposure and potential water intrusion.

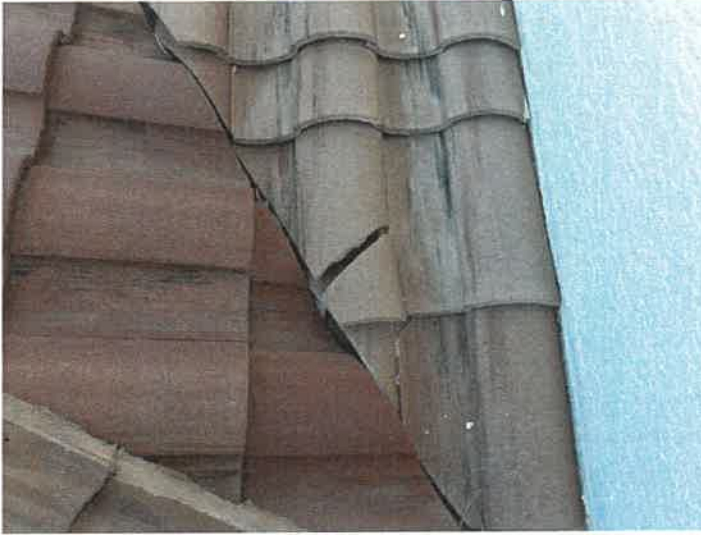
Building 15157: Repaired Displaced/Missing Roof Tile

Replaced and secured the missing roof tile.

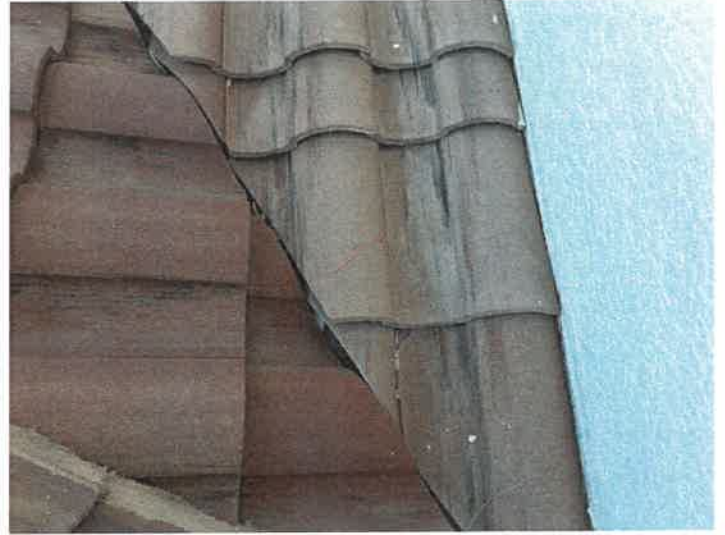
Building 15157: Identified Cracked Roof Tiles

Cracked roof tiles can allow premature underlayment deterioration from excessive UV exposure.

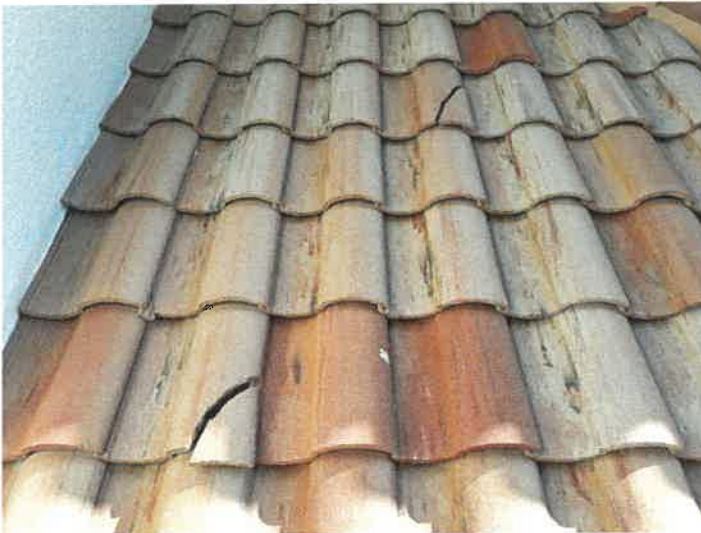
Building 15157: Repaired Cracked Roof Tiles

The cracked roof tiles were repaired with Titebond sealant.

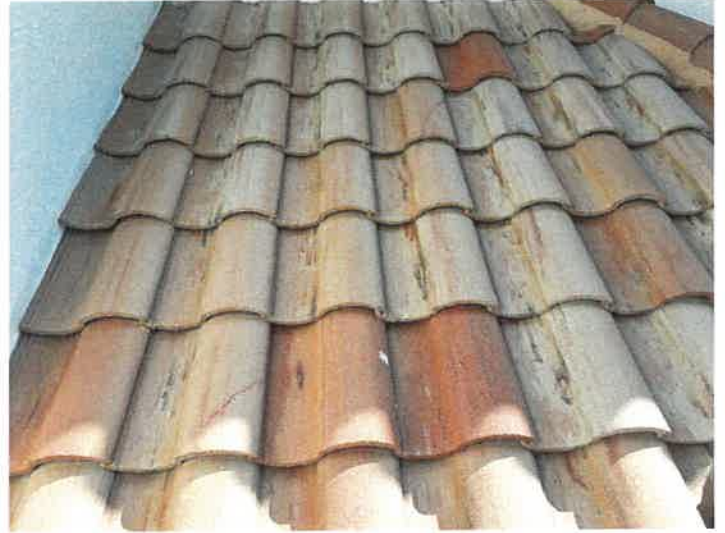
Building 15157: Identified Cracked Roof Tiles

Cracked roof tiles can allow premature underlayment deterioration from excessive UV exposure.

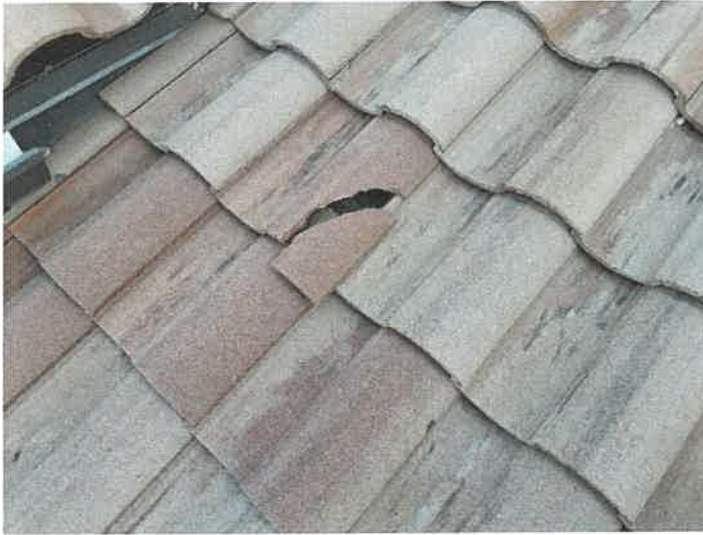
Building 15157: Repaired Cracked Roof Tiles

The cracked roof tiles were repaired with Titebond sealant.

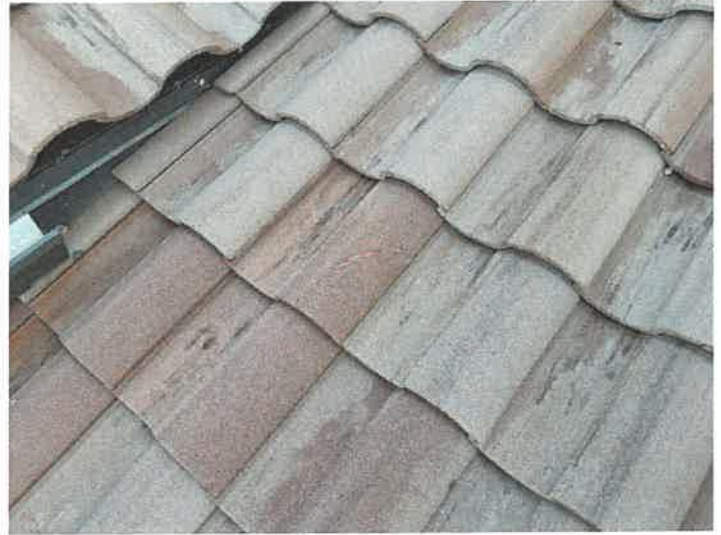
Building 15157: Identified Cracked Roof Tiles
Cracked roof tiles can allow premature underlayment deterioration from excessive UV exposure.

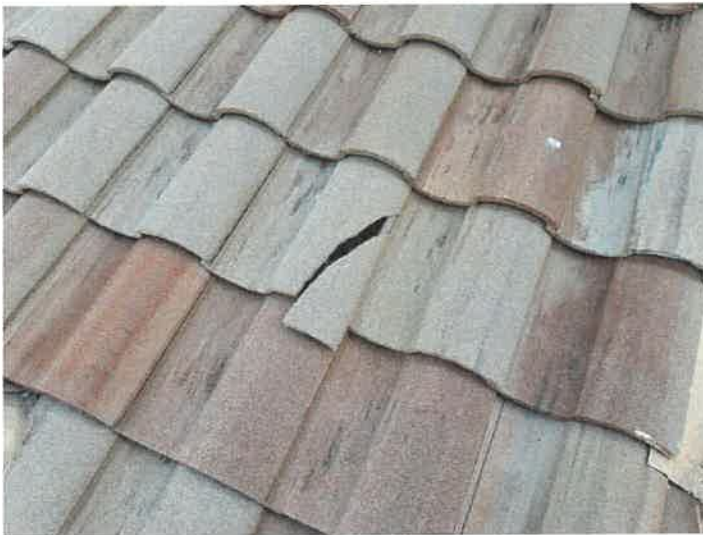
Building 15157: Repaired Cracked Roof Tiles
The cracked roof tiles were repaired with Titebond sealant.

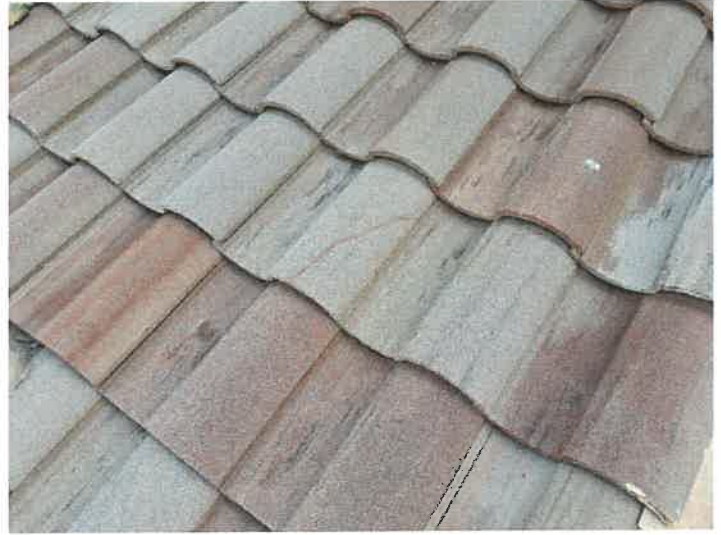
Building 15157: Identified Cracked Roof Tiles
Cracked roof tiles can allow premature underlayment deterioration from excessive UV exposure.

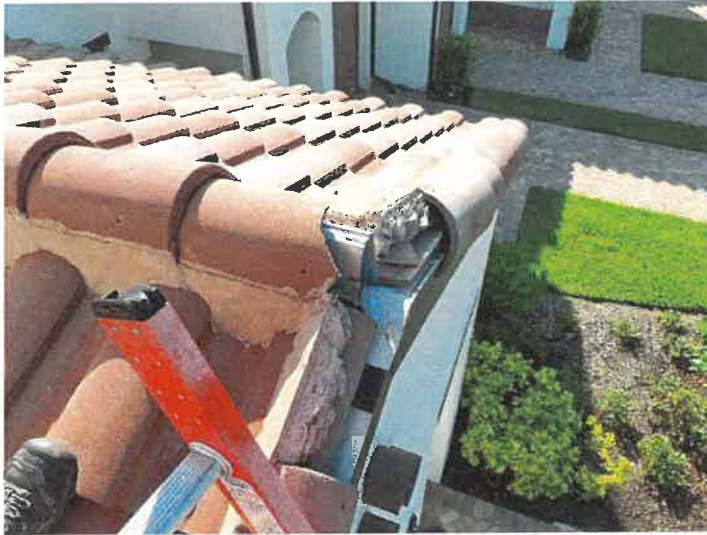
Building 15157: Repaired Cracked Roof Tiles
The cracked roof tiles were repaired with Titebond sealant.

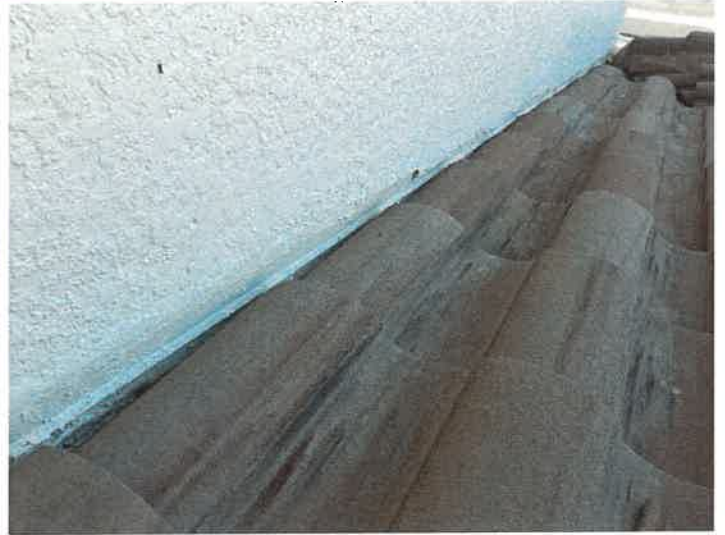
Building 15157: Cracked/Missing Ridge Tiles
Crowther Roofing suggests replacing three (3) ridge tiles.

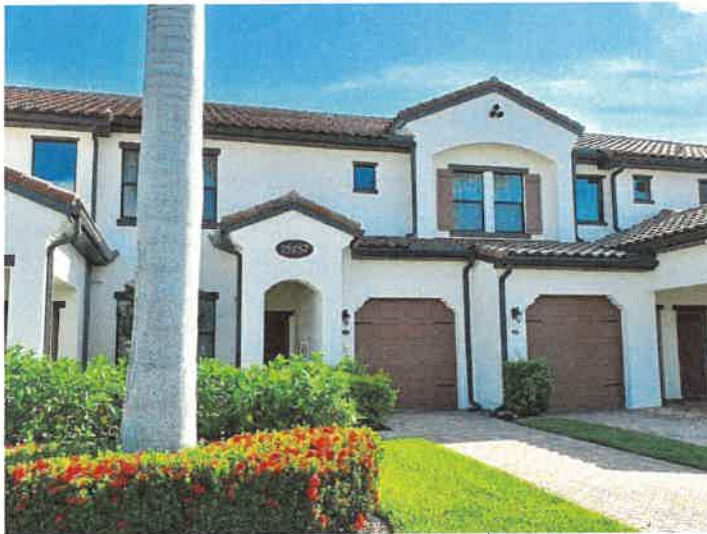
Building 15157: Counter Flashings
The counter flashing appears to be in good condition.

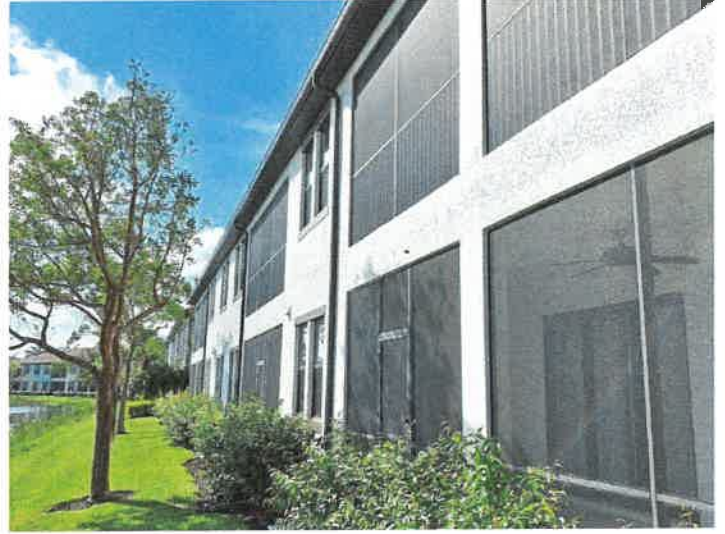
Building 15157: Downspouts
The downspouts appear to be in good condition.
