Inspection Report

Facility: Livingston Lakes Condo
Address: 15098 Palmer Lake Circle,
Naples, FL 34109

Work Order #: 13028

Re.: Inspection Report (2 of 3) for Livingston Lakes

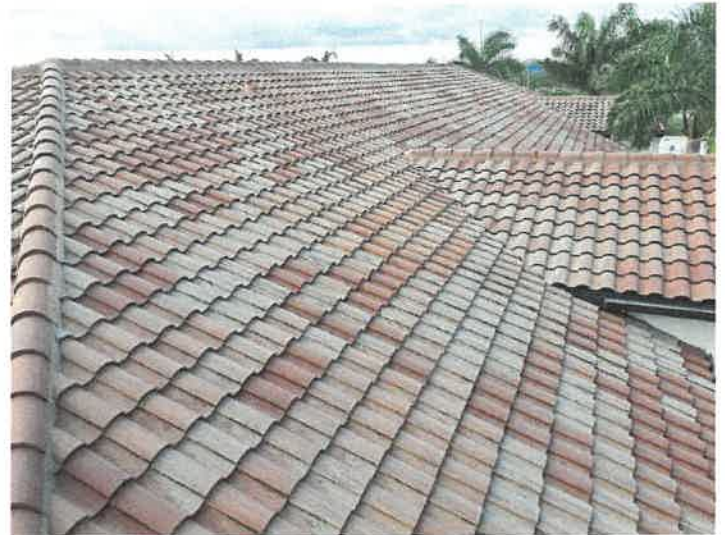
Building 15098: Surface Overview
The roof surface appears to be in good, maintainable condition at this time.

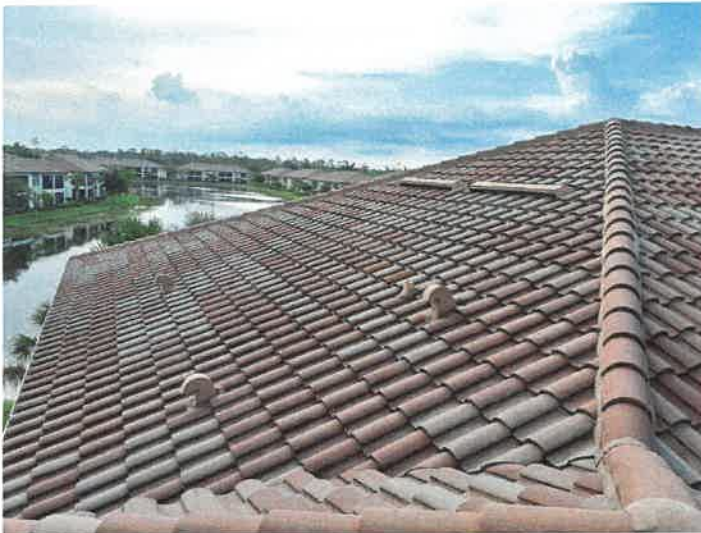
Building 15098: Appearance Overview
The roof appearance is in good, maintainable condition.

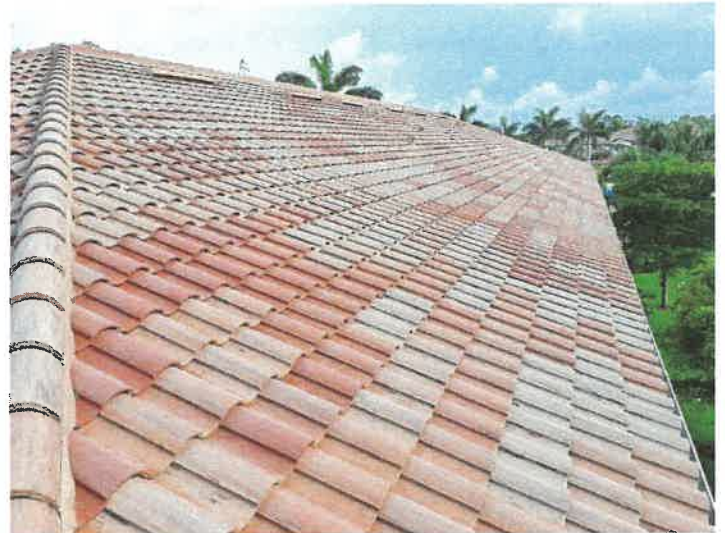
Building 15098: Surface Overview
The roof surface appears to be in good, maintainable condition at this time.

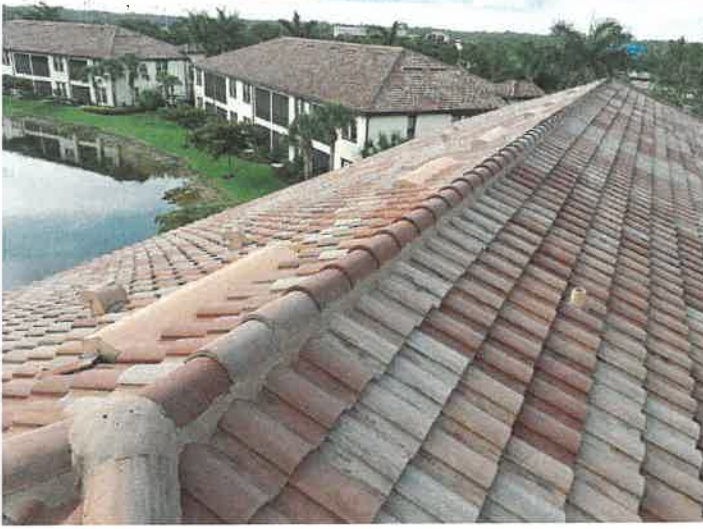
Building 15098: Ridge Tiles

Ridge tiles appear to be in good condition.

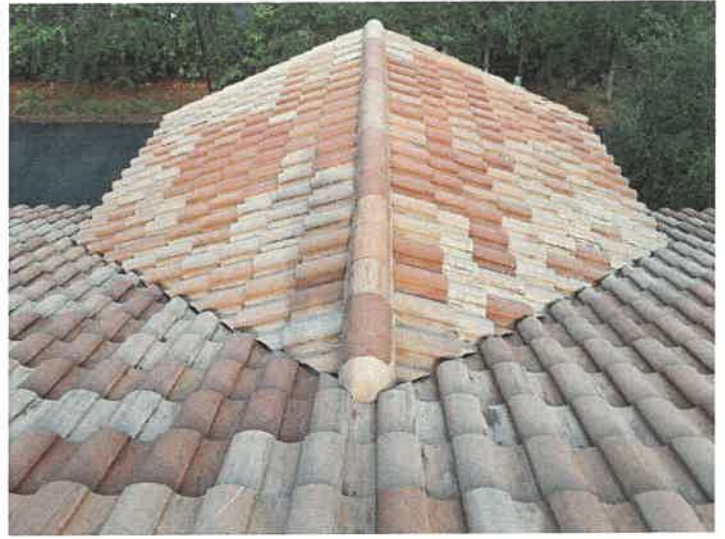
Building 15098: Valley

The valley tiles appear to be in good condition.

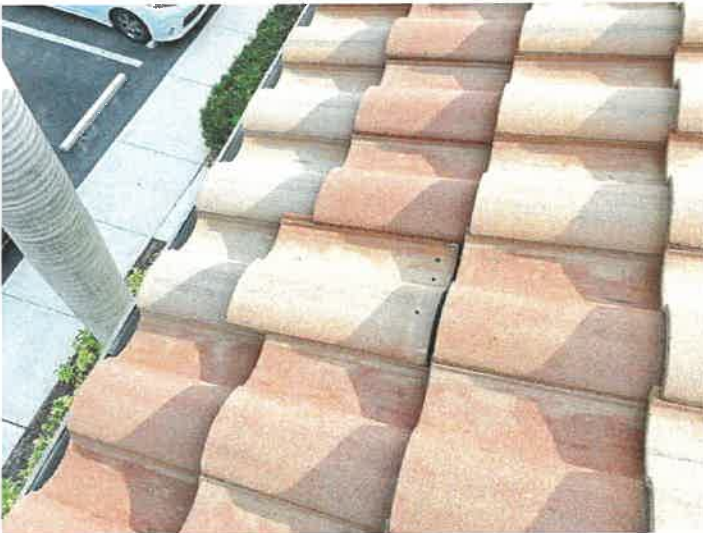
Building 15098: Displaced/Missing Roof Tile

Displaced or missing roof tiles can allow premature underlayment deterioration from excessive UV exposure and potential water intrusion.

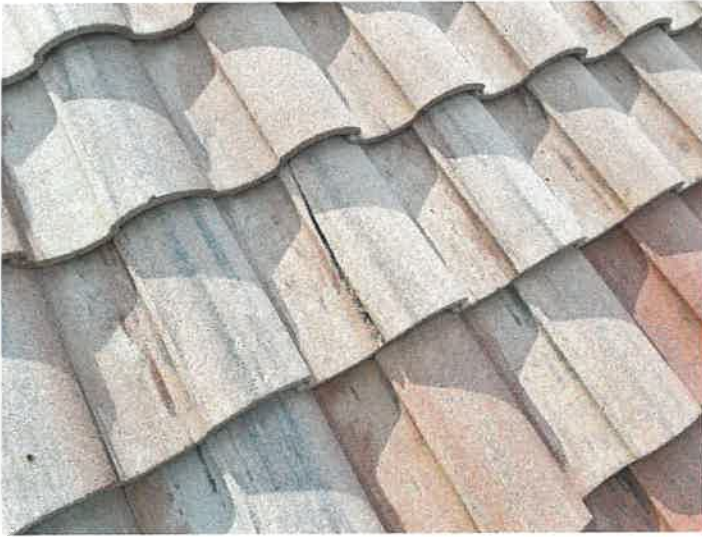
Building 15098: Identified Cracked Roof Tiles

Cracked roof tiles can allow premature underlayment deterioration from excessive UV exposure.

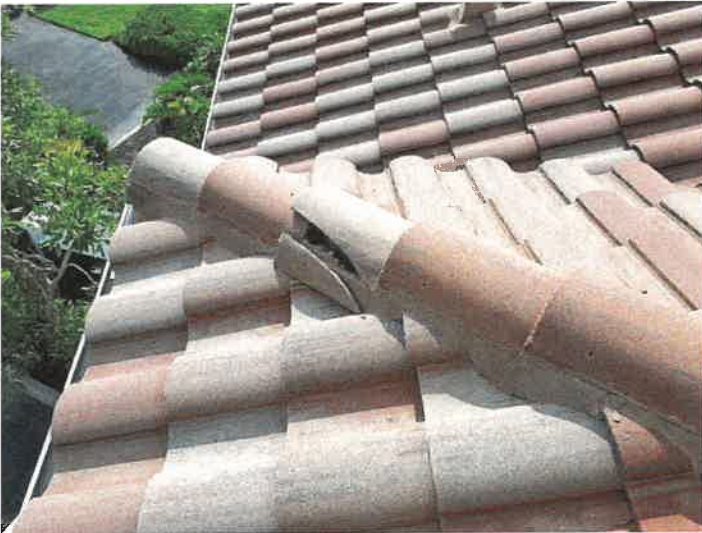
Building 15098: Identified Cracked Roof Tiles

Cracked roof tiles can allow premature underlayment deterioration from excessive UV exposure.

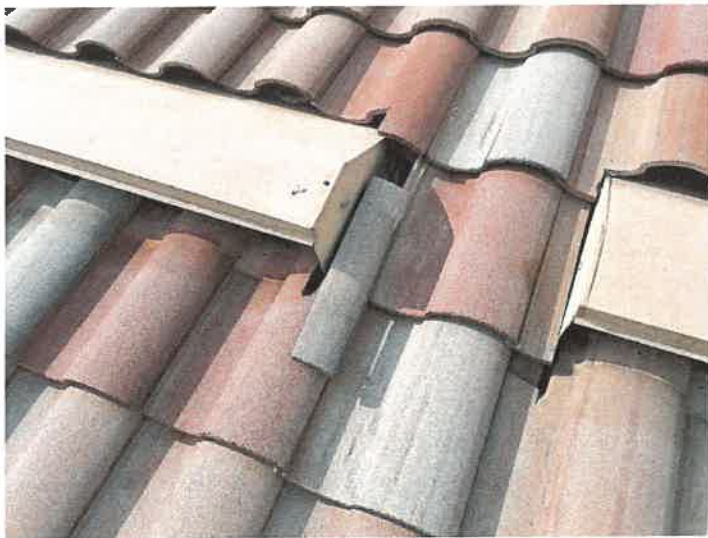
Building 15098: Displaced/Missing Roof Tile

Displaced or missing roof tiles can allow premature underlayment deterioration from excessive UV exposure and potential water intrusion.

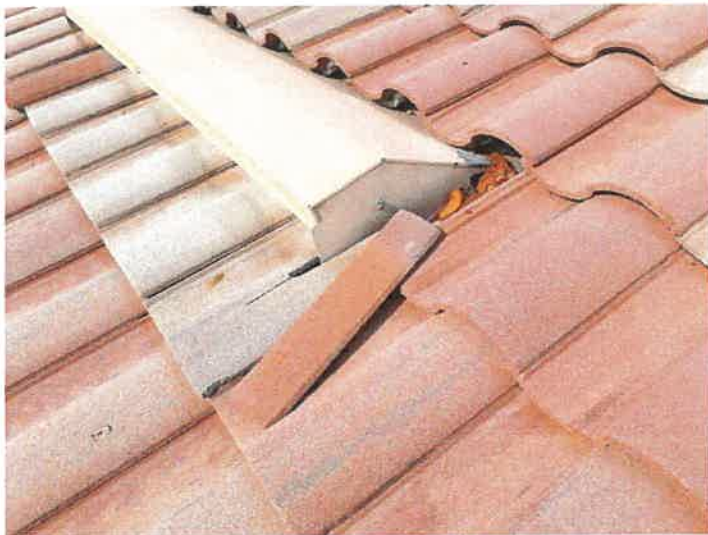
Building 15098: Displaced/Missing Roof Tile

Displaced or missing roof tiles can allow premature underlayment deterioration from excessive UV exposure and potential water intrusion.

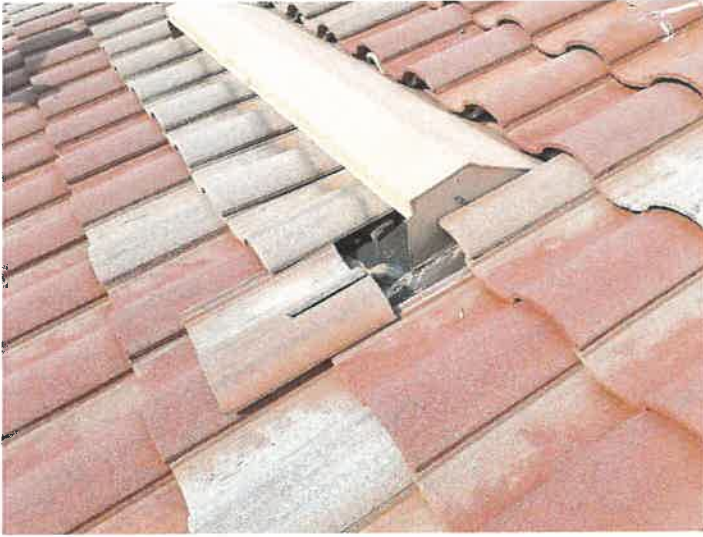
Building 15098: Displaced/Missing Roof Tile

Displaced or missing roof tiles can allow premature underlayment deterioration from excessive UV exposure and potential water intrusion.

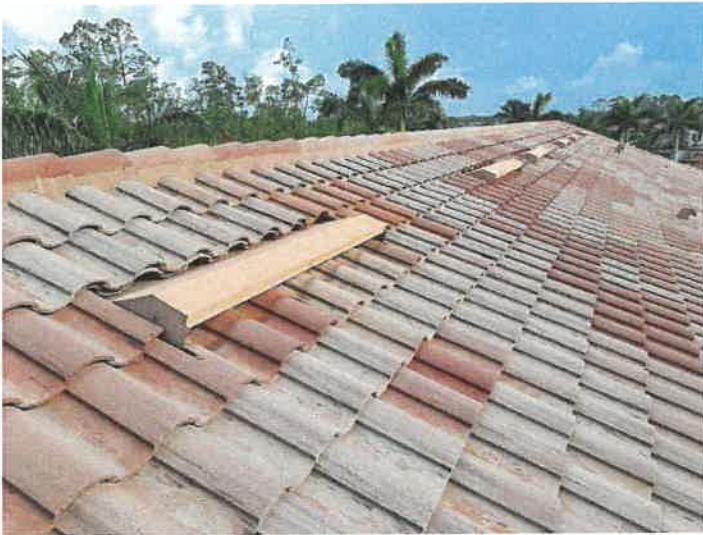
Building 15098: Roof Vents

Roof vents appear to be in good condition.

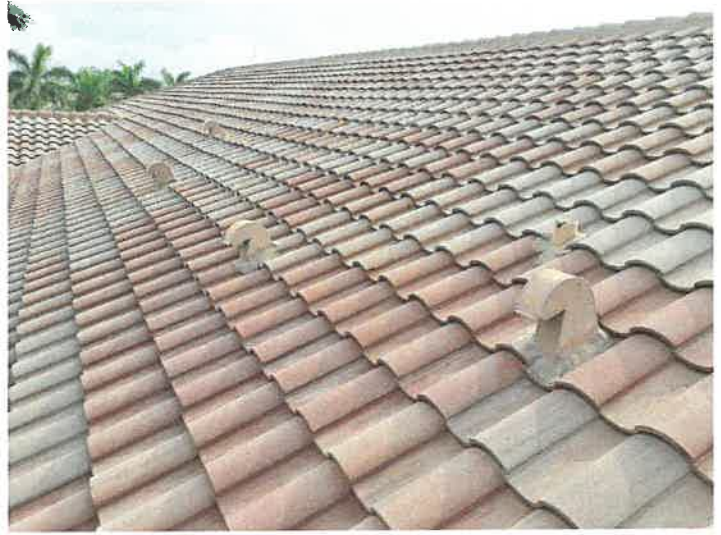
Building 15098: Roof Vents

Roof vents appear to be in good condition.

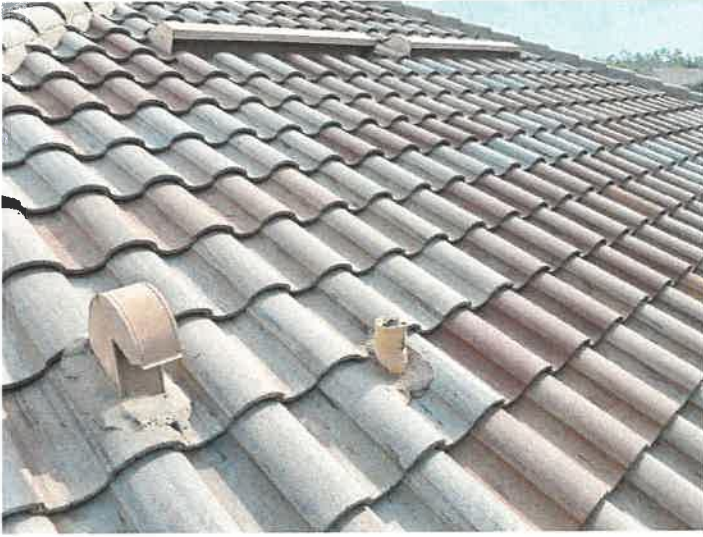
Building 15098: Lead Boots
Lead boots appear to be in good condition.

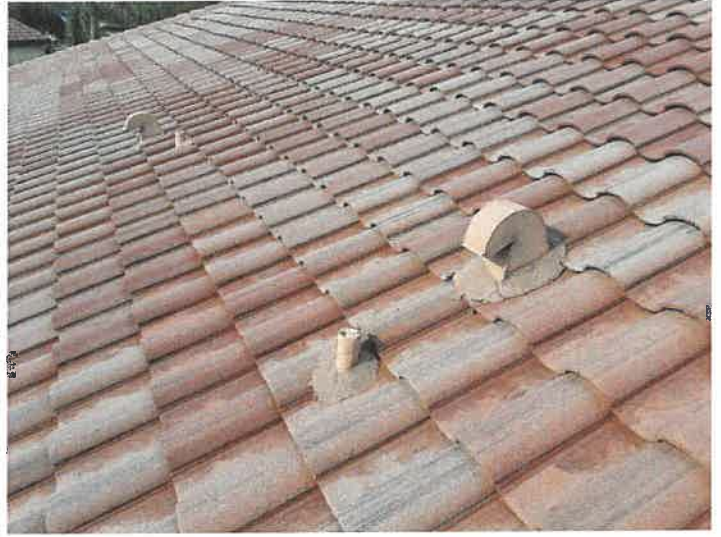
Building 15098: Lead Boots
Lead boots appear to be in good condition.

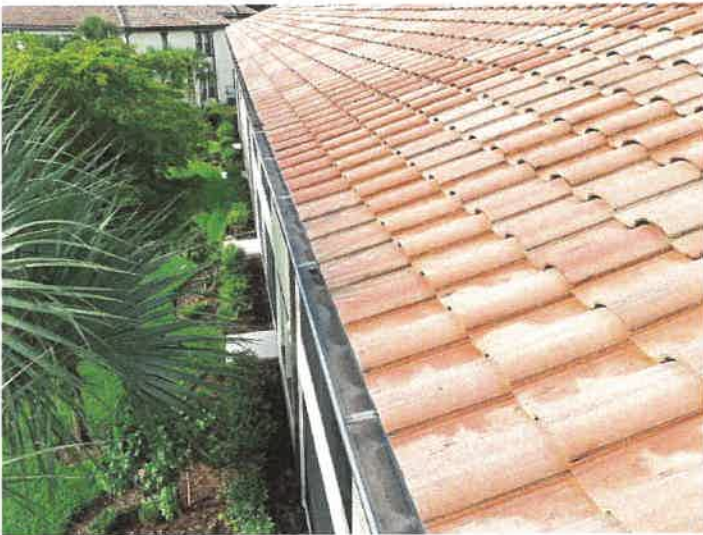
Building 15098: Gutters
The gutters appear to be in good condition.

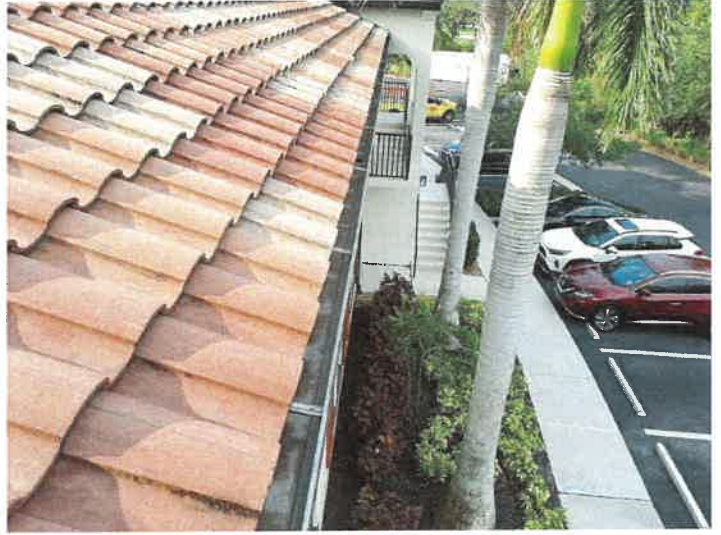
Building 15098: Gutters
The gutters appear to be in good condition.

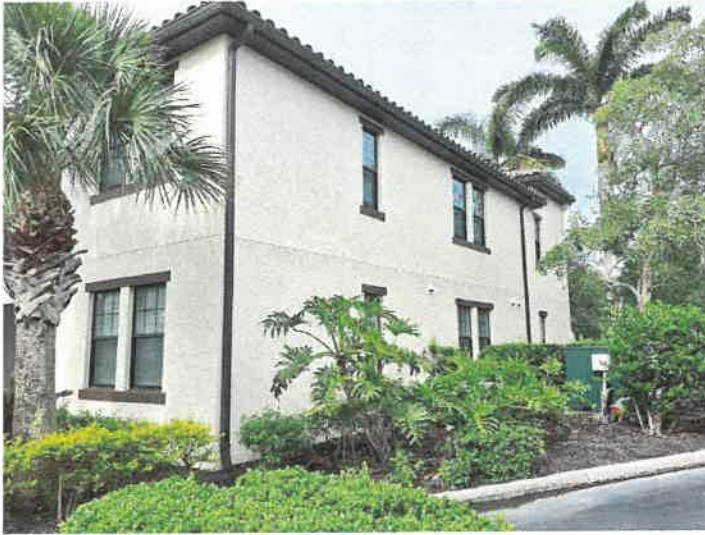
Building 15098: Downspouts
The downspouts appear to be in good condition.

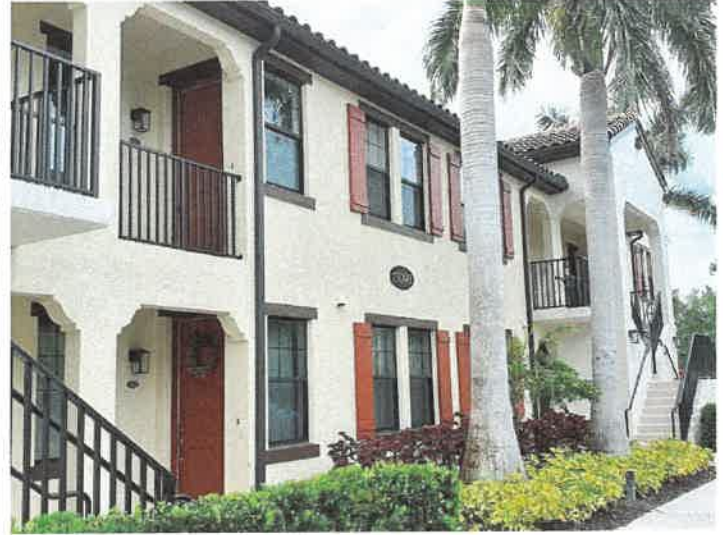
Building 15098: Downspouts
The downspouts appear to be in good condition.

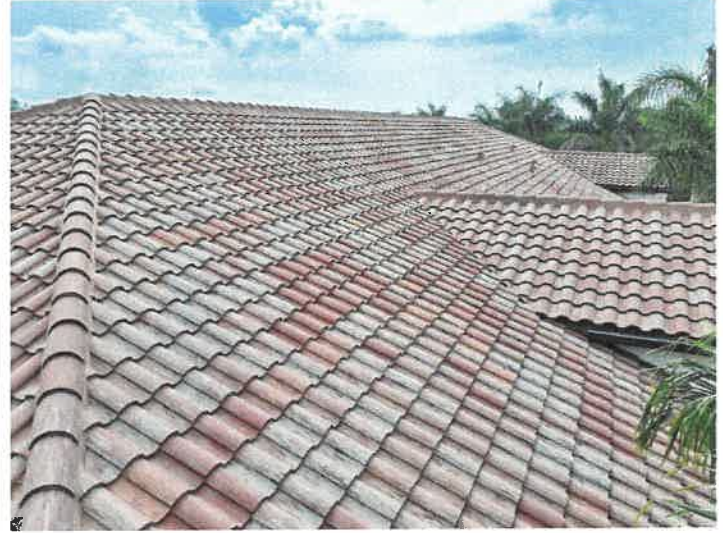
Building 15102: Surface Overview
The roof surface appears to be in good, maintainable condition at this time.

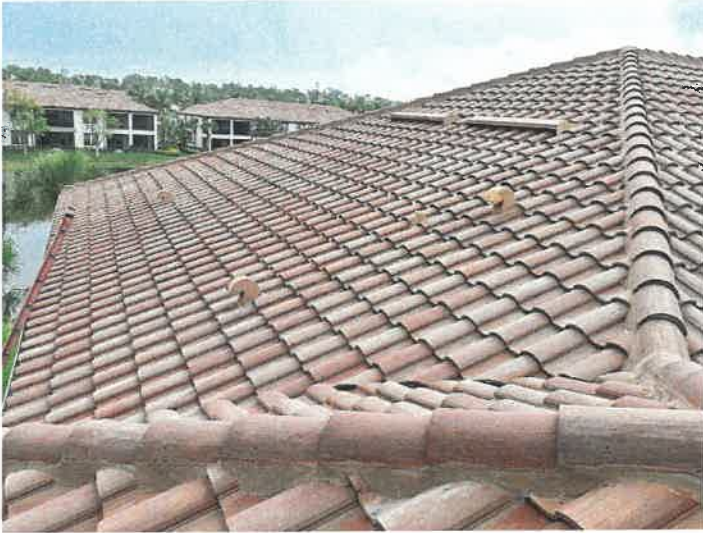
Building 15102: Appearance Overview

The roof appearance is in good, maintainable condition.

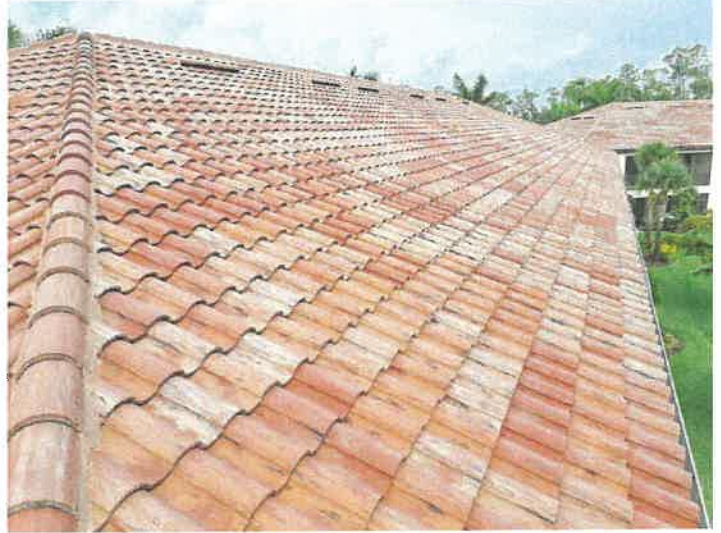
Building 15102: Surface Overview

The roof surface appears to be in good, maintainable condition.

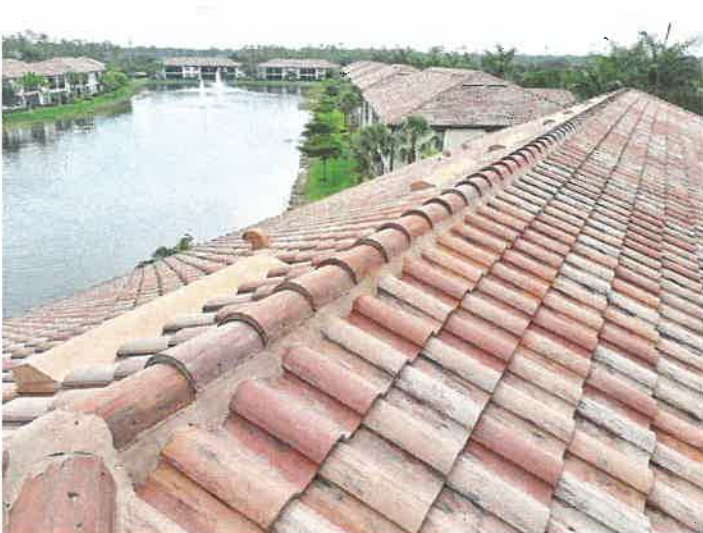
Building 15102: Ridge Tiles

Ridge tiles appear to be in good condition.

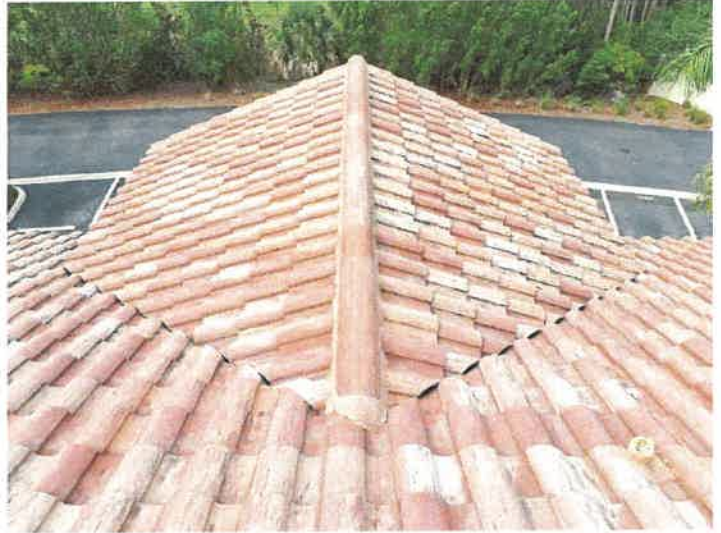
Building 15102: Valley

The valley tiles appear to be in good condition.

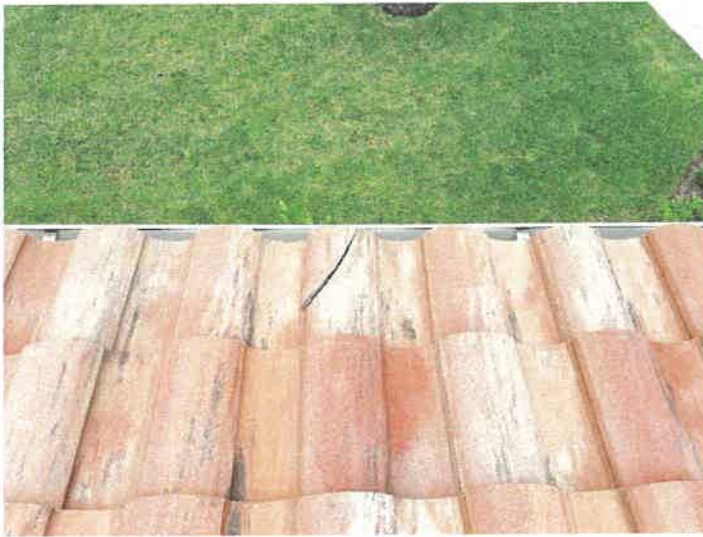
Building 15102: Identified Cracked Roof Tiles

Cracked roof tiles can allow premature underlayment deterioration from excessive UV exposure.

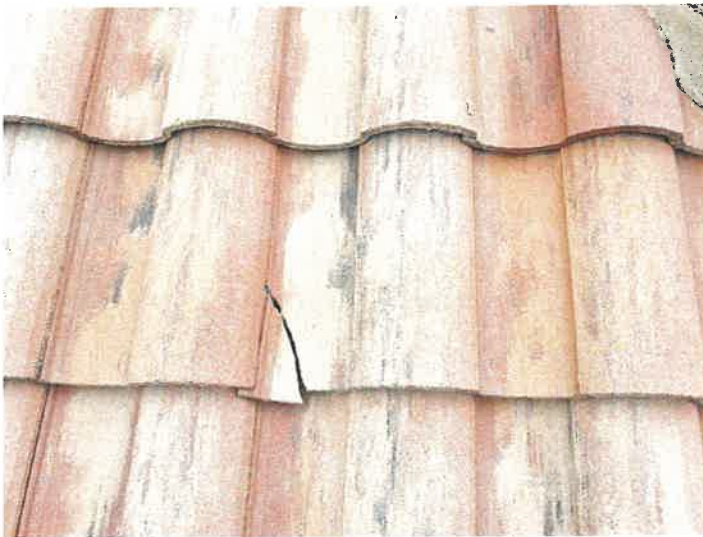
Building 15102: Identified Cracked Roof Tiles

Cracked roof tiles can allow premature underlayment deterioration from excessive UV exposure.

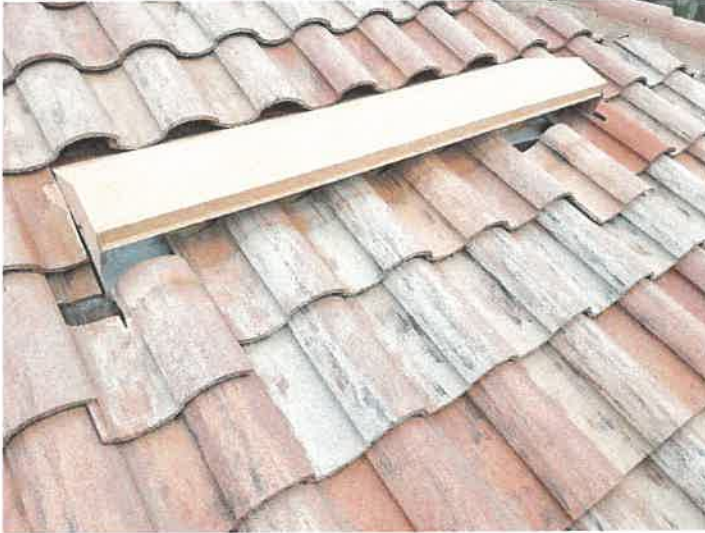
Building 15102: Displaced/Missing Roof Tile

Displaced or missing roof tiles can allow premature underlayment deterioration from excessive UV exposure and potential water intrusion.

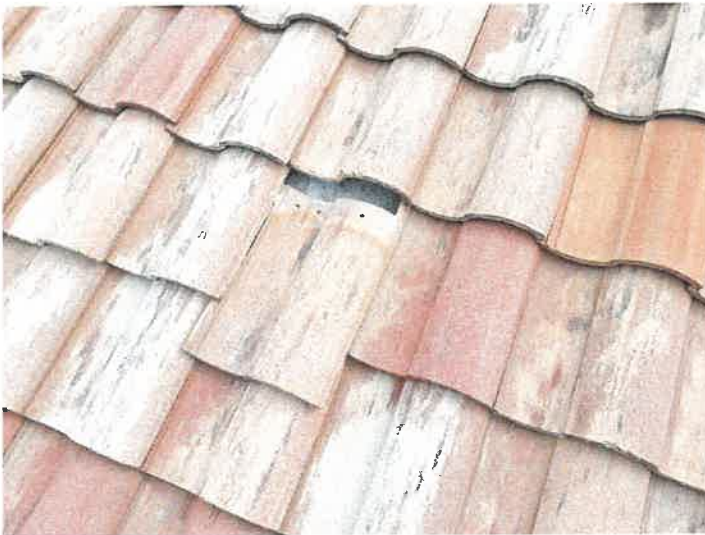
Building 15102: Displaced/Missing Roof Tile

Displaced or missing roof tiles can allow premature underlayment deterioration from excessive UV exposure and potential water intrusion.

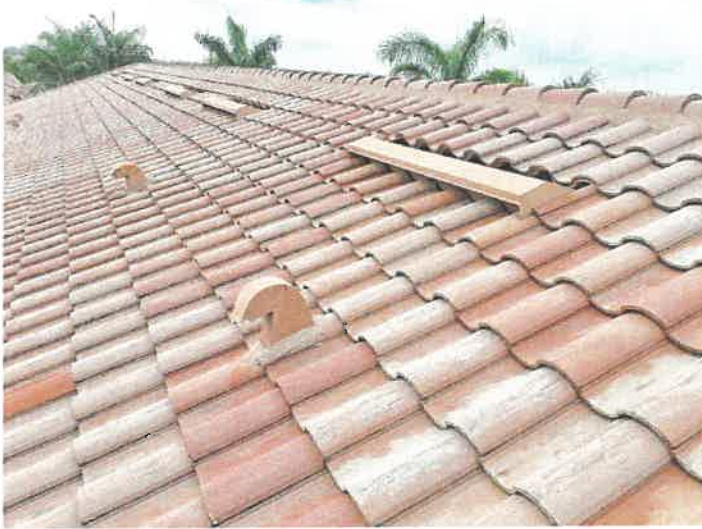
Building 15102: Roof Vents
Roof vents appear to be in good condition.

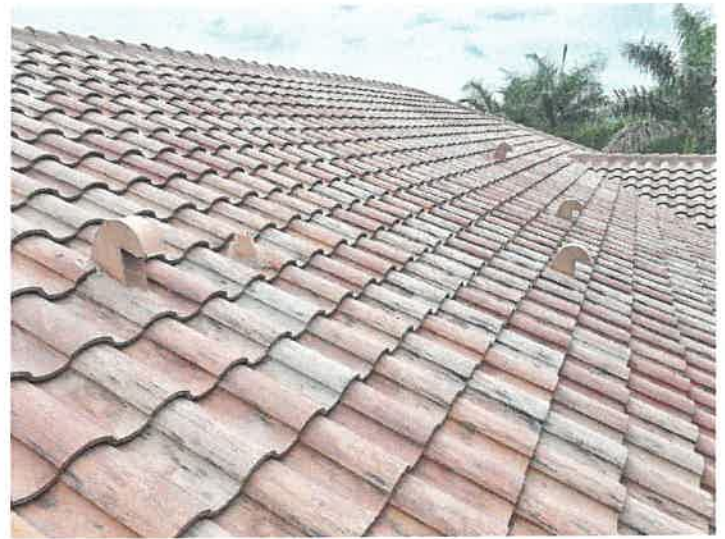
Building 15102: Roof Vents
Roof vents appear to be in good condition.

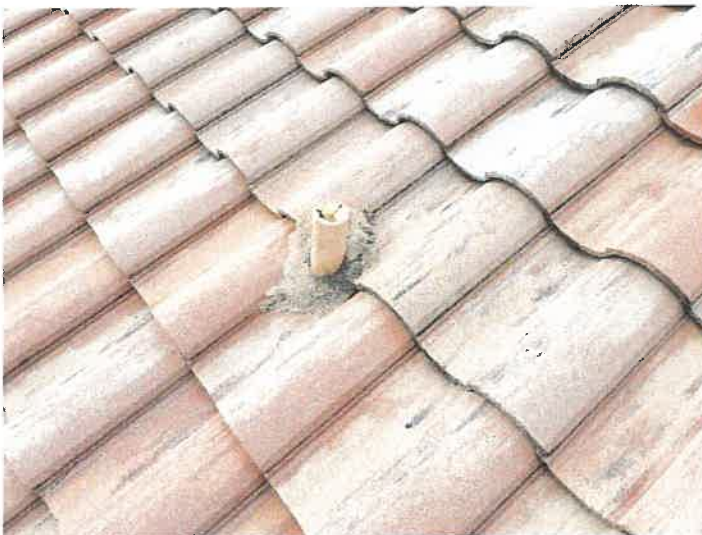
Building 15102: Lead Boots
Lead boots appear to be in good condition.

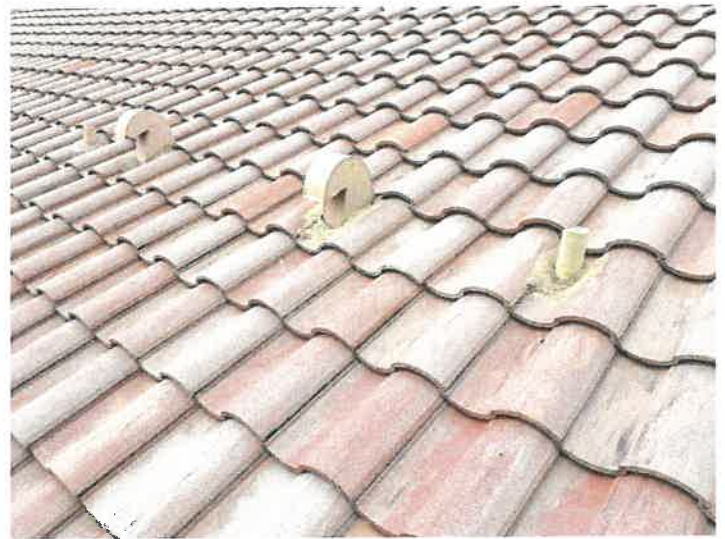
Building 15102: Lead Boots
Lead boots appear to be in good condition.

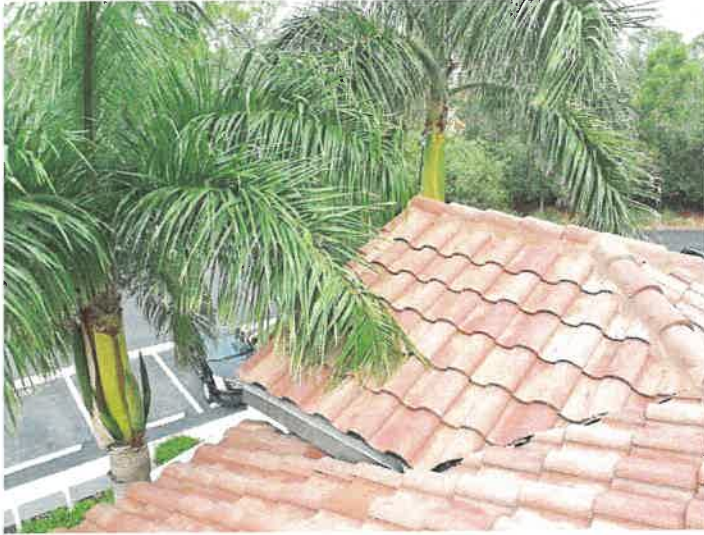
Building 15102: Tree Branches

Identified tree branches hanging over the roof surface. Branches on the roof surface can cause deterioration of membrane, and act as an access for rodents and unwanted bugs/pests.

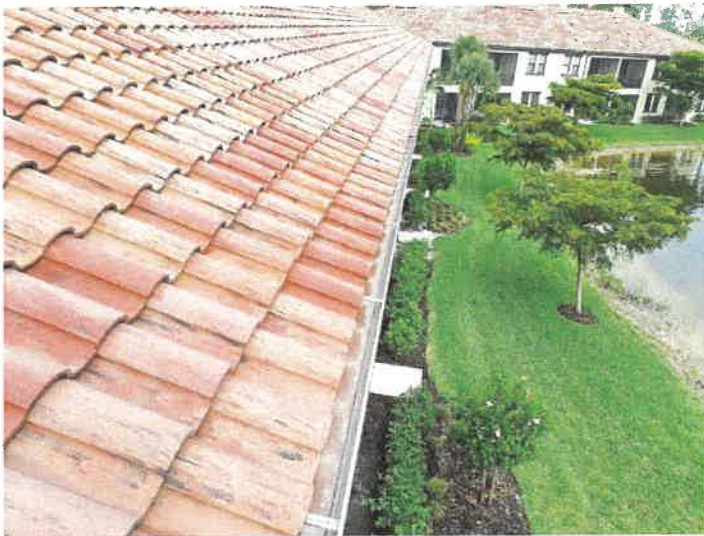
Building 15102: Gutters

The gutters appear to be in good condition.

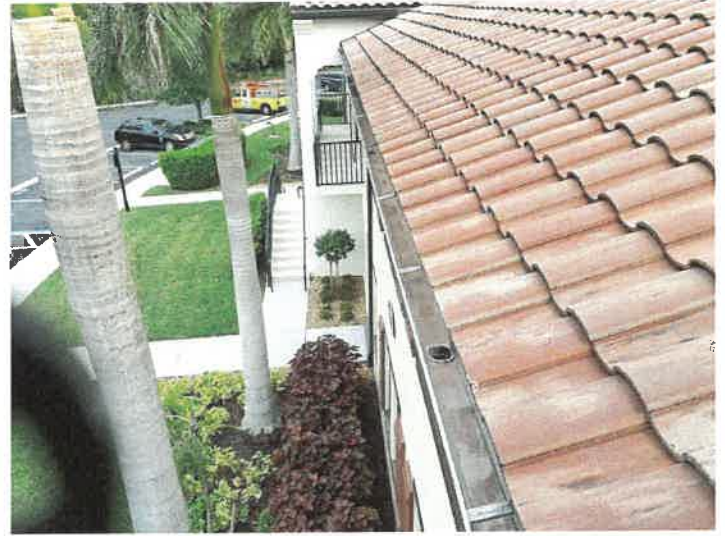
Building 15102: Gutters

The gutters appear to be in good condition.

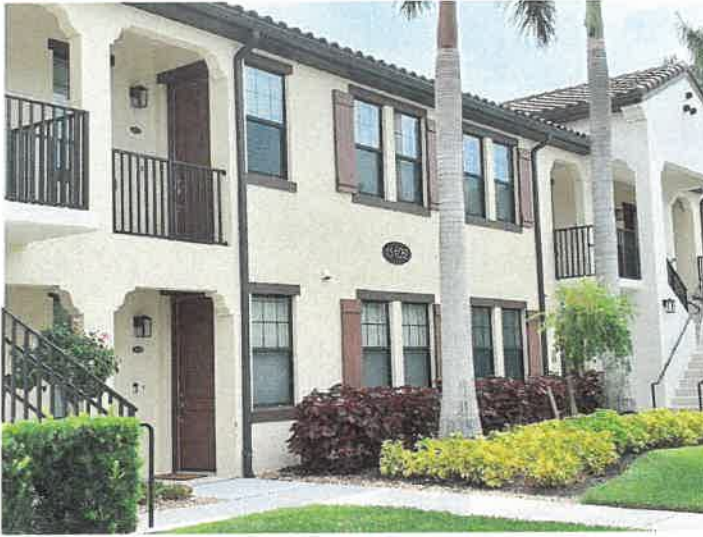
Building 15102: Downspouts

The downspouts appear to be in good condition.

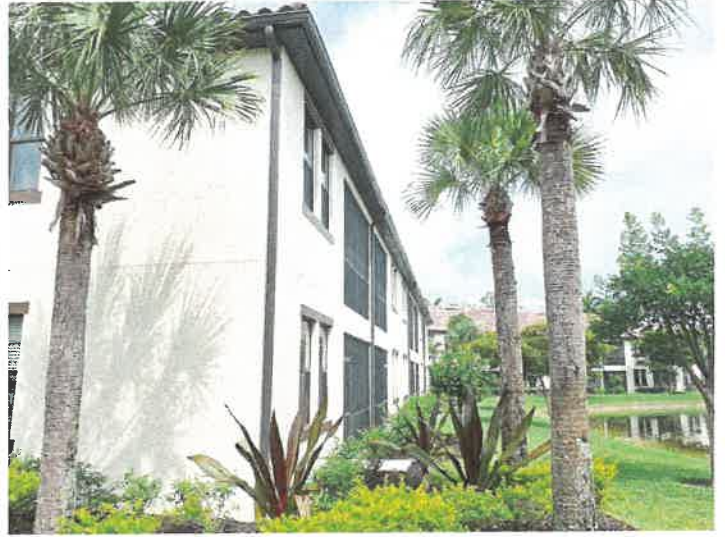
Building 15102: Downspouts

The downspouts appear to be in good condition.

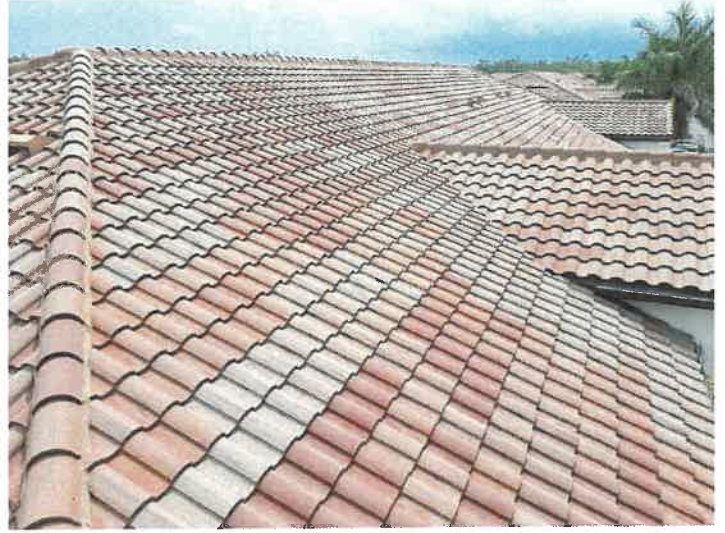
Building 15106: Surface Overview

The roof surface appears to be in good, maintainable condition at this time.

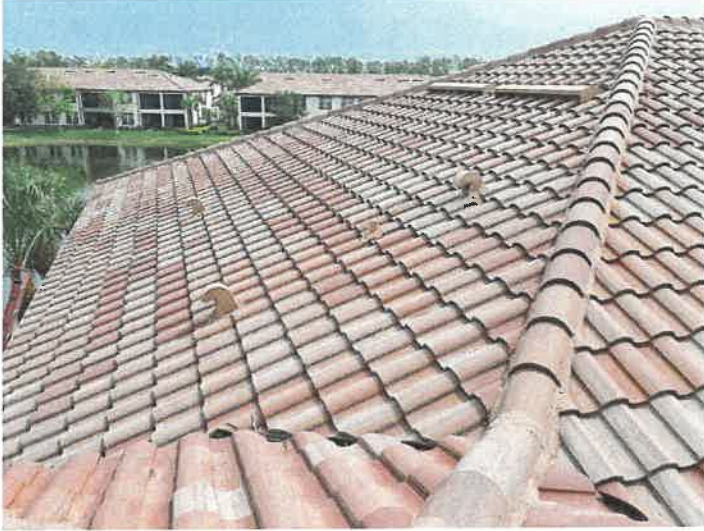
Building 15106: Appearance Overview

The roof appearance is in good, maintainable condition.

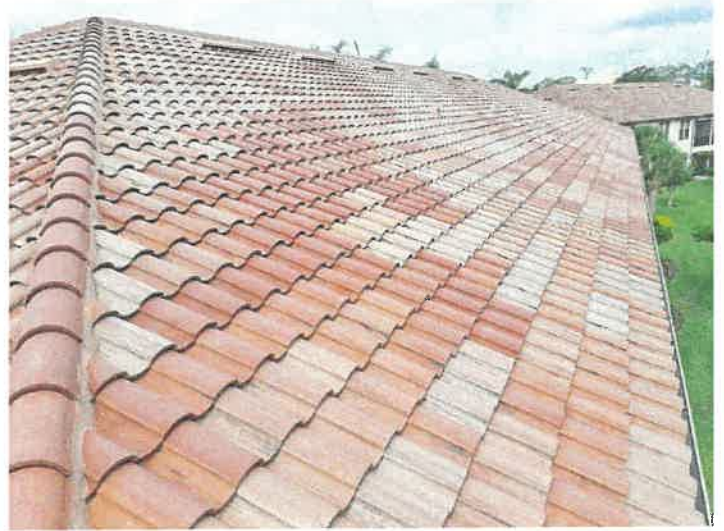
Building 15106: Appearance Overview

The roof appearance is in good, maintainable condition.

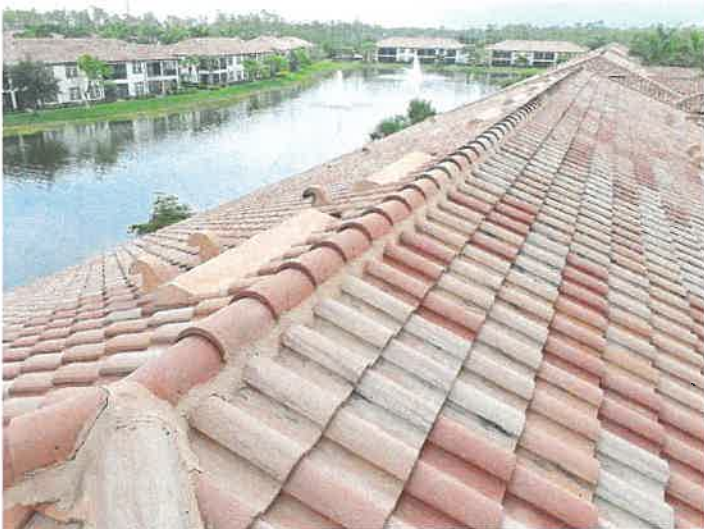
Building 15106: Ridge Tiles

Ridge tiles appear to be in good condition.

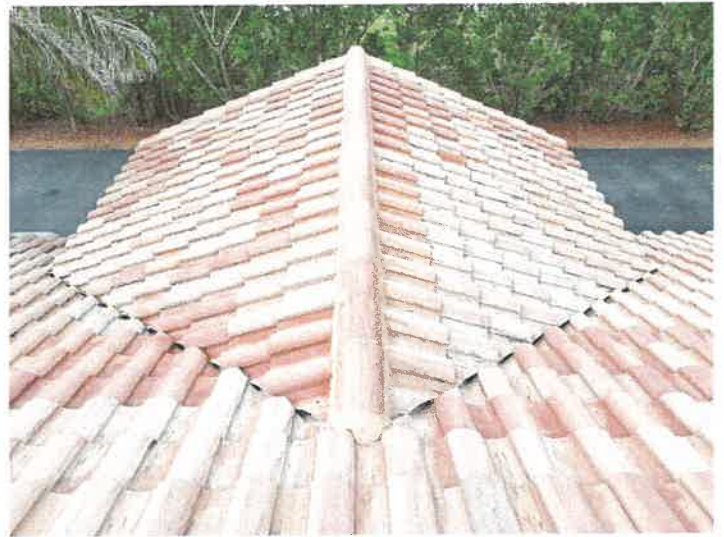
Building 15106: Valley

The valley tiles appear to be in good condition.

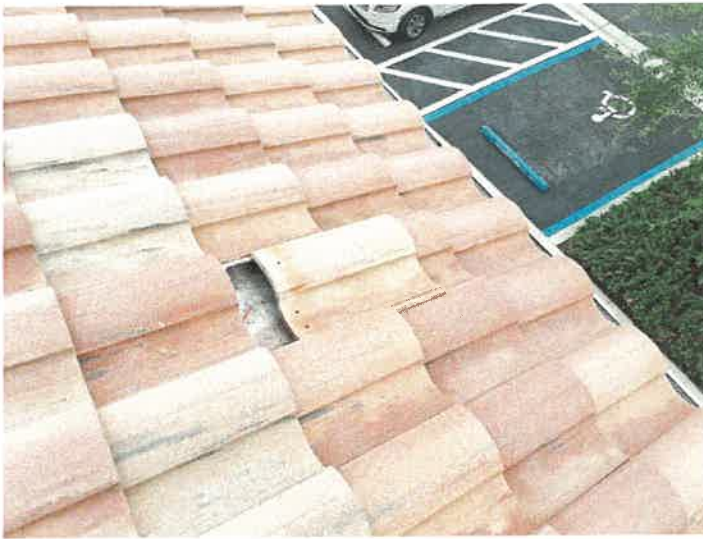
Building 15106: Displaced/Missing Roof Tile

Displaced or missing roof tiles can allow premature underlayment deterioration from excessive UV exposure and potential water intrusion.

Replaced and secured the missing roof tile.

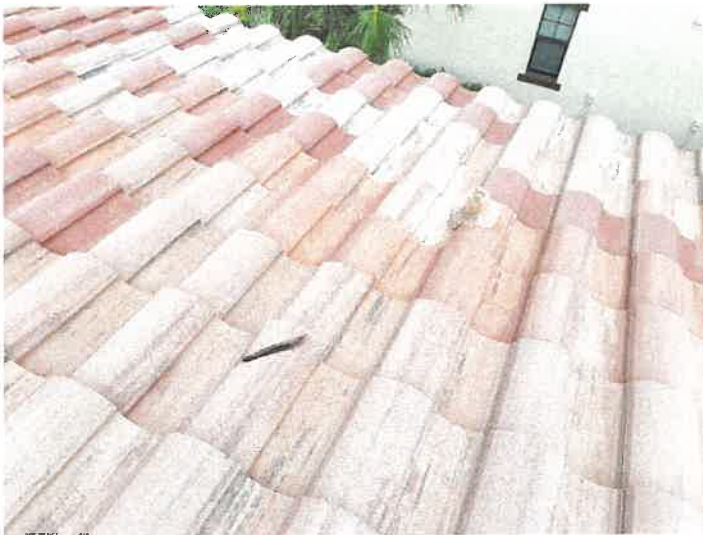
Building 15106: Identified Cracked Roof Tiles

Cracked roof tiles can allow premature underlayment deterioration from excessive UV exposure.

The cracked roof tiles were repaired with Titebond sealant.

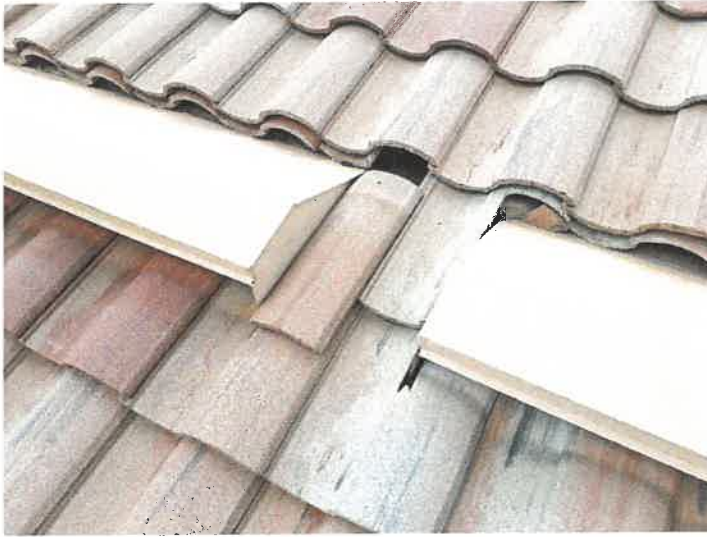
Building 15106: Displaced/Missing Roof Tile

Displaced or missing roof tiles can allow premature underlayment deterioration from excessive UV exposure and potential water intrusion.

Replaced and secured the missing roof tile.

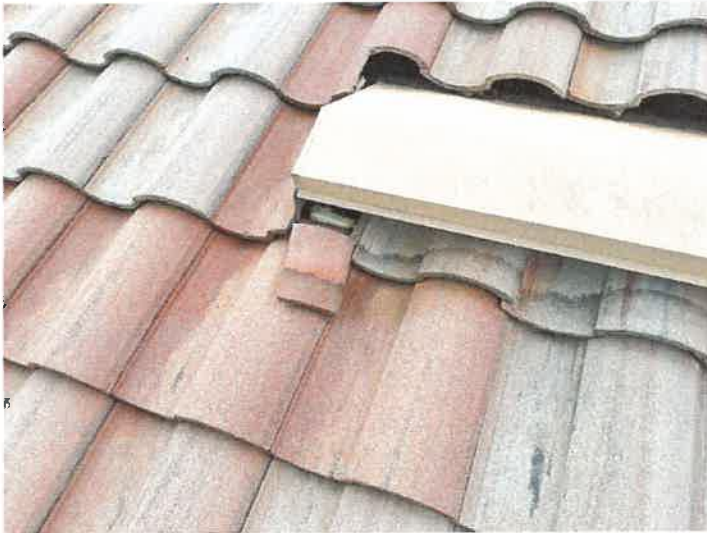
Building 15106: Displaced/Missing Roof Tile

Displaced or missing roof tiles can allow premature underlayment deterioration from excessive UV exposure and potential water intrusion.

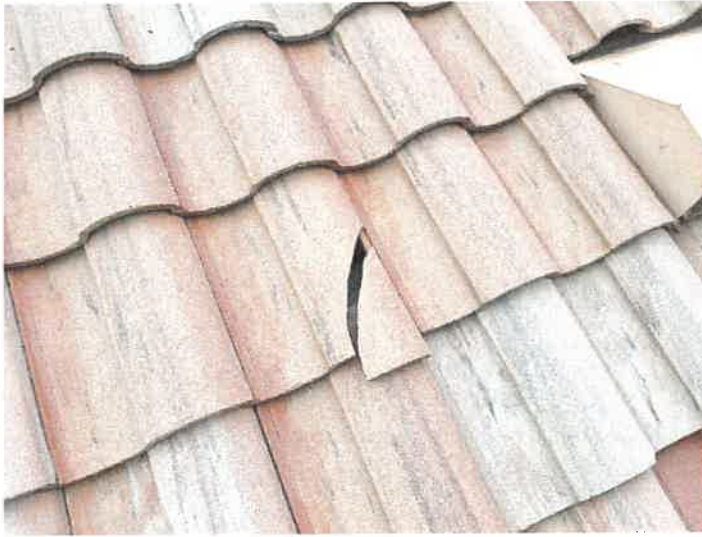
Building 15106: Identified Cracked Roof Tiles
Cracked roof tiles can allow premature underlayment deterioration from excessive UV exposure.

Building 15106: Repaired Cracked Roof Tiles
The cracked roof tiles were repaired with Titebond sealant.

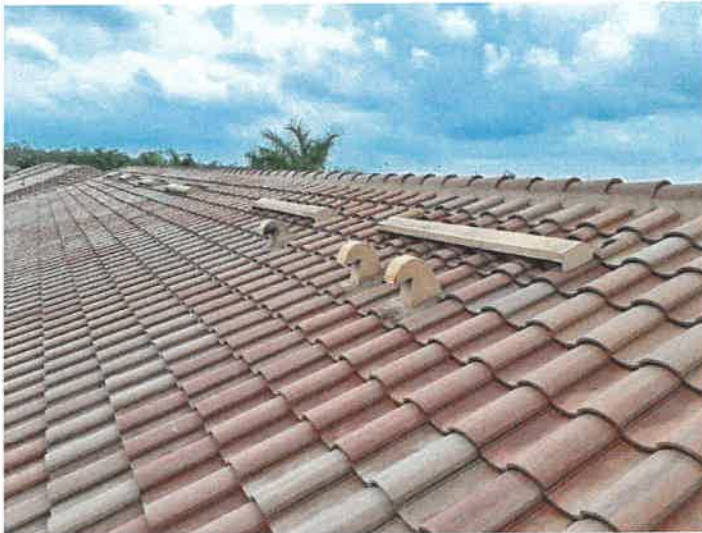
Building 15106: Roof Vents
Roof vents appear to be in good condition.

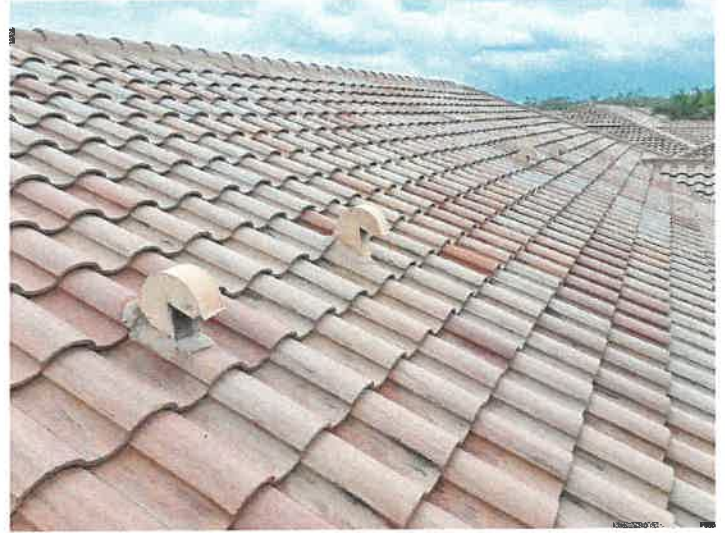
Building 15106: Roof Vents
Roof vents appear to be in good condition.

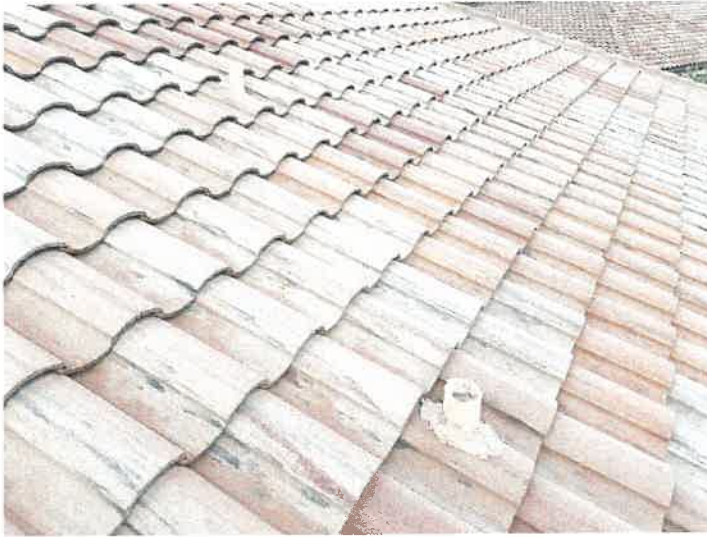
Building 15106: Lead Boots
Lead boots appear to be in good condition.

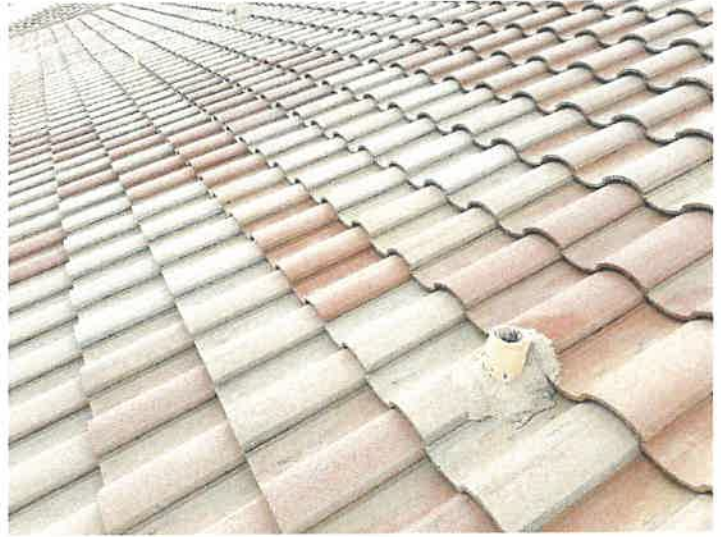
Building 15106: Lead Boots
Lead boots appear to be in good condition.

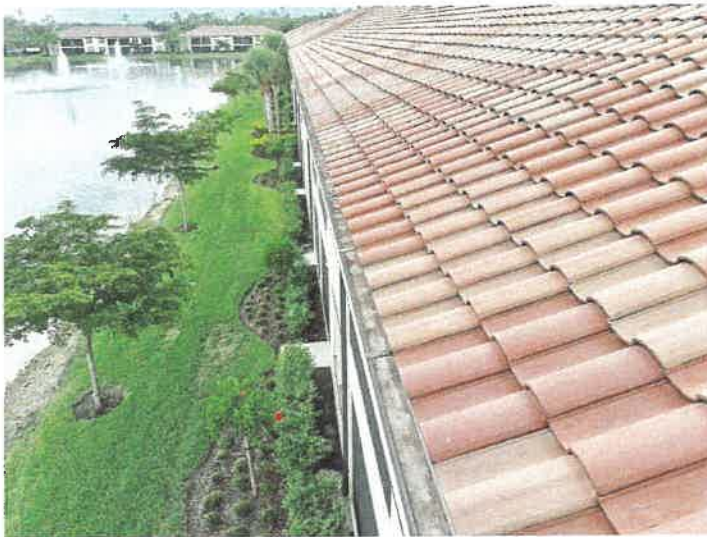
Building 15106: Gutters
The gutters appear to be in good condition.

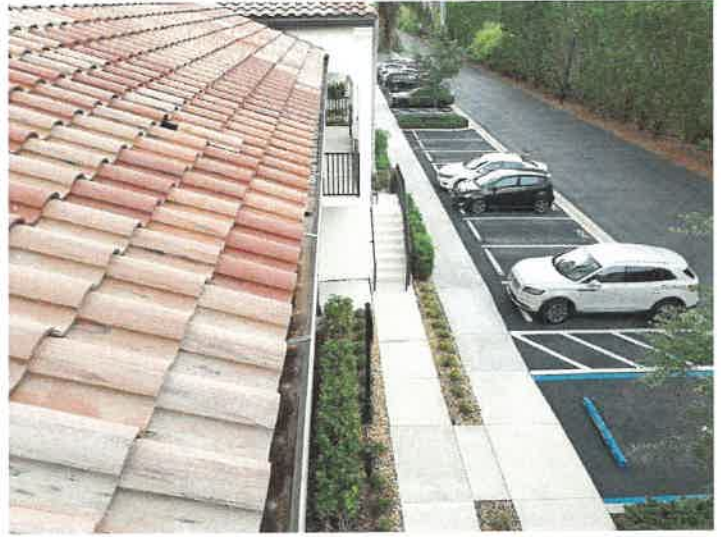
Building 15106: Gutters
The gutters appear to be in good condition.

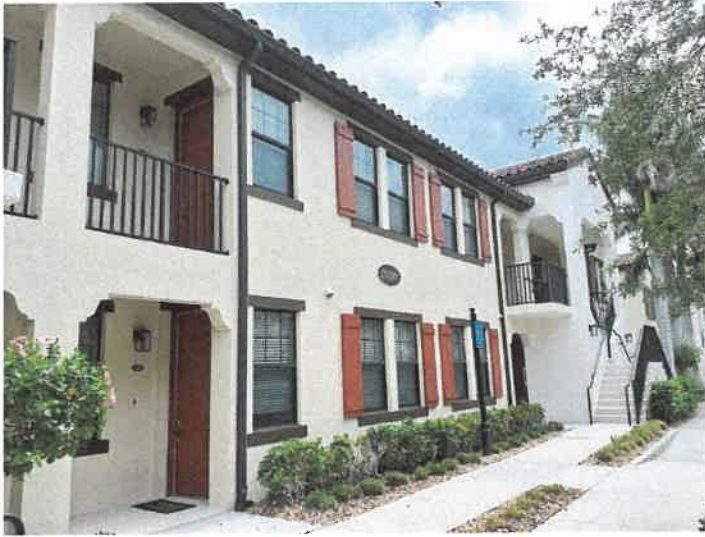
Building 15106: Downspouts
The downspouts appear to be in good condition.

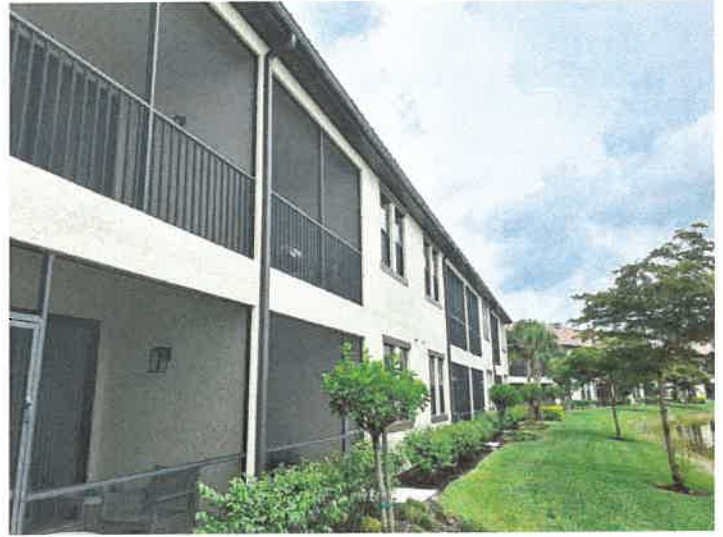
Building 15106: Downspouts
The downspouts appear to be in good condition.

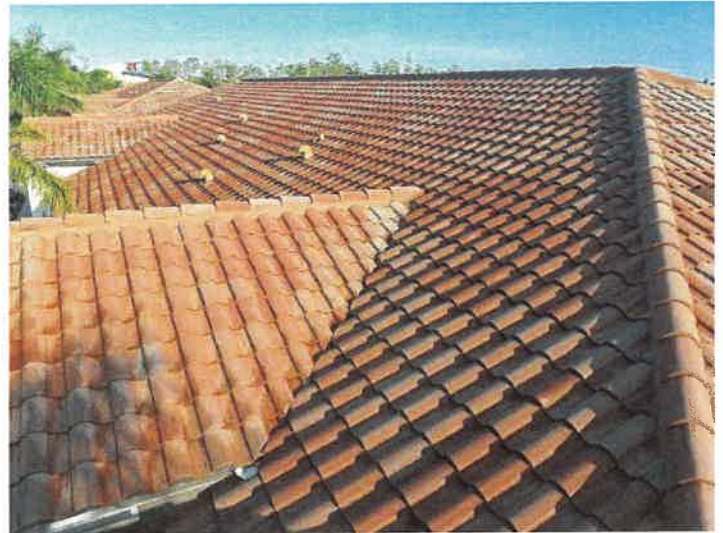
Building 15110: Surface Overview
The roof surface appears to be in good, maintainable condition at this time.
