Inspection Report

Facility: Livingston Lakes Condo
Address: 15098 Palmer Lake Circle,
Naples, FL 34109

Work Order #: 13028

Re.: Inspection Report (2 of 3) for Livingston Lakes

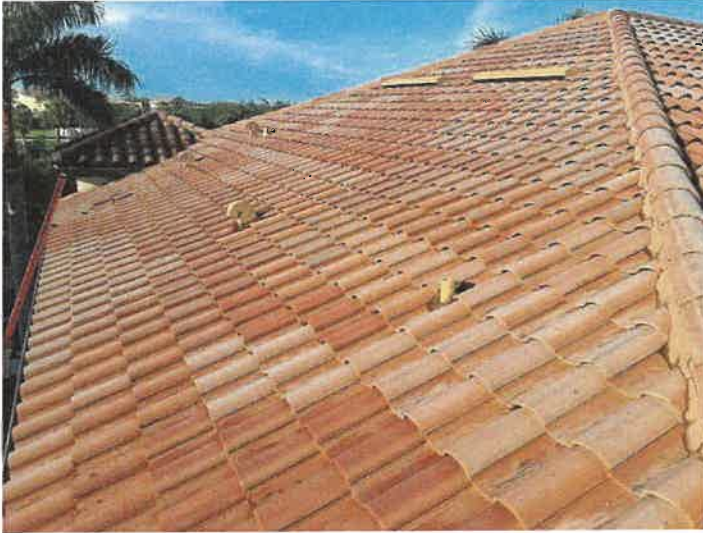
Building 15110: Appearance Overview

The roof appearance is in good, maintainable condition.

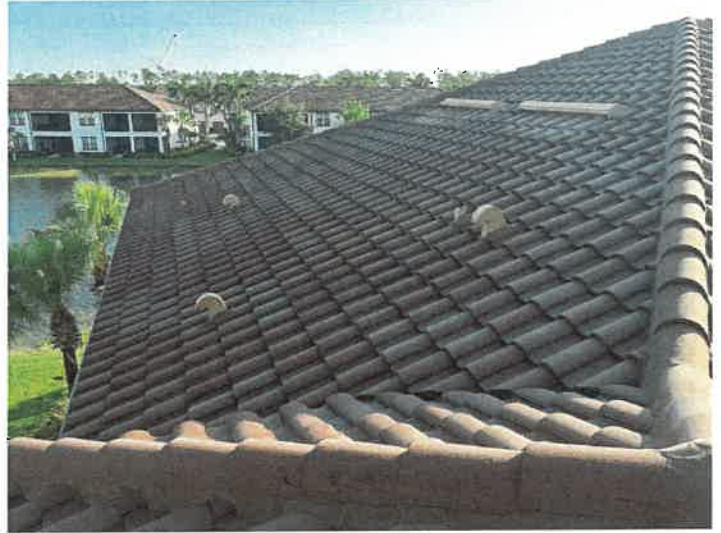
Building 15110: Surface Overview

The roof surface appears to be in good, maintainable condition at this time.

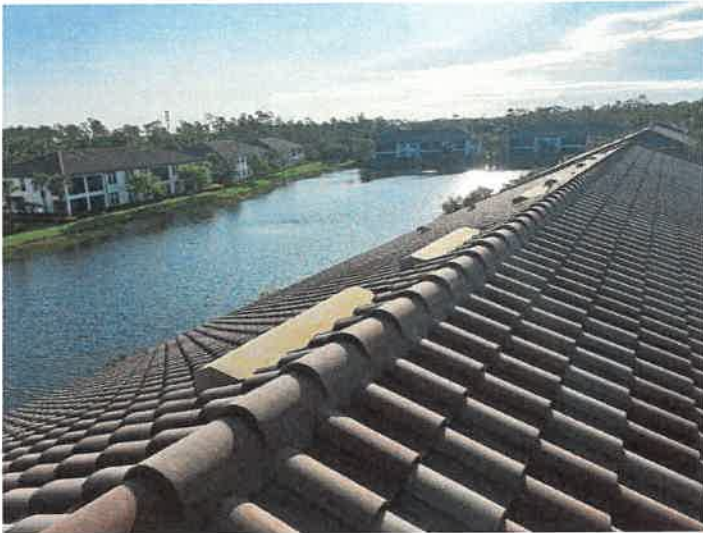
Building 15110: Ridge Tiles

Ridge tiles appear to be in good condition.

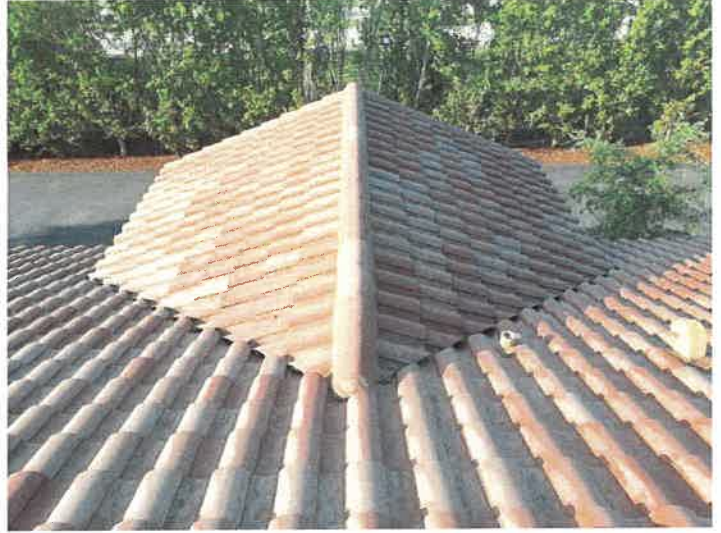
Building 15110: Valley

The valley tiles appear to be in good condition.

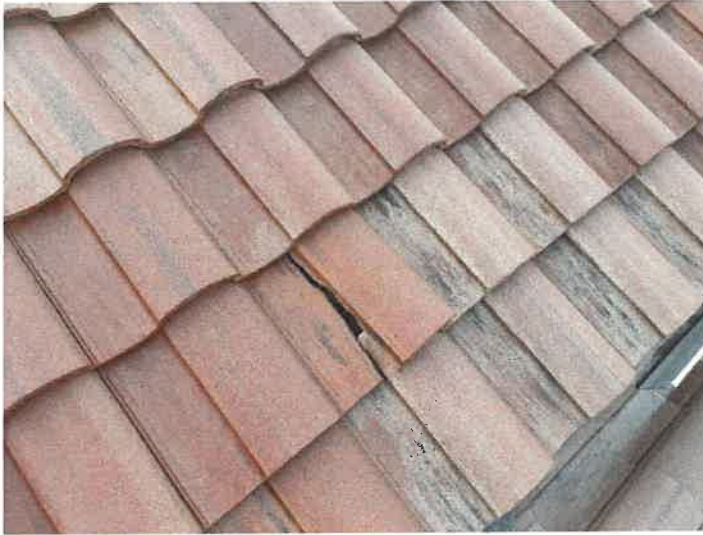
Building 15110: Identified Cracked Roof Tiles

Cracked roof tiles can allow premature underlayment deterioration from excessive UV exposure.

The cracked roof tiles were repaired with Titebond sealant.

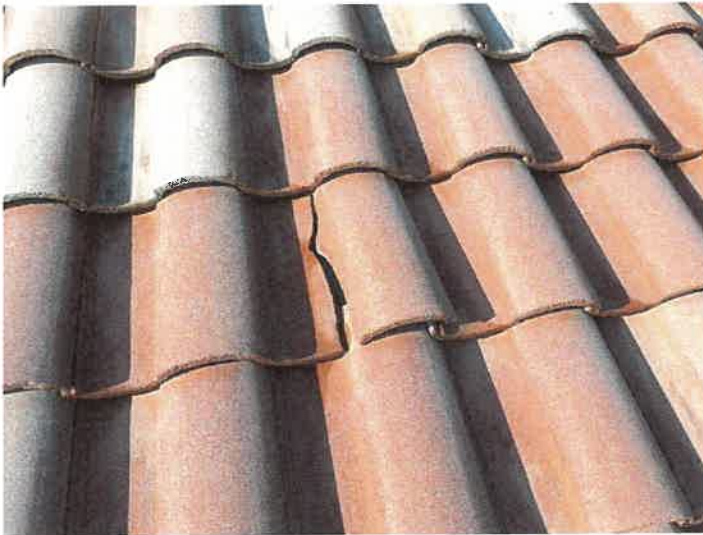
Building 15110: Identified Cracked Roof Tiles

Cracked roof tiles can allow premature underlayment deterioration from excessive UV exposure.

The cracked roof tiles were repaired with Titebond sealant.

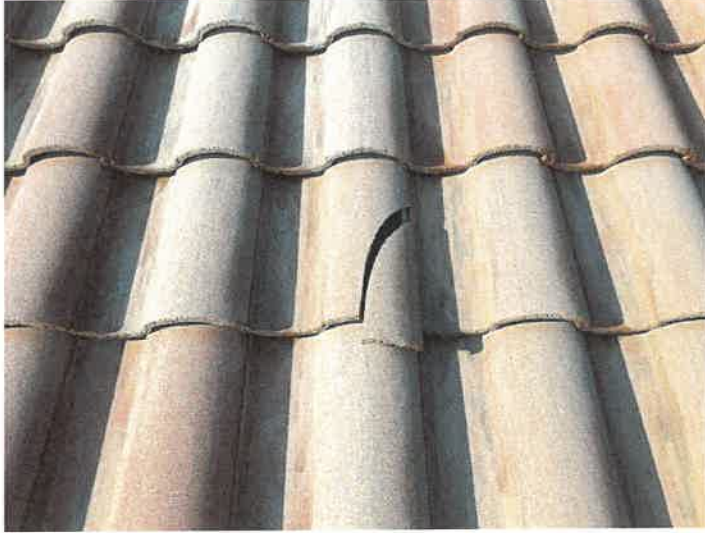
Building 15110: Identified Cracked Roof Tiles

Cracked roof tiles can allow premature underlayment deterioration from excessive UV exposure.

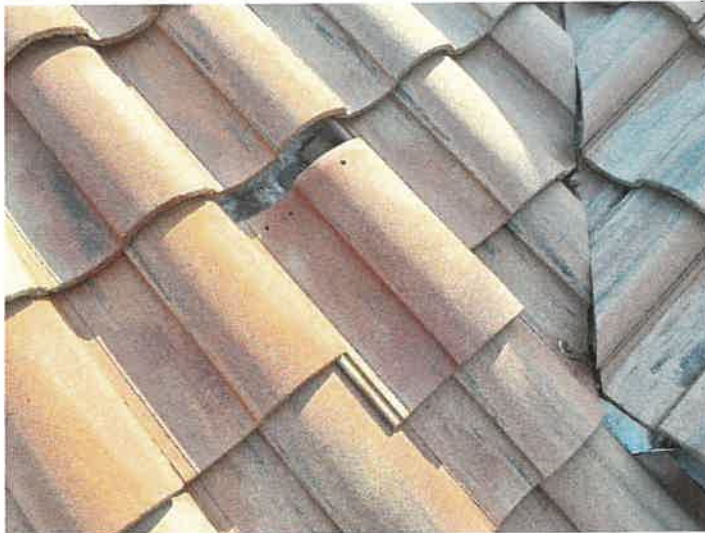
Building 15110: Displaced/Missing Roof Tile

Displaced or missing roof tiles can allow premature underlayment deterioration from excessive UV exposure and potential water intrusion.

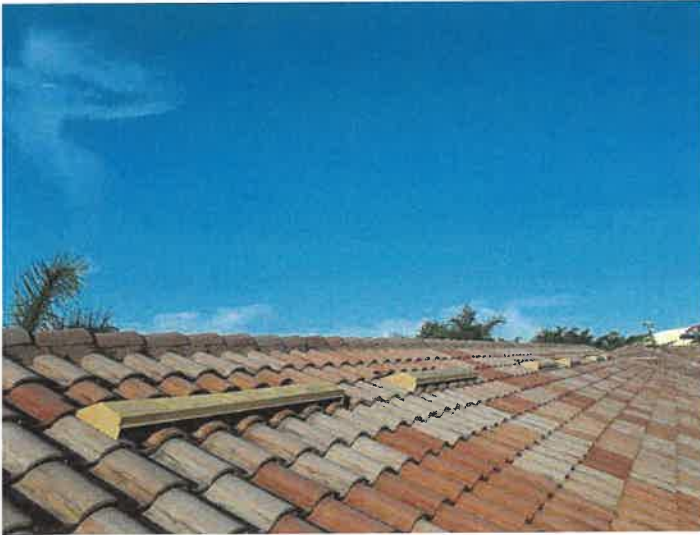
Building 15110: Roof Vents
Roof vents appear to be in good condition.

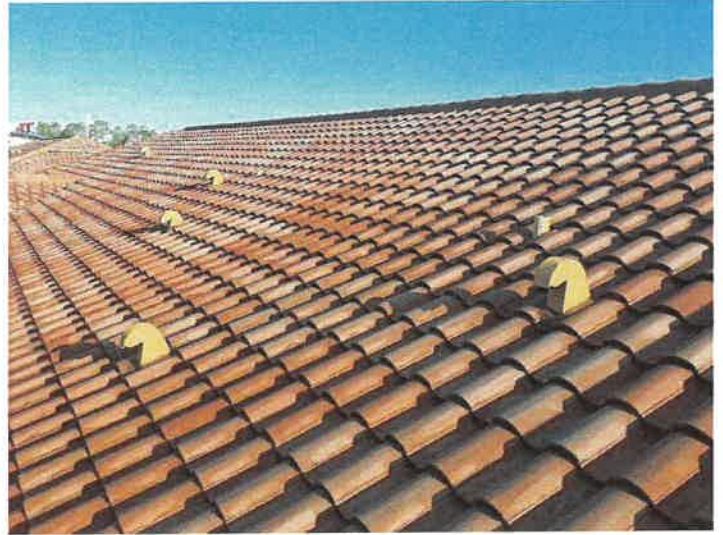
Building 15110: Roof Vents
Roof vents appear to be in good condition.

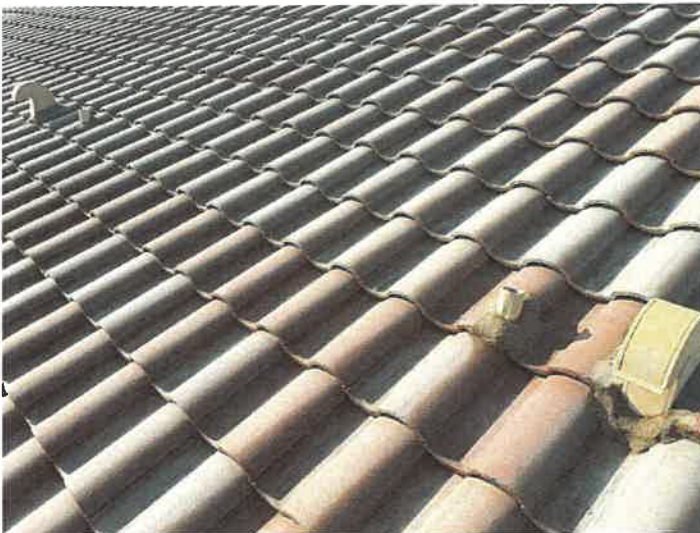
Building 15110: Lead Boots
Lead boots appear to be in good condition.

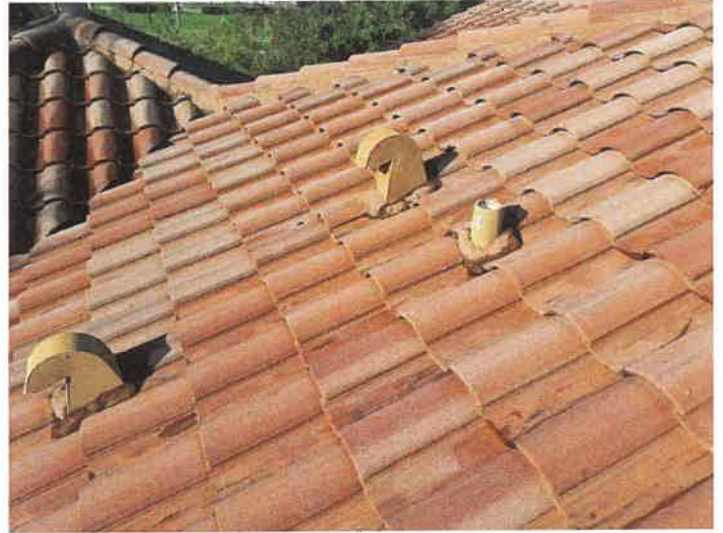
Building 15110: Lead Boots
Lead boots appear to be in good condition.

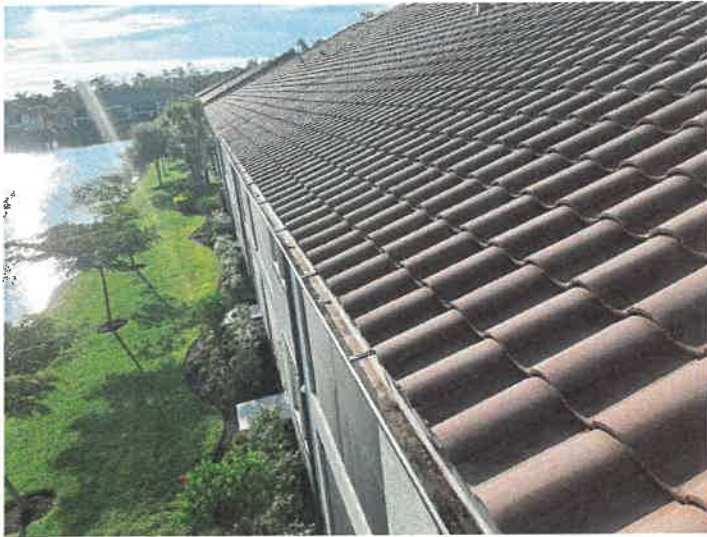
Building 15110: Gutters

The gutters appear to be in good condition.

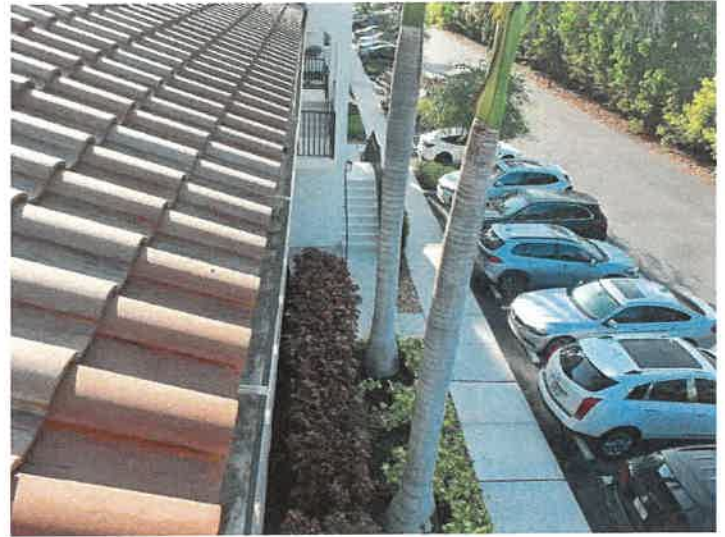
Building 15110: Gutters

The gutters appear to be in good condition.

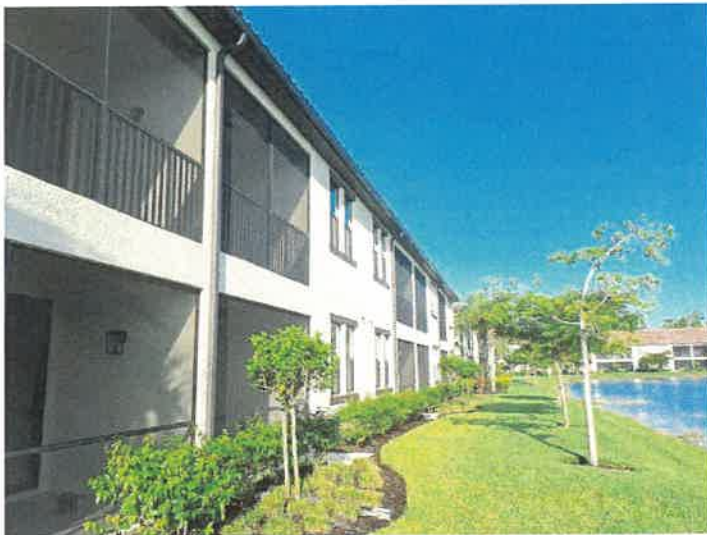
Building 15110: Downspouts

The downspouts appear to be in good condition.

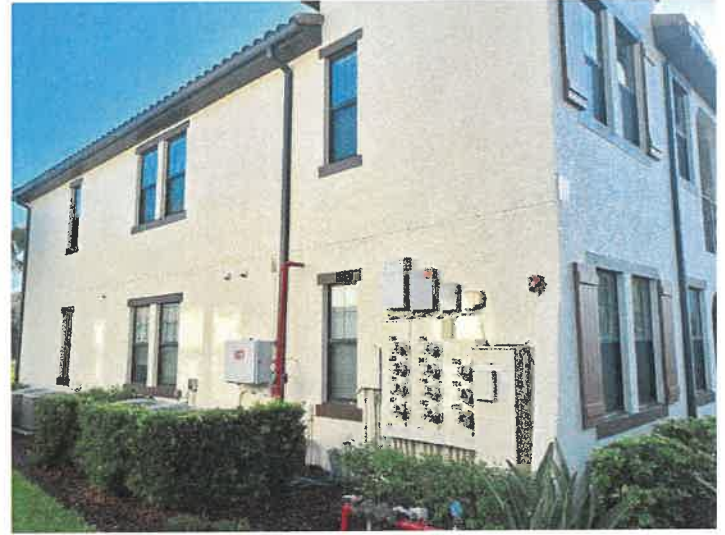
Building 15110: Downspouts

The downspouts appear to be in good condition.

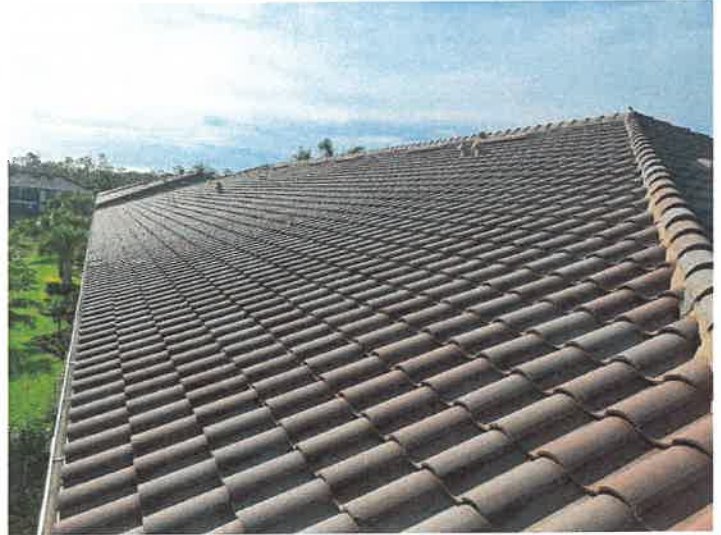
Building 15114: Surface Overview
The roof surface appears to be in good, maintainable condition at this time.

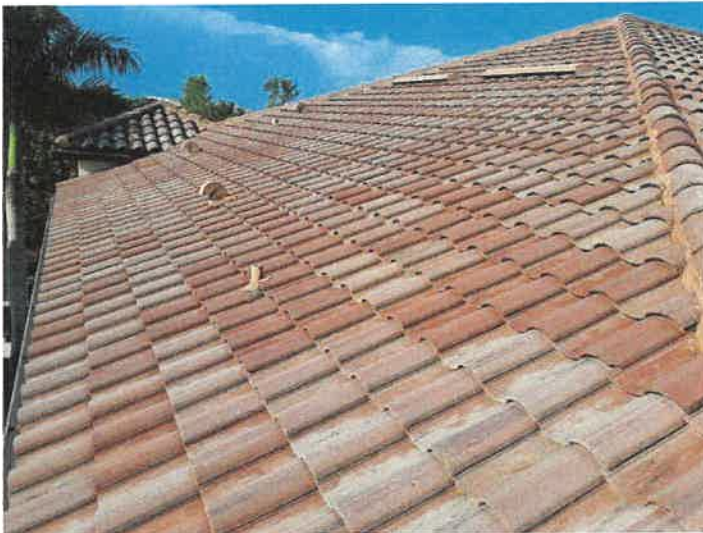
Building 15114: Appearance Overview
The roof appearance is in good, maintainable condition.

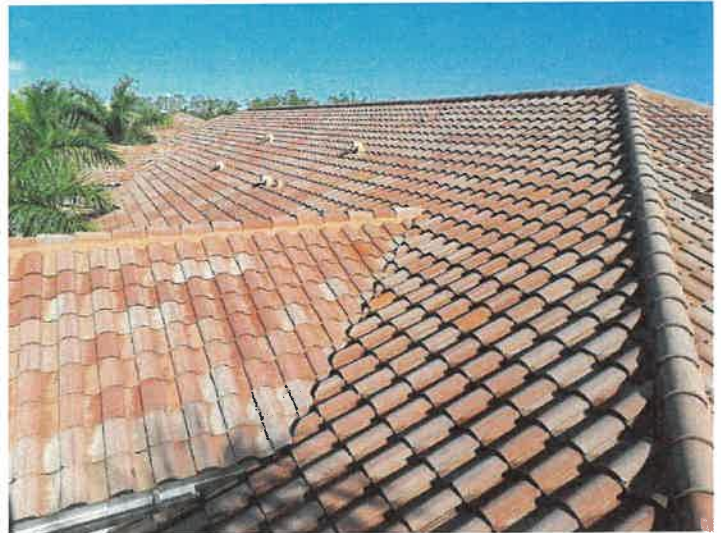
Building 15114: Field Tiles
Field tiles appear to be in good condition.

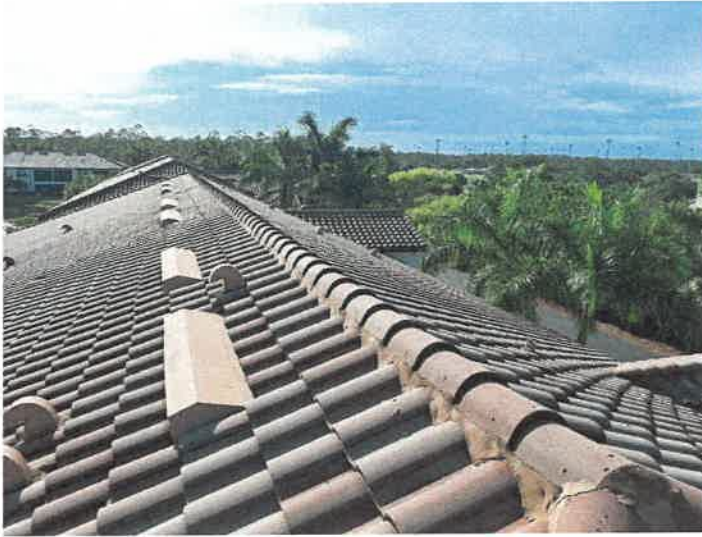
Building 15114: Ridge Tiles

Ridge tiles appear to be in good condition.

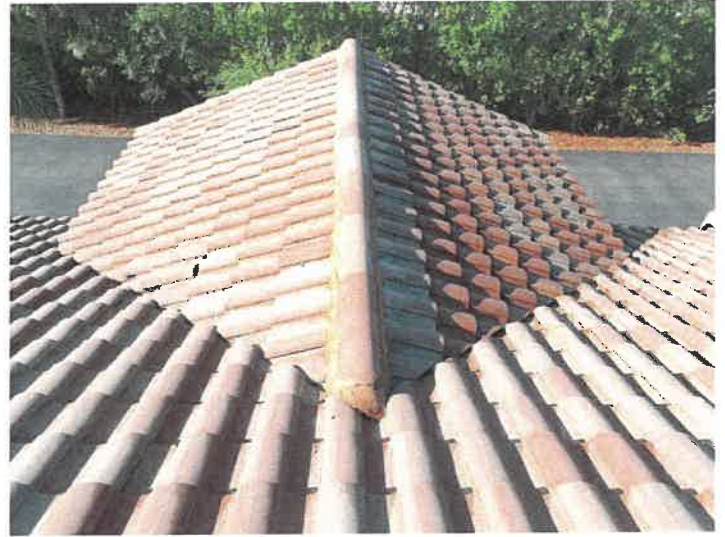
Building 15114: Valley

The valley tiles appear to be in good condition.

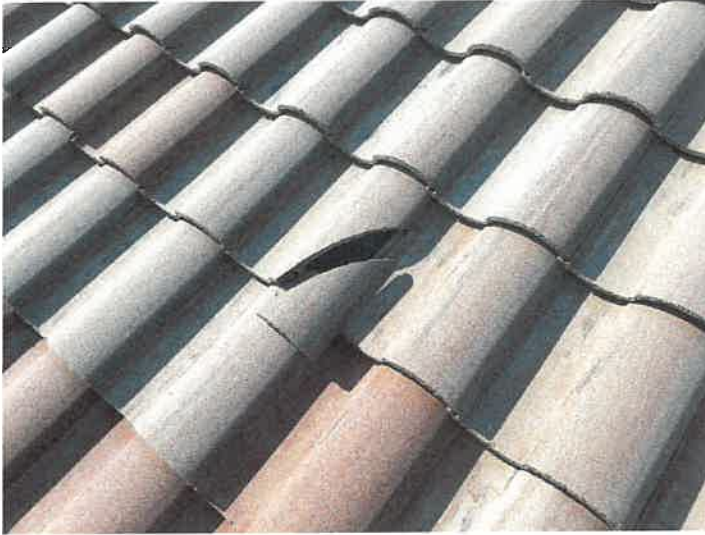
Building 15114: Identified Cracked Roof Tiles

Cracked roof tiles can allow premature underlayment deterioration from excessive UV exposure.

The cracked roof tiles were repaired with Titebond sealant.

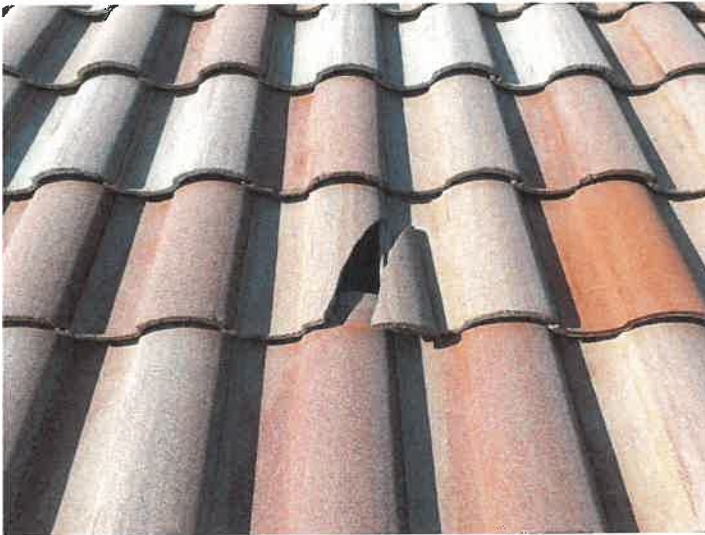
Building 15114: Identified Cracked Roof Tiles

Cracked roof tiles can allow premature underlayment deterioration from excessive UV exposure.

The cracked roof tiles were repaired with Titebond sealant.

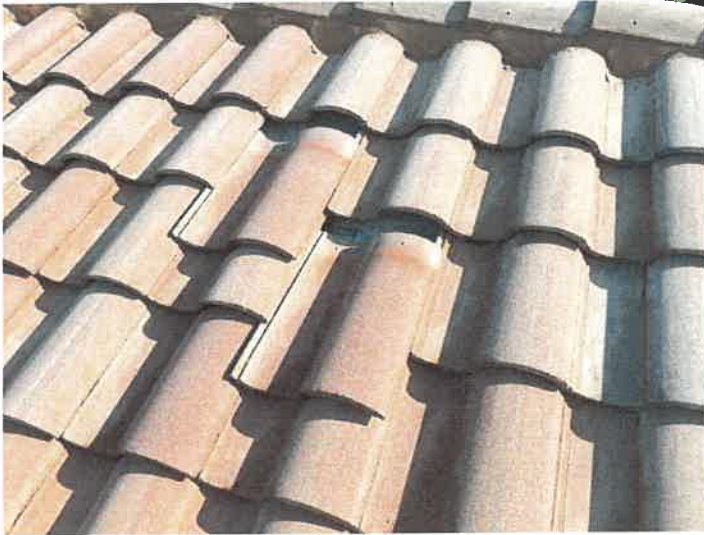
Building 15114: Displaced/Missing Roof Tile

Displaced or missing roof tiles can allow premature underlayment deterioration from excessive UV exposure and potential water intrusion.

Replaced and secured the missing roof tile.

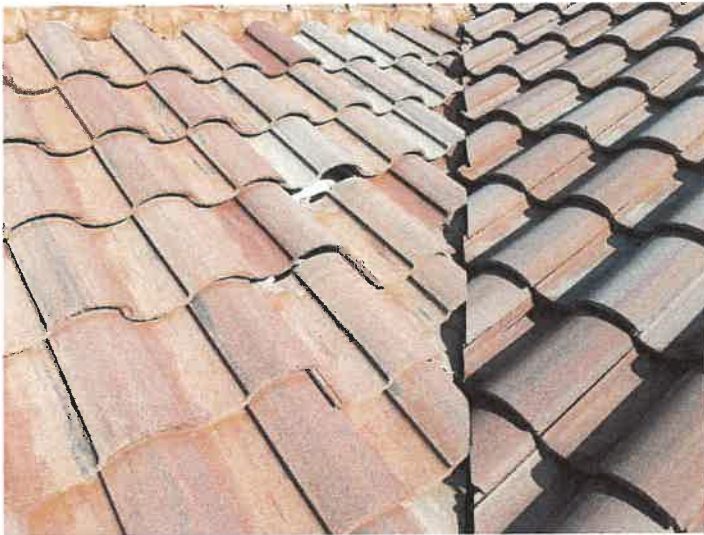
Building 15114: Displaced/Missing Roof Tile

Displaced or missing roof tiles can allow premature underlayment deterioration from excessive UV exposure and potential water intrusion.

Replaced and secured the missing roof tile.

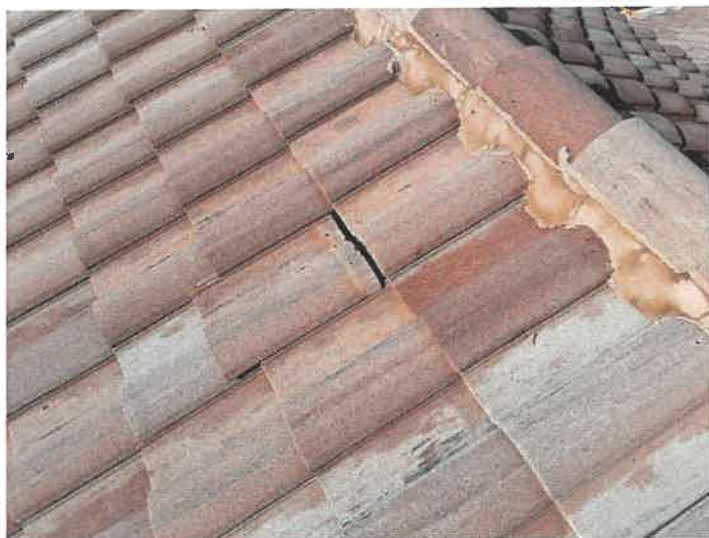
Building 15114: Displaced/Missing Roof Tile

Displaced or missing roof tiles can allow premature underlayment deterioration from excessive UV exposure and potential water intrusion.

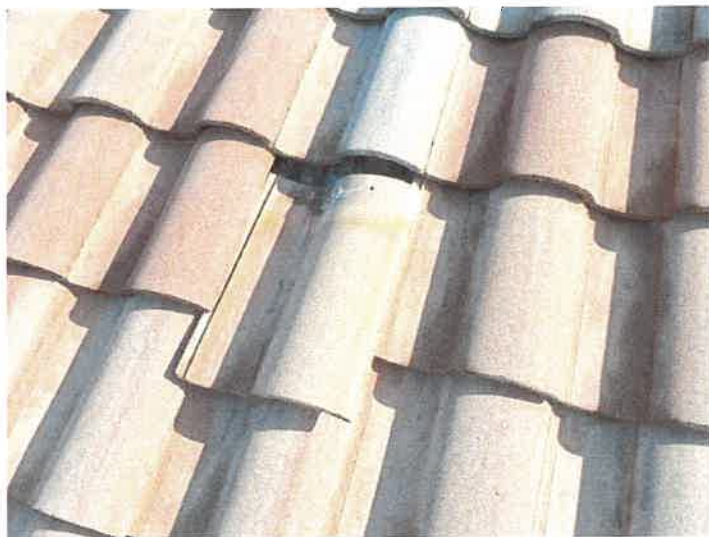
Building 15114: Displaced/Missing Roof Tile

Displaced or missing roof tiles can allow premature underlayment deterioration from excessive UV exposure and potential water intrusion.

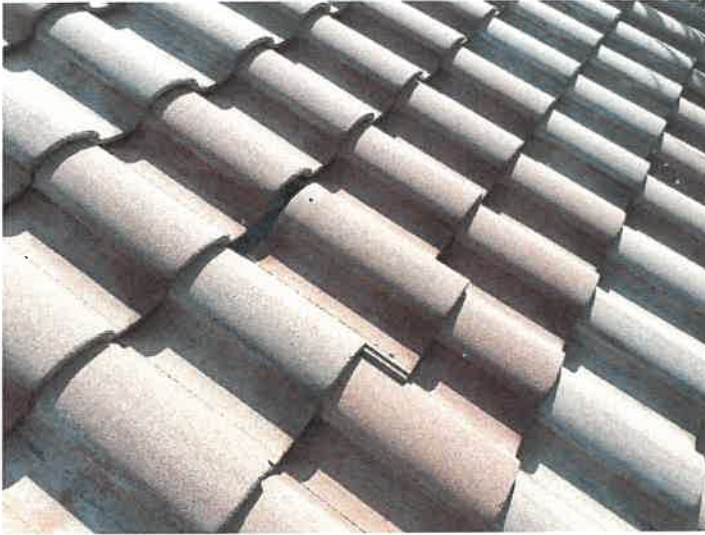
Building 15114: Displaced/Missing Roof Tile

Displaced or missing roof tiles can allow premature underlayment deterioration from excessive UV exposure and potential water intrusion.

Replaced and secured the missing roof tile.

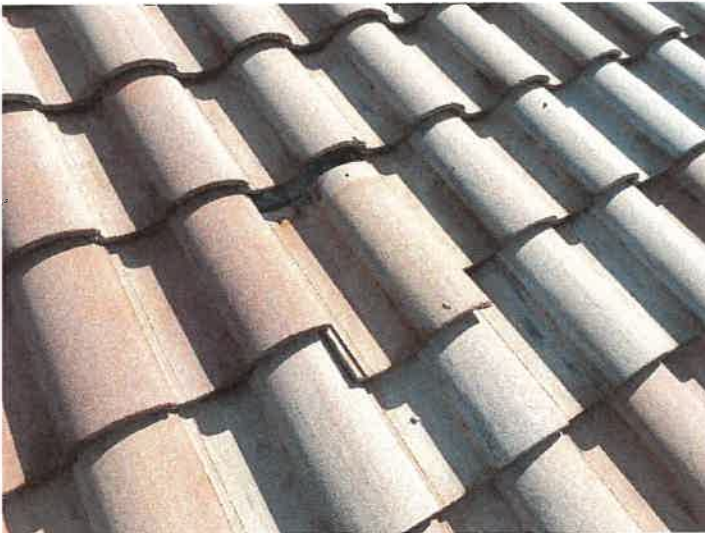
Building 15114: Displaced/Missing Roof Tile

Displaced or missing roof tiles can allow premature underlayment deterioration from excessive UV exposure and potential water intrusion.

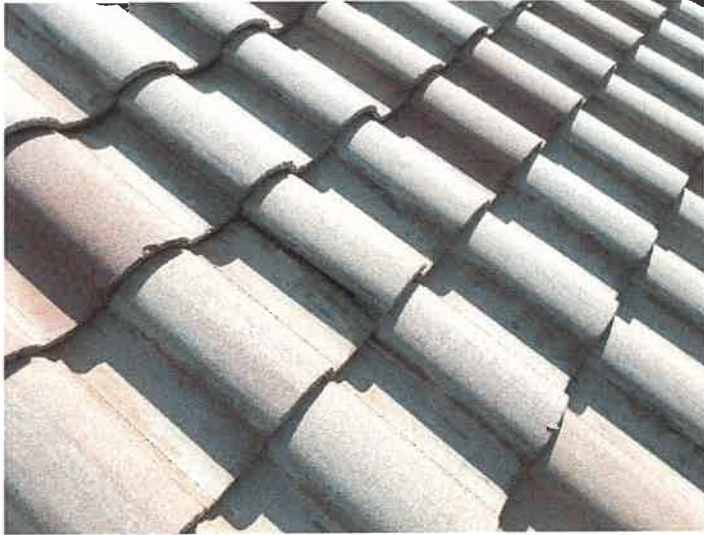
Building 15114: Identified Cracked Roof Tiles

Cracked roof tiles can allow premature underlayment deterioration from excessive UV exposure.

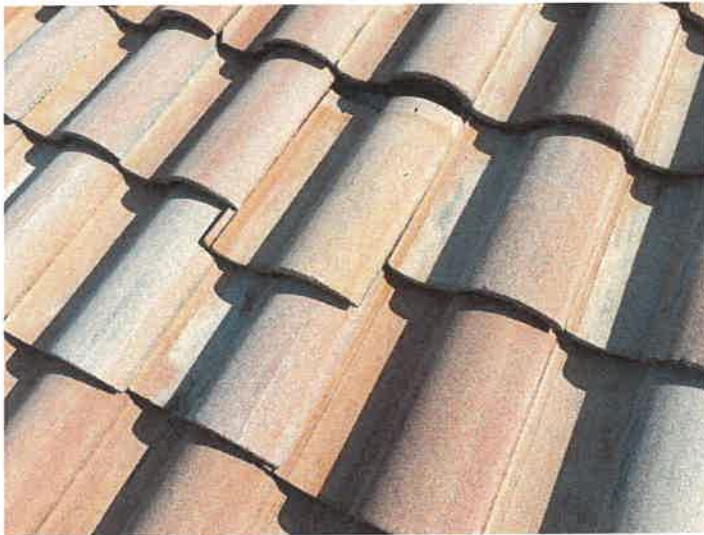
Building 15114: Displaced/Missing Roof Tile

Displaced or missing roof tiles can allow premature underlayment deterioration from excessive UV exposure and potential water intrusion.

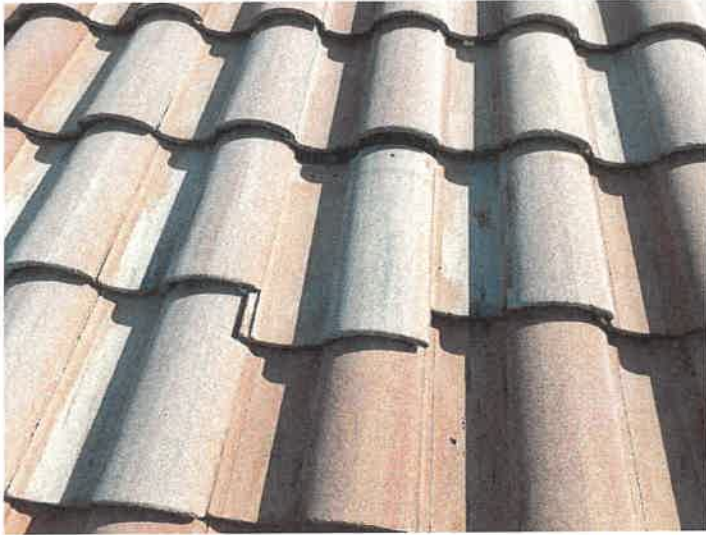
Building 15114: Displaced/Missing Roof Tile

Displaced or missing roof tiles can allow premature underlayment deterioration from excessive UV exposure and potential water intrusion.

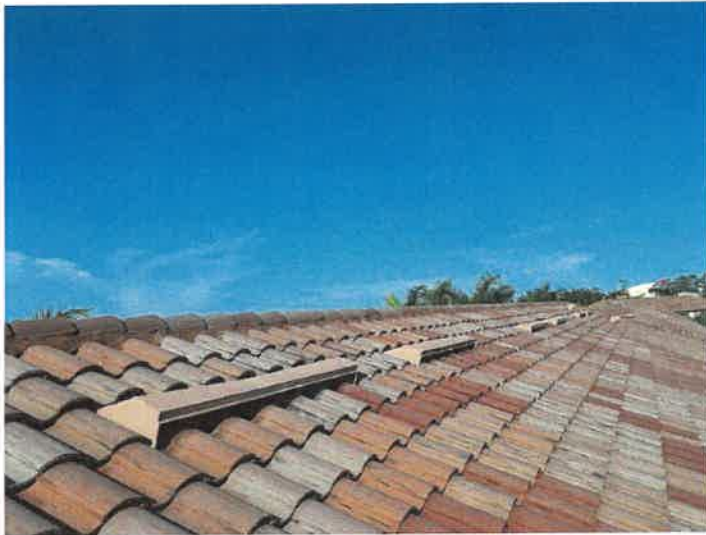
Building 15114: Roof Vents

Roof vents appear to be in good condition.

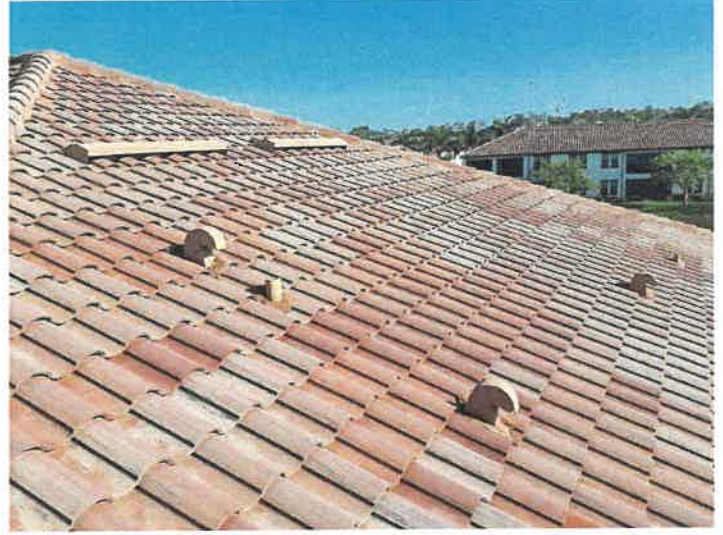
Building 15114: Roof Vents

Roof vents appear to be in good condition.

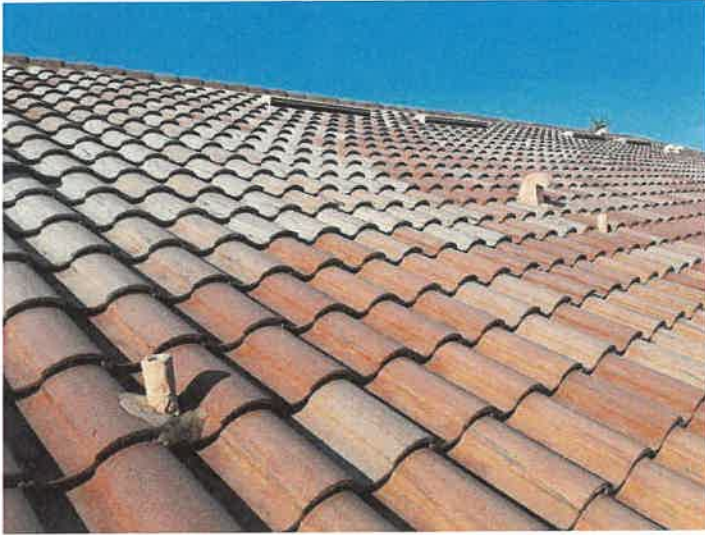
Building 15114: Lead Boots
Lead boots appear to be in good condition.

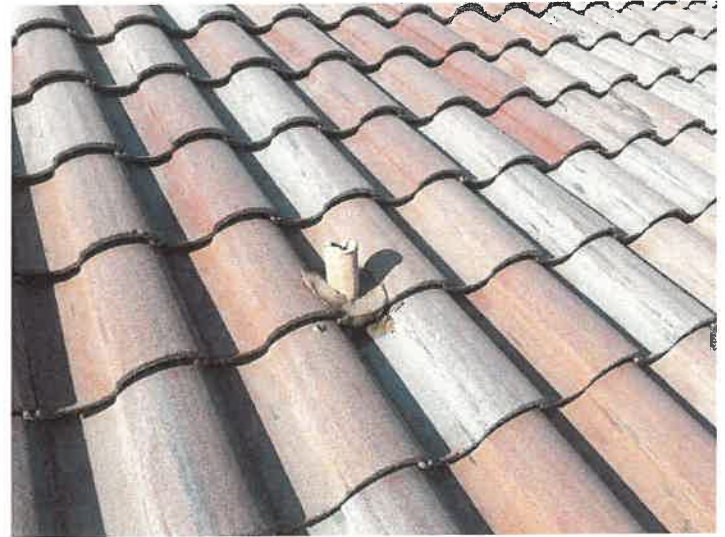
Building 15114: Lead Boots
Lead boots appear to be in good condition.

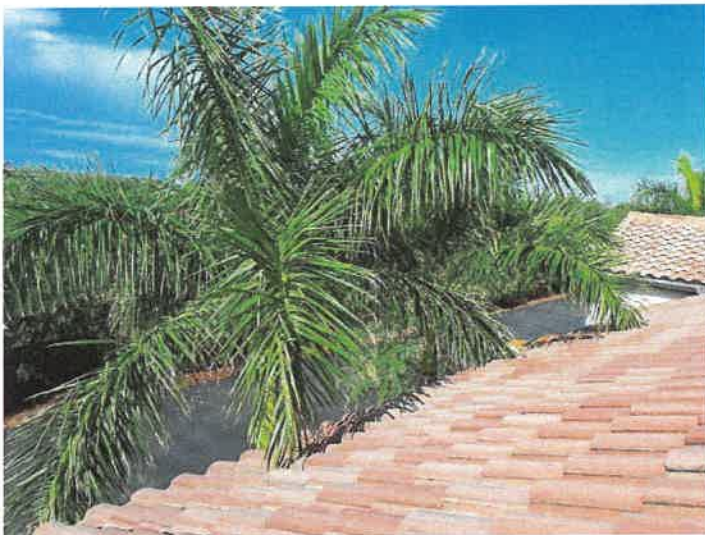
Building 15114: Tree Branches
Identified tree branches hanging over the roof surface.
Branches on the roof surface can cause deterioration of membrane, and act as an access for rodents and unwanted bugs/pests.

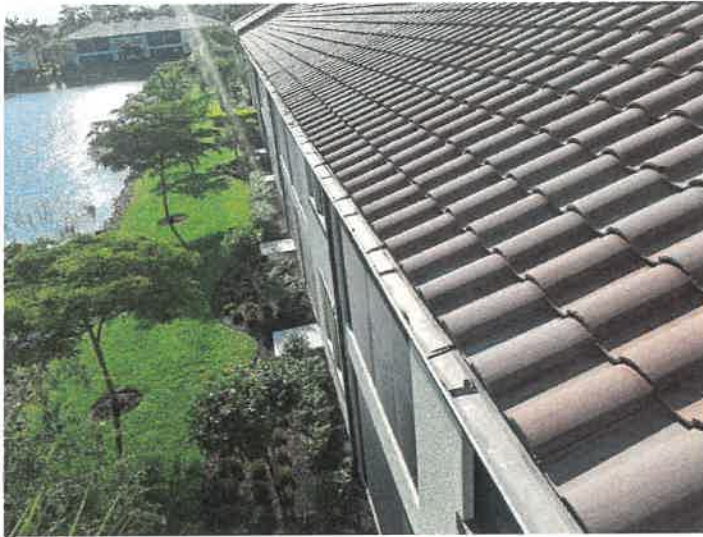
Building 15114: Gutters

The gutters appear to be in good condition.

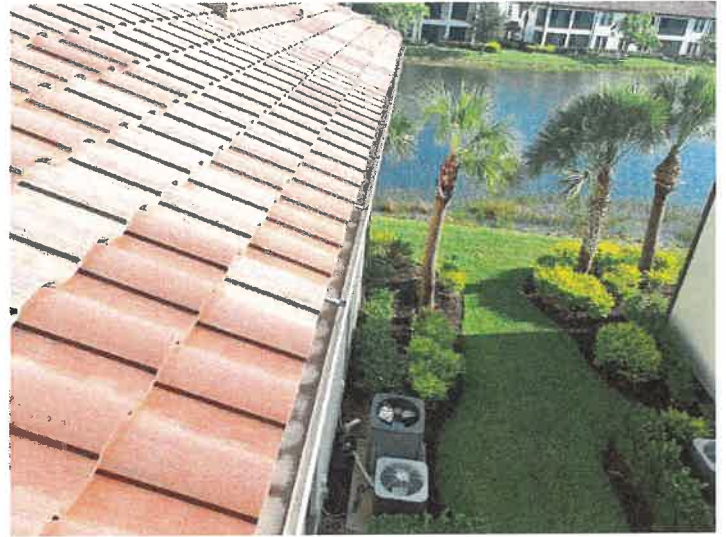
Building 15114: Gutters

The gutters appear to be in good condition.

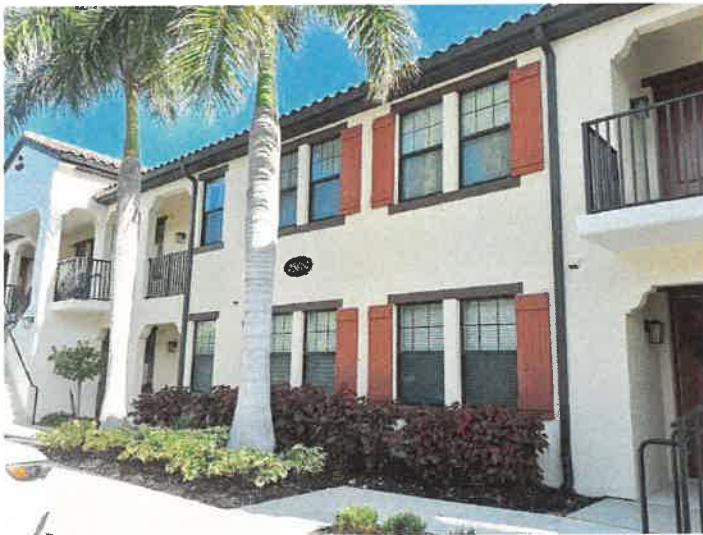
Building 15114: Downspouts

The downspouts appear to be in good condition.

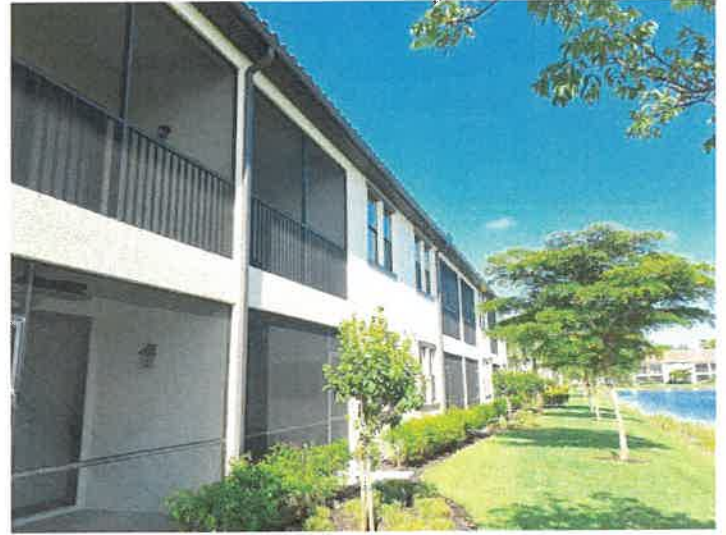
Building 15114: Downspouts

The downspouts appear to be in good condition.

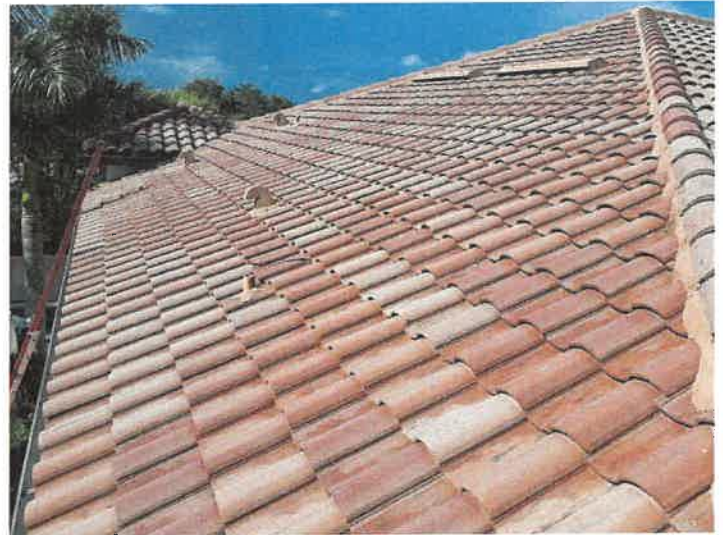
Building 15114: Surface Overview
The roof surface appears to be in good, maintainable condition at this time.

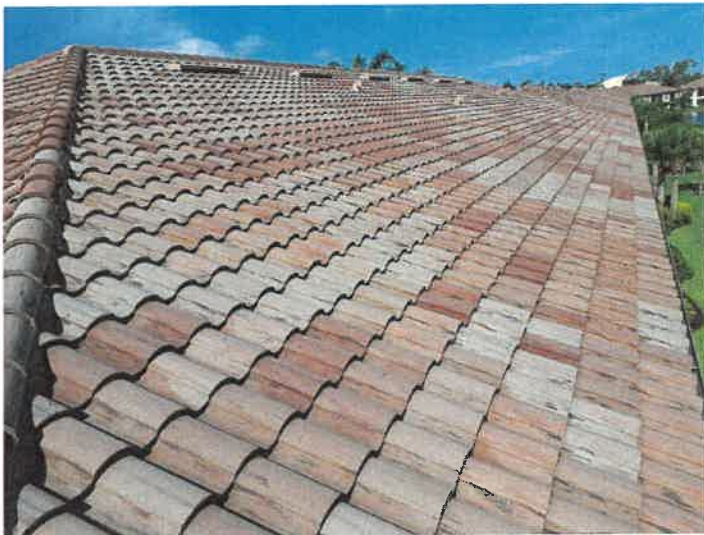
Building 15114: Appearance Overview
The roof appearance is in good, maintainable condition.

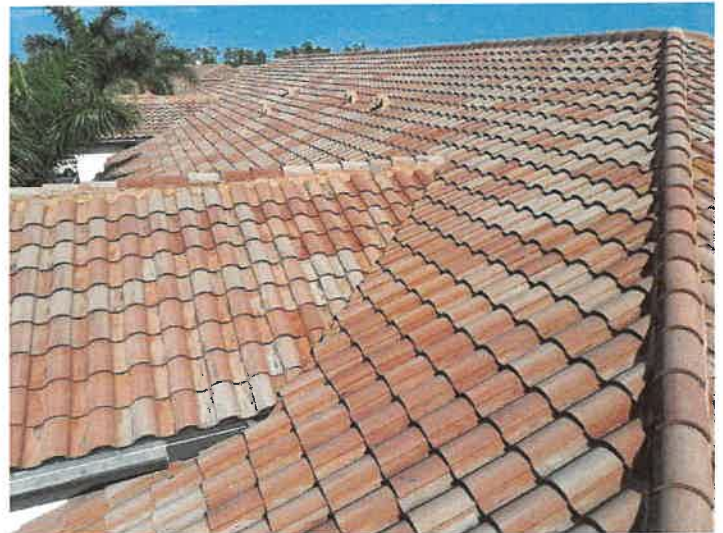
Building 15114: Appearance Overview
The roof appearance is in good, maintainable condition.

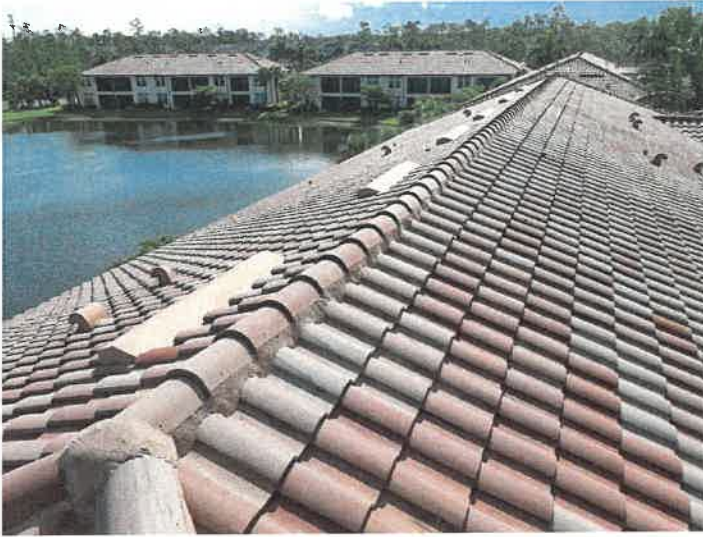
Building 15114: Ridge Tiles

Ridge tiles appear to be in good condition.

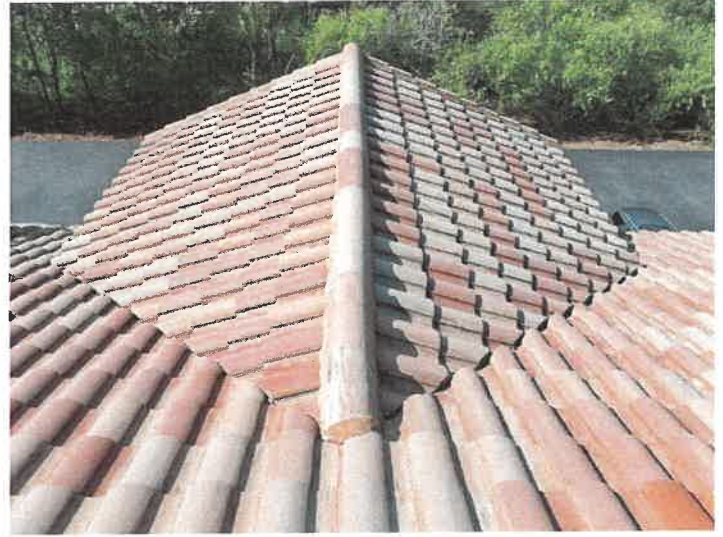
Building 15114: Valley

The valley tiles appear to be in good condition.

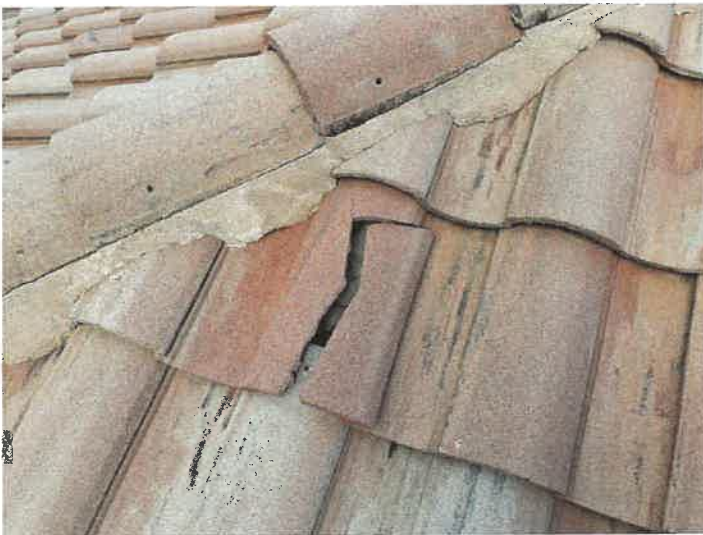
Building 15114: Identified Cracked Roof Tiles

Cracked roof tiles can allow premature underlayment deterioration from excessive UV exposure.

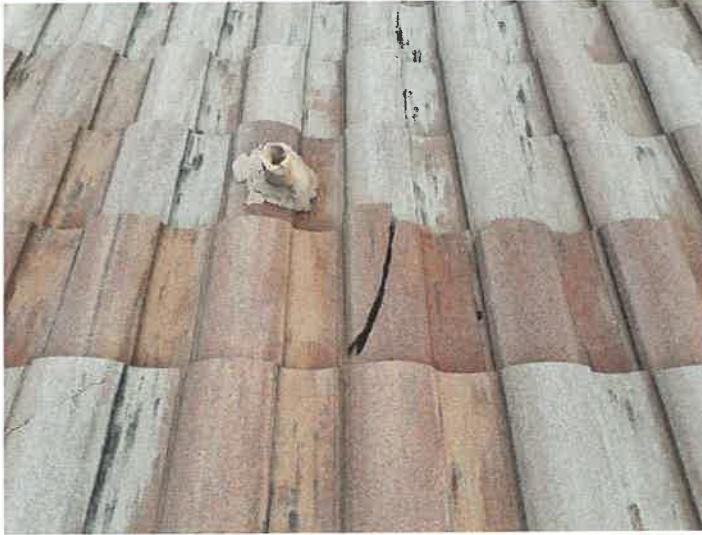
Building 15114: Identified Cracked Roof Tiles

Cracked roof tiles can allow premature underlayment deterioration from excessive UV exposure.

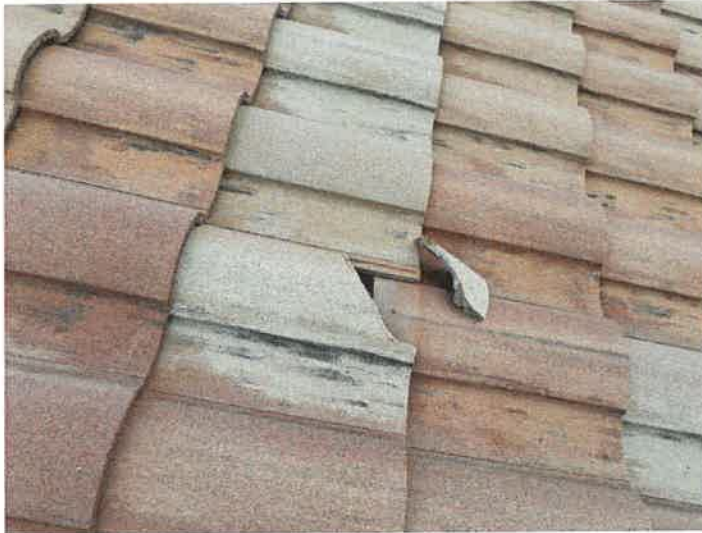
Building 15114: Identified Cracked Roof Tiles

Cracked roof tiles can allow premature underlayment deterioration from excessive UV exposure.

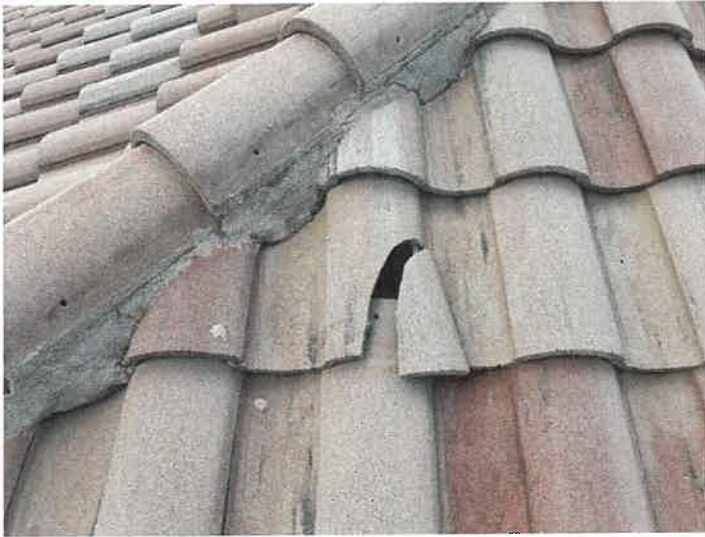
Building 15114: Identified Cracked Roof Tiles
Cracked roof tiles can allow premature underlayment deterioration from excessive UV exposure.

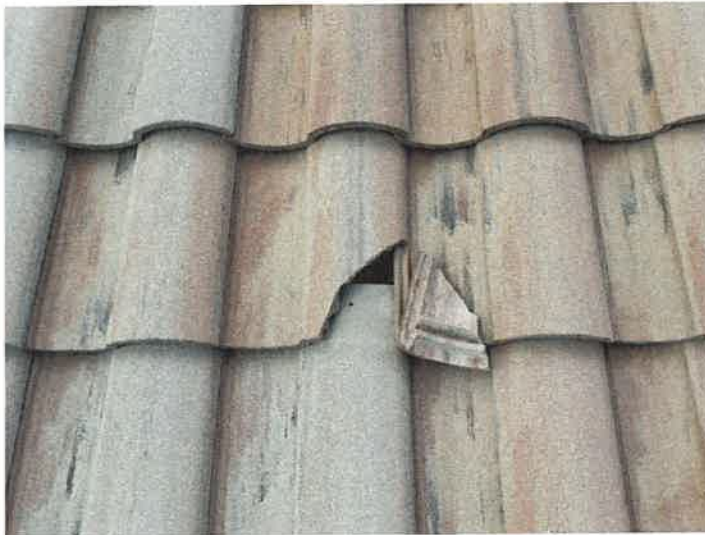
Building 15114: Identified Cracked Roof Tiles
Cracked roof tiles can allow premature underlayment deterioration from excessive UV exposure.

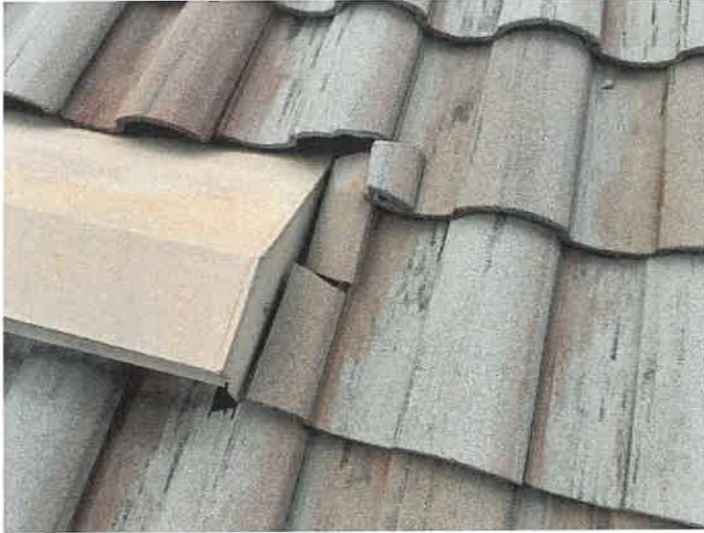
Building 15114: Identified Cracked Roof Tiles

Cracked roof tiles can allow premature underlayment deterioration from excessive UV exposure.

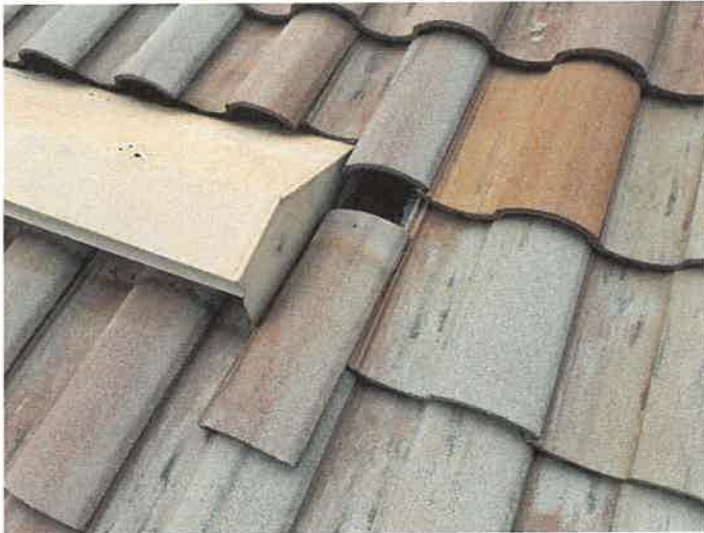
Building 15114: Displaced/Missing Roof Tile

Displaced or missing roof tiles can allow premature underlayment deterioration from excessive UV exposure and potential water intrusion.

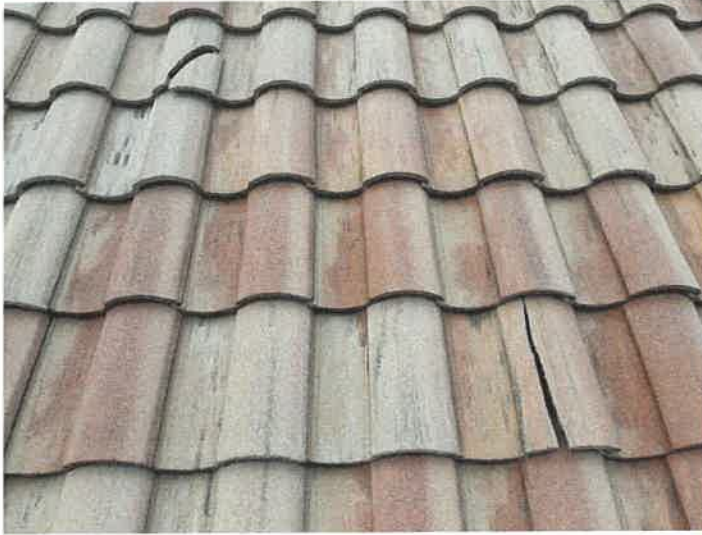
Building 15114: Identified Cracked Roof Tiles

Cracked roof tiles can allow premature underlayment deterioration from excessive UV exposure.

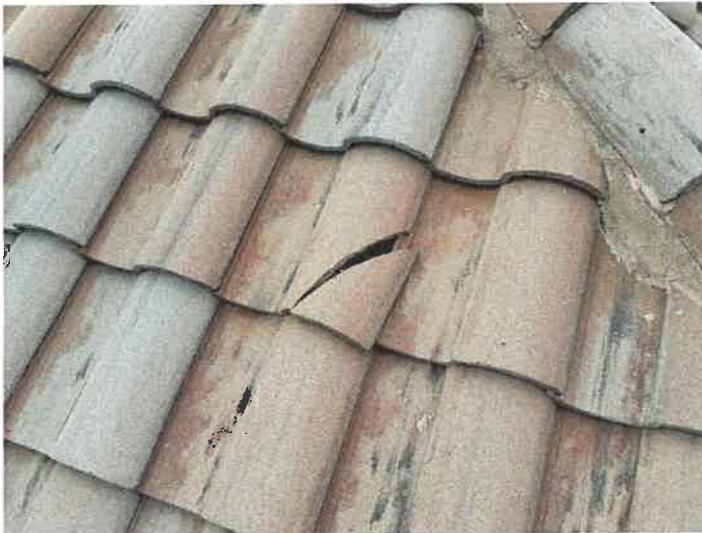
Building 15114: Identified Cracked Roof Tiles

Cracked roof tiles can allow premature underlayment deterioration from excessive UV exposure.

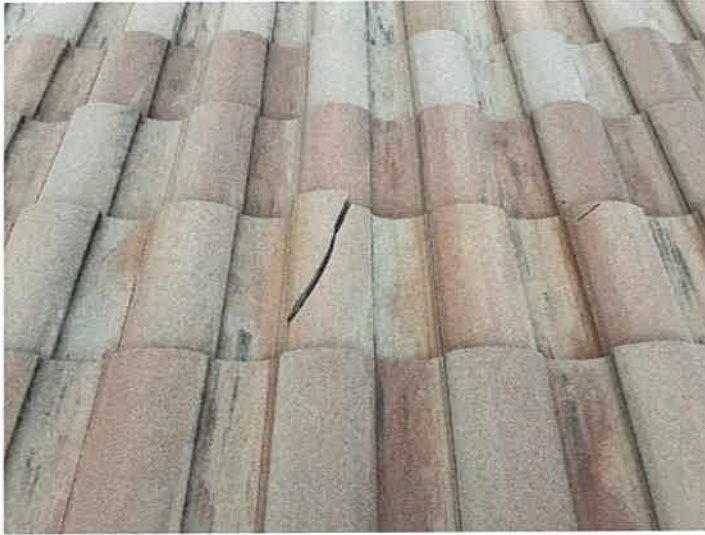
Building 15114: Identified Cracked Roof Tiles

Cracked roof tiles can allow premature underlayment deterioration from excessive UV exposure.
