Inspection Report

Facility: Livingston Lakes Condo
Address: 15098 Palmer Lake Circle,
Naples, FL 34109

Work Order #: 13028

Re.: Inspection Report (2 of 3) for Livingston Lakes

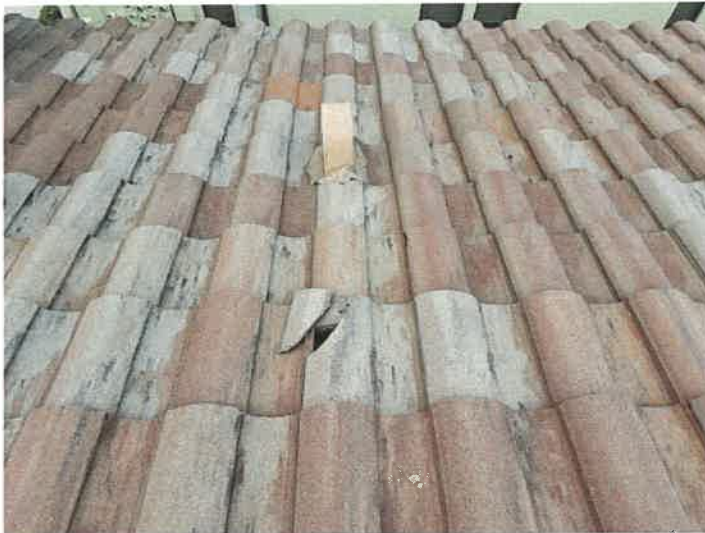
Building 15114: Identified Cracked Roof Tiles

Cracked roof tiles can allow premature underlayment deterioration from excessive UV exposure.

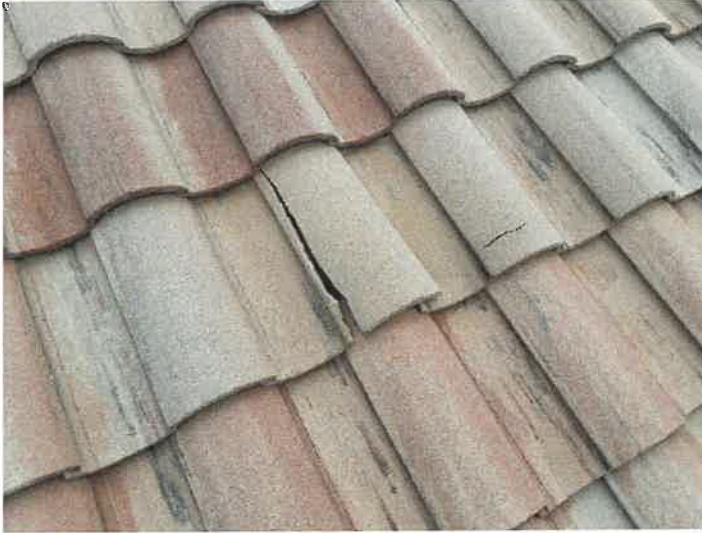
Building 15114: Identified Cracked Roof Tiles
Cracked roof tiles can allow premature underlayment deterioration from excessive UV exposure.

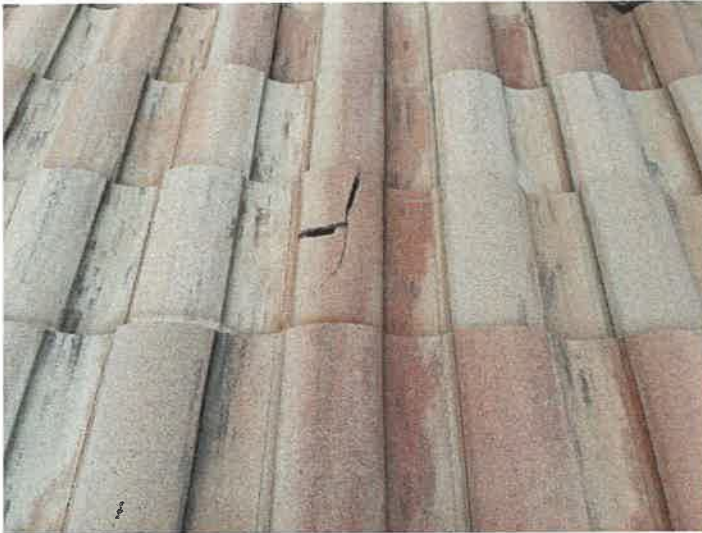
Building 15114: Identified Cracked Roof Tiles
Cracked roof tiles can allow premature underlayment deterioration from excessive UV exposure.

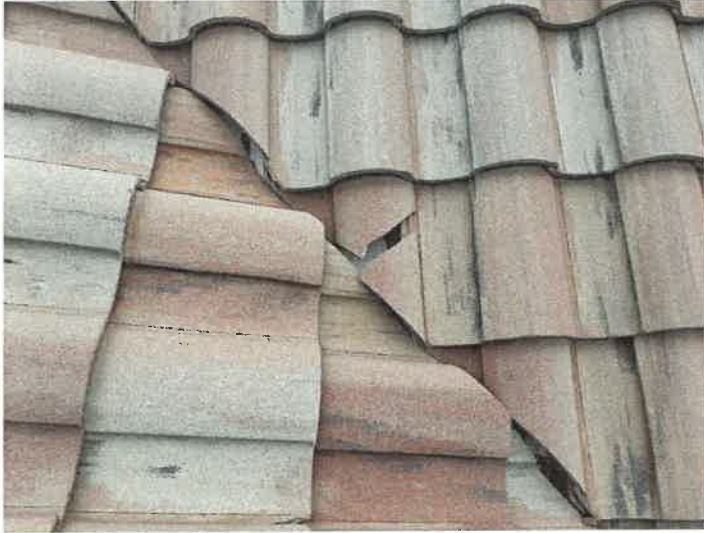
Building 15114: Identified Cracked Roof Tiles

Cracked roof tiles can allow premature underlayment deterioration from excessive UV exposure.

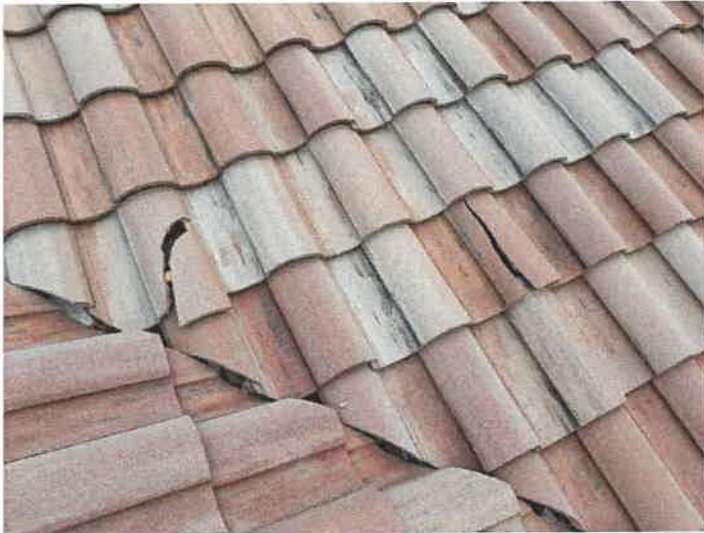
Building 15114: Identified Cracked Roof Tiles

Cracked roof tiles can allow premature underlayment deterioration from excessive UV exposure.

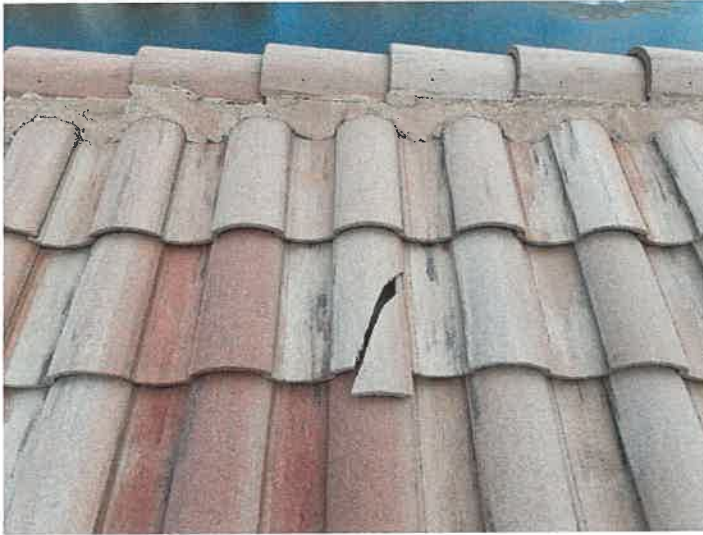
Building 15114: Identified Cracked Roof Tiles

Cracked roof tiles can allow premature underlayment deterioration from excessive UV exposure.

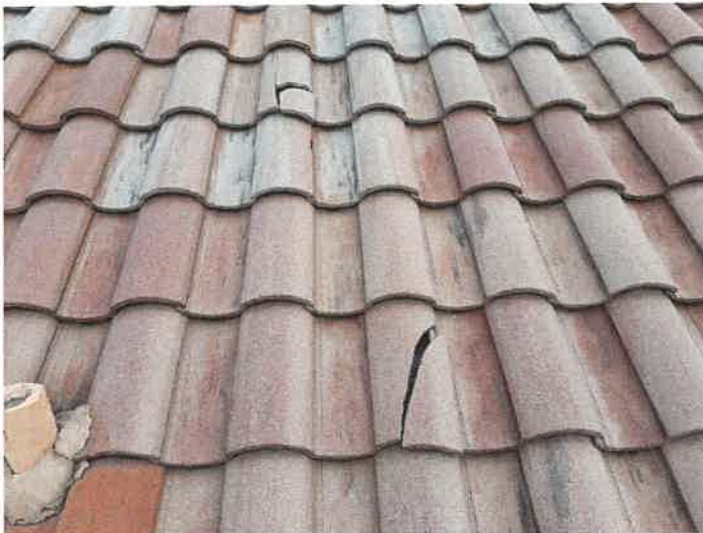
Building 15114: Identified Cracked Roof Tiles

Cracked roof tiles can allow premature underlayment deterioration from excessive UV exposure.

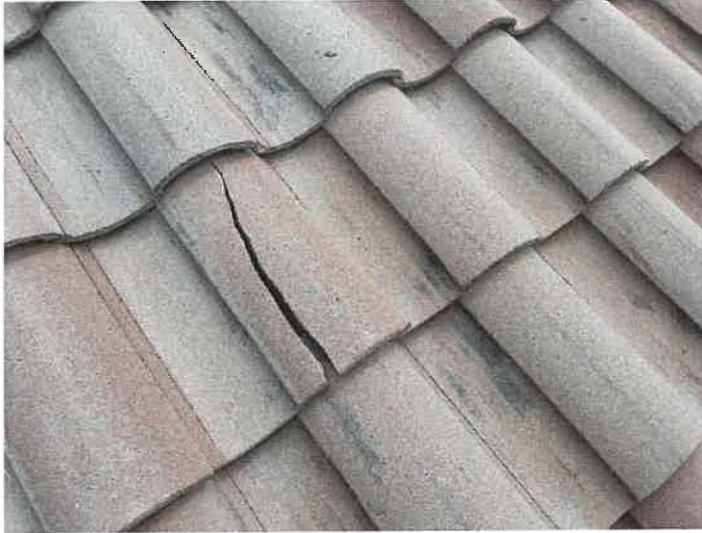
Building 15114: Identified Cracked Roof Tiles

Cracked roof tiles can allow premature underlayment deterioration from excessive UV exposure.

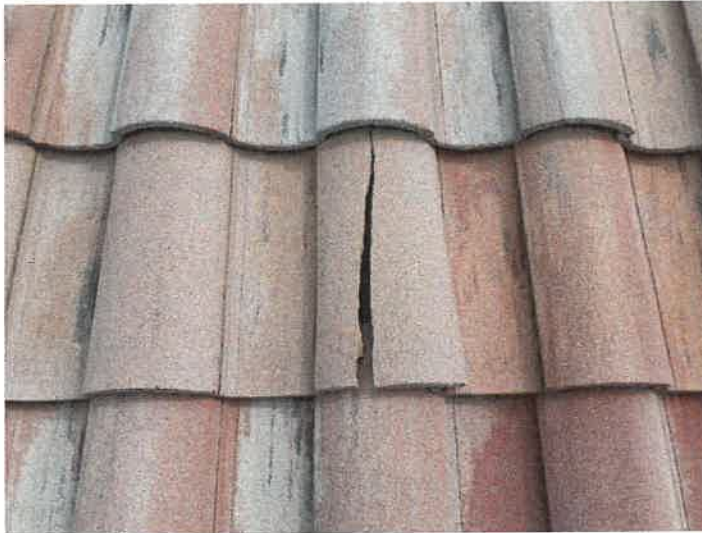
Building 15114: Identified Cracked Roof Tiles

Cracked roof tiles can allow premature underlayment deterioration from excessive UV exposure.

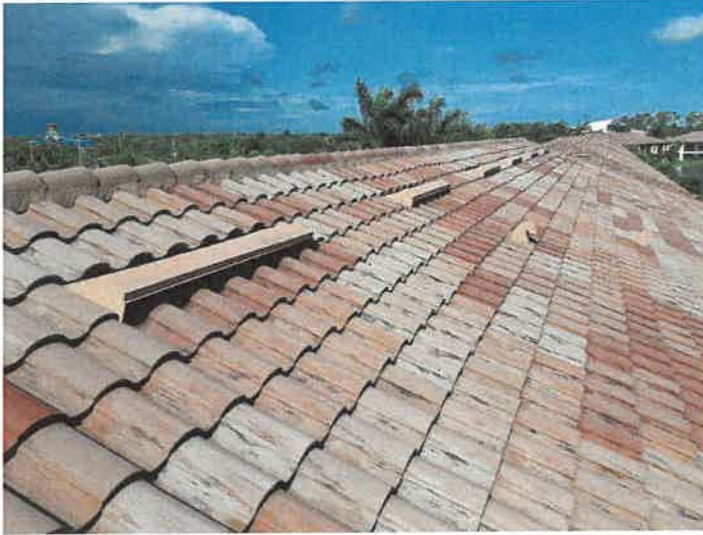
Building 15114: Roof Vents
Roof vents appear to be in good condition.

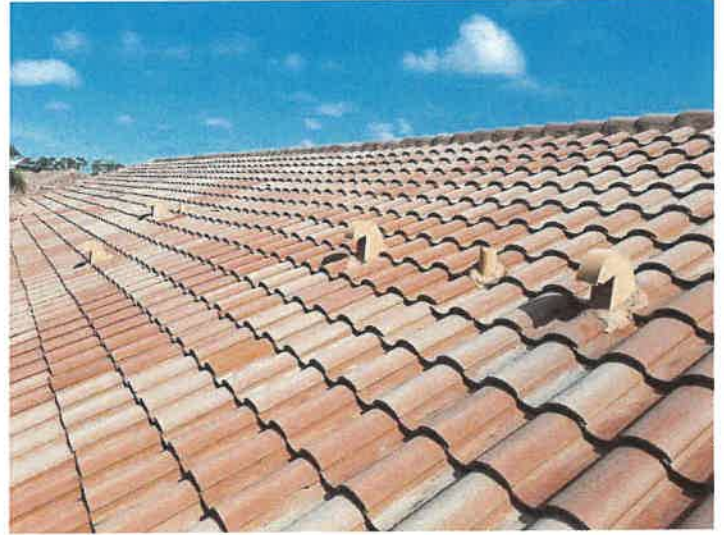
Building 15114: Roof Vents
Roof vents appear to be in good condition.

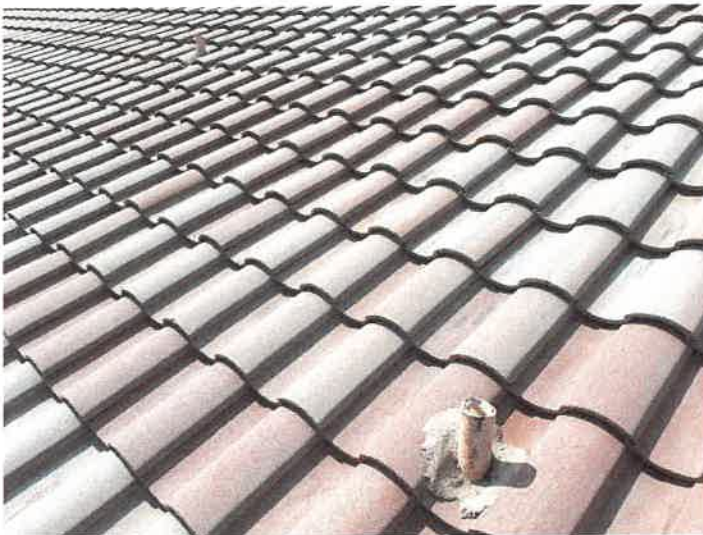
Building 15114: Lead Boots
Lead boots appear to be in good condition.

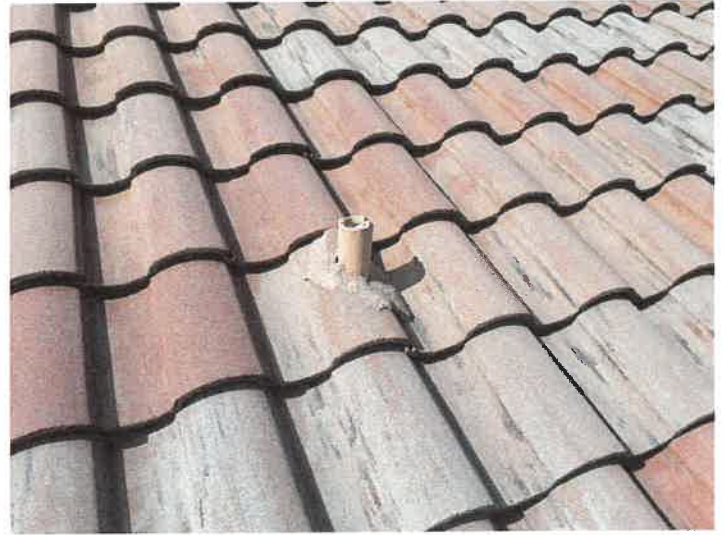
Building 15114: Lead Boots
Lead boots appear to be in good condition.

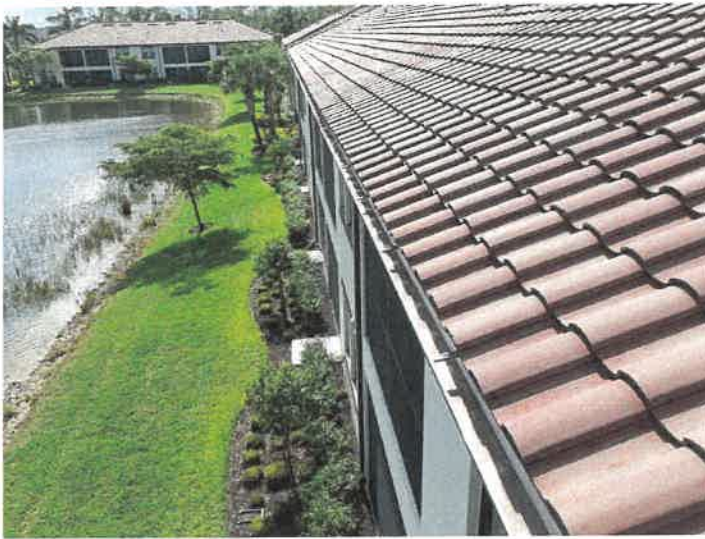
Building 15114: Gutters

The gutters appear to be in good condition.

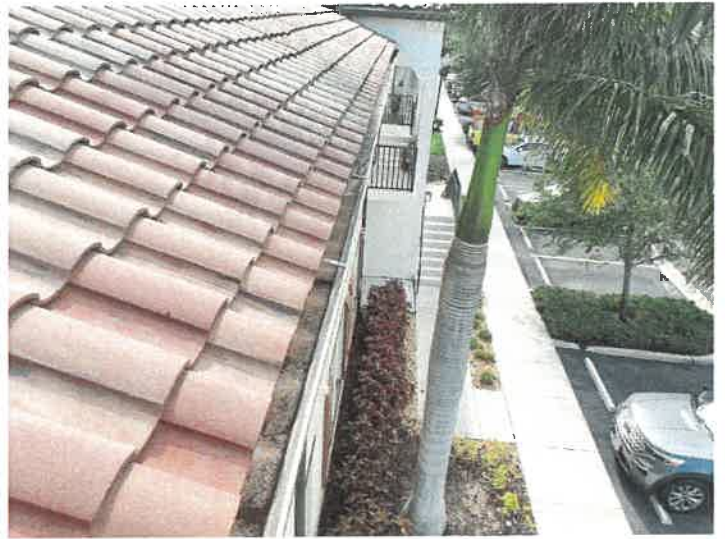
Building 15114: Gutters

The gutters appear to be in good condition.

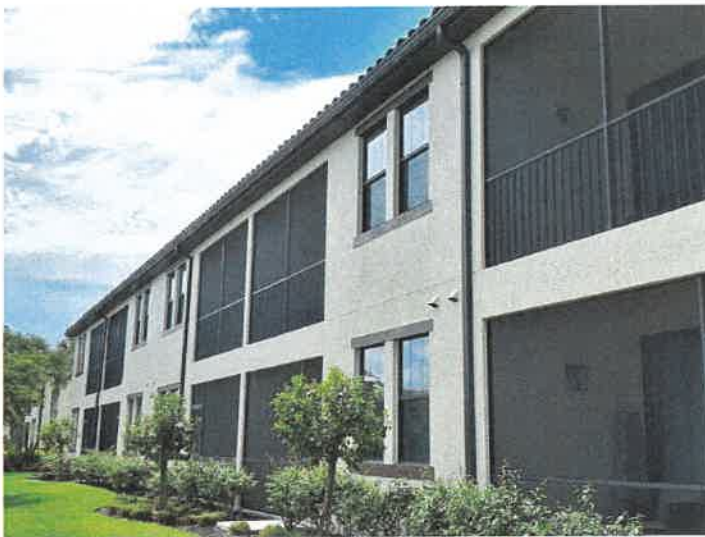
Building 15114: Downspouts

The downspouts appear to be in good condition.

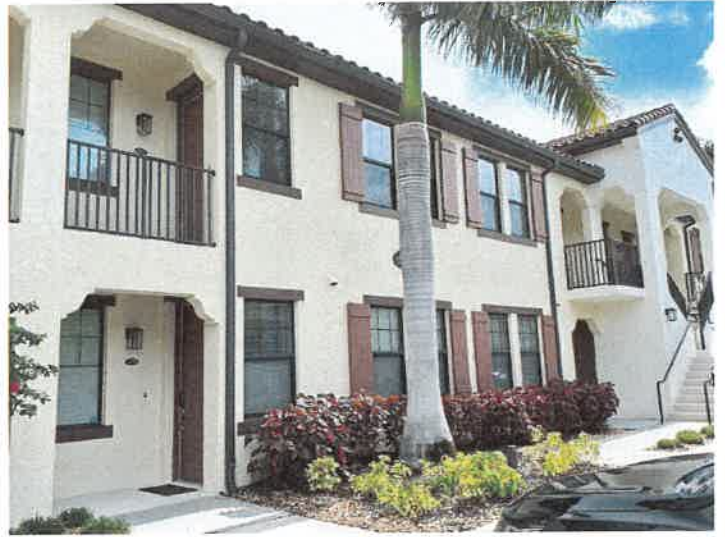
Building 15114: Downspouts

The downspouts appear to be in good condition.

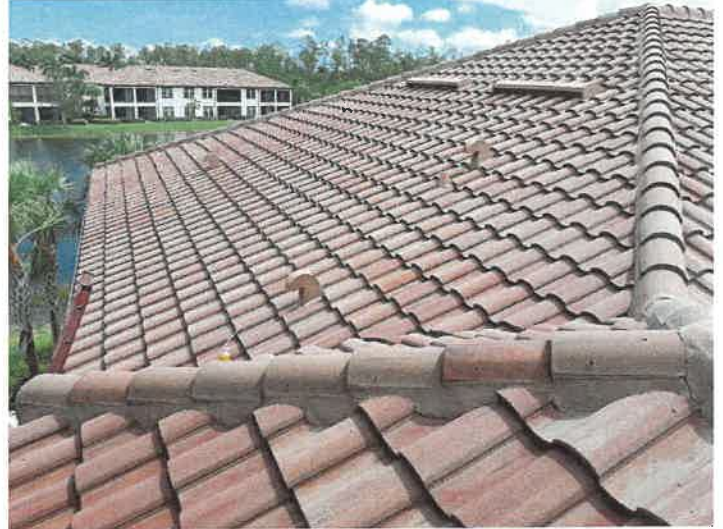
Building 15122: Surface Overview
The roof surface appears to be in good, maintainable condition at this time.

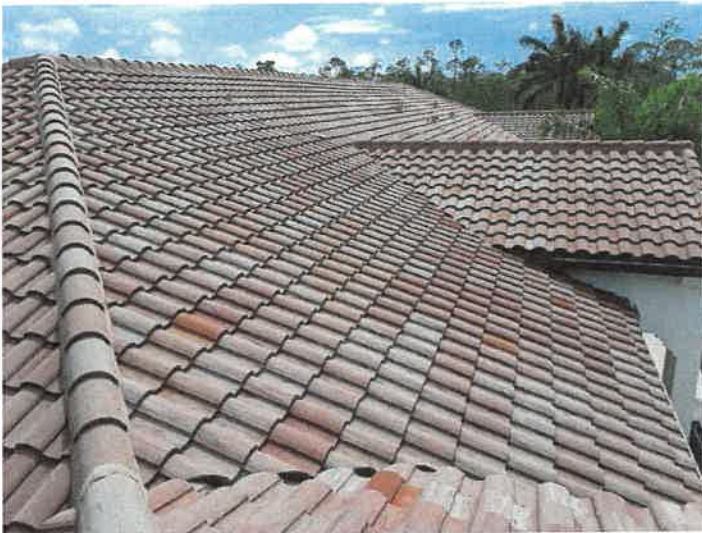
Building 15122: Appearance Overview
The roof appearance is in good, maintainable condition.

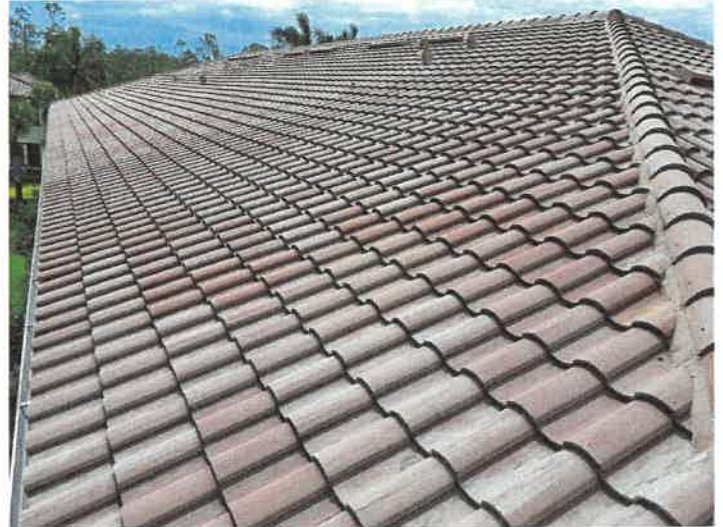
Building 15122: Surface Overview
The roof surface appears to be in good, maintainable condition at this time.

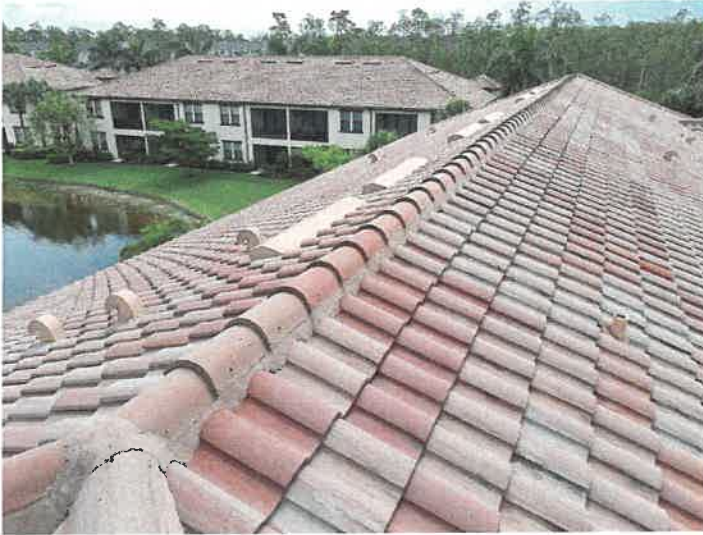
Building 15122: Ridge Tiles
Ridge tiles appear to be in good condition.

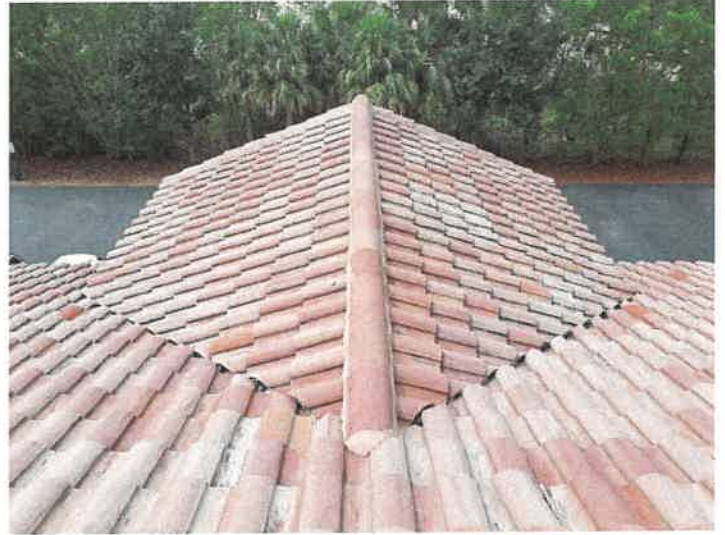
Building 15122: Valley
The valley tiles appear to be in good condition.

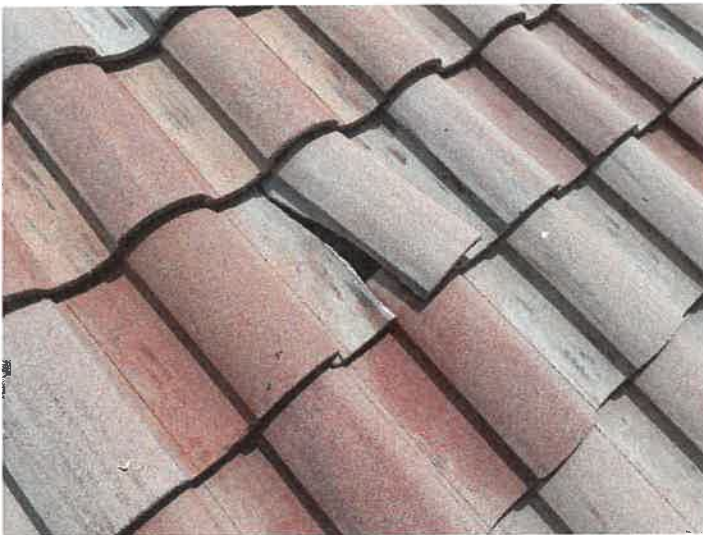
Building 15122: Identified Cracked Roof Tiles
Cracked roof tiles can allow premature underlayment deterioration from excessive UV exposure.

Building 15122: Repaired Cracked Roof Tiles
The cracked roof tiles were repaired with Titebond sealant.

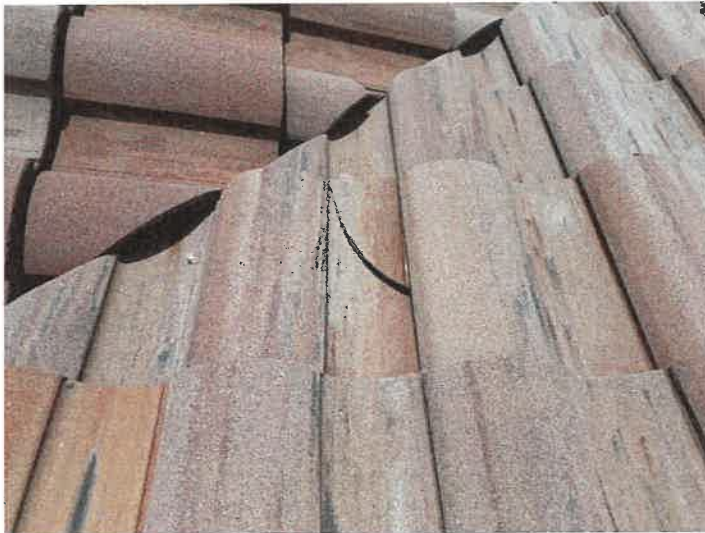
Building 15122: Identified Cracked Roof Tiles

Cracked roof tiles can allow premature underlayment deterioration from excessive UV exposure.

Building 15122: Repaired Cracked Roof Tiles

The cracked roof tiles were repaired with Titebond sealant.

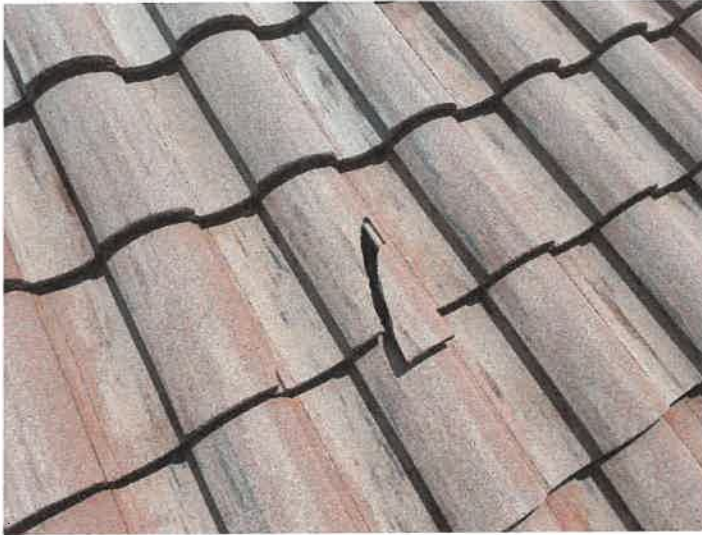
Building 15122: Identified Cracked Roof Tiles

Cracked roof tiles can allow premature underlayment deterioration from excessive UV exposure.

Building 15122: Repaired Cracked Roof Tiles

The cracked roof tiles were repaired with Titebond sealant.

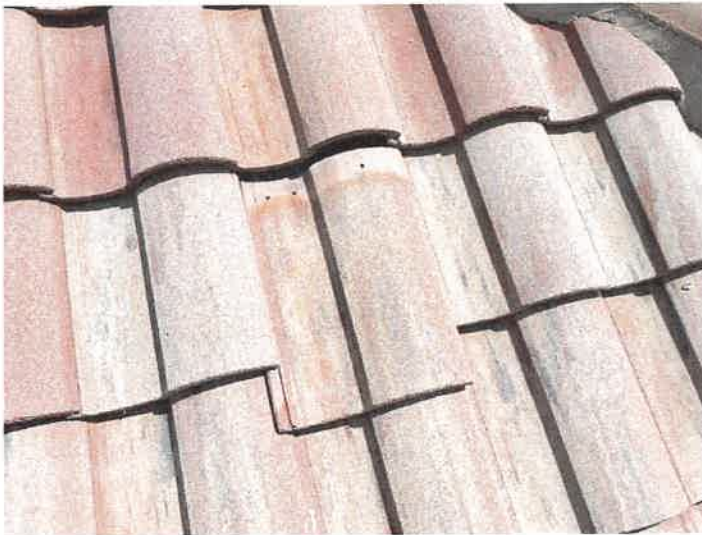
Building 15122: Displaced/Missing Roof Tile

Displaced or missing roof tiles can allow premature underlayment deterioration from excessive UV exposure and potential water intrusion.

Building 15122: Repaired Displaced/Missing Roof Tile

Replaced and secured the missing roof tile.

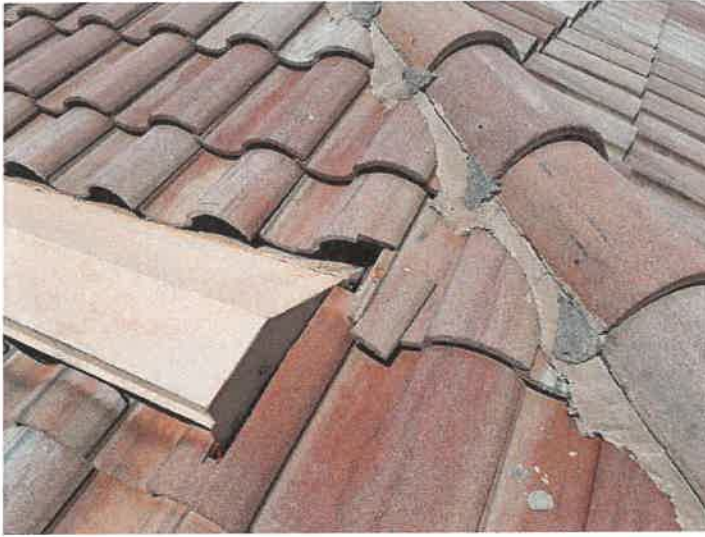
Building 15122: Identified Cracked Roof Tiles

Cracked roof tiles can allow premature underlayment deterioration from excessive UV exposure.

Building 15122: Repaired Cracked Roof Tiles

The cracked roof tiles were repaired with Titebond sealant.

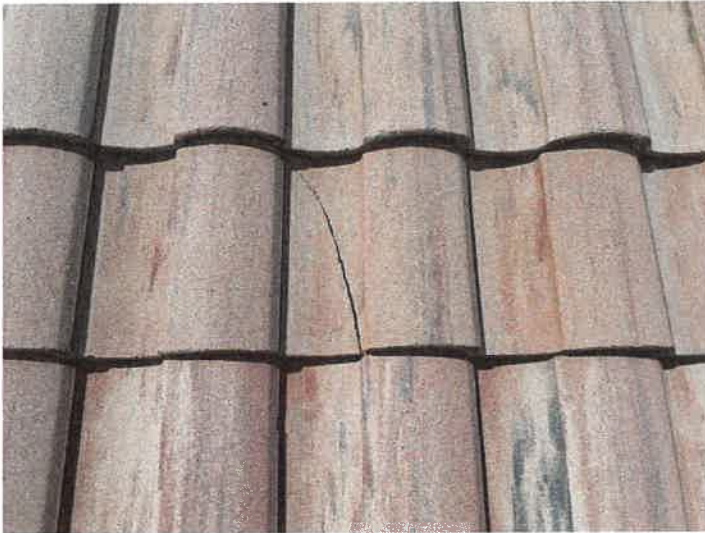
Building 15122: Identified Cracked Roof Tiles

Cracked roof tiles can allow premature underlayment deterioration from excessive UV exposure.

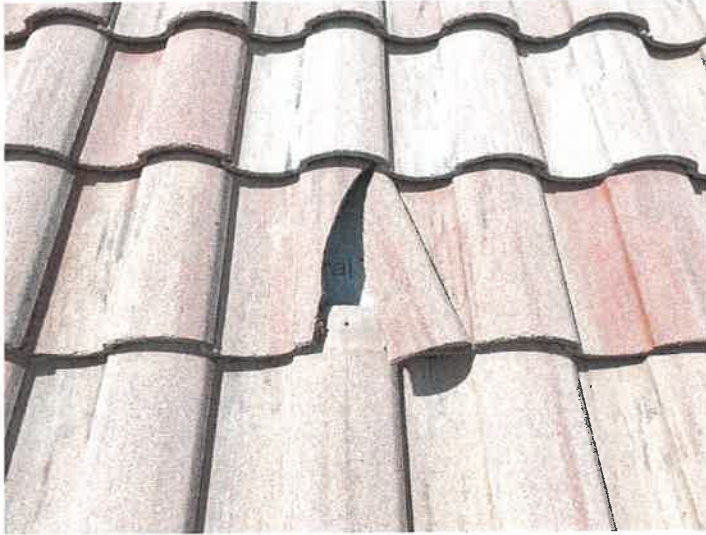
Building 15122: Identified Cracked Roof Tiles
Cracked roof tiles can allow premature underlayment deterioration from excessive UV exposure.

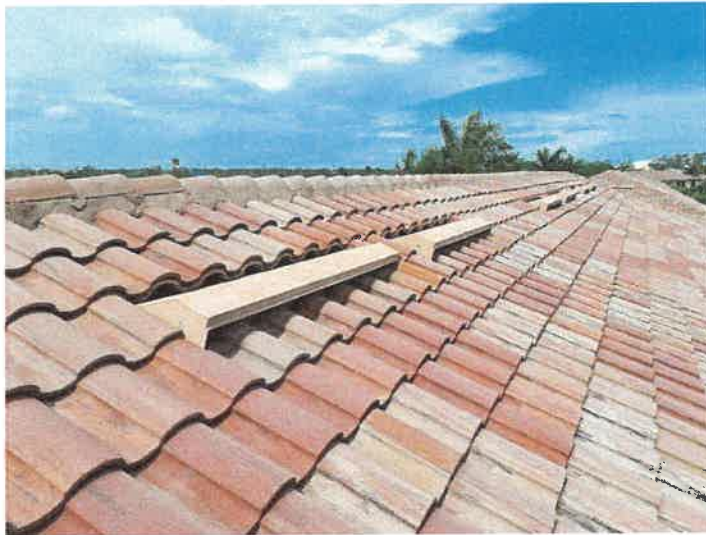
Building 15122: Roof Vents
Roof vents appear to be in good condition.

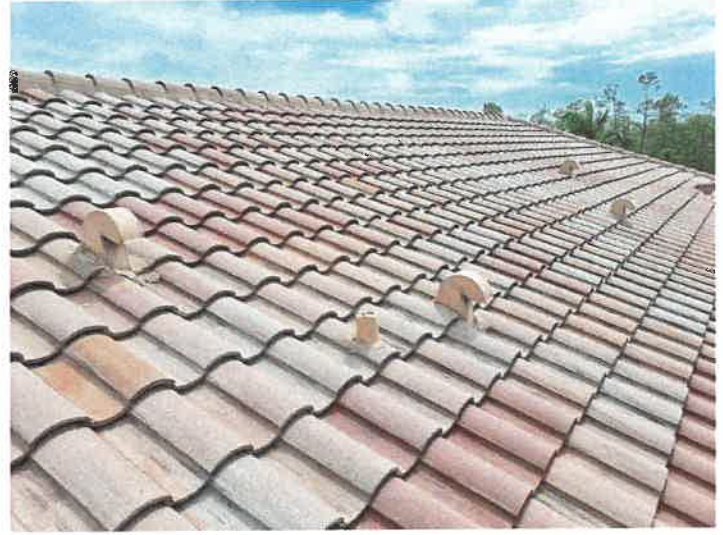
Building 15122: Roof Vents
Roof vents appear to be in good condition.

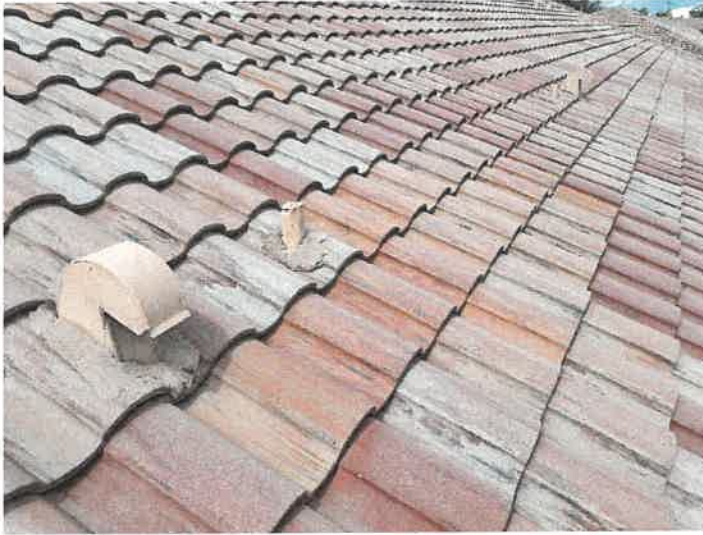
Building 15122: Lead Boots
Lead boots appear to be in good condition.

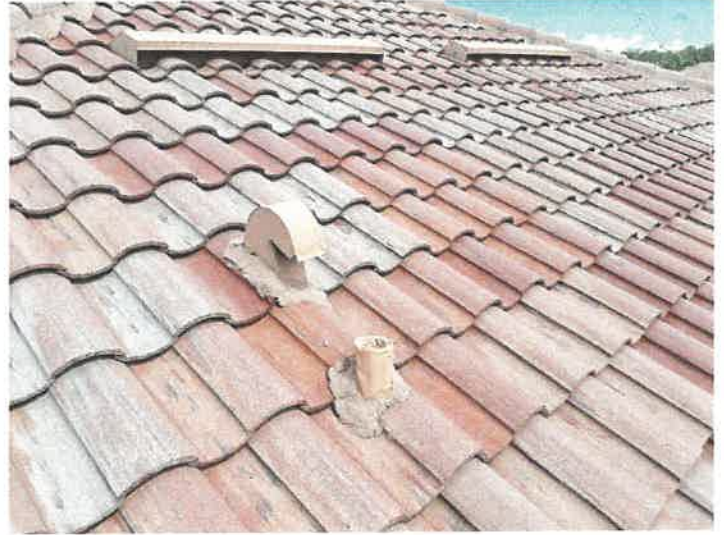
Building 15122: Lead Boots
Lead boots appear to be in good condition.

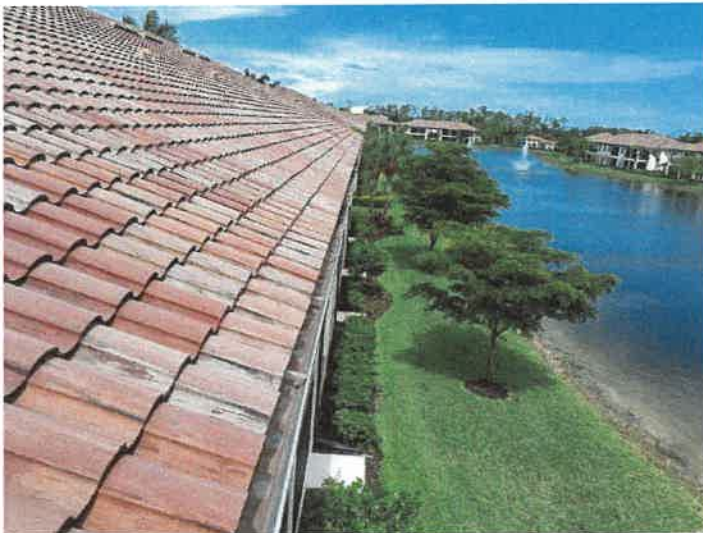
Building 15122: Gutters
The gutters appear to be in good condition.

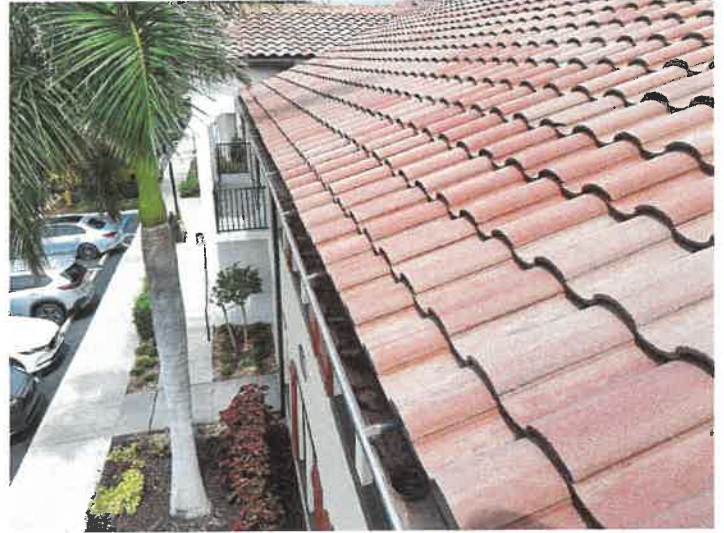
Building 15122: Gutters
The gutters appear to be in good condition.

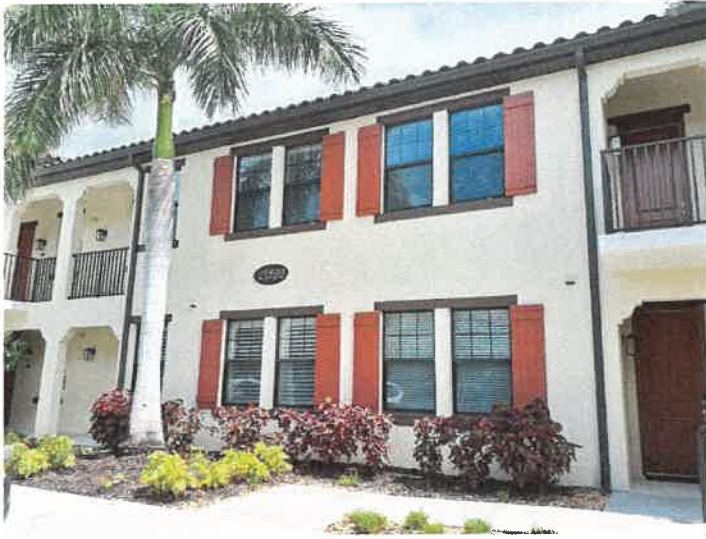
Building 15122: Downspouts
The downspouts appear to be in good condition.

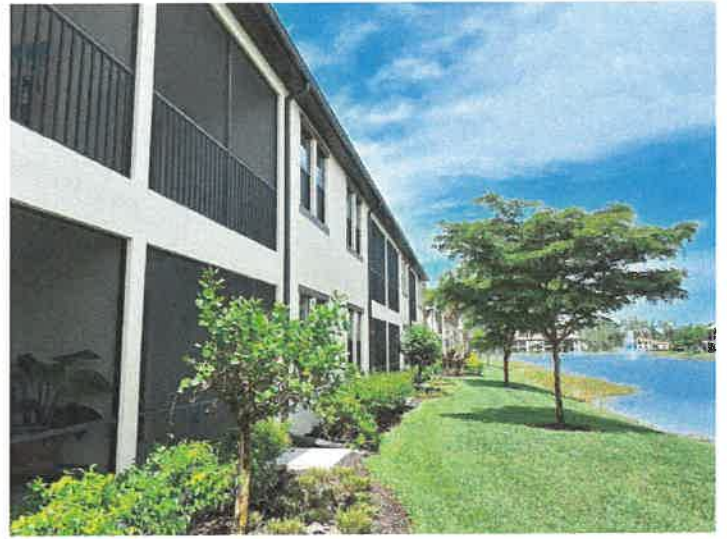
Building 15122: Downspouts
The downspouts appear to be in good condition.

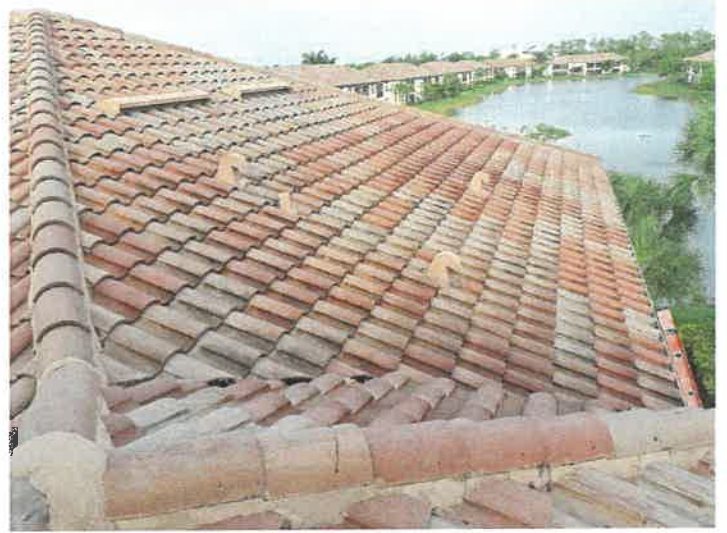
Building 15126: Surface Overview
The roof surface appears to be in good, maintainable condition at this time.

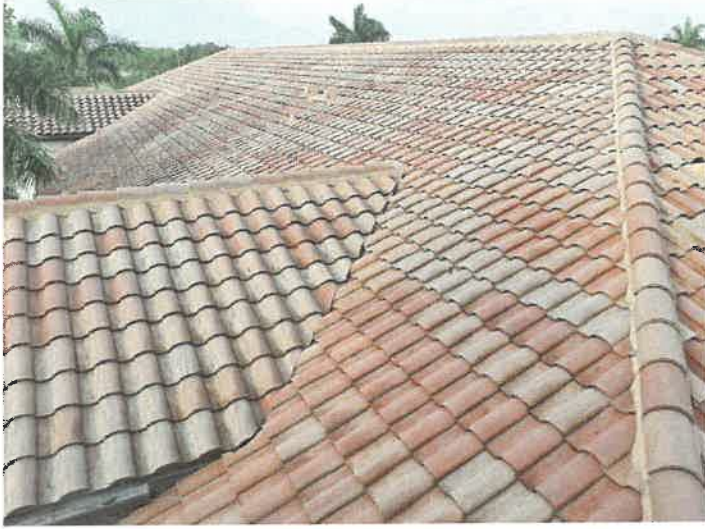
Building 15126: Appearance Overview

The roof appearance is in good, maintainable condition.

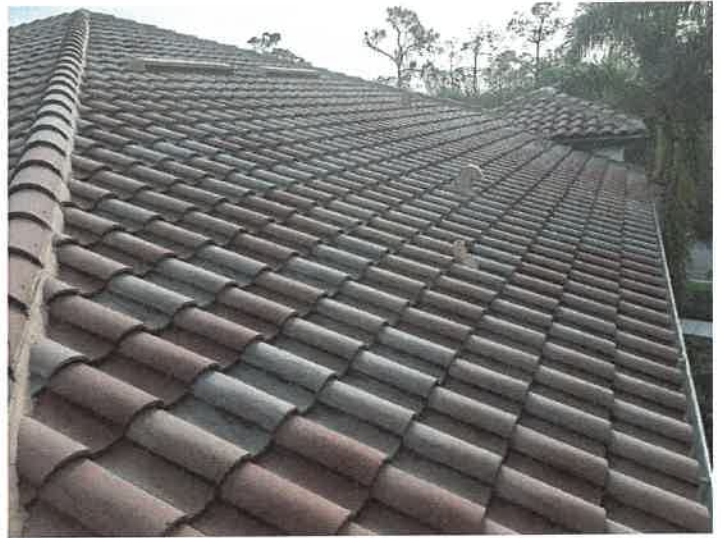
Building 15126: Surface Overview

The roof surface appears to be in good, maintainable condition at this time.

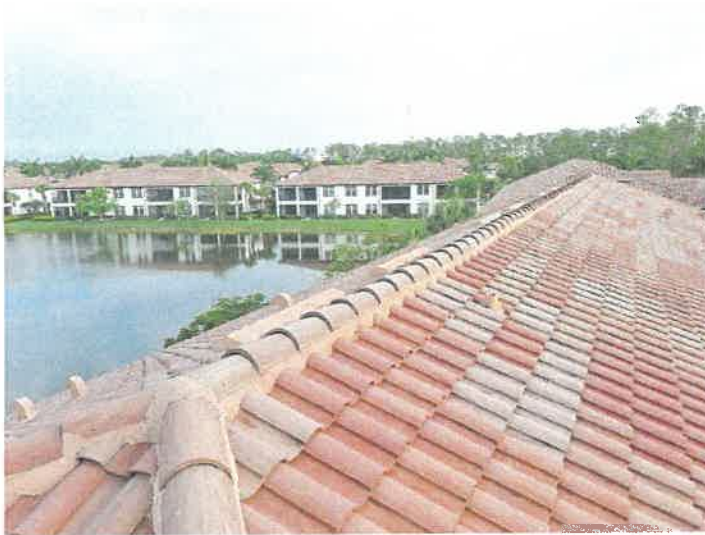
Building 15126: Ridge Tiles

Ridge tiles appear to be in good condition.

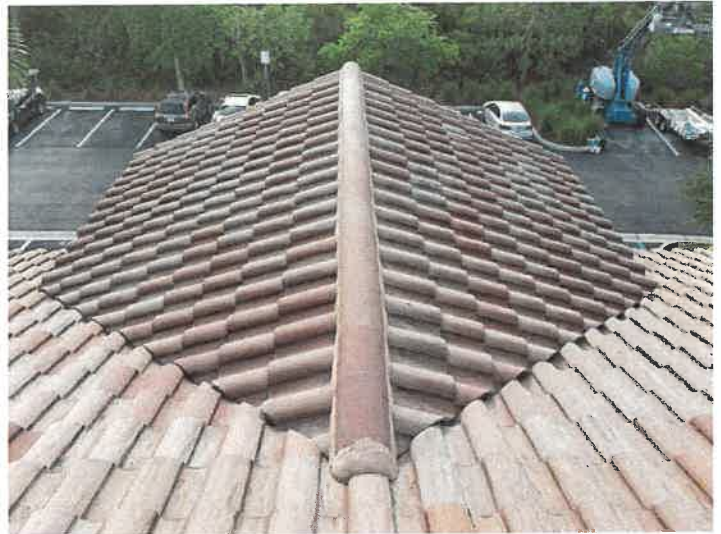
Building 15126: Valley

The valley tiles appear to be in good condition.

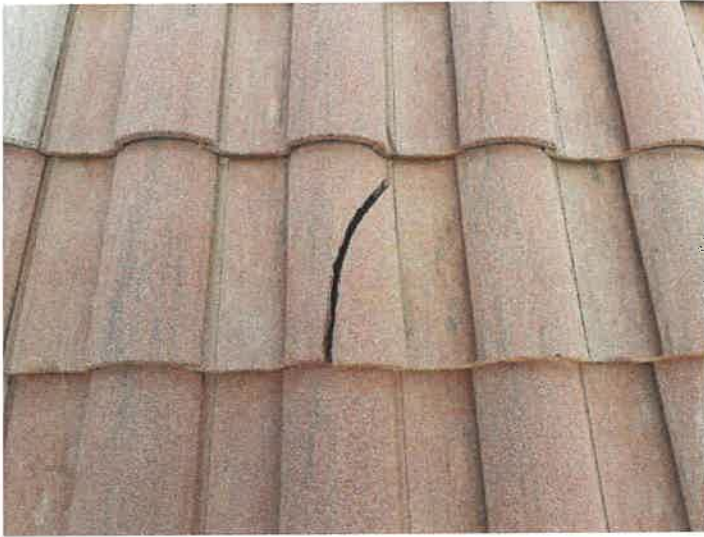
Building 15126: Identified Cracked Roof Tiles
Cracked roof tiles can allow premature underlayment deterioration from excessive UV exposure.

Building 15126: Repaired Cracked Roof Tiles
The cracked roof tiles were repaired with Titebond sealant.

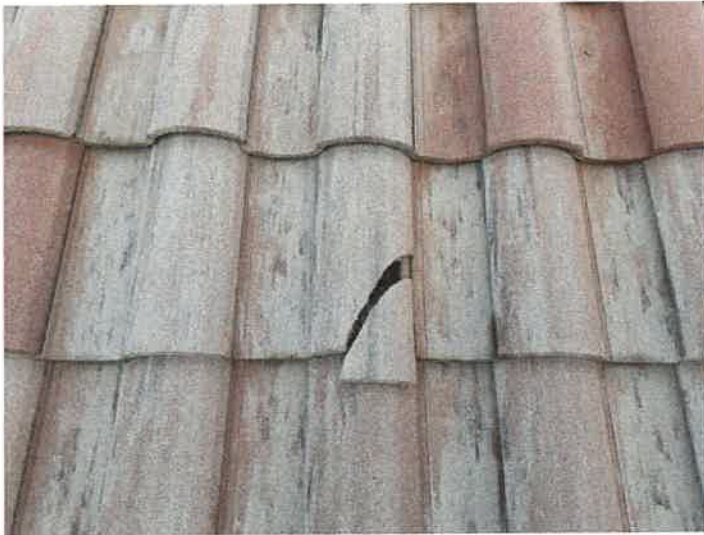
Building 15126: Identified Cracked Roof Tiles
Cracked roof tiles can allow premature underlayment deterioration from excessive UV exposure.

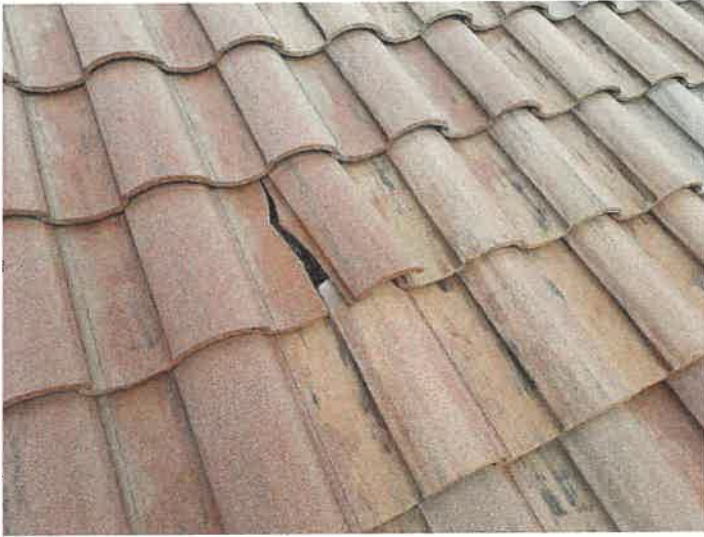
Building 15126: Identified Cracked Roof Tiles

Cracked roof tiles can allow premature underlayment deterioration from excessive UV exposure.

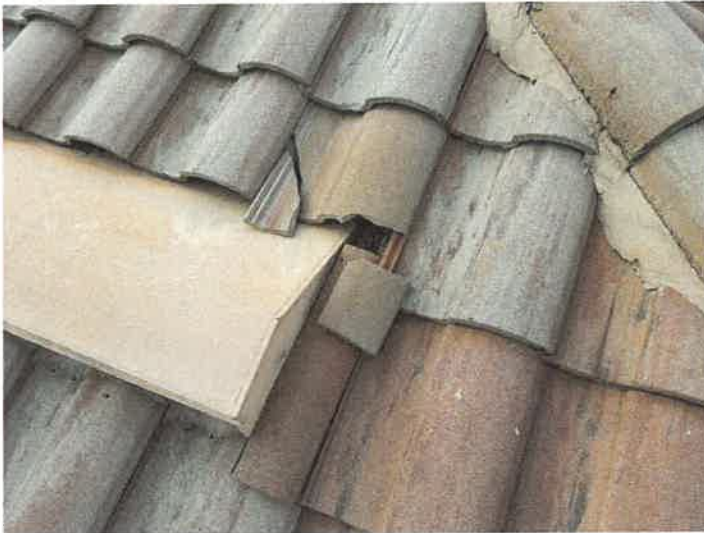
Building 15126: Identified Cracked Roof Tiles

Cracked roof tiles can allow premature underlayment deterioration from excessive UV exposure.

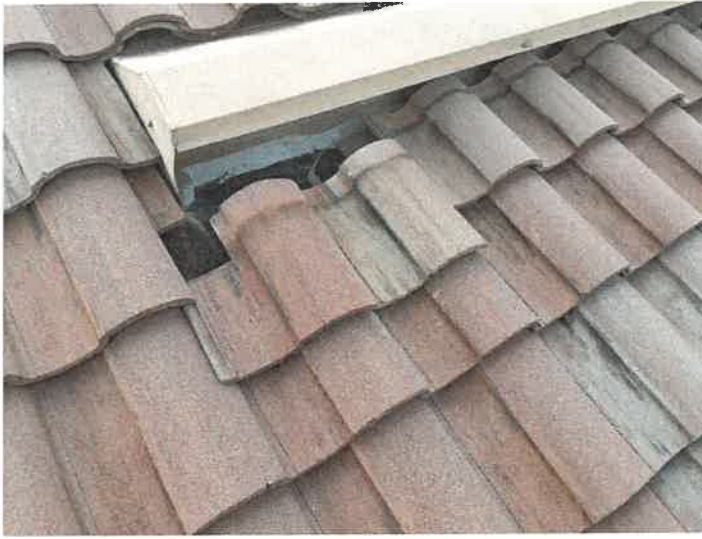
Building 15126: Displaced/Missing Roof Tile

Displaced or missing roof tiles can allow premature underlayment deterioration from excessive UV exposure and potential water intrusion.

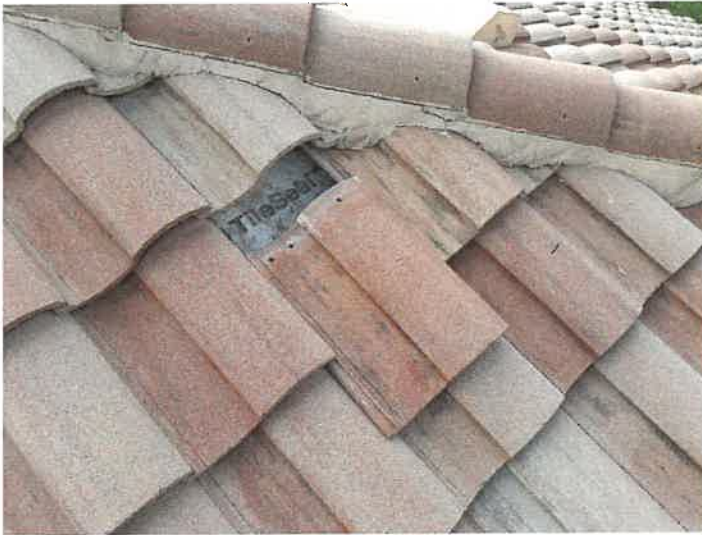
Building 15126: Displaced/Missing Roof Tile

Displaced or missing roof tiles can allow premature underlayment deterioration from excessive UV exposure and potential water intrusion.

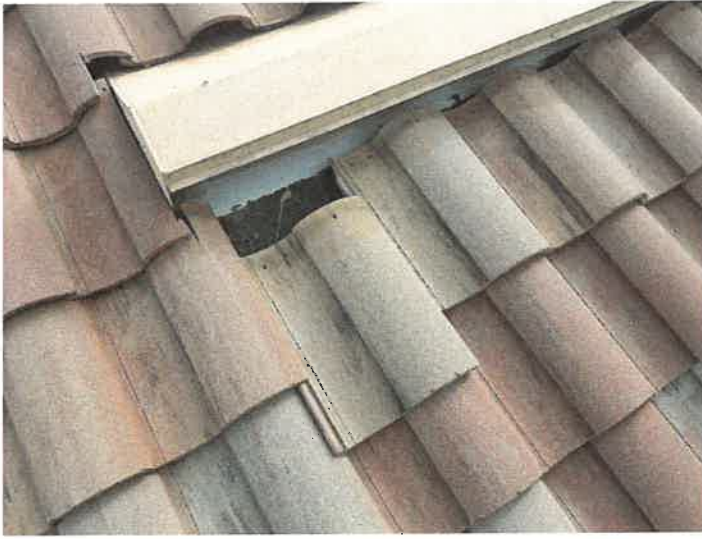
Building 15126: Displaced/Missing Roof Tile

Displaced or missing roof tiles can allow premature underlayment deterioration from excessive UV exposure and potential water intrusion.

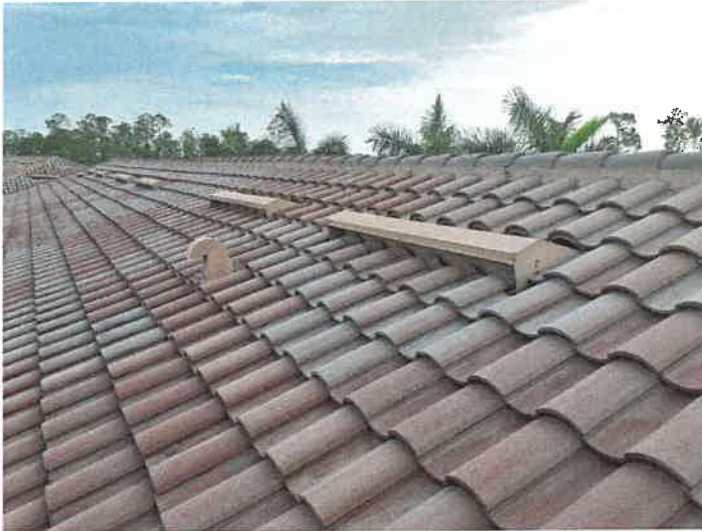
Building 15126: Roof Vents

Roof vents appear to be in good condition.

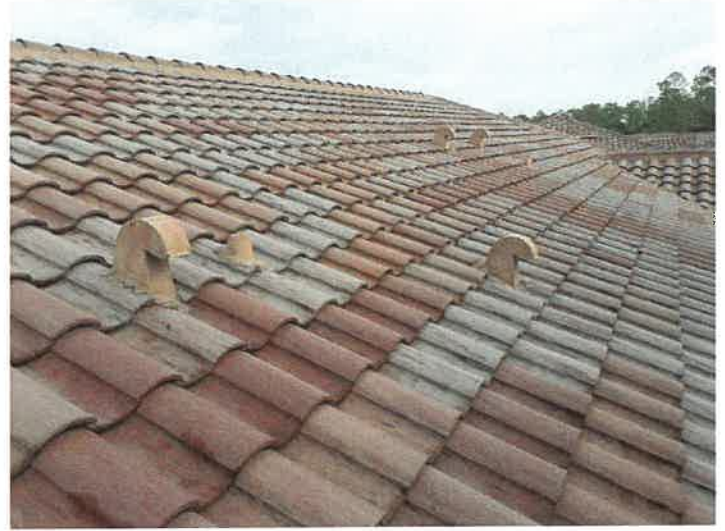
Building 15126: Roof Vents

Roof vents appear to be in good condition.

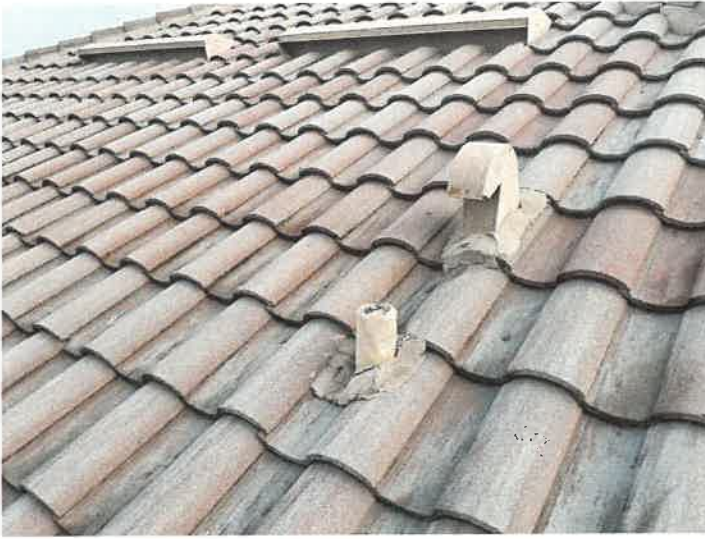
Building 15126: Lead Boots
Lead boots appear to be in good condition.

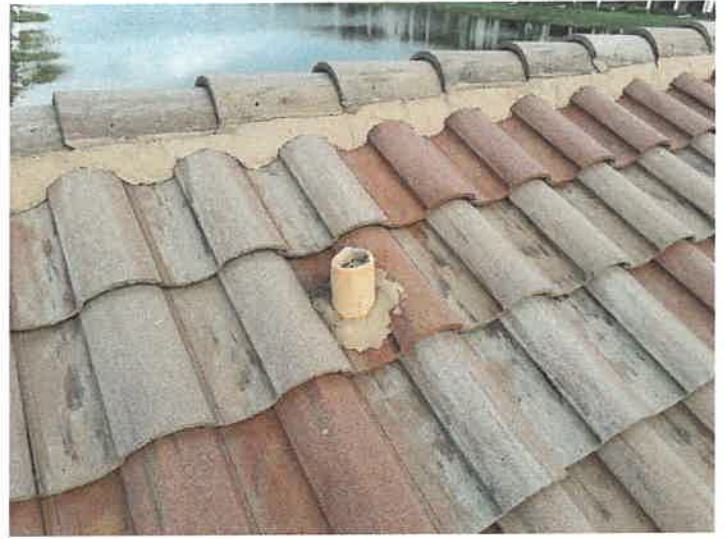
Building 15126: Lead Boots
Lead boots appear to be in good condition.

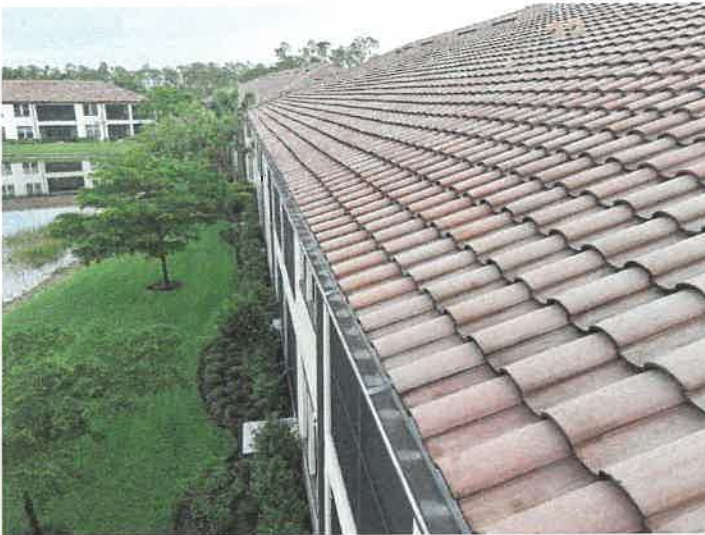
Building 15126: Gutters
The gutters appear to be in good condition.

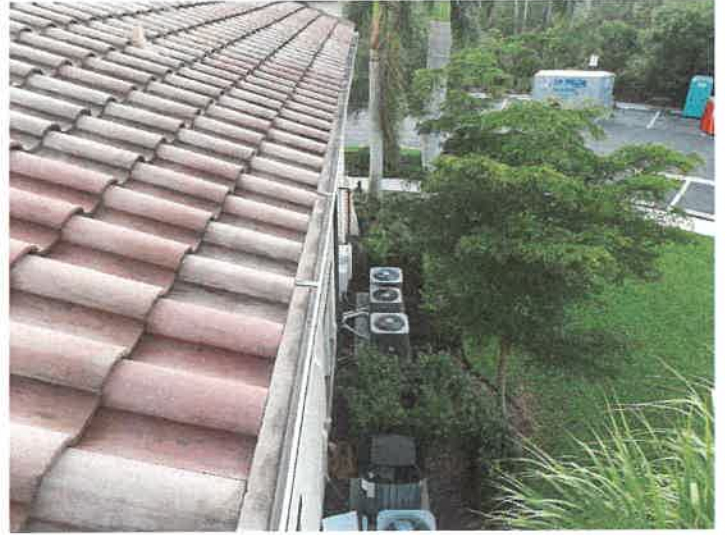
Building 15126: Gutters
The gutters appear to be in good condition.

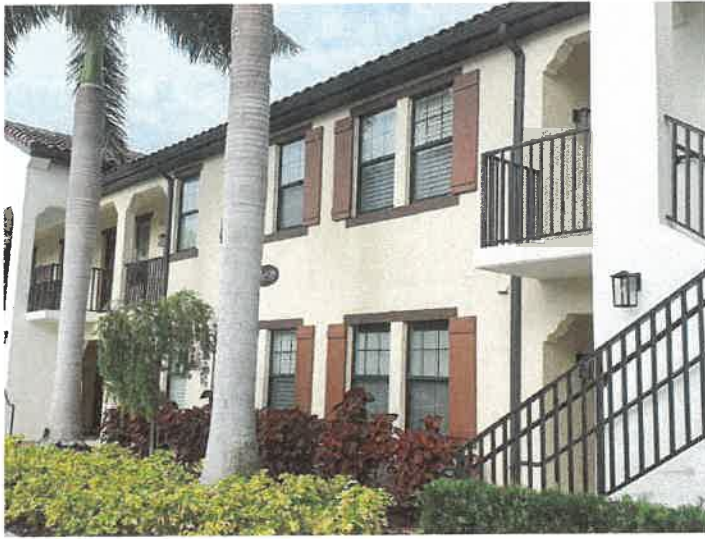
Building 15126: Downspouts
The downspouts appear to be in good condition.
