Inspection Report

Facility: Livingston Lakes Condo
Address: 15098 Palmer Lake Circle,
Naples, FL 34109

Work Order #: 13028

Re.: Inspection Report (2 of 3) for Livingston Lakes

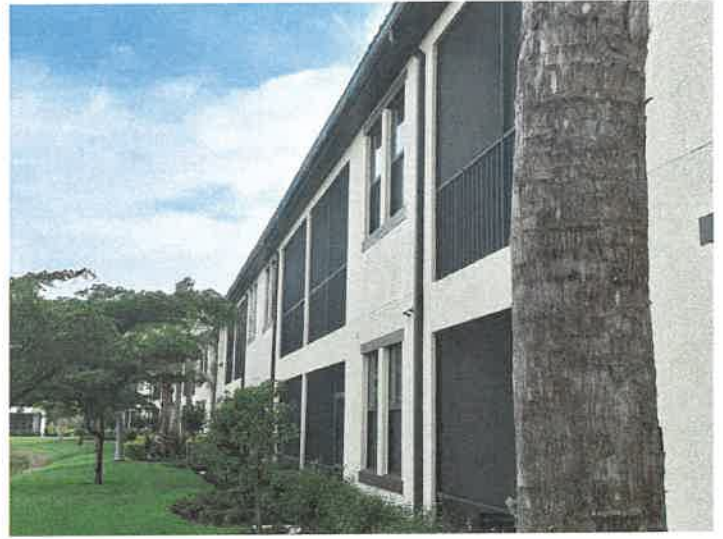
Building 15126: Downspouts
The downspouts appear to be in good condition.

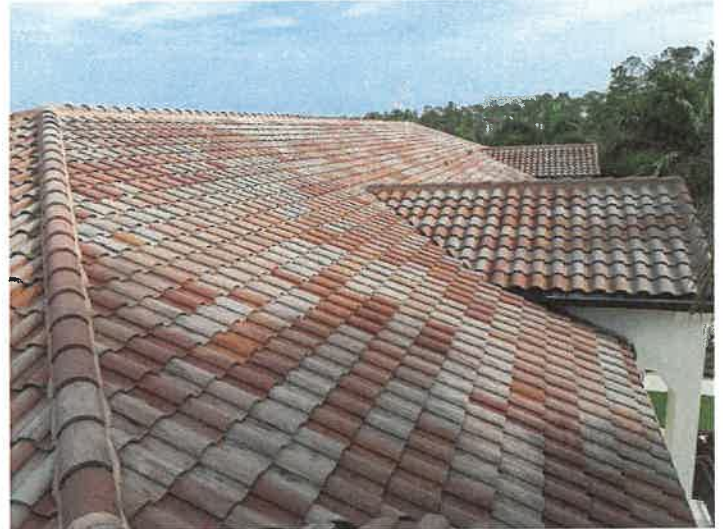
Building 15130: Surface Overview
The roof surface appears to be in good, maintainable condition at this time.

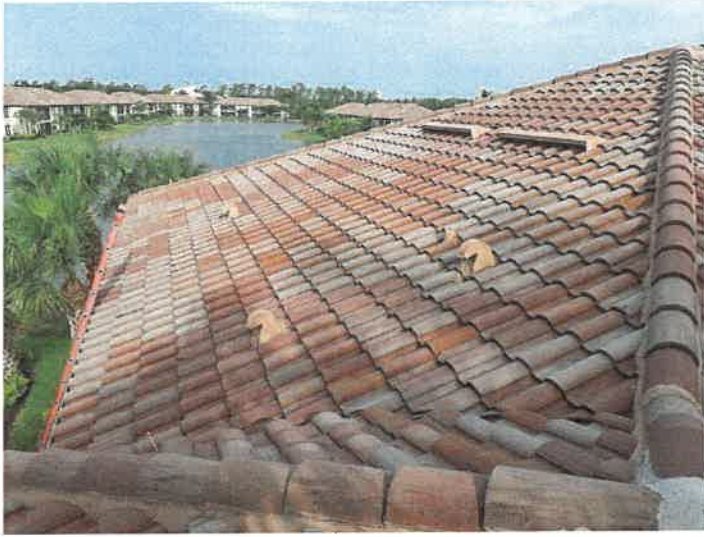
Building 15130: Appearance Overview

The roof appearance is in good, maintainable condition.

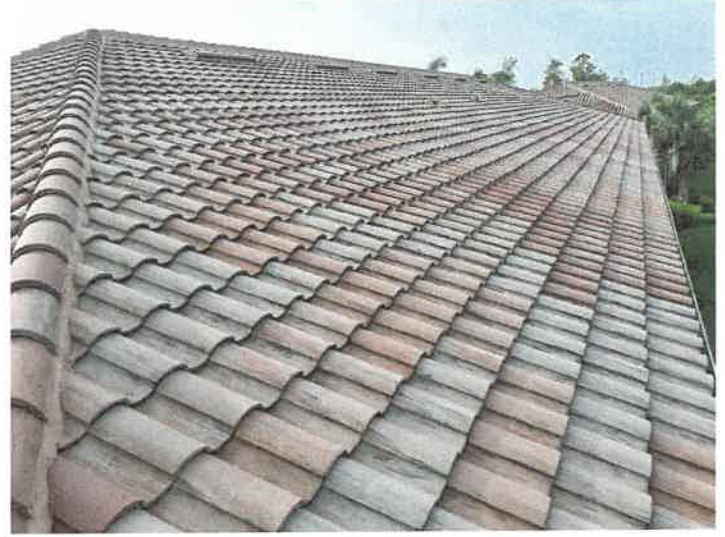
Building 15130: Surface Overview

The roof surface appears to be in good, maintainable condition at this time.

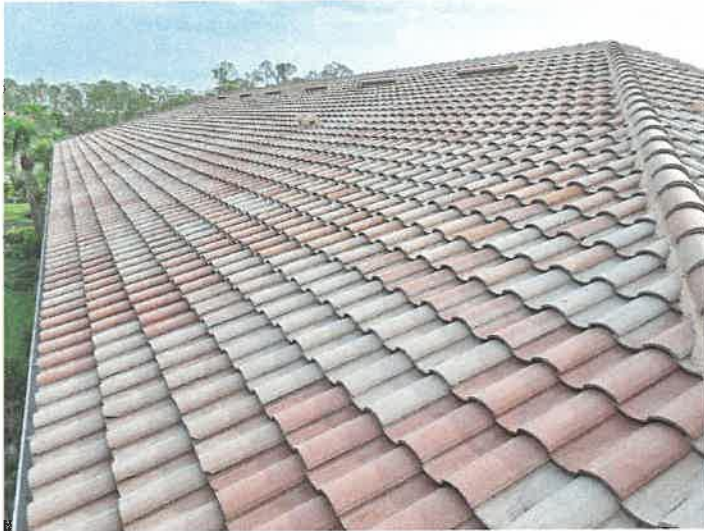
Building 15130: Field Tiles

Field tiles appear to be in good condition.

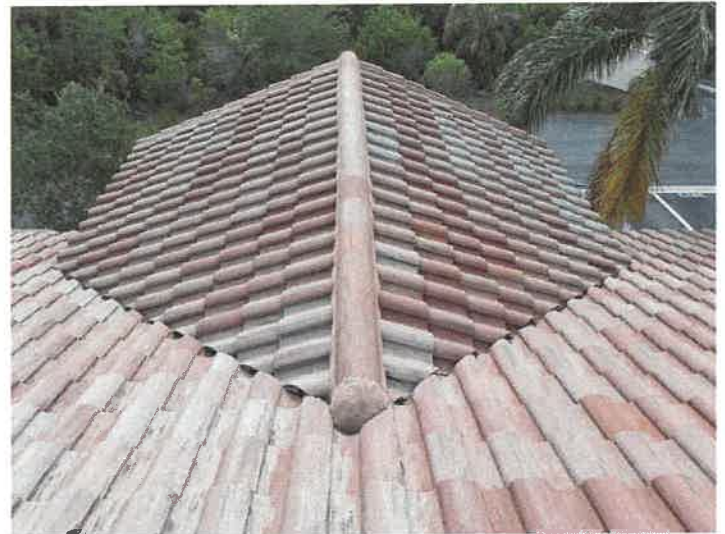
Building 15130: Valley

The valley tiles appear to be in good condition.

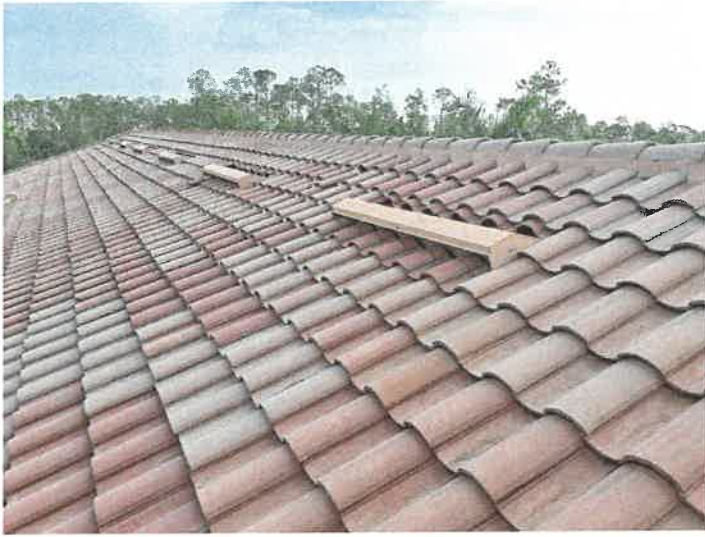
Building 15130: Roof Vents
Roof vents appear to be in good condition.

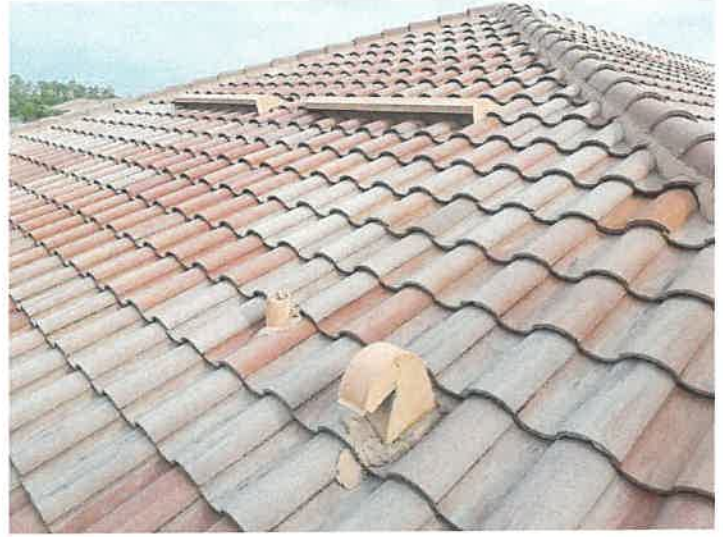
Building 15130: Roof Vents
Roof vents appear to be in good condition.

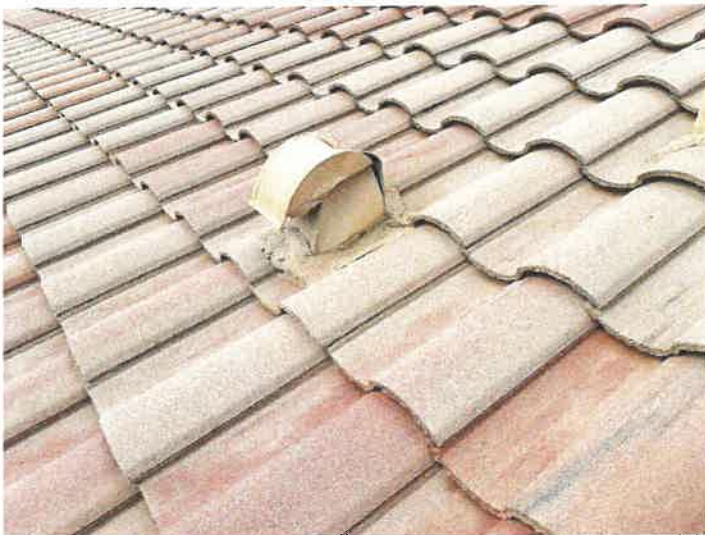
Building 15130: Gooseneck Vent Deformed
Gooseneck vent is deformed and needs to be replaced.

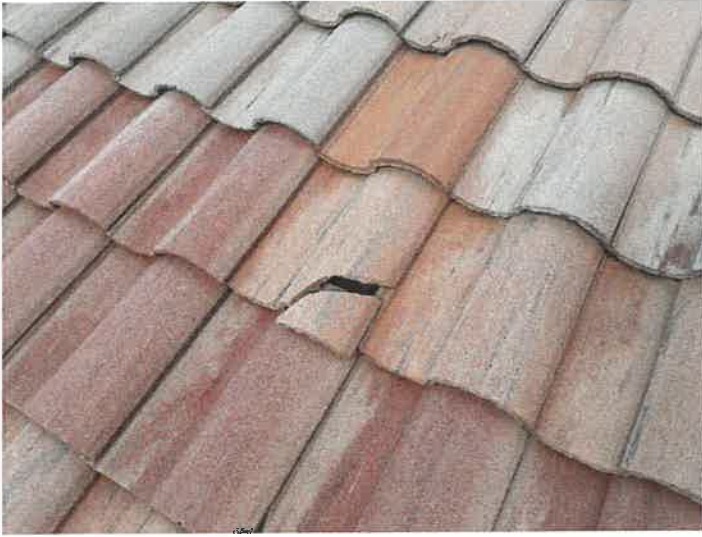
Building 15130: Identified Cracked Roof Tiles

Cracked roof tiles can allow premature underlayment deterioration from excessive UV exposure.

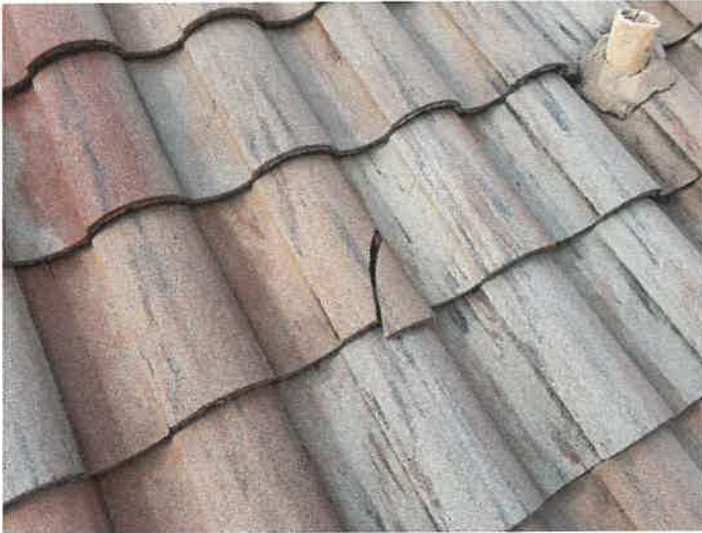
Building 15130: Identified Cracked Roof Tiles

Cracked roof tiles can allow premature underlayment deterioration from excessive UV exposure.

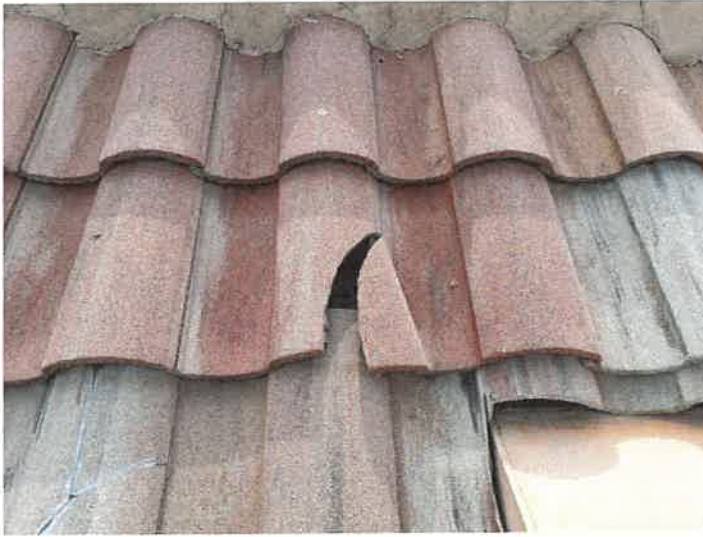
Building 15130: Identified Cracked Roof Tiles

Cracked roof tiles can allow premature underlayment deterioration from excessive UV exposure.

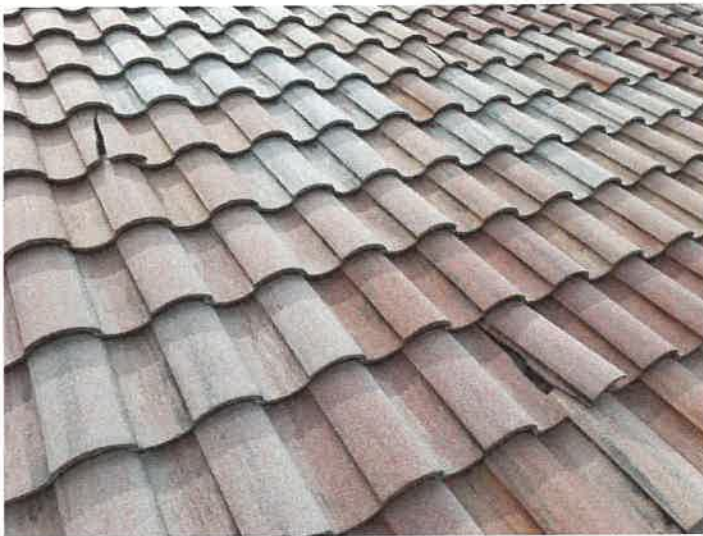
Building 15130: Identified Cracked Roof Tiles

Cracked roof tiles can allow premature underlayment deterioration from excessive UV exposure.

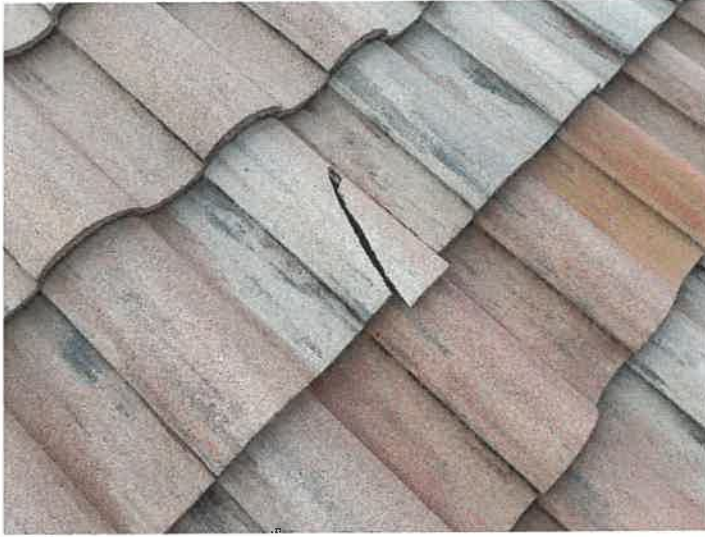
Building 15130: Identified Cracked Roof Tiles

Cracked roof tiles can allow premature underlayment deterioration from excessive UV exposure.

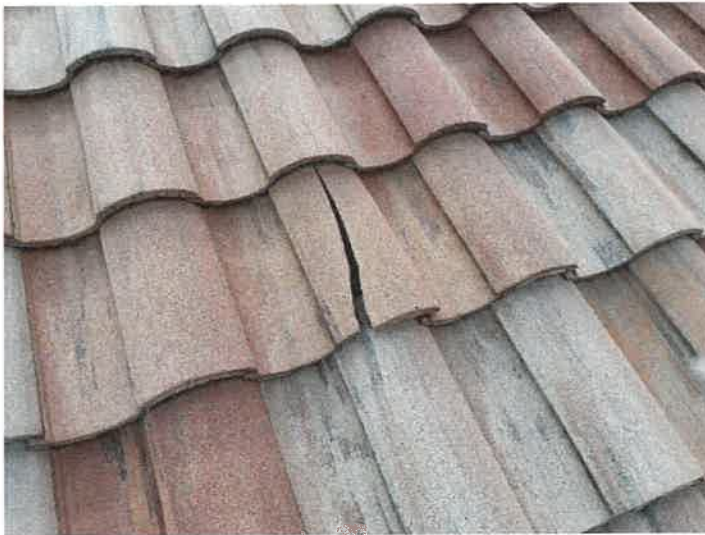
Building 15130: Identified Cracked Roof Tiles

Cracked roof tiles can allow premature underlayment deterioration from excessive UV exposure.

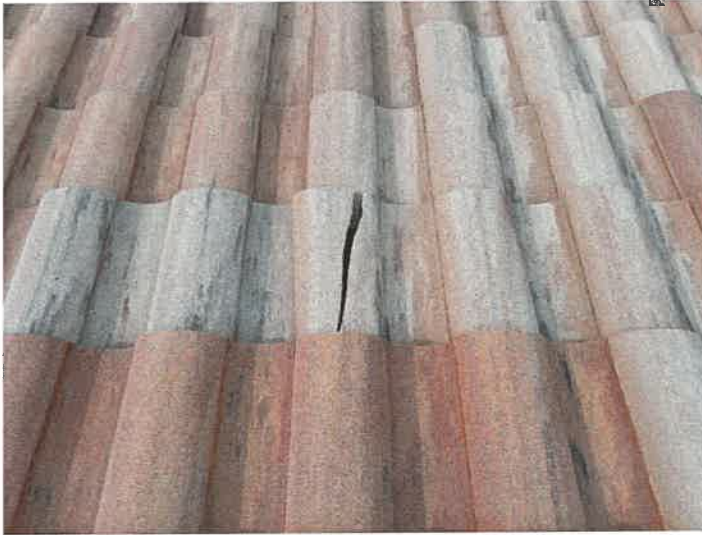
Building 15130: Identified Cracked Roof Tiles
Cracked roof tiles can allow premature underlayment deterioration from excessive UV exposure.

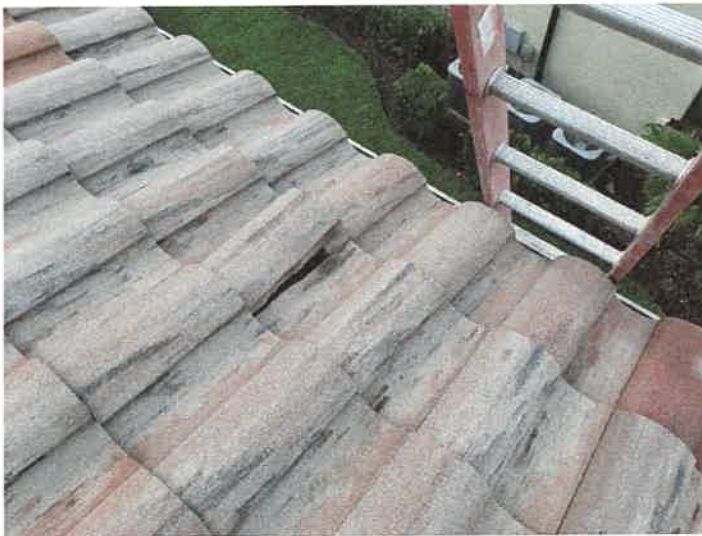
Building 15130: Identified Cracked Roof Tiles
Cracked roof tiles can allow premature underlayment deterioration from excessive UV exposure.

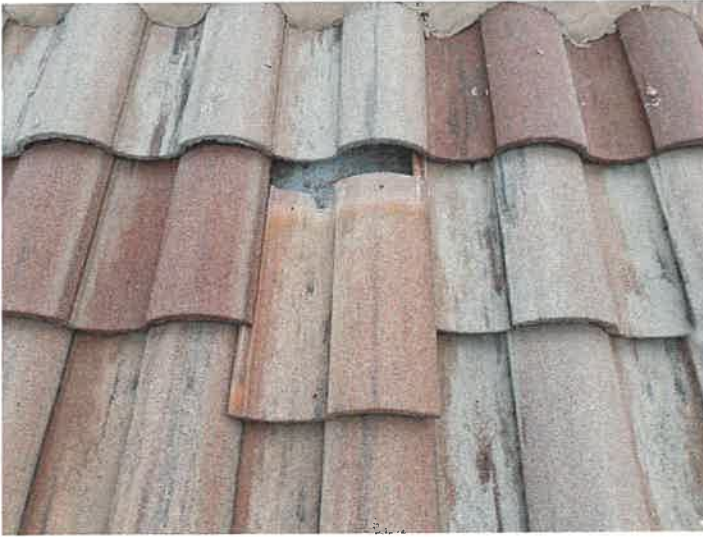
Building 15130: Displaced/Missing Roof Tile

Displaced or missing roof tiles can allow premature underlayment deterioration from excessive UV exposure and potential water intrusion.

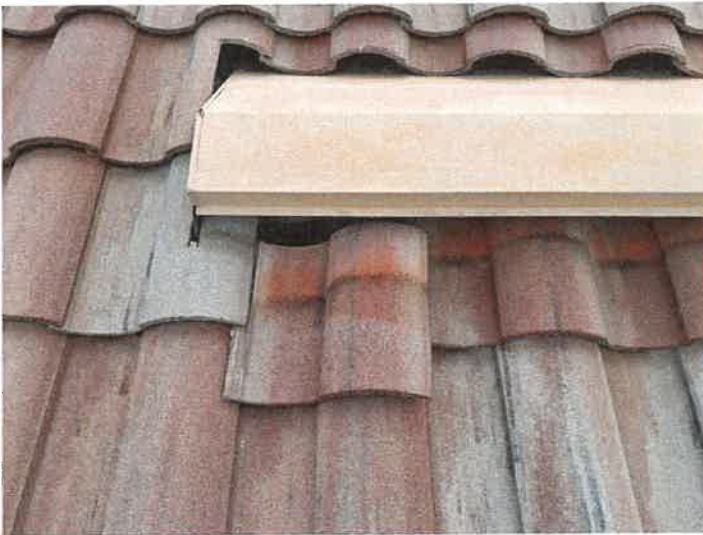
Building 15130: Displaced/Missing Roof Tile

Displaced or missing roof tiles can allow premature underlayment deterioration from excessive UV exposure and potential water intrusion.

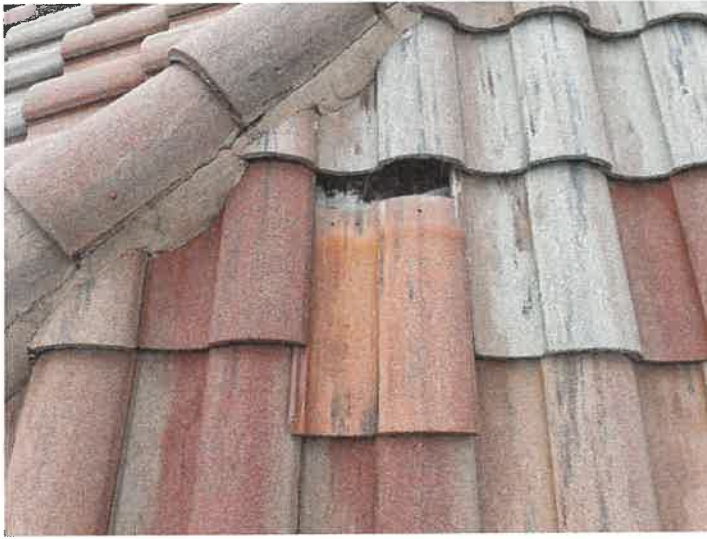
Building 15130: Displaced/Missing Roof Tile

Displaced or missing roof tiles can allow premature underlayment deterioration from excessive UV exposure and potential water intrusion.

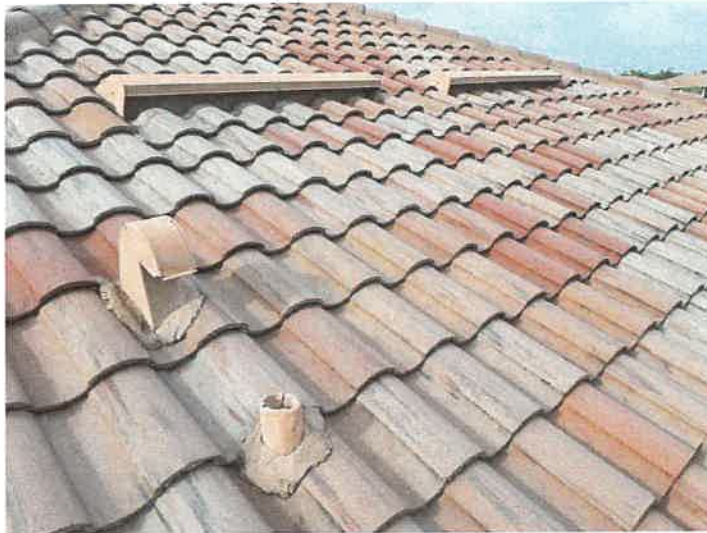
Building 15130: Repaired Displaced/Missing Roof Tile

Replaced and secured the missing roof tile.

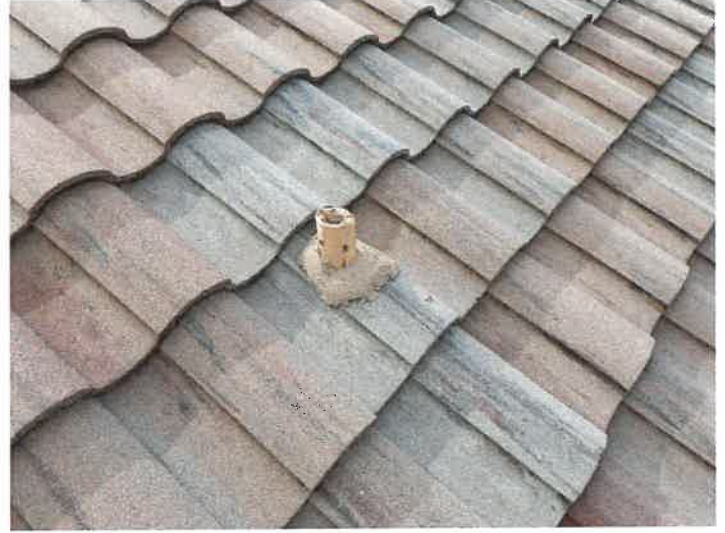
Building 15130: Lead Boots

Lead boots appear to be in good condition.

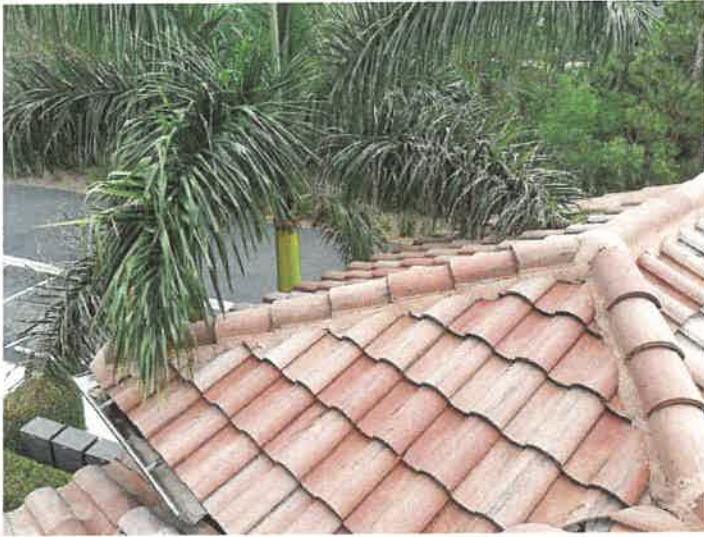
Building 15130: Tree Branches

Identified tree branches hanging over the roof surface. Branches on the roof surface can cause deterioration of membrane, and act as an access for rodents and unwanted bugs/pests.

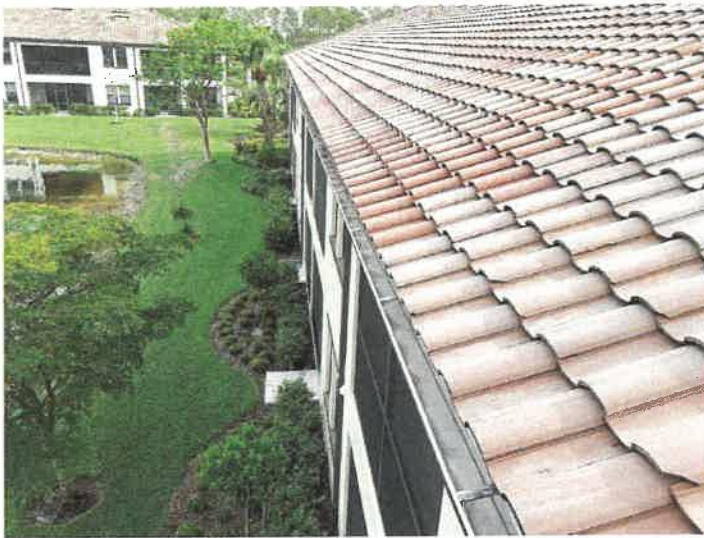
Building 15130: Tree Branches

Cut back the branches away from the roof surface and disposed of properly.

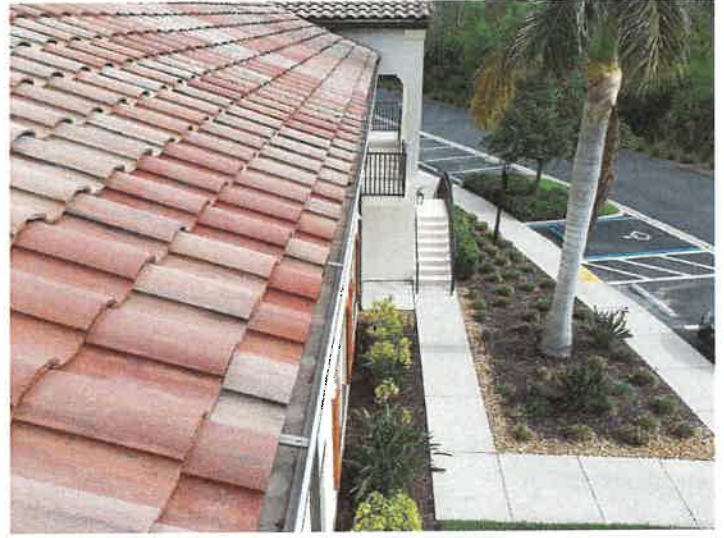
Building 15130: Gutters

The gutters appear to be in good condition.

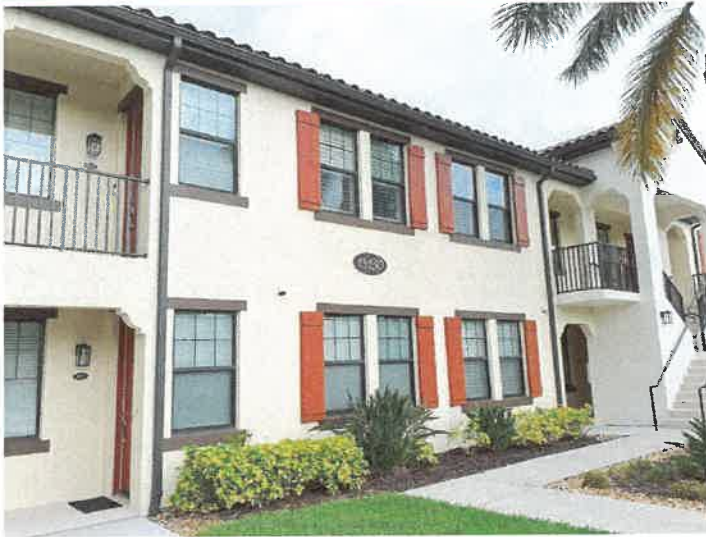
Building 15130: Downspouts

The downspouts appear to be in good condition.

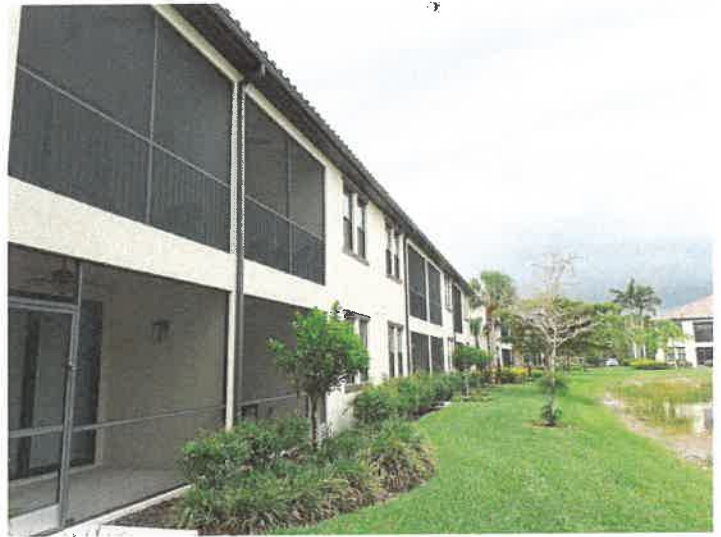
Building 15130: Downspouts

The downspouts appear to be in good condition.

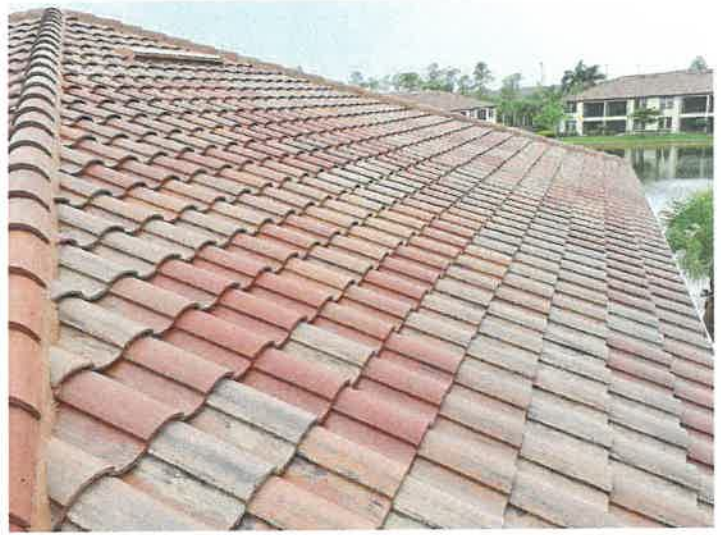
Building 15136: Surface Overview
The roof surface appears to be in good, maintainable condition at this time.
